Final Report

Use of Adhesives to Retrofit  
Out-of-Plane Distortion Induced  
Fatigue Cracks

1. Report No. <b>MN/RC-2006-04</b>	2.	3. Recipients Accession No.	
4. Title and Subtitle <b>Use of Adhesives to Retrofit Out-of-Plane Distortion Induced Fatigue Cracks</b>		5. Report Date <b>February 2006</b>

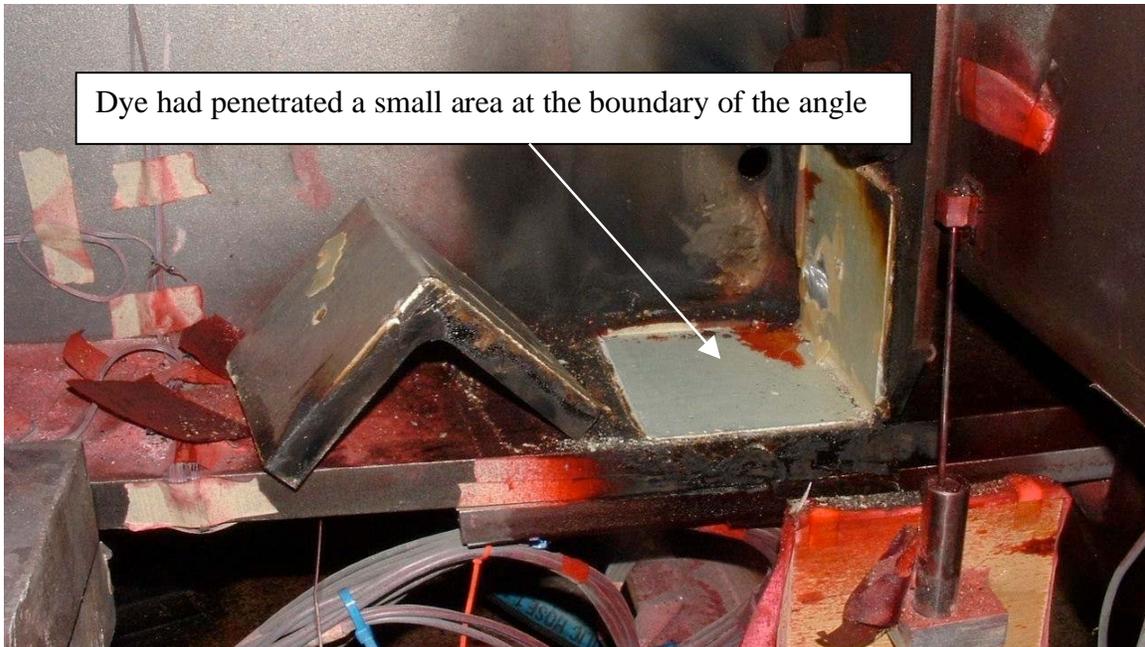
Figure 4.46 Detached angle at web gap NW-C

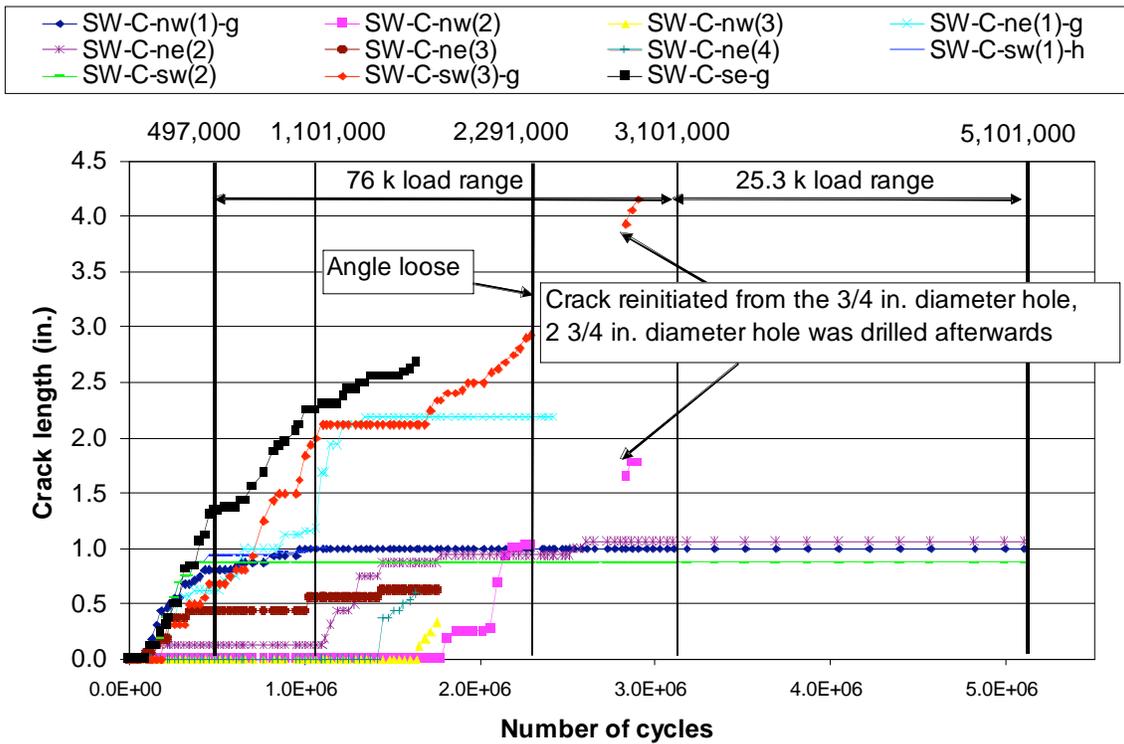
Figure 4.47 Crack growth at web gap SW-C

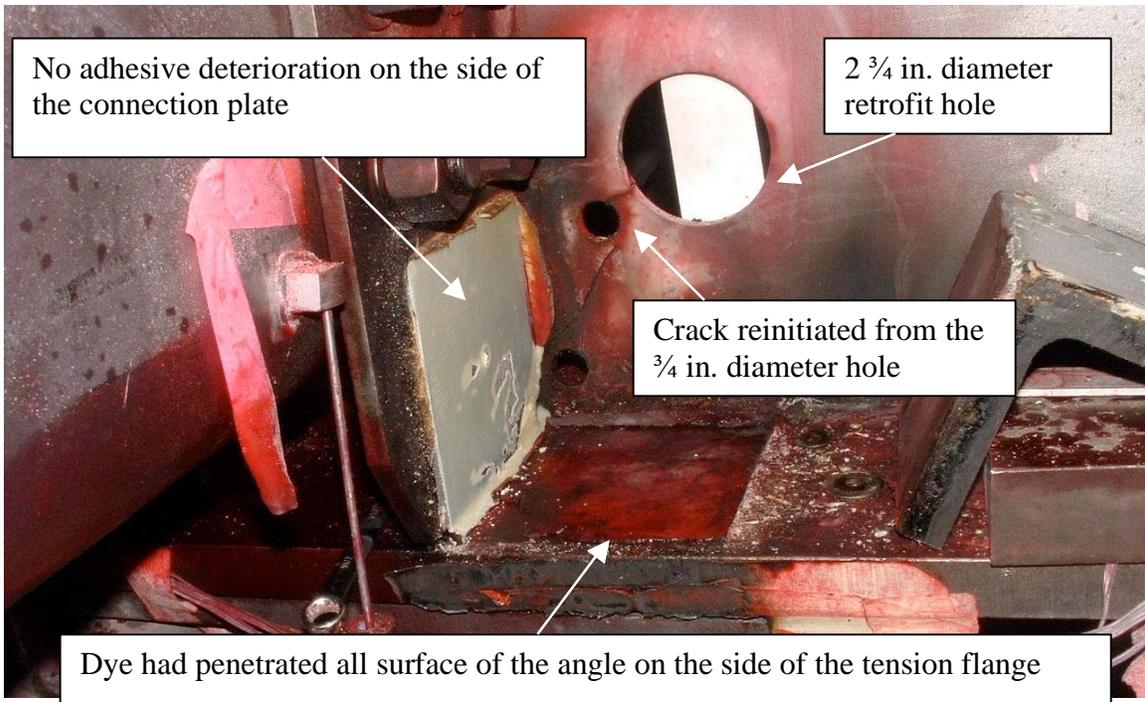
Figure 4.48 Detached angle at web gap SW-C

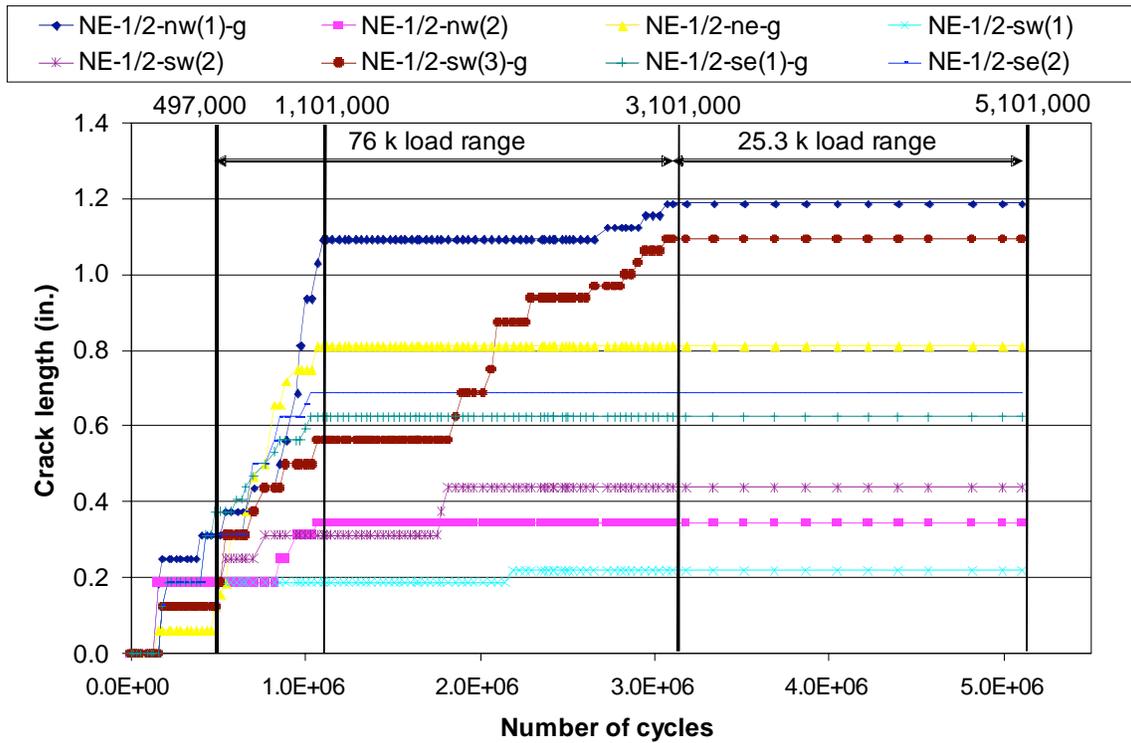
Figure 4.49 Crack growth at web gap NE-1/2

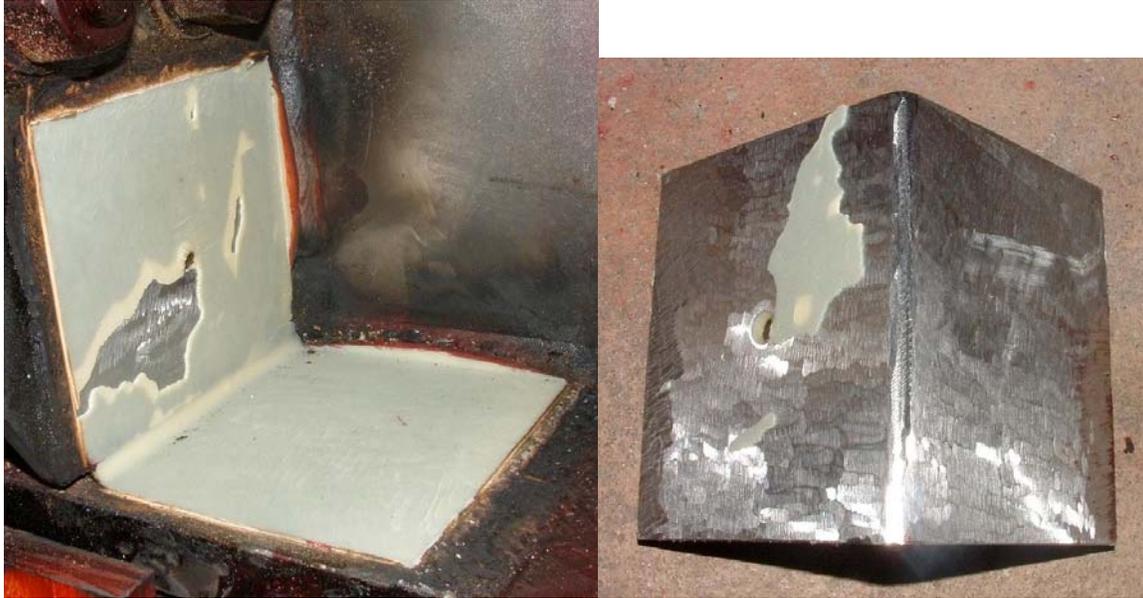
Figure 4.50 Detached angle at web gap NE-1/2

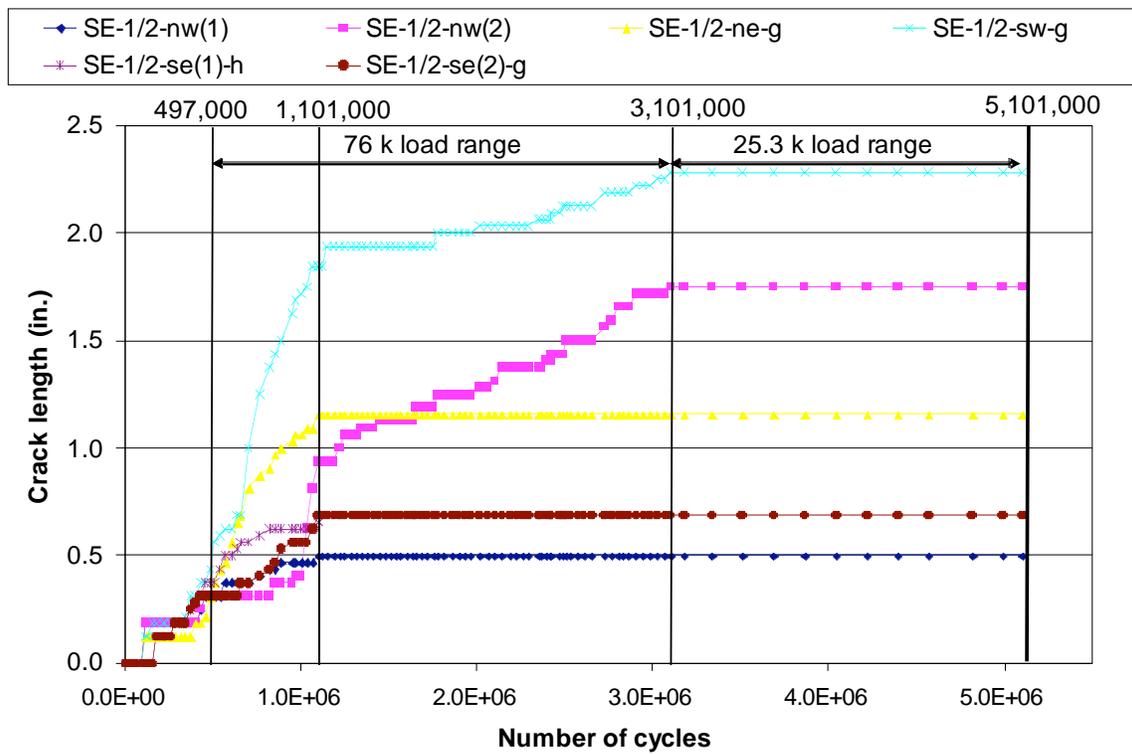
Figure 4.51 Crack growth at web gap SE-1/2

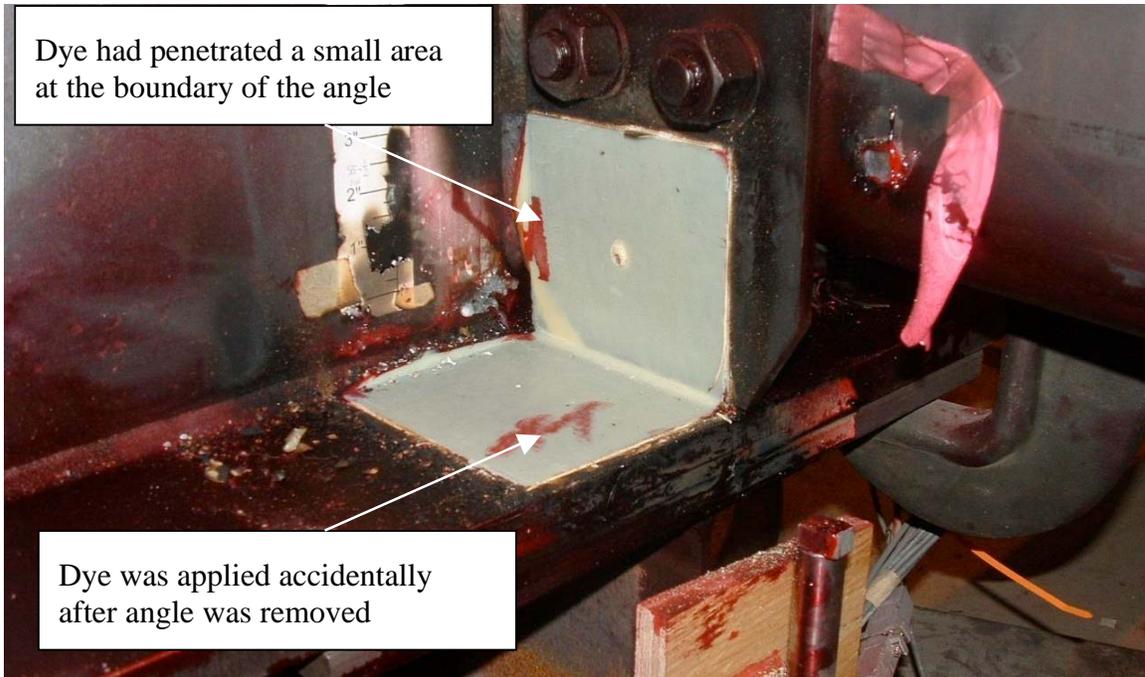
Figure 4.52 Detached angle at web gap SE-1/2

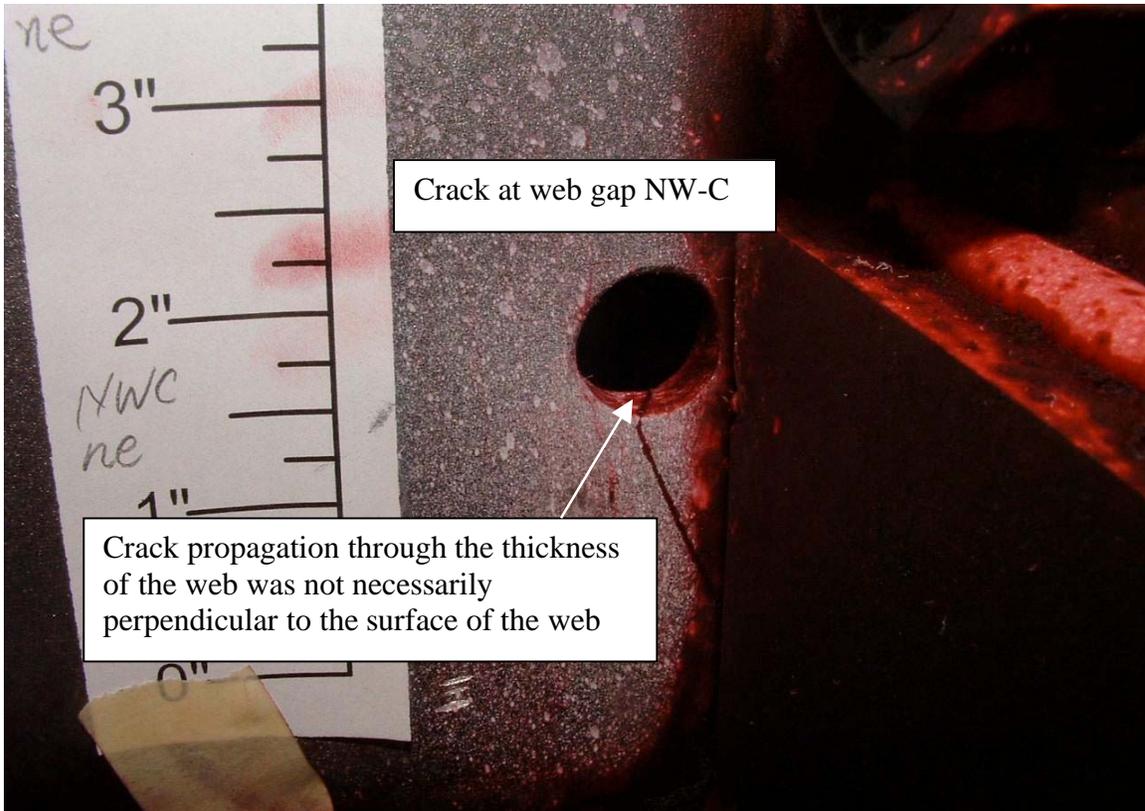
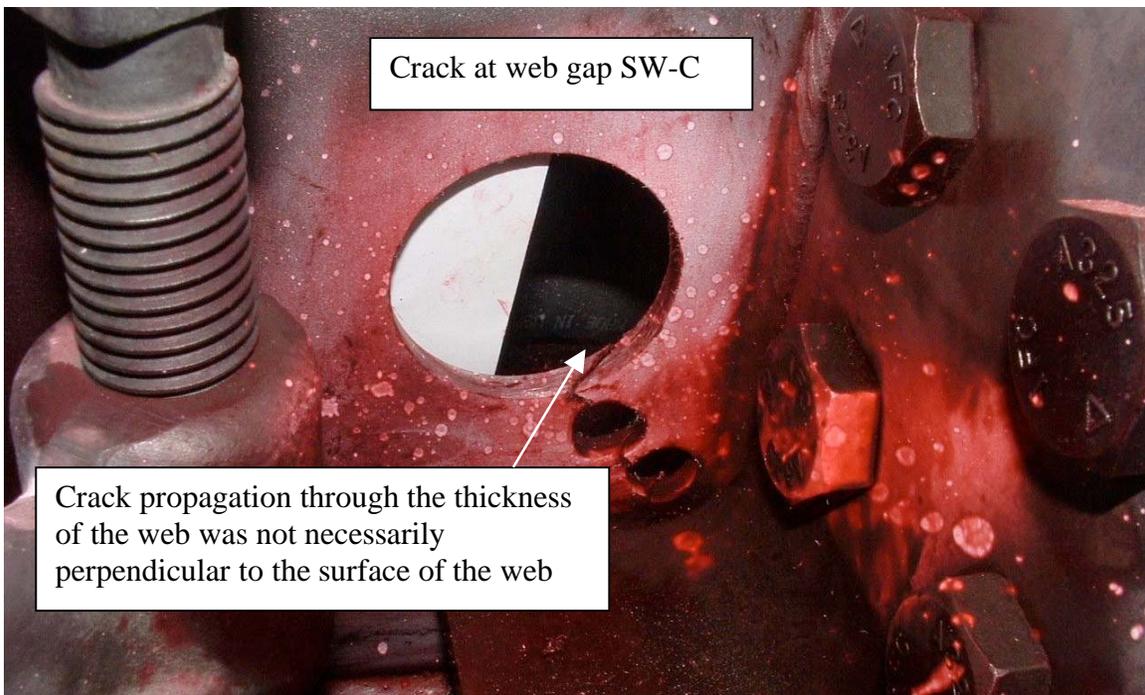
Figure 4.53 Crack propagation through the thickness of the web

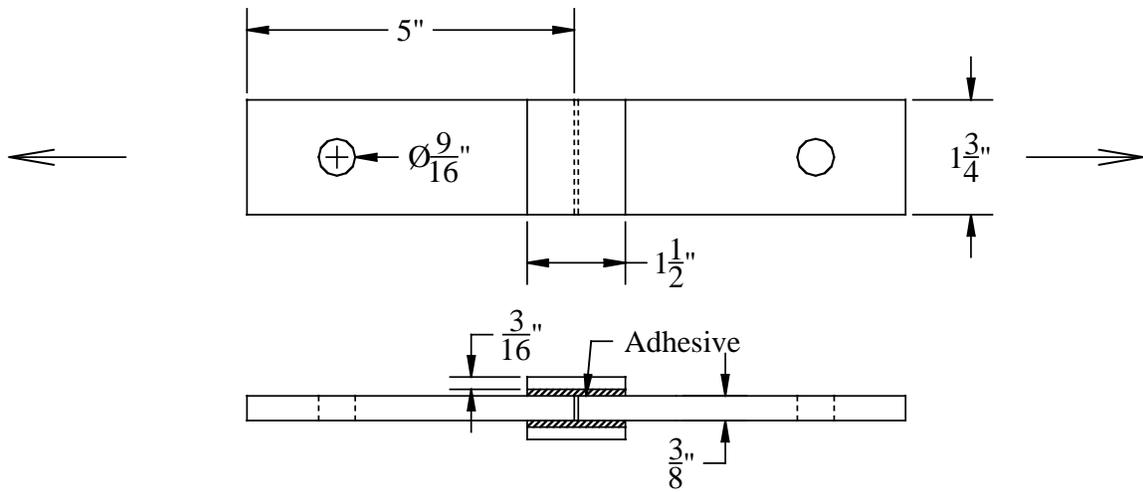
Figure 5.1 Coupon specimen dimension

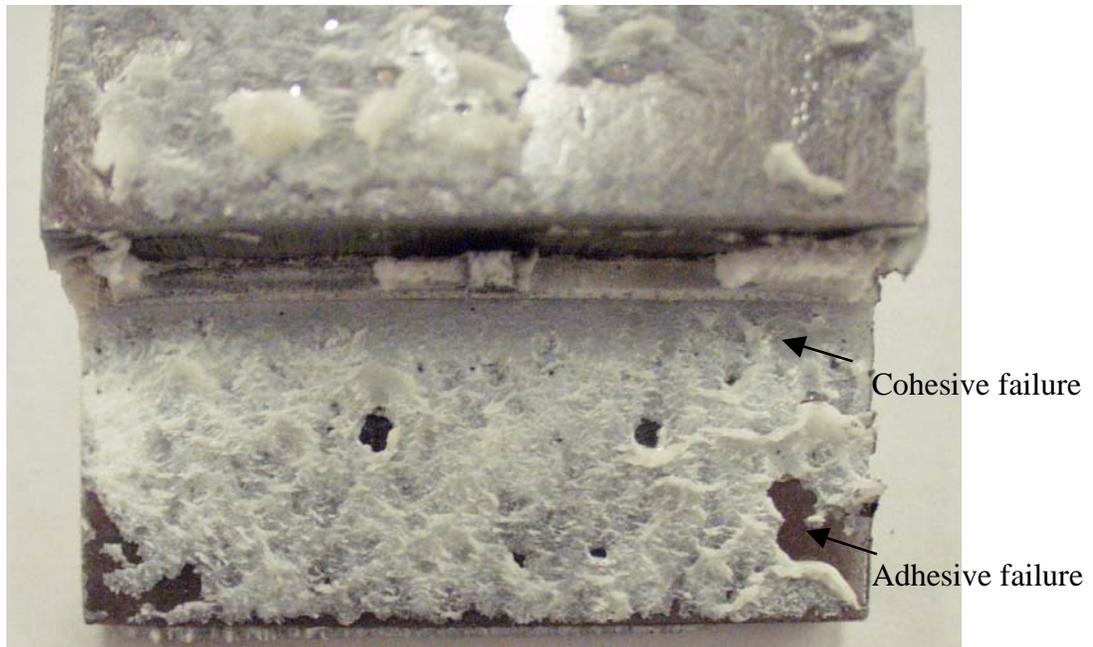
Figure 5.10 Failure mode of a standard baseline specimen (Room temperature cured, tested in lab ambient air, No GPS, bondline thickness  $t_a= 0.020$  in.)

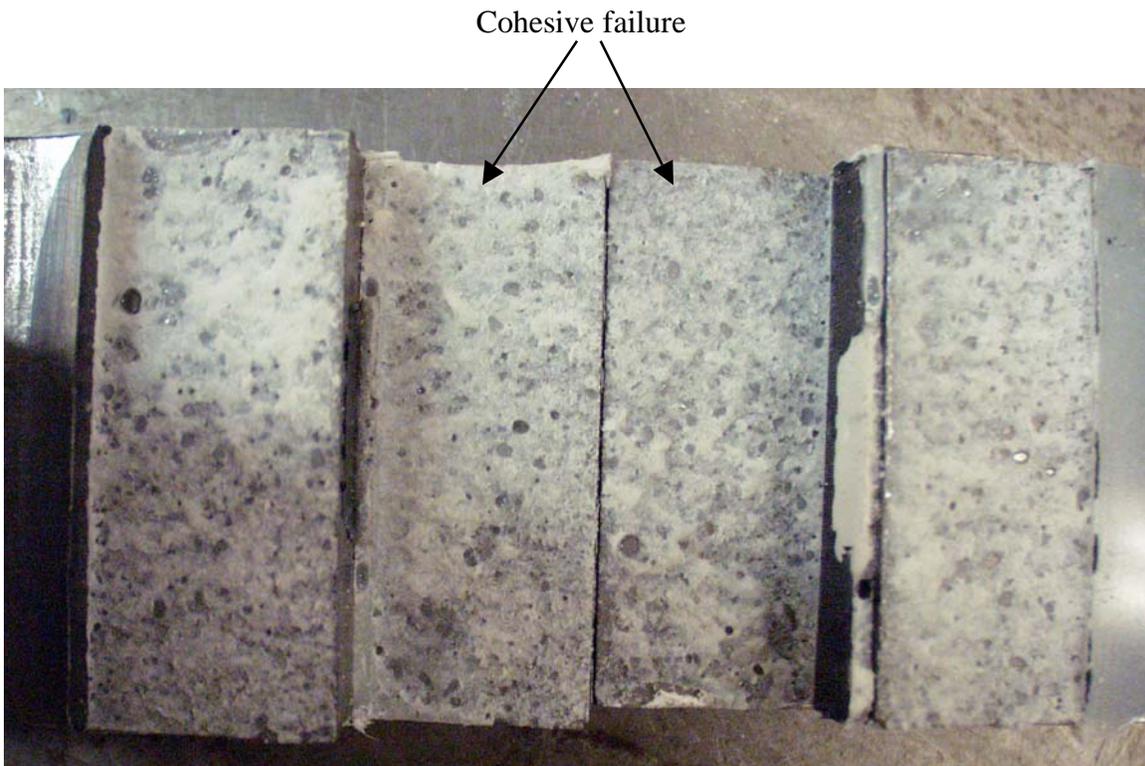
Figure 5.11 Failure mode of a specimen pretreated by GPS (Room temperature cured, tested in lab ambient air, bondline thickness  $t_a= 0.020$  in.)

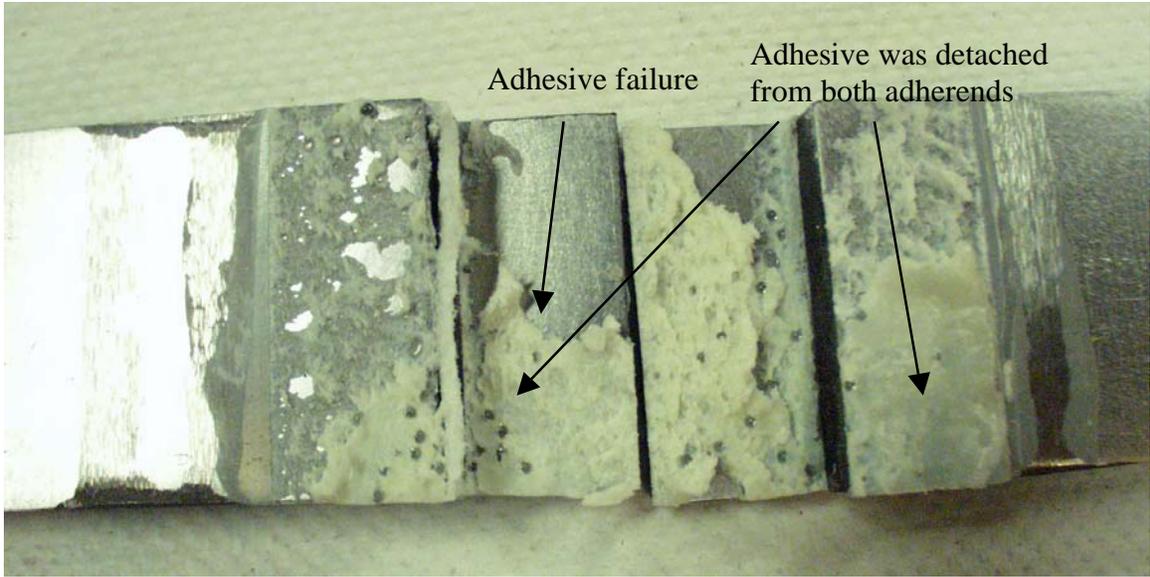
Figure 5.12 Failure mode of a specimen tested at 122°F (Room temperature cured, No GPS, bondline thickness  $t_a= 0.020$  in.)

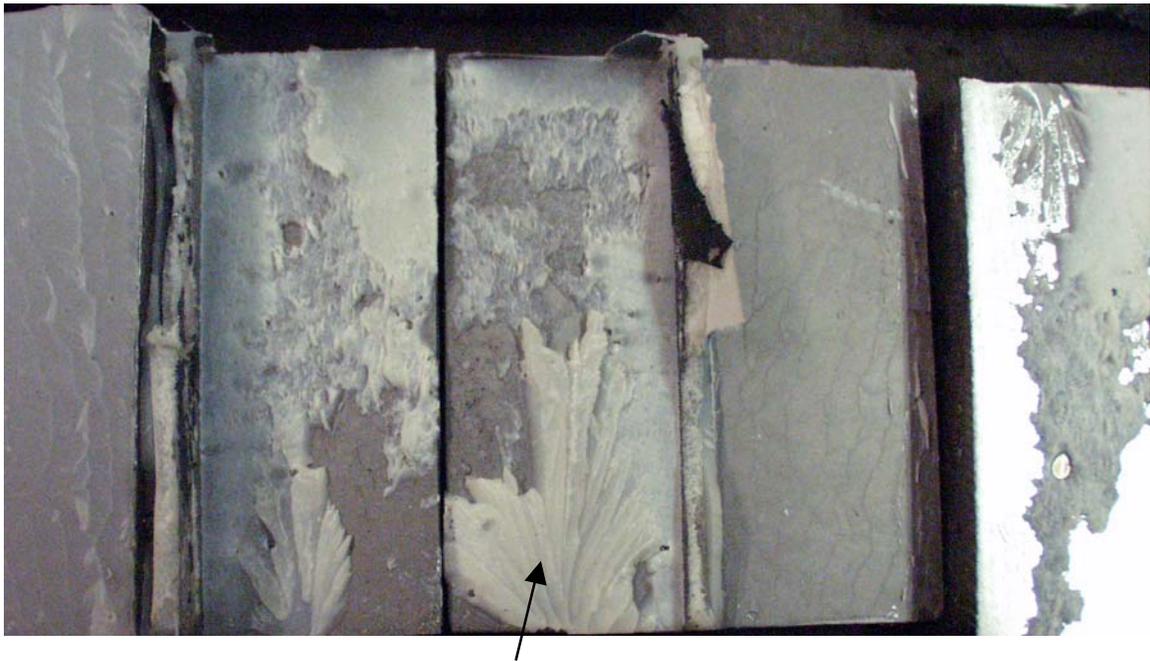
Figure 5.13 Failure mode of a specimen tested at -40°F (Room temperature cured, No GPS, bondline thickness  $t_a= 0.020$  in.)

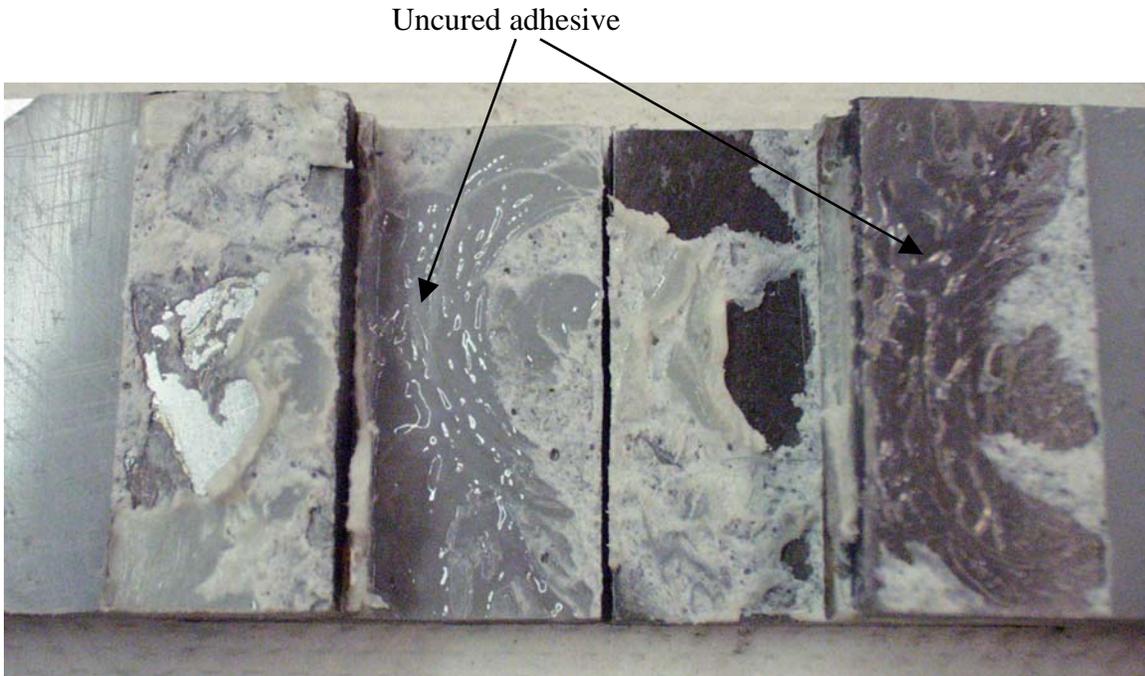
Figure 5.14 Failure mode of a cold temperature(50°F) cured baseline specimen (Tested in lab ambient air, No GPS, bondline thickness  $t_a= 0.020$  in.)

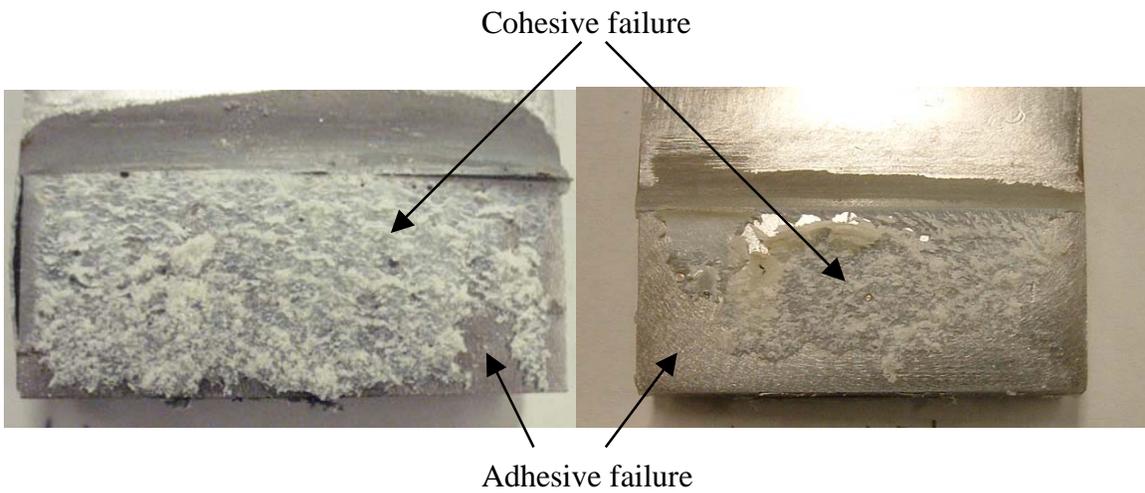
Figure 5.15 Failure mode of specimen kept in lab air at 65°F for 180 days (left) and 447 days (right) (Tested in lab ambient air, No GPS, bondline thickness  $t_a= 0.020$  in.)

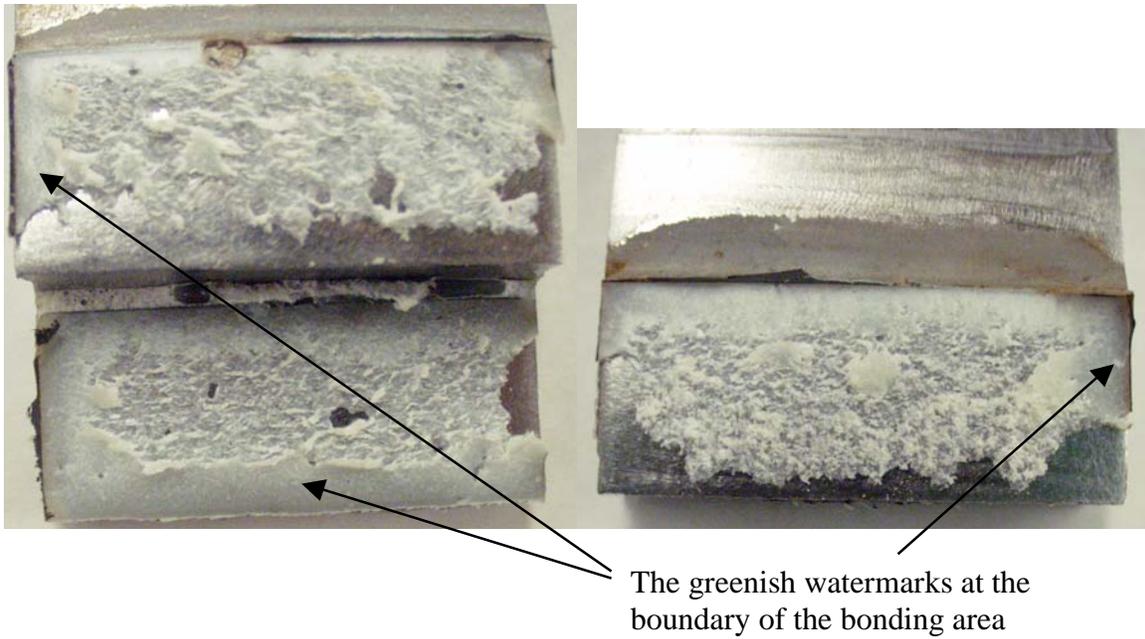
Figure 5.16 Failure mode of specimen immersed in tap water at 65°F for 92 days (left) and 201 days (right) (Tested in lab ambient air, No GPS, bondline thickness  $t_a = 0.020$  in.)

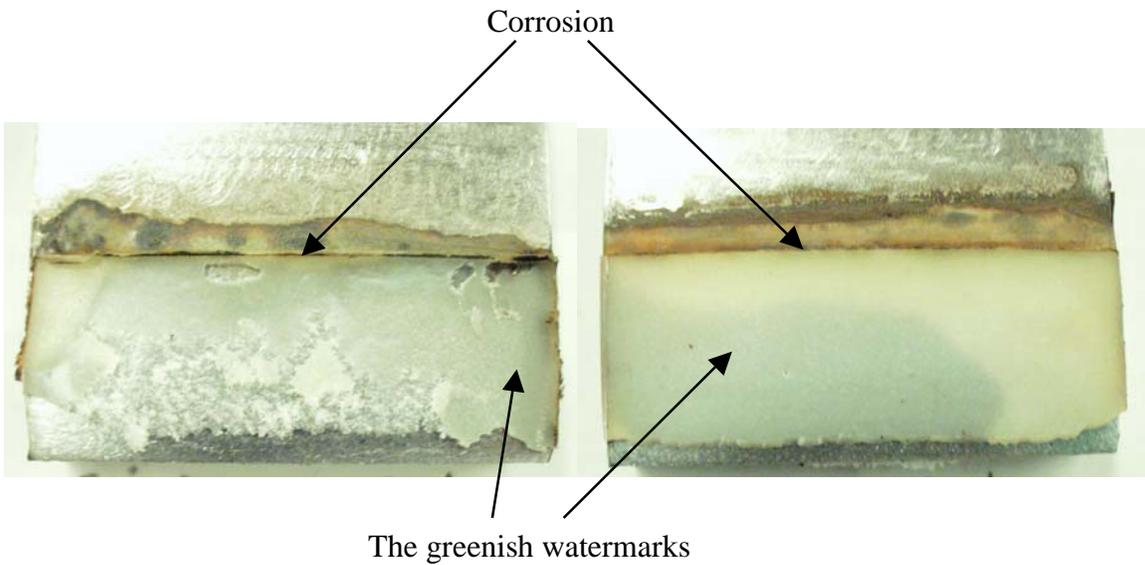
Figure 5.17 Failure mode of specimen immersed in tap water at 111°F for 92 days (left) and 210 days (right) (Tested in lab ambient air, No GPS, bondline thickness  $t_a = 0.020$  in.)

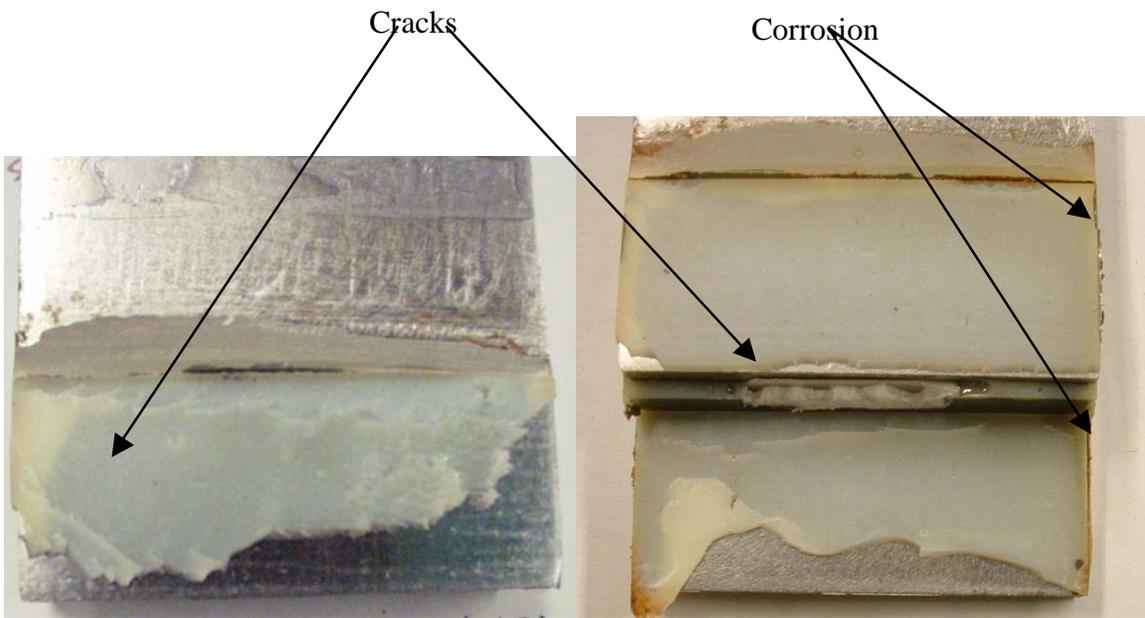
Figure 5.21 Failure mode of unloaded specimen subjected to temperature cycles between  $-4^{\circ}\text{F}$  and  $122^{\circ}\text{F}$  for 197 days (left) and 380 days (right) (Tested in lab ambient air, No GPS, bondline thickness  $t_a = 0.020$  in.)

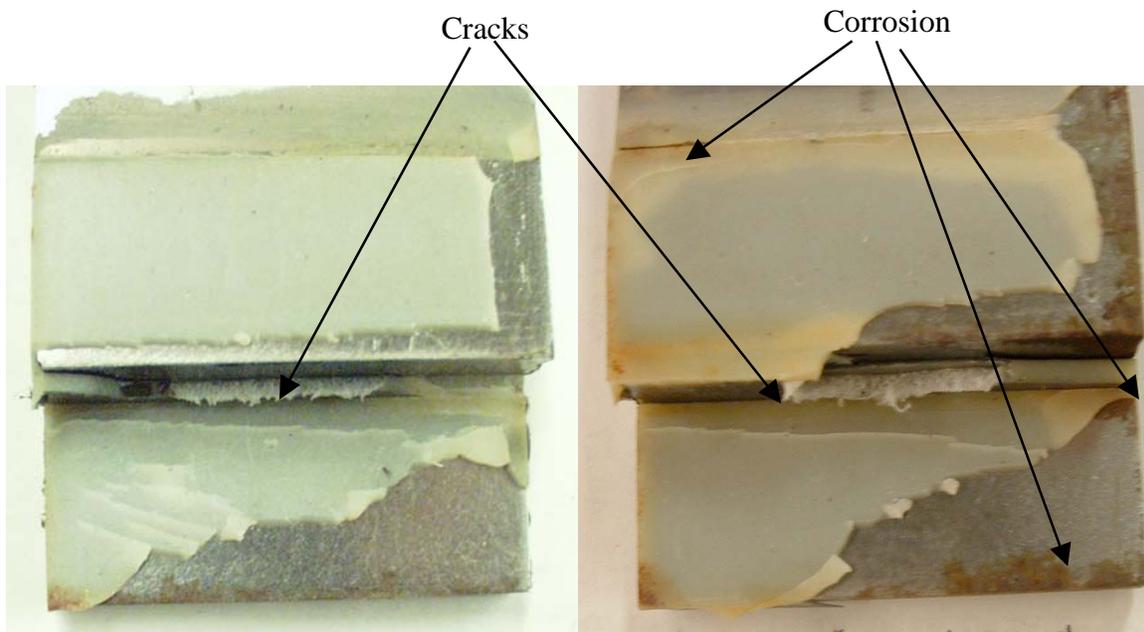
Figure 5.23 Failure mode of loaded(0.95 k) specimen subjected to temperature cycles between -4°F and 122°F for 211 days (left) and 370 days (right) (Tested in lab ambient air, No GPS, bondline thickness  $t_a = 0.020$  in.)

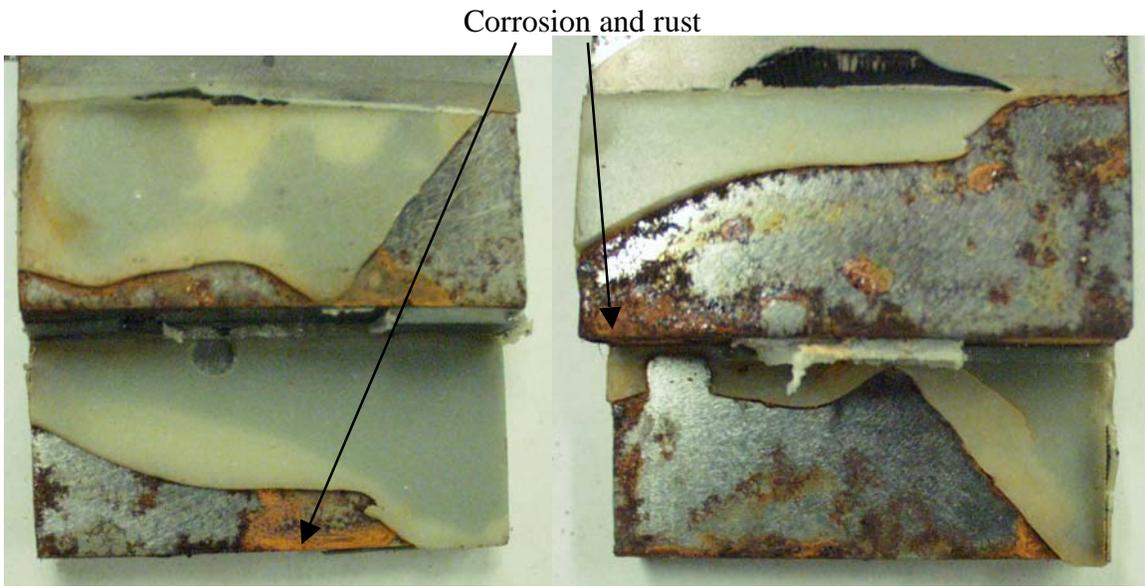
Figure 5.24 Failure mode of loaded(0.95 k) specimen subjected to temperature cycles between -4°F and 122°F (Failed in the hot chamber after 124 days of environment exposure, No GPS, bondline thickness  $t_a=0.020$  in.)

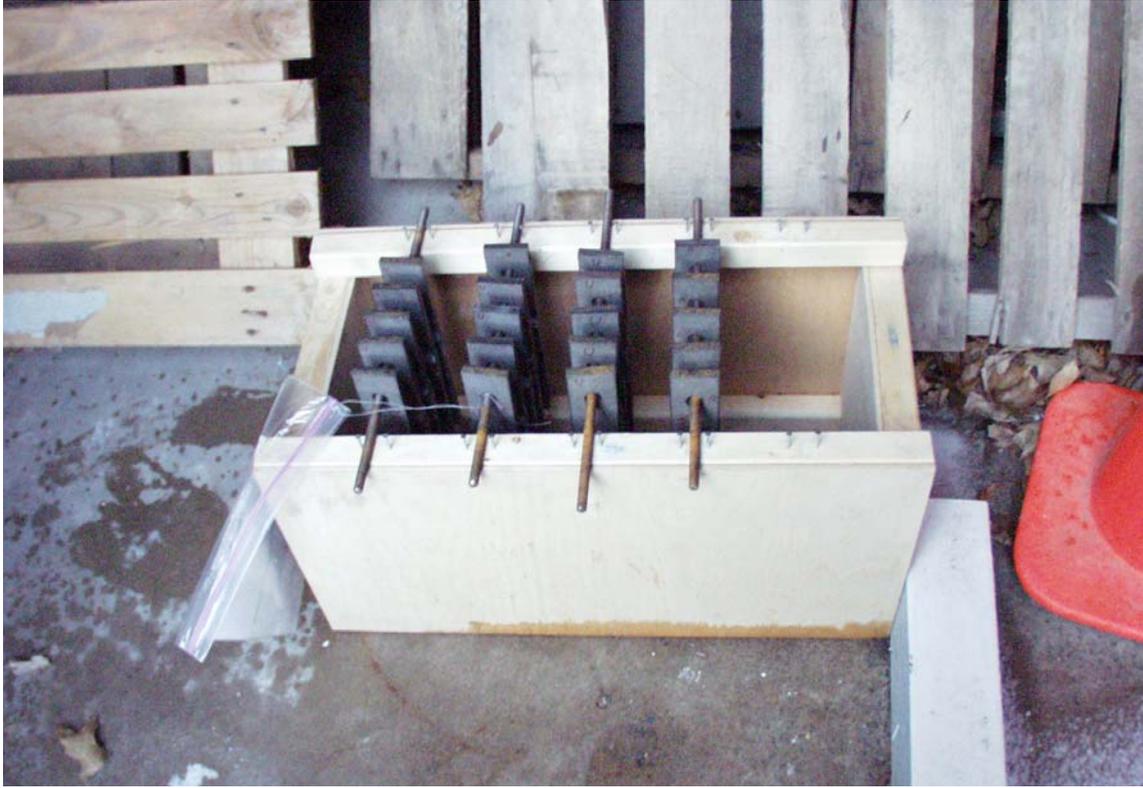
Figure 5.25 Coupon specimens kept outdoors

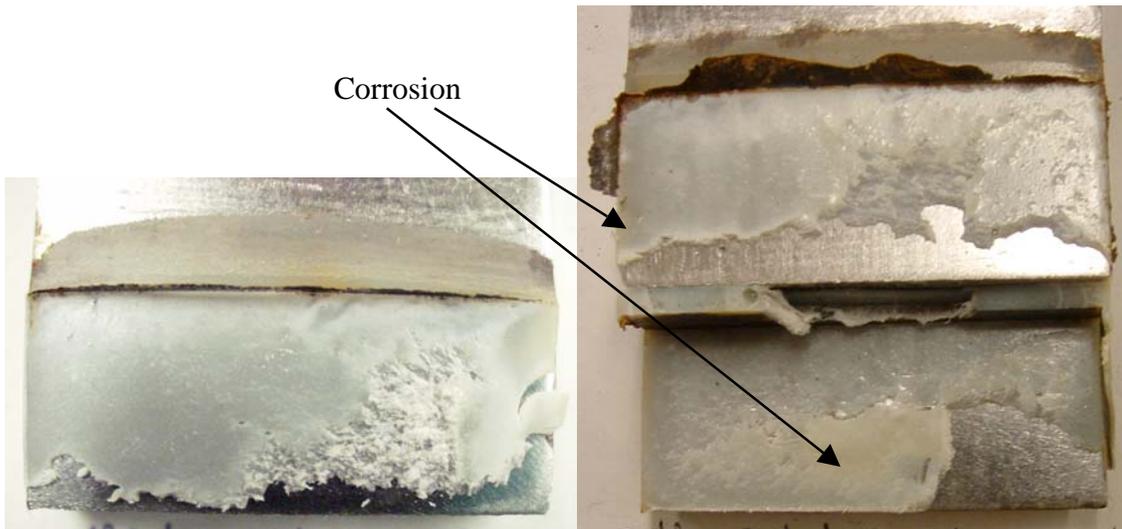
Figure 5.26 Failure mode of specimen kept outdoors for 184 days (left) and 271 days (right, cyclically loaded) (Tested in lab ambient air, No GPS, bondline thickness  $t_a = 0.020$  in.)

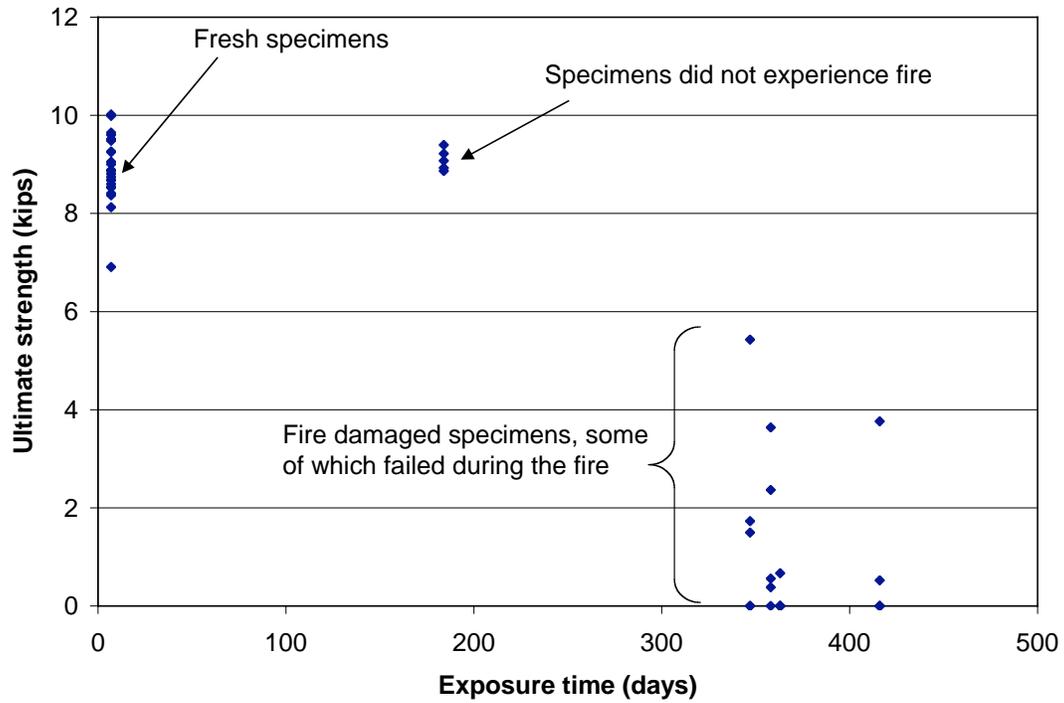
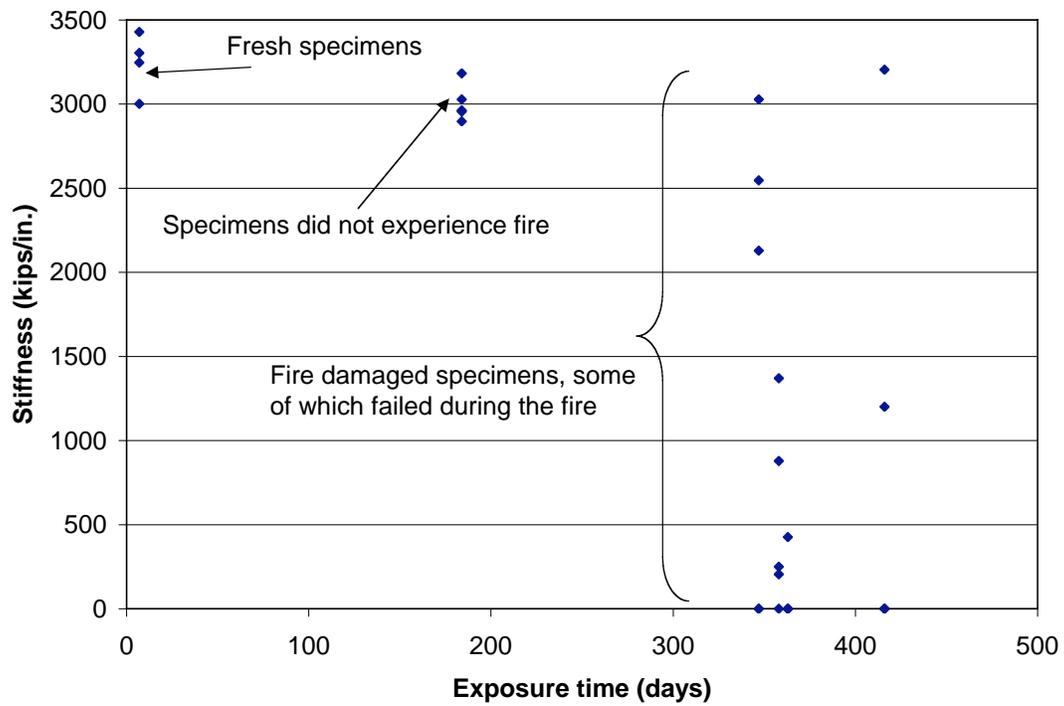
Figure 5.27 Ultimate strength and stiffness of specimens exposed to the outdoor environment and an unexpected fire (No GPS, bondline thickness  $t_a = 0.020$  in.)

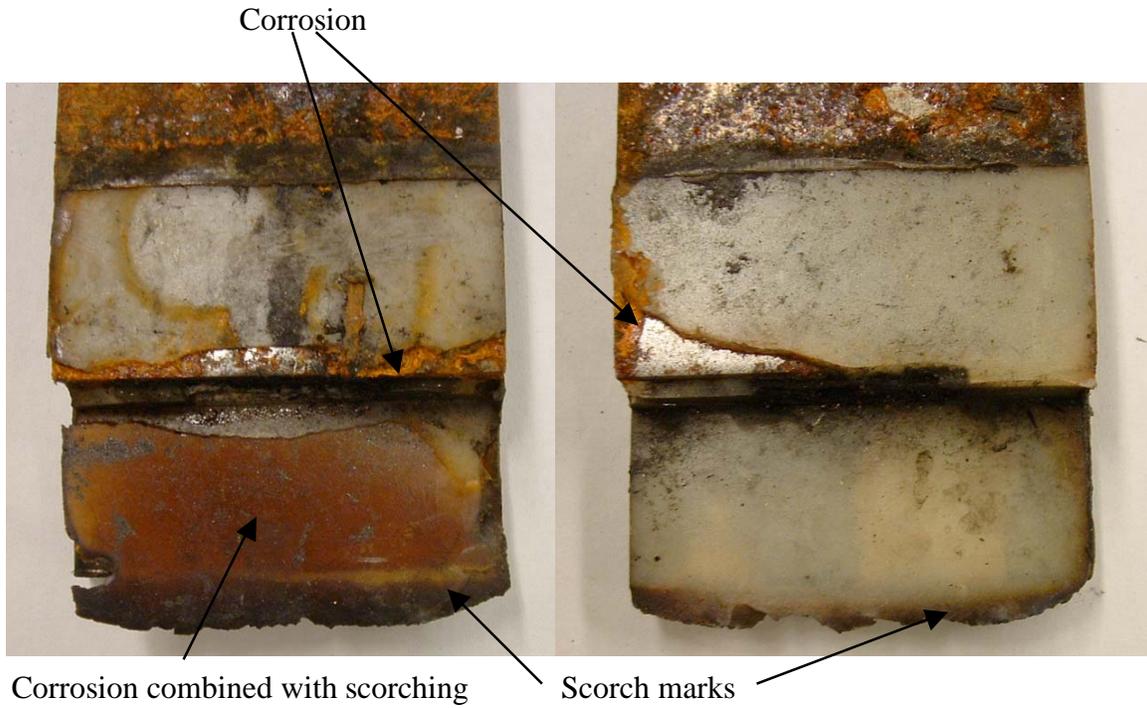
Figure 5.28 Failure mode of specimen that failed during the fire after 371 days of outdoor exposure (No GPS, bondline thickness  $t_a = 0.020$  in.)

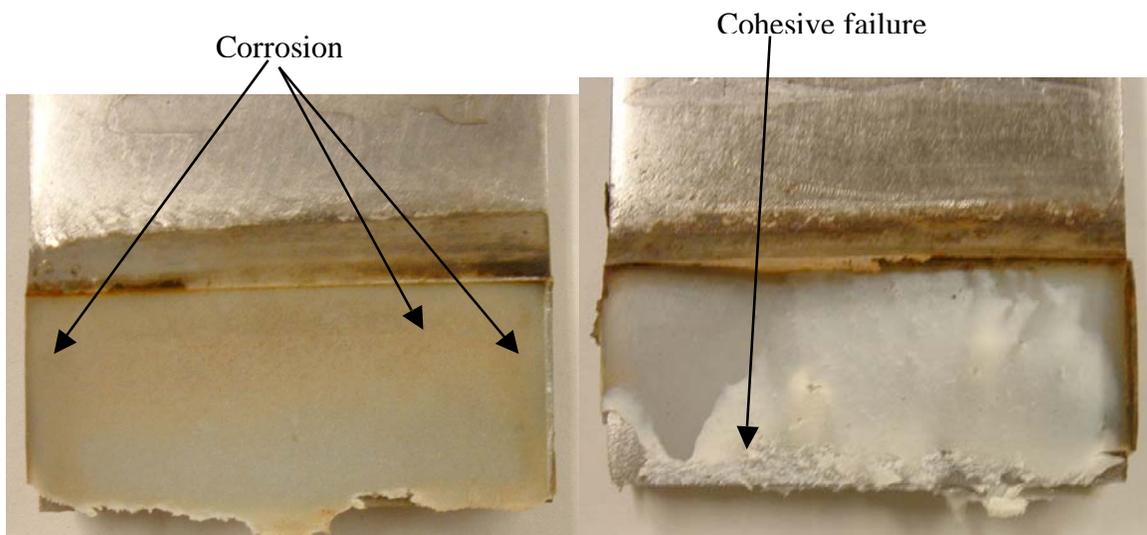
Figure 5.29 Failure mode of specimen that underwent fire after 371 days of outdoor exposure (left: ultimate strength=0.7 k, stiffness=400 k/in.; right: ultimate strength=5.4 k, stiffness=3000 k/in.)

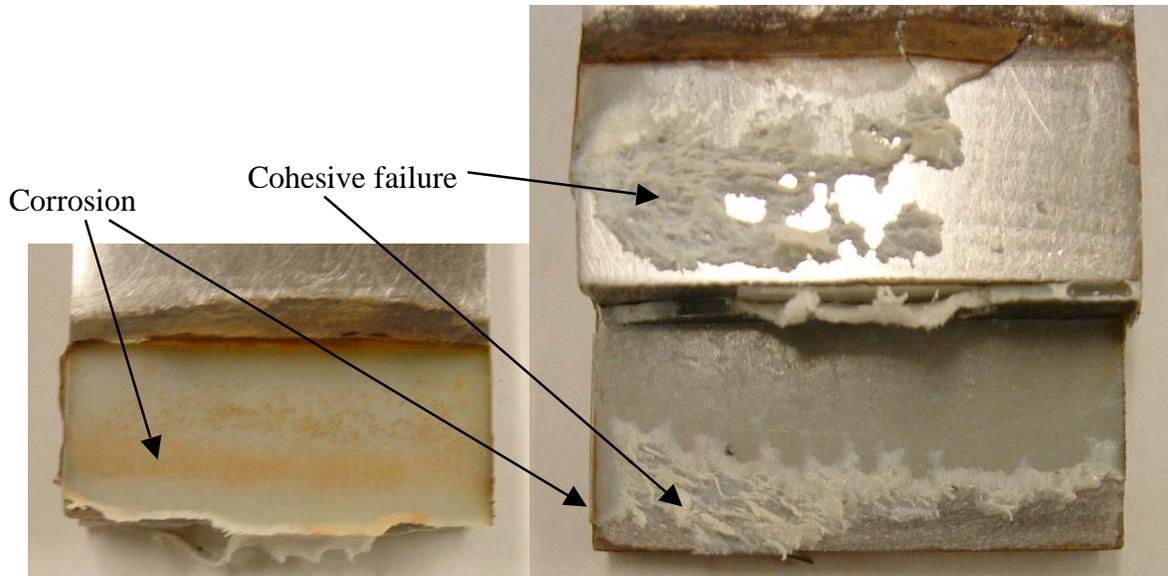
Figure 5.30 Failure mode of specimen that underwent fire after 374 days of outdoor exposure (GPS pretreated) (left: ultimate strength=1.2 k, stiffness=1800 k/in.; right: ultimate strength=7.5 k, stiffness=2800 k/in.)

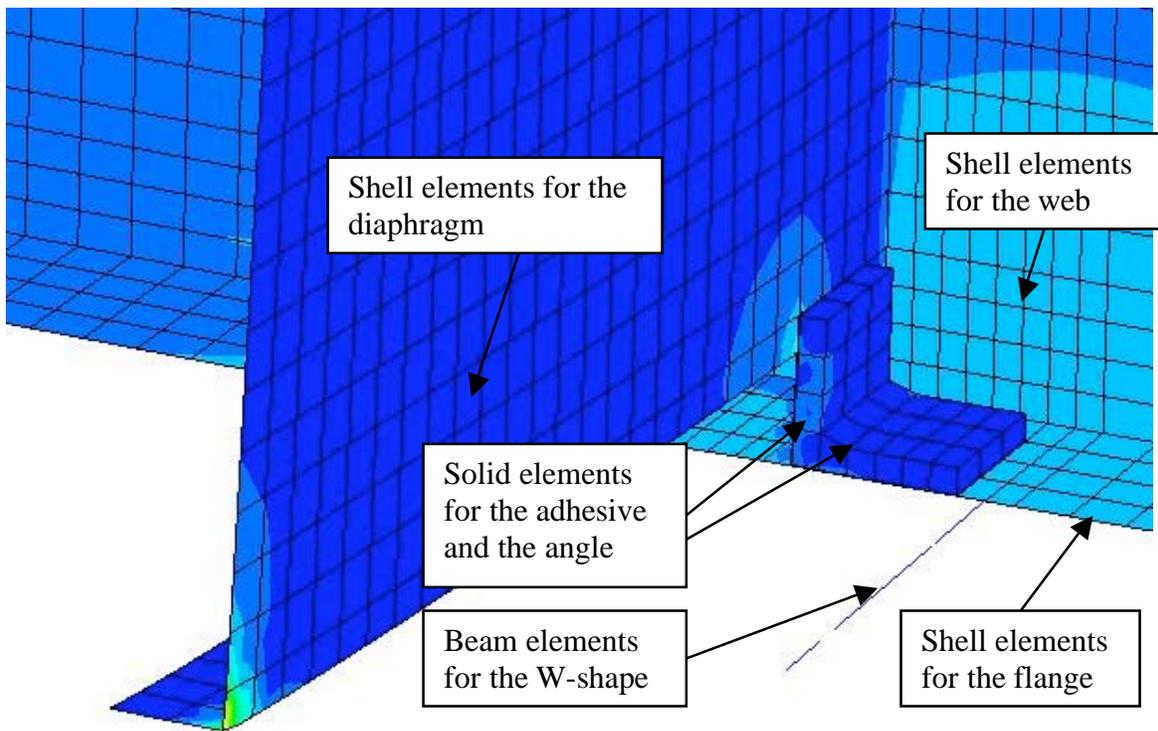
Figure 5.31 A 20-node solid element (brick element) was used to model both the adhesive and the angle for the large-scale specimen
