Final Report

Use of Adhesives to Retrofit  
Out-of-Plane Distortion Induced  
Fatigue Cracks

1. Report No. <b>MN/RC-2006-04</b>	2.	3. Recipients Accession No.	
4. Title and Subtitle <b>Use of Adhesives to Retrofit Out-of-Plane Distortion Induced Fatigue Cracks</b>		5. Report Date <b>February 2006</b>

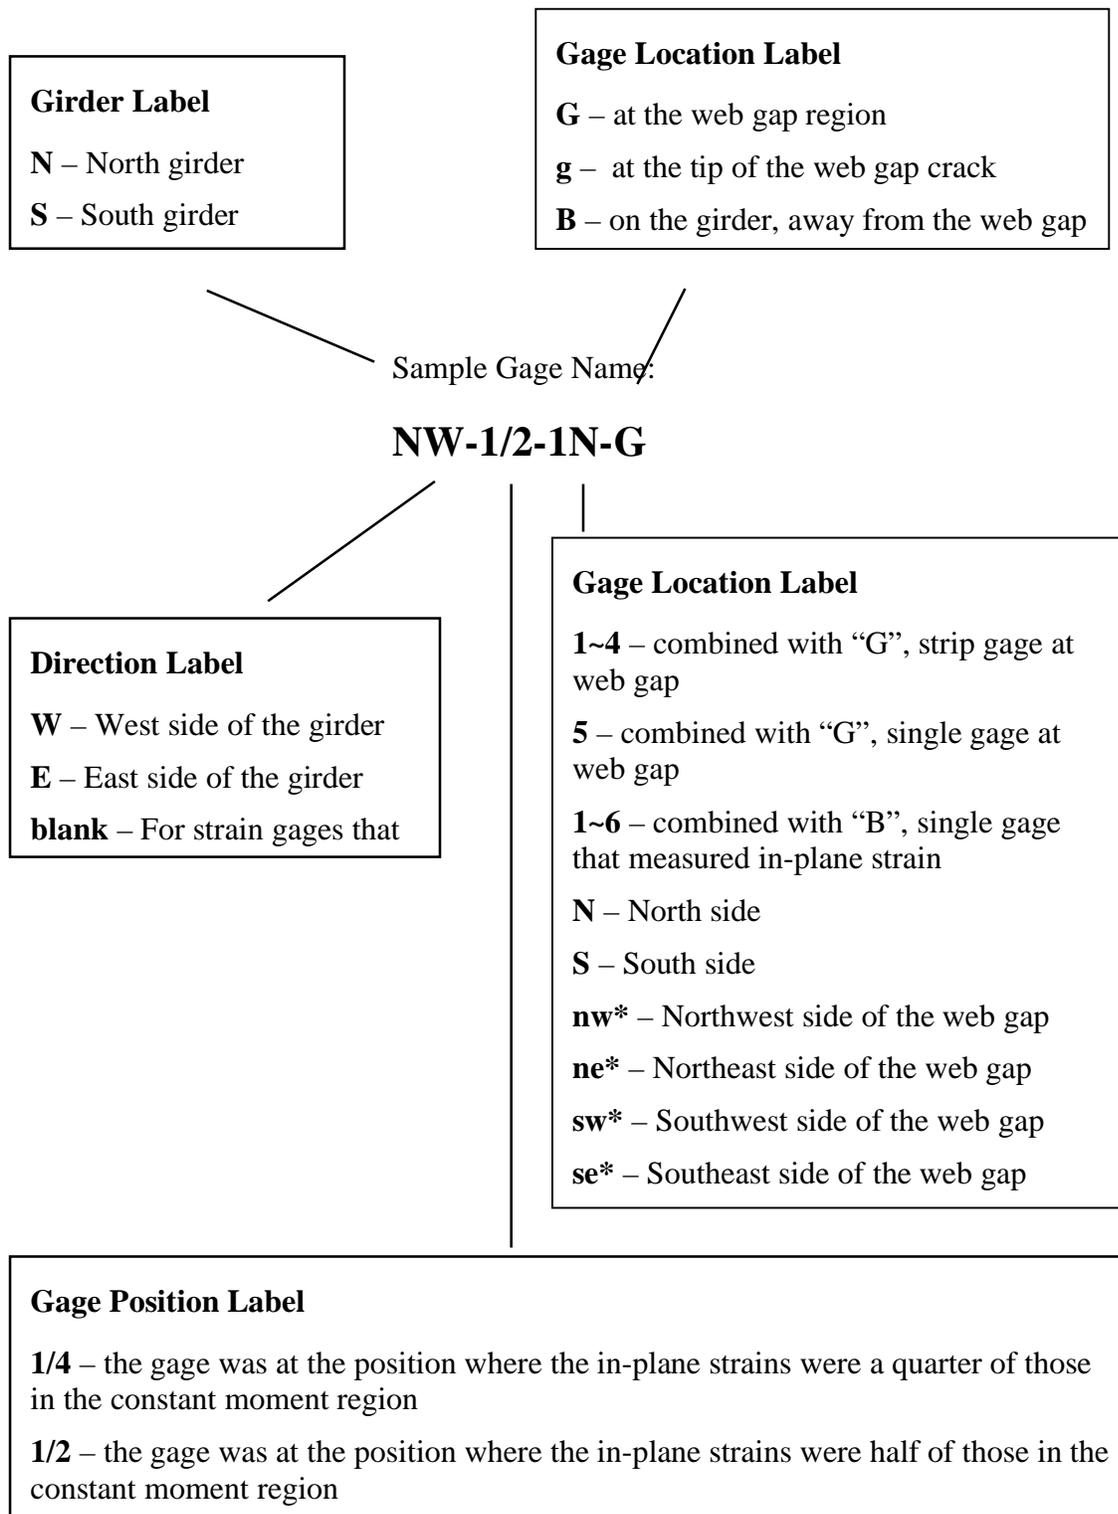
Figure H.1 Gage labeling for the large-scale test

Web gap location	Gage label	Girder	Location and position	Gage type
NW-1/2	NW-1/2-nw(1)-g	North	Northwest side of the web gap, crack tip	Single
	NW-1/2-ne-g	North	Northeast side of the web gap, crack tip	Single
	NW-1/2-se(2)-g	North	Southeast side of the web gap, crack tip	Single
SW-1/2	SW-1/2-nw-g	South	Northwest side of the web gap, crack tip	Single
	SW-1/2-ne(1)-g	South	Northeast side of the web gap, crack tip	Single
	SW-1/2-se-g	South	Southeast side of the web gap, crack tip	Single
NW-C	NW-C-ne-g	North	Northeast side of the web gap, crack tip	Single
	NW-C-se(1)-g	North	Southeast side of the web gap, crack tip	Single
SW-C	SW-C-nw(1)-g	South	Northwest side of the web gap, crack tip	Single
	SW-C-ne(1)-g	South	Northeast side of the web gap, crack tip	Single
	SW-C-sw(3)-g	South	Southwest side of the web gap, crack tip	Single
	SW-C-se-g	South	Southeast side of the web gap, crack tip	Single
NE-C	NE-C-nw-g	North	Northwest side of the web gap, crack tip	Single

NE-C-ne(1)-g	North	Northeast side of the web gap, crack tip	Single
	NE-C-sw(3)-g	North	Crack was at the flange-web weld, crack tip	Single
	NE-C-se-flangeweb-g	North	Southwest side of the web gap, crack tip	Single
SE-C	SE-C-nw(1)-g	South	Northwest side of the web gap, crack tip	Single
	SE-C-ne-g	South	Northeast side of the web gap, crack tip	Single
	SE-C-sw-g	South	Southwest side of the web gap, crack tip	Single
	SE-C-se-g	South	Southeast side of the web gap, crack tip	Single
NE-1/2	NE-1/2-nw(1)-g	North	Northwest side of the web gap, crack tip	Single
	NE-1/2-ne-g	North	Northeast side of the web gap, crack tip	Single
	NE-1/2-sw(3)-g	North	Southwest side of the web gap, crack tip	Single
	NE-1/2-se(1)-g	North	Southeast side of the web gap, crack tip	Single
SE-1/2	SE-1/2-ne-g	South	Northeast side of the web gap, crack tip	Single
	SE-1/2-sw-g	South	Southwest side of the web gap, crack tip	Single
	SE-1/2-se(2)-g	South	Southeast side of the web gap, crack tip	Single
