# **Audit Tool for the Central Corridor Pedestrian Environment**

Prepared for the District  
Councils Collaborative

By **Josh Tolkan**  
of the Center for Urban  
and Regional Affairs

January 2008

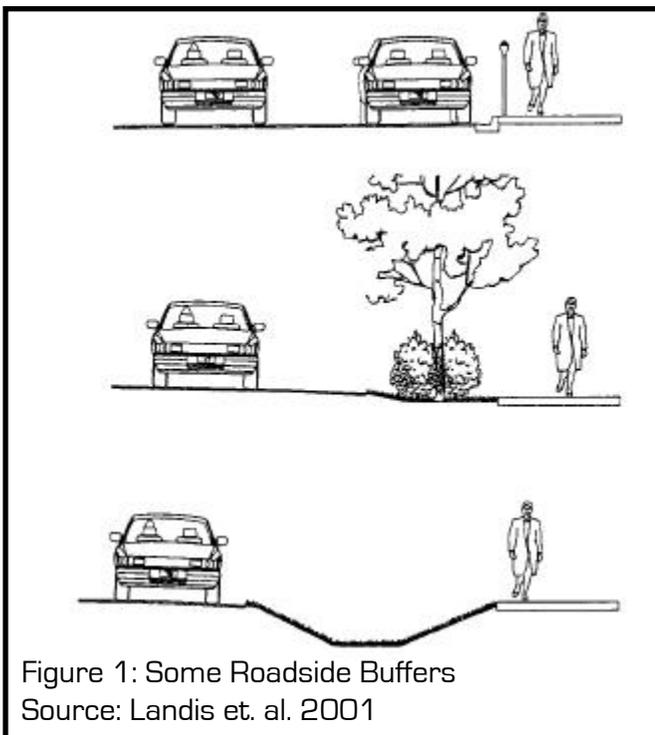
Buffers are an important element to protect pedestrians from the noise and fast moving cars of the street. Landis' (2001) model shows a strong correlation between a roadside buffer and pedestrian's perception of safety. A row of parked cars, a line of trees, or a grass swale can be effective at buffering the sidewalk from the road. A high percentage of roadsides with on-street parking and high total buffer width were more favorable to pedestrians. Figure 1 shows examples of roadside buffers.

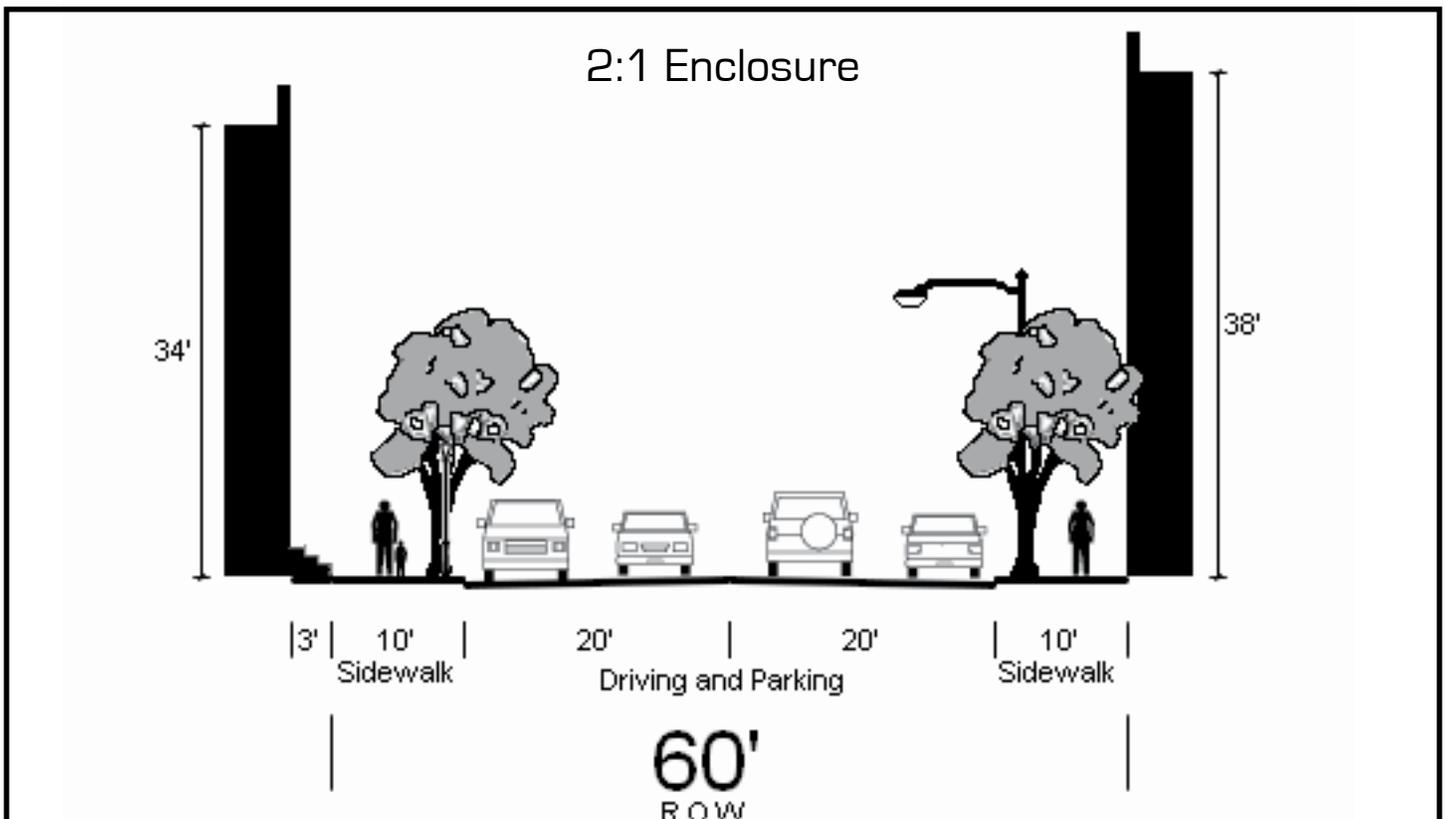
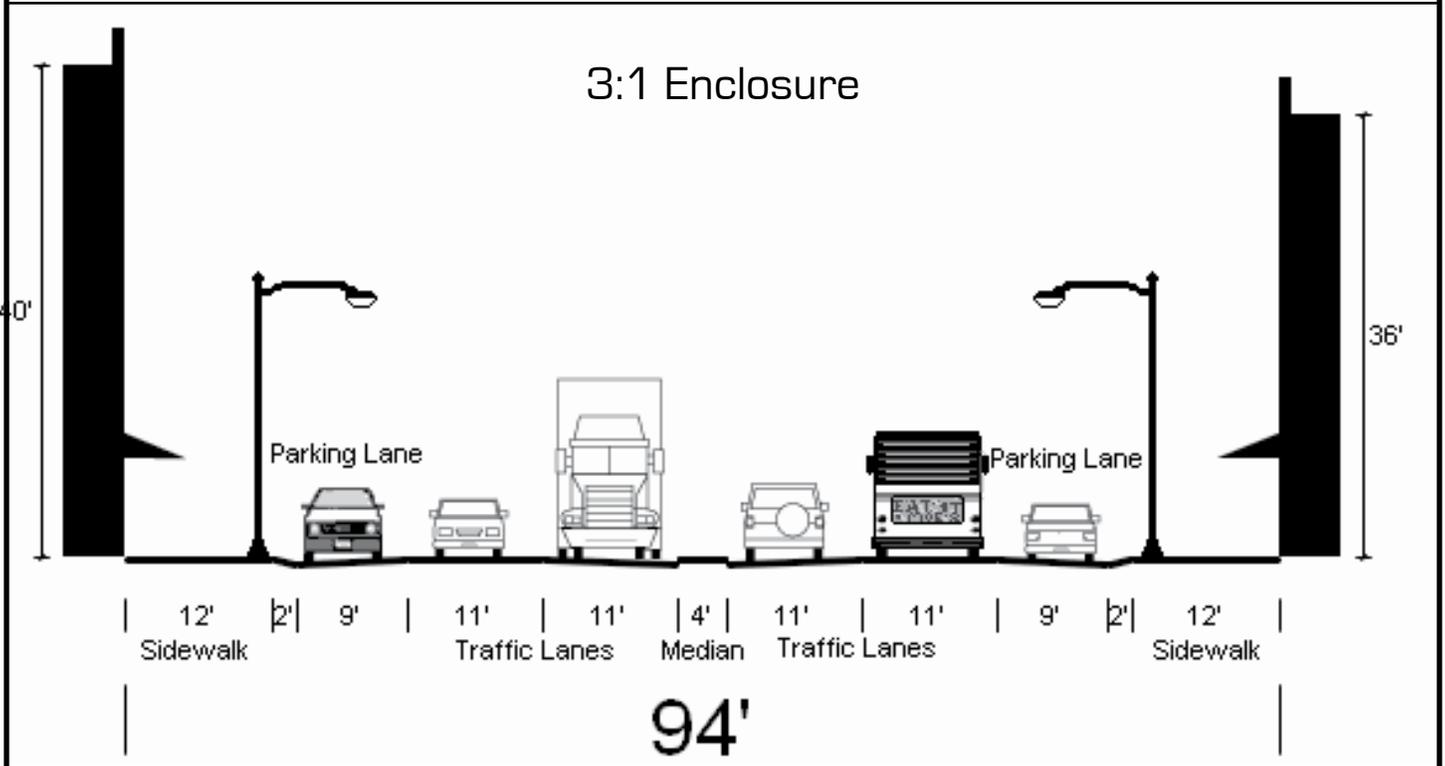
Figure 2: Sample street width to building height ratios. (width:height)

Enclosure is further evaluated with the *street cross section* variable, which is recorded from Sketch-Up files. Urban Strategies created three-dimensional Sketch-Up files of a quarter-mile radius around each proposed LRT station area. Due to the limitations of the data, only the first quarter-mile in each direction from each station area is available. This measurement is taken by finding the proportional average building height for each quarter-mile segment. The proportional average is the sum of the product of each building's height and width, divided by the sum of all building widths. Then the average street width is found in each quarter-mile segment, excluding those buildings that are set back very far from the road. The ratio of the road width to the proportional average building height is reduced to its simplest form.

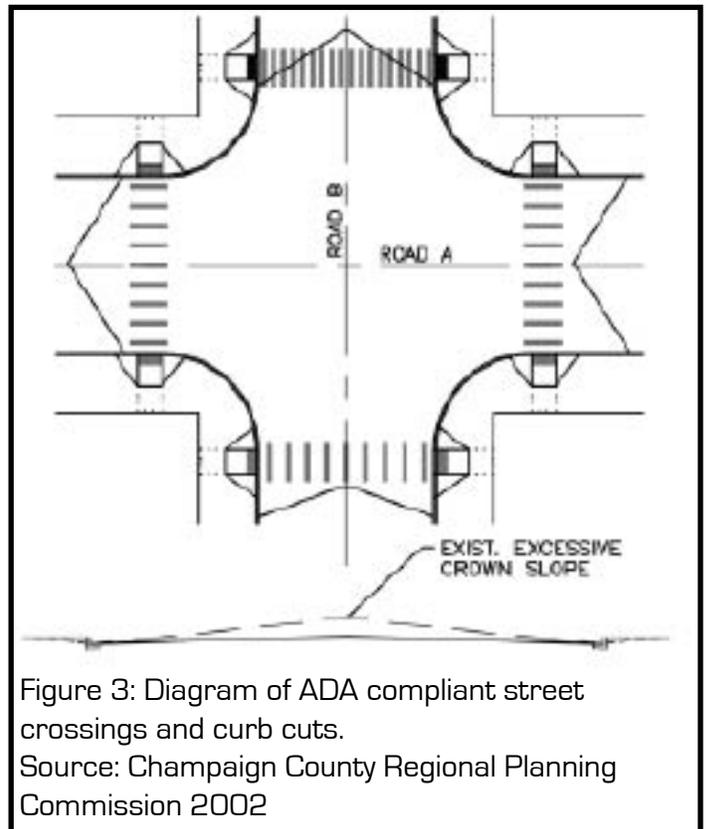
Figure 3: Diagram of ADA compliant street crossings and curb cuts.  
Source: Champaign County Regional Planning Commission 2002

Accessibility for the handicapped is an important issue that also falls under the accessibility category. The Americans with Disabilities Act has new construction standards that help to make intersections safe for the handicapped. Crossing signals should allow 1 second for every 3.5 feet of road width. Crosswalks should be signaled with tones and well as lights. Textured road treatments are suggested in the crosswalks as well. Curb cuts should have ramps to the street at a slope of no greater than 1:20. Additionally, it is preferable for the curb cut to point in the direction the pedestrian needs to go when crossing the in the crosswalk so that no turning is necessary once on road level. This means that the standard four-way intersections need to have two curb cuts at each corner (see figure 3) (Champaign County Regional Planning Commission 2002).

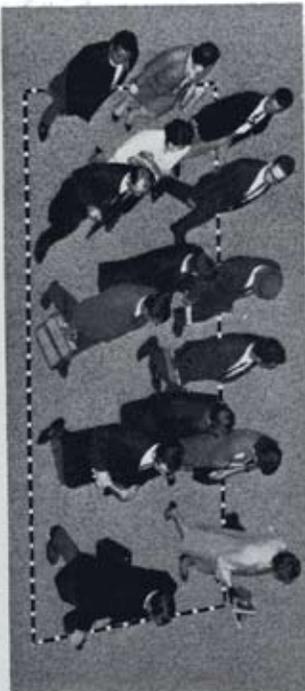
Level of Service E

At walkway level-of-service E, virtually all pedestrians would have their normal walking speeds restricted, requiring frequent adjustments of gait. At the lower end of the range, forward progress would only be made by shuffling. Insufficient area would be available to bypass slower-moving pedestrians. Extreme difficulties would be experienced by pedestrians attempting reverse-flow and cross-flow movements. The design volume approaches the maximum attainable capacity of the walkway, with resulting frequent stoppages and interruptions of flow. This design range should only be employed for short peaks in the most crowded areas. This design level would occur naturally with a bulk arrival traffic pattern that immediately exceeds available capacity, and this is the only design situation for which it would be recommended. Examples would include sports-stadium design, or rail transit facilities where there may be a large but short-term exiting of passengers from a train. When this level-of-service is assumed for these design conditions, the adequacy of pedestrian holding areas at critical design sections, and all supplementary pedestrian facilities, must be carefully evaluated.

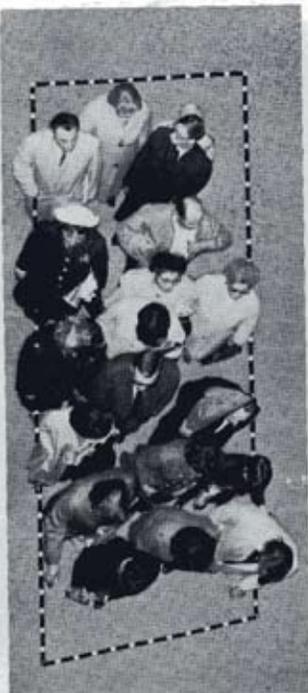
Level of Service F

At walkway level-of-service F, all pedestrian walking speeds are extremely restricted, and forward progress can only be made by shuffling. There would be frequent, unavoidable contact with other pedestrians, and reverse or crossing movements would be virtually impossible. Traffic flow would be sporadic, with forward progress based on the movement of those in front. This level-of-service is representative of a loss of control, and a complete breakdown in traffic flow. Pedestrian areas below 5 square feet are more representative of a queuing, rather than a traffic-flow situation, and this level-of-service is not recommended for walkway design.

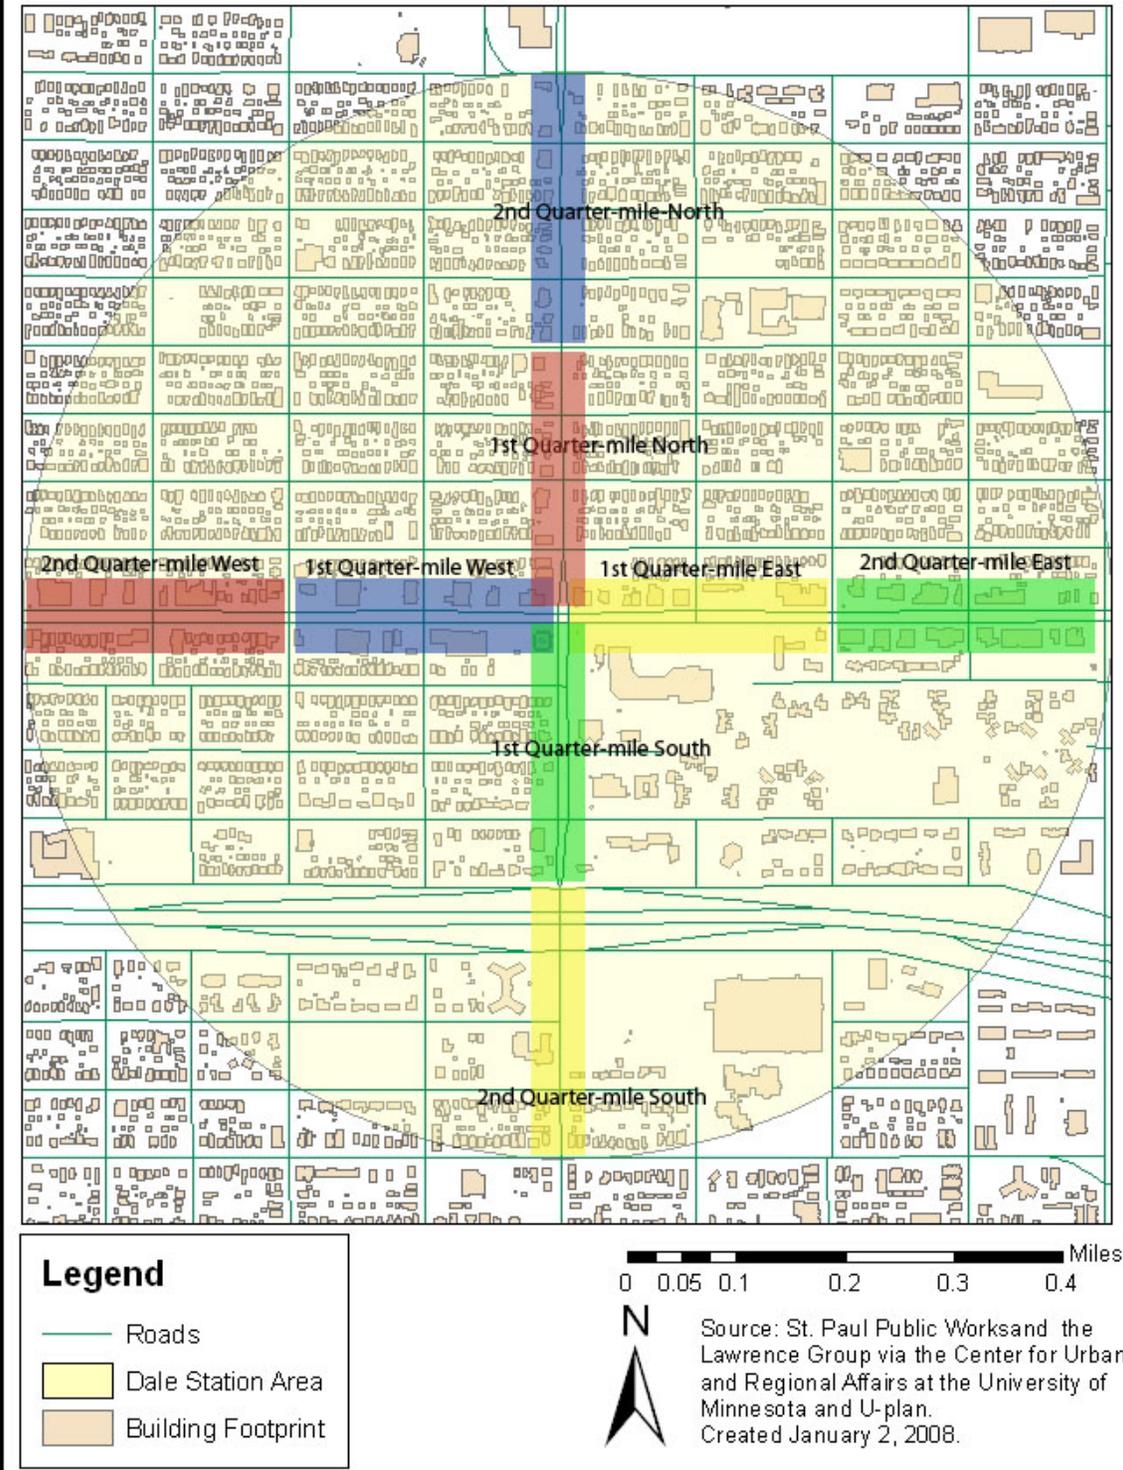
Diagram of Quarter-mile Section Breakdown Scheme  
Half mile radius around Dale and University  
St. Paul, Minnesota

Survey data is collected at each block. And then aggregated to quarter-mile sections. GIS data is recorded at the quarter-mile section when initially recorded. There have been two drafts of the walking survey to date and the distinctions between the two are noted. The methods for recording the data for this pedestrian survey are described below. Some variables that the researcher wished to address but could not due to time constraints are noted along with suggestions of how the researcher wished to evaluate them. Appendix D contains a table summarizing all the measurements.

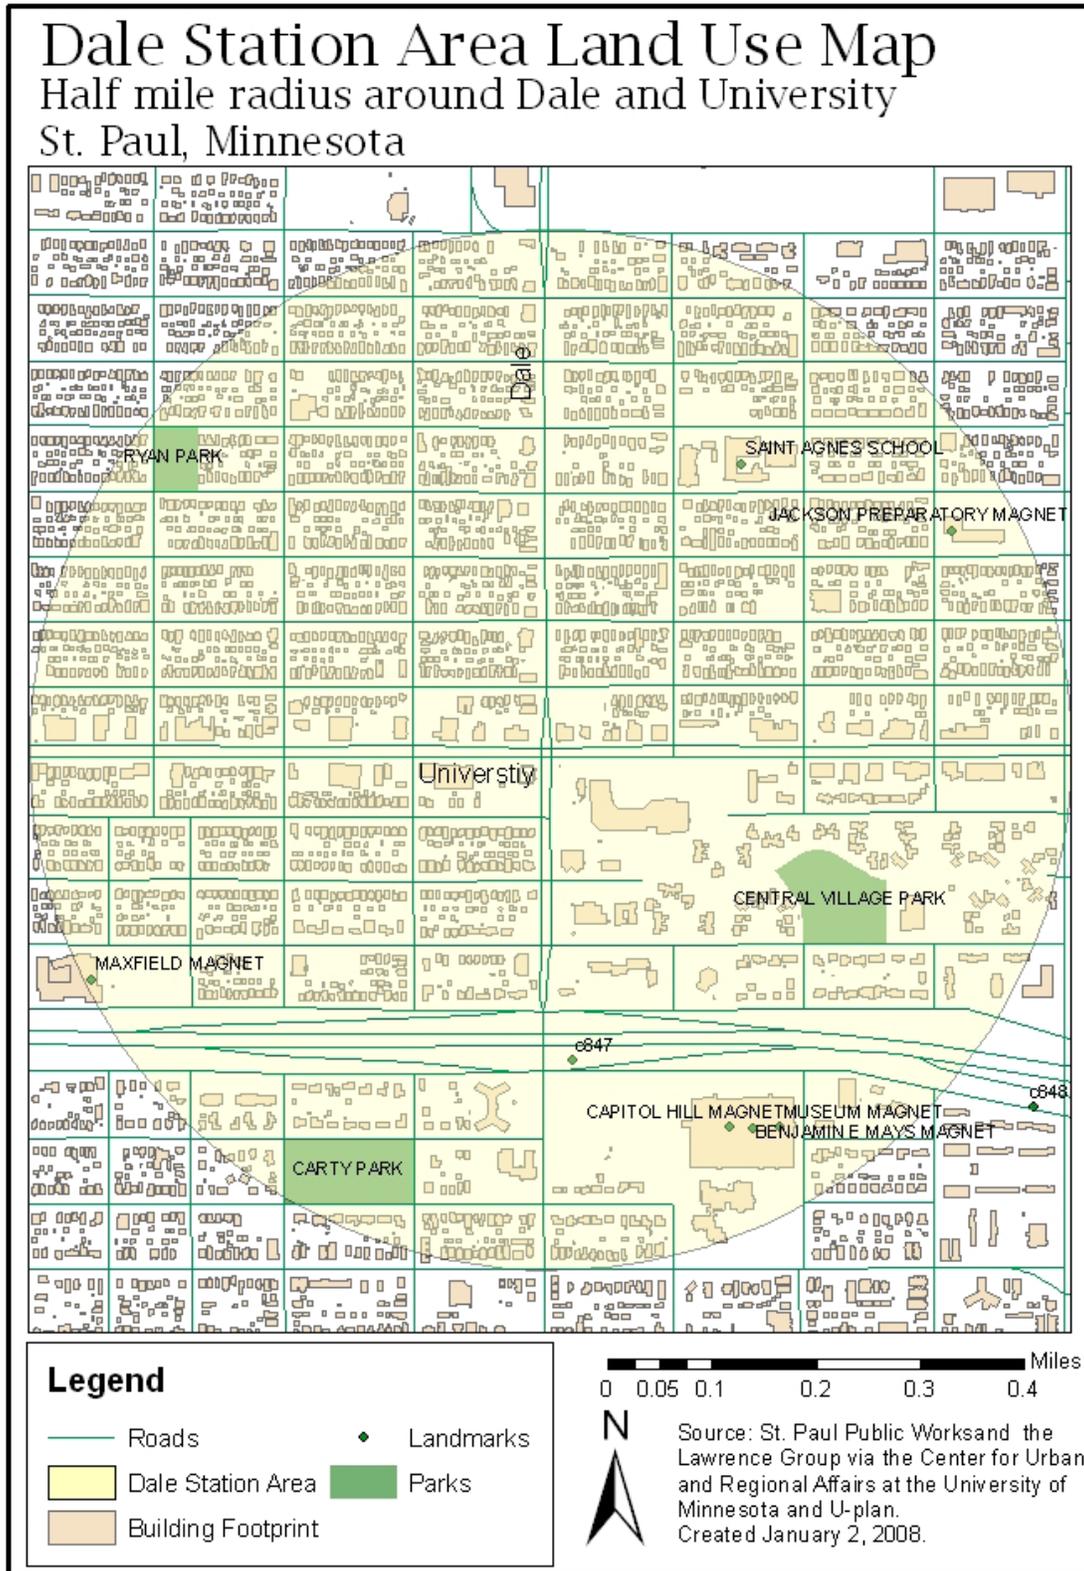
### Appendix F: Dale Land Use Maps

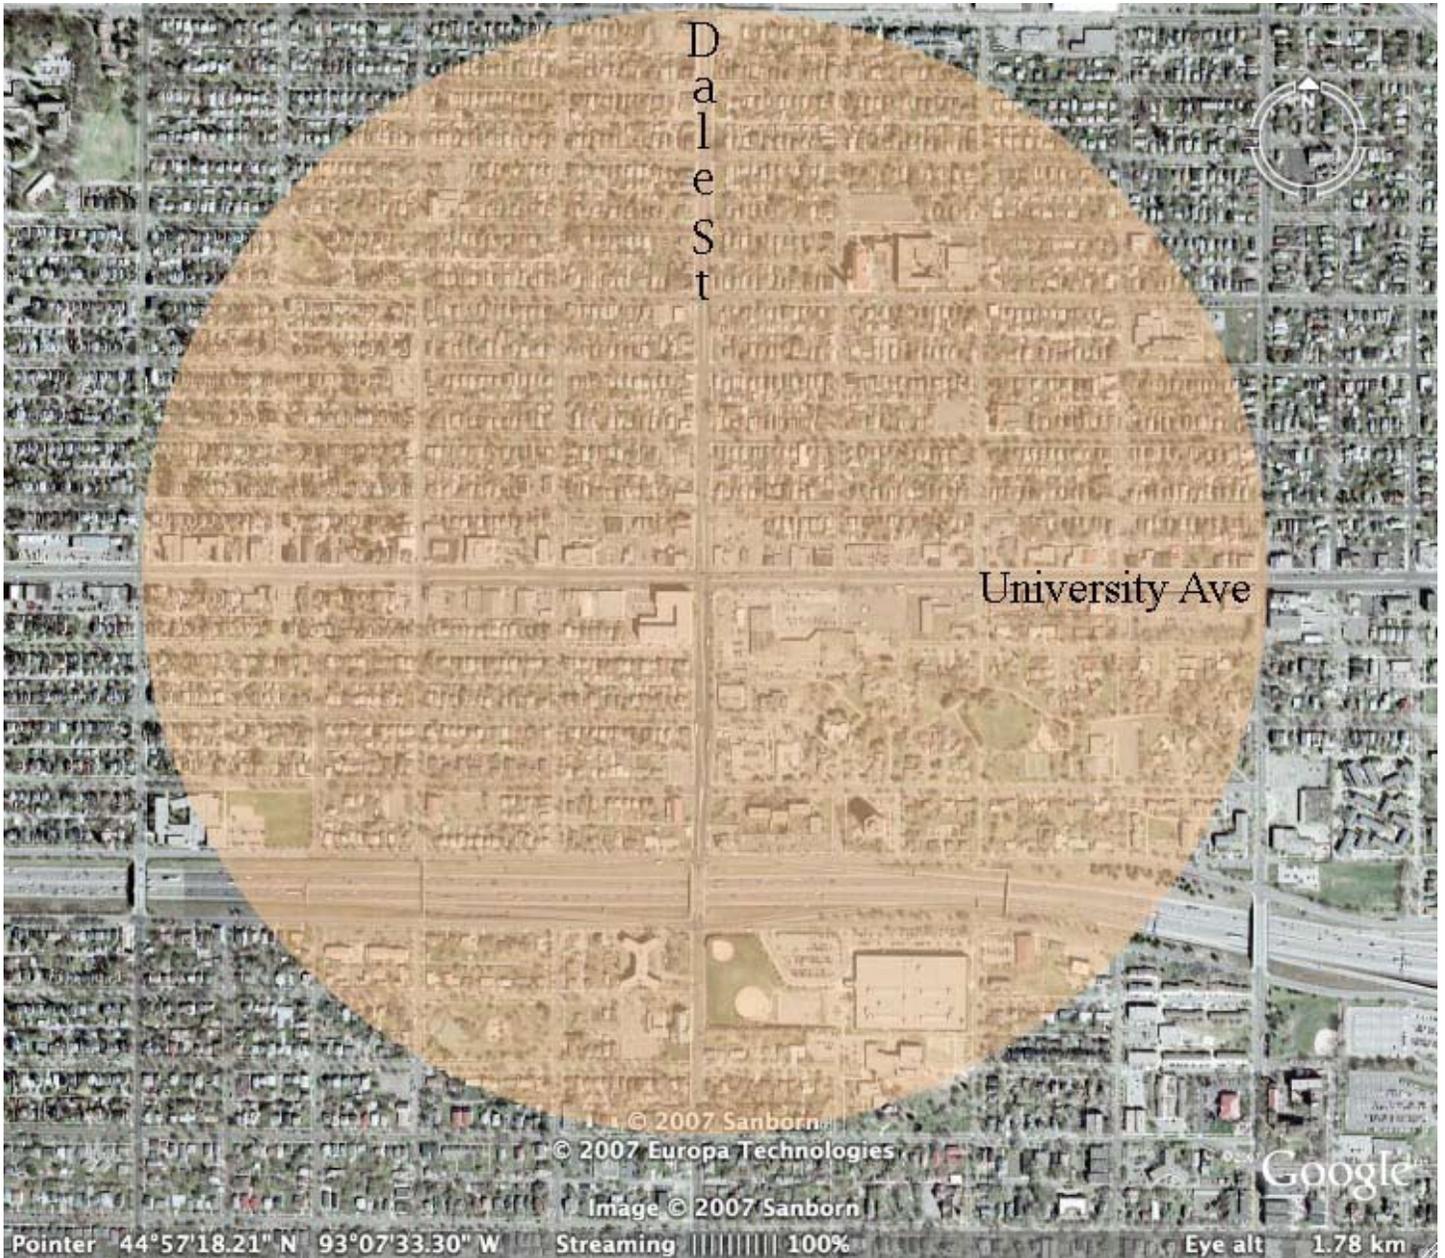
Appendix F: Dale Land Use Maps Continued

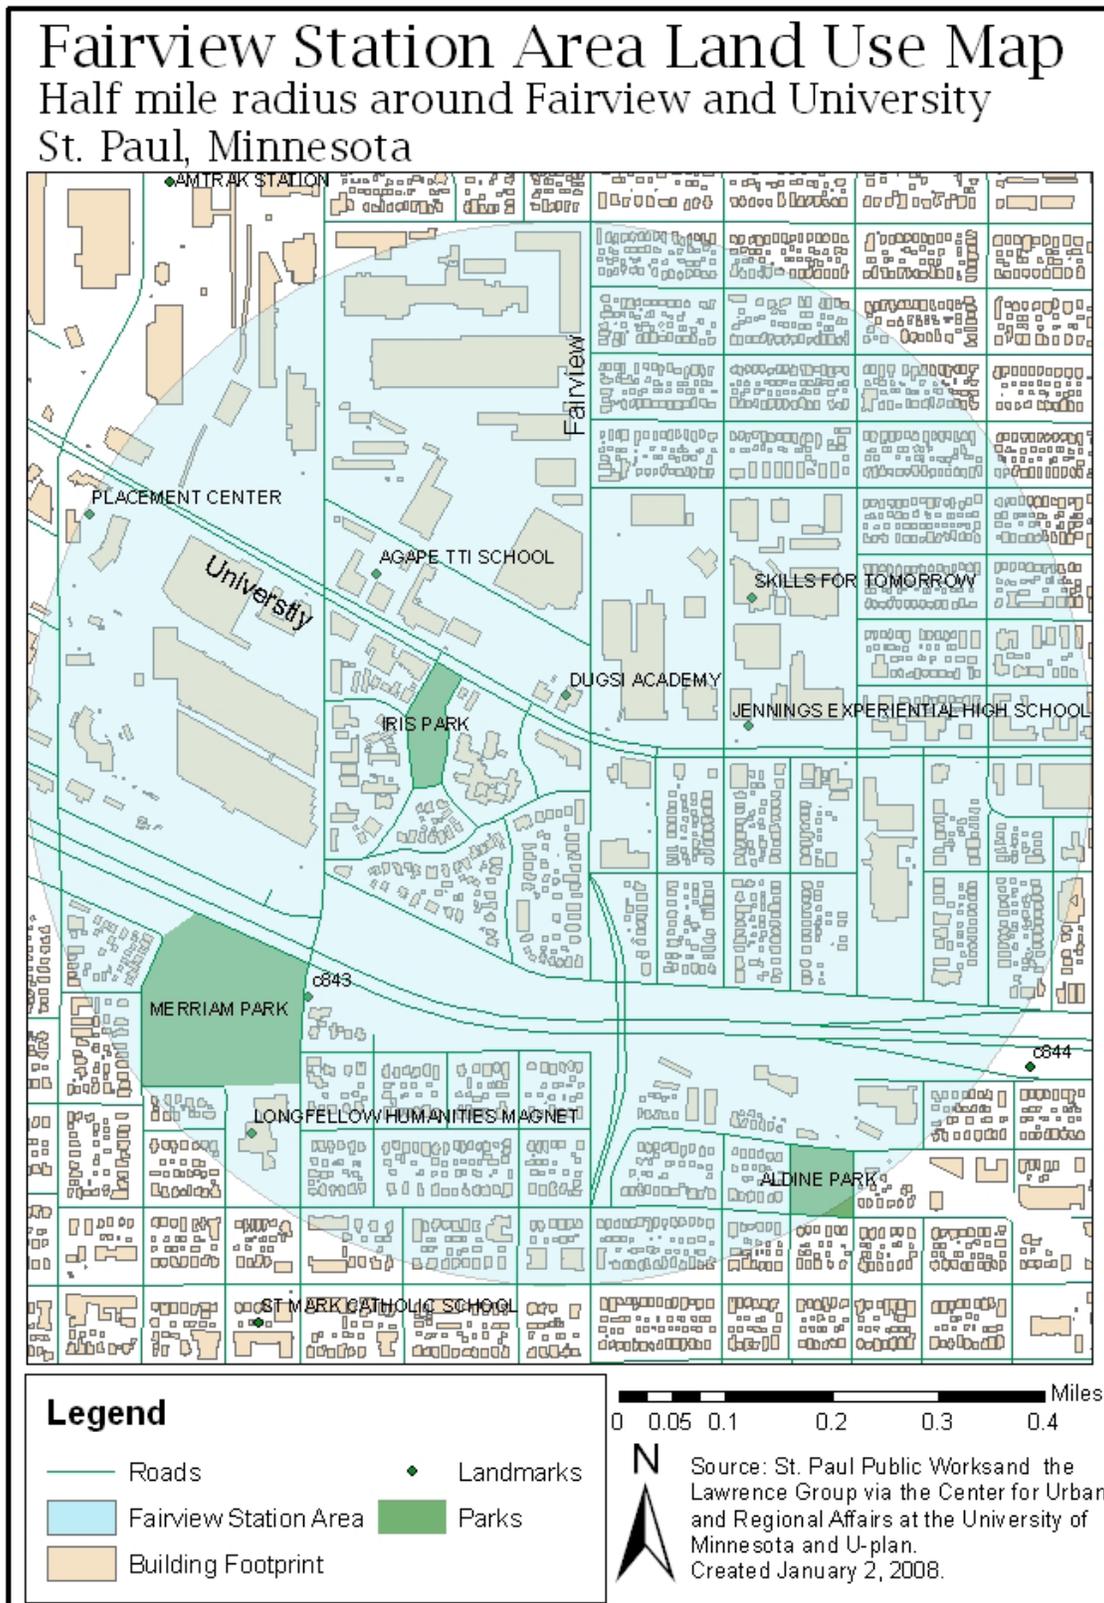
Appendix G: Fairview Land Use Maps

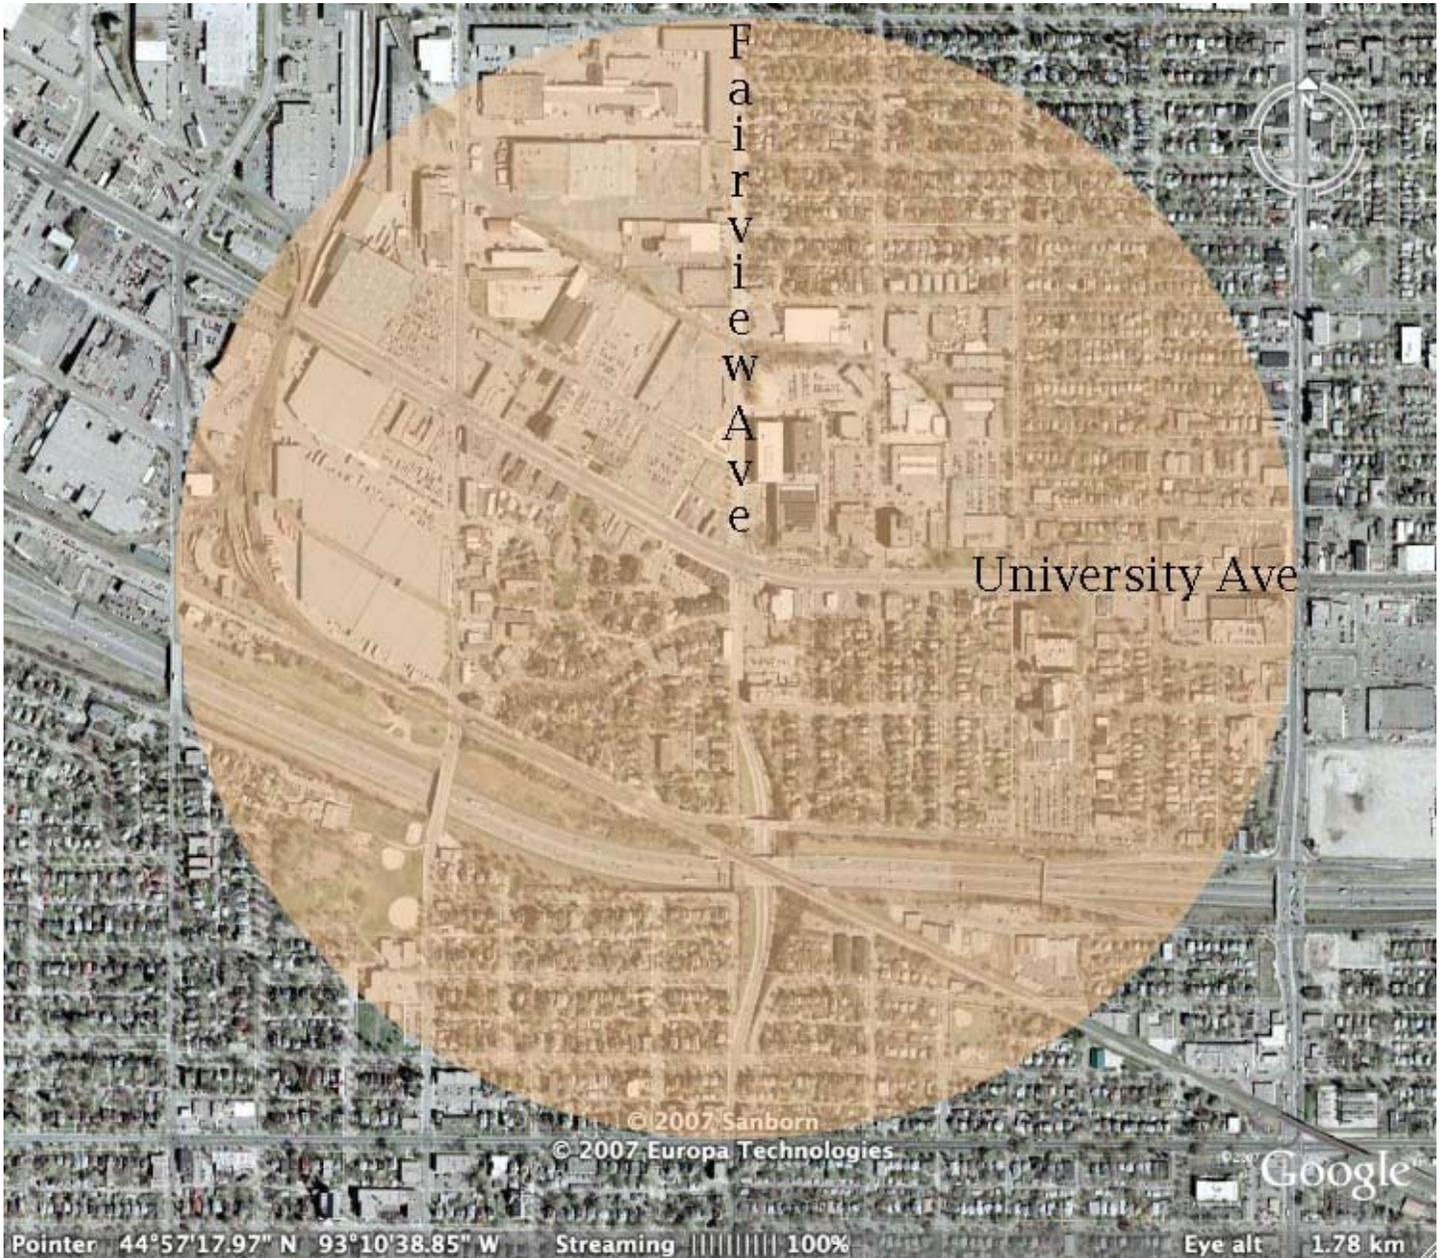
Appendix G: Fairview Land Use Maps Continued
