Review of Georgia's Rural Intersection Crashes: Application of Methodology for Identifying Intersections for Intersection Decision Support (IDS)

Report #5 in the Series: Toward a Multi-State
Consensus on Rural Intersection Decision Support

Final Report

July 2007

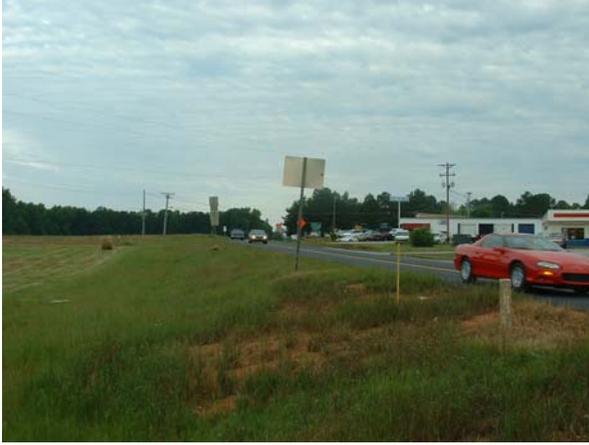
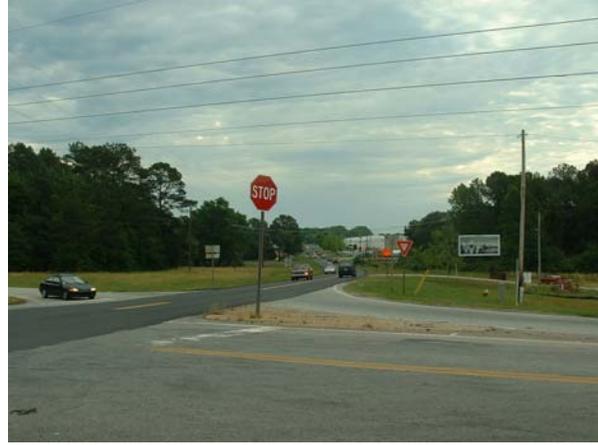
FIGURE 4-3
Looking West (left photo) and East (right photo) from the GA 83 Approach

It was observed during the field review that a major movement for traffic approaching the intersection on GA 83 is to turn right, towards Madison. There were also many vehicles leaving Madison (going west on GA 12) that were turning left onto GA 83 southbound, likely heading to I-20 located a few miles to the south. At the time of the field review, the traffic volumes on GA 12 were also observed to be high enough that there were a limited number of lags available for vehicles stopped and waiting to cross or turn onto GA 12 (see **Figure 4-3**).

The intersection is located on a horizontal curve along GA 12, which is visible in the aerial photo. However, the photos in **Figure 4-3** show that available sight distance is acceptable. The west approach of GA 12 also has a small crest vertical curve which can hide a vehicle on the other side of the crest (left photo of **Figure 4-3**), but timings made the morning of the field review revealed that ten seconds of sight distance was generally still available for approaching vehicles. Observed improvements to the intersection include transverse rumble strips on the Confederate Road approach. There is also a channelized right turn lane for northbound GA 83 (**Figure 4-4**) with a YIELD sign.

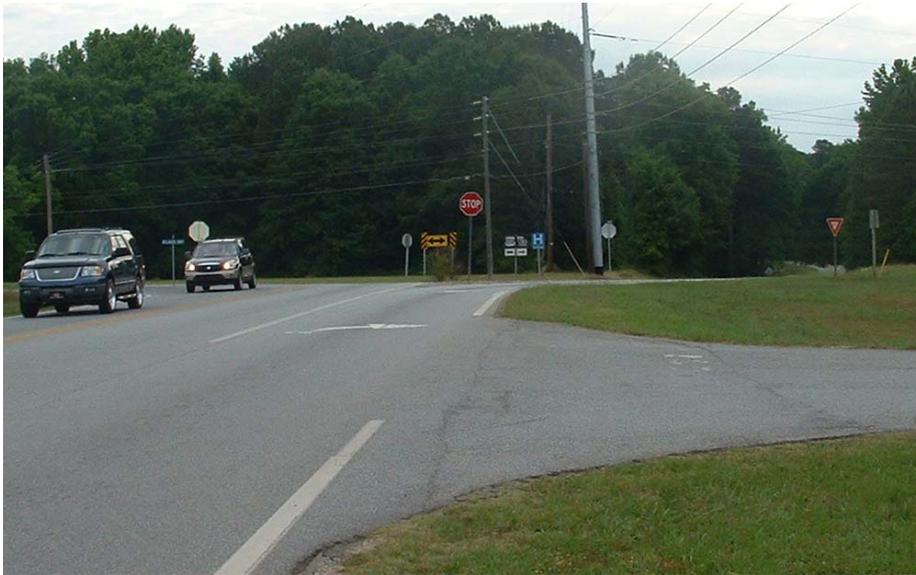
FIGURE 4-4
Northbound Approach of GA 83

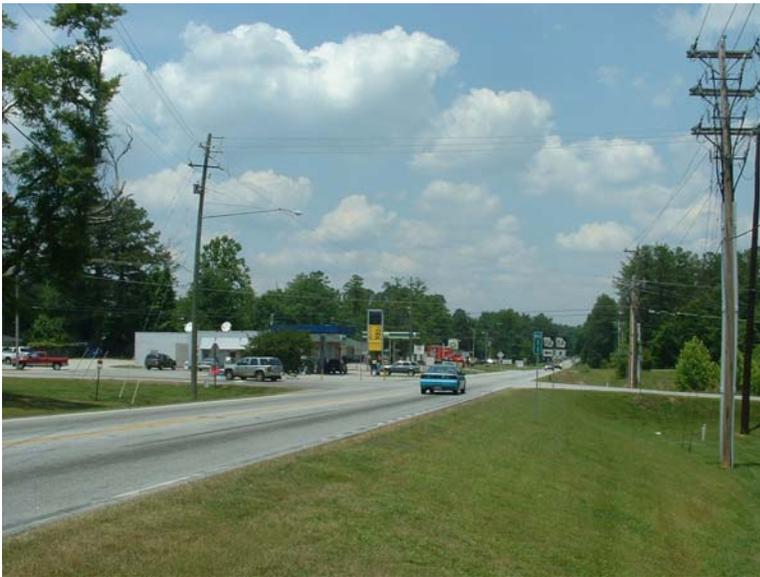
FIGURE 4-5
On GA 54 Looking North at Candidate Intersection

speed limit for GA 54 is 45 mph and 35 mph on GA 154. Intersection lighting is provided at the intersection (visible in **Figure 4-5**), otherwise the intersection was unimproved.

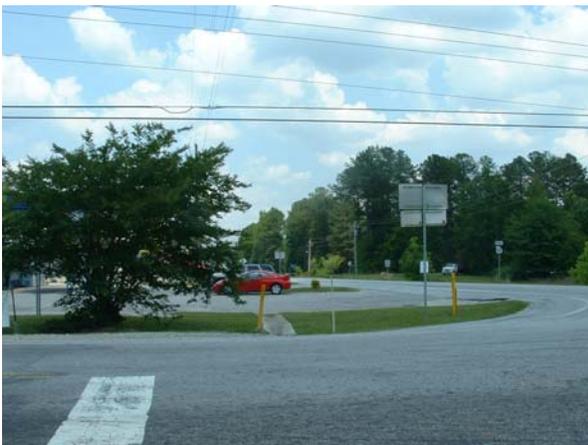
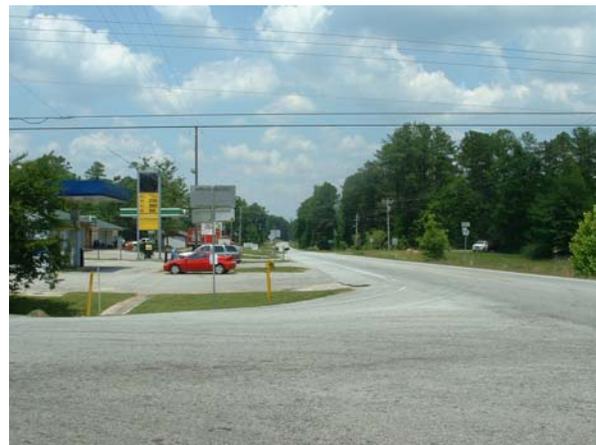
FIGURE 4-6
On West Approach of GA 154, Improved Sight Distance if Driver Creeps Past STOP Sign

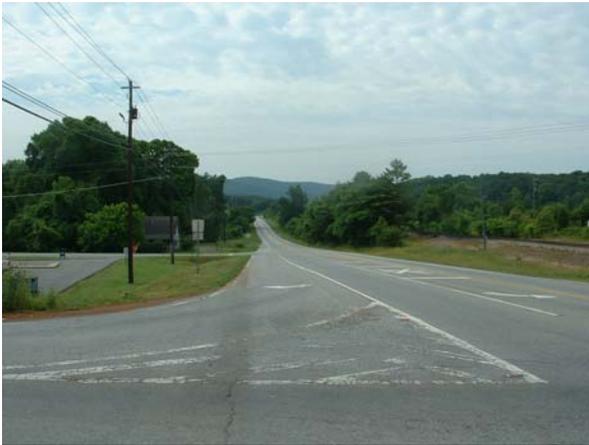
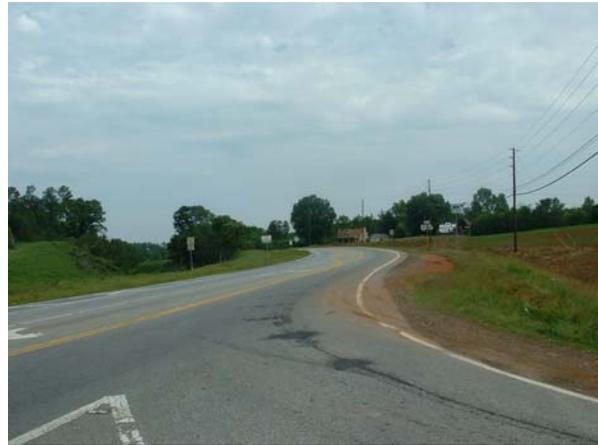
FIGURE 4-7

Looking South (left photo) and North (right photo) from the East Approach of GA 140

The intersection of GA 61 (also marked as US Highway 411) & GA 140 is located in a rural portion of Bartow County. GA 61 is a rural, two-lane highway with a posted speed limit of 55 mph. At the intersection, GA 61 left and right turn lanes are provided for both approach directions (visible in **Figure 4-7**). GA 140 is also a rural two-lane highway with a 55 mph speed limit, but both approaches are stop controlled. Both approaches of GA 140 also include a channelized right turn lane with a YIELD sign (**Figure 4-8 and 4-9**).

At this location, the crash diagrams in **Appendix A** show that an overwhelming majority of the crossing path crashes involve a driver from the east approach crossing GA 61. Also, many of these crashes involve a vehicle southbound on GA 61. The photos in **Figure 4-7** and **Figure 4-9** demonstrate that the line of sight for these drivers is not obstructed and sufficient sight distance is available. There is a combination horizontal and vertical curve located north of the intersection which may be creating difficulties in identification and selection of a safe lag. This crash pattern is an area of particular interest that could be investigated as part of collection of driver behavior data.

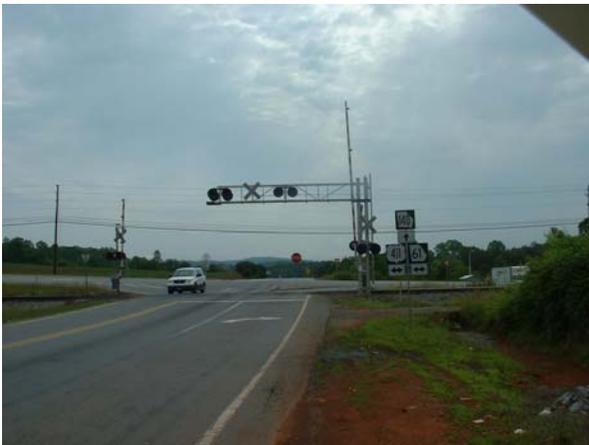
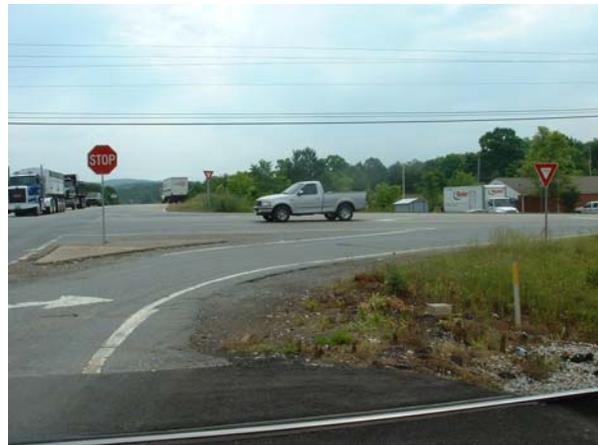
FIGURE 4-8

GA 140 Eastbound Approach (left photo) and Channelized Right Turn Lane (right photo)

An active railroad line closely parallels GA 61 to the west, creating an at-grade railroad crossing in close proximity to the intersection (**Figure 4-8**). Because of this, deployment of a IDS system at this location must be able to also sense when a train is approaching and the gates are down. That way, a driver stopped on the east approach and planning to cross GA 61 wouldn't be given a message that it is safe to cross while the gates are down.

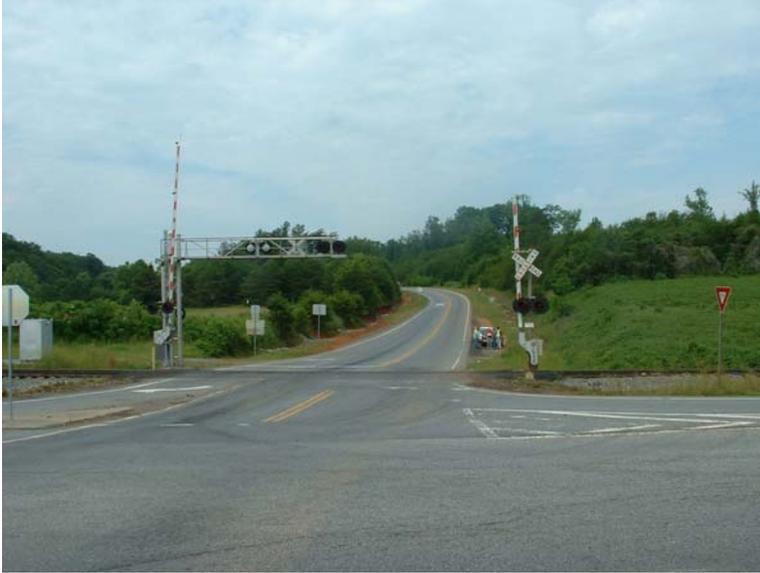
FIGURE 4-9

View of Railroad Crossing from the East Approach of GA 140

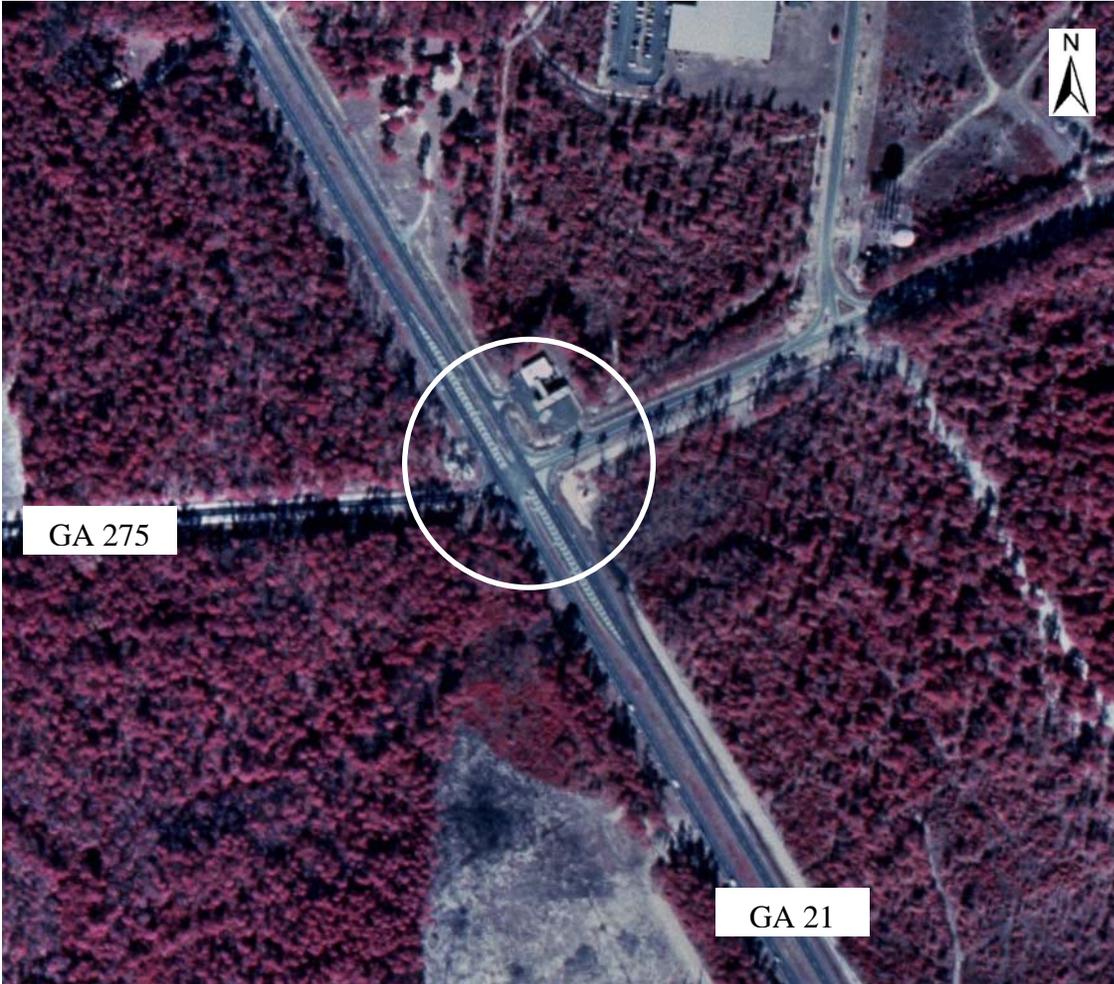
FIGURE B-2
Aerial Photo of GA 21 & GA 275 (#2)
Source: Eaton County

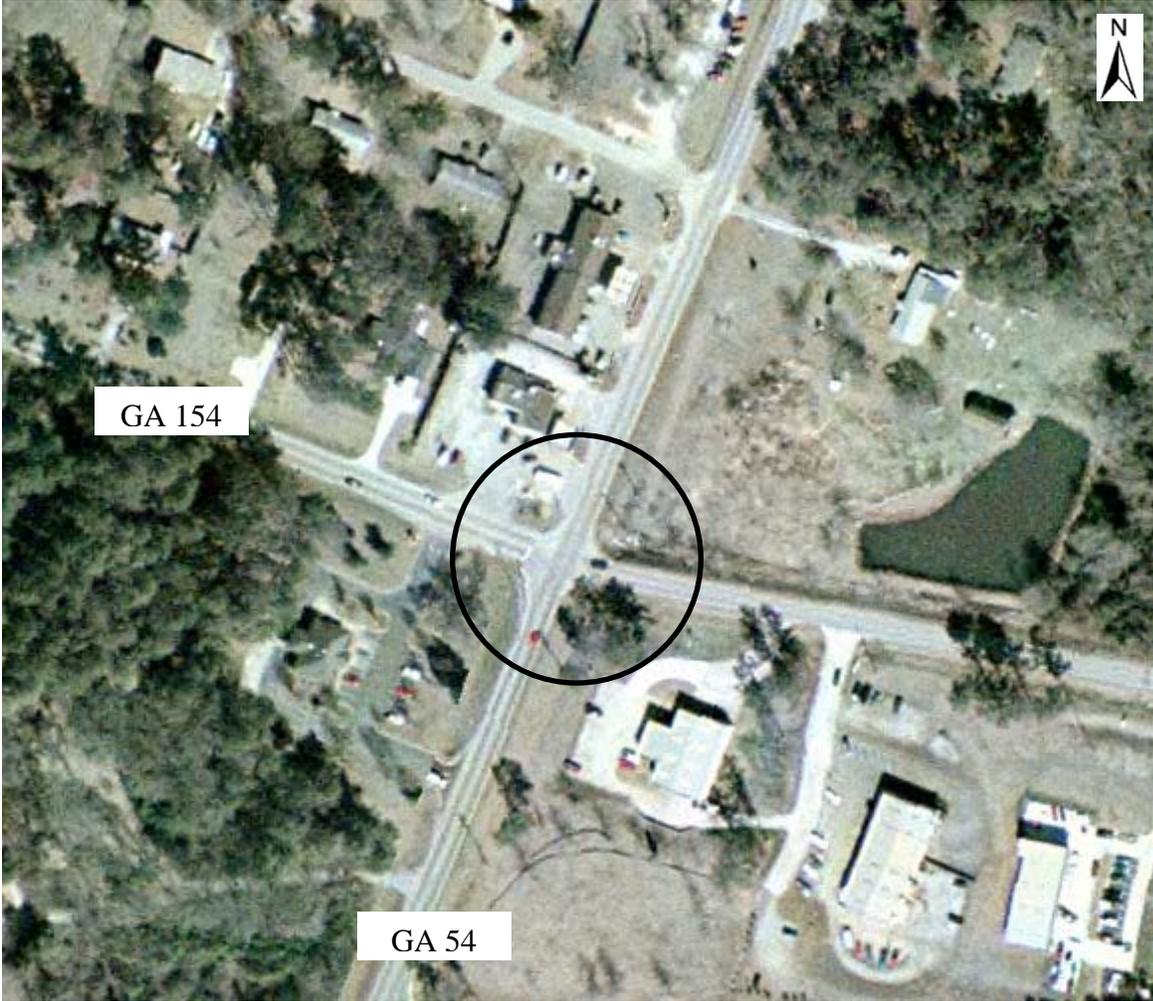
FIGURE B-3
Aerial Photo of GA 54 & GA 154 (#3)
Source: Georgia DOT
