**An Assessment of Land Use Impacts on
Channel Morphology in a Western Minnesota Watershed**

A dissertation submitted to the Faculty of the Graduate School of the
University of Minnesota

William Thomas Christner Jr.

December 2009

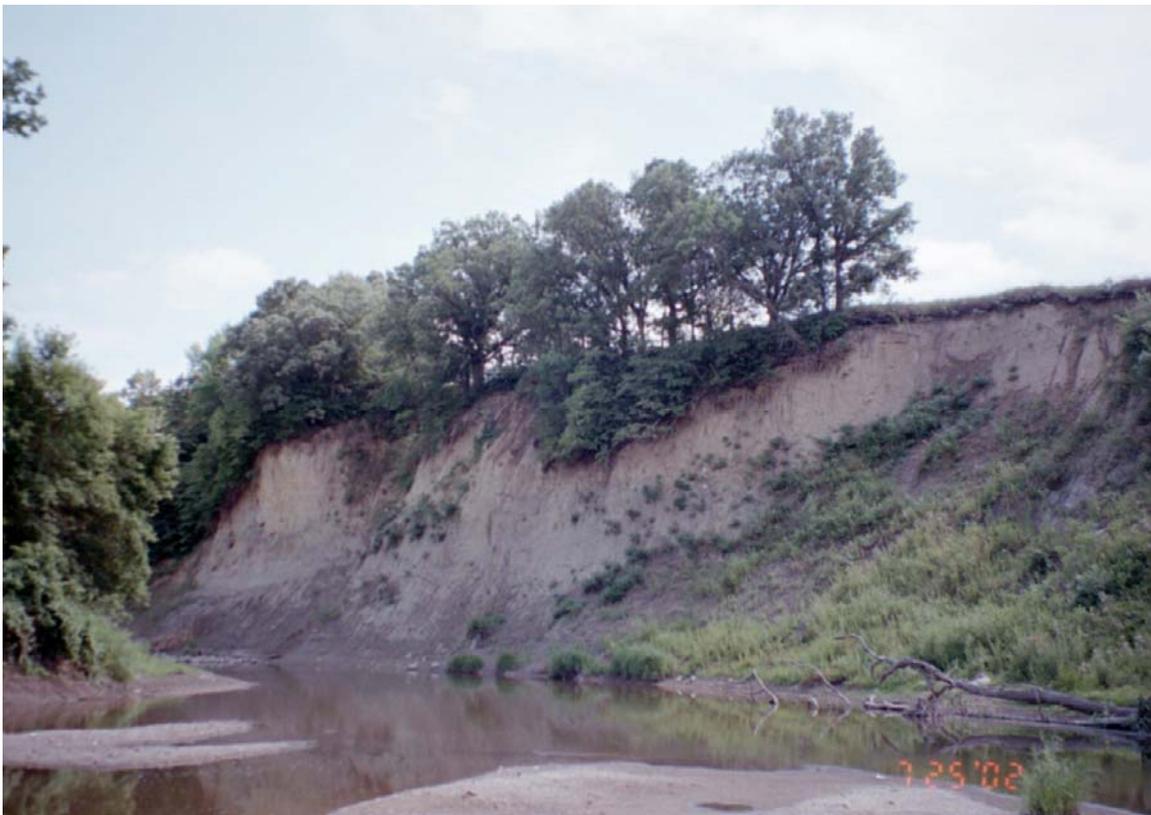
Figure 4.11. Downstream view at XS-128 illustrating the steep bluffs found along the SF LqP River in the Lower watershed. Soil material is actively eroding into the SF LqP River due to erosion at the toe-of-slope. Vegetated area in foreground is a remnant slope failure.

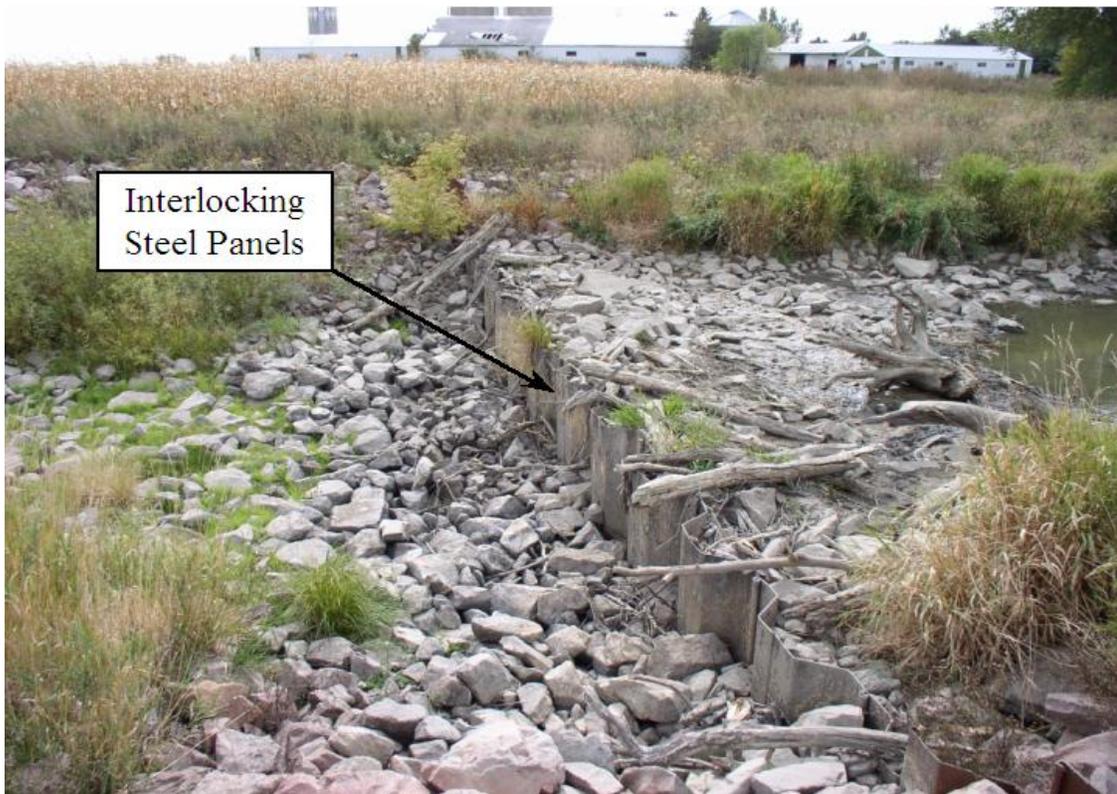
Figure 4.14. Installation of inter-locking steel panels to arrest channel erosion initiated by the construction of the by-pass channel between river miles 61.6 and 65.9.

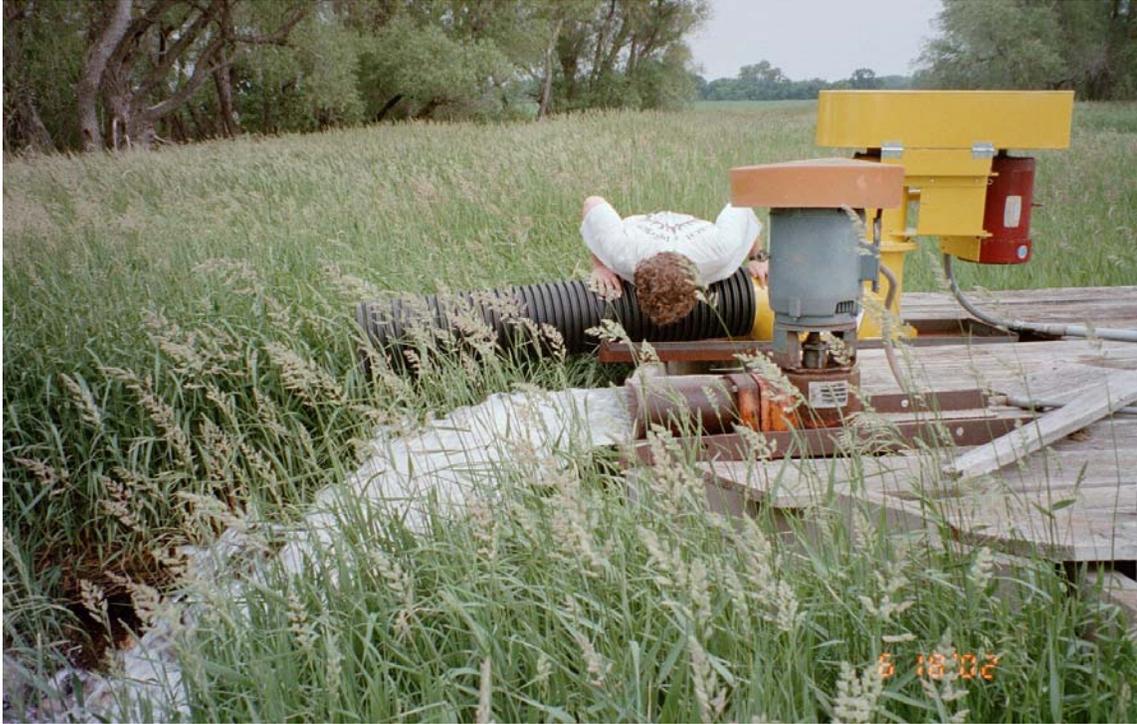
Figure 4.17. Discharge from sub-surface drainage collection tank near CoE cross-section #32 into SF LqP River.

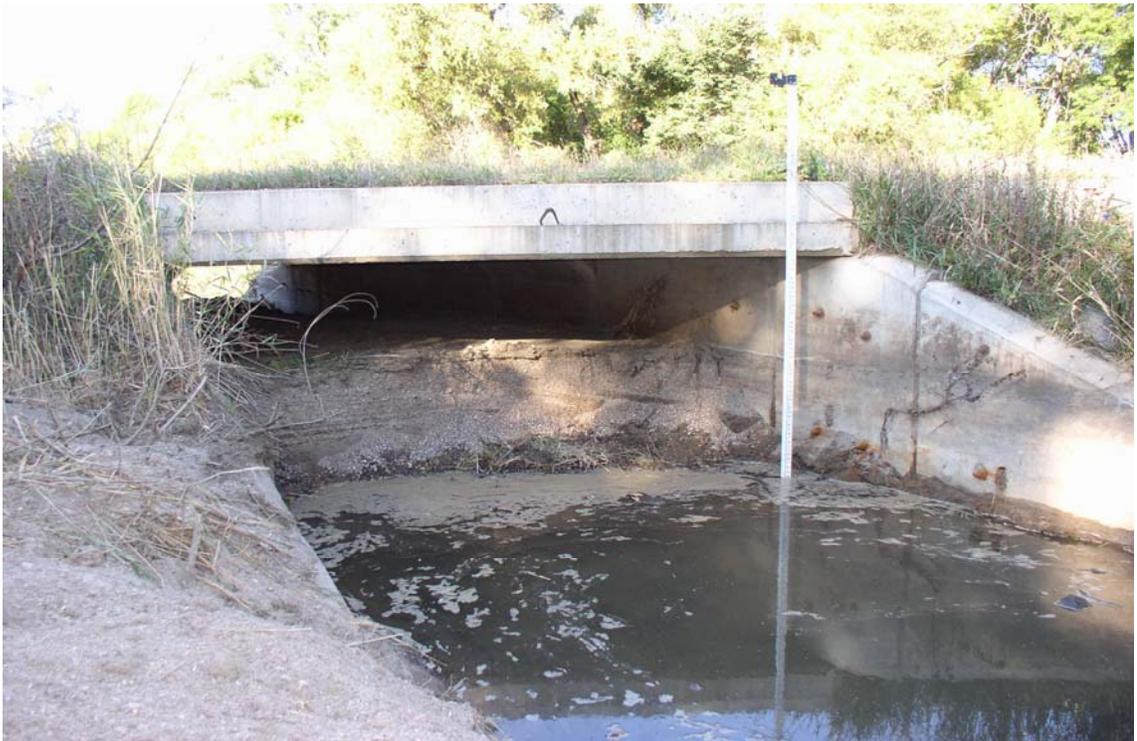
Figure 6.2. Sediment accumulation in a box culvert at U.S. Army Corp of Engineer’s bridge #23 in the Upper watershed of the South Fork Lac qui Parle River.
