Evaluation of Electrochemical
Chloride Extraction (ECE)
and Fiber Reinforced Polymer (FRP)
Wrap Technology

1. Report No. MN/RIC-2000-24	2.	3. Recipient's Accession No.	
4. Title and Subtitle EVALUATION OF ELECTROCHEMICAL CHLORIDE EXTRACTION (ECE) AND FIBER REINFORCED POLYMER (FRP) WRAP TECHNOLOGY		5. Report Date June 2000

Final Report

Mark Chauvin
Carol K. Shield
Catherine E. French
Department of Civil Engineering

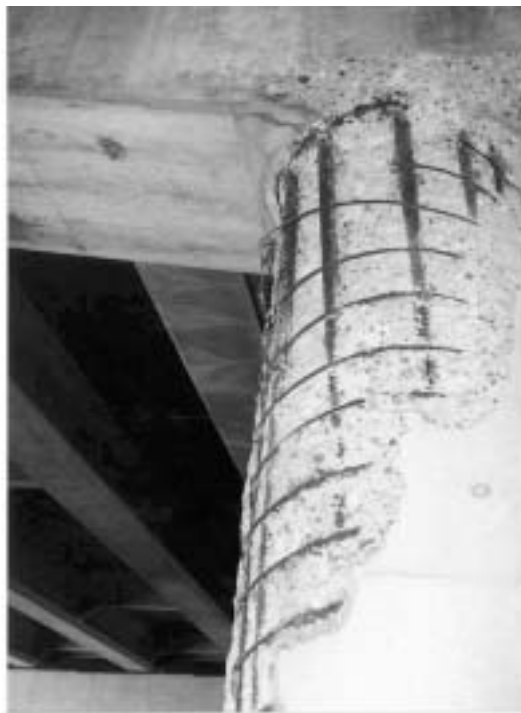
Figure 3.5: Repair on Pier 34 North between columns 34B and 34C [66]

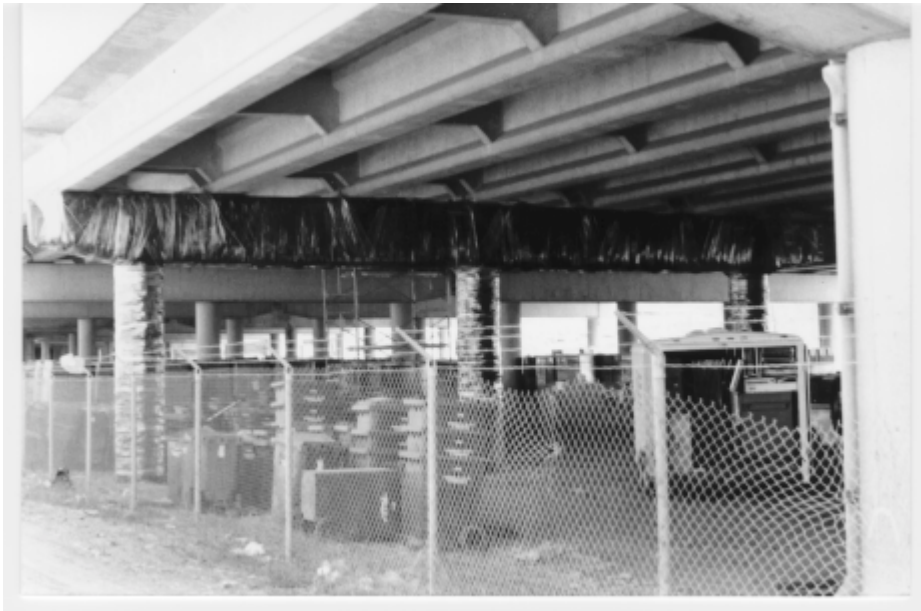
Figure 3.14: ECE system in place on Pier 34 North

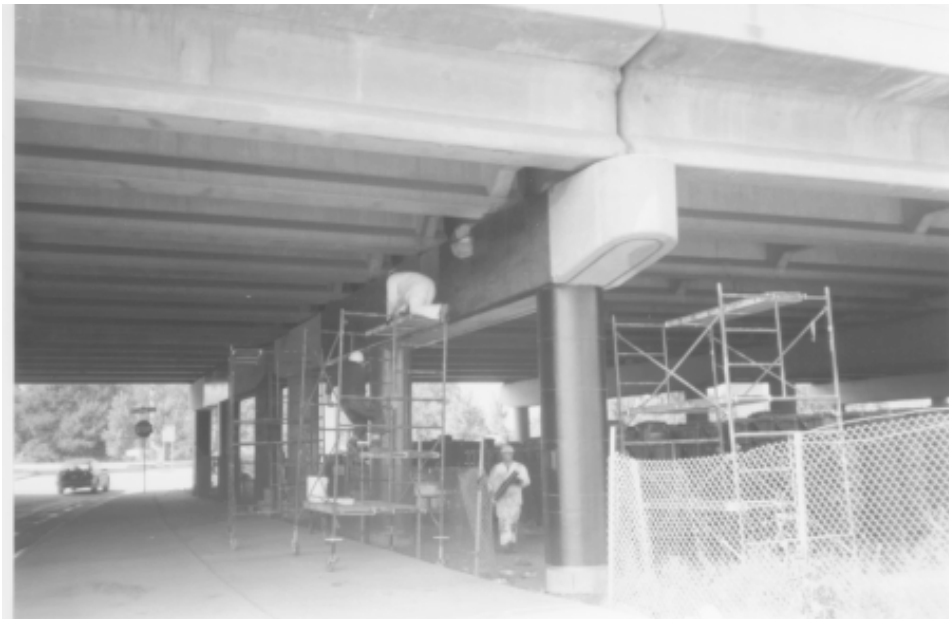
Figure 3.18: MBrace CFRP in place on Column 40A

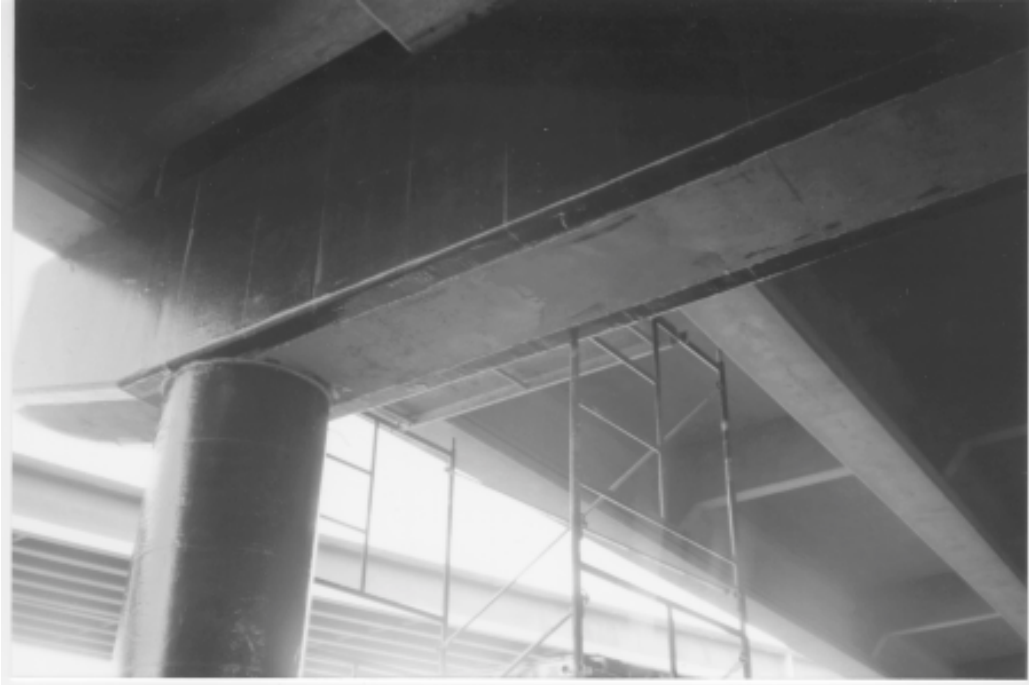
Figure 3.19: Installation of AMOCO CFRP in progress above Column 34F

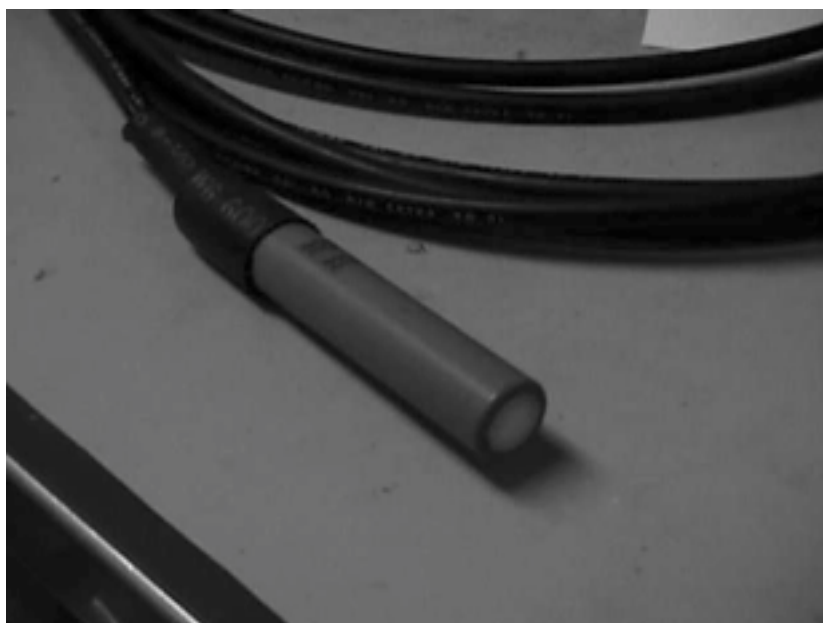
Figure 5.1: Schematic of Ag/AgCl reference electrode

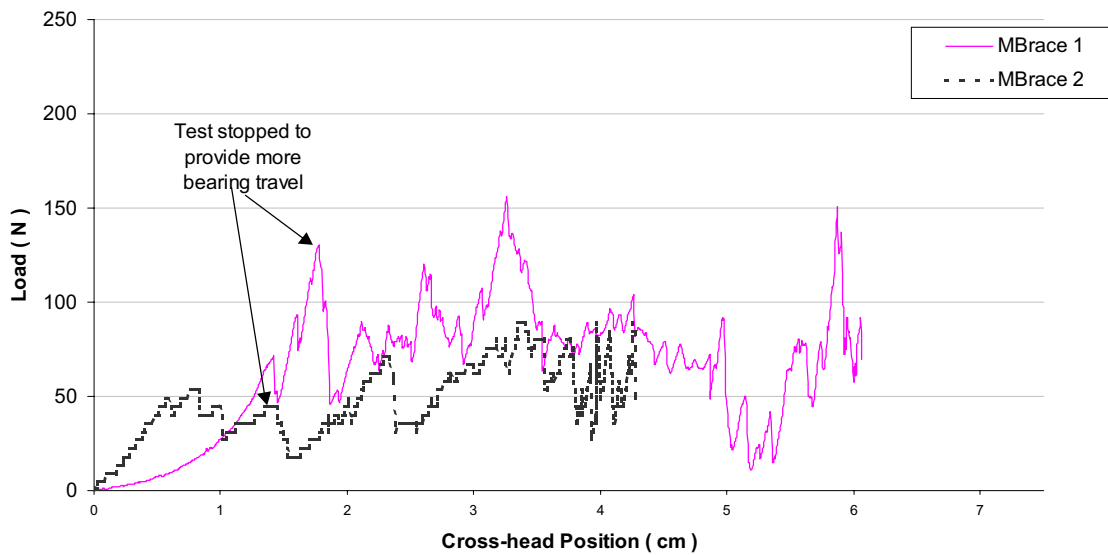
Figure 6.12: Peel test results of MBrace CFRP wrap
