2004-17B

Final Report

**PERFORMANCE TESTING OF EXPERIMENTAL
DOWEL BAR RETROFIT DESIGNS
PART 2 – REPEATABILITY AND MODIFIED
DESIGNS**

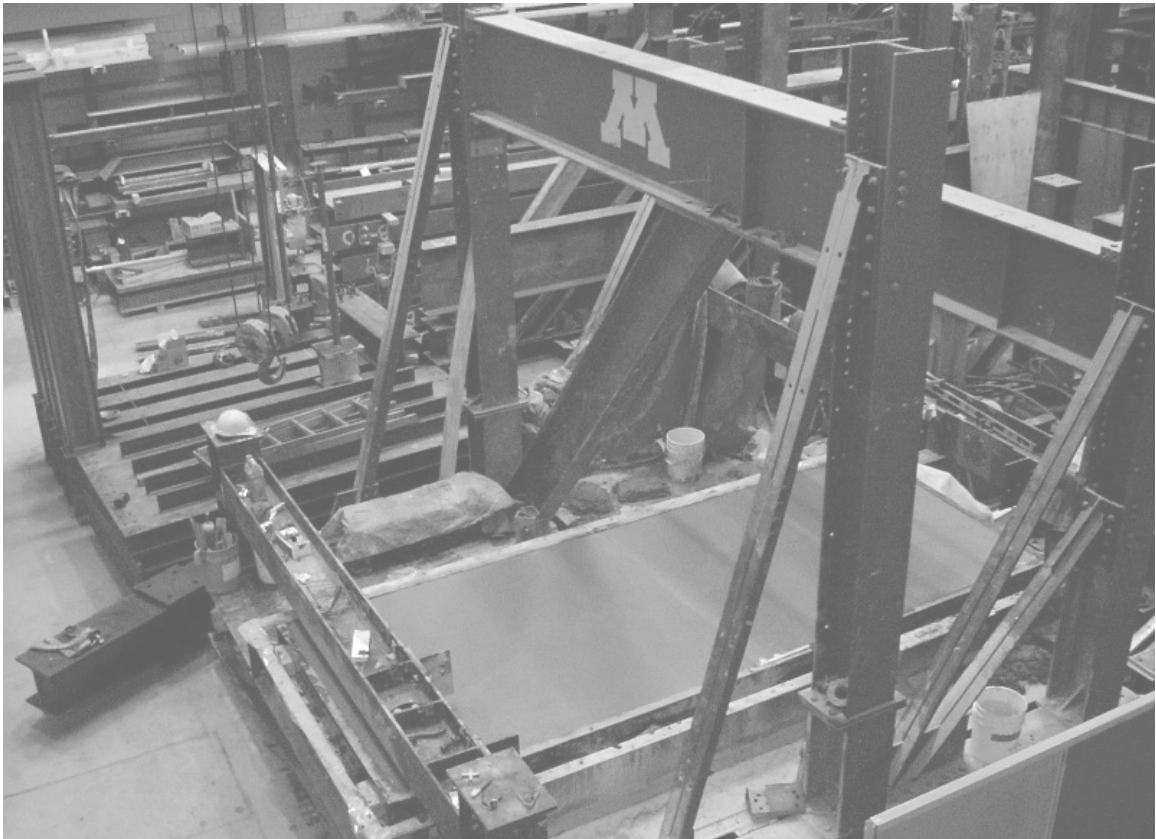
FIGURE 4-1: MINNE-ALF TEST FRAME WITH SPECIMEN

supplied from an outside vendor. The test slabs were cast in place on top of the pavement foundation material. The dimensions of all specimens were 15 feet in length, 6 feet wide, and 7.5 inches deep. The slabs were cast without dowel bars since the focus of this project is to determine the effects of retrofitting dowels in existing pavements. Figure 4-1 shows the Minne-ALF test facility with a test specimen immediately after casting.

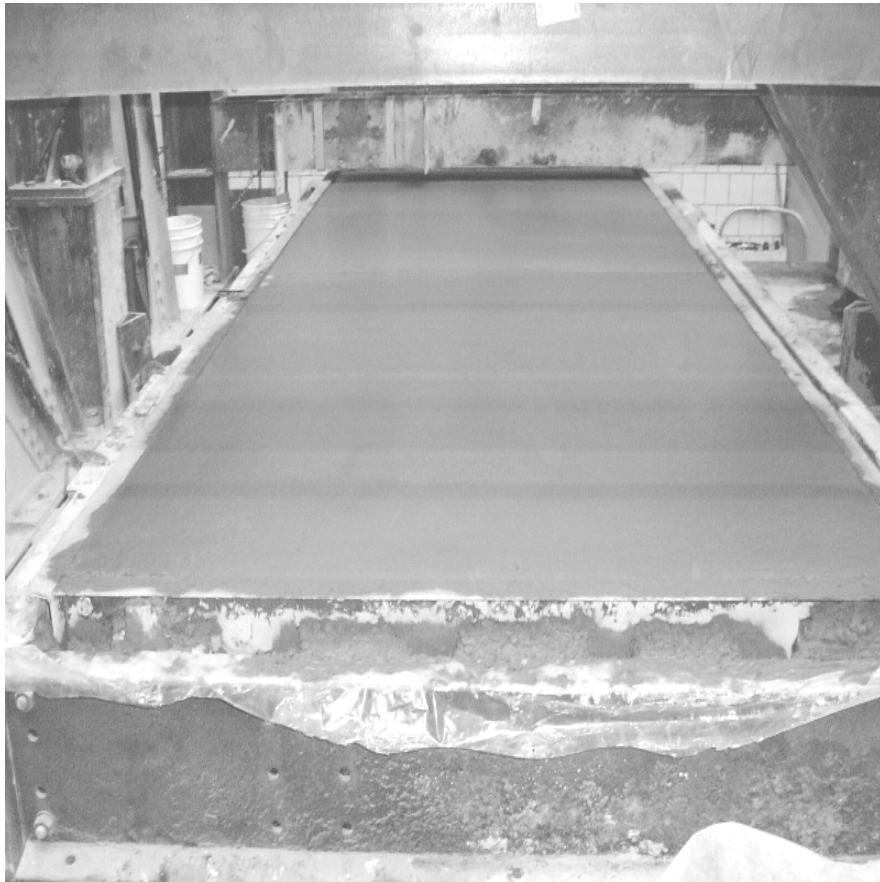
FIGURE 4-3: TEST SPECIMEN IMMEDIATELY AFTER CASTING

After the mix was confirmed to have acceptable slump and air content, the concrete was loaded into a crane operated dump bucket. The bucket was then maneuvered over the foundation and placed within the forms. As soon as the concrete was shoveled into place, a pencil vibrator was used for consolidation. This process was repeated until the required amount of concrete was placed. Roughly 1.5 cubic yards of concrete was craned in at a time, making about three loads necessary. After consolidation, a leveling screed was drawn back-and-forth across the surface to strike off any excess concrete. Next, a bullfloat, and later hand floats and trowels were used to achieve a smooth, finished surface. Figure 4-3 is a close up of a test specimen immediately after casting.

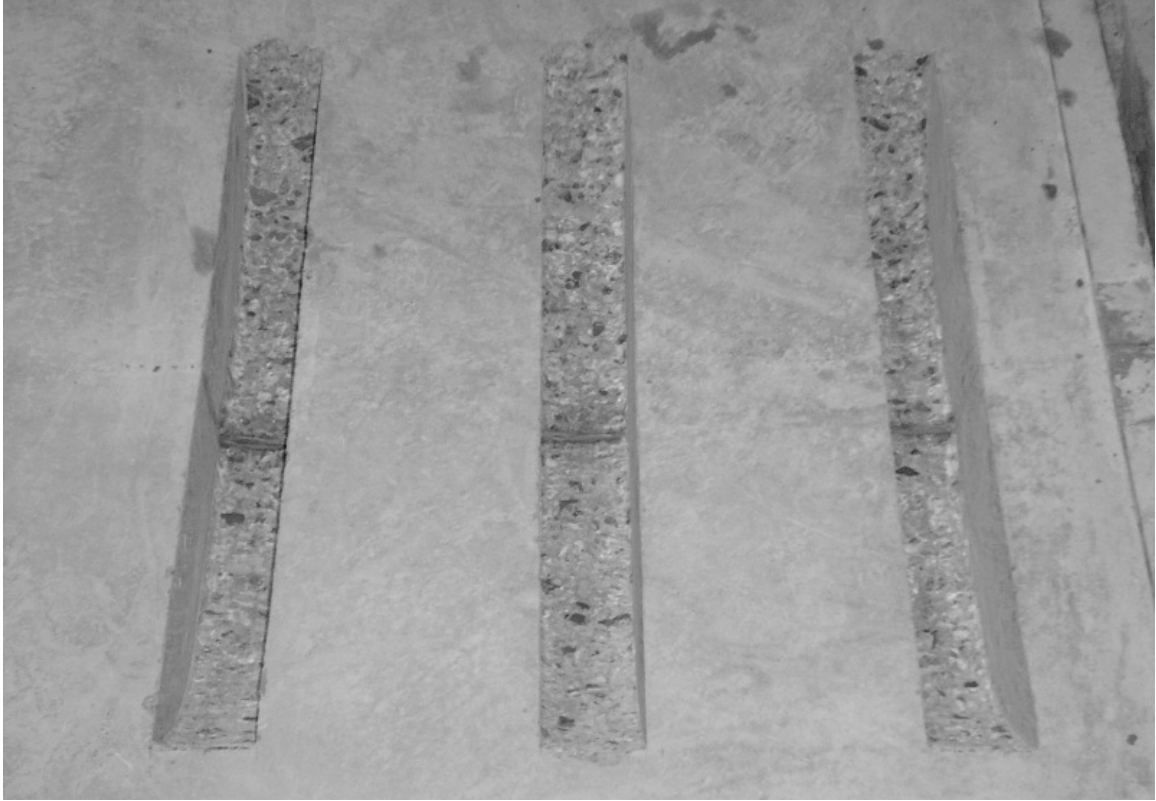
FIGURE 4-6: FINAL SLOTS AFTER REMOVAL OF DEBRIS AND CLEANING

When all the material had been removed, the slots were thoroughly cleaned. The slots were cleaned with water, compressed air, and brushes. Careful cleaning had to be performed so proper bonding of the concrete to the backfill material could be achieved. Figure 4-6 shows three slots with the plywood joint in the center after removal of all material and cleaning. The rectangular piece of wood that was removed from the joint when the slots were cut now needed to be replaced. Each slot was fitted with a custom cut, $\frac{1}{4}$ -inch thick piece of plywood to match the existing joint. The fitted plywood pieces each contained an appropriately positioned hole to allow for the dowel to snugly pass through. Prior to the backfilling of the slots, the dowels were placed in the slots and checked for proper alignment.

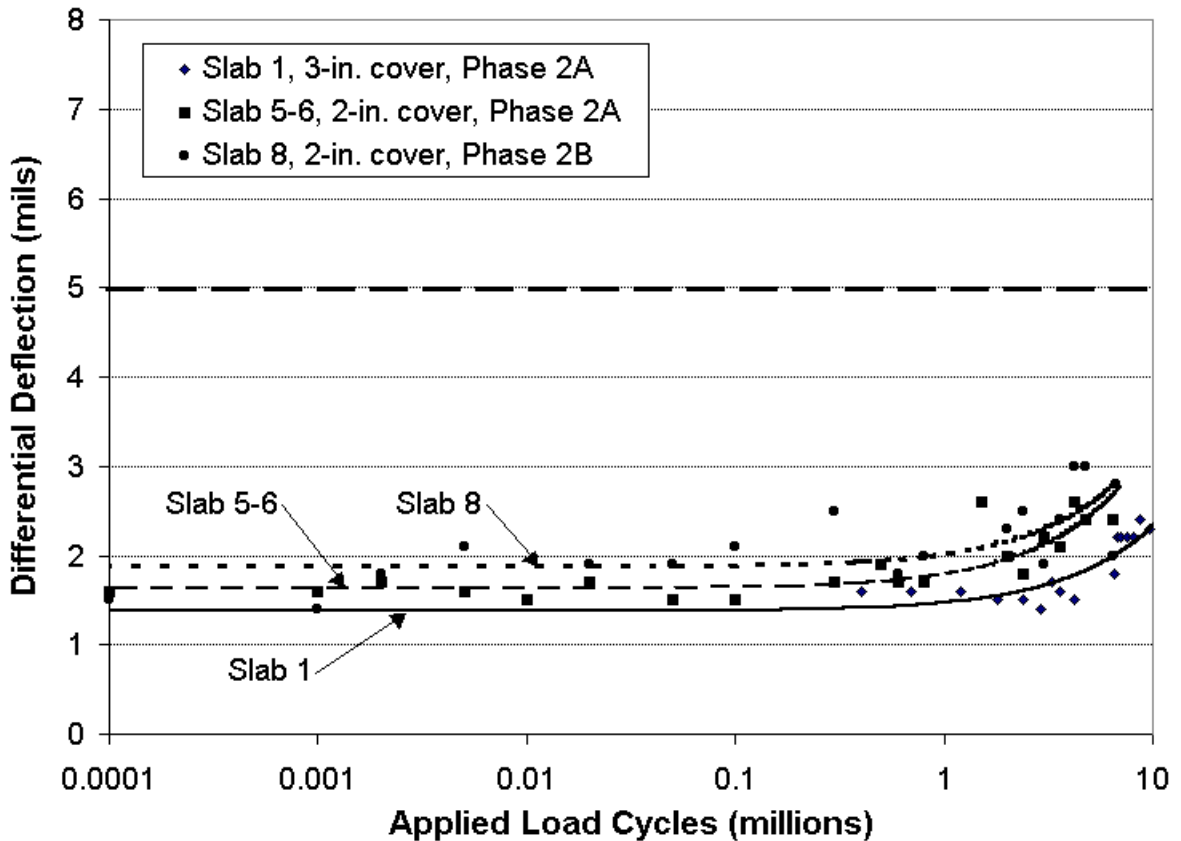
FIGURE 5-2: DIFFERENTIAL DEFLECTION EFFECTS OF CHANGING AMOUNT OF CLEAR COVER

The differential deflection performance of the dowel bar details mentioned above (Slabs 1, 5-6 and 8), relative to changing clear cover, are presented here. Figure 5-2 represents graphically the results obtained for the three dowel bar details in terms of differential deflection vs. applied load cycles.

The performance trends for differential deflection vs. applied load cycles were qualitatively similar to those found for LTE. The dowel bar details tested with two inches of clear cover resulted in slightly higher differential deflections than the detail tested with three inches of cover. From Figure 5-2, all three specimens exhibited differential deflections ranging from 1.4 mils to 3 mils throughout the duration of the 6.7 million applied load cycles. The three specimens in Figure 5-2 were well below the partial failure criteria of developing more than 5 mils of differential deflection. Slab 1 Phase 2A, with a dowel bar configuration placed with 3 inches of clear cover resulted in the lowest differential deflections. Slab 5-6 Phase 2A and slab 8 Phase 2B, which both used 2 inches of clear cover over the dowels, had increasingly larger overall differential deflections. Similar to the LTE results, after approximately 700,000 load cycles, more differential deflection was observed for all slab specimens.

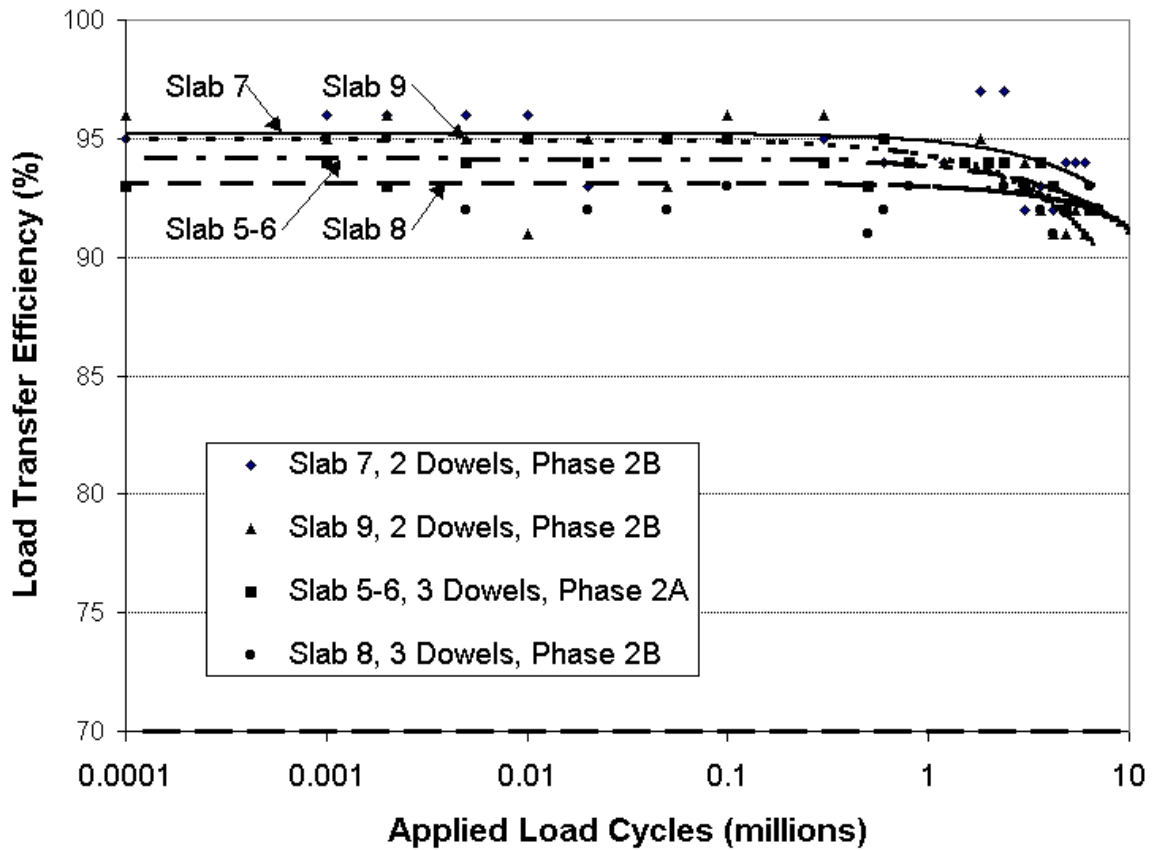
FIGURE 5-3: LTE EFFECTS OF CHANGING THE NUMBER OF DOWEL BARS

The performance of the four dowel bar details, as indicated by measured LTE, did not vary significantly as the number of dowel bars were reduced from 3 to 2 as indicated in Figure 5-3. At the onset of testing, load transfer efficiencies ranged from 93 percent to 96 percent. The specimens containing 2 dowels (Slabs 7 and 9 from Phase 2B) performed slightly better than the details with 3 dowels (Slabs 5-6 from Phase 2A and 8 from Phase 2B). However, the differences in LTE between the specimens were very small, on the order of 1 to 3 percent. As with other specimens, load transfer efficiencies started to decline for all specimens nearing 1 million applied load cycles. But, this decline was relatively minor as well, with final recorded LTE values ranging from 91 percent to 94 percent. All the details (Slabs 5-6, 7, 8, and 9) were well above the partial failure criterion of 70 percent LTE.

The performance of the dowel bar details as measured by load transfer efficiency does not appear to be greatly affected by reducing the number of dowel bars. Since the dowel bar details containing 2 dowels performed as well or better than the details with 3 dowels, with respect to LTE, it is concluded that reducing the number of dowels may be an effective cost saving measure. It is important, however, to consider LTE along with differential deflection (discussed in the following section) in order to make conclusive determinations as to the performance of the specimens.

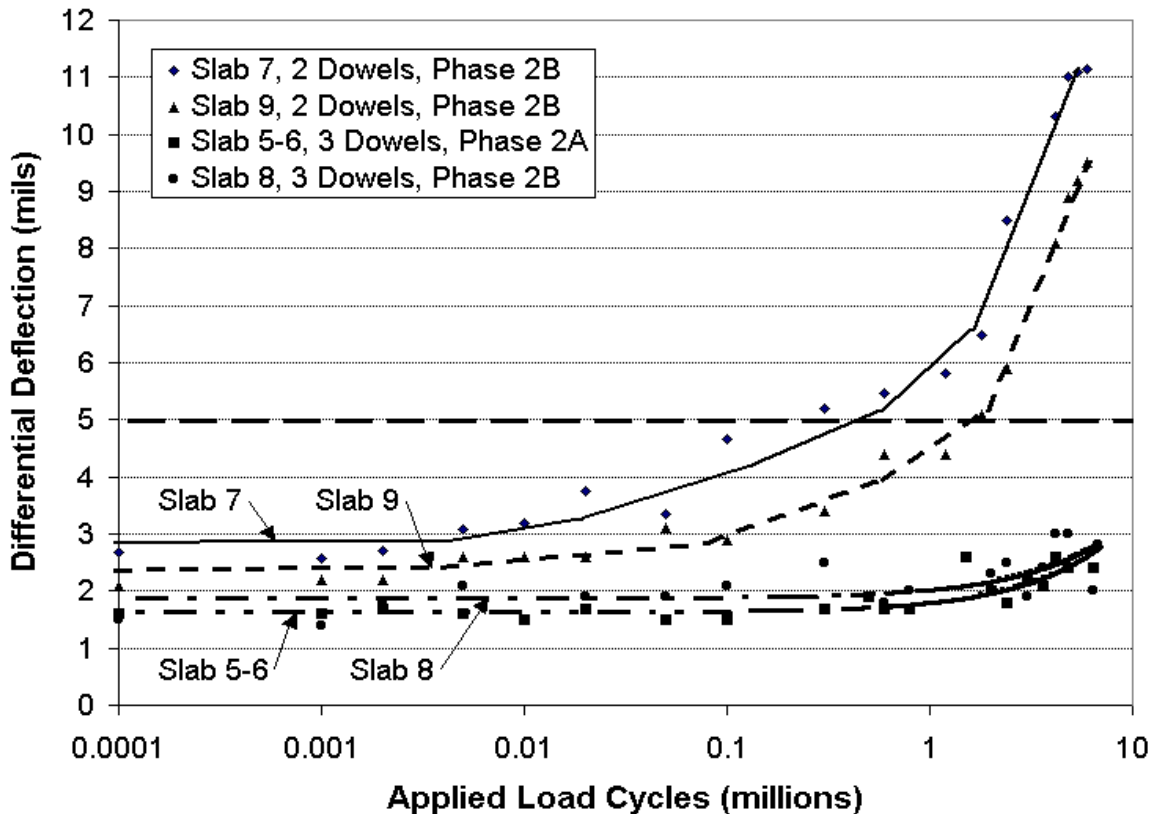
FIGURE 5-4: DIFFERENTIAL DEFLECTION EFFECTS OF CHANGING THE NUMBER OF DOWEL BARS

The differential deflections of the specimens with varying number of dowel bars are shown in Figure 5-4. While the LTE results remained consistently high for all 4 specimens during the testing (Section 5.3.2.1), the differential deflections showed significant variations. The two details containing 3 bars (Slab 5-6 and Slab 8) exhibited relatively low differential deflections throughout test duration, with slight increases in differential deflections beginning at 700,000 load cycles and continuing thereafter. Moreover, maximum differential deflections for the specimens containing 3 dowels never exceeded 3 mils, which is well below the differential deflection failure criterion (5 mils).

Conversely, the two slab specimens retrofitted with only 2 dowel bars (Slab 7 and Slab 9) attained much larger differential deflections over the duration of testing. Both specimens exhibited very similar rates of increasing differential deflections. Dowel bar details for Slab 7 and Slab 9 in Figure 5-4 initially produced differential deflections between 2 and 3 mils. Near 5,000 cycles of applied load, both specimens began to show an increasing trend in differential deflection. At roughly 400,000 load cycles, Slab 7 was undergoing differential deflections larger than 5 mils (i.e., the partial failure criterion for differential deflection). Slab 9 crossed the 5 mil differential deflection limit at about 1.5 million load cycles. Both specimens then continued to show rapidly increasing differential deflections throughout the duration of the tests until their conclusion at 6.7 million applied load cycles. Slab 7 dowel bar detail ended with a final differential deflection of 11.1 mils, while Slab 9 finished slightly lower with 9.5 mils differential deflection.

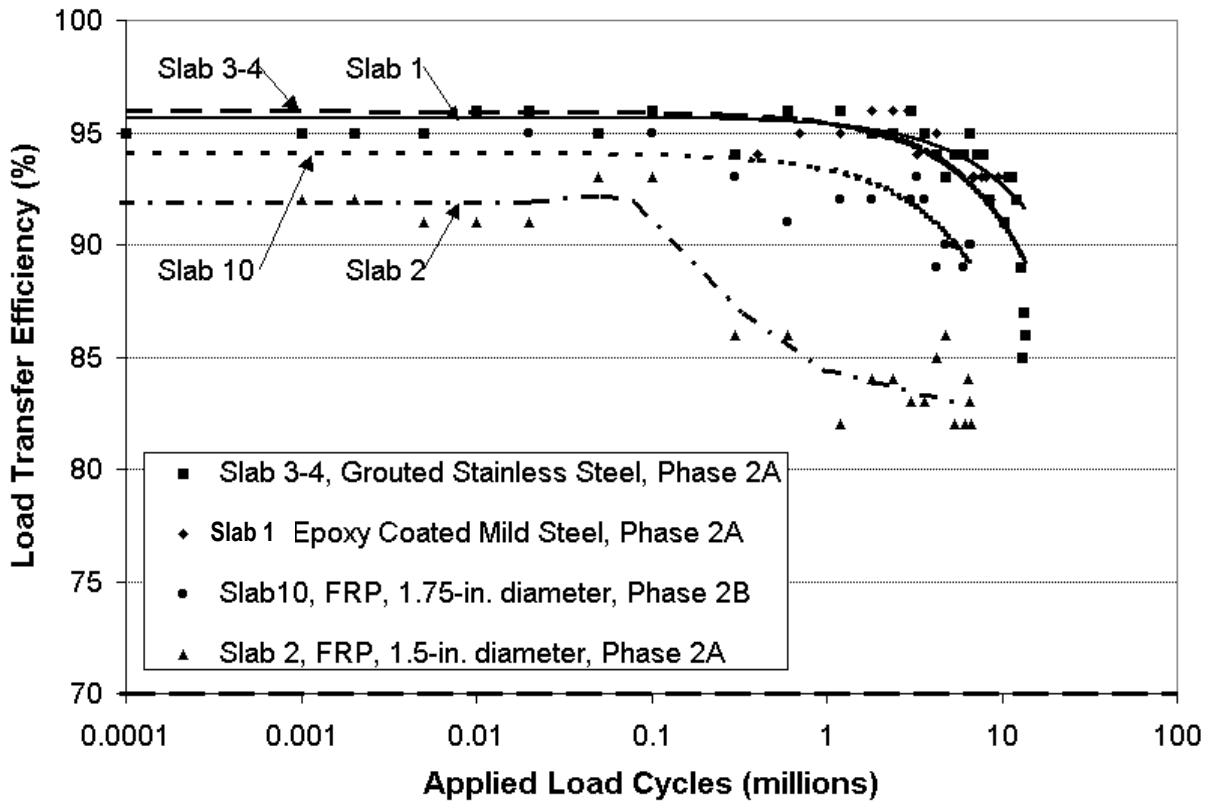
FIGURE 5-5: LTE COMPARISON OF DOWEL BAR MATERIALS AND FRP DIAMETER

Figure 5-5 shows the performance of the different dowel bar materials with respect to load transfer efficiency. Slab 1, containing epoxy coated mild steel dowels, and Slab 3-4, containing grouted stainless steel tube dowels, demonstrated very similar load transfer efficiencies through about 8 million load cycles. Slab 3-4, however, shows a significant drop in LTE after 8 million load cycles. The grouted stainless steel tube dowel performed as well as the epoxy coated solid steel dowel up to 8 million cycles, but afterwards the performance of the former began to deteriorate faster.

The specimens containing FRP dowels (Slab 2 and Slab 10) performed with lower LTEs than Slabs 1 and 3-4. Slab 2, containing FRP dowels with a diameter of 1.5 inches, showed a significant drop in LTE after 100,000 load cycles after starting with a nearly constant LTE of 92 percent. The magnitude of this drop was not seen in any of the other dowel bar materials tested. The performance of the FRP dowels is due to the lower stiffness of the dowels, since the FRP has a lower modulus of elasticity than steel.

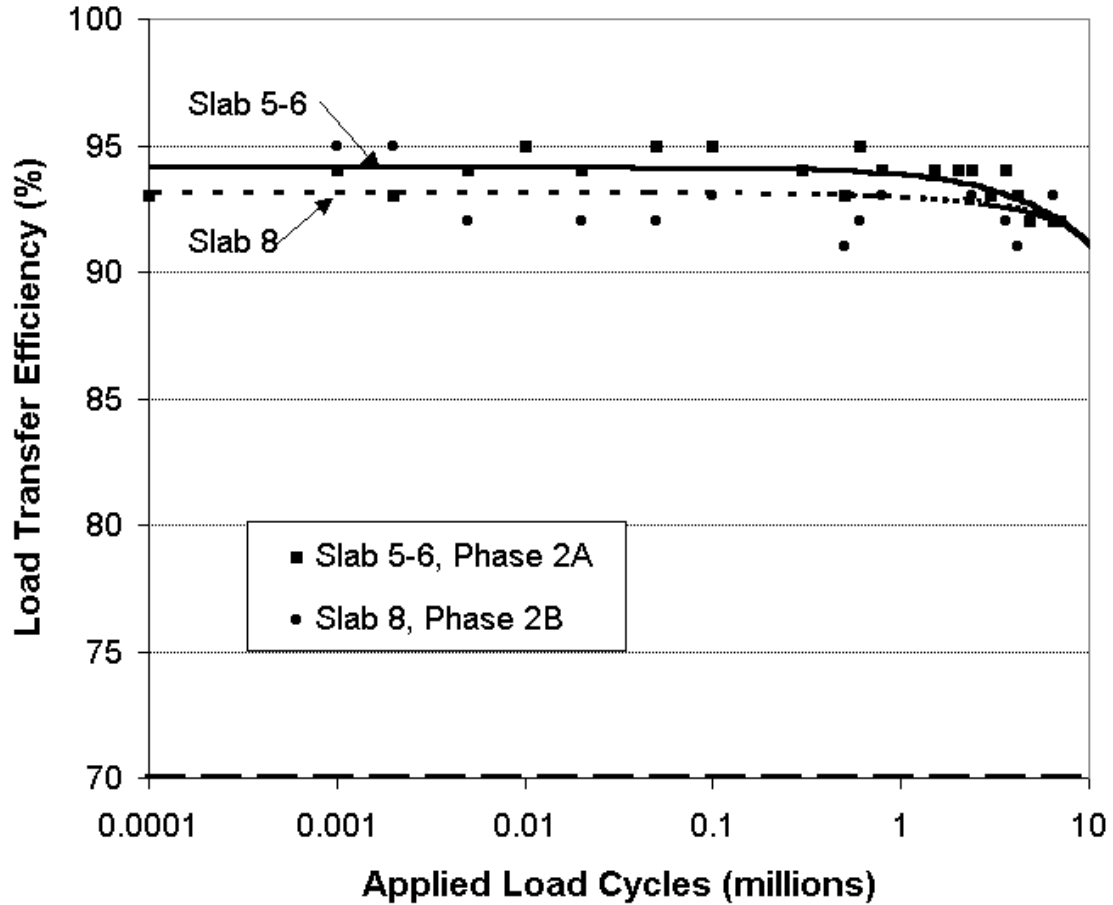
FIGURE 5-8: LTE COMPARISON OF REPLICATE SPECIMENS (3 DOWELS, 2 INCHES COVER)

Figure 5-8 presents graphically the results for Slabs 8 and 5-6 with respect to LTE. The performance of Slab 8 closely matched the performance of Slab 5-6. Figure 5-8 indicates that only a 1 percent difference in LTE was found throughout the majority of the tests, with Slab 5-6 performing slightly better at 95 percent LTE. After 2.4 million load cycles, Slab 5-6 began to decline in LTE at a faster rate than Slab 8. Upon completion of testing at 6.7 million cycles, both specimens exhibited LTE values near 92 percent. Based on the

data shown in Fig. 5-8, the accuracy of the results for Slab 5-6 are confirmed by the close agreement with the data for the repeat test of Slab 8.

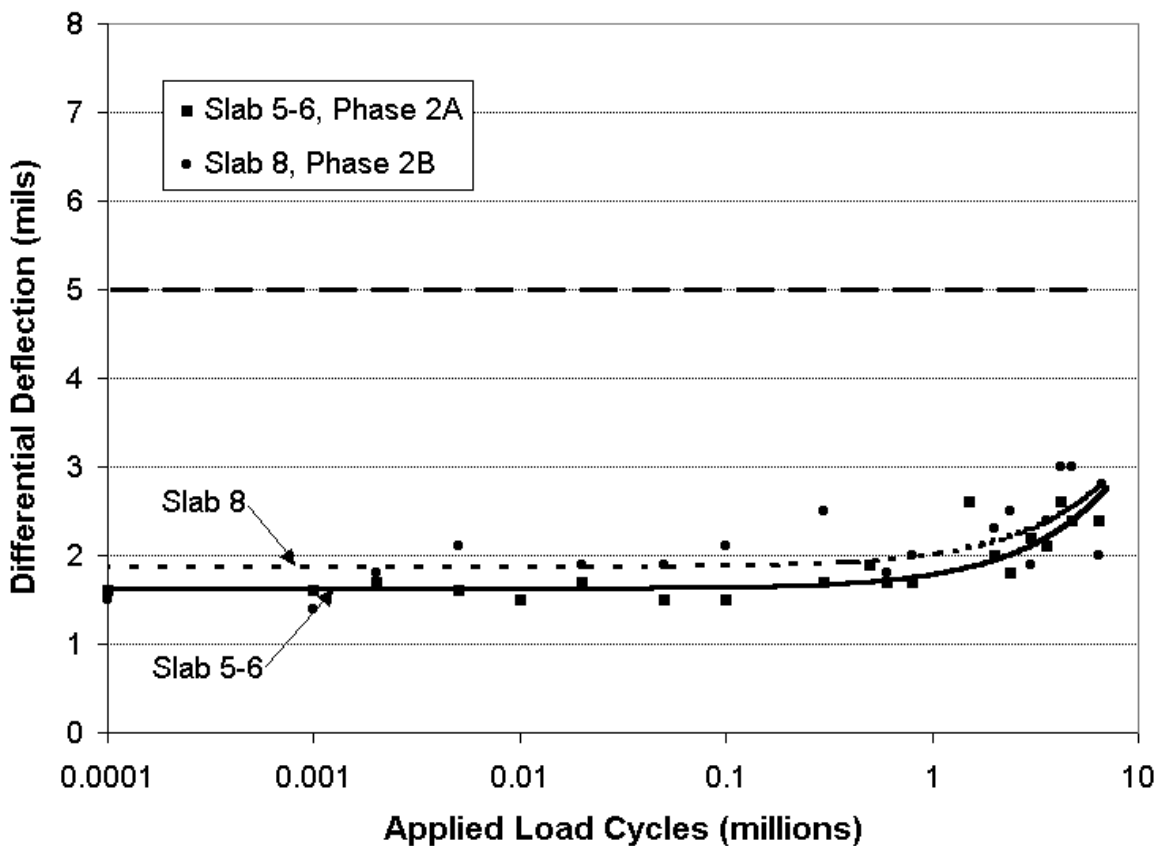
FIGURE 5-9: DIFFERENTIAL DEFLECTION COMPARISON OF REPLICATE SPECIMENS (3 DOWELS, 2 INCH COVER)

Figure 5-9 presents graphically the results for Slabs 8 and 5-6 with respect to differential deflection. The results for differential deflection were similar to those found for load transfer efficiency in the previous section. Slab 8 performed with slightly higher differential deflections than the original specimen, Slab 5-6. Differential deflections for

both specimens remained between 1.5 and 2.5 mils through 1 million load cycles. Relatively slow increases in differential deflections were then observed after 1 million load cycles until completion of testing at 6.7 million cycles. The rate of increase for both specimens was nearly identical. Slab 5-6 ended with maximum differential deflections of 2.6 mils, while Slab 8 reached 3 mils. Both specimens were below the partial failure criterion of 5 mils differential deflection at the end of the test.

The small differences in LTE and differential deflection between the original specimen (Slab 5-6) and the replicate specimen (Slab 8) can most likely be attributed to inherent

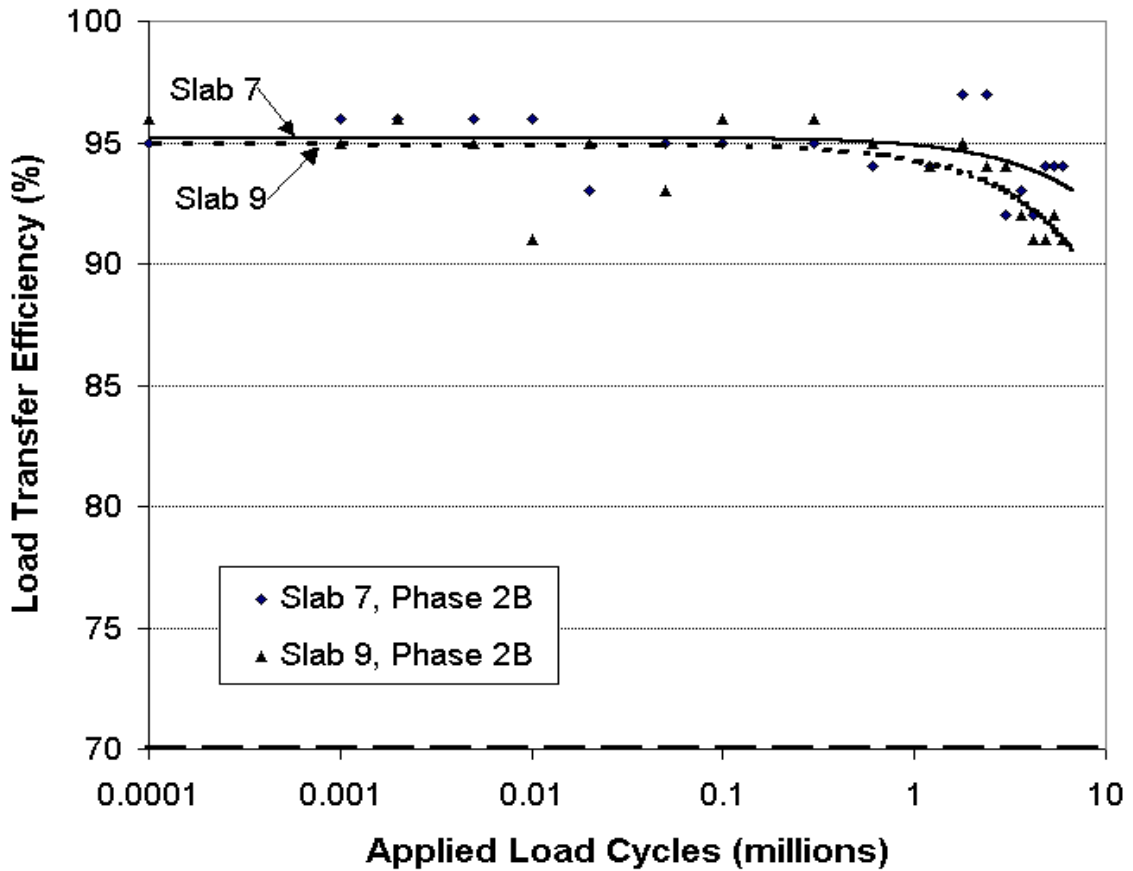
FIGURE 5-10: LTE COMPARISON OF REPLICATE SPECIMENS (2 DOWELS, 2 INCH COVER)

Figure 5-10 presents graphically the results for Slab 7 and Slab 9 with respect to LTE. The performance of Slab 9 was nearly identical to the original specimen, Slab 7. Both specimens performed with load transfer efficiencies near 95 percent through 600,000 applied load cycles. Slab 9 exhibited a faster decline in LTE after 600,000 load cycles. Slab 7 and Slab 9 ended the tests with LTEs of 92 and 91 percent, respectively. The comparable performance with respect to LTE of the replicate specimen (Slab 9) to the original specimen (Slab 7) confirms the accuracy of results for this dowel bar detail.

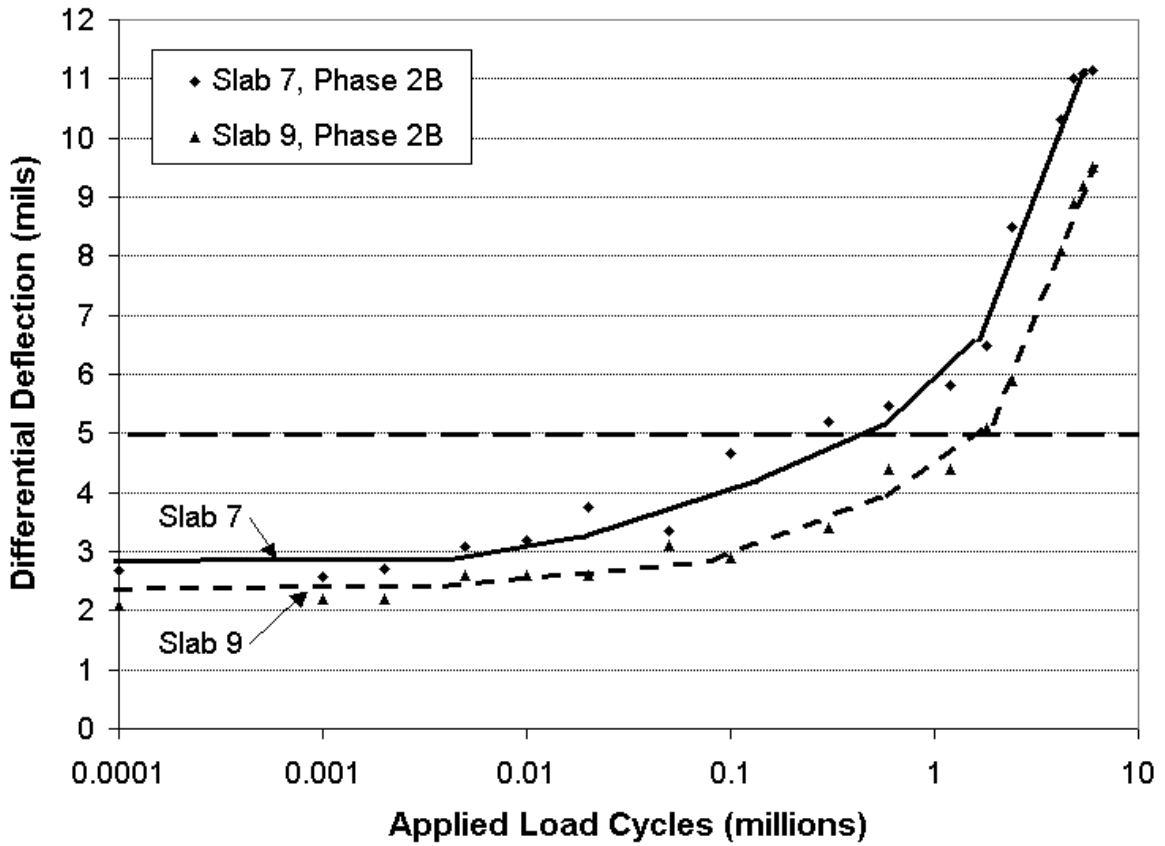
FIGURE 5-11: DIFFERENTIAL DEFLECTION COMPARISON OF REPLICATE SPECIMENS (2 DOWELS, 2 INCH COVER)

Figure 5-11 graphically presents the results for Slab 7 and Slab 9 with respect to differential deflection. The replicate specimen, Slab 9, performed at the same rate of increasing differential deflection as the original specimen, Slab 7. Both Slab 7 and Slab 9 began with differential deflections between 2 and 3 mils until 5,000 load cycles. Slab 9 maintained slightly lower differential deflection readings throughout the duration of testing. The 2 inches of clear cover and use of 2 bars resulted in more flexible

specimens. Near 1 million load cycles, both specimens exceeded the partial failure criterion of 5 mils differential deflection. The consistency of results between Slab 7 and Slab 9 confirm the accuracy in measured performance of LTE and differential deflection.
