2003-18

Final Report

**Fatigue Evaluation of Steel
Box-Girder Pier Caps: Bridge 69832**

March 2004

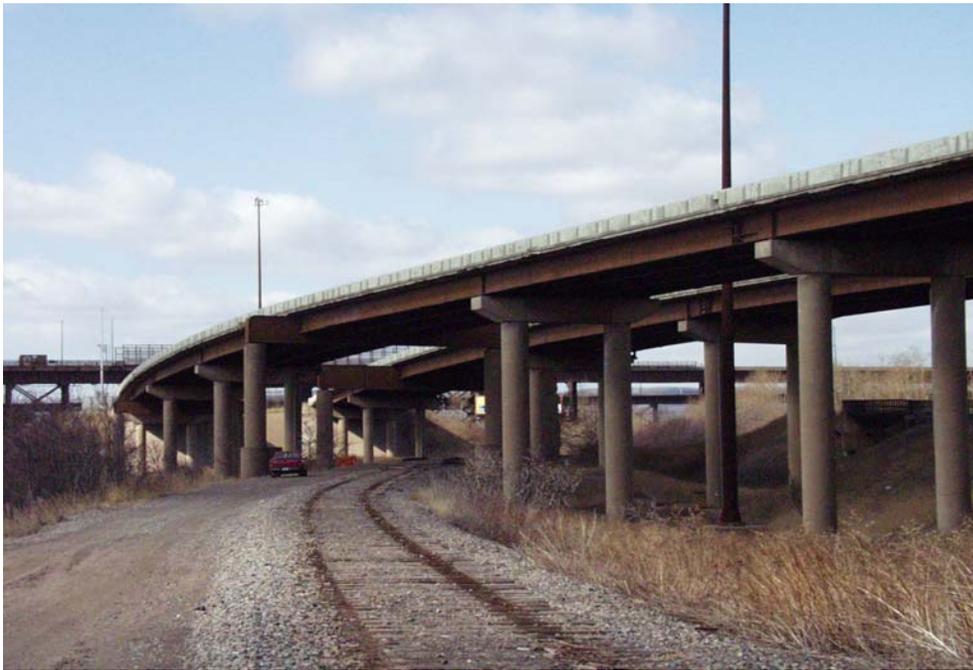
Figure 2.1: Bridge 69832

Bridge 69832, constructed in 1967, is shown in Figure 2.1. It carries two lanes of northbound Interstate 35 into downtown Duluth and the port area. Because it is the main artery into downtown Duluth and the port area, the bridge is subjected to heavy truck traffic.

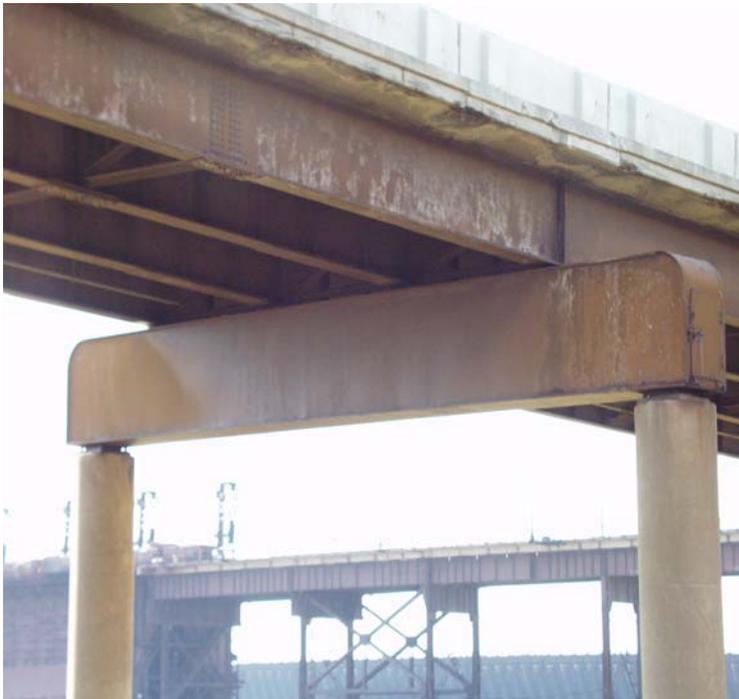
Figure 2.3: Steel pier cap with girders bearing on top

Of the steel-box designs, the first type had the girders resting on sole plates attached to the top of the steel-box pier cap (Figure 2.3). These have shown no problems with fatigue, as the girders are free to move separately from the pier cap.

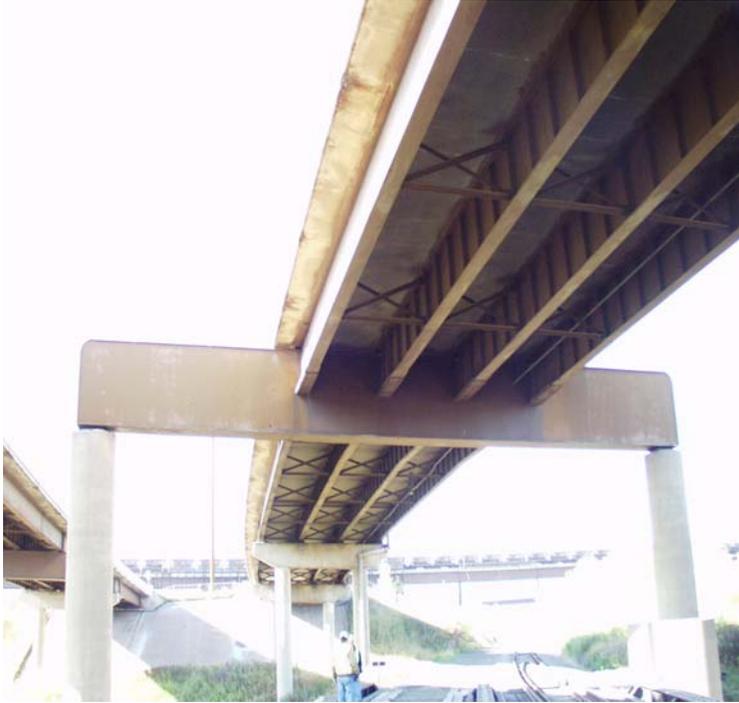
Figure 2.4: Steel pier cap with girders continuous through pier cap

The second type of steel-box pier cap was designed so that the girders are continuous through the pier cap (Figure 2.4). It is assumed these pier caps were designed with the girders integral to the pier cap to meet clearance requirements for crossing railroad lines. The pier caps are deeper than the girders, so the box consists of two cells at those cross sections where the girders pass through. The depth at which the girders pass through the pier caps varied affecting the stiffener details. Figure 2.5 gives the dimensions for a typical cross section of this type of pier cap.

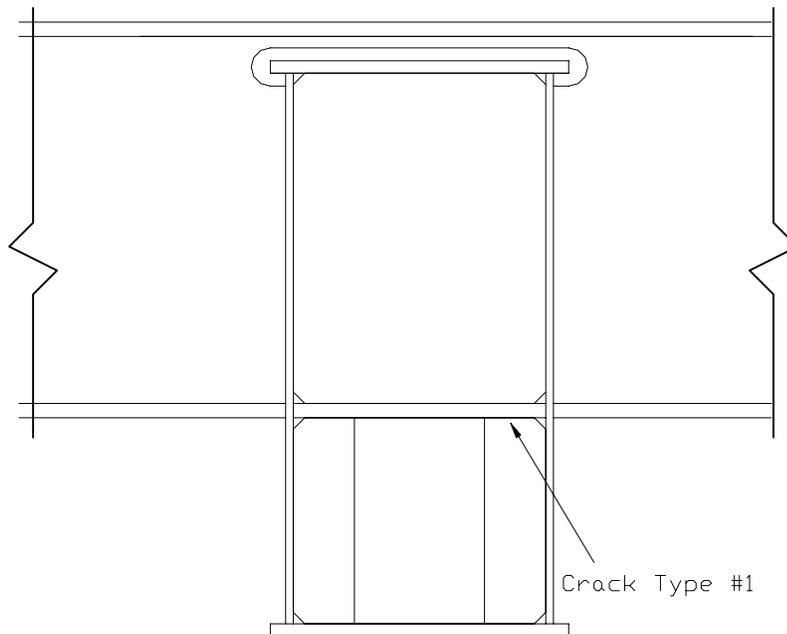
Figure 2.6: Cross-section of Pier Cap 5 showing crack type 1

Three different crack types have been observed on Bridge 69832, depending on the stiffener details of the pier cap. These cracks were first documented in June of 1999 (1). Crack type 1 occurred at the weld connecting the stiffener to the bottom flange continuity plate inside the pier cap (Figure 2.6). Cracks like this have occurred at Girders A, B, and C on Pier Cap 5. All of these cracks are located on the stiffeners on the North side only. As shown in Figure 2.7, these cracks propagate through the welds but have not propagated into the base metal. Eventually, the cracks may completely sever the weld of the stiffener to the continuity plate, which so far has only occurred at Girder C (2). Once this occurs, however, the crack is isolated since there isn't any path for the crack to propagate further. Therefore the consequences of crack type 1 are limited.

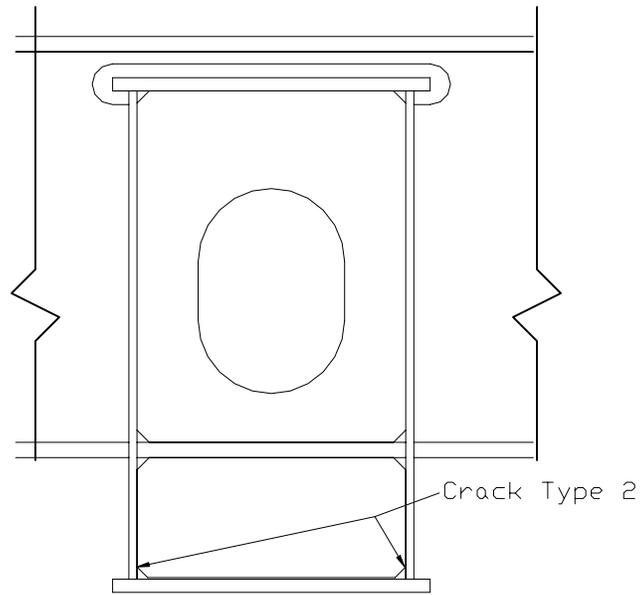
Figure 2.8: Cross-section of pier cap 9 showing crack type 2

Crack type 2 occurred at the termination of the vertical weld connecting the bulkhead to the pier cap web (Figure 2.8). It was customary at the time this bridge was designed to not weld stiffeners to the tension flange, so this bulkhead was not welded to the bottom flange of the pier cap. (This practice has subsequently been identified as contributing to distortion-induced fatigue, and there have been requirements in the AASHTO specifications since 1985 to require a positive connection of such a stiffener as this bulkhead to all elements of the cross section.) Crack type 2 has occurred at girder D of pier cap 9 and Girders A and D of Pier Cap 11. The cracks on the north side in Girder D of Pier Cap 9 have propagated into the web of the pier cap (Figure 2.9), which is potentially a very serious condition (2). All others currently are propagating up the weld, which should limit the consequences to separation of the bulkhead from the web.

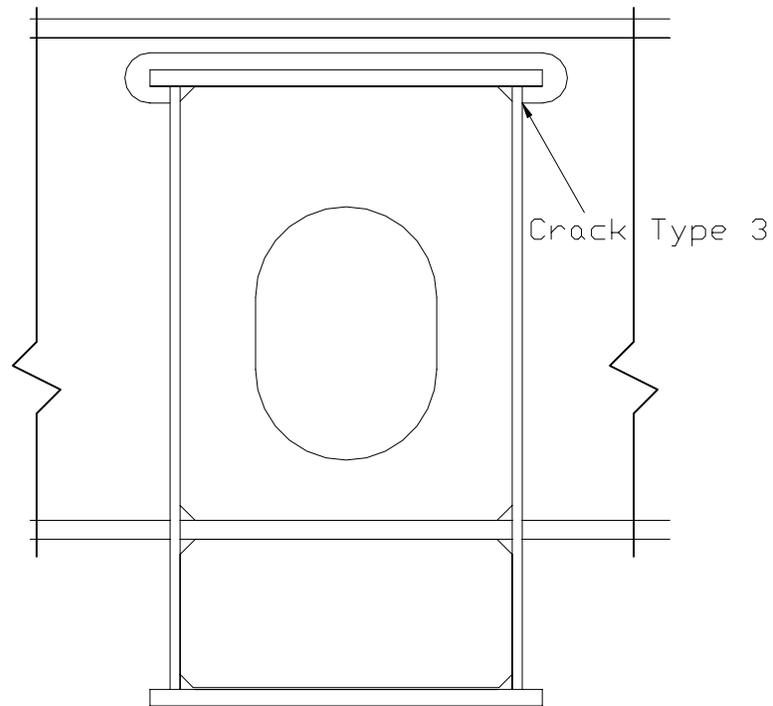
Figure 2.10: Cross-section of pier cap 11 showing crack type 3

Crack type 3 is a crack located at the toe of the weld connecting the girder web to the exterior of the pier cap web (Figure 2.10). It has only been found on Girder C of pier cap 11 on the north side, and is not propagating into the base metal (Figure 2.11)(2). It is believed that this crack is driven by the bending stresses in the web, which will decrease as the crack extends eventually arresting the crack. Therefore, it is believed that the consequences of this crack are limited, provided sufficient shear capacity of the web welds remain after the crack arrests.

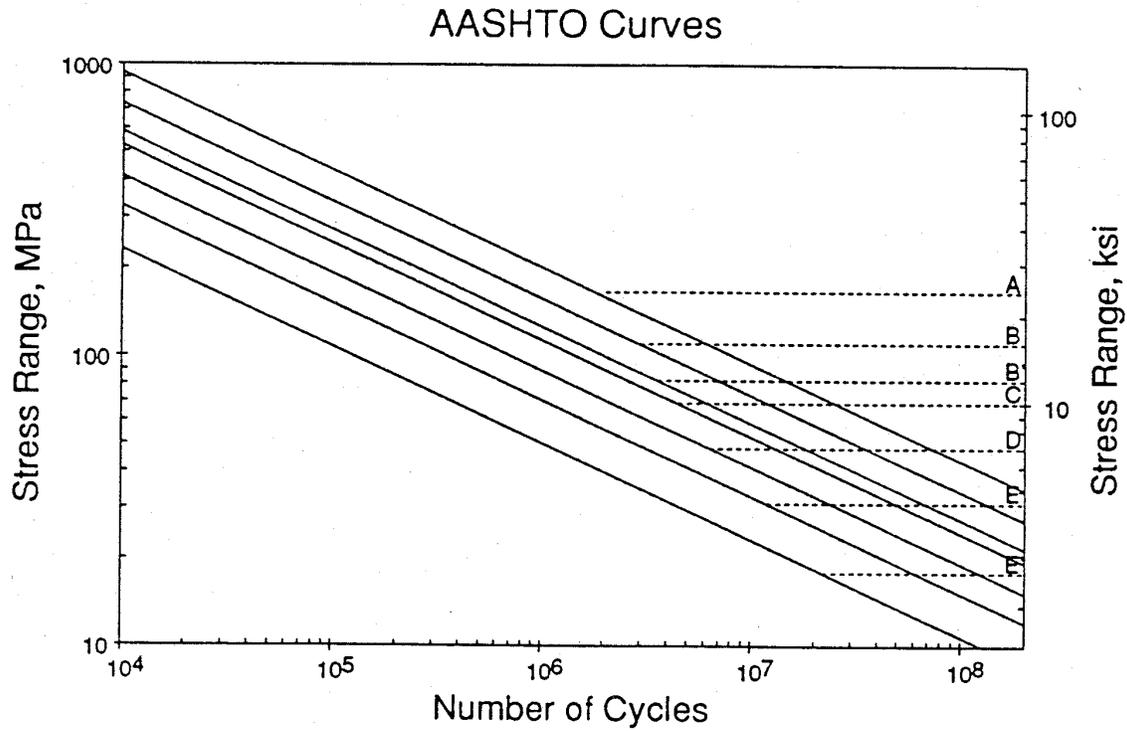
Figure 2.12: AASHTO S-N curves

The constants A and $(\Delta F)_{th}$ are summarized in Table 2.1. The fatigue truck in the AASHTO LRFD Specifications is 0.75 times the HS-20 design truck, or a gross-vehicle weight of 54 kips, representing the effective load of a variable series of trucks. The constant-amplitude fatigue limit (CAFL), designated $(\Delta F)_{th}$ in AASHTO, is the stress range below which fatigue cracking does not occur. Equation 2.1 indicates that the allowable stress range need not be taken less than half the CAFL. In effect, this indicates that the fatigue life is unlimited if the stress range from a load approximately twice the load of the fatigue truck is less than the CAFL.

In Bridge 69832, the details where fatigue cracking has occurred are Category C. The Category C detail has a (ΔF)_{th} of 10 ksi, therefore if the stress range exceeds 10 ksi on a daily basis or more frequently, the detail has a finite life and cracking will occur at some point.

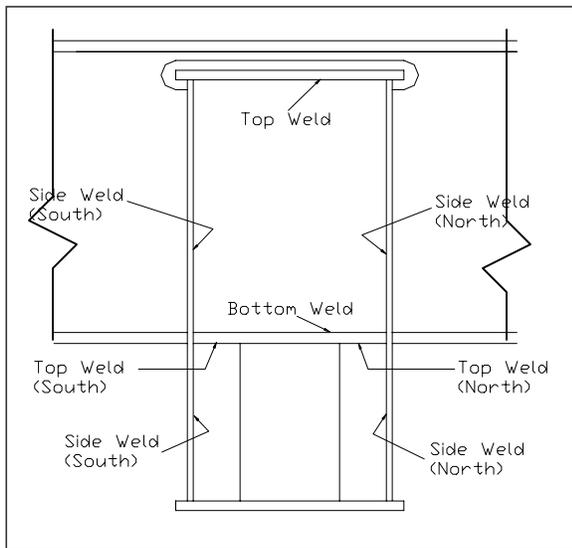
Figure 2.13: Location of weld measurements

On Pier Cap 5 an inspection of various details was performed to determine any discrepancies between those detailed and those constructed. Measurements were taken of the weld sizes, the heights and widths, and the size of gaps at various locations. This inspection was performed to see if there was an explanation for why details on only one side of the box cracked in some cases. The location of where the measurements were taken is shown in Figure 2.13 and a summary of the results compared to the drawing requirements is given in Table 2.2.

The largest discrepancy was found in the size of fillet weld connecting the stiffener to the bottom flange continuity plate. The plans call for a $\frac{3}{8}$ " weld while those measured were greater than $\frac{3}{4}$ ". It appeared that the stiffener was not flush against the continuity plate and that the larger weld may have been required to cover this gap. This would decrease the throat thickness of the weld and thus the strength and fatigue resistance of the weld.

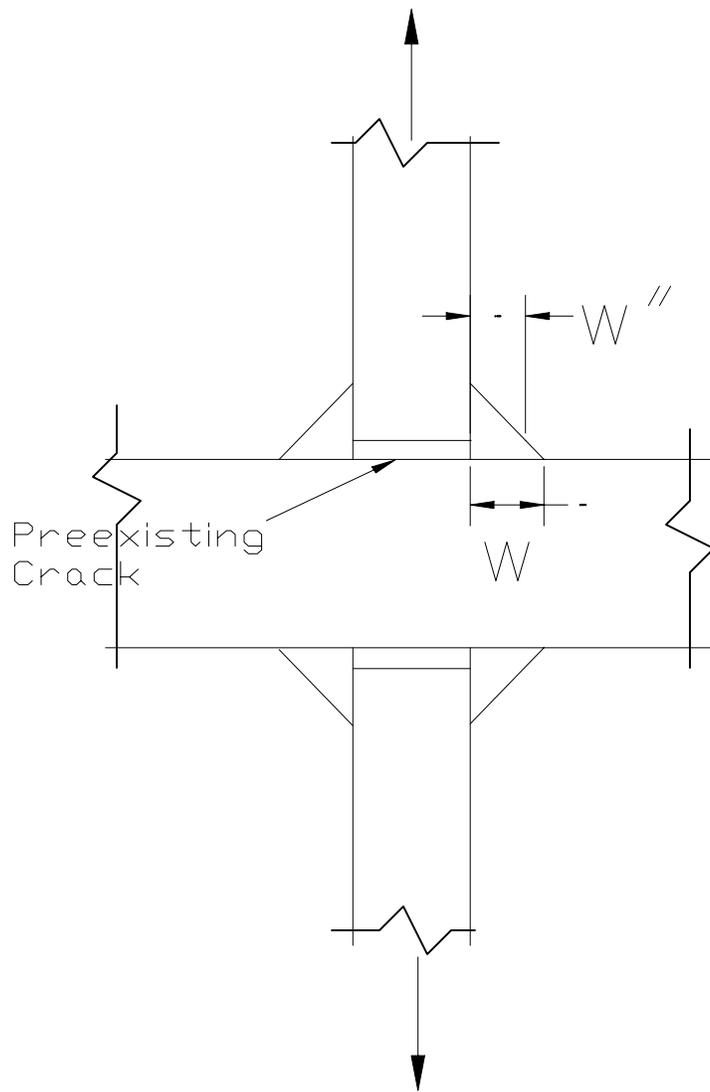
Figure 2.14: Crack-like notch between fillet welds in a cruciform connection

When pairs of transverse fillet welds are used to attach a plate loaded in tension a reduction factor (R_F) calculated as in Equation 2.2 is applied to the design stress range for fatigue (6). This reduction factor accounts for the possibility of fatigue cracking through the throat of the weld. The unfused space between the fillet welds acts as a preexisting crack at the root of the weld. The reduction factor governs on thick plates as the length of the preexisting crack is increased. .

When the dimensions that were detailed in the plans are used ($t_p = 0.6875$ inches, $w = 0.375$ inches), the reduction factor, R_F , equals 0.482. This cuts the design stress range for the weld on the stiffener in half lowering it from that of a category C detail, which is 10 ksi to around 5 ksi. When the values that were actually measured are inserted into the equation ($t_p = 0.625$ inches, $w = 0.75$ inches), the reduction factor equals 1.0 or in other words no reduction is applied. However, if the top of the stiffener is not flush with the continuity plate, the dimension w should be taken at the top of the stiffener, shown as w'' in Figure 2.14 and estimated as small as 0.32 inches in some of the details. A reduction factor of about 0.46 is calculated using $w = 0.32$ inches, which means the allowable stress range is closer to that of a category E instead of a category C detail.

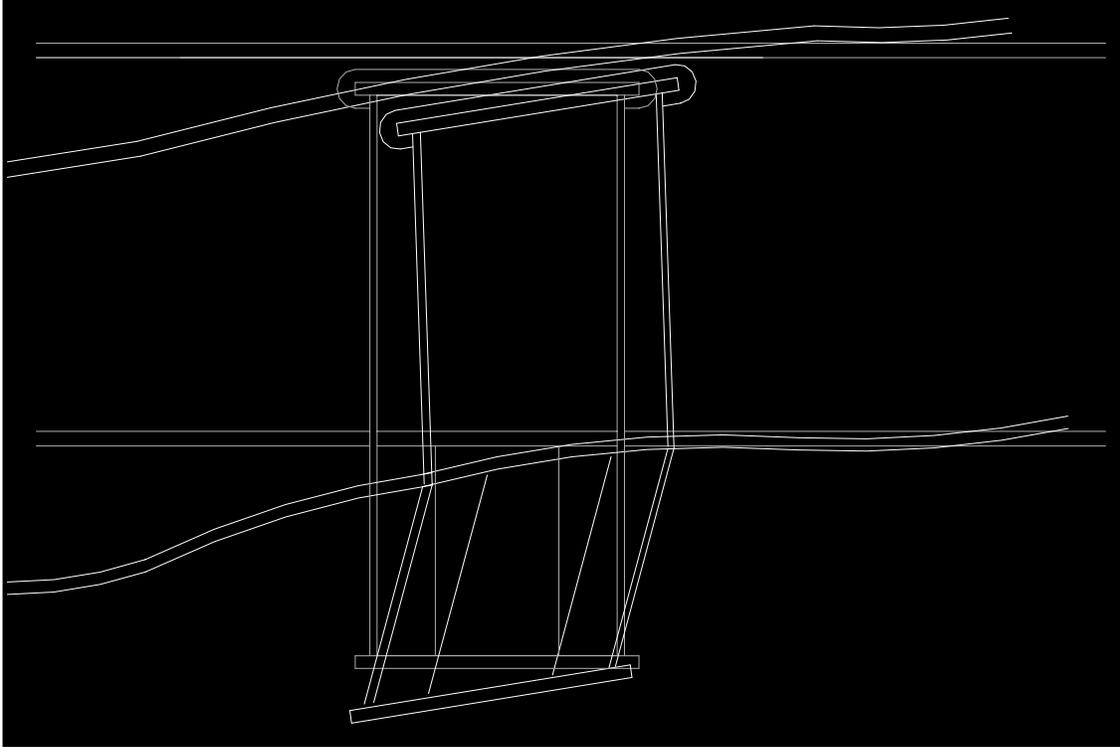
Figure 2.15: Exaggerated displaced shape showing concentration of distortion in lower cell

Because of the opening of the lower cell, it is more flexible than the top cell of the pier cap, concentrating the distortion in the bottom cell as shown in Figure 2.15. Instead of remaining perpendicular with the girder as it rotates, the bottom flange of the pier cap is restrained by the supports at the piers. This causes the lower cell to shear, taking on the shape of a parallelogram. High stress ranges are created in the stiffeners as they resist this shearing.

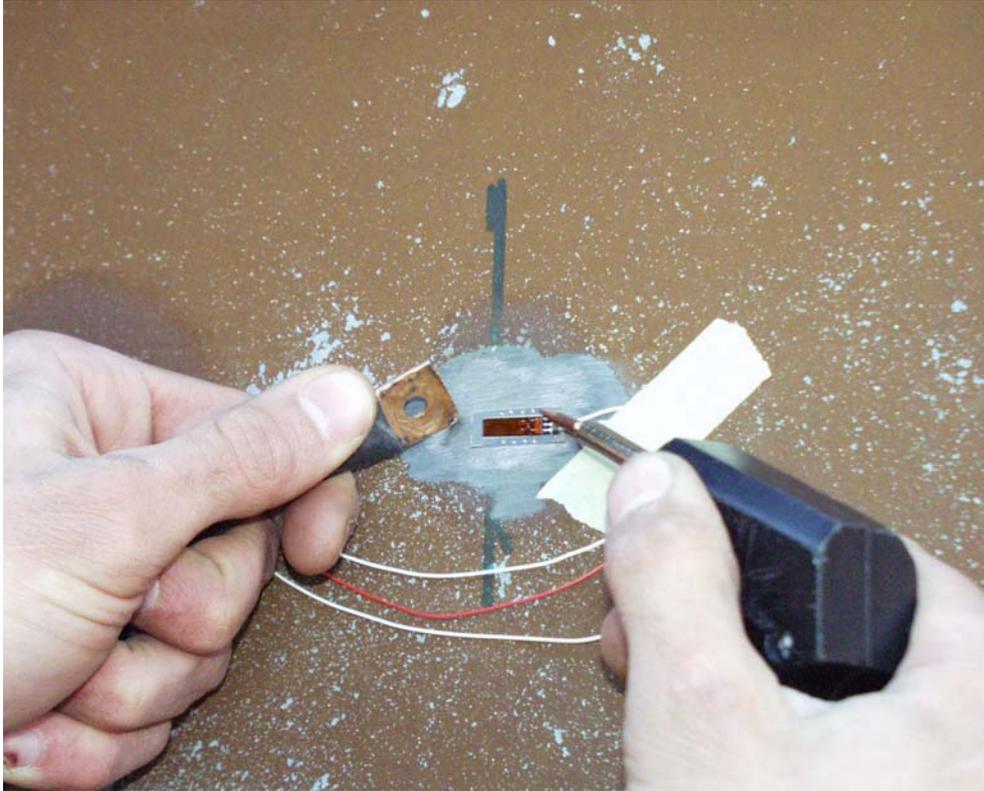
Figure 3.1: Welding of a strain gage

For installation of each gage, first the area was marked. Then the surface was ground smooth and cleared of paint. Next the area was cleaned of debris with a degreaser. Each gage was taped into place and then spot welded to attach it (Figure 3.1). Finally the gage was covered with caulking and duct tape to protect it from the environment.

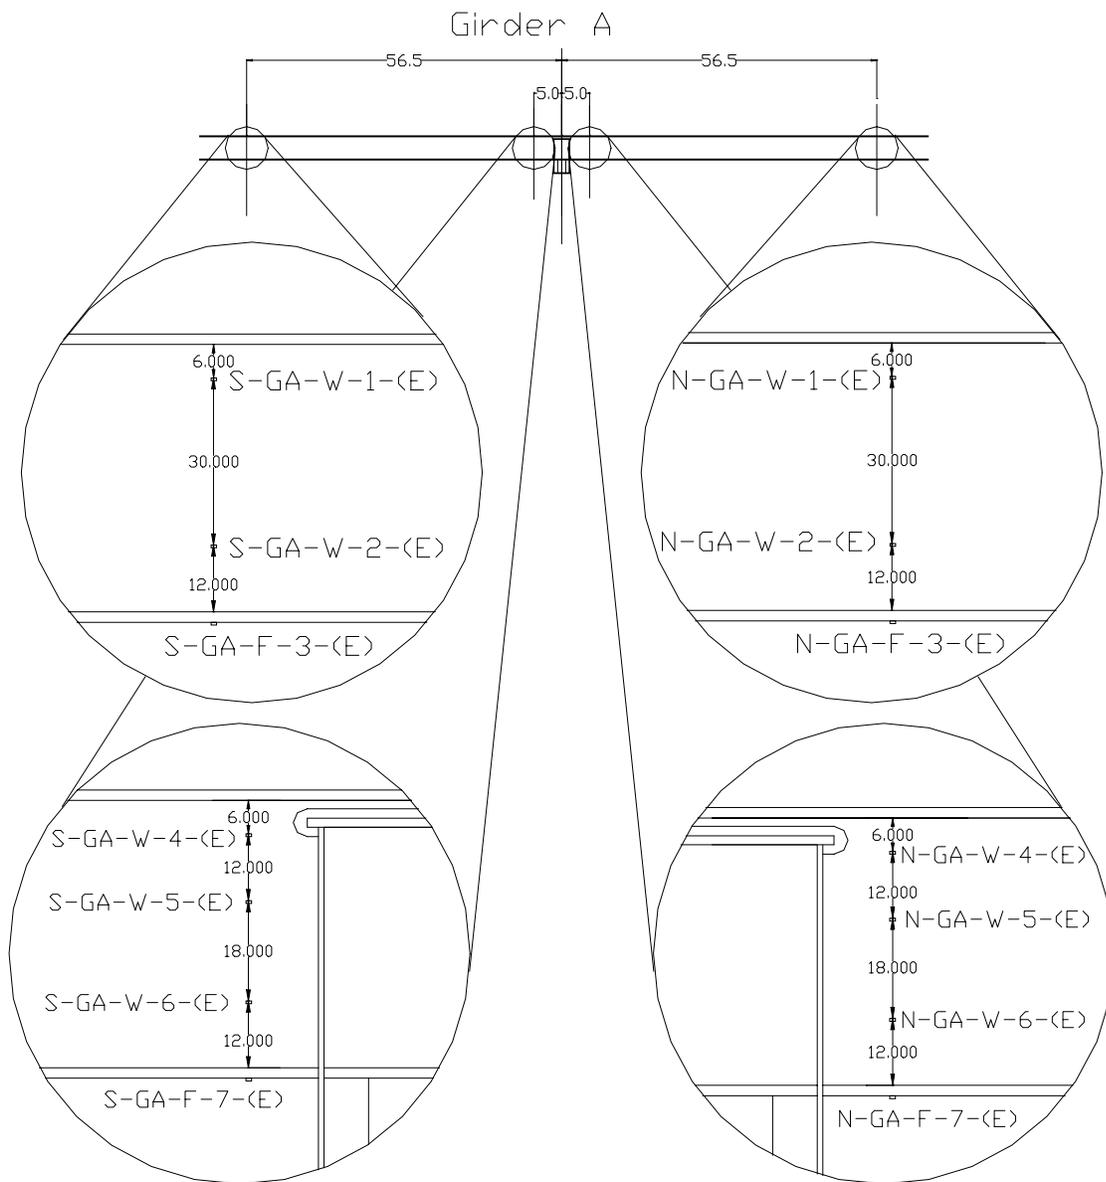
Figure 3.2: Girder A gage placement

For obtaining the strains due to bending in each girder, several gages were mounted at various cross-sections of the girder (Figure 3.2). On spans immediately adjacent to Pier Cap 5, three gages were placed at the midspans. One gage was located on the bottom flange, and the other two were spaced vertically along the web. Four gages were also placed in the negative moment region of each girder five feet from the center of the pier cap on both sides. One was placed on the bottom flange, and the other three were spaced through the web.

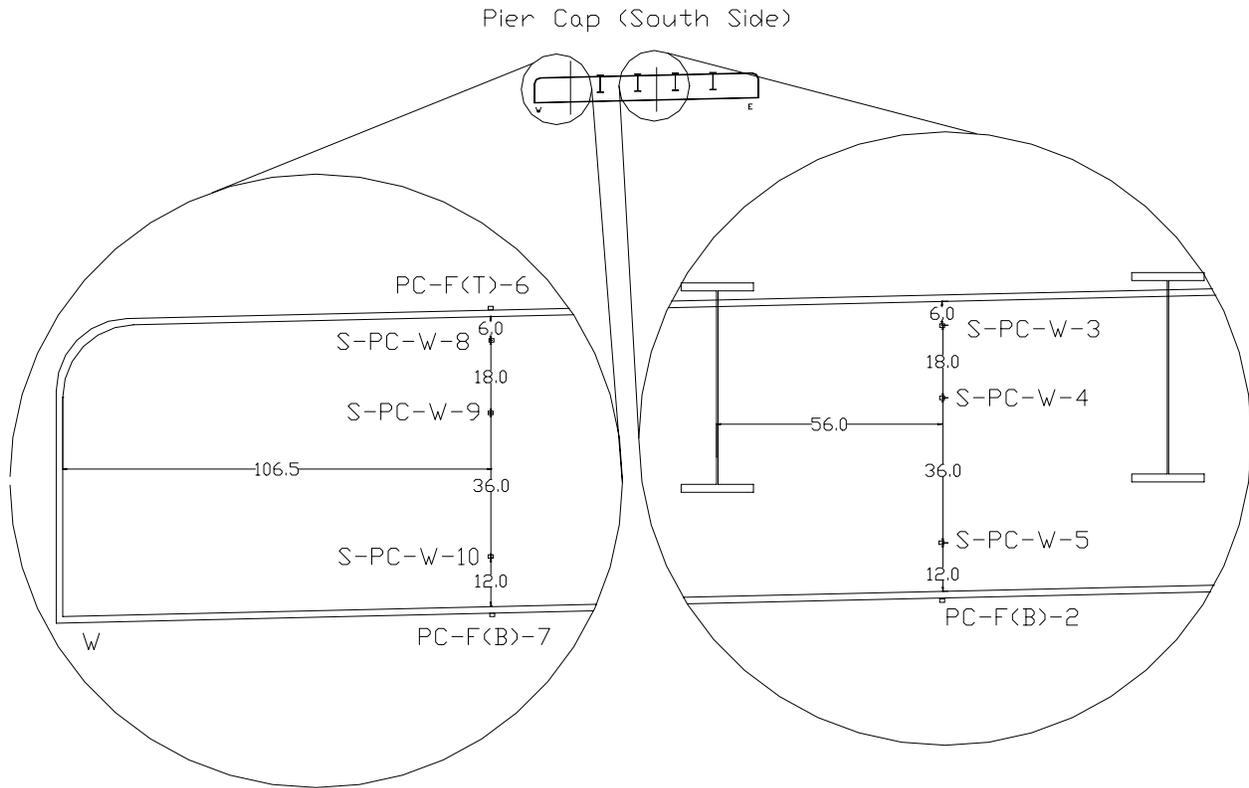
Figure 3.3: Pier cap gage placement

Gages were also placed on the pier cap to obtain strains from bending (Figure 3.3). Gages were located midway between the two center Girders B and C, and midway between the West pier and Girder A. One gage was placed on the bottom flange at each location, and three gages were spaced vertically along the web on both sides of the pier cap. One gage was placed on the top flange at the location between Girder A and the pier.

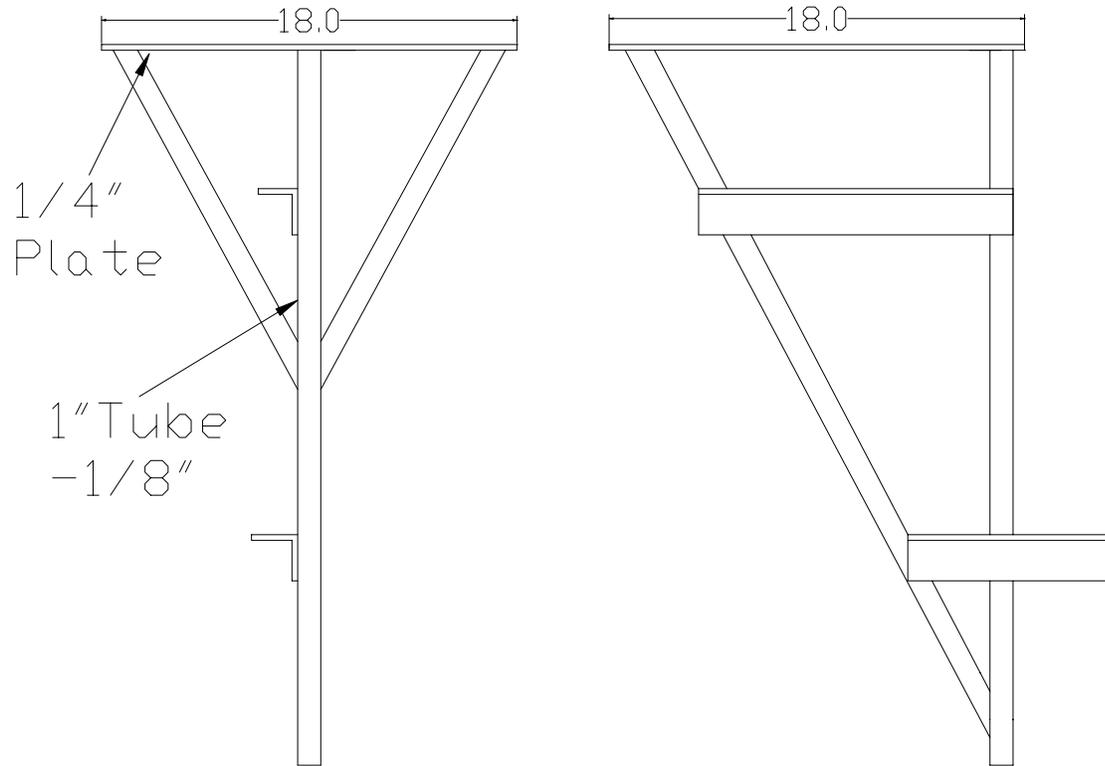
Figure 3.4: Bracket design plans

To determine differential rotation between the pier cap and the girders, brackets were constructed to support LVDTs and inclinometers. The brackets were constructed of 1"x 1/8" square tubing, 1/4" plate, and 1 1/2"x 1 1/2"x 1/8" angle (Figure 3.4).

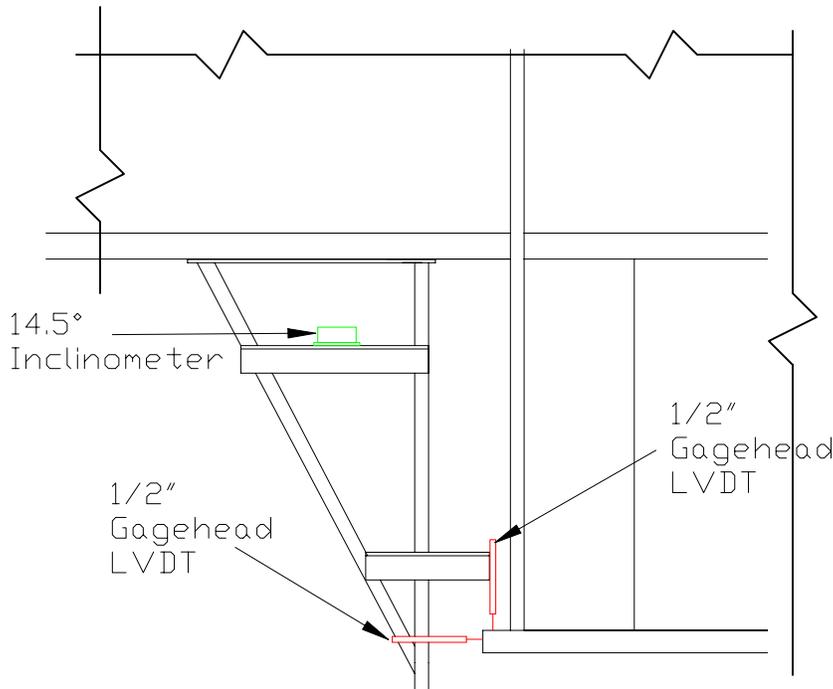
Figure 3.5: Installation of bracket

For instrumentation a bracket was C-clamped to the bottom flange of the girder (Figure 3.5). It was clamped approximately eight inches from the face of the pier cap. A 14.5° inclinometer was bolted to the upper angle for measuring the rotation of the girder. A $\frac{1}{2}$ " GCD Series Gagehead LVDT was clamped horizontally to the bracket and reached to the bottom flange of the pier cap. A $\frac{1}{4}$ " GCA Series Gagehead LVDT was clamped vertically to the lower angle and also reached to the bottom flange of the pier cap. The Gagehead LVDTs were used to measure the difference in rotation between the girder and the lower cell of the pier cap.

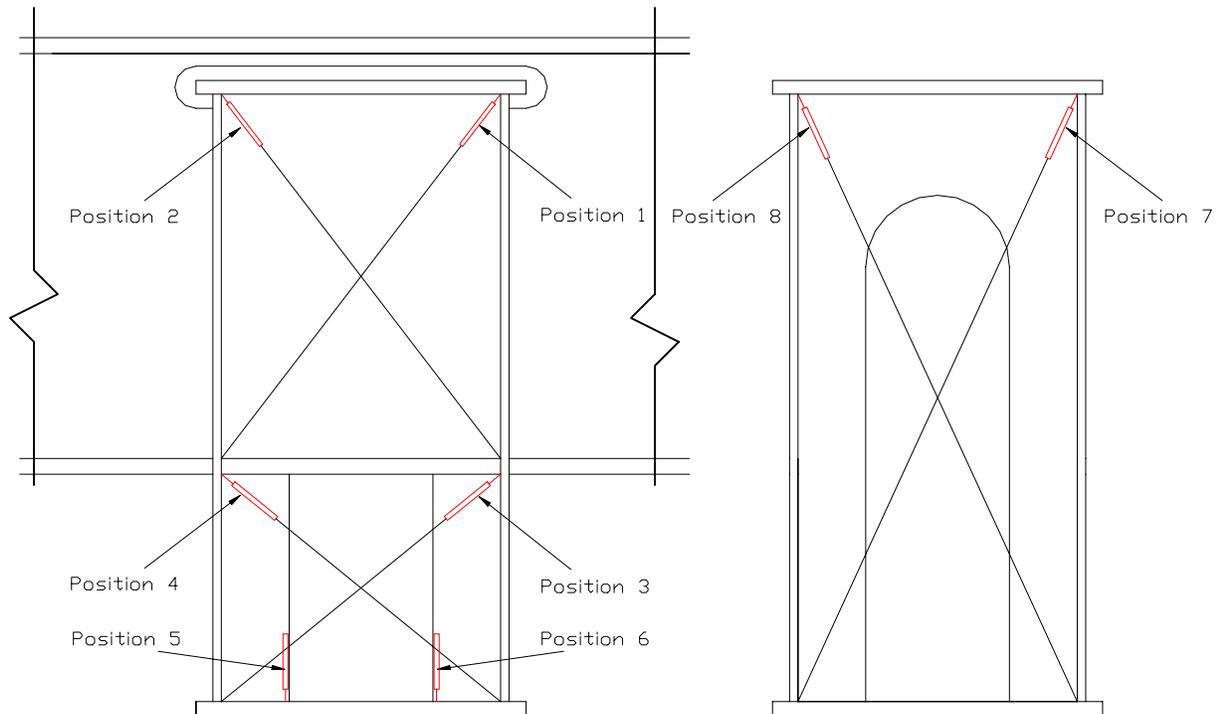
Figure 3.7: Interior of Pier Cap 5 LVDT placement

After the strain gages were mounted, two ½" GCD Series Gagehead LVDTs were installed inside the pier cap. Because of the limited number of LVDTs, two LVDTs were iterated through eight different positions at each girder intersection (Figure 3.7). Positions 1 and 2 measured shearing of the top cell of the pier cap by recording any changes in the length of the diagonal. Positions 3 and 4 measured shearing of the lower cell. Positions 5 and 6 measured the gap opening between the stiffener and the bottom flange of the pier cap. Positions 7 and 8 measured shearing of the pier cap at the intermediate stiffeners.

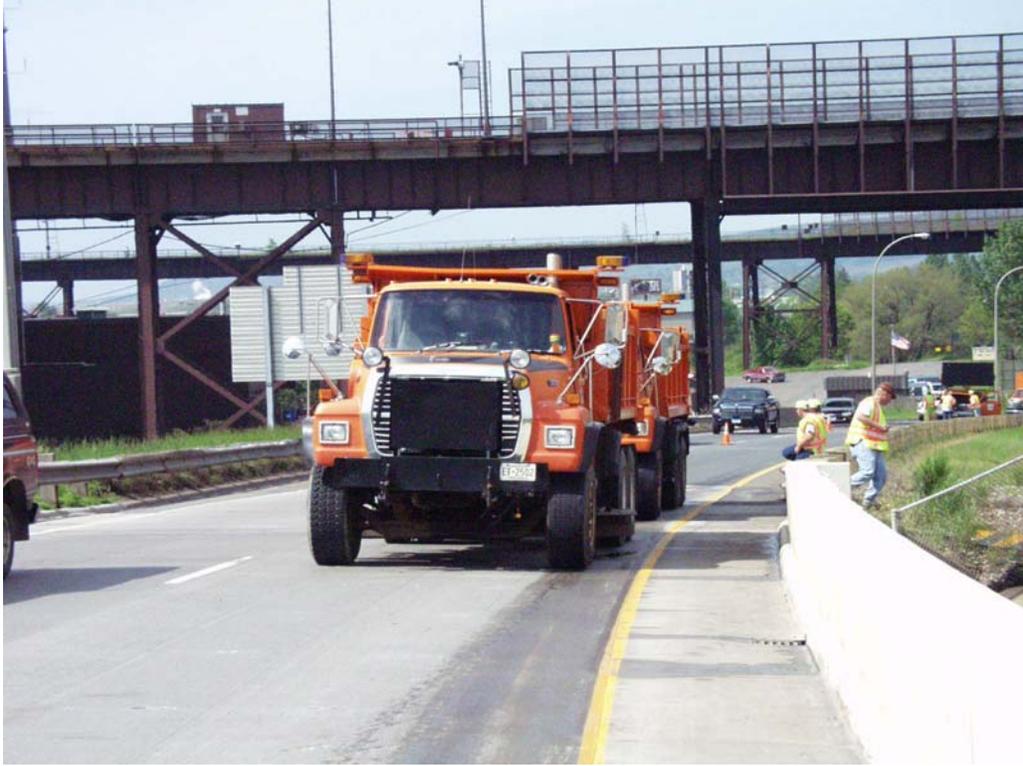
Figure 3.8: Mn/DOT three-axle truck

For comparison with live traffic data and for calibration of finite element models, a truck test was performed on Bridge 69832. Four three-axle Mn/DOT trucks were used for the test (Figure 3.8). Each truck weighed approximately 50 kips. The front axle carried approximately 28% of the total weight while the second and third axle both carried approximately 36% of the total weight. Table 3.1 gives the exact weights and dimensions of each truck.

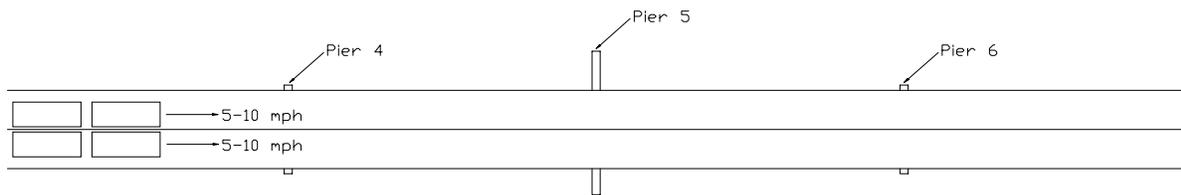
Figure 3.9: Truck Test 1

In the first pass the four trucks ran in a 2x2 formation (Figure 3.9). The trucks followed the car lanes with spacing at a minimum between trucks. The trucks traveled at 5-10 mph keeping the formation through pier 7.

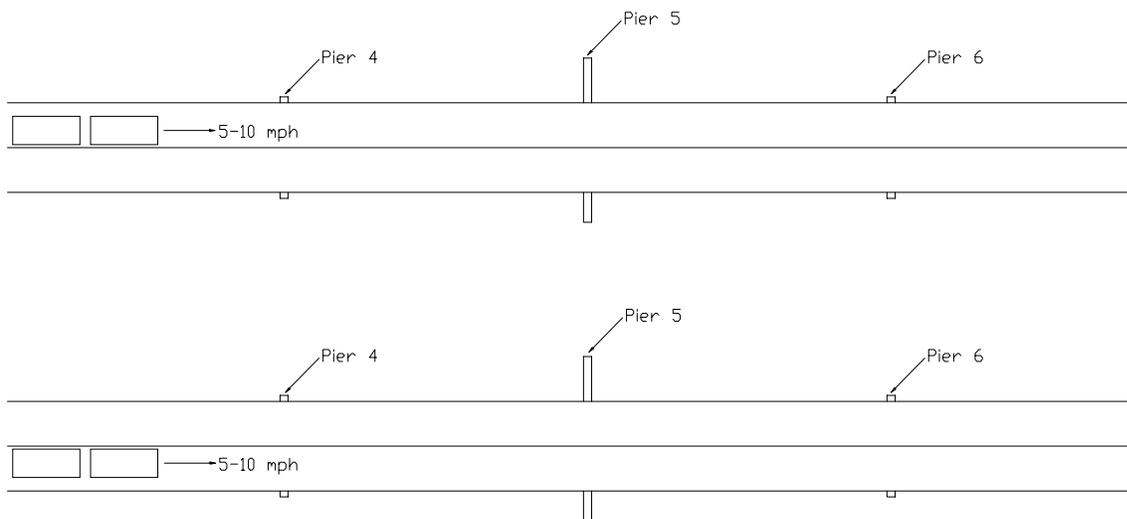
Figure 3.10: Truck Test 2

Truck test #2 was split into two parts. First two trucks traveled in the left lane at 5-10 mph with spacing as close as possible. Once the first two trucks had cleared pier 7, the second two trucks traveled in the right lane at 5-10 mph with spacing as close as possible (Figure 3.10).

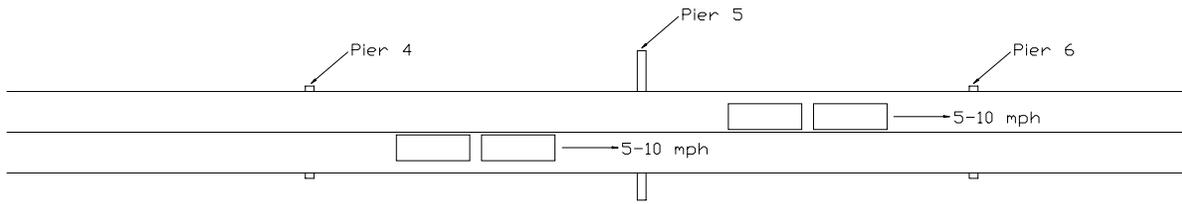
Figure 3.11: Truck Test 3

Truck Test #3 had two trucks in the left lane and two trucks in the right. Approximately 1 span (110 ft) was kept between each set of trucks (Figure 3.11). The trucks traveled across keeping the same distance apart at 5-10 mph.

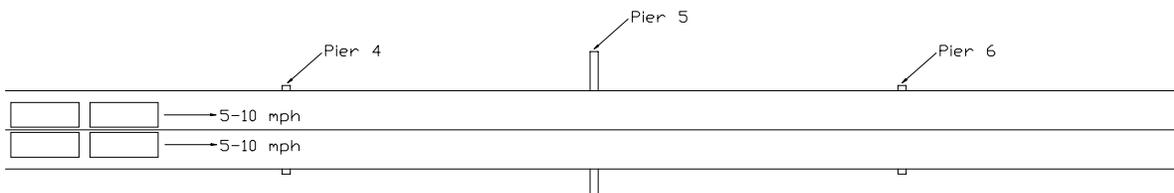
Figure 3.12: Truck Test 4

Truck Test #4 was a repeat of Truck Test #1 (Figure 3.12).

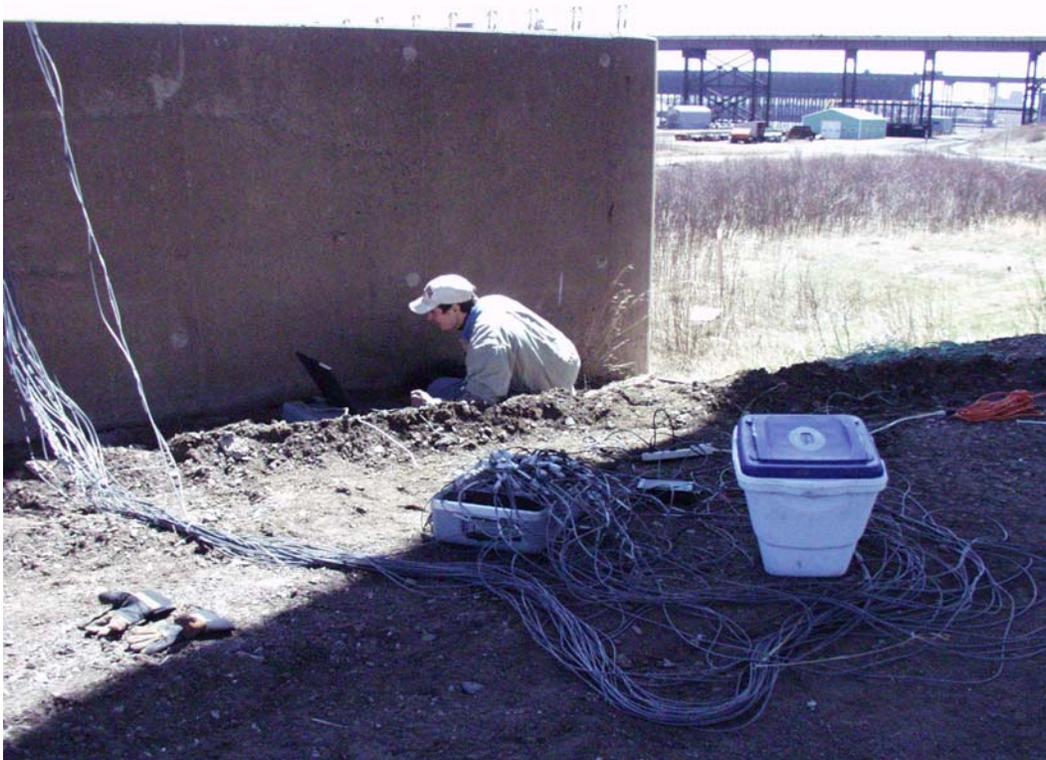
Figure 3.13: PC9000 data acquisition system

Two Campbell PC9000 data acquisition systems were used for reading the sensors (Figure 3.13). Data was collected at a rate of 66.7 Hz (a sample every 0.015 seconds). A combination of $\frac{1}{4}$ bridge circuits (the strain gages) and voltage differentials (the LVDTs and inclinometers) were monitored.

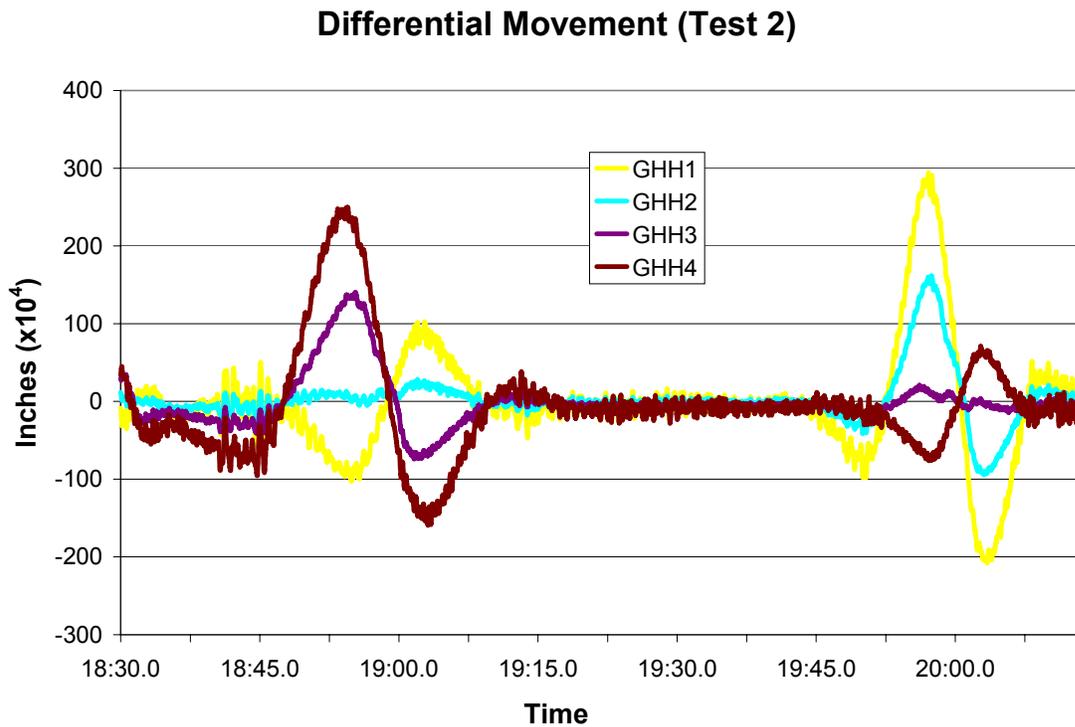
Figure 4.5: Horizontal LVDT readings showing differential movement of girders (Test 2)

The differential movement shows that the exterior girder nearest the load undergoes the largest deformation (Figure 4.5). The other girders then decrease in the movement, with the opposite exterior girder showing a negative value. The pier cap is caused to twist from the load on the other girders, but the opposite exterior girder does not rotate enough to match this twisting of the pier cap. Thus it is resisting the rotation of the pier cap.

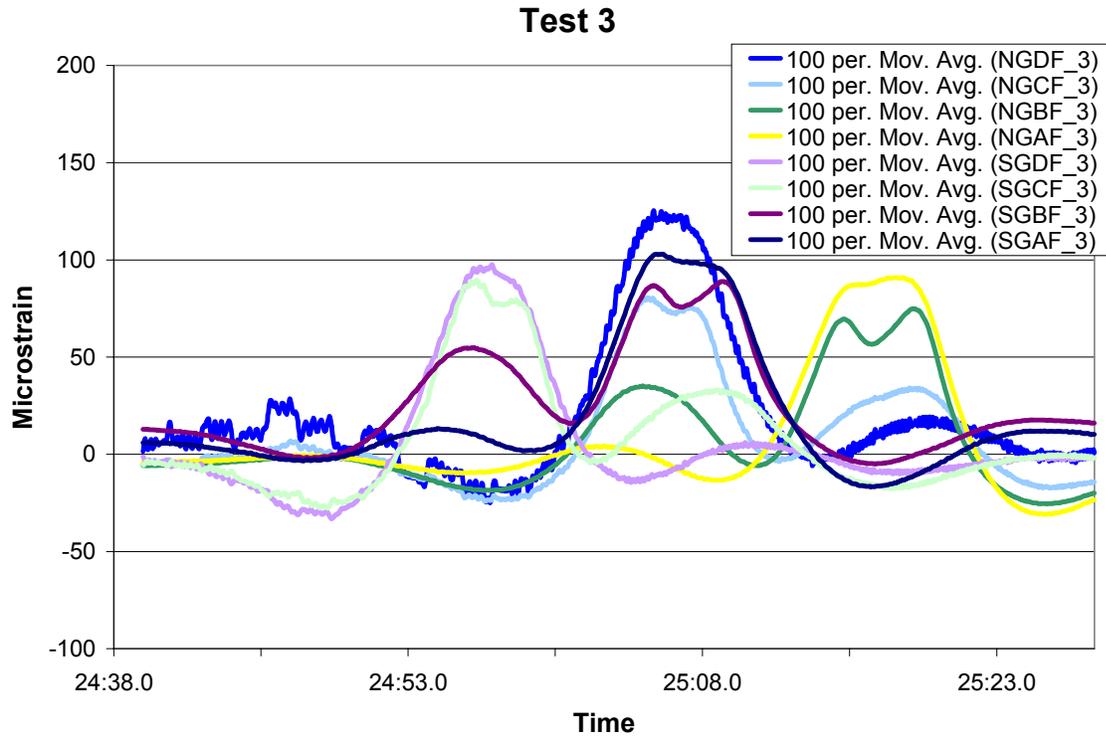
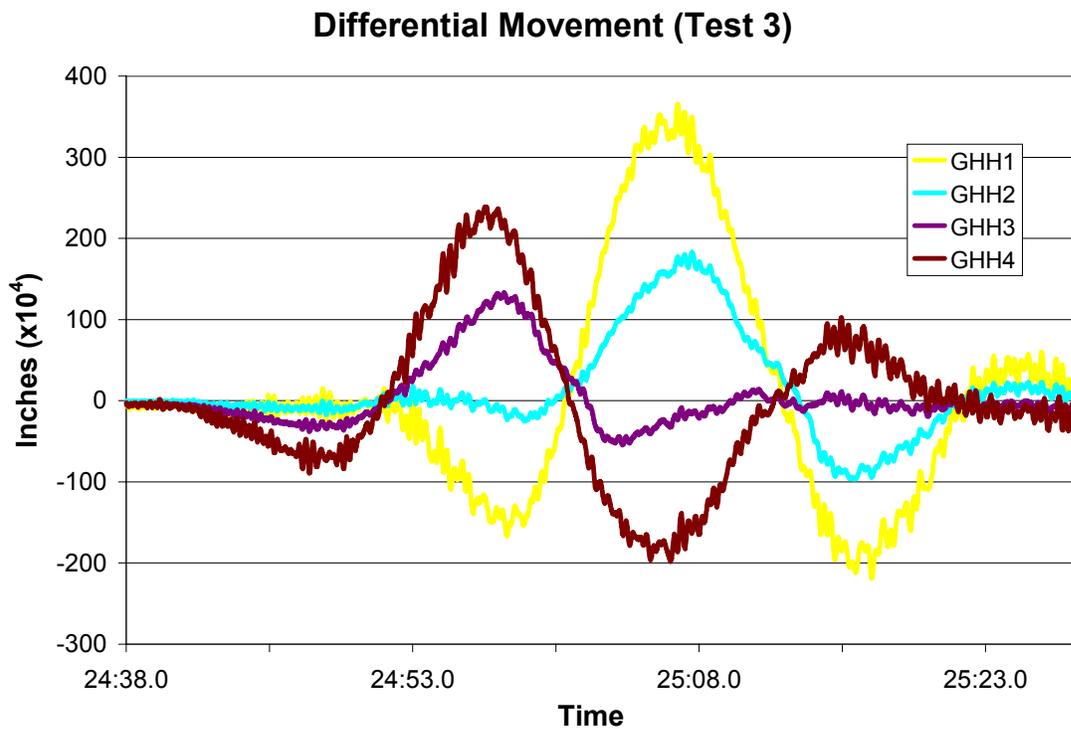
Truck Test 3 did not provide a large amount of useful data (Figure 4.6 & Figure 4.7). With the over lapping of the loads it was difficult to decipher the components of the values.

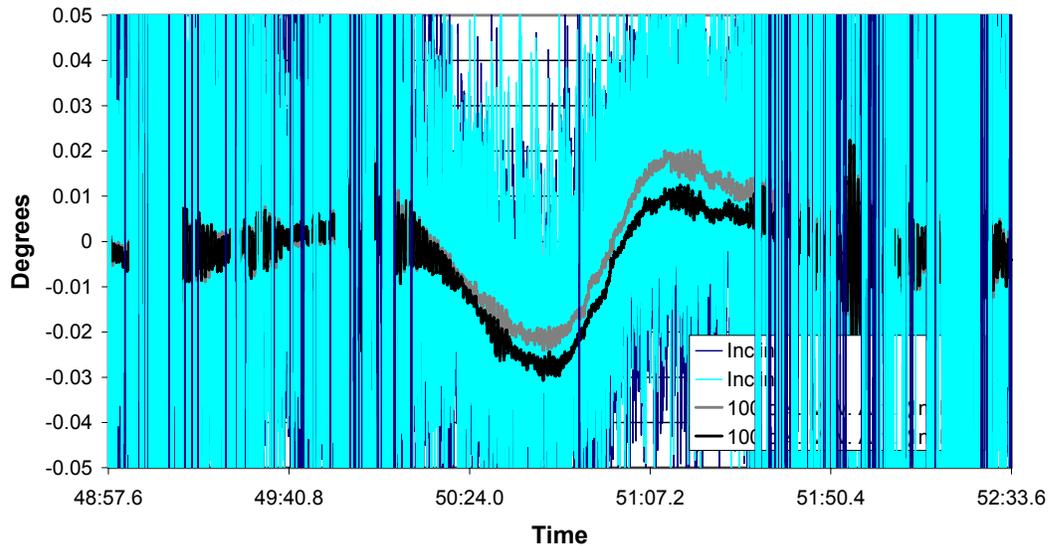
Figure 4.8: Inclinometer readings from Mn/DOT Snooper

As noted above, at a previous date the snoopers were recorded going over the bridge. It was the only pass by a vehicle that produced readable data for the inclinometers. All other passes proved to be too noisy to decipher any legitimate data. The inclinometers were located on girders C and D for the snoopers test. As the plot shows the results were still very noisy (Figure 4.8).

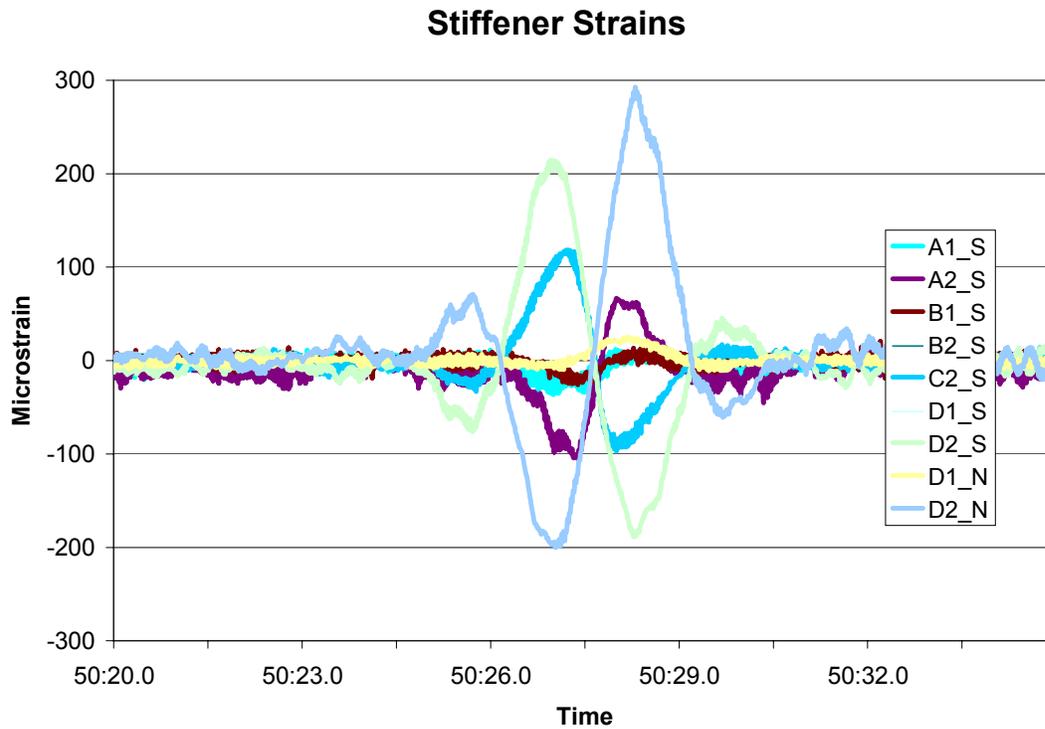
Figure 4.11: Stiffener strains from interior of pier cap

Figure 4.11 shows the typical reaction of the strains in the stiffeners for a vehicle traveling in the right lane. These readings correspond with the movement determined from the horizontal LVDTs for a vehicle traveling in the right lane during the truck tests. The highest strain recorded from the strain gages was $450\mu\epsilon$ located on the North stiffener at girder D. This equated to approximately a 105 kip load in the right lane. This strain translates to an approximate stress range of 13 ksi, higher than the CAFL of 10 ksi for a type C detail.

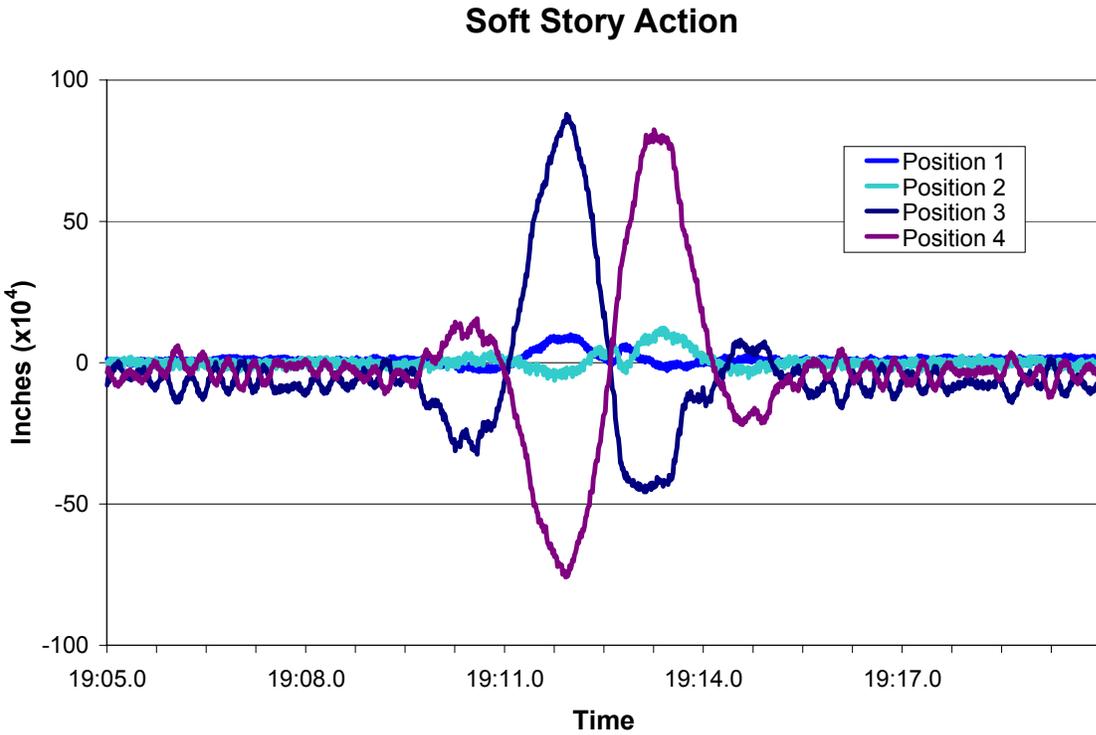
Figure 4.12: Shearing of the top and bottom cells

To confirm the shearing of the lower cell of the pier cap, LVDTs were placed diagonally across the cells. Positions 1 & 2 were in the top cell and positions 3 & 4 were in the bottom cell. As the cell shears it takes the shape of a parallelogram and the length of the diagonals change. Figure 4.12 demonstrates this taking place. Very little deformation took place in the top cell compared to the bottom cell. This is due to there being an opening in the lower cell, creating a softer story compared to a full continuity plate in the top cell making it much more rigid.
