2003-18

Final Report

**Fatigue Evaluation of Steel
Box-Girder Pier Caps: Bridge 69832**

March 2004

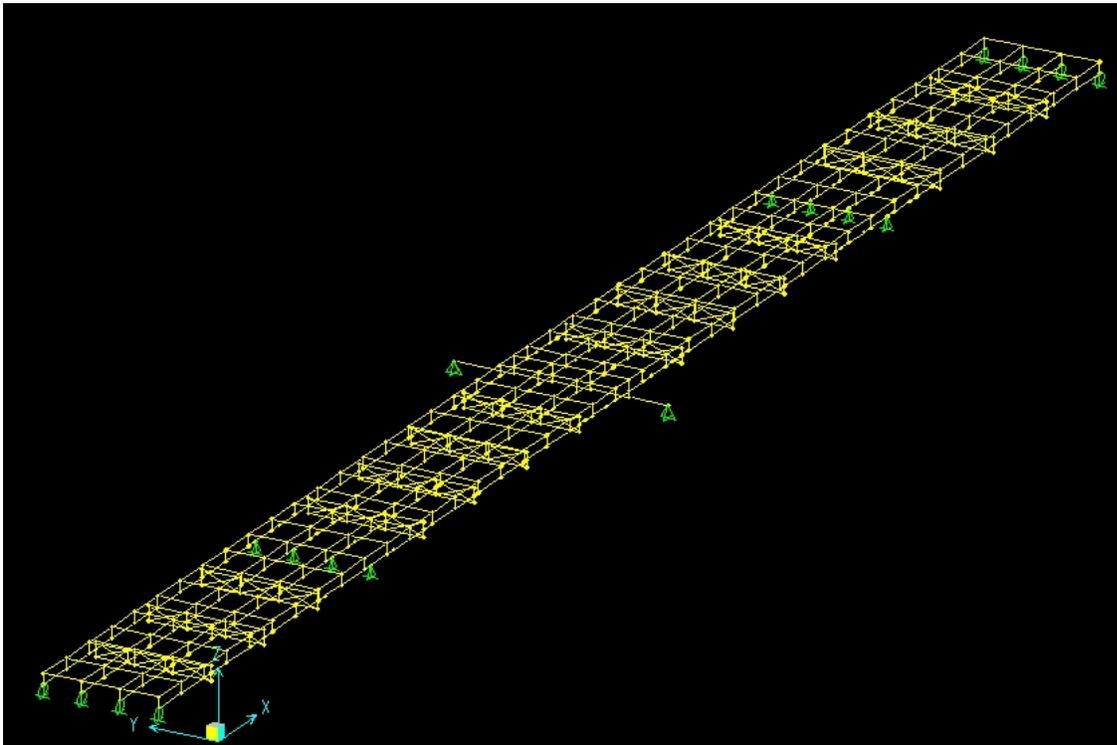
Figure 5.1: Three-dimensional grillage model

To understand the forces in the bridge and its overall behavior due to vehicle loading a three-dimensional grillage model was created using SAP 2000. The 4-span continuous section with Pier Cap 5 at the center was modeled. All components of the bridge were composed of frame elements (Figure 5.1).

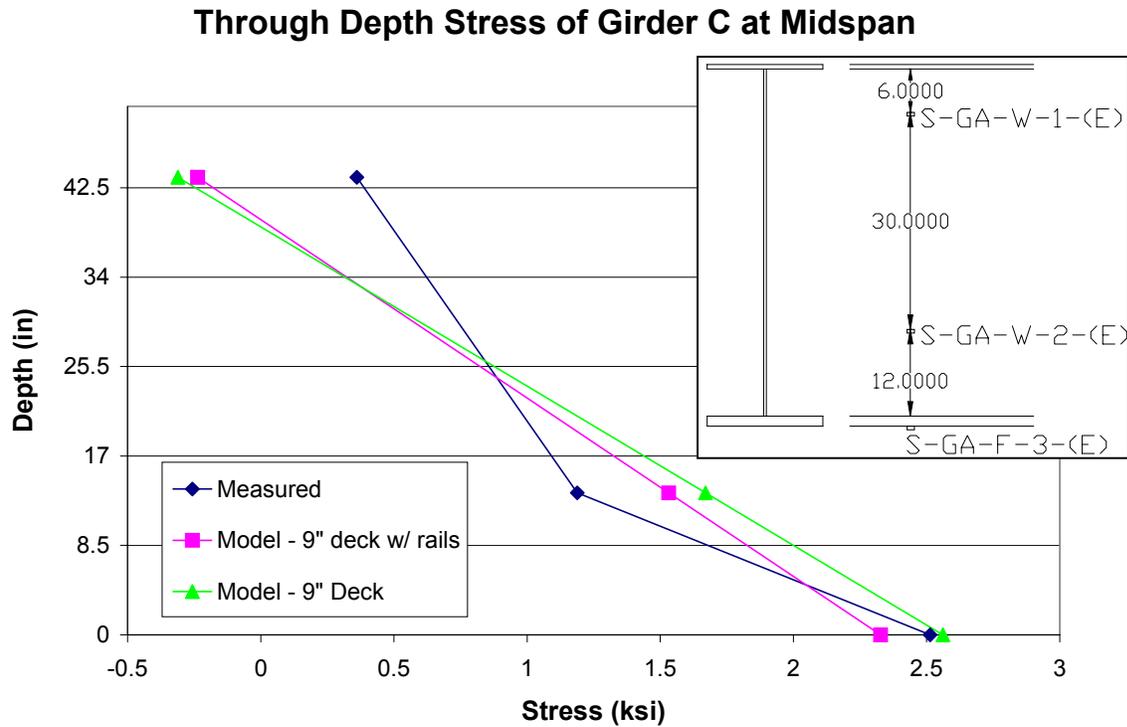
Figure 5.4: Through depth stresses on Girder C at midspan due to 50-kip truck

A comparison was also made of the stresses through the depth of the girder. Strain gages were placed at three locations through the depth at midspan. Figure 5.4 shows how the grillage models compare to the measurements taken for a 50-kip truck traveling in the right lane.

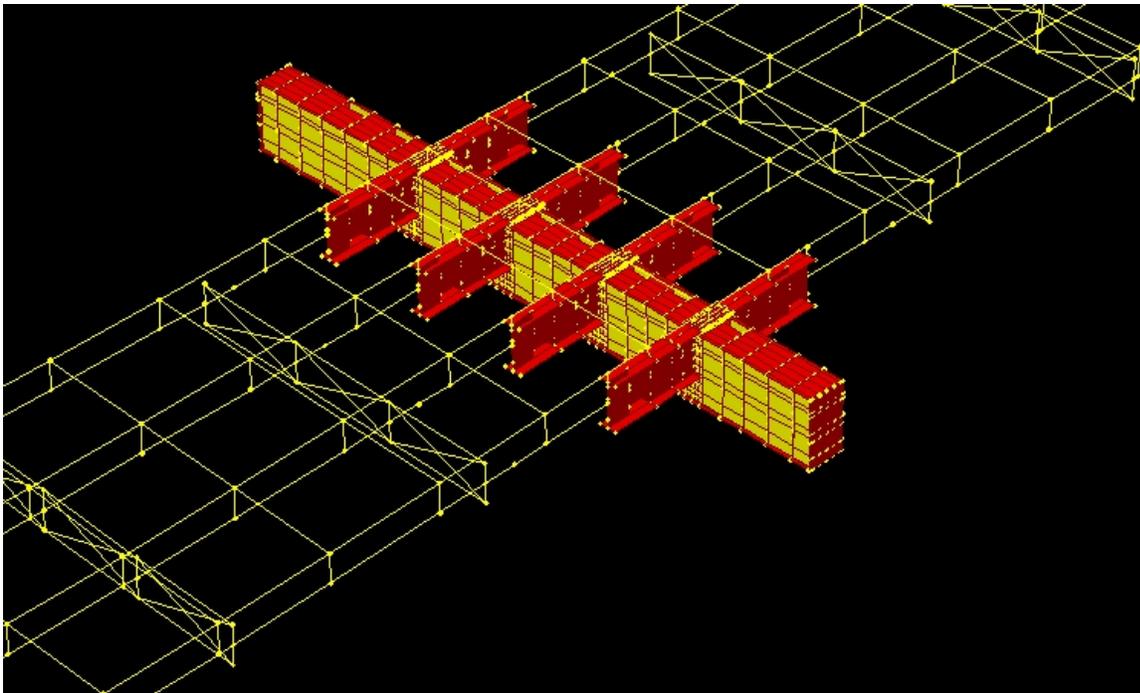
Figure 5.6: Shell element model integrated into grillage model

To be able to view the stresses and reaction of the stiffeners within the pier cap that are experiencing problems a shell element model was created that closely represented the details of the pier cap. This model depicted the steel box of the pier cap and included all the stiffeners located within the pier cap. It also modeled a section of the girders as they intersected the pier cap. This shell element model was then inserted into the grillage model replacing the frame elements that made up the pier cap and the portions of the girder modeled (Figure 5.6).

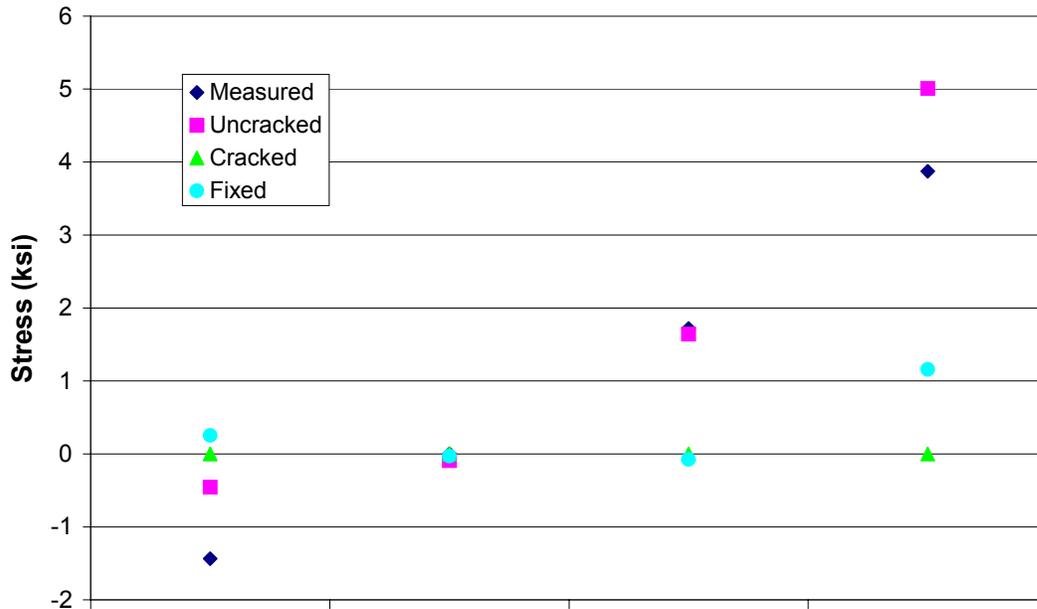
Figure 5.7: Stiffener stresses for the three shell element models

To confirm the reliability of the model, the stresses from the stiffeners on the uncracked model were compared to the stresses obtained from the strains for a theoretical 50-kip truck in the right lane. Since only uncracked stiffeners were instrumented the uncracked model would most closely represent the measured results. Stresses at the locations of the strain gages on the stiffeners for the uncracked model, the cracked model, and the retrofitted model were obtained. Figure 5.7 shows these stresses compared to those that were determined from the field measurements.
