Final Report

Fatigue-Resistant Design for Overhead Signs,
Mast-Arm Signal Poles, and Lighting Standards

1. Report No. MN/RC-2006-07	2.	3. Recipients Accession No.	
4. Title and Subtitle Fatigue-Resistant Design for Overhead Signs, Mast-Arm Signal Poles, and Lighting Standards		5. Report Date March 2006

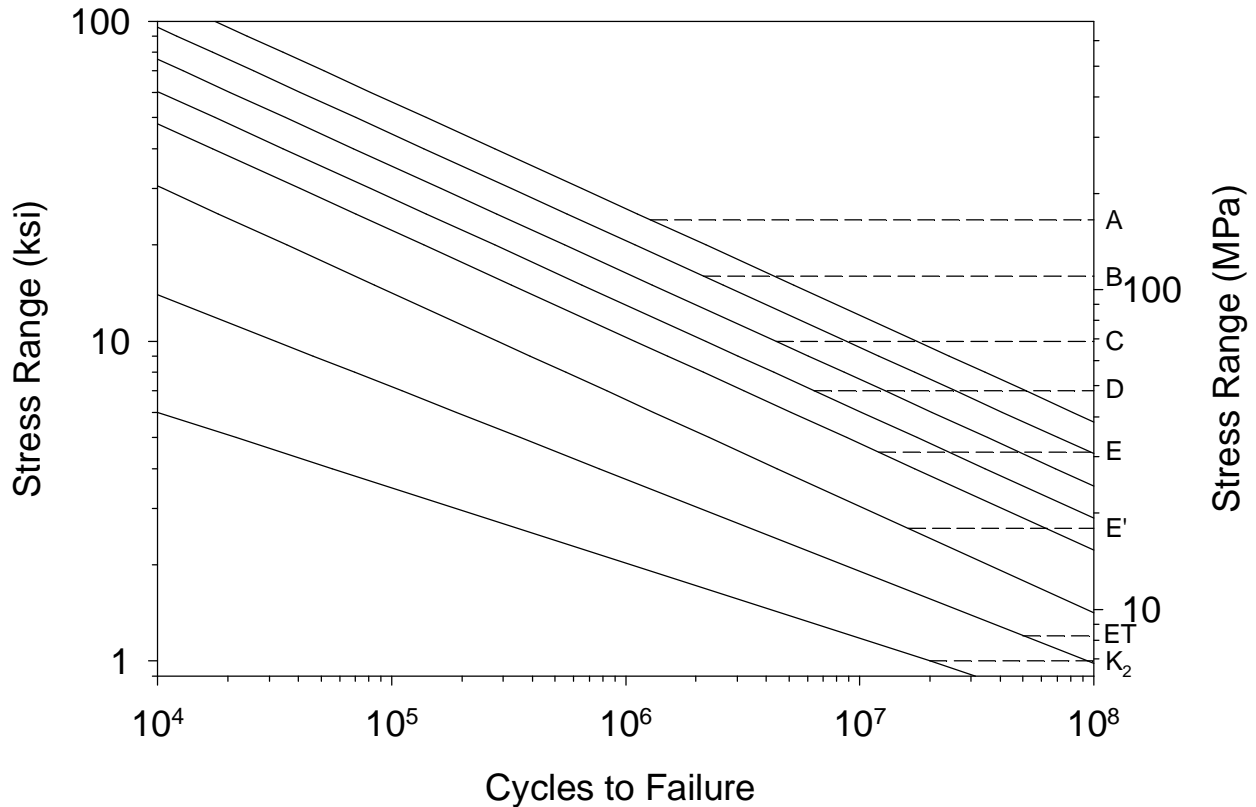
Figure 2.10 Nominal stress S-N curves used in AASHTO, AISC, AWS specifications

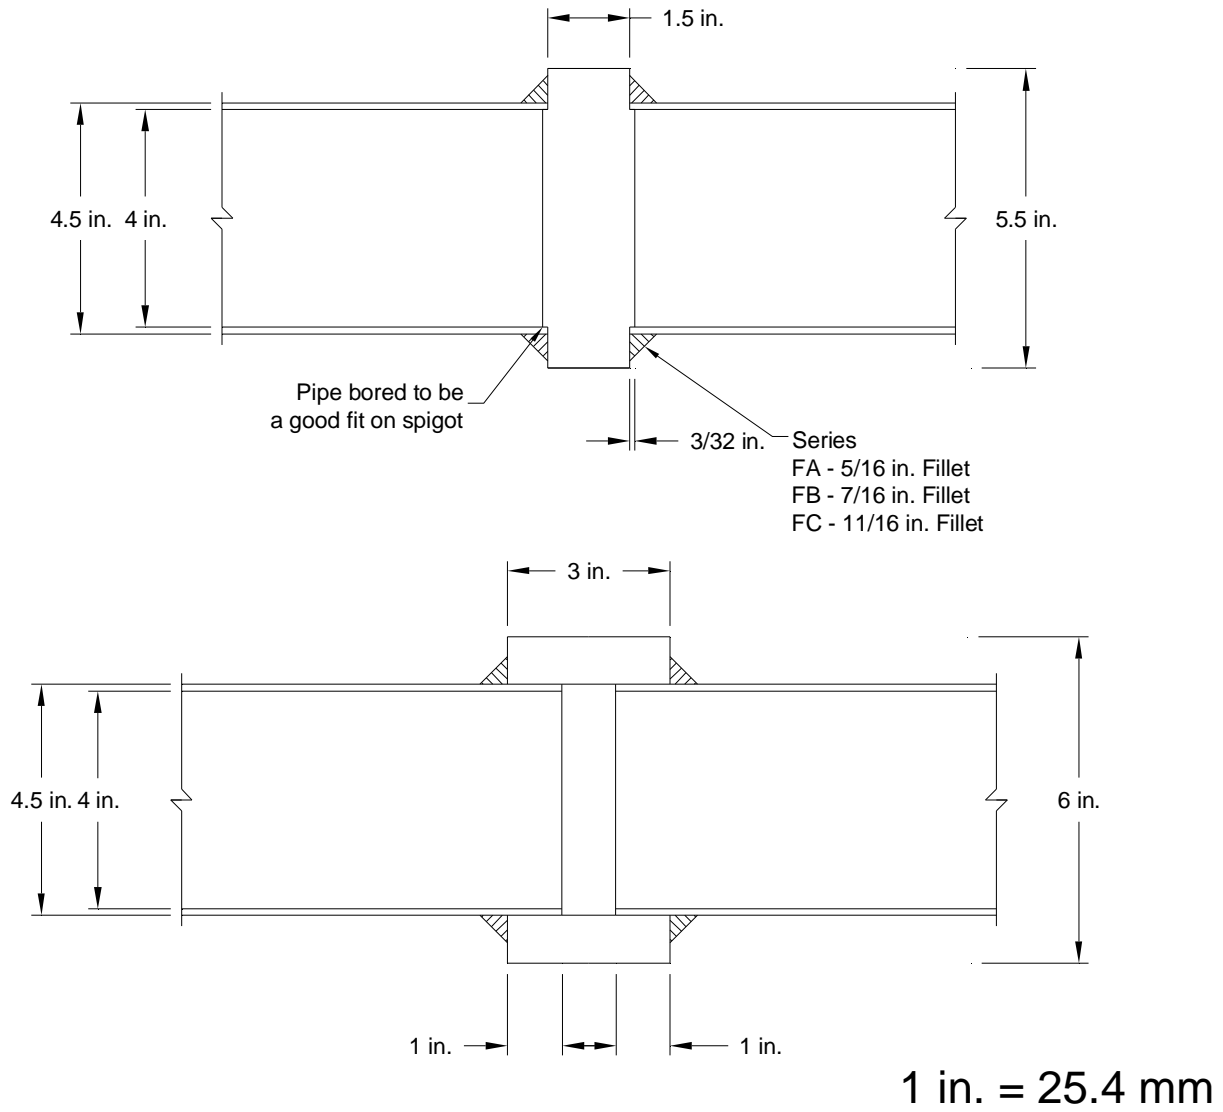
Figure 3.2 Schematic of Archer and Gurney specimens. Top: Type F specimen. Bottom: Type S specimen.

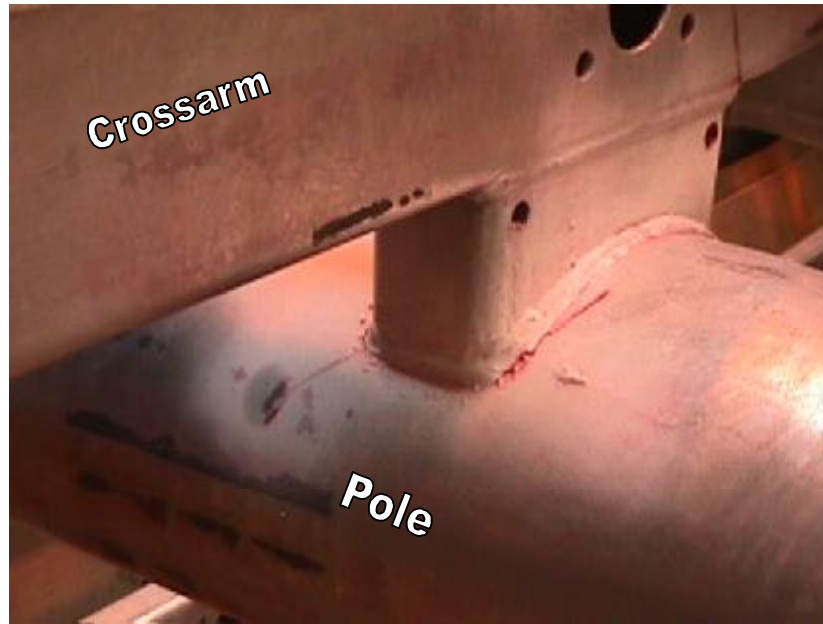
Figure 3.6 Close-up view of spacer connection between pole and crossarm.

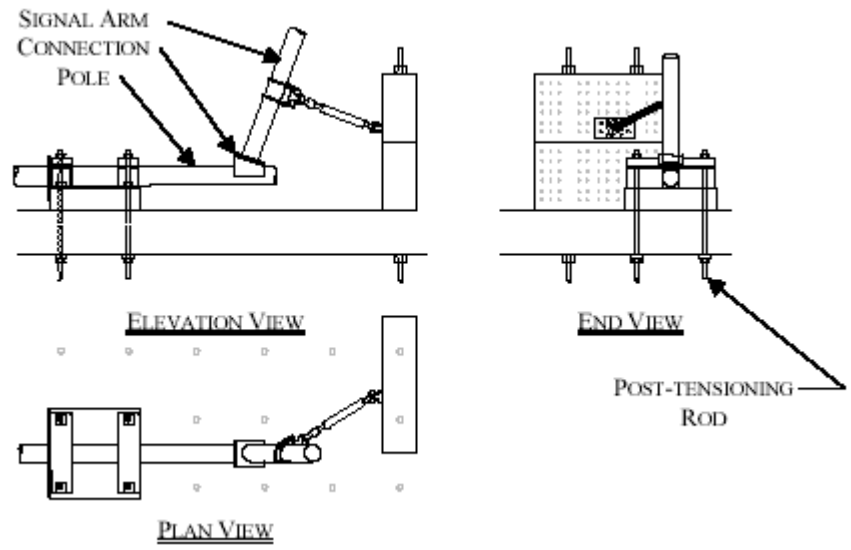
Figure 3.13 Laboratory set-up for Wyoming testing (29).

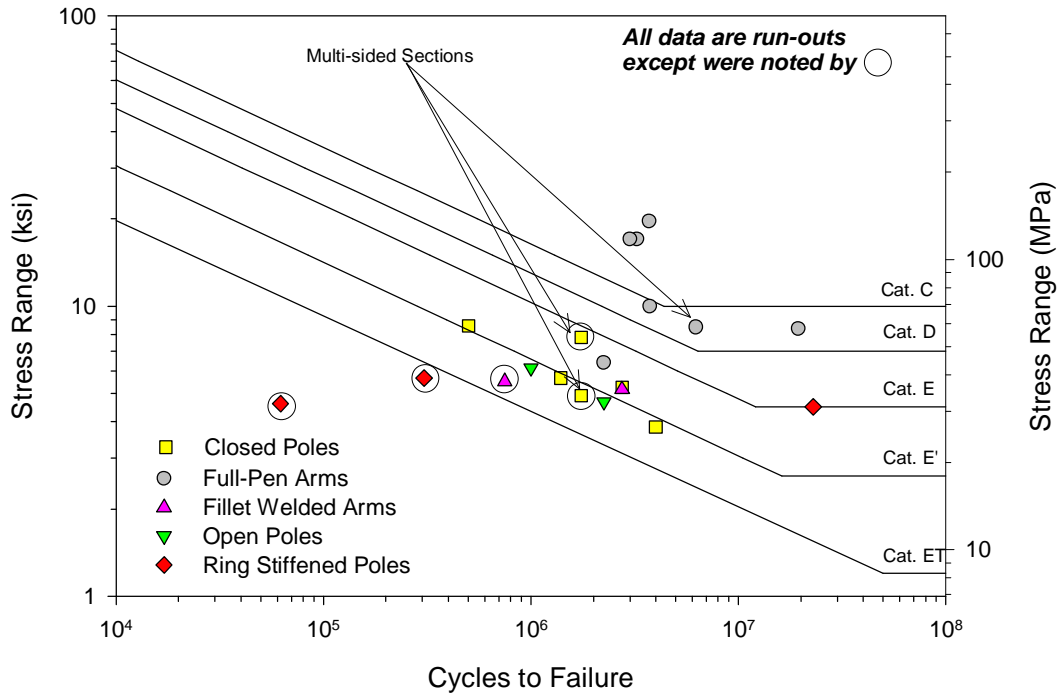
Figure 3.15 Fatigue data of mast arms and box connections conducted at University of Wyoming.

Figure 3.15 shows selected fatigue data for mast arms and box-connections tested in this project. Again, this does not represent all the data collected because many of the specimens were from retired structures, cracked prematurely and were therefore neglected. However, a few of the specimens taken out of service demonstrated a fair amount of fatigue resistance and are reported in this report. The majority of the data presented are those of “run-outs”, or tests that were terminated prior to cracking. Displaying the run-outs can at least demonstrate a minimum amount of fatigue resistance. The selected data has been plotted in Figure 3.15 against the AASHTO S-N curves. Conclusions regarding this data are difficult because the majority of the data points are run-outs. Most of the full-penetration welded mast arms plotted above the Category D line, whereas the fillet welded connections are down by the Category E' line. There also seems to be little difference between the open and closed box connections of the poles, as they all seem to plot well against the Category E' line. The surprising data is that of the ring stiffened box connections because two of these connections (which were virgin) cracked prior to achieving Category ET, but testing on the third was terminated at Category E'. This connection should perform better than the open and closed connections because the rings prevent “oil-canning” which would reduce secondary bending effects in the pole.

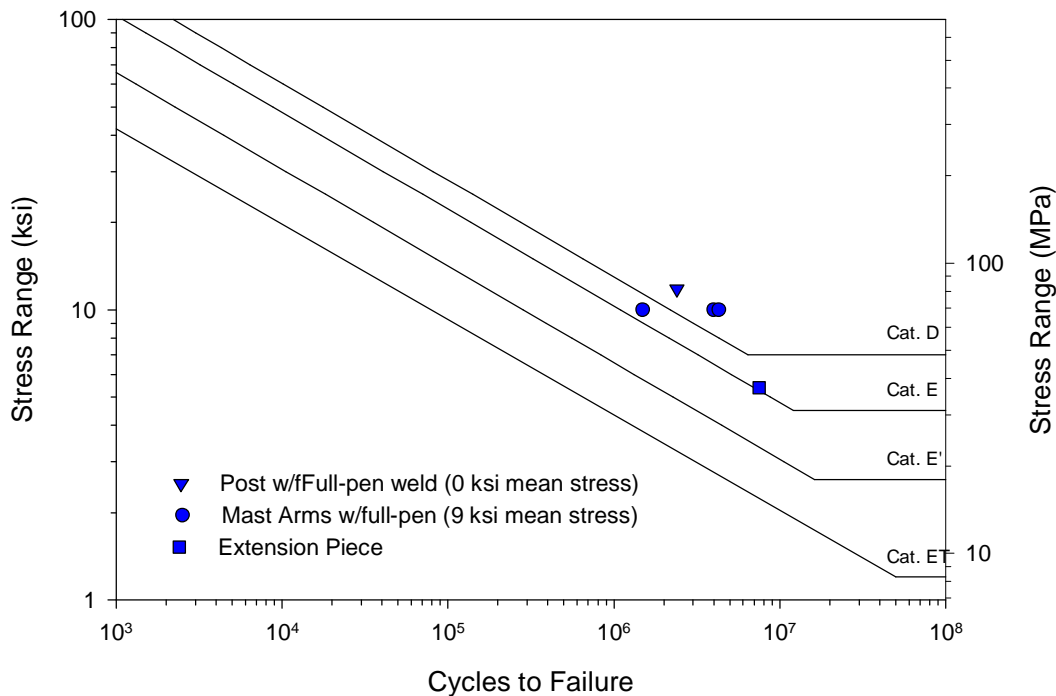
Figure 3.16 Plot of the Gilani pole and mast arm data along with relevant AASHTO design curves.

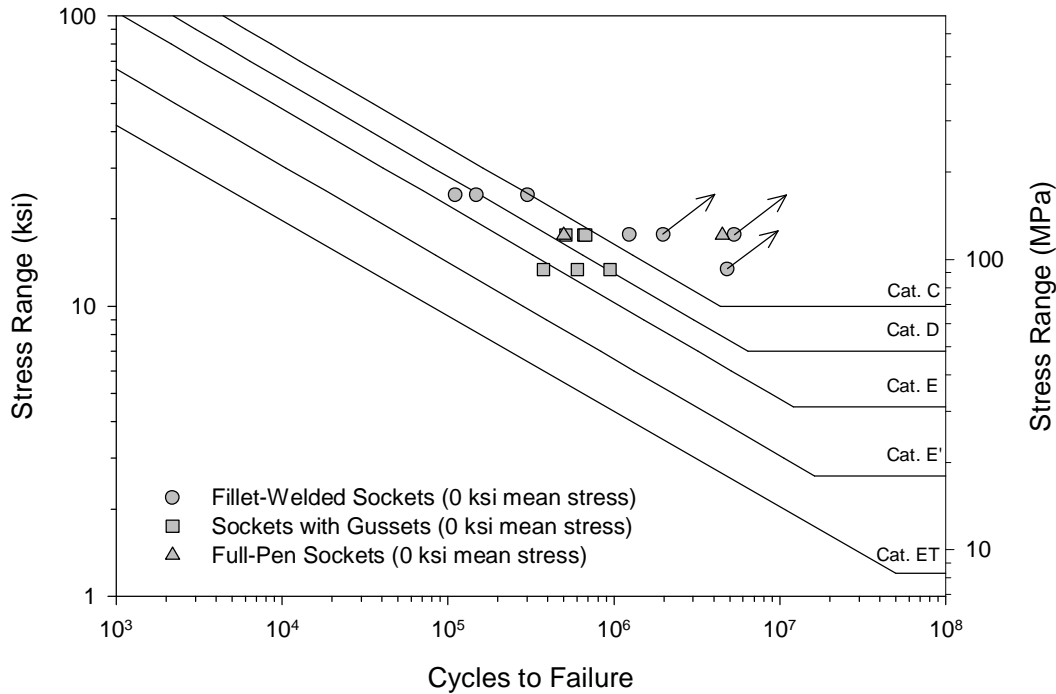
Figure 3.21 Plot of the fatigue data of three different types of tube-to-plate connections tested by Valmont.

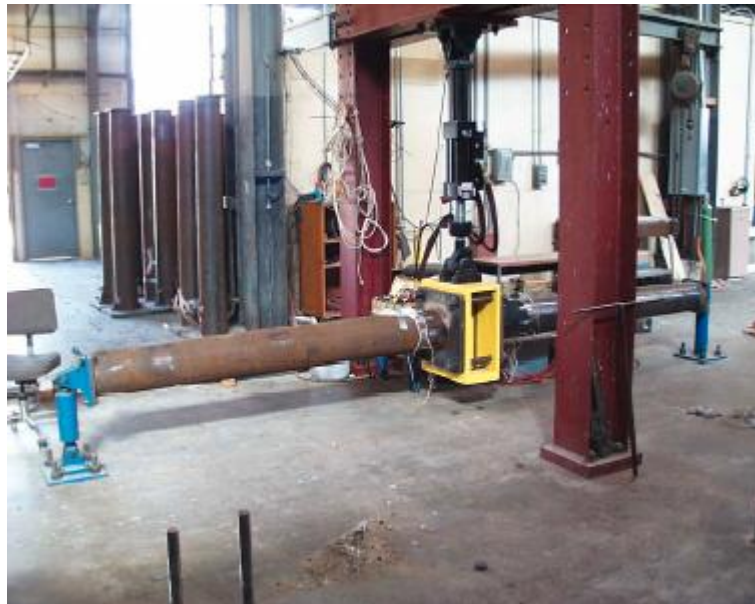
Figure 3.22 UTexas mast arm fatigue setup.

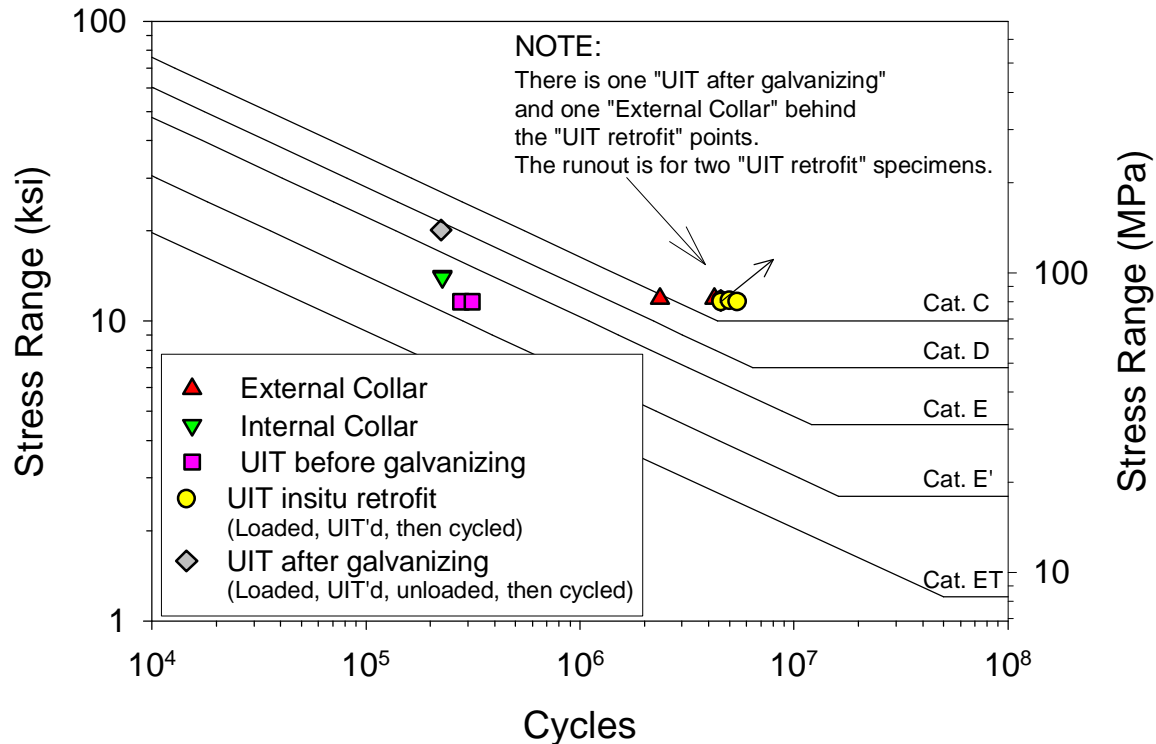
Figure 3.25 UTexas fatigue data for miscellaneous socket connections.

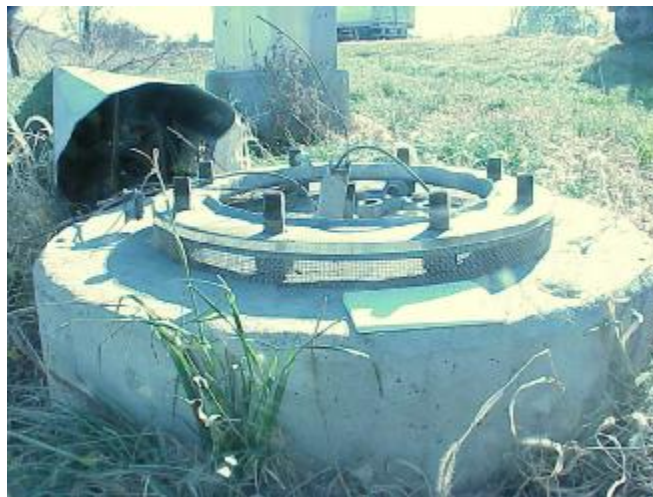
Figure 3.26 Collapsed I-29 high mast tower in Sioux City, Iowa.

An AASHTO fatigue analysis was conducted on the failed poles as well of those still in-service. The analysis used AASHTO recommended fatigue loads and detail categorizations. However, the vortex shedding provisions were known to be incorrect, and a more detailed steady-state dynamic analysis was used to predict the stress ranges for vortex shedding loading. However, assumed values of correlation length and damping ratio had to be assumed to conduct this analysis. Most of the in-service poles were found to fail the AASHTO fatigue analysis, though many of them failed from higher mode vortex shedding vibration. It was unclear what mode the poles would truly vibrate in under vortex shedding and an extensive long-term, field monitoring project is on going to determine the loads and vibration properties of high mast poles. Recommendations were made to thicken all pole bases in future designs to reduce the stress ranges from vibration to enhance fatigue life.

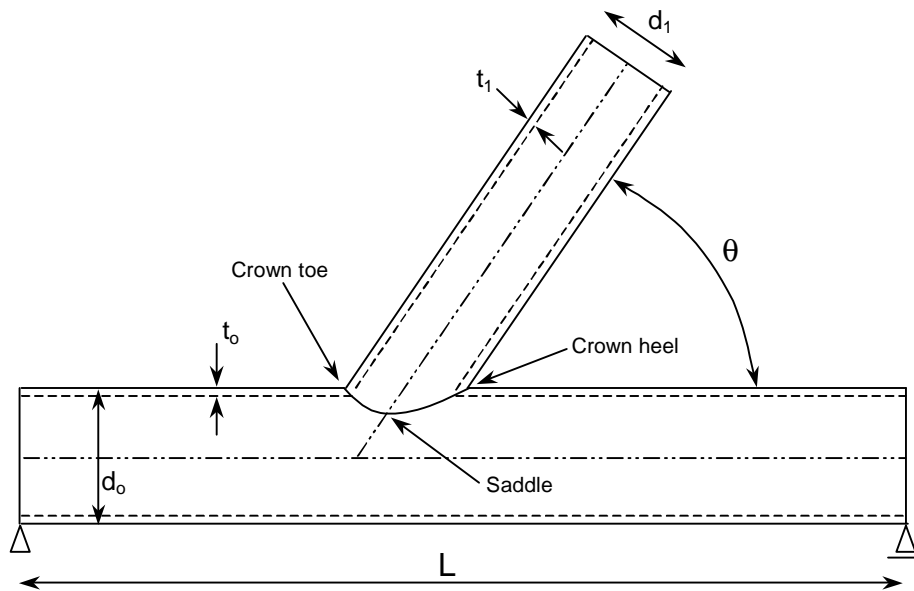
Figure 3.27 Definitions of CHS T and Y-joint dimensions.

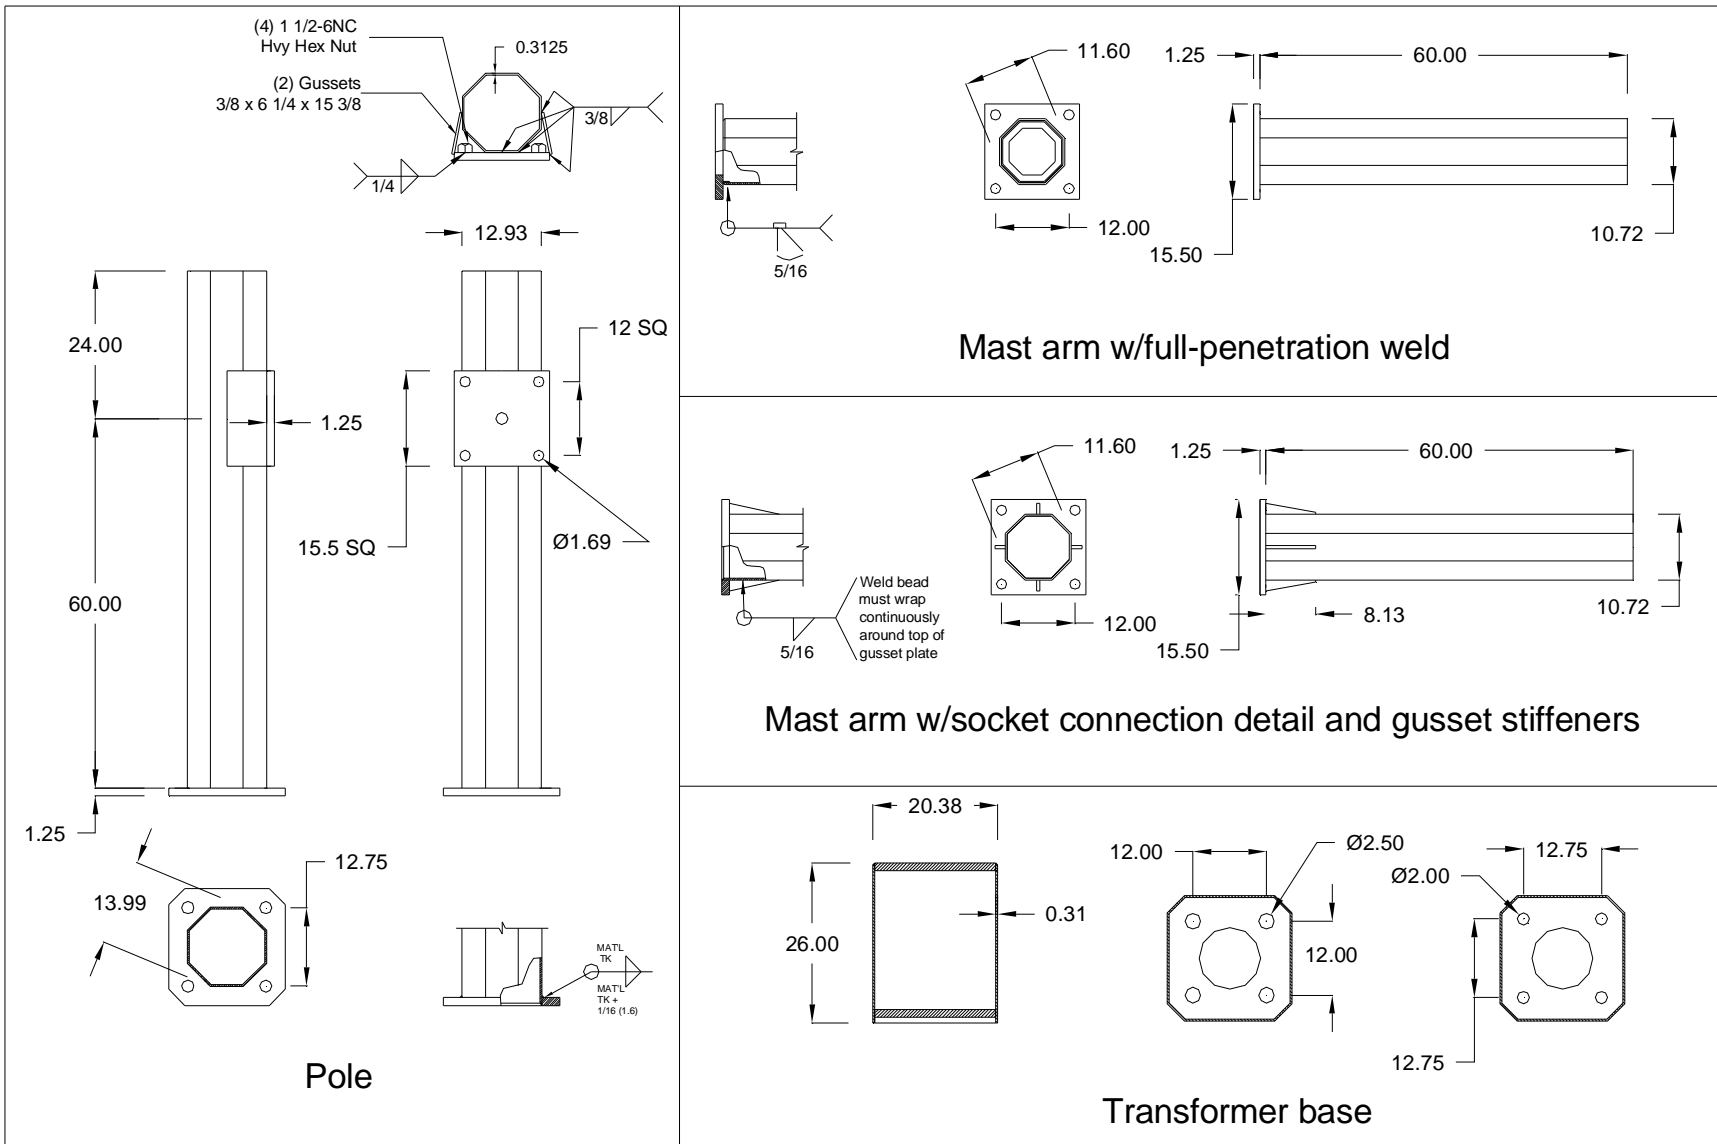
Not to scale, units = inches, 1 inch = 25.4 mm

All detailing of the Type I specimens can be found in Figure 4.1. In addition to the eight mast arms and poles, Mn/DOT also specifies the use of a transformer base with these kinds of poles. Historically, these boxes placed between the foundation and the pole base actually housed electrical transformers, which are no longer needed with modern electrical systems, however their use still exist in Minnesota. All Type I specimens were tested with a transformer base present to accurately represent the boundary conditions in the pole socket connection.

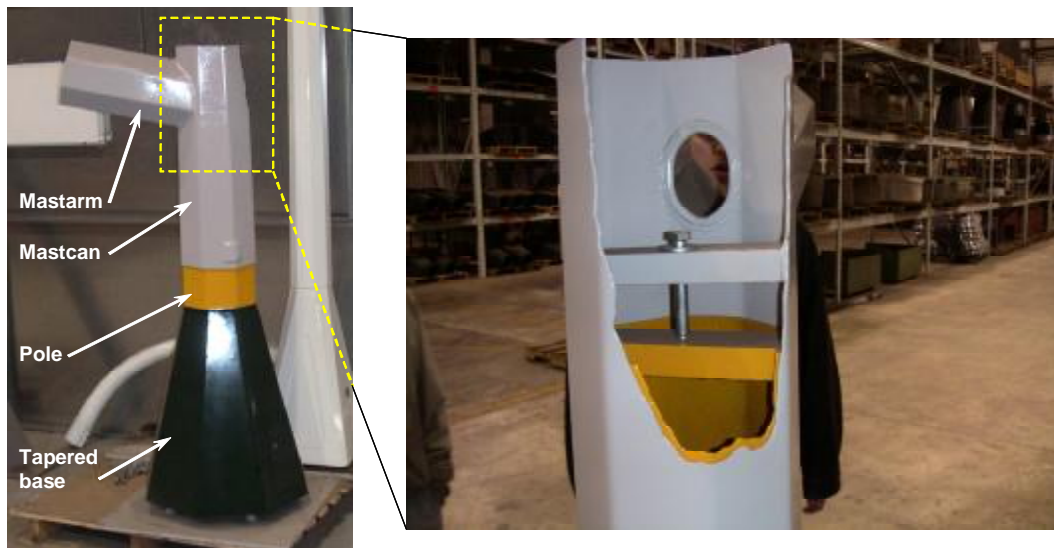
Figure 4.3 Mock-up of Type II specimen with cut-away view of mast can detail.

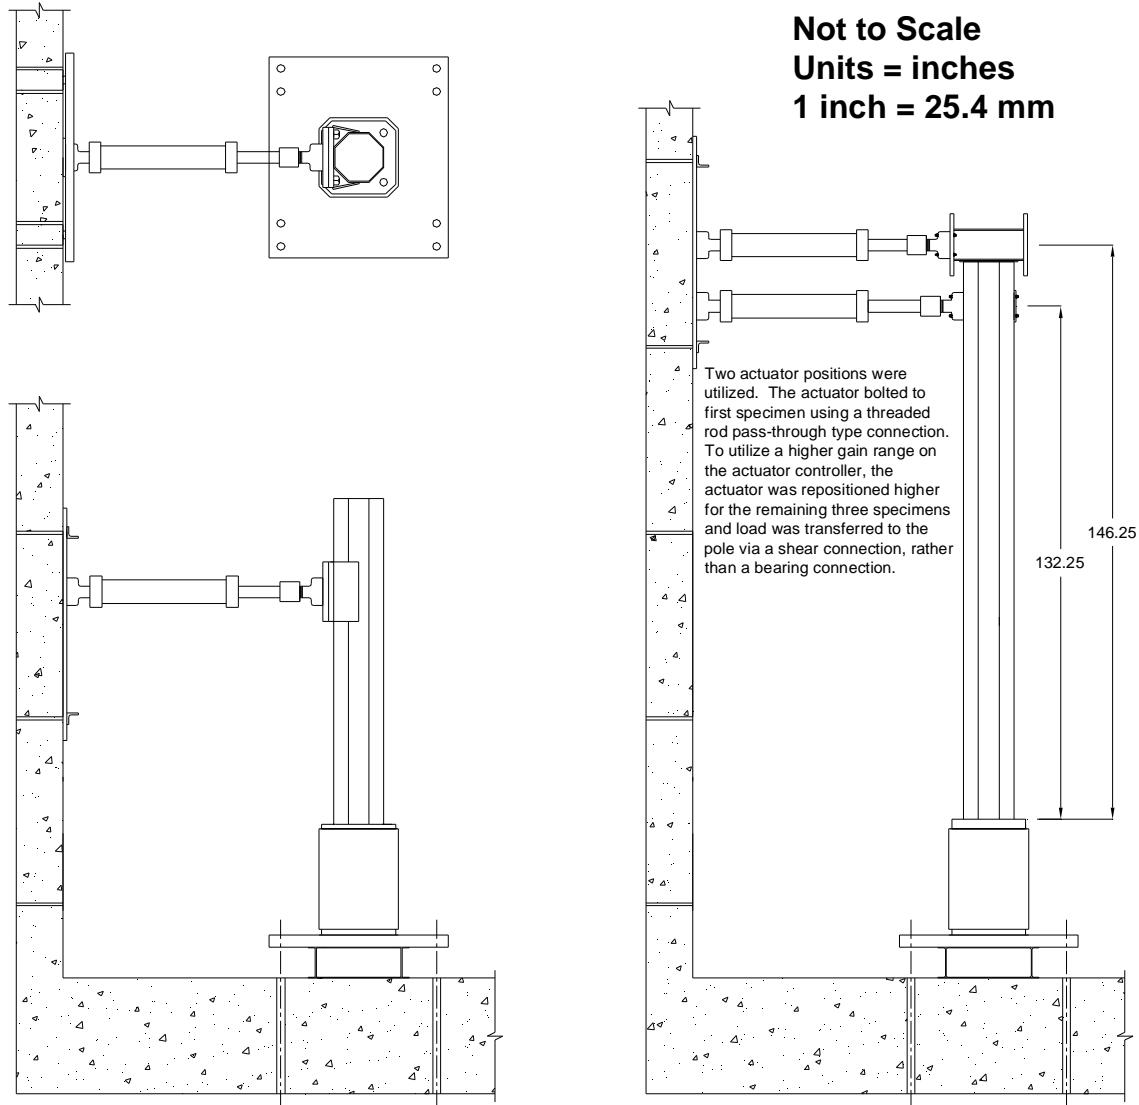
Figure 4.7 Schematic of Frame 2 layout.

Frame 2 was also used to cycle the long pole specimens, with two minor modifications. One, the actuator was moved to a new height to accommodate the longer specimen. Second, since the long poles did not have box connections, a different method of attaching the actuator to the pole was devised. The actuator on the first long pole specimen was bolted to the pole by passing threaded rods through the tube and the actuator clevis was post-tensioned to the pole tube with a backing plate on the opposite side of the tube. This is the same method the actuator was connected to the mast arms in Frame 1. Strain gauges verified the correct loading was getting into the pole with this connection, however, the threaded rods tended to rub on the sides of the tube creating a loud rubbing noise. A new connection was used on the remaining three long pole specimens, where a 9.5 mm (0.375 inch) thick plate was welded to the top of the pole. A small W-section with end plates was then welded to the top of this plate, creating a connection that transferred load into the pole via shear, not bearing. The new connection eliminated the rubbing noise and also increased the moment arm distance such that a higher gain range could be utilized in the actuator controlling system. These two types of connections are shown in Figure 4.7.

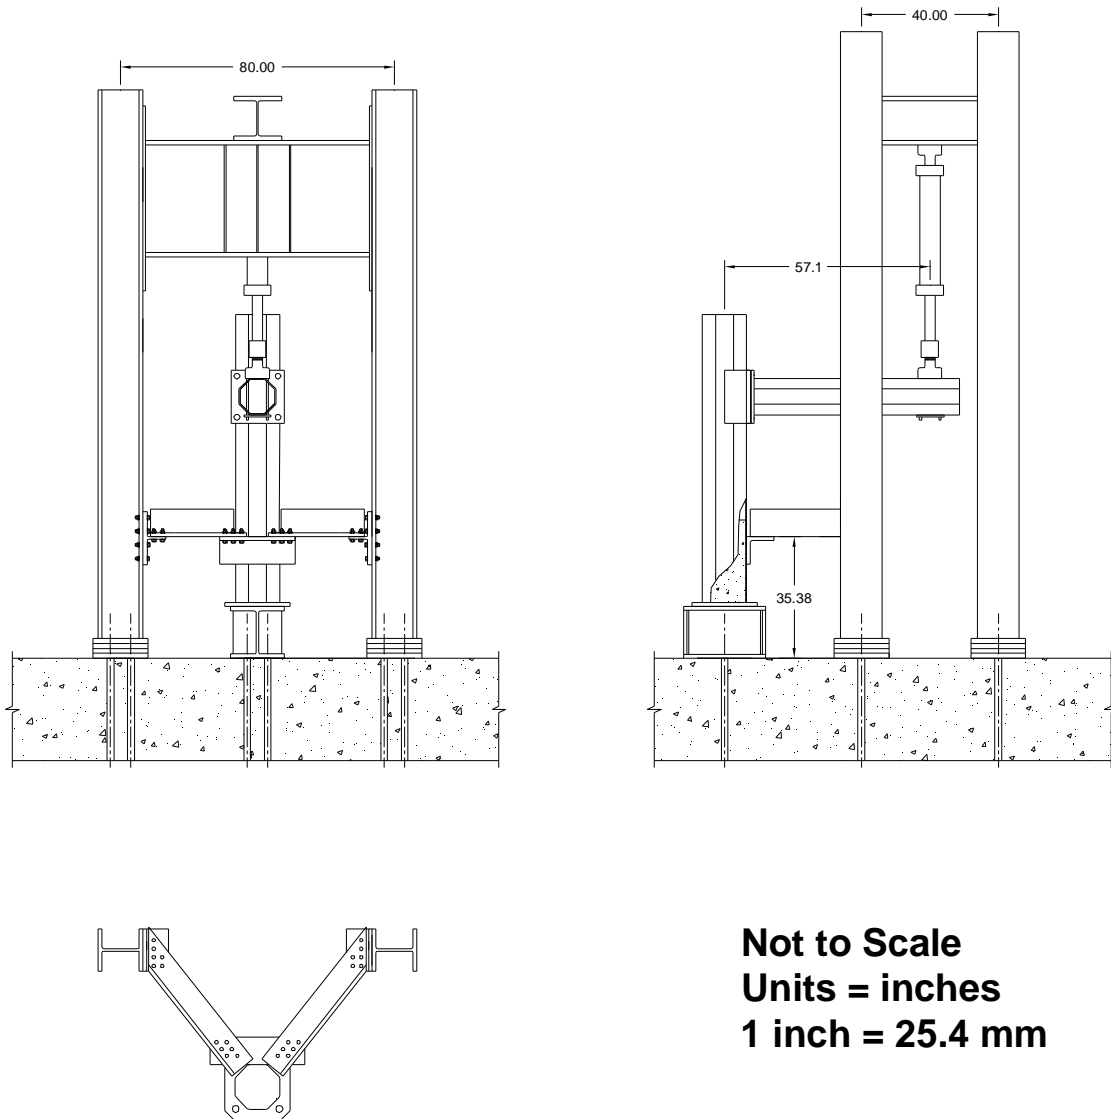
Figure 4.8 Schematic of Frame 3 loading system.

203.2 mm x 28.6 mm (8 x 8 x 1.125 inch) angle. This angle section was further reinforced with two like angles which helped carry the force back into the load frame columns. The system of heavy angles and stub W14x159 resisted the applied moment via a force couple, and this caused the moment at the pole socket connection to be near zero as it lied in the middle of the heavy angles and the strong floor. The interior of the pole tube was also filled with concrete to prevent the tube from crushing under the applied moment.

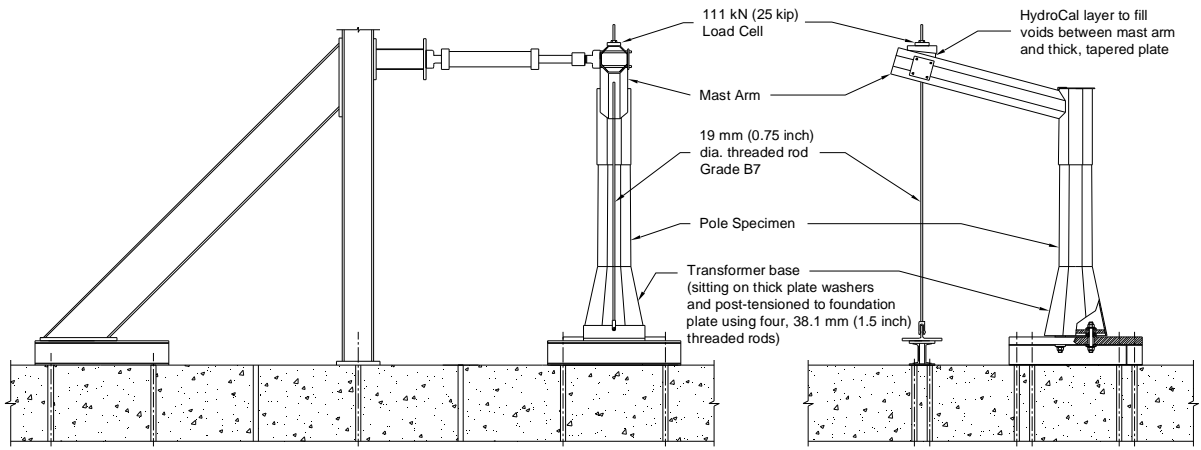
Figure 4.9 Schematic of Frame 1 for Type II specimens.

All eight mast arms were able to be cycled using the same pole. Therefore, Frame 1 had to be modified again so the actuator could be repositioned to cycle just the remaining pole specimens. A schematic of this modified load frame is shown in Figure 4.12. The frame was modified by shifting the foundation plate over one hole set on the laboratory strong floor, and adding a second braced column for the actuator to react off. This frame allowed for the actuator to pull the top of the pole specimen, inducing a linear moment diagram in the pole to fatigue the welded details used in the pole base.

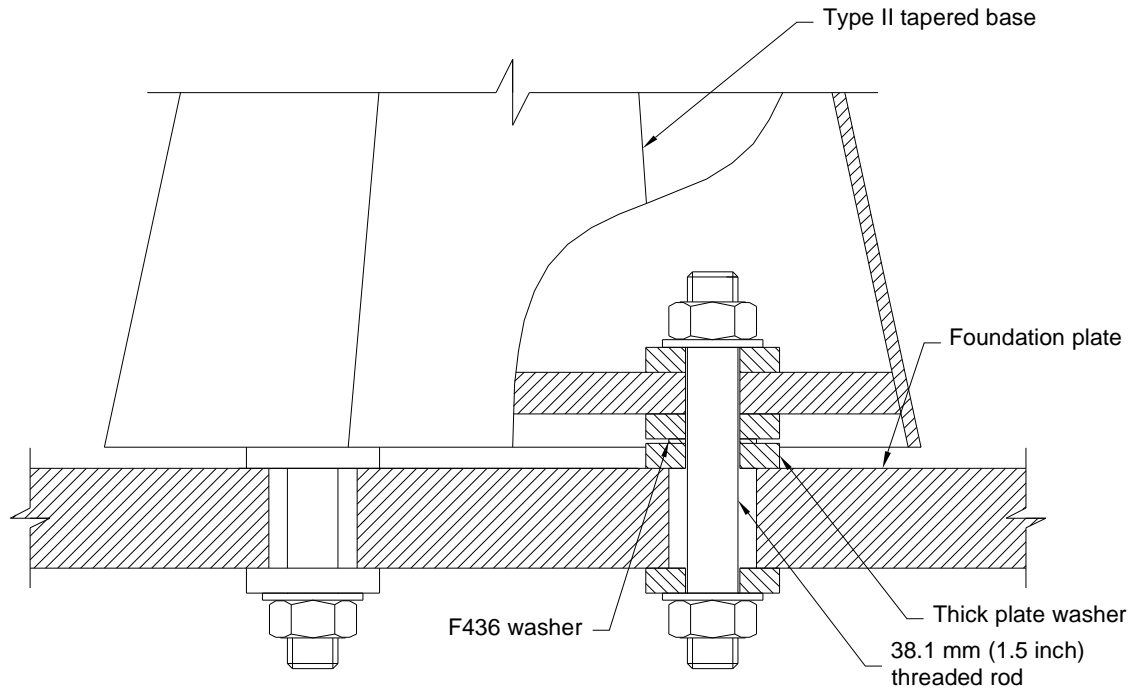
Figure 4.10 Type II pole foundation connection.

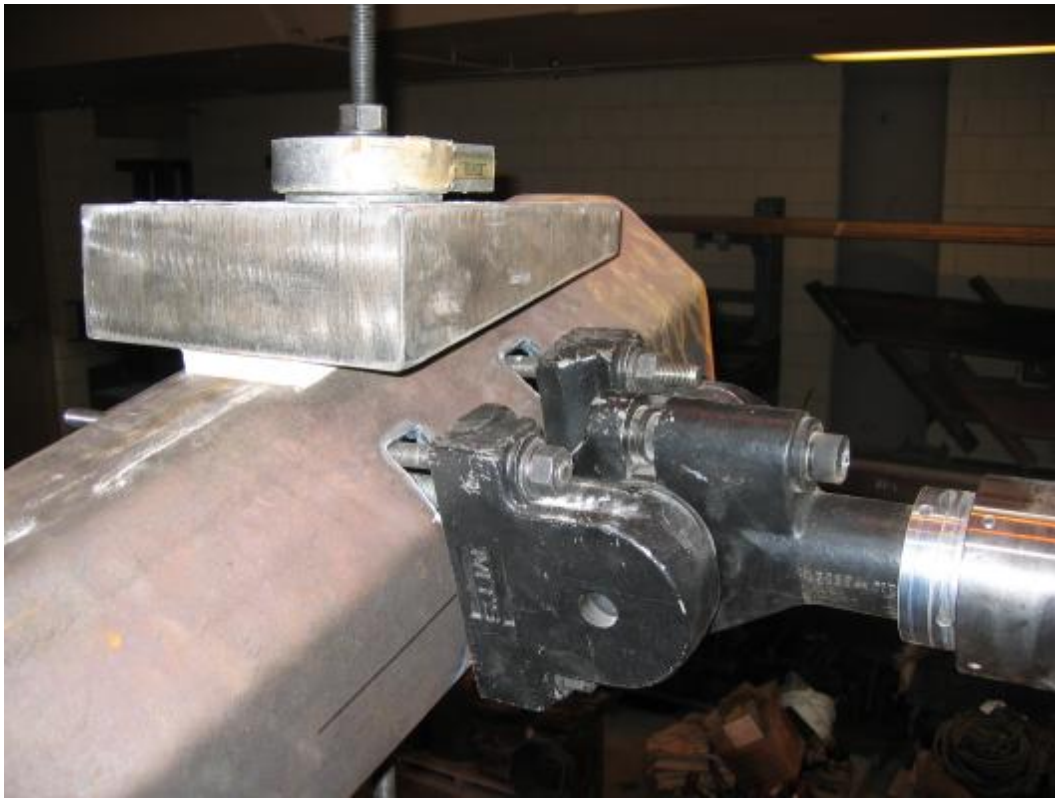
Figure 4.11 Thick plate washer beneath load cell for Type II specimen out-of-plane loading.

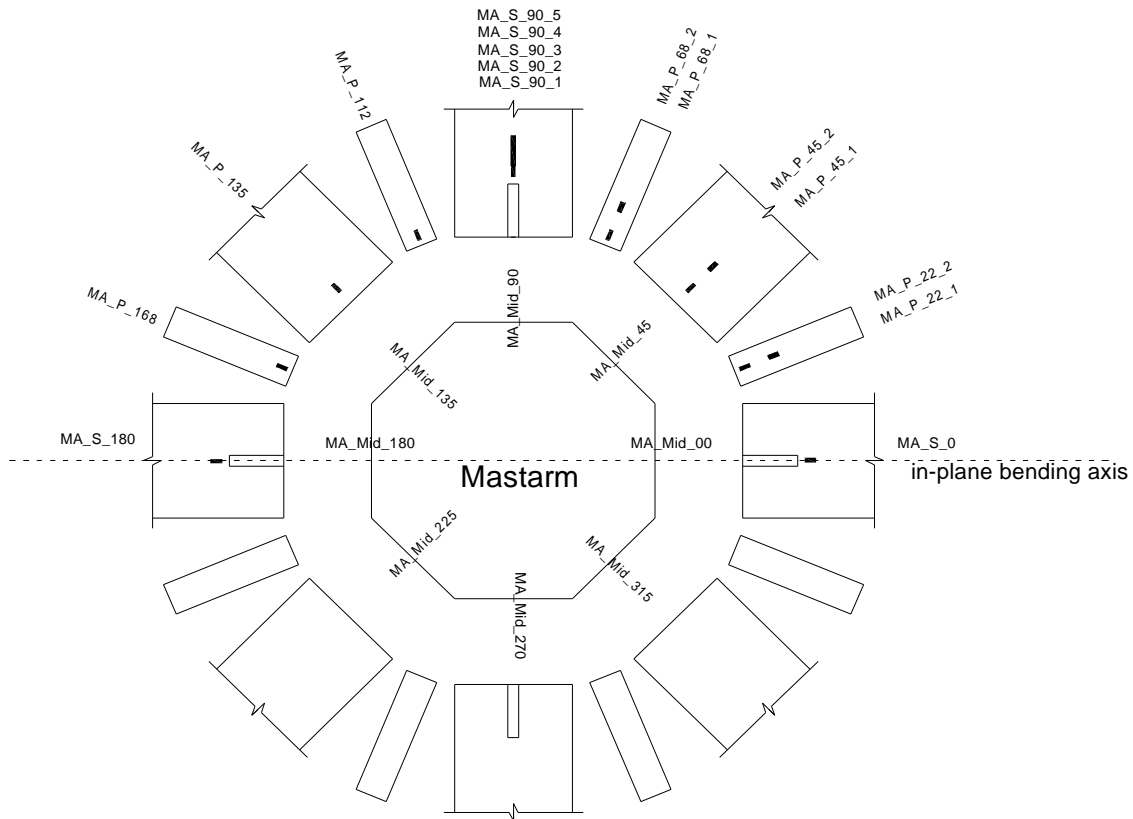
Figure 5.2 Mast arm strain gauge locations and labels.

In the literature review, it was presented that gusset stiffeners were stress risers and have been shown to have fatigue resistance equal to or worse than a bare socket connection. For this reason, one of the gussets on the mast arm had a strip gauge placed 5 mm (0.20 inch) away from the gusset weld toe. The strip gauge has five strain gauges in a row so this would allow for an accurate extrapolation of strain at the weld toe. As verification, two of the other gussets were only given one, 1 mm, uniaxial strain gauge located 5 mm (0.20 inch) from their weld terminations to verify the extrapolation accuracy of the strip gauge. Each flat and corner in the upper 180 degrees of the mast arm was given one or two 1 mm (0.04 inch), uniaxial strain gauges to determine the SCF at the weld toe. Ideally, two gauges should be used at each location such that linear interpolation could be used to extrapolate the strain at the weld toe, however, limitations on the number channels available on the data collection system dictated that only one gauge could be used at some locations. If a location could only use one gauge, it was attempted to make sure a symmetric point would have two gauges to verify the strain extrapolation.

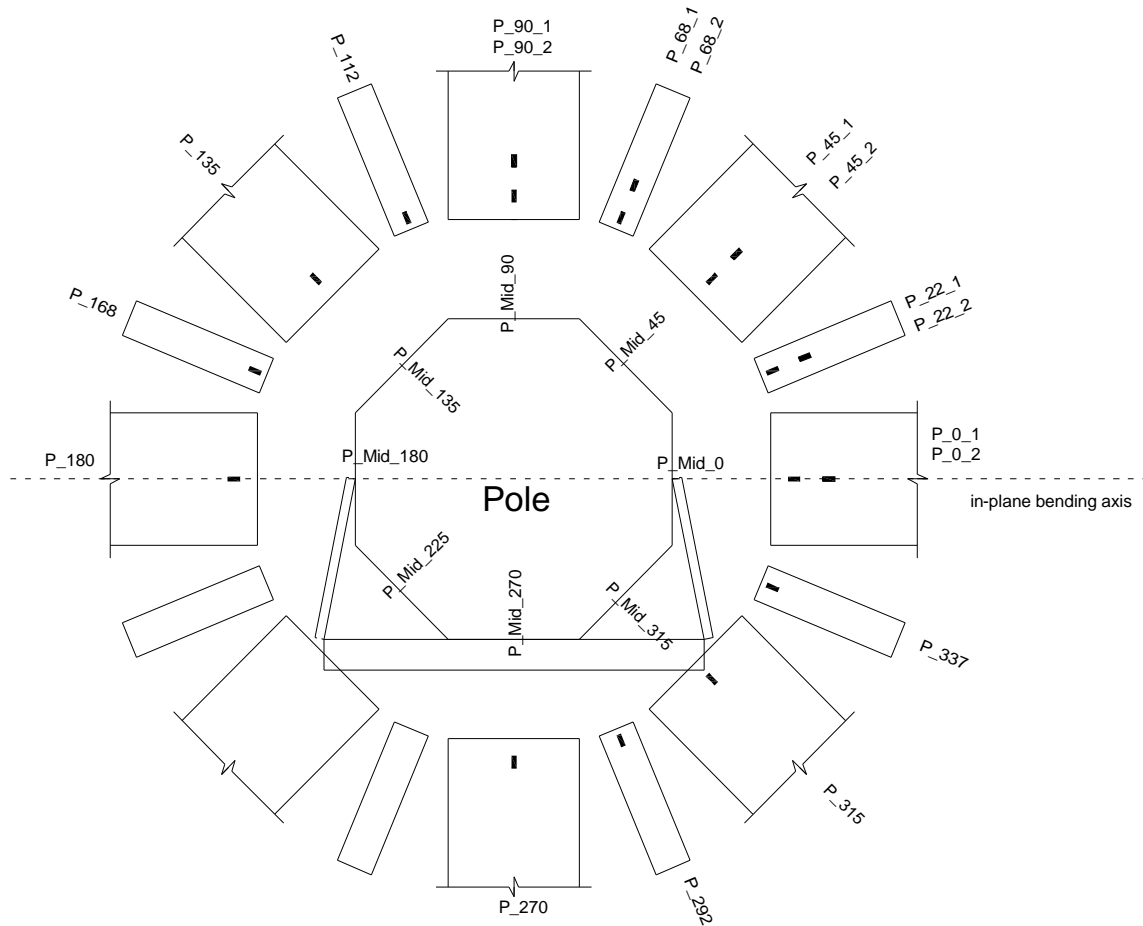
Figure 5.3 Pole strain gauge layout and labeling.

the pole section. Unlike the mast arm, the pole section will be subjected not only to bending moments and shears, but axial loads and a torque depending on the loading, therefore more strain gauges were placed around a 270 degree arc around the pole perimeter, at the weld toe of the fillet-welded socket connection. Some locations used two strain gauges for stain extrapolation at the weld toe. The strain gauge locations on the pole are shown in Figure 5.3.

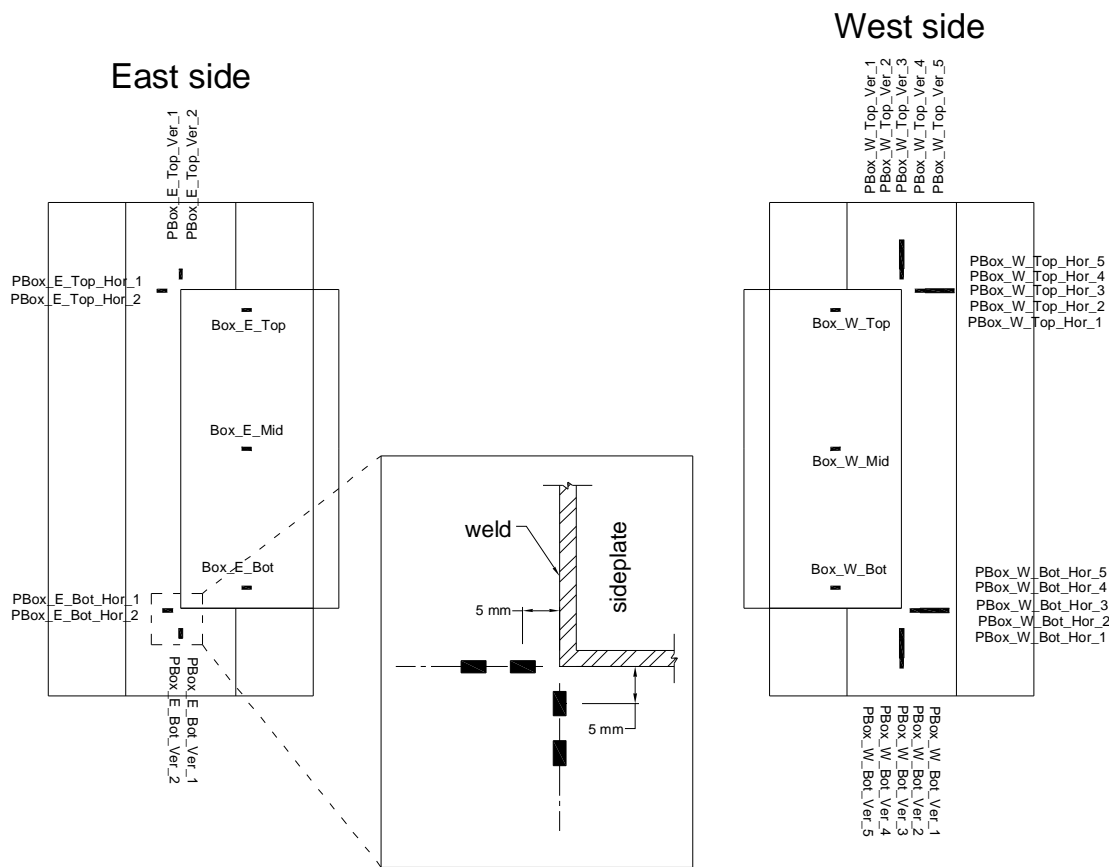
Figure 5.4 Box connection strain gauge layout and labels.

three, 6.35 mm (0.25 inch) uniaxial strain gauges were placed on the top, middle, and bottom of the two side plates, in between the flange plate and the pole. Since previous box connection failures formed cracks in the pole tube at the corner of the box, many more smaller gauges were used to understand the strain concentration at this point on the test specimen. On the East side of the box connection, two strain gauges were used for strain extrapolations at the top and bottom corners of the box connection, in two orthogonal directions. This is shown in Figure 5.4 that at each corner, two gauge clusters can extrapolate the horizontal and vertical strain at the corner of the box. The strain gauges were aligned longitudinally with the weld toe on the pole tube, offset 5 mm (0.20 inch) away from the weld toe. On the West side of the tube, strip gauges were used instead of two independent strain gauges. The first gauge in the strip was aligned as in the East side, with the first gauge centered 5 mm (0.20 inch) away from the weld toe on the tube.

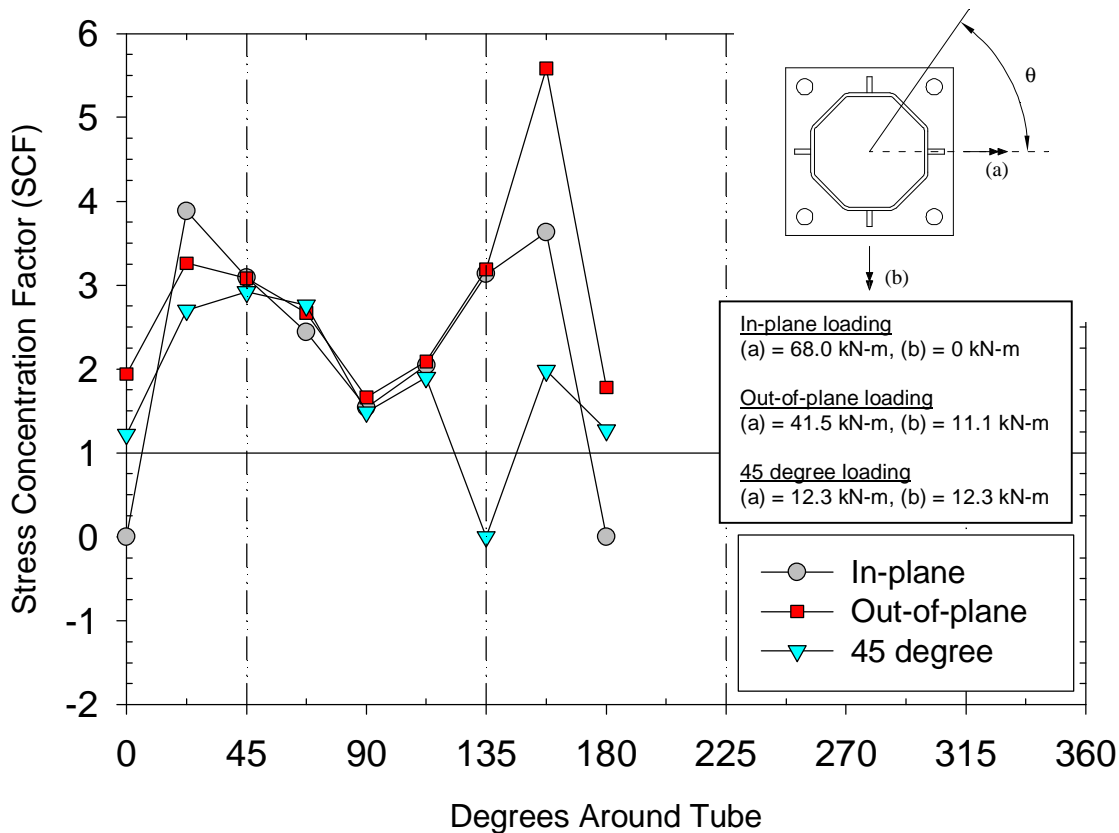
Figure 6.1 SCFs of gusset-stiffened mast arm socket connection under three different loadings.

at discrete points around the tube circumference, in the tube wall at the intersection of the base plate. Since two strain gauges were used at each location, the measured strains used in the SCF calculation were found using CIDECT (35) extrapolation procedures. In some cases, zero strain is predicted (e.g., at the neutral axis for in-plane loading) and the SCF cannot be defined because of a divide by zero discontinuity and is instead reported as zero. The three plots shown in Figure 6.1 do not show drastic changes in the SCF, and at the heaviest loaded portions of the tube vary between 1.5 and 3.5. It should be noted at the 90 degree location, the strain gauges were placed at the tip of the gusset plate stiffener, not at the toe of the tube/base plate weld. Though not apparent at this point, the next section will discuss the same type of plot, but for the pole socket connection, and the definition of “relative” will become more important.
