Final Report

Fatigue-Resistant Design for Overhead Signs,
Mast-Arm Signal Poles, and Lighting Standards

1. Report No. MN/RC-2006-07	2.	3. Recipients Accession No.	
4. Title and Subtitle Fatigue-Resistant Design for Overhead Signs, Mast-Arm Signal Poles, and Lighting Standards		5. Report Date March 2006

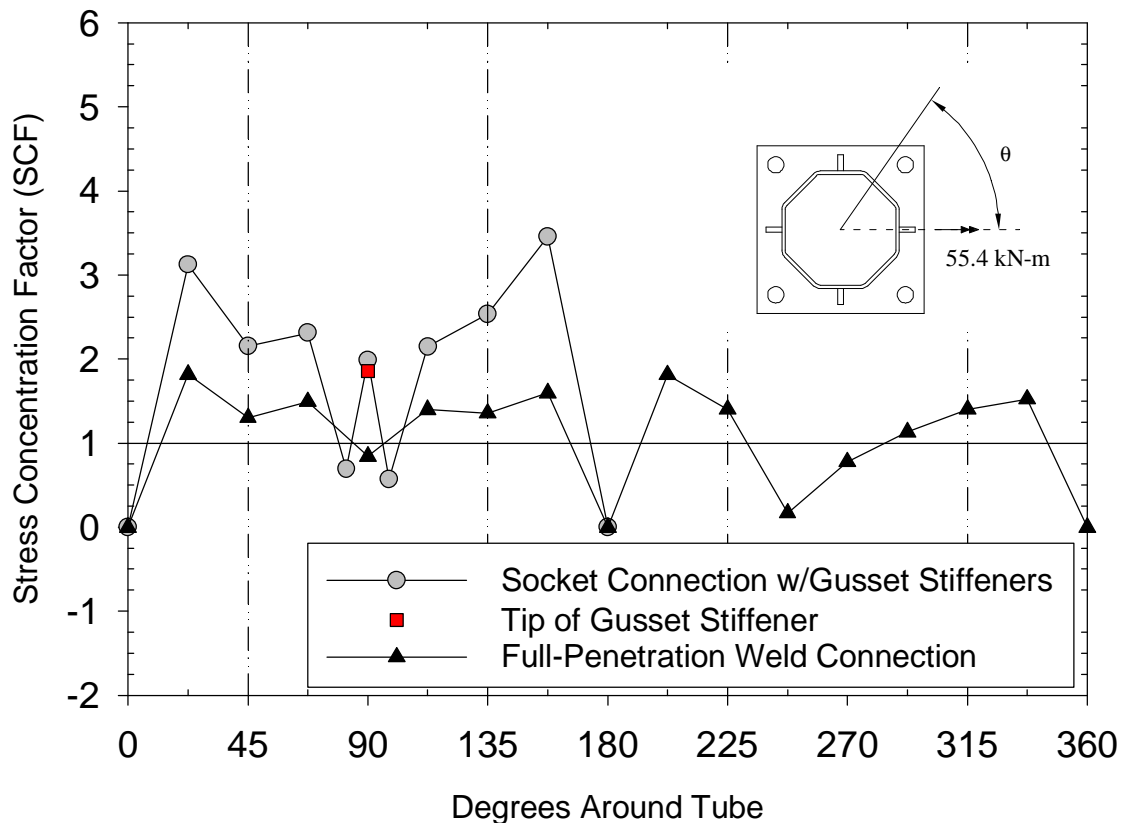
Figure 6.10 Type I mast arm SCFs from Frame 3.

The SCFs on the mast arm with the full-penetration are lower than those from the mast arm with gusset stiffeners, hence a longer fatigue life would be expected. However, like other specimens previously presented (Type I poles with 31.8 mm and 63.5 mm thick base plates), the full-penetration weld detail is still susceptible to the shear lag effect at the 90 degree position as the SCF drops below 1.0. On the compression side of the tube, the SCF pattern is no longer symmetric. The compression data was attained after the mast arm cracked on its first side and was then rotated to continue cycling. Therefore, the compression data was attained on a cracked section, but load/displacement plots did not indicate bilinear behavior which would indicate crack closure was occurring to sway the SCF calculation. Compression data was not attained in the gusset stiffened mast arm because the gauges were damaged during hammer peening operations before the mast arm could be flipped over to test the compression side.

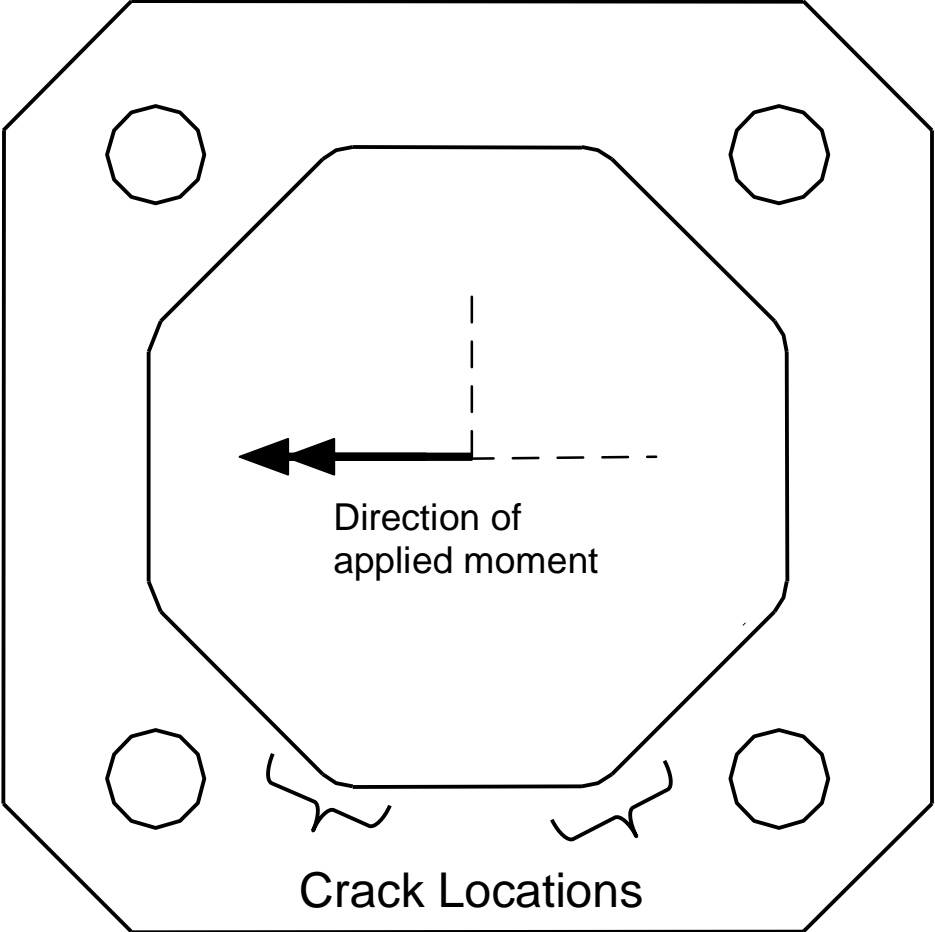
Figure 7.1 Location of cracks in socket connections.

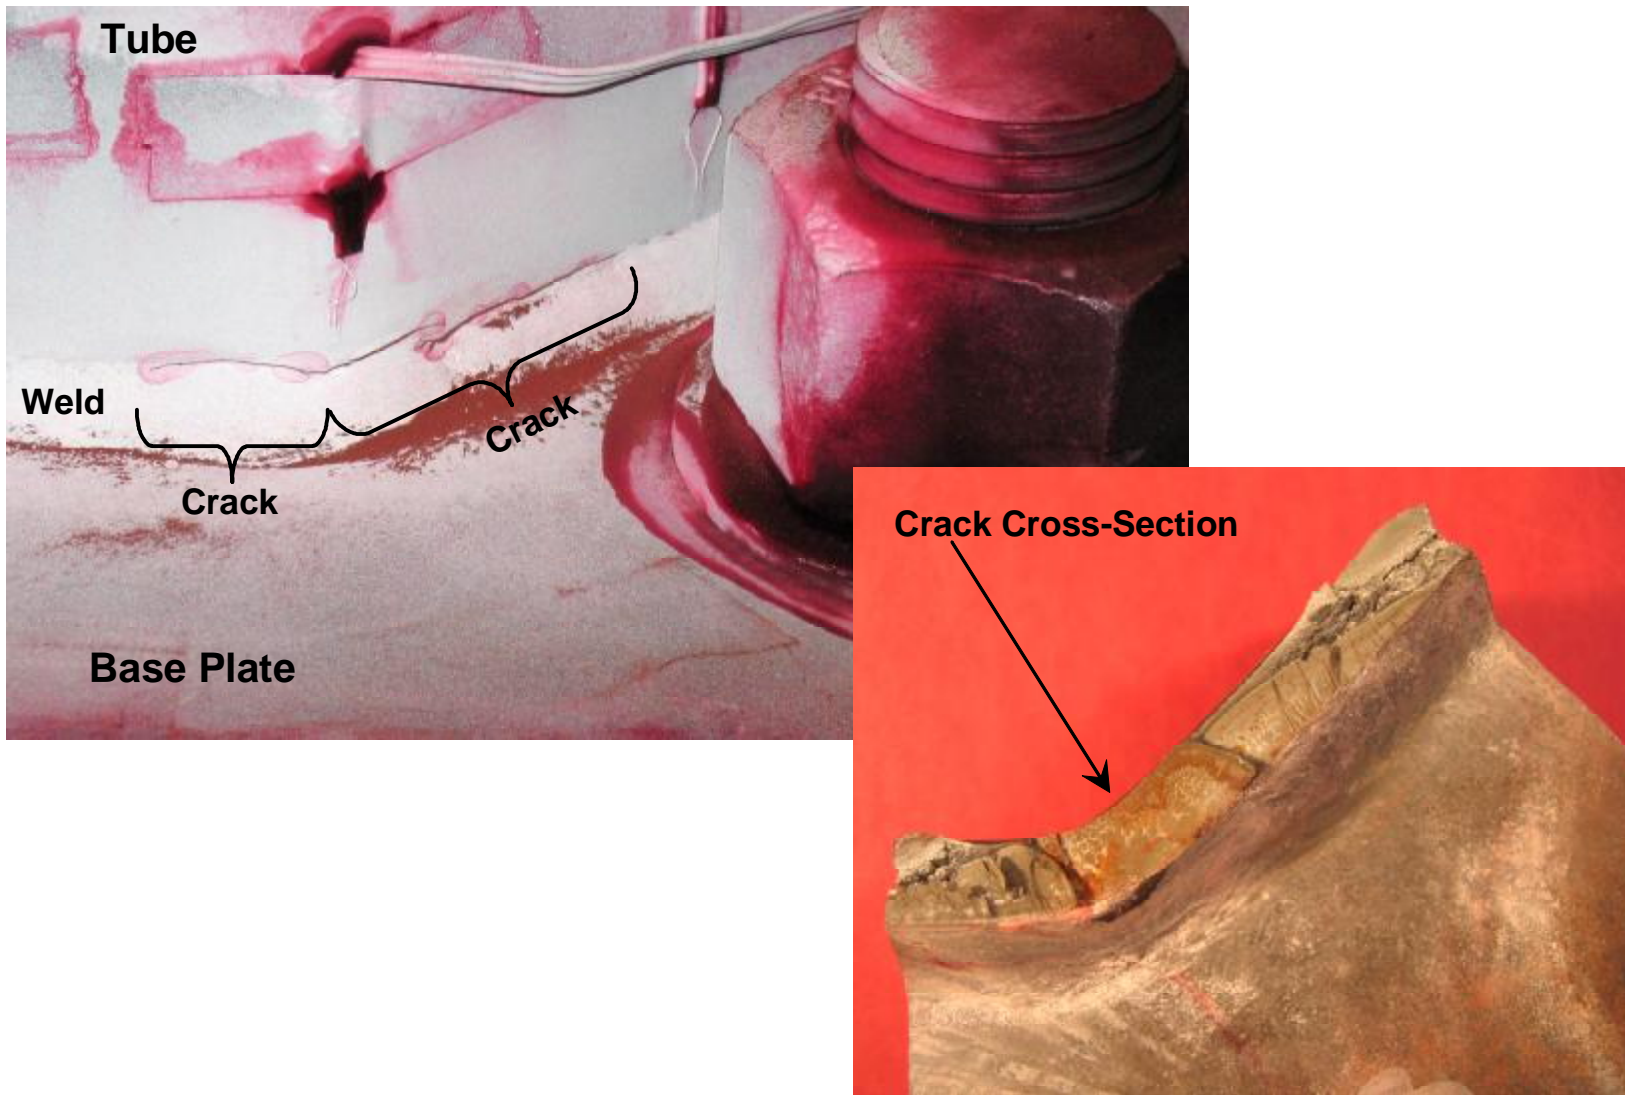
Figure 7.2 Weld toe cracks in pole socket connections.

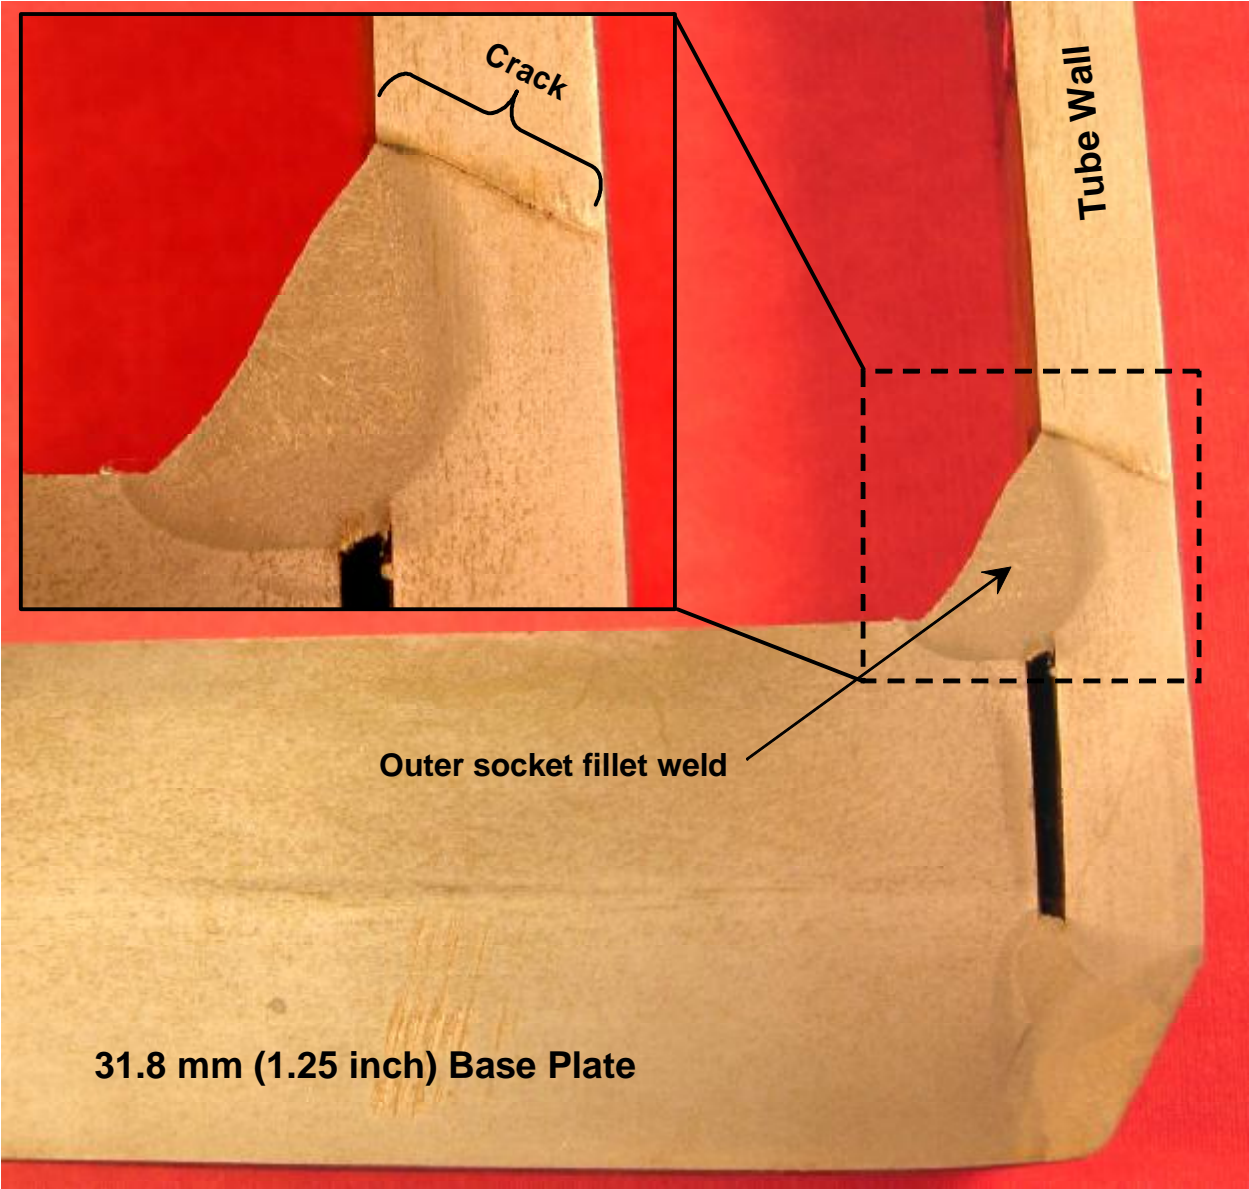
Figure 7.3 Macro etched cross-section of weld toe crack.

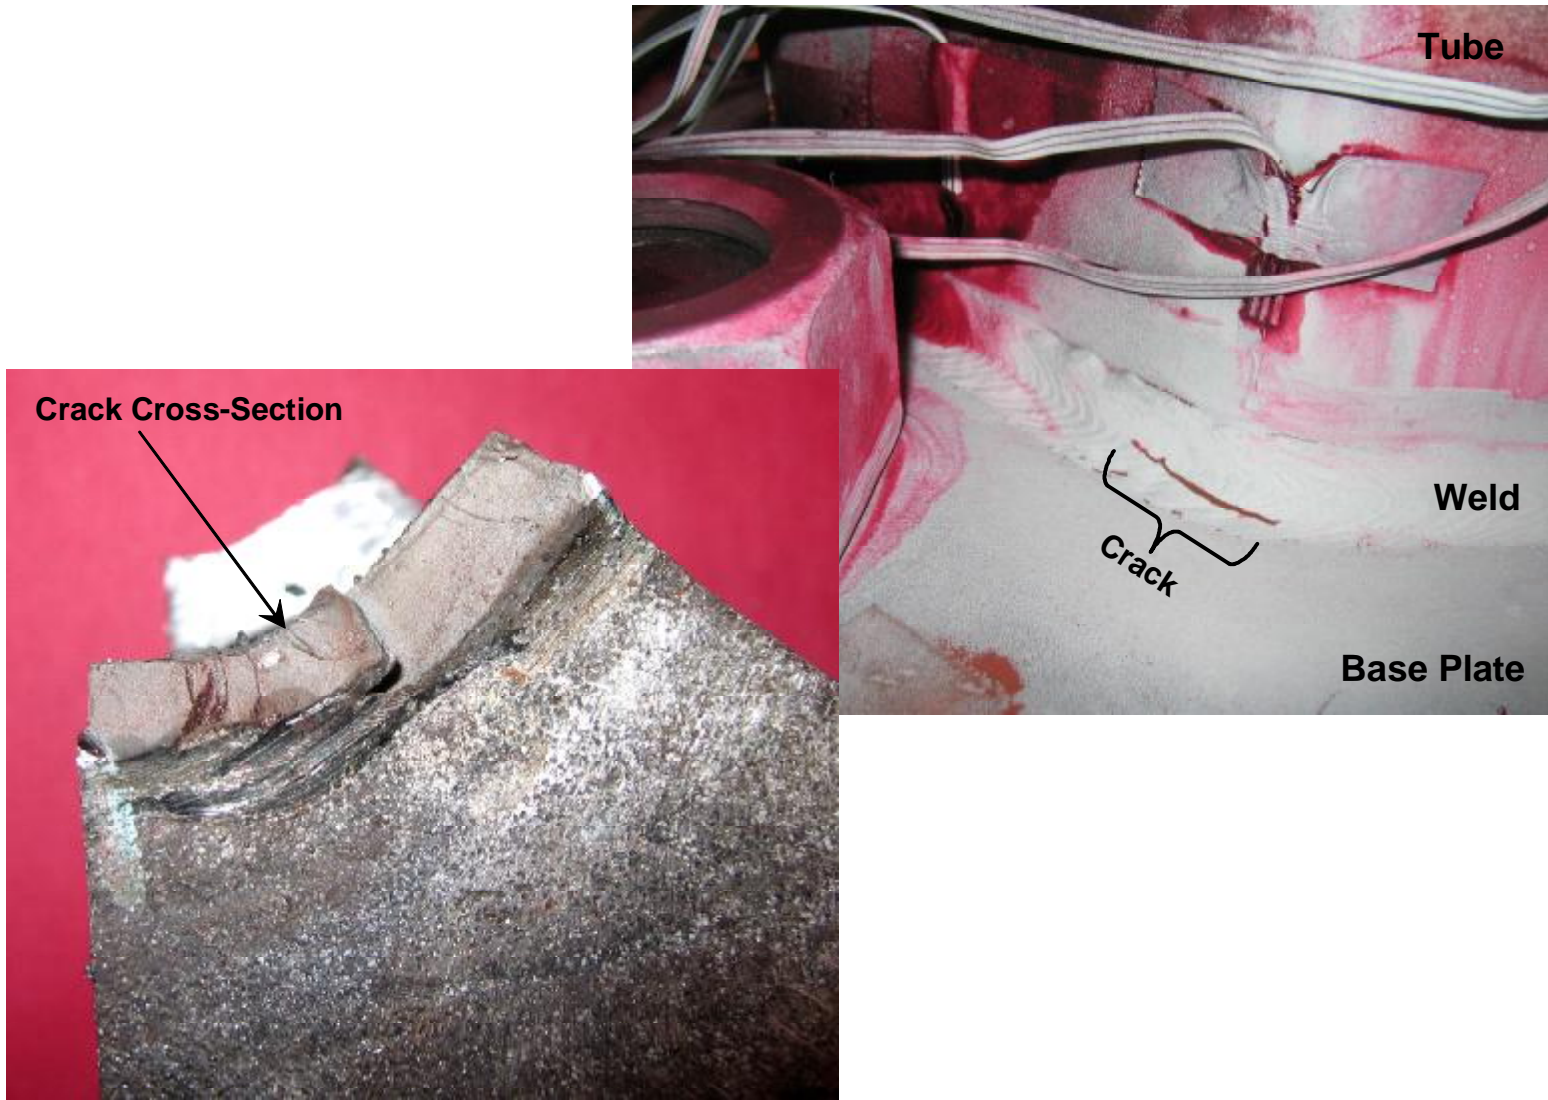
Figure 7.4 Weld root cracks in pole socket connections.

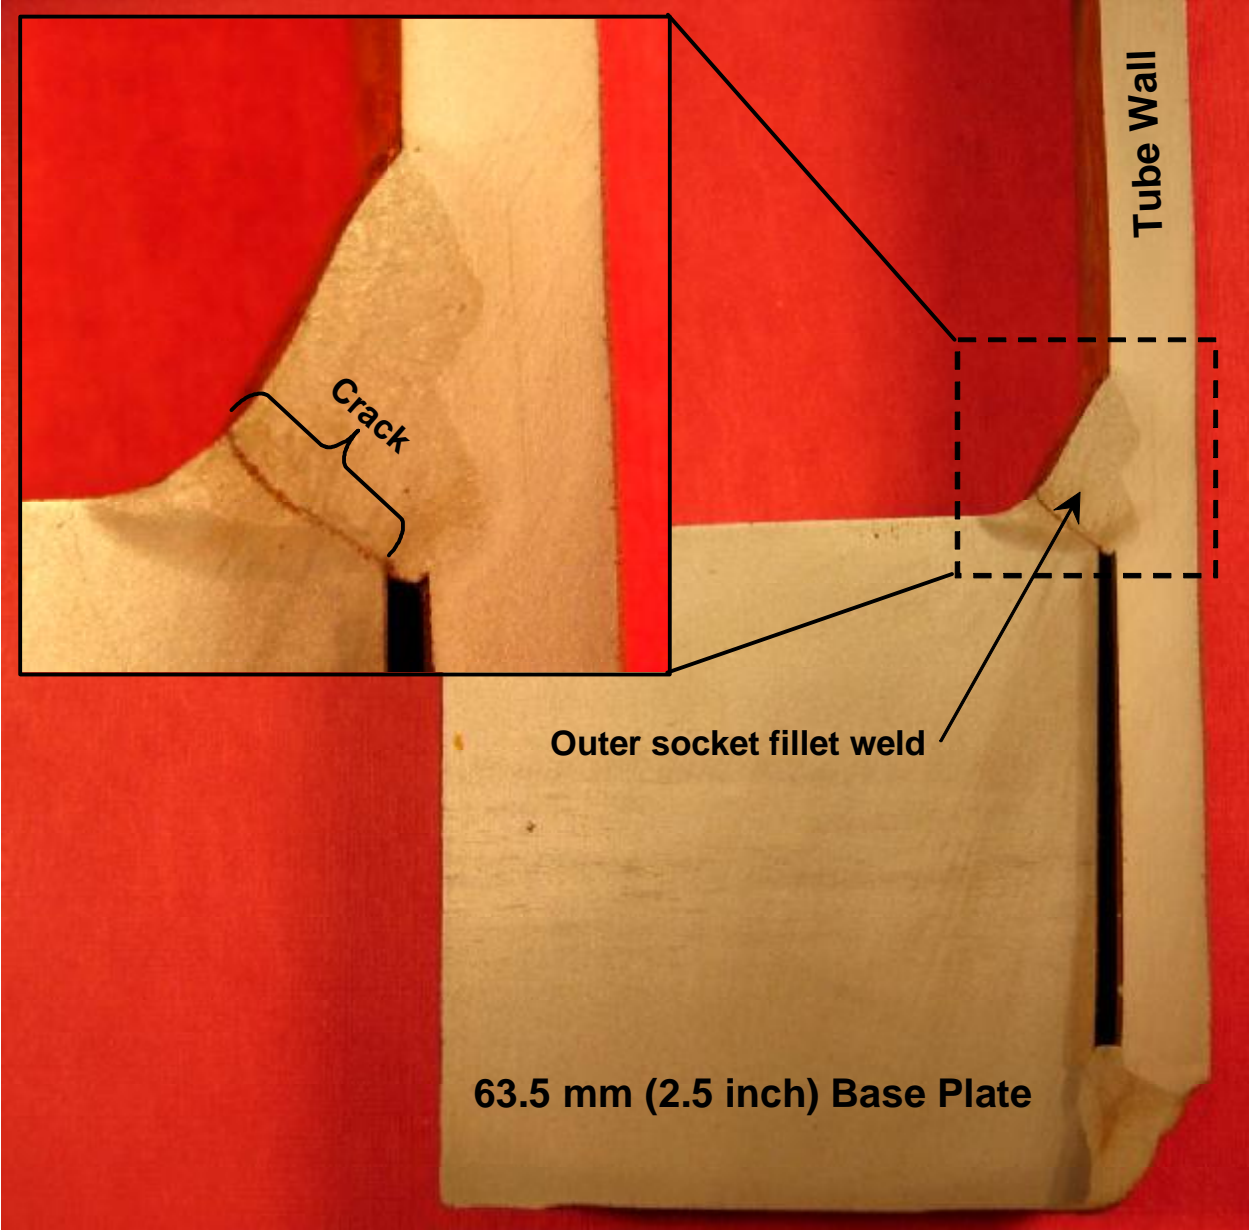
Figure 7.5 Macro etched cross-section of weld root crack.

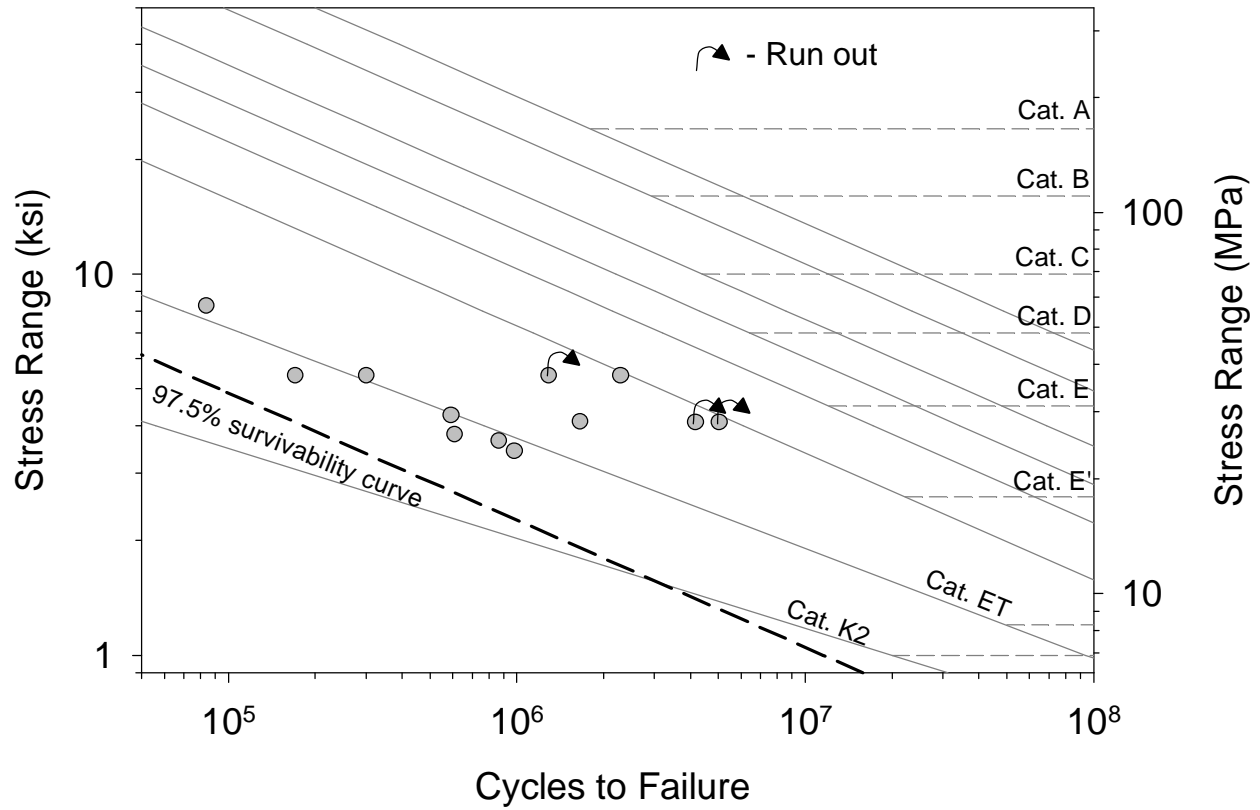
Figure 7.6 S-N plot of untreated socket connections with 31.8 mm (1.25 inch) thick base plates.

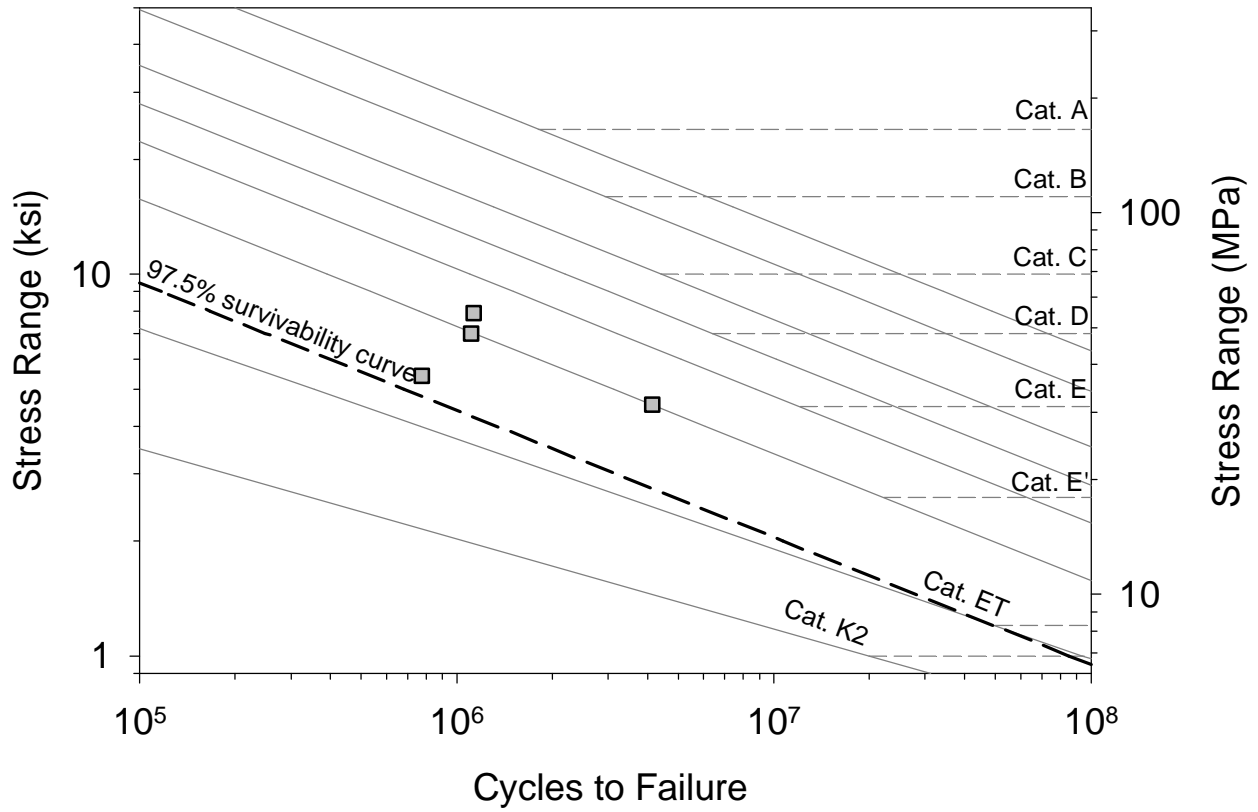
Figure 7.7 S-N plot of hammer-peened repaired socket connections with 31.75 mm (1.25 inch) thick base plates.

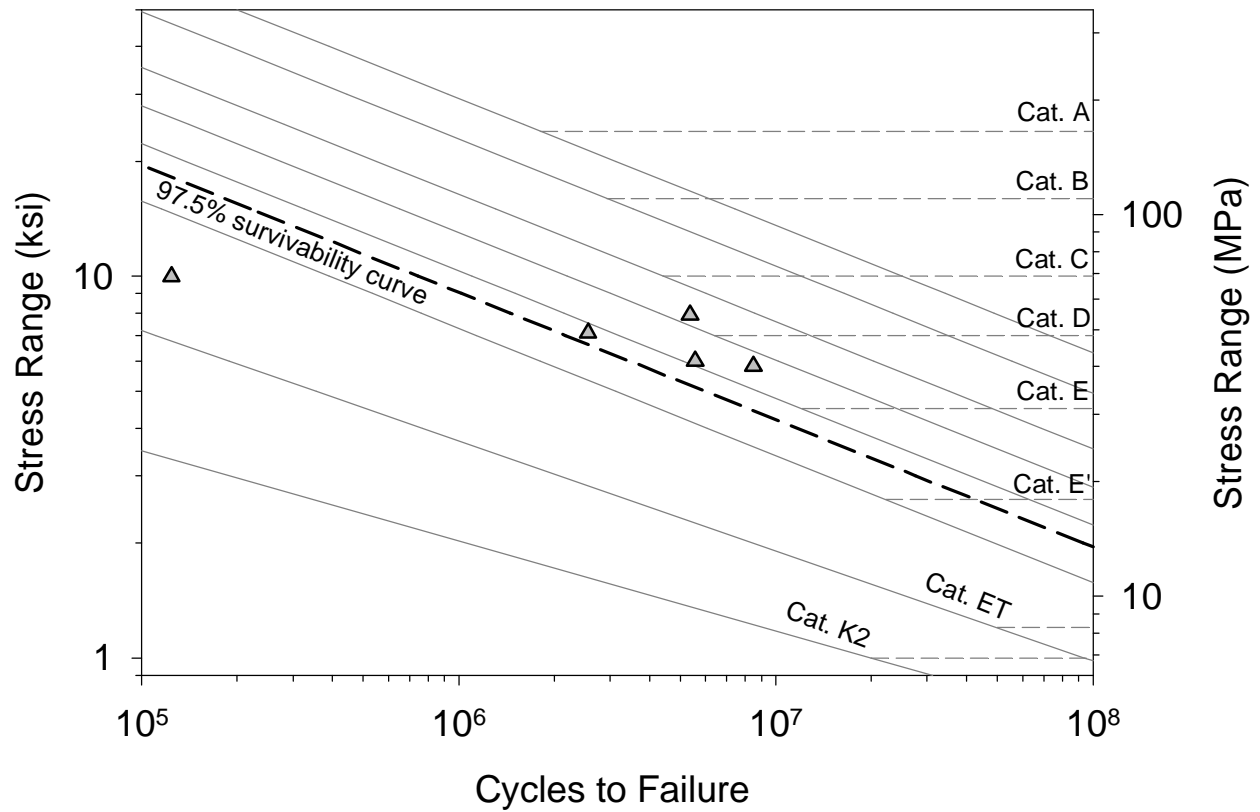
Figure 7.8 S-N plot of hammer-peen retrofitted socket connections with 31.75 mm (1.25 inch) thick base plates.

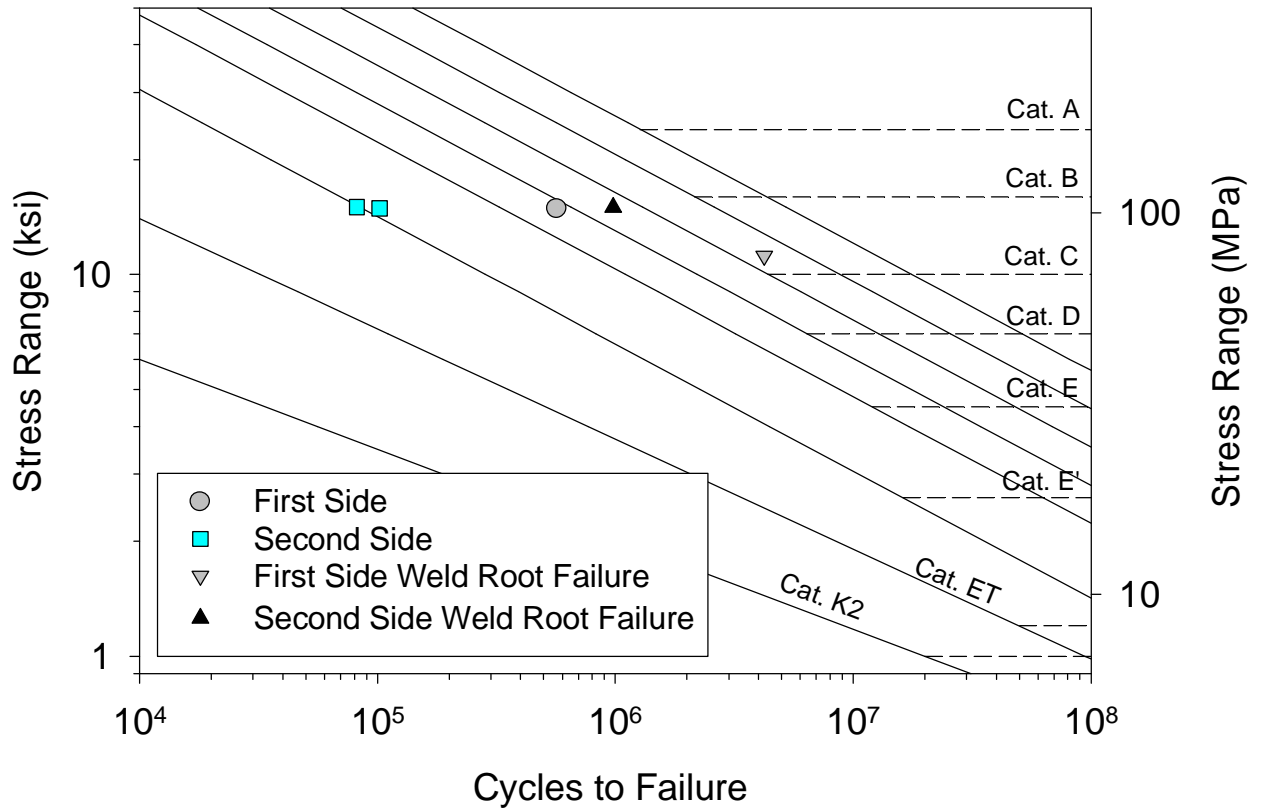
Figure 7.9 S-N plot of thick base plate socket connection with 7.94 mm (5/16 inch) pole wall thickness.

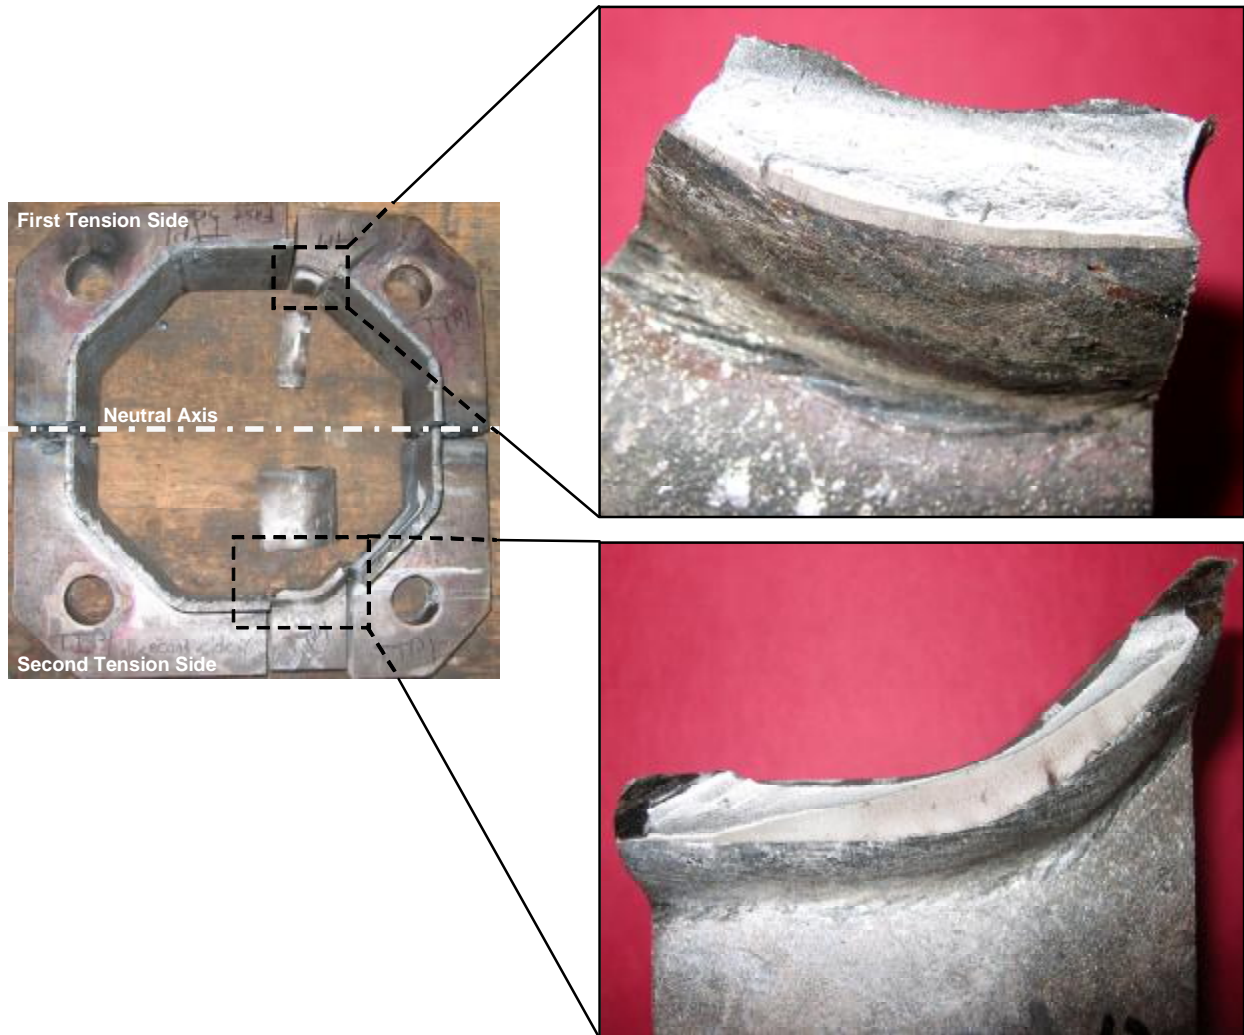
Figure 7.11 Crack surfaces of excavated Pole 2 socket.

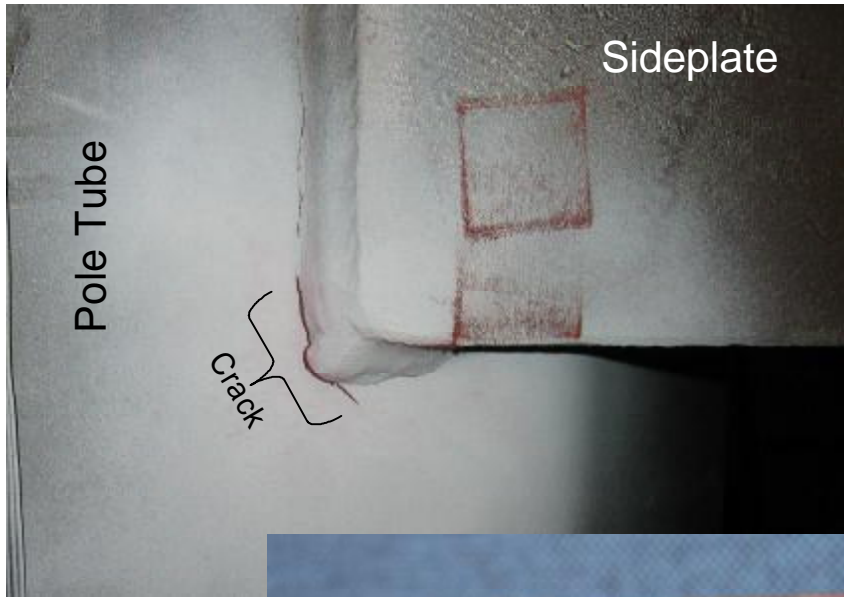
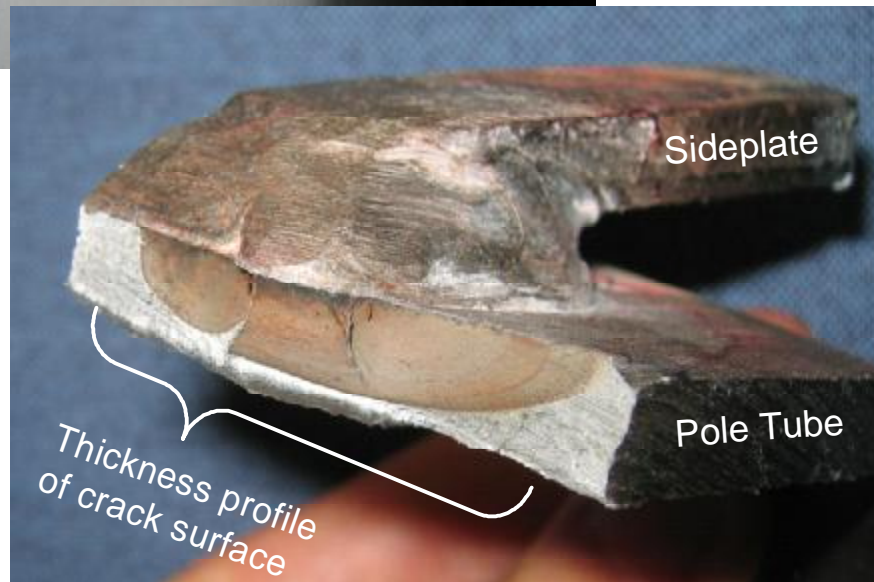
Figure 7.12 Crack in box connection from out-of-plane loading (Pole #6).

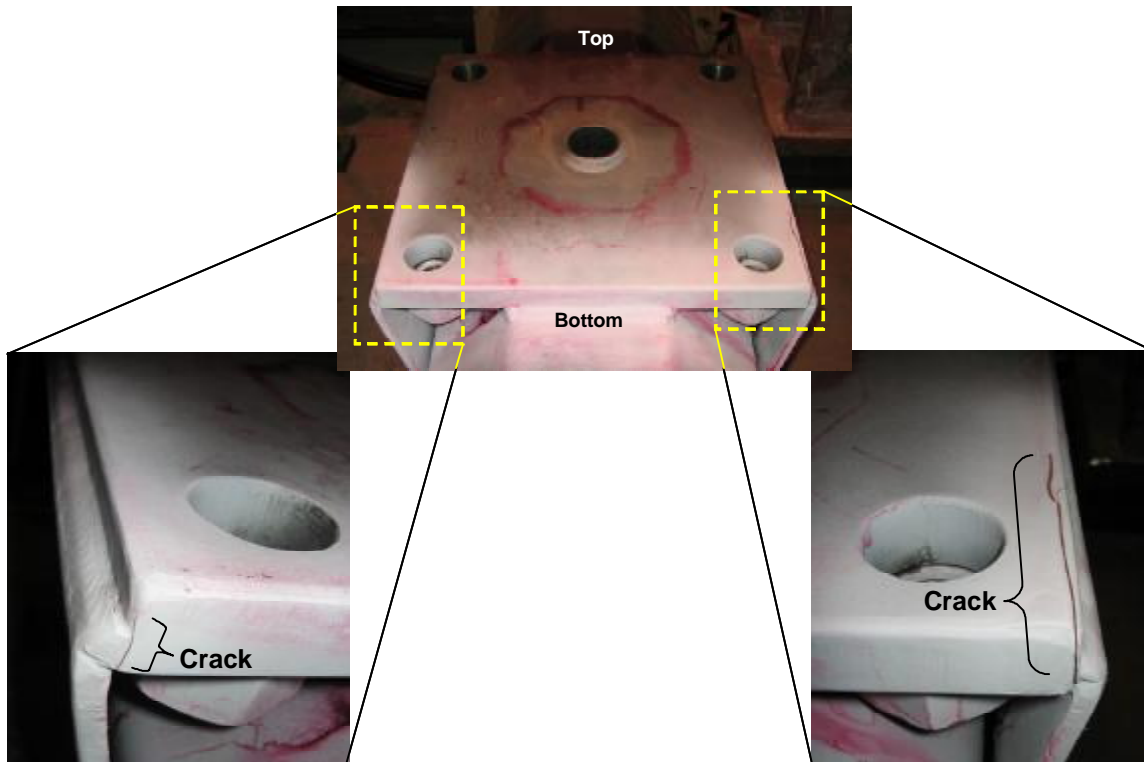
Figure 7.13 Type I box connection cracking from in-plane loading (T1P2)

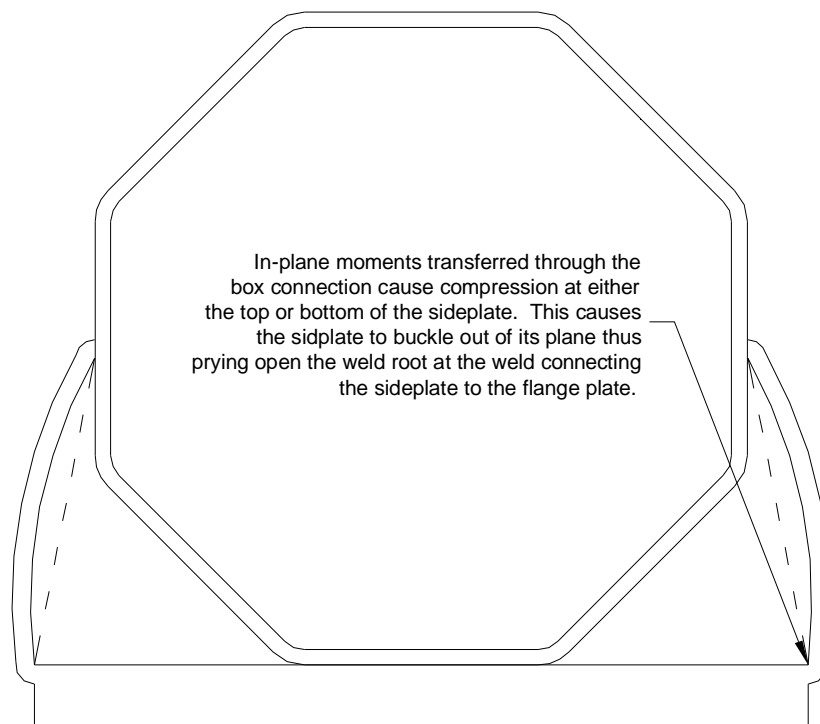
Figure 7.14 Cross-section of box connection depicting side plate deformation under in-plane loading.

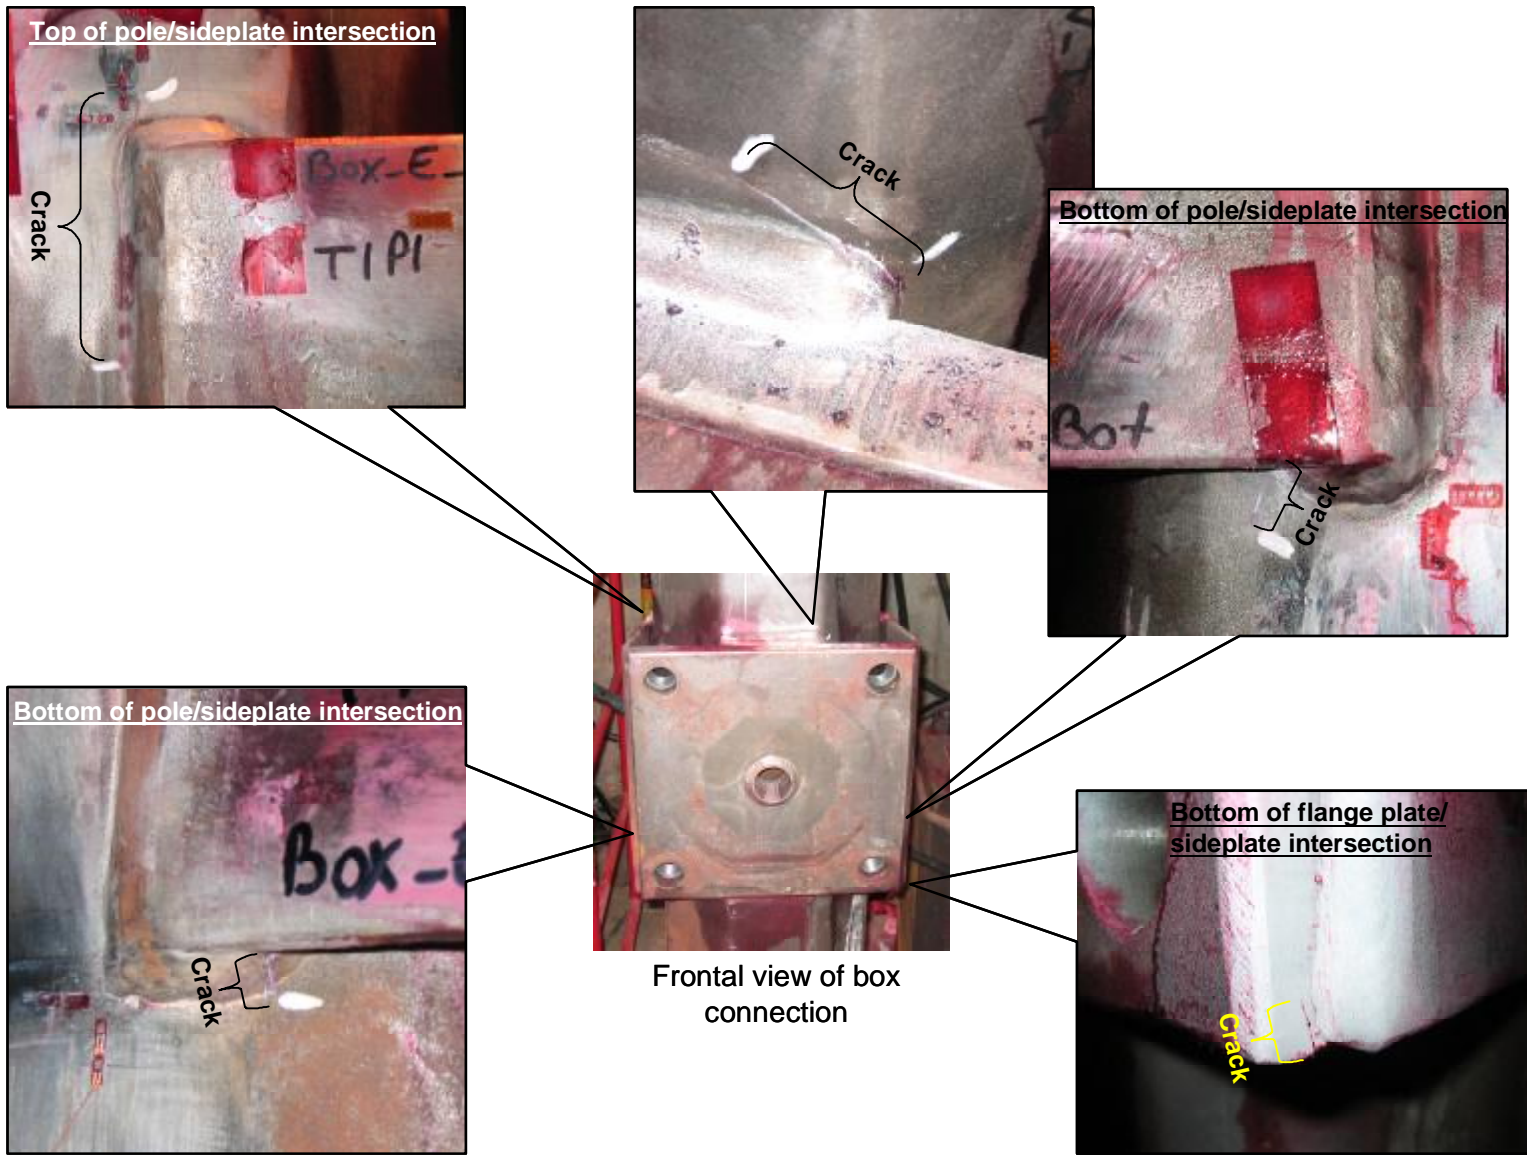
Figure 7.15 Box connection cracks in Type I Pole 1 (T1P1)

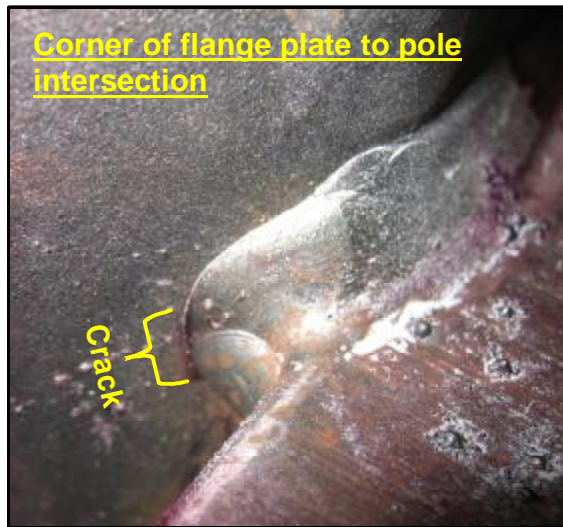
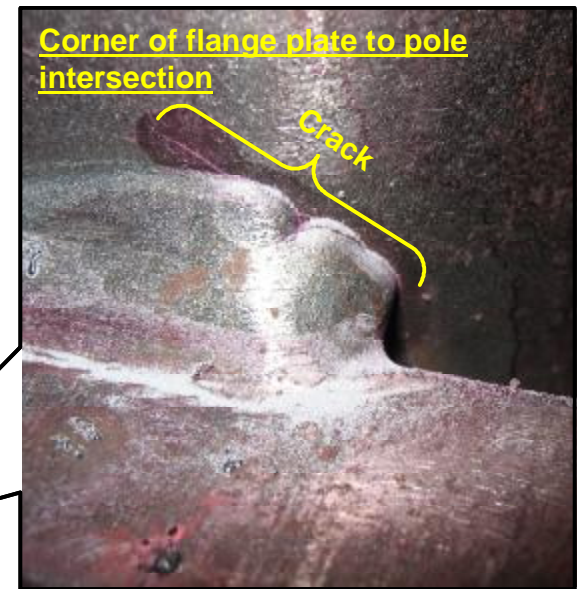
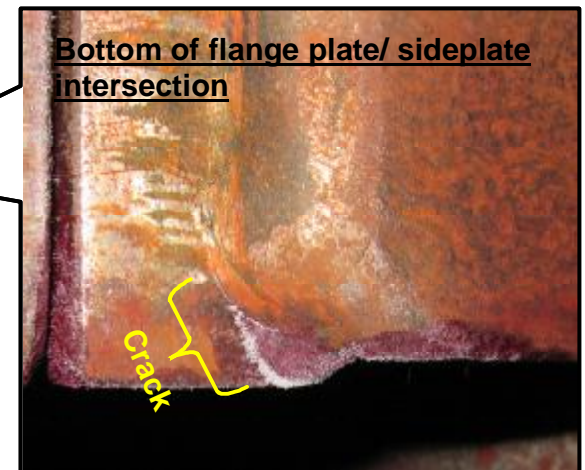
Frontal view of box connection

Figure 7.16 Box connection cracks in T1P3

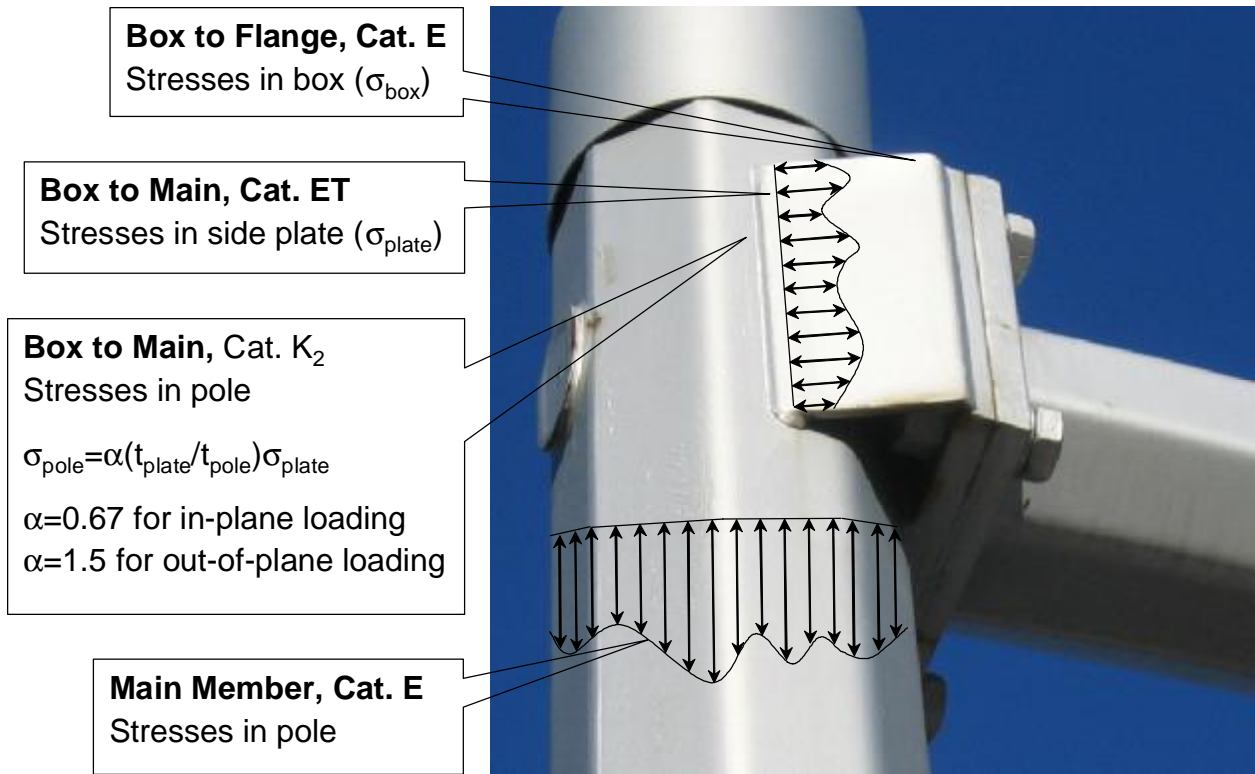
Figure 7.17 2001 Specifications fatigue checks on box connections.

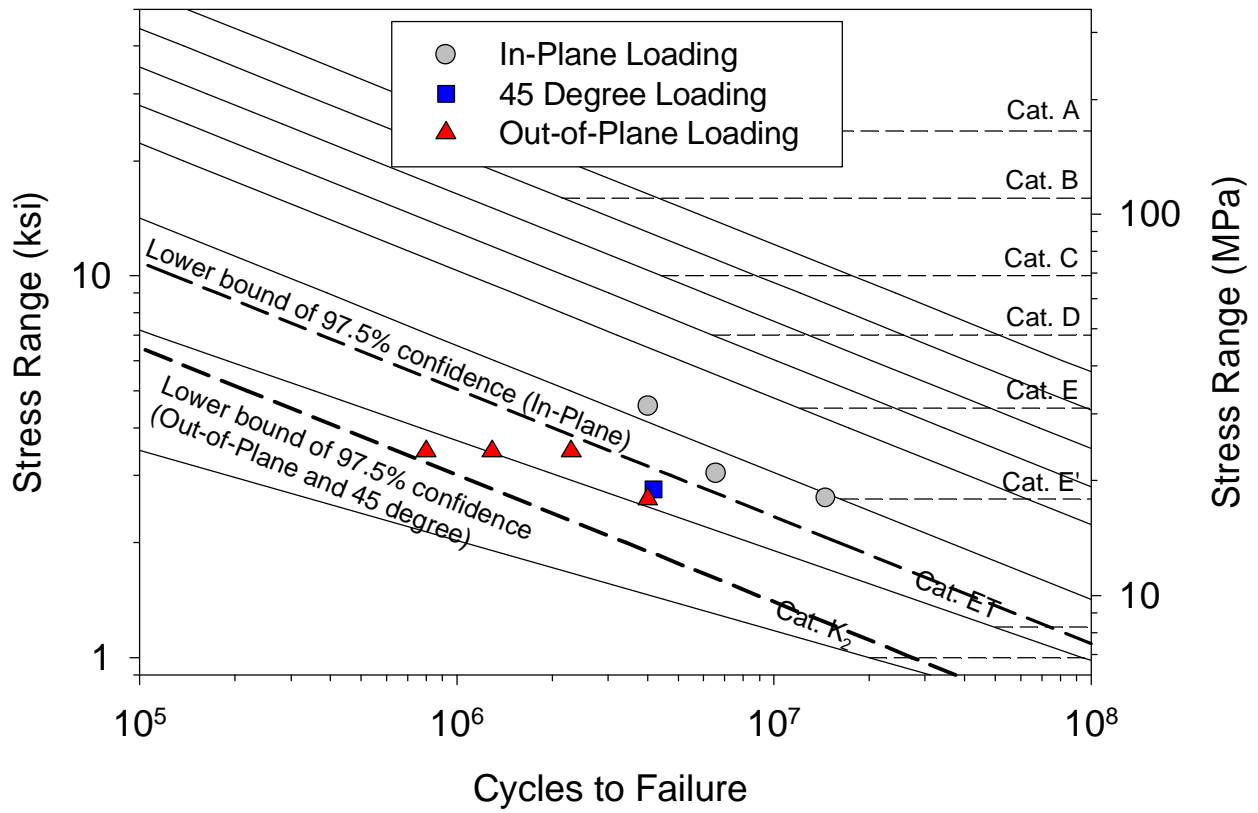
Figure 7.18 S-N plot of Type I box connection fatigue data.

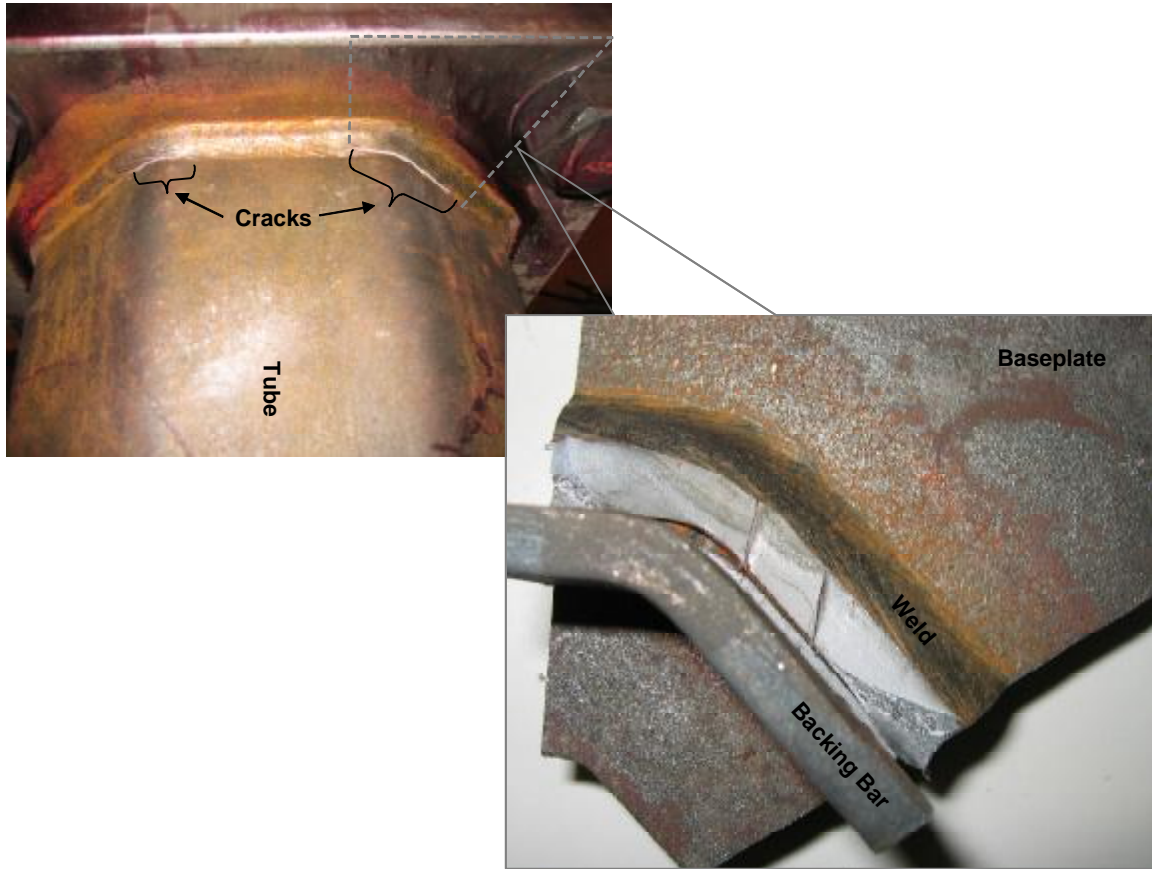
Figure 7.19 Typical cracks on Type I full-penetration weld mast arm.
