Final Report

Fatigue-Resistant Design for Overhead Signs,
Mast-Arm Signal Poles, and Lighting Standards

1. Report No. MN/RC-2006-07	2.	3. Recipients Accession No.	
4. Title and Subtitle Fatigue-Resistant Design for Overhead Signs, Mast-Arm Signal Poles, and Lighting Standards		5. Report Date March 2006

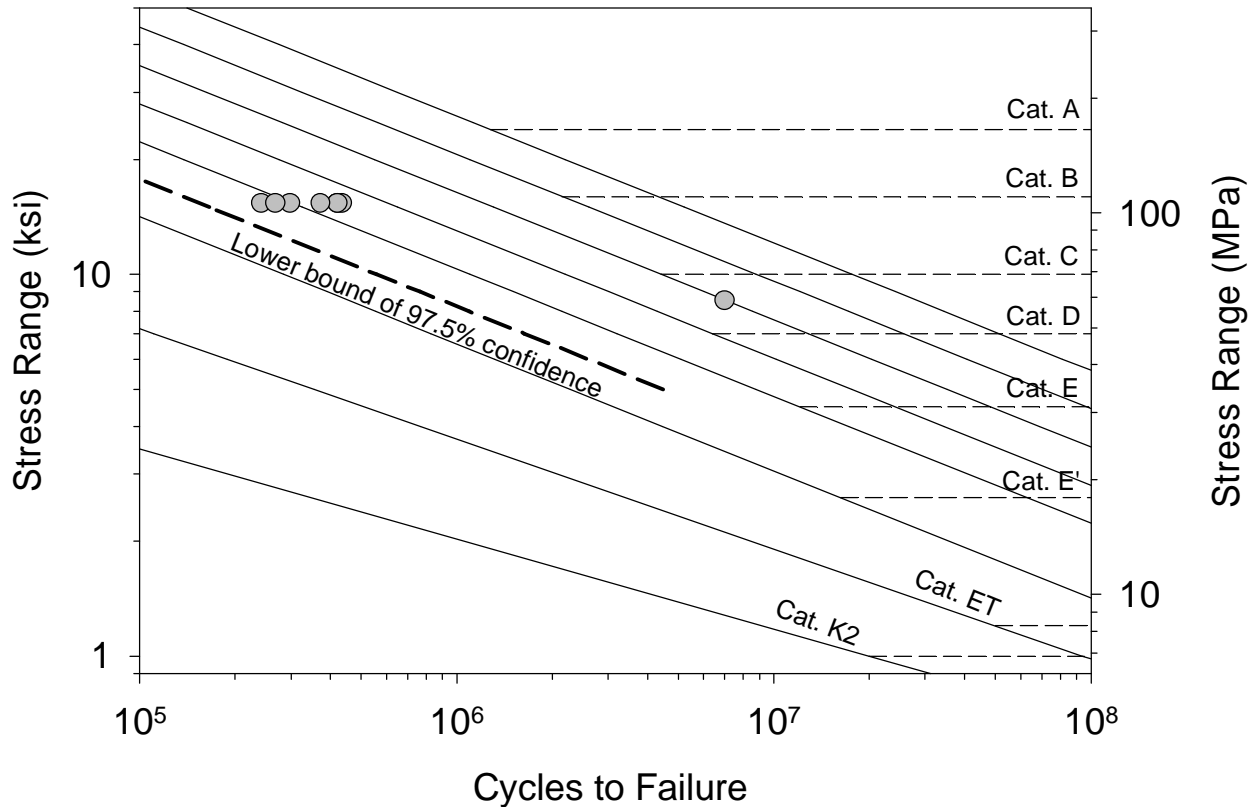
Figure 7.20 Fatigue results of Type I, full-penetration weld mast arm plotted against S-N curves.

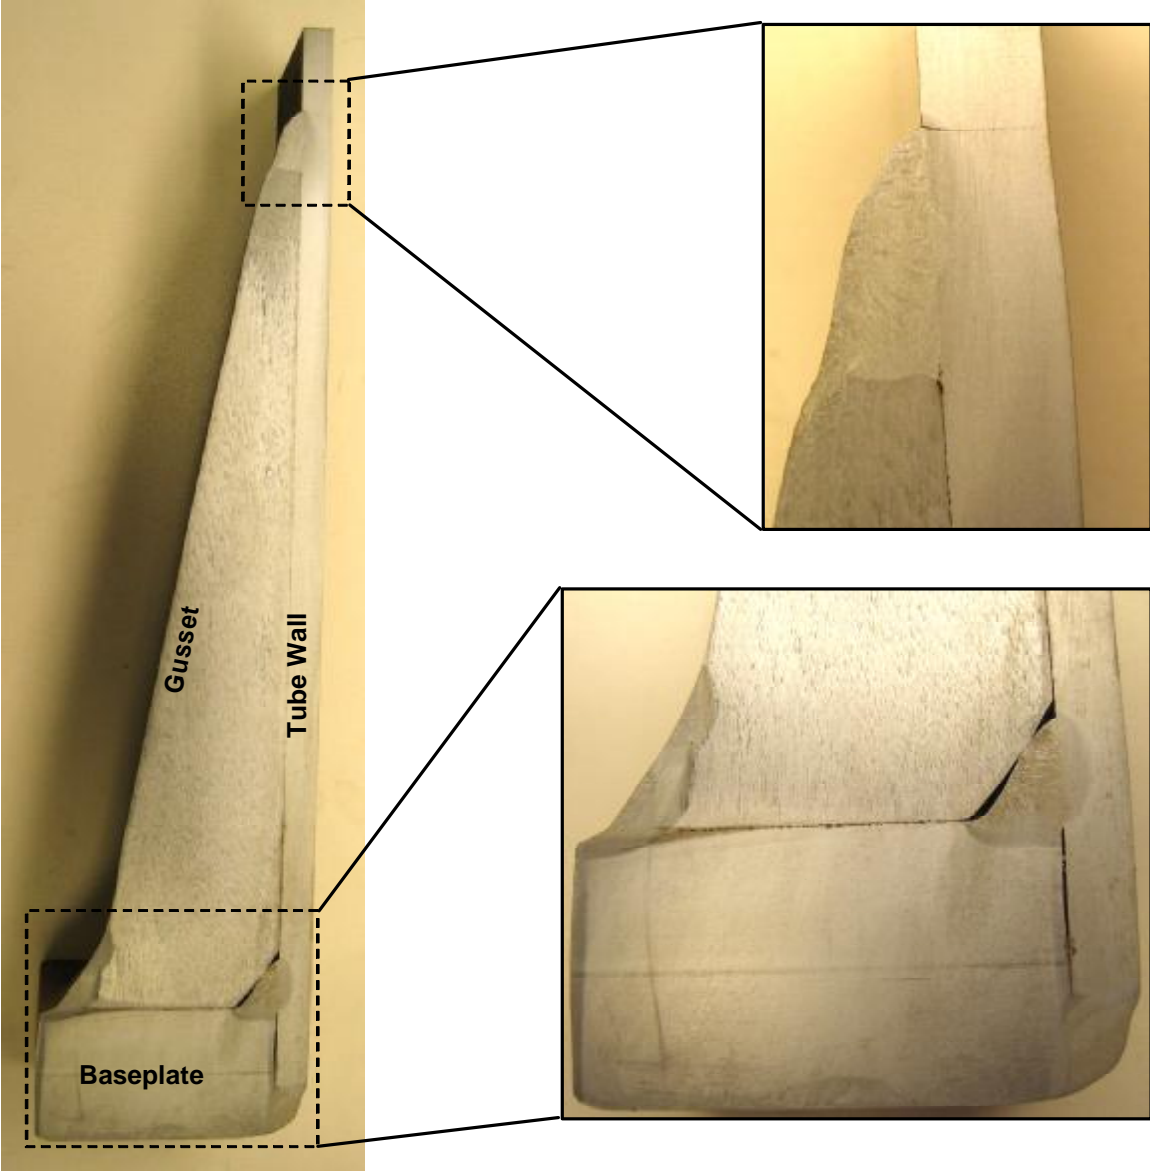
Figure 7.21 Macro etch of gusset stiffener cross-section.

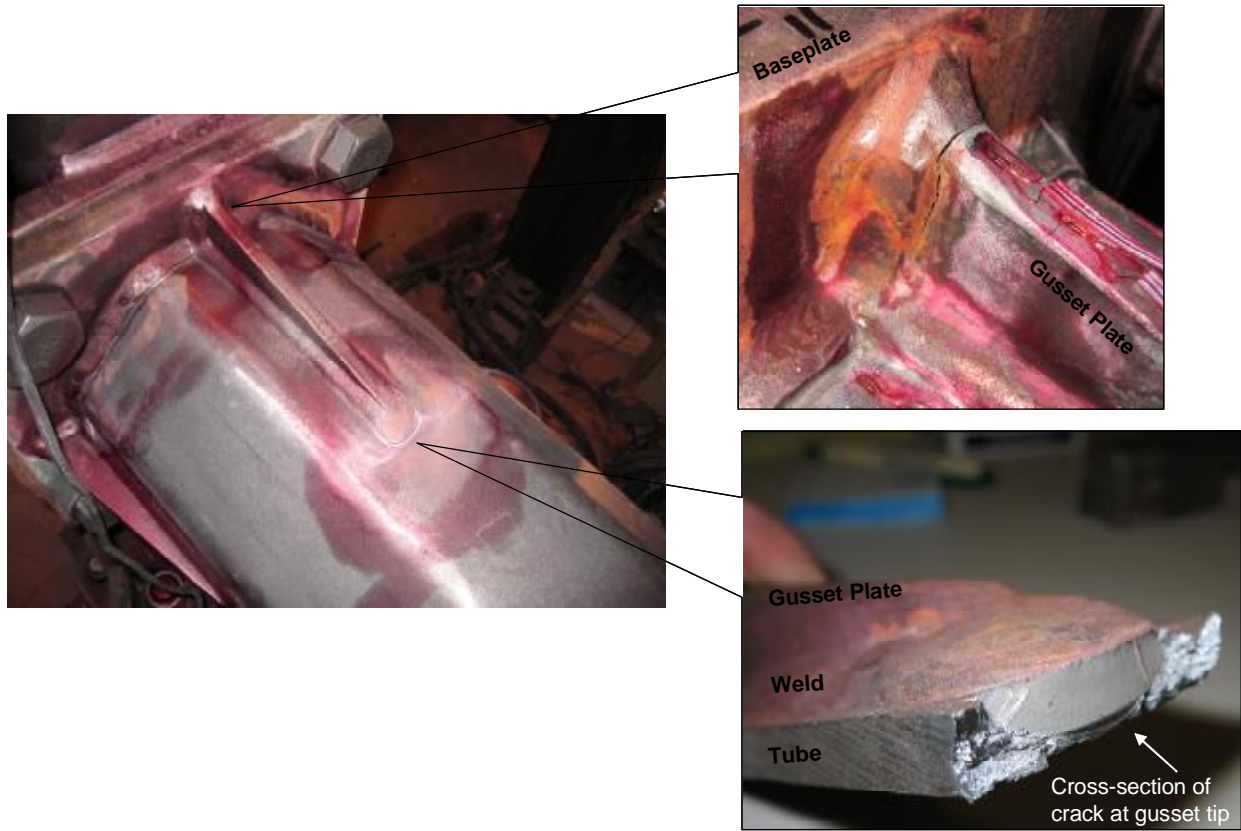
Figure 7.22 Typical cracks found in gusset plates.

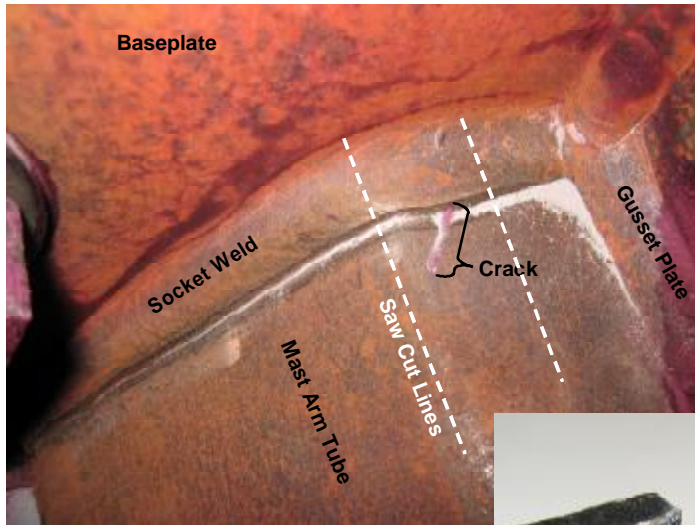
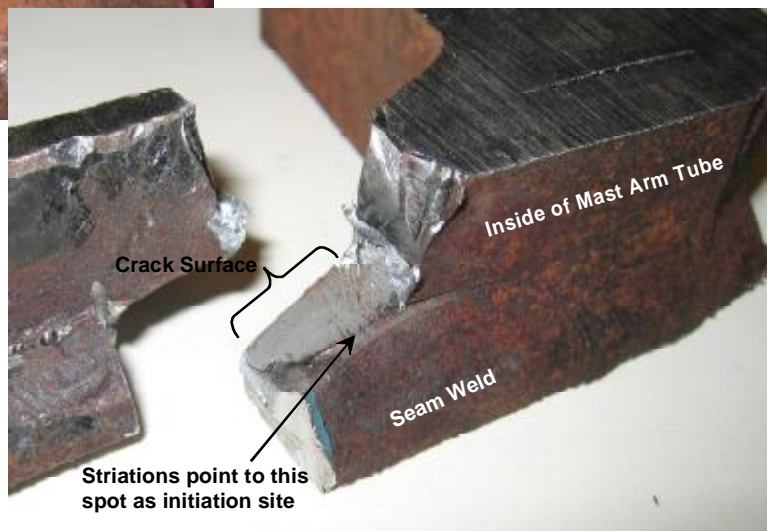
Figure 7.23 Seam weld crack in gusset-stiffened specimen.

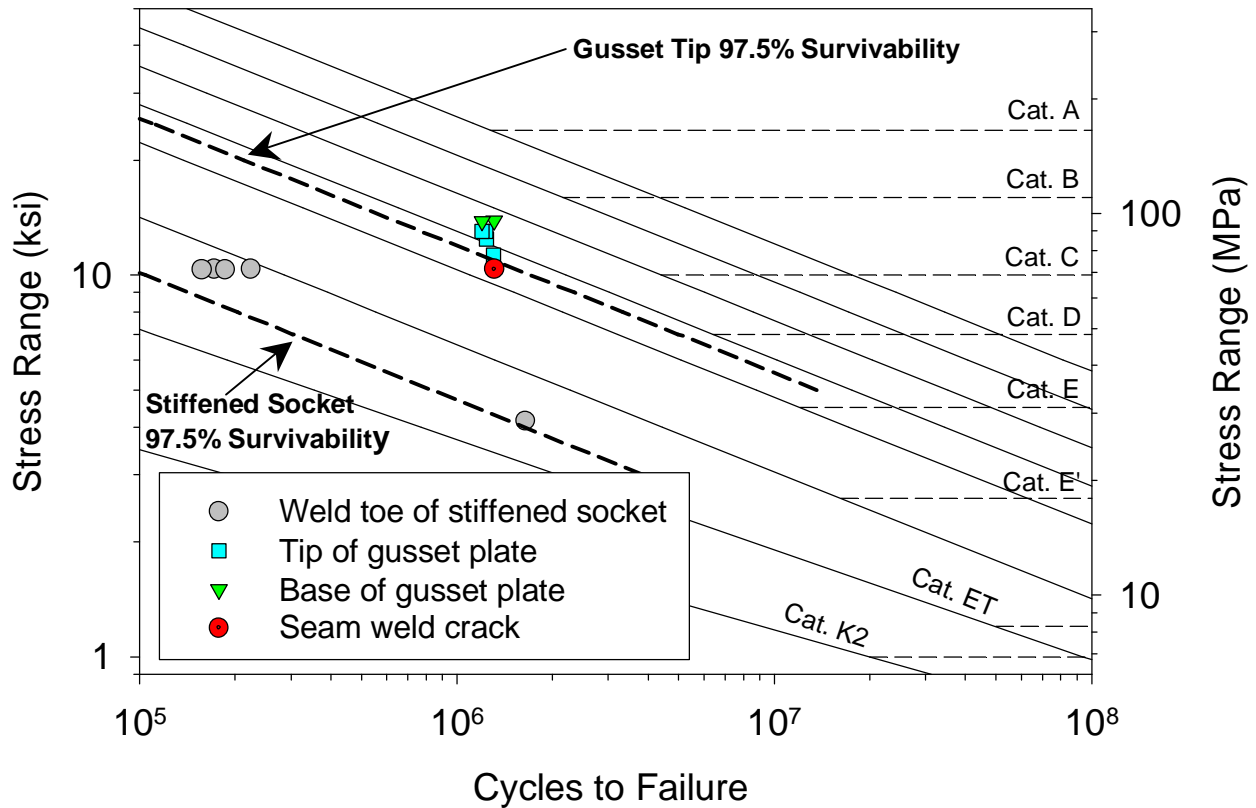
Figure 7.24 S-N plot of gusset-stiffened mast arm specimens.

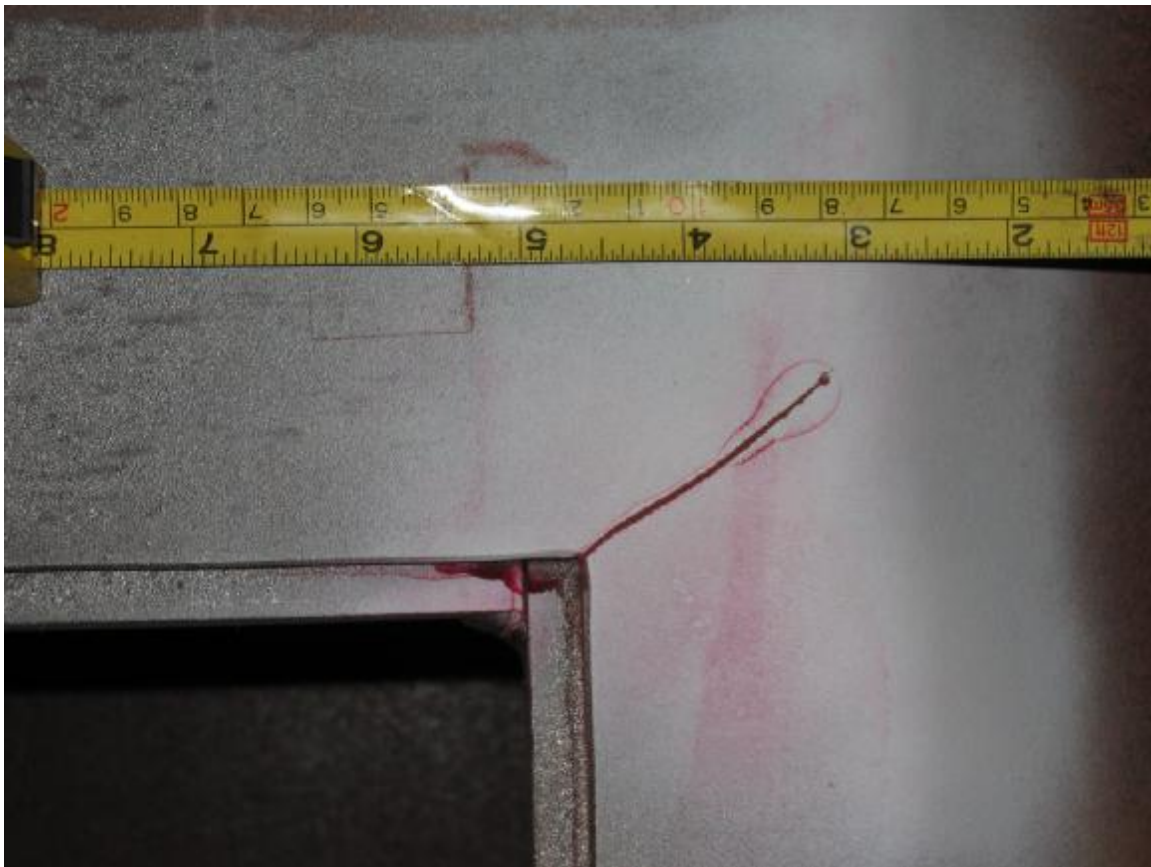
Figure 7.25 Crack in first transformer base originating from access hole.

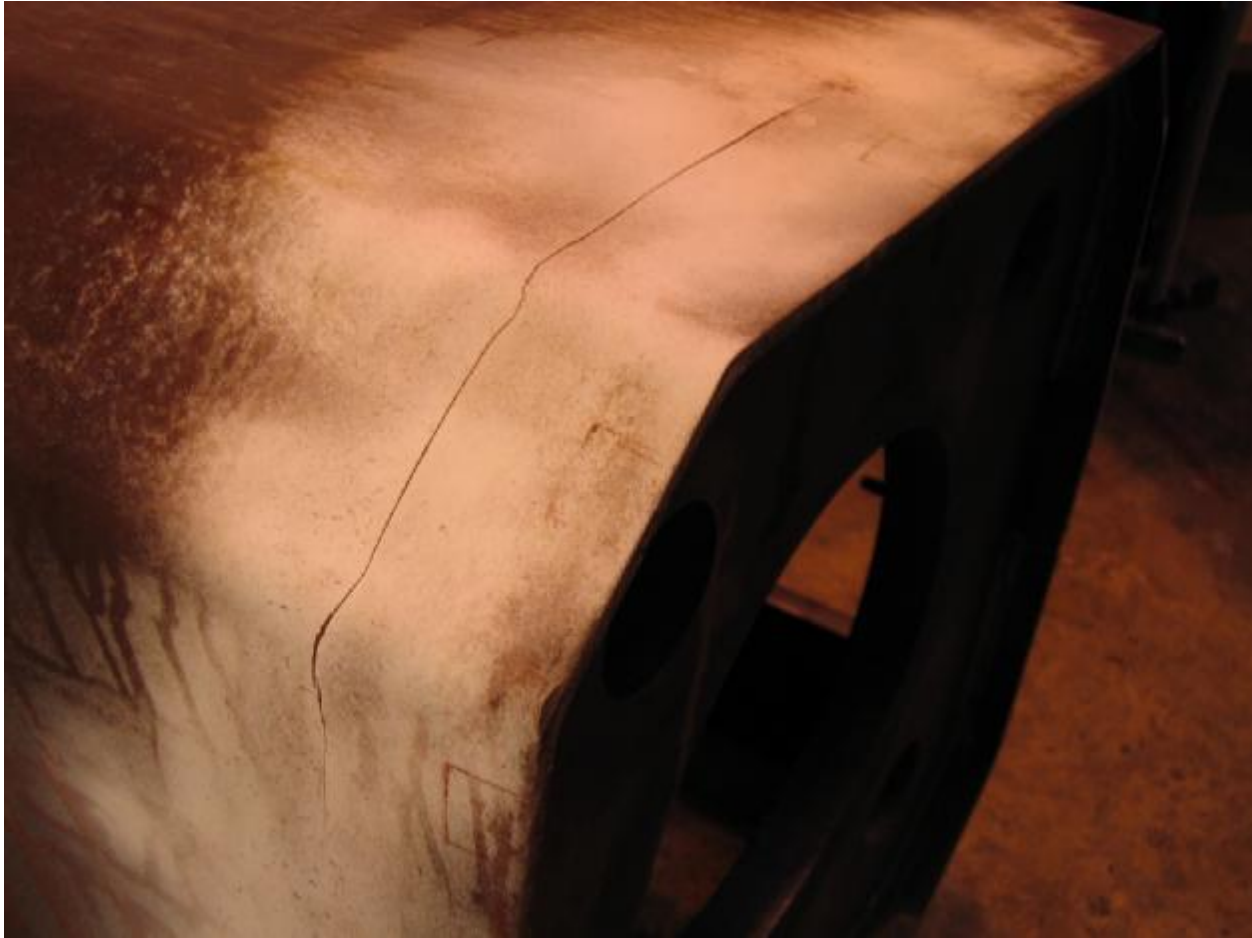
Figure 7.26 Crack in second transformer base.

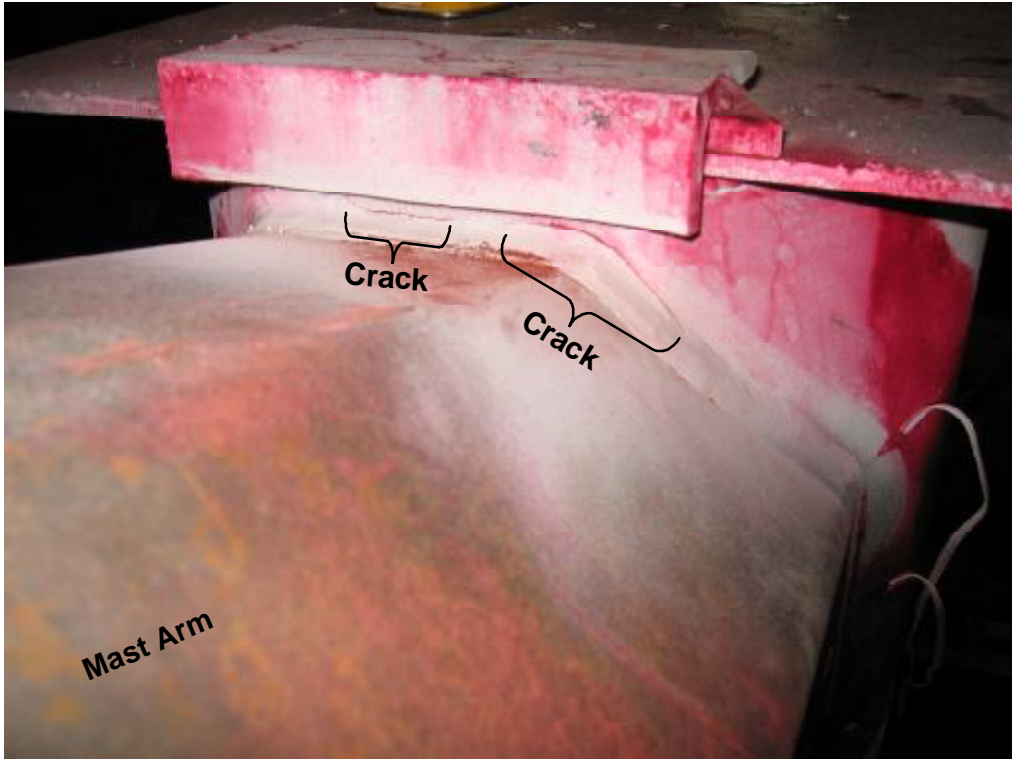
Figure 7.27 In-plane crack for Type II specimen.

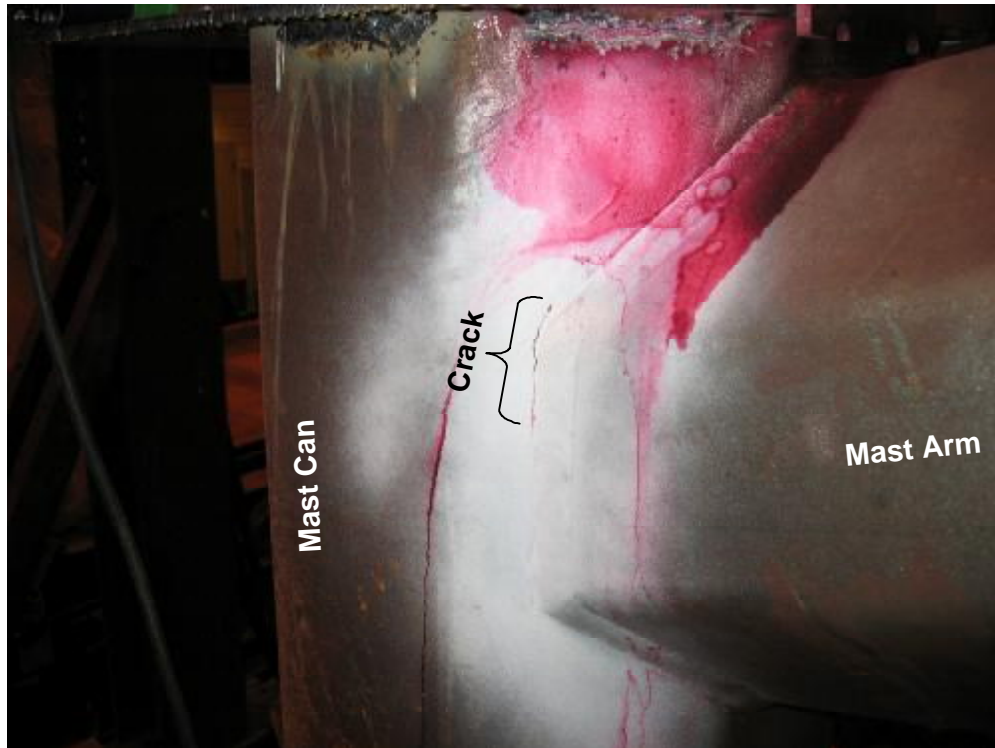
Figure 7.28 Out-of-plane cracks for Type II specimen.

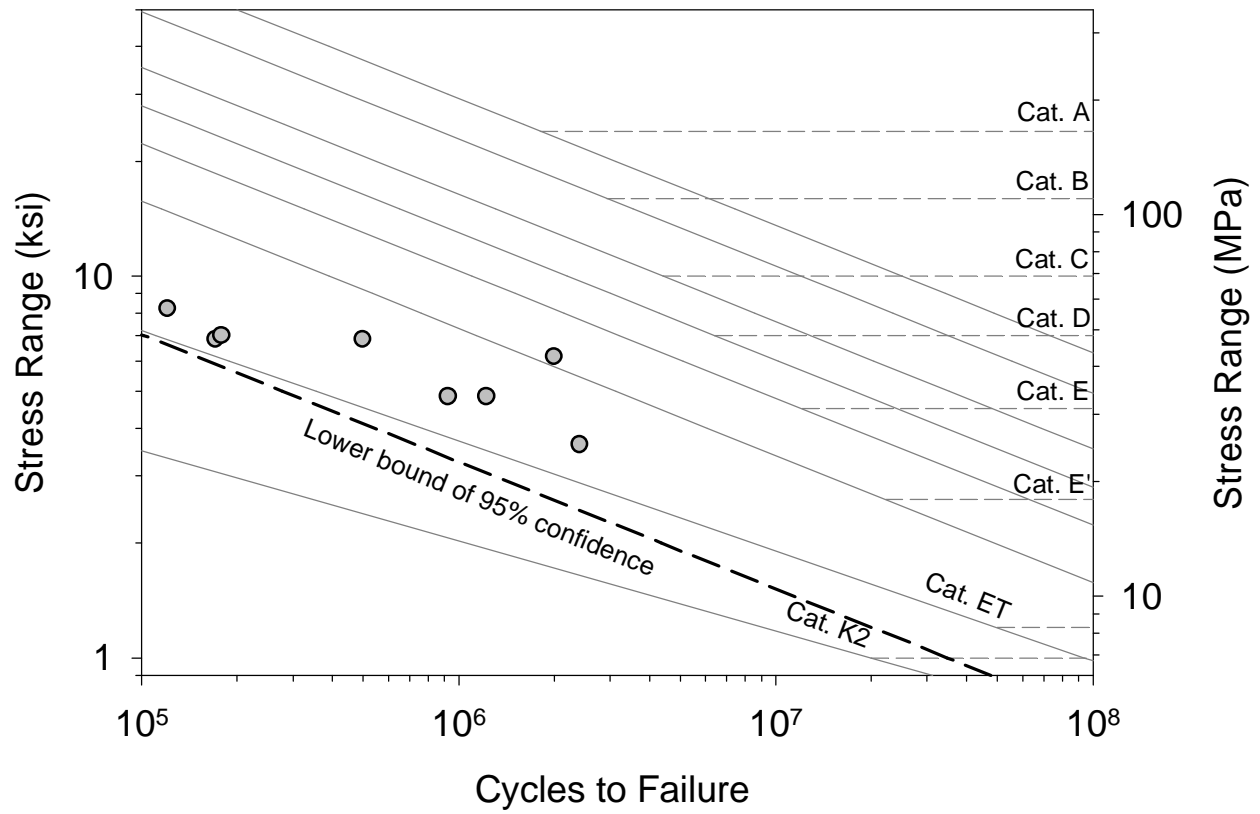
Figure 7.29 S-N plot of Type II mast arm fatigue results.

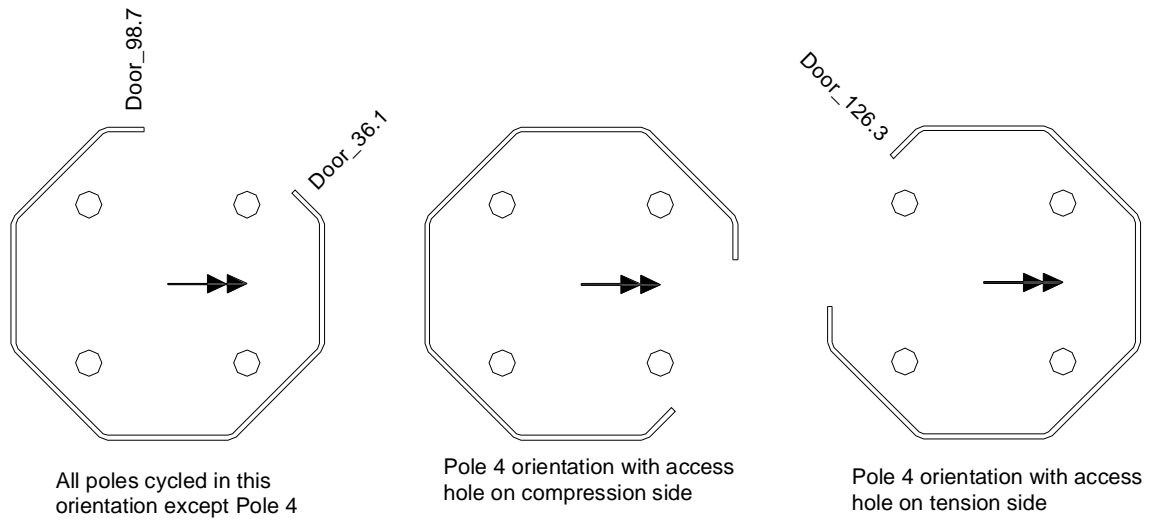
Figure 7.30 Orientations of Type II pole specimens

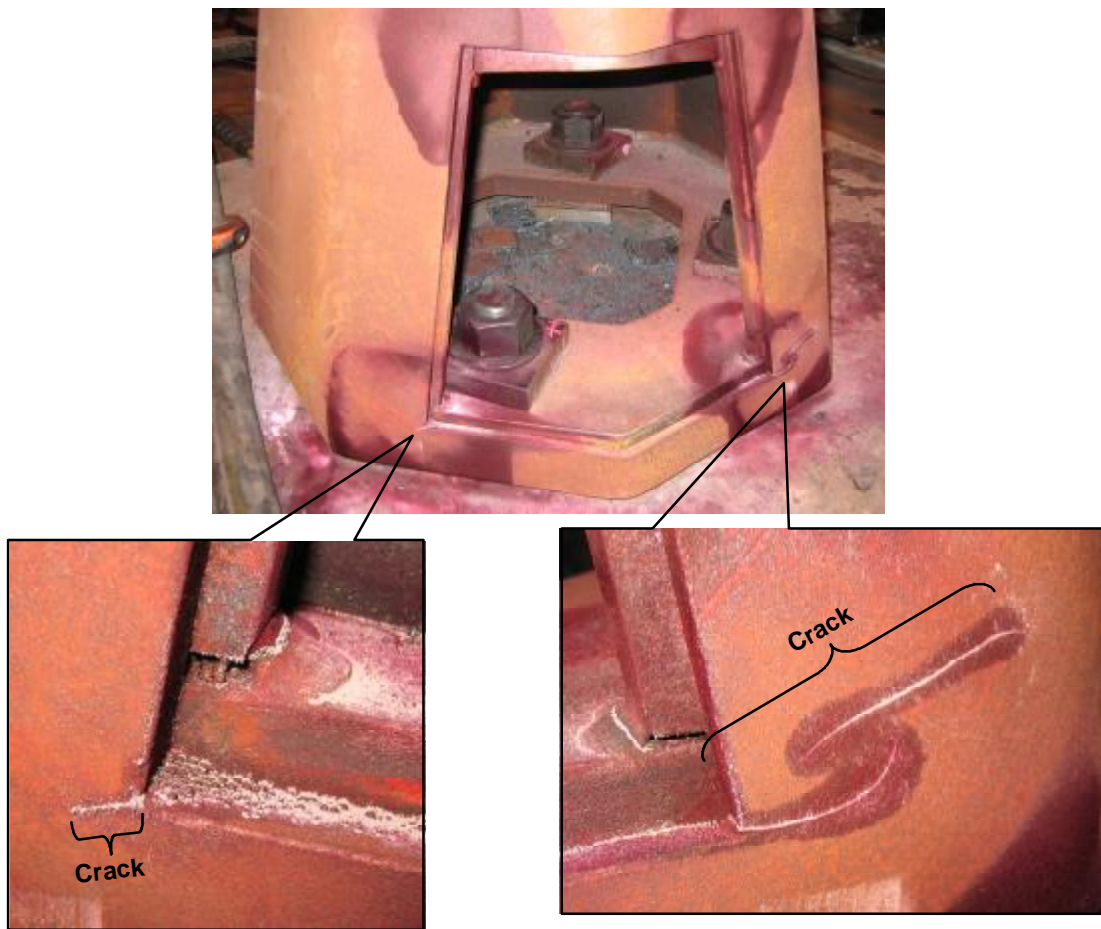
Figure 7.31 Access hole cracks in Type II poles.

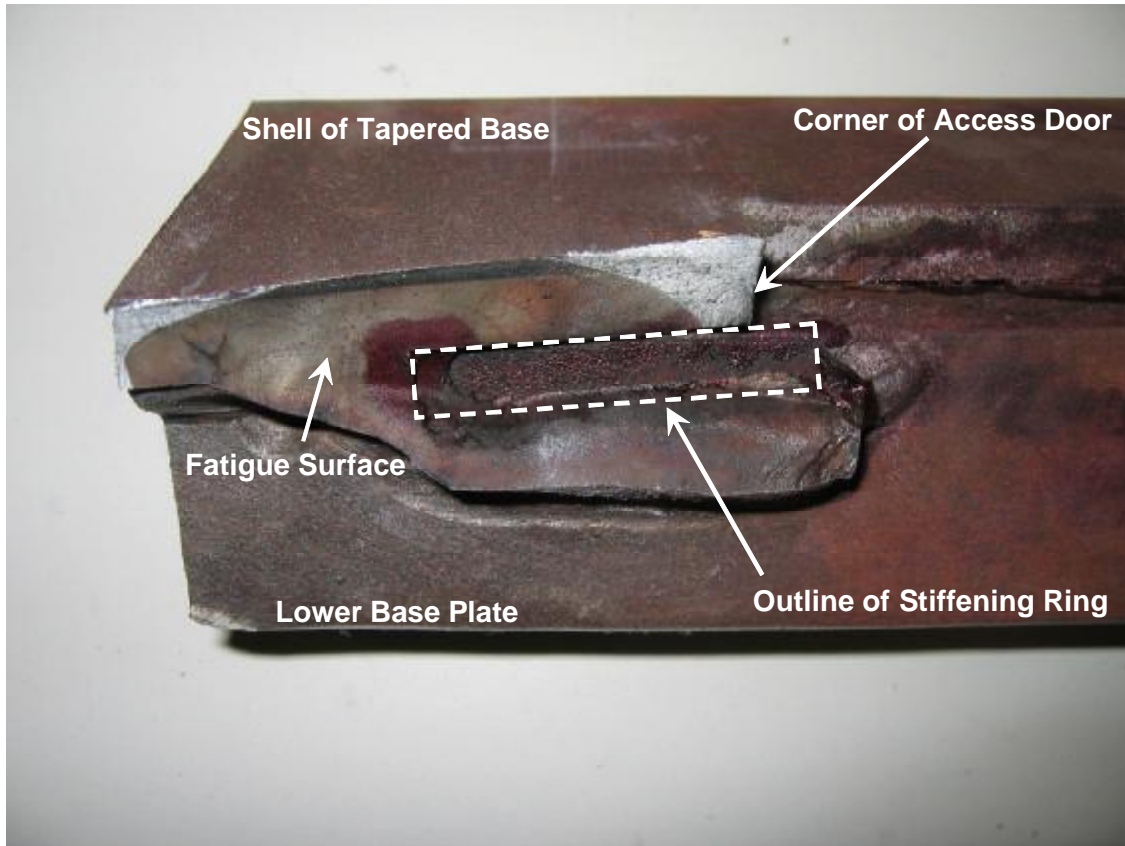
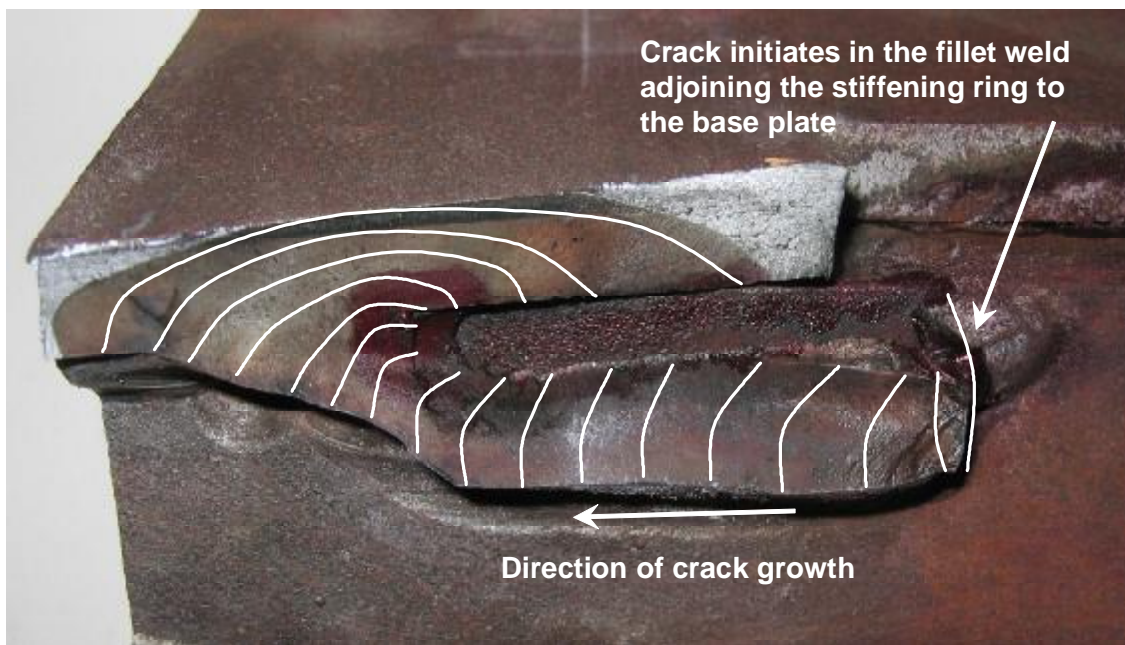
Figure 7.32 Cracking in tapered base shell originating from stiffening ring.

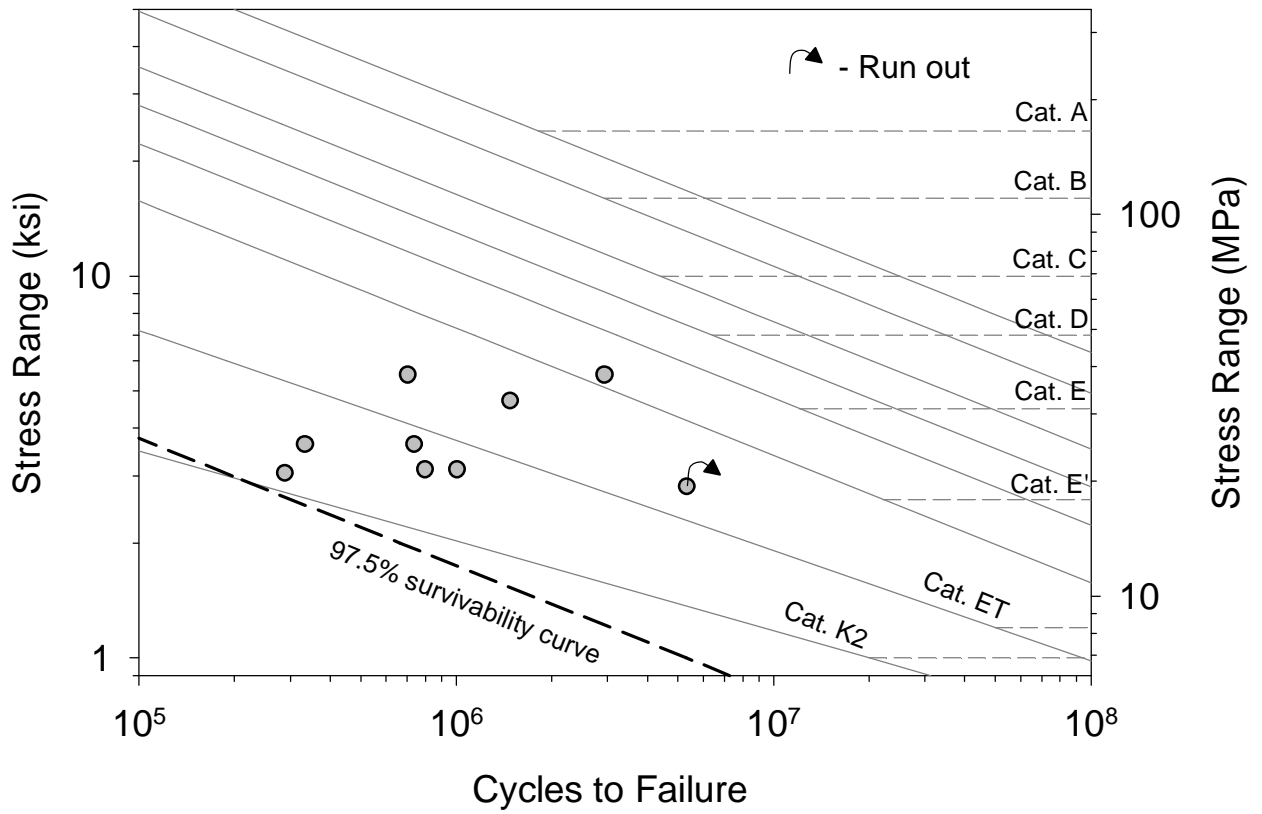
Figure 7.33 S-N plot of Type II pole specimens.

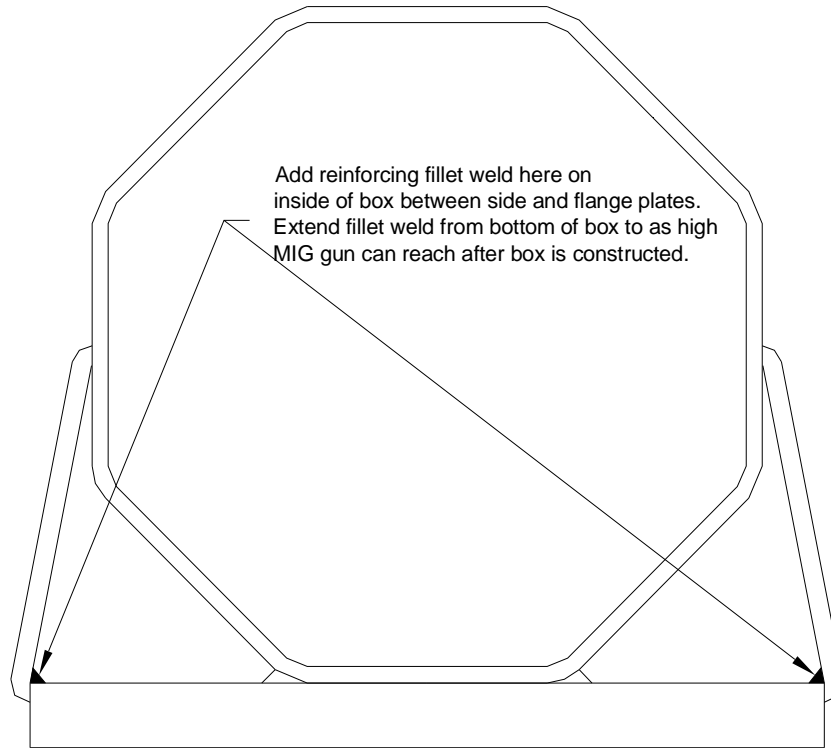
Figure 8.1 Detail recommendations for Type I box connection.

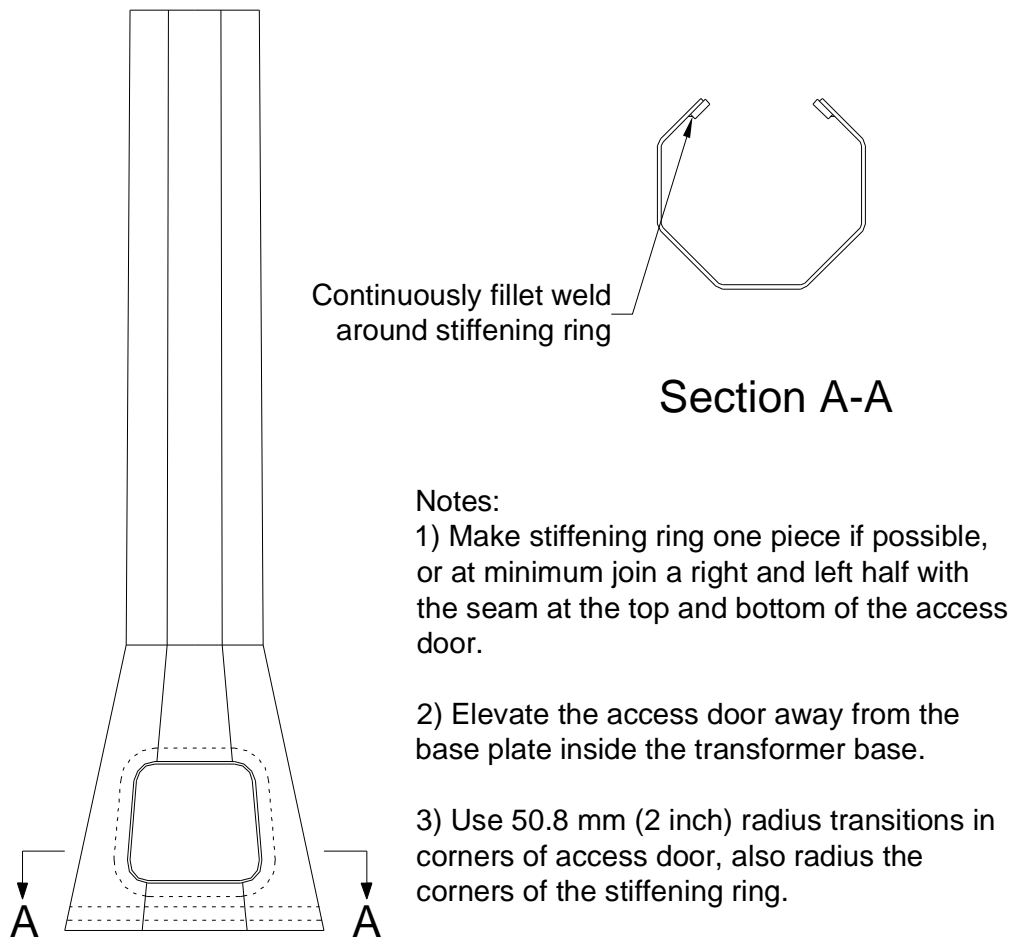
Figure 8.2 Access hole detail recommendations.
