INVESTIGATION OF AIRFIELD DRAINAGE
ARCTIC AND SUBARCTIC REGIONS

FIELD RECONNAISSANCE AND ANALYSIS

St. Anthony Falls Hydraulic Laboratory
University of Minnesota

April 1949

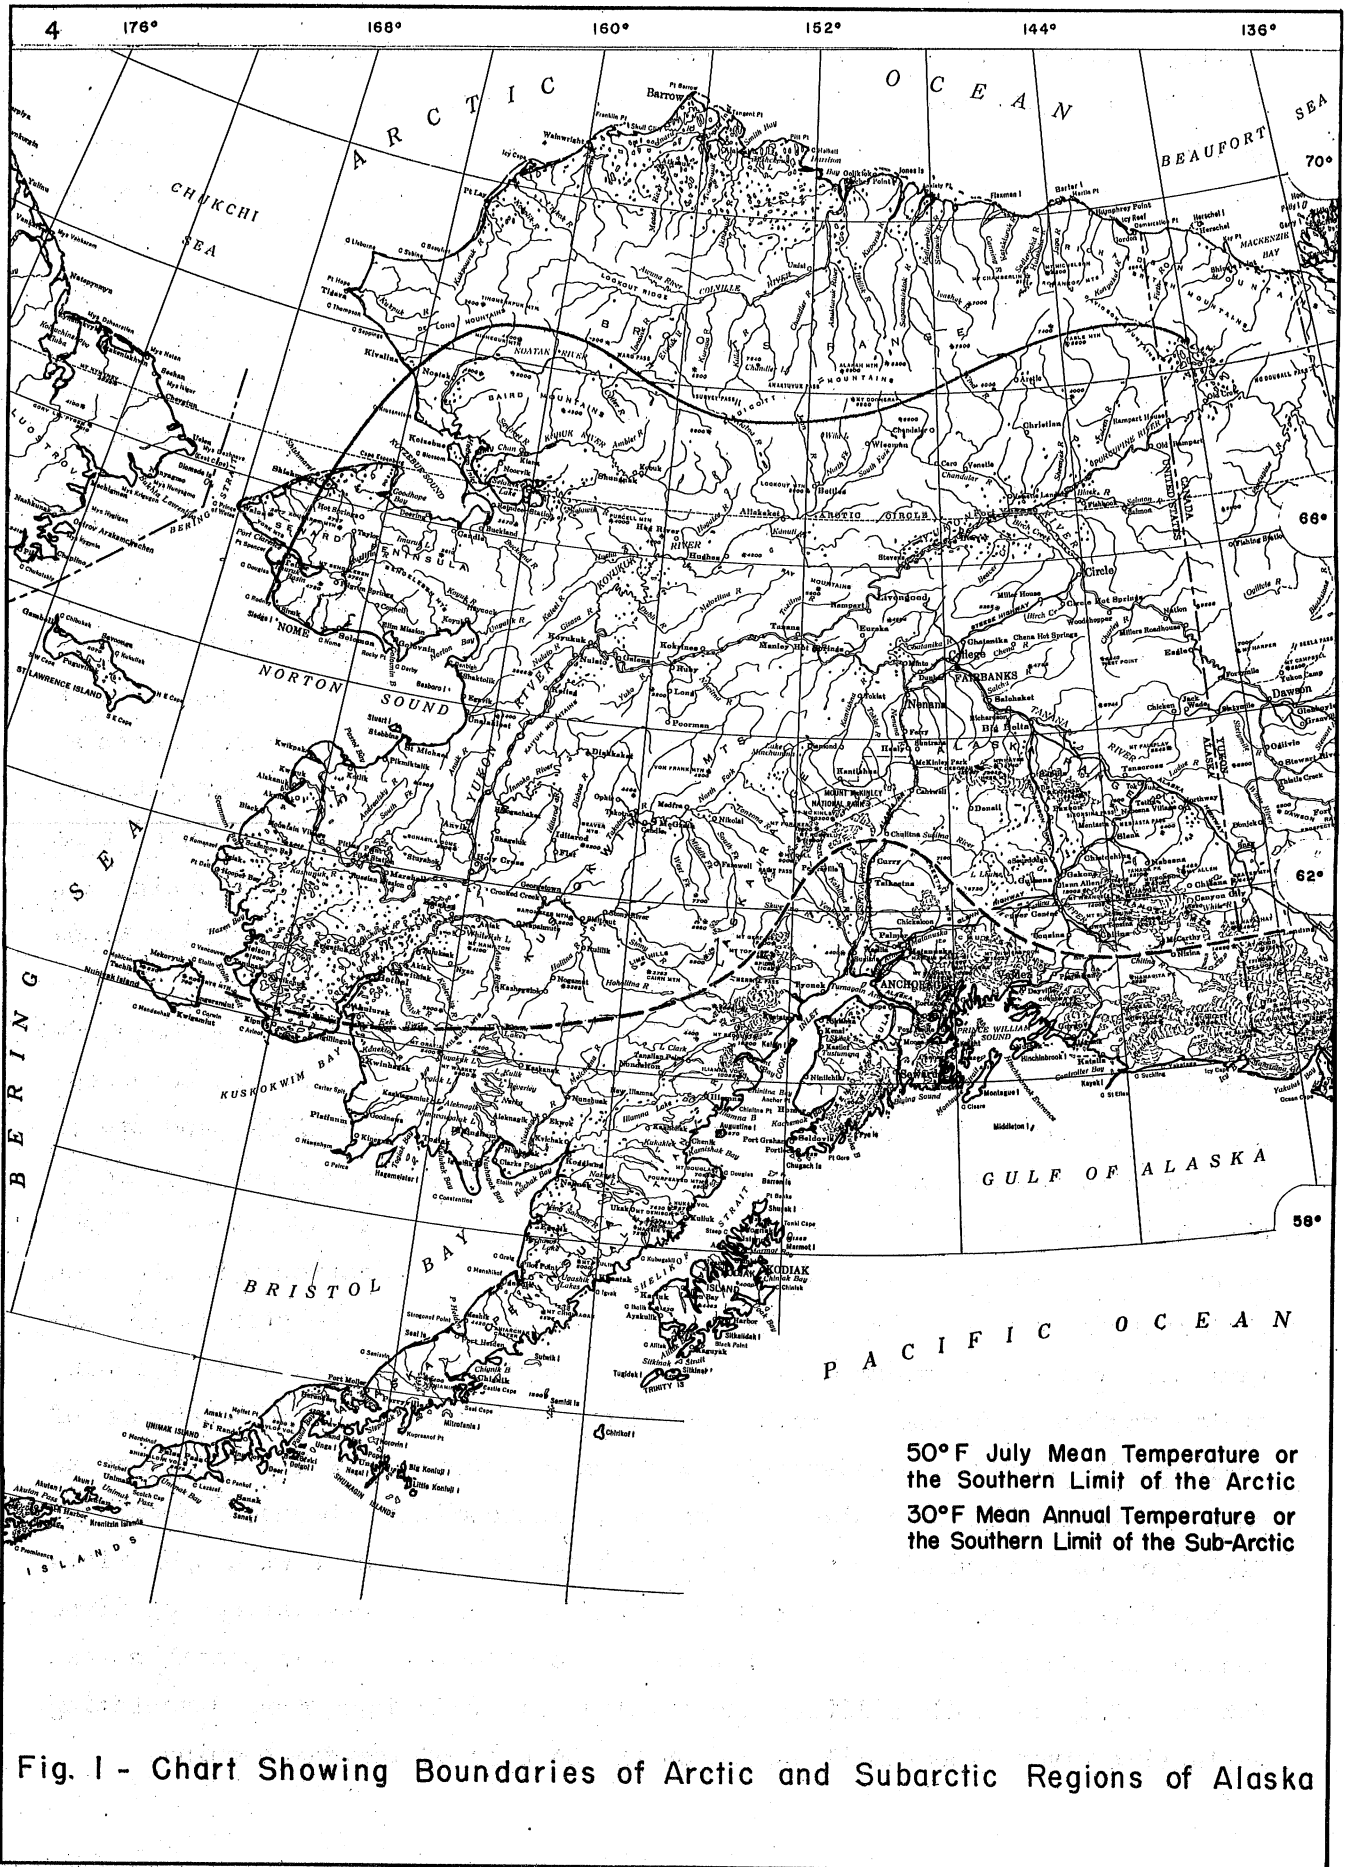
5. Limits of Research Area. The portion of Alaska with which this report is concerned lies to the north of the 30° F mean annual isotherm. This invisible boundary is presumed to be the southern limit of permafrost. There is some evidence to corroborate this view. Figure 1, showing the boundaries, is a general map of the research area.

12. The Southern Limit of the Arctic. Contrary to popular belief, the Arctic Circle drawn at $66^{\circ} 30'$ north latitude is not the boundary between the arctic and subarctic zones. The modern scientific delimitation of the Arctic is that area in which the mean temperature for the warmest summer month is less than 50° F. The 50° F July isotherm also approximates the northern limit of trees. This new concept of boundary between arctic and subarctic zones is more than just of passing interest as it divides the area of Alaska into two regions, each distinct from the other in many ways. It should be noted that the actual location of the 50° F isotherm on Fig. 1 has been moved in a southerly direction from the position obtained by interpolation of Weather Bureau temperature data. This was thought advisable in view of the absence of Weather Bureau stations in the higher altitudes and consequent colder regions of Brooks Range. The amount of change is partly on the basis of observation of the northern limit of tree growth during a flight to Barrow. Field notes taken during the trip indicate nearly a total absence of trees on the slopes of Brooks Range which face north. It is certain also that the mean July temperature, in the parts of Brooks Range that exceed altitudes of 3000 ft, is below 50° F. For the reasons thus stated, the 50° F July isotherm, or the southern limit of the Arctic, occupies a position on the slopes of Brooks Range which face south (Fig. 1).

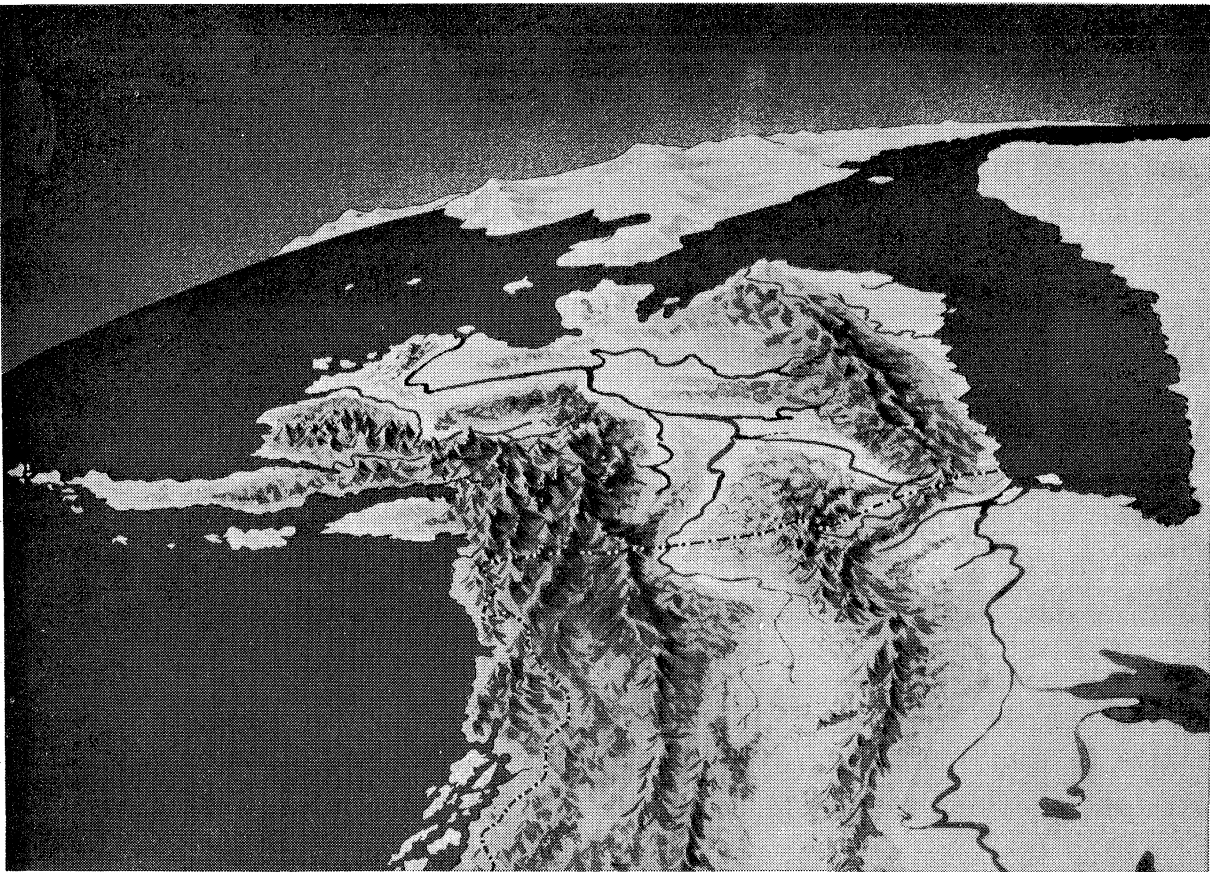
Fig. 2 - Schematic Perspective of the Topography of Alaska

Figure 2 schematically illustrates the topography of Alaska. The relative positions of mountain ranges are very important. Later paragraphs indicate that these areas of higher altitude are considered as weather-affecting factors.

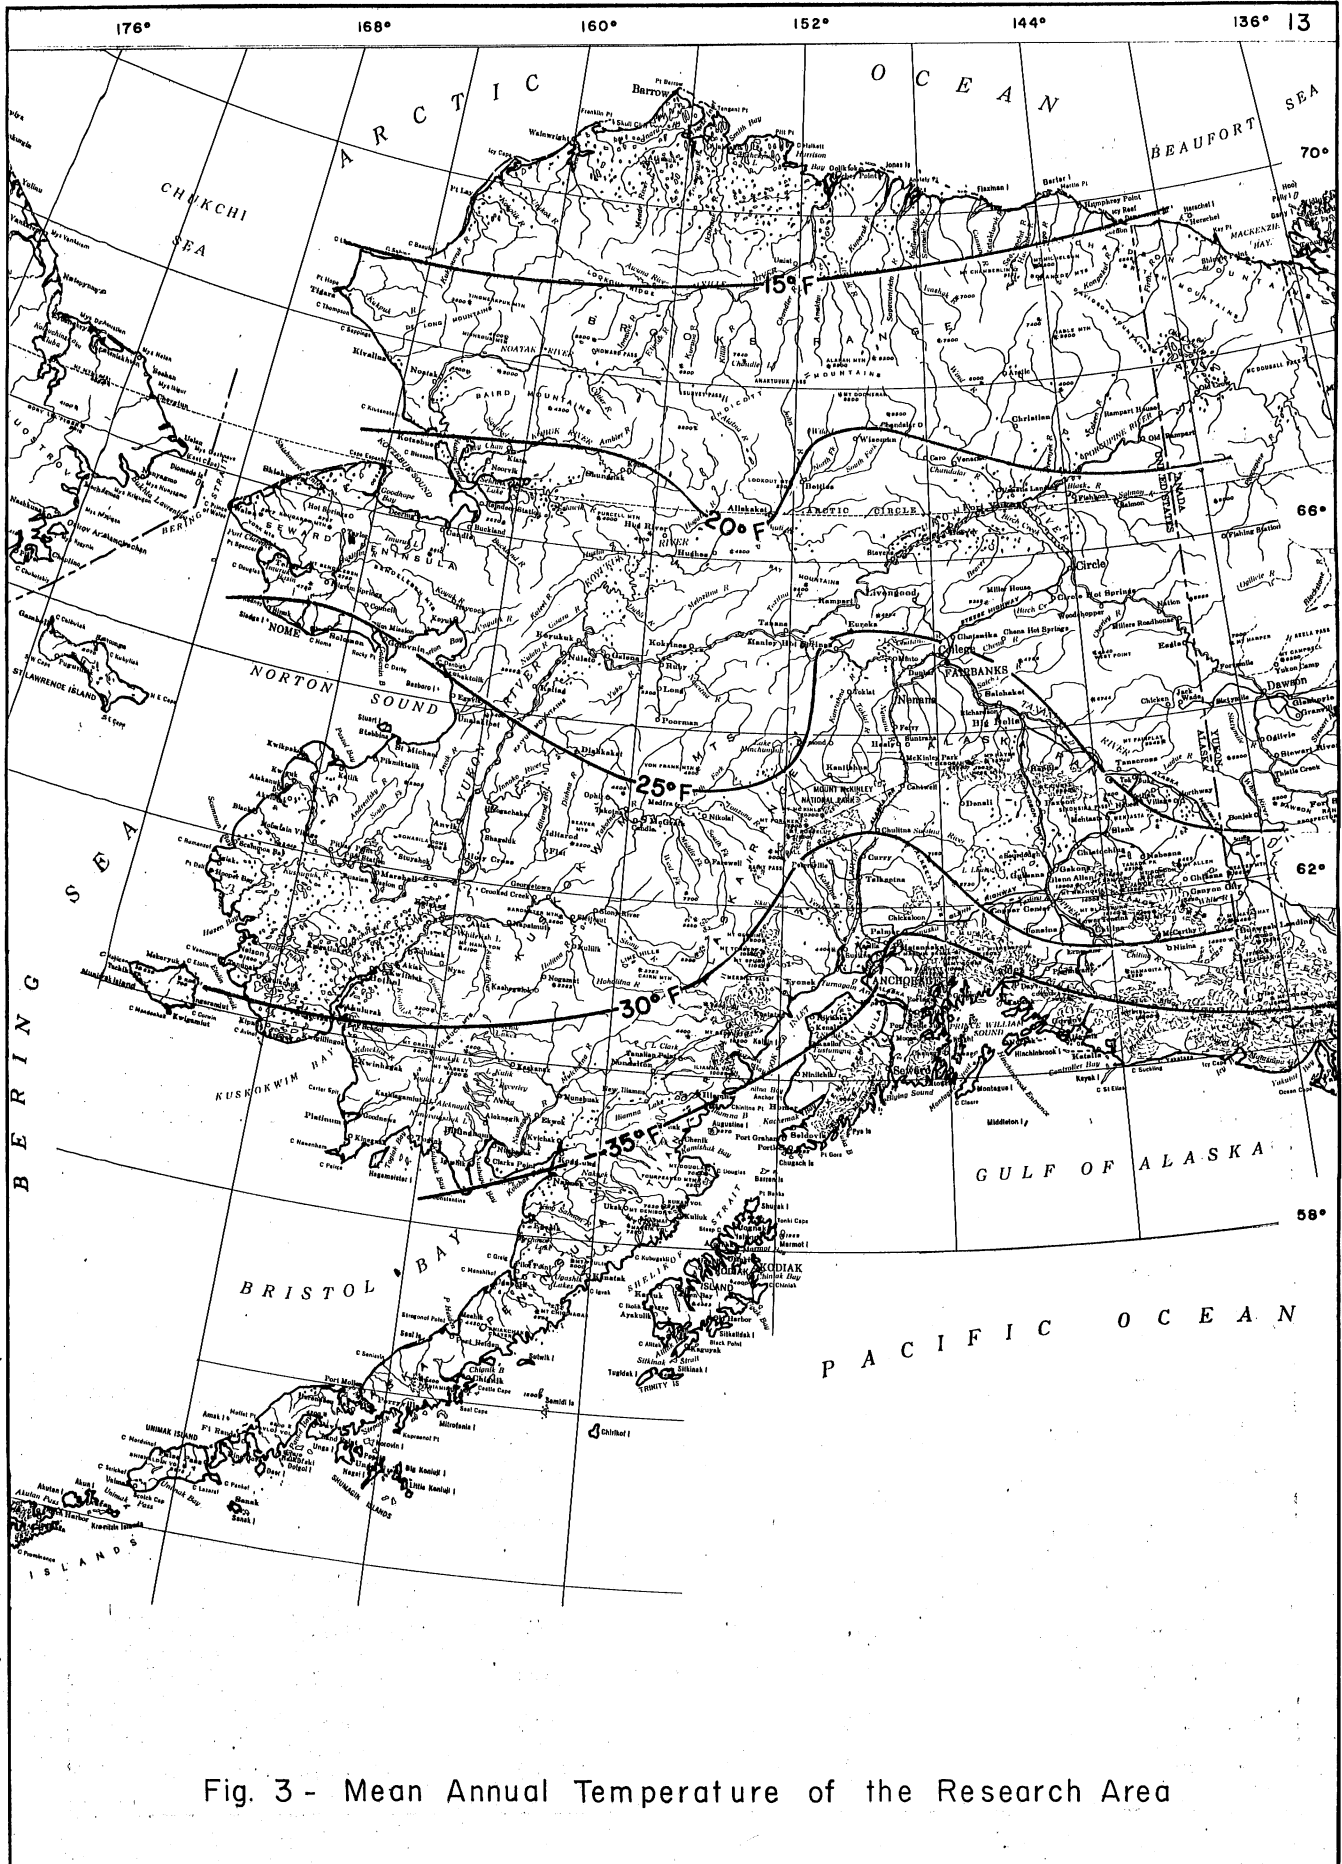
Fig. 3 - Mean Annual Temperature of the Research Area

16. General. The subarctic region of Alaska is characterized by great extremes in temperature between summer and winter. Maximum summer temperatures frequently exceed 80° F while a record low of -76° F has been recorded in the Yukon valley. Isotherms of mean annual temperatures are shown in Fig. 3. These show rather plainly the influence of the Bering Sea and the Gulf of Alaska. In summer the effect of the cool waters of the former are noticeable for several hundred miles inland. Although the winters are cold, the cold intensity is not unbearable, as high winds with temperatures below -10° are very infrequent. There also seems to be an absence of severe local winds in the summer. In the arctic region freezing temperatures occurred in each month of the year and it was not uncommon for snow to fall in June and August, with traces sometimes in July. This condition had a decided effect on drainage design in that infiltration could not be considered. In the sub-Arctic, freezing temperatures in the summer are very rare except in the vicinity of Kotzebue and Shishmaref. These two stations are located very close to the arctic region boundary and perhaps should be included in that area for design purposes.

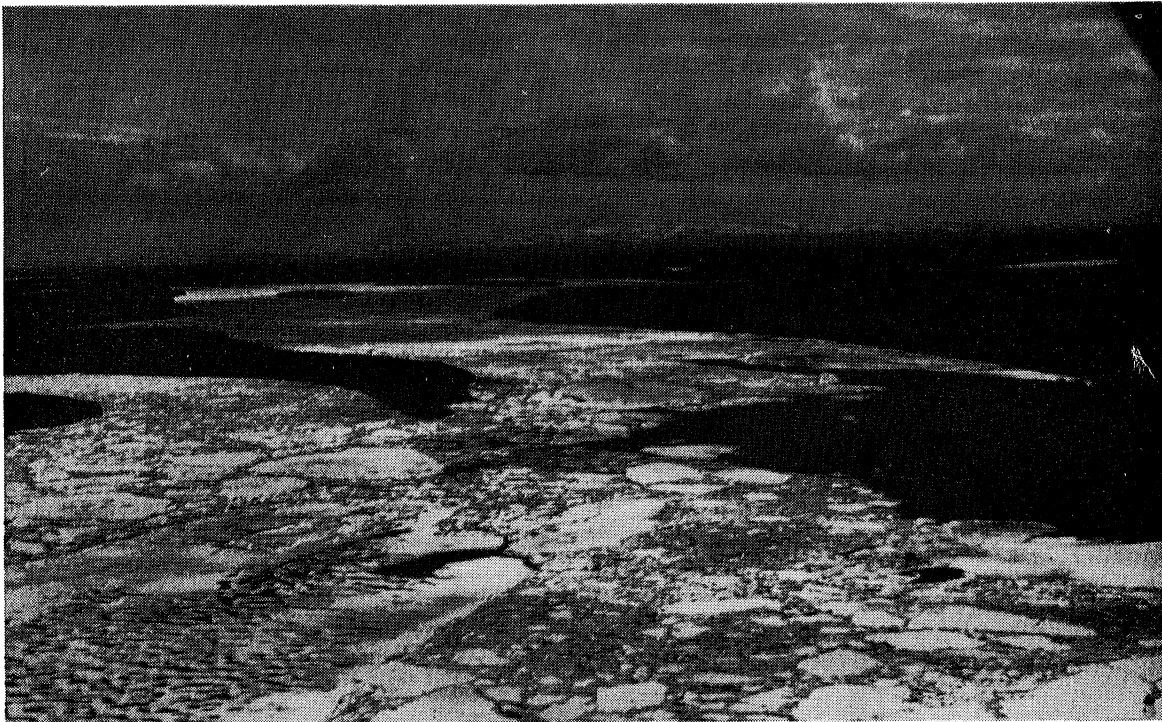
Plate No. 5 — Ice Jam in Kuskokwim River at Aniak

The fall from the upper to the lower end of this ice jam is about 25 ft.

The river stage on May 16, 1948 was 25 ft above the ordinary river level.

31. Flood Conditions. At the time of the investigation, the river stage was within 2 ft of the runway elevation and had been higher. This is indicated by the photographs on Plate 4. At 3:30 p.m. May 16, eight P-51 fighter planes of the 57th Fighter Group bombed the ice jam with rockets. This action resulted in little relief and waters continued to rise. By 8:00 a.m. May 17, water was 2 ft deep at the Civil Aeronautics Administration control building, and overtopped the east end of the runway, causing a large discharge to the south and west across the strip. Considerable erosive damage resulted to the south bank slopes and many large cakes of ice were stranded on the runway. The Fighter Group returned equipped with 500-pound bombs with a delayed action fuse. More positive results were obtained and conditions started to improve about one hour after the bombing. At 11:00 p.m. May 17, the water level had subsided more than 6 ft.

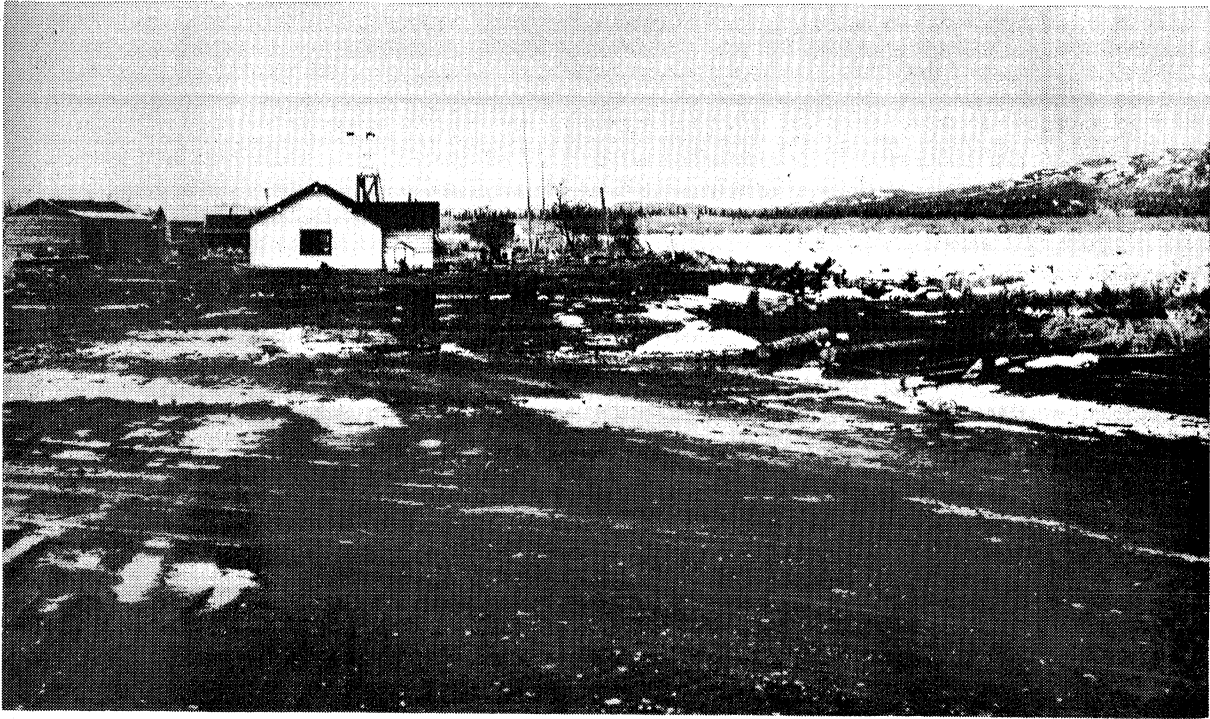
Large chunks of ice were noted on the east end of the runway on May 16, 1948.

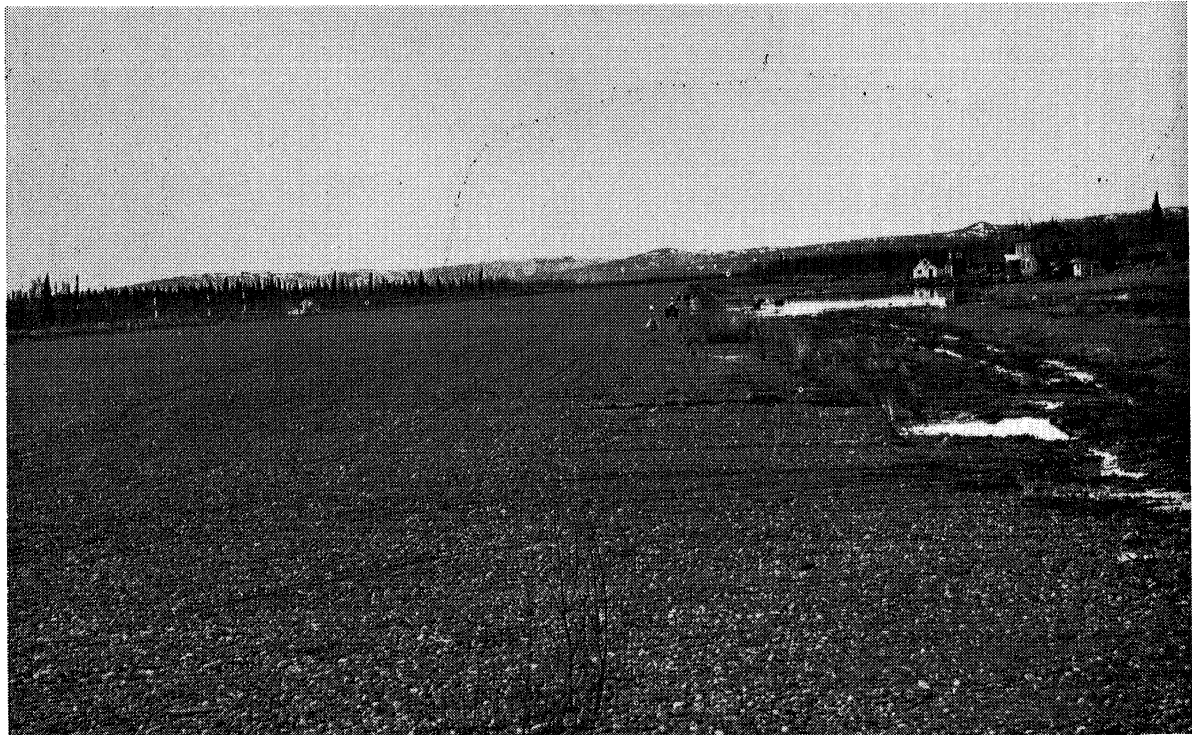
Plate No. 6 - Drainage Conditions at Aniak Airfield

Looking west along the north shoulder of the runway..

29. Drainage System. The airport drainage system at Aniak for surface waters consists of shallow open ditches, one on either side of the runway. The ditch on the north side of the runway slopes to the west and discharges into a slough which is connected to the Kuskokwim River. During the time of high river stages there is considerable flow of water in the sloughs. At the time of the investigation there was evidence that the range road had been overtopped because of inadequate culvert capacity (photograph on Plate 6). Surface waters flow directly from the runway down very flat bank slopes into the shallow side ditches without the use of collecting inlets. There was no evidence of serious erosion, which indicates that rains are of light intensity.

32. Verification of Design Criteria. Calculations using the new design criteria were made to verify culvert capacity of the structure located on the north side of the runway opposite station 25 + 00. One of the photographs on Plate 6 indicates the type of drainage area which is estimated to contain 30 acres, including 9.3 acres of gravel-surfaced runway. In general, the ground surface is relatively bare, with patches of sparse grass growth occupying probably 40 per cent of the area outside the runway. The ground surface is nearly flat with no perceptible slopes in any direction. Assuming that at some future date the runway may be surfaced with an impervious layer of zero infiltration capacity, and estimating 0.2 in. per hr infiltration for the remainder of the area, computations using the new design criteria indicate a flow of less than 12 cfs at the site of the culvert. In other words, on the basis of the new design criteria this existing drainage facility is of adequate capacity, a view which was corroborated by statements of local maintenance men.

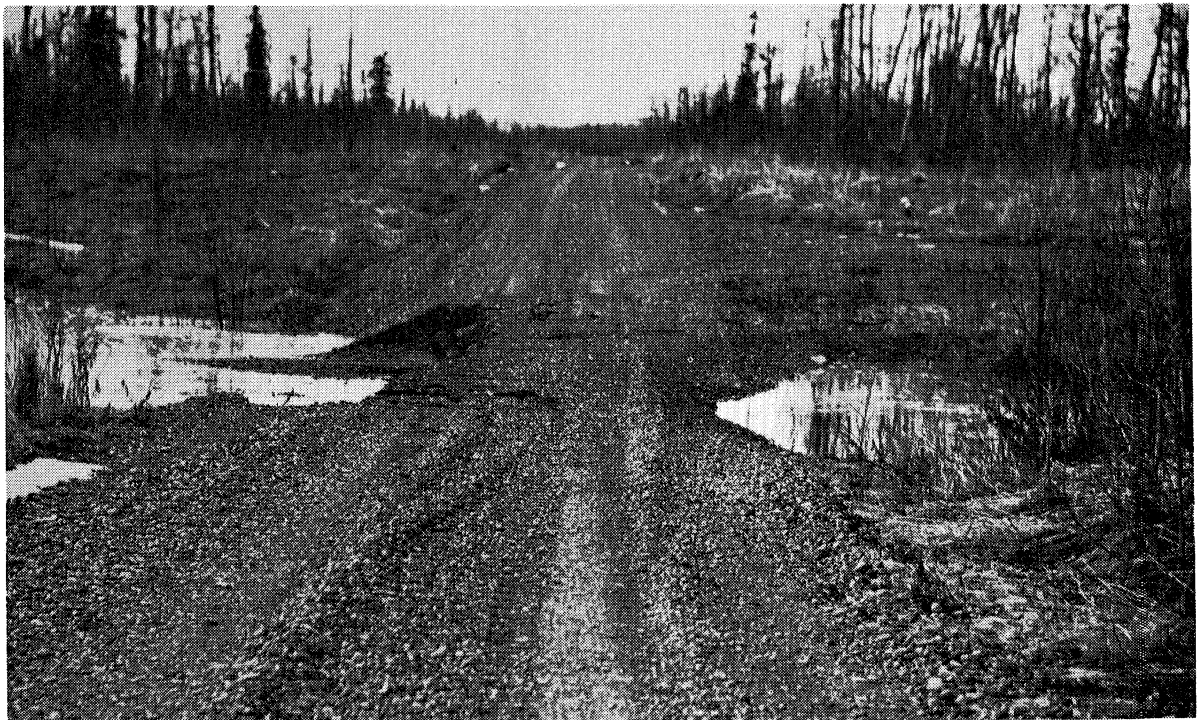
High river stages of May 16, 1948 created a discharge which exceeded the culvert capacity of this site.

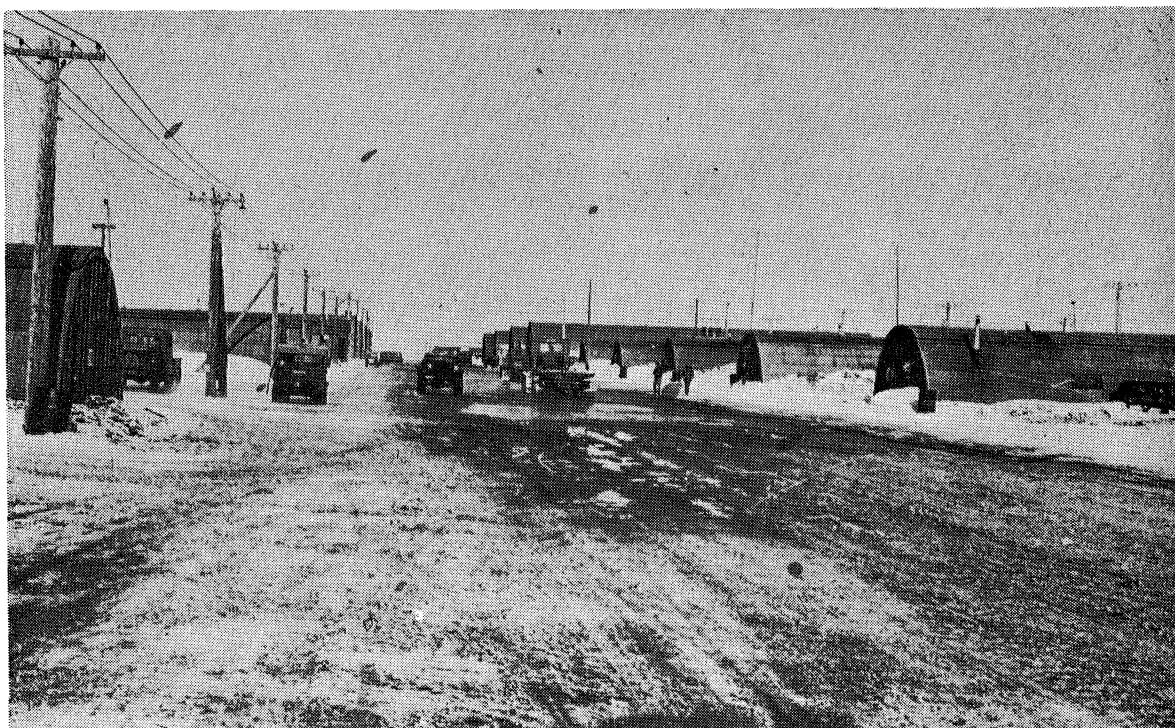
Drainage at Barrow is largely by infiltration into a pervious soil.

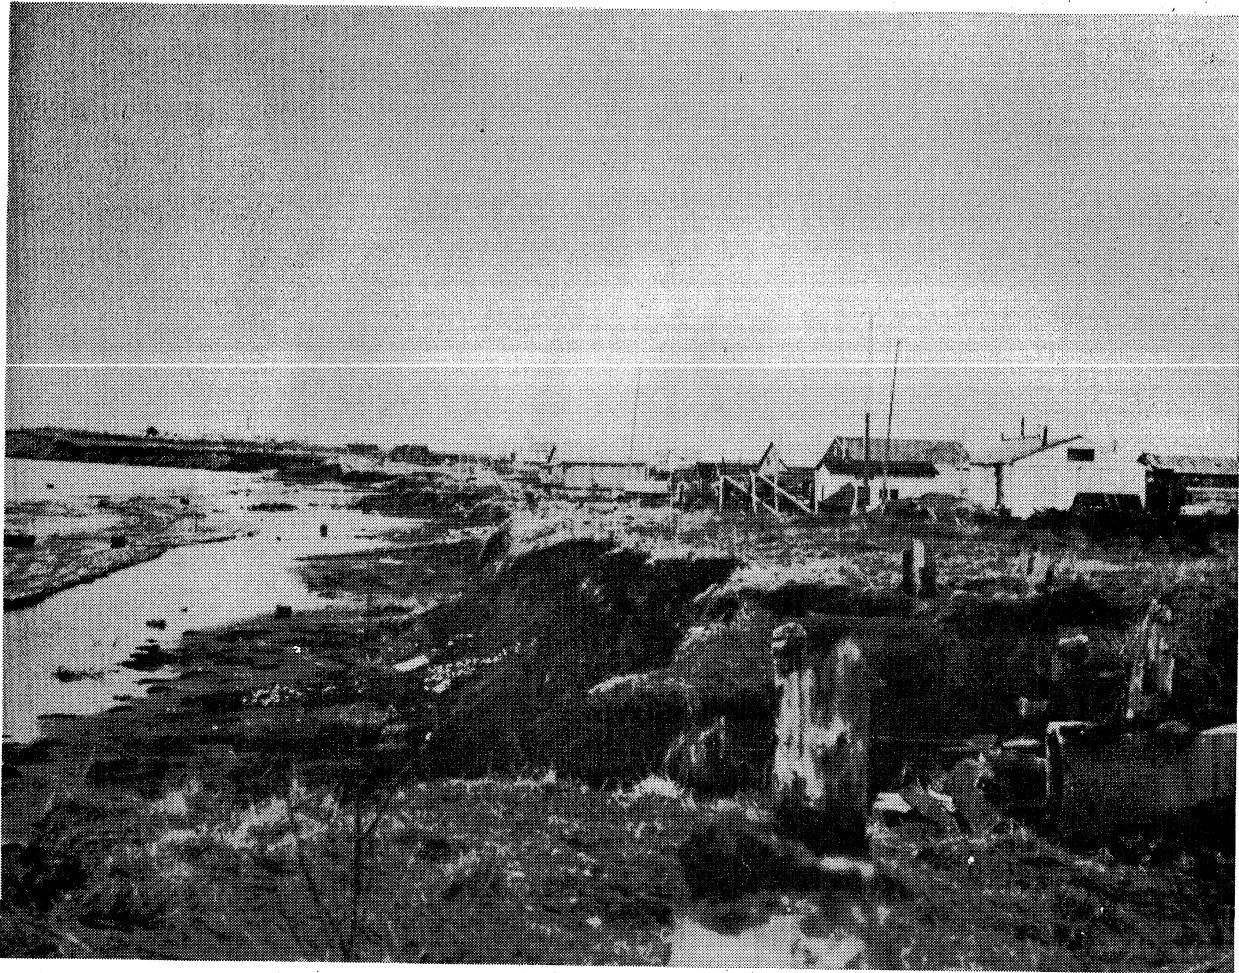
Plate No. 9—River Bank Erosion at Bethel, Alaska

River bank erosion at Bethel is indirectly caused by thawing permafrost.

turn results in sloughing of the banks. This action removes about 20 ft of bank each year and every so often all buildings must be moved back to new locations. In 1939 all buildings were moved back several hundred feet. Since that time about 300 ft of river bank has disappeared. A peninsula shown in one of the photographs on Plate 14 vanished since 1913. It is impossible to maintain any type of dock or wharf.

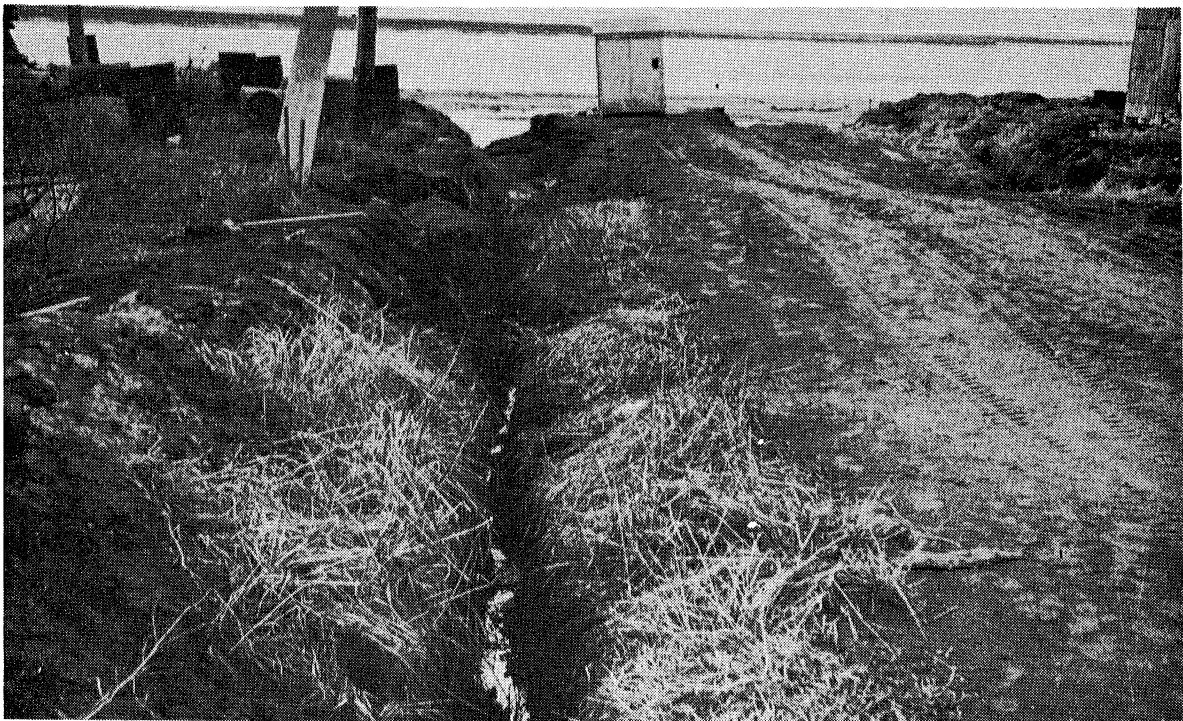
Plate No.12 - Drainage Conditions at Bethel

Narrow ditches are very difficult to maintain and are not recommended for areas where it is impossible to keep the ground frozen.

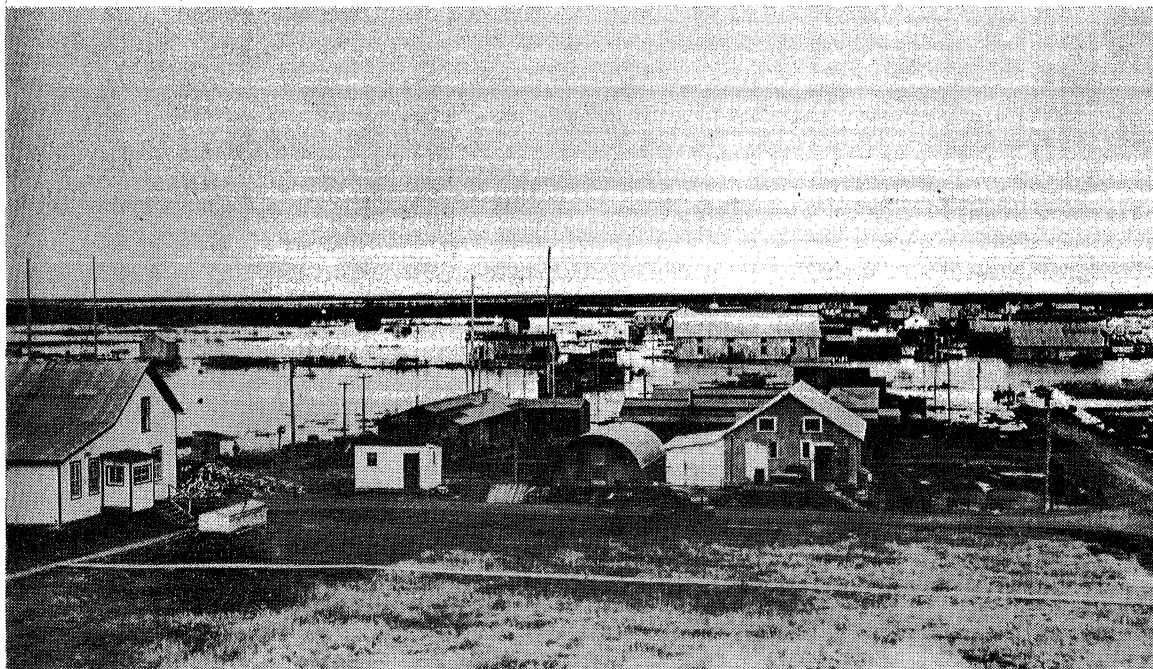
The ice-jam flood of 1946, as shown above, represents the highest river stage since 1911. The water is 9.7 ft. higher than indicated in the picture below.

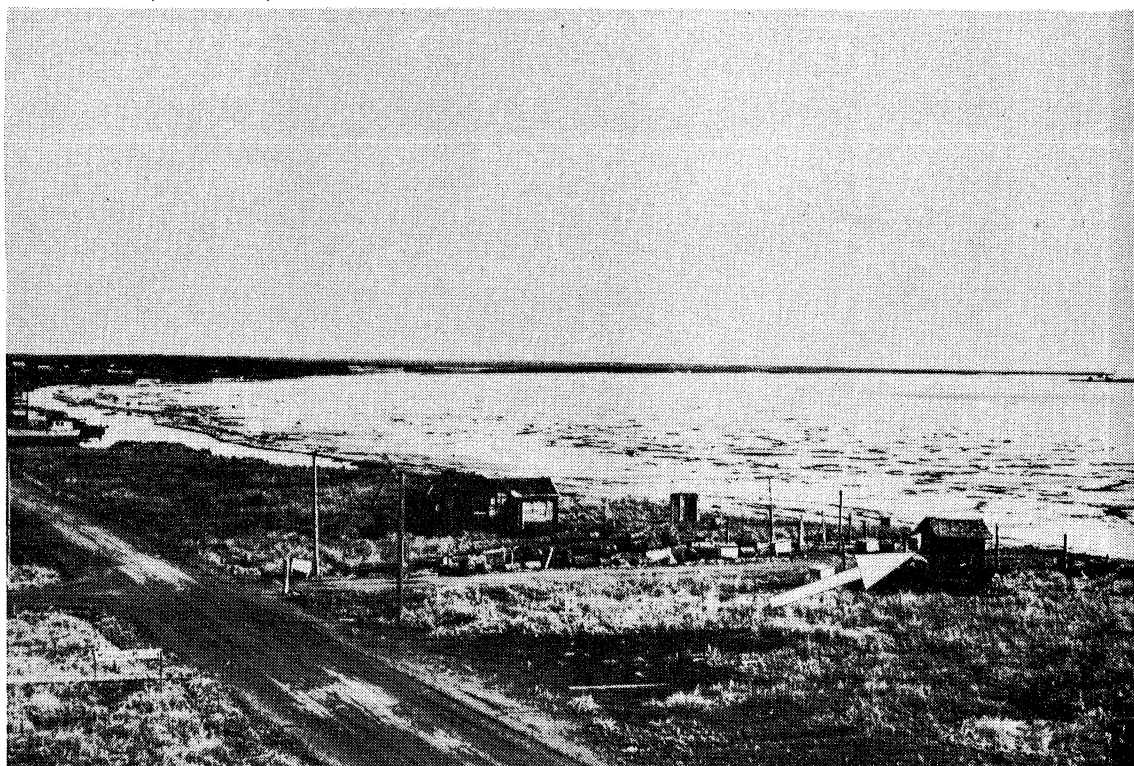
Plate No.14 - Contrasting River Conditions at Bethel

This picture, taken of the same area May 17, 1948, shows a marked change in conditions. The arrows in the top and bottom photographs point to the same building.

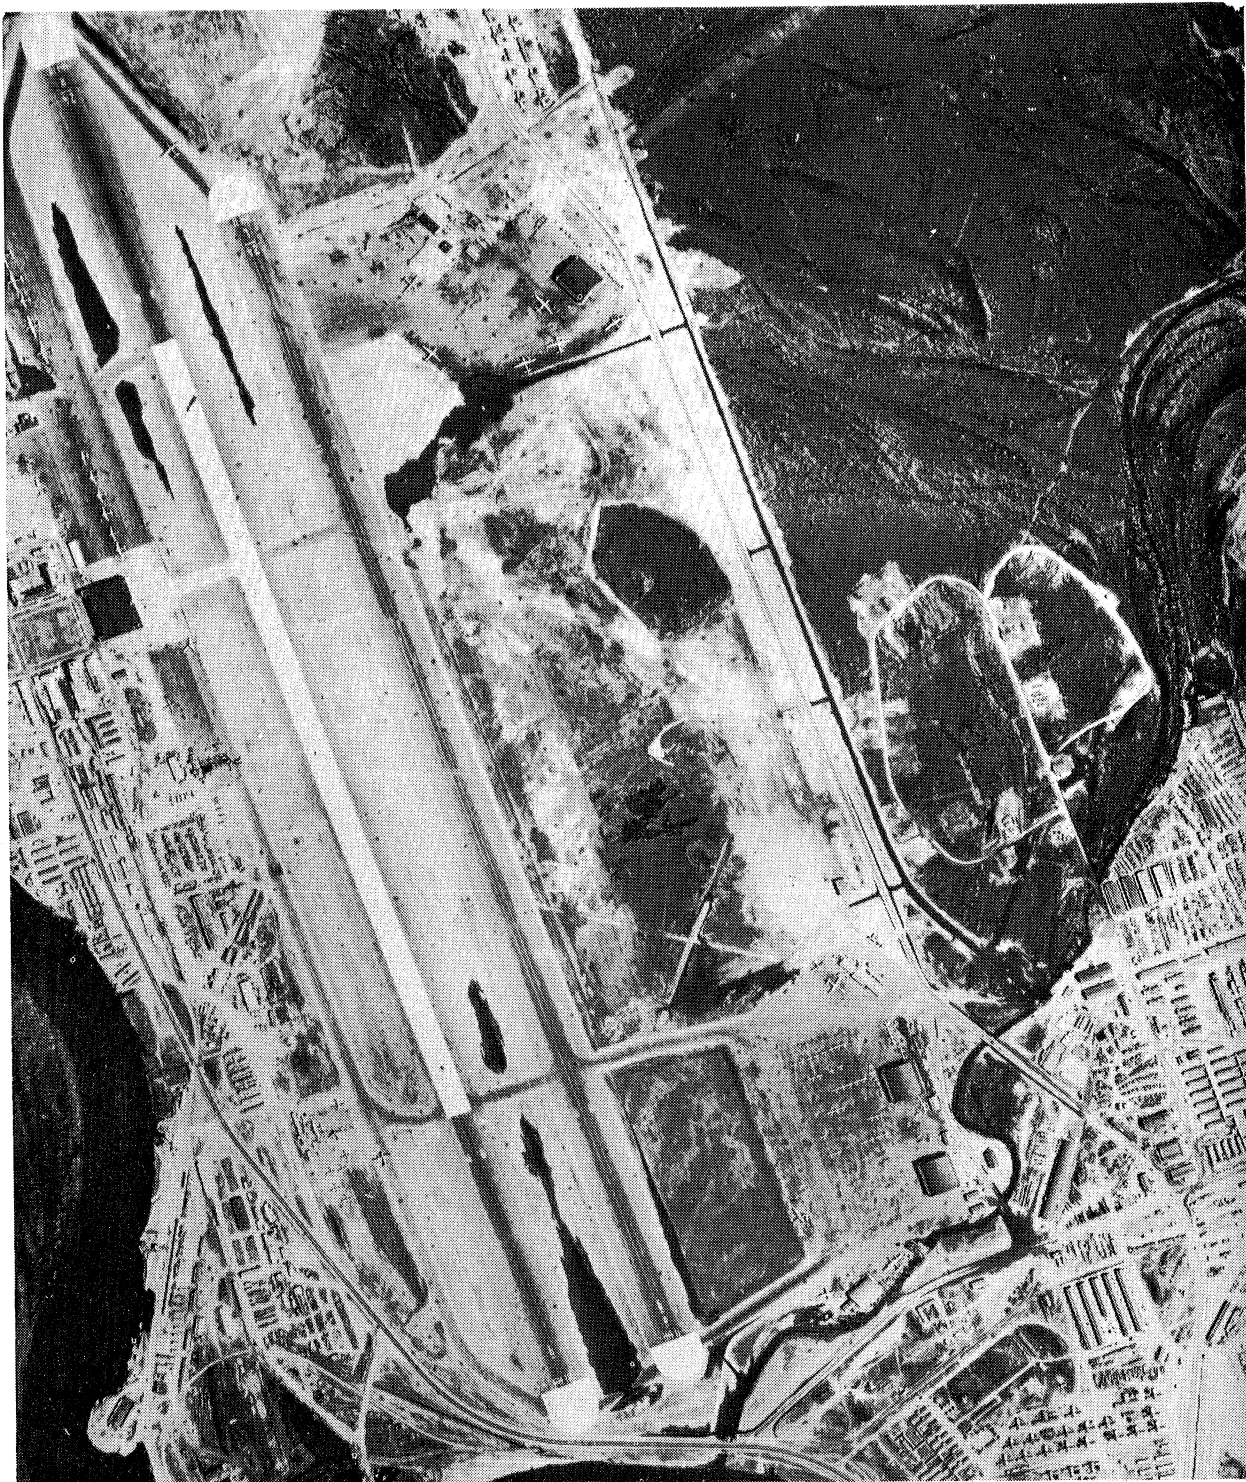
Plate No.20-Drainage Conditions at Ladd Field

High Chena River stages during May 1948 caused a reversal of flow
in drainage conduits and inundated large areas.

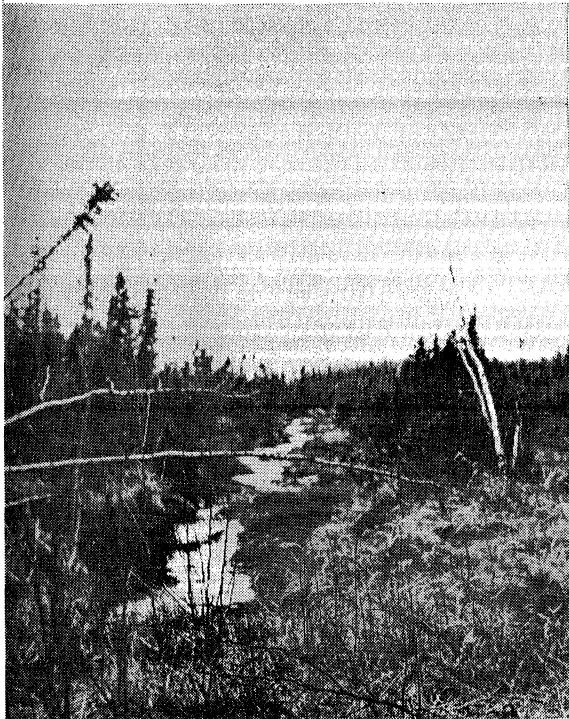
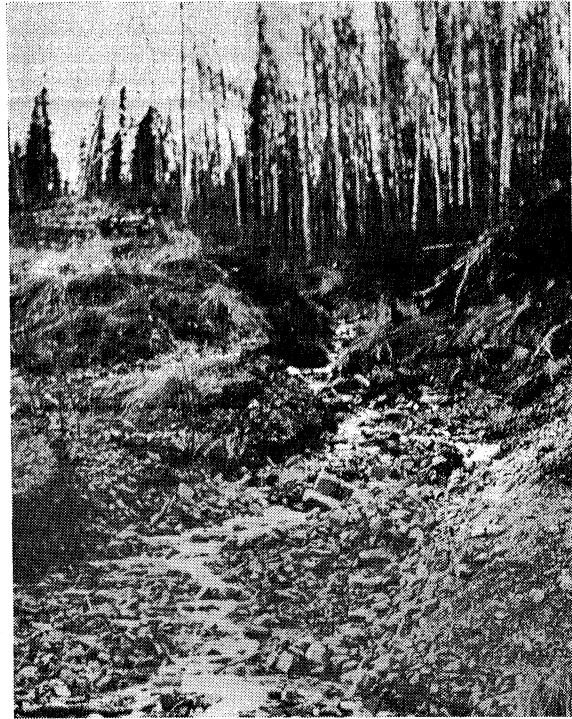
A diversion ditch conveys runoff away from the airfield.

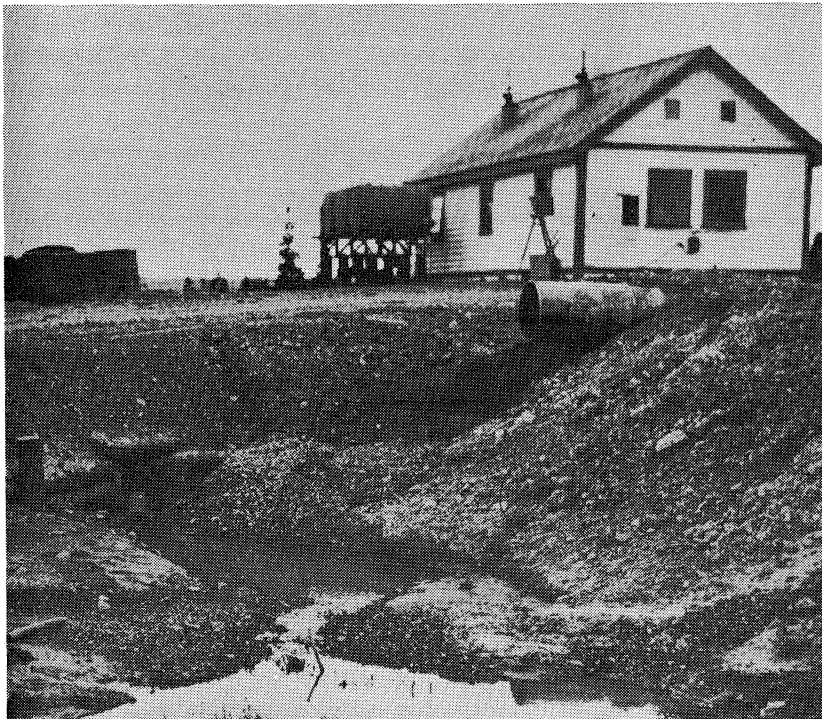
Plate No.23 – Drainage Facilities at Minchumina Airfield

Many materials and innovations are used to provide drainage structures.

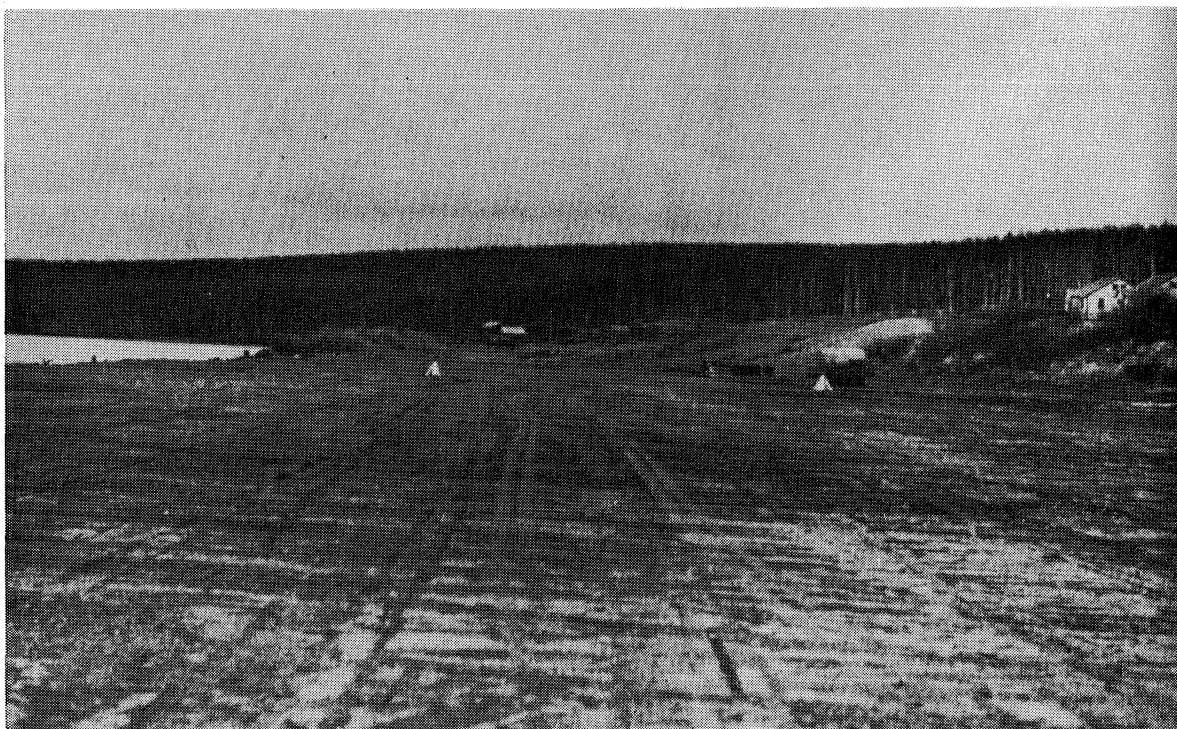
The picture above shows the northwest end of the short runway shortly after its completion in 1946.

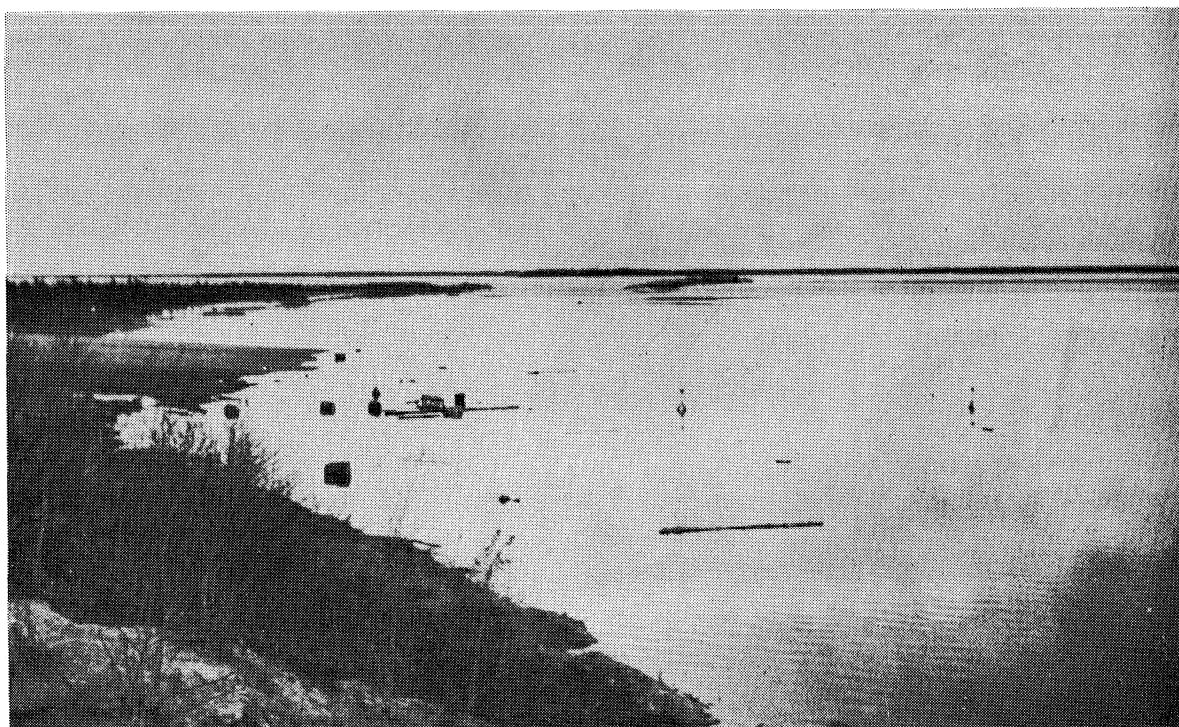
Plate No 24-Contrasting Conditions of One Runway at Minchumina

This picture is a view of the short runway during the flood of May 20, 1948.

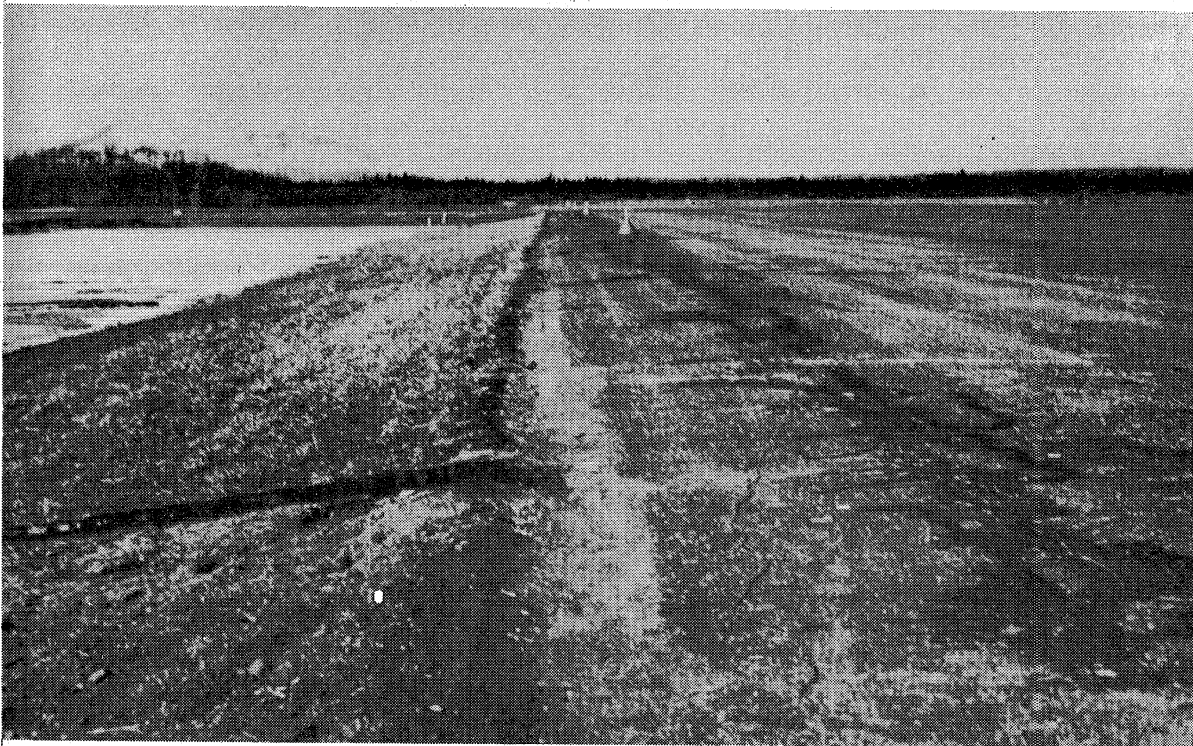
Plate No.30—Drainage Conditions along Runway Shoulders at McGrath

The drainage structure at this section is made of oil drums.
