INVESTIGATION OF AIRFIELD DRAINAGE
ARCTIC AND SUBARCTIC REGIONS

FIELD RECONNAISSANCE AND ANALYSIS

St. Anthony Falls Hydraulic Laboratory
University of Minnesota

April 1949

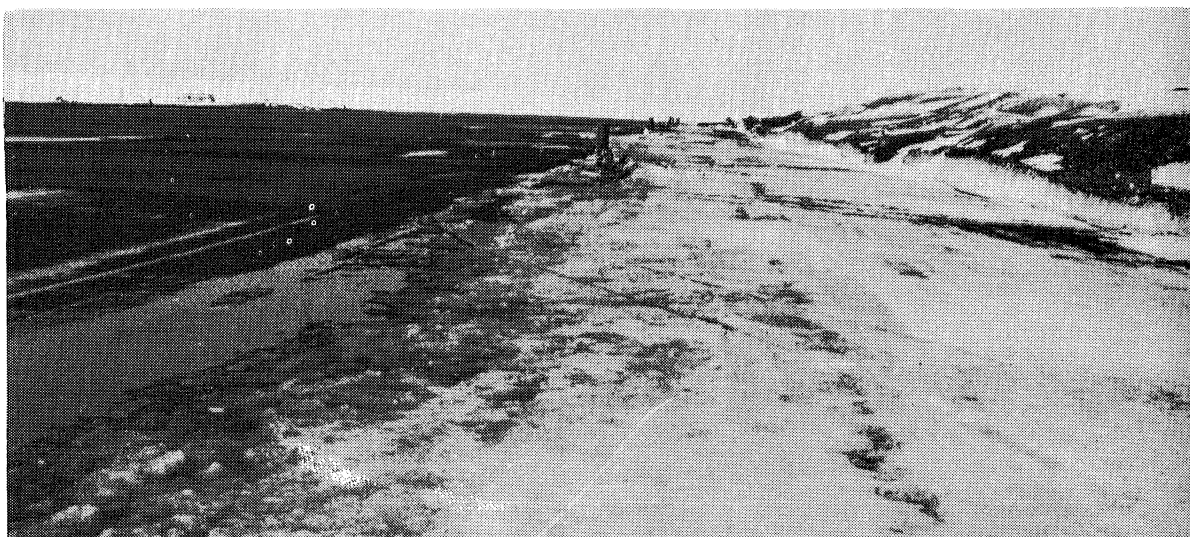
Looking west along the runway on May 10, 1948.

77. Drainage in the Village and at the Municipal Field. There are no special facilities entailed in the drainage system for the village of Nome. Runoff from the roofs of buildings falls directly on the ground then via overland flow to shallow open ditches. Runoff from other areas is also conveyed to the eventual outlet by a crude system of shallow open channels. The local municipal airfield, a gravel-surfaced strip 190 ft wide and 3200 ft long, is located between two creeks. The land on either side of the runway slopes steeply away, a condition which provides almost an ideal system of natural

drainage. The actual runway grades are not truly uniform with consequent areas of depression. Runoff which reaches these depressions cannot escape except by evaporation or infiltration. Local Alaskans refer to this field as an all-weather strip and report that drainage difficulties are of a minor nature.

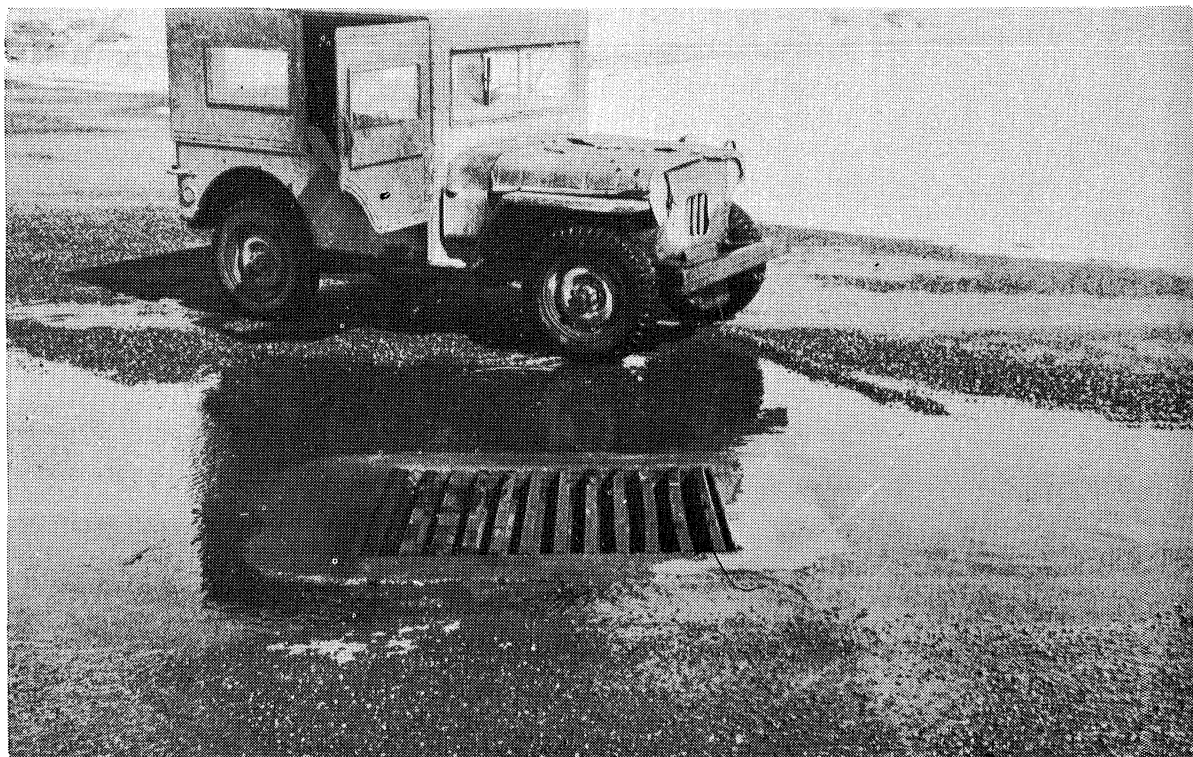
Plate No. 35 - Drainage Conditions at Nome Airfield

The grating for drainage inlet structures are made of light-weight railroad rails.

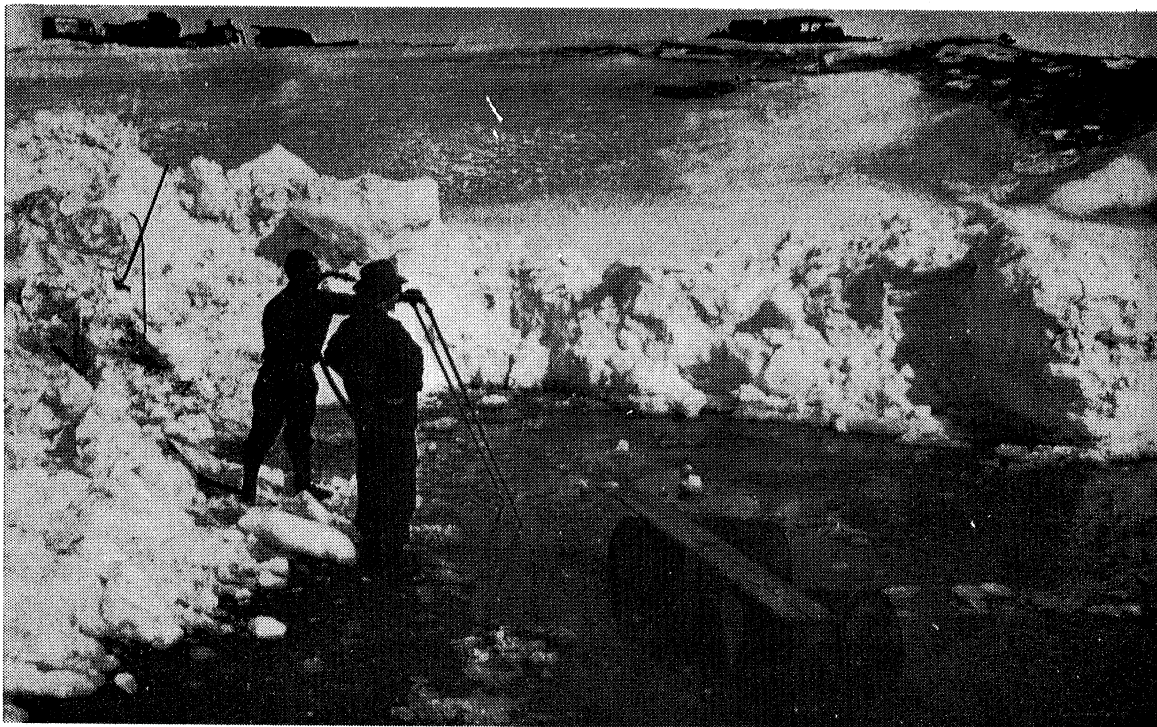
A steam-thawing operation is in progress to free a drainage inlet structure of ice.

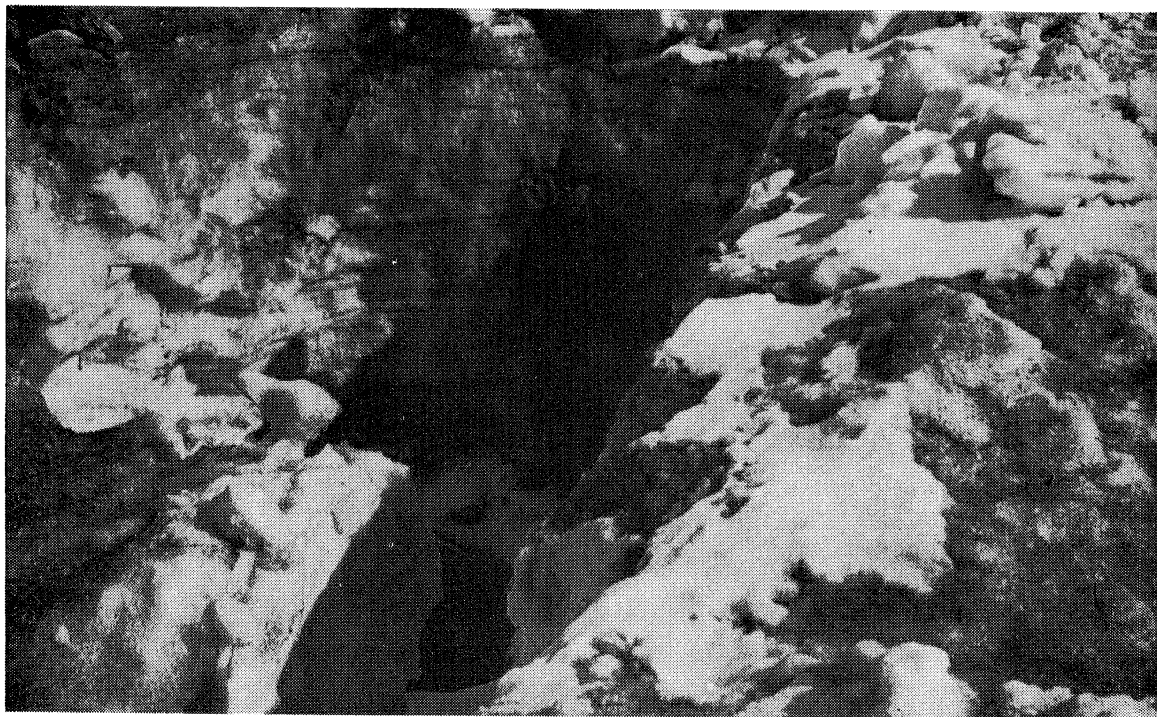
Plate No. 37 - Steam Thawing

Considerable work was required to remove the ice and snow that impeded drainage into this inlet.

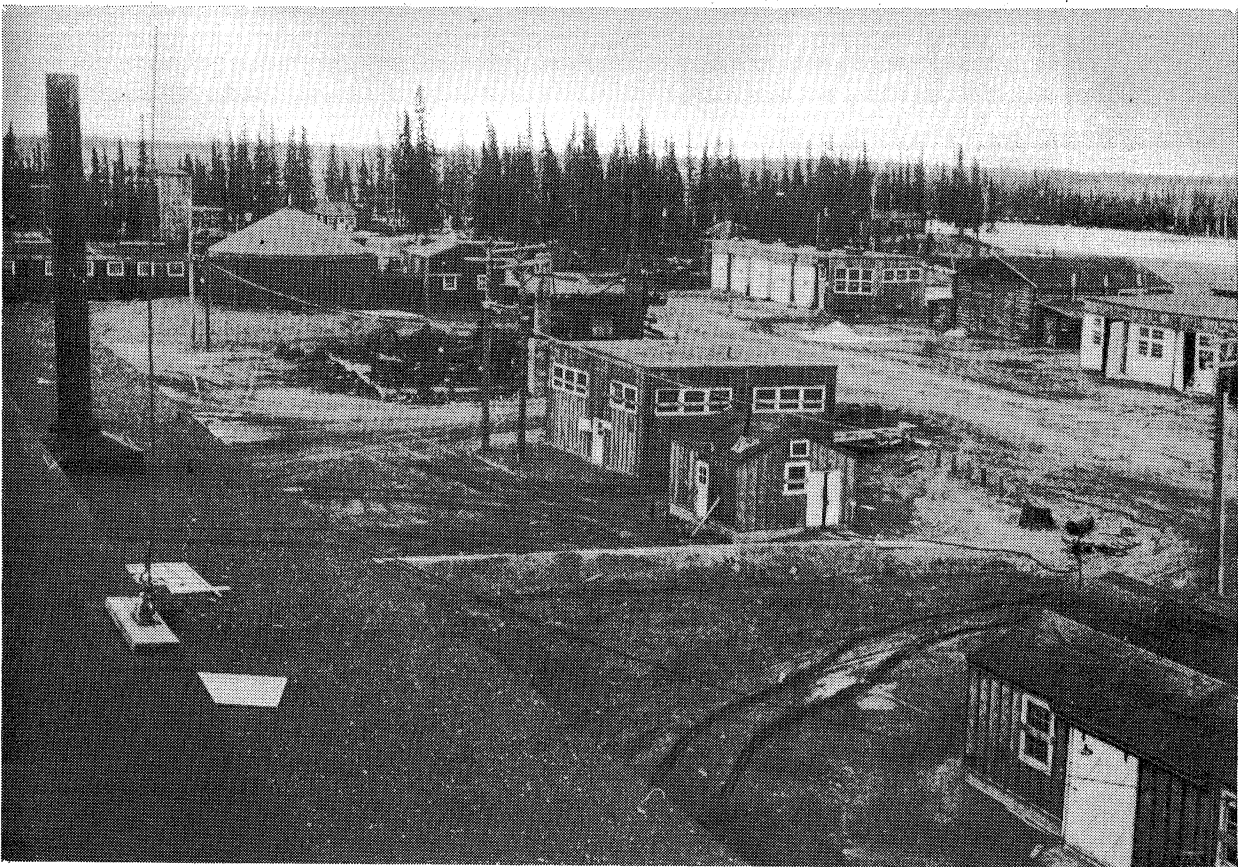
Plate No.38 - Workshop Area at Northway

A large percentage of drainage is accomplished by proper grading. Runoff proceeds via overland flow to wide shallow ditches or to natural swales and depressions.

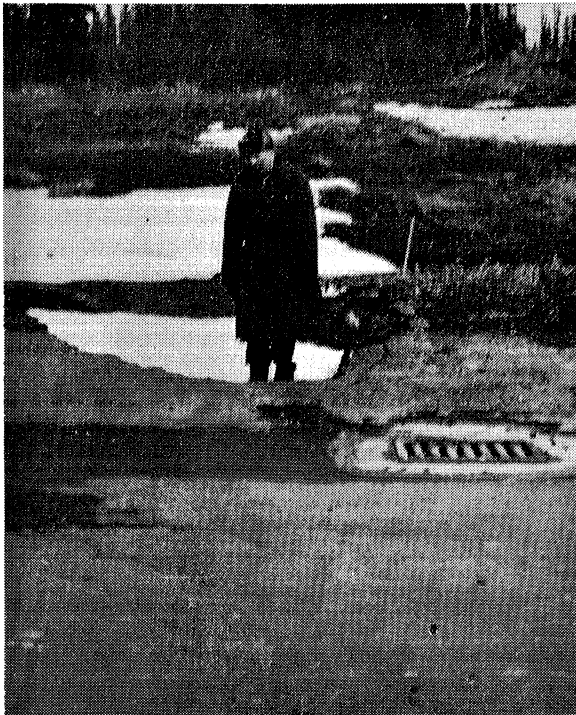
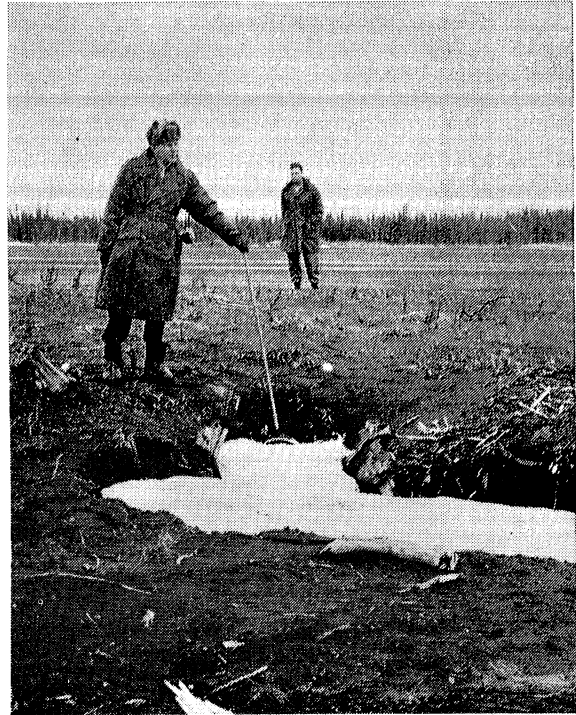
Drainage outfall structures are equipped with steam pipes to facilitate thawing.

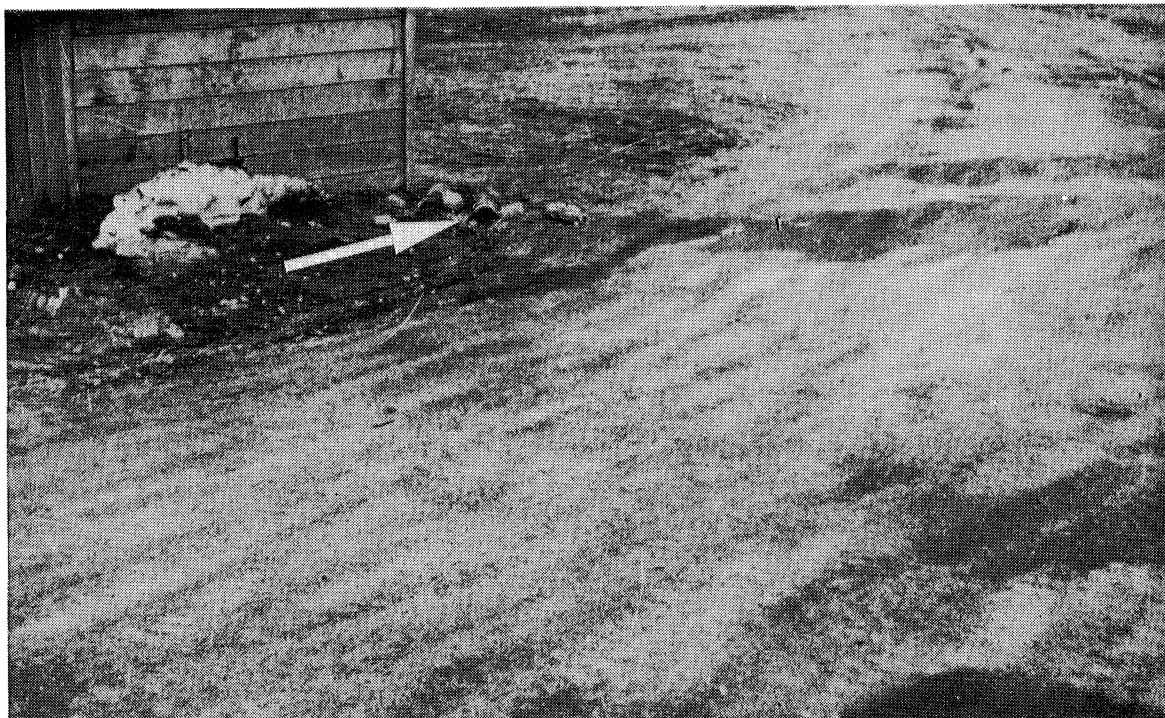
The 4-in. wooden pipe shown in the upper left part of the picture is the outlet to 10,000 sq ft of surface area.

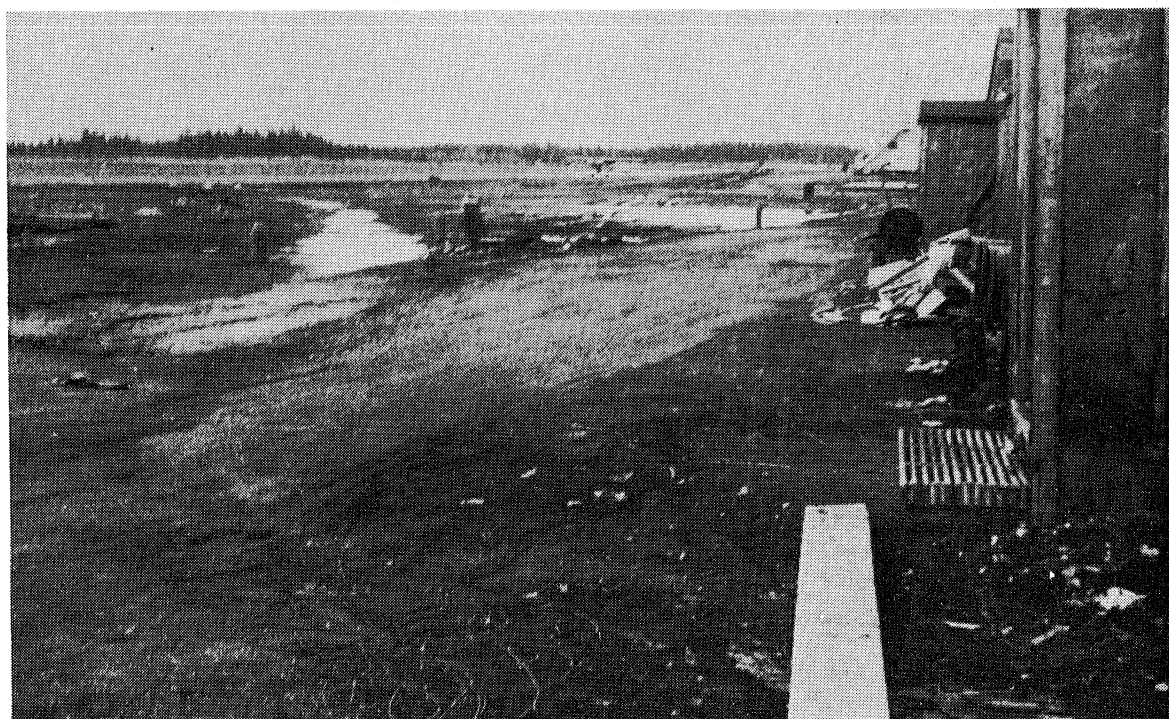
Plate No. 41 - Drainage Conditions at Northway

Wide, shallow drainage ditches in which heavy snow-moving equipment can operate are preferred in this area from a maintenance standpoint.

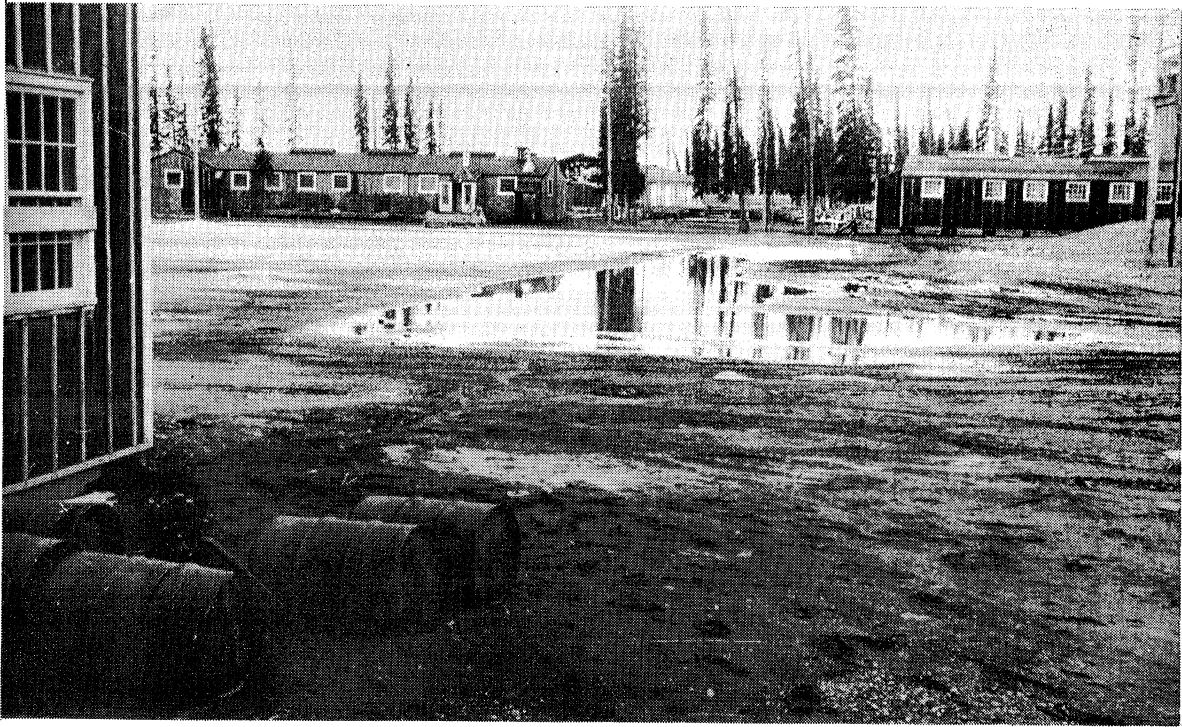
Areas where ponding can occur are not recommended for arctic and subarctic regions.

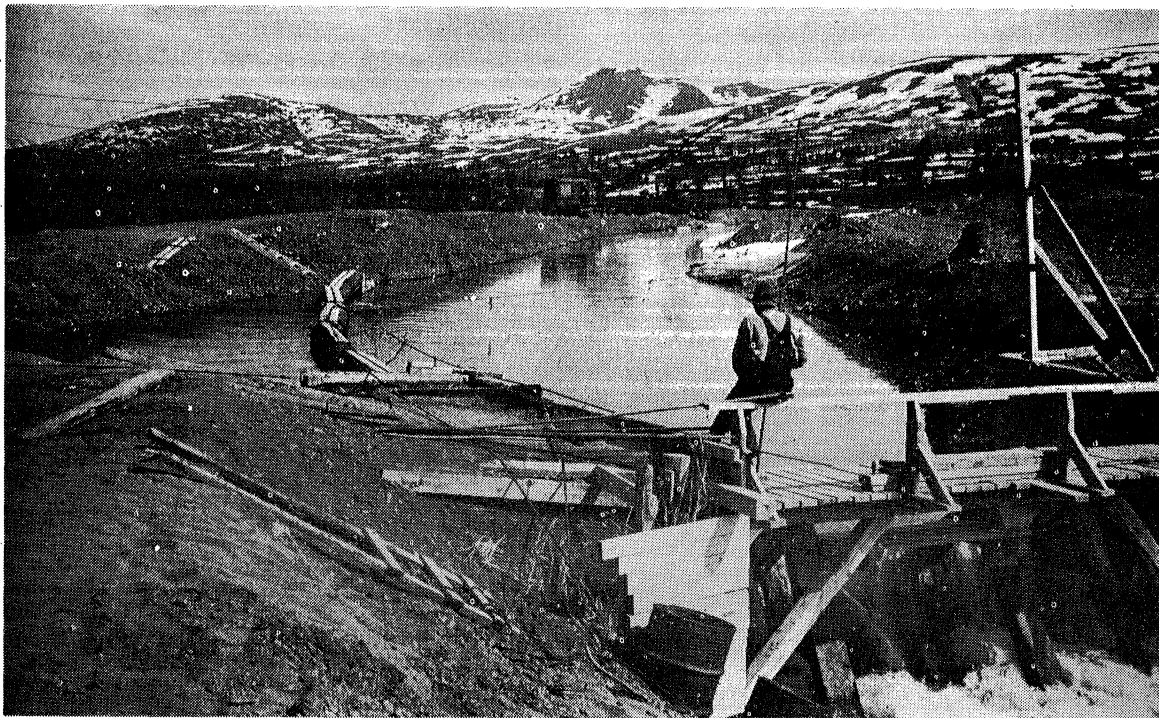
In the spring of each year a dragline operating 24 hours per day is engaged to remove large cakes of floating ice from the diversion channel.

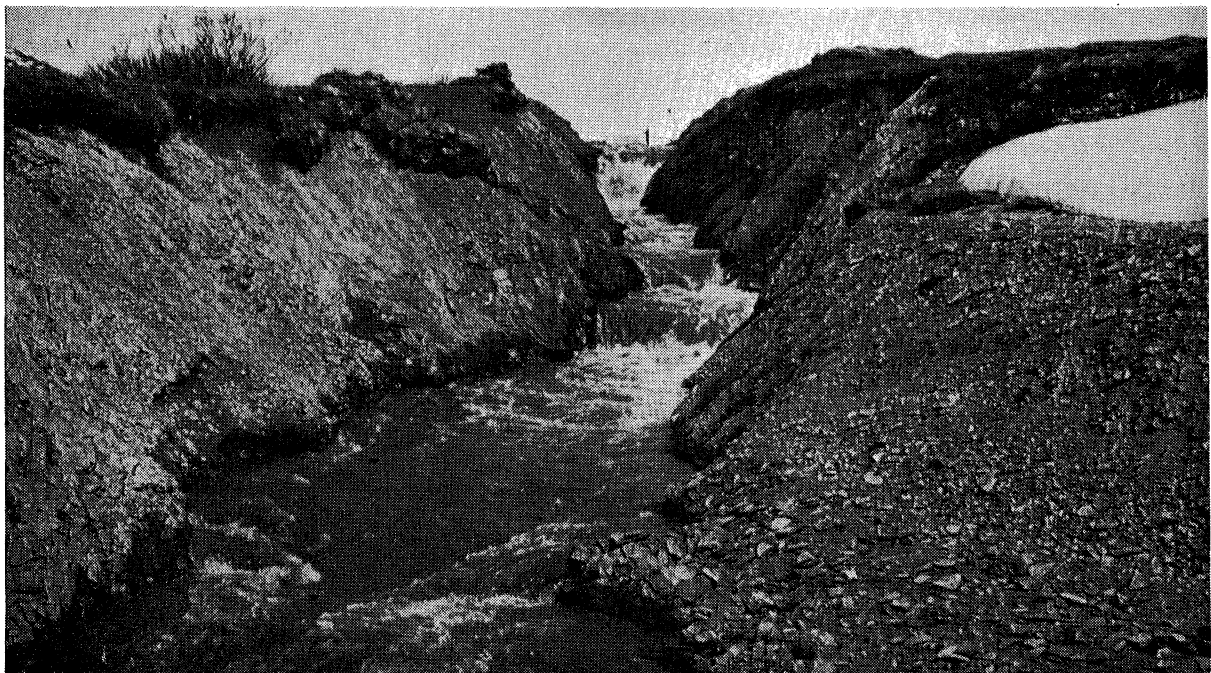
Plate No.46-Diversion Channel Outlet at Nyac

Two-thirds of the channel flow is diverted in order to carry away large volumes of floating ice.

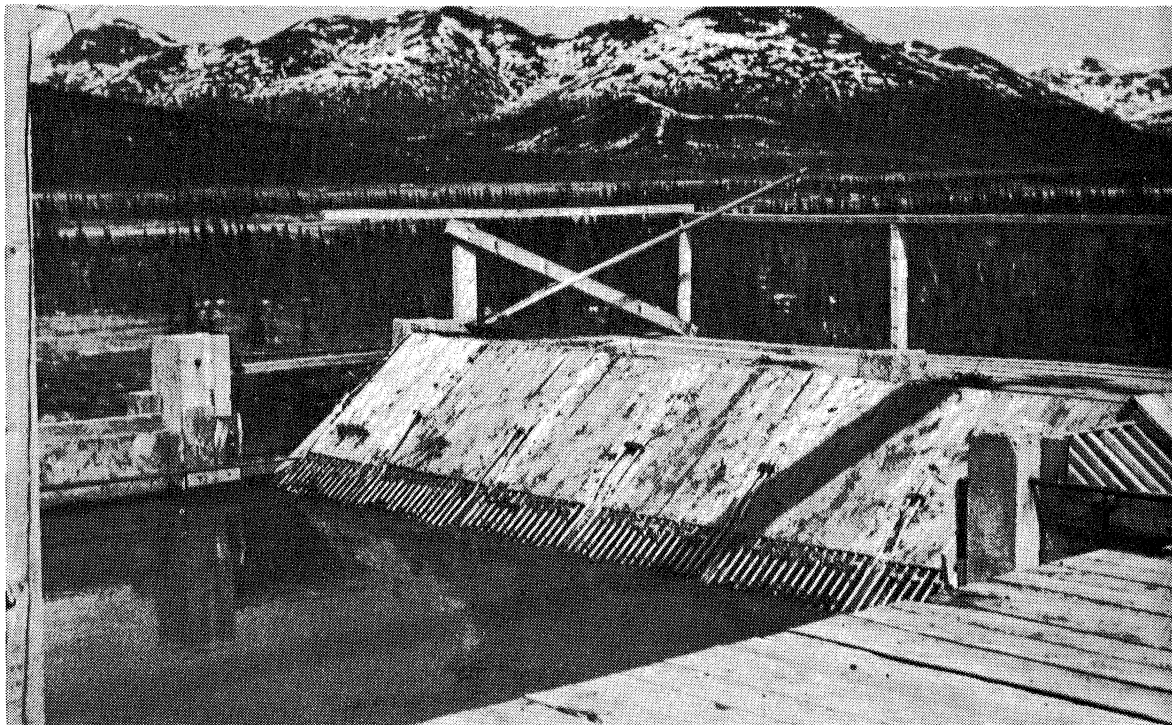
Plate No.47-Intake to the Penstock at the Nyc Power Plant

This heating element melts ice that would otherwise clog the inlet grating.

guide large ice cakes through the gate sections or to connect a 300-amp arc welder to a specially designed grating in case clogging of it by needle or frazil ice becomes imminent (photographs of Plate 47). Mr. Crowdy pointed out that only after considerable experimentation was it possible to determine such things as rate of diversion, heating required for the intake grating, and overall maintenance technique.

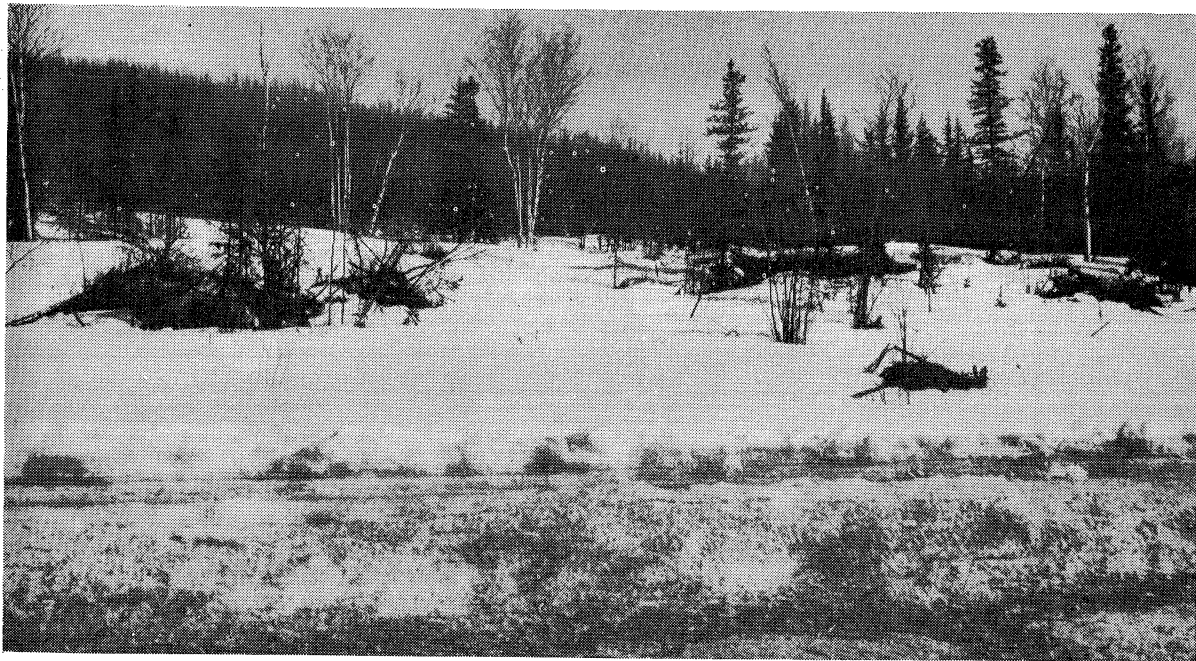
Plate No.52 - Surface Icing on Richardson Highway

A short distance upstream from the ice-covered highway many leaning trees were noted.

94. Description. The Richardson Highway from Fairbanks to Big Delta traverses a distance of 91 miles. In general, it follows the wide valley of the Tanana River. It is fairly straight except for relatively short stretches where it is necessary to either climb over ridges or follow the base of some bluff. During the trip of May 5, the roadway was in good shape despite inadequate maintenance. Of the entire 91 miles, the first 20-mile stretch between Fairbanks and Eielson Air Force Base was in the poorest condition. This was due, no doubt, to the heavier and greater traffic to which it had been subjected. At one section there was evidence of icing (photographs on Plate 52). About 800 ft of highway had been covered with ice to depths of from 2 to 4 ft.

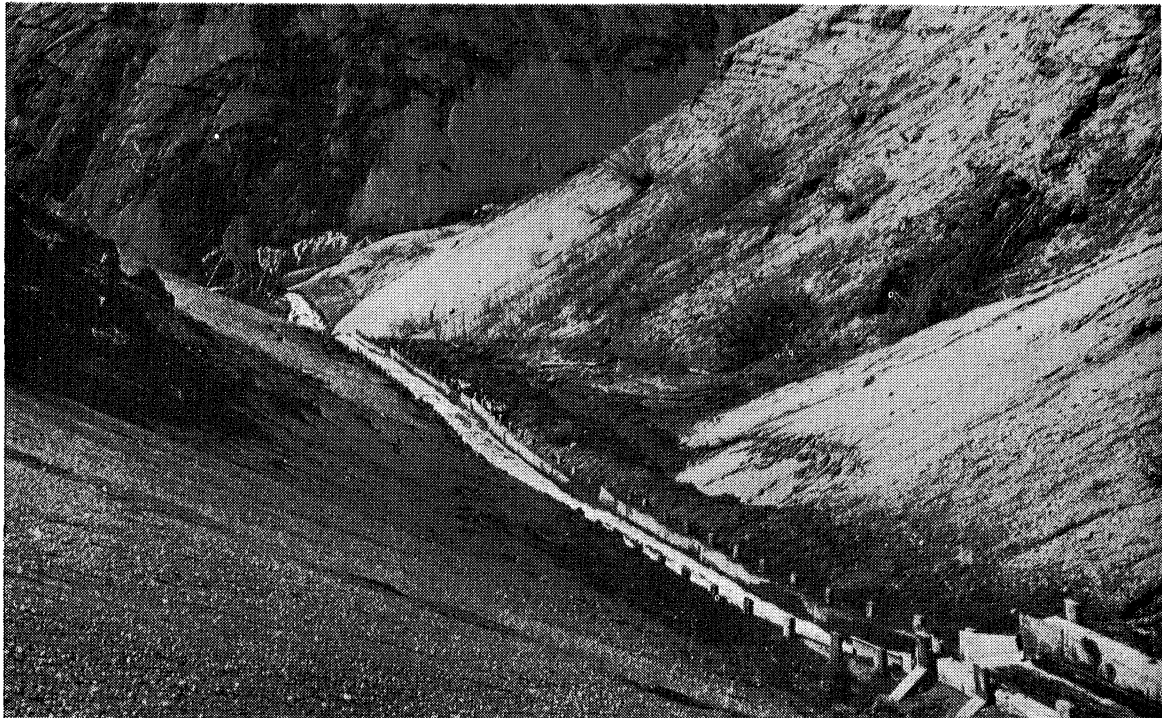
To stop erosion in this gully it was necessary to construct a long timber flume.

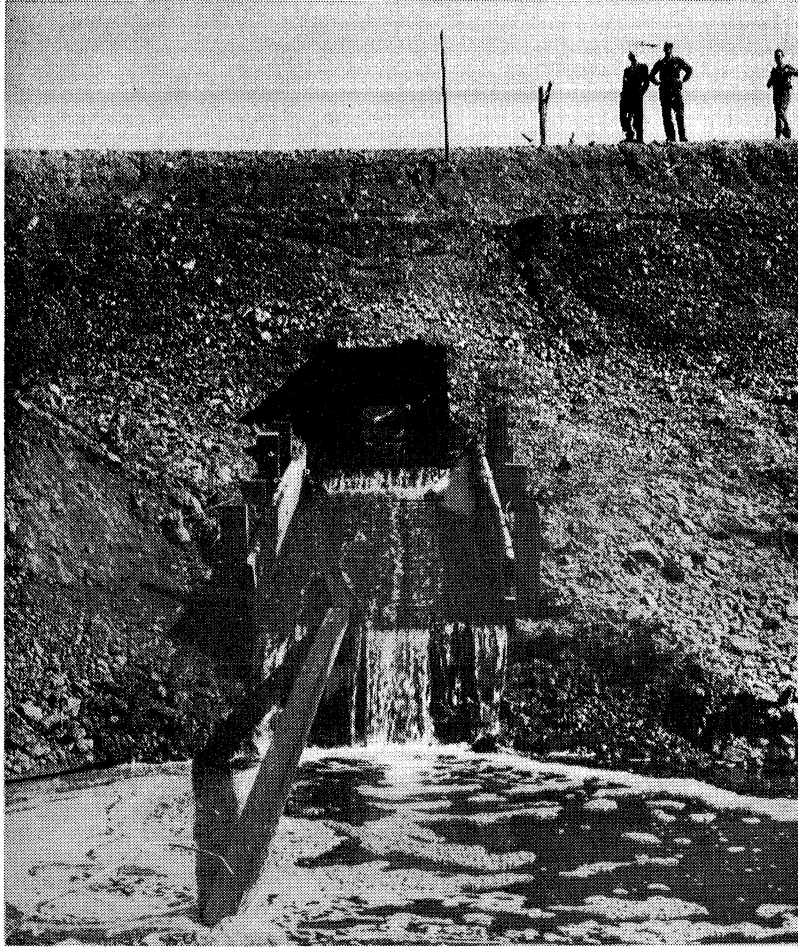
Timber box culvert near Northway.

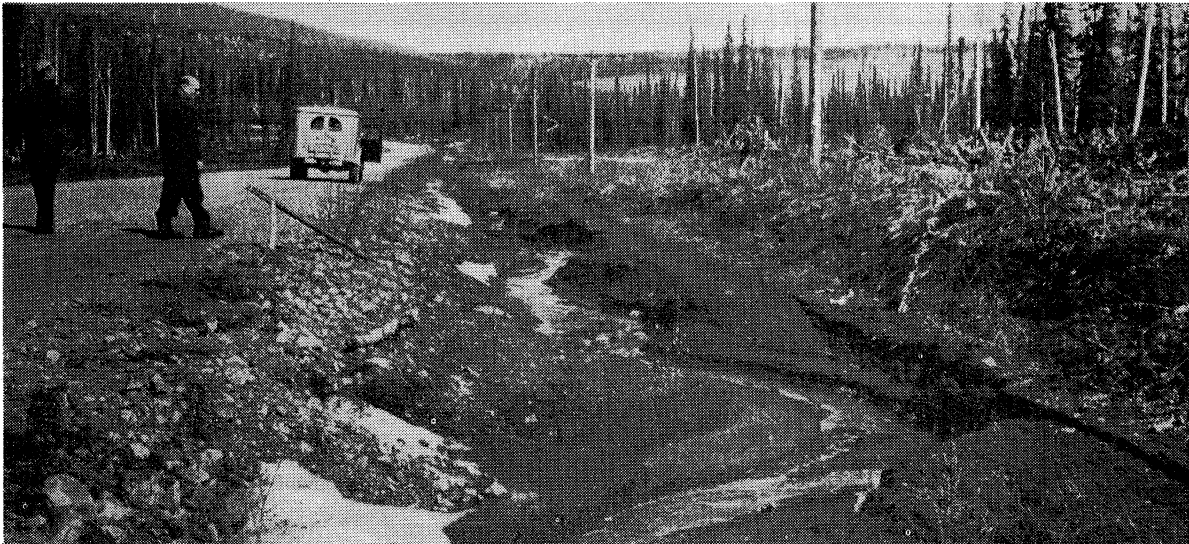
Plate No.56 - Drainage Facilities on the Alaska Highway

Erosion of highway ditches was quite severe in the section near Northway.

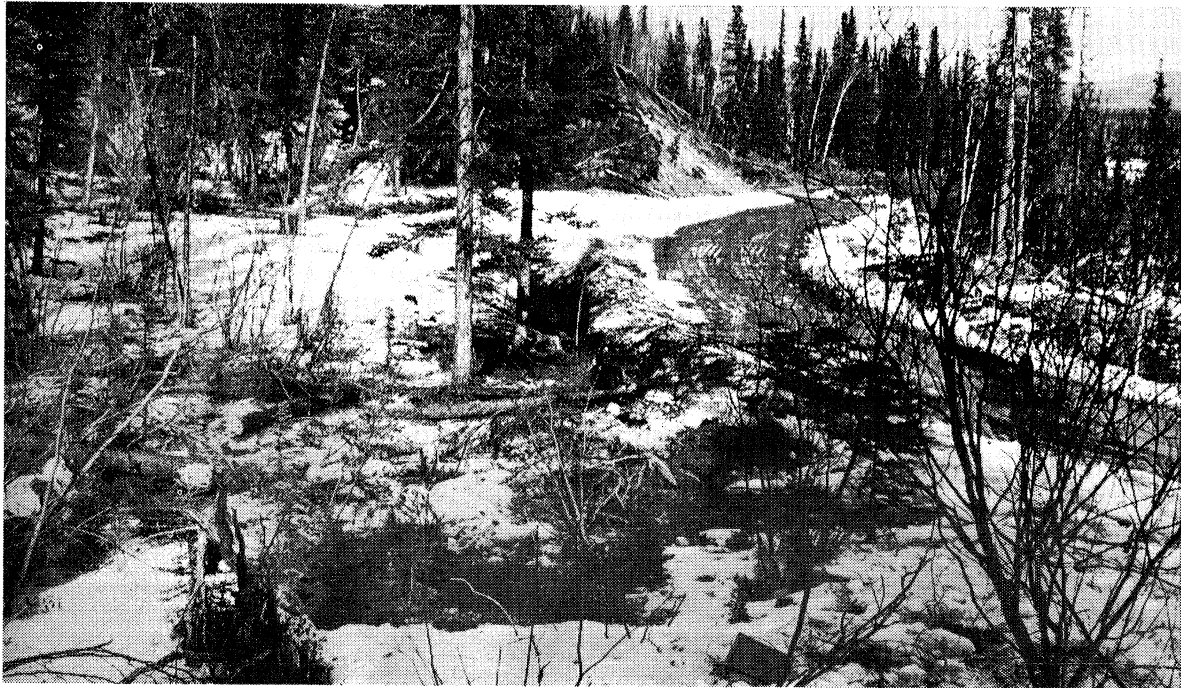
At this location it was necessary to provide drainage by blasting a channel through the ice.

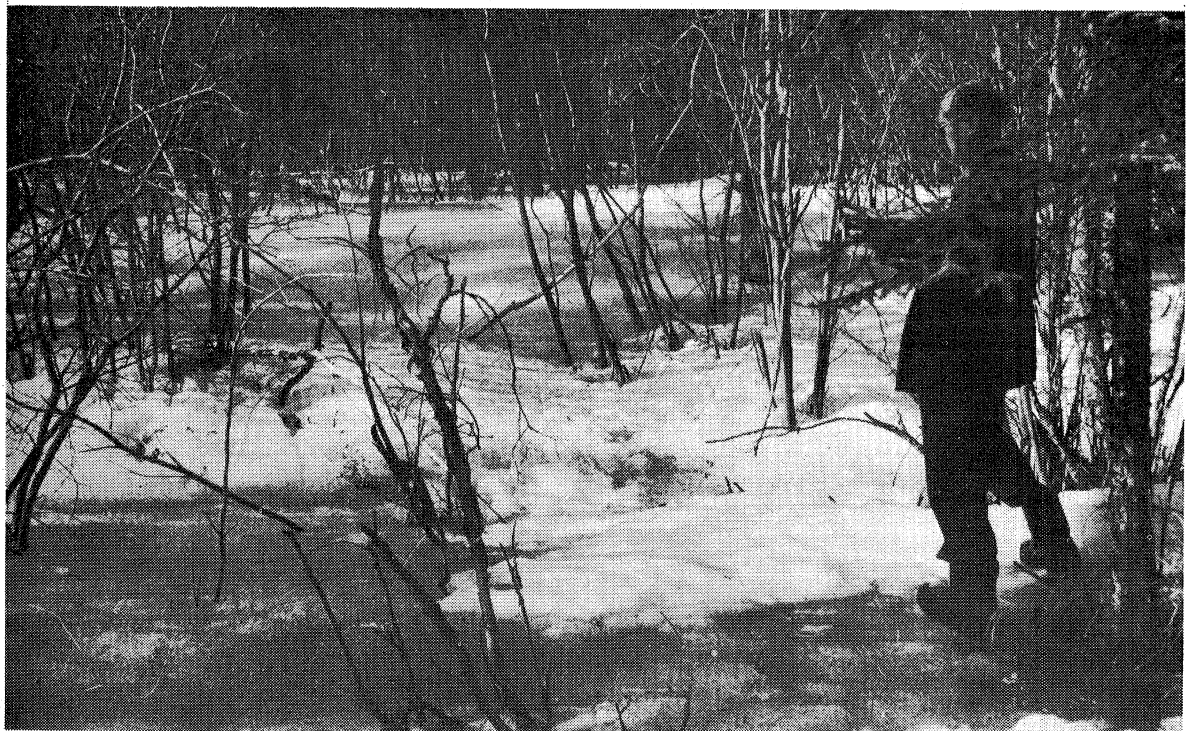
Plate No.58 - Surface Icing on Tok Highway

The icing 600 ft upstream from the road was nearly 6 ft thick.

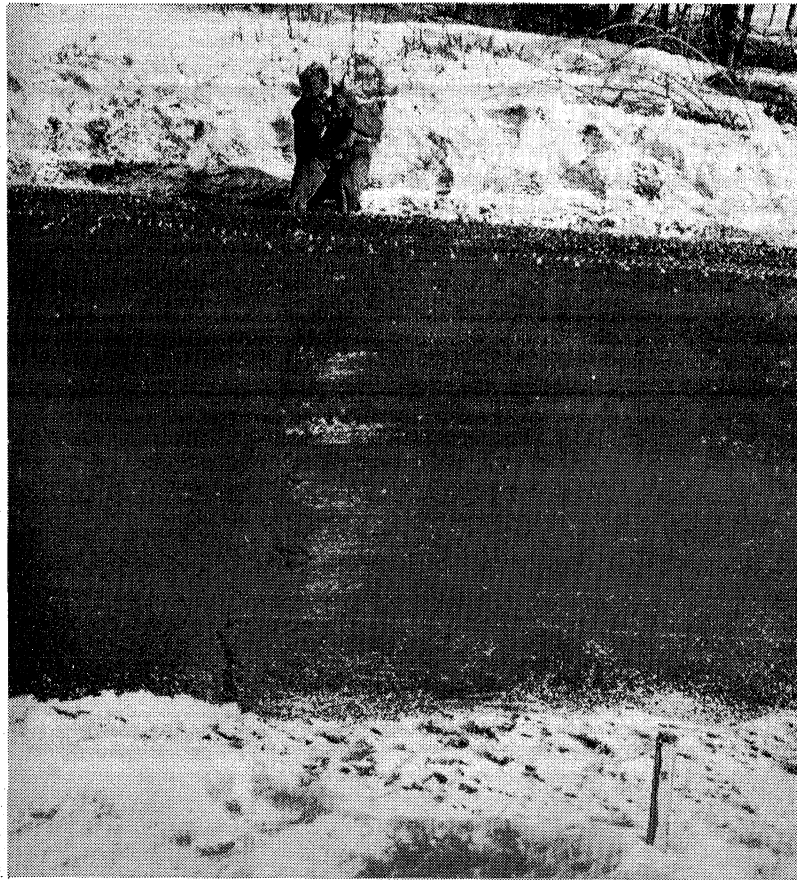
Large transverse cracks similar to the one indicated in the photograph were noted at many culvert locations on the Steese Highway.

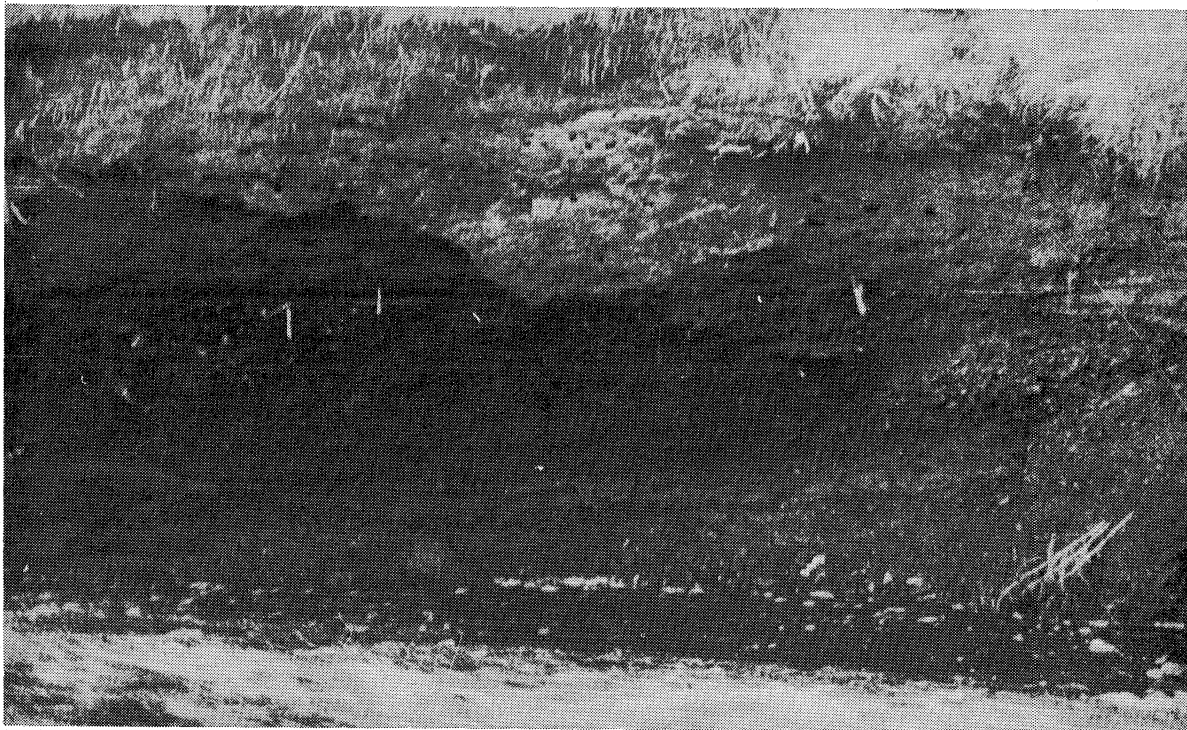
A soil profile at an eroded stream bank near Fox indicates many layers of varied texture.

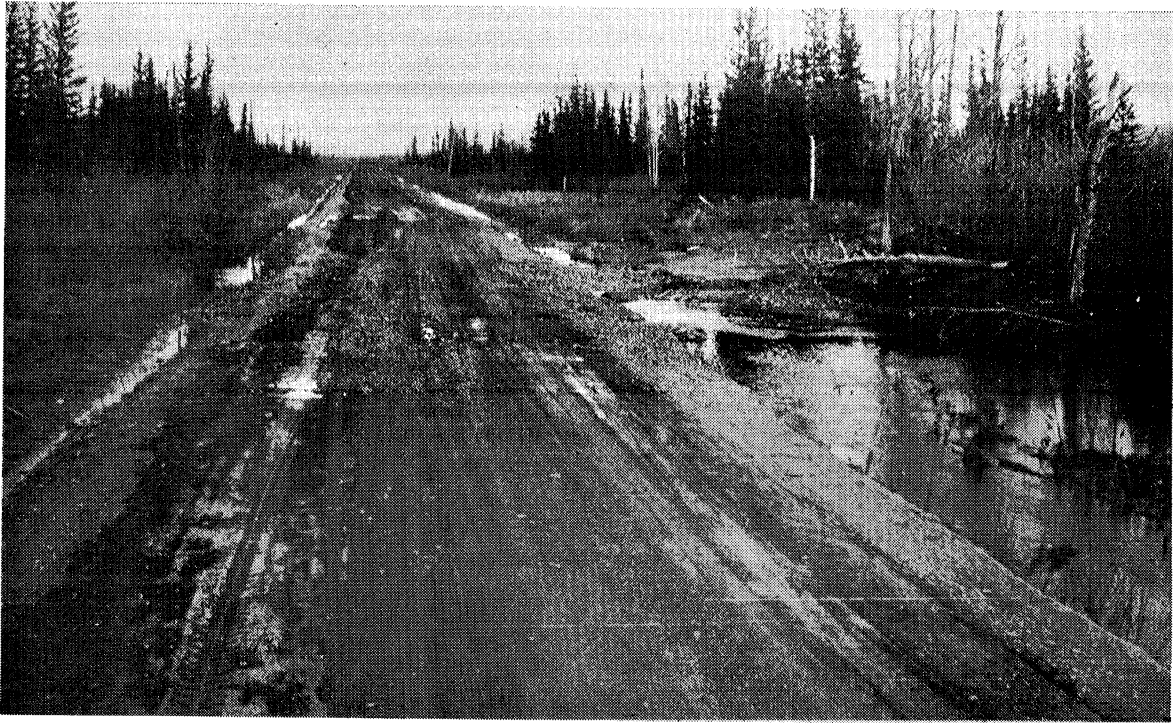
A 10-hour duration rain of May 23, 1948 resulted in considerable damage to roads.

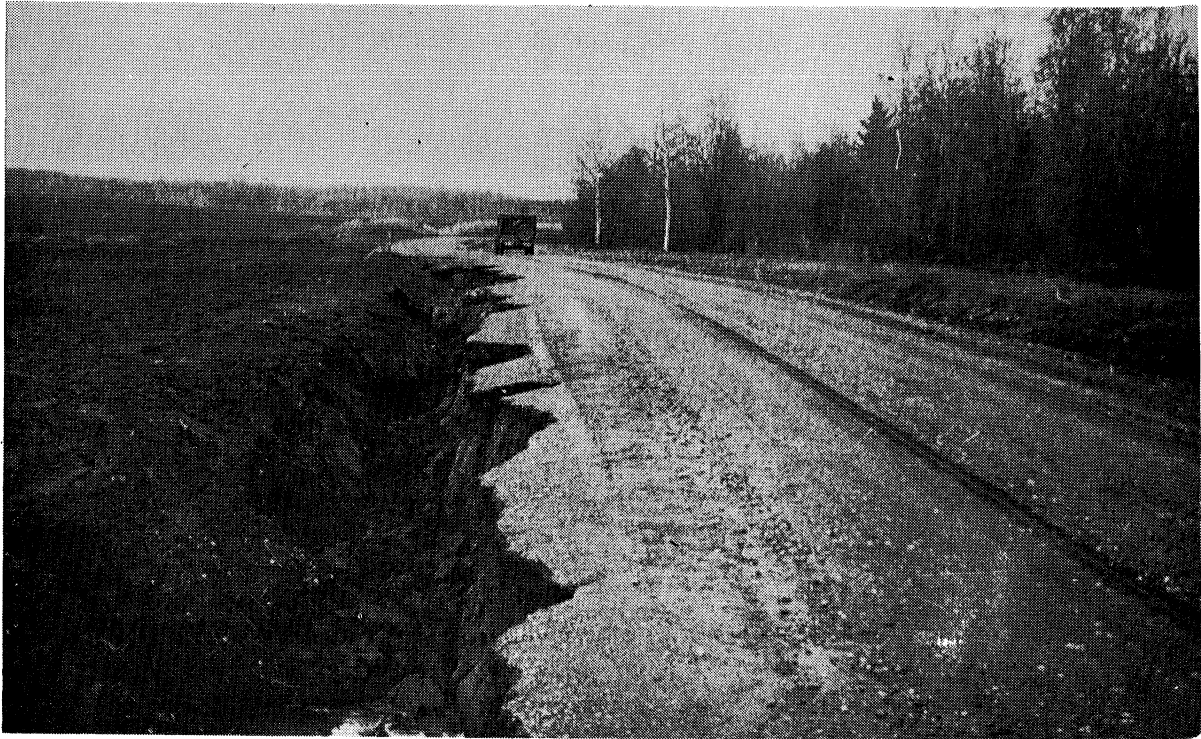
This gully resulted even though the ground was frozen.

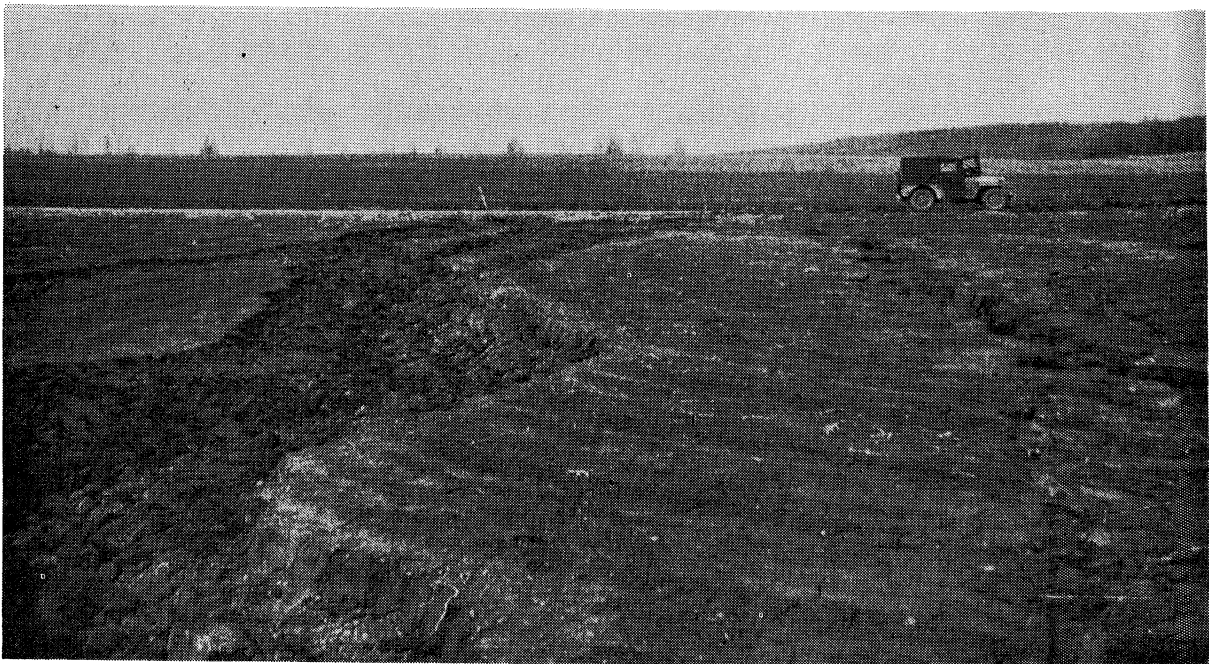
Plate No.62 - Erosion near Fairbanks, Alaska

Runoff from a small agricultural area resulted in the erosion illustrated by the above picture. The entire discharge passed through a 10 in. x 10 in. timber culvert.
