Performance Assessment of Oversized Culverts to Accommodate Fish Passage

Minnesota
Department of
Transportation

John Nieber, Principal Investigator
Department of Bioproducts and Biosystems Engineering
University of Minnesota

Research Project
Final Report 2011-19

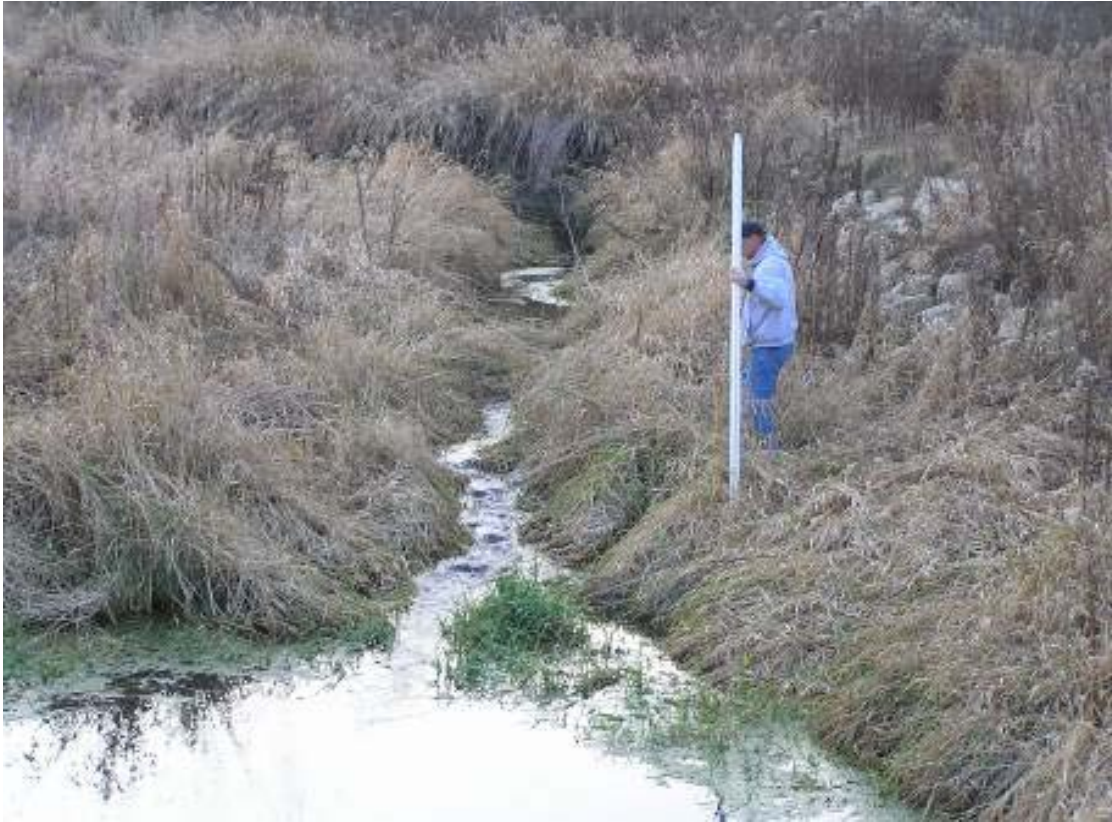
Figure 5.1. Photograph of rip-rap placed at upstream end of the pool to prevent the formation of a head cut developing from the recessed culvert installation.

The need to protect this elevation drop created during installation of the recessed culvert was well represented in the field. The field surveys documented head cutting mitigation efforts at all but two of the recessed study sites. No evidence of head cuts moving upstream from a recessed culvert installation was observed at any of the seventeen study sites where rock had been put in place. At the two sites where no rock had been placed no head cuts had developed at the time of

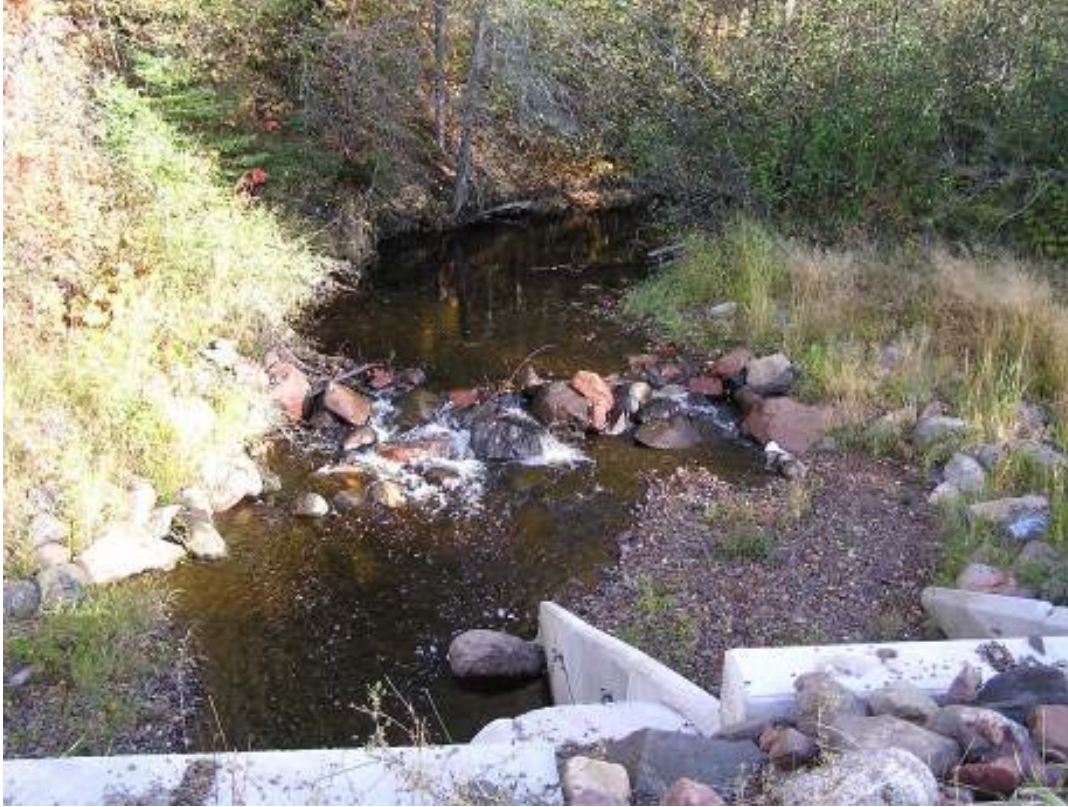
Figure 5.2. Photograph of rock placed in the channel immediately above the culvert to protect against head cut development.

the survey. All mitigation study sites featured some form of rock weir or immobile rip-rap placed in the channel to serve as grade control and protect against the possibility of a head cut. Two different configurations were observed. At culvert sites with pools both upstream and downstream of the culvert, rock is placed where the channel enters the upstream pool and where the channel exits the downstream pool (Figure 5.1). At sites where the stream channel flows directly into the culvert, the rock is placed just upstream of the culvert entrance (Figure 5.2).

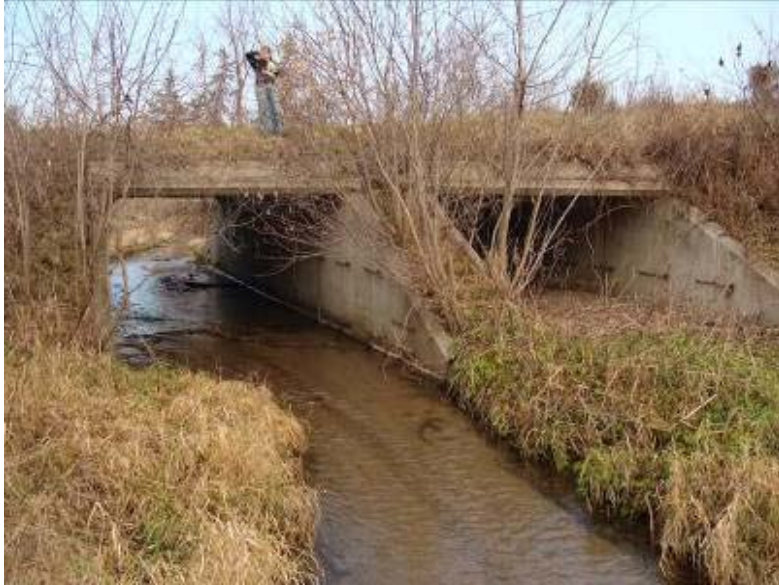
Figure 5.3. Photograph showing a highly mobile sand bed at Gorman Creek. Note the side culvert filled in with sediment (Goodhue County).

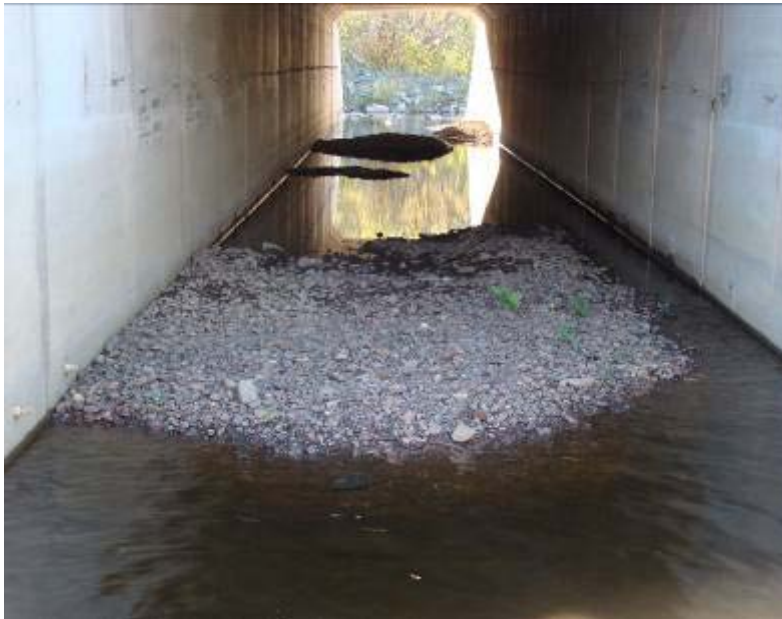
Figure 5.4. Photograph showing gravel and small cobble accumulating in the side barrel at Beaver River site (St. Louis County).
