***ULTRASONIC LINEAR ARRAY EVALUATION
OF CONCRETE PAVEMENTS***

A DISSERTATION
SUBMITTED TO THE FACULTY OF THE GRADUATE SCHOOL
OF THE UNIVERSITY OF MINNESOTA
BY

June 2013

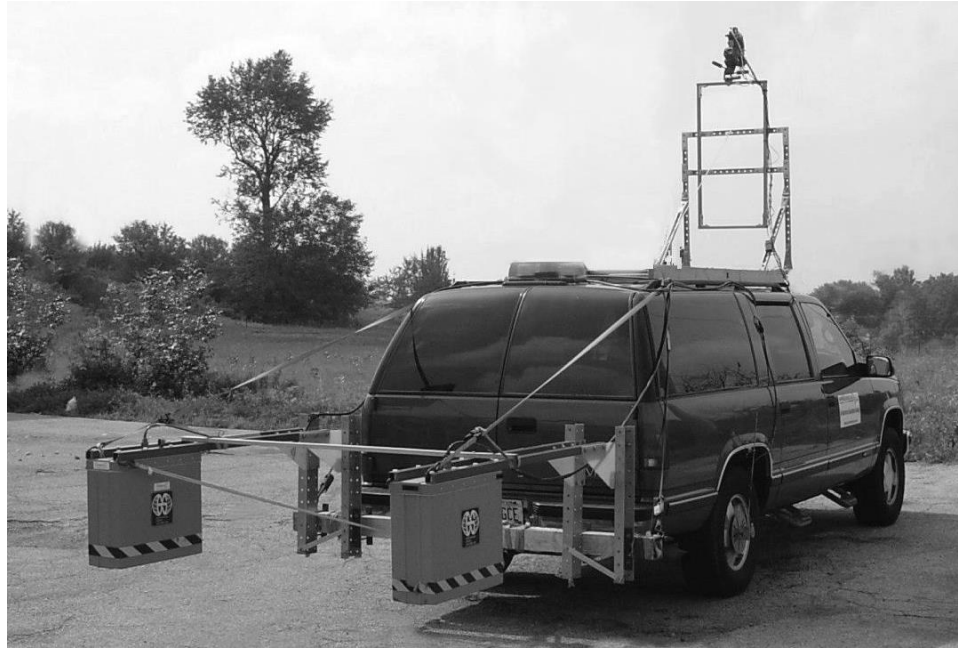
Figure 2-2. Air coupled GPR mounted on a van for highway speed measurements (Maser, 2000).

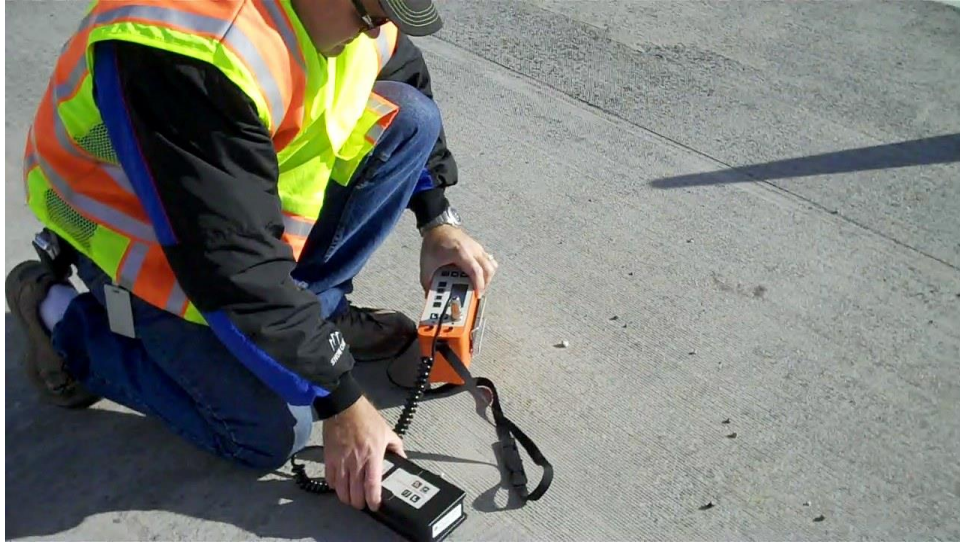
Figure 2-4. Example eddy current magnetic based device (pachometer).

Magnetic pulse-induction and the distribution of the eddy current induced by an applied magnetic field can be used to determine the position, size, shape, and orientation of metal inclusions in a pavement. Figure 2.4 shows an example measurement with a pachometer which is a conventional eddy current based method. Numerous evaluations of the accuracy of one magnetic pulse-induction device, the MIT Scan-2, have shown it to be a reliable tool for locating metal inclusions with high accuracy (Hoegh et al., 2008; Hossain et al., 2006). However, if either the dimensions or metal properties are not known it is difficult to determine the location of the subsurface inclusion. It should be noted that this method does not detect any type of non-metallic inclusions or defects (Rao et al., 2009).

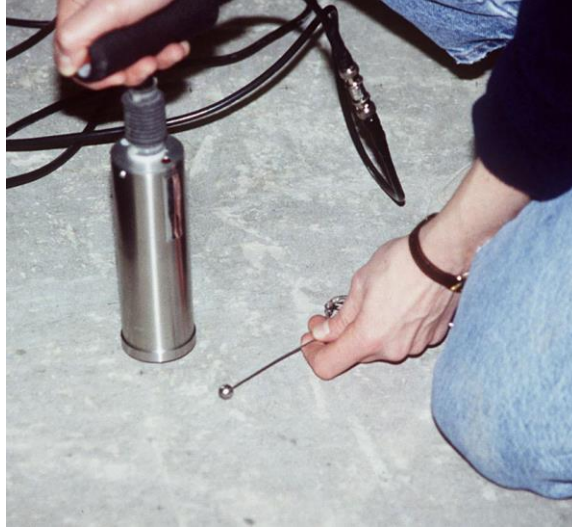
Figure 2-8. Impact echo setup with a steel ball mounted on a steel spring rod (Carino, 2001).

Figure 2.8 shows a conventional impact echo setup where a round metal ball is used to create the impact (Carino, 2001; Sansalone, 2007). IE is capable of detecting planar layer interfaces, which can be used for thickness determination or the detection of other plate-like inclusions. Testing with this method can be time consuming and only allows for one signal pair to be sent and received per scan. With only one mechanical impact signal and spectral analysis methods that require multiple reflections at the same boundary, there are difficulties in evaluating the complex geometries required for irregular flaw detection (Carino, 2001; Schubert, 2008; Schubert, 2003). Novel evaluation techniques and hardware such as air coupled impact echo have been developed to allow for more productive measurements and multiple measurement pairs (Borwick, 1990; Buckley, 1999; Popovics, 2012; Zhu et al., 2002; Zhu et al., 2007).

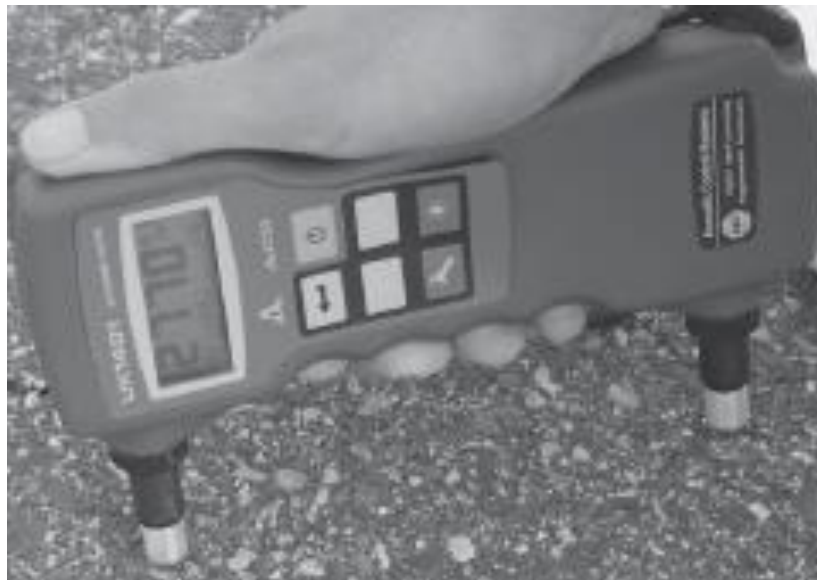
Figure 2-11. UK1401 ultrasonic pulse velocity device (Khazanovich et al., 2005).

These issues can be resolved with the use of DPC transducers, similar to the UPV device shown in Figure 2.11, which eliminate the need for a manual mechanical impact. This allows for transducer arrays with multiple angles of transmission and reception that can be used to also address some of the reliability issues dealing with conventional impact echo discussed previously (Shubert et al., 2008). This arrangement allows the transducer spacing to be reduced for higher precision measurements. Two versions of DPC ultrasonic array technology are shown in figures 2.13 and 2.14. The A1220, shown in figure 2.13, consists of sets of 12 emitting transducers and 12 receiving transducers. MIRA, shown in figure 2.14, consists of a linear array of 40 sending and receiving transducers arranged in 10 channels of 4 transducers.

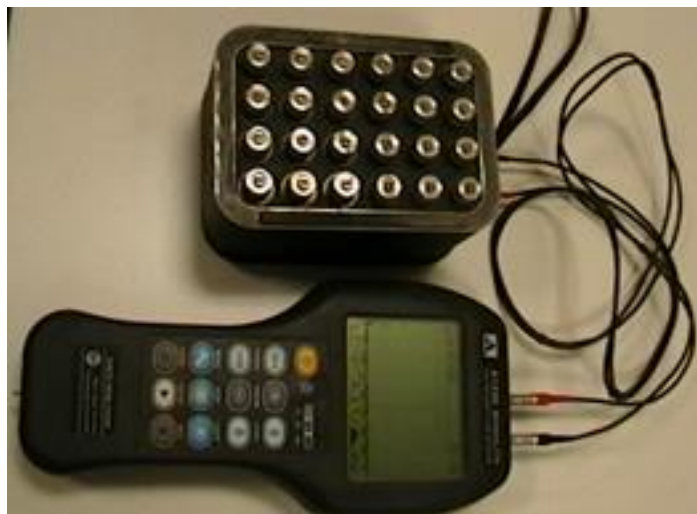
Figure 2-13. A1220 ultrasonic pulse-echo device.

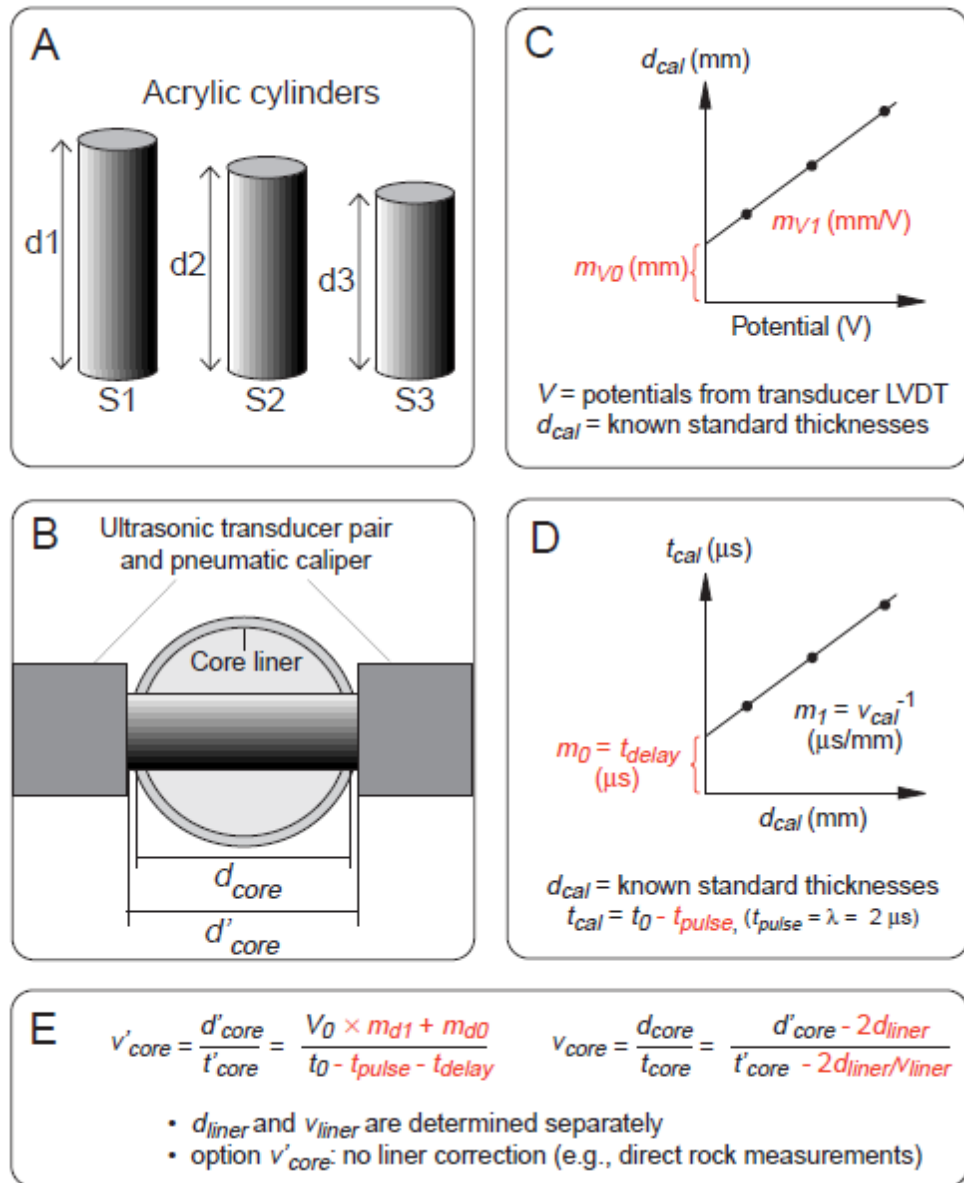
Figure 2-25. Deep sea core measurement procedure of estimating the delay related to electronic circuitry (Blum, 1997).

To resolve the issues listed above, it is especially important to have detailed information on the process of signal generation and rigorous methods of determining the undifferentiable delay related to the transducer faces and electronic circuitry. Alternatively, the total system delay can be accounted for without identifying each separate factor by introducing multiple measurements. For instance, the delay from peak detection can be assumed to be constant and subtracted from the total time measurement. In the case of deep sea cores, measurements of physical standard distances with least squares regression can be used to estimate the hardware delay as shown in figure 2.25 (Blum, 1997).

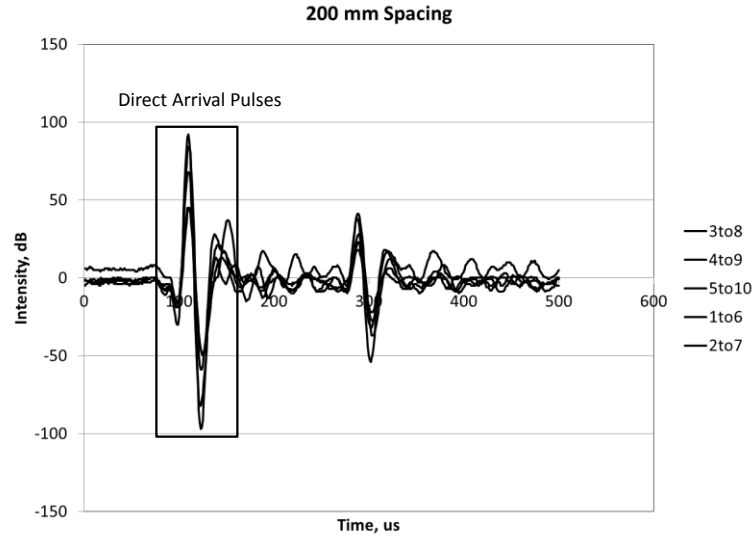
Figure 2-26. Example direct arrival pulses for five 200 mm spaced transducer channel pairs.

Figure 2.26 shows the results of 5 sending and receiving transducer pairs from an example measurement with MIRA on a typical concrete pavement. Although the position of each of the transducer pairs is slightly different, they are all spaced at 200 mm apart. It can be observed that although the amplitude of each signal can be variable, each pulse arrival shape and arrival time is repeatable. This illustrates the capability of using this system arrangement and direct arrivals of each transmitted shear wave near the surface to calculate the shear wave velocity.

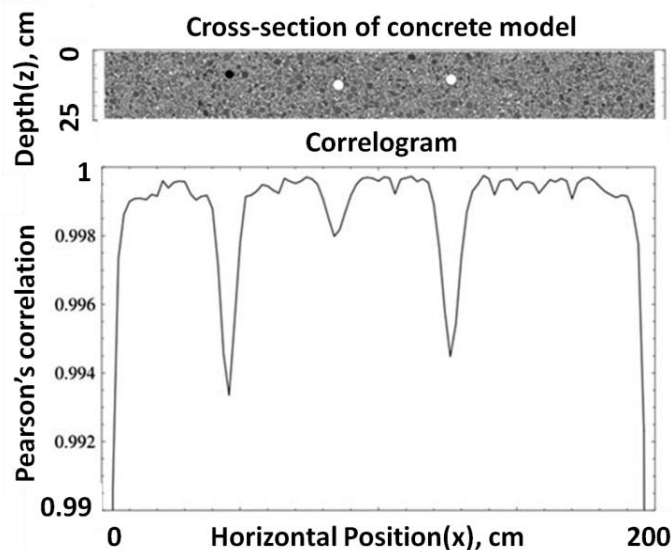
Figure 2-29. Example of an impact-echo correlogram based on Pearson’s Correlation Coefficient (Schubert et al., 2001).

In this method, a correlogram can be constructed of the correlation coefficients associated with each measurement location. By quantifying the similarity of the signal at each location with a reference acoustic signature representing a “damage-free” position, areas with low correlation coefficients would indicate the presence of scatterers. Through analysis of numerically simulated and laboratory test data, Schubert and Koehler concluded that the IESA method is an ideal extension to traditional evaluation procedures based on stationary reflections or resonances by large planar flaws. Figure 2.29 shows an example correlogram, where a dip in Pearson’s correlation can be observed at the three simulated inclusions of a concrete plate.

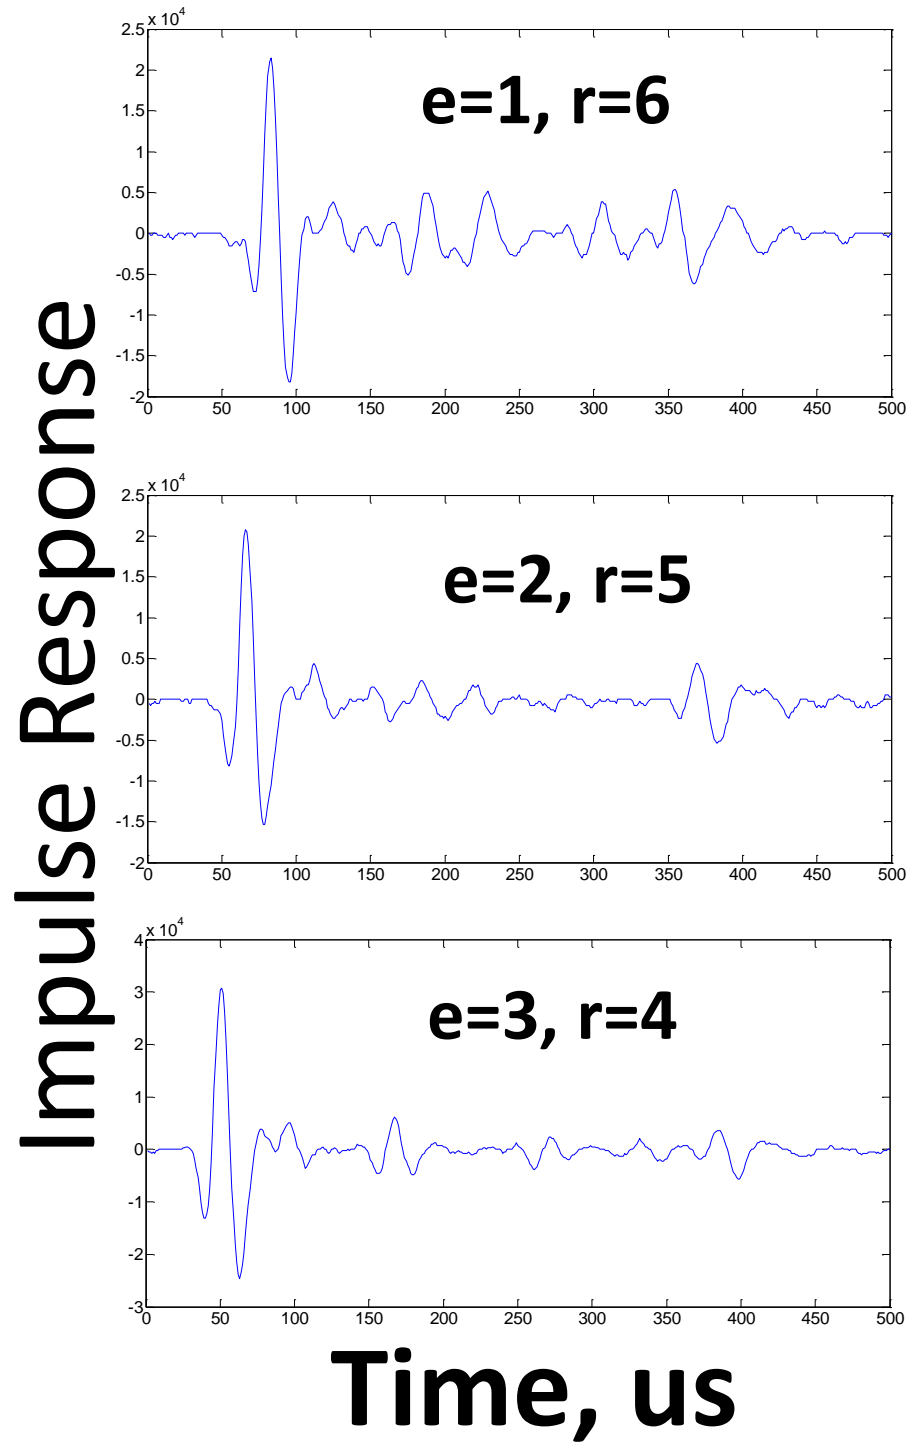
Figure 3-4. Example emitting-receiving pairs from a ultrasonic linear array scan.

Figure 3.4 shows 3 example impulse responses, $\Psi_{1,6}(t)$, $\Psi_{2,5}(t)$, $\Psi_{3,4}(t)$ of the total 45 emitting and receiving pairs comprising the example scan. It can be observed that there are peaks in amplitude at certain locations within the time histories in addition to the direct arrival positions. While these spikes in amplitude are associated with reflectivity within the ROI, such as reinforcements and layer boundaries, the location of the cause of these reflections are difficult to interpret.

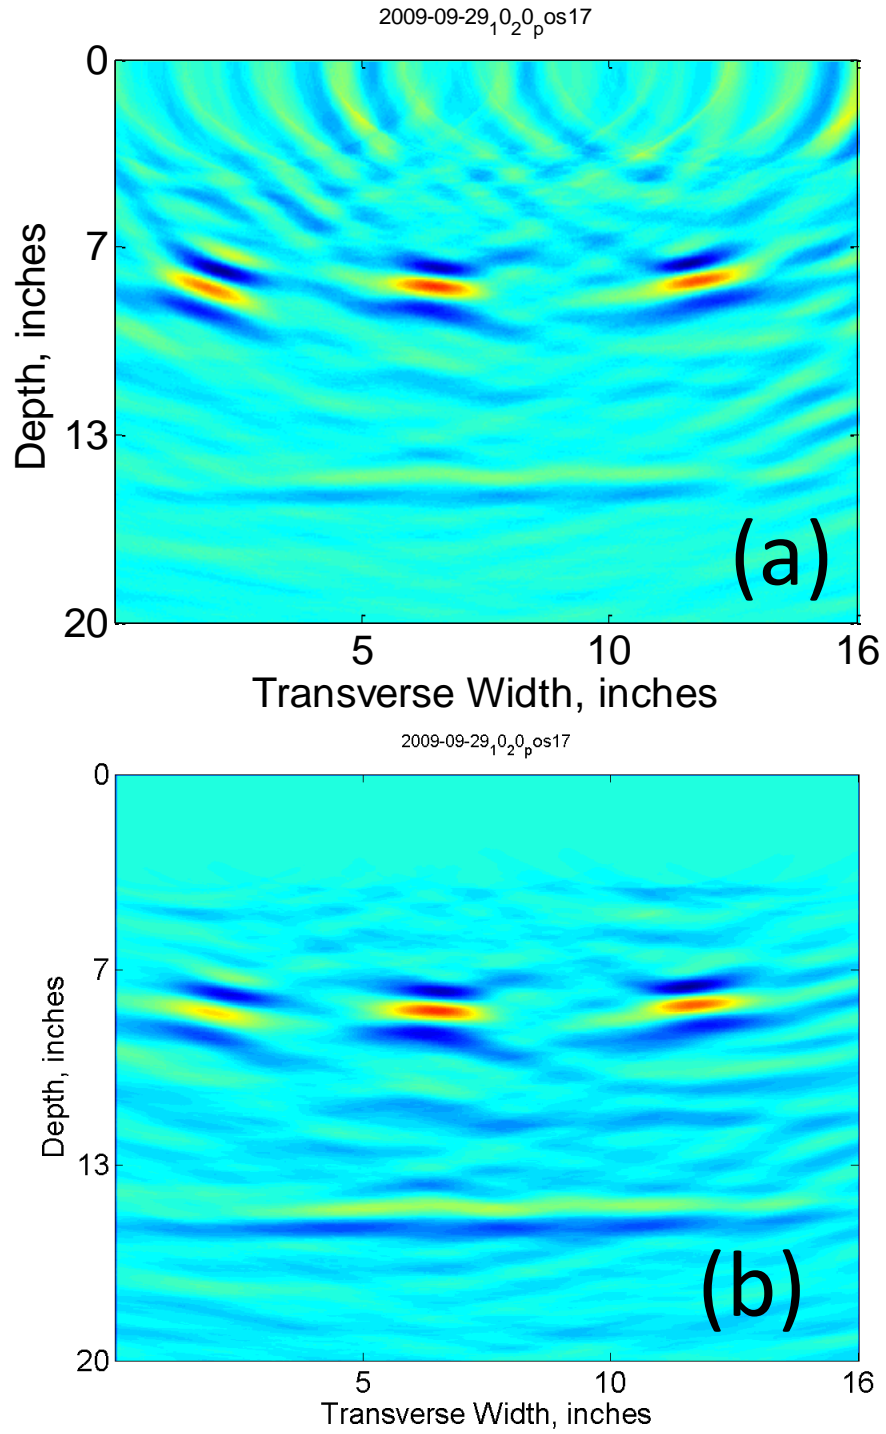
Figure 3-5. Example SAFT reconstruction with the apodization factor equal to (a) 1 and (b) defined by equation 3.7.

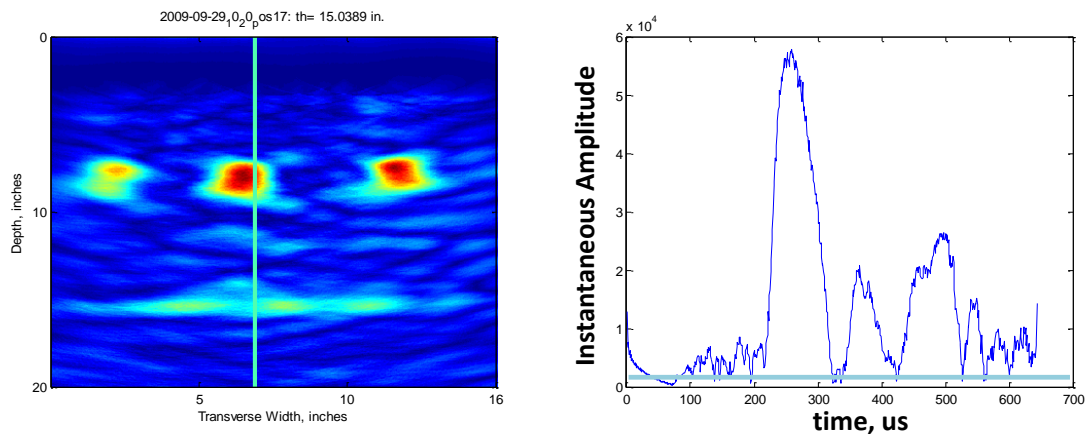
Figure 3-8 SAFT-IA reconstruction and example column data.

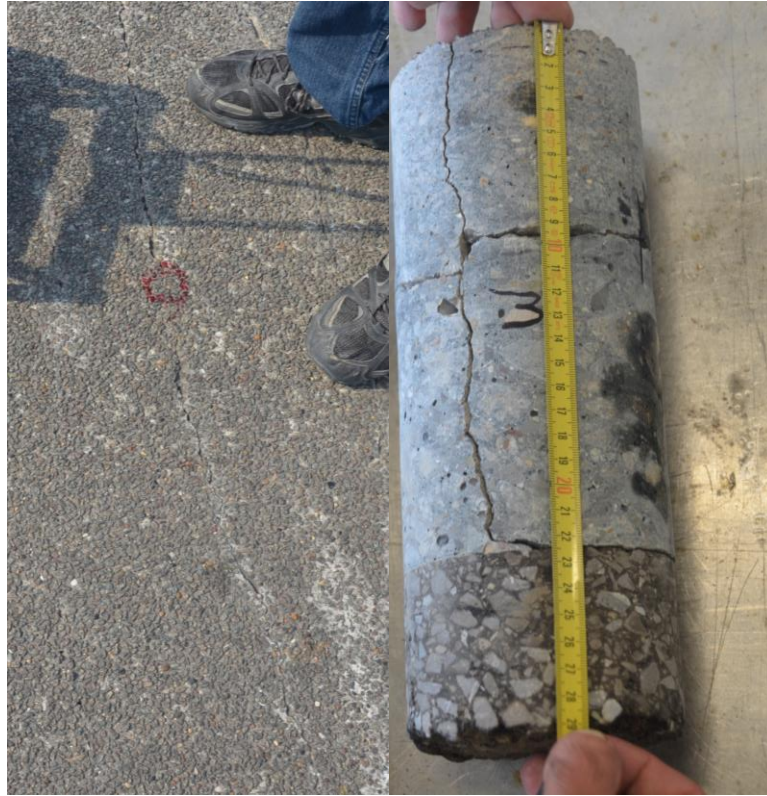
Figure 4-10. Forensic verification of the delaminated concrete condition with vertical crack.

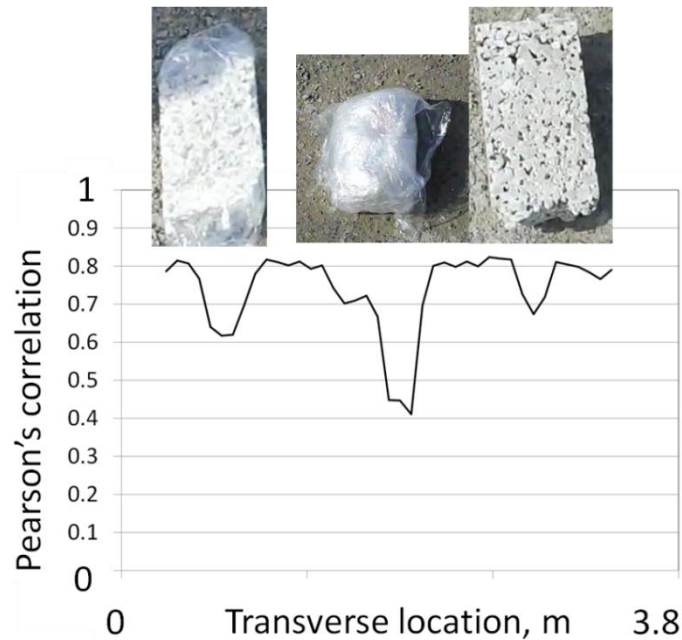
Figure 4-22. Correlograms from 41 adjacent measurements above the fabricated distresses using the averaged reference scan.

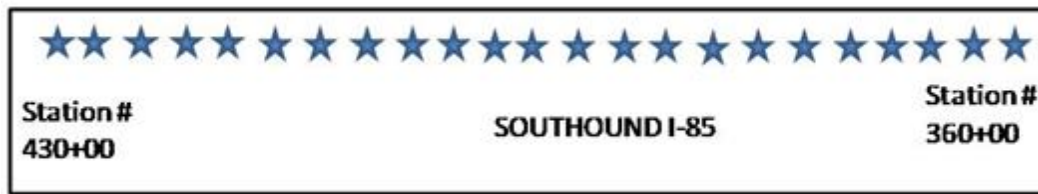
5.1b. Southbound shoulder general layout.

Figure 5-1. Illustration of the general layout of testing (not to scale/proportional).

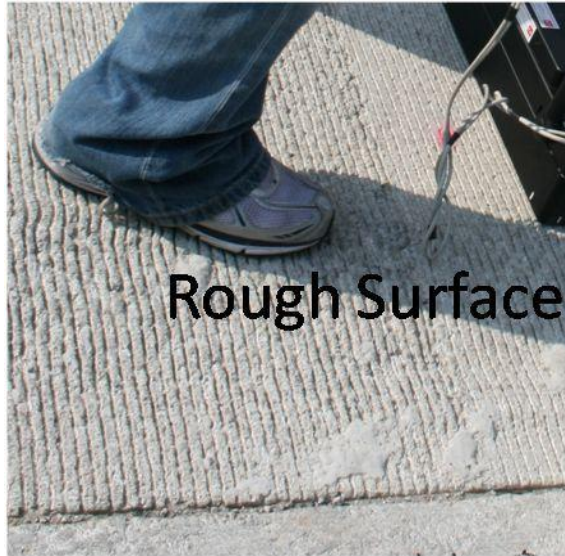
Figure 5-5. Example of a rough surface that required the device to be move to the left for proper coupling of the transducers.

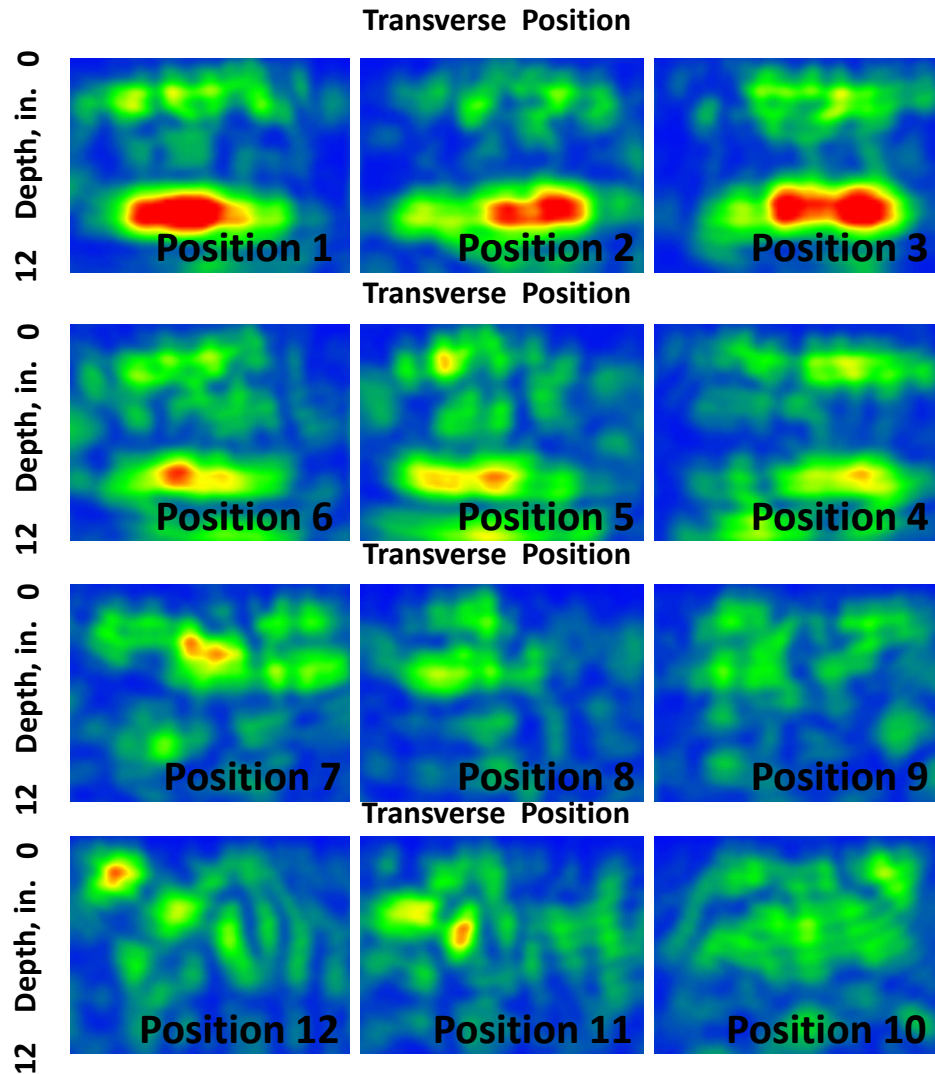
Figure 5-18. SAFT-IA reconstructions associated with the 12 MIRA scan positions shown above (depth of each scan: 300 mm).

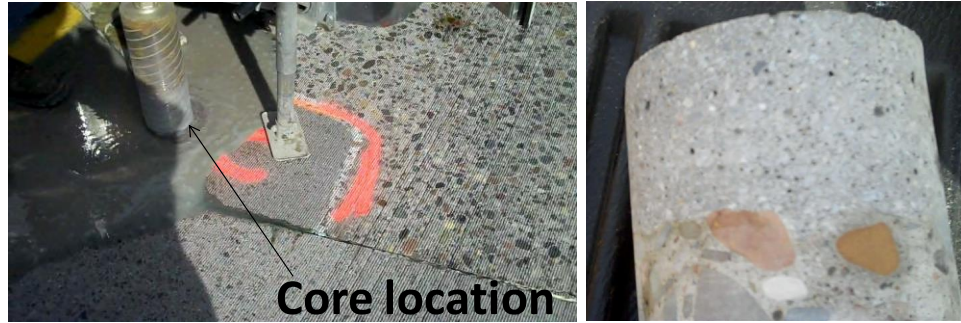
Figure 5-19. Core location (left) and result showing properly bonded partial depth repair.

A core was taken at a location within the partial depth repair (towards the fog line and away from the transverse joint) as shown in Figure 5.19. The core at this location showed a proper bond between the partial depth repair and the existing concrete upon inspection of the cross-section as shown in Figure 5.19 on the right. This core result confirmed the SAFT-IA reconstructions in this vicinity where a strong backwall reflection indicated a proper bond. This core did not agree with the chain drag results which showed general debonding of the partial depth repair.

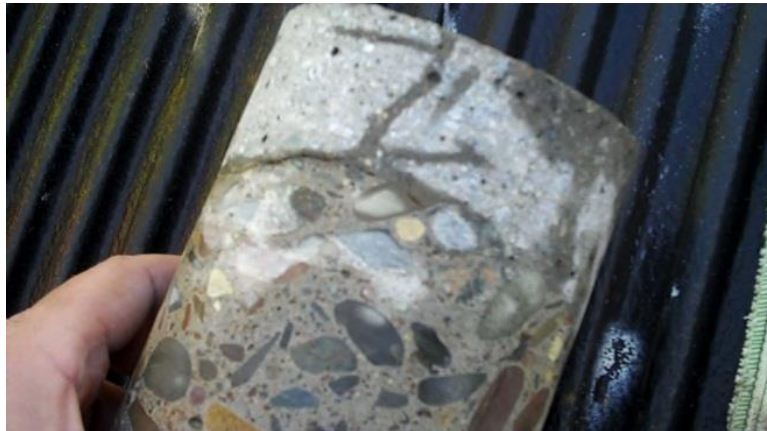
Figure 5-23. Core showing debonding of the partial depth repair.

A similar process was used to pinpoint a debonded location in other joint locations where SAFT-IA analysis indicated debonding. Another core verifying debonding of the partial depth repair as indicated by SAFT-IA diagnosis is shown in Figure 5.23.

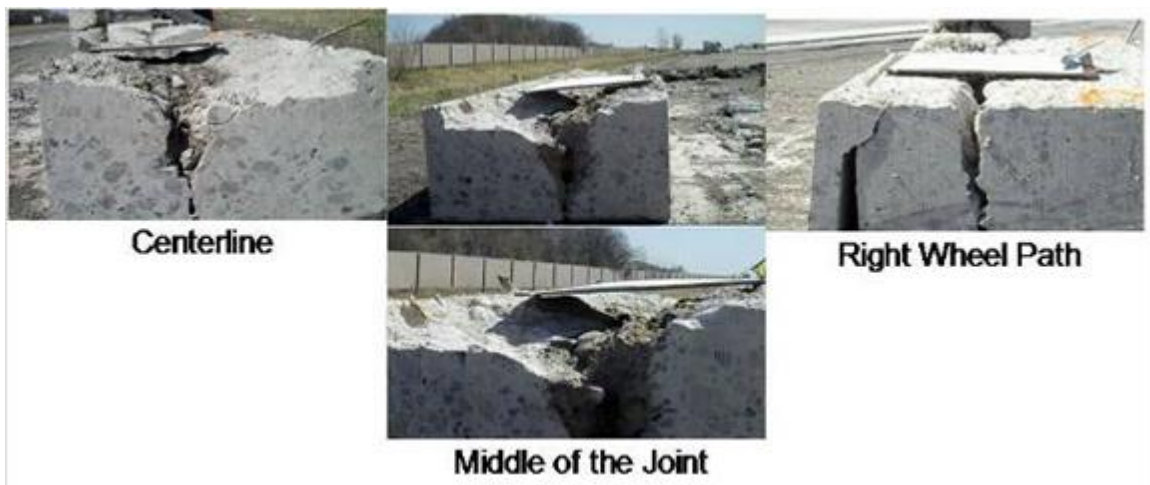
Figure 5-25. Forensic sample sections used to verify the concrete condition on the underside at various locations near the transverse joint.

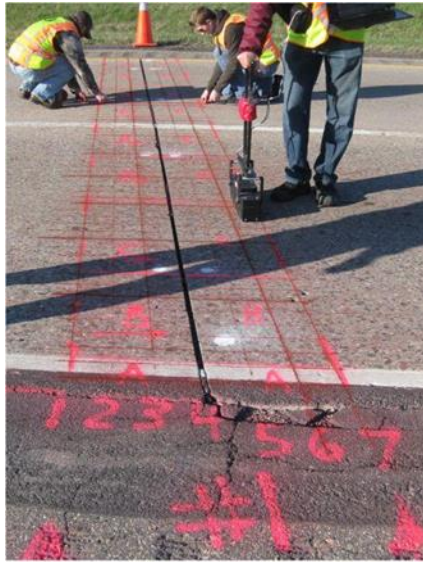
Figure 5-26. Example ultrasonic scan.

In this study a MnDOT owned and operated 2.6 GHz ground-coupled antenna was used. A grid was painted above the concrete joints, with 2 foot intervals marked transversely. The 2 ft points are marked with dashed lines at the top of the image shown in figure 5.26. The first mark was 4 inches from the right edge of concrete while the last mark was 4 inches from the left edge of concrete.

The data obtained from the ultrasonic linear array measurements were processed using the Synthetic Aperture Focusing Technique (SAFT) reconstruction methods described in this thesis including SAFT-Pan and SAFT 3D reconstructions allowing for detailed reconstruction of subsurface features. An example measurement from this study can be observed in figure 5.26.

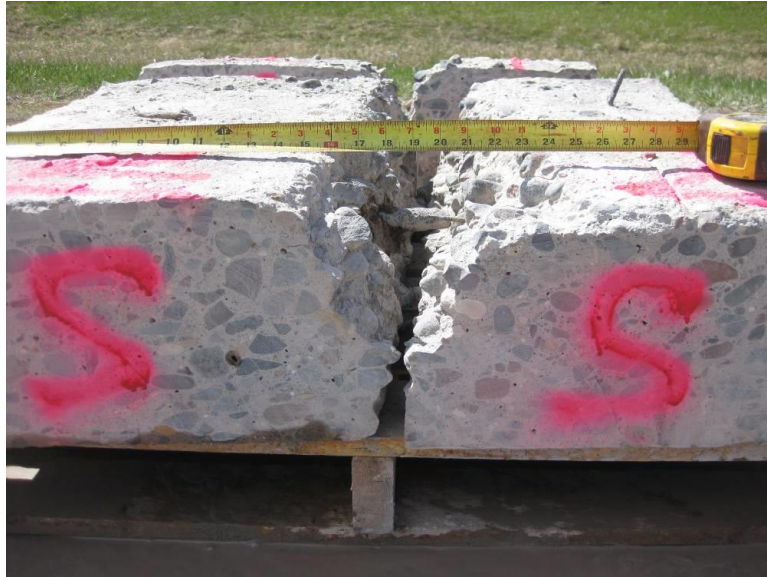
Figure 5-30. Example “tenting” distress observed at joint 2, in both approach and leave slab #2 as viewed from the south side of the slab.

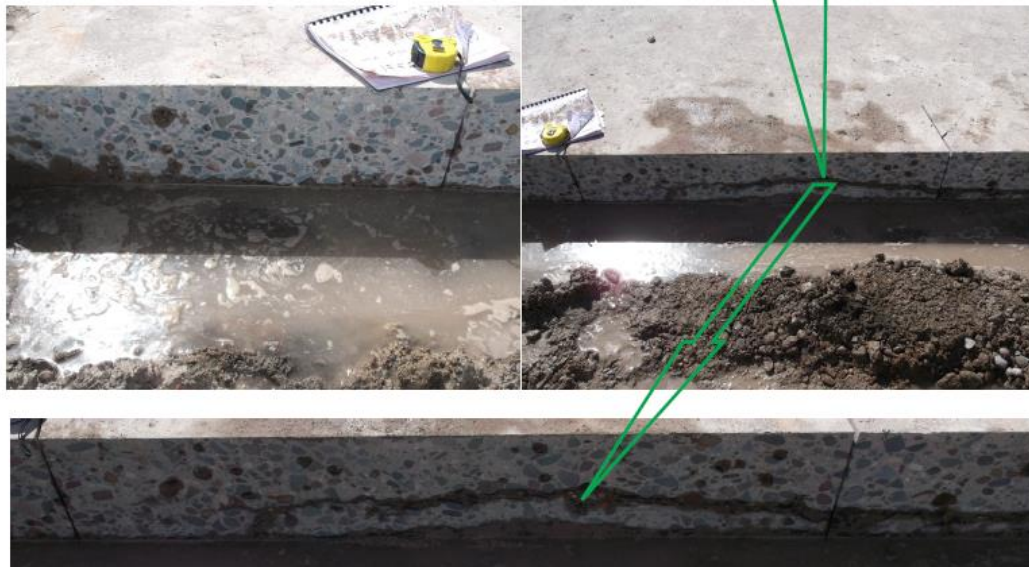
Figure 5-33. SAFT Panoramic reconstruction and comparison with the actual delamination crack path at 18 in. from Joint #2 in the approach slab.
