# Investigation of the Impact of the I-94 ATM System on the Safety of the I-94 Commons High Crash Area

Minnesota  
Department of  
Transportation

John Hourdos, Principal Investigator  
Department of Civil Engineering  
University of Minnesota

Research Project  
Final Report 2014-19

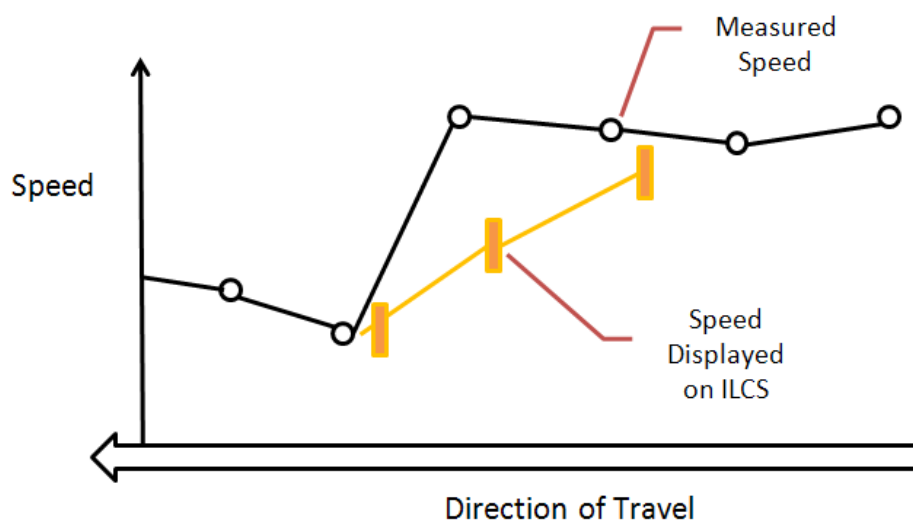
Figure 1. Display of advisory speed limits on DMS as it relates to freeway speeds.

Advisory speeds posted on the overhead signs change by no more than 5 MPH with each change in speed, and can be updated every 30 seconds if traffic conditions warrant. The minimum advisory speed displayed is 30 MPH and the maximum advisory speed displayed is 50 MPH. If the current speeds on the roadway are below 30 MPH the signs go blank. It is important to note a characteristic of the current implementation which may be the reason for not realizing its full potential. The MnDOT freeway detection infrastructure is mainly comprised by single loop detectors measuring volume and occupancy. Speed is estimated from the two primary measurements and a locally calibrated effective vehicle length constant. The latter is calibrated offline. This speed estimation procedure introduces noise in the 30sec speed time series. To alleviate this problem and create a stable algorithm speed is updated every 30sec but averaged over a 90sec window. This helps to reduce outliers but also increases the systems response time. MnDOT has been replacing detection at key locations with radar units and is in the process of updating the system to work on a 10sec update cycle.

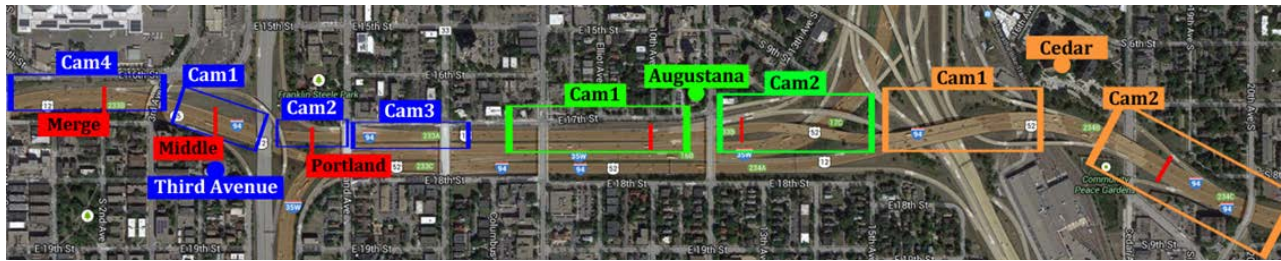
Figure 6. Map of video and machine vision sensors along I-94

Middle, and Portland), Augustana includes two cameras and two MVSs, and Cedar includes two cameras and a single MVS.

To study the shockwaves more directly, the data available from the machine vision detectors was analyzed. In particular, data from the rightmost lane at locations referred to as Middle (Camera 1 in Figure 6) and Portland (Camera 2 in Figure 6) were correlated to visualize the evolution of traffic conditions. The Middle and Portland MVS’s are separated by roughly 450 feet.

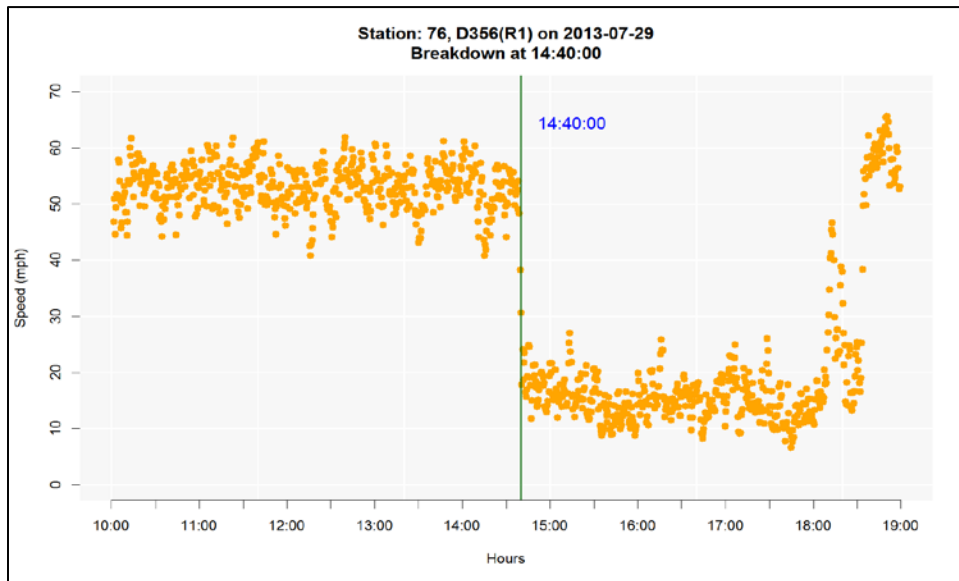
Figure 8. Identified time of breakdown for July 29, 2013

In order to synchronize these measurements for analysis, the onset of congestion at the most downstream detector (D356) was identified for every 'typical' day between January 1, 2011 and August 8, 2013. Holidays and days with unusual weather were excluded from this set. A simple algorithm was developed to locate the first breakdown in traffic for each afternoon. Using data from 10 AM to 7 PM aggregated to 5-minute intervals, the two hour window with the largest difference in average speed between the first and second hours was located. The center point of this two hour window was identified as the time of breakdown. Figure 8 shows a sample plot showing the identified breakdown for July 29, 2013.

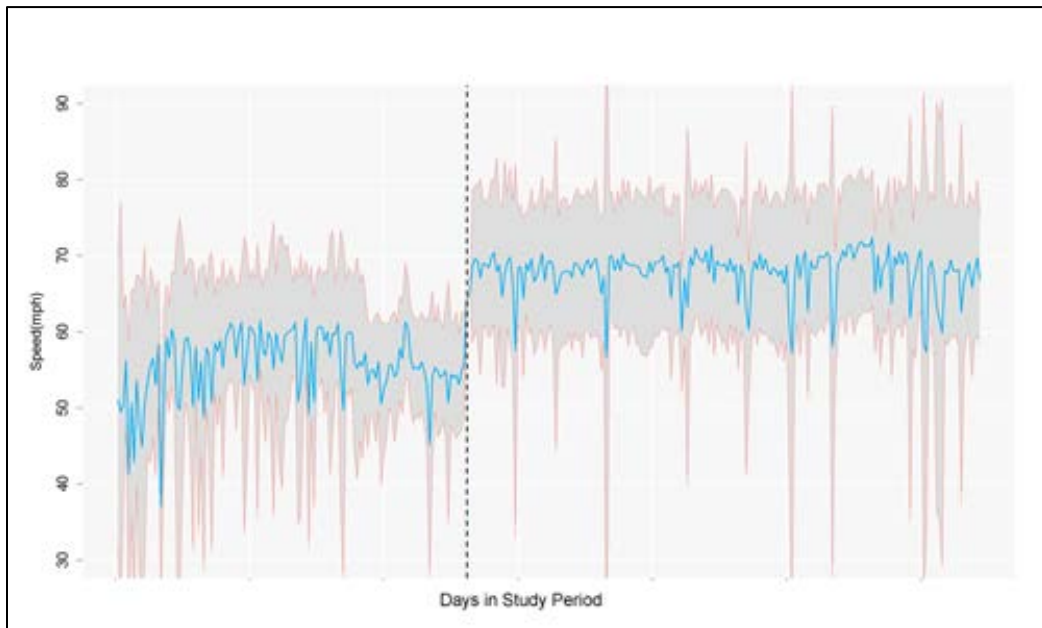
Figure 10. Mean speed  $\pm$  1 standard deviation for detector D2685 showing a sudden change in measured speed

Between 9 and 11 AM on nearly all days free flow conditions were experienced along the corridor. As such, the speeds were assumed to stay relatively stable over time, allowing the effective field length of each detector in the corridor to be calibrated. Figure 10 shows the average speed during this time for a sample detector. Note the significant and sudden shift.

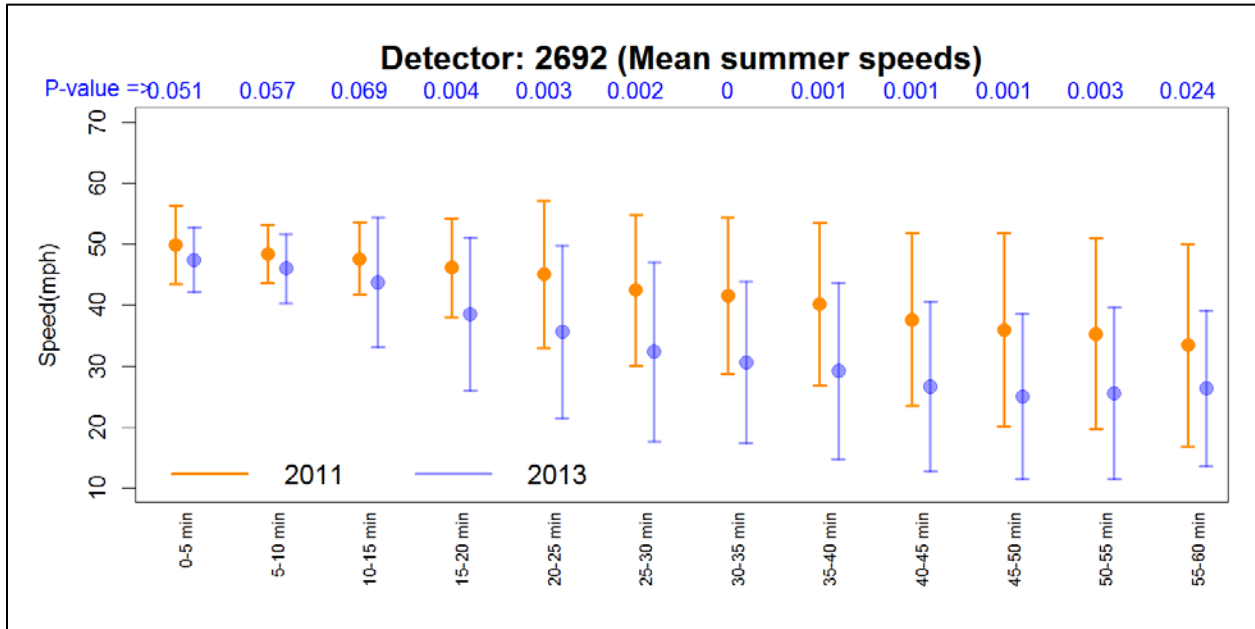
Figure 12. Mean and 1 standard deviation for speeds at detector D2692 for 2011 v. 2013

To extract useful statistical data from these speed measurements, the data from the summer months of 2011, 2012, and 2013 were analyzing using the student t-test. For each 5-minute interval after breakdown, the p-value was determined for 2011 v. 2013 and 2012 v. 2013. The p-value indicates how likely the two data sets are from the same underlying pattern. If the p-value is high, the two samples are likely based in the same distribution, while p-values below 0.05 indicate a strong confidence (95%) that the two data are significantly different. Figure 12 below shows a sample figure showing these results for the first upstream detector in the right lane (D2692) for 2011 v. 2013.

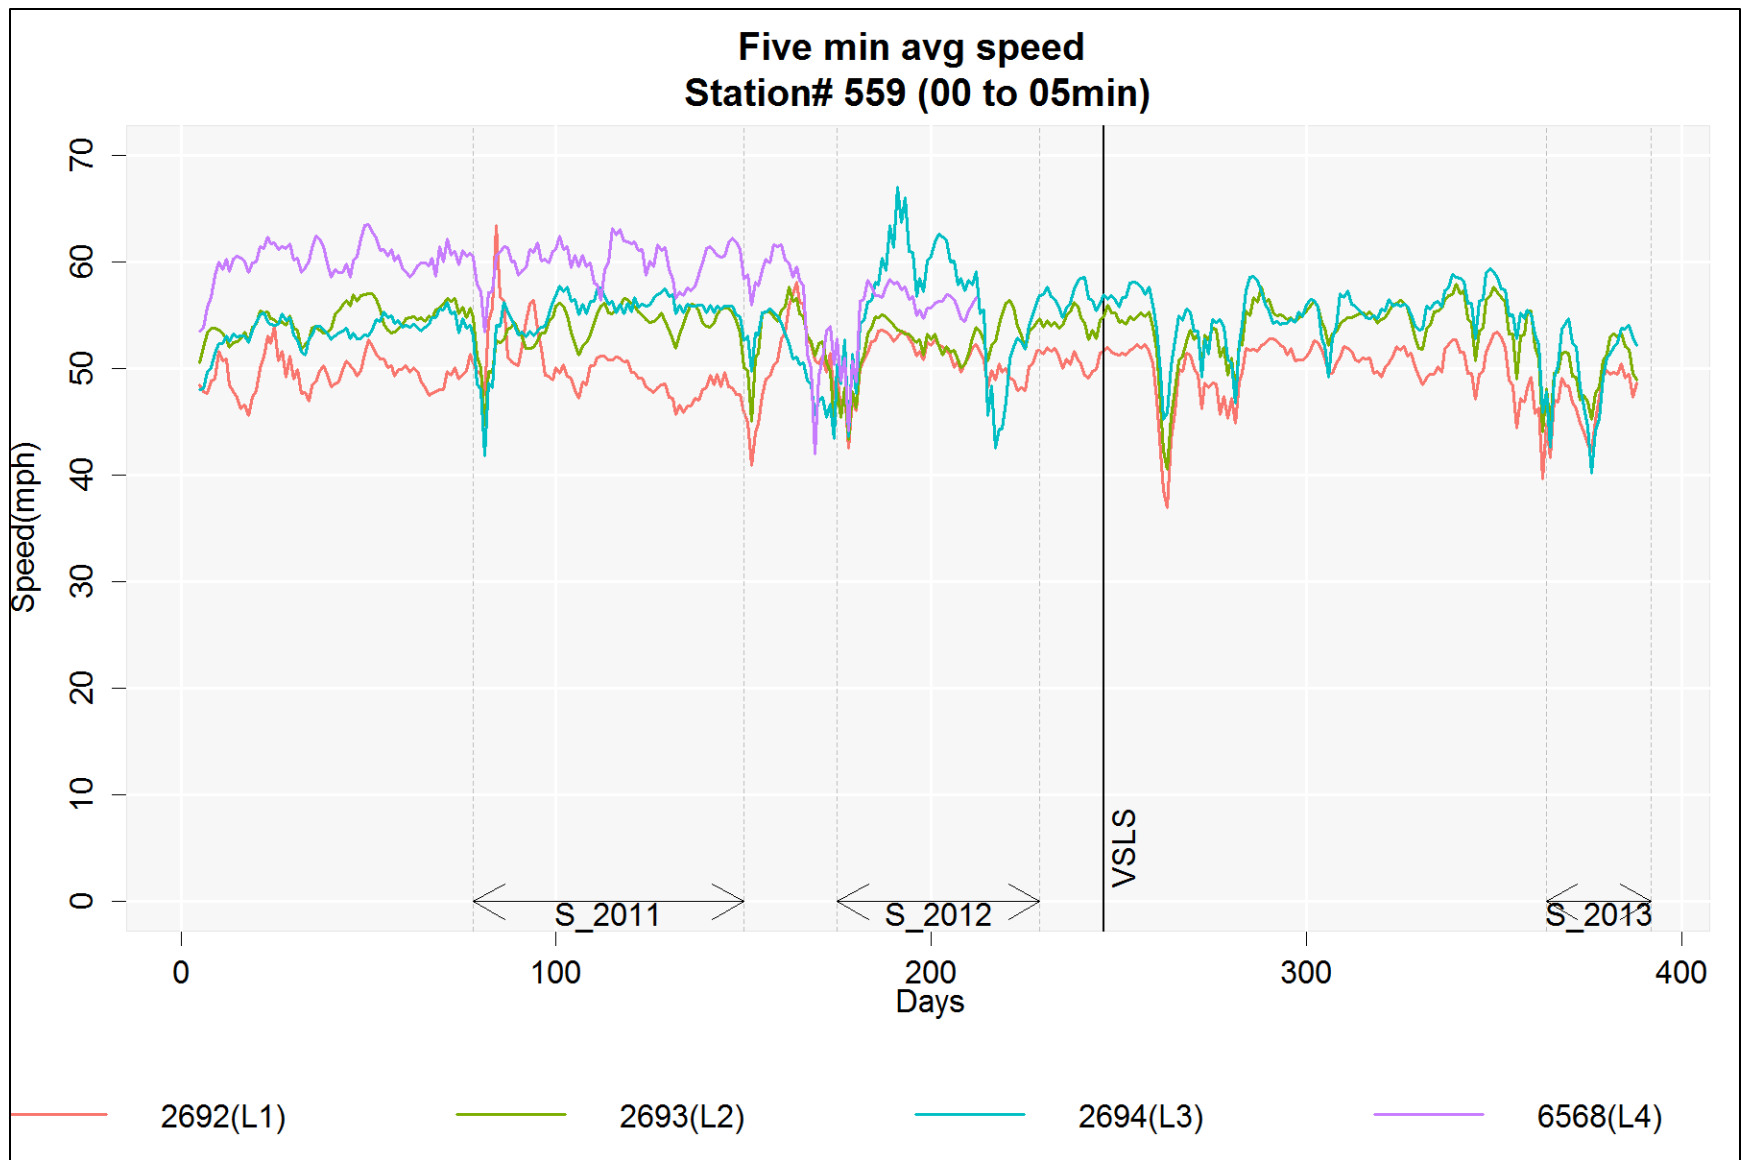
Figure 13. Average speed for station S559 0-5 minutes after breakdown

Several of the 5-minute intervals were also isolated for the stations (with each detector individually plotted), such as 0-5 minutes after breakdown, for closer inspection. Figure 13 shows a sample plot of just the first five minutes of activity after breakdown for station S559. Note that the detectors are labeled as L1 through L4 in the figure, corresponding to detectors from right to left across the roadway.

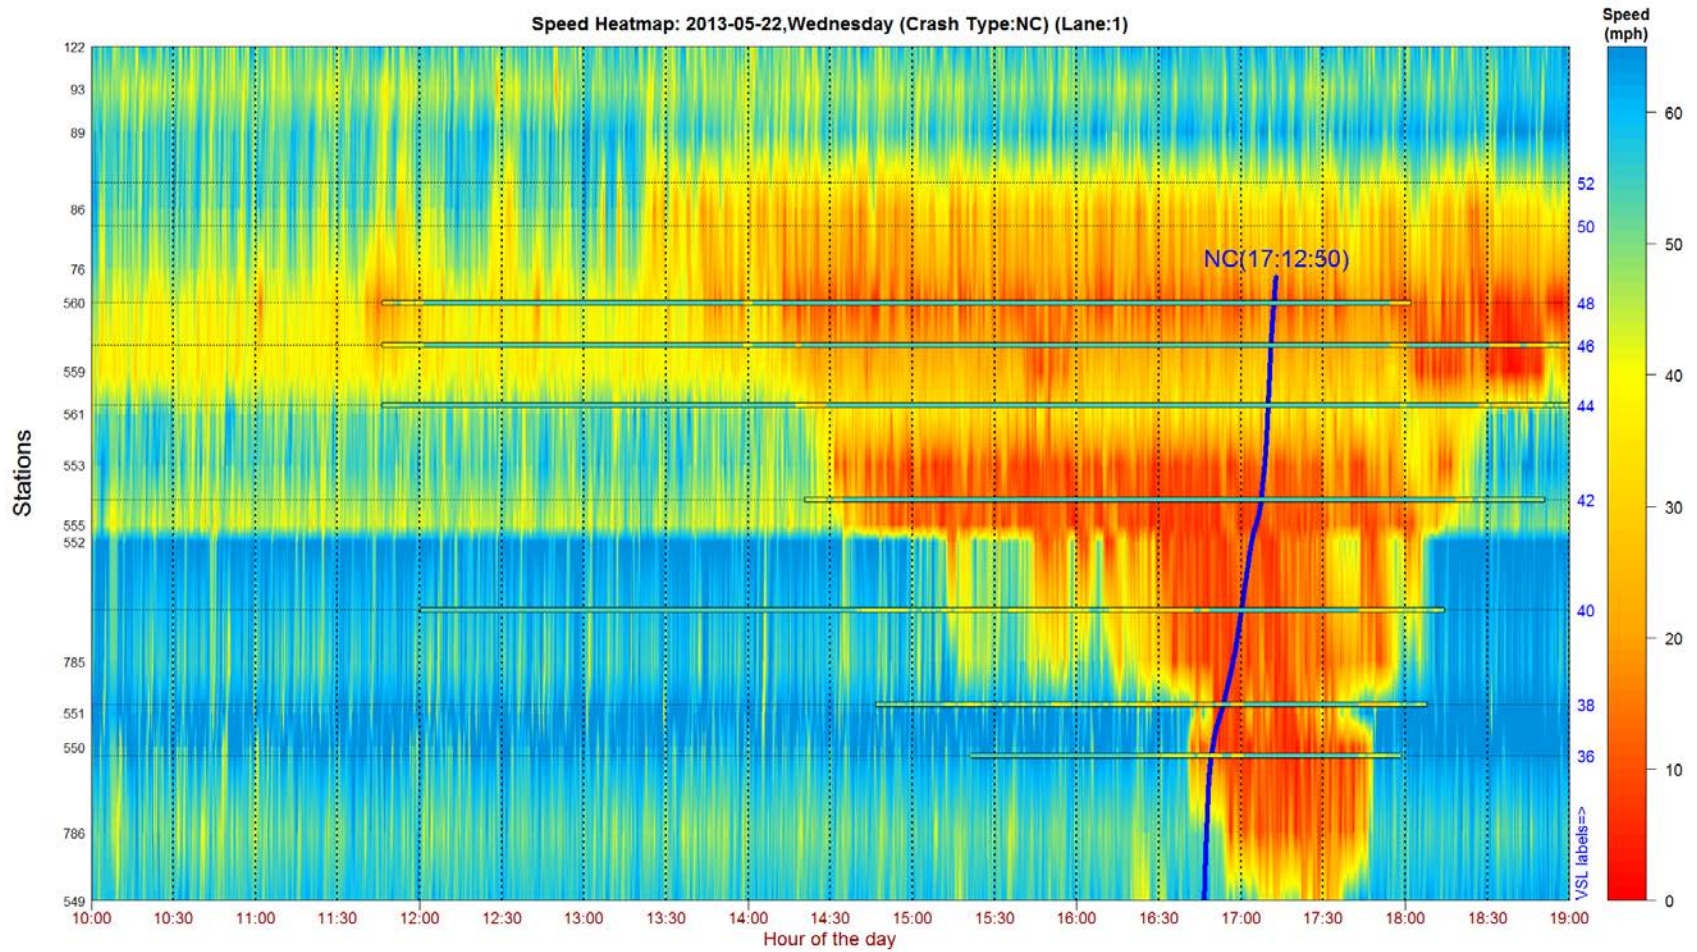
Figure 14. Speed plot with estimated vehicle trajectory for a near crash event on April 4, 2013

At this new time, the speed was again linearly interpolated and used to step back to the previous 30-second interval. The process was continued until the trajectory of the vehicle reached the edge of the corridor of interest. Figure 14 shows a sample produced by this method.

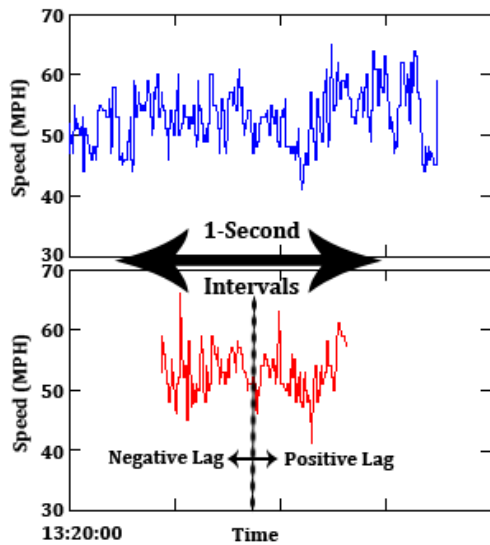
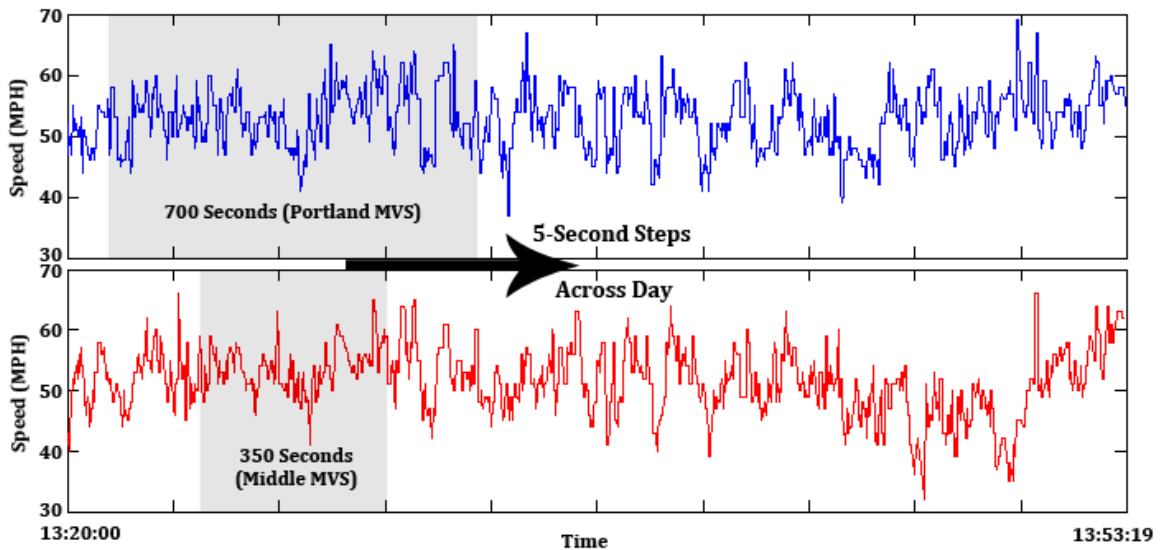
**Step 1: Select time windows (above)**

**Step 3: Advance windows by 5 seconds and repeat Step 2 (below)**

Figure 15. Generating the Correlogram

This methodology produces a correlation curve describing the relationship between the Middle and Portland data sets. By stepping across the day at 5-second intervals, the two-dimensional correlation curves are aggregated to form a three-dimensional Correlogram where intensity is represented by color.

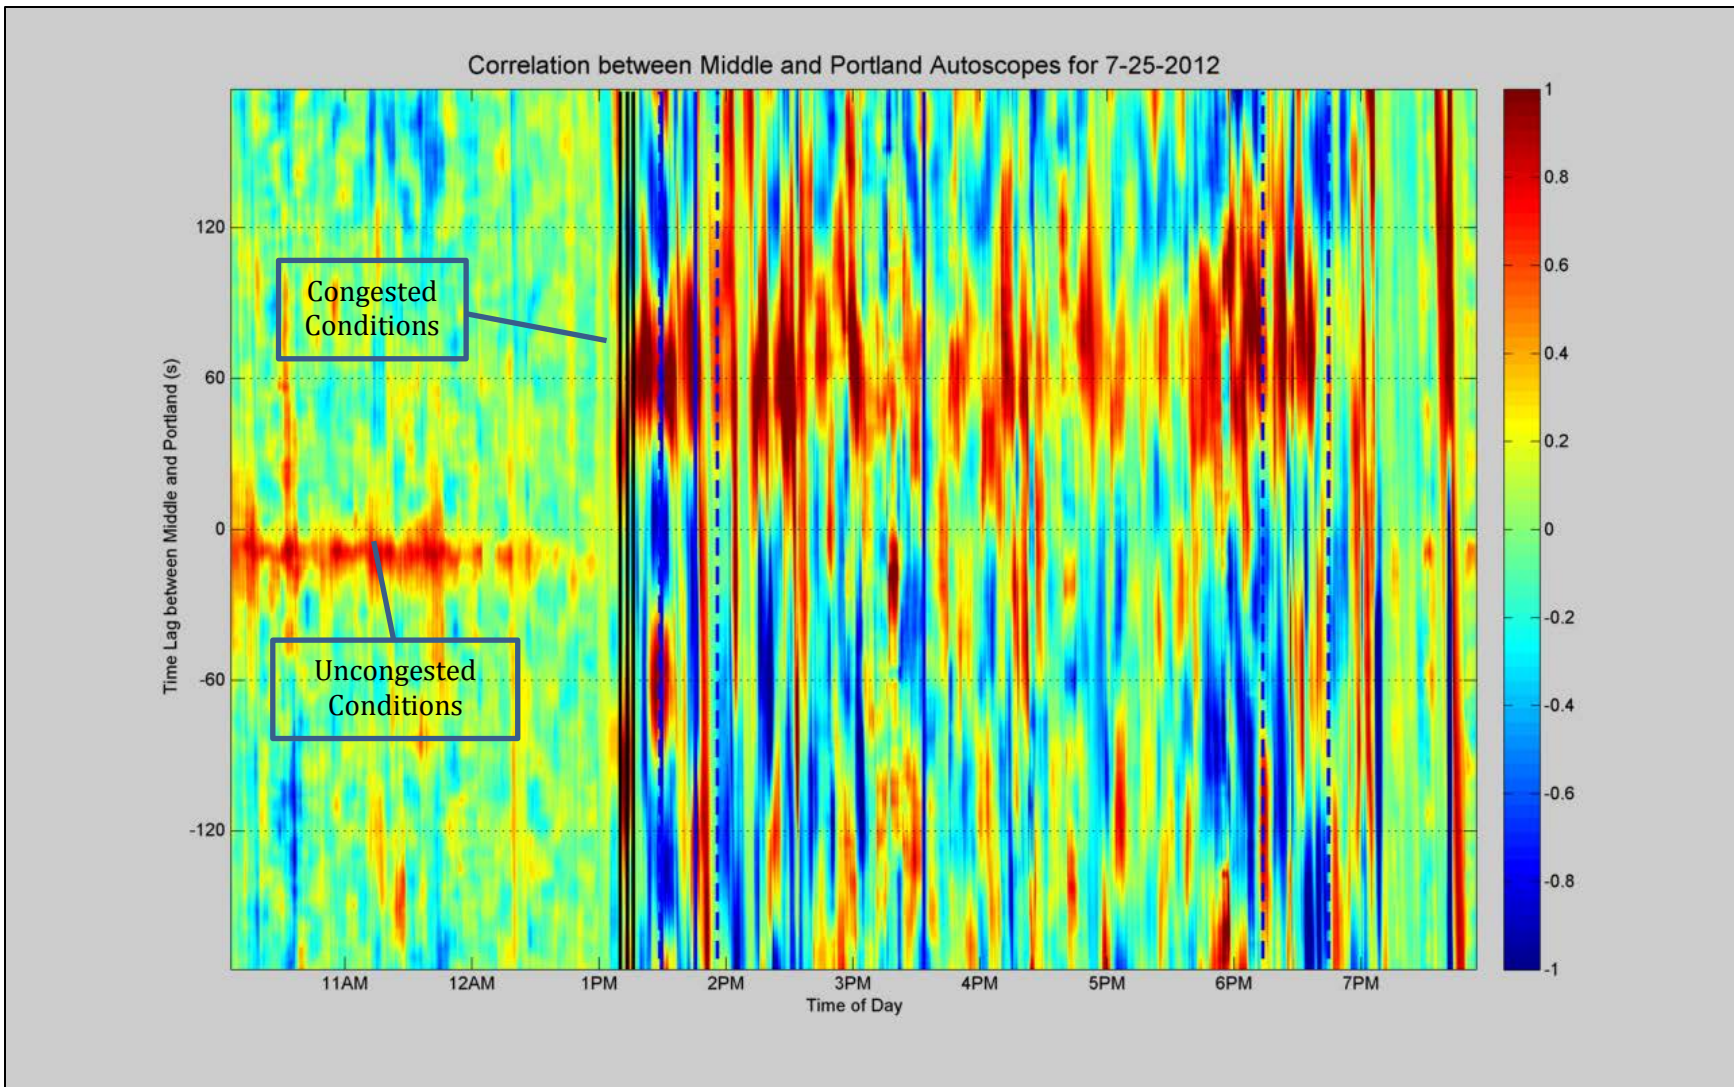
Figure 16. Correlogram for July 25, 2012

Figure 16 shows a sample Correlogram for July 25, 2012 which highlights key features of the Correlogram.

The highly positively-correlated band before noon and just below zero lag represents uncongested conditions. As vehicles pass from the upstream to downstream machine vision sensor at free flow speeds, very little time passes leading to strong correlation at low time differences. At roughly 12:30 PM the correlation drops off, with no significant correlation found at any lag. This represents the time interval when the downstream MVS began experiencing shockwaves that did not propagate sufficiently to reach the upstream MVS. Near 1:15 strong positive correlation regions begin appearing near the 60-second positive lag mark. These indicate shockwaves traveling upstream. This is confirmed by the three vertical black lines marking the first three shockwaves for the day as observed manually.

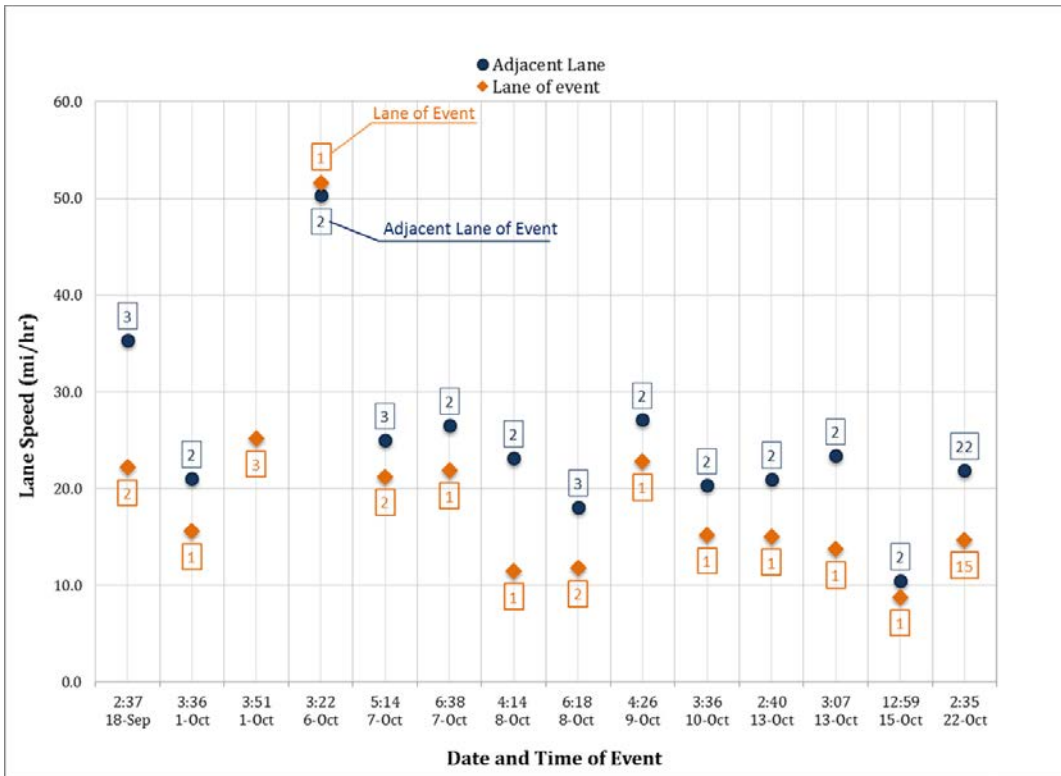
Figure 18. Crash events collected in 2008 - Average speed of event lane and adjacent lane

Figure 18 and Figure 19 present a graphical representation of the near crash and crash incidents from video collection data. These plots are chronologically organized by date and time recorded. Each point in these plots corresponds to the average lane speed of the lane where an incident took place and its adjacent lane. During peak times (3:30PM to 6:30PM), the majority of crashes and near crashes occurred at speeds below 30mph of speed, with an adjacent lane demonstrating a similar speed.

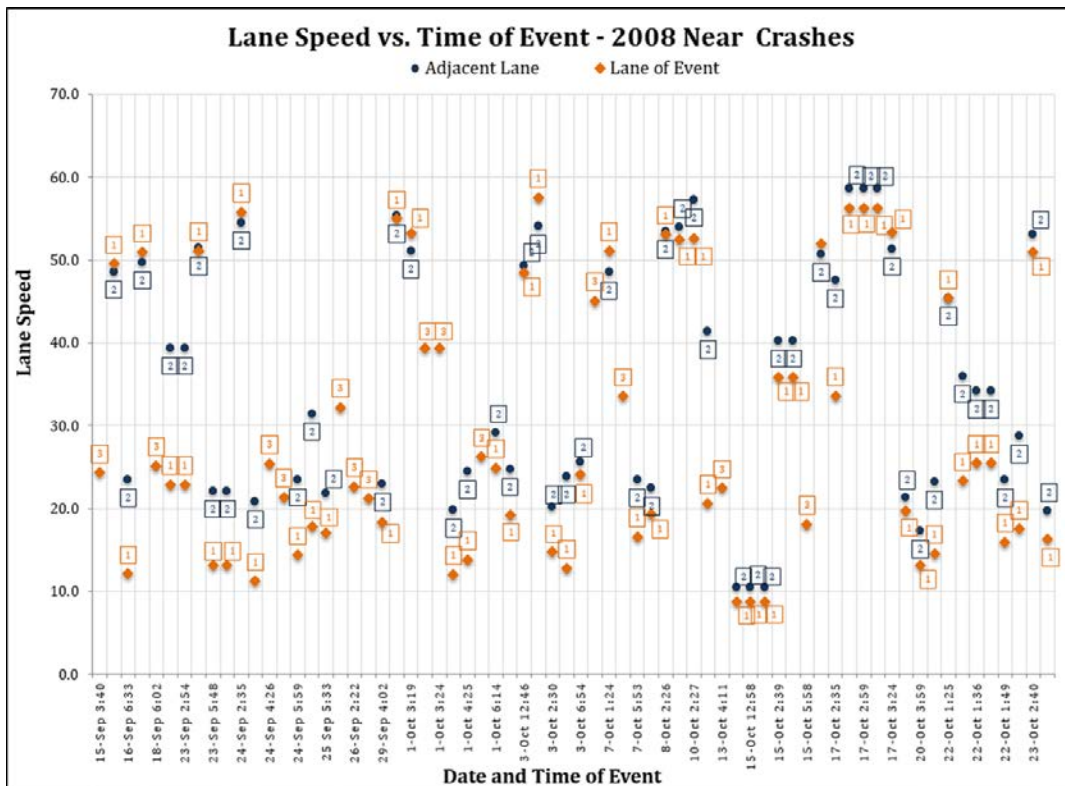
Figure 19. Near crash events collected in 2008 - Average speed of event lane and adjacent lane

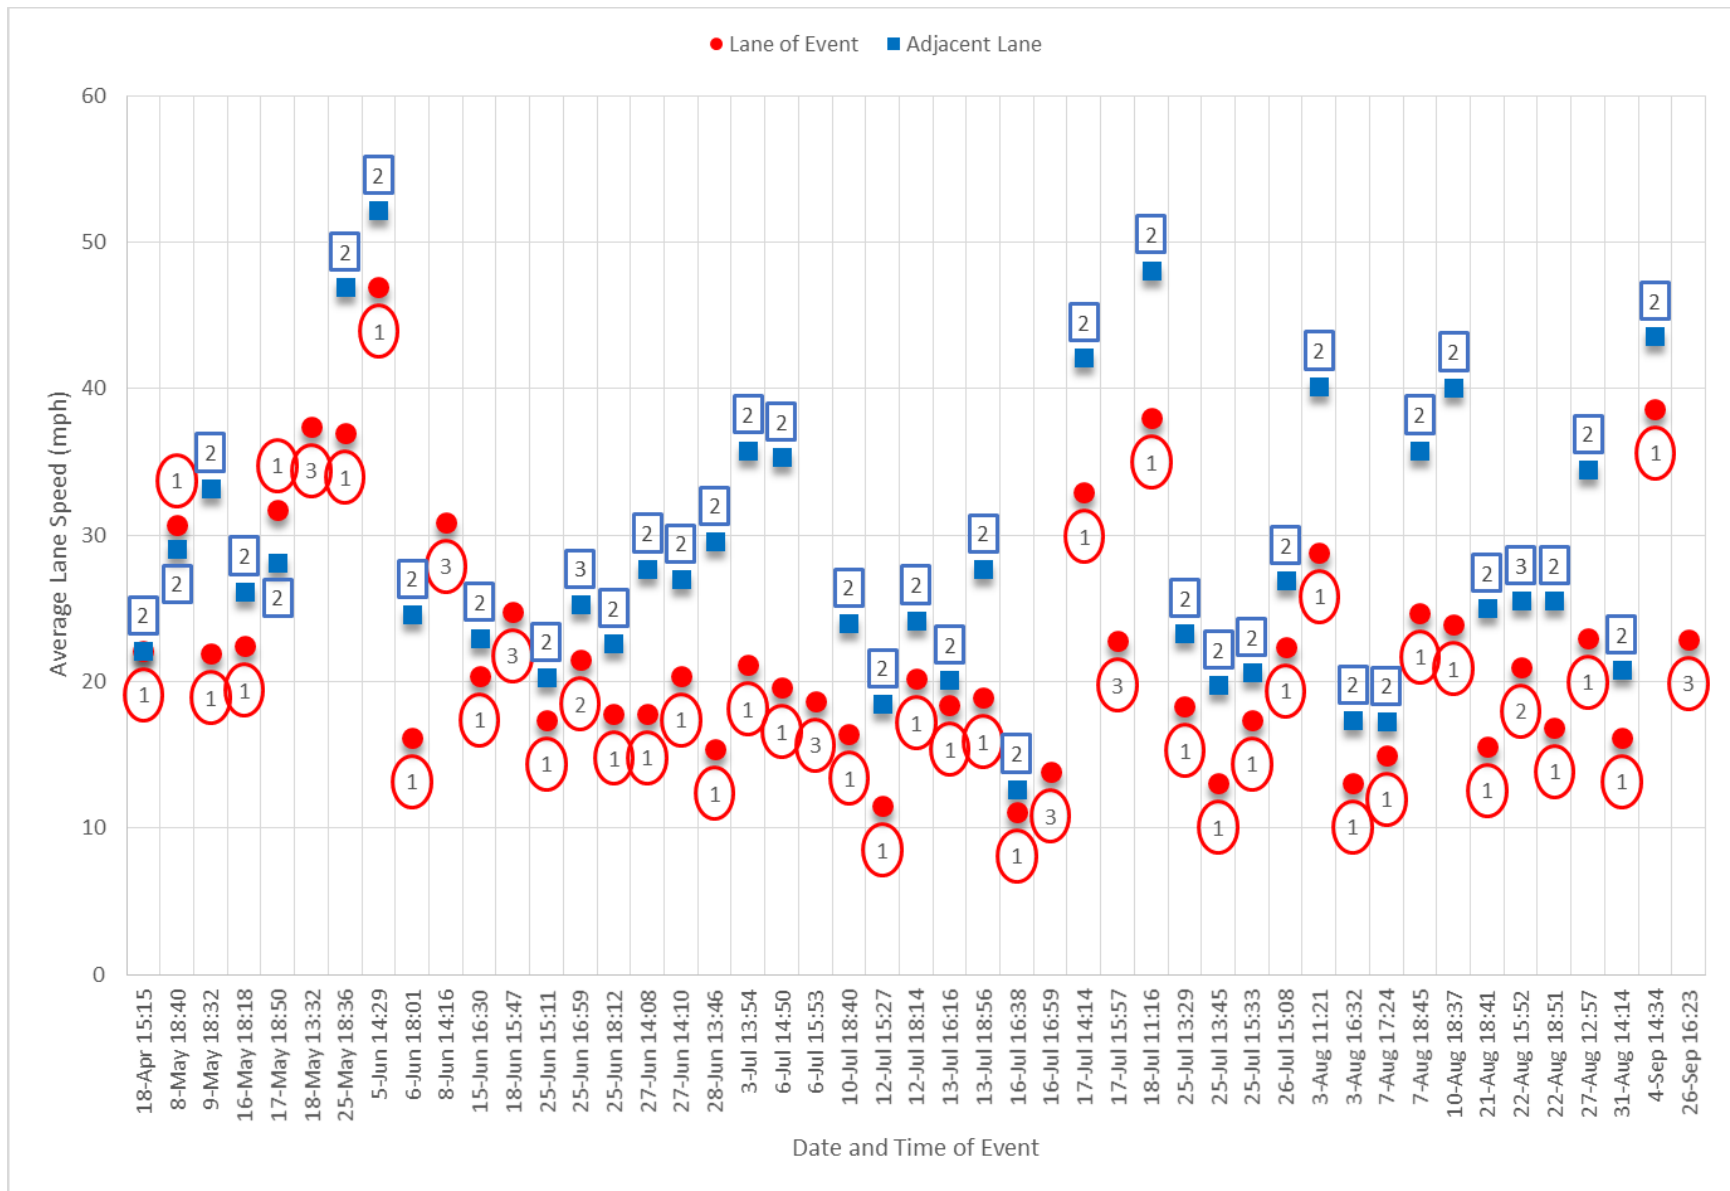
Figure 21. Crash events collected in 2012 Before VSL - Average speed of event lane and adjacent lane

The incidents collected from the observed video, were organized and analyzed with their corresponding average lane speed of event and adjacent lane. Table 4 and Figure 21 contain the crash incidents from video collection from April 2012 to September 7th, 2012, with average and adjacent lane speeds. The numerous near crash events for this same period, which were presented in the Task 2 report, are not reproduced here.

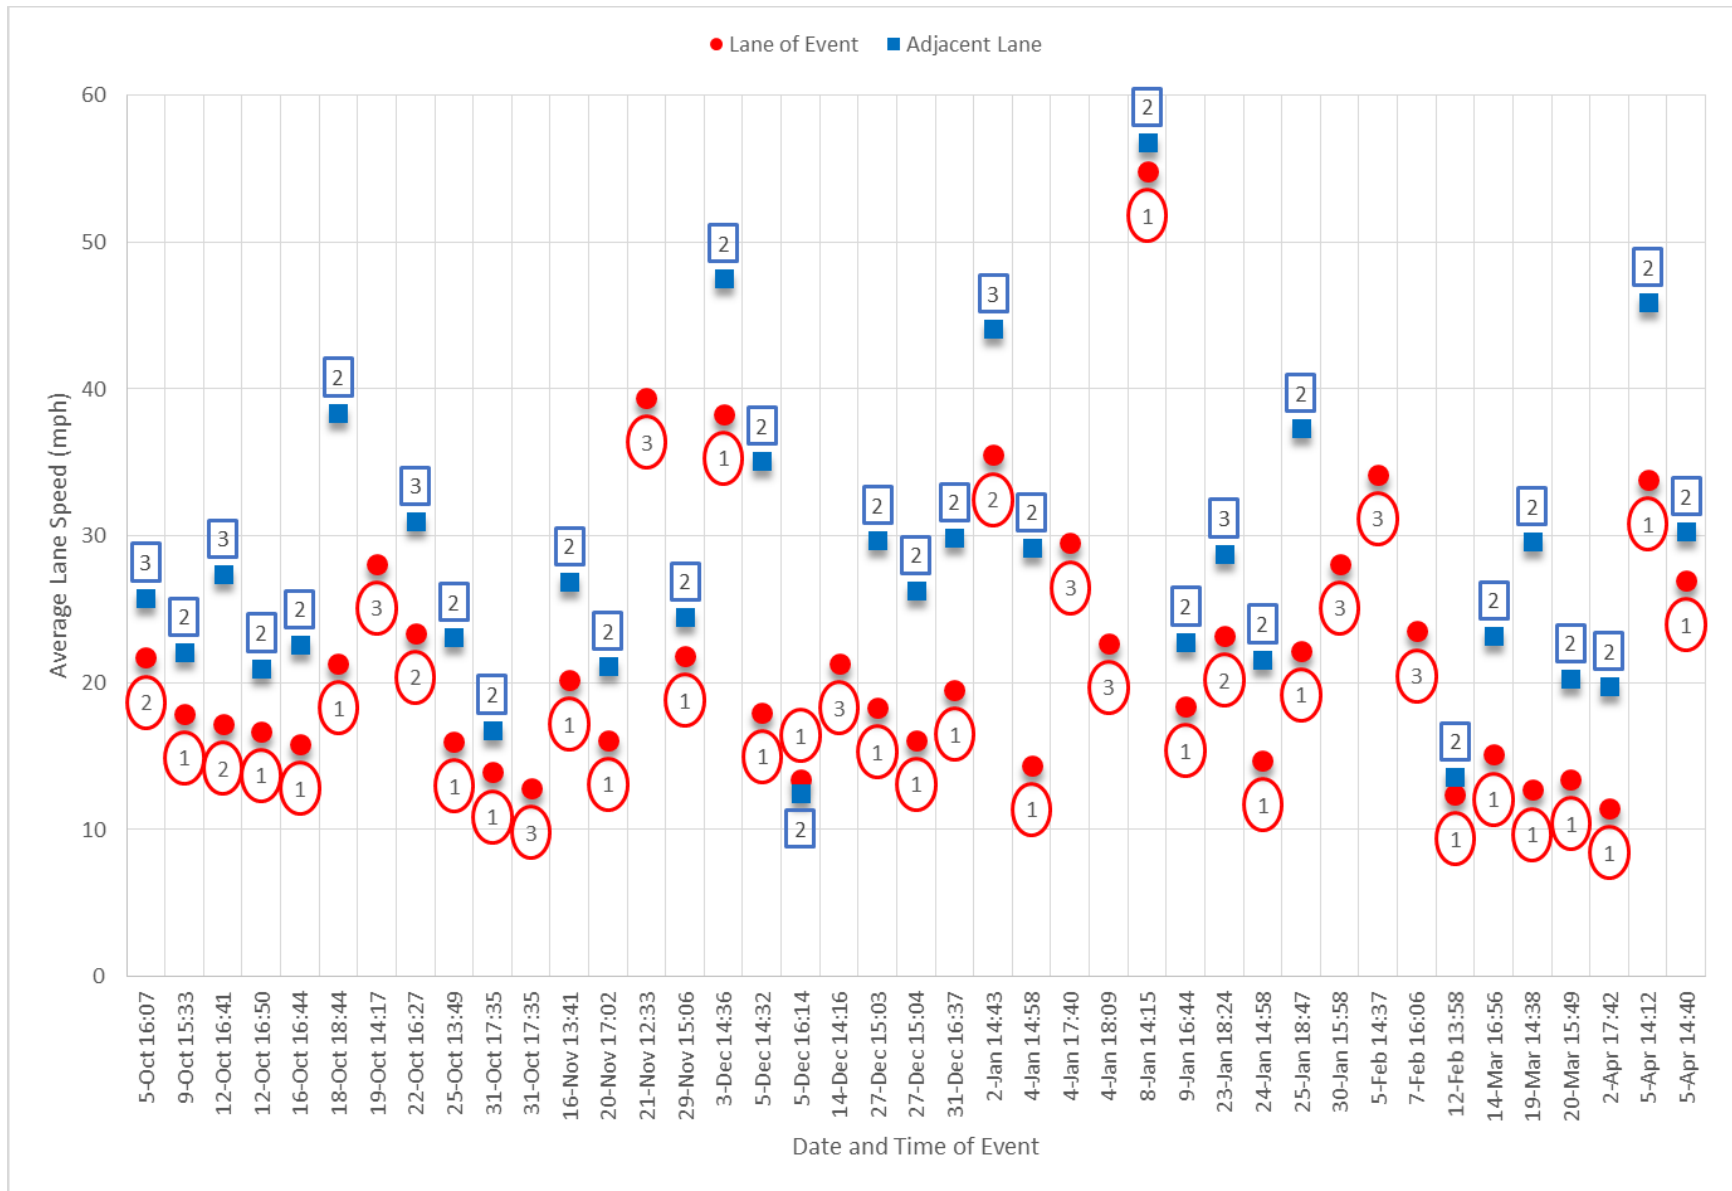
Figure 23. Crash events collected between October 2012 and April 2013 after VSL implementation

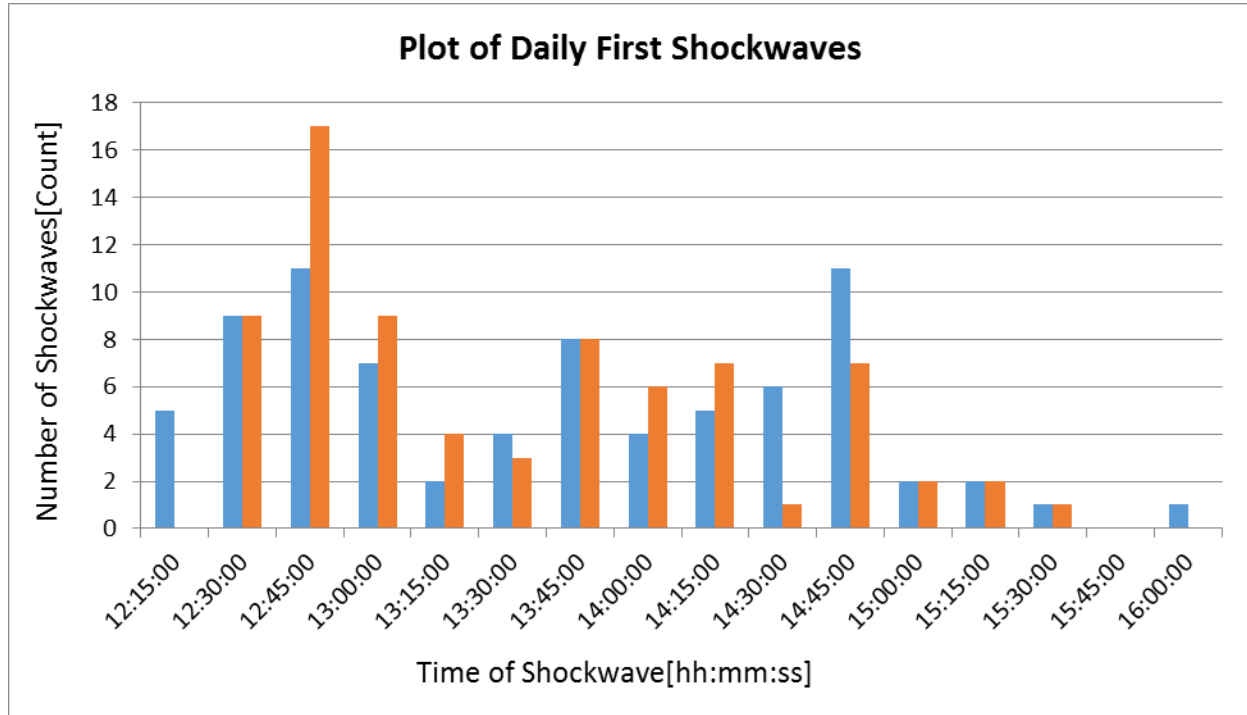
Figure 28. Time of onset of the first shockwave Before and After VSL

The first three shockwaves of each day were analyzed to uncover differences between pre-VSL and post-VSL behavior. Across the Before dates, the first shockwaves of each day ranged from 12 PM to nearly 4 PM. In the After dates, the first shockwaves started slightly later and ended slightly earlier (ranging between 12:15 and 3:30 pm). Figure 28 shows the frequency across the afternoon for both Before and After.

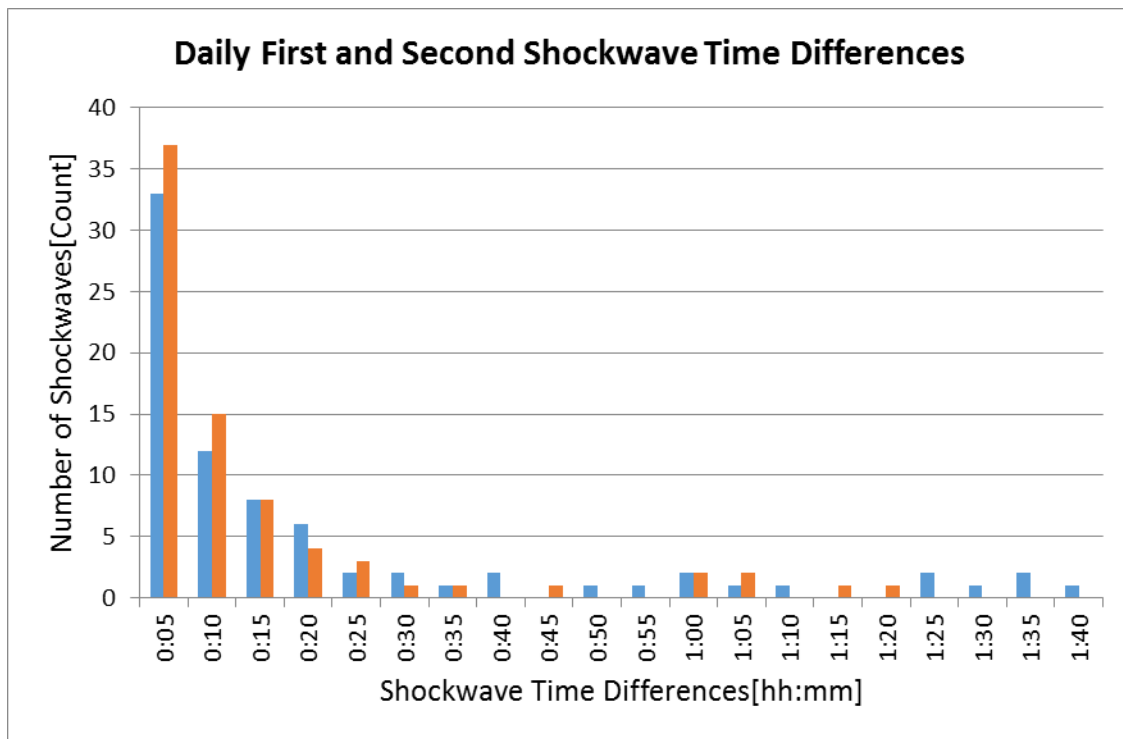
Figure 31. Gap between first and second shockwave onset Before and After VSL

The time difference between consecutive observed shockwaves was also examined for differences between the before and after conditions. The results indicate that most first and second shockwaves are separated by five minutes or less, as can be seen in Figure 31.

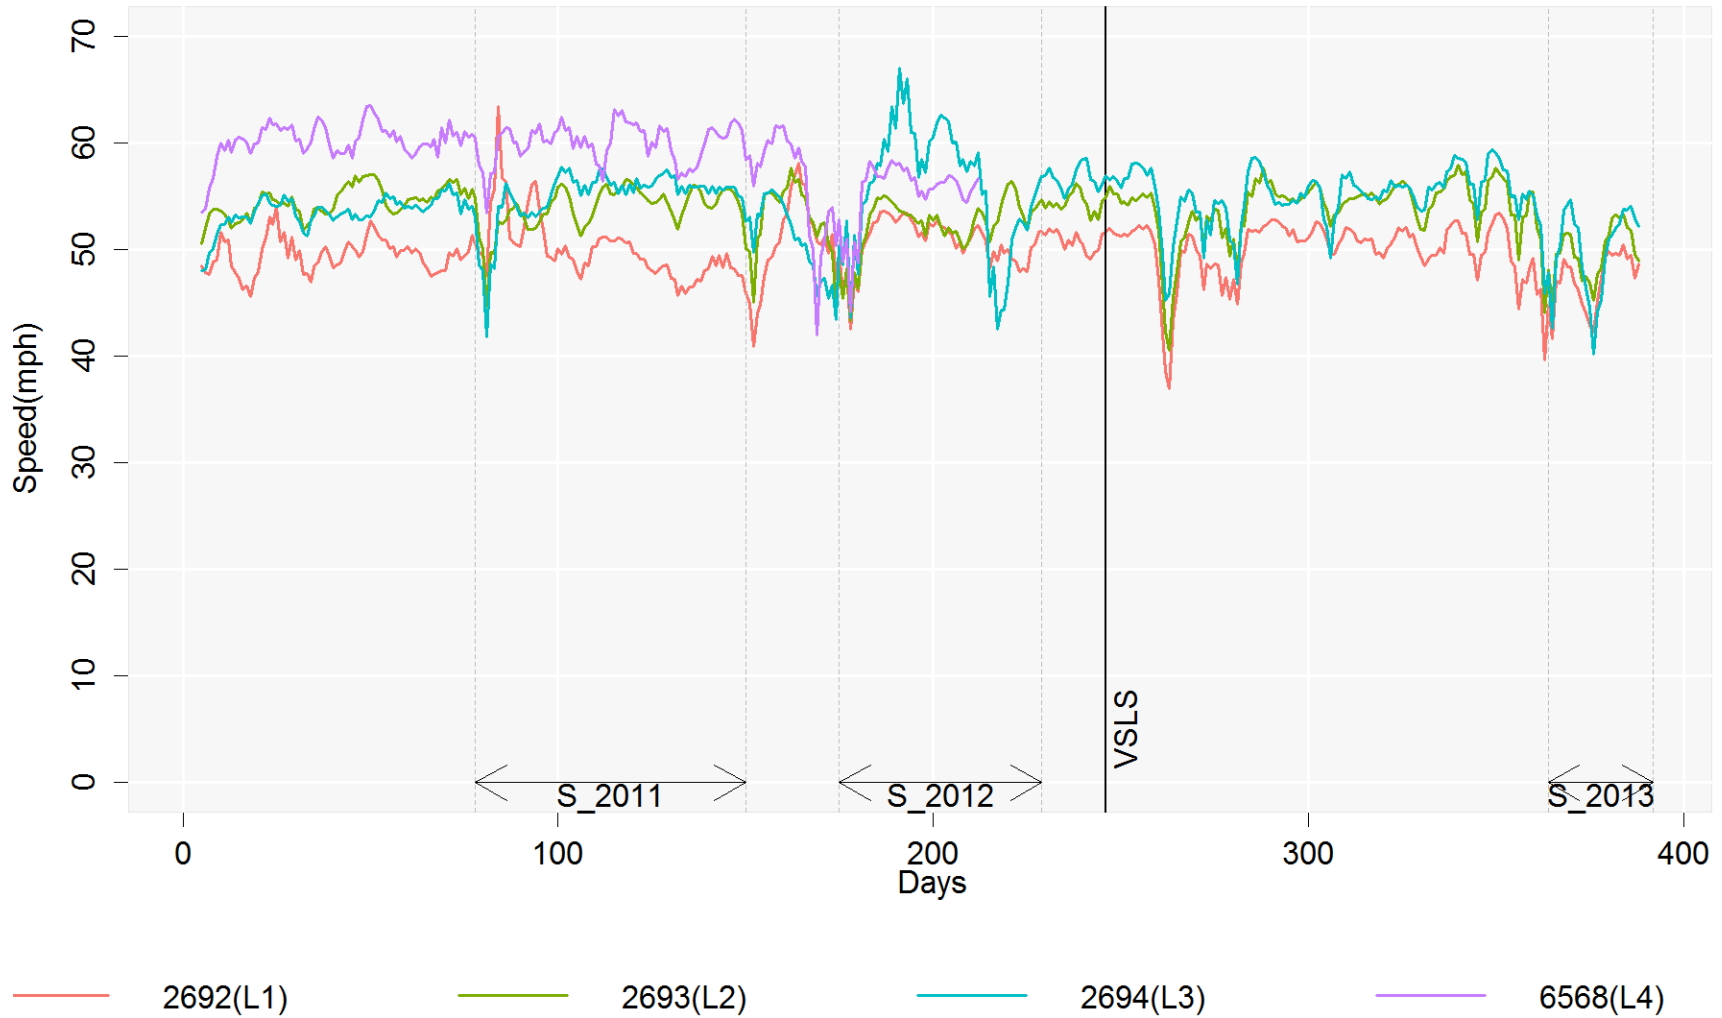
Figure 38. Five minute average speed (0 to 5 minutes after breakdown) for station 559

After visually comparing the speeds from each 5-minute period Before and After VSL activation, significant differences are found between the 2011 and 2013 data, but not between the 2012 and 2013 data. Only dates from the summer of each year were used. Figure 41, Figure 42, and Figure 43 show the speed profiles for 2011 v. 2013 for the detectors at station 559 (nearest to the bottleneck). Above each 5-minute interval, the p-value is printed to show whether the two data sets are significantly different (0.05 or less indicating greater than 95% confidence of significant difference).

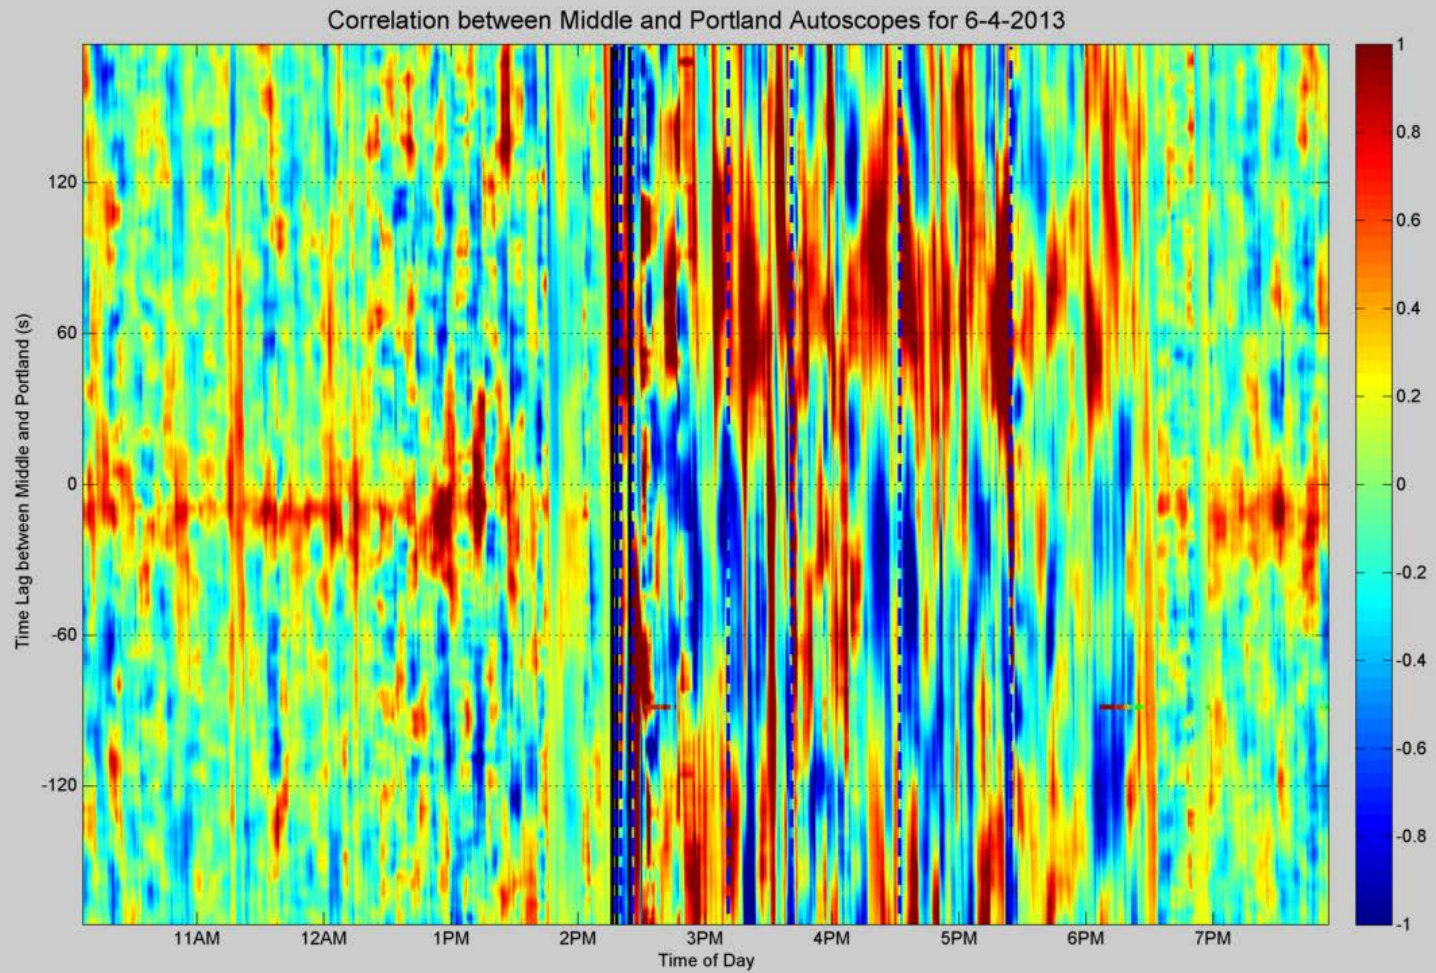
Figure 53. Correlogram for June 4, 2013
