UNIVERSITY OF MINNESOTA
ST. ANTHONY FALLS LABORATORY
Engineering, Environmental and Geophysical Fluid Dynamics

PROJECT REPORT 482

Testing a Single Lateral of an Underdrain System

Prepared for
Johnson Screens
New Brighton, MN

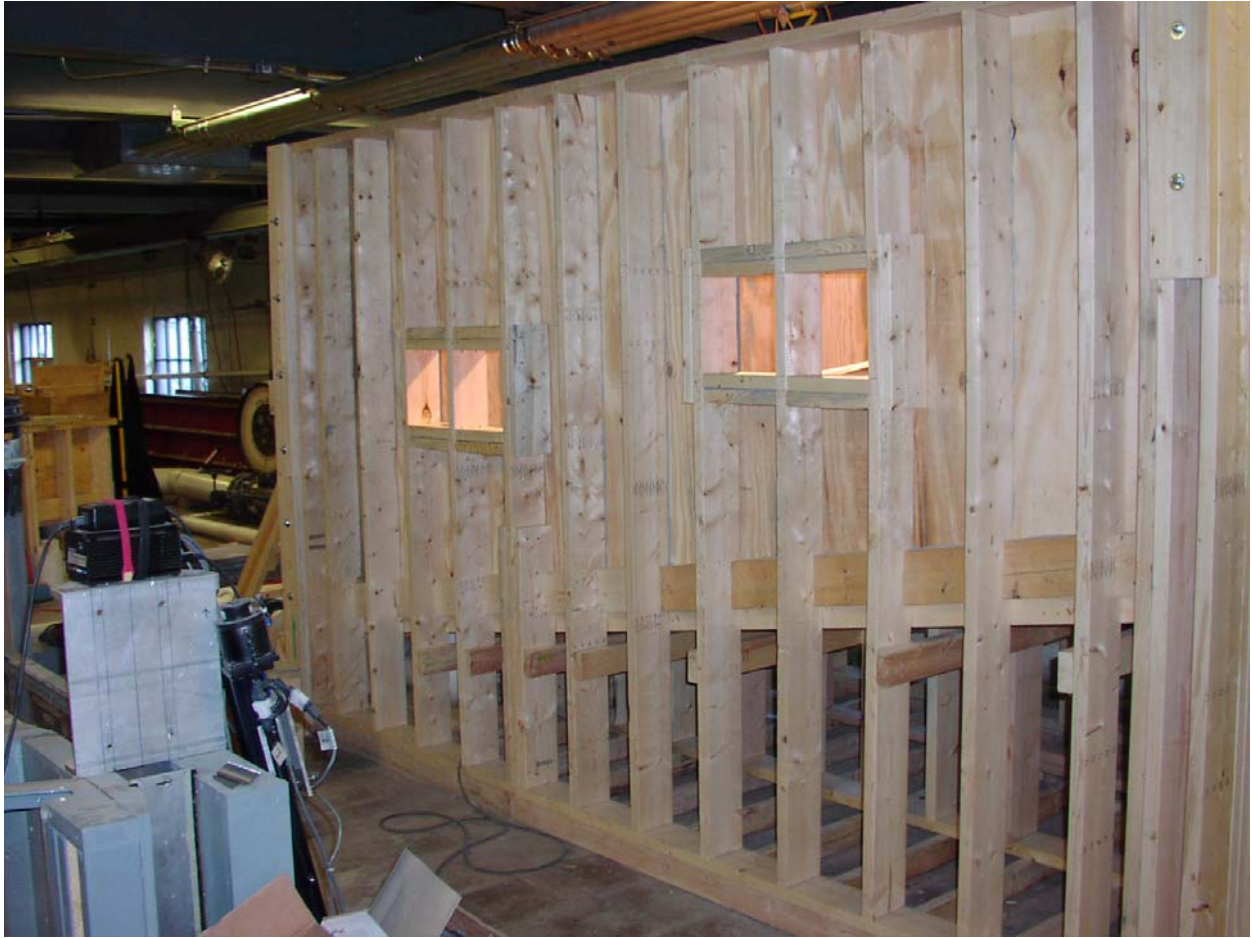
Figure 2.3. The basin test-stand made of lumber and plywood.

The basin was constructed from lumber and plywood (Figure 2.3). The laterals and a part of the drain pipes (vertical shafts) were supplied by Johnson Screens.

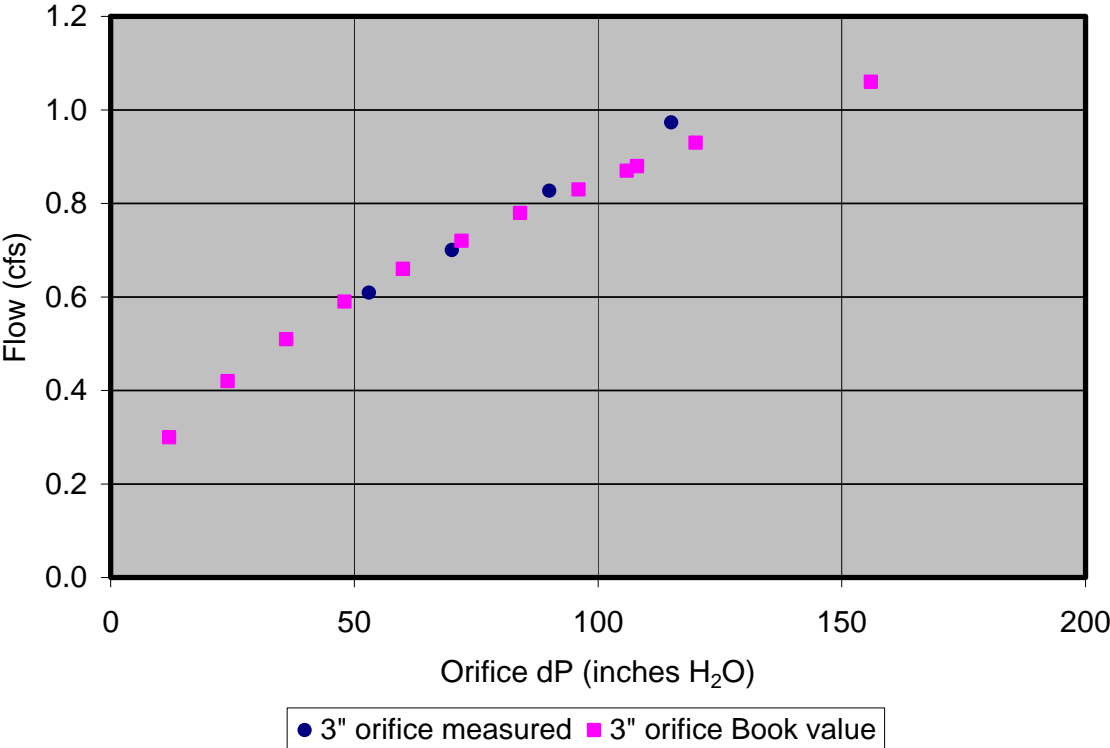
Figure 2.4. Verifying the standard values of the orifice flow meter against measured flows using the SAFL weighing tanks.

To measure the flow rate through the system during the hydraulic tests, a standard orifice flow meter equipped with a differential pressure transducer was placed in the supply line. Two orifice plates were used for the tested range of flows. For high flow rates a 3-inch plate and for low flow rate a 1.5-inch plate. The orifice flow meter was also checked against the SAFL weighing tanks. For the 3-inch plate, at flows around 0.87 cfs, the standard flow values were slightly different from those measured by the weighing tanks (Figure 2.4). Since the difference was very small, it was decided to use standard flow values.

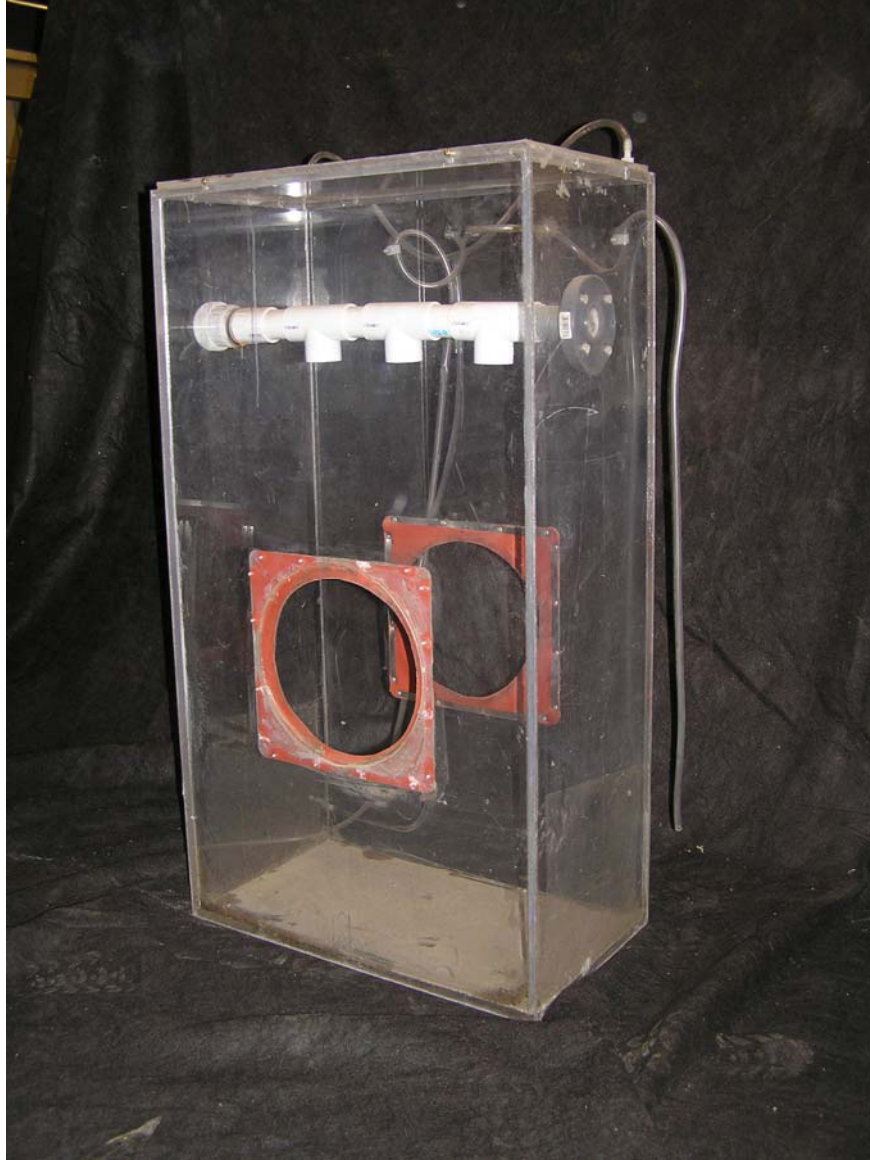
Figure 2.5. The flow-capturing apparatus to measure the flow rate out of two rings of orifices.

To determine the flow distribution along the lateral a flow chamber was built to capture the flow out of two rings of orifices over a period of time. The flow-capturing apparatus was comprised of a closed tank, two ¼" tubes, a manifold, and a 1.5" flexible hose (Figure 2.5). The tank was made of Plexiglas with a width and length of 12" and 25", respectively, and could be moved and positioned along the lateral.

The dimensions of the flow chamber were determined so as to take advantage of lines of symmetry in the manifold system. Thus, the internal width of the tank was equal to the distance between two adjacent rings of orifices and the internal length of the tank was equal to the distance between the center points of two adjacent laterals. One of the ¼” tubes was connected to a pressure tap outside of the tank to provide the local basin water surface elevation (depth). The other ¼” tube was connected to a pressure tap to provide the water pressure inside the tank. The 1.5” hose was connected to a throttling valve and a pump and was used to extract water from the tank via a withdrawal manifold (Figure 2.6).

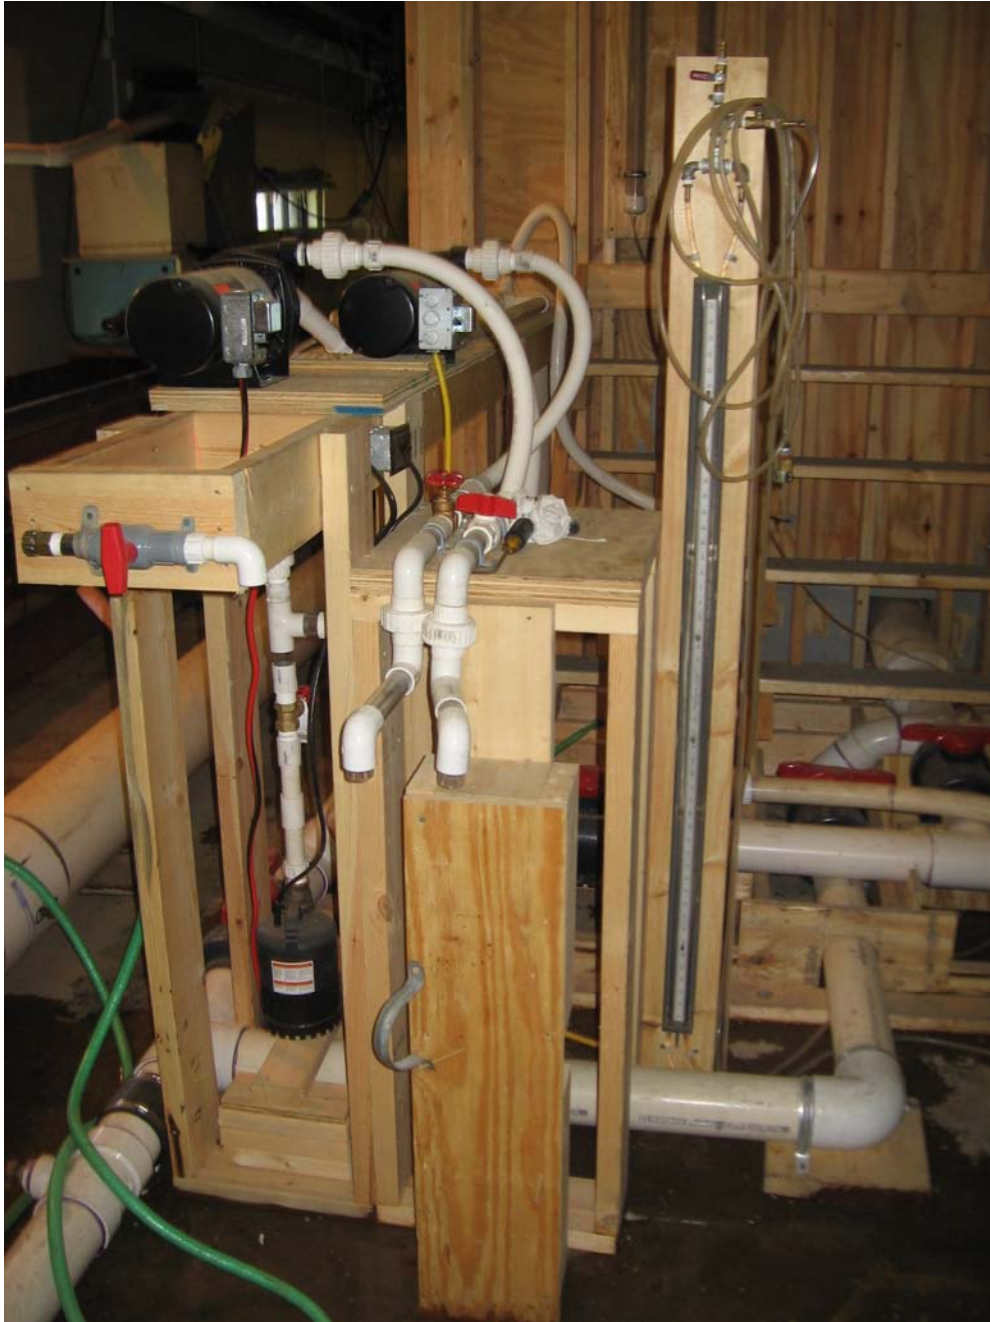
Figure 2.6. The pumps and plumbing used to measure the flow withdrawn from the flow chamber during the backwash mode.

The two ¼” tubes were connected to a graduated manometer and would provide the water pressure difference inside and outside of the flow chamber. Under backwash conditions, with the pump on, water was withdrawn from the flow chamber, with the rate controlled by the valve. When the valve was adjusted such that the water pressure inside and outside of the flow chamber were the same and steady over time, the flow through the pump was equal to the orifice rings discharge that would occur in the absence of the flow chamber.

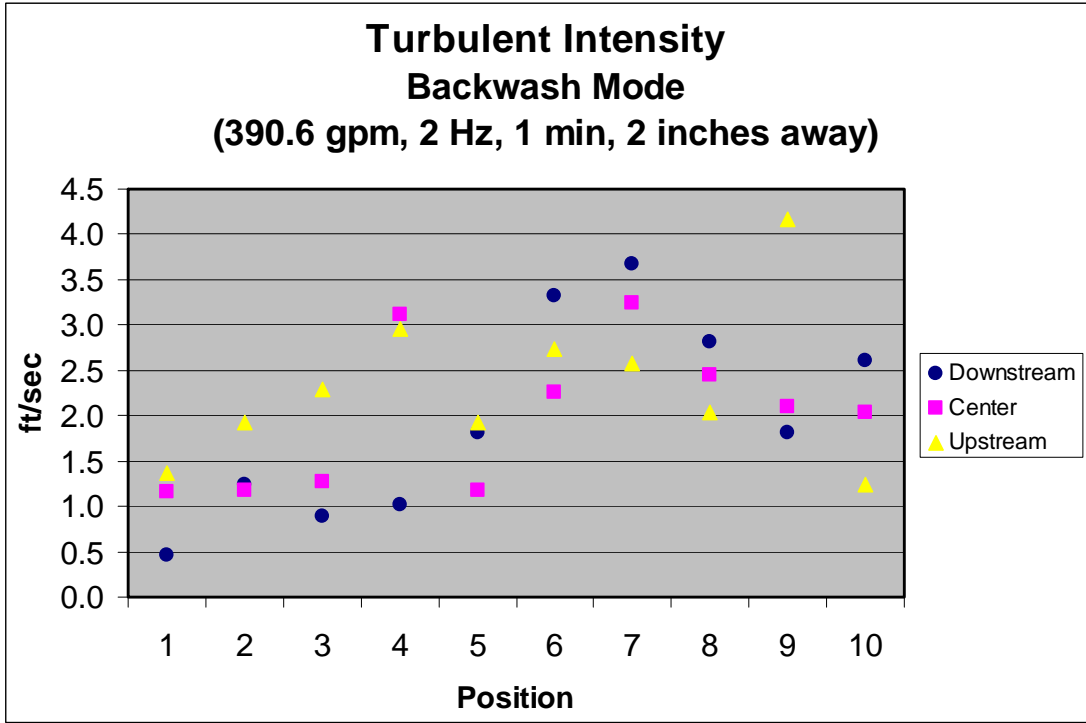
Figure 3.2. Turbulent intensities estimated at 10 locations along the lateral under the backwash mode.

velocities. However, no directional velocity was detected. The turbulent intensity estimated at each location is given in Table 3.2 and Figure 3.2. The average turbulent intensities were comparable as shown in Table 3.2.

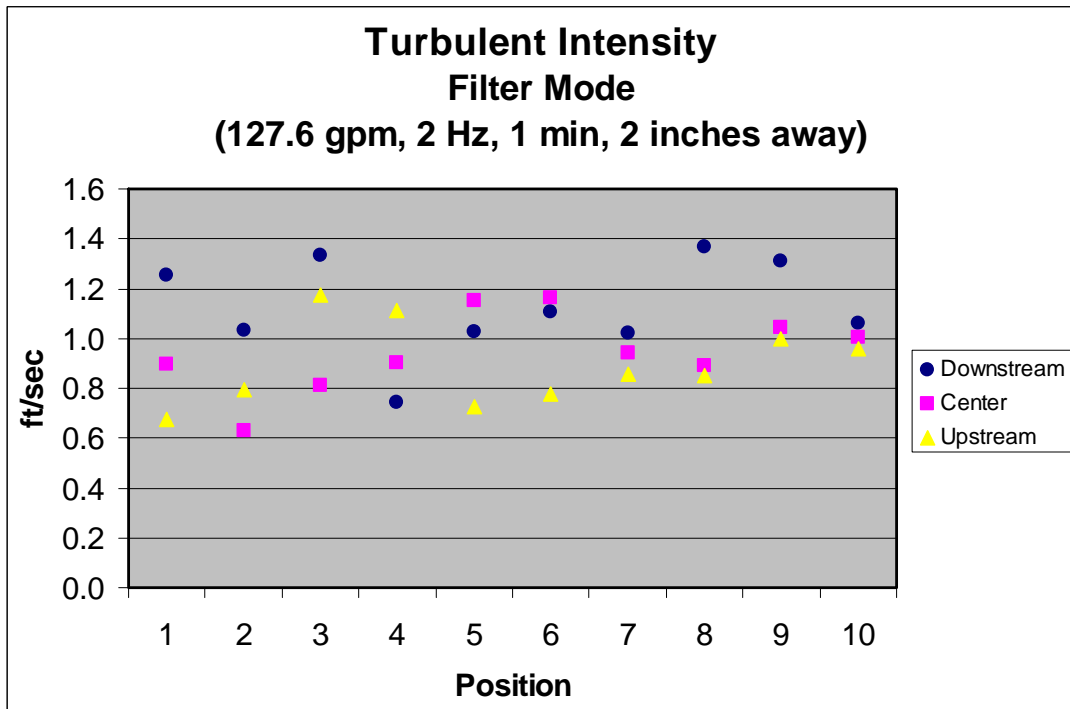
Figure 3.3. Turbulent intensities estimated at 10 locations along the lateral under the filter mode.

The first test series was conducted at 30 points, similar to the last backwash test series. Velocities were measured at a frequency of 2 Hz for a period of one minute. The point velocities were measured two inches away from the lateral. The flow rate was at 127.6 gpm (4.9 gpm/ft²). The turbulent intensities are summarized in Table 3.3 and Figure 3.3. The average turbulent intensities at the three regions of the lateral were comparable.

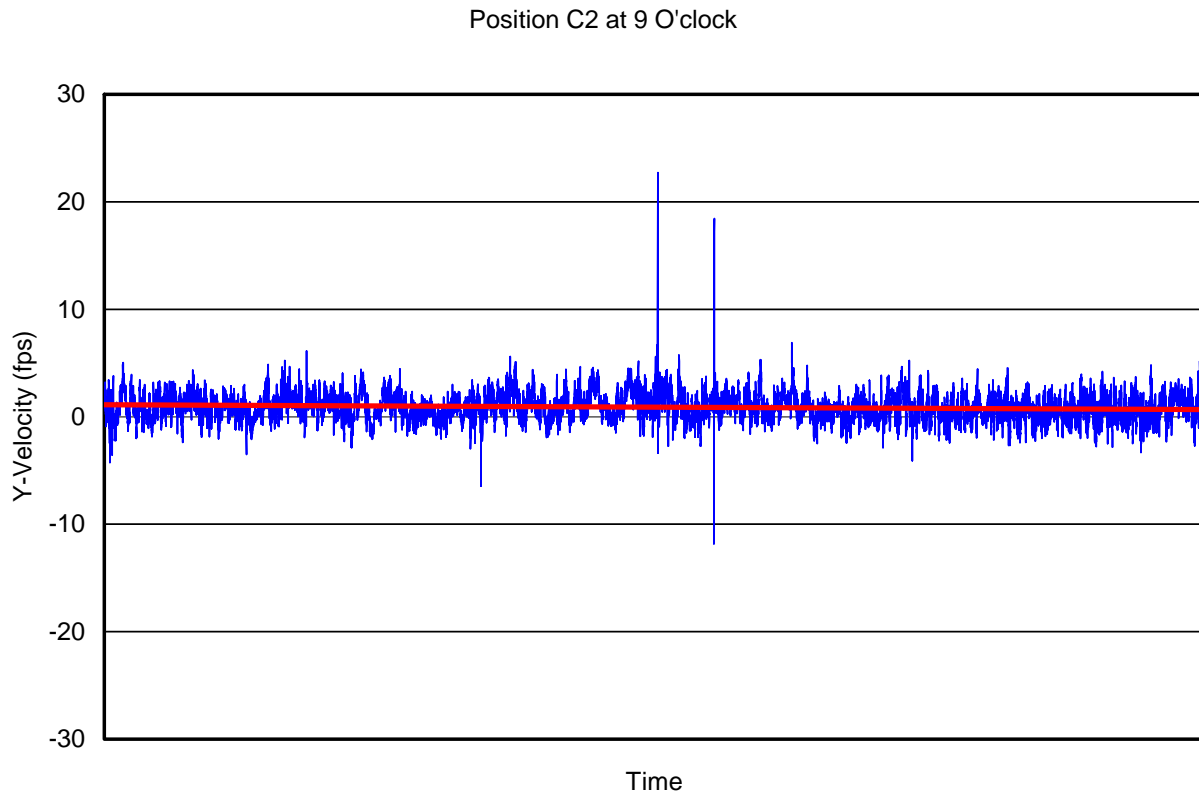
Figure A.5. Time series of the y-component of velocities measured at location C2 (Figure 3.1a) with the ADV measurement point at the 9 o'clock position. The measurement point was 1.5 inches away from the lateral and the frequency of measurements was set at 25 Hz for a period of 10 minutes, i.e. 15,000 measurements.

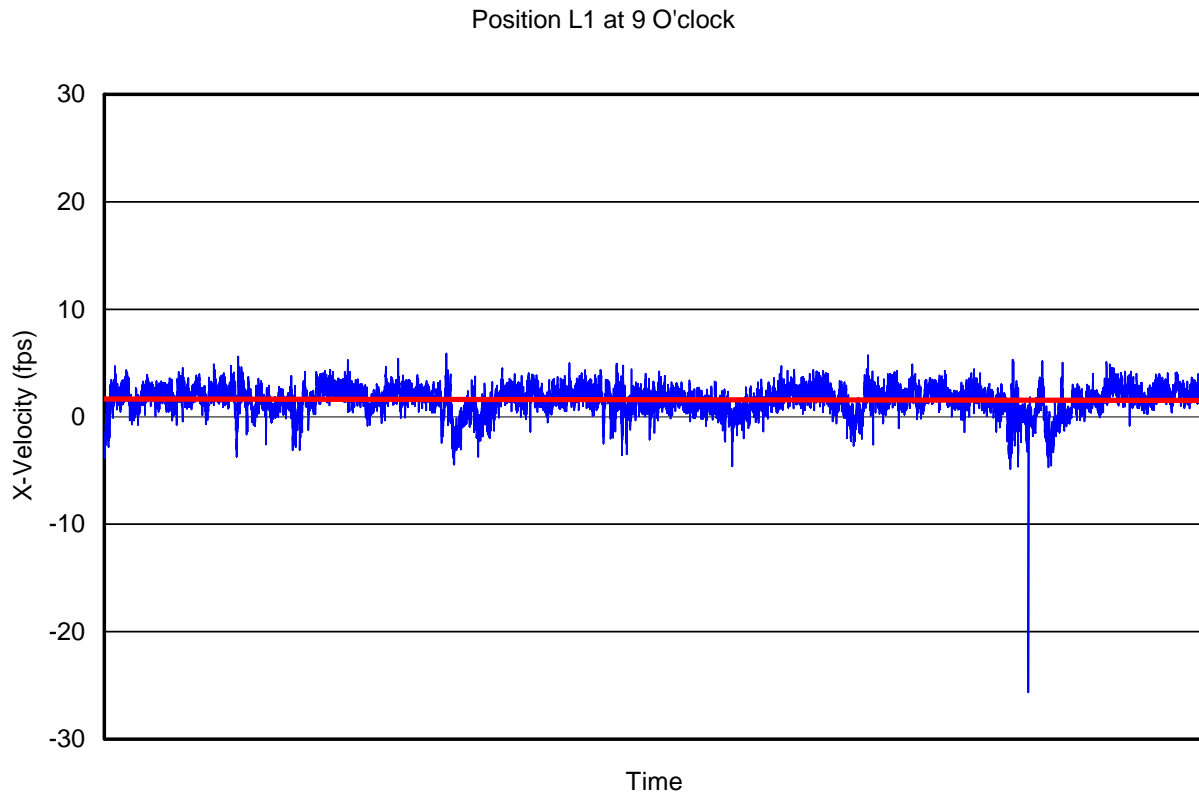
Figure A.7. Time series of the x-component of velocities measured at location L1 (Figure 3.1a) with the ADV measurement point at the 9 o'clock position. The measurement point was 1.5 inches away from the lateral and the frequency of measurements was set at 25 Hz for a period of 10 minutes, i.e. 15,000 measurements.

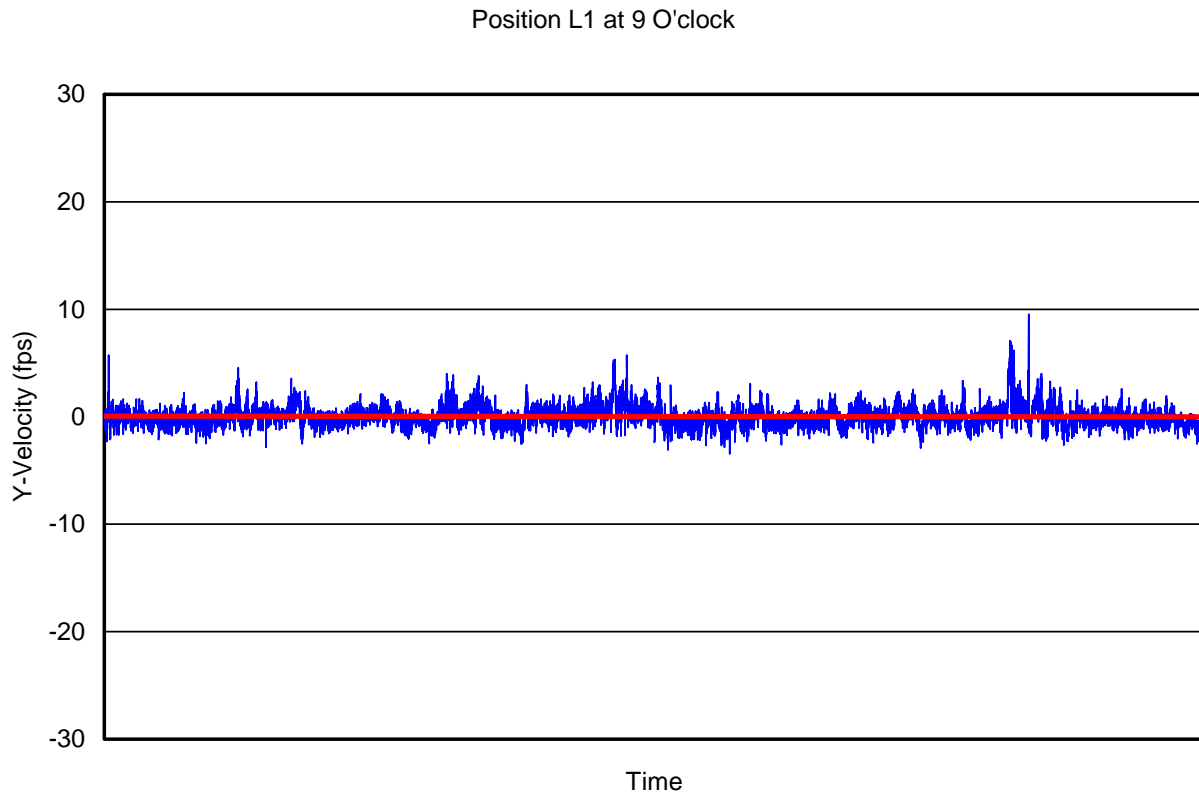
Figure A.8. Time series of the y-component of velocities measured at location L1 (Figure 3.1a) with the ADV measurement point at the 9 o'clock position. The measurement point was 1.5 inches away from the lateral and the frequency of measurements was set at 25 Hz for a period of 10 minutes, i.e. 15,000 measurements.
