Impact of Asphalt Mixture Design Parameters on Transverse Cracking Performance and  
Laboratory Testing Results

A THESIS  
SUBMITTED TO THE FACULTY OF THE GRADUATE SCHOOL  
OF THE UNIVERSITY OF MINNESOTA  
BY

Benjamin William Helmer

April 2015

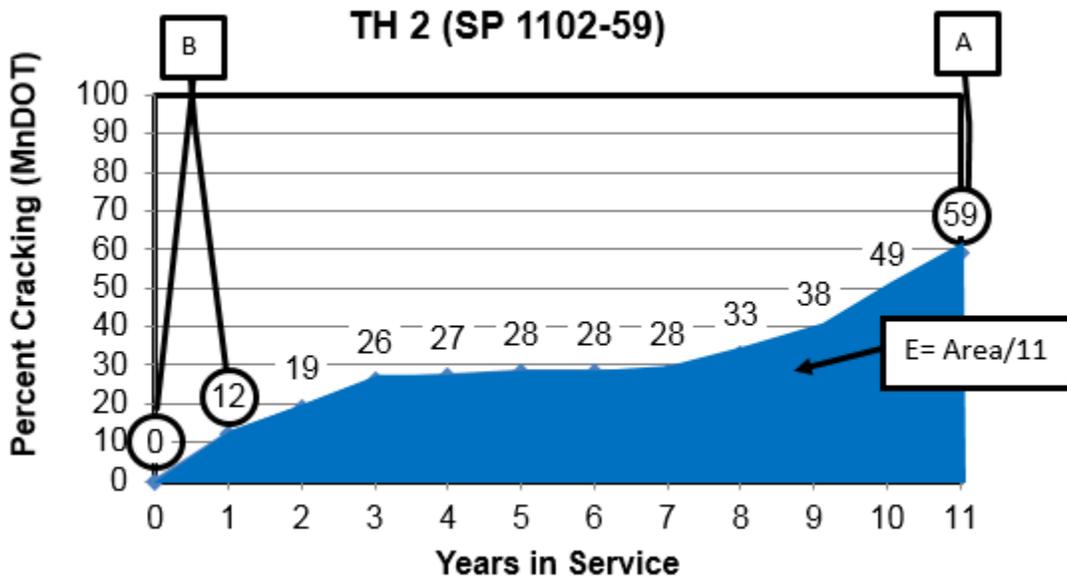
E. Total Transverse Cracking (TCTotal): this measure is best described in Figure 3. The value is the sum of the area under the percent cracking versus years in service curve (total cracking performance) divided by the total years in service. While the other measures result in percent cracking per year, this measure quantifies the total amount of cracking a roadway experiences. For the values in Figure 3, 28.8 percent is the total transverse cracking amount.

Figure 3: Example of different cracking measures

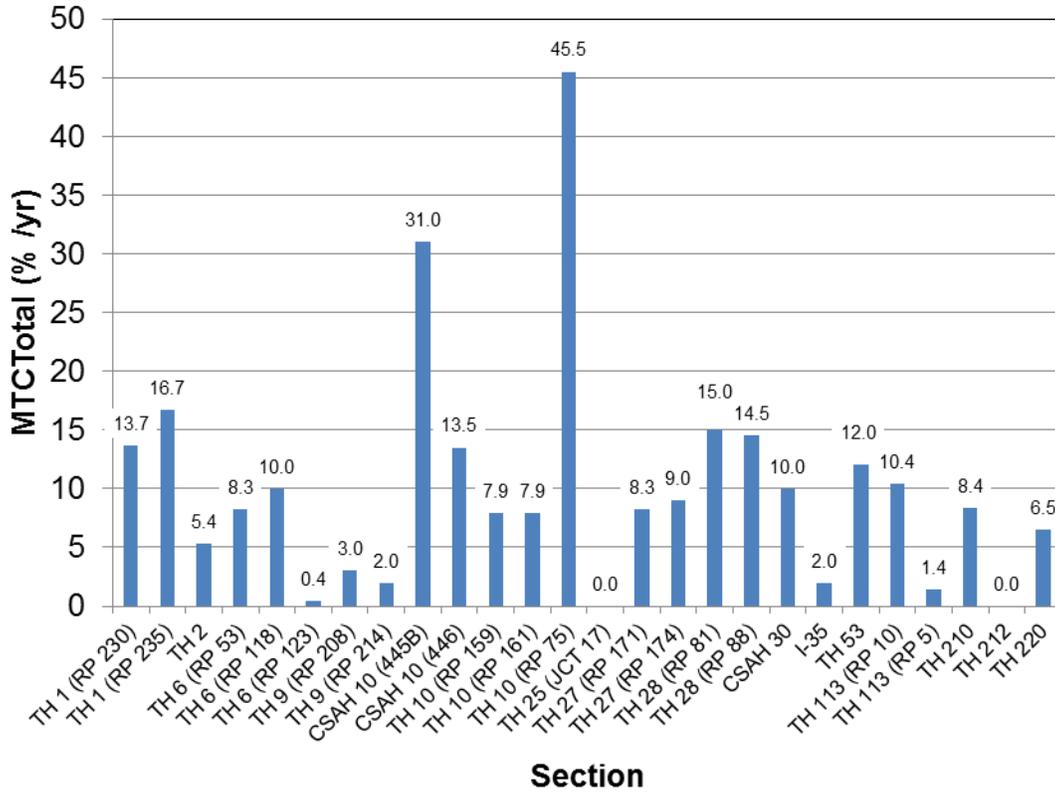
Figure 22: Maximum transverse cracking (MTCTotal) for all study sections

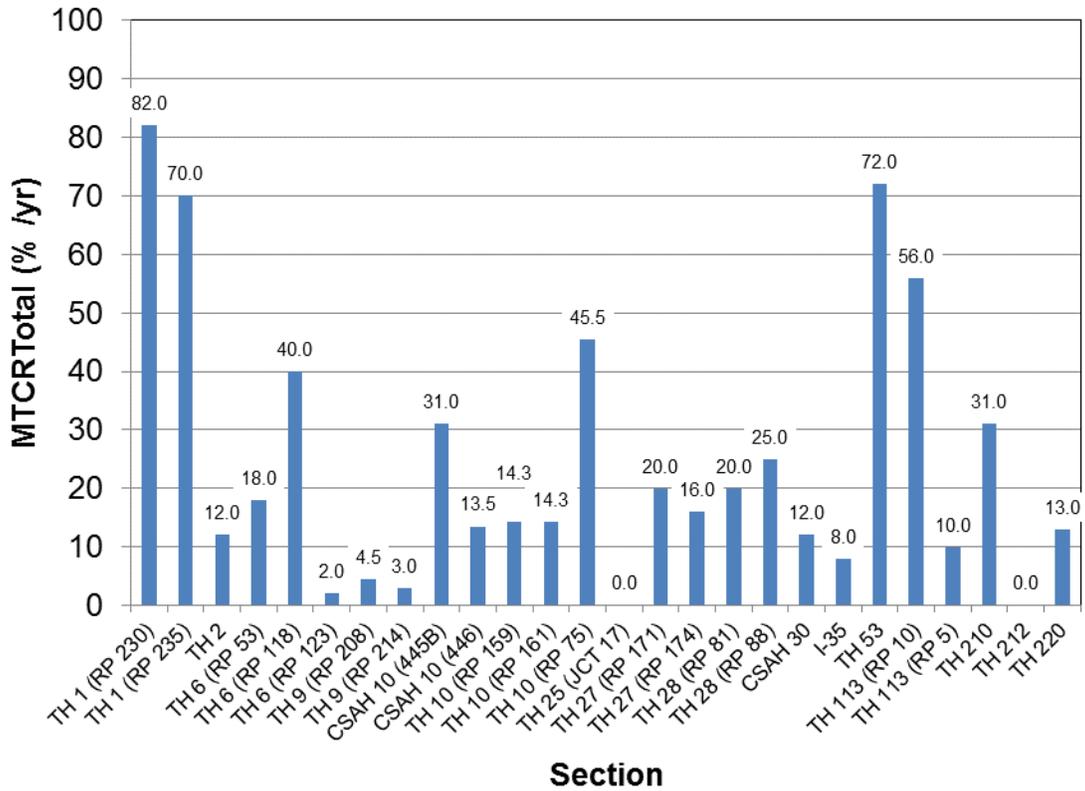
The maximum transverse cracking rate (MTCRTotal) data is presented in Figure 23. Once again this measure represents the maximum cracking increase that a pavement section experienced between two consecutive crack counts. Three of the study sections (TH 1 and TH 53 which are all located in Northern/North Eastern Minnesota) experienced relatively high cracking rates (between 70 and 82% cracking within a year). While more details are presented in the analysis of this data, generally the overlay sections showed higher cracking rates early in service. Alternatively, reclaim sections showed a higher cracking rate later in service.

Figure 23: Maximum transverse cracking rates (MTCRTotal) for all study sections

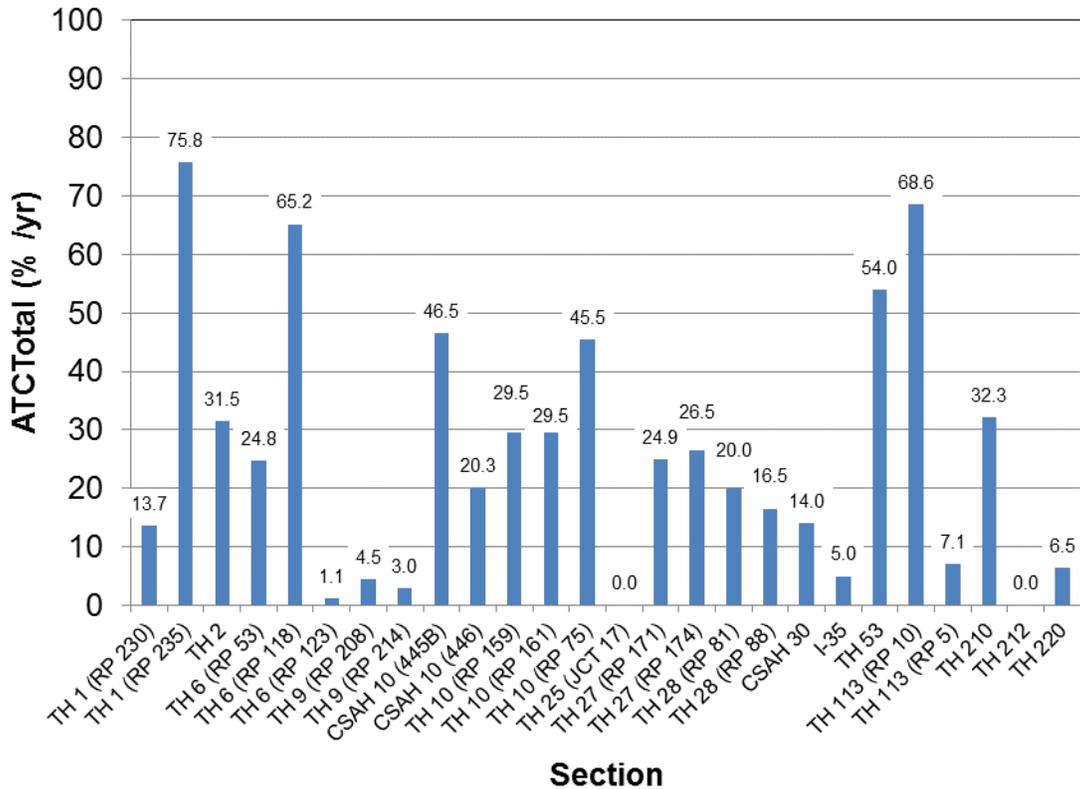
The average transverse cracking (ATCTotal) information for all sections is presented in Figure 24. This measure differs from the previous measures in the sense that it accounts for cracking performance of the pavement section for each service year. Thus, this measure provides credit to pavements that have performed well for several years before cracking over a comparable section that displayed cracking within the first few years of service. The previous measures only focus on the maximum cracking amounts from all available data or maximum rate of cracking. With this measure the TH1 RP 230 and RP 235 sections show significantly different performance as the RP 235 experienced cracking early in the service life where as RP 230 experienced cracking later in the life.

Figure 24: Average transverse cracking (ATCTotal) for all study sections

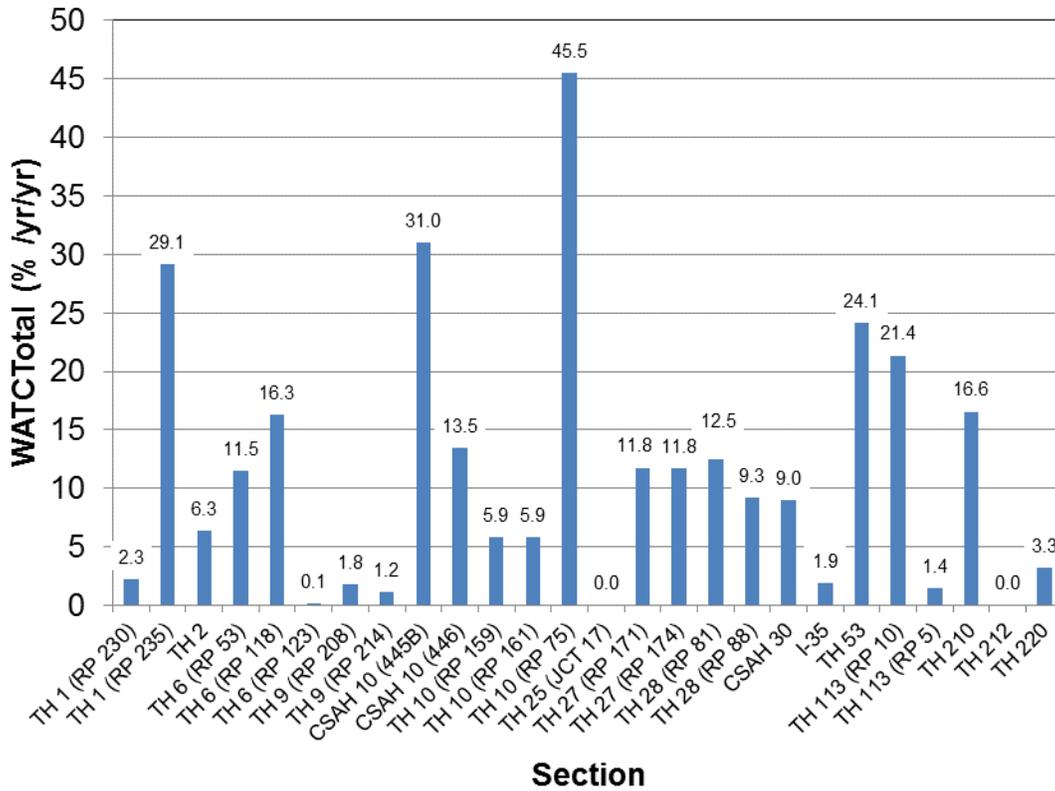
The weighted average transverse cracking (WATCTotal) data for all sections is presented in Figure 25. This measure attempts to further quantify the historical performance of a roadway. It is similar to ATCTotal, as it factors in the transverse cracking amount for each year, but applies a weight factor to all years. WATCTotal reflects cracking late in the service life positively as compared to early cracking. Similar relationships are shown to ATCTotal; this measure was developed to identify if trends are maintained during comparison from one measure to the other.

Figure 25: Weighted average transverse cracking (WATCTotal) for all study sections

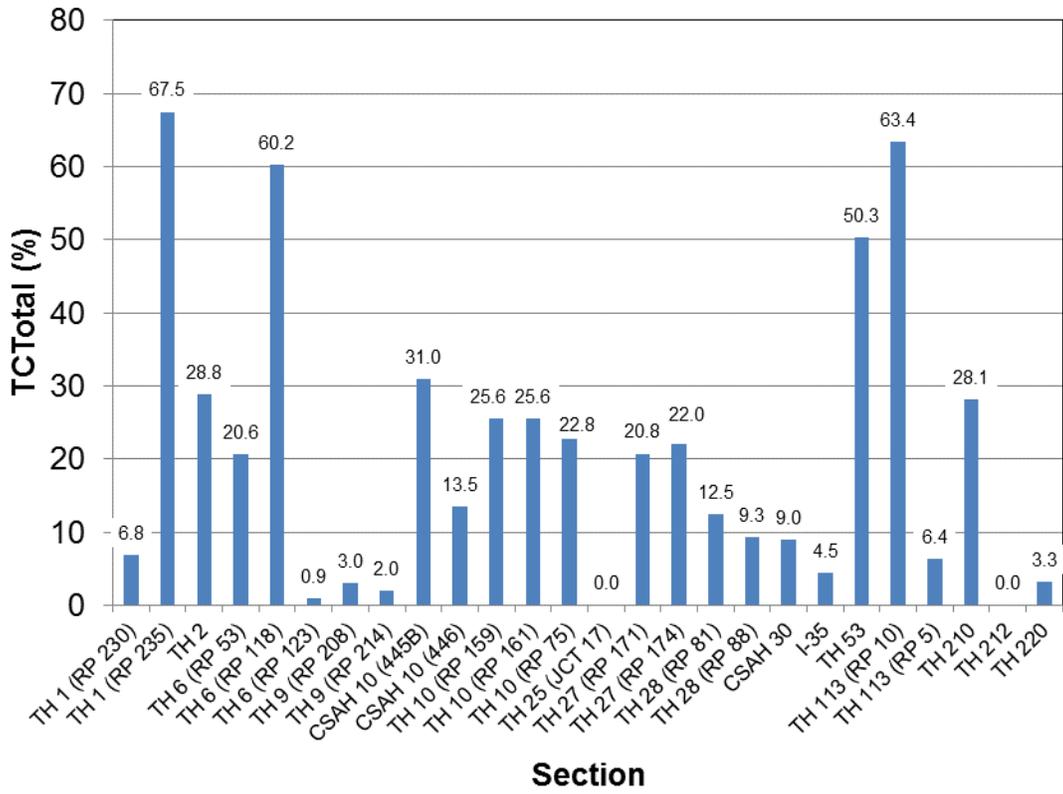
Total transverse cracking (TCTotal) for all sections can be found in Figure 26. While previous measures are calculated using only the annual cracking amounts, TCTotal evaluates the sum of the area under the percent cracking versus years in service curve (total cracking performance). This is conducted to essentially quantify all the cracking experienced by a roadway. Again, the different measures are used to determine if a different perspective of cracking disproves any preliminary conclusions made during the analysis process.

Figure 26: Total transverse cracking (TCTotal) for all study sections

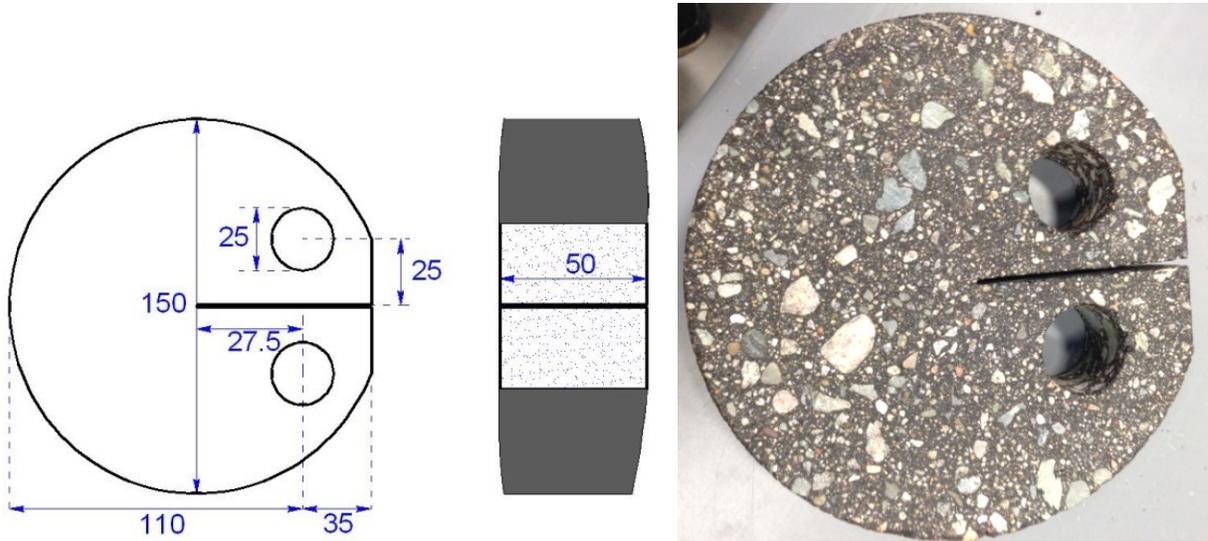
Specimens for the DCT test can come from gyratory compacted pills or field cores. In the case of this study, all specimens came from field cored samples. Sample preparation involves sawing the pills or cores into 50 mm thick disks. Generally, both faces (top and bottom) of the disk are saw cut. The flat face, 25 mm diameter loading holes, and notch are then cut. See Figure 27 for a schematic of the typical DCT specimen and an actual prepared sample.

Figure 27: (a) Disk-shaped compact tension specimen geometry (dimensions in mm);  
 (b) prepared DCT specimen

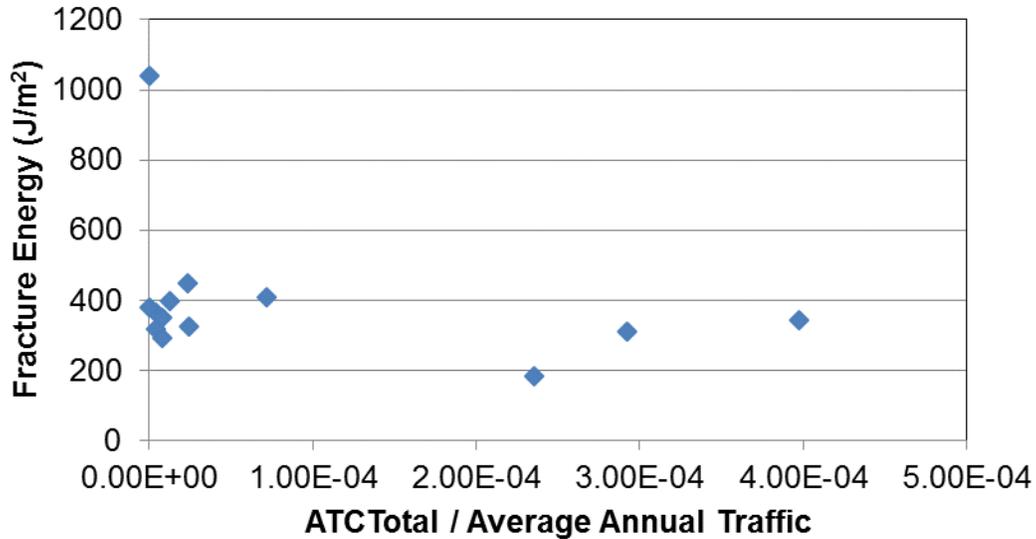
A typical relationship between fracture energy and transverse cracking data normalized for traffic level is illustrated in Figure 41. Total annual traffic, total annual truck traffic and daily traffic rates were all considered for this topic. All plots produced using this method resulted in a cluster of data near the origin and several points straying from this location, resulting in no true relationship. Upon removal of the “stray data”, no relationship was found as the trend was essentially nonexistent. The data from this effort appears to validate that no strong correlation exists between traffic levels and fracture energy. Additional plots related to this topic can be found in the Appendix to this document.

Figure 41: Fracture energy versus ATCTotal normalized for average annual traffic

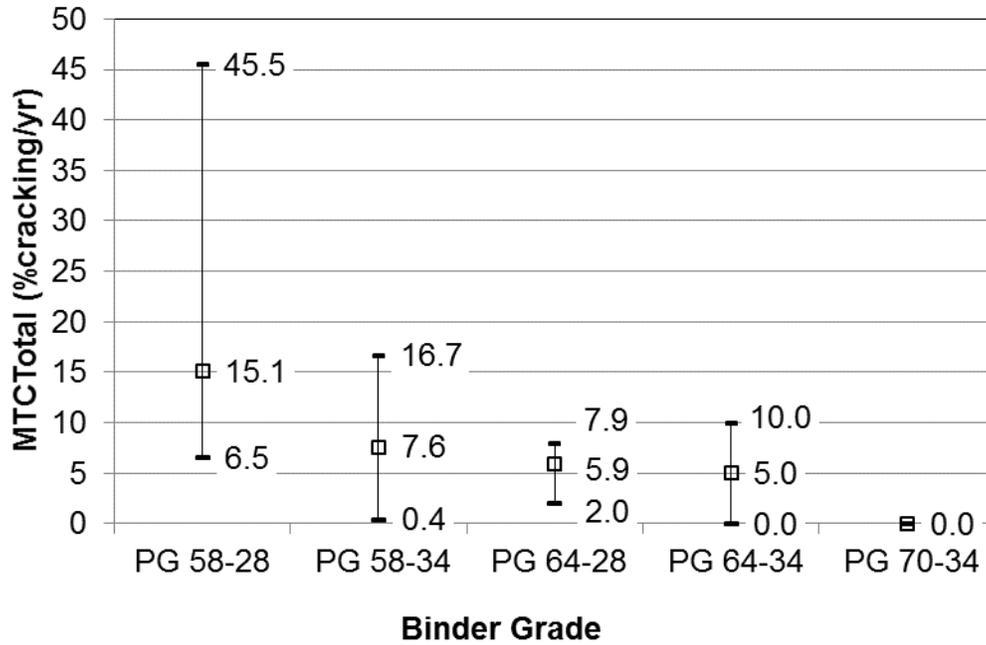
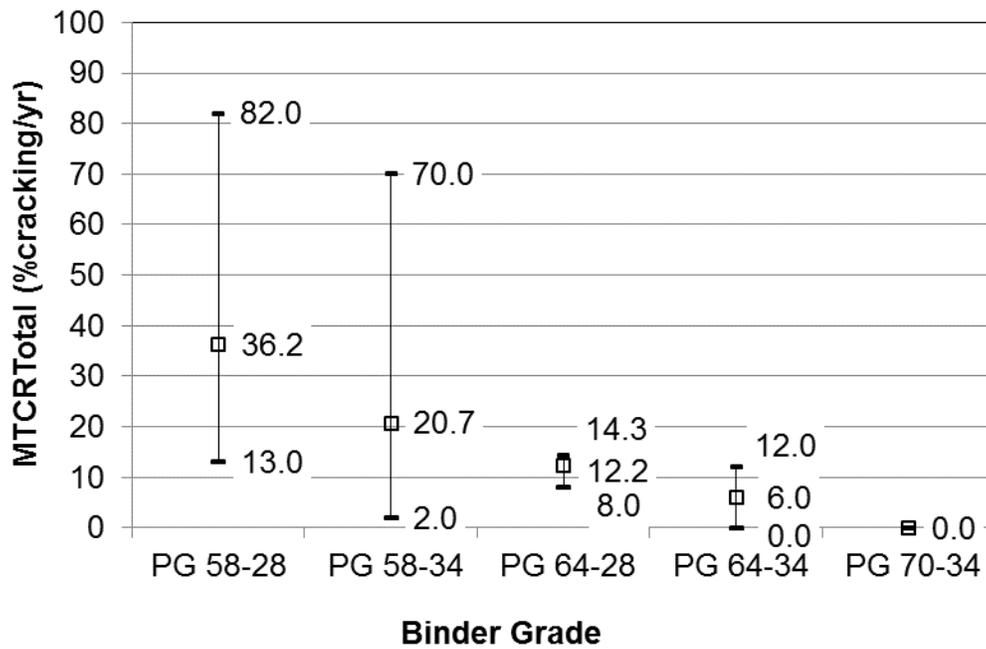
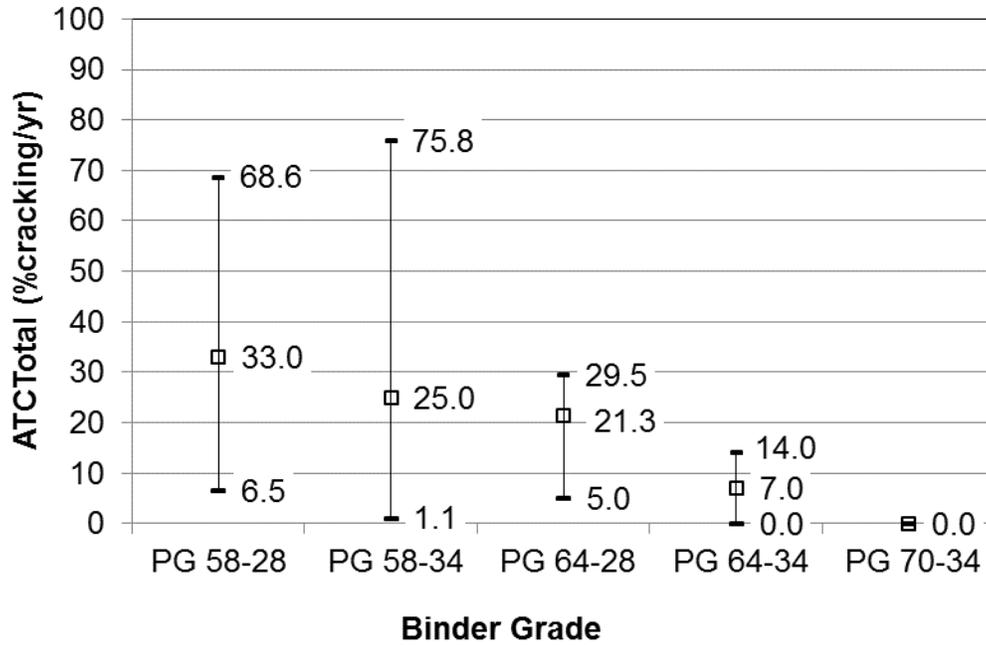
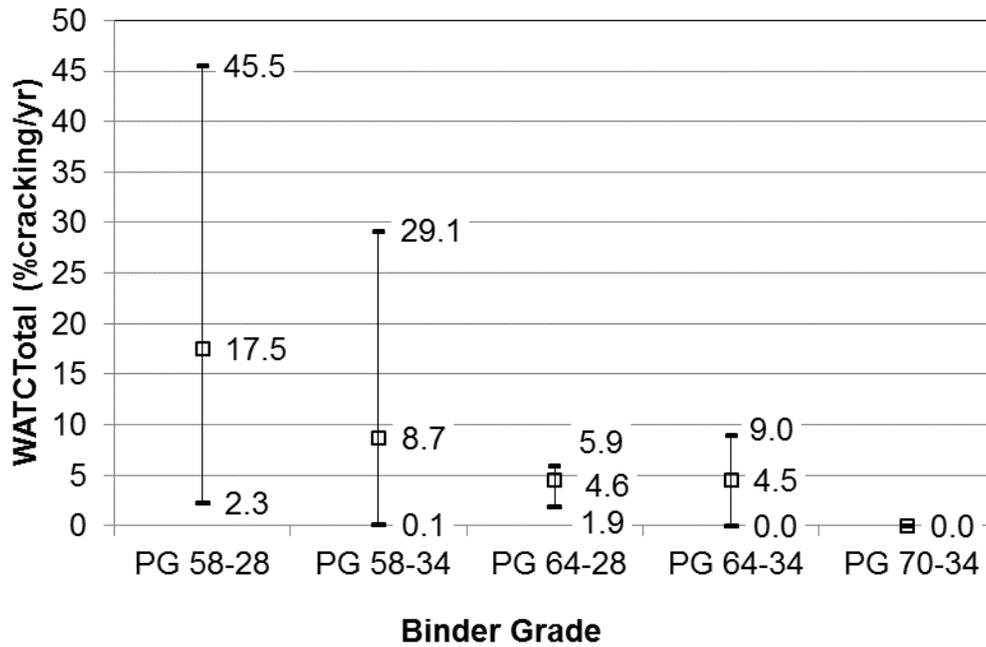
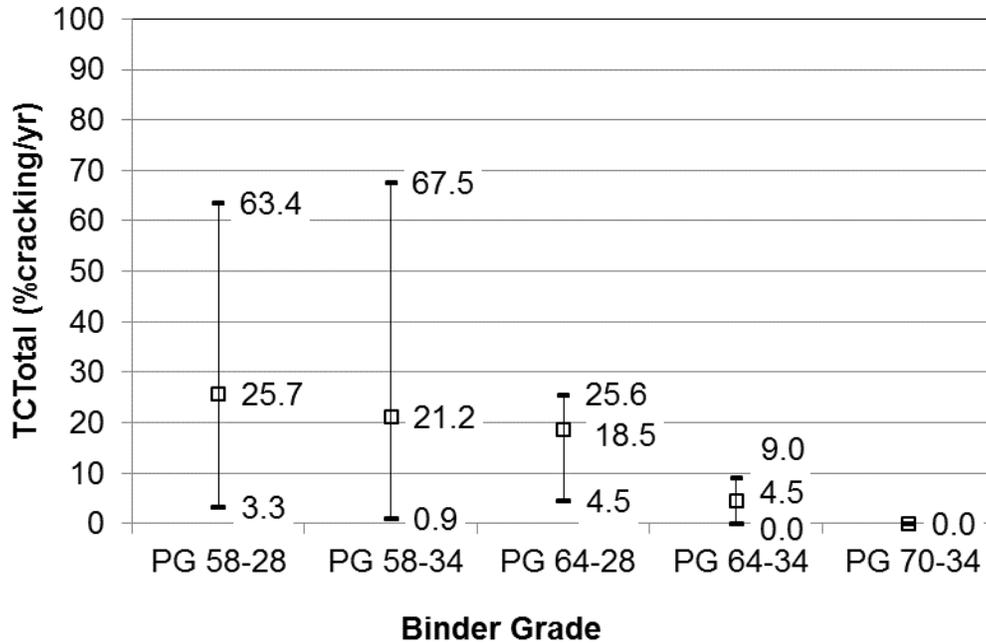
The plots presented in Figure 51 to Figure 55 compare the results of PG grade against maximum total transverse cracking amount. These plots incorporate a box-and-whisker design, where the average is the “box” with the maximum and minimum values as the “whiskers”. The average values are for all pavement sections that were constructed using same grade of the virgin binder in the mix. The plots are generated in the order of decreasing averaged cracking measures with the PG grades. From these plots a loose trend of decreasing transverse cracking performance is observed as the binder grade goes in the order of PG 58-28, PG 58-34, PG 64-28, PG 64-34 and PG 70-34.

Figure 51: Effect of asphalt binder grade on the maximum total transverse cracking amount (MTCTotal)

Figure 52: Effect of asphalt binder grade on the maximum total transverse cracking rate (MTCRTotal)

Figure 53: Effect of asphalt binder grade on the average total transverse cracking amount (ATCTotal)

Figure 54: Effect of asphalt binder grade on the weighted average total transverse cracking amount (WATCTotal)

Figure 55: Effect of asphalt binder grade on the total transverse cracking amount (TCTotal)

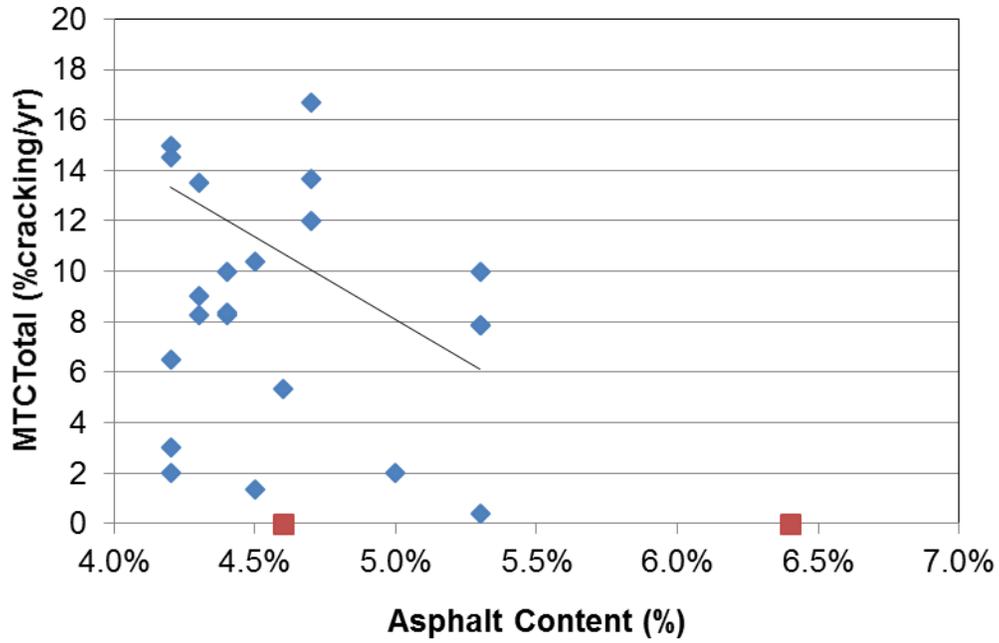
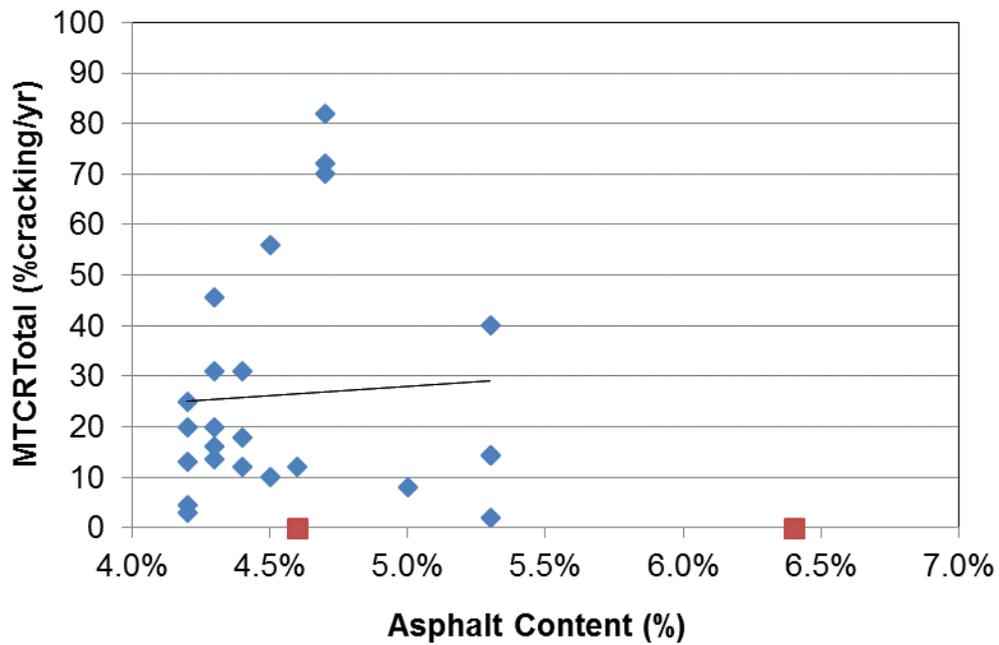
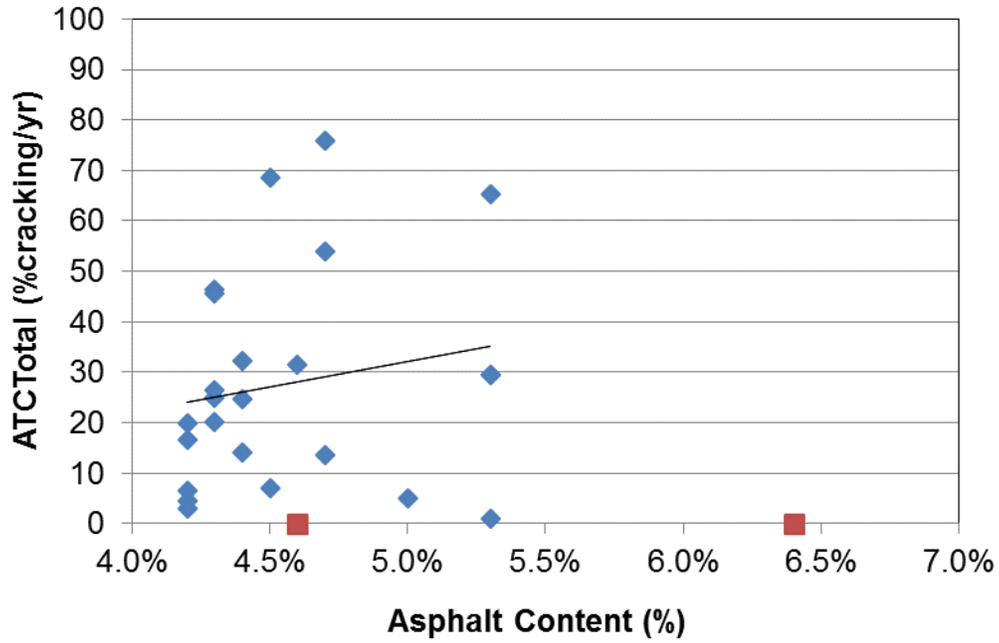
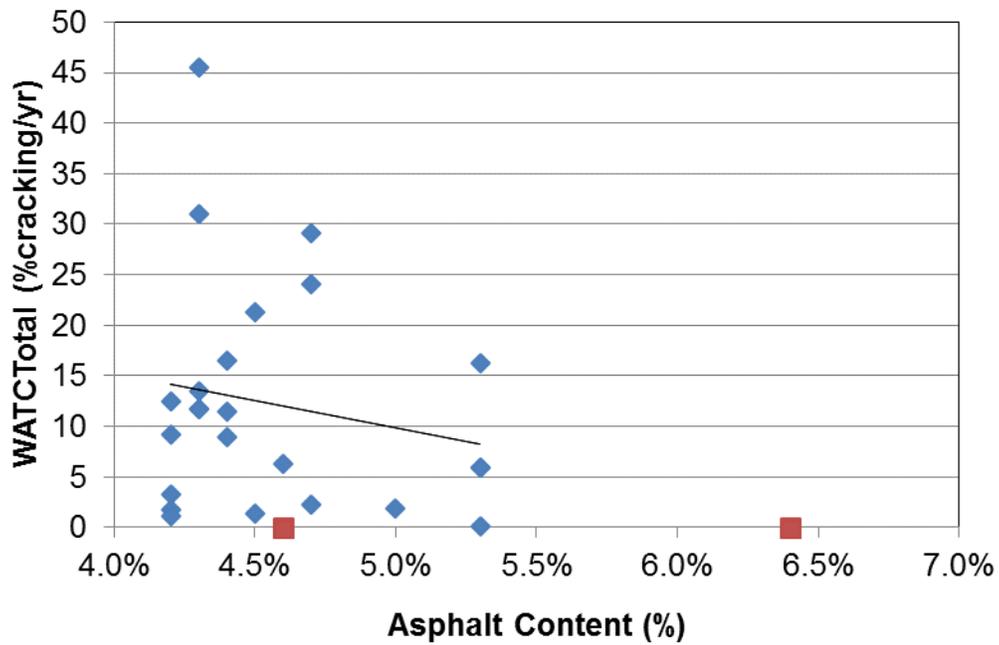
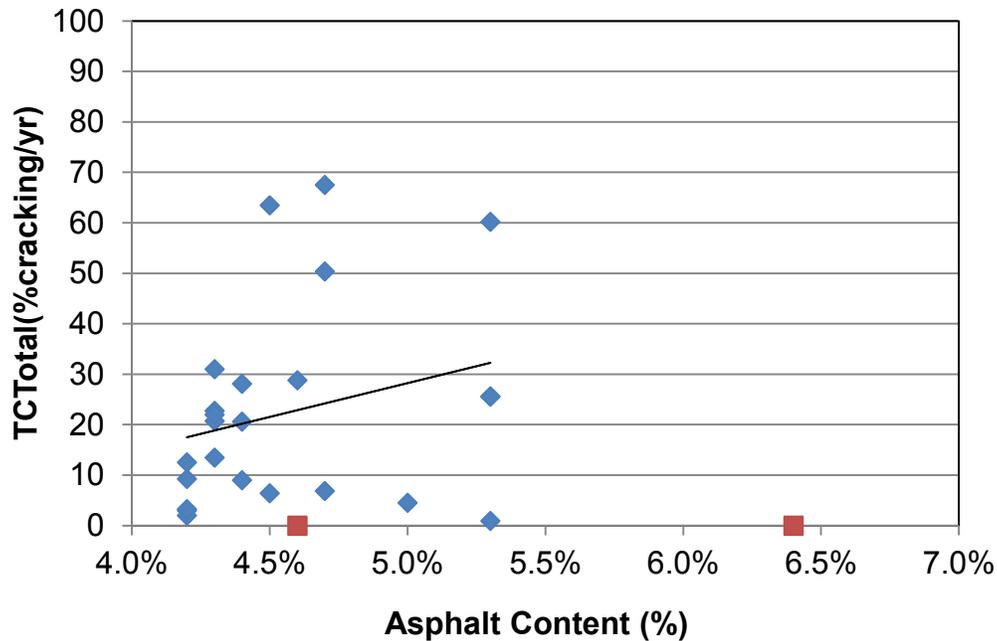
However, the other measures show slight upward trends suggesting cracking performance decreases as binder content increases. It should be noted that a large amount of scatter is present in these plots. This indicates that other factors may also be important and asphalt binder content alone cannot be used as an independent performance measure. While a general trend may exist that concurs with the recommendations from earlier research, other factors (possibly binder aging) have an impact on performance. This strongly illustrates the need for a performance test, as many factors have an impact on cracking performance.

Figure 61: Effect of percentage of asphalt content on the maximum total transverse cracking amount (MTCRTotal)

Figure 62: Effect of percentage of asphalt content on the maximum total transverse cracking rate (MTCRTotal)

Figure 63: Effect of percentage of asphalt content on the average total transverse cracking amount (ATCTotal)

Figure 64: Effect of percentage of asphalt content on the weighted average total transverse cracking amount (WATCTotal)

Figure 65: Effect of percentage of asphalt content on the total transverse cracking amount (TCTotal)

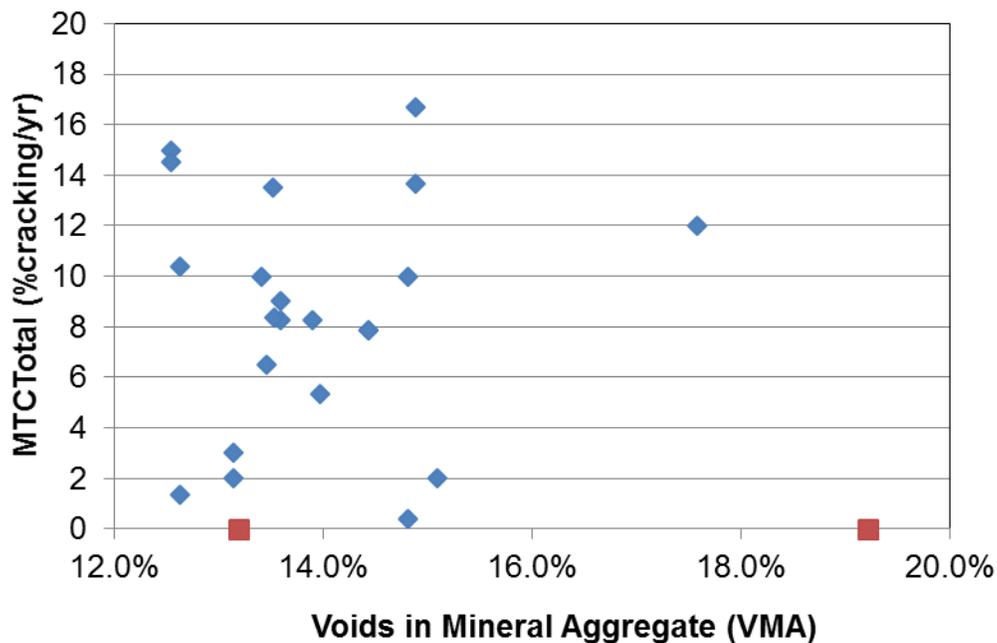
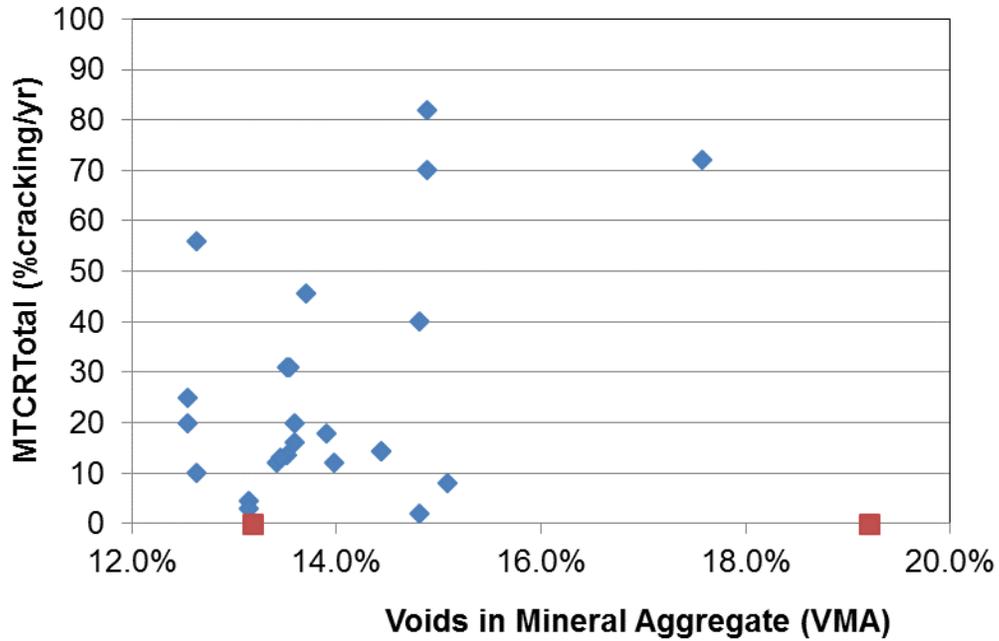
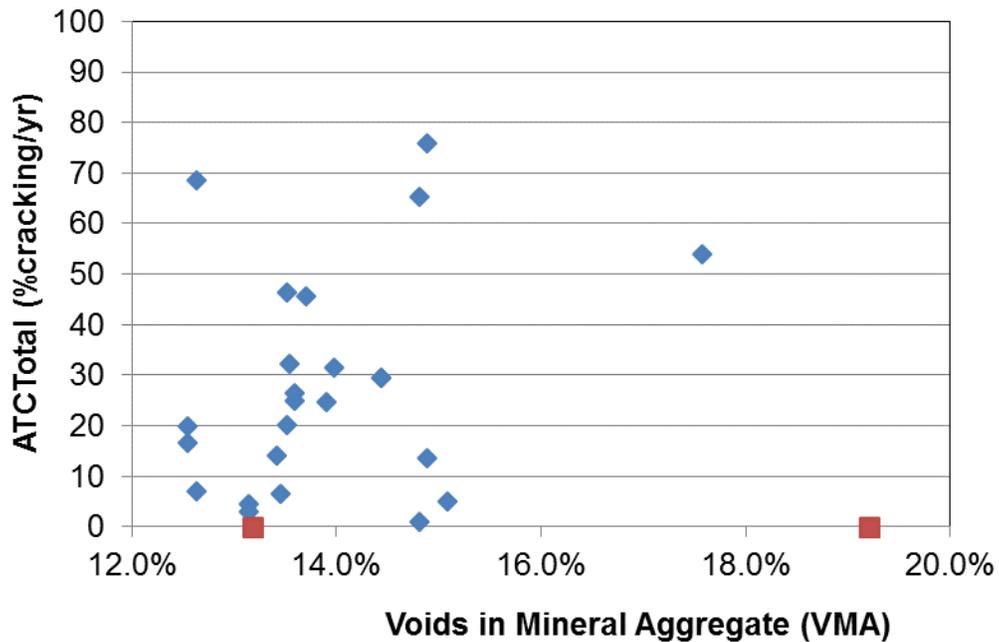
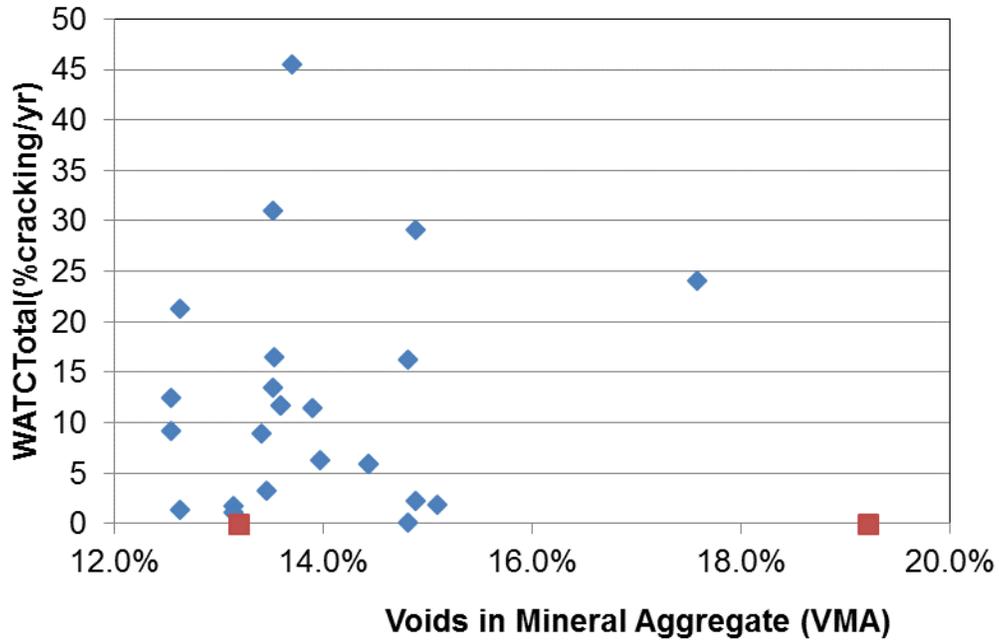
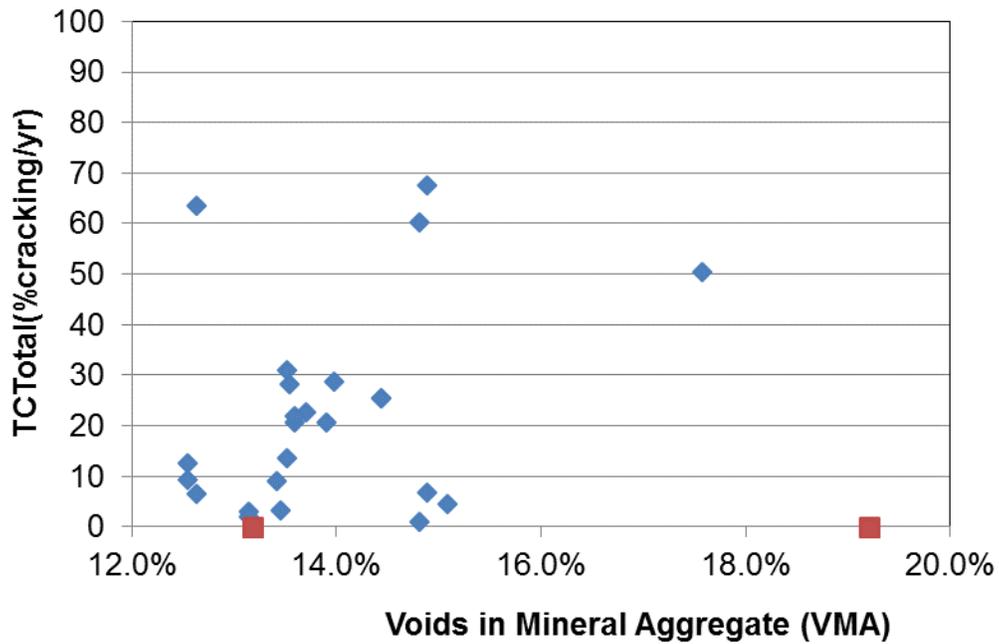
Figure 71 to Figure 75 show the comparison between transverse cracking measures and the voids in mineral aggregate (VMA) of each mix. Contrary to earlier recommendations, the data in this portion of the study does not appear to have any type of trend in relation to VMA and transverse cracking. It should be reiterated that the projects incorporated in this research study were all designed and constructed using two different versions of MnDOT 2360 specifications that required a minimum VMA amount. The newer pavements were constructed with a minimum required asphalt film thickness (AFT). Note that the newer designs utilizing the adjusted asphalt film thickness (AFT) specification have significantly lower VMA amounts. This specification variability may also provide some unknown material discrepancies.

Figure 71: Effect of voids in mineral aggregate (VMA) on the maximum total transverse cracking amount (MTCTotal)

Figure 72: Effect of Voids in Mineral Aggregate (VMA) on the Maximum Total Transverse Cracking Rate (MTCRTotal)

Figure 73: Effect of voids in mineral aggregate (VMA) on the average total transverse cracking amount (ATCTotal)

Figure 74: Effect of voids in mineral aggregate (VMA) on the weighted average total transverse cracking amount (WATCTotal)

Figure 75: Effect of voids in mineral aggregate (VMA) on the total transverse cracking amount (WATCTotal)

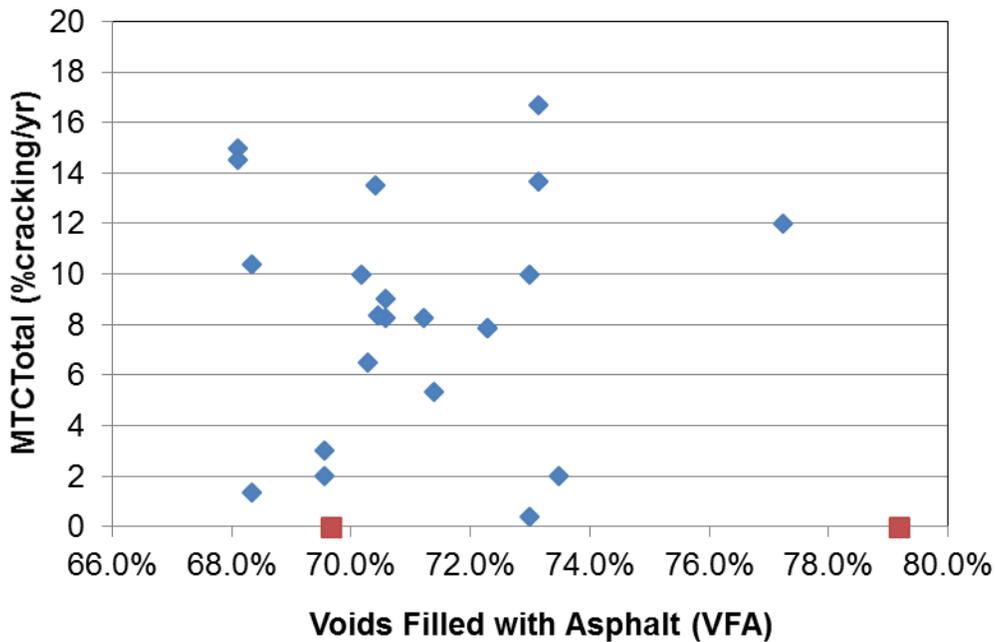
A single MTCTotal versus VFA plot has been provided in this section (Figure 76), as no unique trends were present in VFA comparisons. The remaining plots that result from the analysis of the voids filled with asphalt (VFA) of each mix can be found in the Appendix. The data in this portion of the study does not appear to have any type of trend in relation to VFA and transverse cracking. While all the mixes in this study do not have the same design traffic level (basis for Superpave VFA recommendations), all of the mixes meet the suggested VFA range for the corresponding traffic level.

Figure 76: Effect of voids filled with asphalt (VFA) on the maximum total transverse cracking amount (MTCTotal)

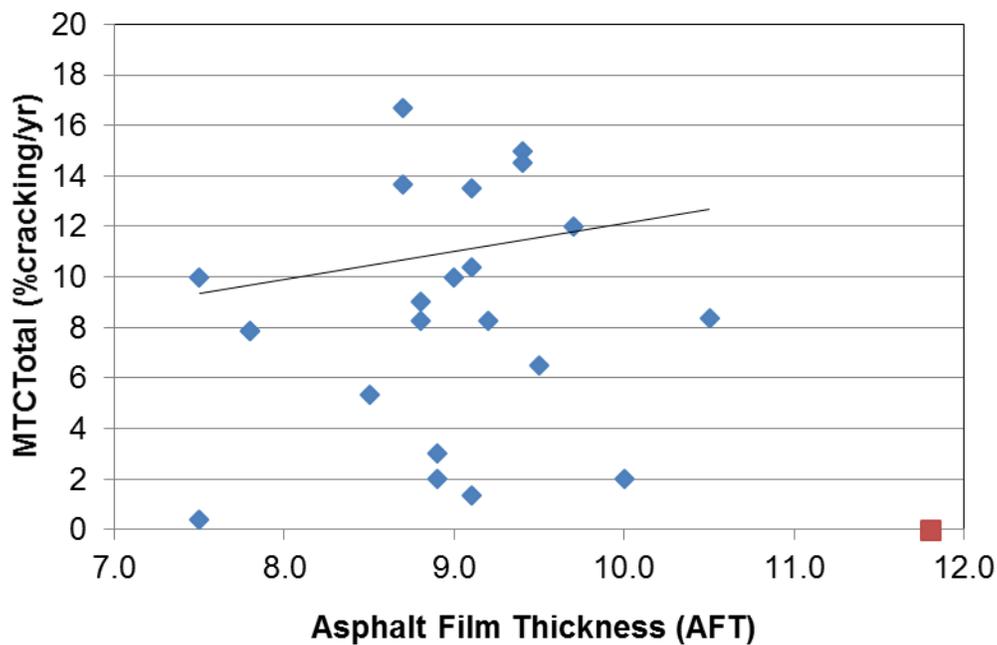
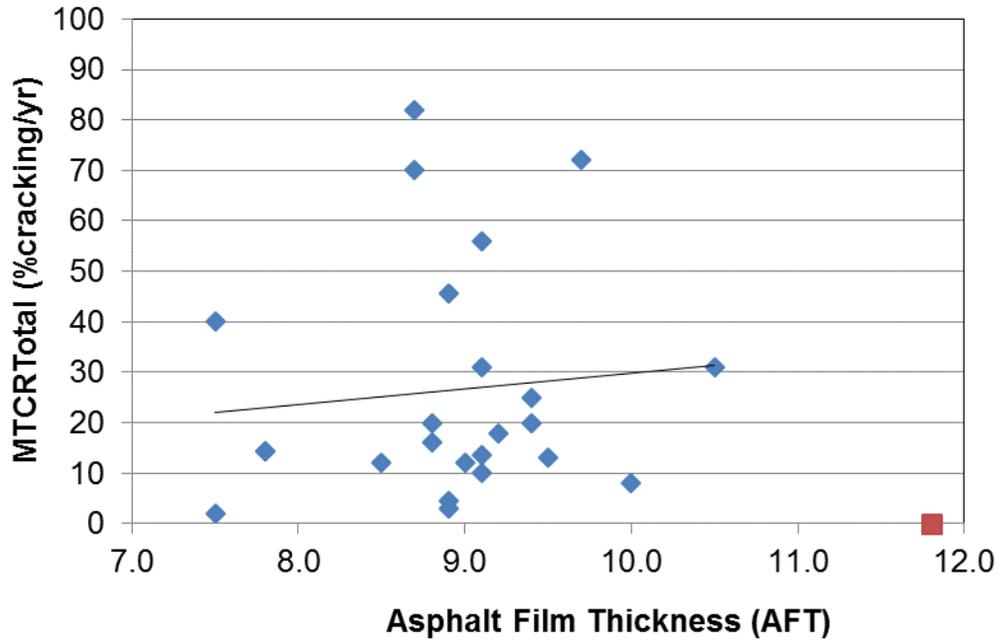
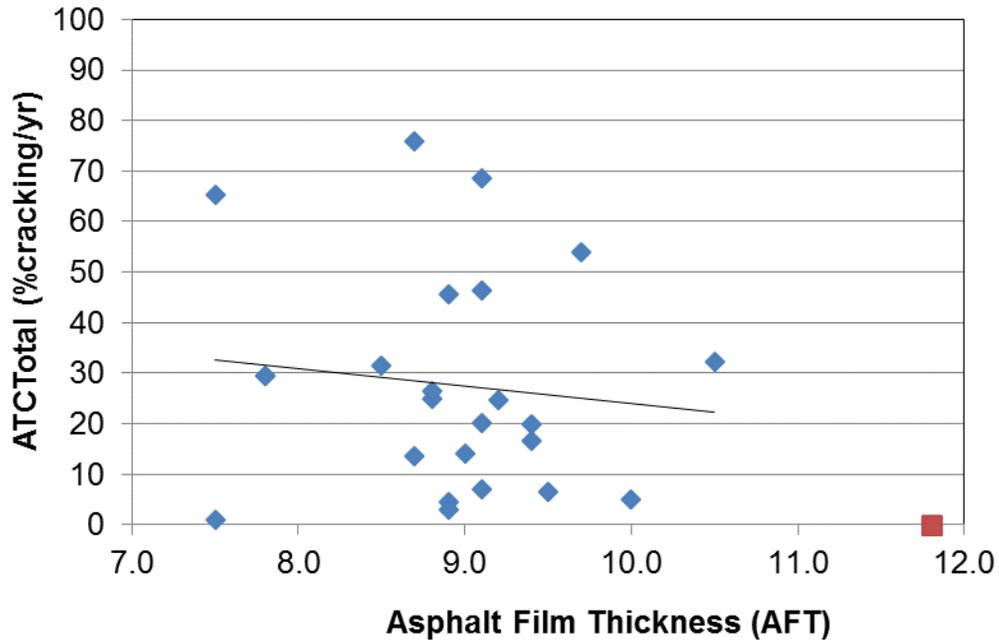
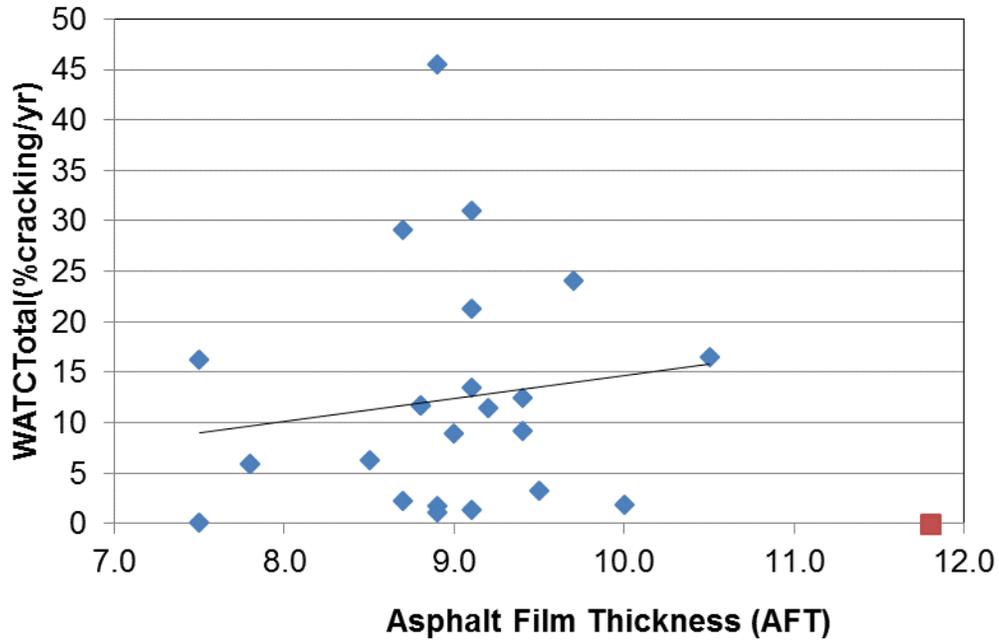
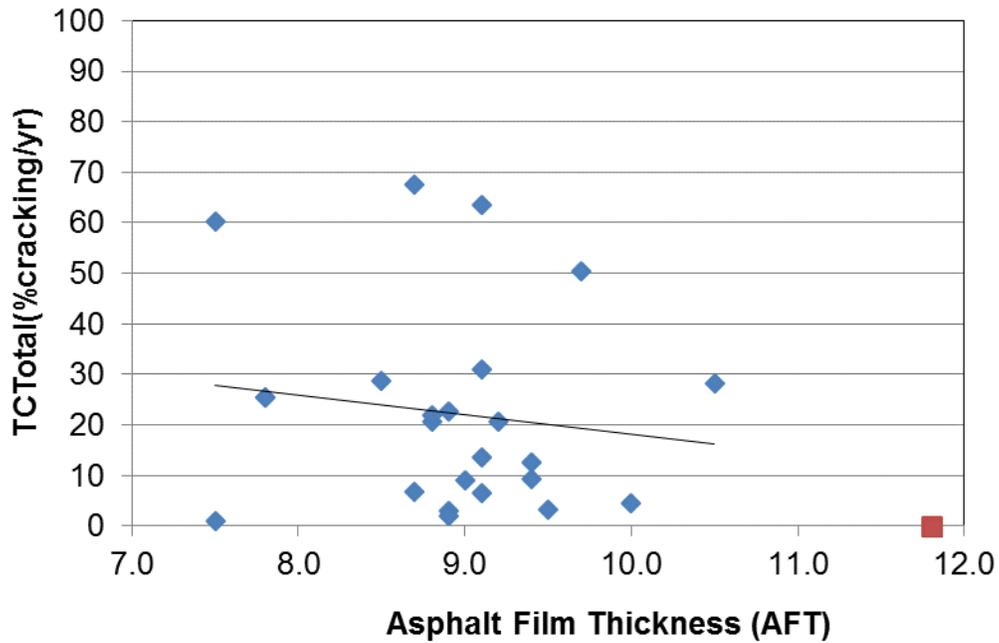
Three of the five plots (MTCTotal, MTCRTotal and WATCTotal) indicate a general trend of slightly deteriorating transverse cracking performance with increasing values of adjusted AFT. The other two measures indicate a slight decrease in cracking as AFT increases. As with other parameters, and similar to asphalt content, the data is still prone to significant scatter. The trends indicated here should not be used for the purposes of drawing conclusions.

Figure 77: Effect of adjusted asphalt film thickness (AFT) on the maximum total transverse cracking amount (MTCTotal)

Figure 78: Effect of adjusted asphalt film thickness (AFT) on the maximum total transverse cracking rate (MTCRTotal)

Figure 79: Effect of adjusted asphalt film thickness (AFT) on the average total transverse cracking amount (ATCTotal)

Figure 80: Effect of adjusted asphalt film thickness (AFT) on the weighted average total transverse cracking amount (WATCTotal)

Figure 81: Effect of adjusted asphalt film thickness (AFT) on the total transverse cracking amount (TCTotal)
