Impact of Asphalt Mixture Design Parameters on Transverse Cracking Performance and  
Laboratory Testing Results

A THESIS  
SUBMITTED TO THE FACULTY OF THE GRADUATE SCHOOL  
OF THE UNIVERSITY OF MINNESOTA  
BY

Benjamin William Helmer

April 2015

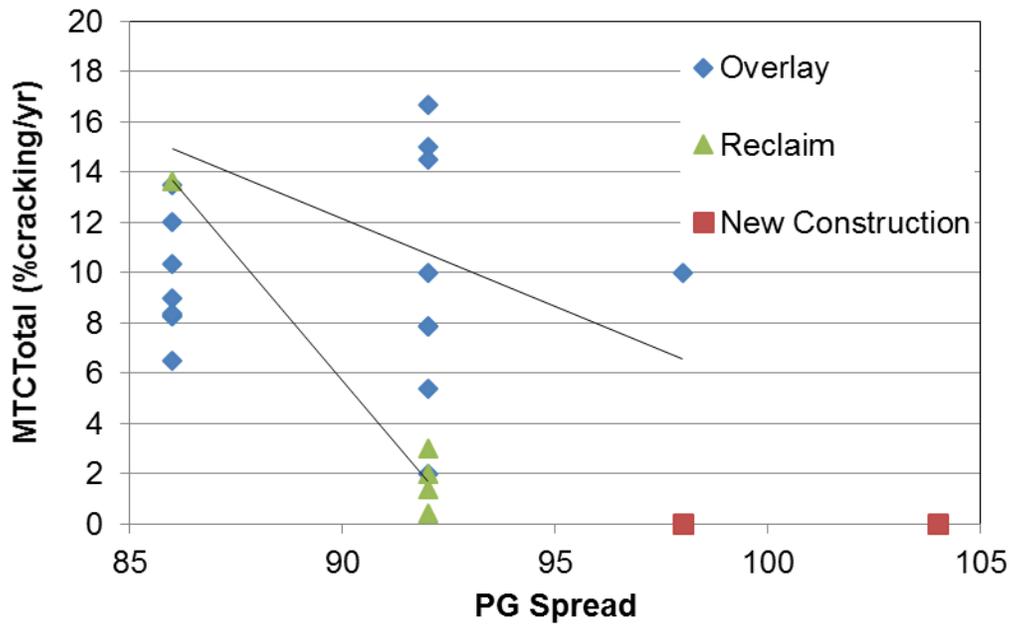
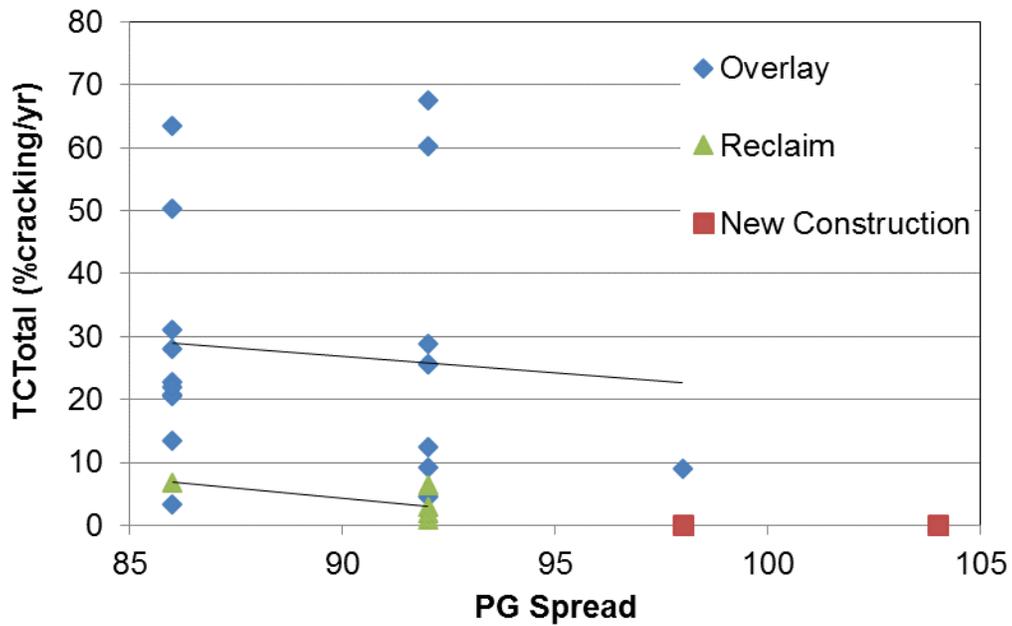
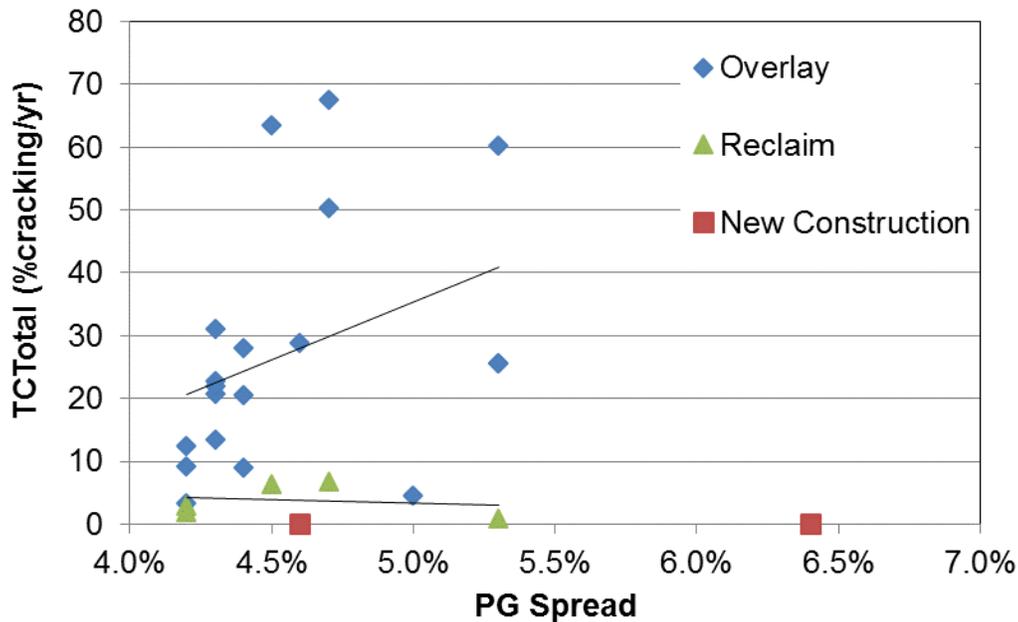
Generally, mix design parameters did not show a strong trend relating construction type and transverse cracking performance. Figure 82 through Figure 84 show two parameters that did exhibit a potential relationship between construction type and field performance. In Figure 82 as PG spread increases from 86 to 92, transverse cracking in reclaim sections shows a significant improvement while overlays exhibit less improvement. To further verify this trend, TCTotal was also examined to see if this trend continued. As shown in Figure 83, this exact relationship is also present. Figure 84 shows a looser version of the same trend as asphalt content increases. The preliminary trend in this instance is that it appears to be advantageous to use higher asphalt content or larger PG spread in reclaim sections as opposed to overlays. This trend should continue to be monitored in future studies.

Figure 82: Effect of Performance Grade spread on the maximum total transverse cracking amount (MTCTotal) categorized by construction type

Figure 83: Effect of Performance Grade spread on the total transverse cracking amount (TCTotal) categorized by construction type

Figure 84: Effect of percentage of asphalt content on the total transverse cracking amount (TCTotal) categorized by construction type

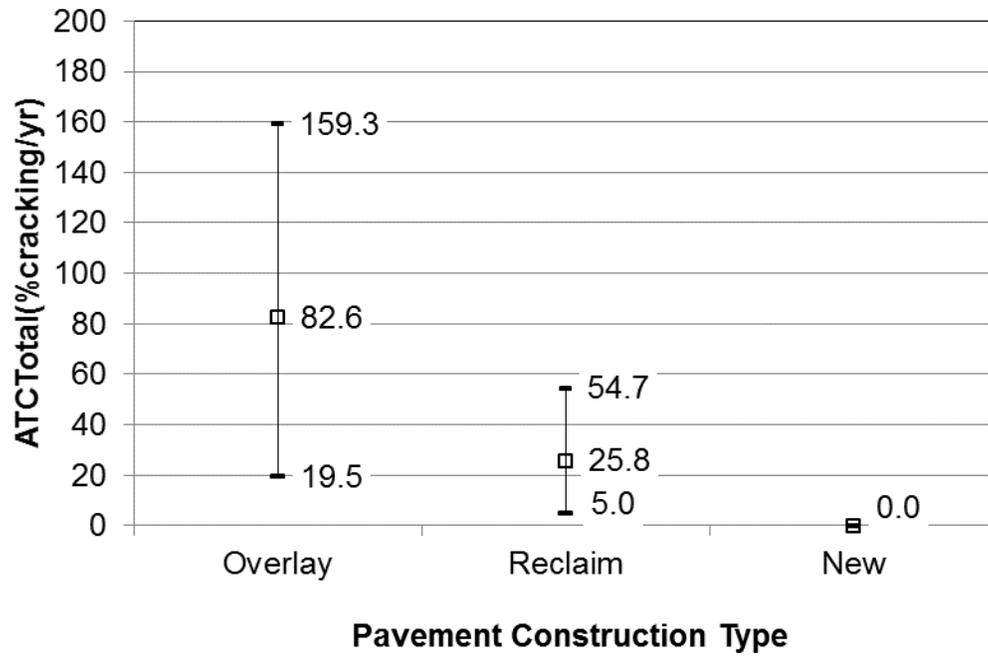
In addition, Figure 91 has been provided to reinforce the point that the reclaim sections from this project exhibit a greater resistance to transverse cracking. Figure 91 has been normalized against the asphalt layer thickness. Normalization of asphalt layer thickness is conducted by multiplying the transverse cracking amounts with the total asphalt layer wear course thickness. In a general sense reclaim projects tend to feature a thicker asphalt layer than overlays. After normalizing for the asphalt layer thickness, reclaim sections still exhibit a superior transverse cracking resistance to overlay sections. Thus, even when the added cost of thicker asphalt layer is accounted for in the analysis the cracking performance is still superior with reclaim sections. It should be noted again that this task features a small amount of sections and these trends are not identified with a high level of confidence. These are initial observations and will continue to be observed as more data is acquired.

Figure 91: Comparison of average total transverse cracking amounts (ATCTotal) normalized against wear course thickness between construction types

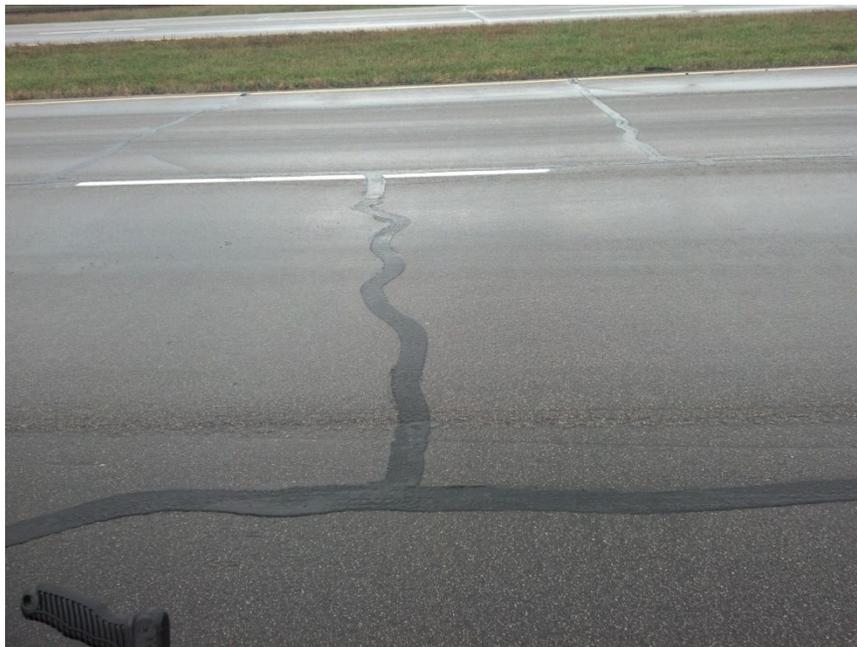
TH 10 poor performer-typical crack configuration

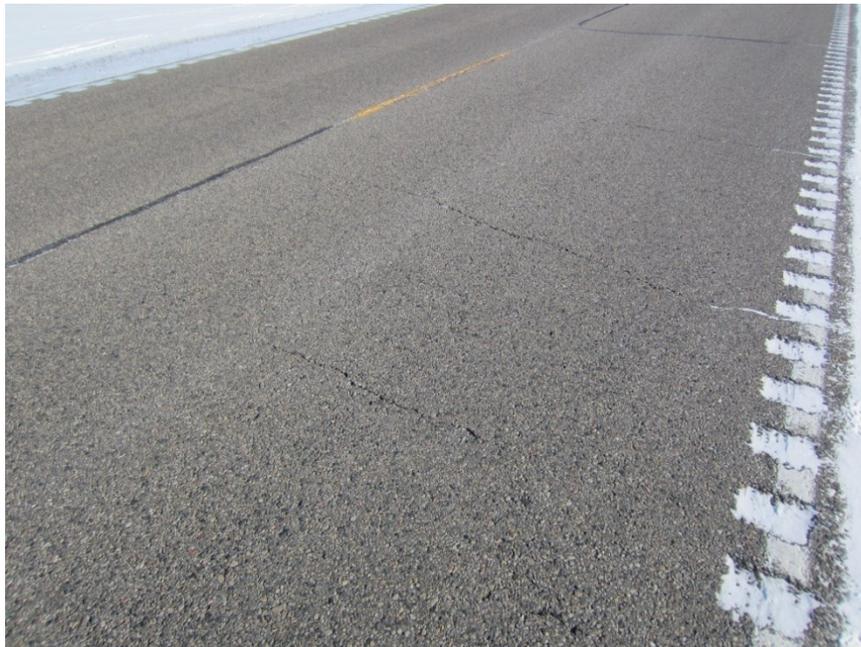
TH 113 poor performer-typical crack configuration

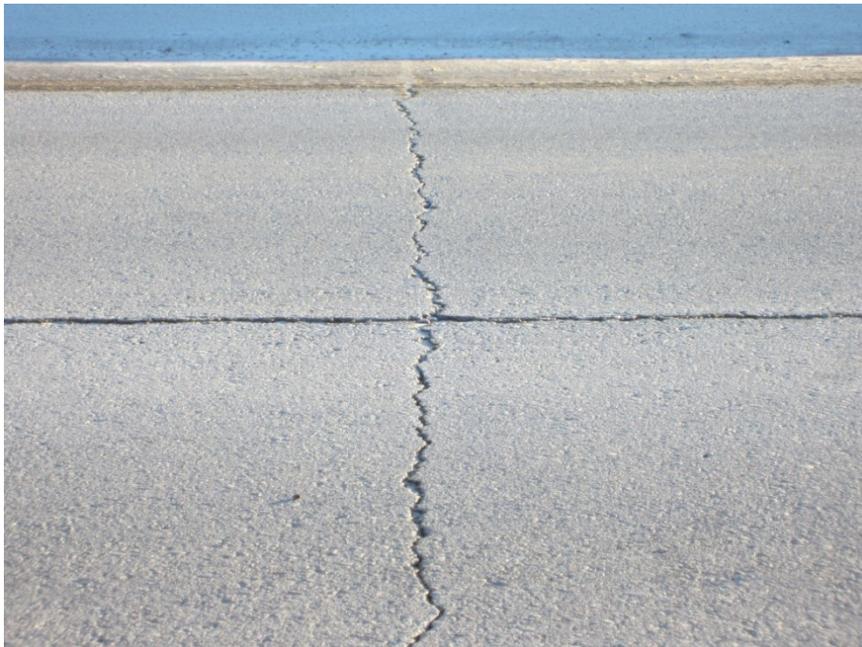
TH 210-typical crack configuration

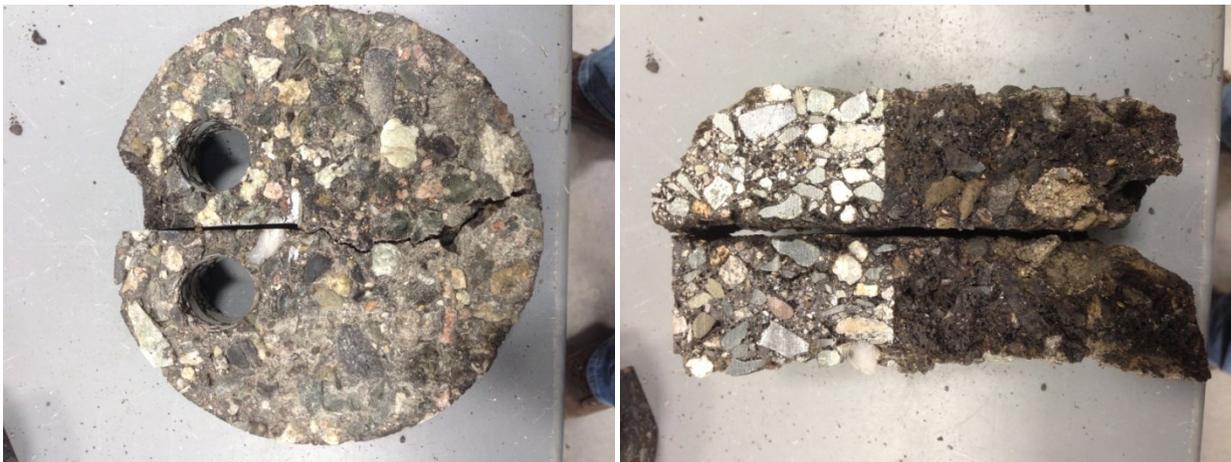
TH 1-RP 235 (poor performer)--(a) specimen profile; (b) fractured cross-section

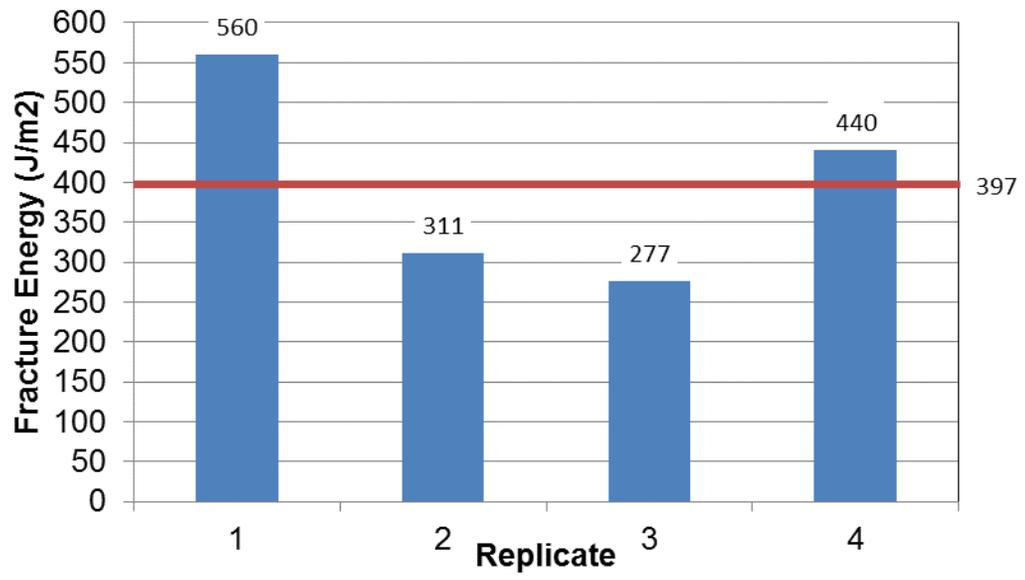
TH 53 DCT results
