Nondestructive Evaluation Advancements for Damage Detection in Concrete

A THESIS
SUBMITTED TO THE FACULTY OF
UNIVERSITY OF MINNESOTA
BY

IN PARTIAL FULFILLMENT OF THE REQUIREMENTS
FOR THE DEGREE OF
Doctor of Philosophy

June 2016

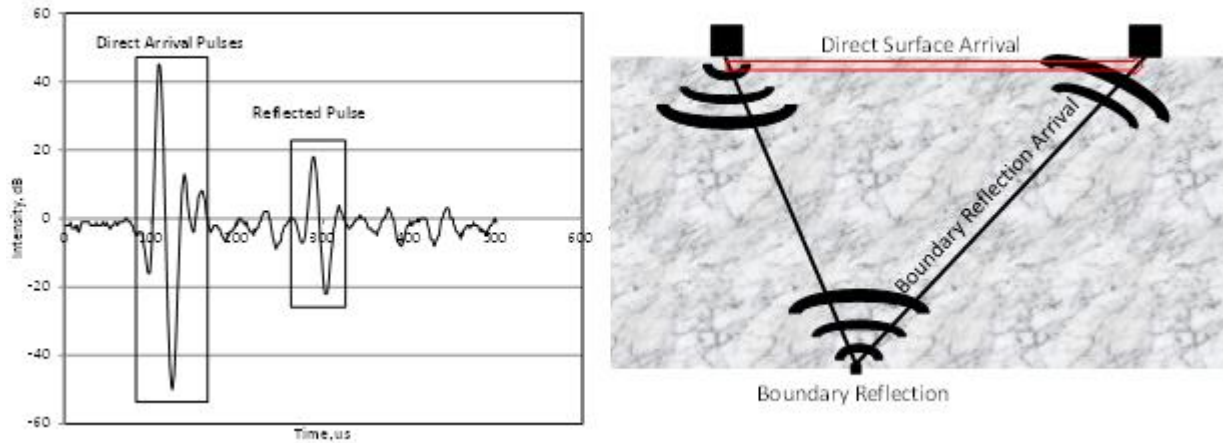
Figure 3. Example impulse time history (left), and corresponding cross section schematic (right) (Hoegh 2013).

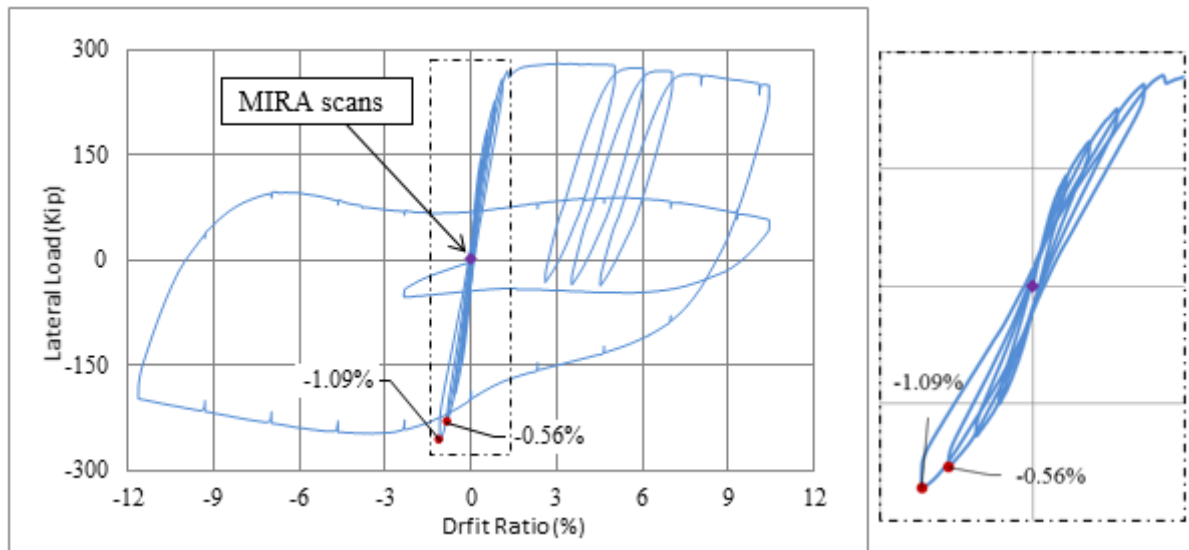
Figure 9. (left) Lateral load vs. drift ratio response and (right) enlarged cycles of interest (MIRA scans were conducted at the points shown after returning from the labelled peak drift locations).

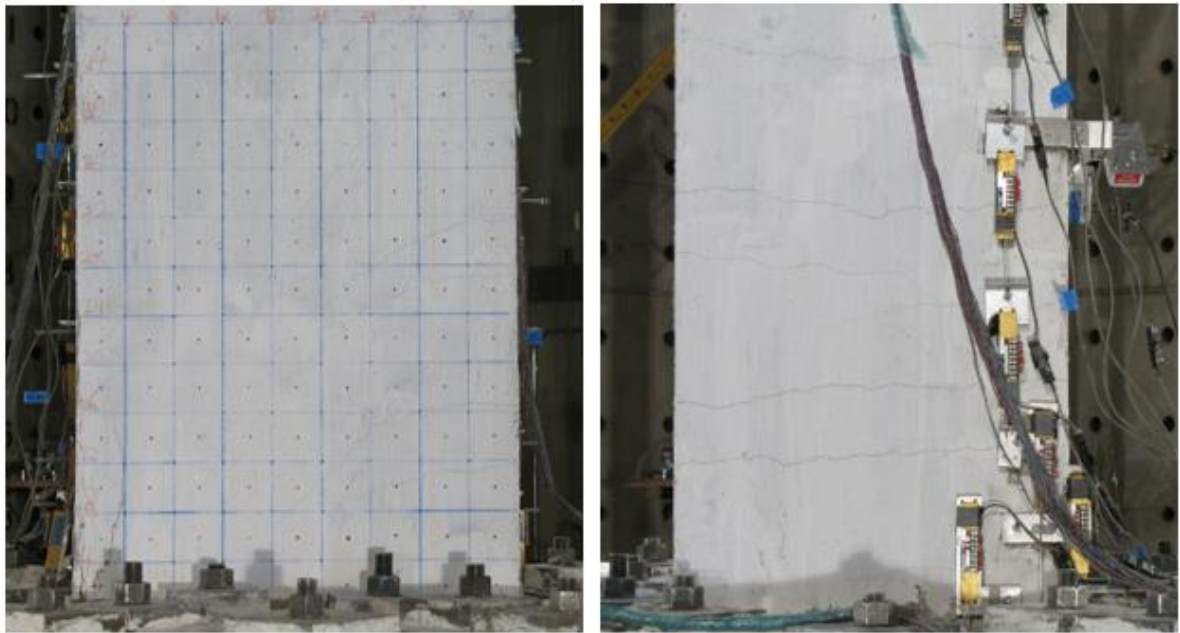
Figure 12. Column condition for 3rd set of MIRA measurements (after 1% drift ratio was attained).

Figure 21 and Figure 22 show a representation of the 2D-UTSA results comparing the original panoramic scans to those after 0.5% and 1% drift ratios, respectively. For each tested location, the $C^{IA,m}$ value was plotted on a scale with 0 indicated by dark shading and 1 indicated by white, with intermediate values shown in lighter shading. In this case, darker locations (lower $C^{IA,m}$ values) indicate an increase in subsurface damage from the original condition, while light locations (higher $C^{IA,m}$ values) indicate little change from the original condition. As can be seen from these figures, ultrasonic array testing can identify levels of degradation before there are external signs of failure. When analyzing these two figures, a general trend of higher damage intensity (dark coloring) can be seen in the left and lower left portion of the images. This area corresponds to the portion of the column that exhibited external damage first, as seen in Figure 12.

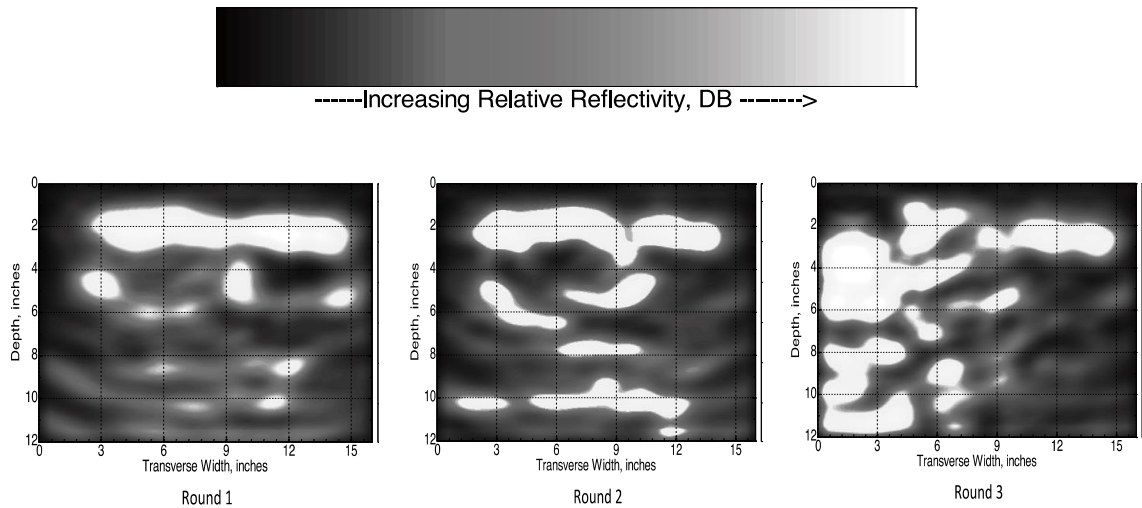
Figure 14. MIRA Reconstructions for 1st round (left) and 2nd round (middle), and 3rd round (right) for a location with relatively high level of damage with loading.

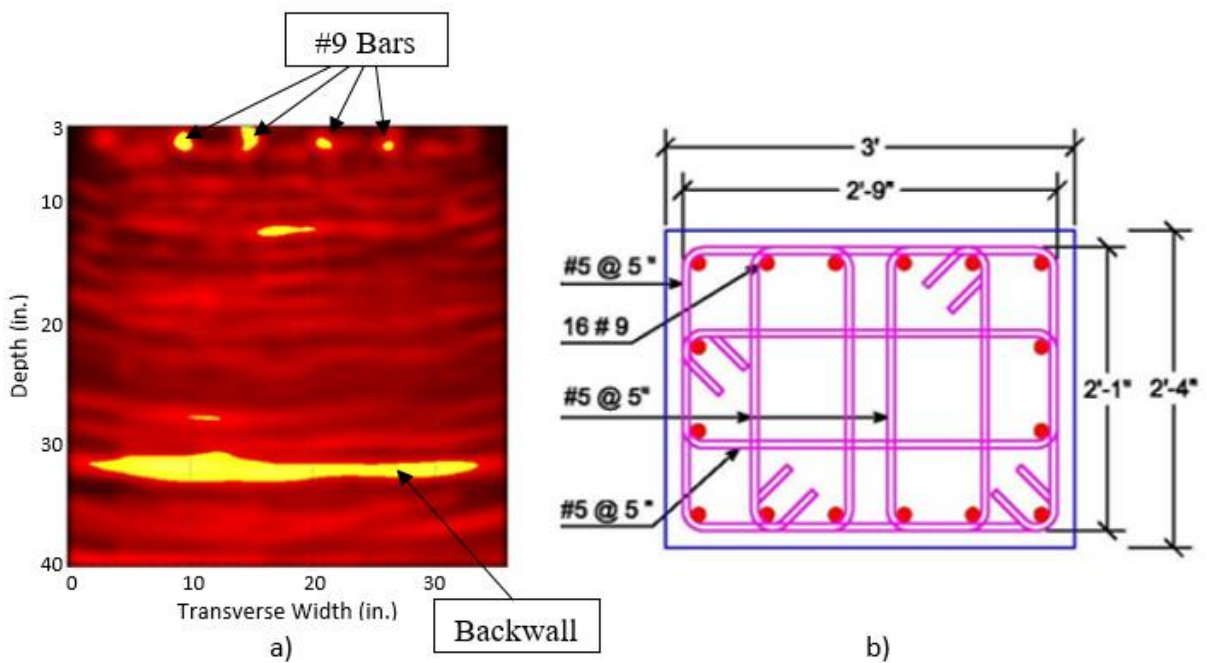
shallower reinforcement locations, as well as the depth of the column along the evaluated cross-section. Even though there is significant attenuation of the wavefront at 28 in. of depth, the change in acoustic impedance at the layer boundary from concrete to air is significant enough to show up in the reconstruction. This is only true if there is not significant enough damage to cause additional scattering of the wavefront. Figure 16 shows the location of the #9 reinforcing bars, as well as the presence of the backwall.

Figure 16. (a) Panoramic reconstructions for 1st measurement showing location of reinforcement and back wall presence, and (b) corresponding design schematic.

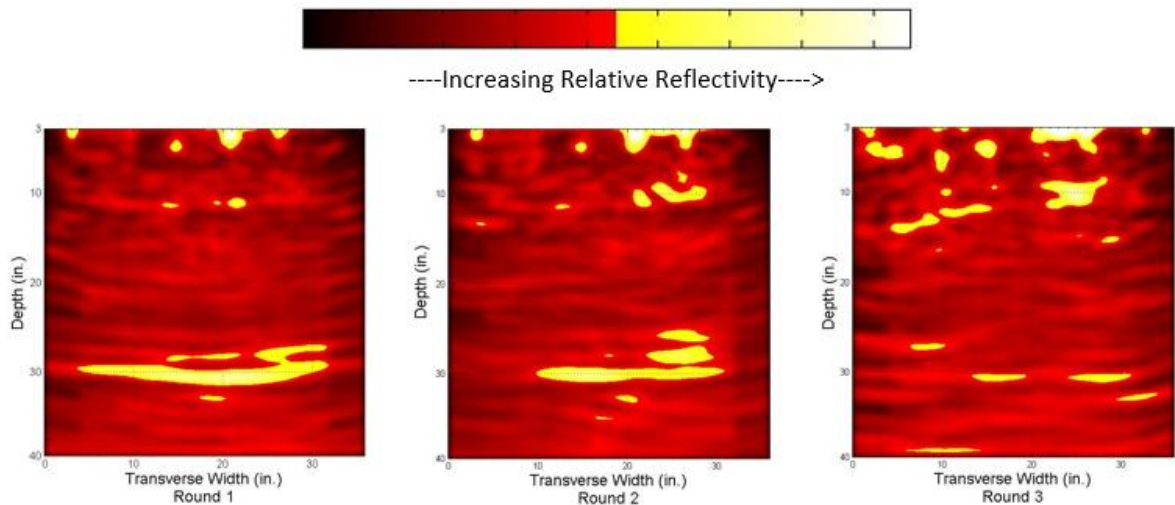
referring to any deviation in wave propagation from that which is expected for a homogenous body, can be used as an indicator of the damage level. The backwall on the left side of the reconstruction is not present after the 2nd round of loading, indicating increased scattering of the wavefront toward the left. The backwall is not present after the 3rd round of testing, indicating significant scattering of the wavefront. The increase in scattering (shadowing of the wavefront) indicates the presence of increased damage at a shallower depth (Schickert et al. 2003). However, since this analysis is qualitative in nature, signature analysis is presented in the following section to quantify the damage caused by loading.

Figure 17. Panoramic reconstructions for 1st measurement (left), 2nd measurement (middle), and 3rd measurement (right) for a location on the bottom of the column.

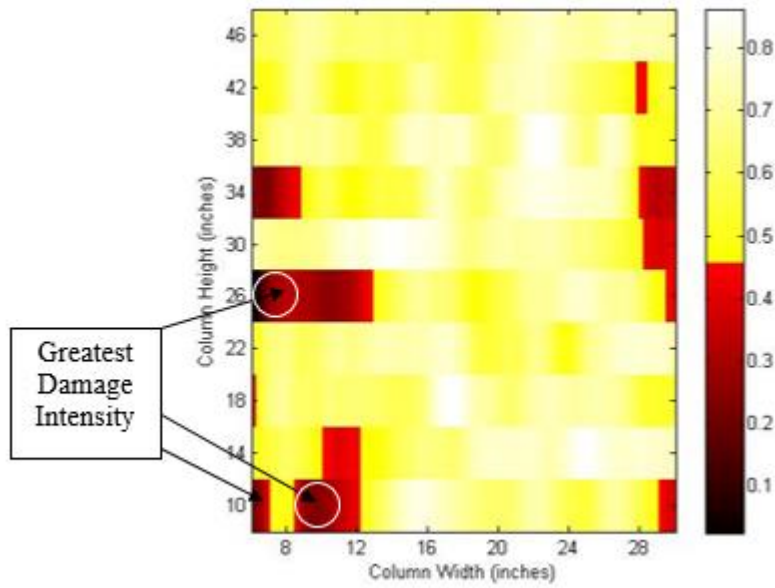
Figure 21. MIRA gradient results after 0.5% drift ratio.

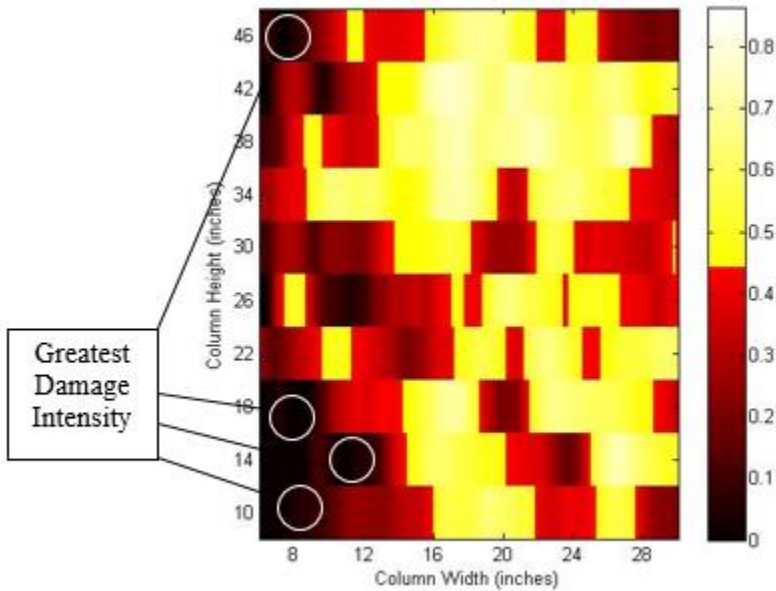
Figure 22. MIRA gradient results after 1% drift ratio.

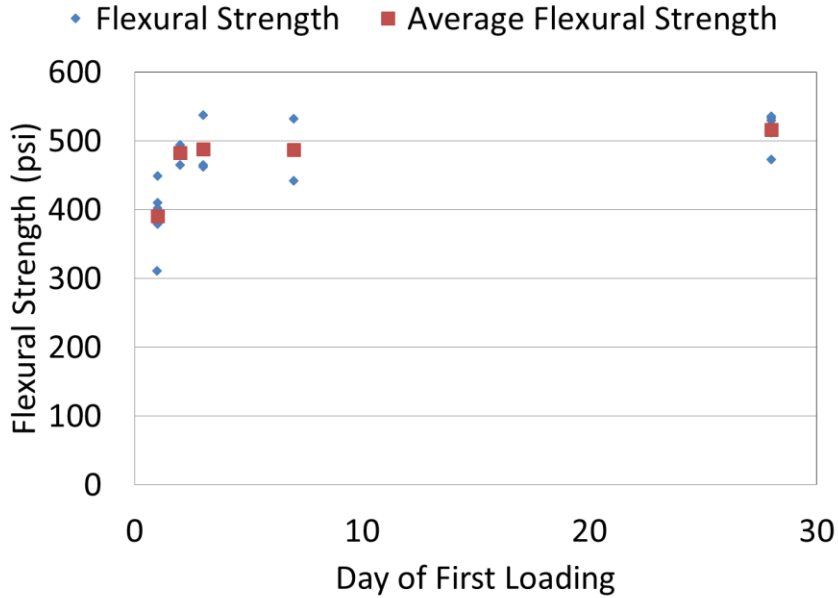
seemed to indicate that the beams which were loaded at early ages were damaged sufficiently to affect ultimate strength.

Figure 23. Ultimate strength vs. day of first loading for round 1.

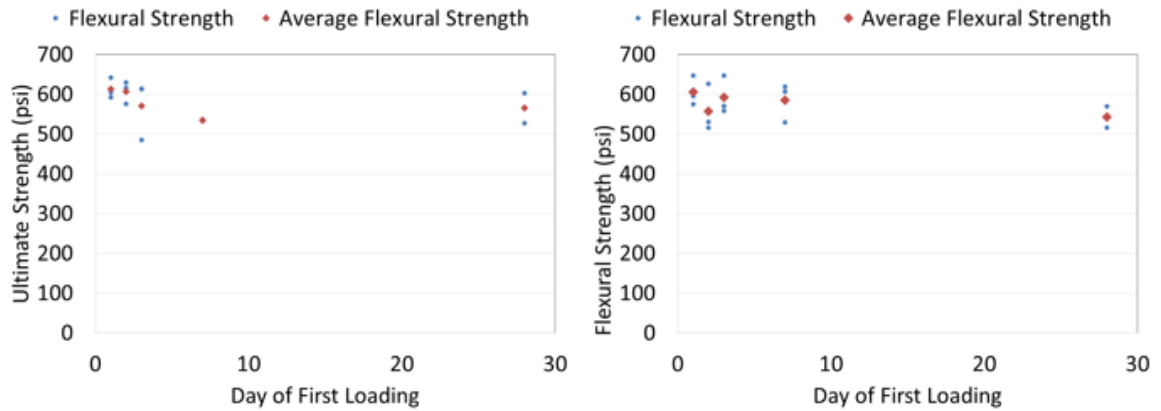
Figure 24. Ultimate strength vs. day of first loading for rounds 2 (left) and 3 (right).

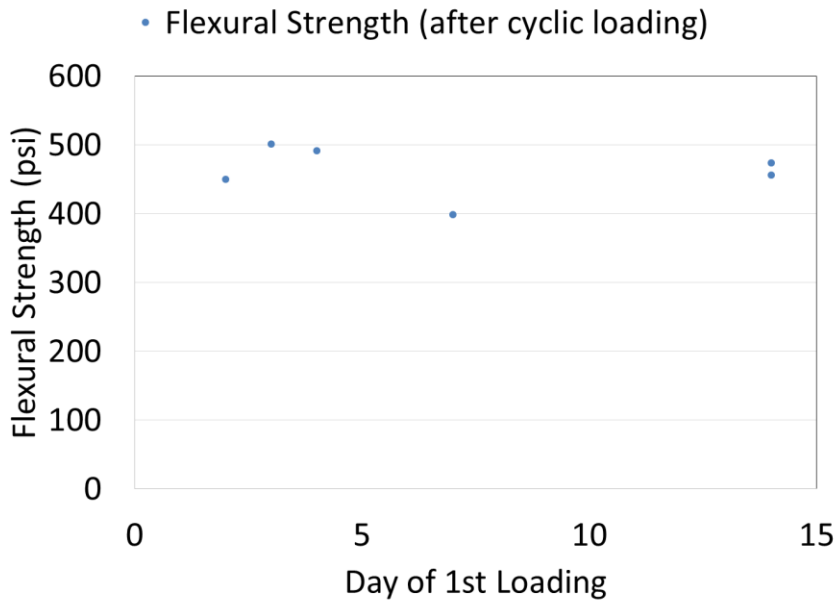
The break strength results versus day of first loading for the fourth round of testing is shown in Figure 25. As can be seen, the results were again inconclusive and appeared to indicate that loading at early ages had no effect on ultimate strength.

Figure 25. Ultimate strength vs. day of first loading for round 4.

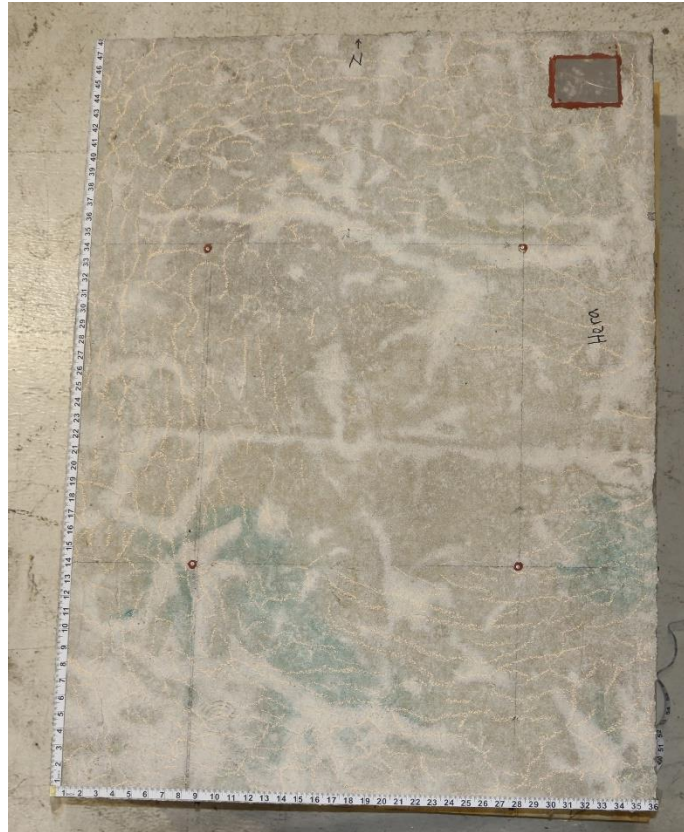
Figure 34. Photograph of condition of slab D.

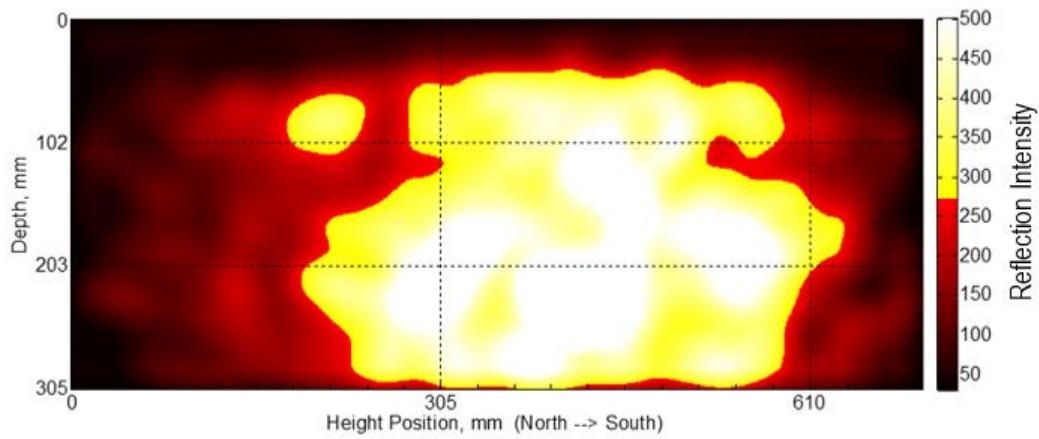
Figure 40. Reconstruction in the middle of slab D indicating damaged concrete condition.

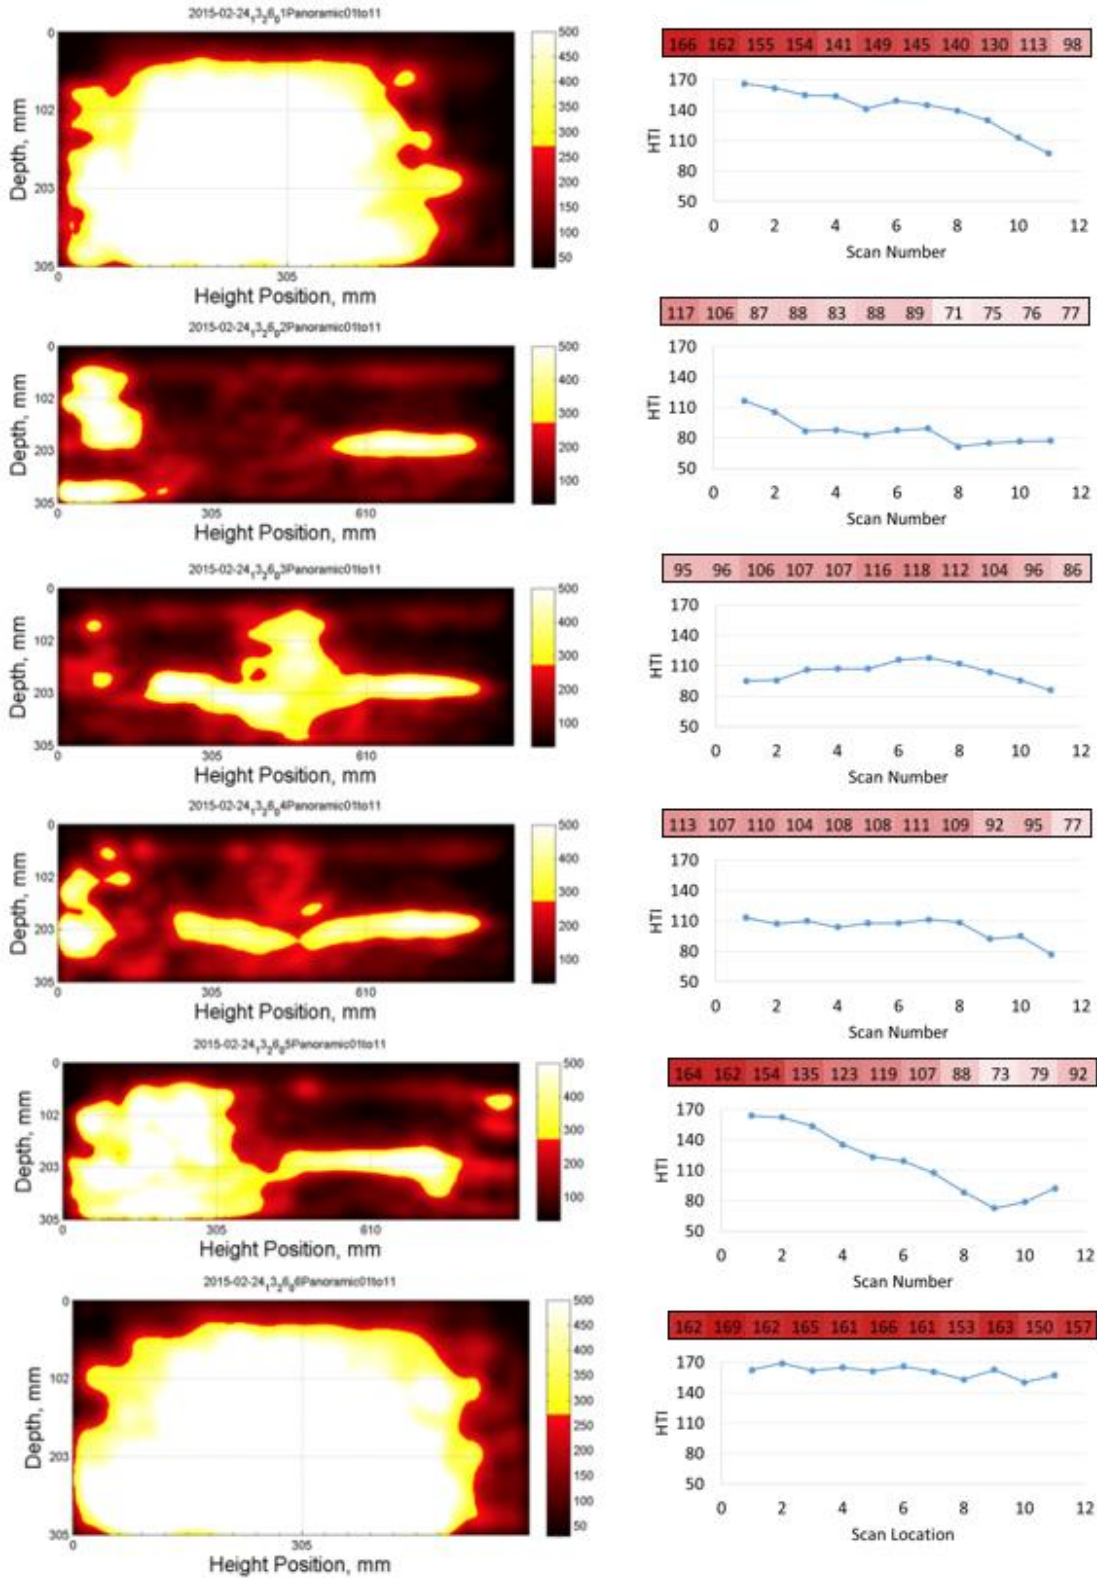
Figure 45. Comparison of panoramic reconstructions (left) and HTI index (right) analyses of sab C.

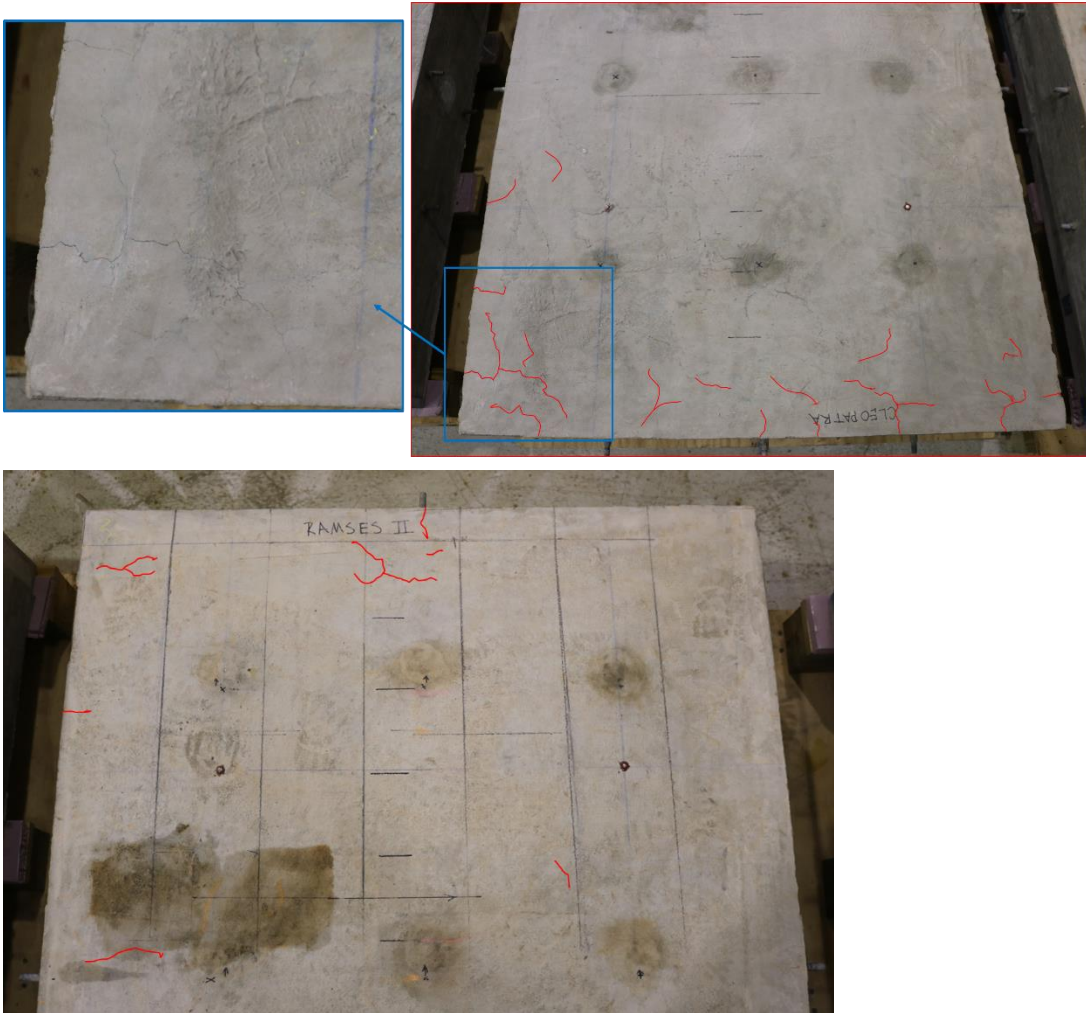
Figure 55. Visible cracking in south portion of slab 2 (top) and north portion of slab 1 (bottom).

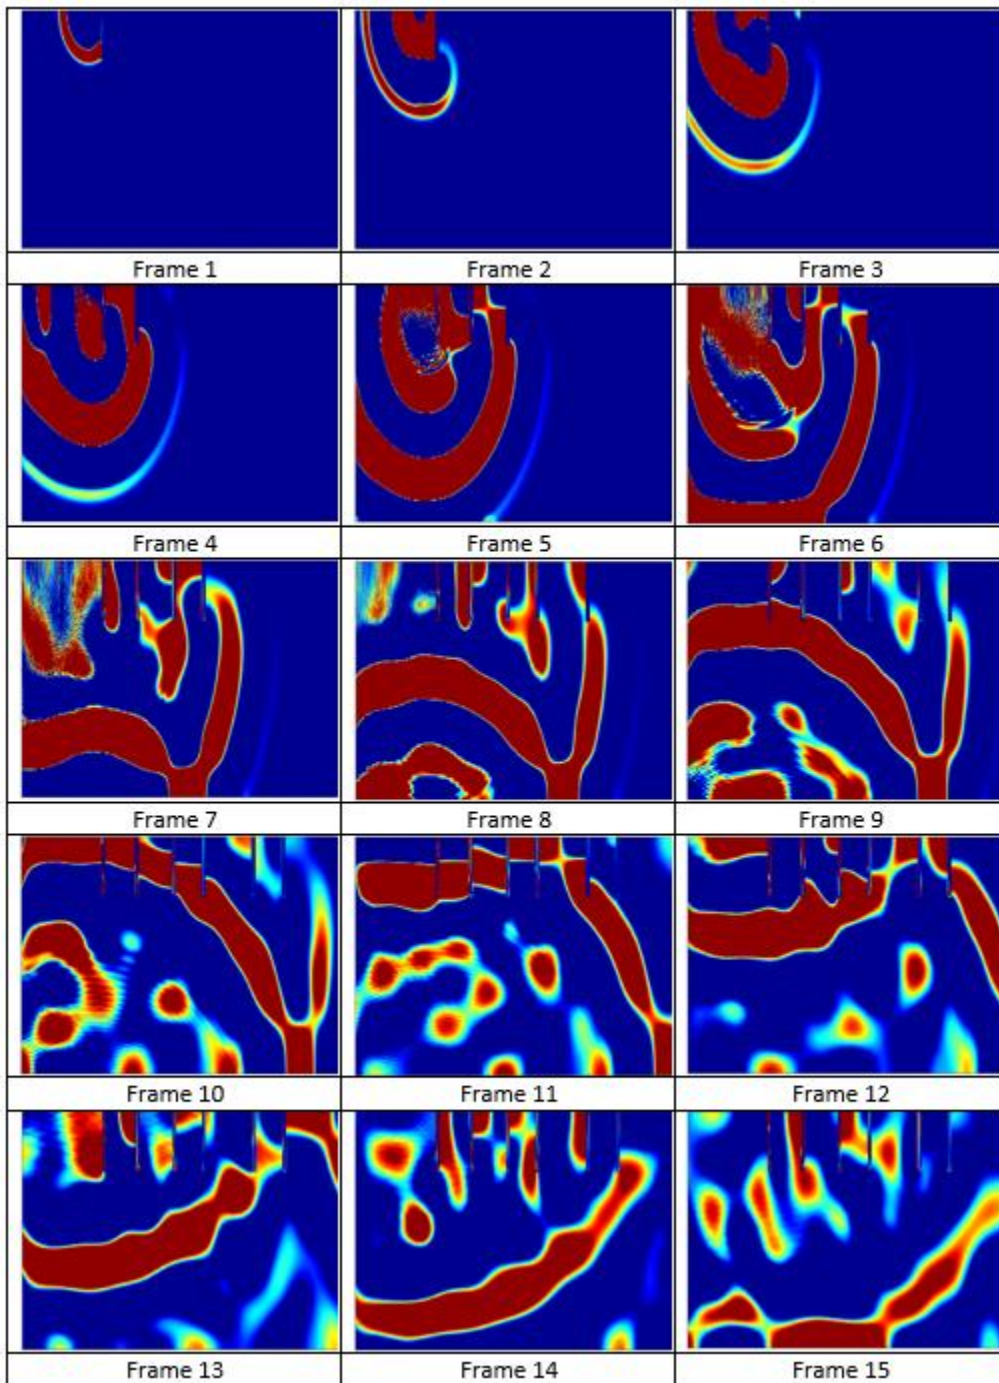
Figure 60. Wave propagation visualization for Case IV, 6 slender cracks.
