Study on Interaction between Rocking-Wall System and  
Surrounding Structure

A DISSERTATION  
SUBMITTED TO THE FACULTY OF  
UNIVERSITY OF MINNESOTA  
BY

IN PARTIAL FULFILLMENT OF THE REQUIREMENTS  
FOR THE DEGREE OF  
DOCTOR OF PHILOSOPHY

December 2016

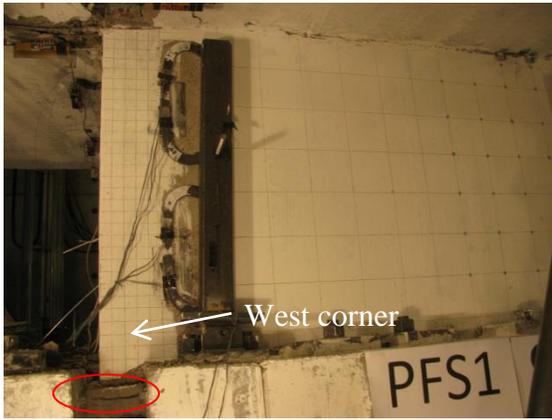
Fig. 6-16 Condition of the fiber grout beneath the west wall corner at 2% drift in Phase 1

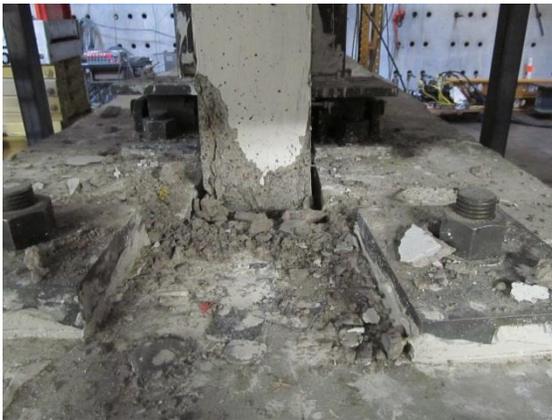
Fig. 6-18 Damage to the east wall corner at the end of Phase 3

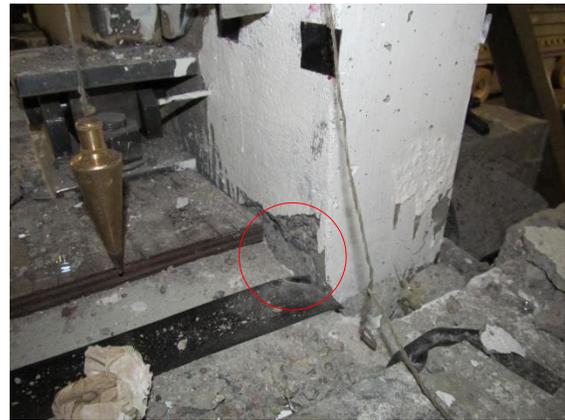
Fig. 6-19 Condition of the east wall corner after the test

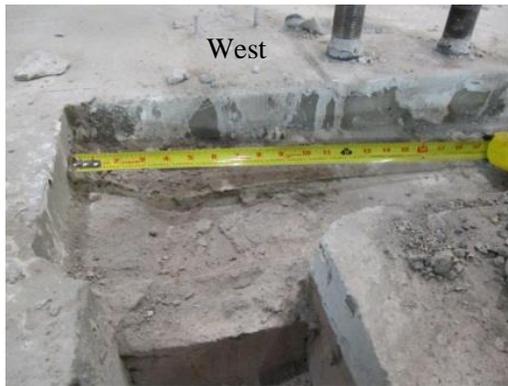
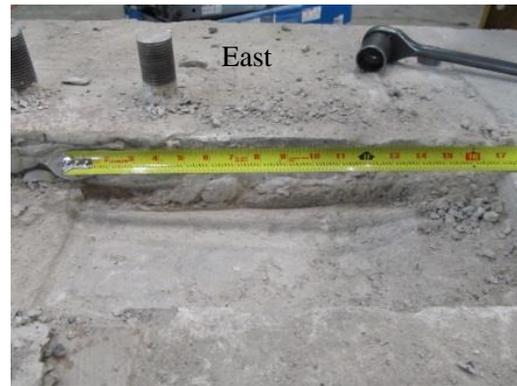
Fig. 6-30 Strain distribution along the wall width at negative peaks in Phase 1

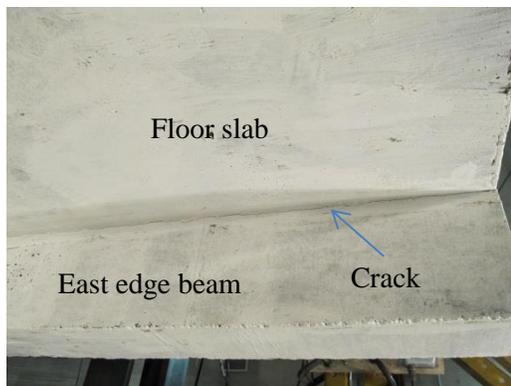
Fig. 6-66 Crack map of the floor after Phase 2

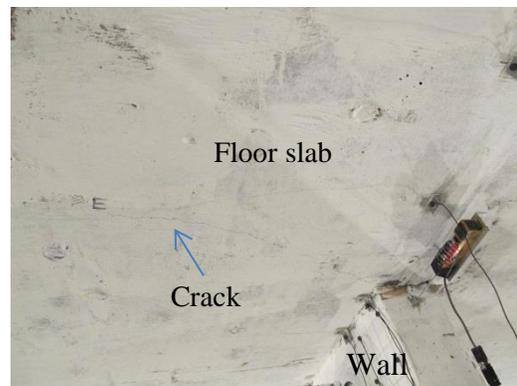
Fig. 6-67 Cracks initiating at the east floor-edge beam connection in Phase 1 (view from underside of floor)

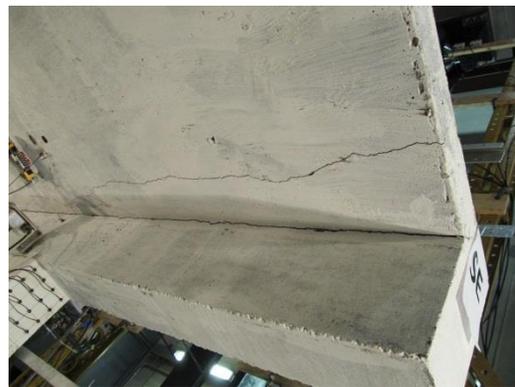
Fig. 6-71 Cracks in the slab extending to the end of the common anchor plate in Phase 1 (view from top of floor)

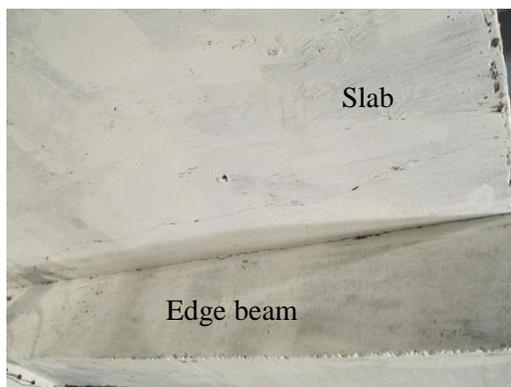
Fig. 6-72 Widely opened cracks at the east floor-edge beam connection in the slab at 2.5% drift in Phase 1 (view from underside of floor)

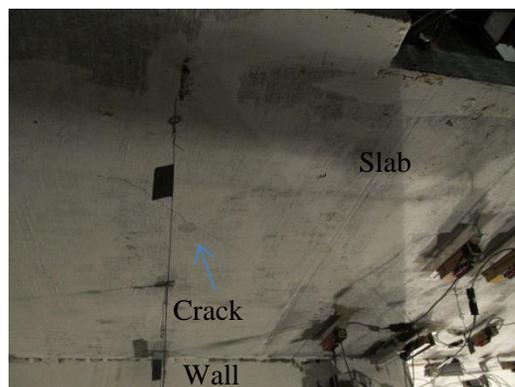
Fig. 6-73 Closed cracks in the slab at "zero load" position after 2.5% drift in Phase 1 (view from underside of floor)

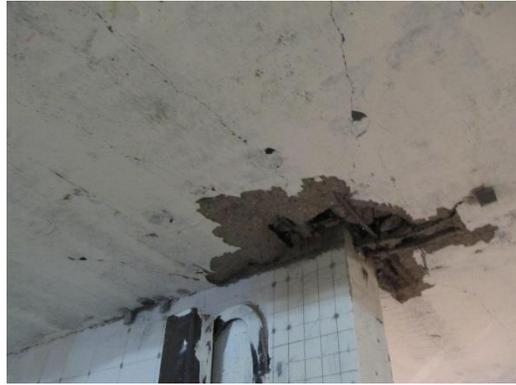
Fig. 6-75 Localized damage at the west wall-floor connection in Phase 3 (view from underside of floor)

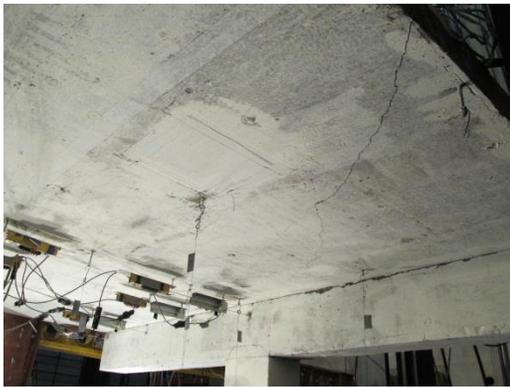
Fig. 6-76 Localized damage at the east wall-floor connection in Phase 3 (view from underside of floor)

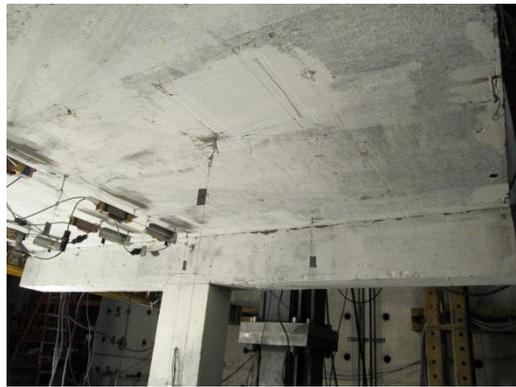
Fig. 6-77 Condition of the damaged bottom surface of the slab in Phase 3

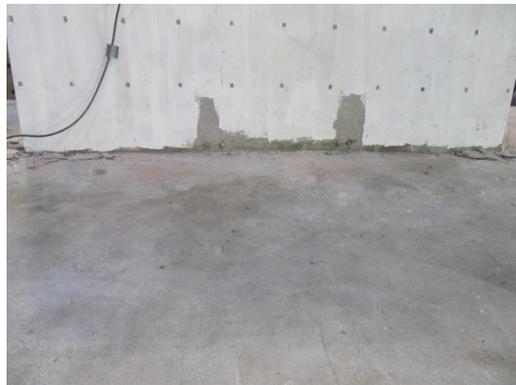
Fig. 6-79 Condition of the damaged top surface of the slab in Phase 3

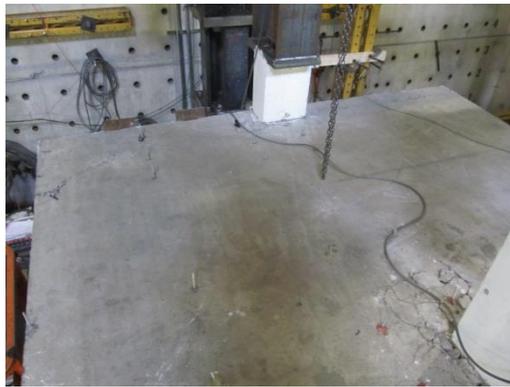
Fig. 6-82 Condition of the slab at floor-edge beam connection after the test

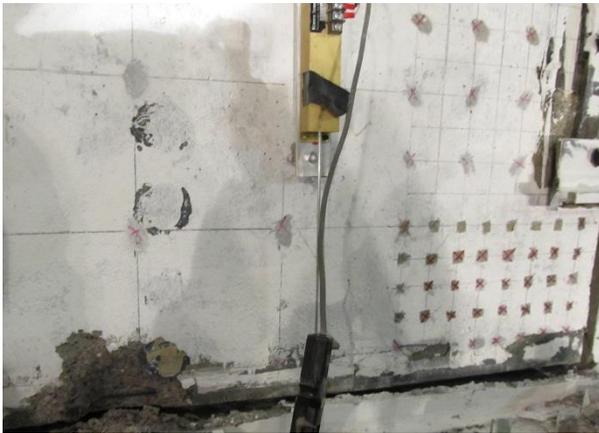
Fig. 7-17 Spalling of fiber grout at 0.5% drift

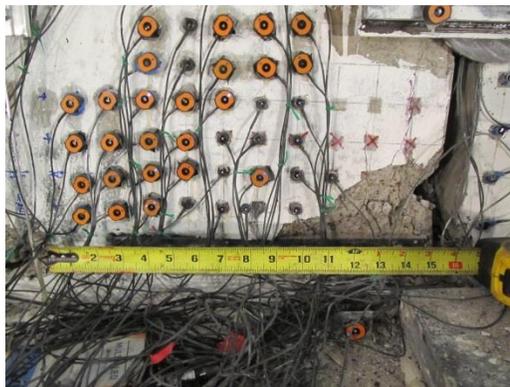
Fig. 7-24 Concrete spalling near the 2<sup>nd</sup> story northeast O-connector at 3% drift in Phase 6 (view from south)

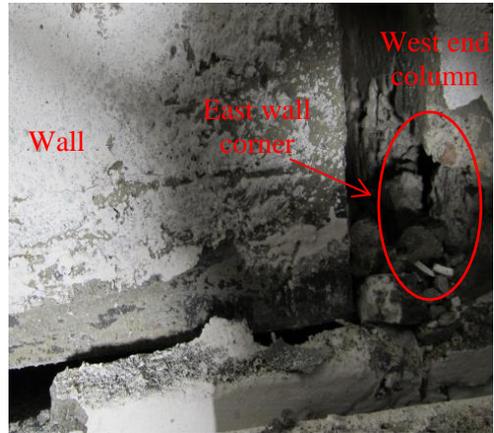
Fig. 7-55 Damage in the west end column at 4% drift in Phase 5 (view from south)

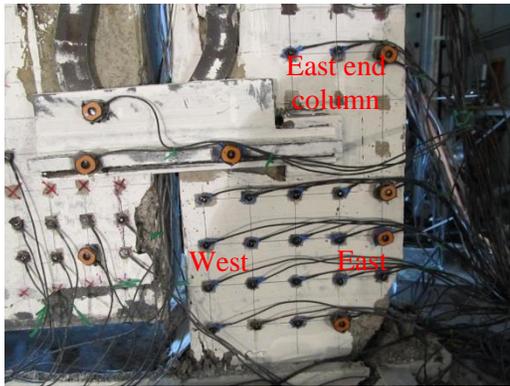
Fig. 7-56 Damage in the east corner of the west end column in Phase 5 (view from north)

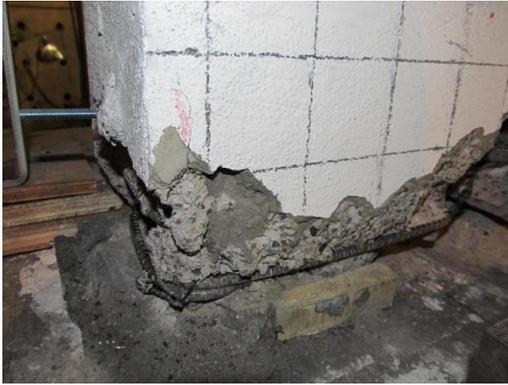
Fig. 7-60 The condition of the east end column after the test (view from north)

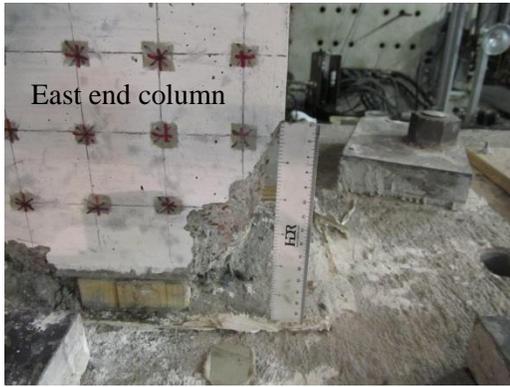
Fig. 7-66 Spalling of the upper corner of the fiber grout beneath the east corner of the east end column at 2.5% in Phase 5

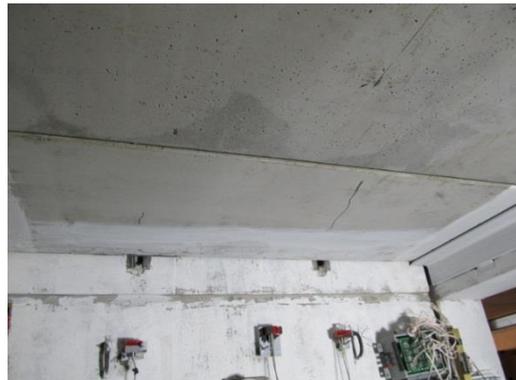
Fig. 7-103 Cracks in the south middle plank at 0.75% drift in Phase 3

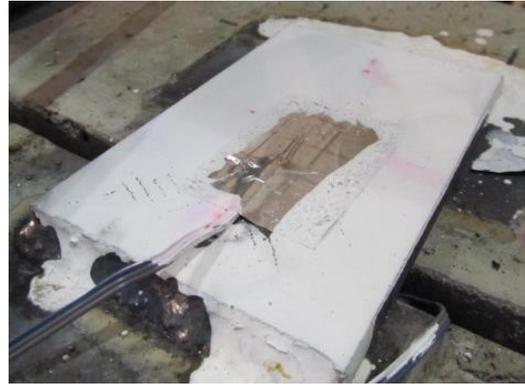
Fig. 7-105 Condition of the BS Italia connection at 4% drift in Phase 5

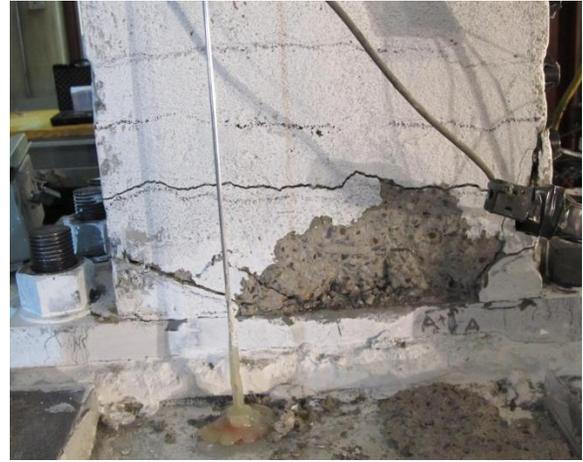
Fig. 7-121 Cracks distributed along the edge column at 1.5% drift in Phase 3

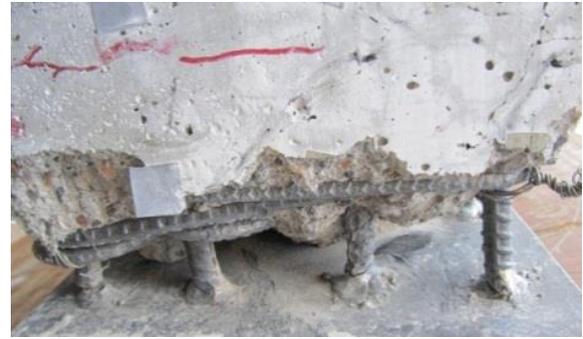
Fig. 7-129 Crushing of the concrete core and fracture of the rebar at the east column base

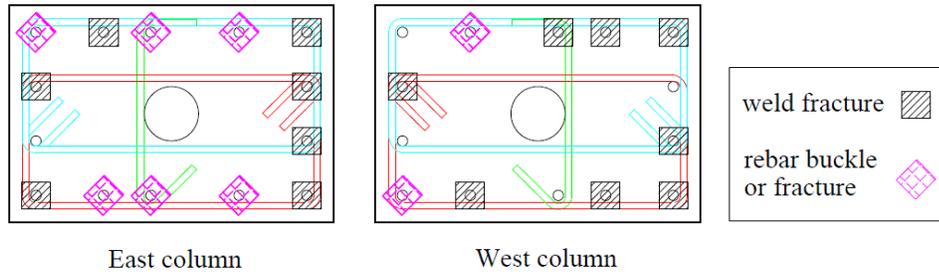
Fig. 7-130 Fracture of the weld for the rebar at the west column base

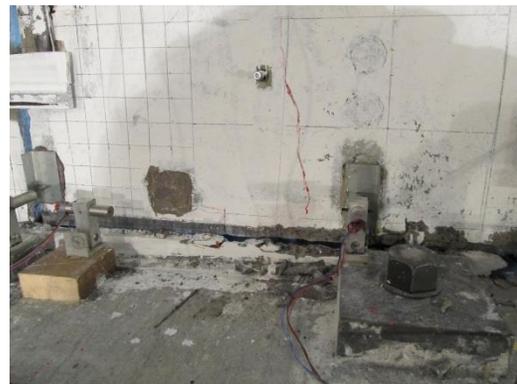
Fig. 8-15 Condition of the west wall corner in PFS1 at 2% drift in Phase 1

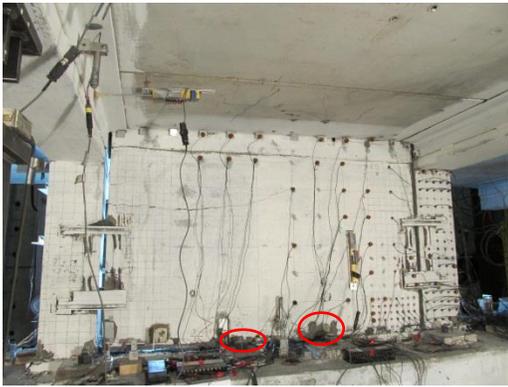
Fig. 8-16 Condition of the west wall corner in PFS2 at 2% drift in Phase 1

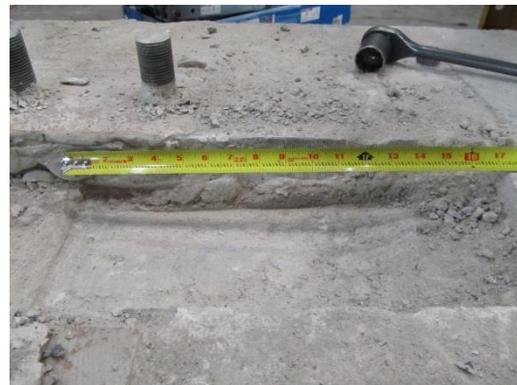
Fig. 8-20 Condition of fiber grout beneath the west corner of the wall after the test of PFS1

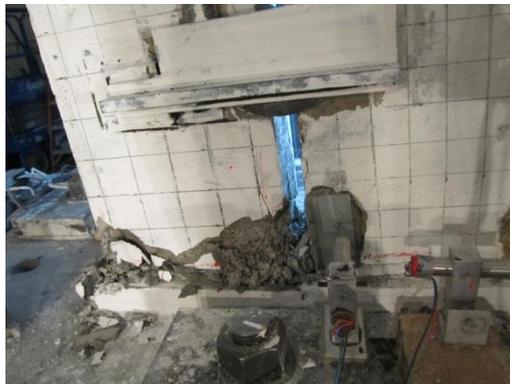
Fig. 8-23 Condition of the fiber grout beneath the east wall corner after the test of PFS2

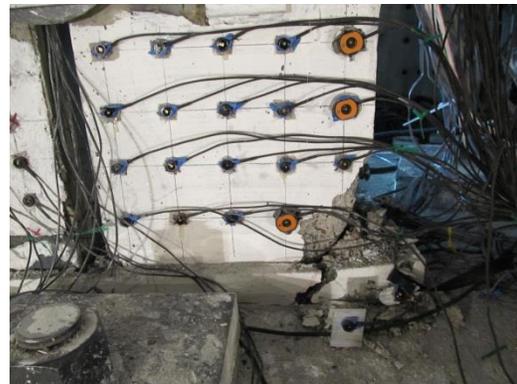
Fig. 8-24 Condition of the fiber grout beneath the west end column after 4% drift in Phase 5 of PFS2

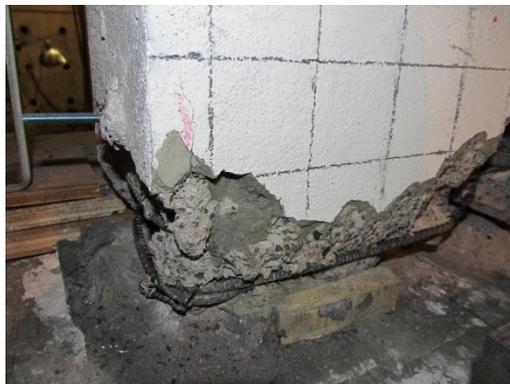
Fig. 8-25 Condition of the fiber grout beneath the east end column after 4% drift in Phase 5 of PFS2

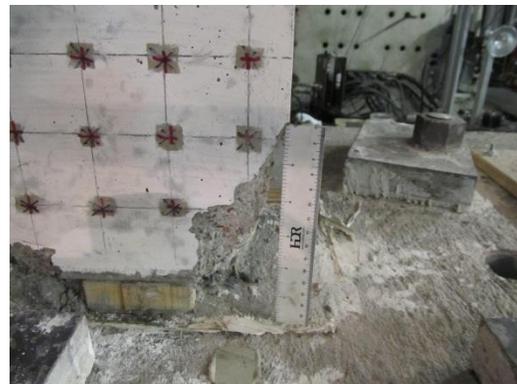
Fig. 8-26 Condition of the fiber grout beneath the west end column after the test of PFS2

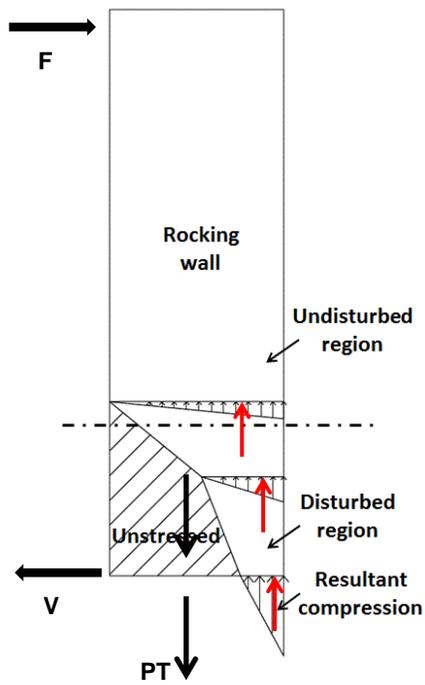
Fig. 9-1 Strain distribution in a rocking wall  
(Base shear not shown for clarity)

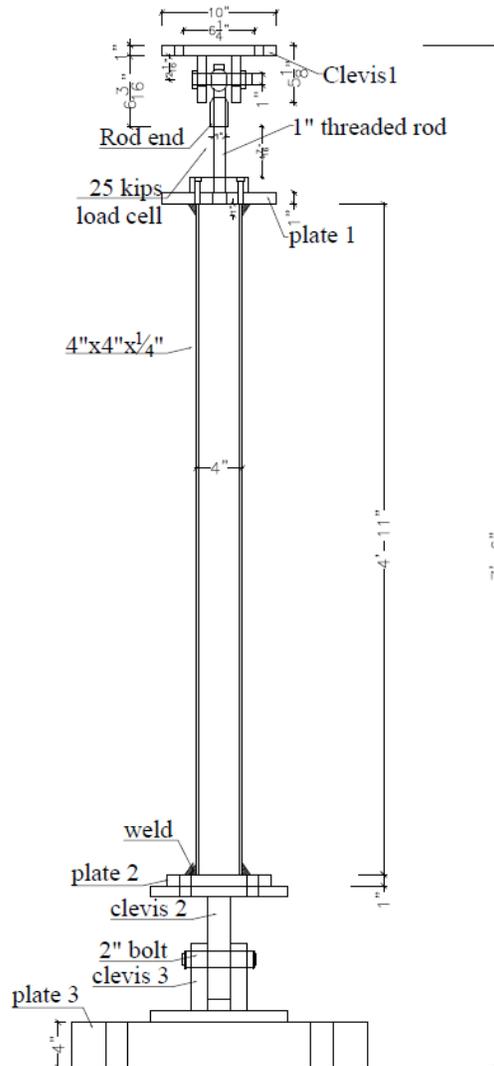
Props were used in PFS1 and PFS2 to simulate a boundary condition case where adjacent frame lines to the rocking wall frame (test specimen) would be columns. The props, as columns, restricted the uplift of the floor slab. Some of the tests on PFS1 and PFS2 were run with props to simulate the condition of the adjacent column frame line, and some tests were run without props. In the latter case, the free edge boundary condition simulated adjacent rocking wall frame lines rocking in phase. Fig. A-1 through Fig. A-8 show the prop details.

Fig. A-1 Detail of the props
