**PORTLAND CEMENT CONCRETE PAVEMENT THICKNESS AND SHEAR WAVE  
VELOCITY VARIATION VERSUS OBSERVED PAVEMENT DISTRESSES**

A THESIS  
SUBMITTED TO THE FACULTY OF  
UNIVERSITY OF MINNESOTA  
BY

IN PARTIAL FULFILLMENT OF THE REQUIREMENTS  
FOR THE DEGREE OF  
MASTER OF SCIENCE

February 2017

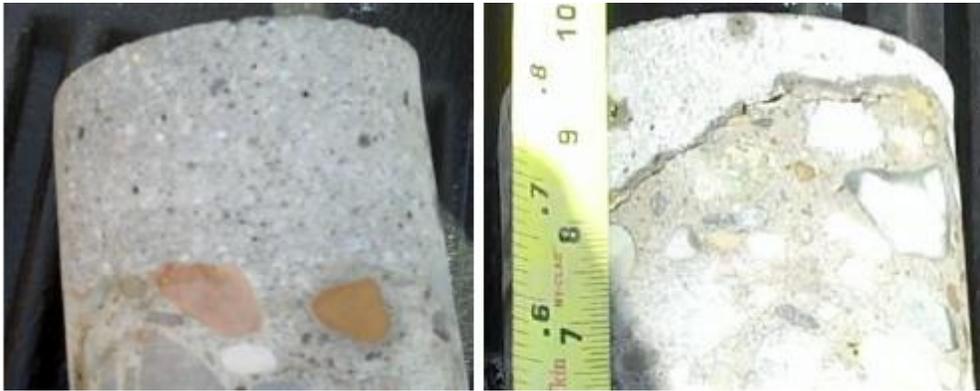
Figure 8: Bonding Verification Cores

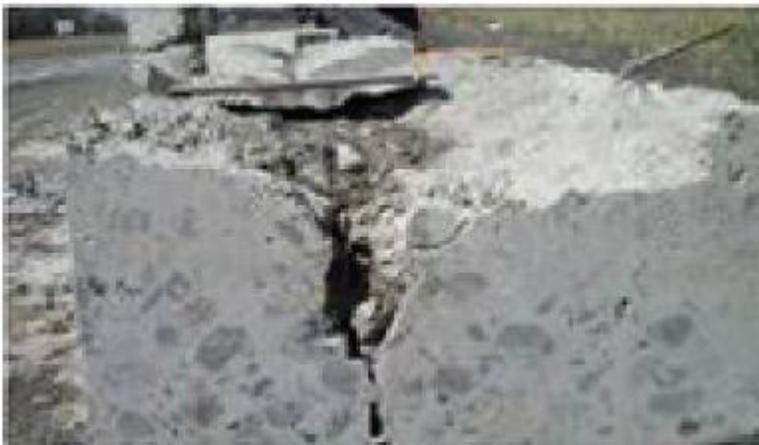
Figure 13: Damaged Joint Detected by MIRA (Hoegh, Khazanovich, and Yu, 2012)

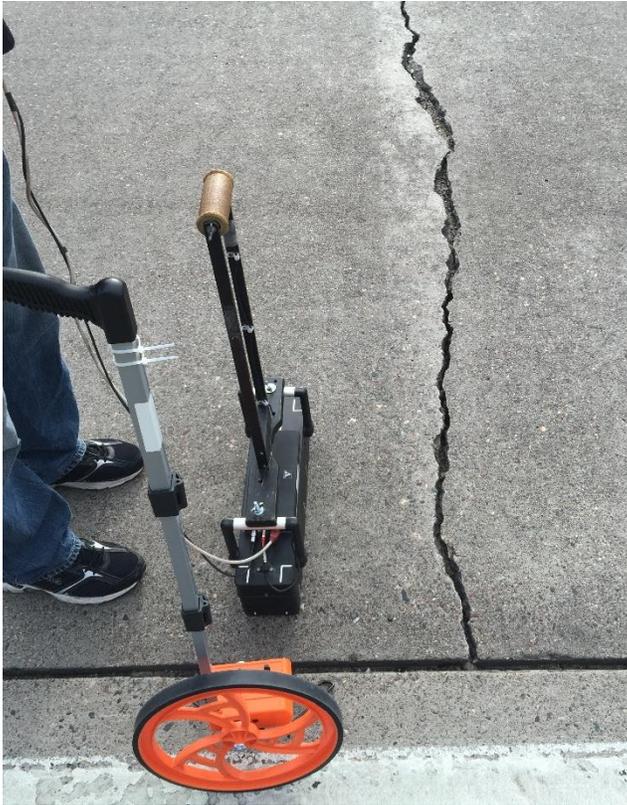
and is in fact distress cracking. An image of the cracking is presented in Figure 28. Thus, the cracked and broken panels recorded in the HWY 60 surveys will be considered in further analysis.

Figure 28: Cracking seen on HWY 60
