PROCEEDINGS OF THE FIRST MULTIDISCIPLINARY CONFERENCE ON SINKHOLES
ORLANDO / FLORIDA / 15-17 OCTOBER 1984

SINKHOLES: THEIR GEOLOGY, ENGINEERING AND ENVIRONMENTAL IMPACT

Altura Minnesota lagoon collapses*

E.CALVIN ALEXANDER, Jr. & PAUL R.BOOK** *University of Minnesota, Minneapolis, USA*

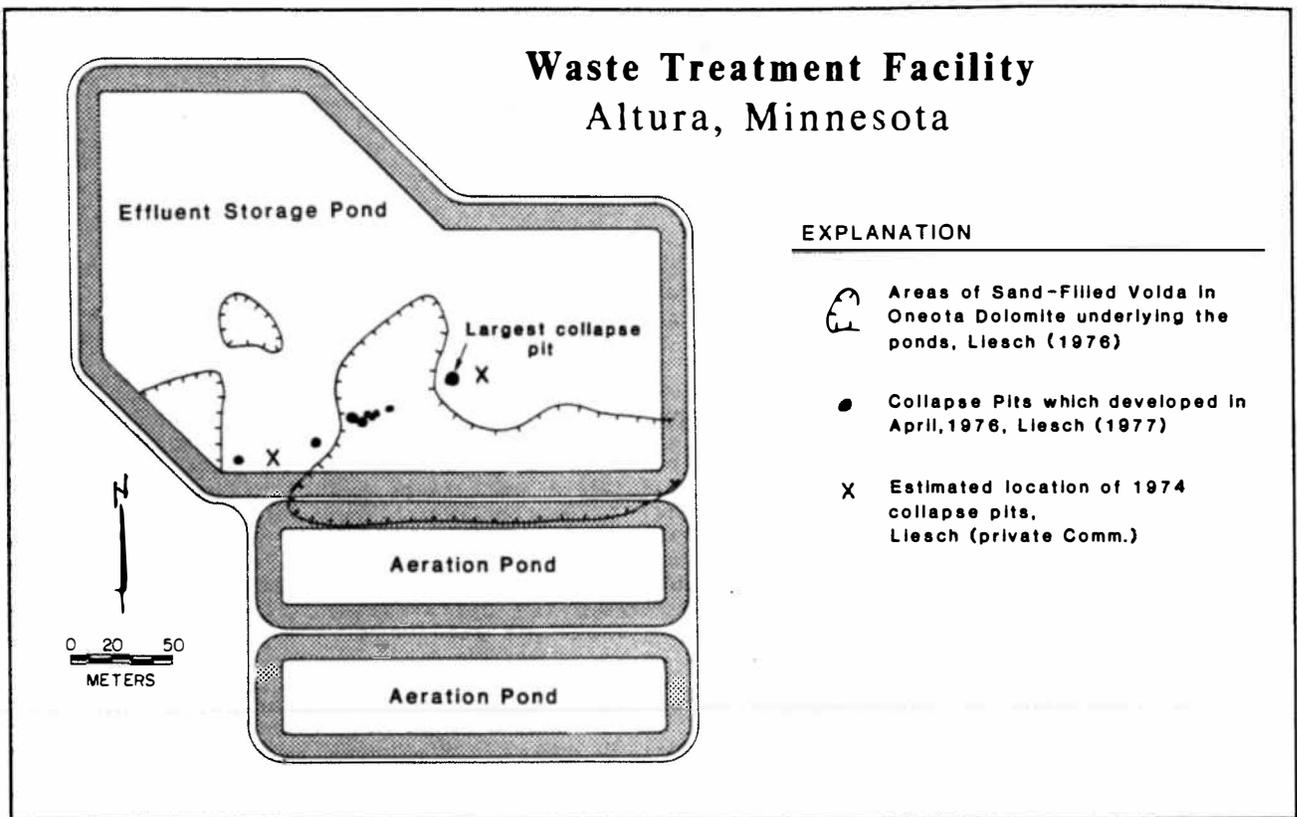
Figure 1: Plan view of the disabled Altura, Minnesota, Waste Treatment Facility showing the locations of the collapse sinkholes in the effluent storage pond.

By the morning of May 7, the effluent storage pond was completely drained. The cause of the leaks was clearly visible. A line of nine sinkholes had opened across the bottom of the pond. At 2:37 PM on May 7, 1976 the tenth and largest sinkhole was observed to develop by sudden collapse. The location in the storage pond of these sinkholes is shown in Figure 1. The largest sinkhole was approximately 3.6 m in diameter and approximately 7.0 m deep as measured to the top of the bedrock rubble.

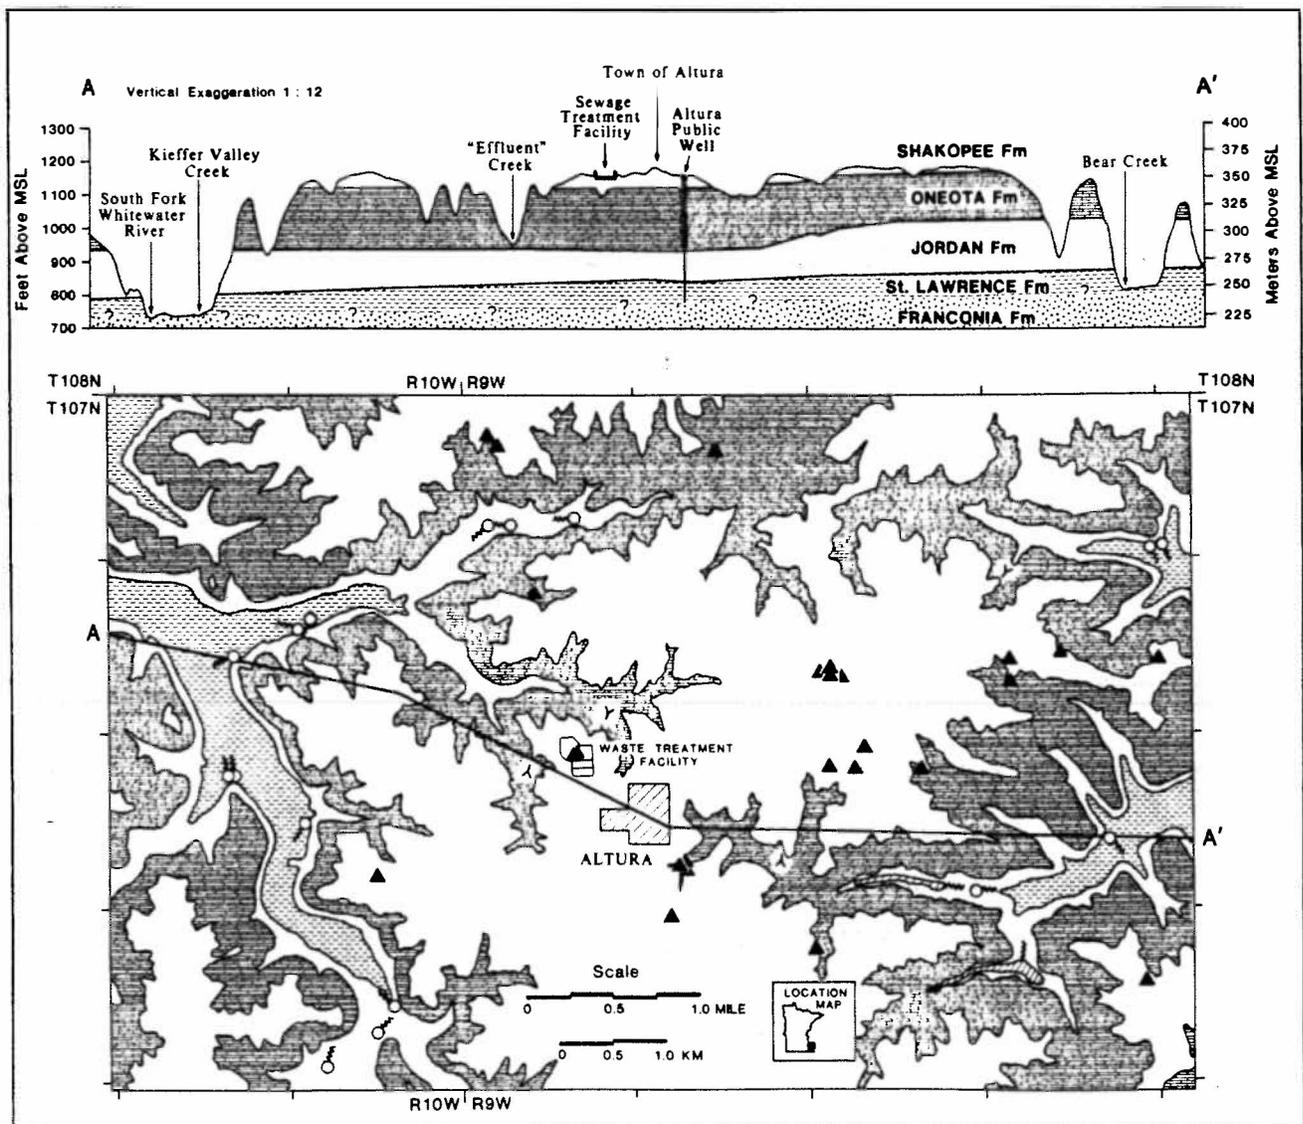
Figure 2: Bedrock geology of the area around Altura, Minnesota. Solid triangles are sinkholes. Open circles and crosshatched areas with squiggly tails are springs and seeps respectively. 'Y's are caves.

The most detailed published bedrock geologic mapping of the area around Altura is Sloan and Austin's (1966) 1:250,000 scale St. Paul sheet. The region's hydrogeology and Paleozoic lithostratigraphy have been mapped at 1:500,000 scale by Broussard and others (1975) and by Mossler (1983). We have mapped the bedrock geology of the Altura 7.5-minute USGS topographic quadrangle at 1:24,000 scale (Book, 1983). Figure 2 is adapted from a portion of Book's (1983) map.

Altura is underlain by a series of lower Ordovician and Cambrian sandstone and carbonate strata which regionally dip very gently to the southwest. The town is situated on an elevated rolling ridge which is more than 100 m above deeply incised stream valleys to the northwest, east and west. The lowest stratum of concern to this study is the Cambrian Franconia Formation. Although the Franconia sandstone is not exposed in the region shown in Figure 2, it is not far below the surface of the deeper valleys and is an important aquifer in the area.

We have located and mapped four caves in the region shown on Figure 2. All four caves are small, phreatic maze caves in the Oneota (Alexander, 1981, 1983a, 1983b). The locations of these caves are shown on Figure 2. Sediment-filled solution cavities are common features in outcrops and quarry walls which expose the Oneota. The karstification of the Oneota probably began during the Ordovician and has continued intermittently until the present. U/Th disequilibrium dating of a speleothem in Skunk Hollow Cave (Alexander, 1983a), one of the caves shown on Figure 2, indicates that the cave is older than $(116 \pm 4) \times 10^3$ yr (R. Lively, pers. comm., 1983).

We have located 23 sinkholes (in addition to the ten in the bottom of the effluent storage pond) in the area covered by Figure 2. Eight of these sinkholes are currently open, while the others have been filled to return the land to agricultural use. The filled holes were identified through interviews with the local landowners. At least five of the sinkholes developed catastrophically in the spring of the year in response to unusually wet conditions. It appears that the sinkholes tend to develop through the New Richmond Sandstone into the underlying Oneota. The New Richmond appears to be an integral part of the sinkhole development phenomena in this area.

The waste treatment facility is on the crest of a knoll immediately northwest of Altura (Fig. 2). The town has three municipal wells, each of which produces water primarily from the Jordan Sandstone. Wells No. 1 and No. 3 are on the west side of town 0.61 km from the treatment facility. Well No. 2 is on the east side of Altura about 1.07 km from the lagoons. Well No. 1 is cased to only 14 m. It is evidently in direct hydraulic connection with the surface, shows evidence of surface contamination, and is used only in emergencies. Public health investigations (see for example Mierau, 1975) indicate that although Well No. 2 is cased and grouted through the Oneota into the Jordan, the well exhausts and draws large volumes of air as the static water level fluctuates. Well No. 2 exhibits seasonal fluctuations in nitrates and coliform bacteria, indicating surface connections and potential contamination. Well No. 2 is shown diagrammatically in the cross section of Figure 2. Well No. 3, though cased and grouted into the Jordan, hydraulically intersects with Well No. 1

The goal of this study was to evaluate the hydrogeologic environment connected with the collapses of the storage lagoon at Altura. The goal was accomplished by detailed geologic mapping and by an inventory of karst features. Interviews with local landowners revealed information on the 23 sinkholes shown in Figure 2, and that catastrophic sinkhole formation is a common occurrence around Altura. The sinkholes range in size from meters to tens of meters across and deep. Most are small and are immediately filled to return the land to its original use. They are also too small and/or too transient to be shown on regional scale geologic or topographic maps. Anecdotal information indicates that the sinkholes most often form in the spring, particularly after heavy rains. As can be seen in Figure 2, most of the sinkholes develop through the New Richmond Sandstone into the underlying Oneota Dolomite.
