DEMOLITION OF A SHALLOW BED AND
RECONSTRUCTION OF A DEEP BED
SINTERING POT FACILITY AT
THE COLERAINE MINERALS RESEARCH LABORATORY
JANUARY 2008 THROUGH OCTOBER 2009

CMRL/TR-09-08
NRRI/TR-2009/32

University of Minnesota Duluth
Natural Resources Research Institute
5013 Miller Trunk Highway
Duluth, Minnesota 55811

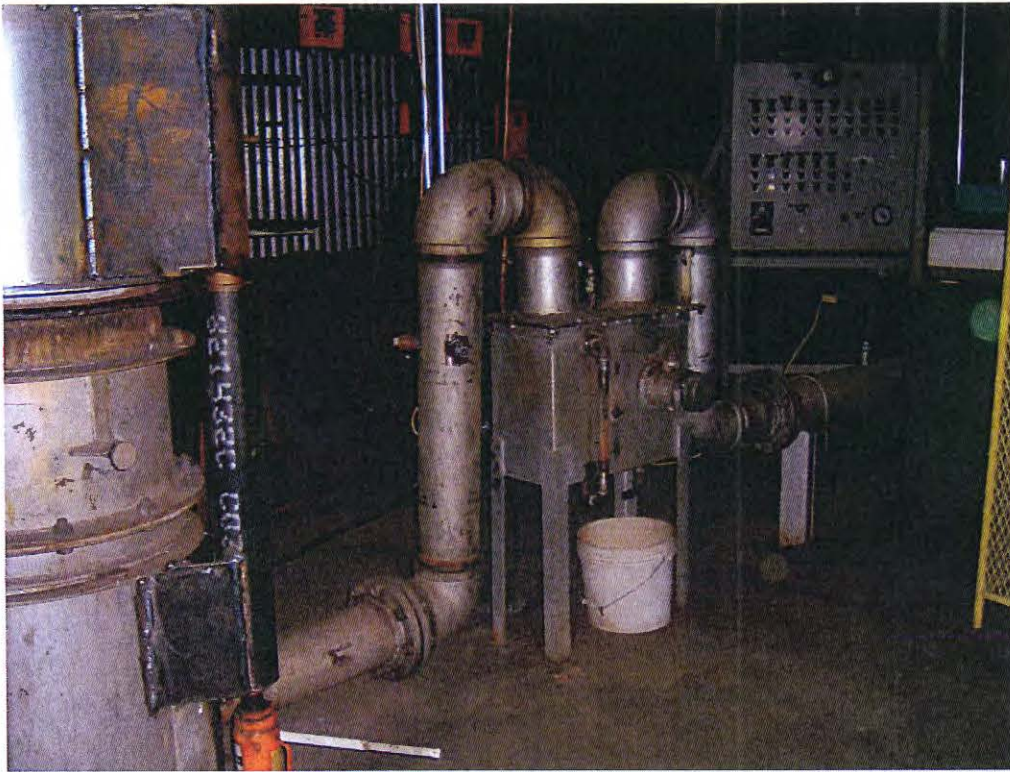
Figure 3 Original Exhaust Piping with Water Quench Tank

The test facility was re-commissioned in early 2008 and was used to perform two sinter programs during the year, the last test being fired in late December. The system operated without problem, but was limited by pot depth (16 inches) and wind box suction (40 inches water). It was not representative of current sinter practice, which utilizes deeper beds (up to 28 inches) and higher suction (up to 70 inches water). Furthermore, the original system used water injection to cool wind box exhaust gases upstream of the suction fan. The water injection system also resulted in corrosion and flow measurement problems.

Phase I: During this phase, a new granulation drum with water spray addition was fabricated. A new burner hood was designed, fabricated and tested. The old burner and gas train were replaced with code-compliant equipment. Approximately 87 sinter tests were fired in 2008 following these modifications. Figure 1 shows the new granulation drum. Figure 2 shows the new burner hood and sinter wind box. Figure 3 shows the exhaust gas piping arrangement with water quench tank. Figure 4 provides a view of the piping leading to the orifice flow meter and suction fan.

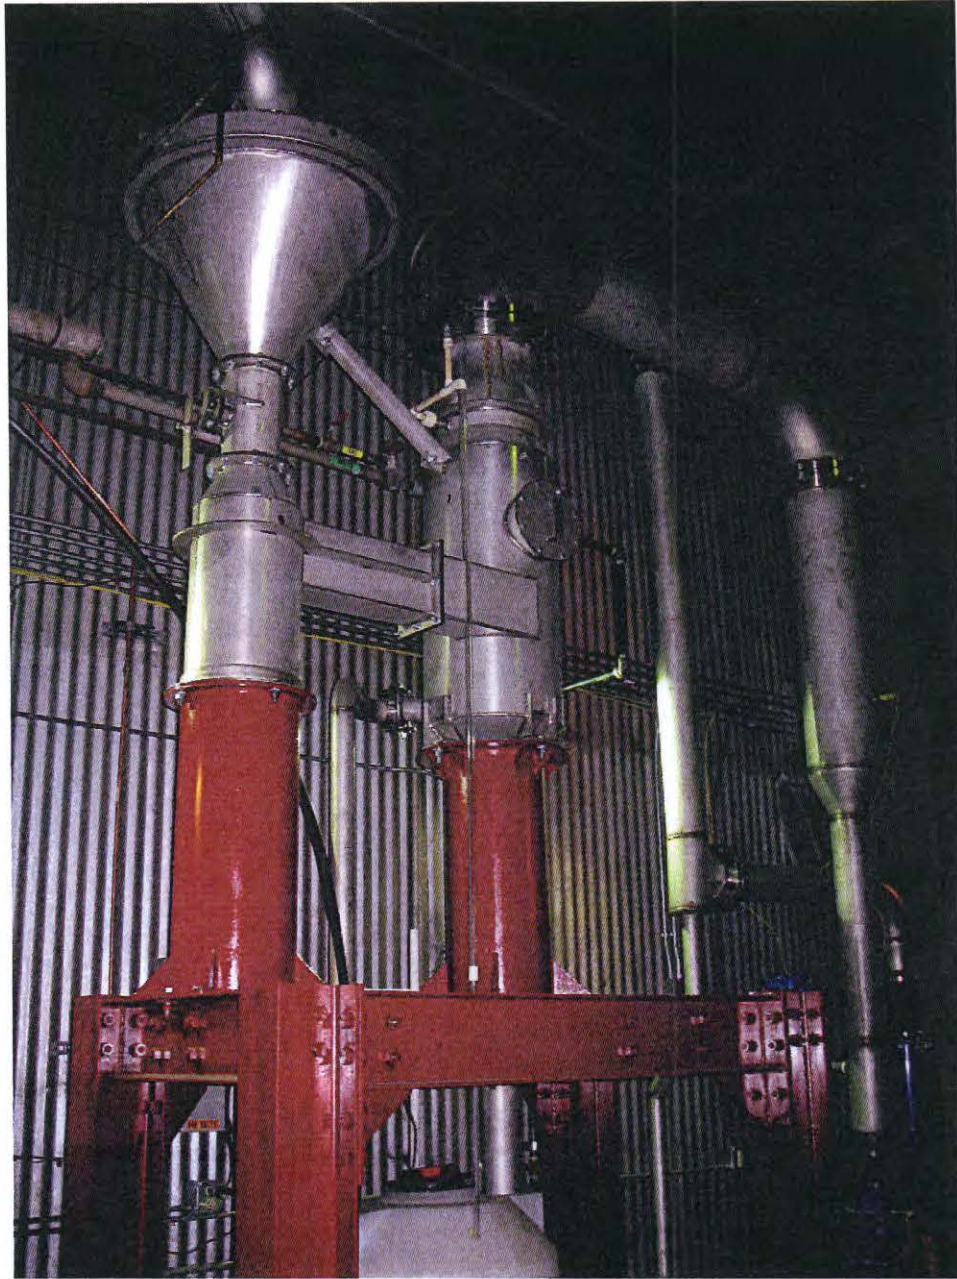
Figure 7 Gas Scrubbing and Exhaust Piping

Phase II: Noramco Engineering provided design, piping and layout drawings. Coleraine personnel carried out most of the fabrication and installation. Marshall Nelson and Associates provided PLC programming and control. All exhaust piping, the suction fan and non-compliant electrical service equipment were removed and were replaced by new stainless steel piping, a dual chamber Venturi gas scrubber, and variable speed blower. Additional programming, thermocouple inputs and pressure control were added to the PLC. A new Pitot tube flow meter was installed upstream of the gas scrubber for exhaust gas flow measurement.

The new blower has demonstrated capability to maintain at least 65 inches of water vacuum at the wind box. It has the capacity to pull higher suction, but has not yet been fully tested to find the upper limit. Wind box suction is controlled through a variable speed drive. Additional thermocouples were added to monitor three temperature points in the wind box, as well as blower inlet and blower outlet temperatures. All new temperature points are recorded in the data logging system. Figure 5 shows new exhaust piping with the old sinter pot in place. Figure 6 shows the new deep pot. Figure 7 shows the gas scrubbing system, and Figure 8 shows the new exhaust blower.

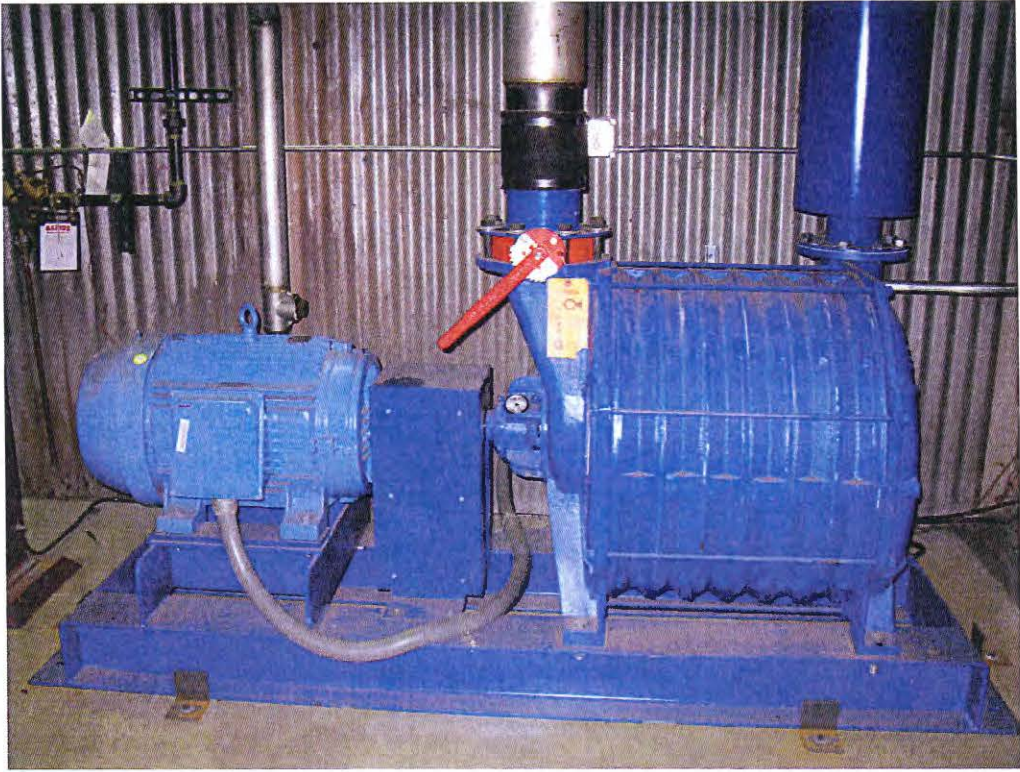
Figure 8 New Exhaust Blower
