# EFFECT OF DEICING SALTS ON WOODY VEGETATION ALONG MINNESOTA ROADS

Investigation No. 636  
Final Report - 1975

Minnesota Highway Department  
Minnesota Local Road Research Board  
in cooperation with  
College of Forestry, University of Minnesota

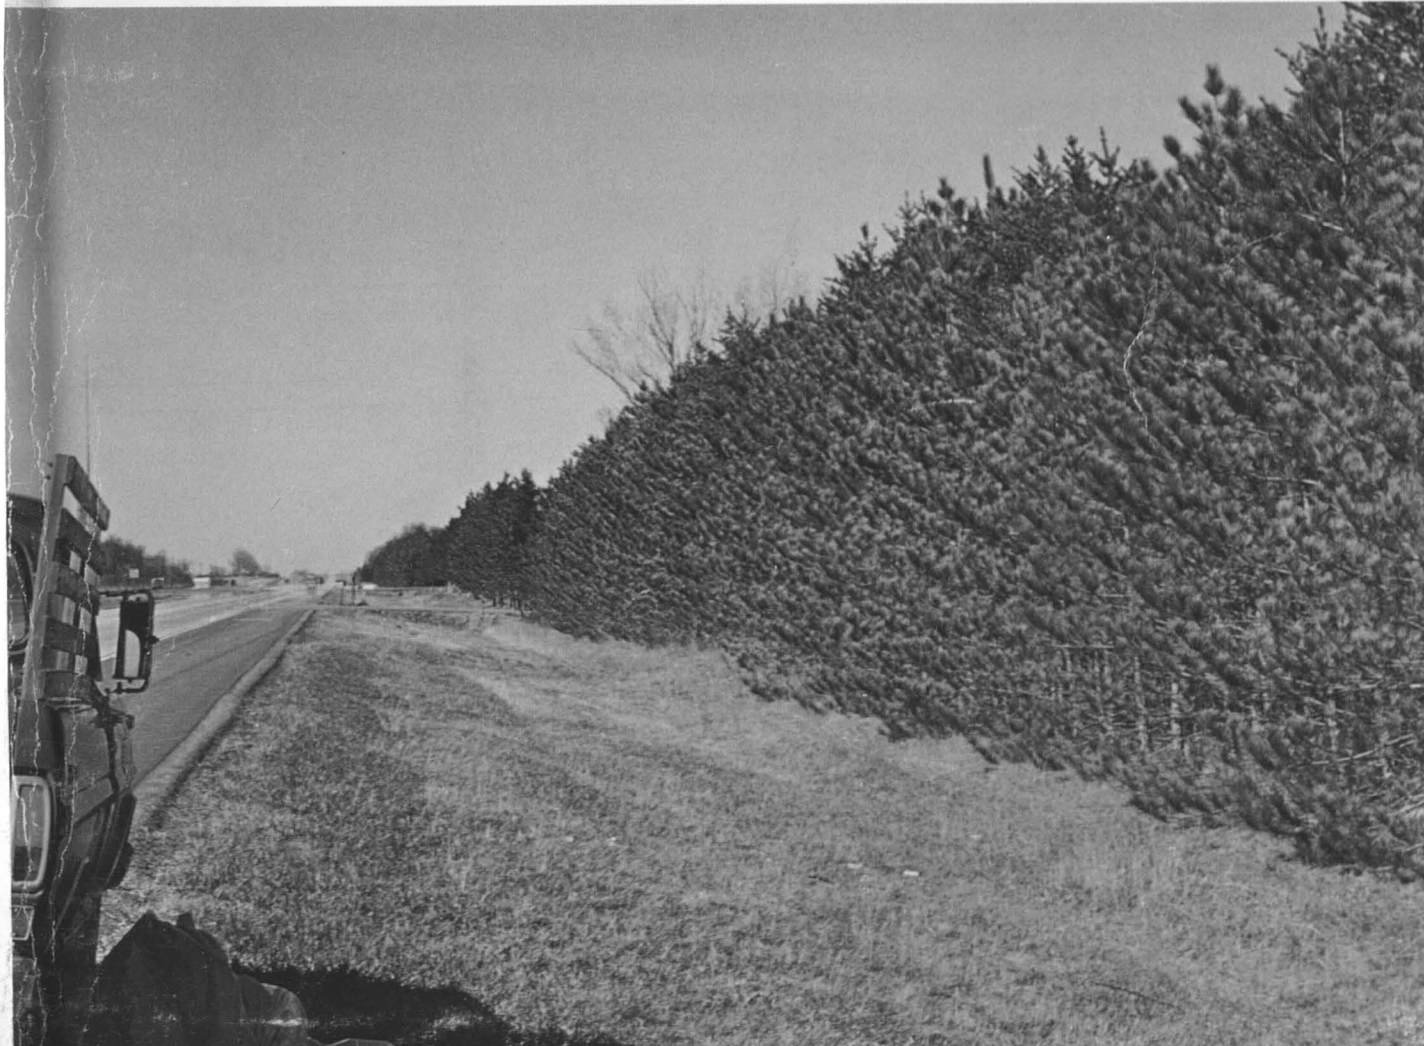
Interstate Highway I-94 in St. Paul following a snow storm. Driving surfaces are dry. Snow-ice mixture is plowed to edge. White on highway and on shoulder is salt.

Red pine browned by spray-salt. East side of TH 65.

2. The tips of 2- and 3-year-old needles, already brown from the previous winter's salt, will bronze still more. Needles that are 2- to 3-years old and more than 1/2 browned tend to fall off prematurely. The entire tree looks a bright rusty brown (cover photo).

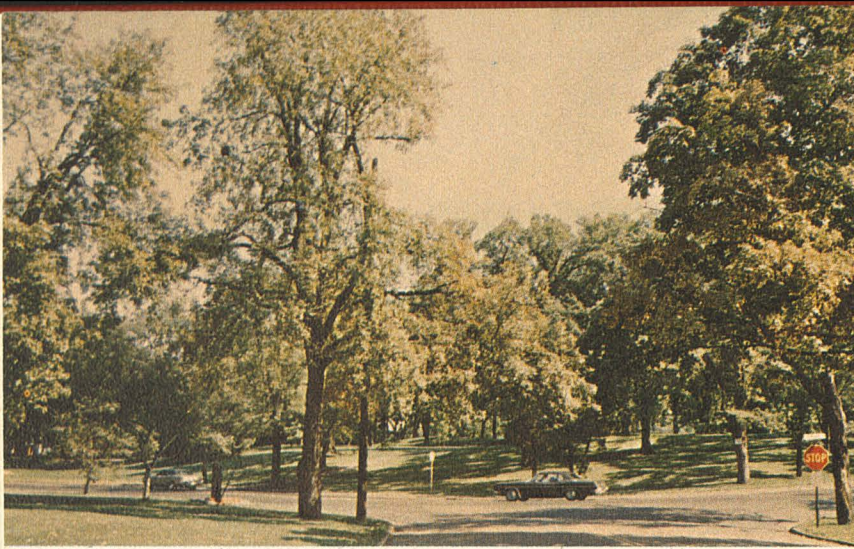
Figure 1. Soil-salt damage on trees next to heavily salted road. Brownish cast to leaves comes from marginal leaf scorch (figure 2). Tree on left has thin crown and small leaves, also characteristic of soil-salt damage.

Many symptoms may occur simultaneously on the tree (figure 1). In most cases the damage developed progressively over a

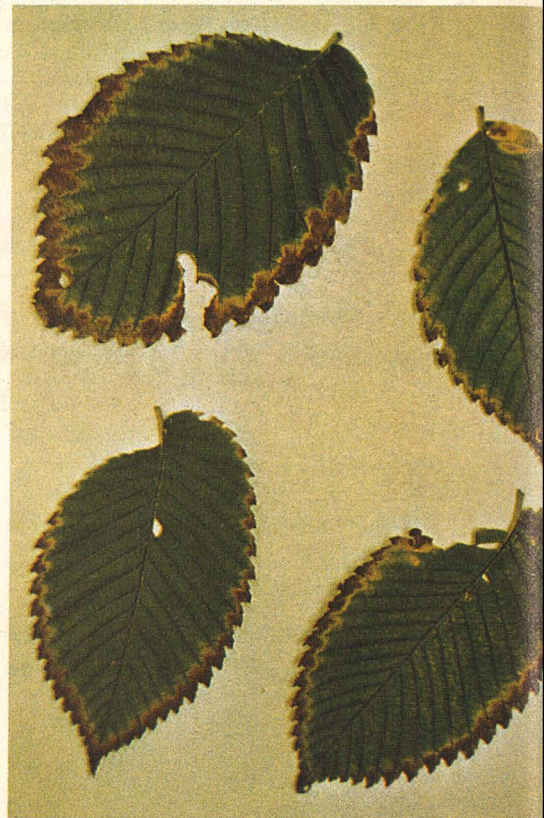
Figure 2. Soil-salt toxicity symptoms on American elm. The characteristic marginal scorch is separated from green interior by narrow yellow band.

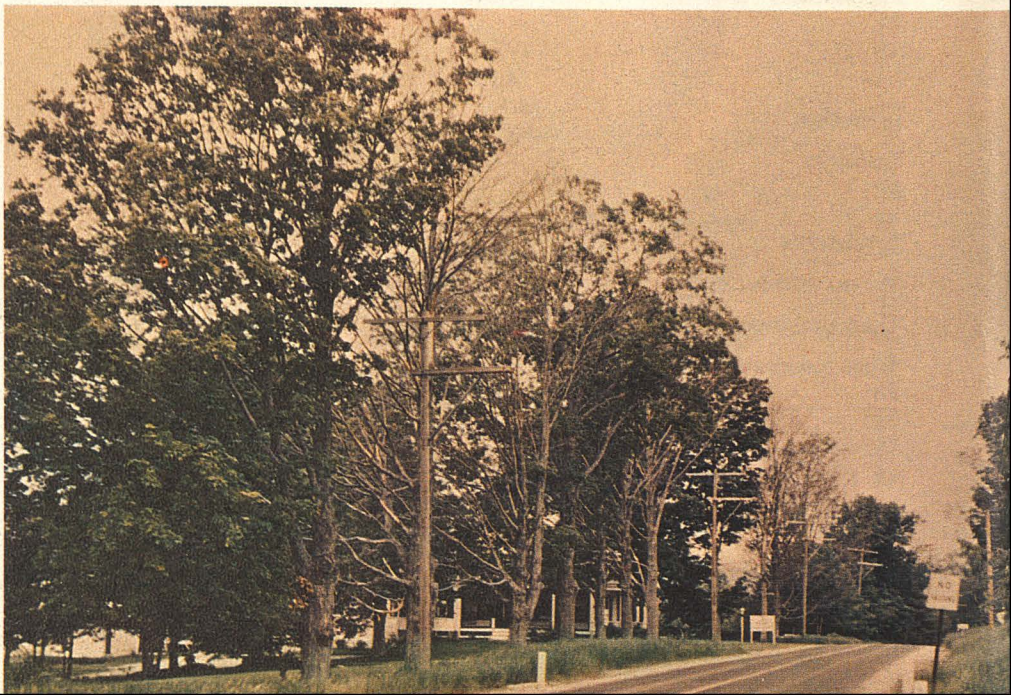
Figure 4. New Hampshire sugar maples killed in maple decline in which soil-salt is involved. Other photos are from Minnesota. (Photo courtesy of Dr. Avery Rich, University of New Hampshire.)

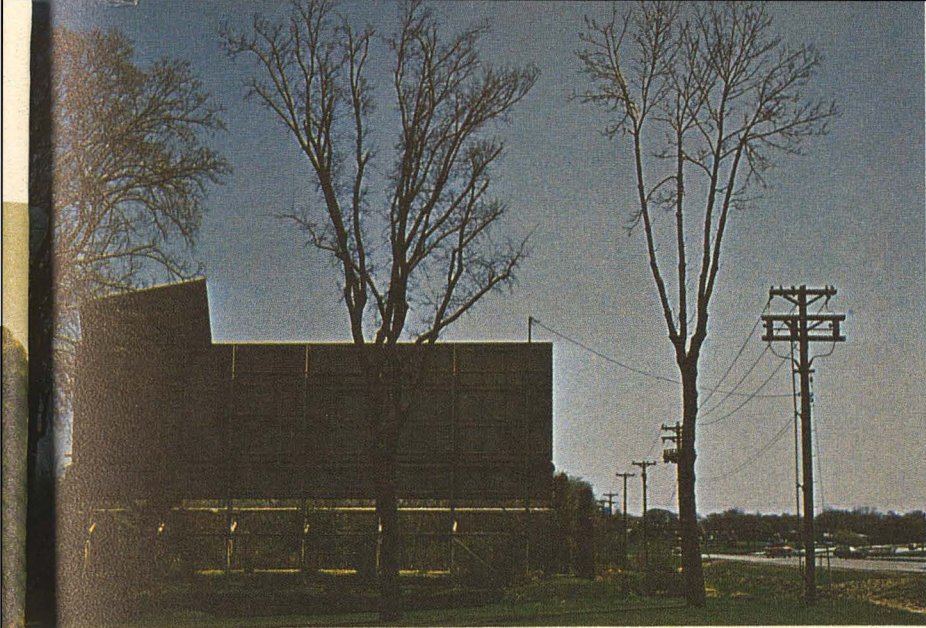
Figure 5. Size and fullness of crowns of American elm decrease with closeness to highway. Cause of decrease may be related to both soil-salt and spray-salt.

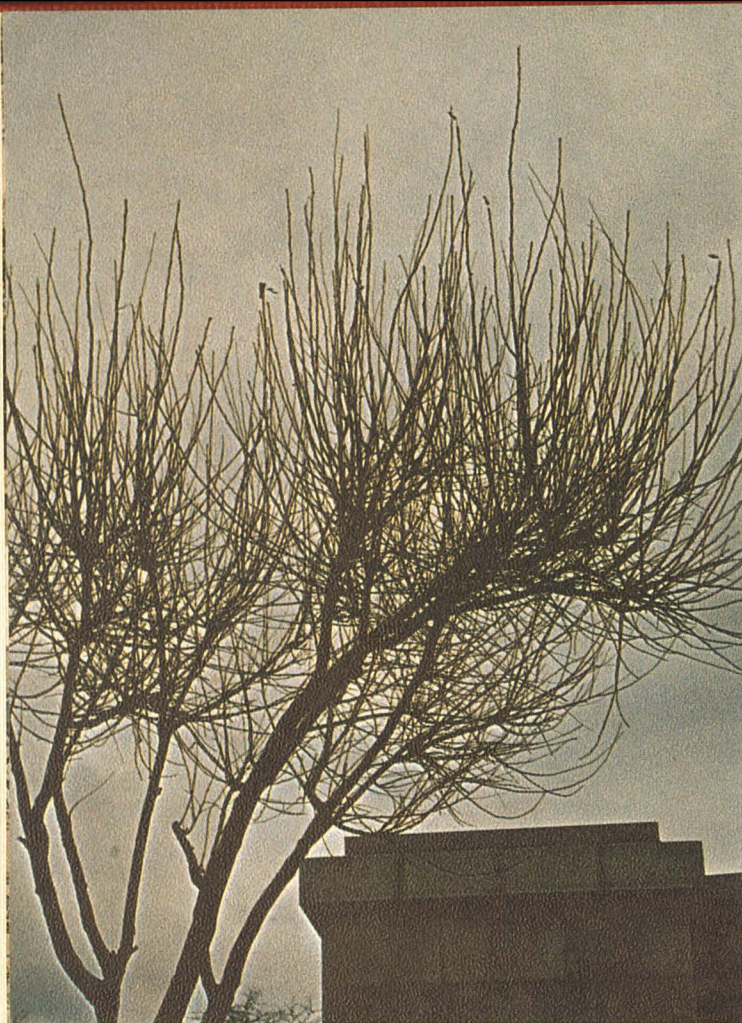
Figure 9. Brooming on flowering crab. Broom caused by release of lateral buds, after terminal buds are killed by salt spray.

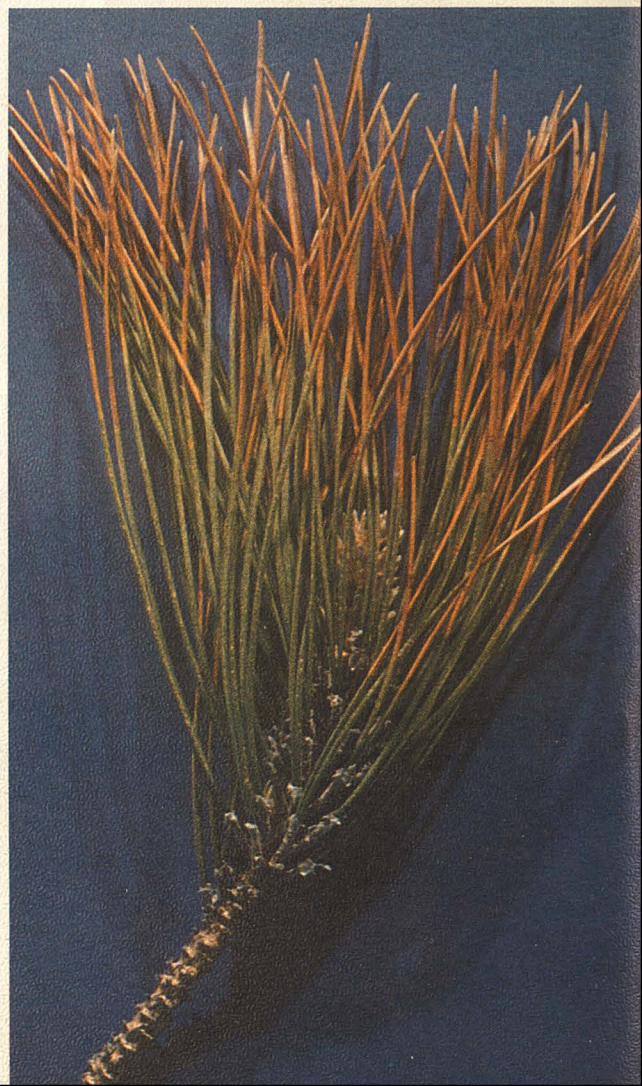
Figure 11. Typical salt damage symptoms on red pine needles.

1. As the weather warms, the tips of 1-year-old needles bleach and then turn bronze (figure 11); 25 to 75 percent bronzing is possible in severe damage. Just before browning, needles become flecked with bleached spots that often disappear later. These flecks help distinguish salt damage from other types of needle browning. Buds are not damaged.

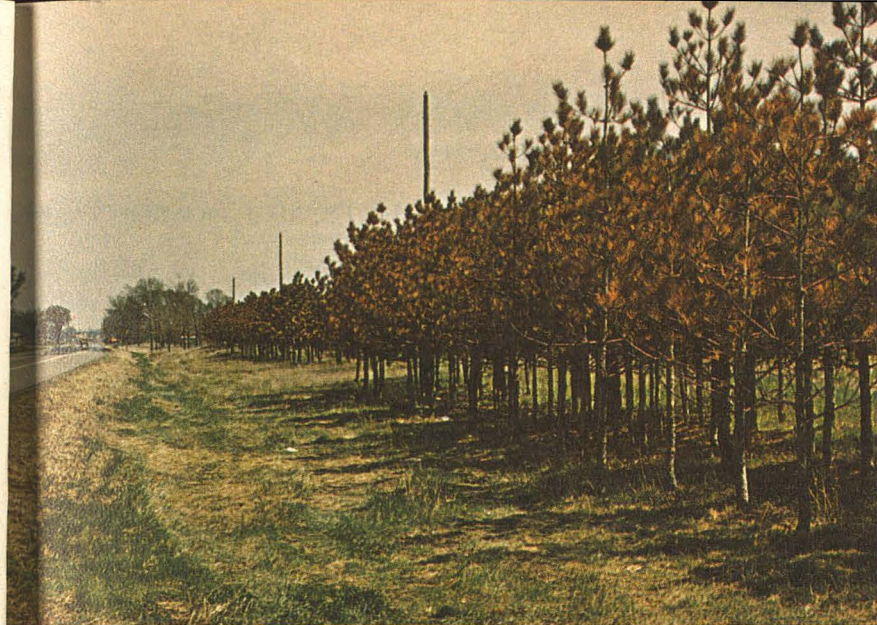
Figure 12. Fourteen-year old red pine showing thin crowns and reduced growth characteristic of trees with persistently browned needles.

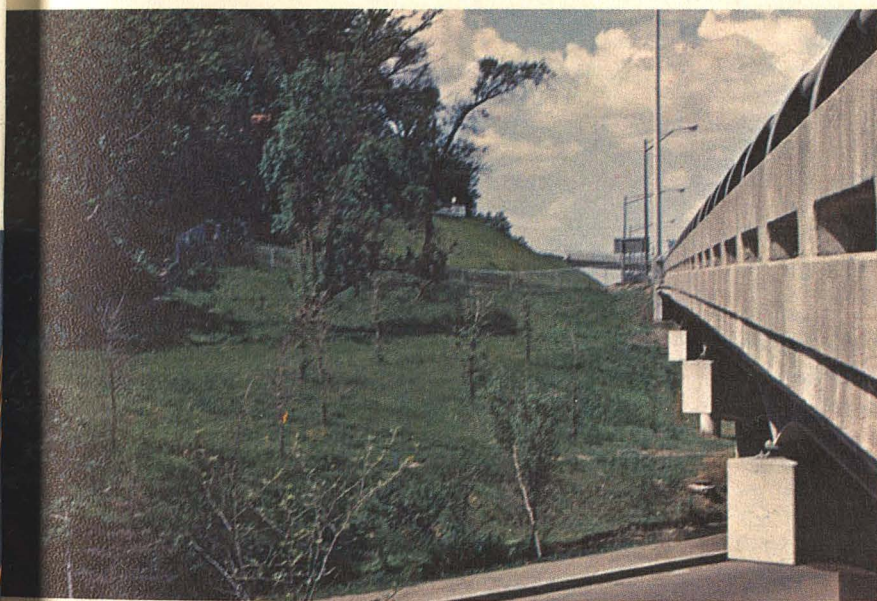
Figure 13. Spray damage beneath 35W at Minnehaha Creek. Trees near highway are coming into leaf late and have severe dieback. Notice arching elm with almost branchless limb facing the road.

Spray damage has a second symptom independent of dieback (figure 13). Full leafing out is delayed in the spring by as much as 3 weeks (Appendix A, studies 5, 7, and 10).

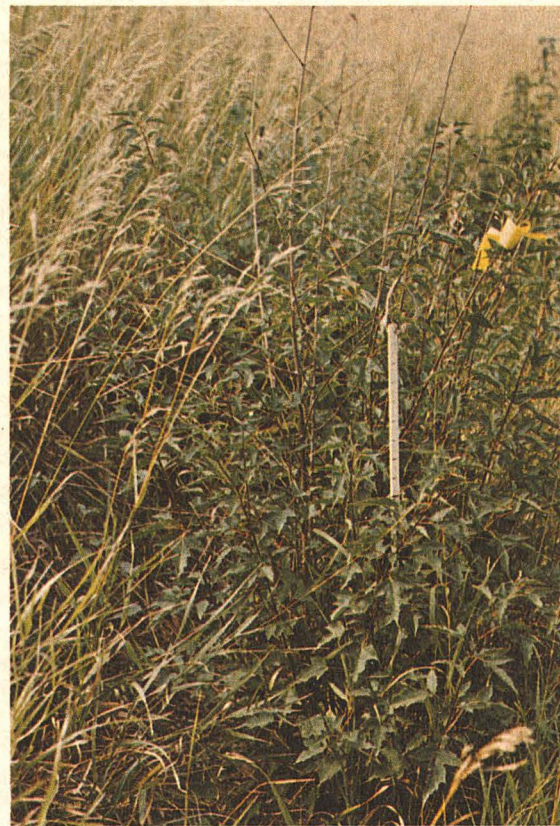
Figure 14. Amur maple shrubs killed back each year. These shrubs cannot escape from weed competition or be seen by traveler.

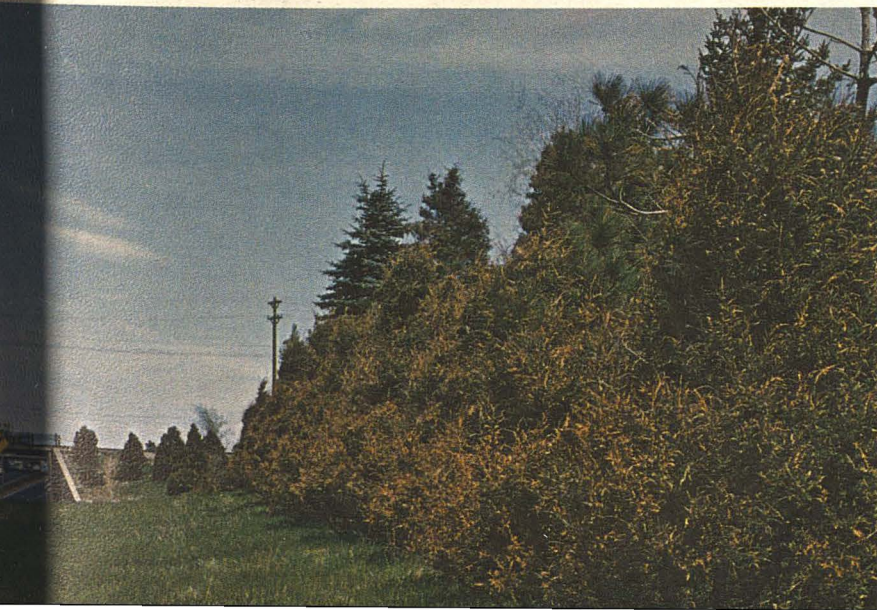
Figure 15. Red cedar browned by salt spray.
