Investigating Inductive Loop Signature Technology for Statewide Vehicle Classification Counts

Chen-Fu Liao, Principal Investigator
Department of Mechanical Engineering
University of Minnesota

October 2018

Research Project
Final Report 2018-31

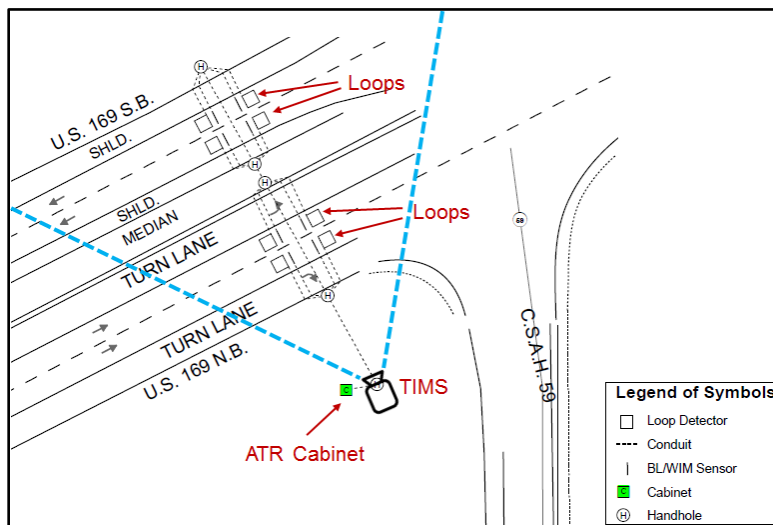
Figure 2.2 Drawing of Existing ATR353 Cabinet, Loop Detectors and TIMS Installation.

Figure 2.2 illustrates the installation location of the inductive loop detectors and the ATR353 controller cabinet located on the SW corner of highway 169 and CSAH50. A photo of the ATR353 site is displayed in Figure 2.3.

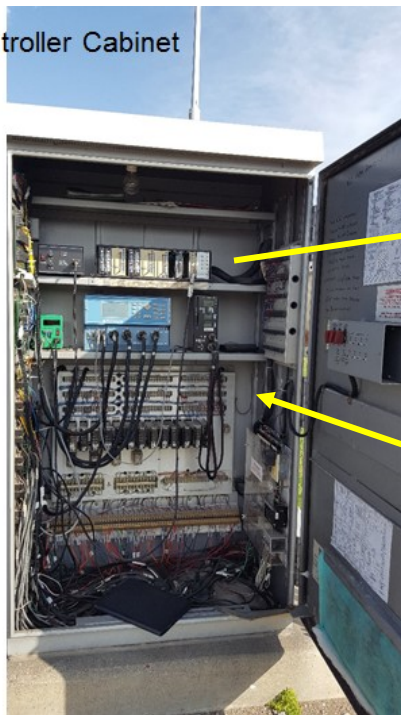
Figure 2.6 Controller Cabinet and Loop Detector Cards at TH169 & TH282 Intersection.

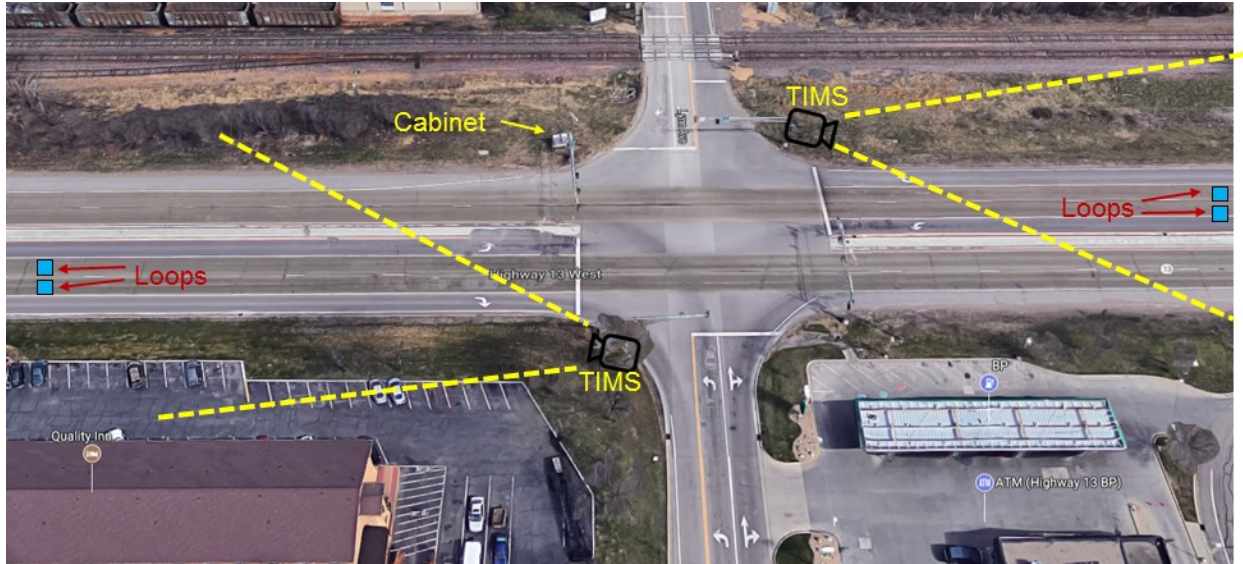
Figure 2.7 Loop Detector Locations and TIMS deployment at TH13 & Lynn Ave Intersection.

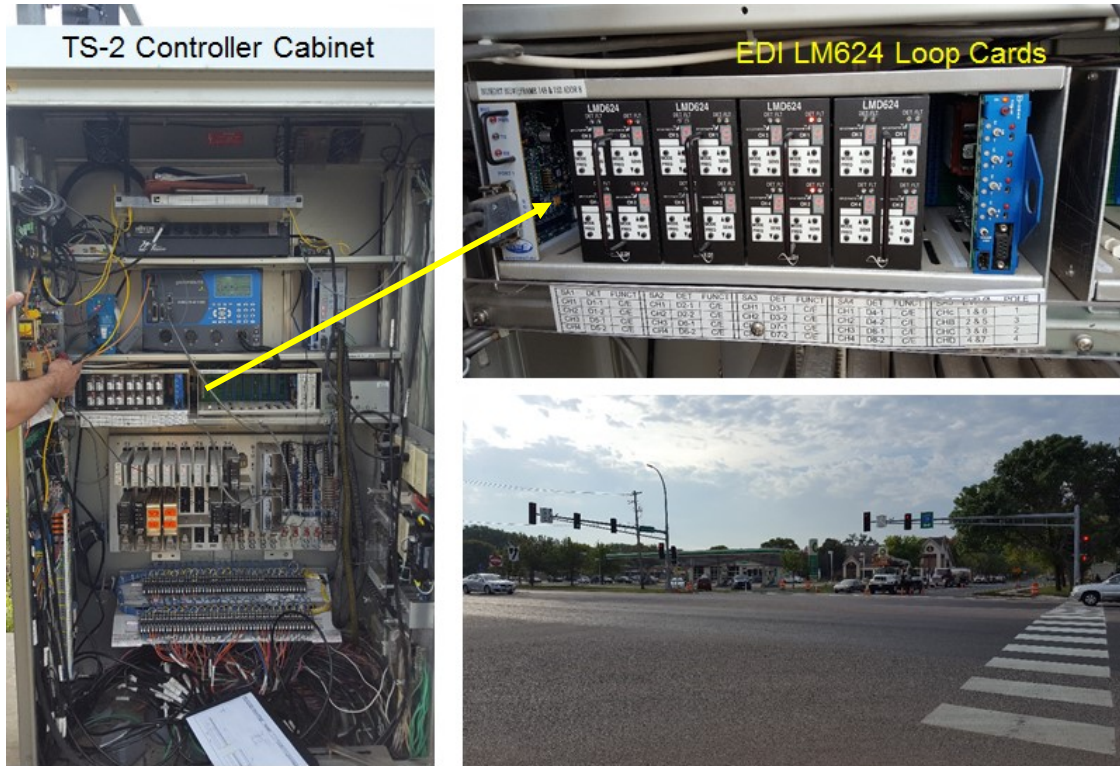
Figure 2.8 Controller Cabinet and Loop Detector Cards at TH13 & Lynn Ave Intersection.

this intersection is housed in a NEMA TS-2 cabinet (see Figure 2.8) in the NW corner of the intersection. EDI LM624 loop detection cards are used at this location.

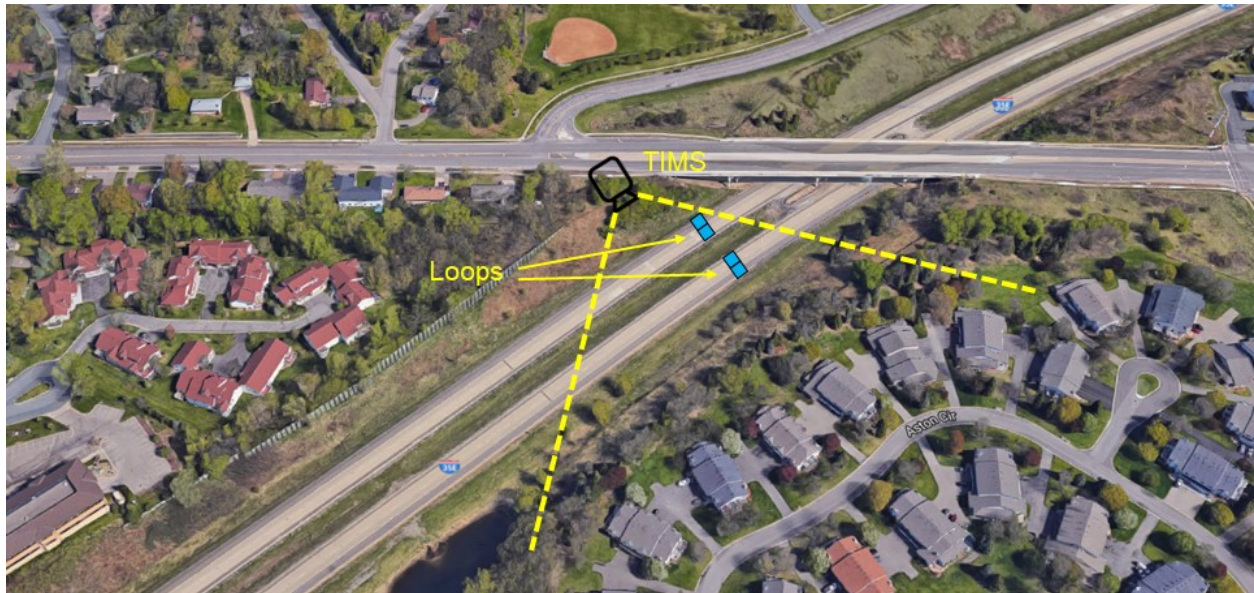
Figure 2.9 Loop Detector Locations on I-35E South of McAndrews Road.

Test site #4 is located on I-35E south of McAndrews Road in Burnsville as illustrated in Figure 2.9 & 2.10.

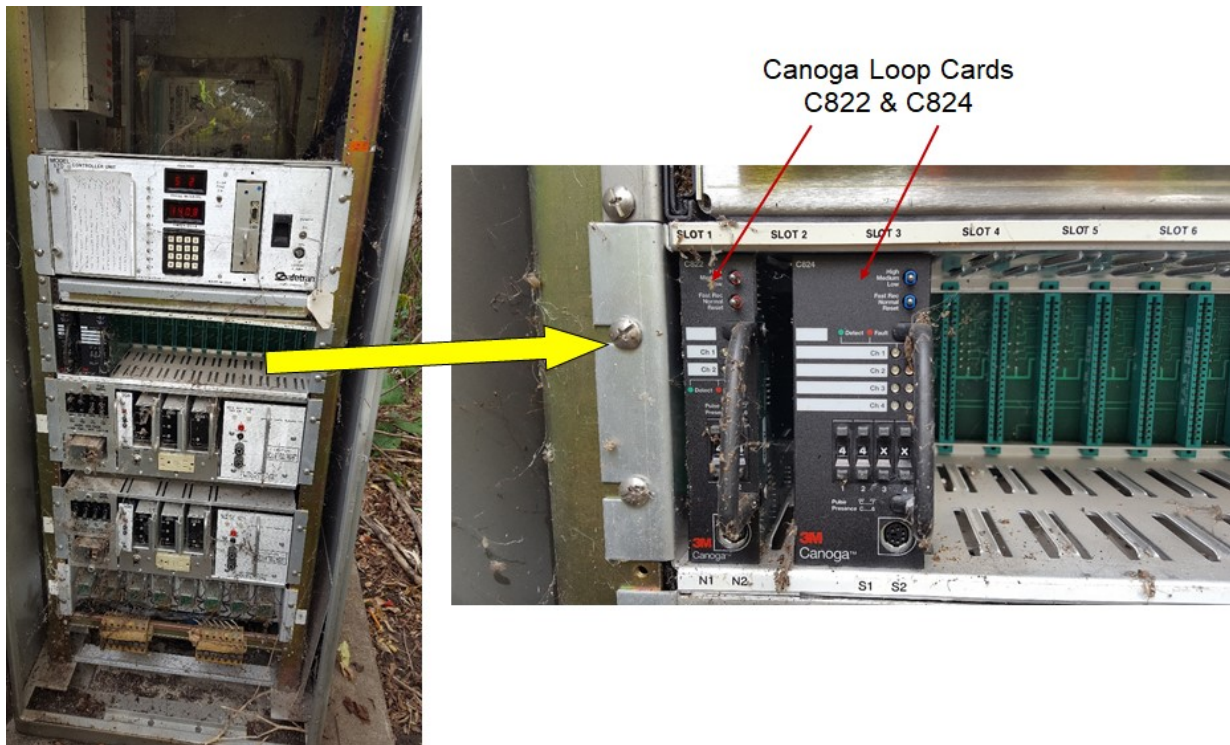
Figure 2.10 Controller Cabinet and Loop Detector Cards at I-35E South of McAndrews Road.

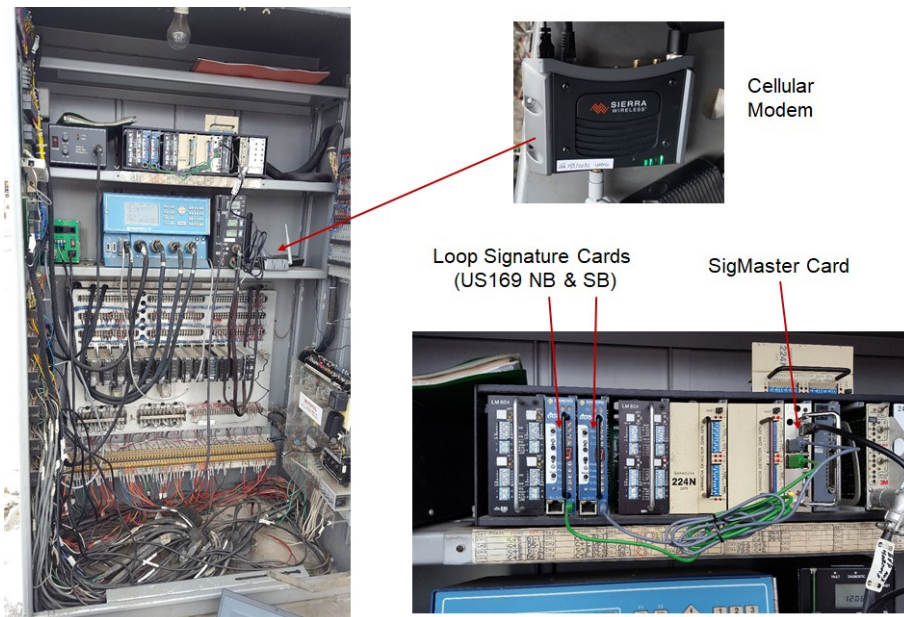
Figure 3.6 Loop Cards and Data Collection Gateway Installed at US-169 & TH-282/Quaker Ave.

Two loop signature cards were installed inside the TS-1 signal controller cabinet at US169 & Quaker Ave. in Jordan MN, as illustrated in Figure 3.6. The first loop card covers the 2 through lane traffic on US-169 NB (signal phase 2) and the other loop card collects data from the 2 through lane traffic in the SB direction (signal phase 6). For signal control cabinet, each loop signature card requires 3 jumpers to be installed in order to provide detection output to the traffic controller. A software setting (BD1) was also adjusted to hold the detection output for 250 ms in order for the traffic controller to capture it. Installation of the data collection system at this site is illustrated in Figure 3.7. The camera views of the video data collection at this site in both NB & SB directions are displayed in Figure 3.8 and 3.9, respectively.

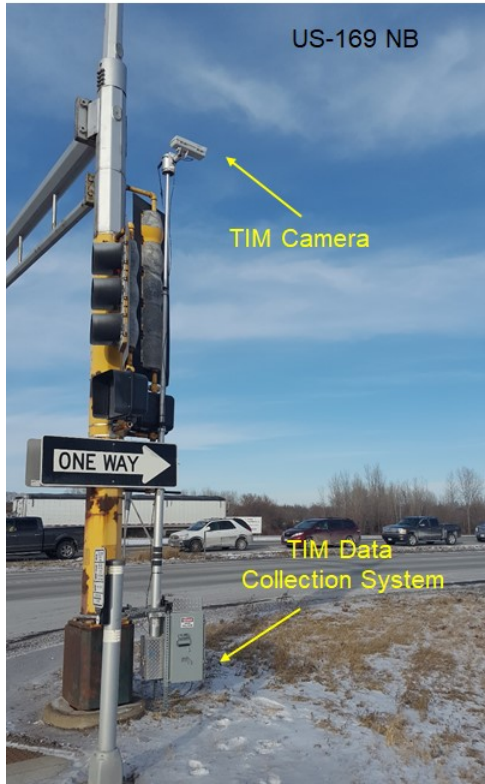
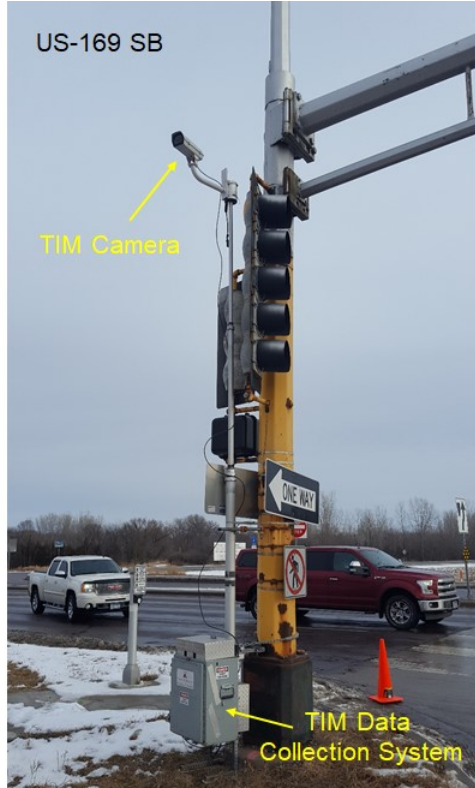
Figure 3.7 Installation of Video Data Collection System at US-169 & TH-282/Quaker Ave.

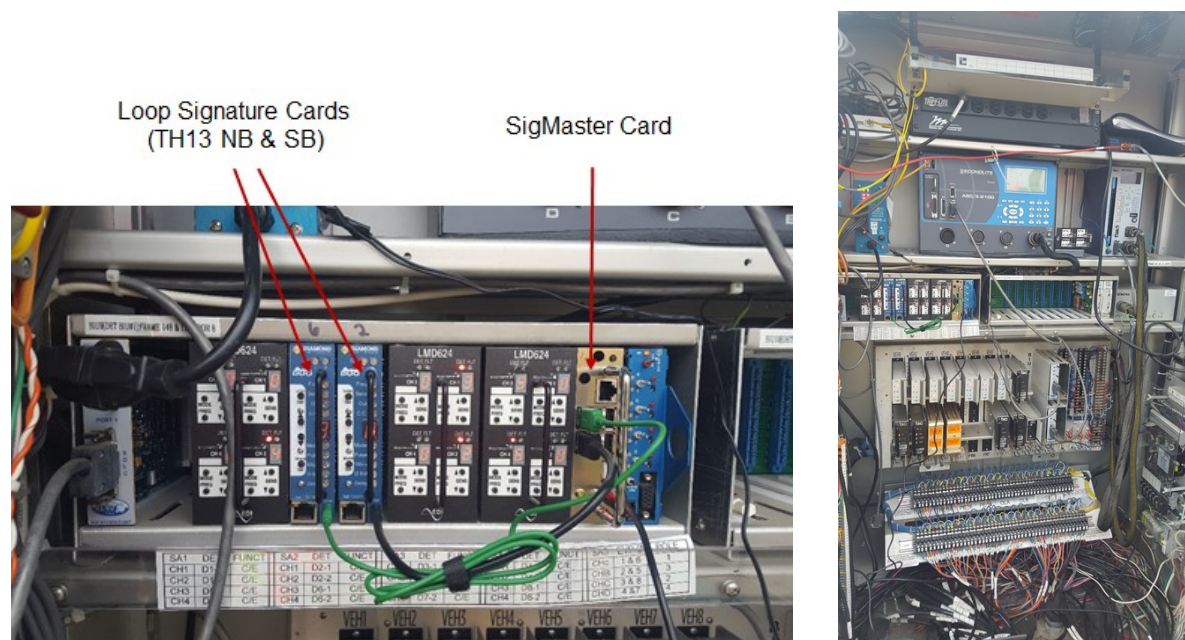
Figure 3.10 Loop Cards Installed at Site #3 (TH-13 at Lynn Ave).

Two loop signature cards were installed inside the TS-2 signal controller cabinet at Highway 13 and Lynn Ave. in Savage MN, as illustrated in Figure 3.10. The first loop card covers the 2 through lane traffic on TH-13 NB (signal phase 2) and the other loop card collects data from the 2 through lane traffic in the SB direction (signal phase 6). For this signal control cabinet, 3 jumpers were installed on each loop signature card in order to provide detection output to the traffic signal controller. A software setting (BD1) was also adjusted to hold the detection output for 120 ms in order for the traffic signal controller to recognize it. Installation of the data collection system at this site is illustrated in Figure 3.11. The camera views of the video data collection at this site in both NB & SB directions are displayed in Figure 3.12 and 3.13, respectively.

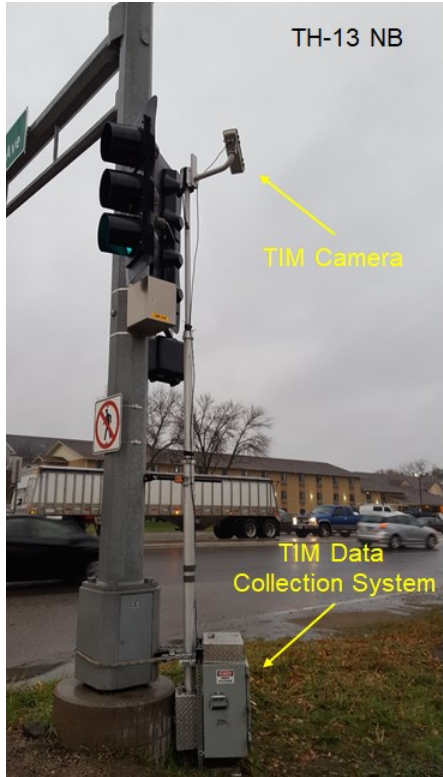
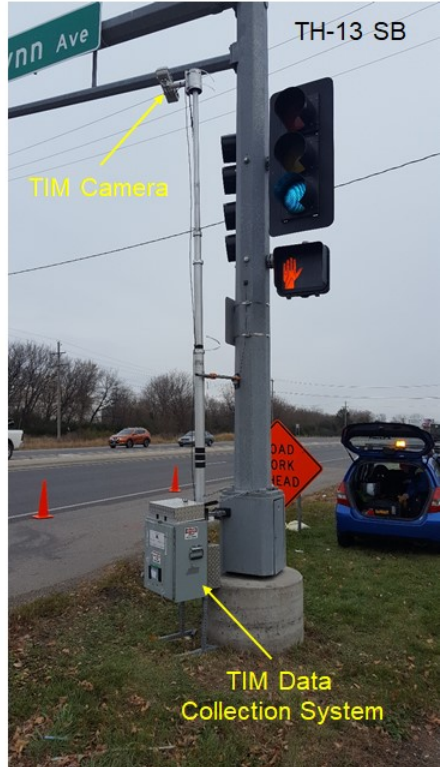
Figure 3.11 Installation of Video Data Collection System at Site #3 (TH-13 at Lynn Ave).

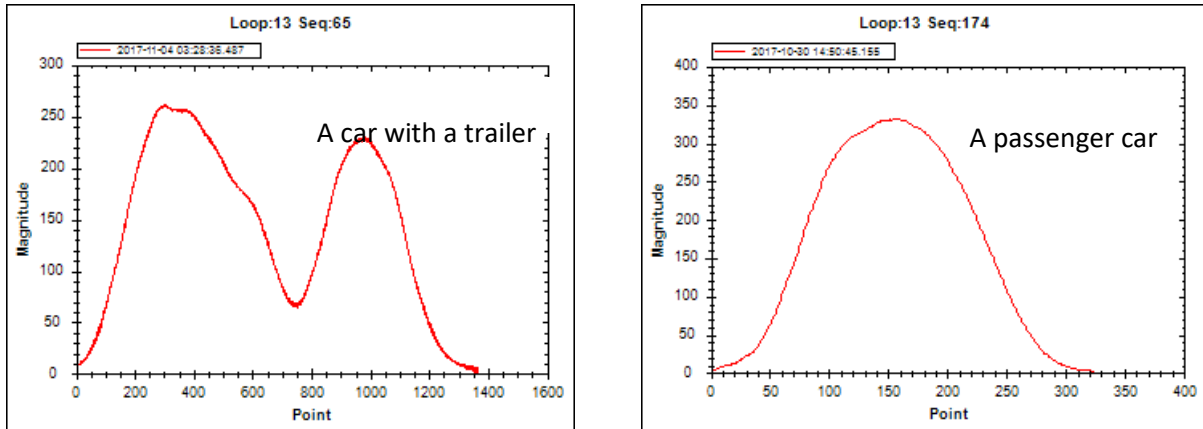
Figure 4.3 Sample Loop Signature Profiles of Two Vehicles.

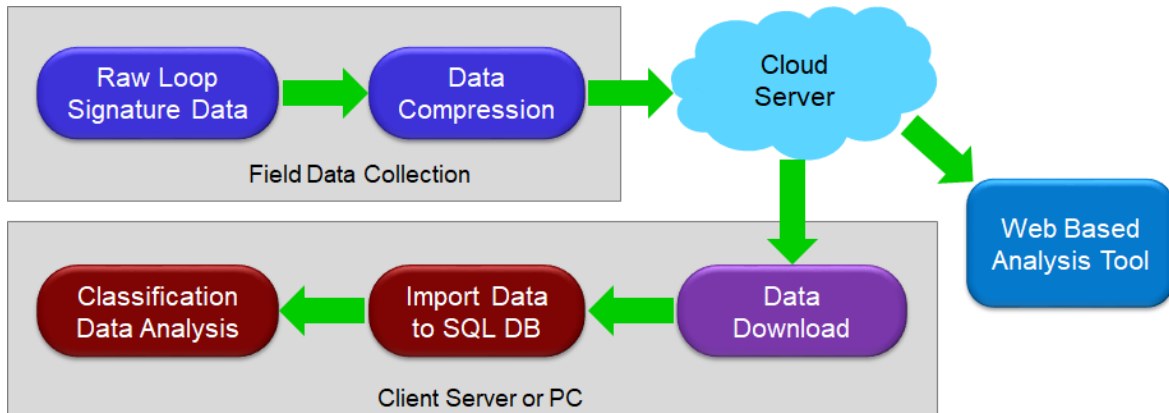
Figure 4.4 Flowchart of Loop Data Processing and Analysis.

Figure 4.4 illustrates the process of uploading the loop signature data to a cloud server and making the data available for data analysis. The cloud server is managed by the loop card vendor. Raw vehicle signature data collected from the loop detector cards were processed and stored locally on the gateway card. Daily loop data were compressed and uploaded to a cloud server via a data modem. The web-based analysis tool on the cloud server allows clients to analyze or visualize the data on a web interface. Users can also download the raw data and import the data to an open source database (MySQL) for further analysis.

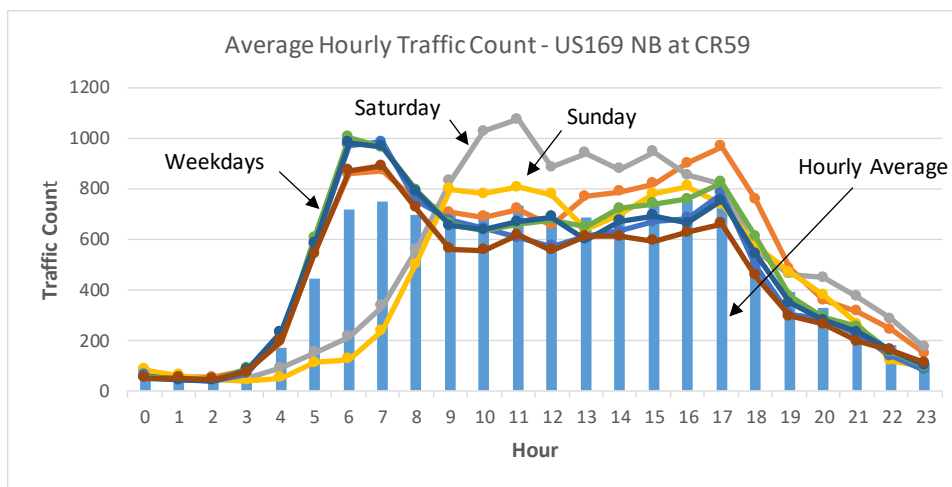
Figure 4.11 One Week of Traffic Volume by Hour at the Site #1.

Figure 4.11 displays the hourly traffic volume at site #1 (US169 at CR59/Delaware Ave. in Jordan, MN) in the NB direction using one week of data from 12/15/2017 to 12/21/2017. The bar chart indicates the average hourly traffic count over the entire week. Throughout the entire data collection period (12/15/2017 – 2/5/2018) at this location, the average daily traffic volume in the NB direction on weekdays is 10,268, and the average daily traffic count in the NB direction on weekends is 8,919. The Annual Average Daily Traffic (AADT) count at this location in 2016 for both directions is 23,000 [15].

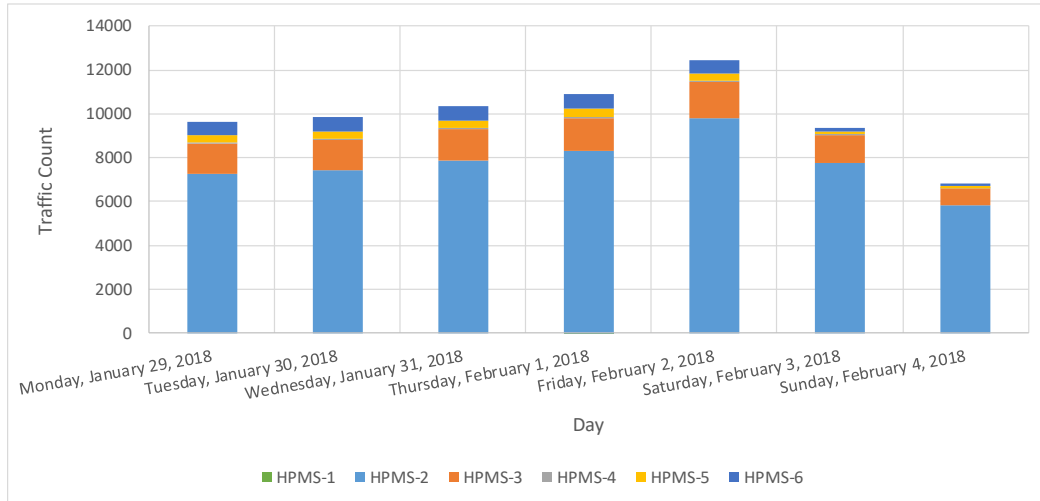
Figure 4.12 One Week of Traffic Count by HPMS Vehicle Classification at the Site #1.

Figure 4.12 shows the distribution of vehicle classification based on the Highway Performance Monitoring System (HPMS) vehicle class groups [16] at the site #1 in the NB direction using one week of loop data. Based on the loop data, class 2 or 3 vehicles averagely make up over 90% of the traffic at this location.

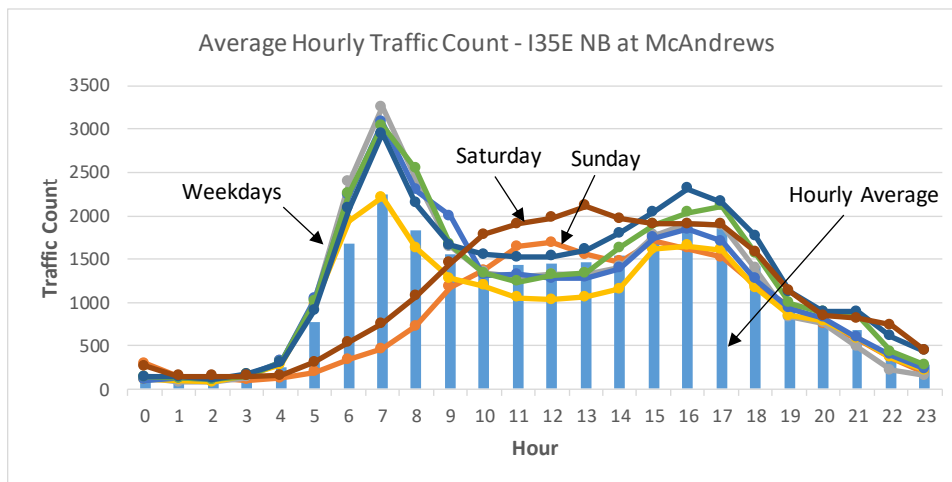
Figure 4.13 One Week of Traffic Volume by Hour at the Site #4.

Figure 4.13 displays the hourly traffic volume at site #4 (I-35E at McAndrews Road in Burnsville, MN) in the NB direction using one week of data from 12/3/2017 to 12/9/2017. The bar chart indicates the average hourly traffic count over the entire week. Throughout the entire data collection period (11/2/2017 – 12/13/2017) at this location, the average daily traffic volume in the NB direction on weekdays is 28,628, and the average daily traffic count in the NB direction on weekends is 22,556. The AADT count at this location in 2016 for both directions is 55,000.

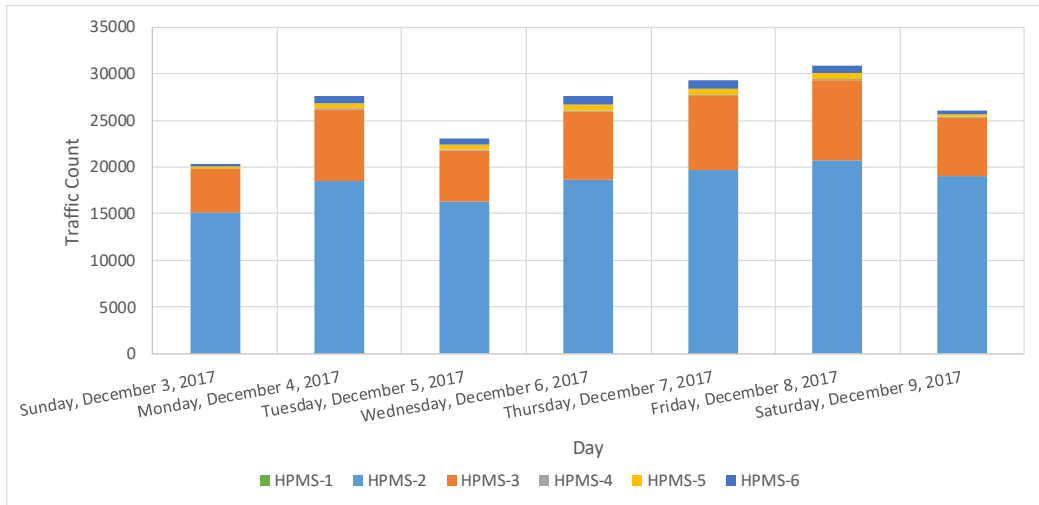
Figure 4.14 One Week of Traffic Counts by HPMS Vehicle Classification at the Site #4.

Figure 4.14 shows the distribution of vehicle classification based on the HPMS vehicle class groups at the site #4 in the NB direction using one week of loop data. Based on the loop signature data, class 2 or 3 vehicles averagely make up over 94% of the traffic at this location.

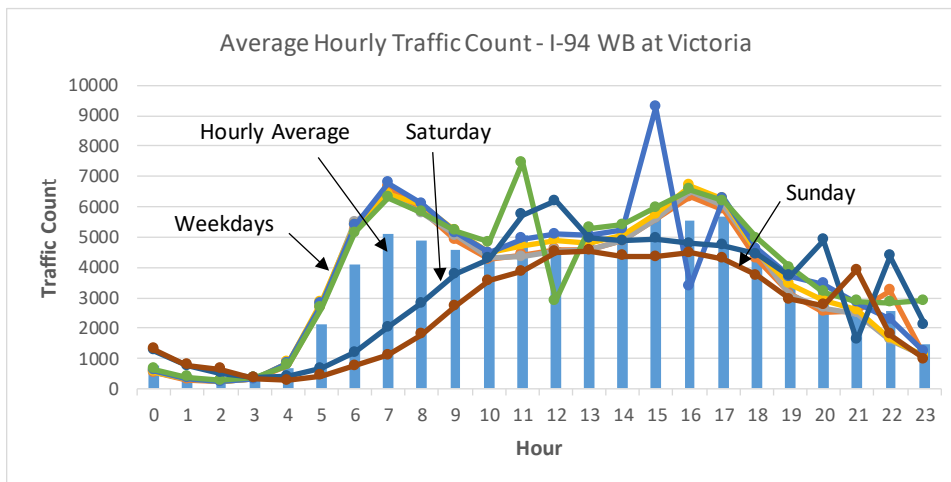
Figure 4.15 One Week of Traffic Volume by Hour at the Site #5.

Figure 4.15 displays the hourly traffic volume at site #5 (I-94 at N Victoria Street in St. Paul, MN) in the WB direction using one week of data from 3/18/2018 to 3/24/2018. The bar chart indicates the average hourly traffic count over the entire week. Throughout the entire data collection period this location, the average daily traffic volume in the WB direction on weekdays is 87,030, and the average daily traffic count in the WB direction on weekends is 68,013. The AADT count at this location in 2016 for both directions is 154,000.

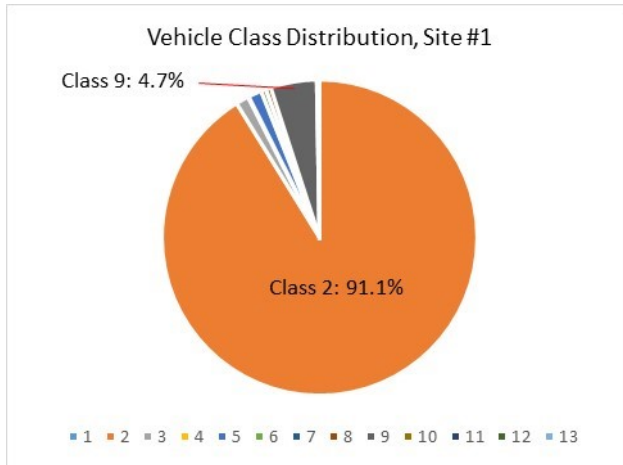
Figure 4.21 Distribution of Vehicle Classification at Site #1.

The research team observed 80 hours (9am-5pm for 11 days) of video data and processed over 58,450 vehicles at this location. As illustrated in Figure 4.21, 91.1% of vehicles at this location are class 2 passenger cars and 4.7% of the traffic is class 9 trucks. The other vehicles combined consist of less than 5% of the total traffic at this site. Figure 4.22 illustrates the daily traffic volume percentage error when comparing the vehicle counts from the loop signature system to the video data. On average, the traffic volume error is within $\pm 1\%$ except on 12/27/2017 which has an error of 2.16%. Comparisons of traffic count in peak and off-peak periods are also displayed in Figure 4.22. There is no significant traffic count error between peak and mid-day hours. The reason for the spike of volume count error is unknown, however, we noticed that the average temperature on 12/27/2017 is relatively lower than the average temperature from previous days as listed in Table 4.11.

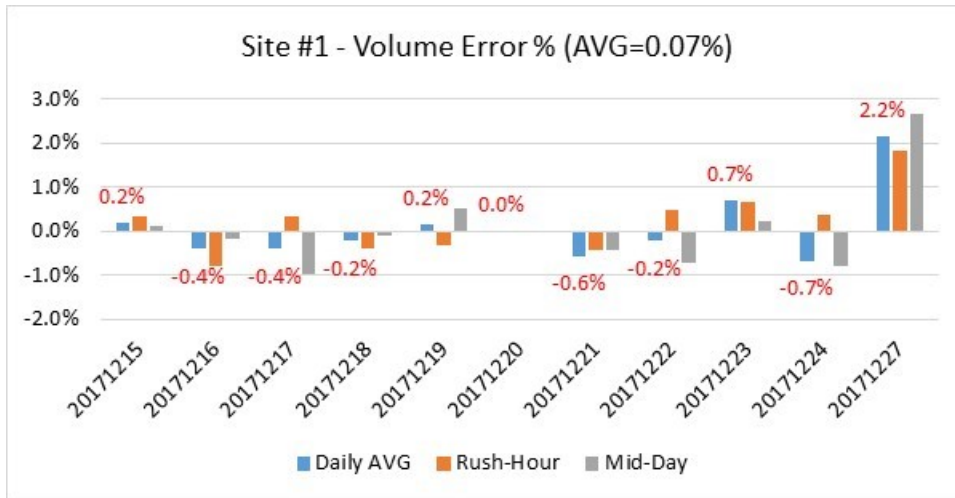
Figure 4.22 Traffic Volume Error Percentage at Site #1.

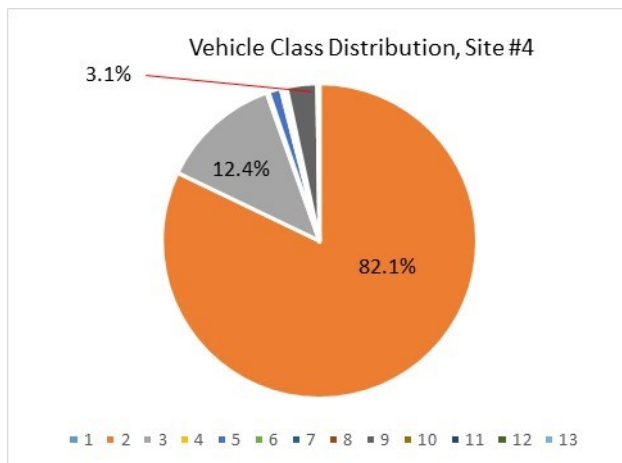
Figure 4.26 Distribution of Vehicle Classification at Site #4.

The research team observed and analyzed 86 hours (9am-5pm for 11 days) of video data and processed over 165,000 vehicles at this location. As illustrated in Figure 4.26, 82.1% and 12.4% of traffic at this location are respectively class 2 and 3 vehicles, and 3.1% of the traffic is class 9 trucks. The other vehicles combined consist of less than 3% of the total traffic at this site. Figure 4.27 illustrates the daily traffic volume percentage error of the loop signature system. On average, the traffic volume error of the loop signature card at site #4 is about 1.1% with a standard deviation of 3.7%. Comparisons of traffic count in peak and off-peak periods are also displayed in Figure 4.27.

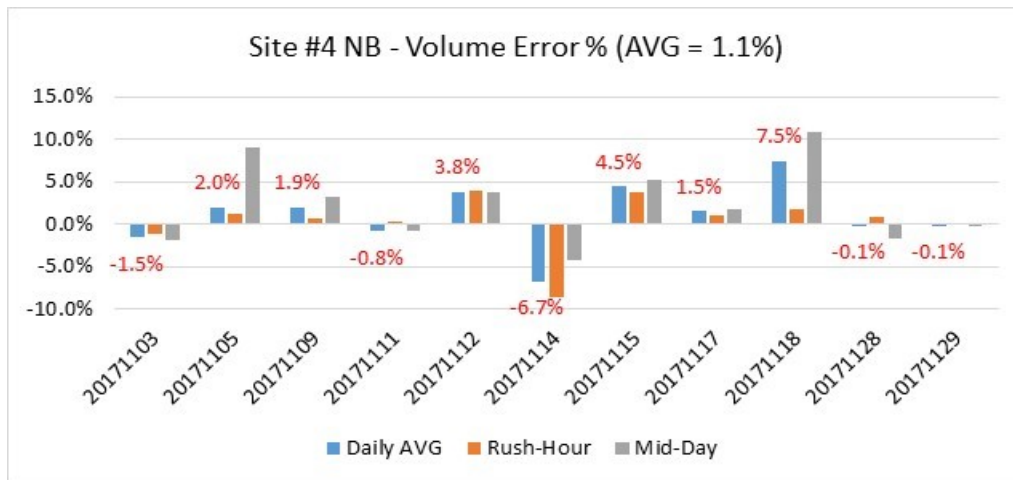
Figure 4.27 Traffic Volume Error Percentage at Site #4 NB.
