Evaluation of the Effectiveness of Stop Lines in Increasing the Safety of Stop-Controlled Intersections

Minnesota Traffic Observatory

Research Project

Final Report 2020-17

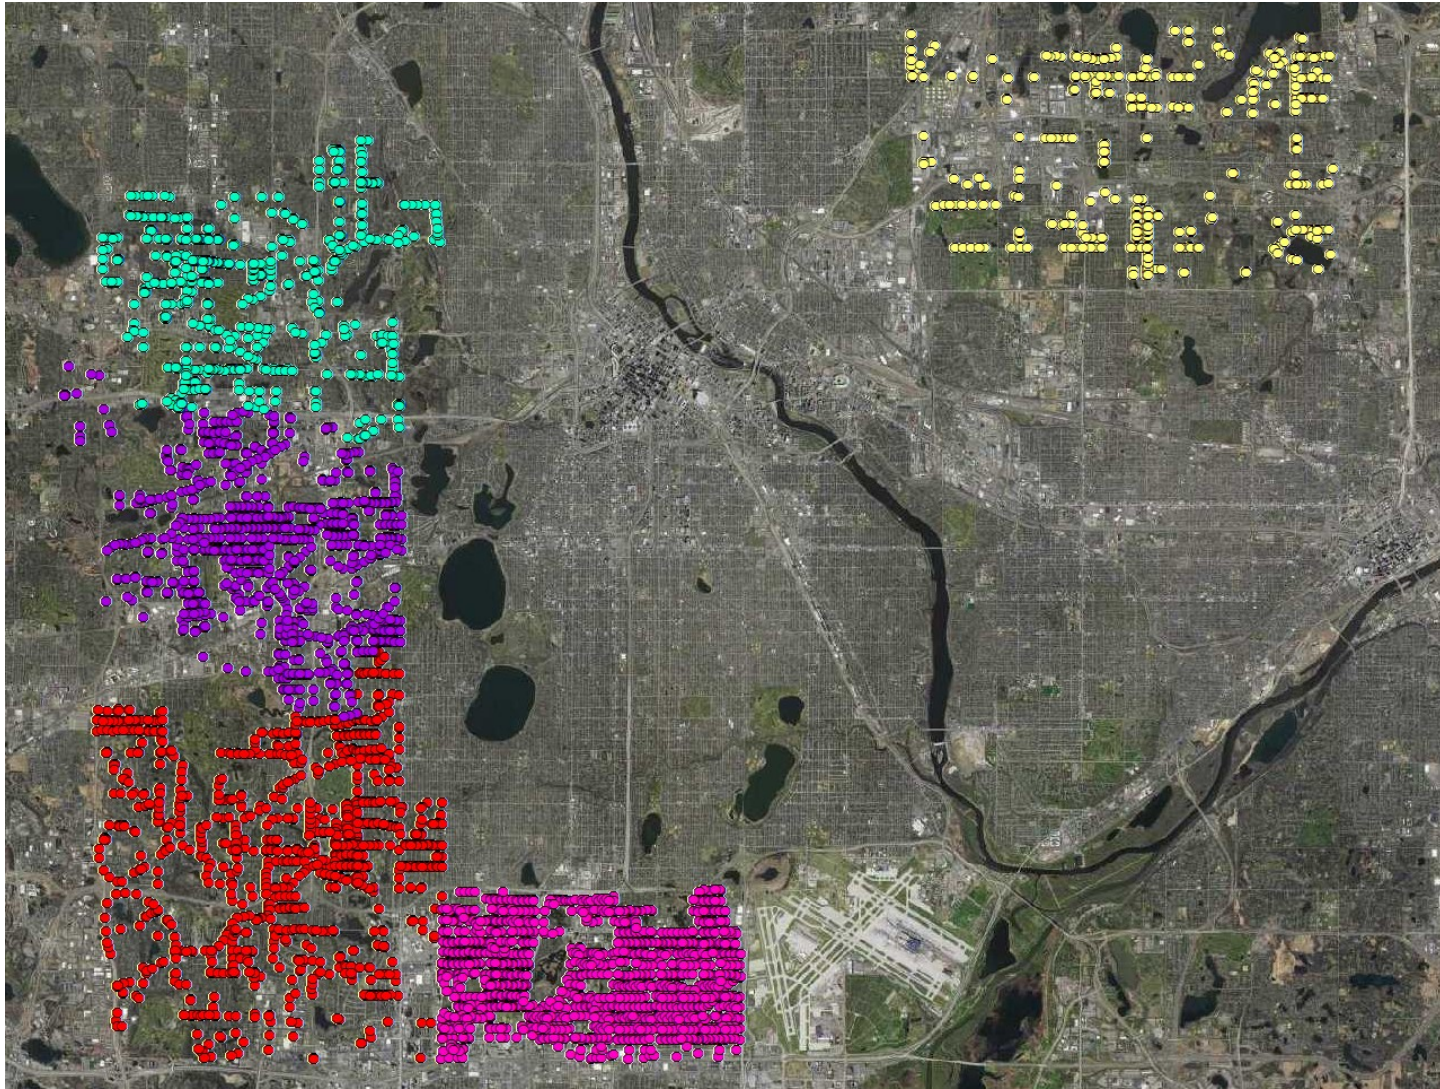
Figure 2.1 Stop sign markers for the five cities that provided data (clockwise from upper right: Roseville, Richfield, Edina, St. Louis Park, and Golden Valley)

Manual adjustments were made to the stop sign and intersection pins to improve the accuracy of the approach identification process. Adjustments of intersection pins consisted of moving the pins to be closer to the center of the intersection (according to the 2016 MnGeo aerial imagery) and adding or removing pins that were erroneously included or omitted during the site identification process. Cases of accidental inclusion or omission commonly involved private driveways that resembled public roads or one-way roads that resembled two-way roads. Adjustments to the stop sign markers consisted of deleting duplicates, adding missing markers, and moving existing markers to their positions relative to the intersection of the polylines on the road layer. The vector from the intersection node to the intersection pin was used later to translate other objects at the intersection.

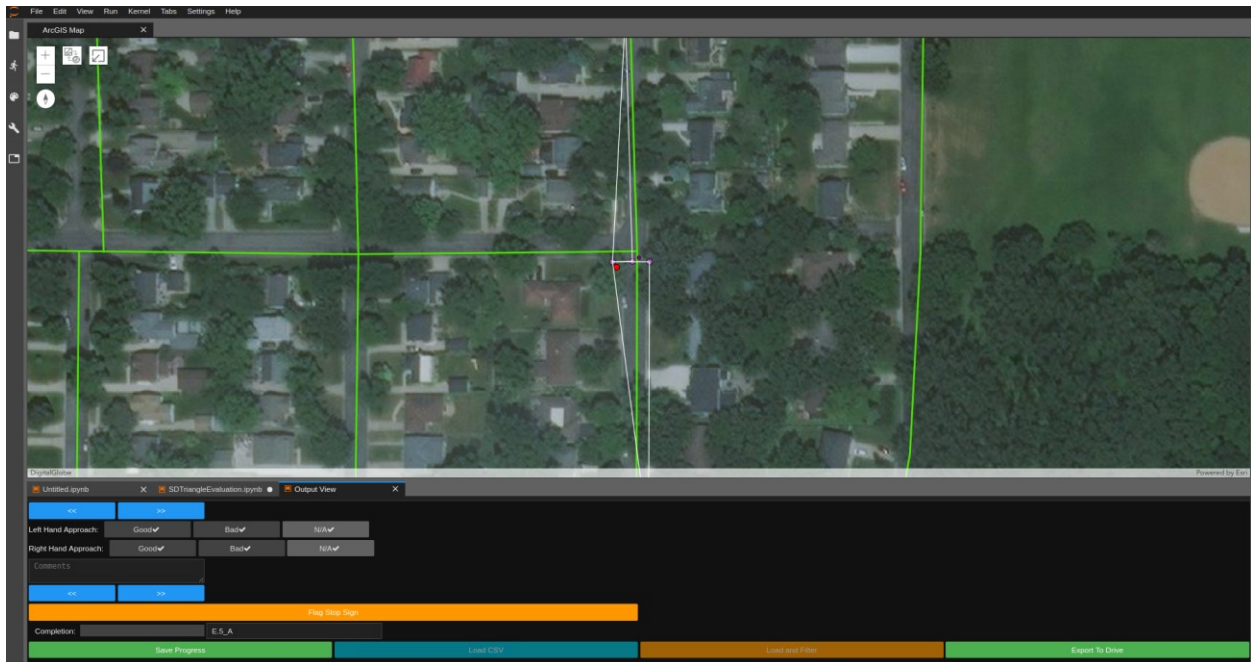
Figure 2.4 User interface of the program used to estimate the adequacy of the sight distances at each site

create the sight triangles is included in Appendix B. Required sight distance triangles were calculated for both the LHM and RHM approaches from the perspective of a driver stopped next to the stop sign. The required sight distance triangles were plotted on the MnGeo 2016 aerial imagery with the Streetnames layer polylines for reference (see Figure 2.4). The 2016 imagery was used because it was the highest quality imagery available that was taken when trees had leaves – a necessary condition for incorporating the impact of vegetation on visibility. A single member of the research team used the aerial images with the overlays to estimate whether the available sight distance for each existing major road approach was sufficient.

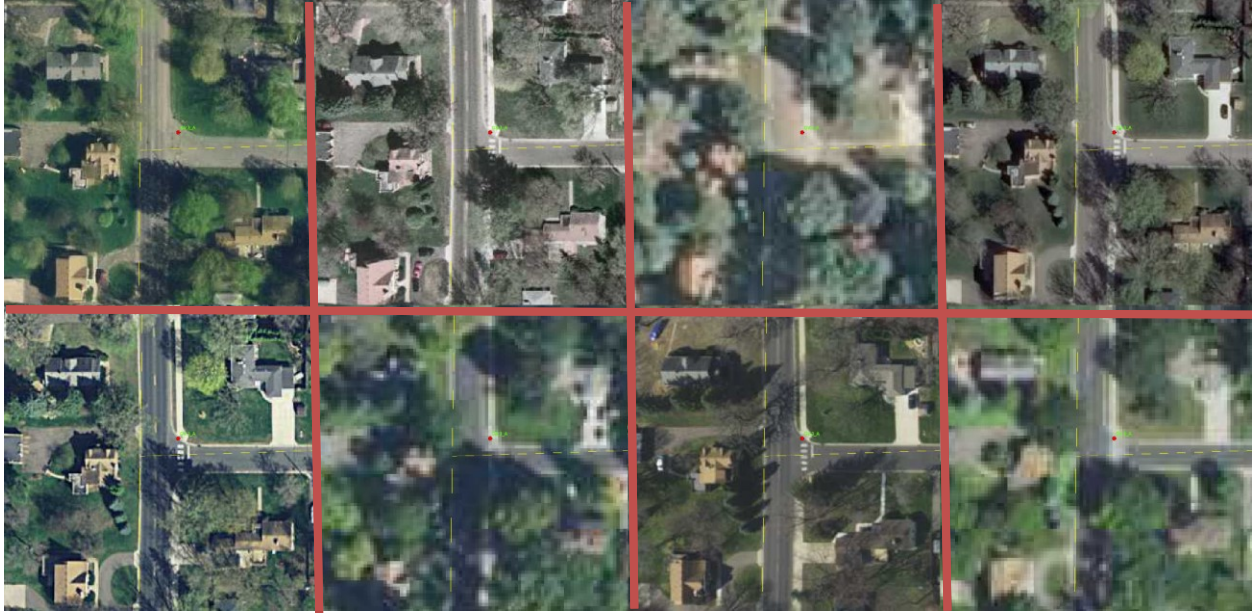
Figure 2.5 Aerial imagery mosaic (left to right, top: 2004, 2006, 2008, 2010; bottom: 2012, 2015, 2016, 2017)

To streamline the review of the MnGeo imagery, the research team created a program to take eight screenshots centered on each intersection in ArcMap – one for each of the available years of imagery. Street polylines and labelled stop sign markers were included to help identify each approach. The eight screenshots were then arranged in chronological order to form a mosaic like the example shown in Figure 2.5. For every approach, the presence of a stop line and the presence of a crosswalk on the near side of the major road was noted for each of the eight years shown in the mosaics. In some cases, the reviewer was unable to determine whether an image showed a crosswalk and/or a stop line due to an obstruction or low image quality. In those cases, the reviewer would look at the preceding and following images and determine whether the presence or lack of a stop line or crosswalk remained the same on either side of the year with the unclear stop sign and/or crosswalk presence. If there was no change on either side, the unclear stop sign and/or crosswalk presence was assumed to have remained constant, otherwise, the approach-year was flagged for further review using the Google imagery. Similarly, the presence of a stop line and/or crosswalk during the years not pictured in the mosaics was interpolated if possible and if not possible, the year was flagged for further review using the Google imagery. For example, the imagery from 2008 (top row, third from the left) in Figure 2.5 is too blurry to clearly see whether a stop line is present. The images from 2006 and 2010 (top row, second and fourth from the left, respectively) both show a stop line at the approach so it is assumed that a stop line would be present in 2008 as well. In 2004, the approach does not have a crosswalk or stop line but it does in 2006. As such, 2005 is flagged for further review.

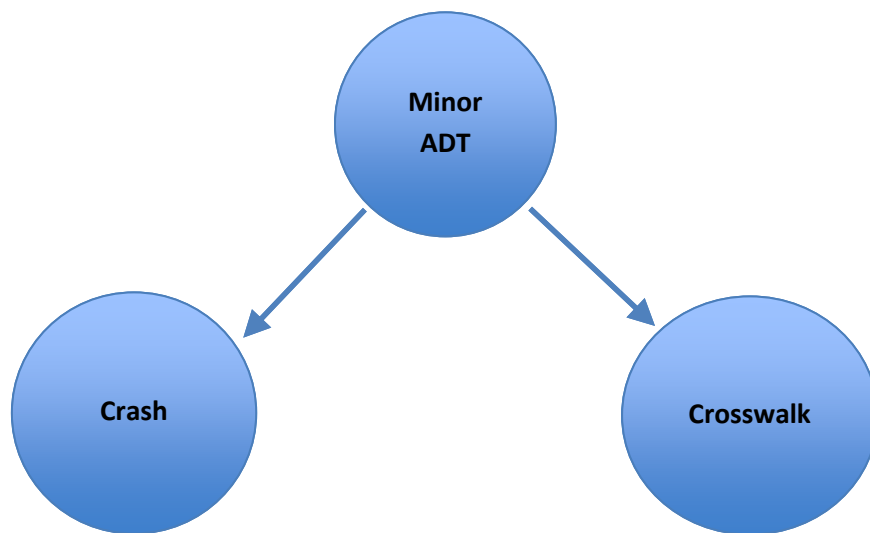
Figure 2.6 Example Causal Structure

As noted earlier, this study uses an observational, cross-sectional design. This type of design can identify correlations between an outcome measure (crash risk) and observed input measure, such as AADT or sight distance, but it cannot do by itself determine if the observed correlations indicate causal connections. For this, additional information, beyond what it is in the study, would be needed. In particular, a correlation between presence of crosswalks and crash occurrence cannot by itself be interpreted as indicating a causal effect. One definite possibility is that crosswalks tend to be installed at intersections having higher minor road traffic volumes. That is, the underlying causal pattern is given by Figure 2.6. Since intersections with more traffic on their minor roads create more opportunities for angle crashes than do those with low minor road volumes they will also tend to show higher crash frequencies, whether or not they have crosswalks. In this case the presence of crosswalk could simply be an indicator that that an intersection has higher minor road traffic.

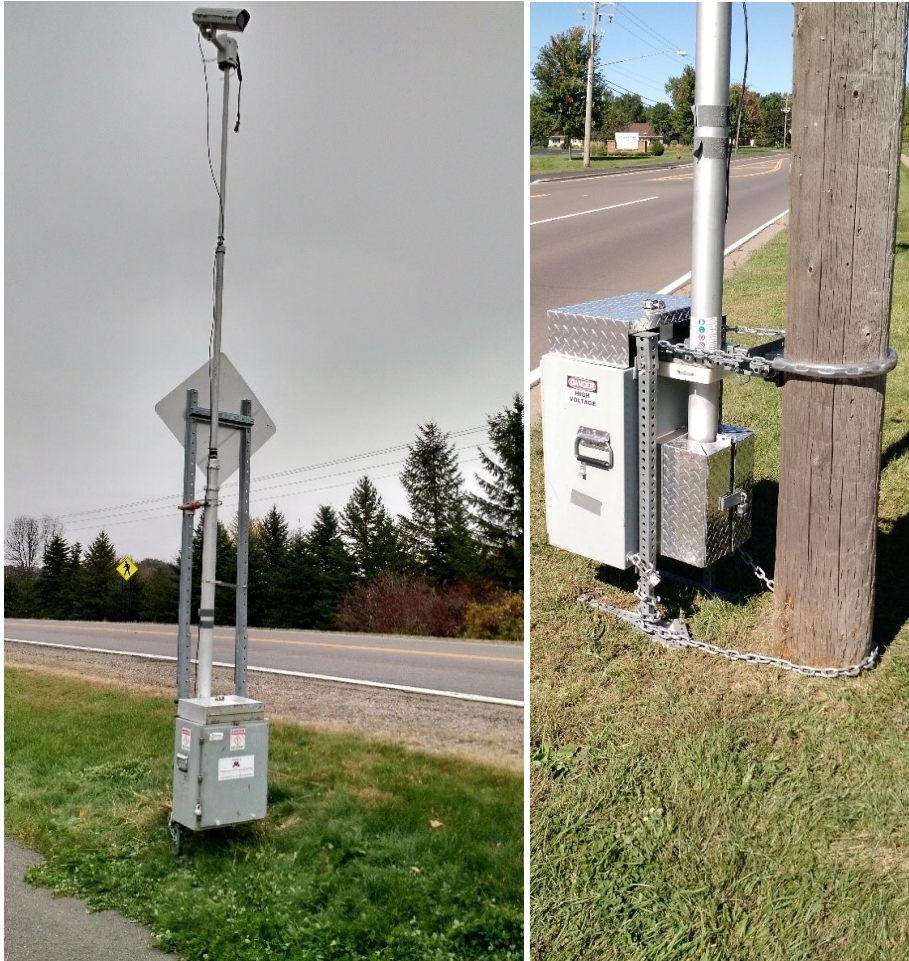
Figure 3.2 MTO camera systems braced on sign post (left) and utility pole (right)

The MTO used nine custom-built camera systems to collect video at the 15 intersections included in the study. The camera systems (shown in Figure 3.2) are self-contained systems include a high-resolution camera mounted to an extendable mast or directly to existing infrastructure via non-invasive steel bands. A weatherproof steel container houses recording equipment and independent battery power. The entire system attaches non-invasively to any conveniently placed pole or tree.

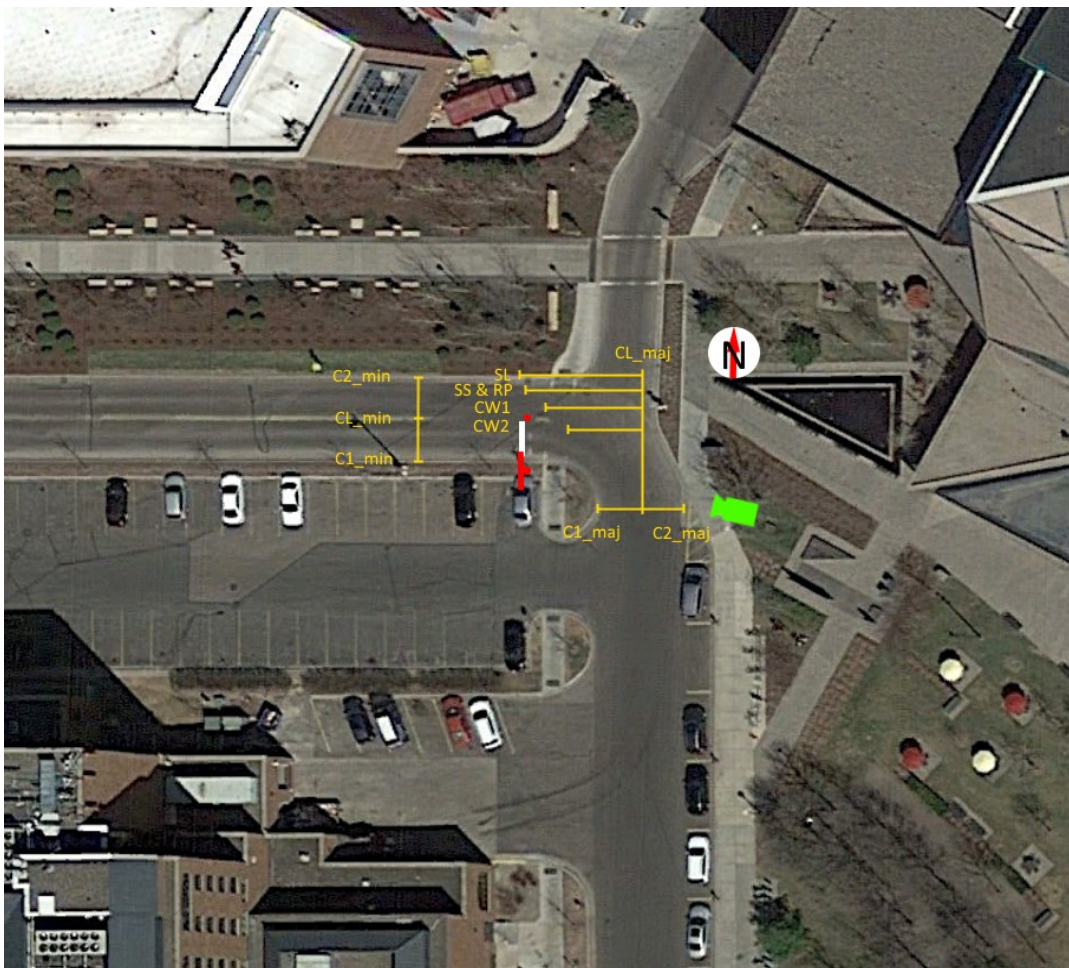
Figure 3.10 Aerial view of the intersection of Walnut St SE and Beacon St SE with measurements marked

The intersection of Walnut St SE and Beacon St SE is a T-intersection located in Minneapolis, on the University of Minnesota campus. Figure 3.10 shows an aerial view of the intersection annotated with key measurements. Figure 3.11 shows the camera view for the site. The site is somewhat unique in that Walnut St is a one-way road (NB) to the north of the intersection. Beacon St had a faded stop line and faded crosswalk prior to this project. Both Walnut St and Beacon St have observed ADTs of approximately 1000 vehicles. This site was chosen because of its unique geometry and proximity to the MTO, which allowed for it to be a testing ground for methods and equipment. The righthand available sight distance was adequate, unless vehicles occupied the parking lot immediately to the right of the intersection, in which case it fell short as seen in Figure 3.12.

Measurements noted on Figure 3.10 are listed in Table 3.11.

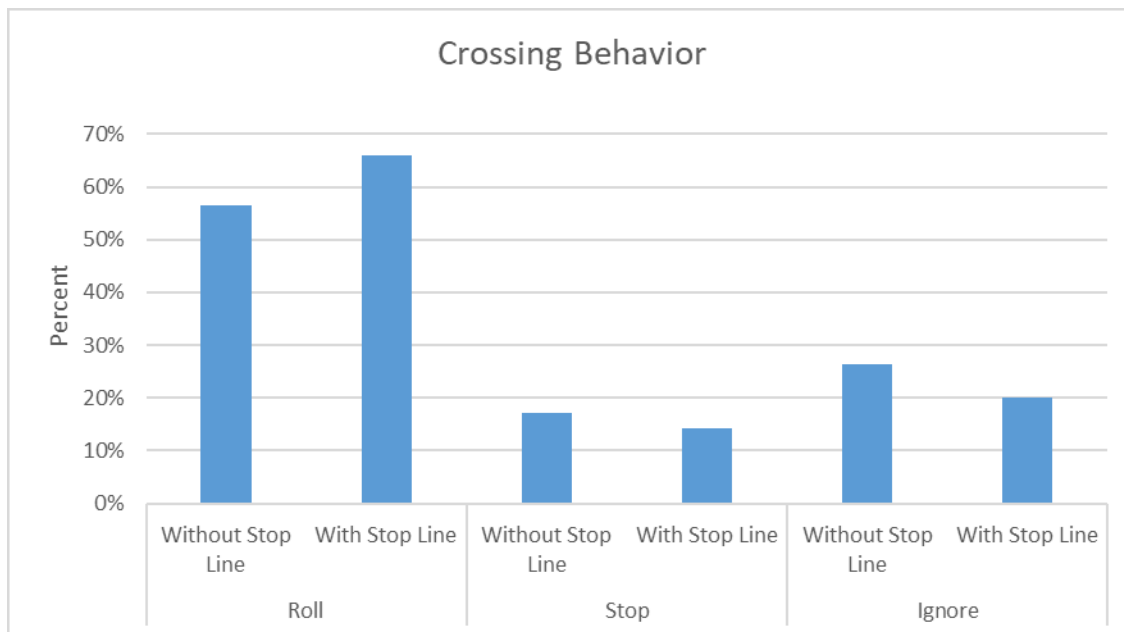
Figure 3.13 EB Beacon St SE distribution of driver crossing behavior as a percentage of all events pre- vs with-stop line

Following the addition of a stop line, EB Beacon St experienced an increase in roll events and decreases in stop and ignore events, as seen in Figure 3.13. Because the majority of drivers roll at this intersection, the impact of the stop line appears minimal. Additionally, the number of drivers ignoring the stop line is high as compared to other locations as well as an expected violation rate of ~5%. Additional information on the roll and ignore events captured by the UGRAs is presented in Figure 3.16.

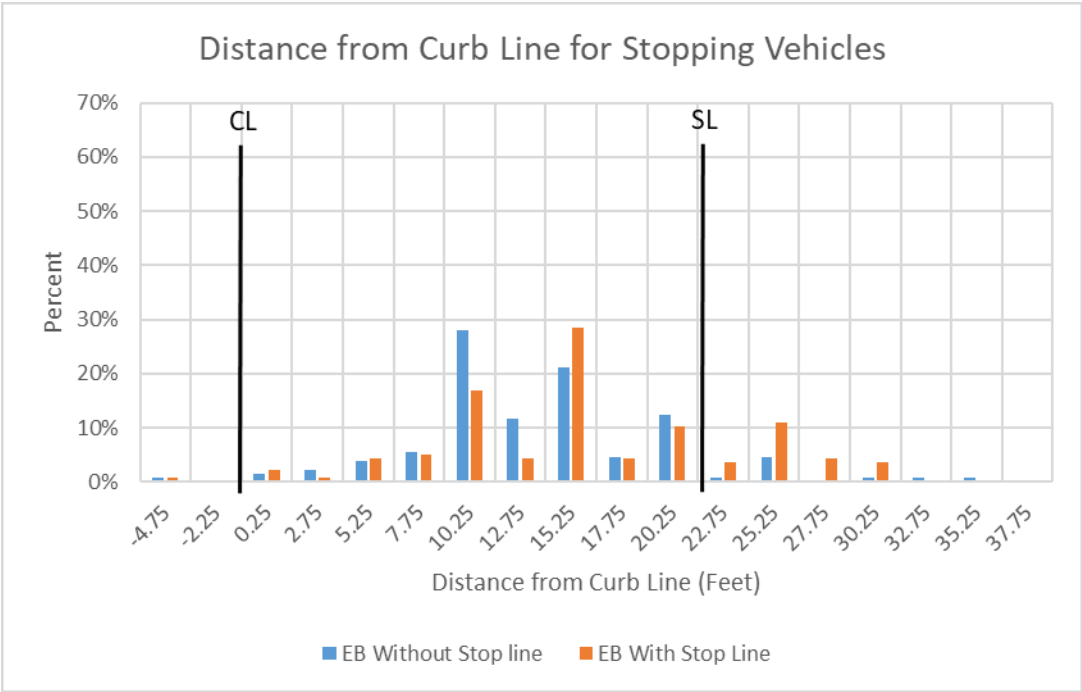
Figure 3.15 Beacon St SE and Walnut St SE Distribution of Stopping Distance During Stop Events

As seen in Figure 3.15, both with and without the stop line, vehicles tend to stop between the stop line and the edge of the major road. While this is still upstream of the conflict point with vehicles on the major road, drivers hardly ever stop behind the stop line. Following the addition of a stop line, the distribution of stop locations shifted upstream towards the stop line, suggesting that the stop line had some impact on drivers’ stop location. However, whether ignoring or rolling, two-thirds of drivers at this site did not stop. The stop line did not appear to have an impact on the percent of drivers that stopped, and only shifted by approximately 5 feet the location they stopped relative to the intersection.

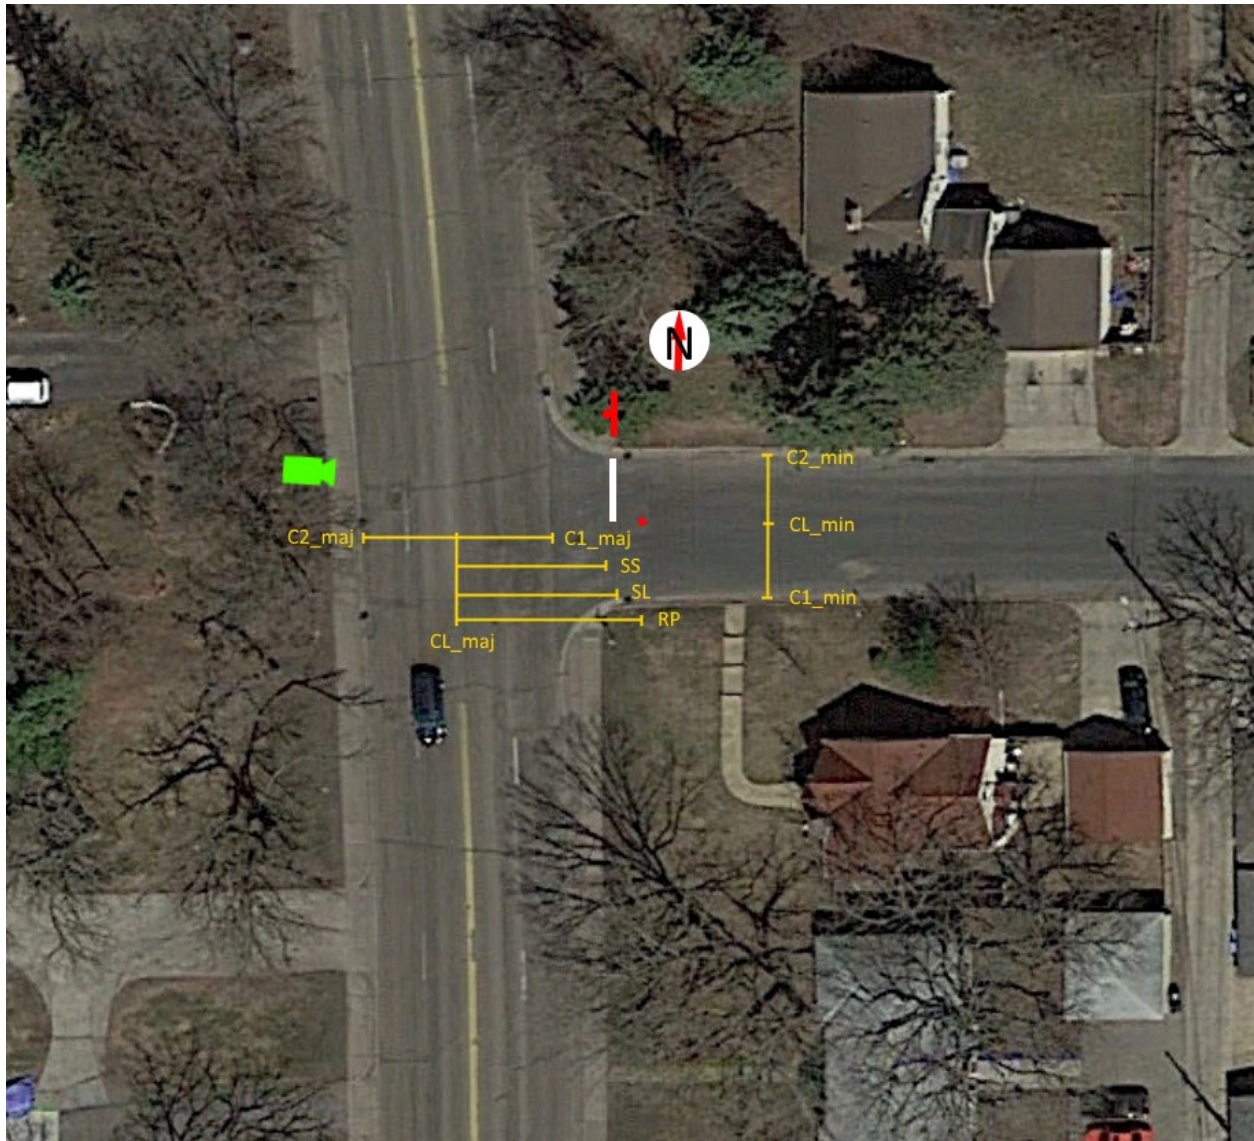
Figure 3.17 – Aerial view of the intersection of Lyndale Ave S and W 72nd St with measurements marked

The intersection of Lyndale Ave S and 72nd St is a T-intersection located in Richfield. The WB approach of 72nd St did not have a stop line or crosswalk prior to this project. Figure 3.17 shows an aerial view of the intersection annotated with key measurements. Lyndale Ave has an AADT of 11,700 vehicles and 72nd St has an estimated ADT of less than 500 vehicles based on project counts. The site was selected as it is a T-intersection with four lanes and has a high AADT on the major road. The research team determined that the available sight distance to both the left and right – but especially to the right – was insufficient as seen in Figure 3.19. Another notable feature of this site is the substantially different traffic demand in each direction of the major road; drivers headed southbound are typically connecting with Interstate 494, while drivers traveling northbound are headed toward downtown Richfield. For the purposes of this analysis, the left- and right-turning events are combined when examining stopping distance, but Figure 3.21 also breaks down the differences in behavior by type of turning movement.

Measurements noted on Figure 3.17 are listed in Table 3.12.

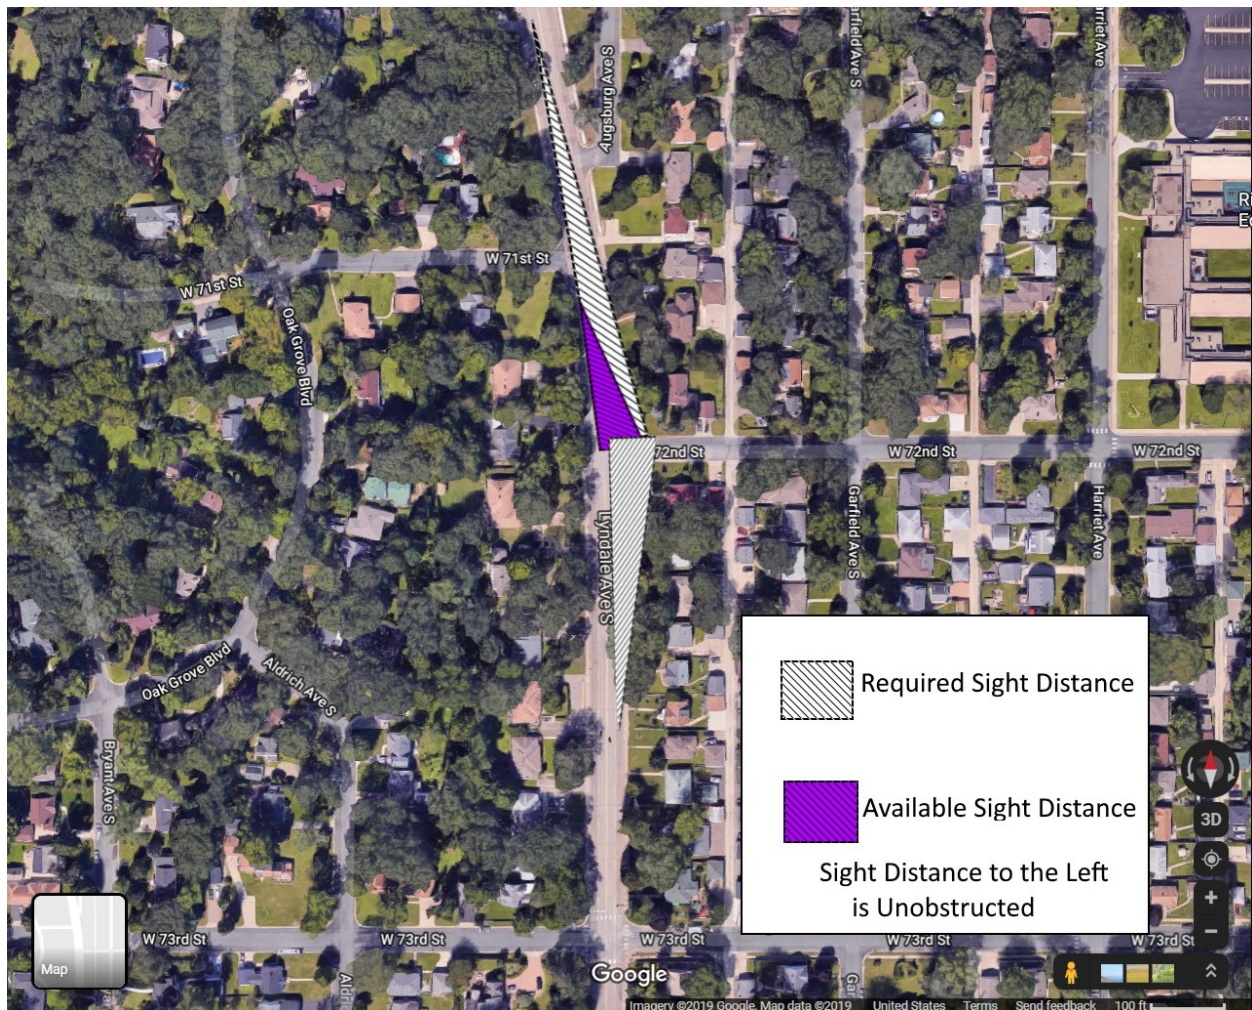
Figure 3.19 Available sight distance and required sight distance at Lyndale Ave S and W 72nd St

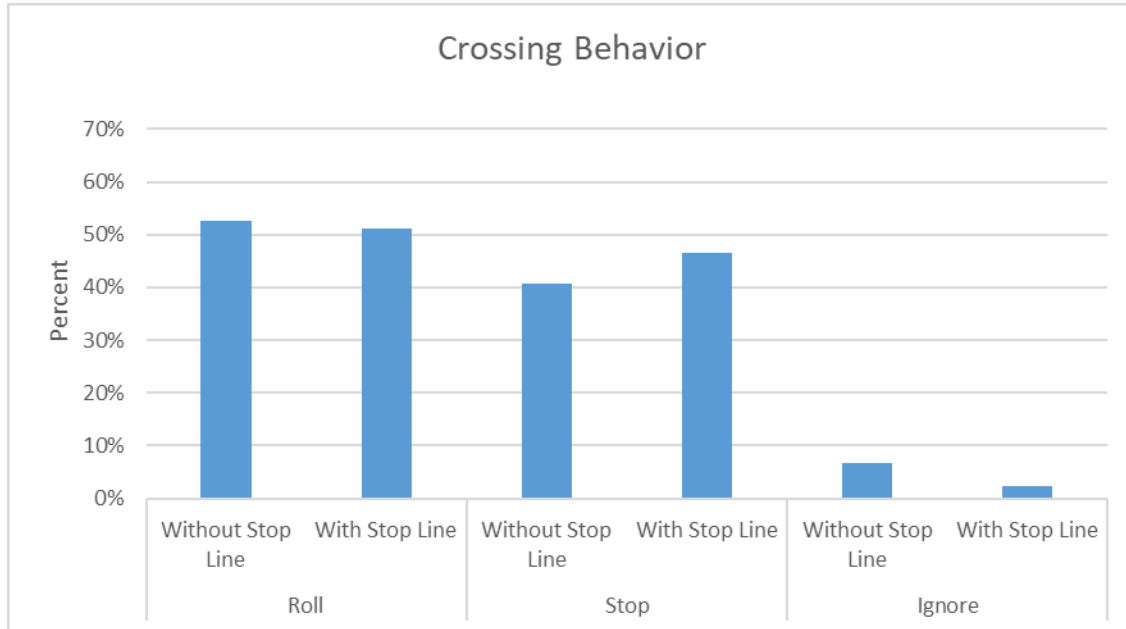
Figure 3.20 EB W 72nd St distribution of driver crossing behavior as a percentage of all events without vs with stop line

decrease in roll and ignore events and a minor increase in stop events, as seen in Figure 3.20. This is expected, as Lyndale Ave is a high AADT road, which forces drivers on 72nd St to stop and wait for a gap to make their movement. The poor visibility to the right also gives drivers a reason to stop. The number of drivers that ignore the stop sign is at generally accepted levels.

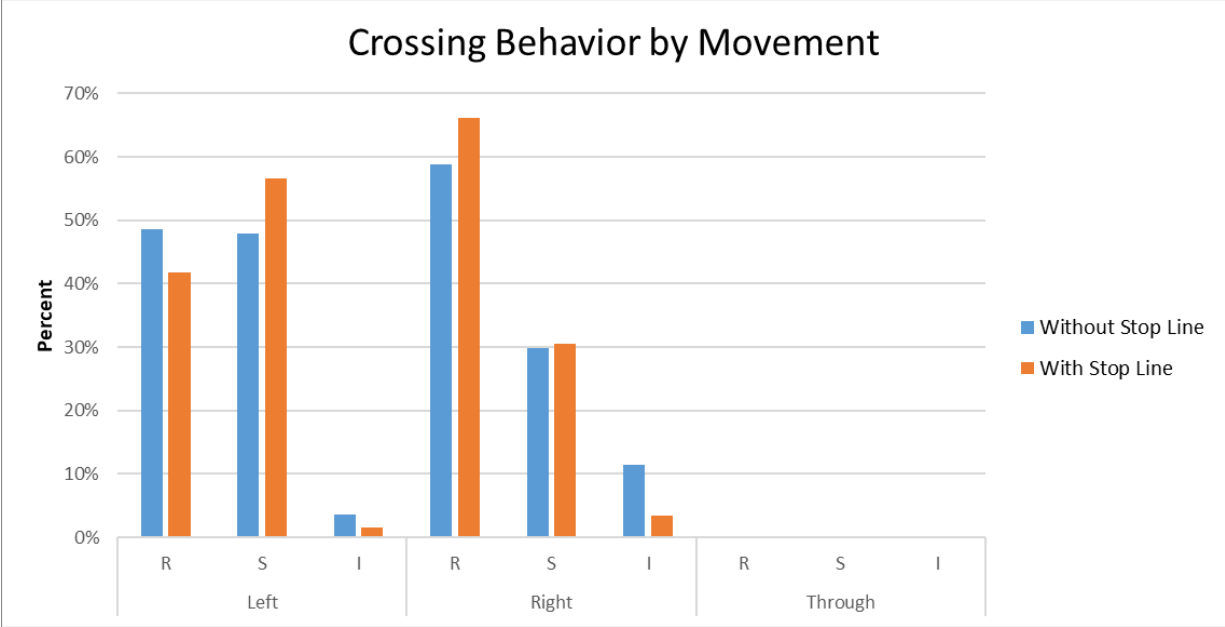
Figure 3.21 EB W 72nd St distribution of driver crossing behavior as a percentage of all events without- vs with - stop line, by driver movement

In difference, in left turning movement, which has a substandard sight distance to the right, the stop line seems to have made a change towards increasing the fraction of drivers that stop by reducing both rolls and ignores. These observations suggest a strong relationship between the effect of the stop line and the available sight distances.

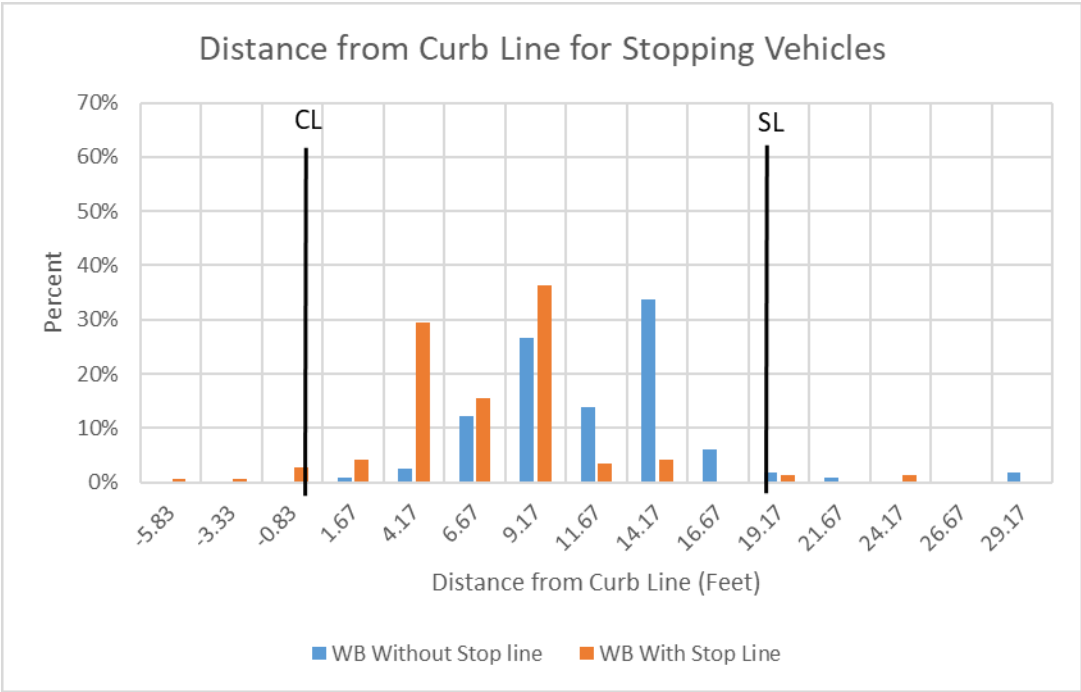
Figure 3.22 Lyndale Ave S and W 72nd St Distribution of Stopping Distance During Stop Events

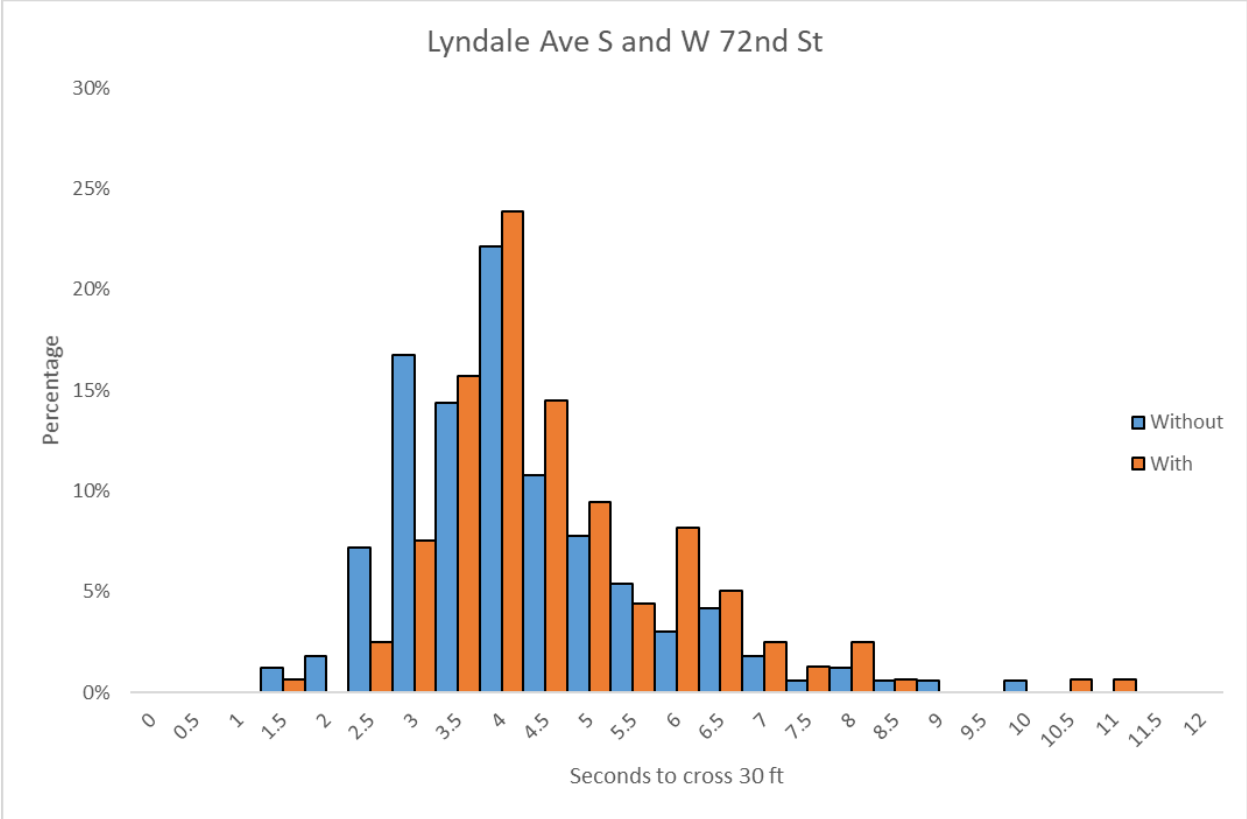
Figure 3.23 Lyndale Ave S and W 72nd St Histogram of Roll and Ignore behaviors, in seconds to travel 30 ft

Regardless, the suggestion here is that the stop line is in the wrong place since, at least from the driver's point of view, there is no satisfactory sight distance if they stop at the correct place. In addition, it may act as a visual cue to the driver to pull forward further towards the intersection, and further toward the point of collision. That said, the stop line did convince more left turning drivers to stop rather than roll and reduced the violations in right turning vehicles. This is further supported in Figure 3.23, where the average time to travel 30 feet increased by about 1 second after the placement of the stop line, meaning although drivers are continuing to roll through or ignore the stop line, they are slowing down more as they pass through the intersection. In the same figure we also see a large reduction in the smallest travel times, supporting the observation of the shift from ignores to rolls for right-turning vehicles.

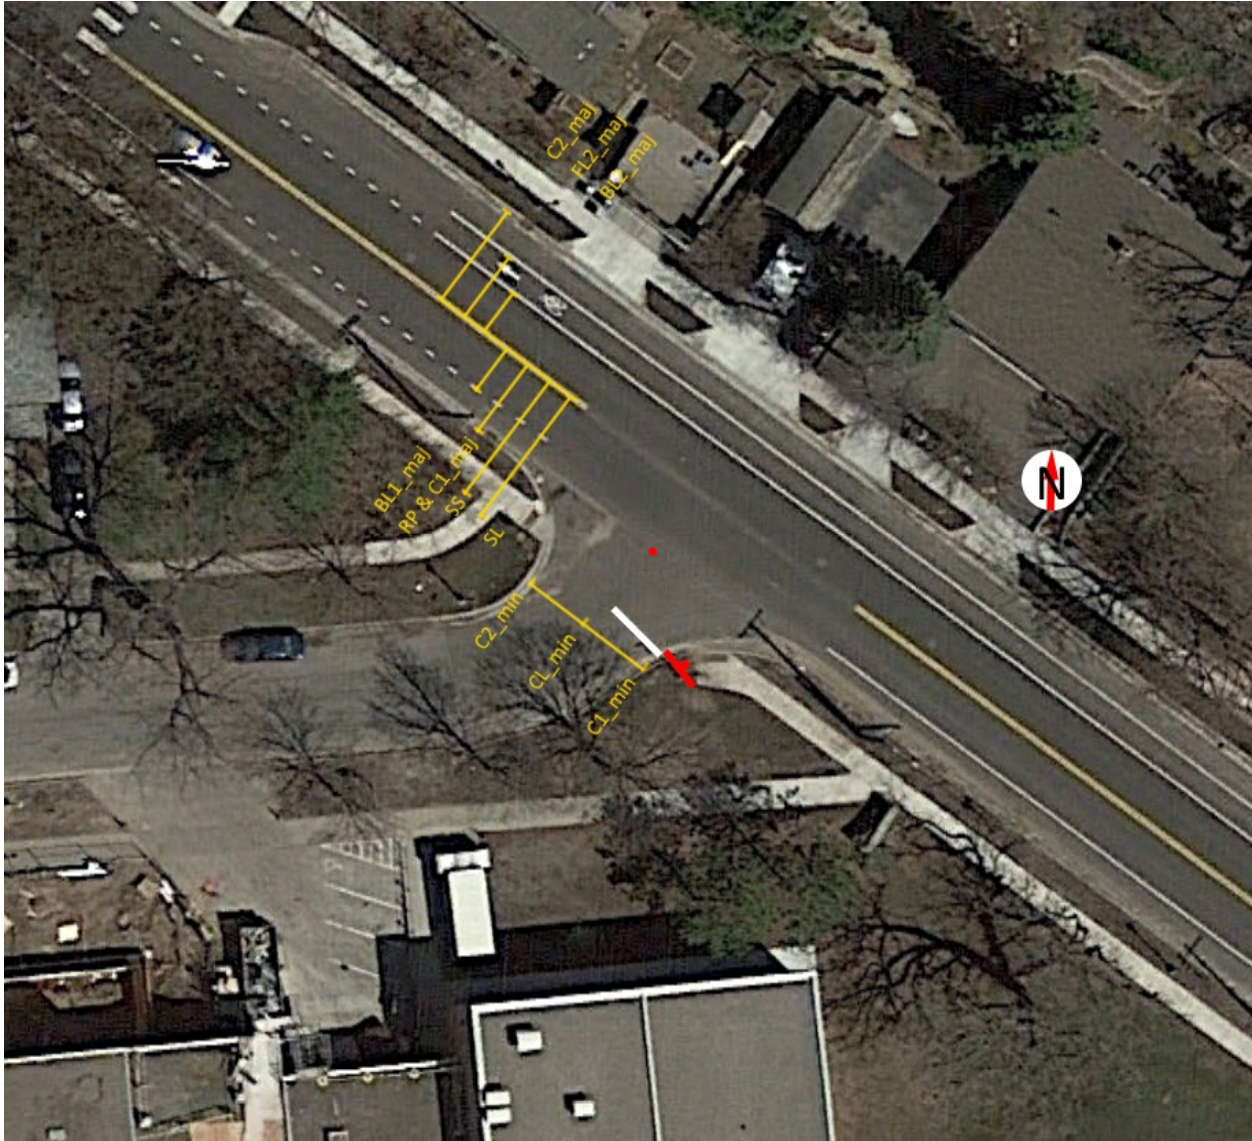
Figure 3.24 Aerial view of the intersection of Como Ave and Knapp St with measurements marked

An aerial view of the site is provided in Figure 3.24. A camera view with overlay lines marked is shown in Figure 3.25. During the summer months, sight distance to the left is obscured by foliage, and sight distance to the right is limited due to the upward grade on Como Ave, as seen in Figure 3.26.

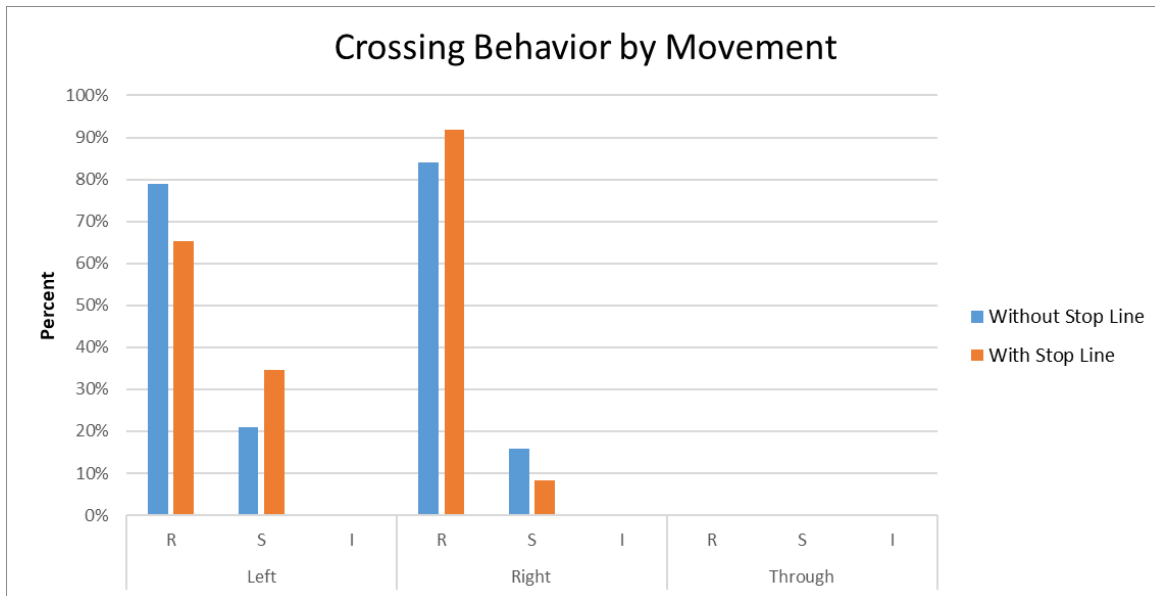
Figure 3.28 EB Knapp St distribution of driver crossing behavior as a percentage of all events without- vs with-stop line, by driver movement

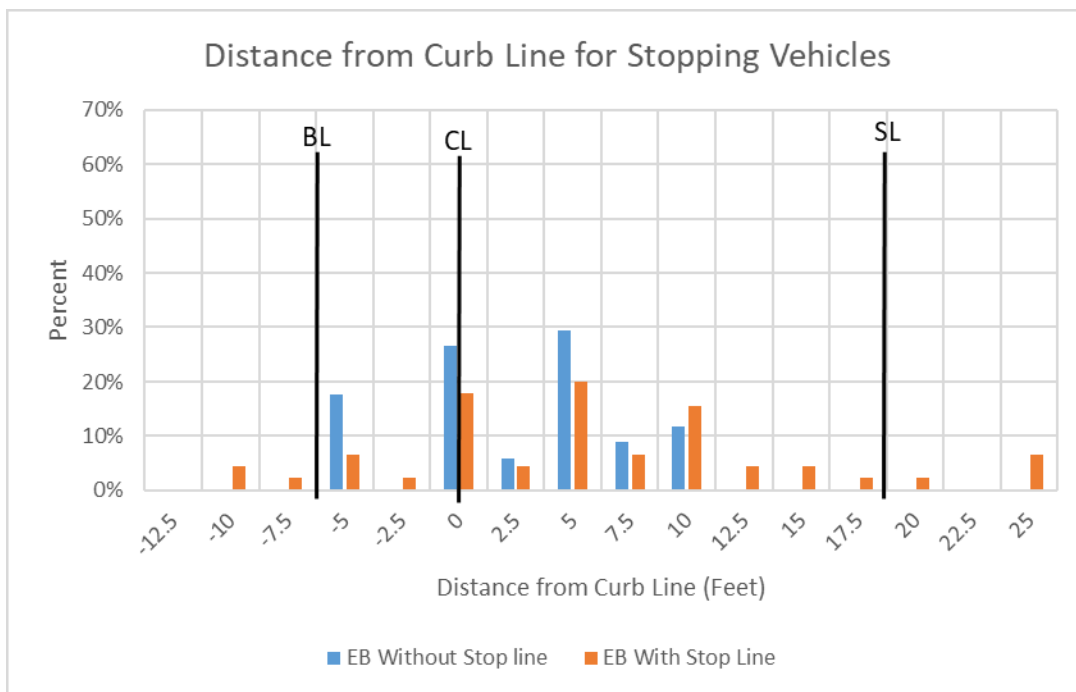
Figure 3.29 Como Ave and Knapp St Distribution of Stopping Distance During Stop Events

As seen in Figure 3.29, without the stop line, most drivers stopped at the curb line or even more toward the centerline, with their front tires into the bike lane. After the placement of the stop line, the distribution of stop locations flattened, and drivers appear to be stopping farther behind the curb line. It is important to highlight here that, given that the vast majority of the rolls over the stops, this graph is based only on an approximately 15% of the observations, predominantly left turning movements. This differs from the earlier site, where the ratio between rolls and stops was closer to 1.

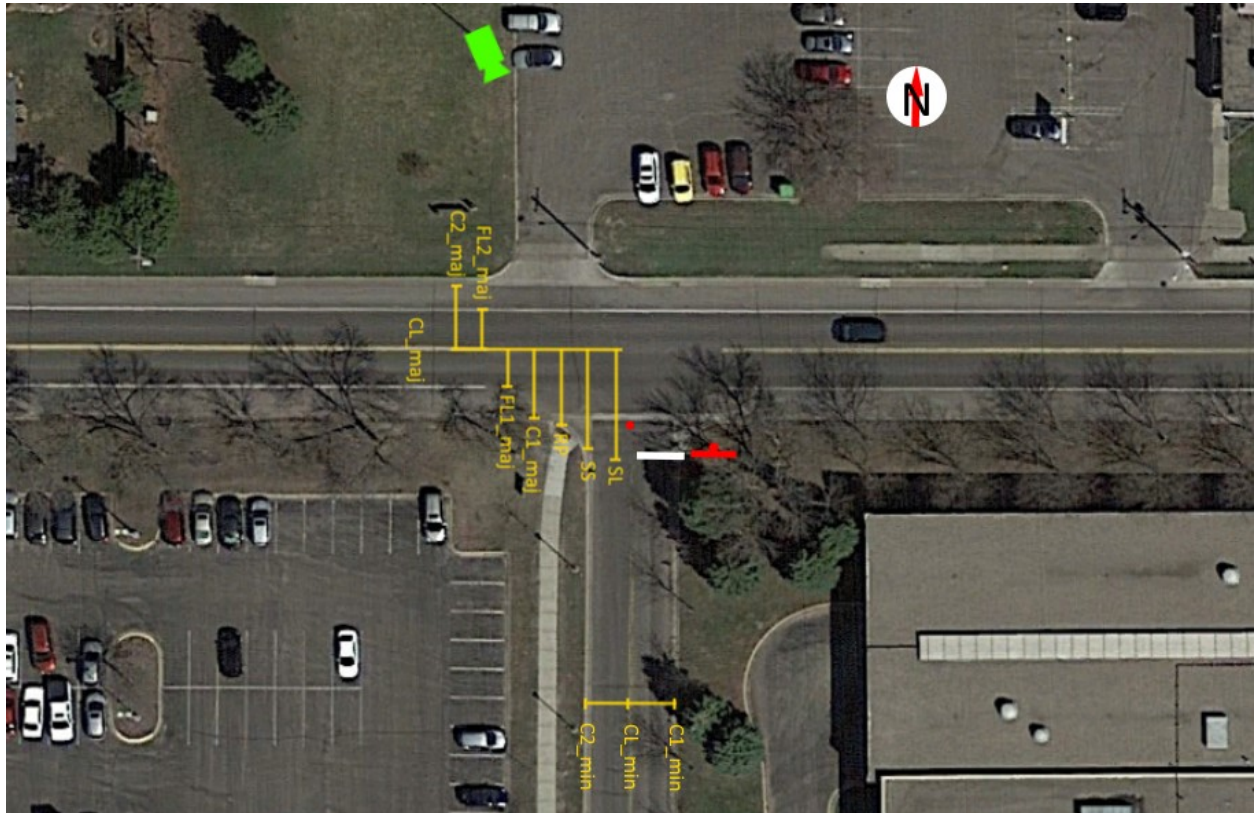
Figure 3.31 Aerial view of the intersection of Woodhill Dr and Civic Center Dr with measurements marked

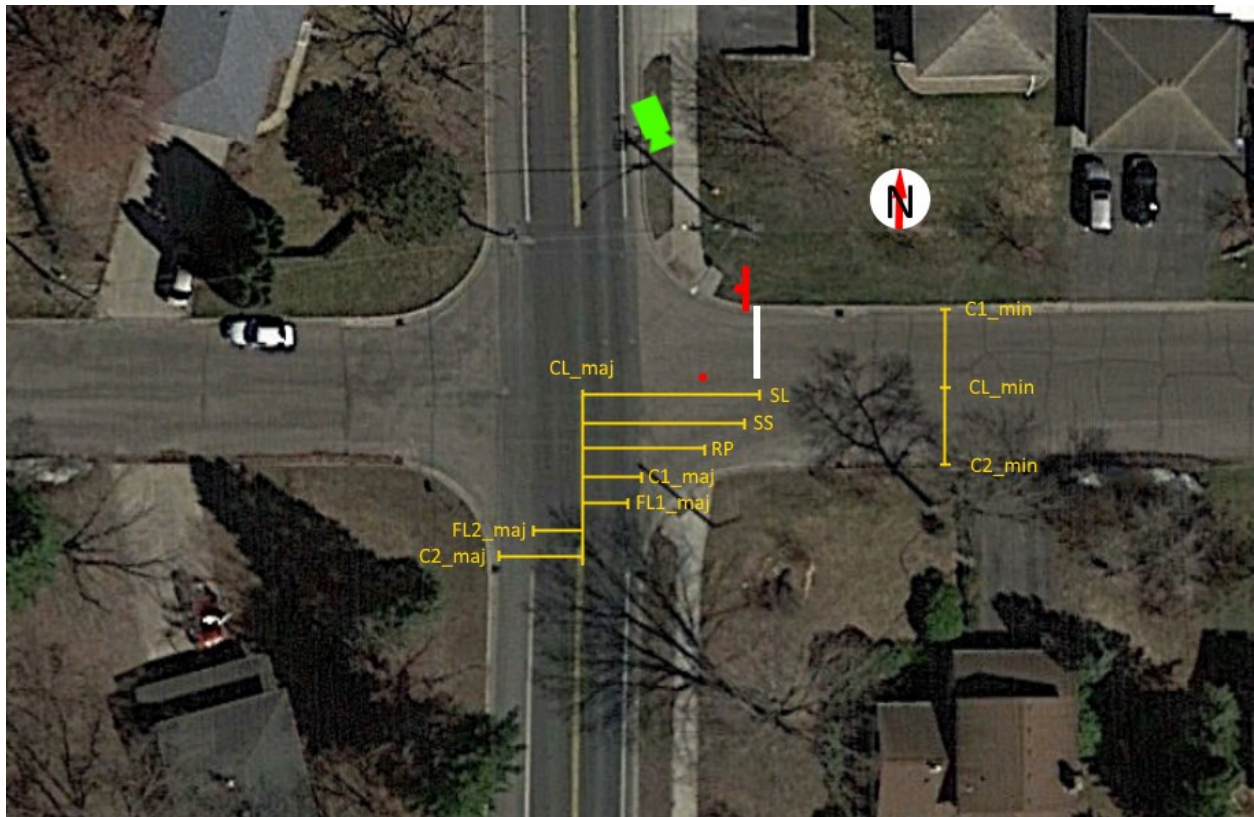
Figure 3.38 Aerial view of the intersection of Dale St N and Iona Ln with measurements marked

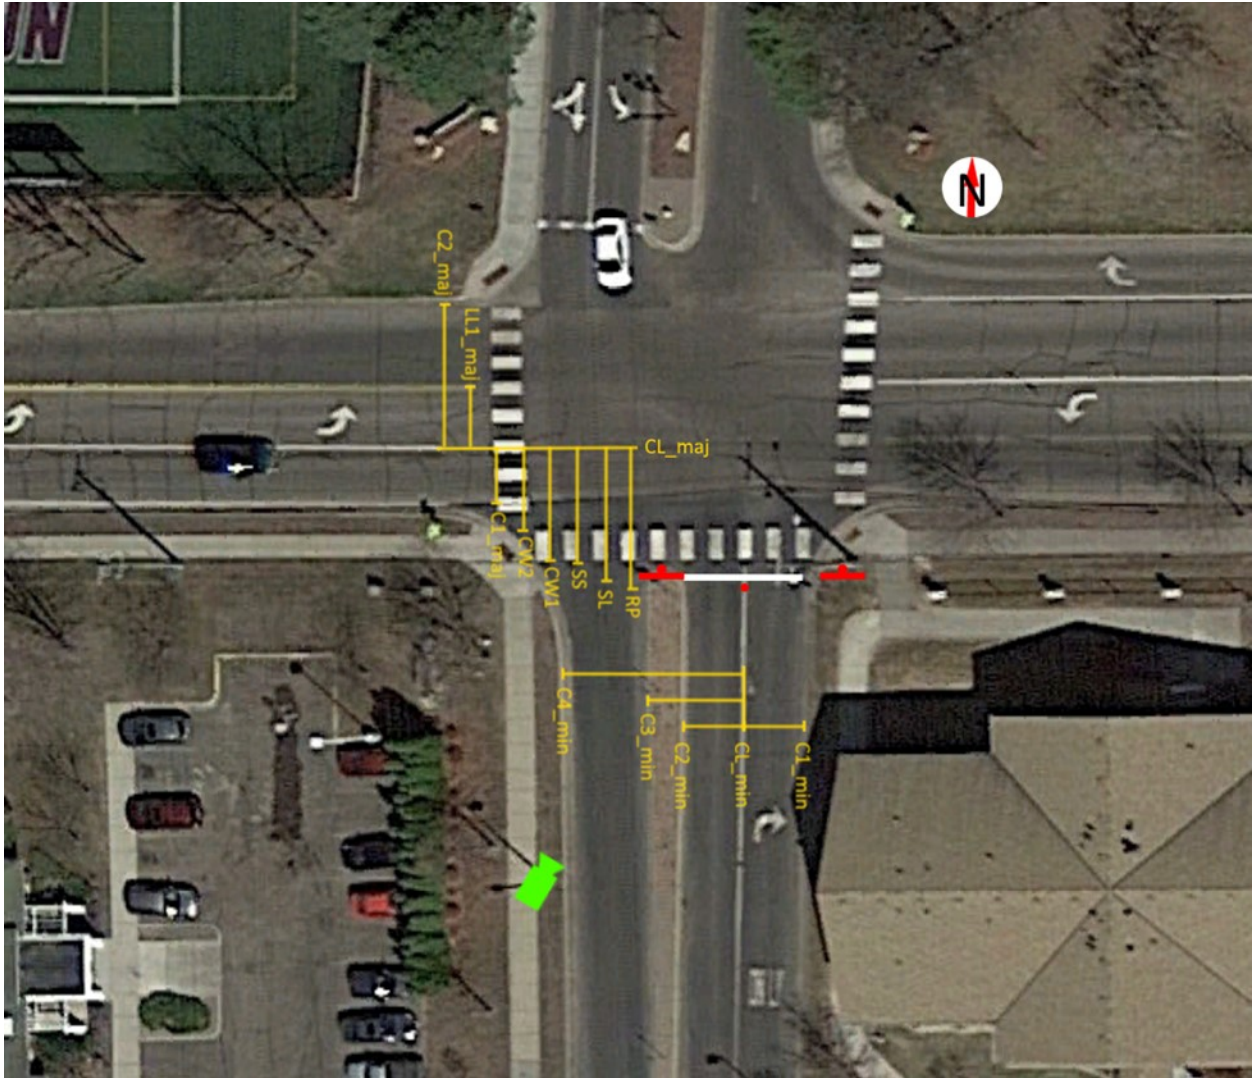
Figure 3.45 Aerial view of the intersection of Lincoln Dr and Lydia Ave W with measurements marked
