Evaluation of the Effectiveness of Stop Lines in Increasing the Safety of Stop-Controlled Intersections

Minnesota Traffic Observatory

Research Project

Final Report 2020-17

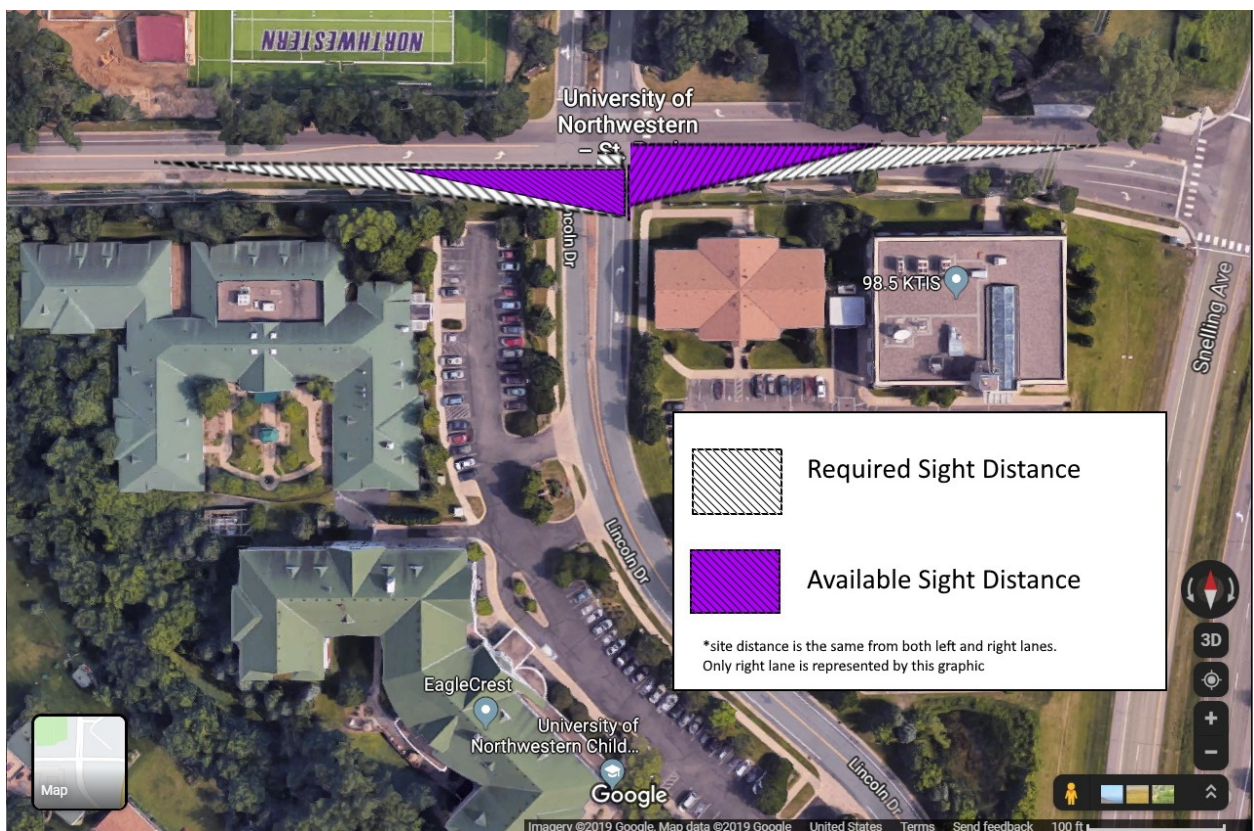
Figure 3.47 Available sight distance and required sight distance at Lincoln Dr and Lydia Ave W, for both left and right lane

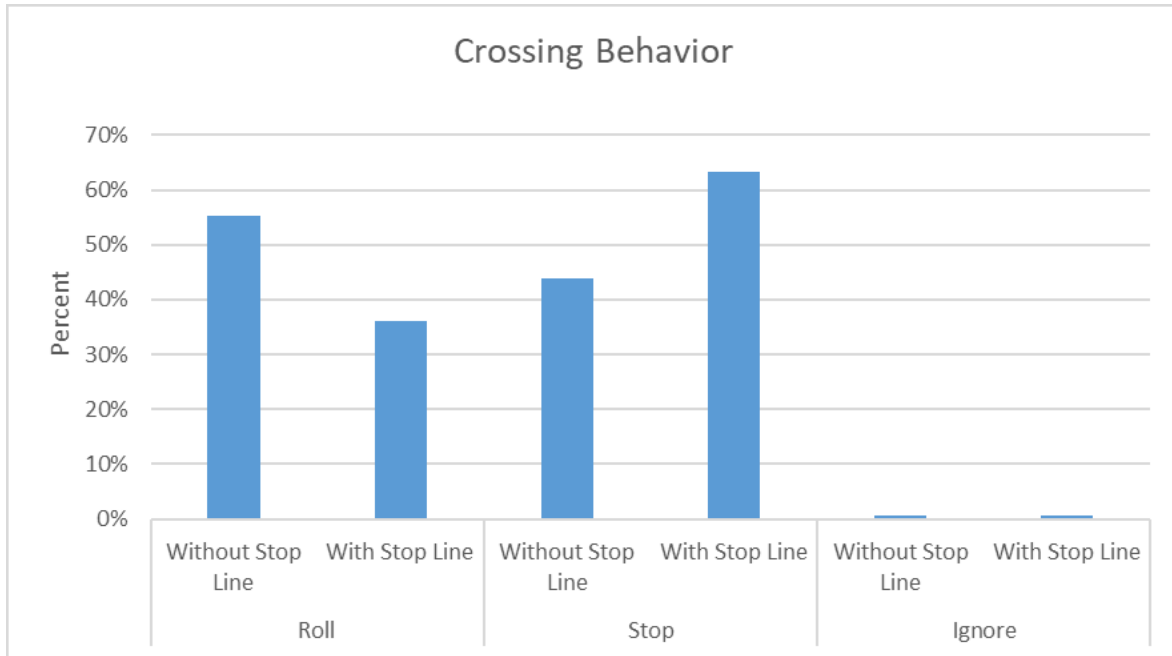
Figure 3.48 Lincoln Dr Left Lane distribution of driver crossing behavior as a percentage of all events without- vs with-stop line

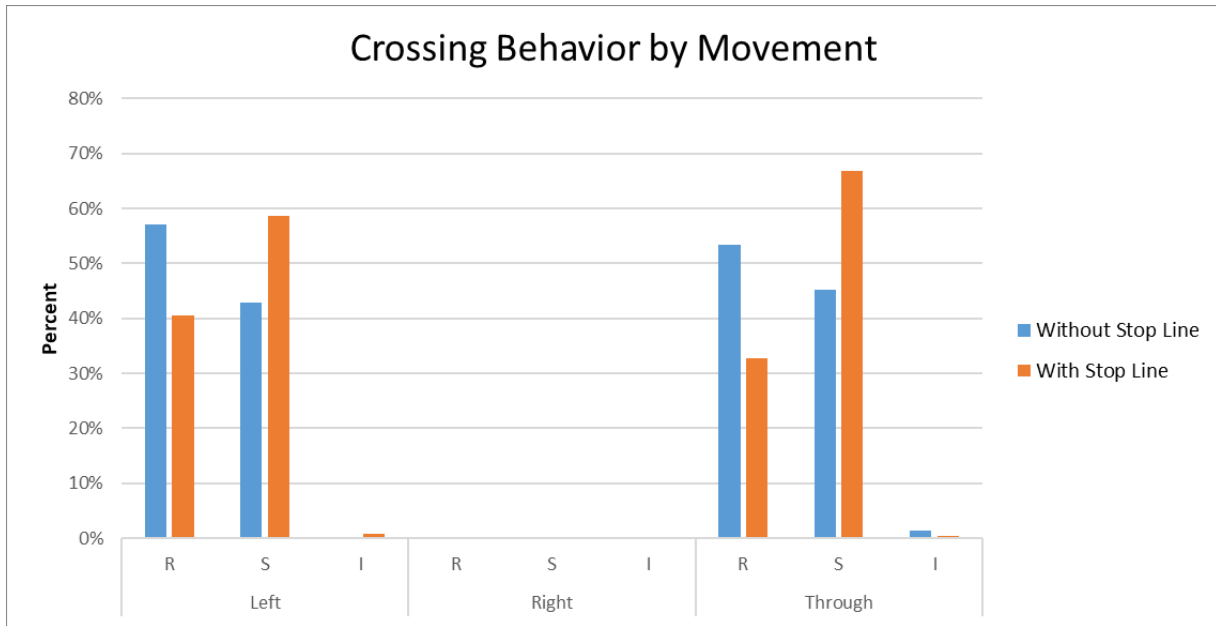
Figure 3.49 Lincoln Dr Left Lane distribution of driver crossing behavior as a percentage of all events without- vs with-stop line, by driver movement

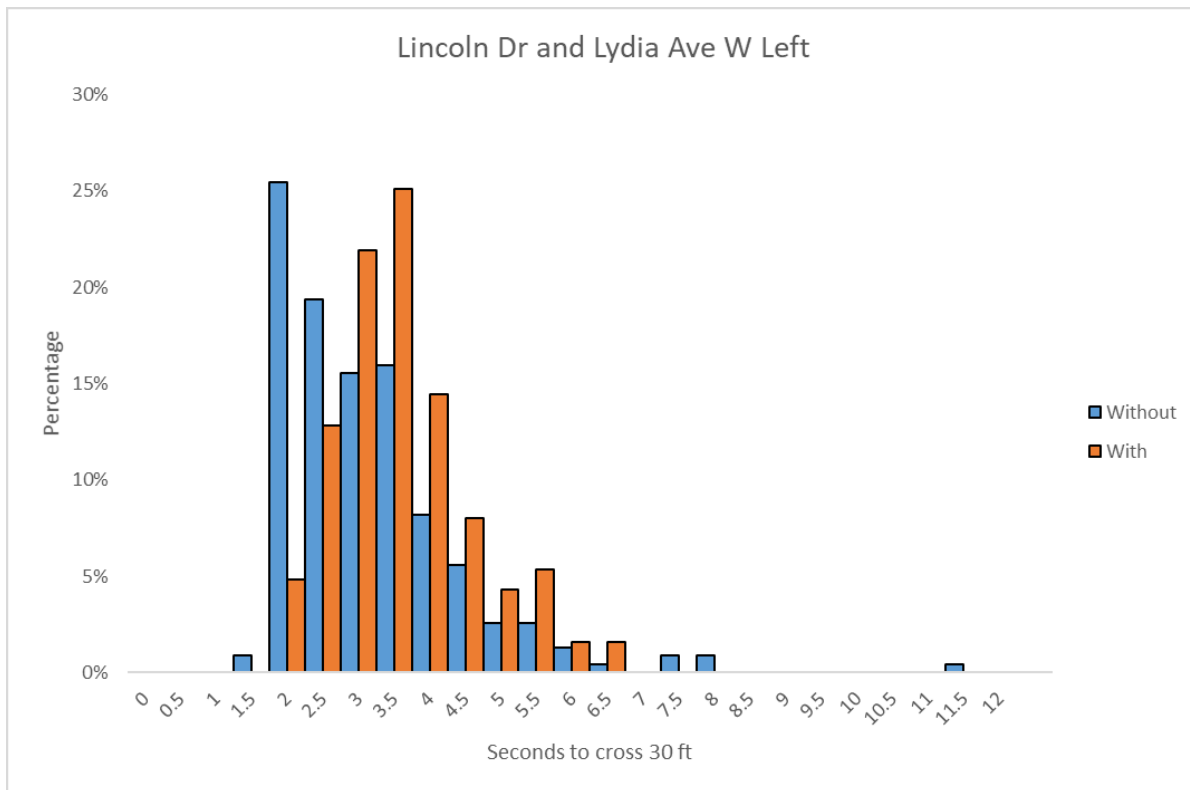
Figure 3.51 Lincoln Dr Left Lane Histogram of Roll and Ignore behaviors, in seconds to travel 30 ft

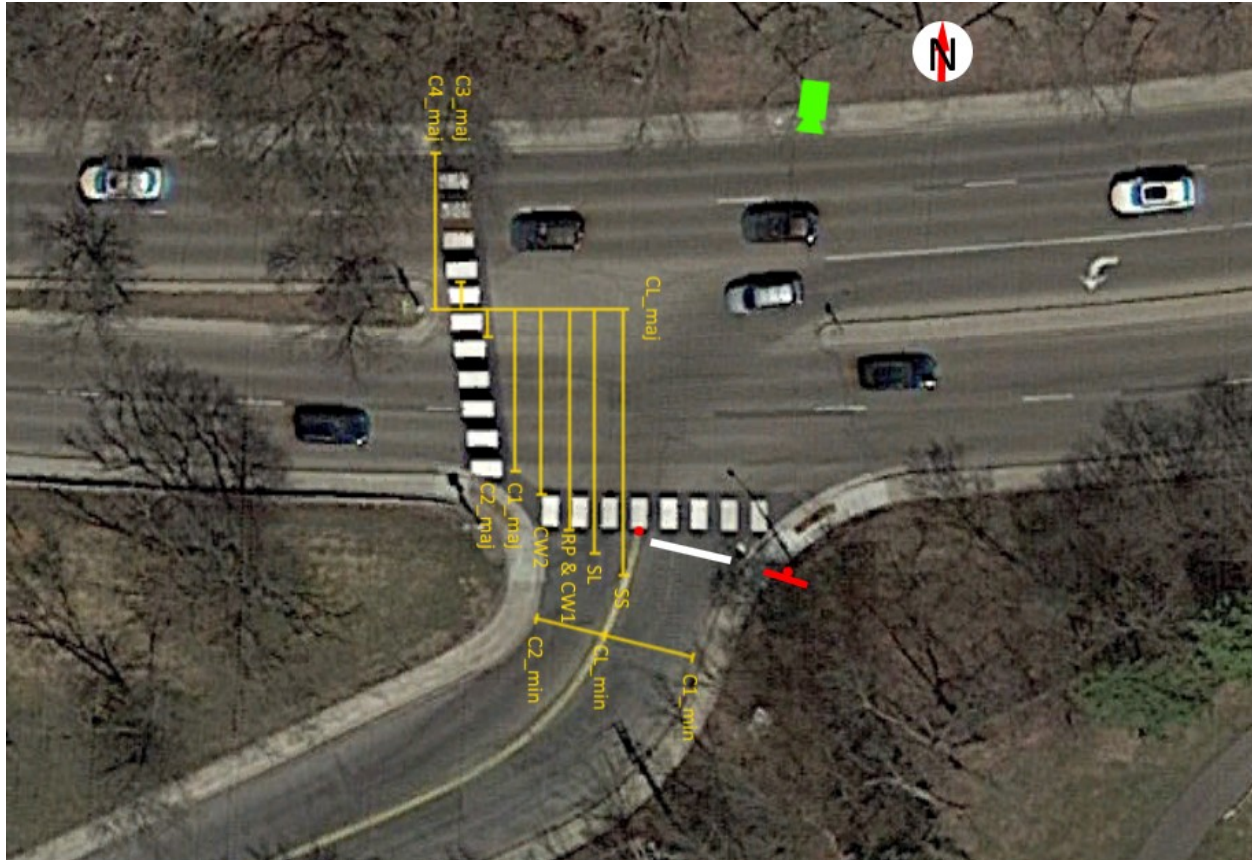
Figure 3.55 Aerial view of the intersection of 50th St W and Eden Ave with measurements marked

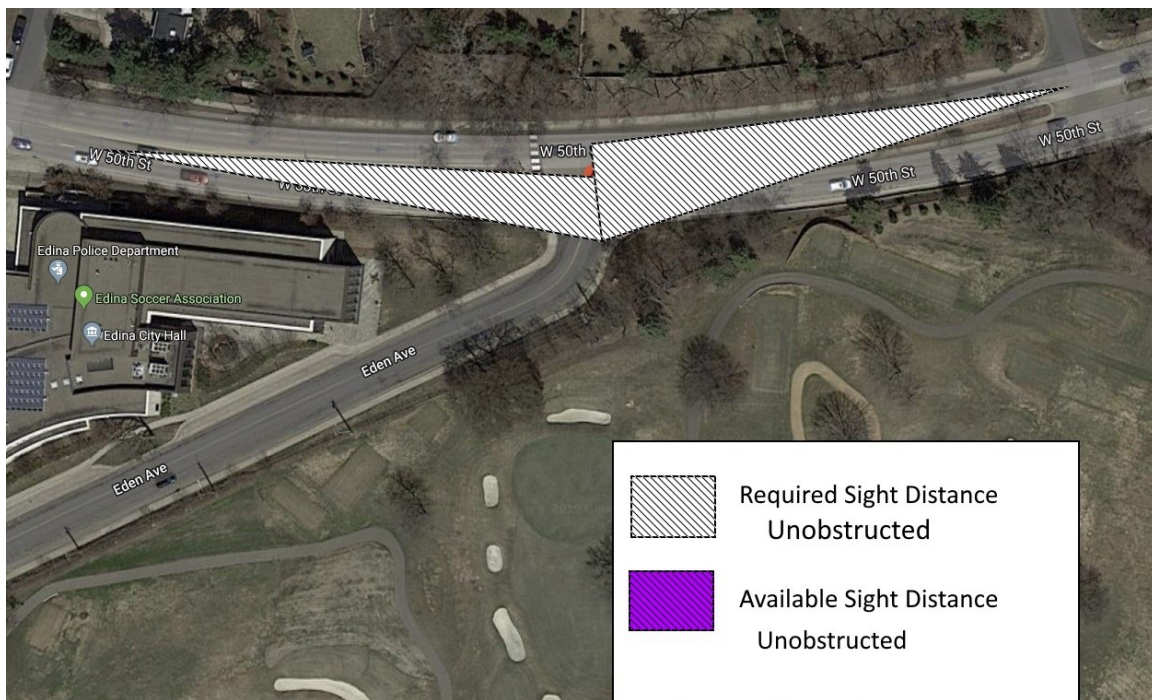
Figure 3.57 Available sight distance and required sight distance at 50th St W

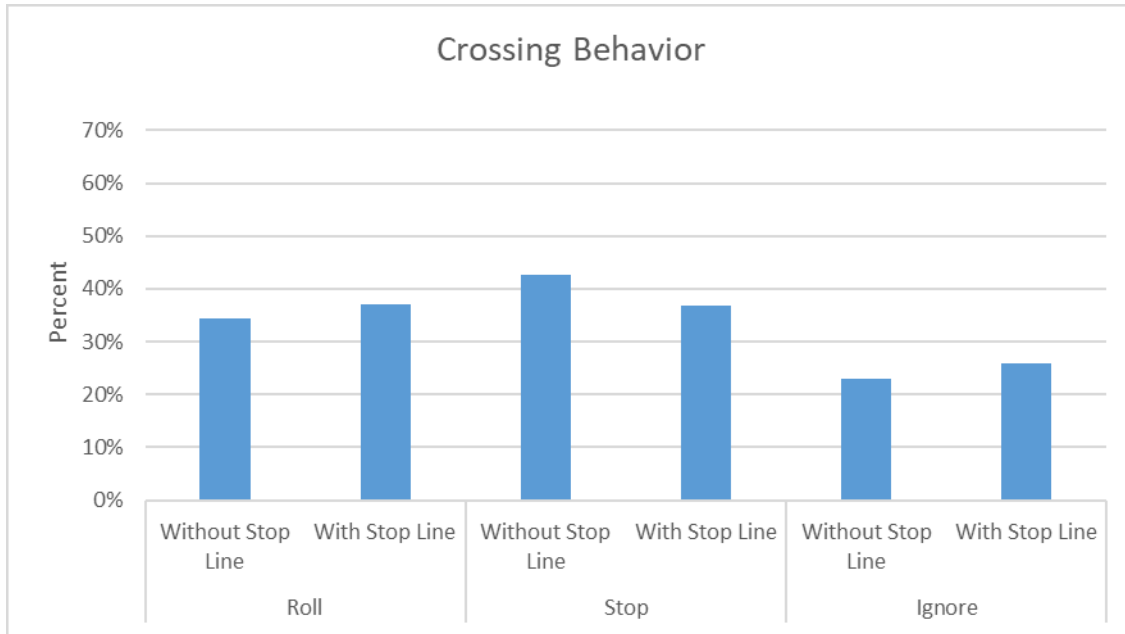
Figure 3.58 50th St W and Eden Ave distribution of driver crossing behavior as a percentage of all events without- vs with-stop line

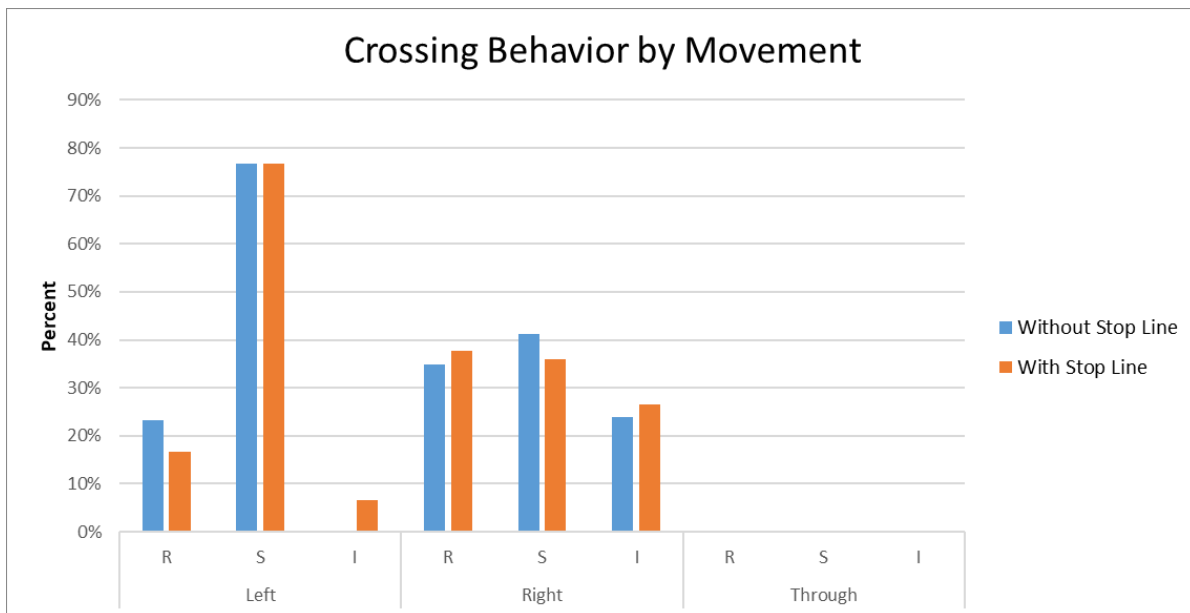
Figure 3.59 50th St W and Eden Ave distribution of driver crossing behavior as a percentage of all events without- vs with-stop line, by driver movement

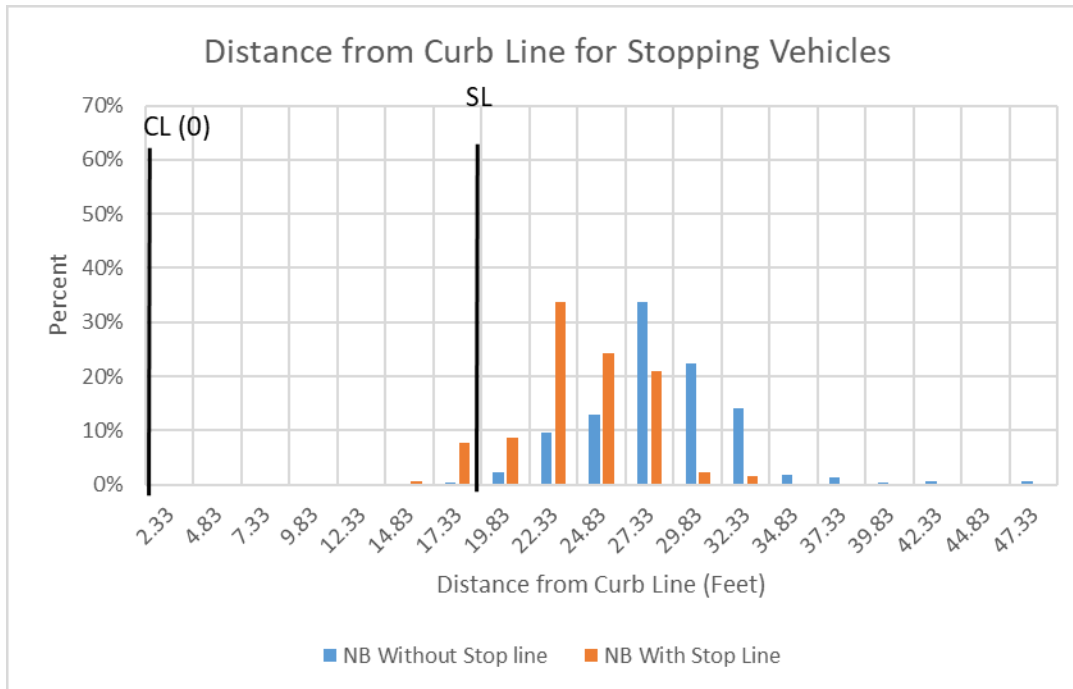
Figure 3.60 50th St W and Eden Ave Distribution of Stopping Distance During Stop Events

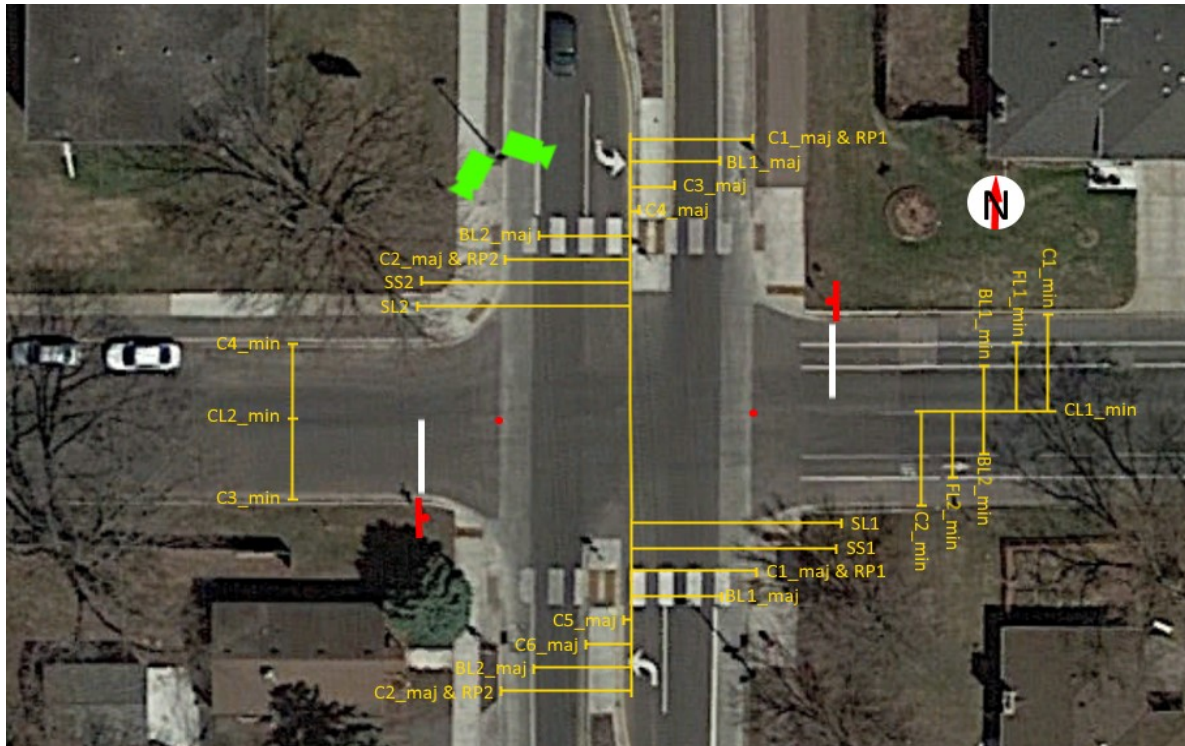
Figure 3.68 Aerial view of the intersection of Portland Ave and E 73rd St with measurements marked

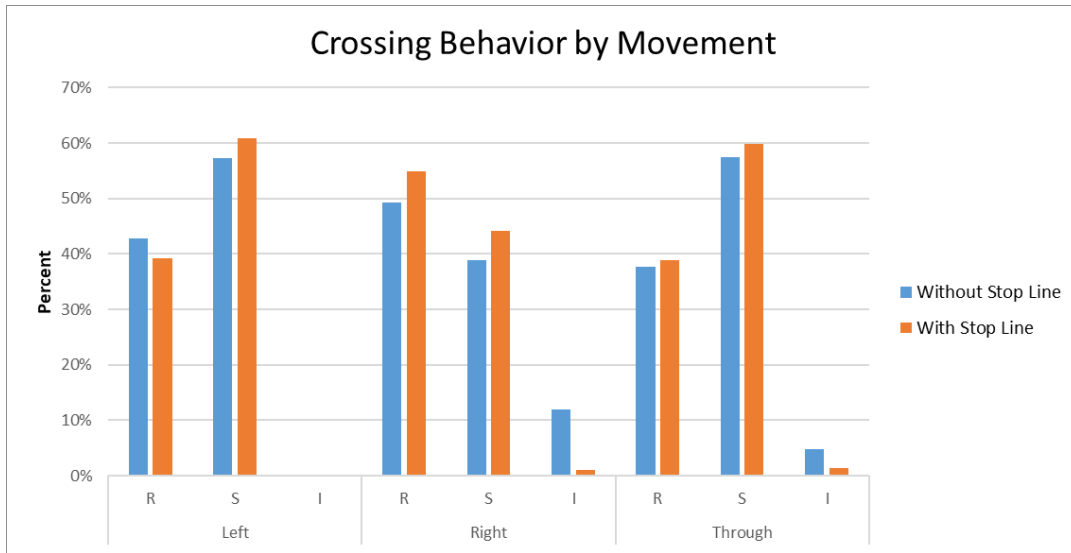
Figure 3.72 Portland Ave and 73rd St EB distribution of driver crossing behavior as a percentage of all events without- vs with-stop line, by driver movement

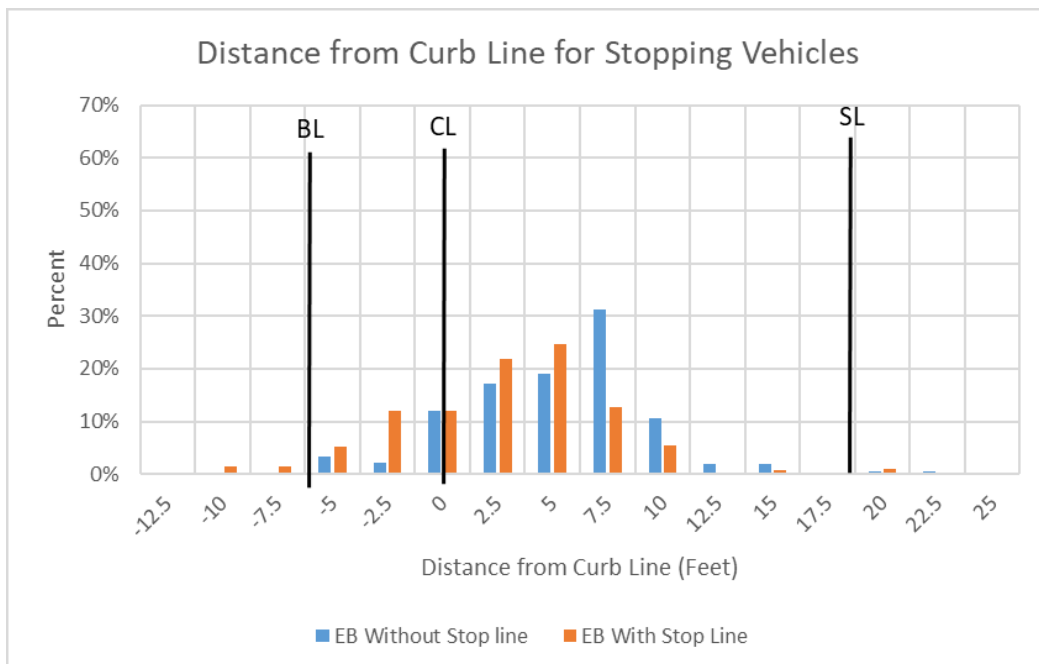
Figure 3.73 Portland Ave and E 73rd St EB Distribution of Stopping Distance During Stop Events

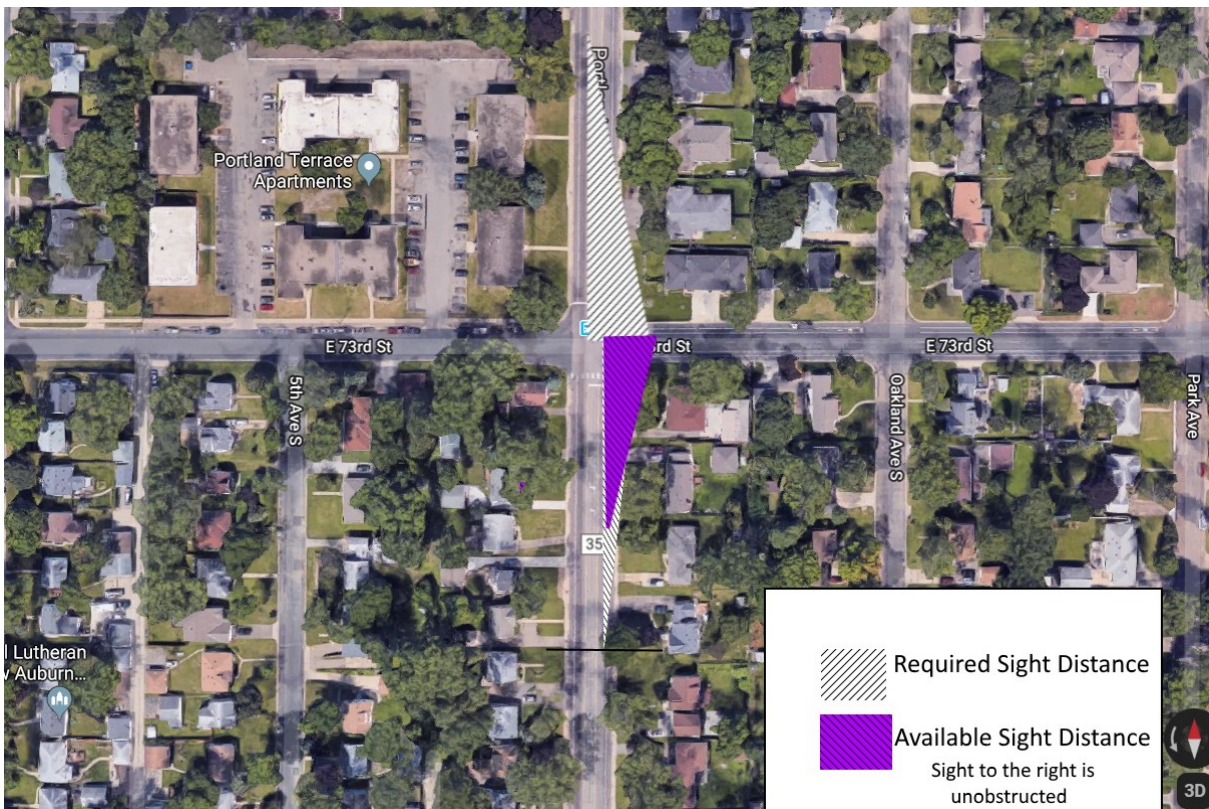
Figure 3.76 Available sight distance and required sight distance at Portland Ave and E 73rd St WB

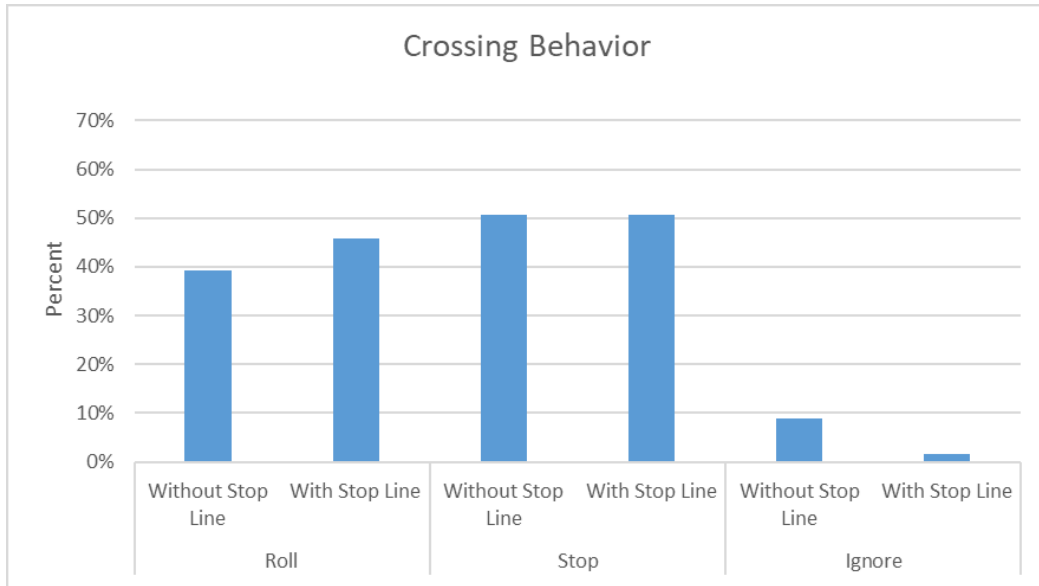
Figure 3.77 Portland Ave and 73rd St WB distribution of driver crossing behavior as a percentage of all events without- vs with-stop line

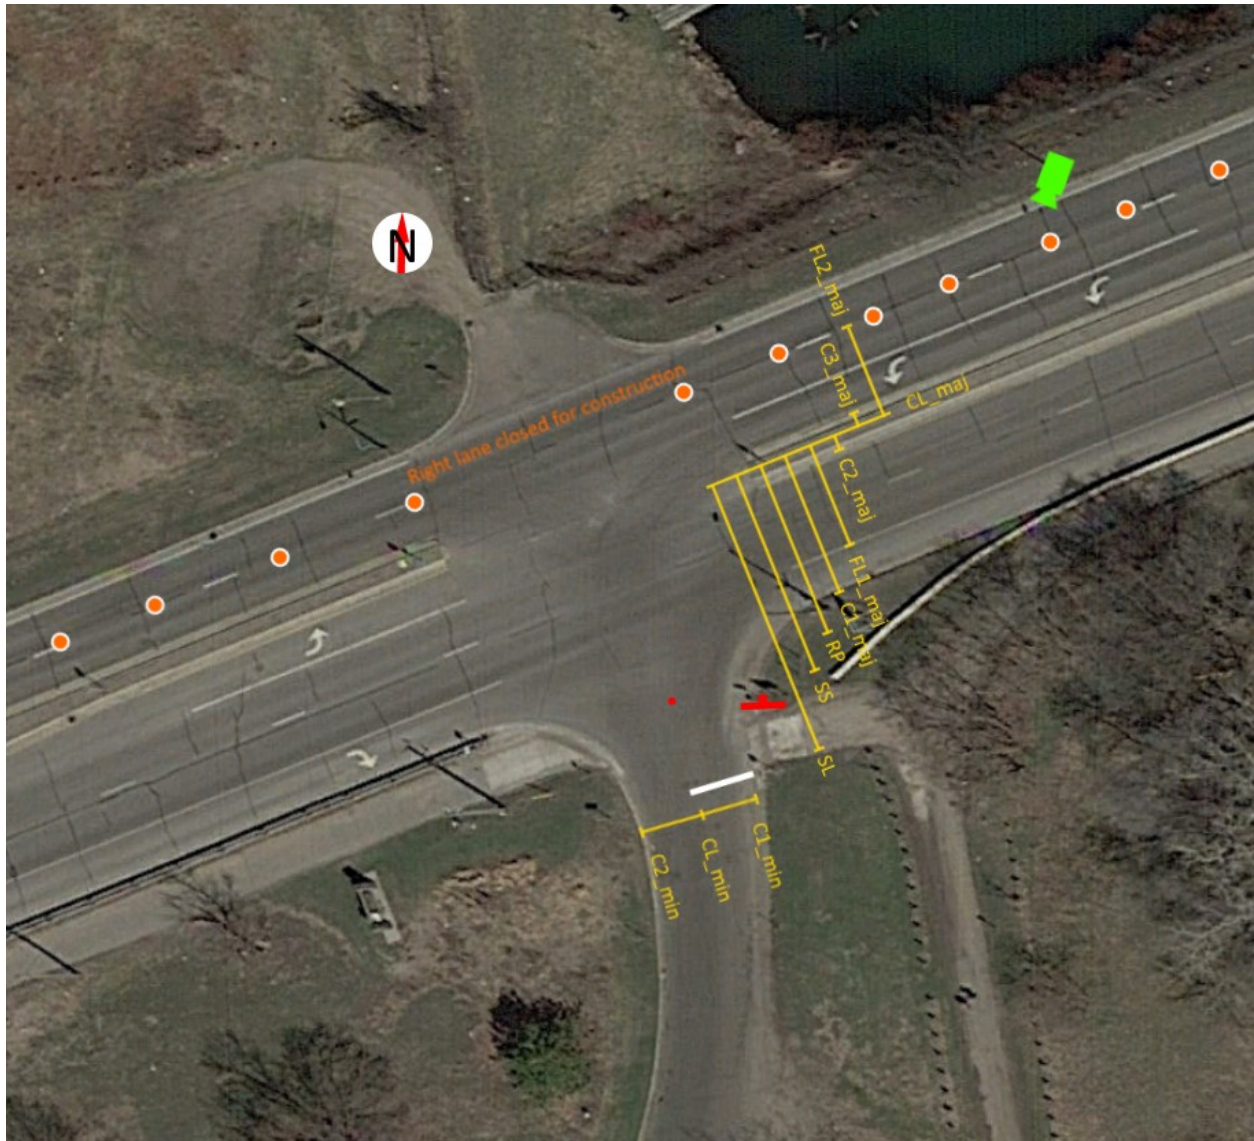
Figure 3.81 Aerial view of the intersection of Warner Rd and Fish Hatchery Rd N with measurements marked

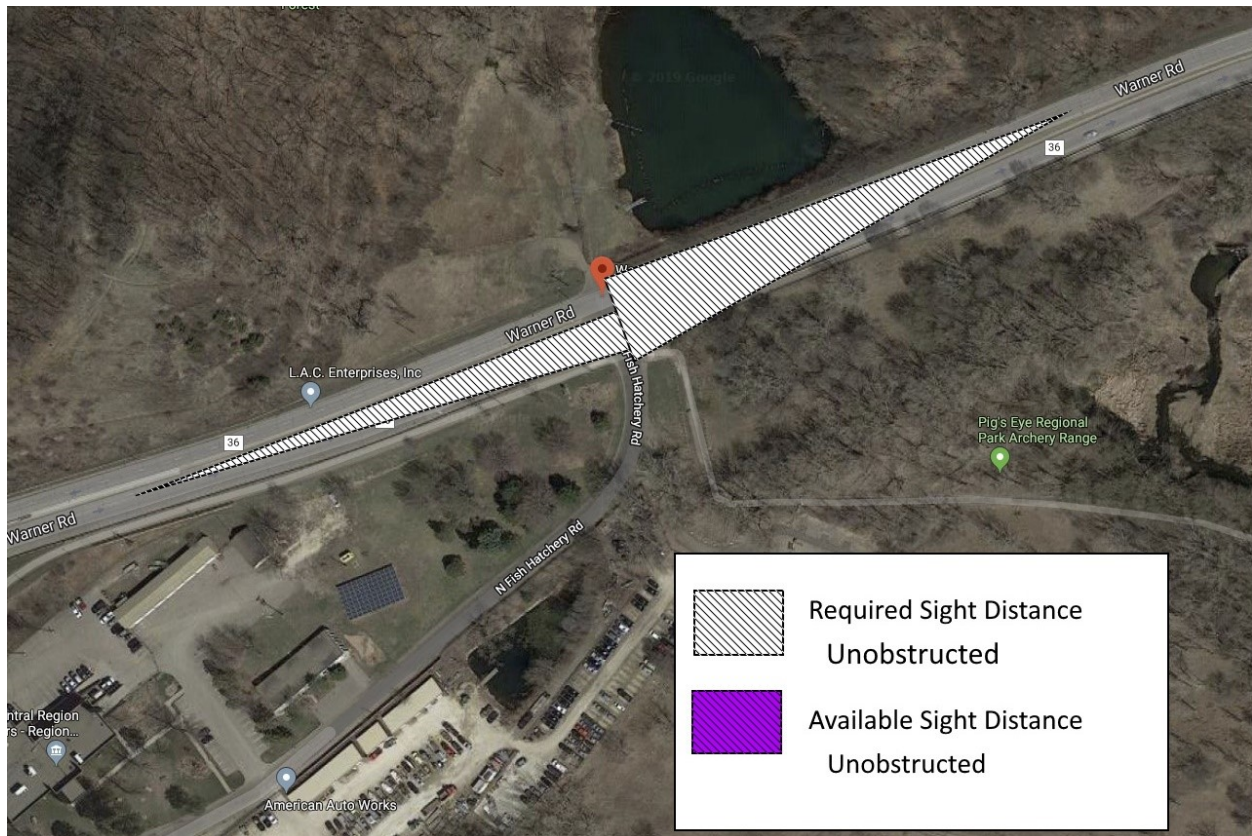
Figure 3.83 Available sight distance and required sight distance at Warner Rd and Fish Hatchery Rd N

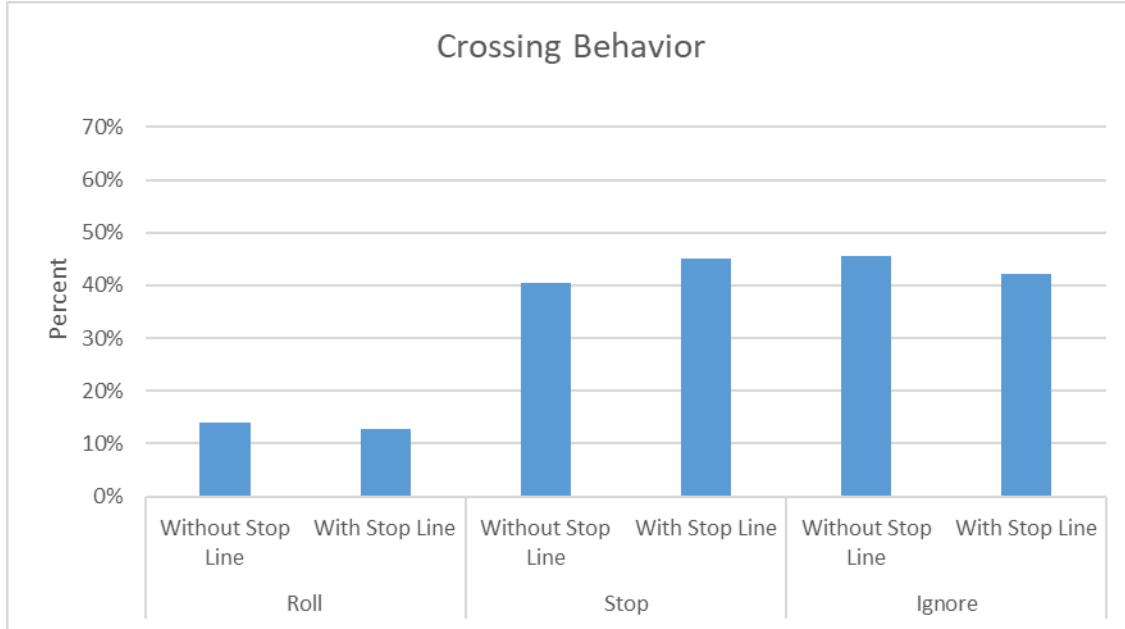
Figure 3.84 Warner Rd and Fish Hatchery Rd N distribution of driver crossing behavior as a percentage of all events without- vs with-stop line

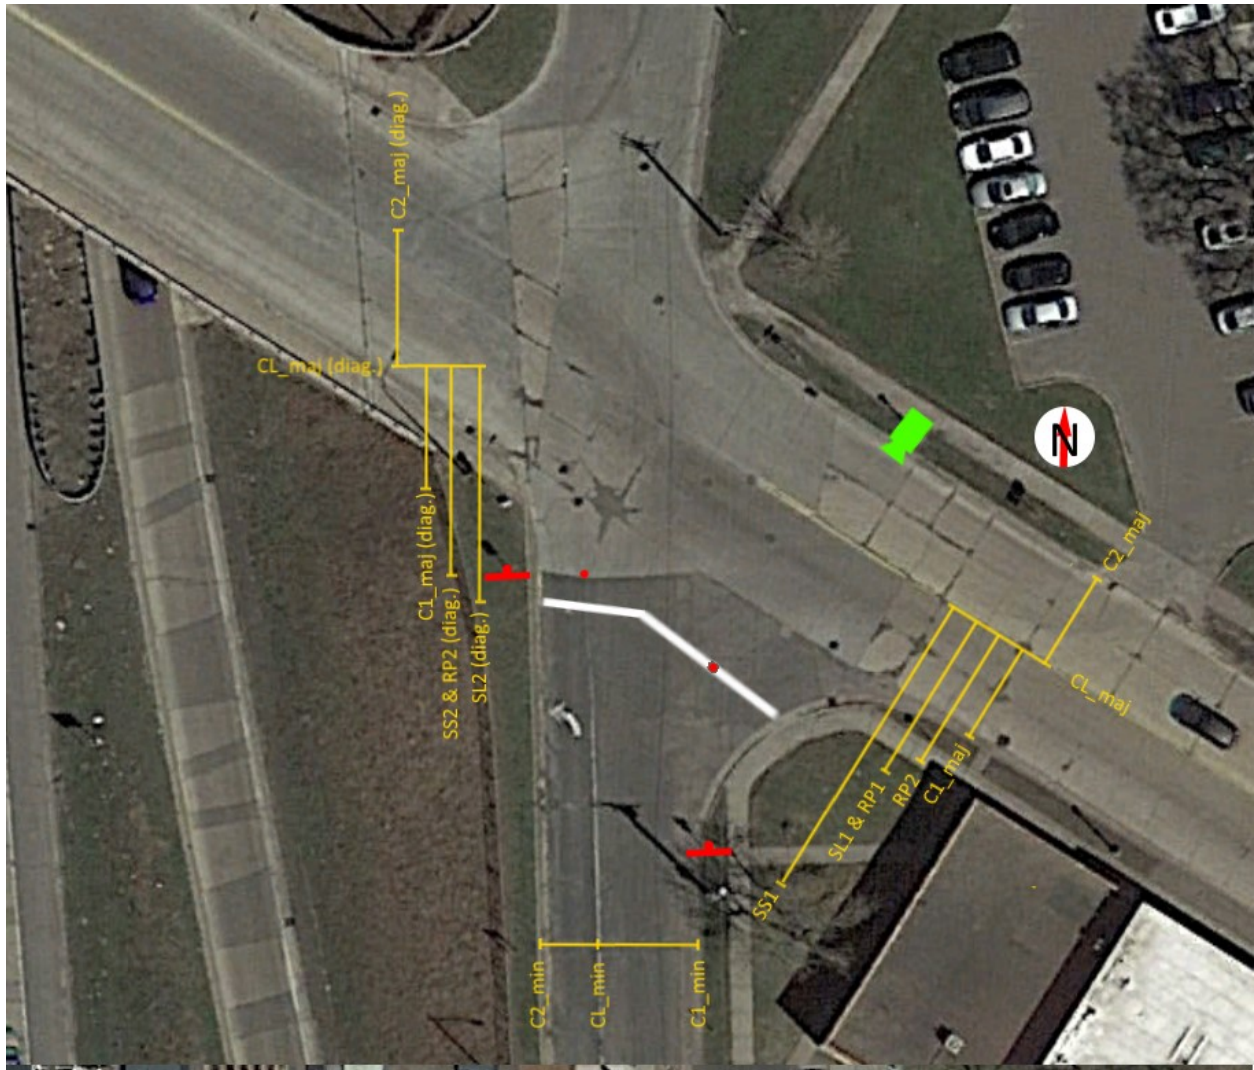
Figure 3.88 Aerial view of the intersection of W Territorial Rd and Cromwell Ave with measurements marked

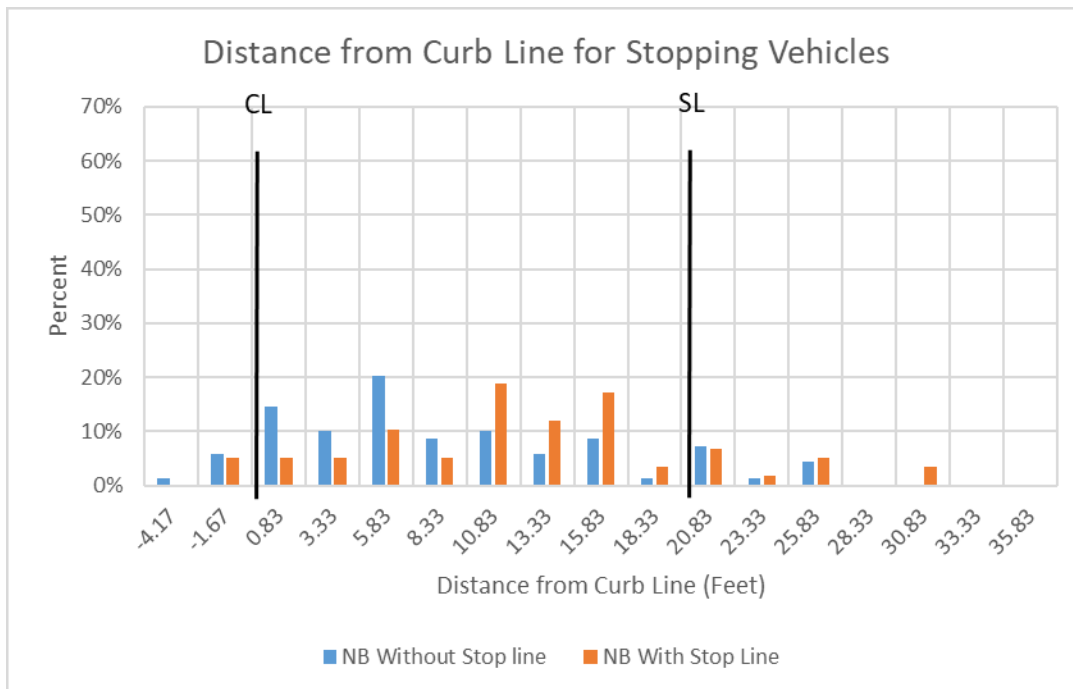
Figure 3.92 W Territorial Rd and Cromwell Ave N (Right) Distribution of Stopping Distance During Stop Events

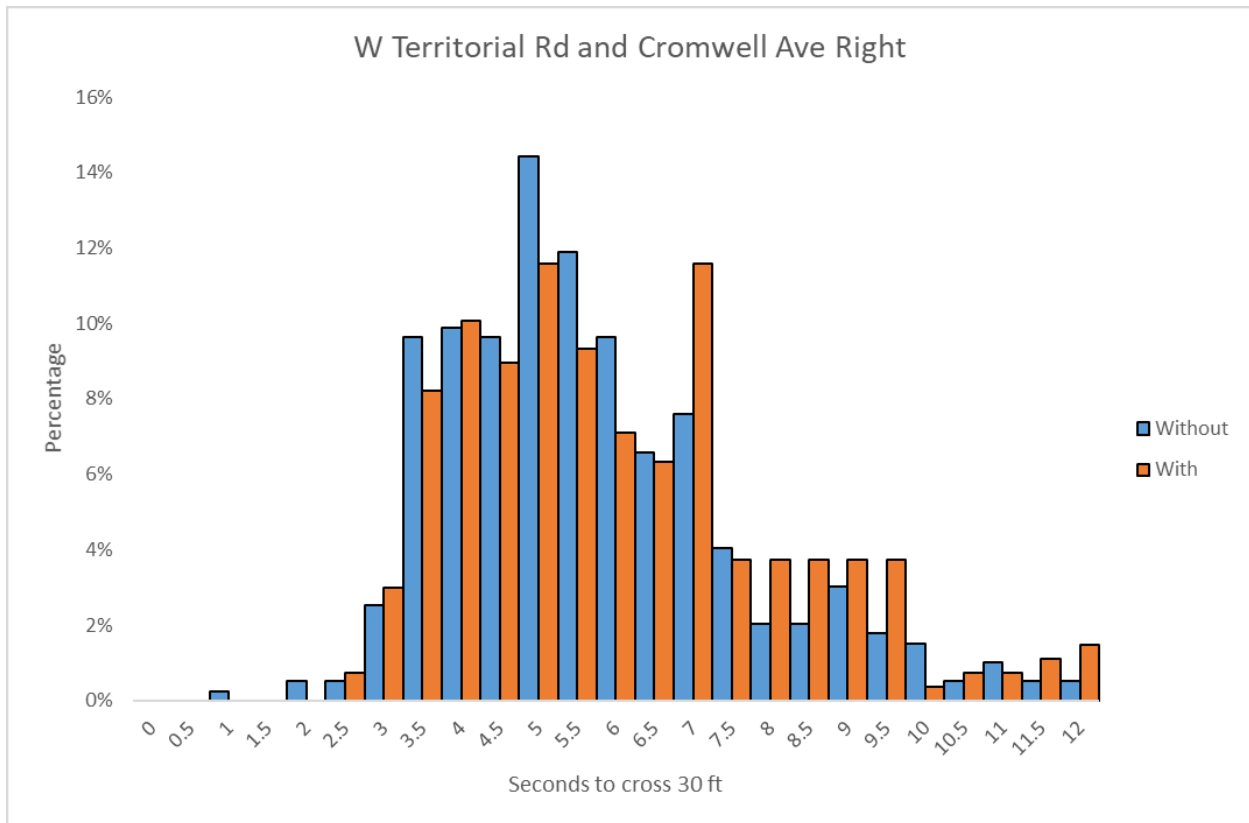
Figure 3.93 W Territorial Rd and Cromwell Ave N (right) Histogram of Roll and Ignore behaviors, in seconds to travel 30 ft

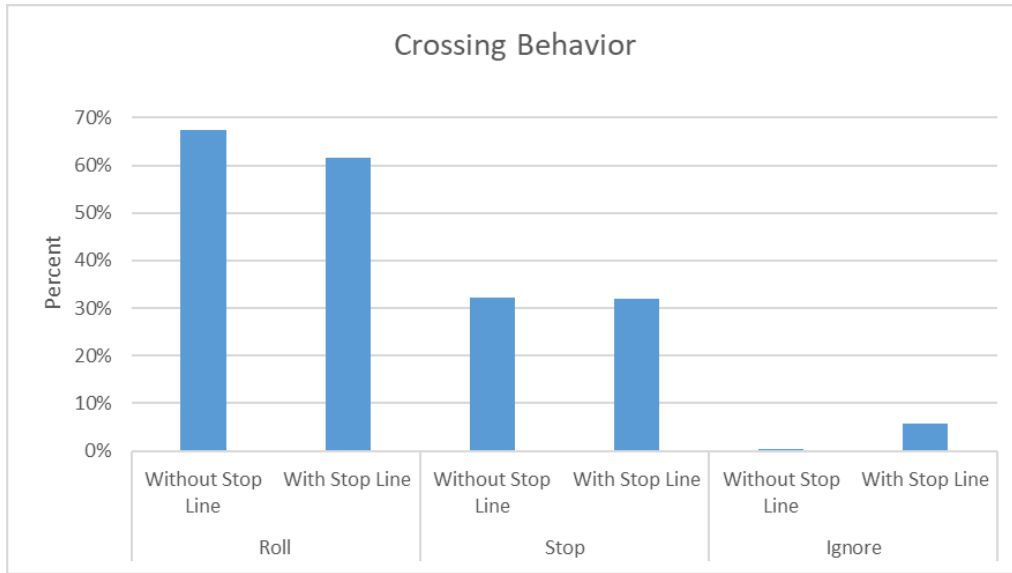
Figure 3.94 W Territorial Rd and Cromwell Ave N (through) distribution of driver crossing behavior as a percentage of all events without- vs with-stop line

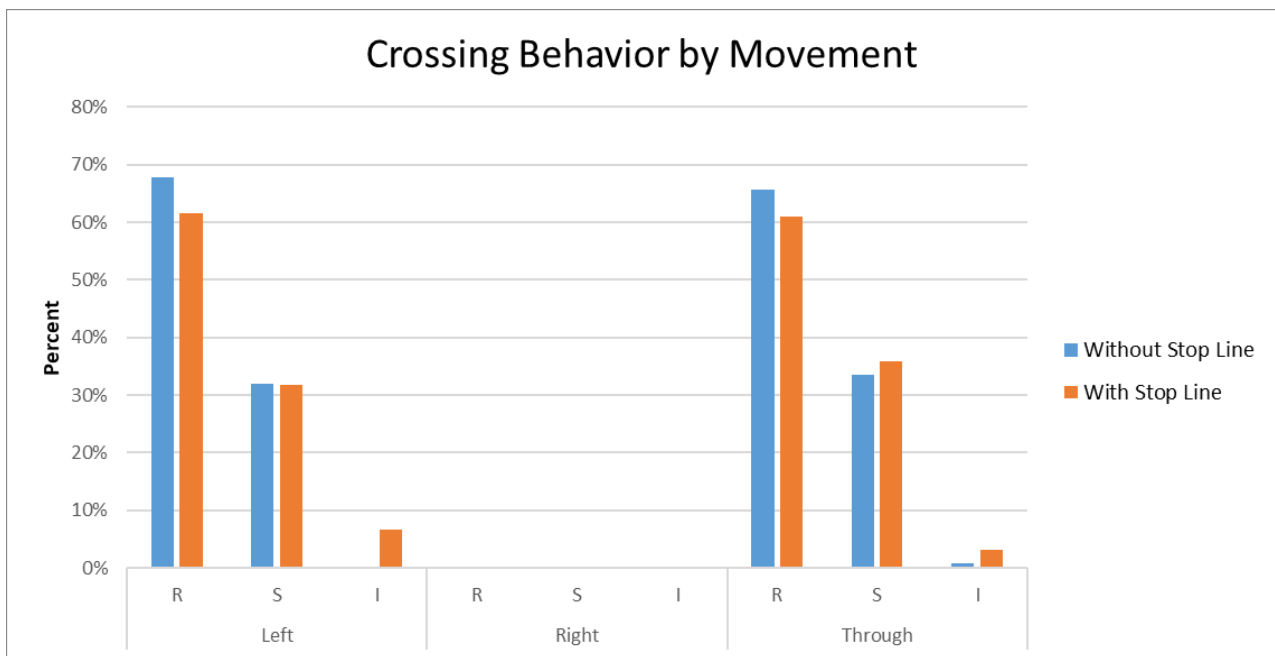
Figure 3.95 W Territorial Rd and Cromwell Ave N (through) distribution of driver crossing behavior as a percentage of all events without- vs with-stop line, by driver movement

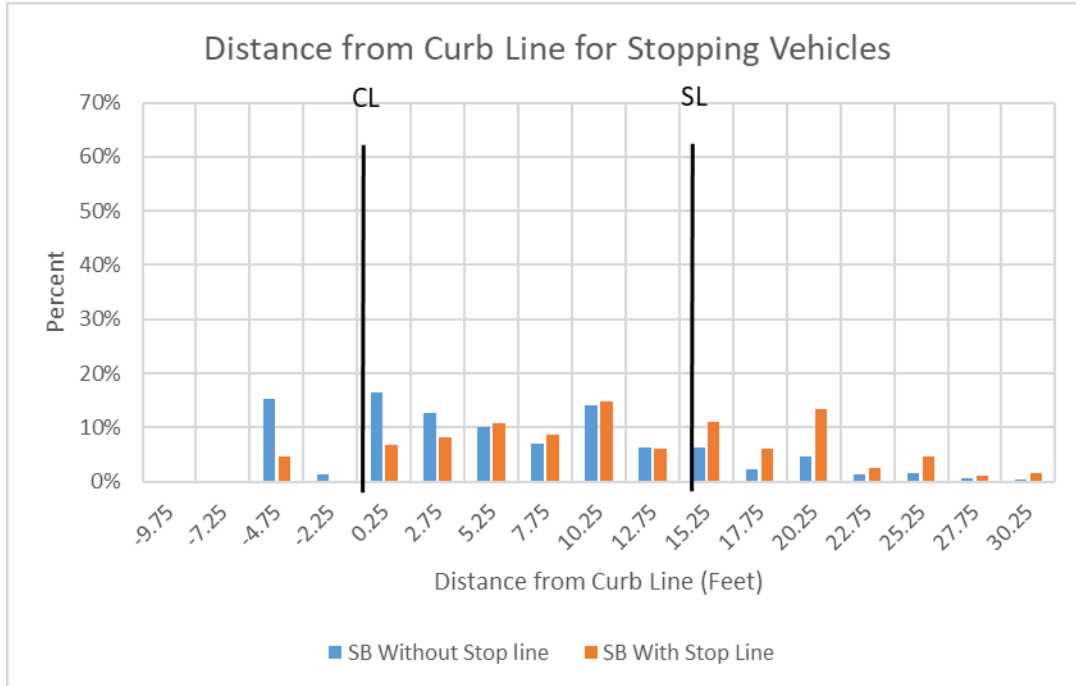
Figure 3.96 W Territorial Rd and Cromwell Ave N (through) Distribution of Stopping Distance During Stop Events

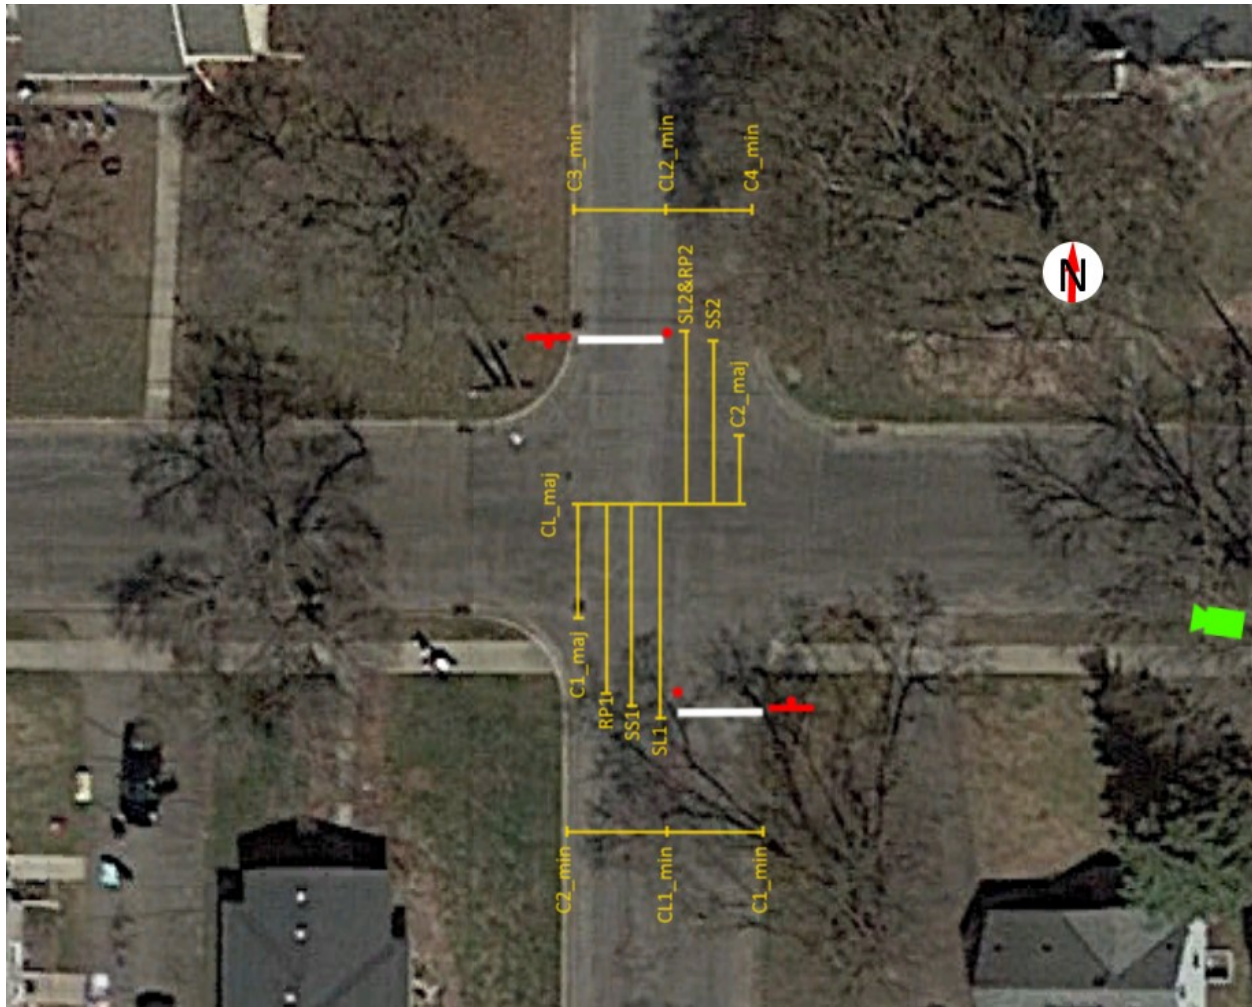
Figure 3.98 Aerial view of the intersection of Raleigh Ave and W 28th St with measurements marked

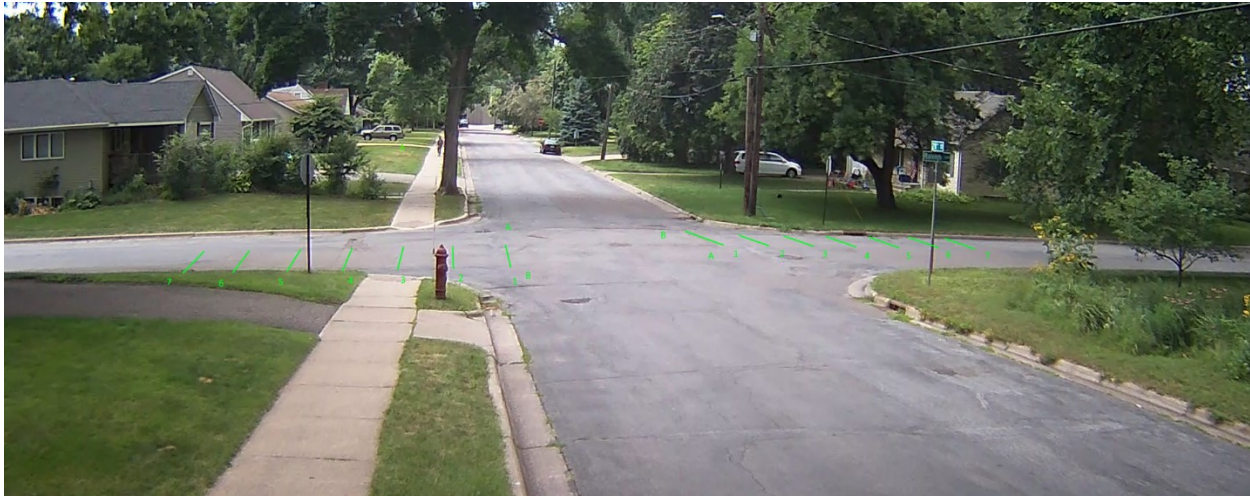
Figure 3.99 Camera view of the intersection of Raleigh Ave and W 28th St with 5-ft overlay lines marked
