Evaluation of the Effectiveness of Stop Lines in Increasing the Safety of Stop-Controlled Intersections

Minnesota Traffic Observatory

Research Project

Final Report 2020-17

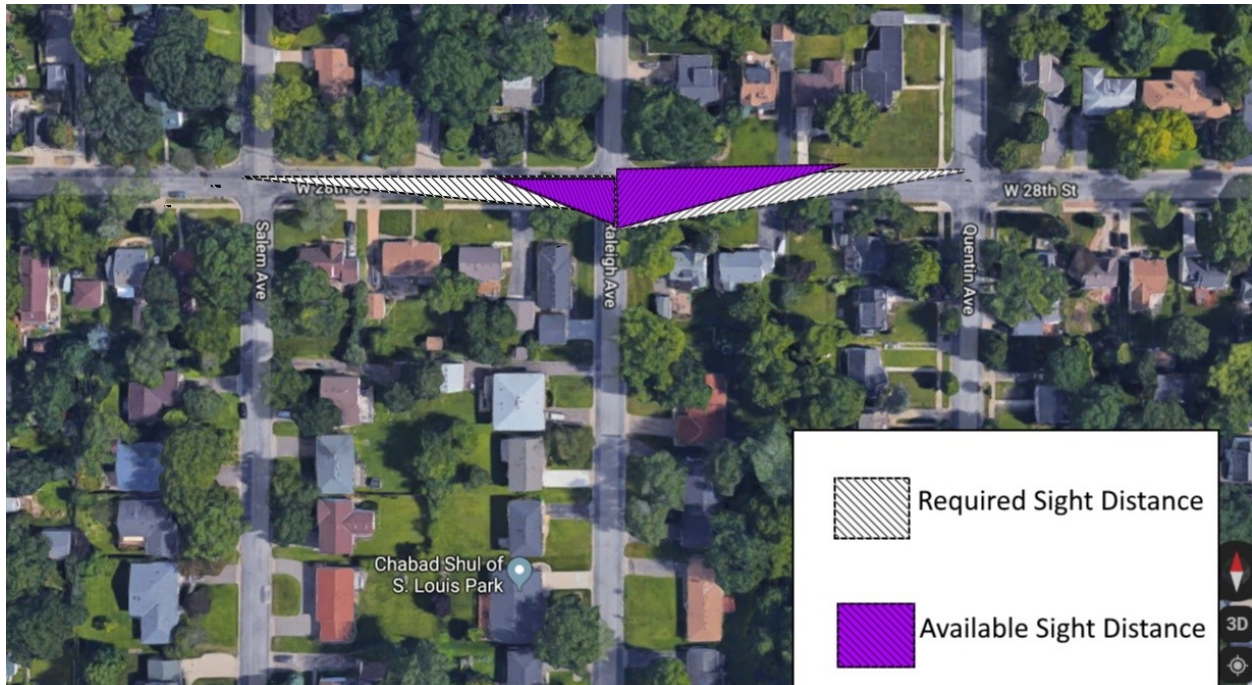
Figure 3.100 Available sight distance and required sight distance at Raleigh Ave and W 28th St NB

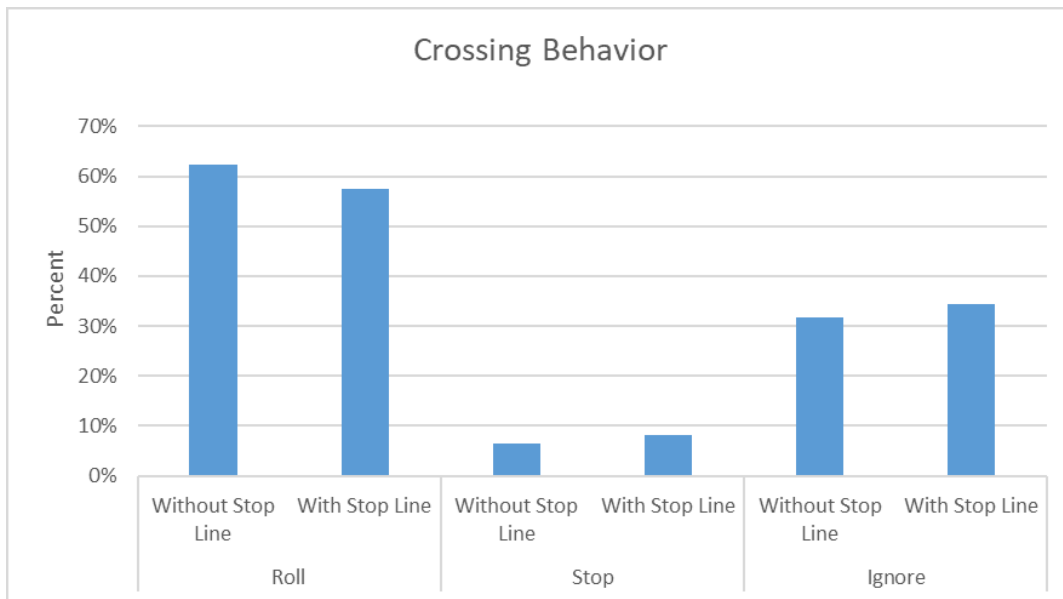
Figure 3.101 Raleigh Ave NB distribution of driver crossing behavior as a percentage of all events without- vs with-stop line

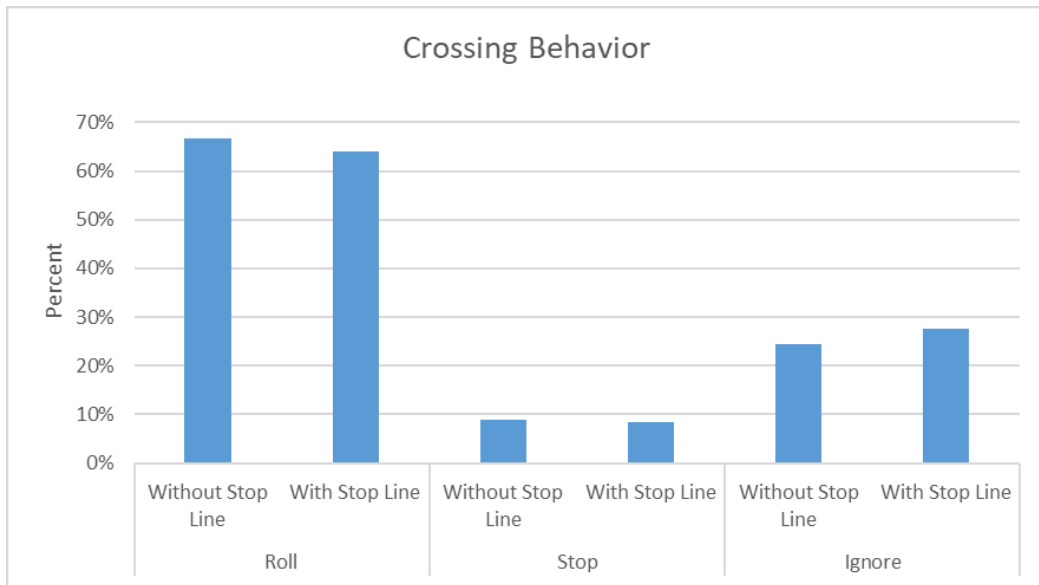
Figure 3.106 Raleigh Ave SB distribution of driver crossing behavior as a percentage of all events without- vs with-stop line

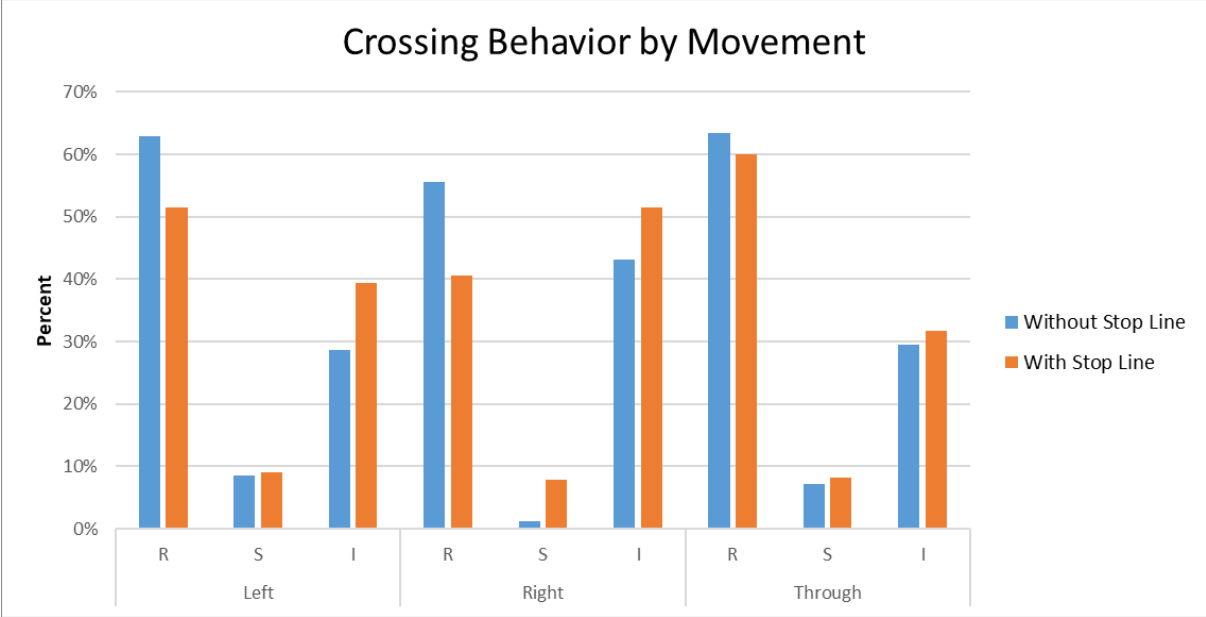
Figure 3.107 Raleigh Ave SB distribution of driver crossing behavior as a percentage of all events without- vs with-stop line, by driver movement

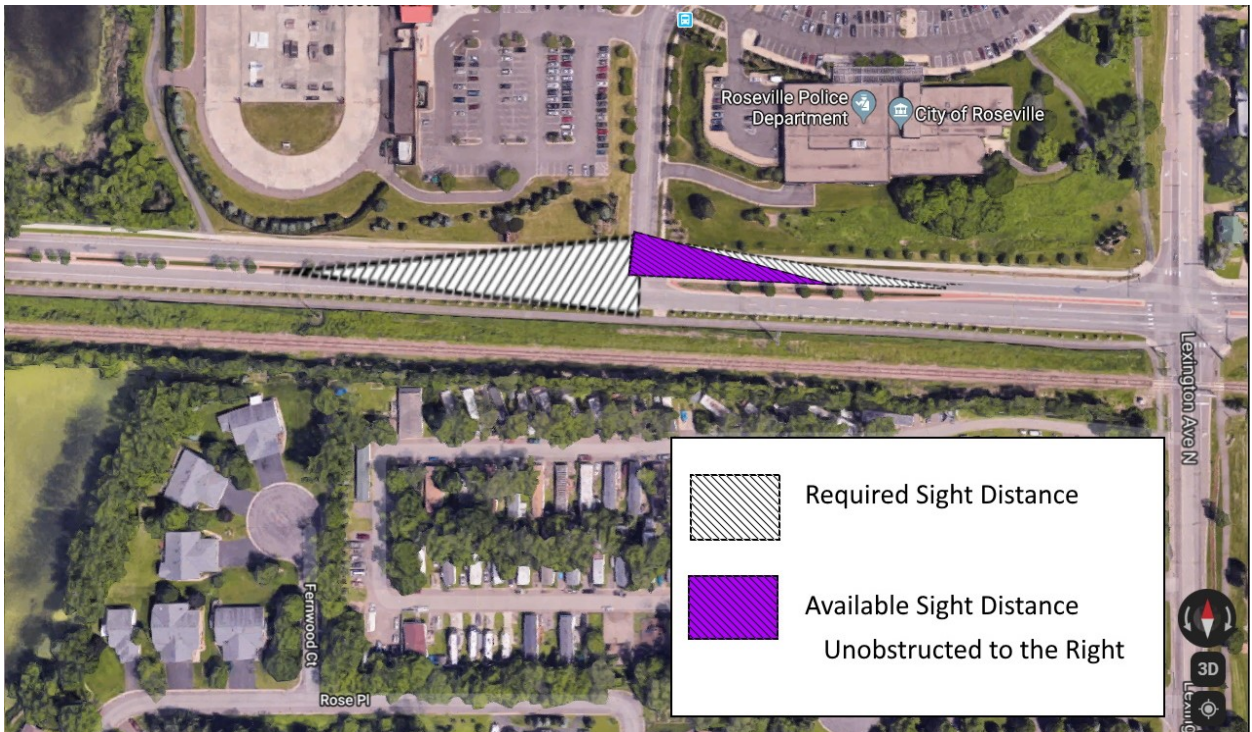
Figure 3.112 Available sight distance and required sight distance at County Rd C W and Civic Center Dr

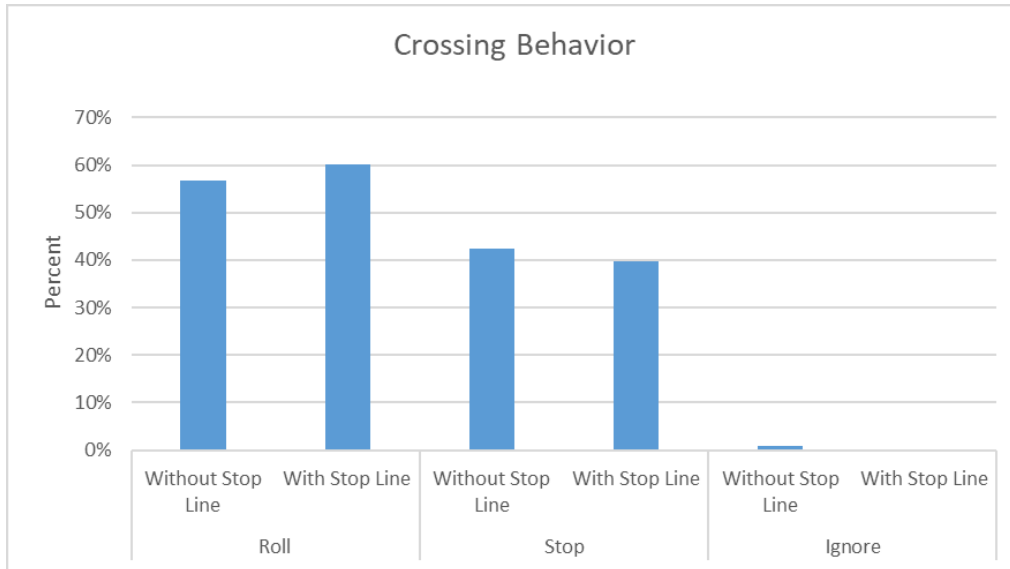
Figure 3.113 County Rd C W and Civic Center Dr distribution of driver crossing behavior as a percentage of all events without- vs with-stop line

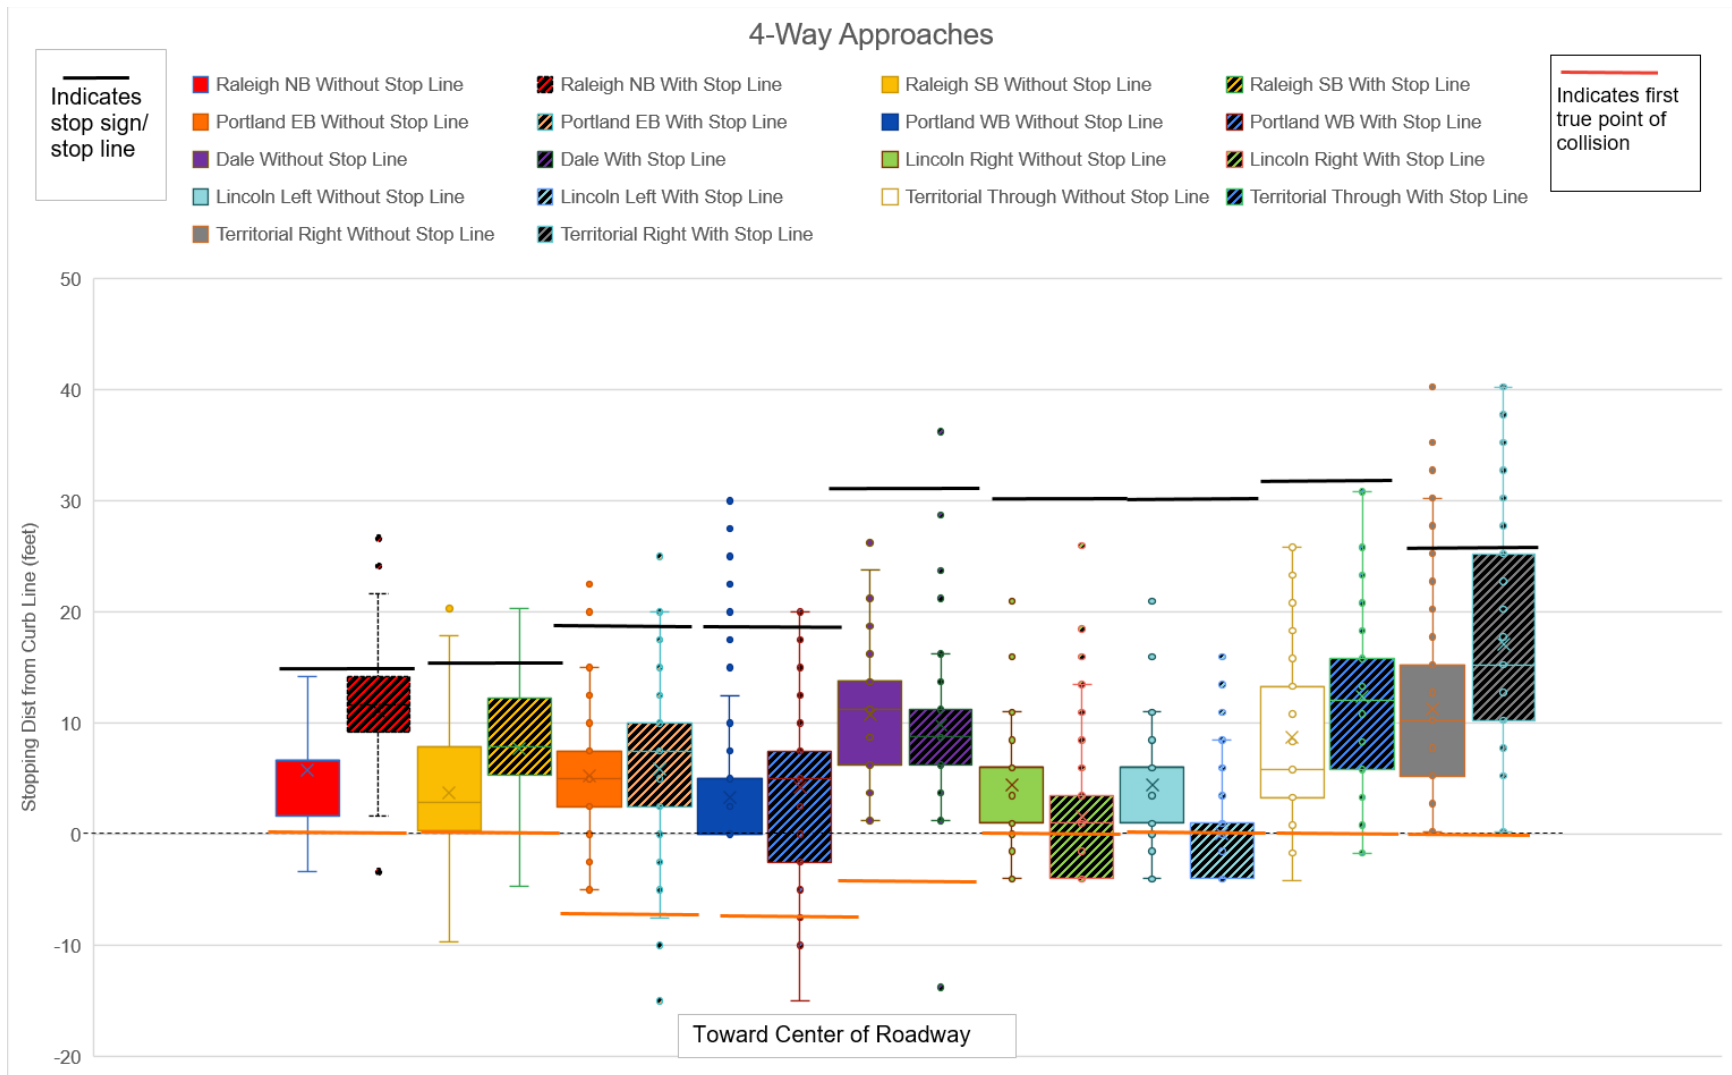
Figure 3.117 Overall Stop Location Distances on 4-way intersections

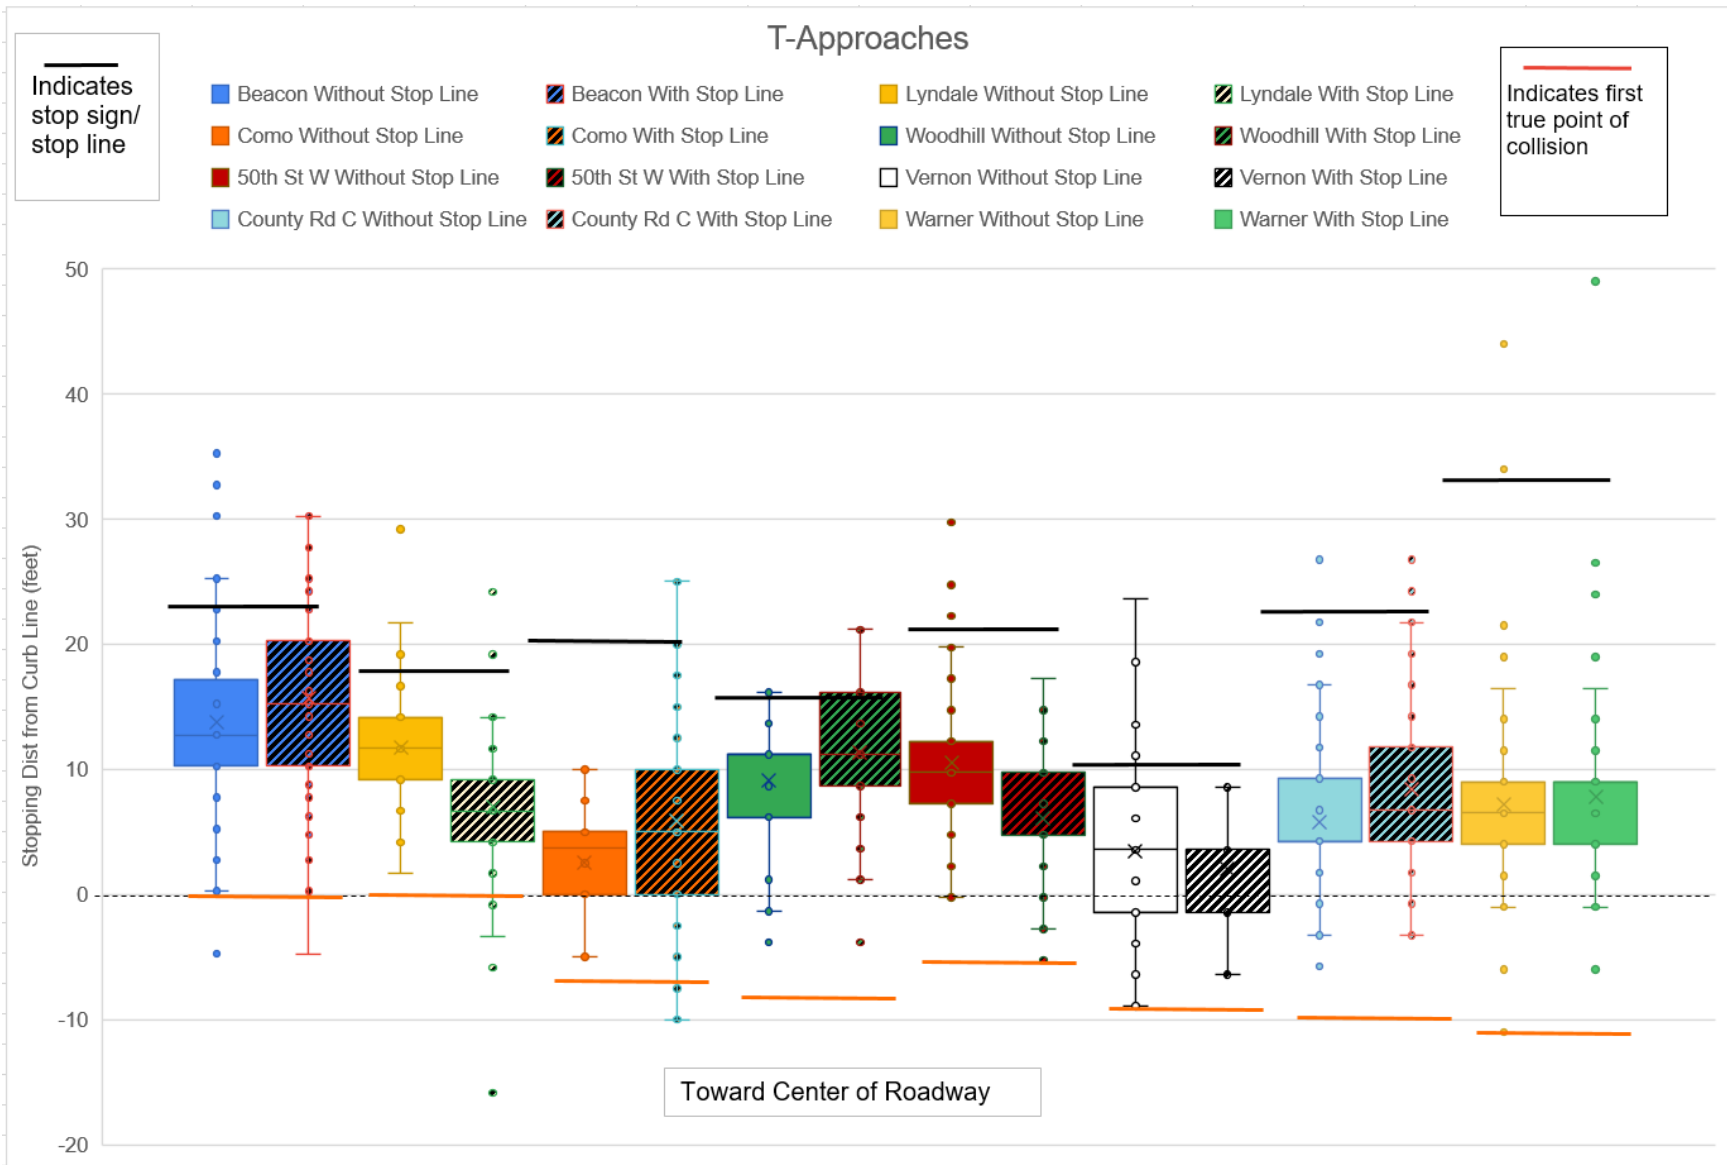
Figure 3.118 Overall Stop Location Distances on T intersections

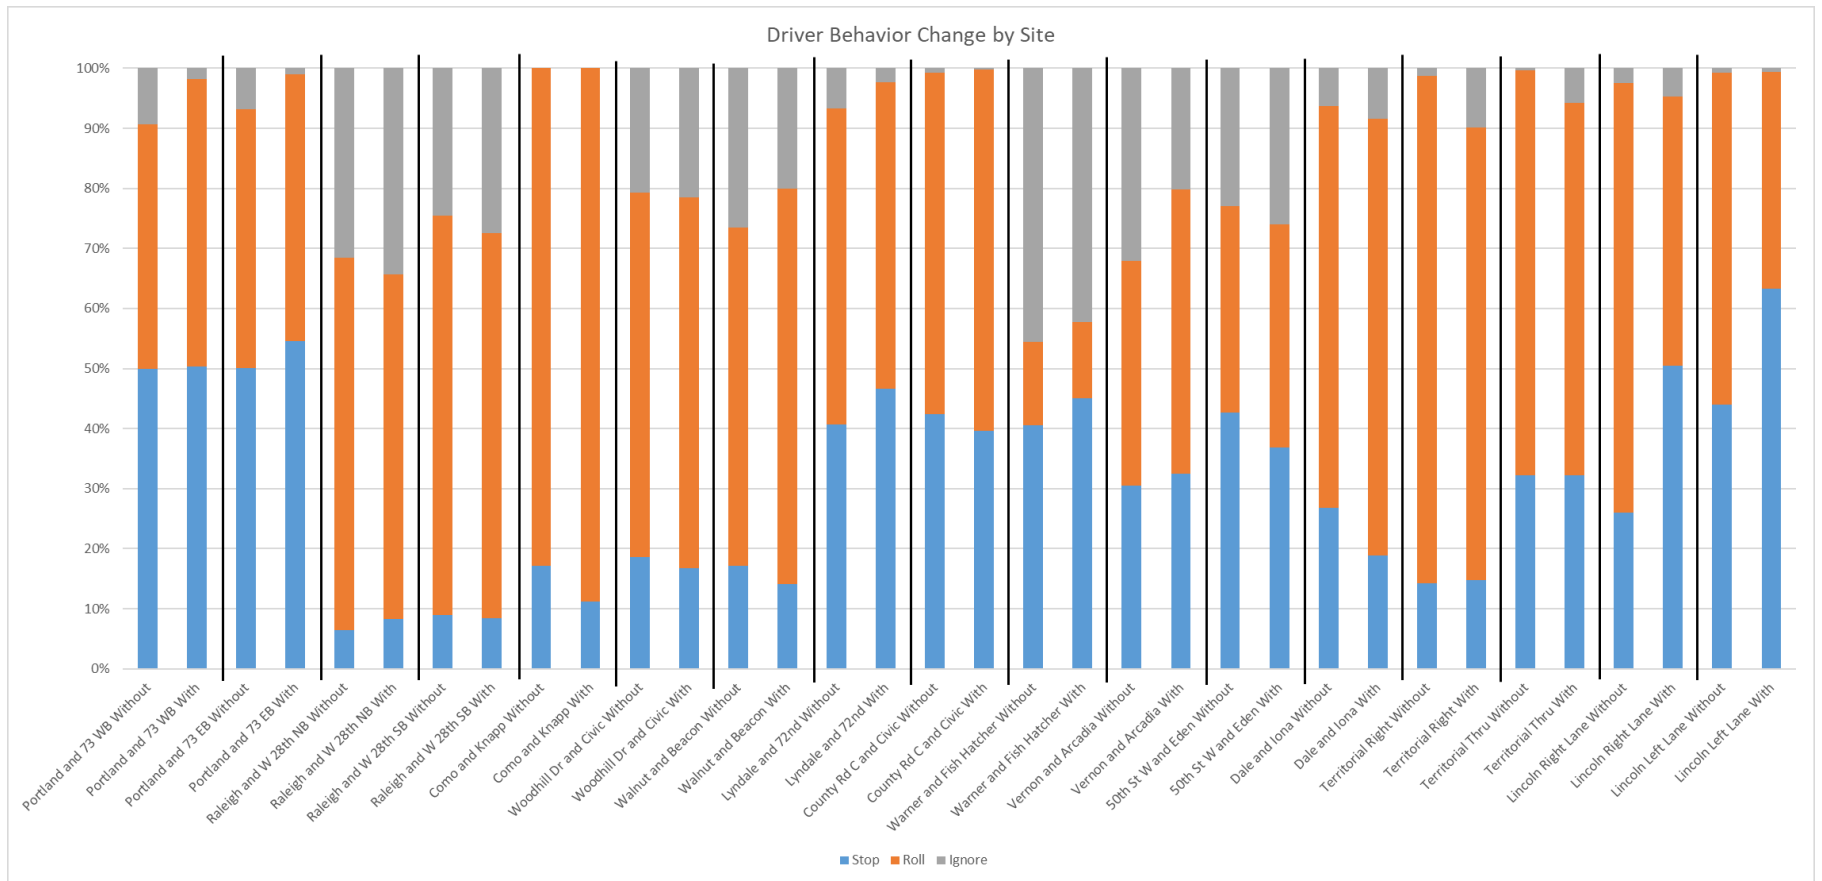
Figure 3.119 Overall Crossing Behaviors before and after the Stop Line installation

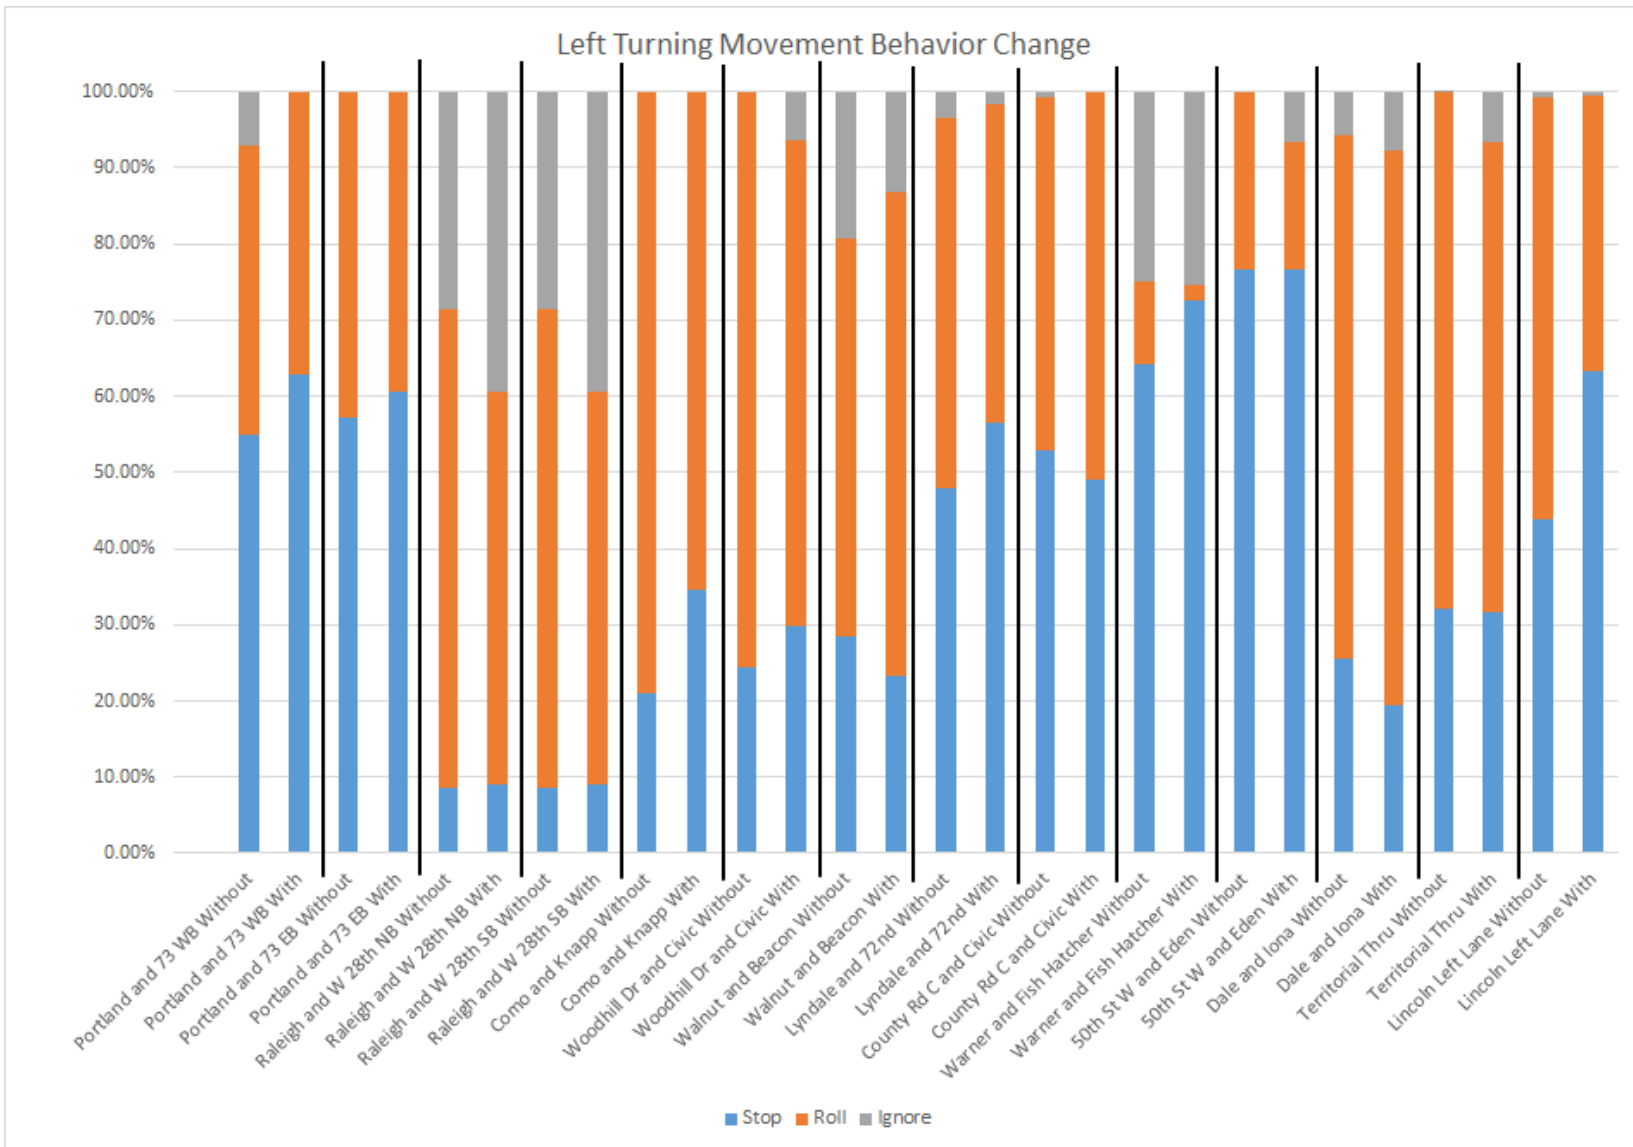
Figure 3.120 Left Turning Movement Crossing Behaviors before and after the Stop Line installation

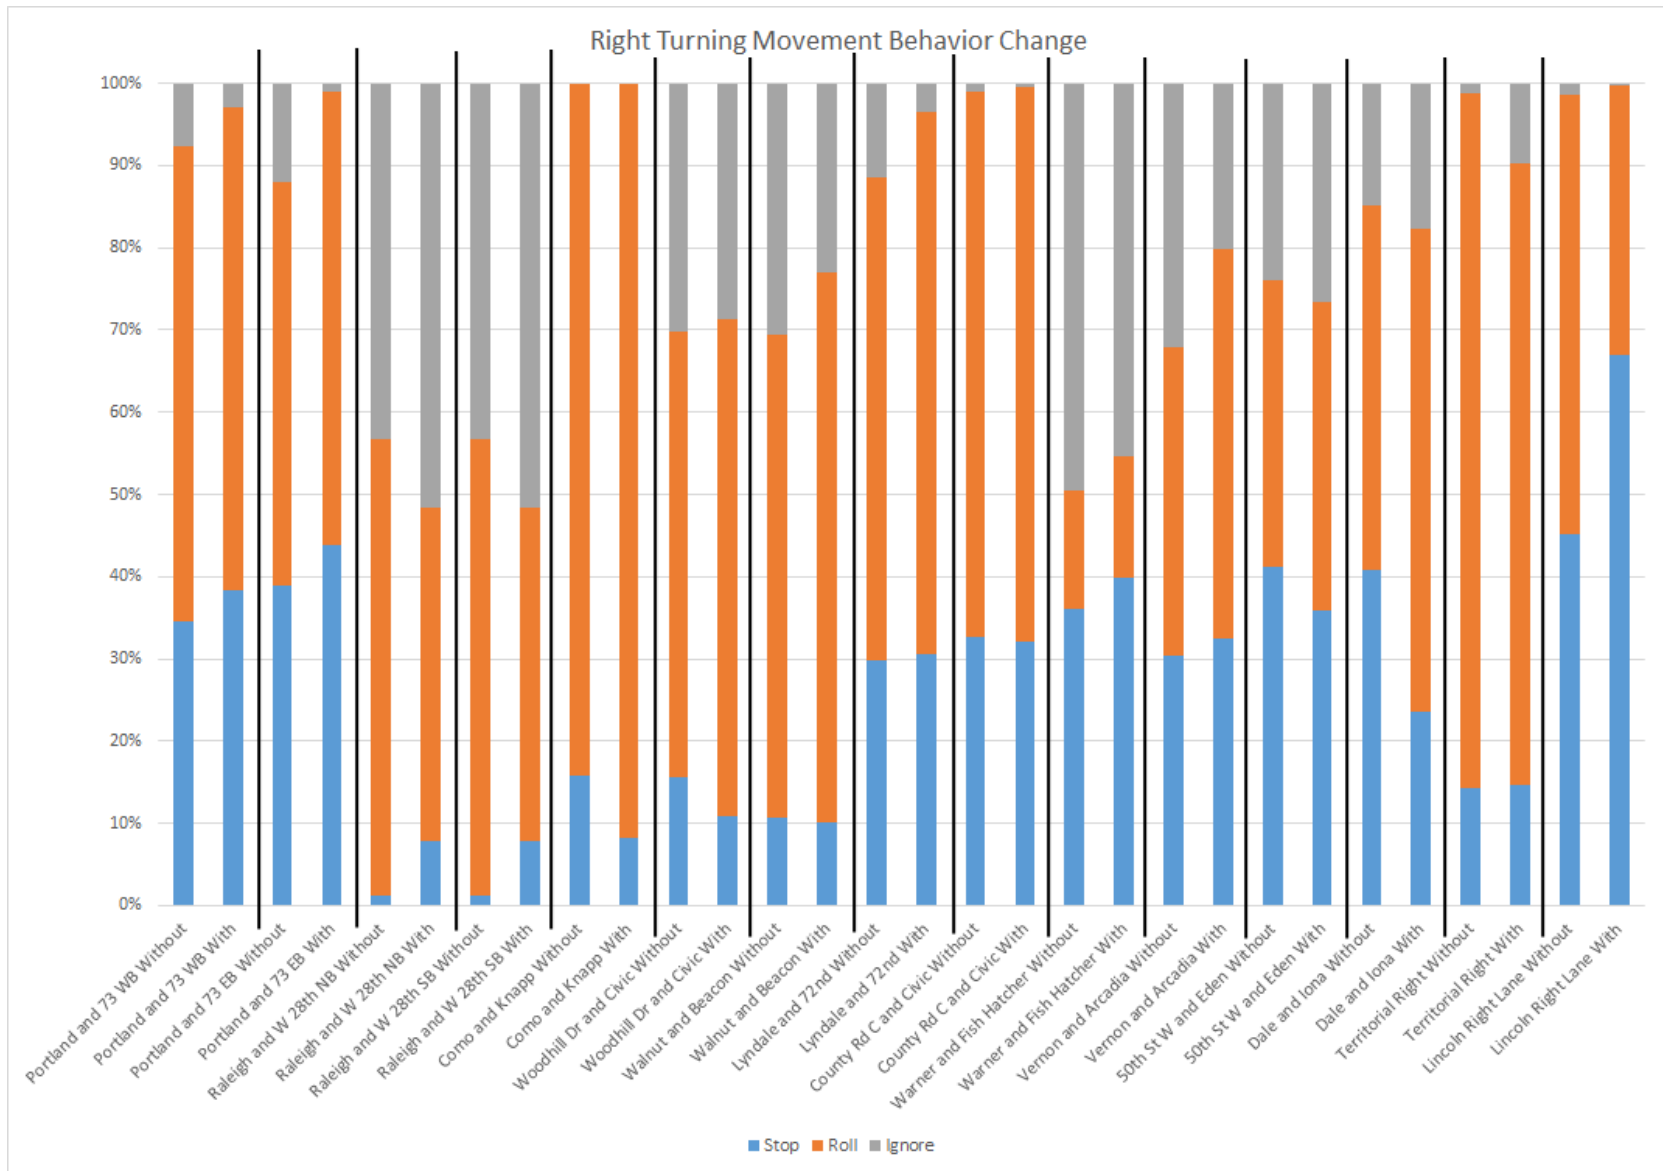
Figure 3.121 Right Turning Movement Crossing Behaviors before and after the Stop Line installation

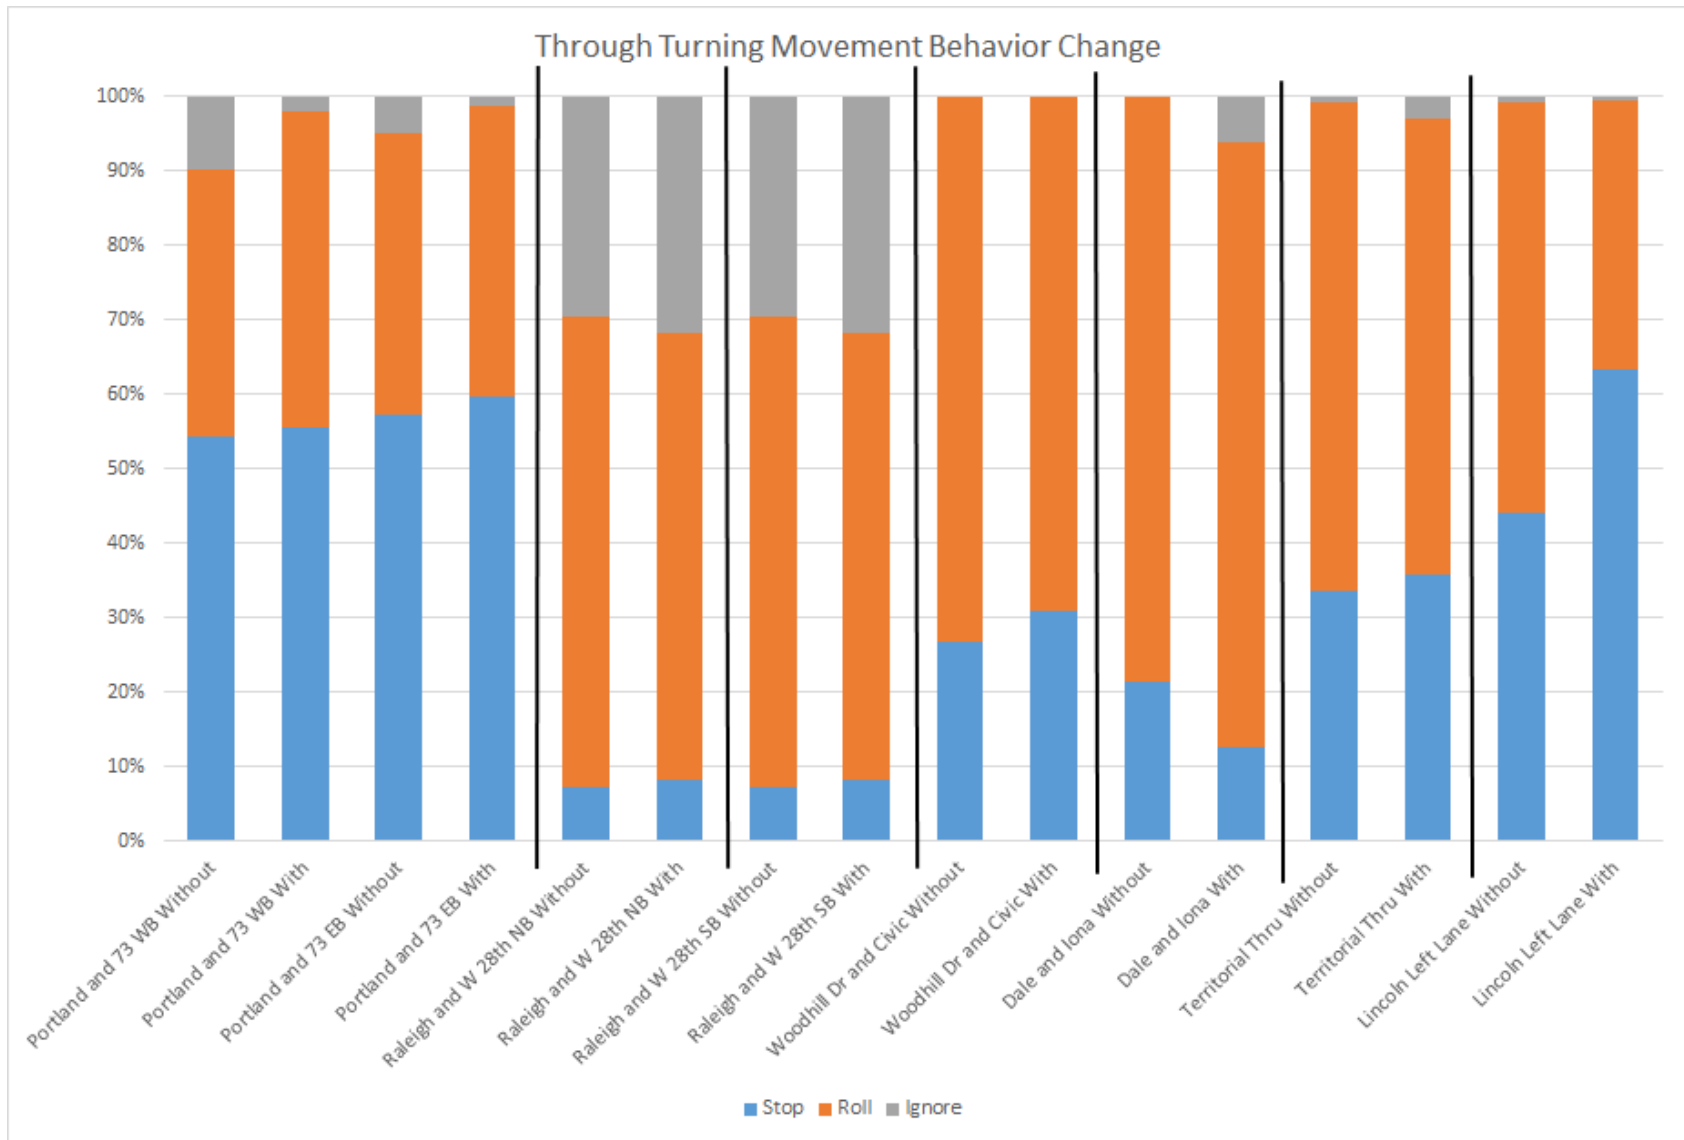
Figure 3.122 Through Movement Crossing Behaviors before and after the Stop Line installation

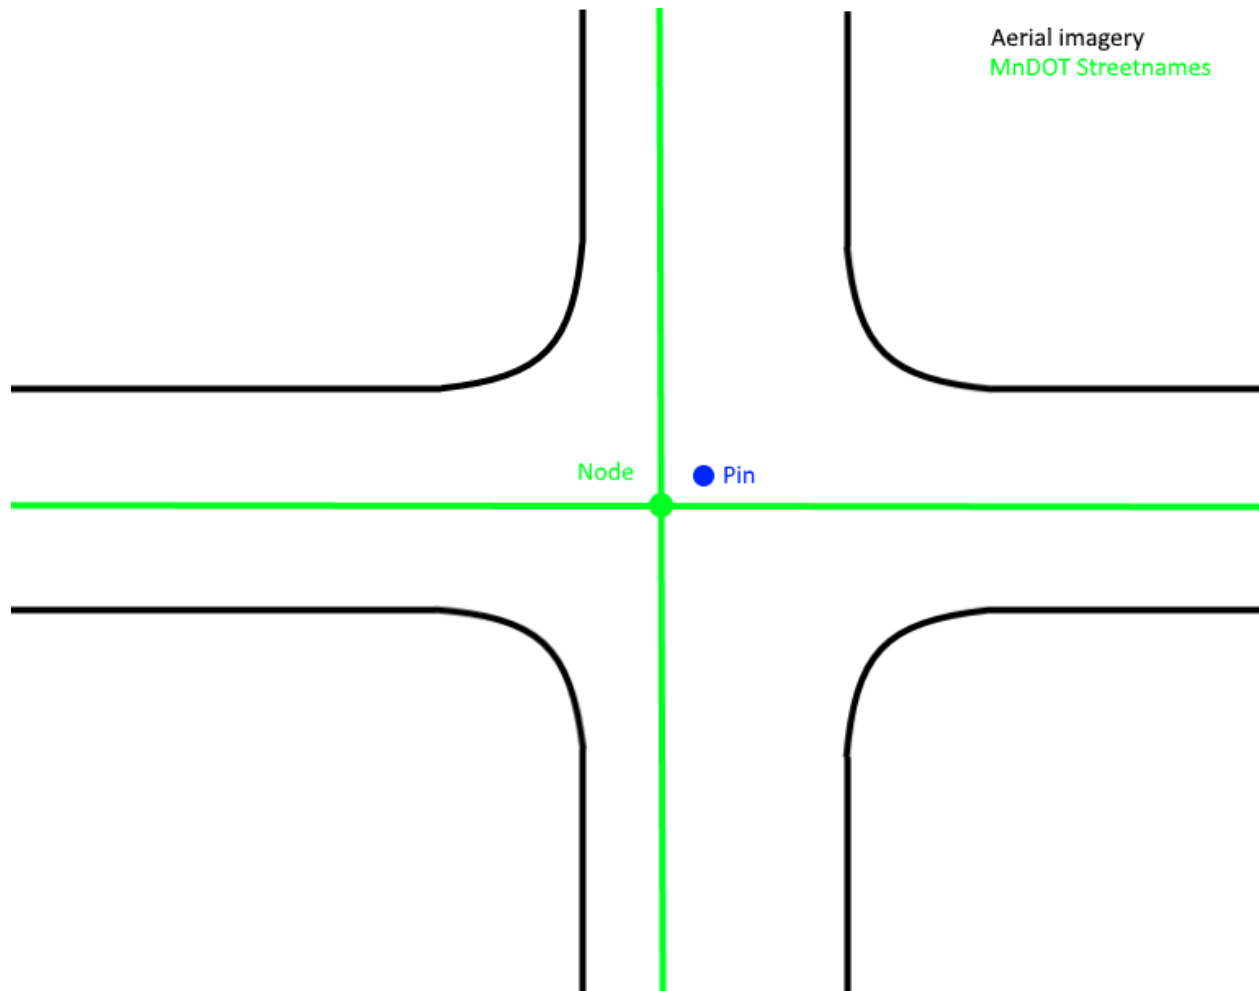
Figure A-0.1 Identification and assignment of approaches – Step 1

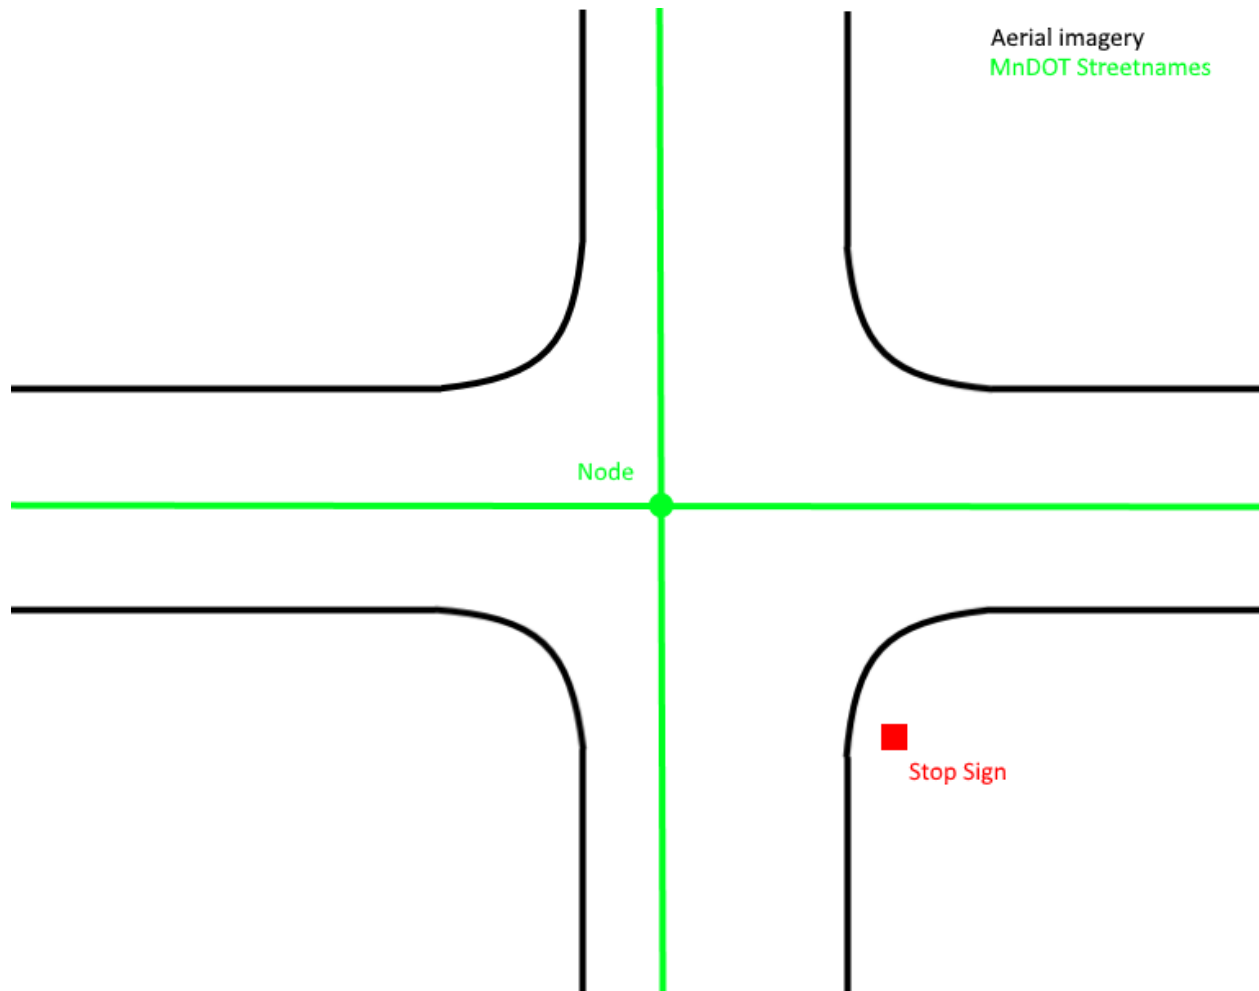
Figure A-0.2 Identification and assignment of approaches – Step 2

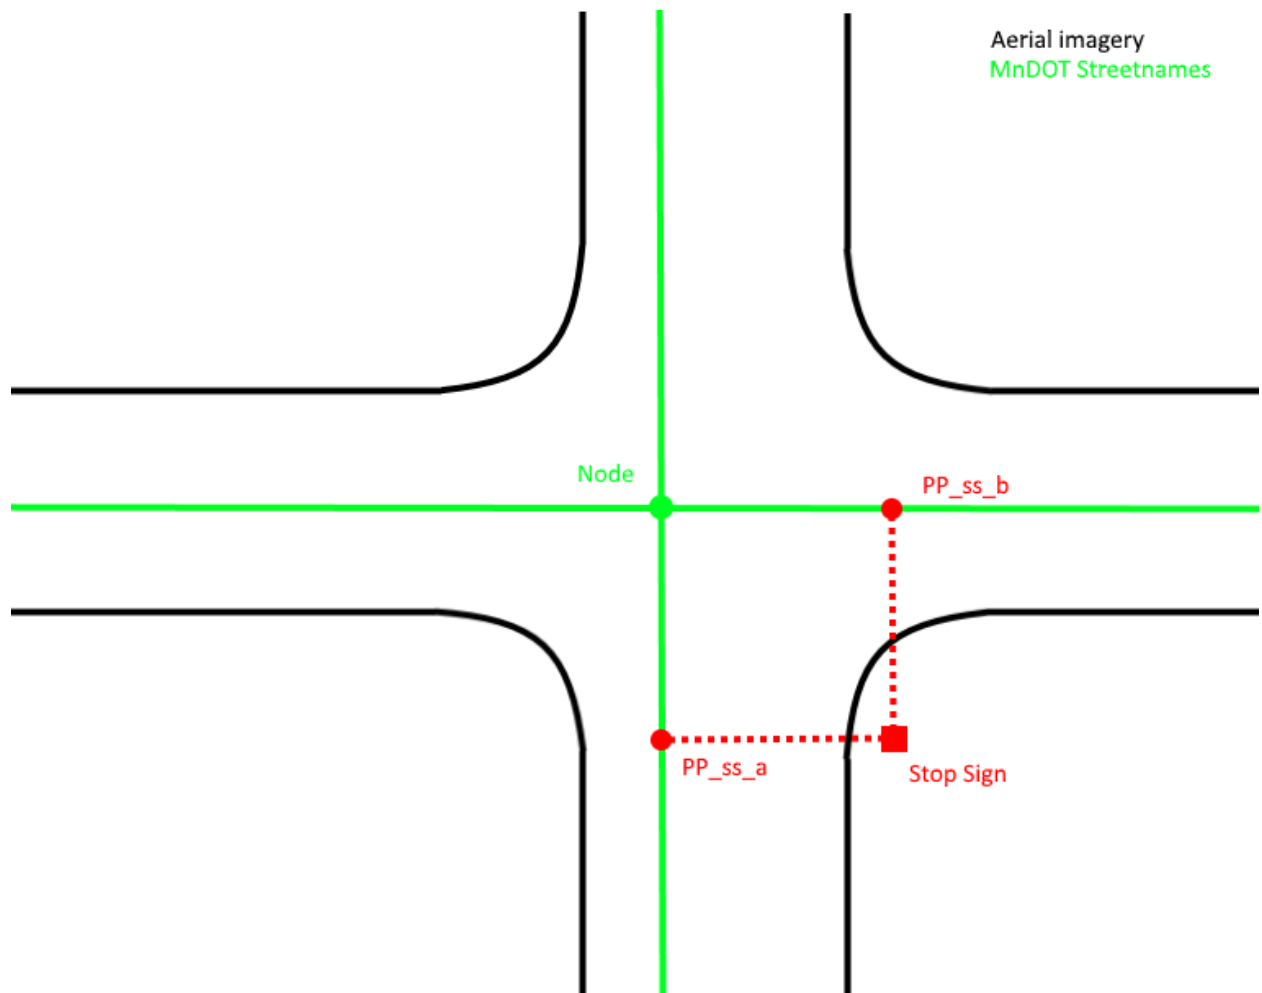
Figure A-0.3 Identification and assignment of approaches – Step 3

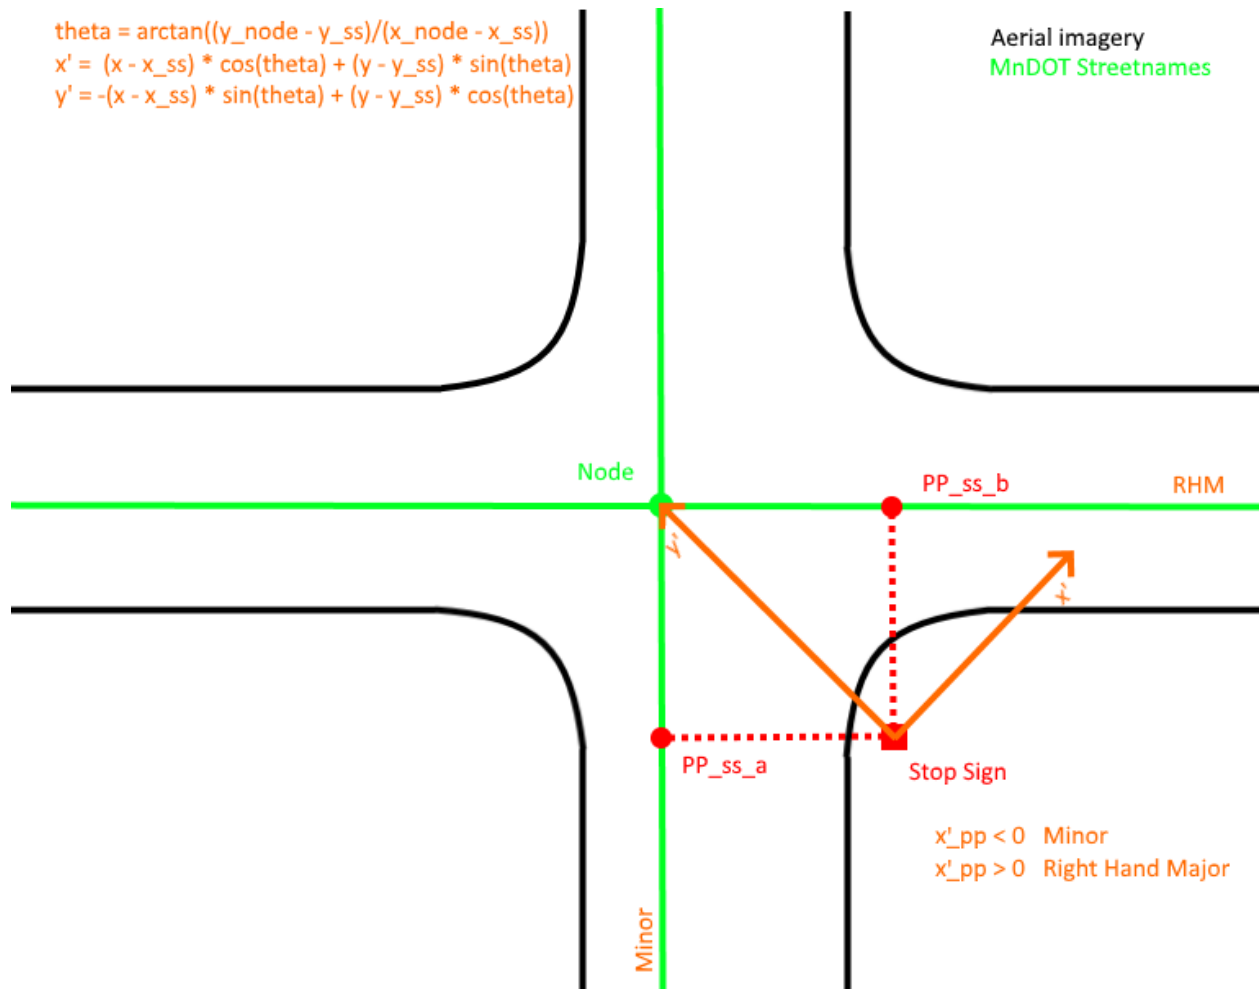
Figure A-0.4 Identification and assignment of approaches – Step 4

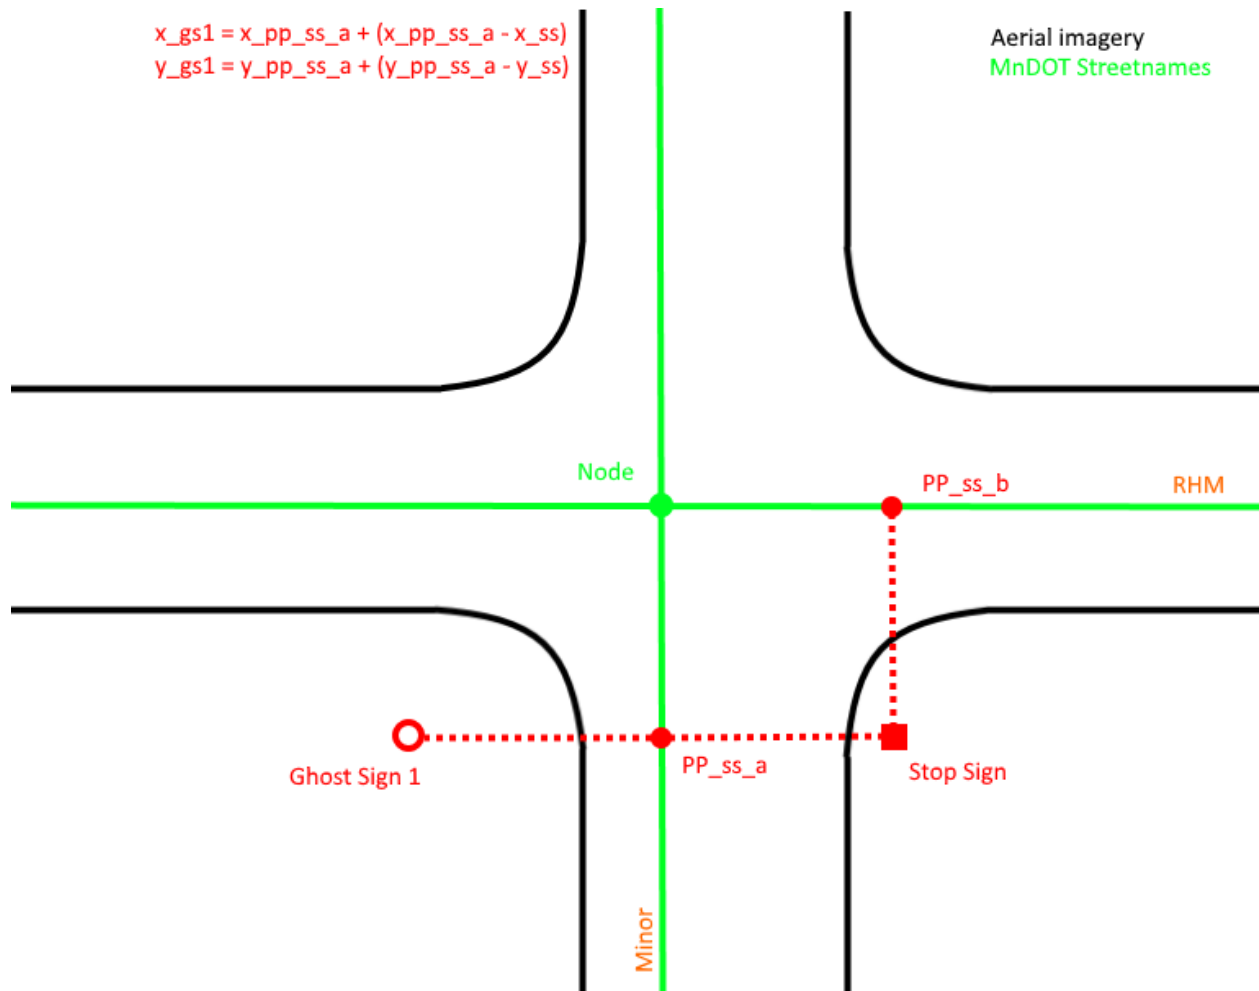
Figure A-0.5 Identification and assignment of approaches – Step 5
