Evaluation of the Effectiveness of Stop Lines in Increasing the Safety of Stop-Controlled Intersections

Minnesota Traffic Observatory

Research Project

Final Report 2020-17

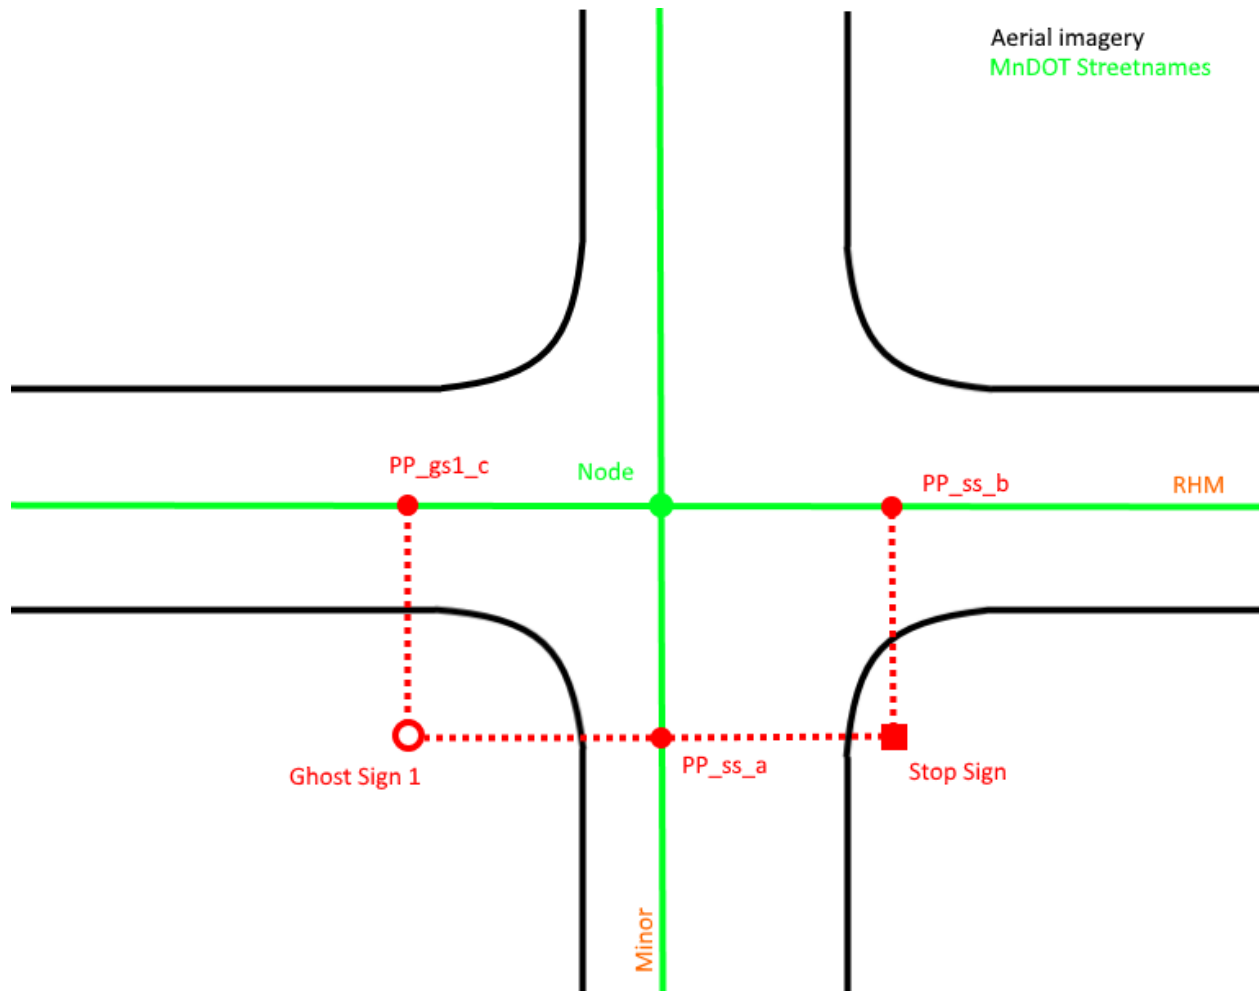
Figure A-0.6 Identification and assignment of approaches – Step 6

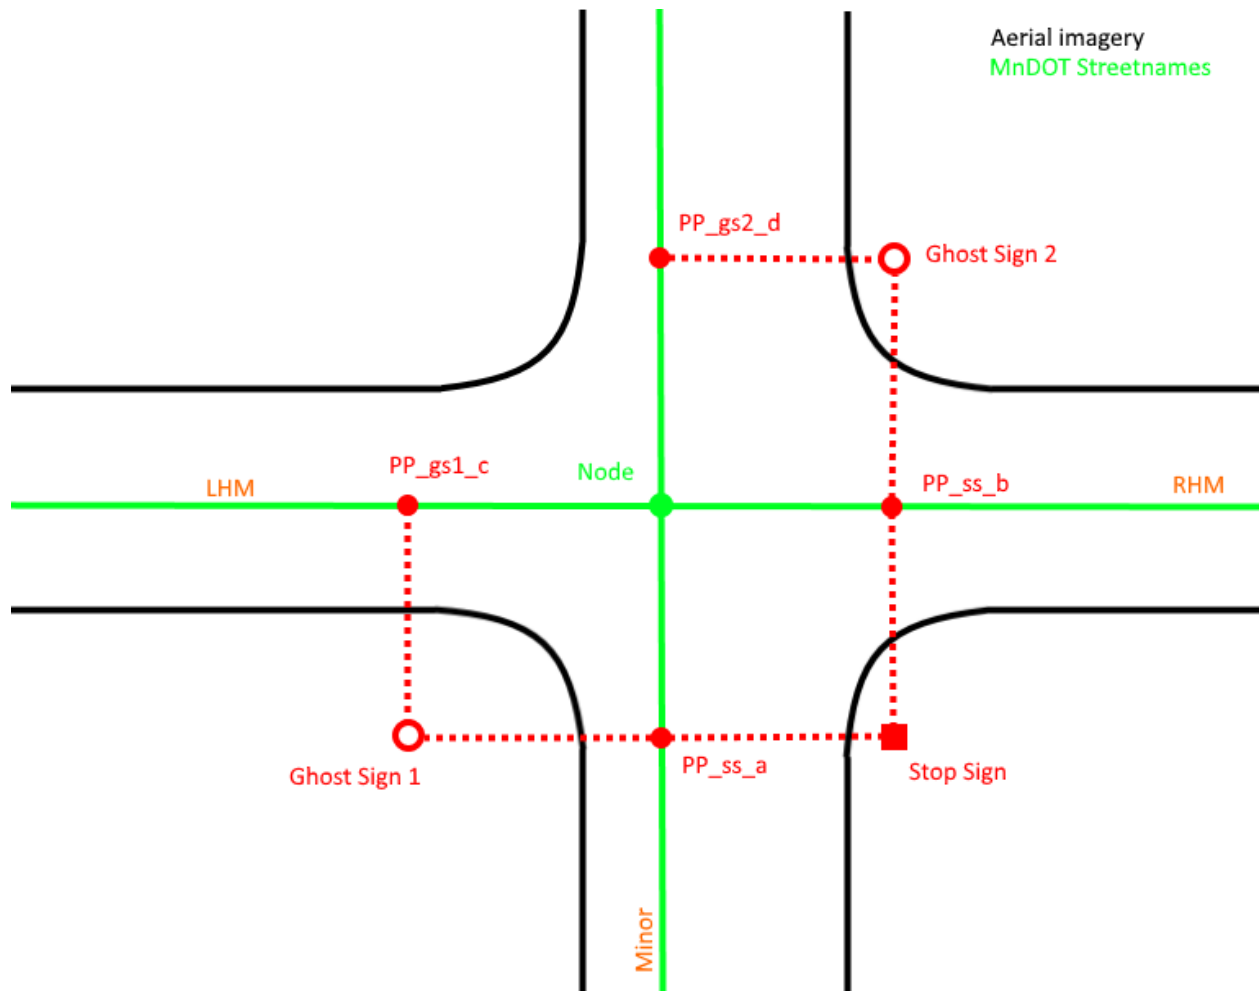
Figure A-0.9 The new ghost sign is projected onto the two nearest polylines.

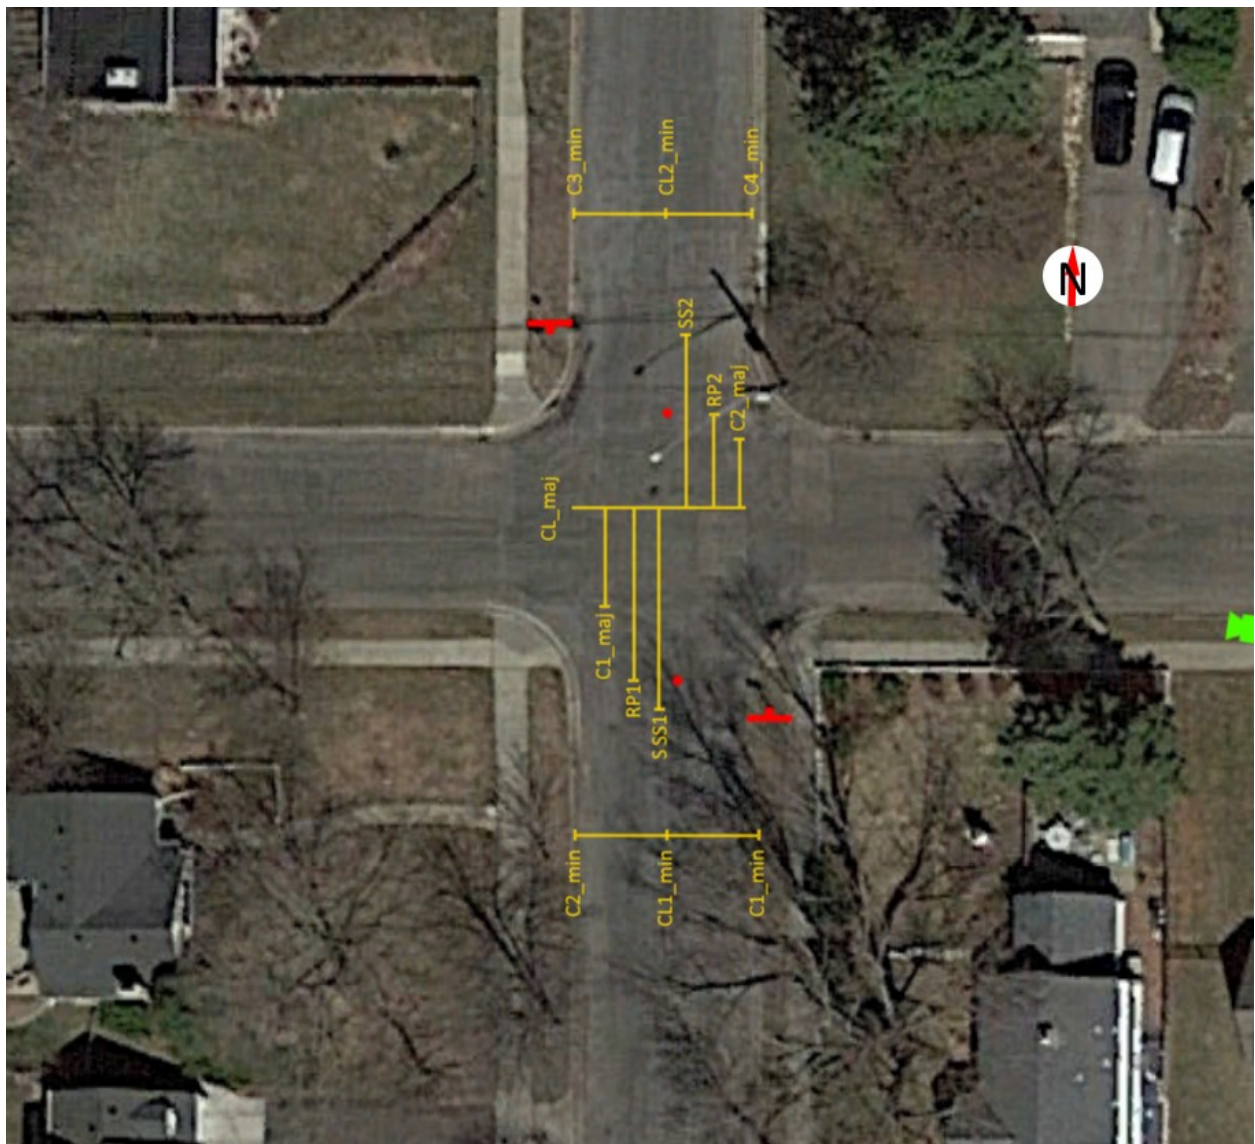
Figure C-0.5 Aerial view of Quentin Ave NB and SB with measurements

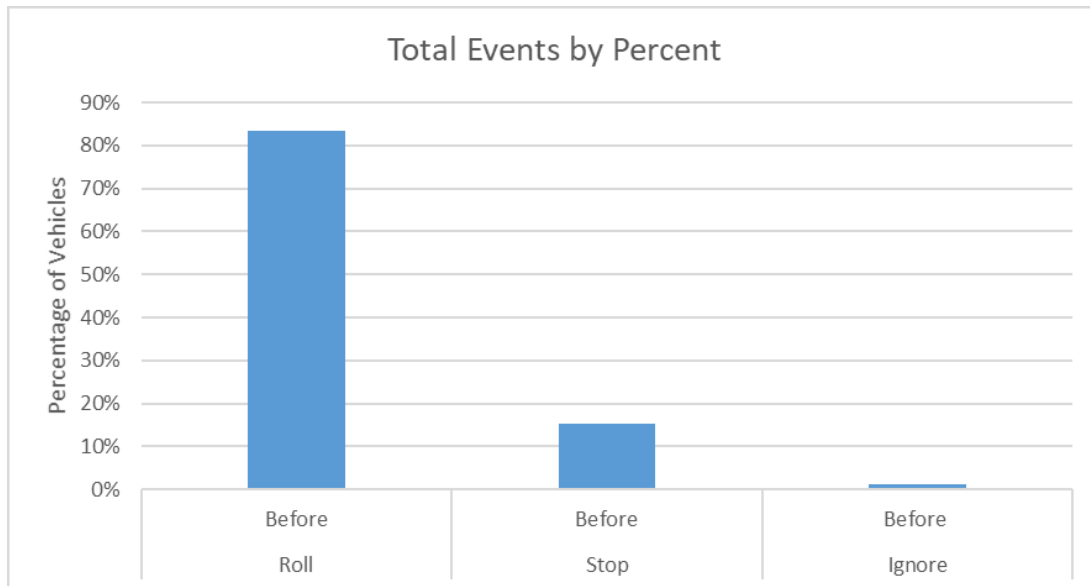
Figure C-0.6 Quentin Ave NB distribution of driver crossing behavior

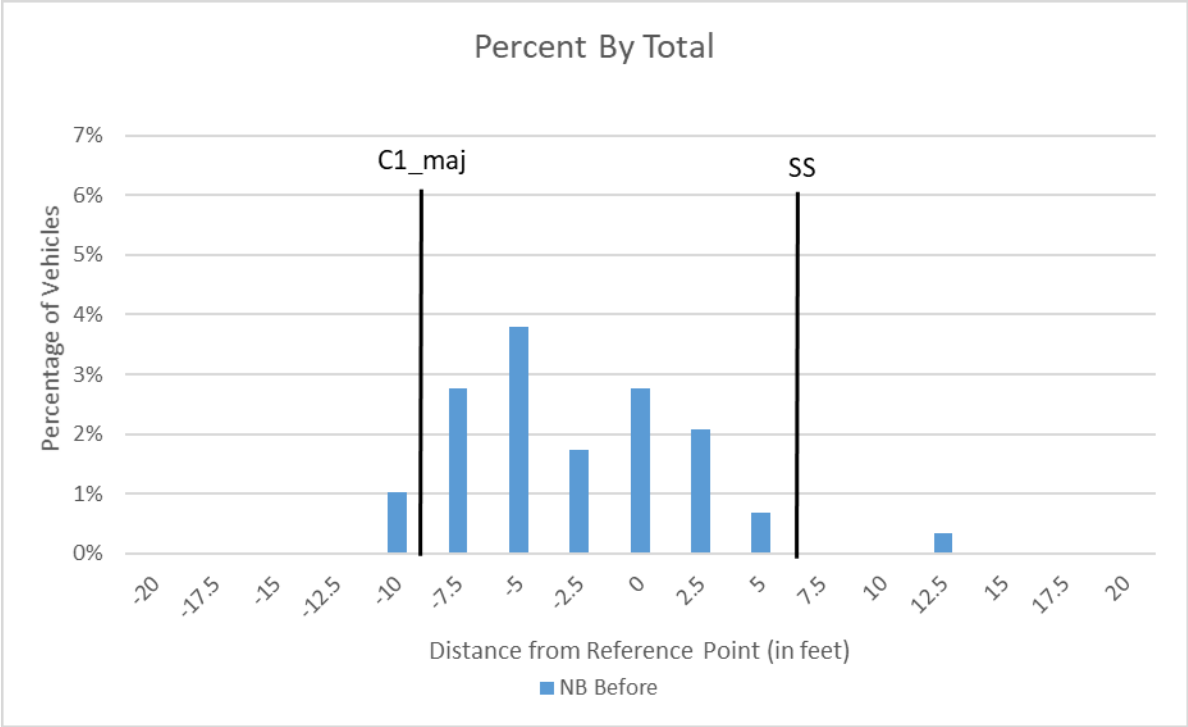
Figure C-0.7 Quentin Ave NB Distribution of Stopping Distance During All Events

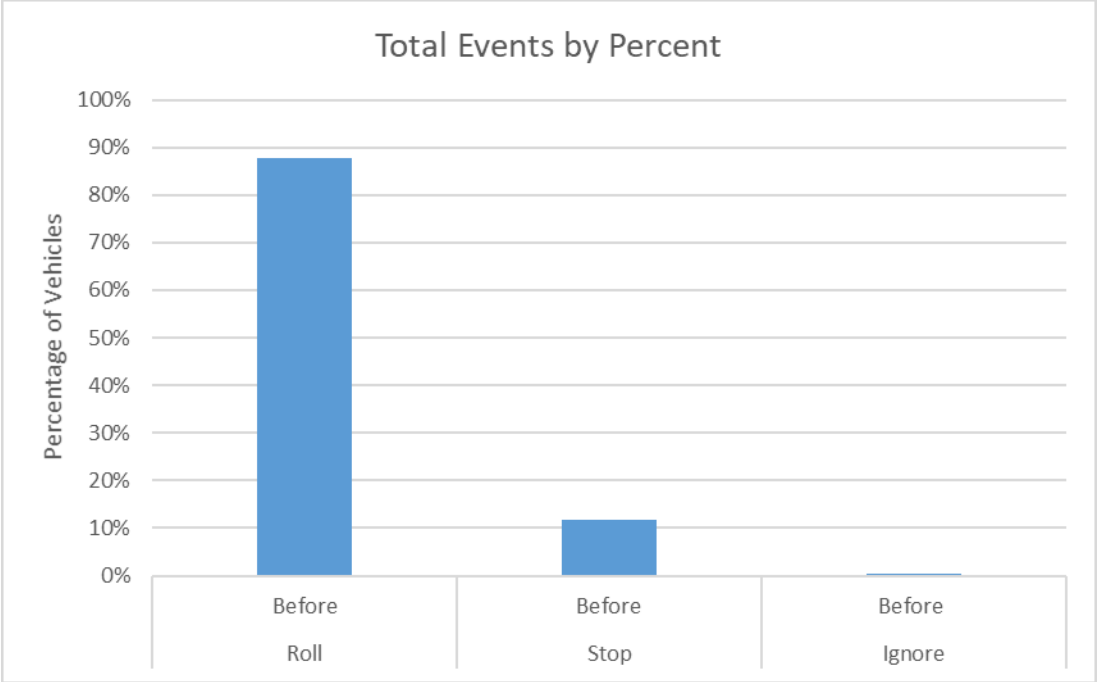
Figure C-0.12 Quentin Ave SB distribution of driver crossing behavior

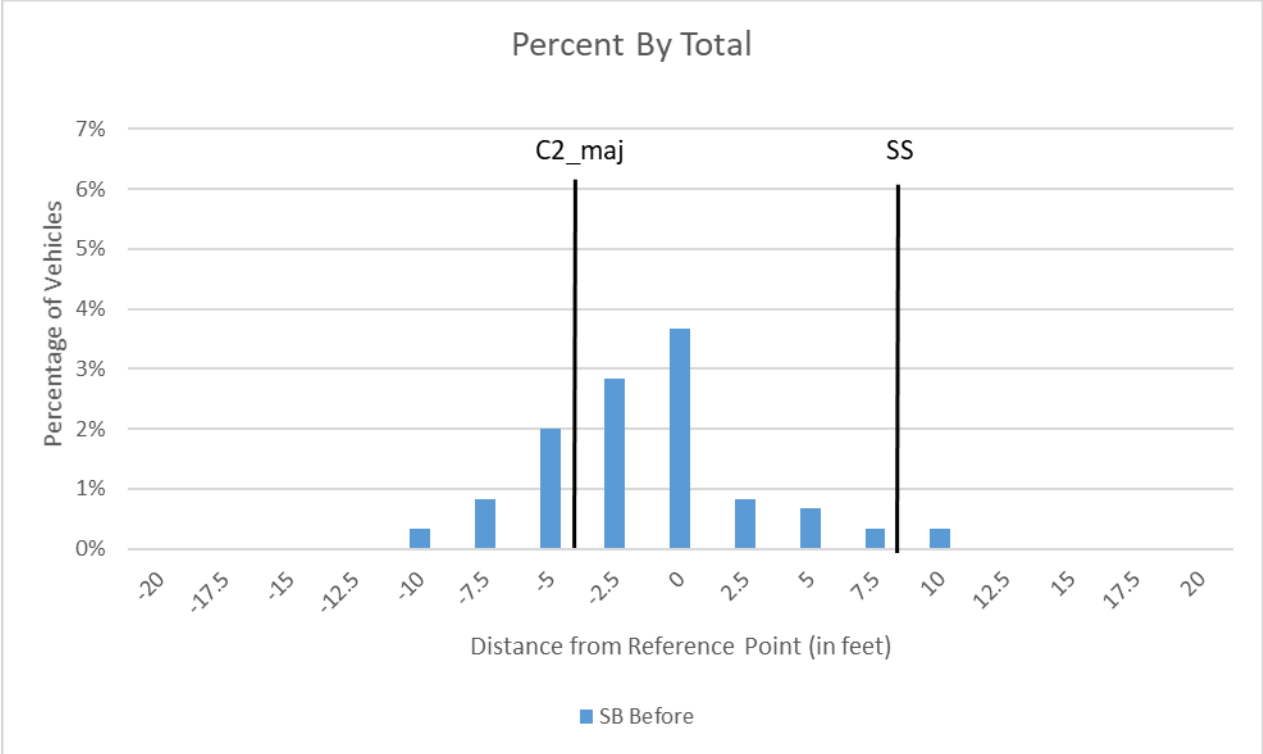
Figure C-0.13 Quentin Ave SB Distribution of Stopping Distance During All Events

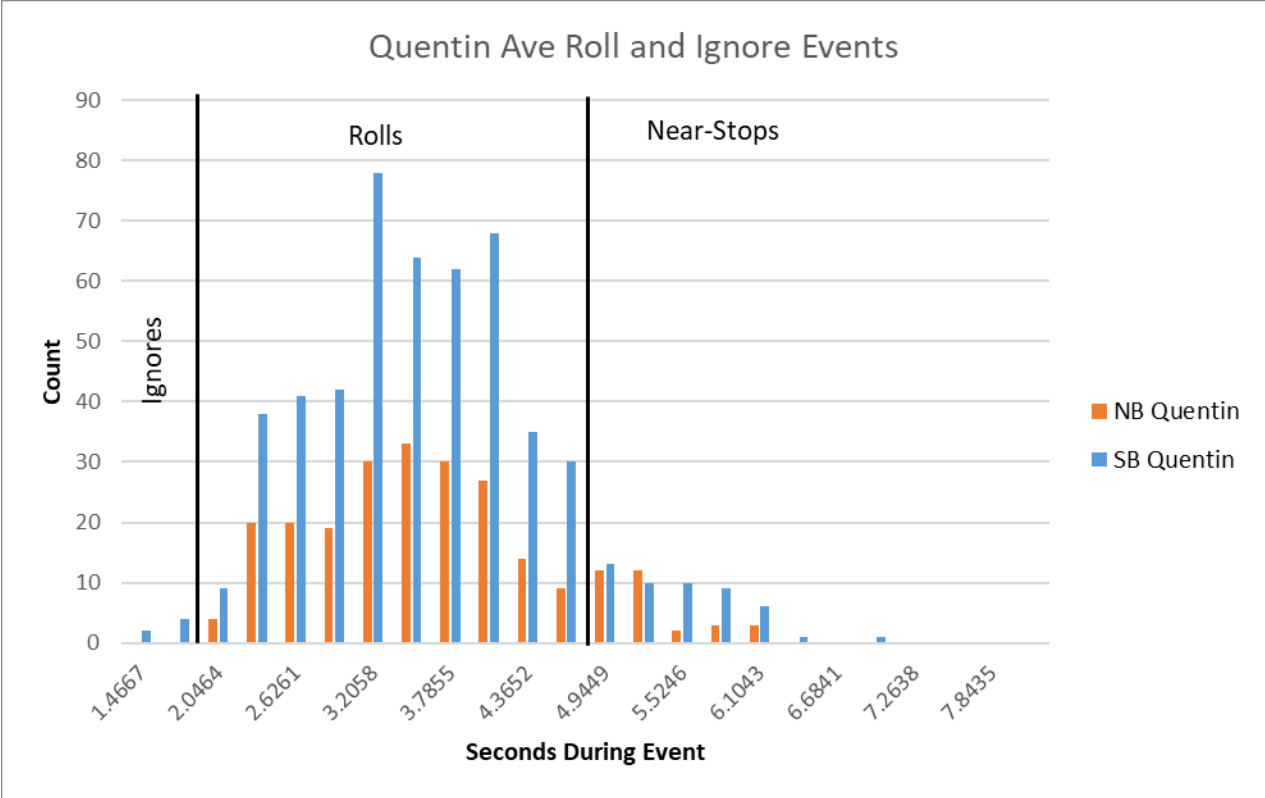
Figure C-0.18 Histogram of time drivers spent at stop sign during roll and ignore events
