Final Report

Review of Wisconsin's Rural
Intersection Crashes: Application of
Methodology for Identifying Intersections for
Intersection Decision Support (IDS)

Report #1 in the Series: Toward a Multi-State Consensus on
Rural Intersection Decision Support

April 2006

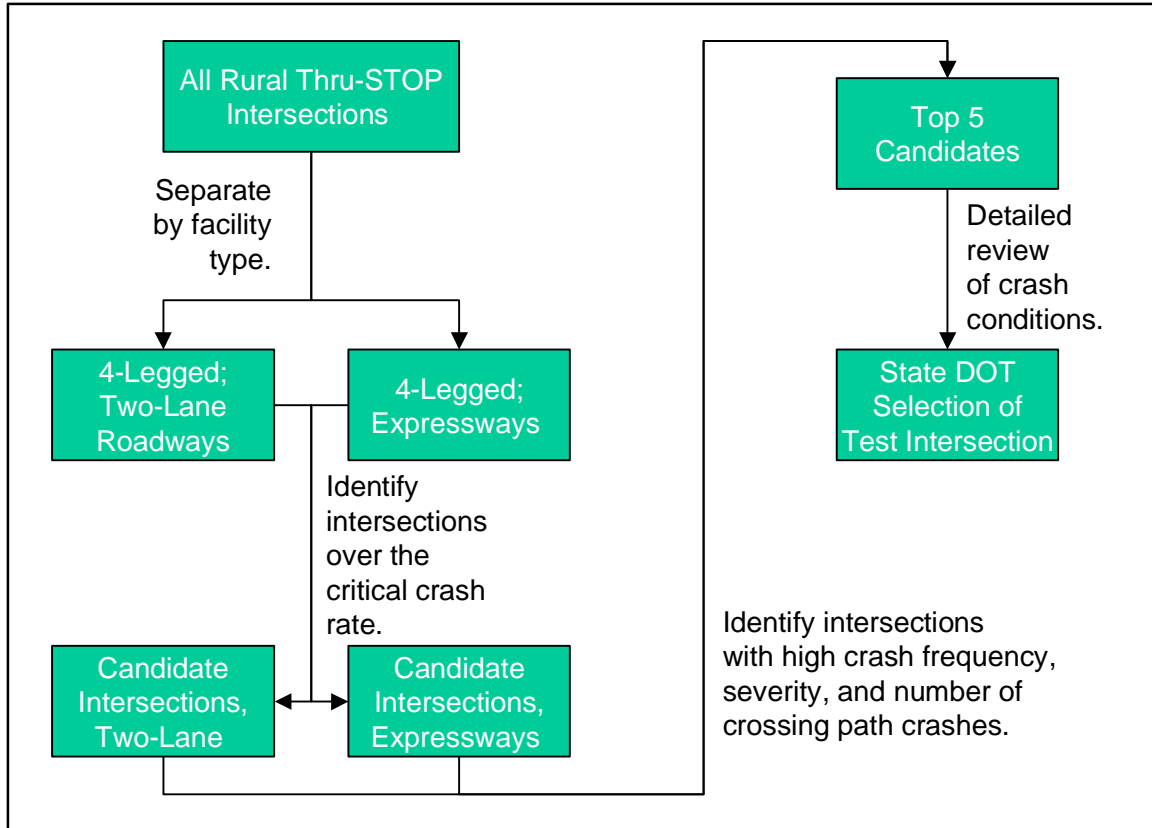
FIGURE 2-1
Preferred Crash Analysis Process

- **Critical Crash Rate** – The first screen was to identify the rural thru-STOP intersections that have a crash rate greater than the critical crash rate. The critical crash rate is a statistically significant rate higher than the statewide intersection crash rate. Therefore, any intersection with a crash rate equal to or above the critical crash rate can be identified as an intersection with a crash problem due to an existing safety deficiency.

- **Crash Conditions and At-Fault Driver Characteristics** – The IDS technology is believed to have the greatest benefit for older drivers. Therefore, the at-fault driver age was reviewed to identify intersections where older drivers were over represented. Other aspects of the crashes that were reviewed include whether the crashes were typically a problem with intersection recognition or gap recognition and the crash location (near lanes or far lanes).

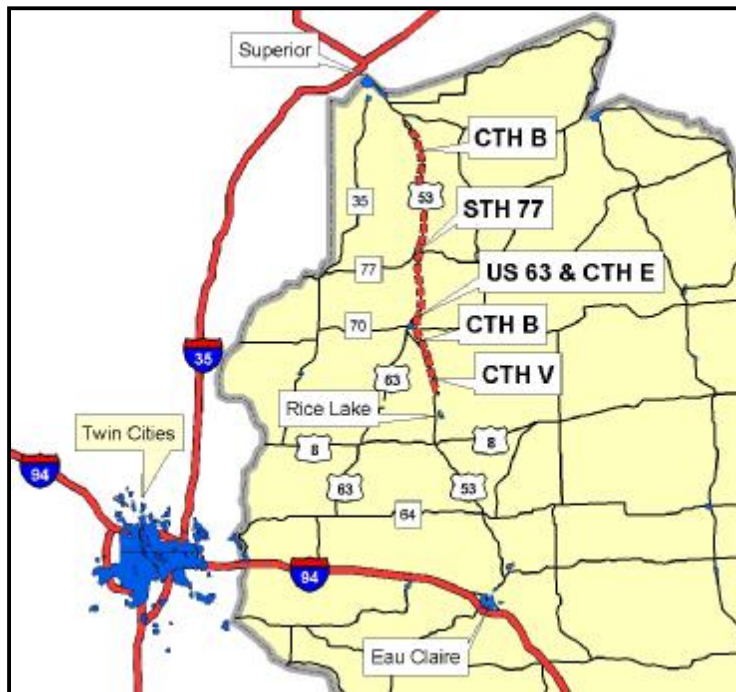
FIGURE 2-2
Wisconsin Study Corridor (U.S. 53 from Rice Lake to Superior)

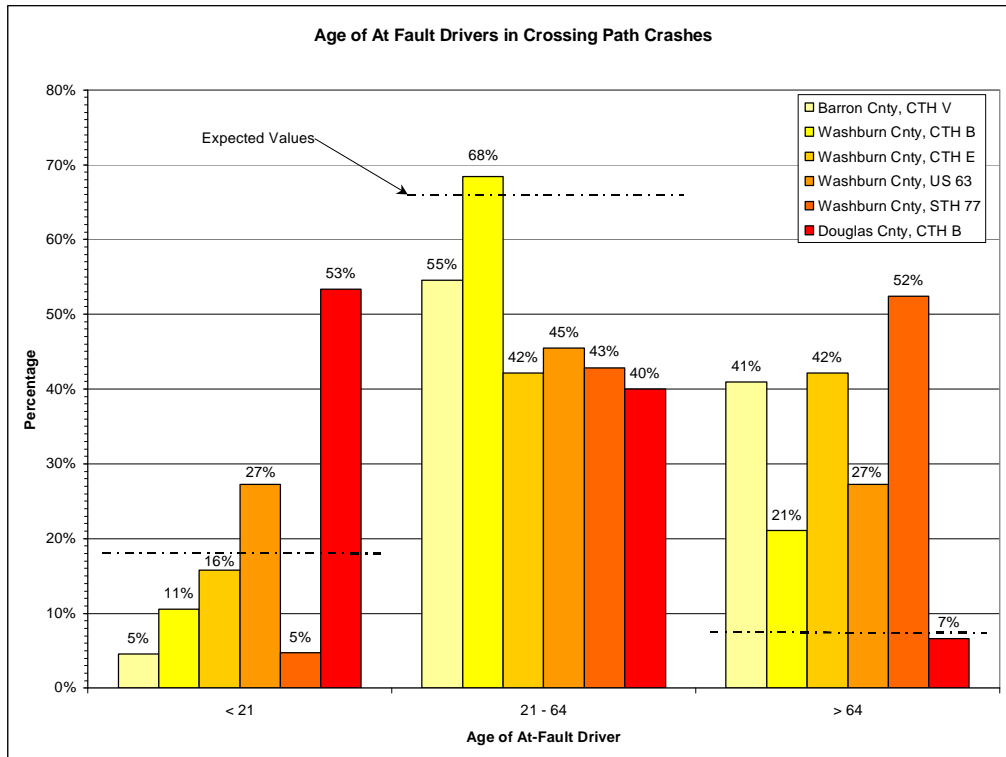
FIGURE 4-2

At-Fault Driver Age of Correctable Crash Types at Candidate Intersections

For each candidate intersection, all crash reports from January 1, 1998 to June 30, 2004 were reviewed to identify the driver whose action caused the accident, also known as the at-fault driver. The age of the at-fault driver is important since the IDS technology may have its greatest benefit in assisting older drivers in particular (see **Figure 4-2**). From the 2002 Wisconsin Traffic Crash Facts, 17.9% of involved drivers were under the age of 21, 66.3% between the age of 21 and 64, and 7.4% over the age of 64 (Note: For 8.4% of involved drivers, the age was unknown. Wisconsin Traffic Crash Facts lists involved drivers and not specifically at-fault drivers. Comparisons between statewide involvement rates and the at-fault age distributions at the six candidate intersections must be carefully considered.)

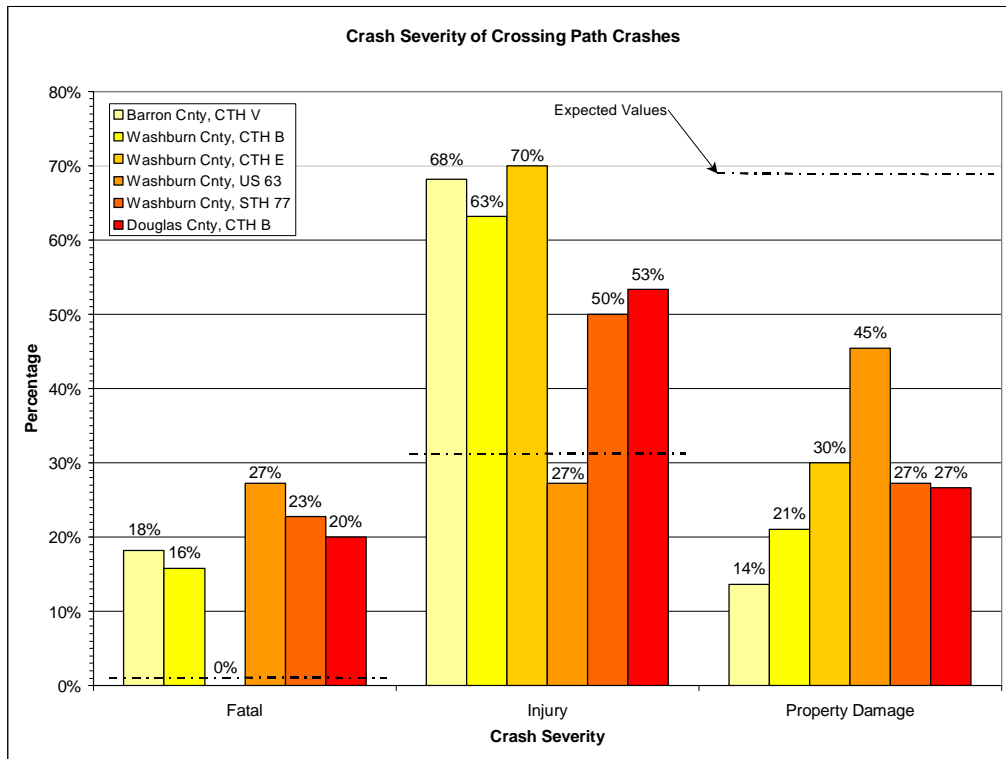
FIGURE 4-3
Crash Severity of Correctable Crash Types at Candidate Intersections

NOTE: Expected values based on crash severity of all crashes reported in 2002 Wisconsin Traffic Crash Facts

Another goal of the IDS technology is to address the most serious intersections crashes, especially fatal crashes. Therefore, the best candidate intersection would have a high distribution of fatal and severe injury crashes. Since the Wisconsin crash records do not separate injuries by level of severity (i.e., severe, moderate, and minor were used in the Minnesota analysis), all injury crashes were kept as a single group. Of Wisconsin's 2002 crashes, fatal crashes represented approximately 0.6% of all of crashes, with injury crashes at 30.7% and property damage (PD) crashes representing 68.7 % of all crashes (Source: 2002 Wisconsin Traffic Crash Facts). **Figure 4-3** shows that all intersections except for CTH E have a much higher distribution of fatal crashes than expected. Even though CTH E had no fatal crossing path crashes, this intersection does have the highest percentage of injury crashes, closely followed by CTH V and CTH B (Washburn County). Further, the U.S. 63 intersection has fewer injury

crashes than expected, but the total of fatal and injury crashes is still higher than the statewide average.

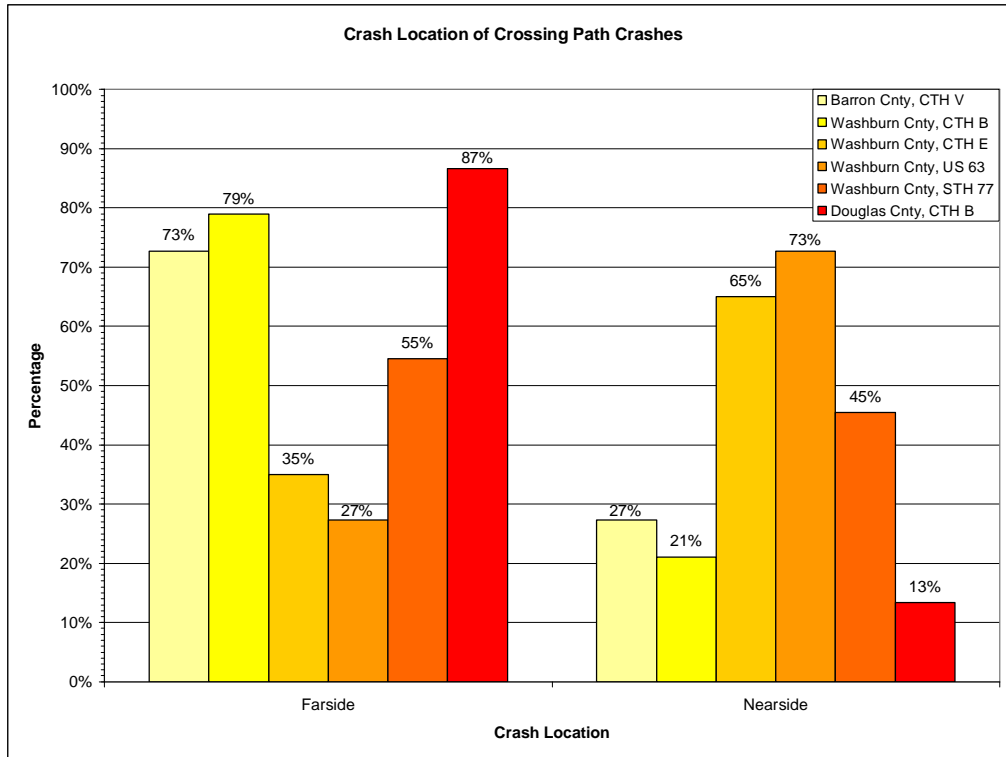
FIGURE 4-4
Crash Location of Correctable Crash Types at Candidate Intersections

At the intersections of CTH V, CTH B (Washburn County) and CTH B (Douglas County), approximately three-quarters or more of the crashes were classified as farside (see **Figure 4-4**), similar to what was observed in Minnesota. However, STH 77 had only 55% farside crashes

while CTH E and U.S. 63 had over half of the crashes occurring on the nearside, 65% and 73% respectively. At STH 77, the likely reason the crashes are almost equally split is because of the median design, which is wider than typical and includes a STOP sign rather than a YIELD sign (see **Section 5.4** for more information). At CTH E and U.S. 63, the high percentage of nearside crashes is believed to be attributed to the land use. These two intersections are located on the edge of Trego, WI and the land use around the intersections is more suburban than rural in nature (see **Section 5.3** for more information).

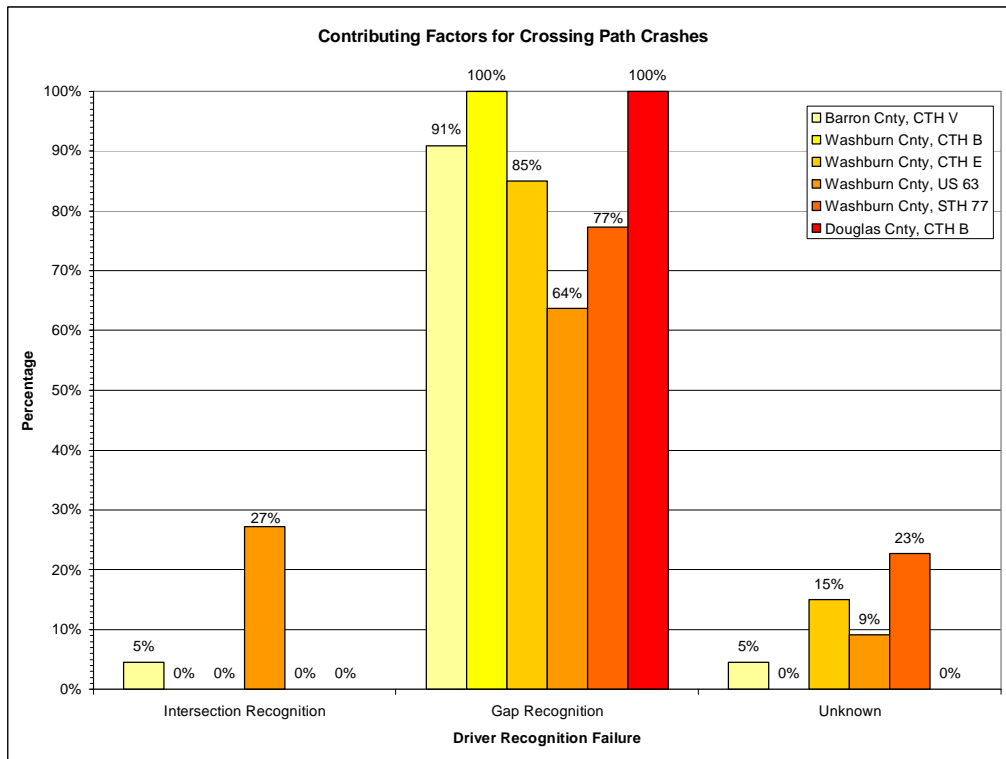
FIGURE 4-5
Contributing Factors of Correctable Crash Types at Candidate Intersections

Another important crash characteristic is whether the at-fault driver failed to recognize the intersection (i.e., ran-the-STOP) or failed to select a safe gap (i.e., stopped, pulled out). Since the IDS device is intended to help drivers with selecting safe gaps, crashes where the driver ran the STOP may not be correctable. To classify the crashes as either intersection recognition or gap recognition, the narratives on the officer reports were reviewed. However, some officer reports were not legible or did not include a narrative. For these crashes, the contributing factor was classified as “unknown.” Also, some narratives did not specifically state whether the driver stopped at the STOP sign. However, for most of these situations, the officer’s narrative provided enough information to make a determination as to whether or not the driver recognized the intersection. For example, the officer may have reported that the driver slowed for the YIELD sign in the median but did not come to a complete stop. In this example, even though the driver did not come to a complete stop, the driver obviously recognized the intersection but was unable to select a safe gap and the crashes was classified as gap recognition.

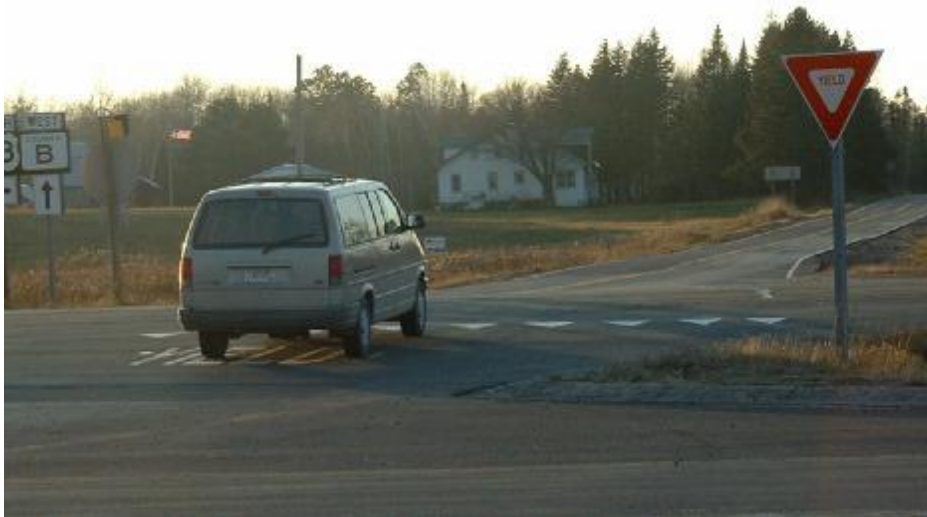
FIGURE 5-1

Typical Intersection Median for U.S. 53 Corridor

- All medians are wide enough to store one or two passenger vehicles. Except for the median at STH 77, none of the intersections is wide enough to store a bus or semi-truck. At STH 77, the median can store a bus or semi with a 55' trailer, but an oversized semi may still not be able to stop safely in the median.

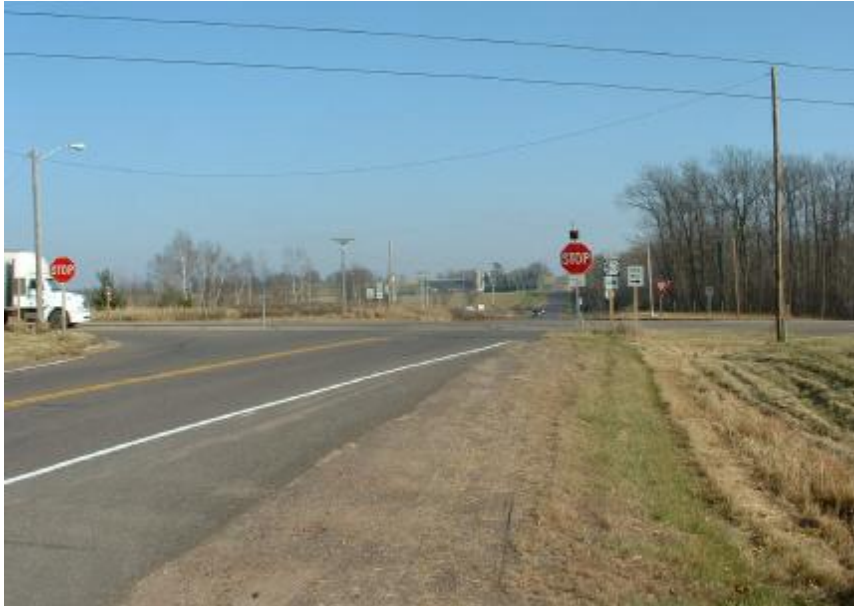
FIGURE 5-2
General Area at CTH V Intersection (west approach)

The intersection of CTH V and U.S. 53 is located approximately one mile to the east of Haugen, Wis. (pop. less than 500). A small pool cue manufacturing company and a farm home are located nearby, but the land use is predominantly agricultural (see **Figure 5-2**). The north approach of U.S. 53 is a crest vertical curve, but the available sight distance is still 12 to 15 seconds for a vehicle stopped in either the median or at the west approach (see **Figure 5-3**).

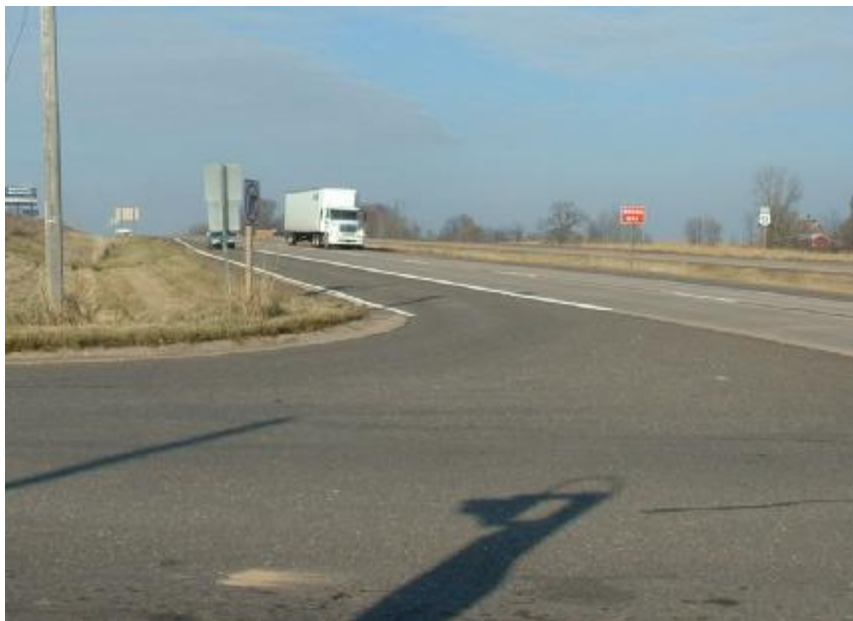
FIGURE 5-3
Crest Vertical Curve to North of CTH V Intersection (looking north from west approach)

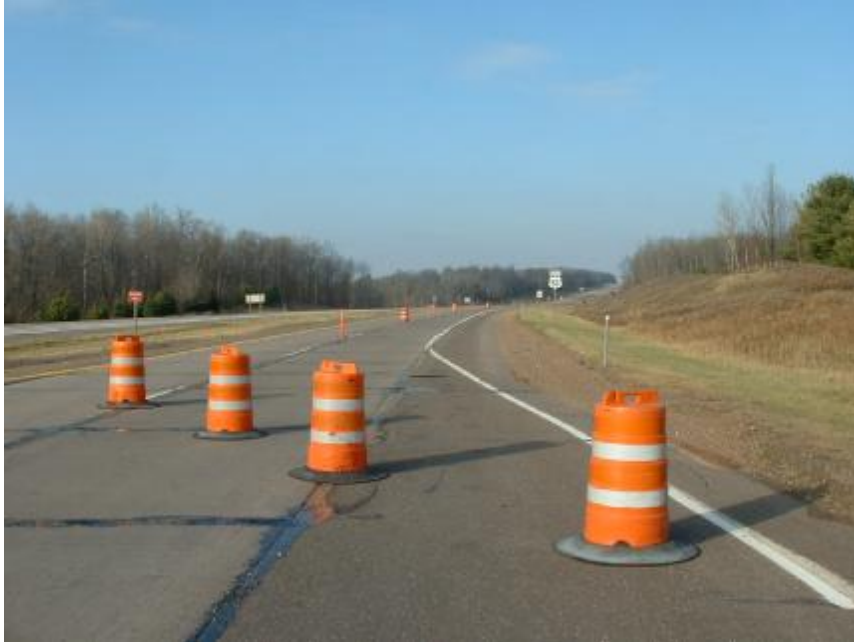
FIGURE 5-4

Horizontal Curve at CTH B (looking north from east approach)

The intersection of U.S. 53 and CTH B is an isolated rural intersection with only farm homes nearby. The intersection is located on a horizontal curve, but available sight distance is still greater than 10 seconds (see **Figure 5-4**).

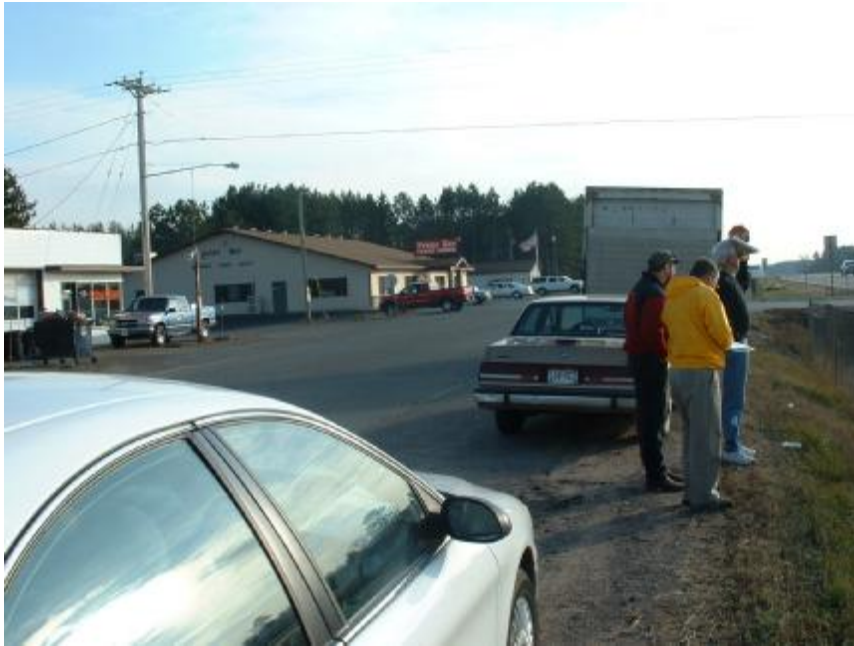
FIGURE 5-5
Example Development at CTH E and U.S. 63 (area east of CTH E)

These two intersections are located approximately 0.5 mile from each other and on the edge of Trego, Wis. Even though the area is not fully developed, both intersections have several businesses located nearby visible from U.S. 53 (see **Figure 5-5**). Therefore, the intersections are not considered to be typical isolated rural intersection. Also at these intersections, the right-turn lanes on U.S. 53 have been offset in order to help improve the sight line for vehicles stopped on the minor street approaches (see **Figure 5-6**). Finally, the U.S. 63 intersection is not a true four-legged intersection. The west approach is a driveway to several small businesses and a frontage road.

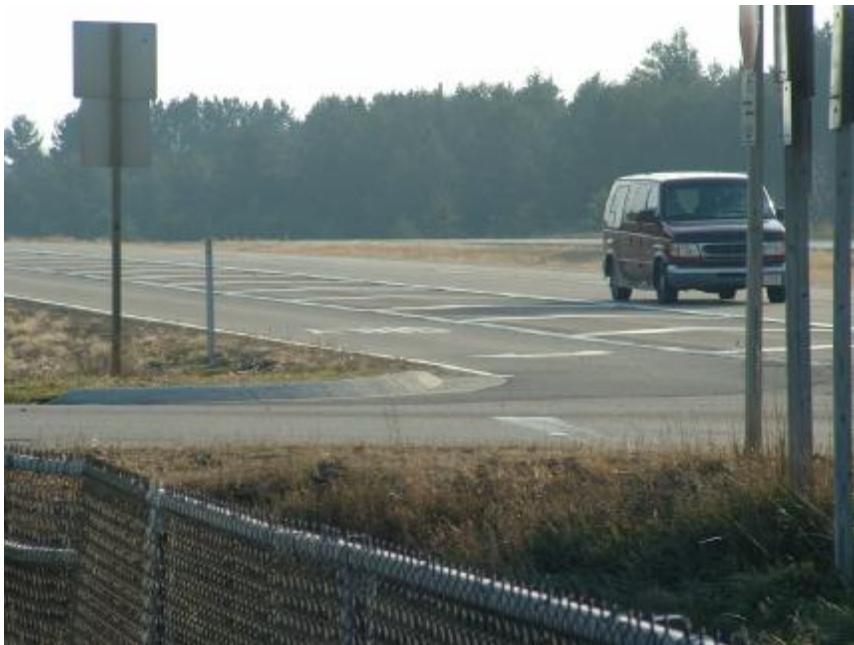
FIGURE 5-6
Example Offset Right Turn Lane at CTH E and U.S. 63 (looking south from east approach)

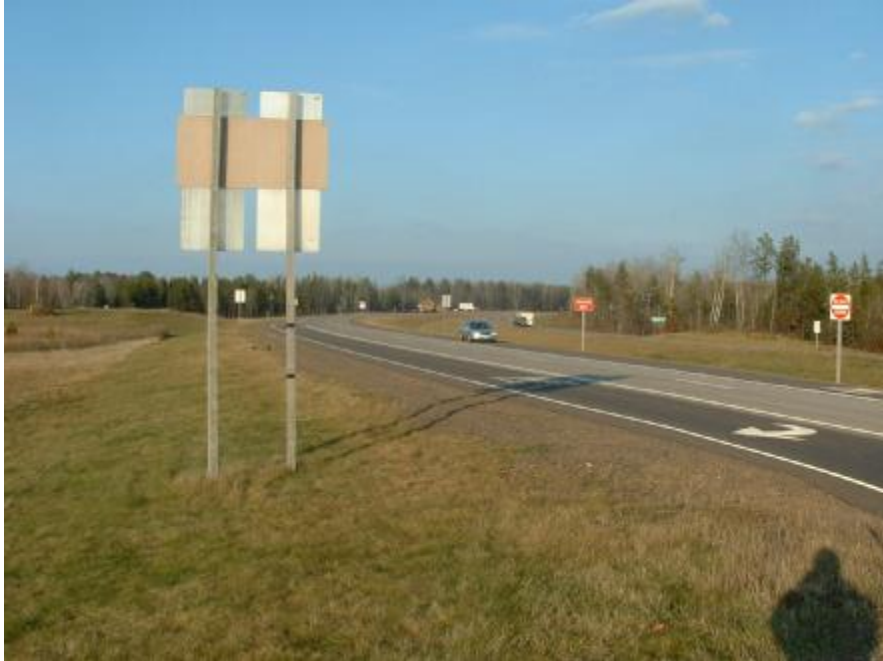
FIGURE 5-7
Horizontal Curve at STH 77 (looking north from west approach)

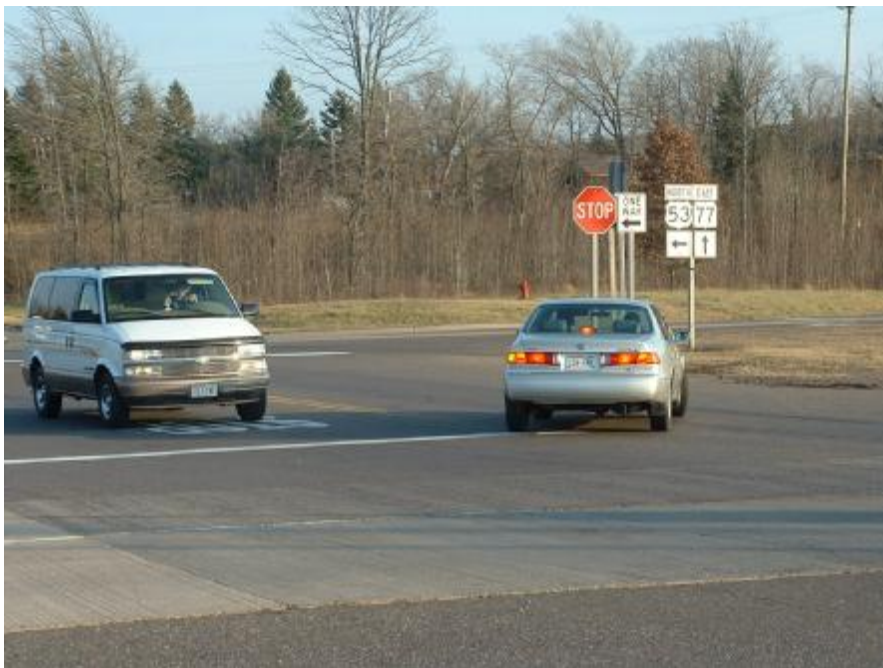
FIGURE 5-8
Median at STH 77

Figure 5-8). This new design is a STOP sign, STOP pavement marking, stop bar, and double yellow centerline in the median.

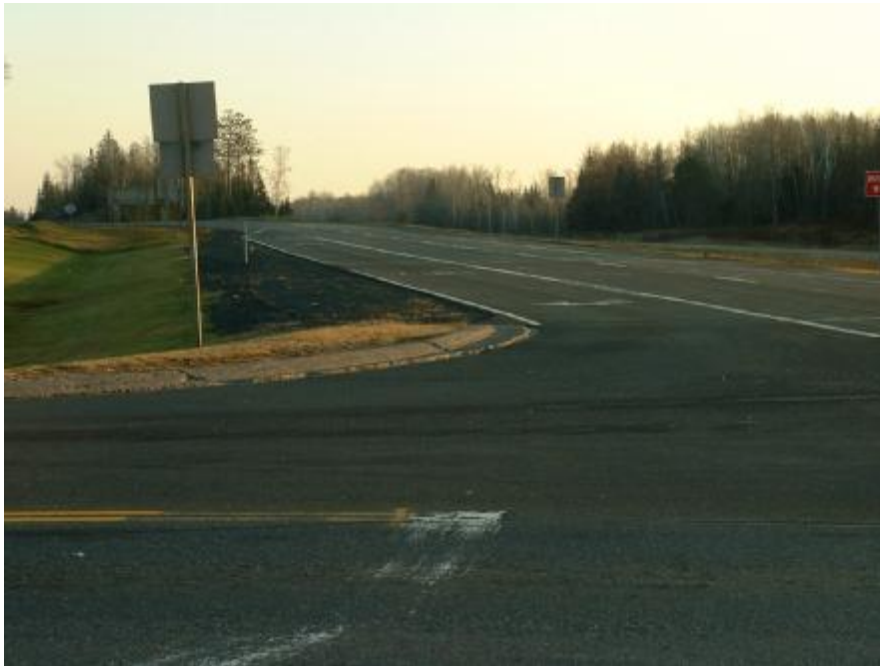
FIGURE 5-9

Horizontal Curve and Grade Separation at CTH B (looking south from east approach)

The CTH B intersection is located approximately one mile west of Hawthorne, Wis. Several gas stations are located at the intersection, yet the intersection is predominately in a rural area. Similar to most intersections, CTH B is located just to the north of a horizontal curve on U.S. 53, but still has adequate sight distance for stopped vehicles (see **Figure 5-9**). In **Figure 5-9**, it can also be seen that this intersection is located just to the north of a portion of U.S. 53 that has independent vertical profiles. However, the location of the separate profiles does not restrict the line of sight for vehicles on the minor approach.

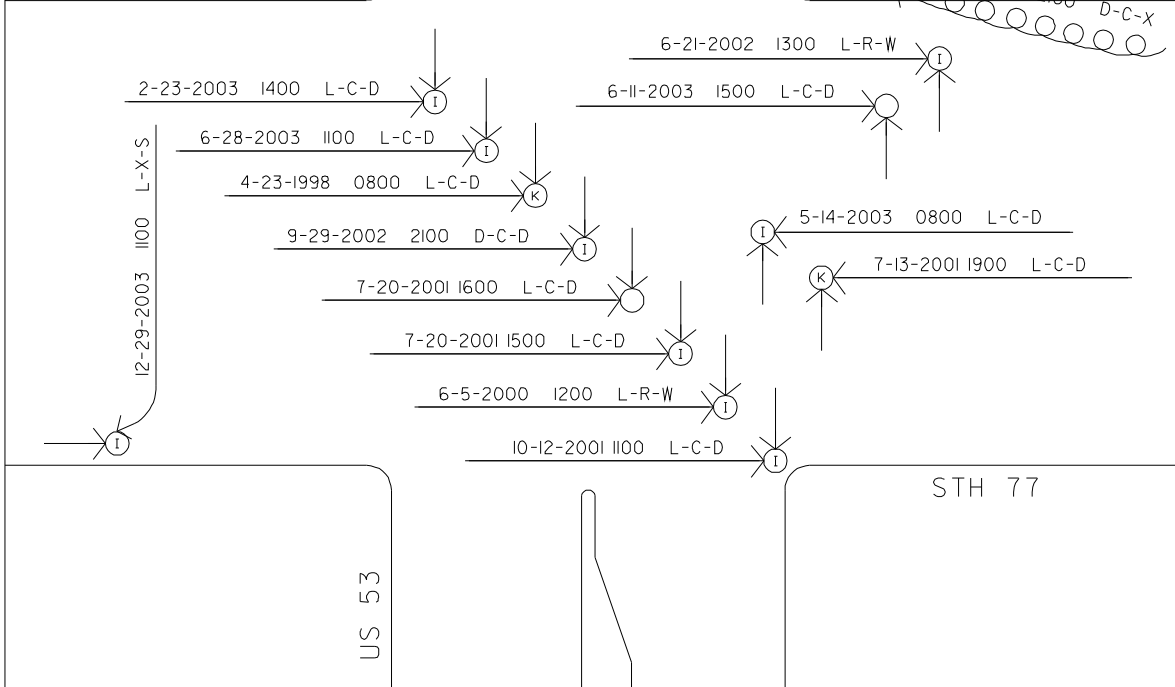
LOCATION: US 53 & STATE HIGHWAY 77 (WASHBURN COUNTY)

Fatal=	5
Injury Total=	15
Property Damage=	10
Total Accidents=	30
