Review of Michigan's Rural Intersection  
Crashes: Application of Methodology for  
Identifying Intersections for Intersection  
Decision Support (IDS)

Report #3 in the Series: Toward a Multi-State  
Consensus on Rural Intersection Decision Support

## **Final Report**

**August 2006**

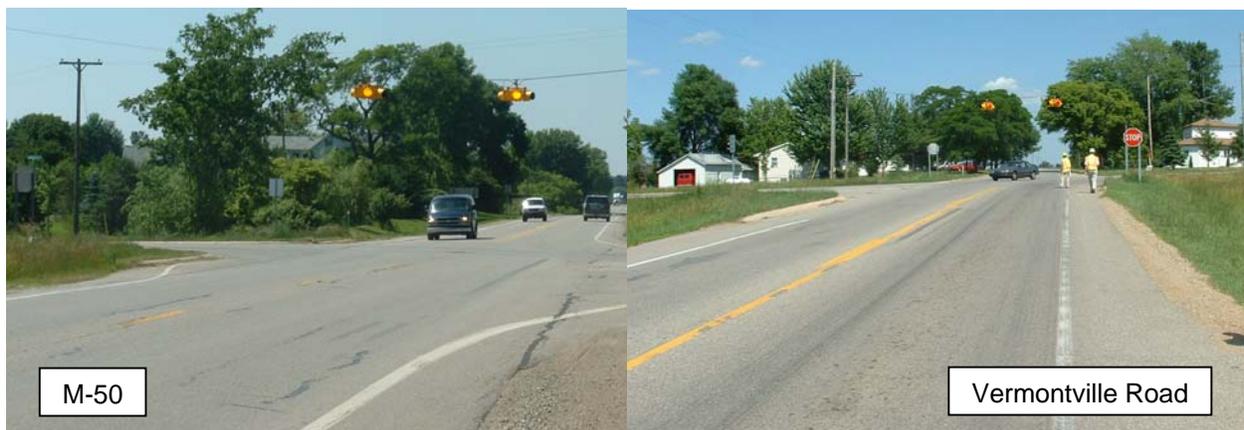
**FIGURE 5-1**  
Typical Approach for M-50 and Vermontville Road

Both roadways are a typical two-lane two-way rural highway with no turn lanes at the intersection (see **Figure 5-1**). In addition to the STOP signs, two red/yellow flashers were installed following a fatal crash in 2001 (see **Figure 5-2**). The terrain in the area is slightly rolling, but neither M-50 approach has a vertical curve that is large enough to hide a vehicle (see **Figure 5-3** and **5-4**). Also, M-50 has no horizontal curves near the intersection that may make it difficult for a stopped vehicle to see an approaching vehicle.

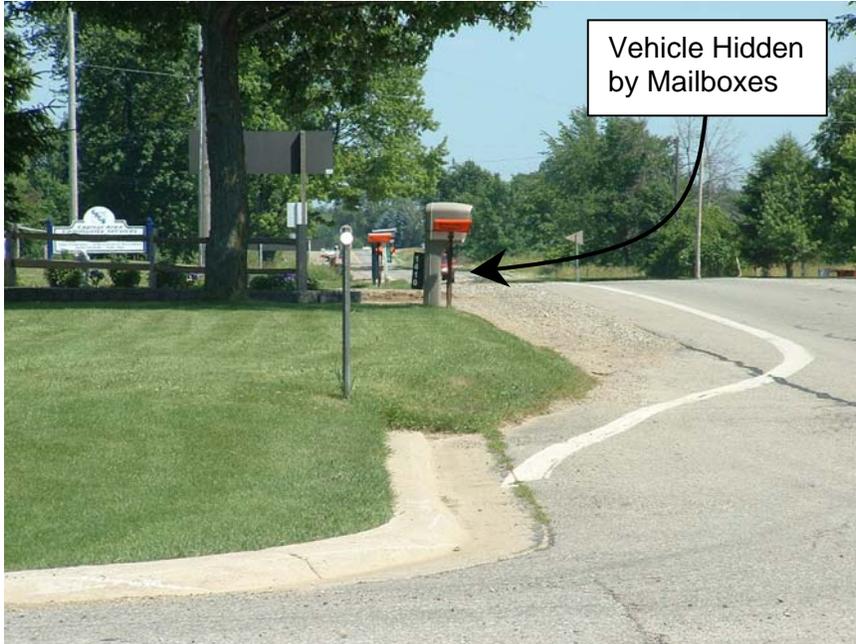
**FIGURE 5-4**  
Looking at SE M-50 from  
the East Approach  
(Vermontville Road)

The final observation was that for a vehicle stopped on the east approach looking at SE M-50, several mailboxes will hide a large portion of M-50. The difficulty of seeing a vehicle from this approach is highlighted in **Figure 5-4**, where a close inspection reveals that a vehicle is partially hidden by the mailbox in the foreground (a portion of the car including one headlight is visible between the poles for the mailbox and the newspaper).

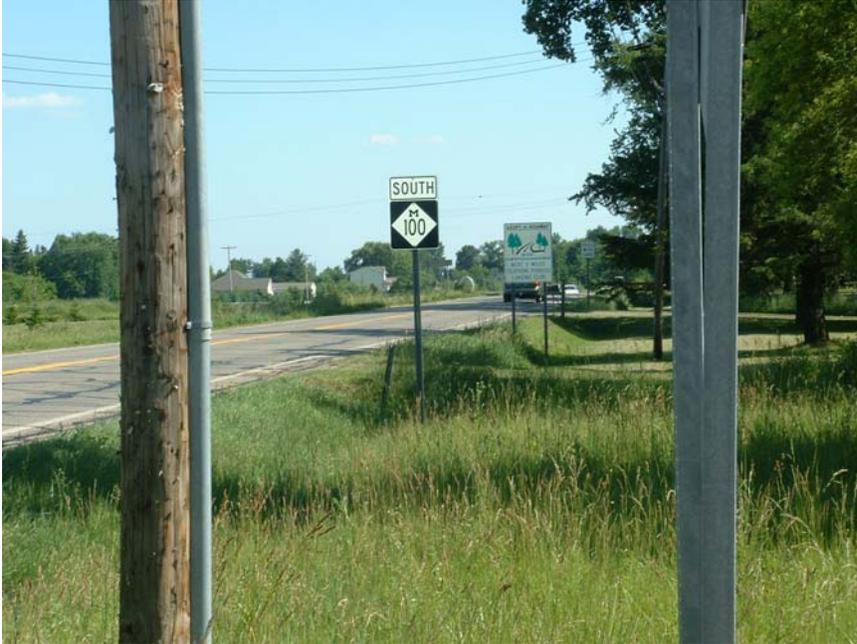
**FIGURE 5-7**  
Cluttered Line of Sight  
While Stopped on the  
West Approach

Despite this change, the intersection was still visited because it was located on the route to another intersection. A general observation for the intersection was that the sight distance was within acceptable ranges if a driver moved up past the STOP sign for a better viewpoint. If stopped at the STOP sign, slight vertical curves combined with trees, back slopes, utility poles or signs restricted the sight distance (see **Figures 5-8** and **5-9**).

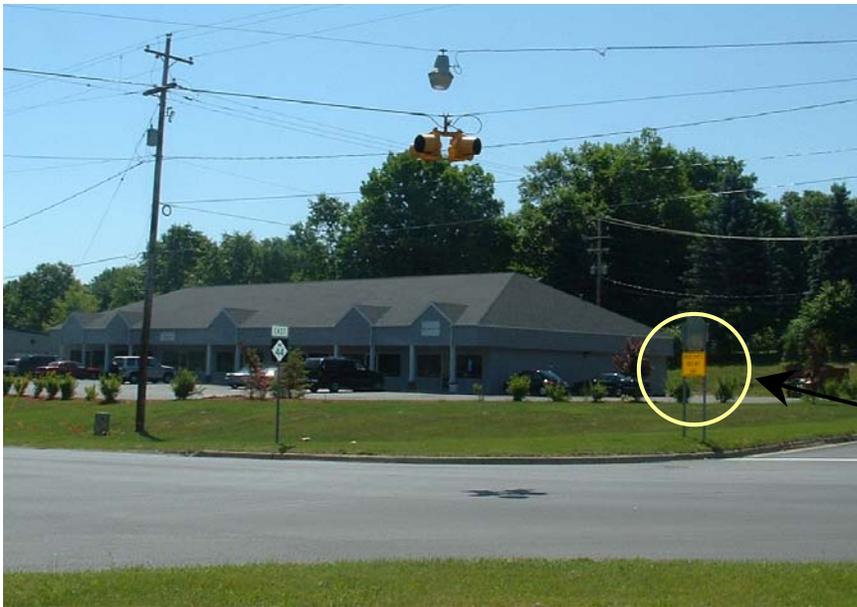
**FIGURE 5-10**  
Intersection  
Improvements

The intersection is located approximately 20 miles from the outer limits of Grand Rapids in an area with several lakes where the surrounding area is primarily developed with single-family residences, which can be described as a bedroom community for Grand Rapids. The land use near the intersection included a gas station, a small strip mall, two repair shops and a small restaurant. The intersection had several improvements, including the installation of a red/yellow overhead flasher, intersection lighting, and CROSS TRAFFIC DOES NOT STOP signs mounted on the STOP signs (see **Figure 5-10**).

Two CROSS TRAFFIC  
DOES NOT STOP signs  
were mounted under each  
STOP sign; one facing  
drivers waiting at the STOP  
sign and the second facing  
drivers stopped on the  
opposing intersection leg.

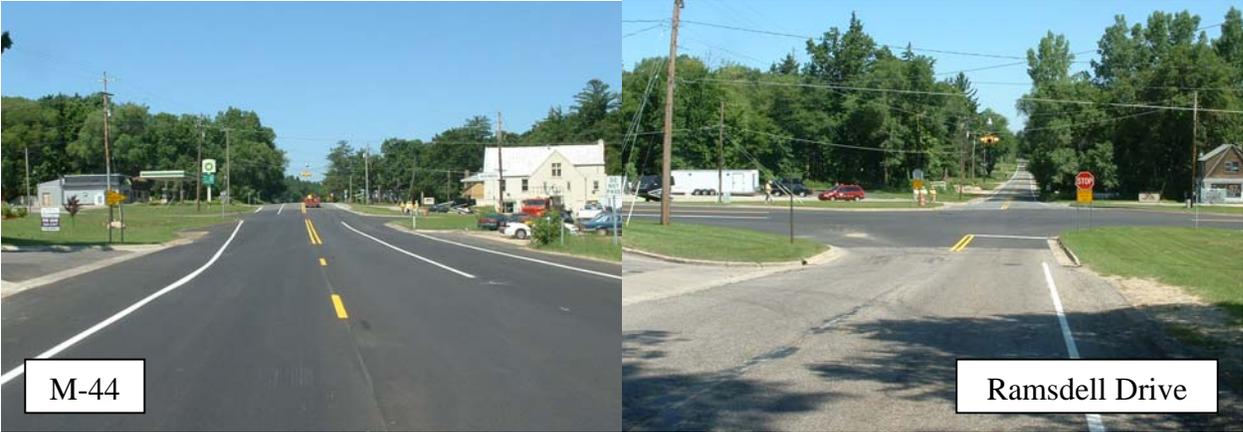
**FIGURE 5-11**  
Intersection Approaches for M-44 and Ramsdell Drive

Both roadways are two-lane highways with unmarked right turn lanes on the M-44 approaches (see **Figure 5-11**). All approaches have a straight alignment (i.e., no horizontal curves), but a crest vertical curve is located just several hundred feet to the west of the intersection, which limits the sight distance for vehicles stopped on the minor street approaches (see **Figure 5-12**). From the MDOT area engineers, it was learned the area had been previously considered for safety improvements. However, the preferred strategy of lowering the crest curve to the west was not determined to be a cost effective safety mitigation strategy for this location.

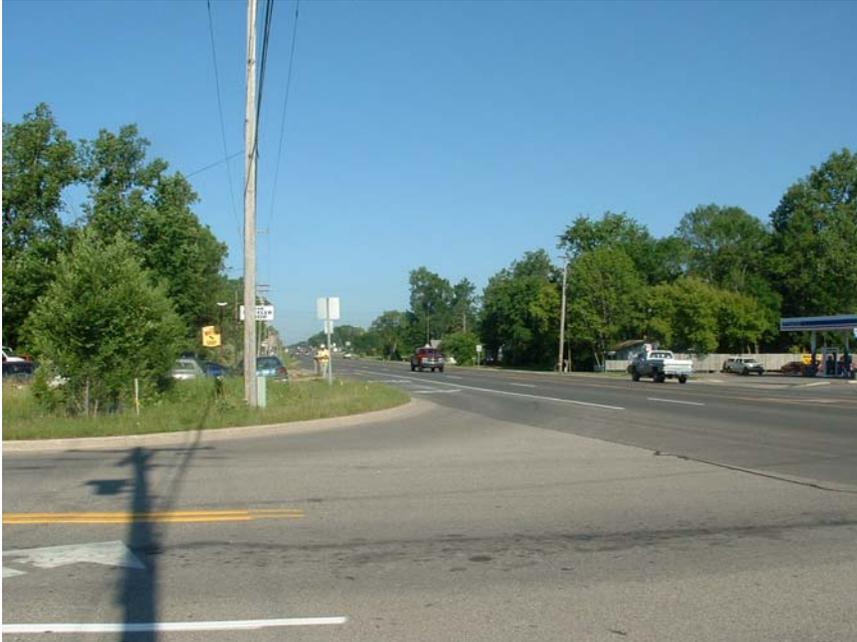
**FIGURE 5-13**  
M-20 West Approach

M-20 is a five-lane roadway (two lanes in each direction plus a continuous center left turn lane) with right turn lanes added at the intersection (see **Figure 5-13**). Vance Road is a two-lane local street that was widened at the intersection to add a left turn lane (see **Figure 5-14**).

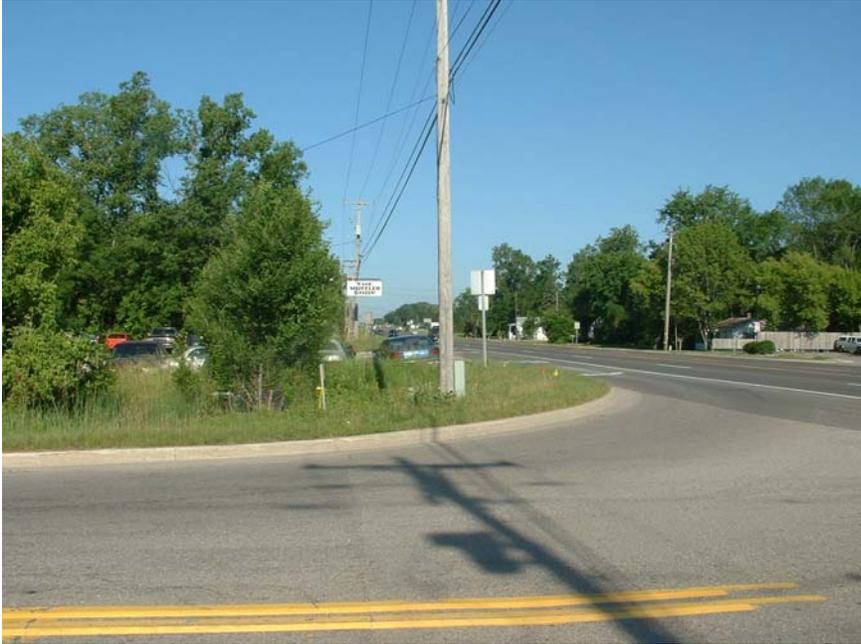
**FIGURE 5-15**  
Intersection Sight  
Distance Restricted by  
Vehicles at Repair Shop

When stopped on the south approach of Vance Road, the sight distance is partially blocked by vehicles parked at a repair shop to the west (see **Figure 5-15**) and trees to the east (see **Figure 5-16**). In order to have clear line of sight, a driver has to move up past the STOP sign.
