2009 ANNUAL REPORT

FENS RESEARCH FACILITY WETLAND BANK II

**Mn/DOT Agreement Number 86250
&
BWSR Easement Number 69-01-07-05**

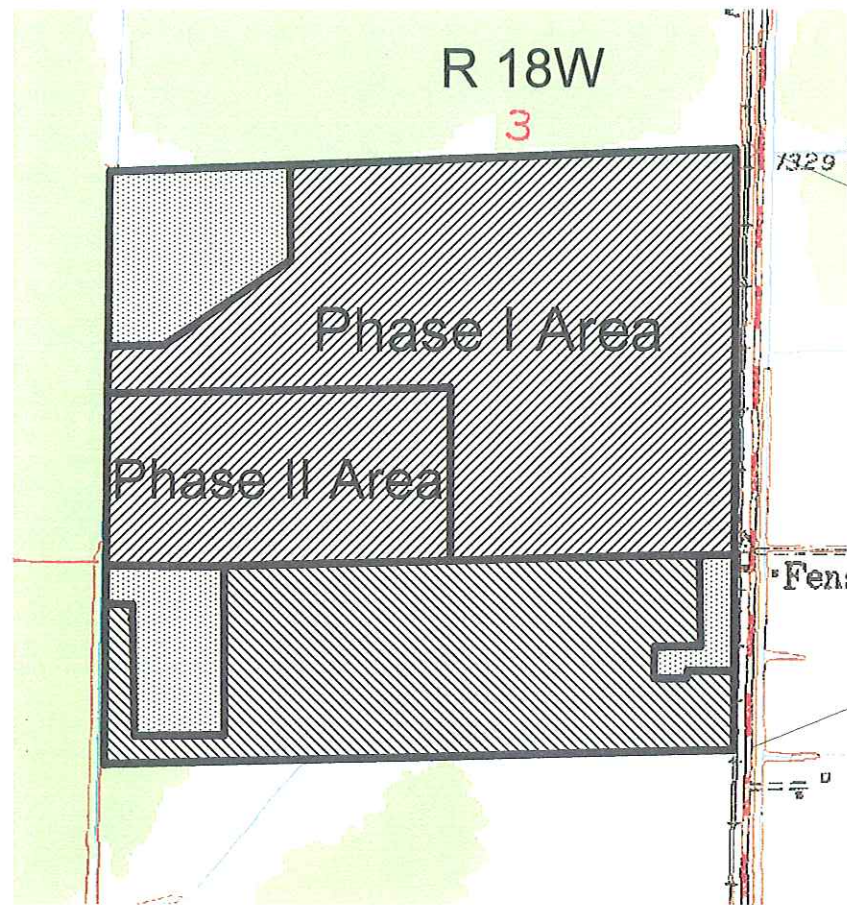
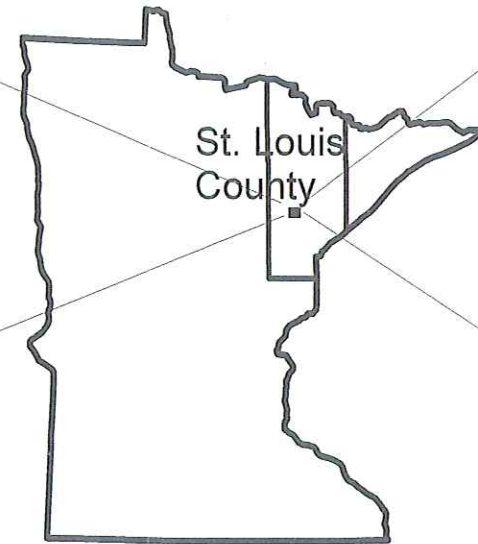
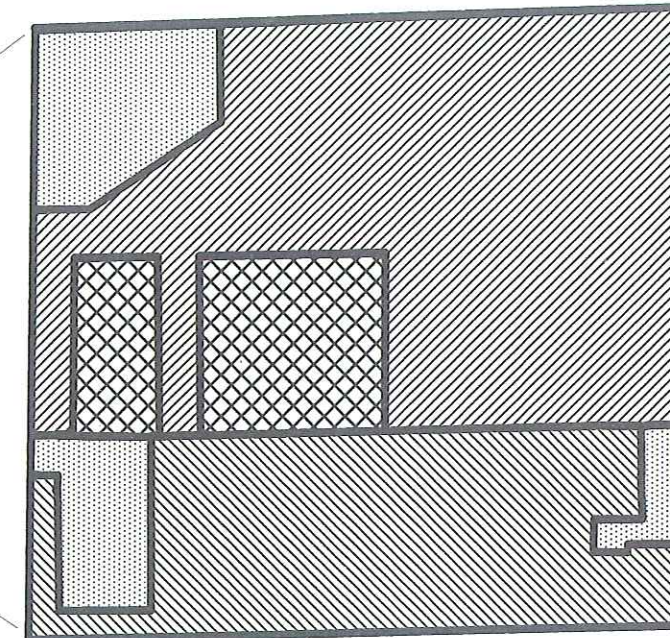
BANK SITES

- 8) Sheet 1 shows bank sites and agreement areas at the Fens Research Facility where the wetland banks are being established.
- 9) The Bank Site is part of the Fens Research Facility, hereafter referred to as the “Fens” (Sheet 1), that is managed by NRRI.

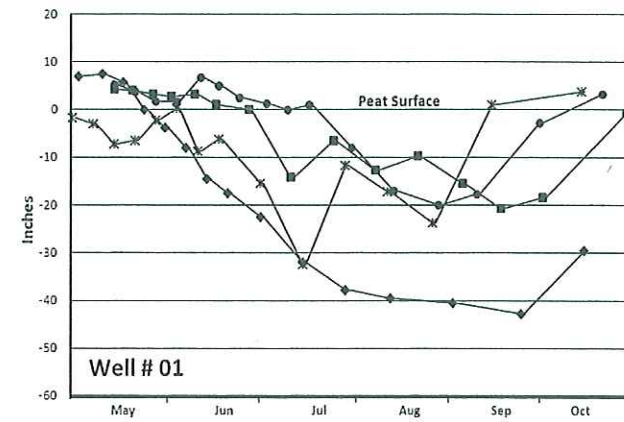
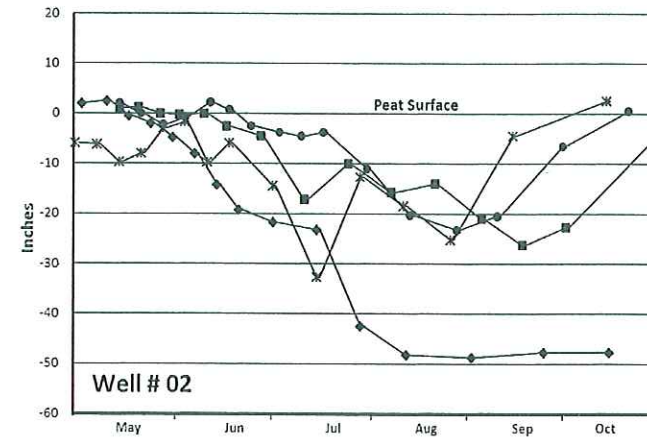
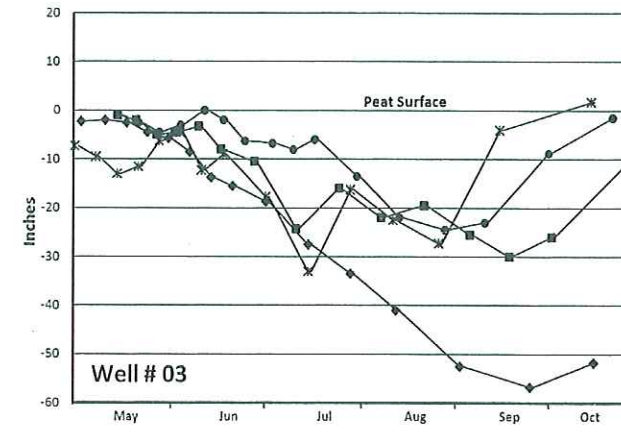
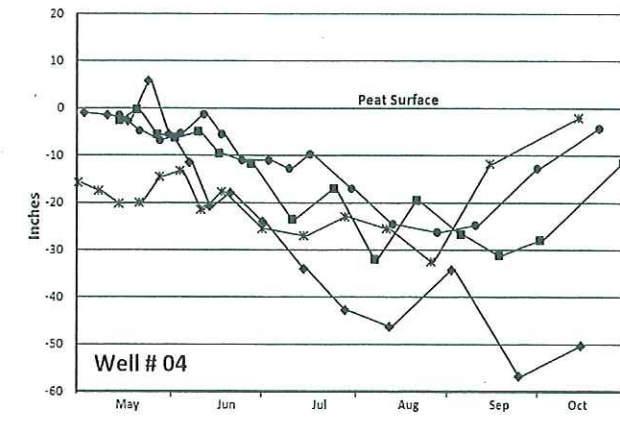
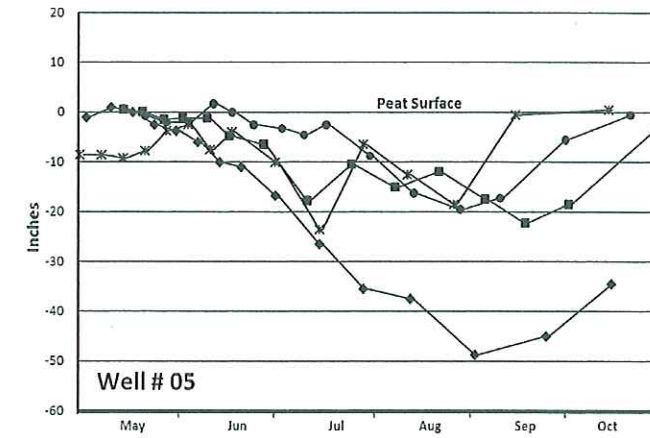
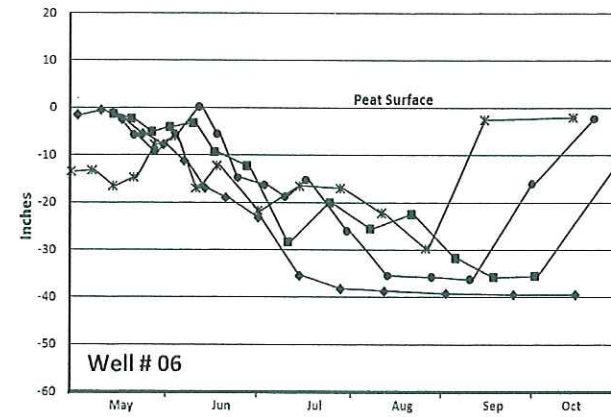
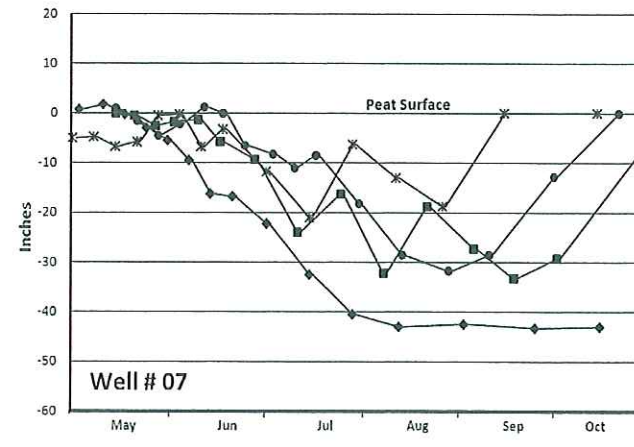
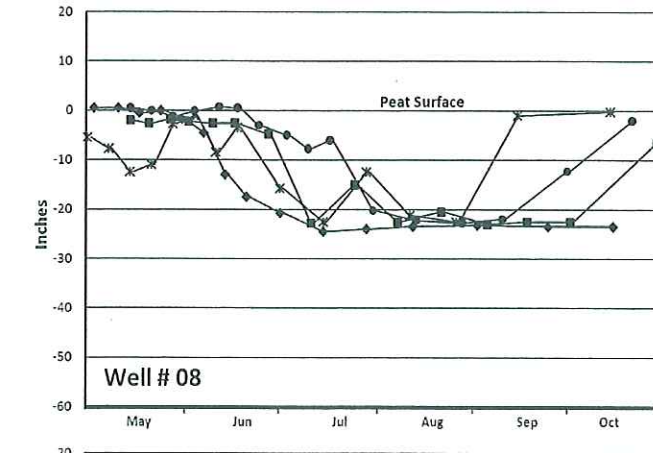
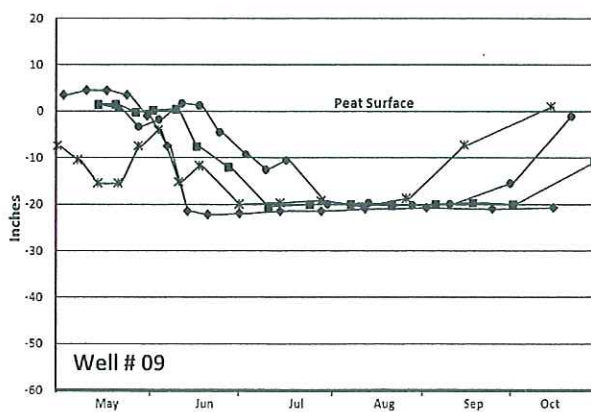
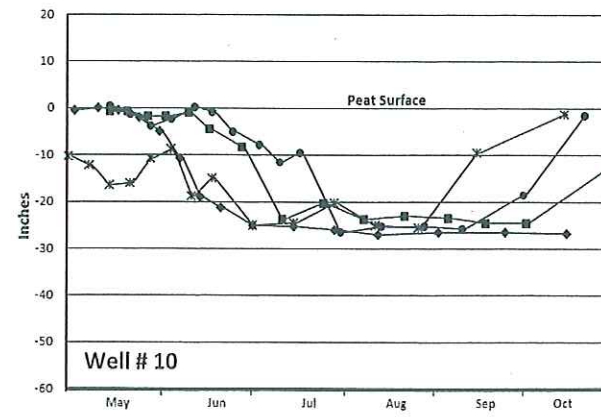
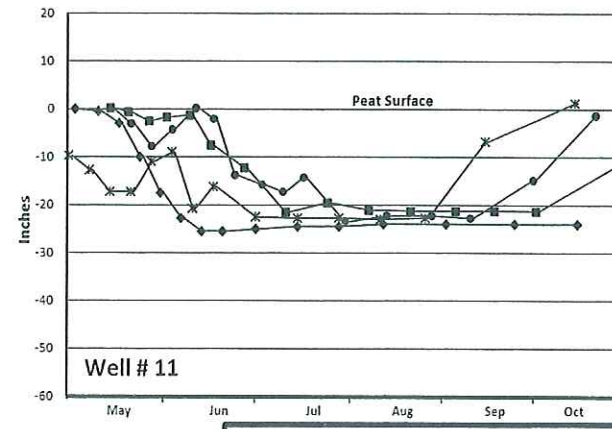
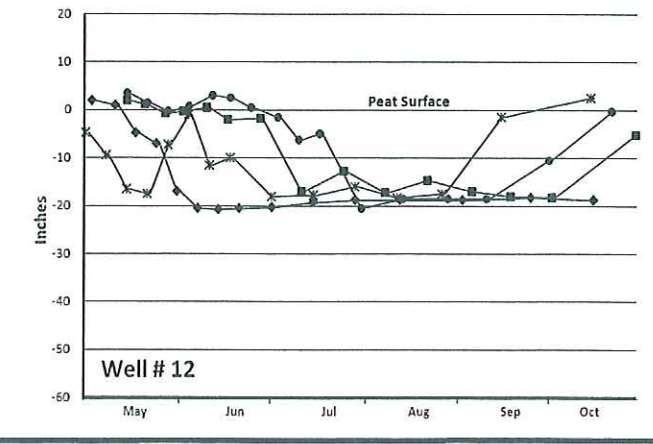
Water Table Levels

Fens Research Facility Wetland Bank II

Portion of S1/2 of Section 3, T55N, R18W, St. Louis County, Minnesota

- ◆ 2006
- * 2007
- 2008
- 2009

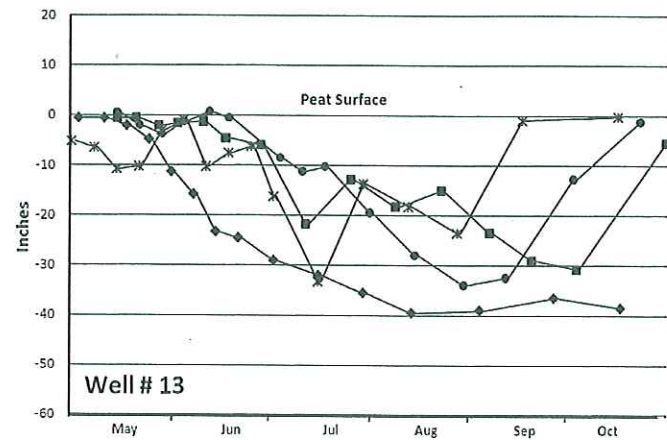
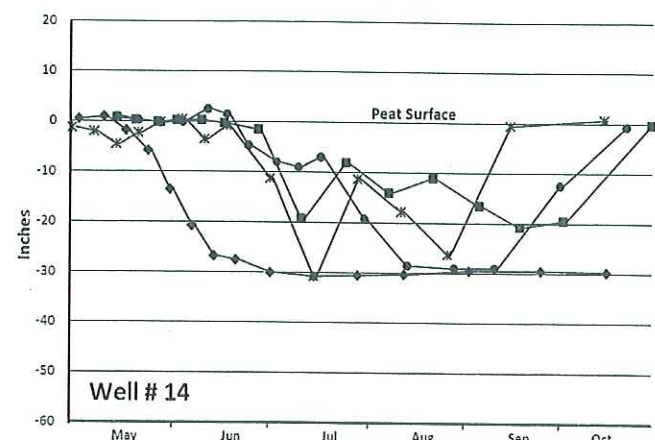
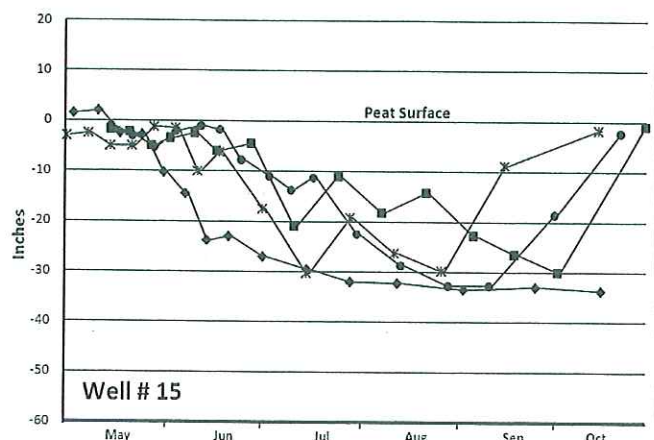
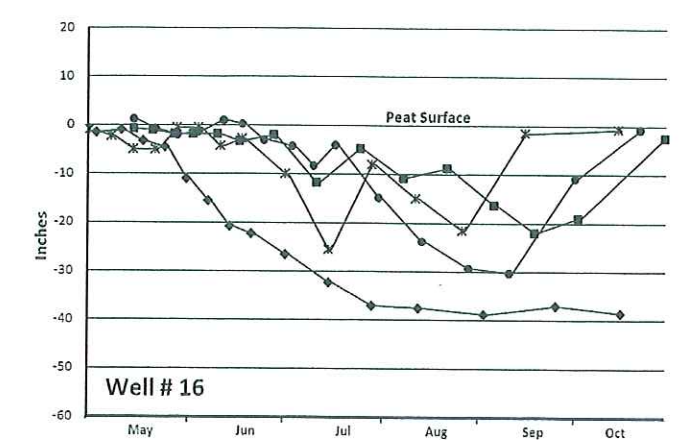
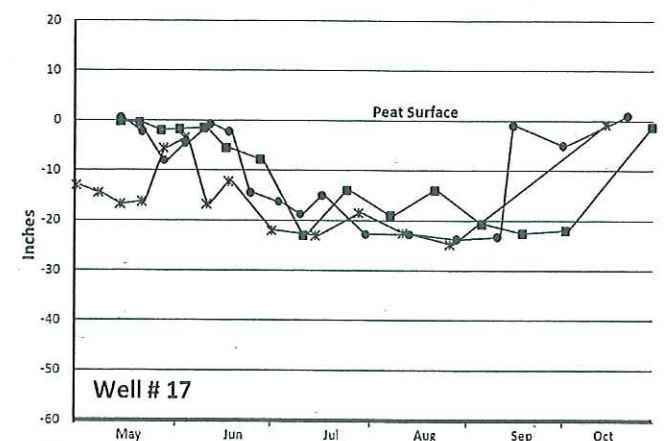
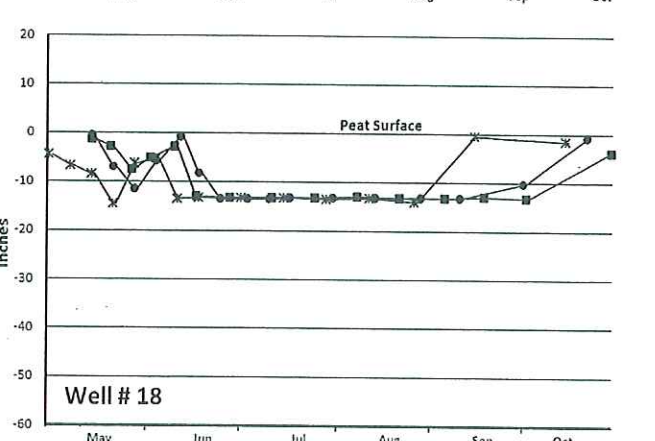
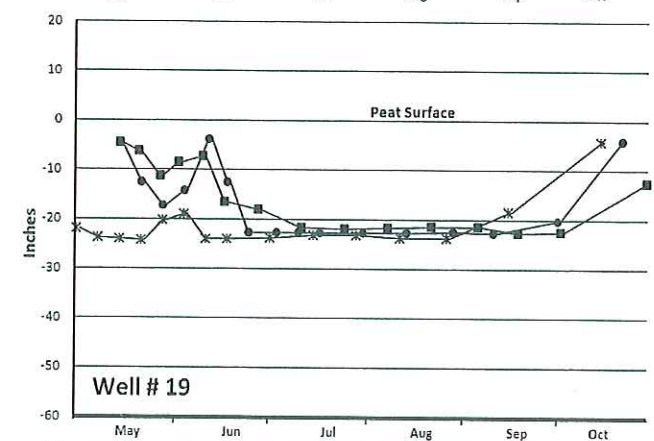
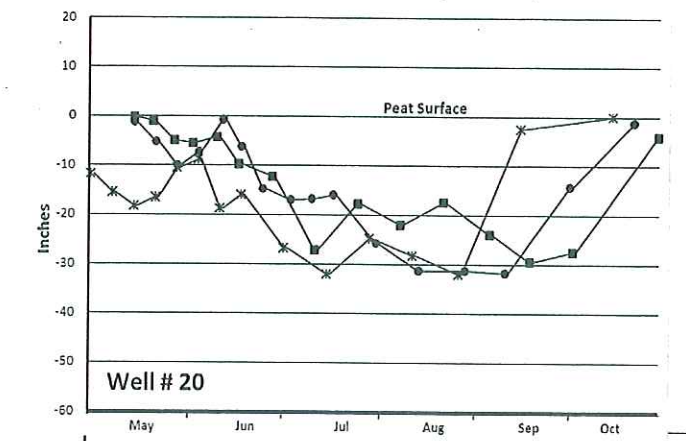
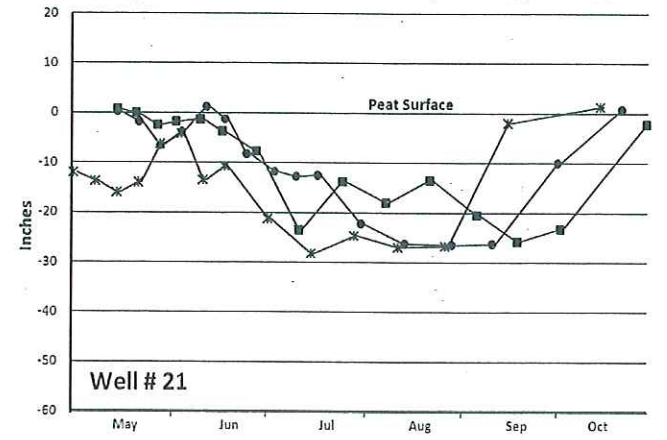
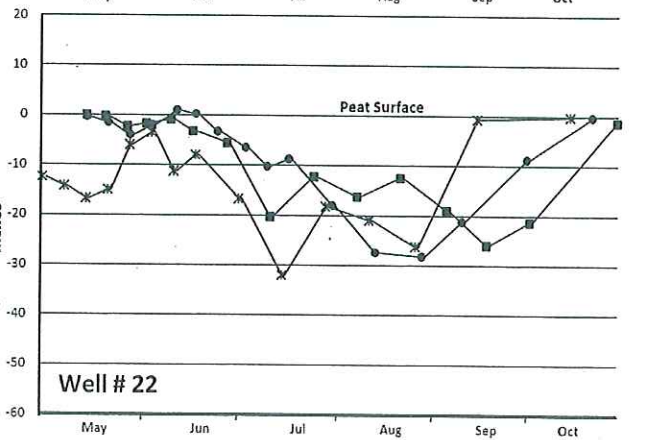
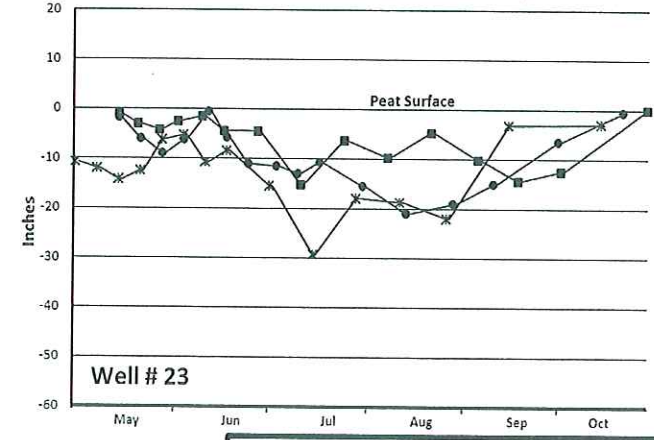
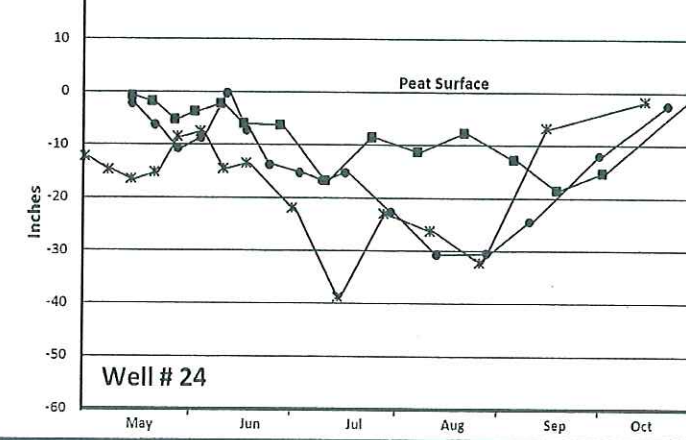
Water Table Levels

Fens Research Facility Wetland Bank II

Portion of S1/2 of Section 3 T55N, R18W, St. Louis County, Minnesota

- ◆ 2006
- * 2007
- 2008
- 2009

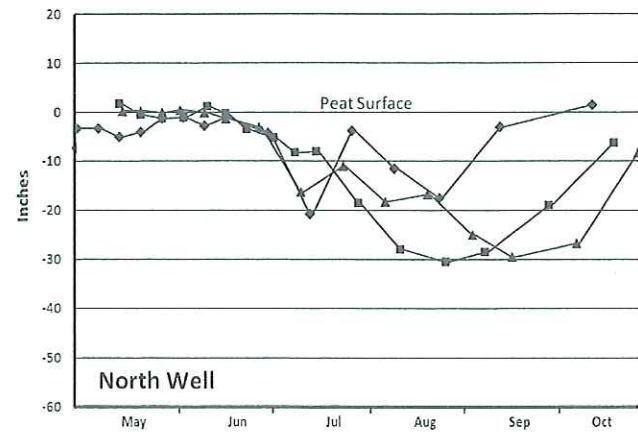
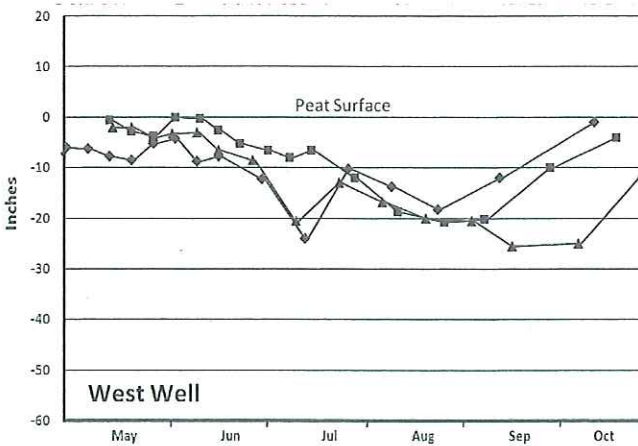
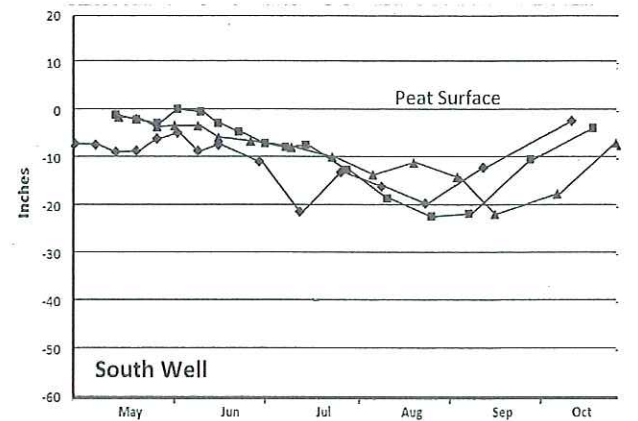
NEARBY WELL MONITORING SITES

Water Table Levels

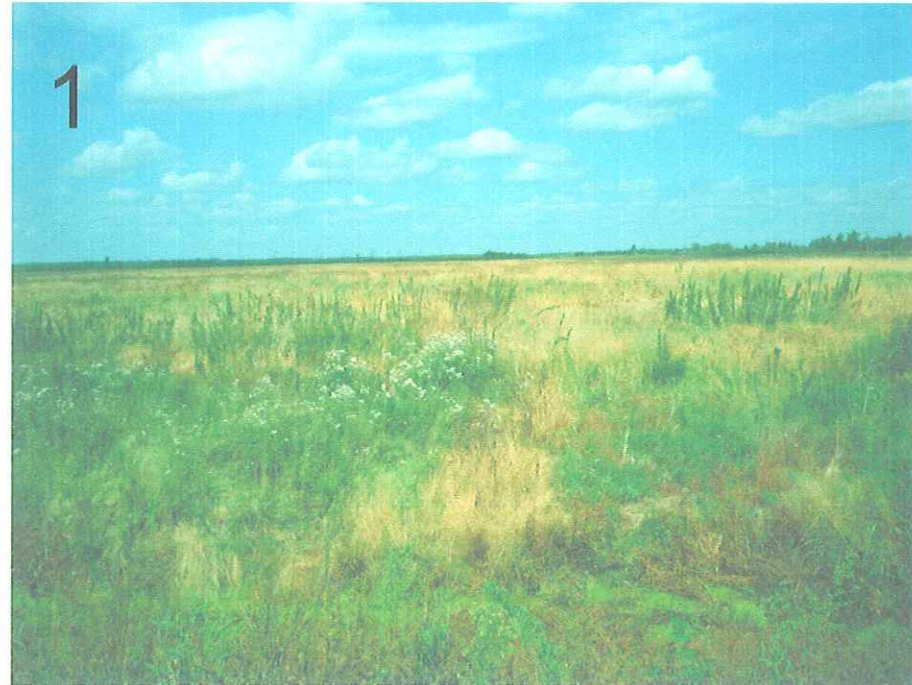
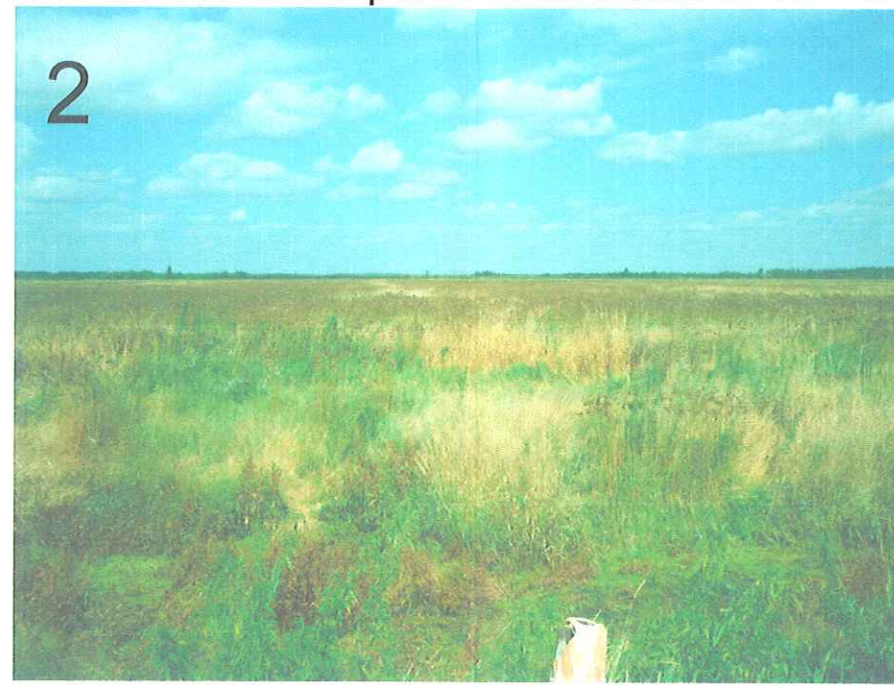
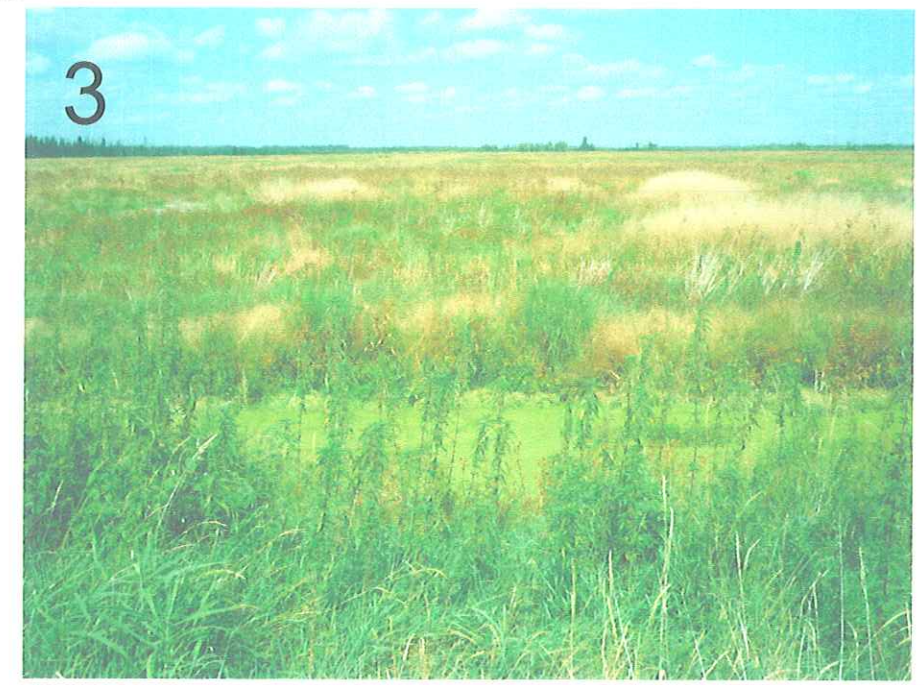
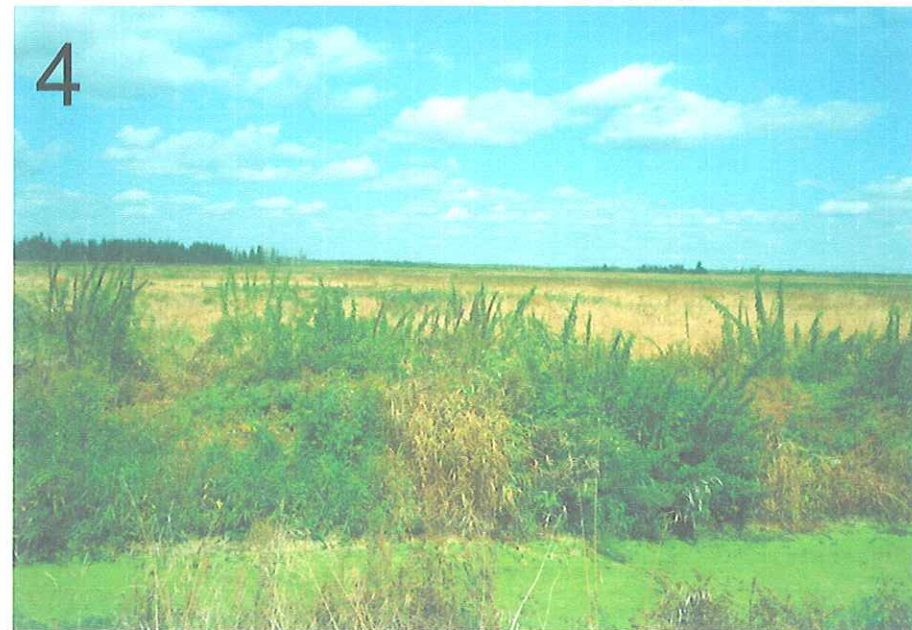
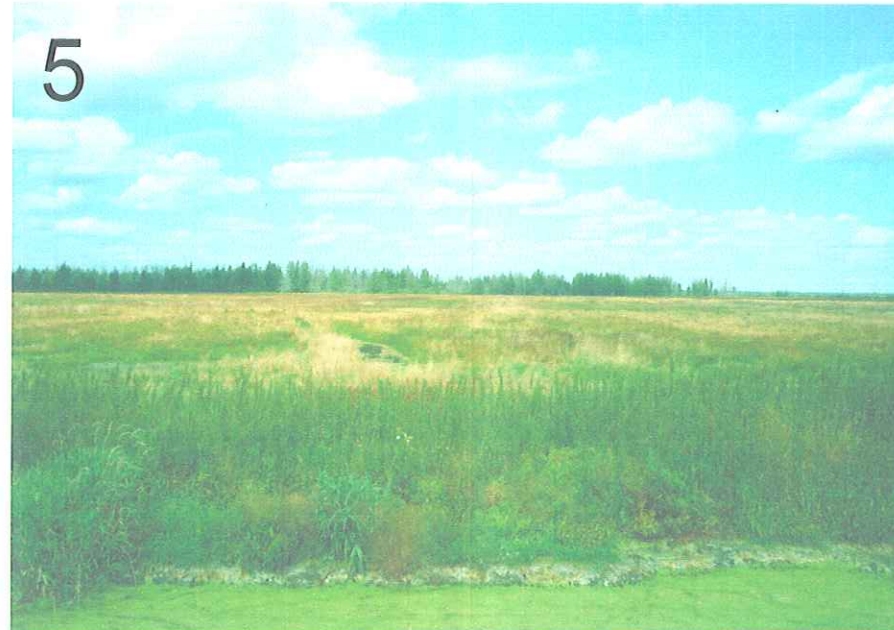
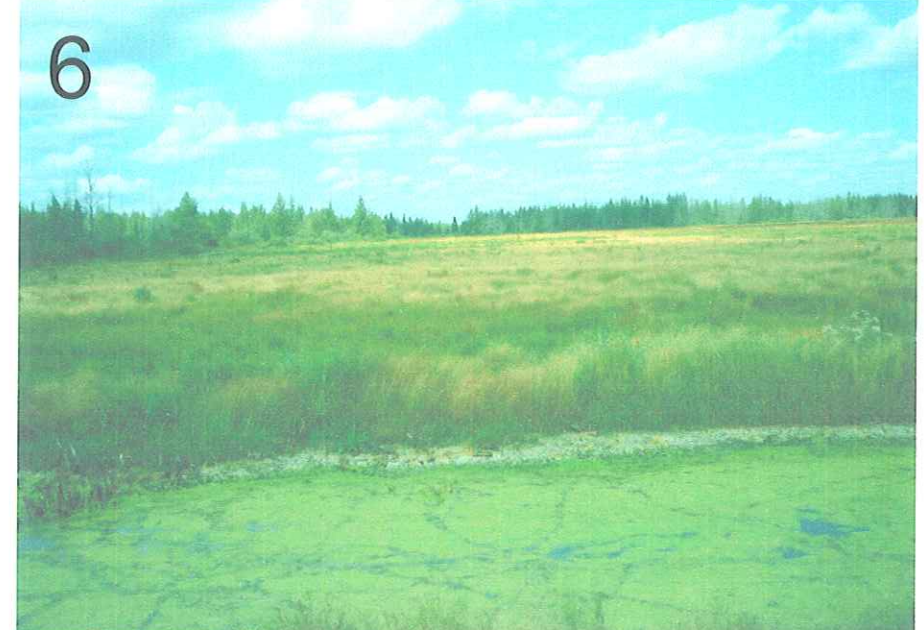
PHOTO REFERENCES

Fens Research Facility Wetland Bank II
 Portion of S1/2 of Sec 3 T55N, R18W; St. Louis County, Minnesota
 2009 Annual Report Photo Reference Points
