## A Preliminary Assessment of Impairments to Melrose Lake, MN 2013

Ruby Irving-Hewey  
Research Assistant  
University of Minnesota

**CAP Report # 181**

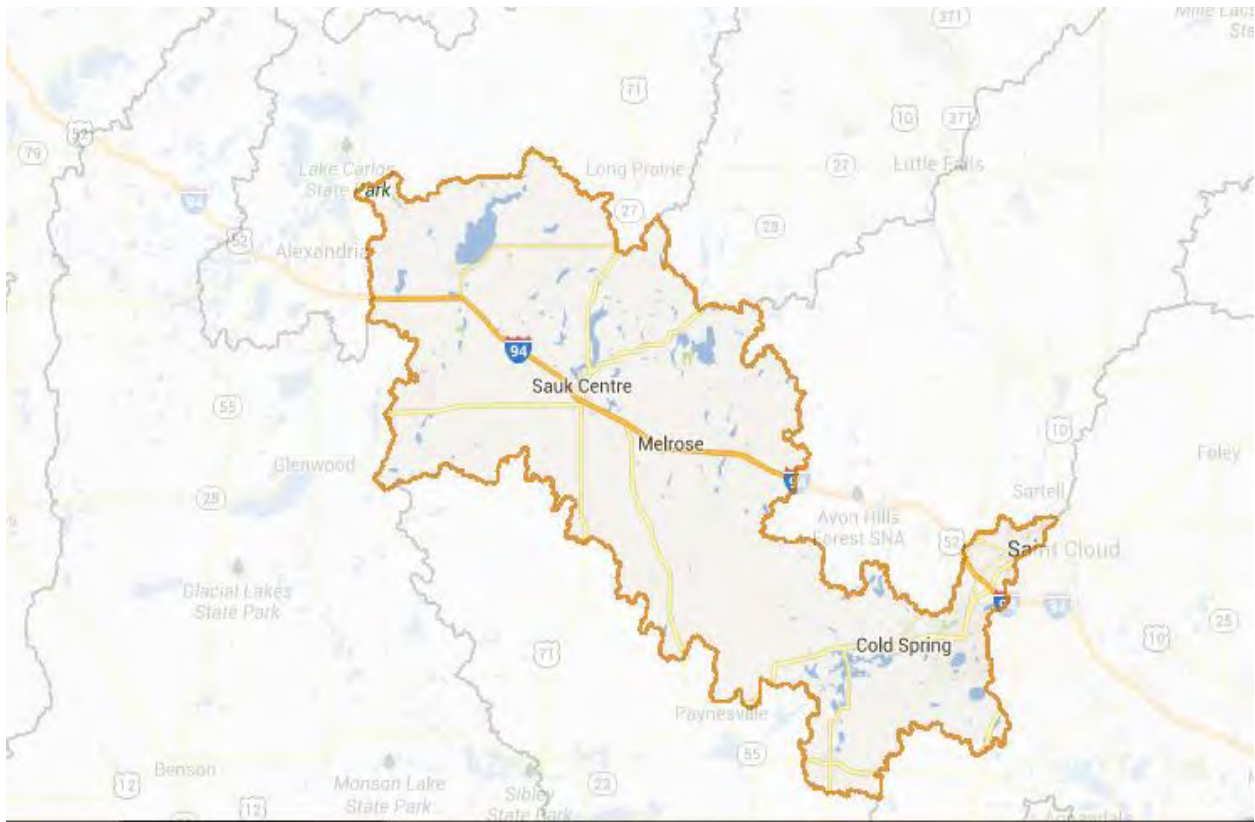
Figure 2: The Sauk River Watershed (MPCA 2013).

Hydrology involves the properties, occurrence, distribution and movement of water in its various forms and involves a number of physical, chemical and biological processes as it travels above, upon and below the Earth's surface (USGS, 2013). A watershed is an area of land that water drains into and can be classified along a scale from major to minor. The two factors that affect a watershed are gravity and topography which influence how the water travels (MDNR, 2013). In the state of Minnesota 81 major and approximately 5,600 minor watersheds have been delineated (MDNR, 2013). Melrose Lake lies on the Sauk River above the Sauk Horseshoe Chain of Lakes within the Sauk River Watershed. Flowing from northwest to southeast the Sauk River begins at Lake Osakis and travels through parts of Douglas, Meeker and Todd County but stretching mainly through Stearns County dropping in elevation approximately 340 feet over its length (MDNR, Watersheds, 2013) and (Waters, 1977). The Sauk River is approximately 120 miles long flowing from its source to its confluence with the Mississippi River near St. Cloud. The watershed covers a total of 1,043 square miles and approximately 90 miles in length (MPCA 2013). The Sauk River Watershed lies within the North Central Hardwood Forest Ecoregion (NCHF) and is dominated by glacial till and drift that contain high fractions of clay and silt (Figure 2).

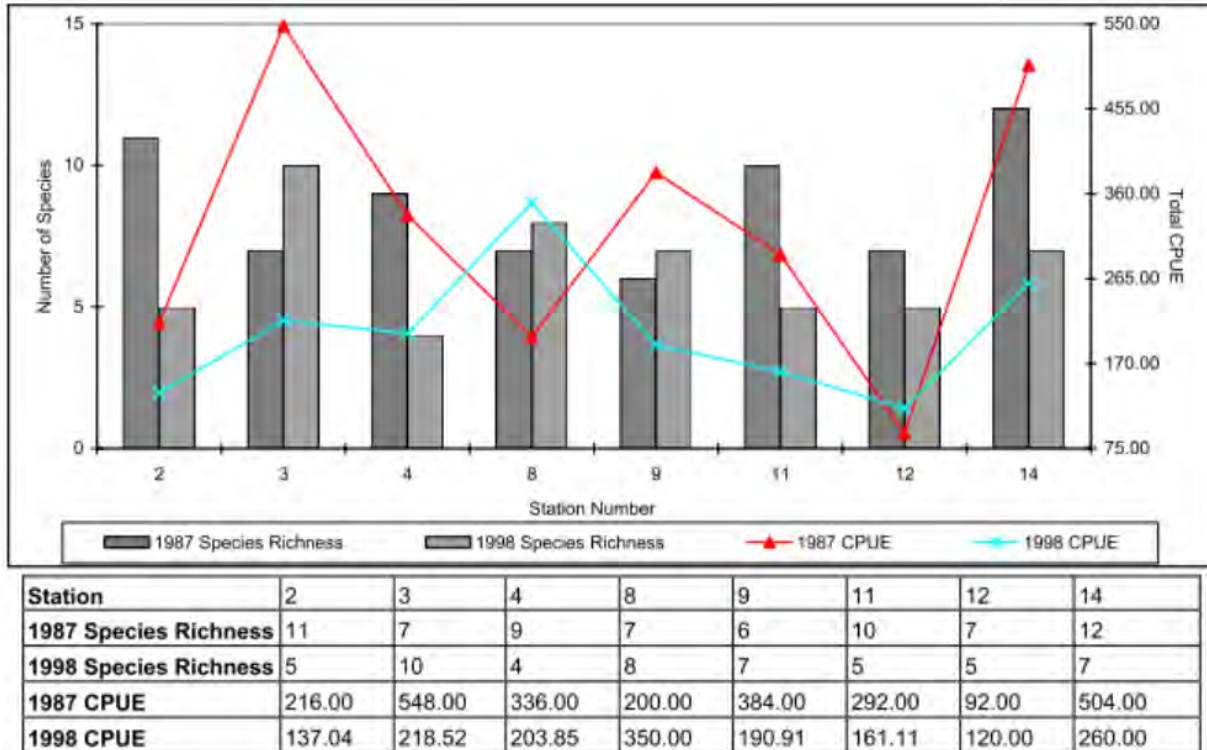
Figure 6: Sauk River species richness and catch per unit effort (CPUE) from electrofishing similar stations 1987 and 1998 (Altena, 1998).

The DNR studied physical and chemical characteristics and the composition and abundance of aquatic organisms of the Sauk River in 1987 and 1998 (Altena, 1998). From five miles below Cold Springs Dam up to Sauk Centre Dam 12 sampling stations were used but only those stations above and below Melrose Dam are highlighted in this report (see Figure 6). Station 8 is approximately 21 miles south of Melrose Dam and station 9 is located just shy of a mile south of Melrose Dam. Station 10 is north of Melrose Dam two miles, station 11 is approximately 4 miles north of Melrose Dam and station 12 is approximately 14 miles north of Melrose Dam. Species richness between sites for the samples taken at Station 8 and Station 9 were similar for both 1987 and 1998. Station 11 and Station 12 however had a considerable drop in species richness from 1987 to 1998 (Figure 6).

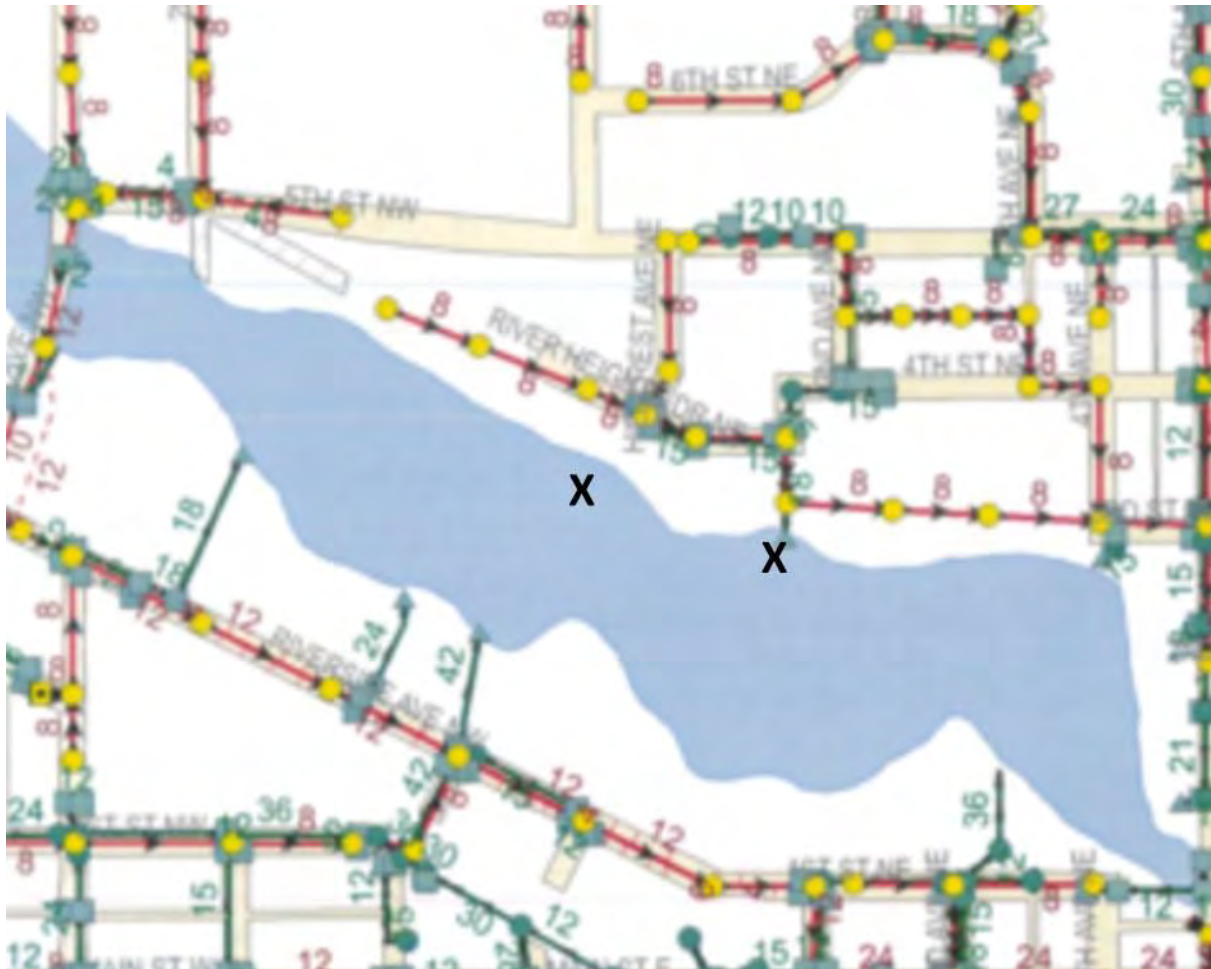
The DO, Conductivity and TDS were measured at various sampling stations during the sampling season (Table 2). The lowest DO level was 2.53mg/L between the dam and the foot bridge at a stormwater outlet on the west bank of Melrose Lake during the month of August. The highest DO was 5.0mg/L and 5.31mg/L and located in the middle of Melrose Lake near the dam and on the east bank just north of the dam during the month of June. TDS/conductivity showed an incremental increase from the end of June until the middle of August except for a spike of 250mg/L that was measured in mid-July. Most of the samples had TP concentrations between 0.135mg/L and 0.191mg/L but in a few instances there were concentrations above 0.329mg/L (Table 2). The TP exceeded the proposed total maximum daily load (TMDL) of 0.1 mg/L in each of the water samples analyzed. These spikes of TP levels were found near the stormwater outfall in the residential area near River Heights Dr NE between the Dam and the footbridge (Figure 8). All but one water samples had TP amounts that exceeded the proposed limit making it a

candidate to be listed as nutrient impaired, these data will be passed along to the SRWD and MPCA which should allow Melrose Lake to be officially listed as impaired and therefore be able to receive additional resources for its rehabilitation.

Figure 8: Sampling stations with the highest levels of TP during the sampling time frame. Photo courtesy of the City of Melrose.

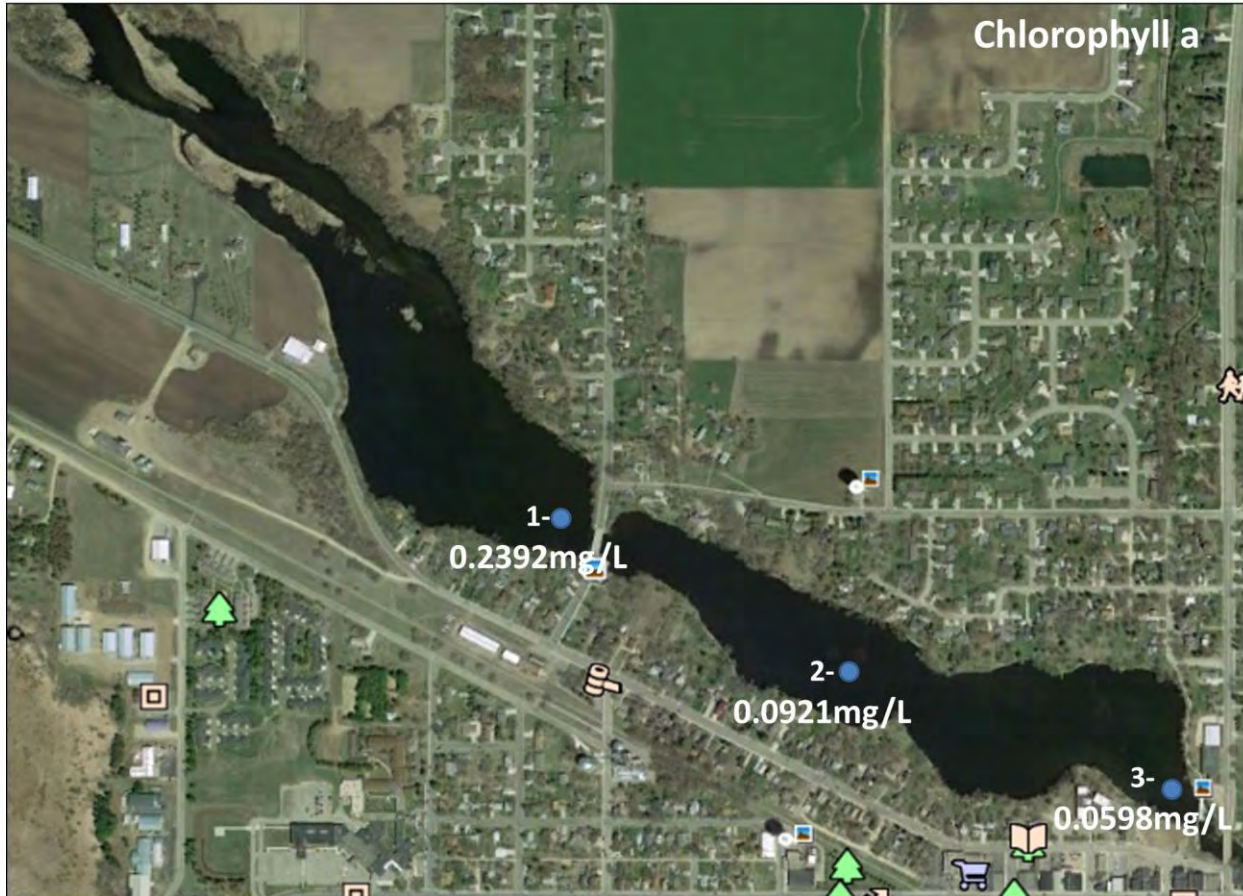
Chlorophyll a was measured at three points along the lake and ranged between 0.0921mg/L and 0.2392mg/L. The highest level of chlorophyll a was found upstream of the foot bridge and the lowest level of chlorophyll a was found near the dam (Figure 10). Chlorophyll a is a measurement of algal biomass and shows a decreasing trend from north of the foot bridge in a shallow area of excessive aquatic vegetative growth to the dam where the water is deeper and the current is stronger.

Chlorophyll-a concentrations for waters in the NCHF Ecoregion of Minnesota that are greater than 0.018 mg/L indicate impairment (MPCA, 2013).

Figure 10: Sampling stations and corresponding chlorophyll a levels. Photo courtesy of Google Earth Maps (2013).

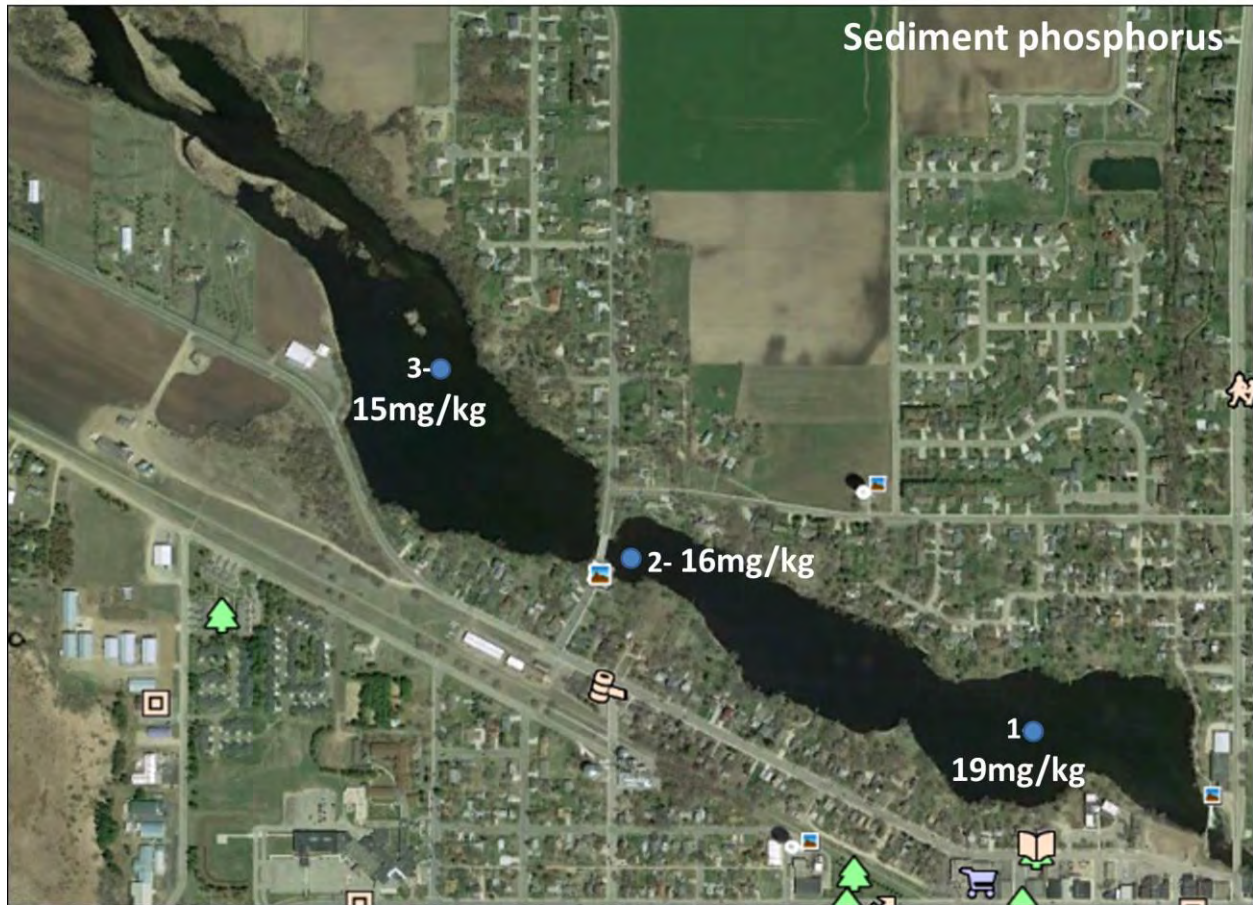
The phosphorus detected in the sediment was found to be between 15mg/kg and 19mg/kg with the highest amount being found closest to the dam (Figure 11). The highest levels of TP in the water samples were also taken from this area and should continue to be monitored. According to the USDA lab, the 15mg/kg of phosphorus is considered high and both levels of 19mg/kg and 16mg/k are considered very high in terms of what is available for vegetative uptake. The amount of phosphorus found in both water and sediment samples were consistently high and contribute to both the excessive vegetation and algae

growth on Melrose Lake. These amounts are indicative of impaired waters and with continued monitoring can lead to nutrient impaired status.

Figure 11: Sediment sample stations and corresponding phosphorus levels (mg/kg). Photo courtesy of Google Maps (2013).
