UNIVERSITY OF MINNESOTA

CENTER FOR TRANSPORTATION STUDIES

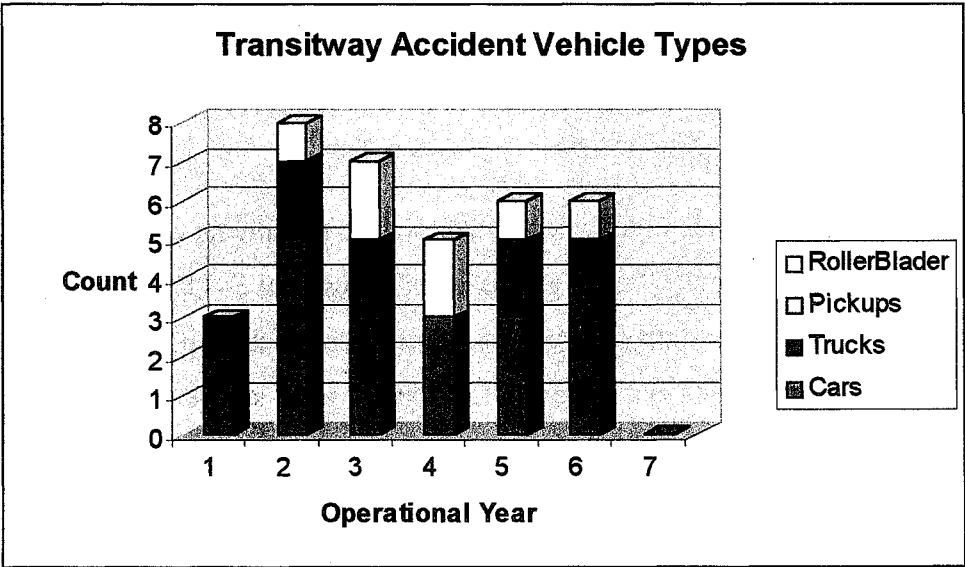
Analyses of the triangular sight distances indicated that some sight distances at intersections have been improved over the Phase I measurements. However, other sight distances have been decreased by the installation of cabinets for the electronic control equipment. At several intersections, vegetation continues to obstruct stop line sight lines. Short triangular sight distances suggest that average approach speeds should be reduced (for non stopping drivers).

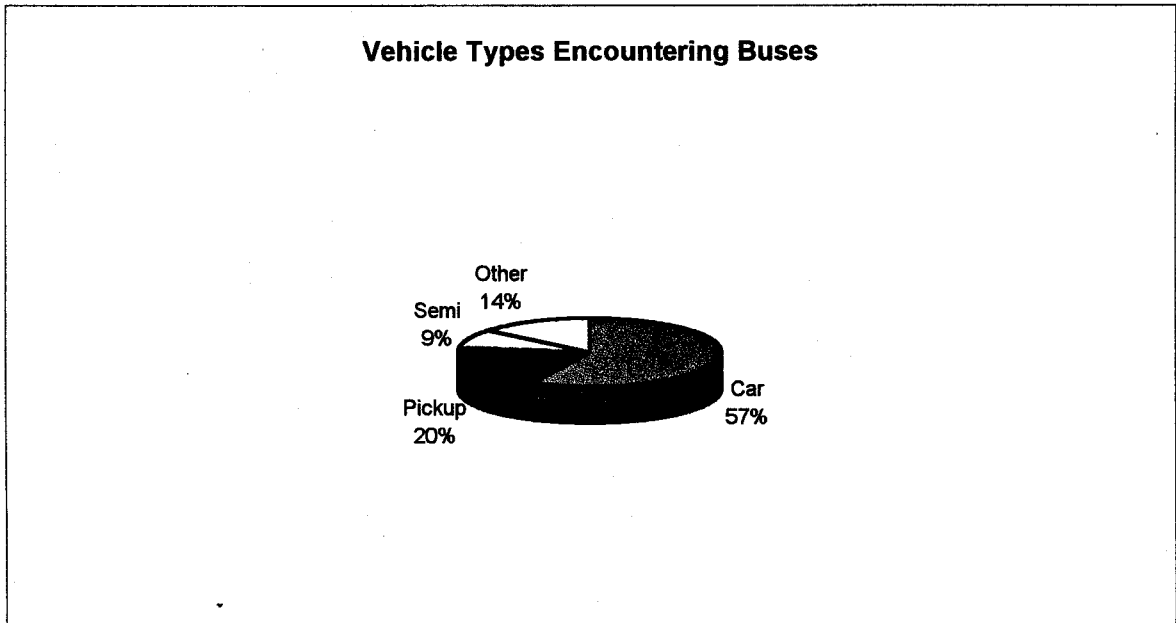
APPENDIX C-4
Transitway Accidents Sorted by Vehicle Type

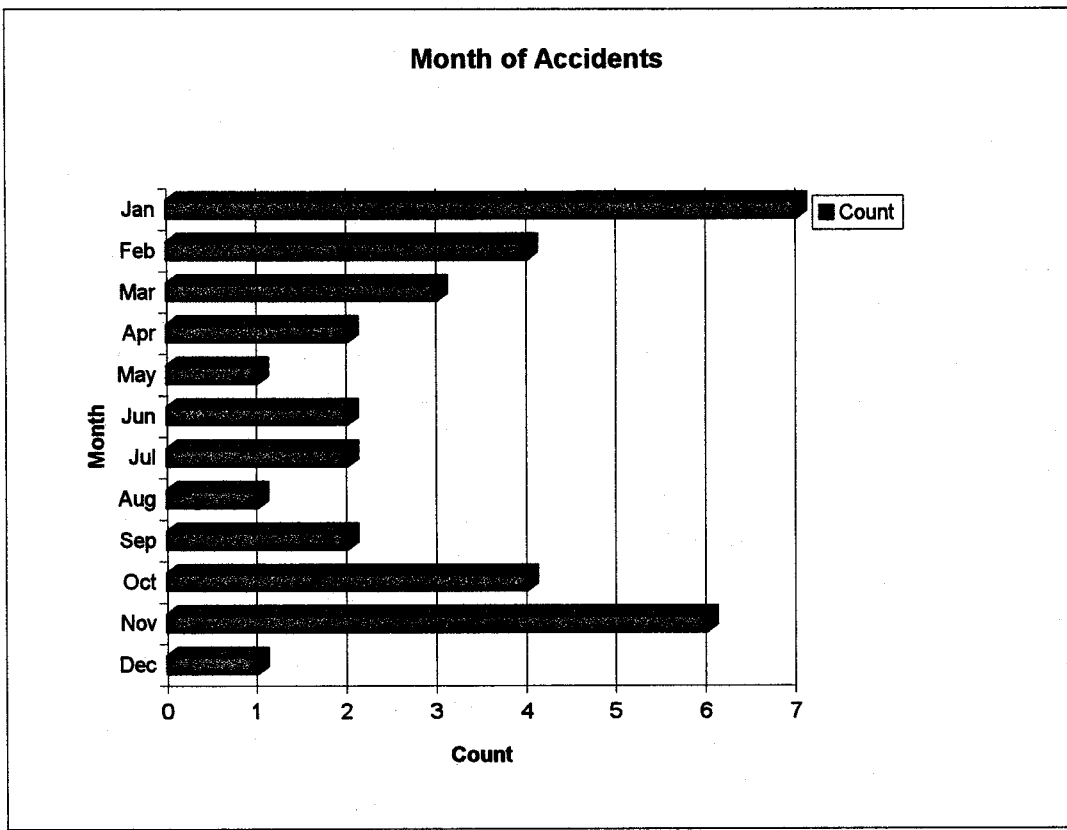
APPENDIX C-6
Transitway Accidents Sorted by Time of Day
