Ice Dam Symptoms and Solutions for a Cold-Climate Roof

**Sustainable Systems Management: Building Science and Technology
University of Minnesota**

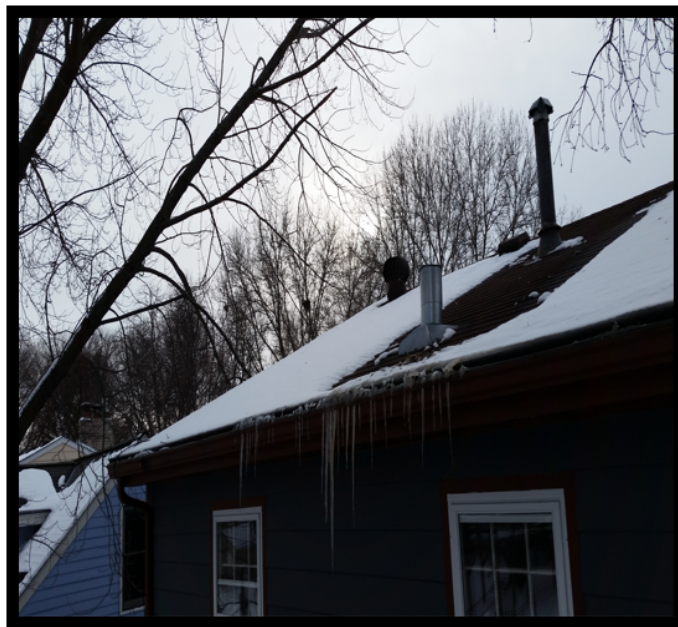
Image 4: Snowmelt pattern in middle of roof indicates uneven heating of the roof deck. This was theorized to be an area where heat leakage was rather high from the house.

A snowmelt pattern was noticed among houses of the same house design. Dr. Robert Seavey owns one of such houses and wanted to understand what was causing this to happen, as a snow melt pattern such as this can indicate possible ice dam formation. A chase way was discovered to be underneath this part of the attic, but was thought to be sealed to the attic. Image 4 gives the snowmelt pattern that inspired the research. The three reasons for ice dams were interpreted in relation to the tested house to determine how this managed to cause such a snow melt pattern.

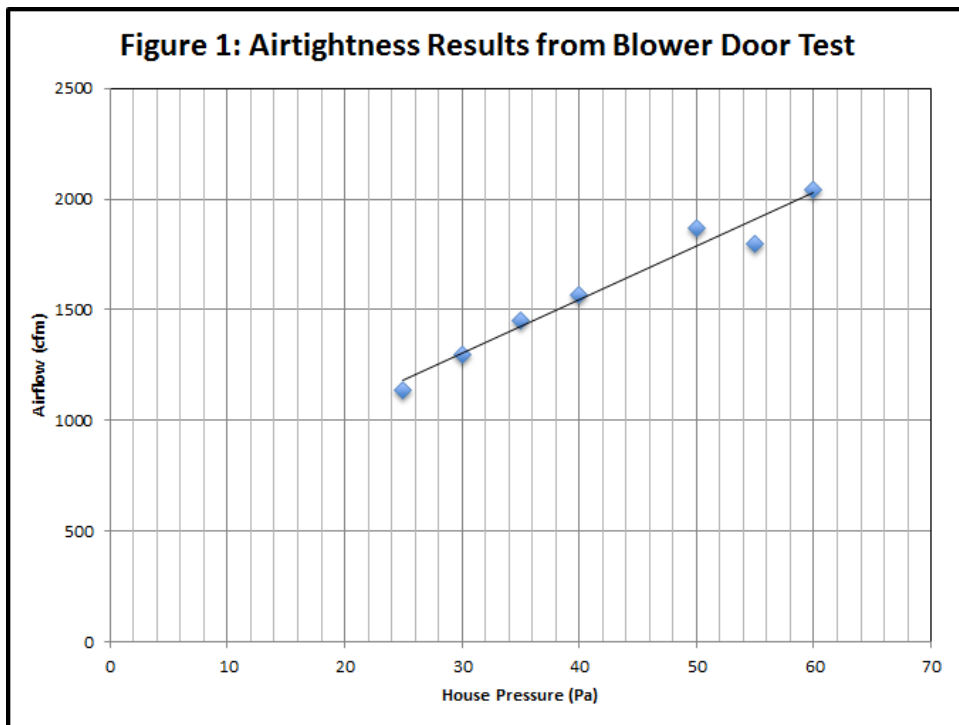
Figure 1: Blower door results for the tested house. A multi point test reduces the error that a single point test at 50 pa will have. **The air leakage for this house is found to be 1870 cfm at 50 Pa.** New homes are expected to have less than 1,500 cfm in MN, so this is a very good rate for an older home.

Table 1 gives the blower door results for the tested house. An airflow of 1870 cfm at 50 Pa is higher than houses currently being built, but is an average number compared to existing houses of similar age and size. A new home of the same volume built to the 2015 MN energy codes would require a air leakage rate of the 1068 cfm, which is not common for many houses built before 2000. Since this house was built in the 1960s, it was not expected to achieve a similar air leakage rate. It performed well with 1870 cfm, but can be significantly reduced. This particular blower door test may have been +/- 5% inaccurate due to heavy winds outside, but regardless finds that the house has considerable leaks to the outside.

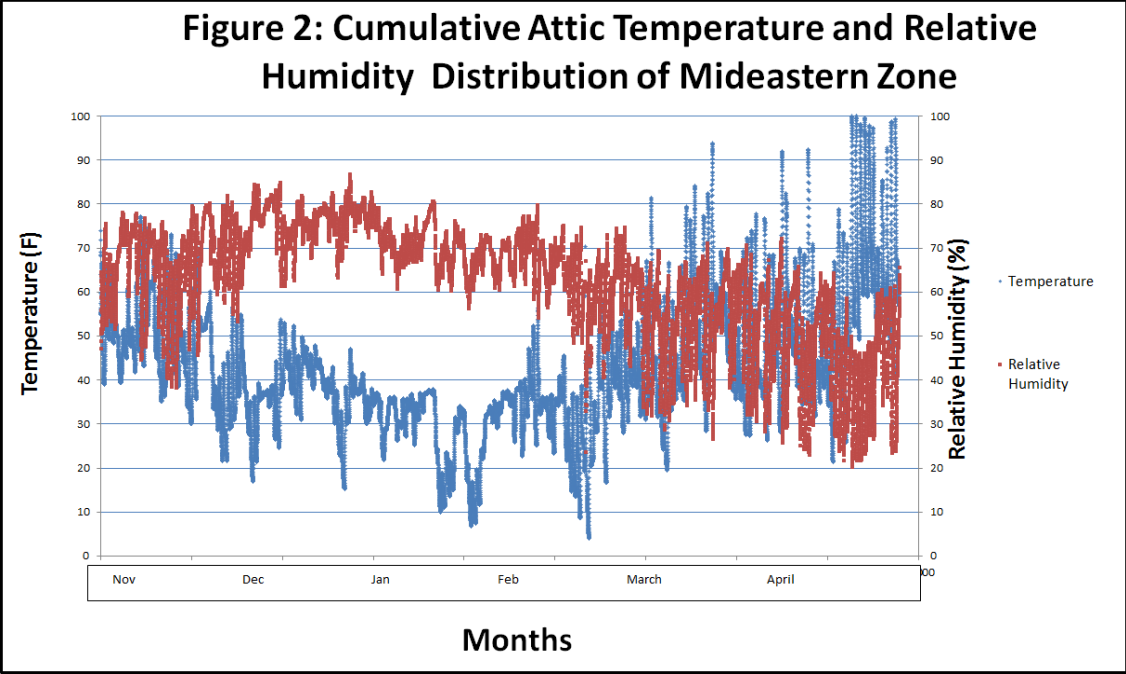
Figure 2: Depicts the attic temperature and relative humidity trends from November 2015- April 2016 in the Mideastern zone. Data for all three zones were collected, but the Mideastern zone contains the chase way that is hypothesized to be causing much of the snow melt pattern on the roof. This data is only for the Mideastern, or “chase way zone”.

The Data Loggers were retrieved and data was downloaded twice throughout their lifetime for interpretation. Both retrievals were combined to make Figure 2. This graph does not reveal much vital information, but it is interesting to note that temperatures in the attic by the chase way was below freezing for almost the entire month of January. Relative Humidity levels during this time were around 50%. This amount of time spent in freezing temperatures can quickly build frost in an attic if there were to be more heat leakage into the attic. R44 Insulation and a good pressure boundary prevented moisture build up and frost. The chase way is found to be leaking heat at higher temperatures than other zones as found by Figure 3. A four-degree temperature difference was consistent for a large period of the time. Figure 3 specifically shows a cold day in January, where attic temperatures dropped below 10 degrees. The chase way leaking four extra degrees may seem minimal, but it is a very significant amount of heat leakage on a cold day. This would be a priority to properly seal if lower energy bills are desired. The top of the chase way would have to be sealed inside the conditioned space and insulated with spray foam to prevent this leakage.

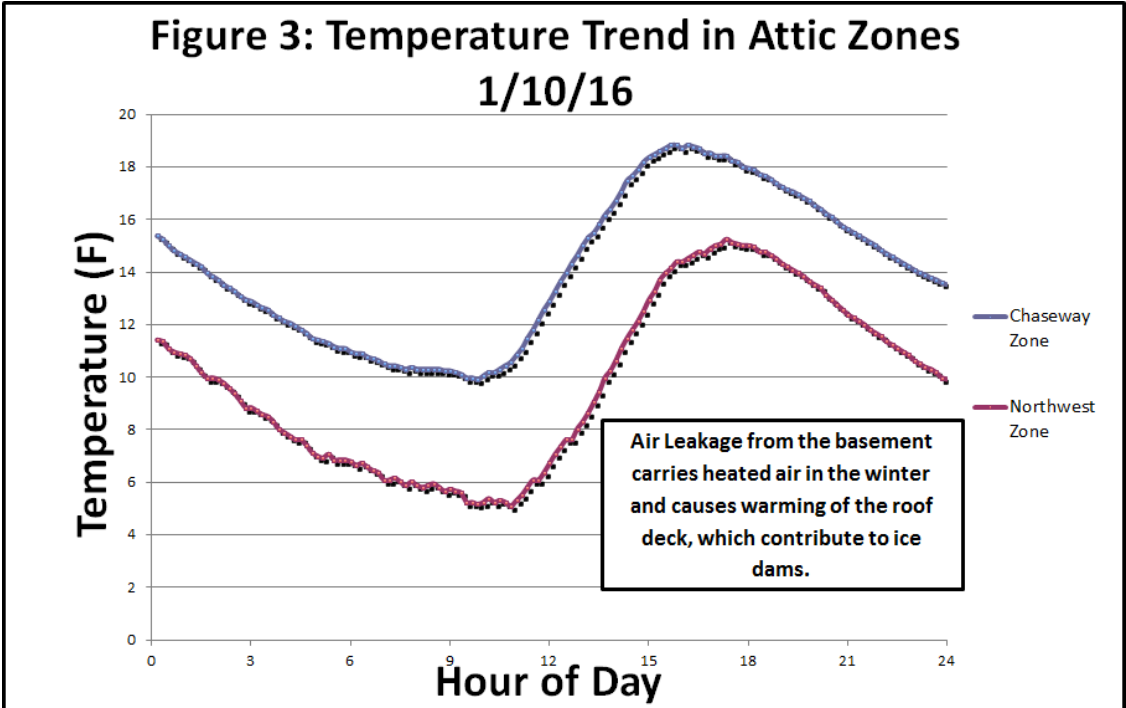
Figure 3: Temperature data from 1/10/2016. This was one of the coldest days of the year, and was selected for interpretation because of the amount of energy

that would disproportionately leak in less insulated or leakier areas. Compared to the Northwest zone, the Chase way zone is found to consistently be 4 degrees warmer. This is a significant difference and was common on many different days of the year.

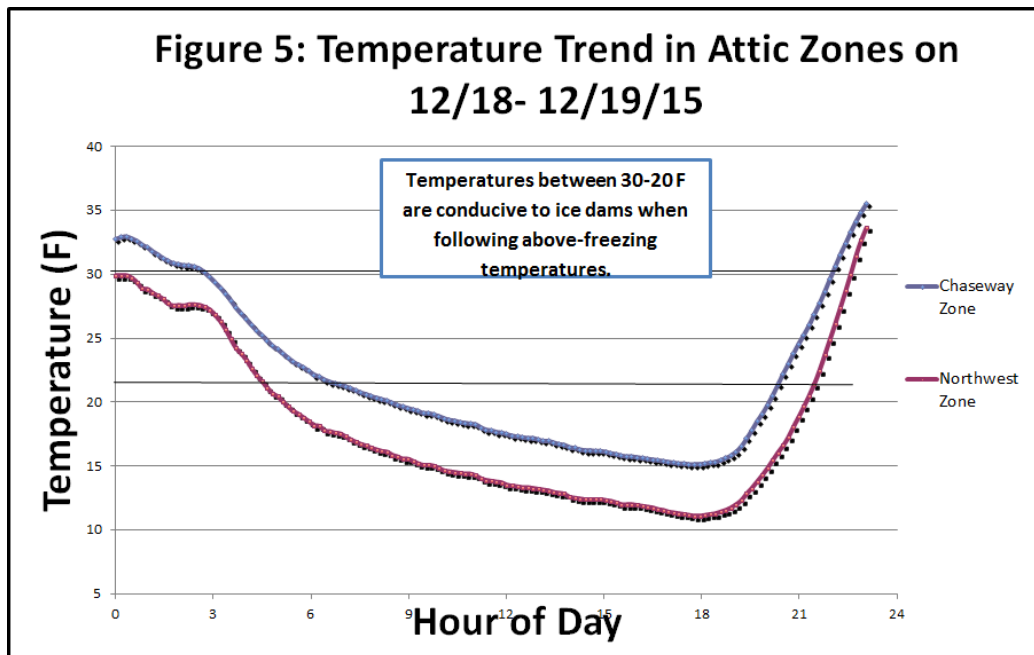
Figure 5: Temperature data from 12/18 and 12/19/2015. This data represents fluctuations in attic temperature above and below freezing. When this happens constantly, snow will melt and freeze and possibly cause ice dams. If one zone is above 32 degrees while another zone is below 32, the snow will melt and freeze disproportionately and can cause visible patterns in the snow on the roof.

Figure 5 shows the temperature data for the same zones on a different day. This day was found to be an example where ice dams may be found given enough snow on the roof. The temperature in the attic space under the roof deck fluctuates between 35 and 15 degrees Fahrenheit. Snow can both melt and freeze on the same day. The chase way's zone again exhibits temperatures of about 4 degrees warmer than the Northwest zone. This will undoubtedly melt snow faster than other zones when it is over 35 degrees. This finding explains the snowmelt pattern depicted on the roof in Image 4. Using this knowledge, the IR camera photos from the inside also show that conditioned air of around 60 degrees from the basement is traveling from the basement into the Mideast zone of the attic via the chase way shown in Appendix 3.

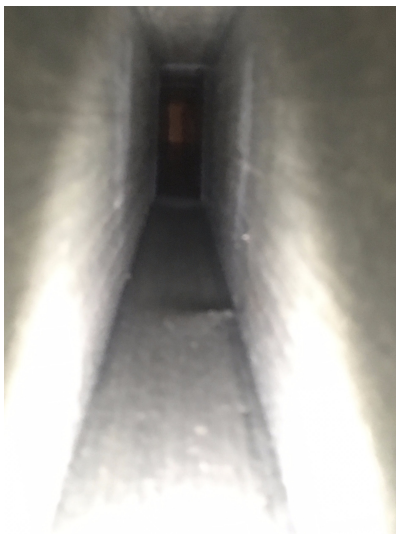
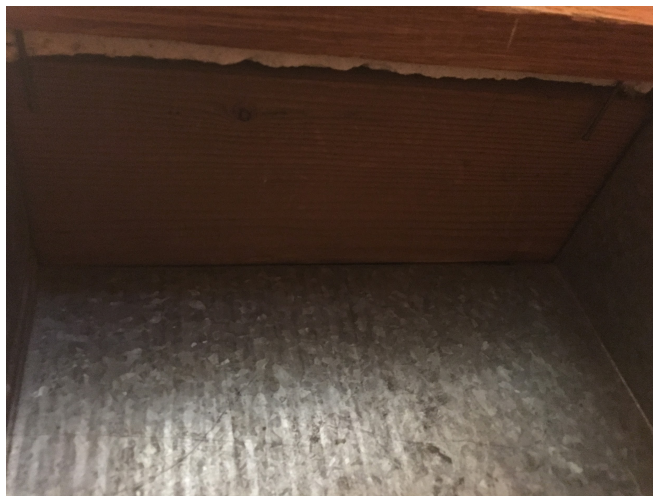
Appendix 4

The image on the left shows the chase that leads from the basement to the second floor. The image on the right shows the very top of the chase, which is showed to be blocked by wood. Conditioned air from the basement is theorized to be bypassing this and

leaking into the attic
