## Moisture Content Variations of Nail-Laminated Timber Bridges in a Northern Climate

1. Report No. <b>MN/RC - 1999-03</b>	2.	3. Recipient's Accession No.	
4. Title and Subtitle <b>Moisture Content Variations of Nail-Laminated Timber Bridges in a Northern Climate</b>		5. Report Date <b>November 1998</b>

## **Final Report**

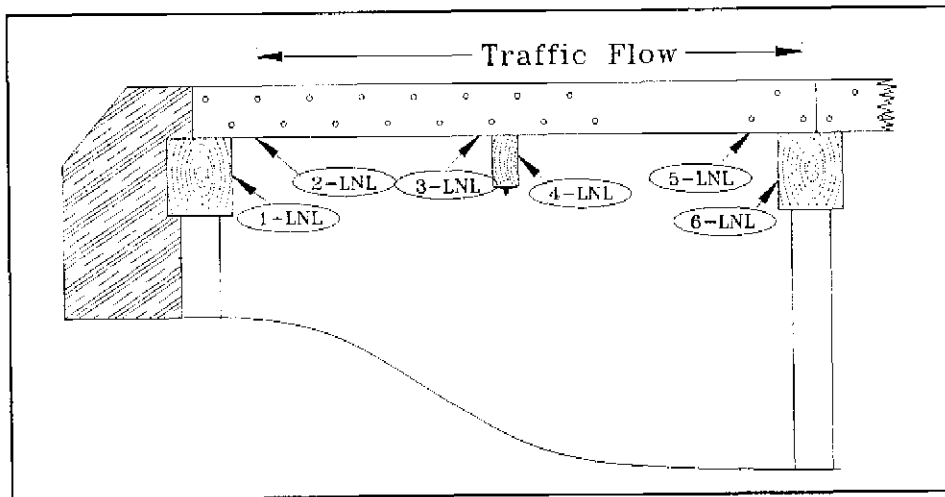
Figure 1 Moisture measurement locations on a longitudinally nail-laminated timber bridge.

Moisture content readings for the four seasonal replications were taken at the following locations on each LNL bridge (Figure 1) and on the two TNL bridges (Figure 2).

- 1-LNL) Abutment cap
- 2-LNL) Laminae at bridge abutment
- 3-LNL) Laminae at mid-span
- 4-LNL) Transverse stiffener beam (TSB)
- 5-LNL) Laminae over pier cap
- 6-LNL) Pier cap

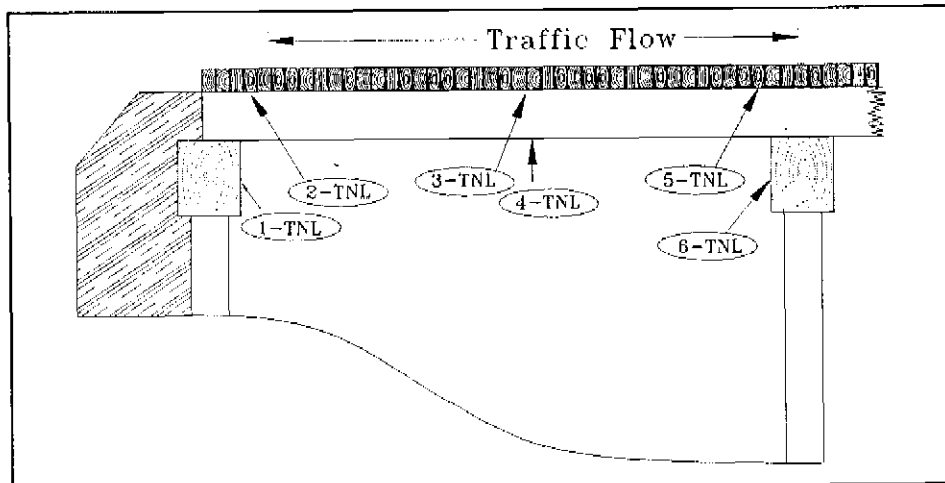
Figure 2 Moisture measurement locations on a transverse nail-laminated stringer bridge

- 1-TNL) Abutment cap
- 2-TNL) Laminae over abutment
- 3-TNL) Laminae at mid-span
- 4-TNL) Beam at mid-span
- 5-TNL) Laminae over pier cap
- 6-TNL) Pier cap

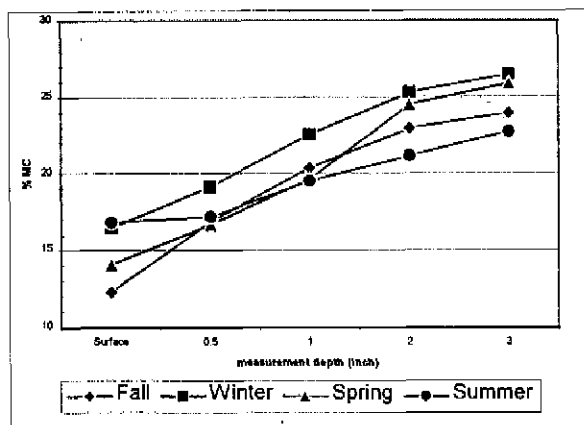
Figure 3 MC of Abutment -St. Louis Cty.

Values from the MC versus depth profile of bridge abutments in St. Louis Cty. (Figure 3) are approximately 3% higher than values in the Sibley County (Figure 4). St. Louis County measurements show a distinct separation of seasonal values at the 2" and a 3" depth, with summer values the lowest, and spring and winter values the highest.

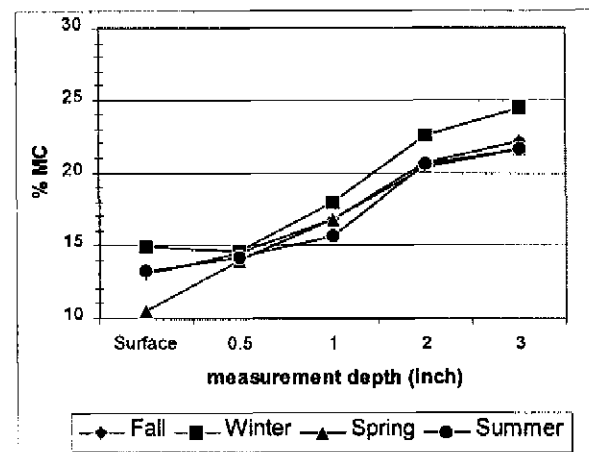
Figure 4 MC of Abutment -Sibley Cty.

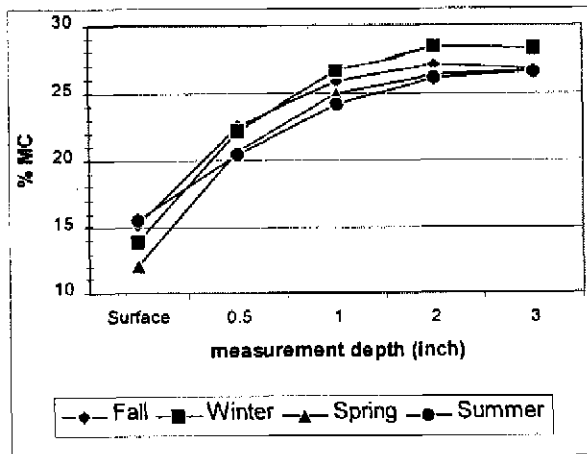
Figure 5 MC of Laminae over Abutment-St. Louis Cty.

Laminae over the abutments in the two regions have very different MC versus depth profiles. In St. Louis County the MC profile is a smooth curve that levels off at ~27% between the 2" and 3" depth (Figure 5) [Note, the maximum values for laminae in St. Louis County are only relative since meter readings higher than 30% were expressed as 30]. Laminae over the abutments in Sibley County are ~10% lower than St. Louis County with a maximum value of about 17% (Figure 6). The MC depth profile in Sibley County is basically linear with a gradual slope that may continue to increase past the 3" depth.

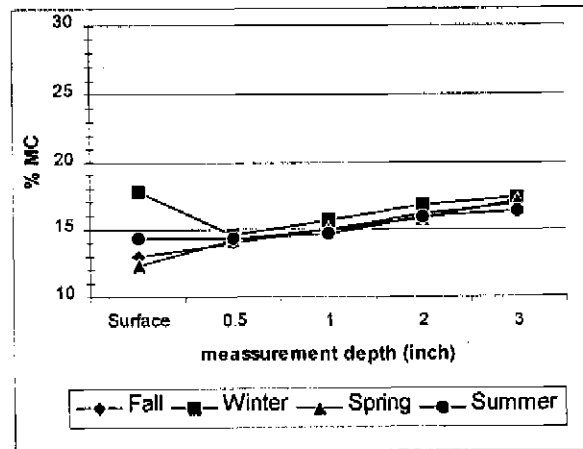
Figure 6 MC of Laminae over Abutment-Sibley Cty.

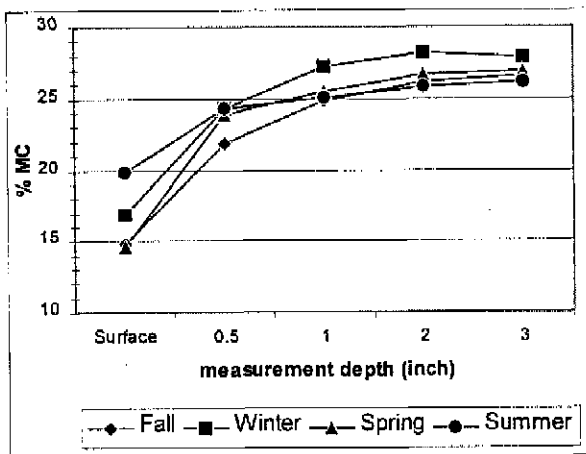
Figure 7 Laminae at Mid-Span-St. Louis Cty.

Mid-span laminae MC measurements are similar to those for laminae over the abutments. Again, the profile for St. Louis County is a curve which levels off at ~27% (Figure 7) and the profile for Sibley County is linear with maximum values at ~17% (Figure 8). The 1" summer measurements in Sibley County are 1% to 2% lower between the depths of 1" and 3".

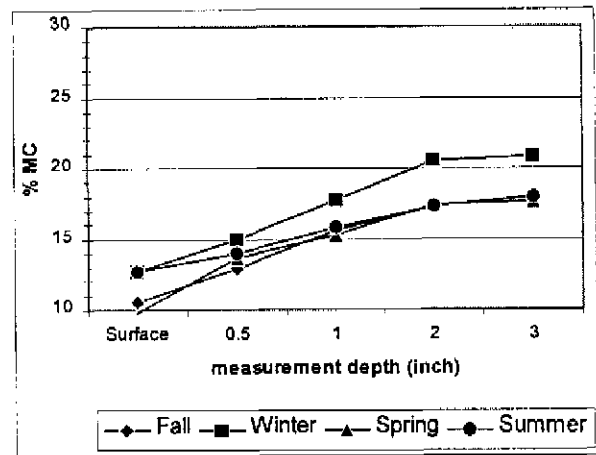
Figure 9 MC of TSB-St. Louis Cty.

The MC depth profile for the TSB in St. Louis County is significantly lower than profiles components in this region (Figure 9). Excluding the winter measurements, this

profile is linear up to the 2" depth and is levels to the 3" depth with a maximum MC of ~18%. The Sibley County TSB profile is also linear from 0.5" up to 2", it reaches a maximum MC of ~15% and then drops back to ~14% at the 3" depth (Figure 10).

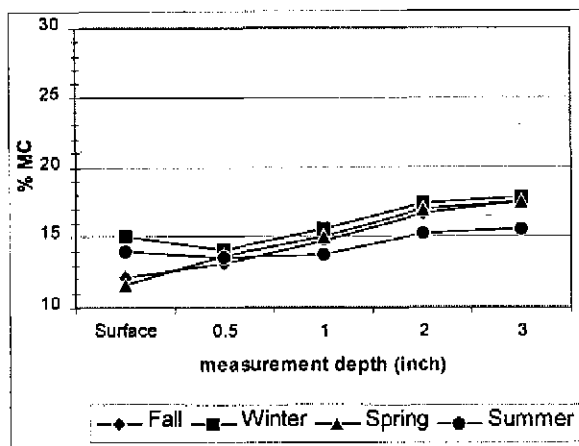
Figure 8 Laminae at Mid-Span-Sibley Cty.

b)  $m_s = \sim 17\%$  This is the EMC of mid-span laminae in Sibley County (Figure 8).

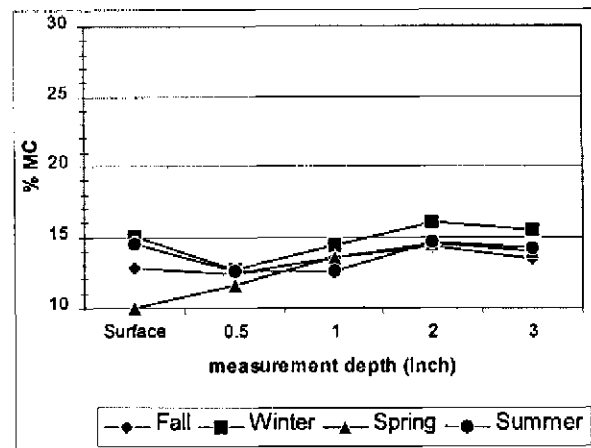
Figure 10 MC of TSB-Sibley Cty.

- a)  $S_o = 7.6\%$  The fasteners holding a TSB to the deck generally extend through the tangential direction of the TSB.
- b)  $m = \sim 15\%$  This is the EMC of a TSB in Sibley County (Figure 10).

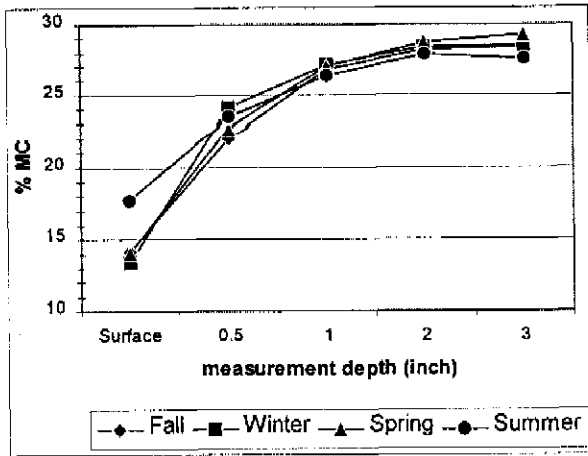
Figure 11 MC of Laminae Over Pier Caps - St. Louis Cty.

The MC profiles for laminae over the pier cap are again similar in patterns to the profiles of the laminae over the abutments and laminae at mid-span. Measurements in St. Louis County produce curves which levels at ~28% MC (Figure 11). The profiles for the Sibley County measurements are fairly linear with a maximum MC of ~18% at the 3" depth (Figure 12).

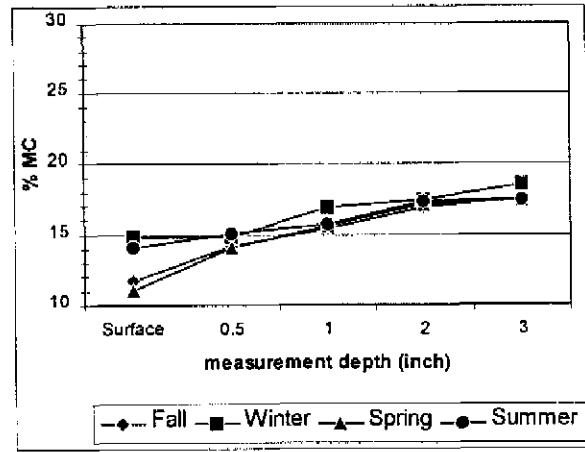
Figure 12 MC of Laminae Over Pier Caps - Sibley Cty.

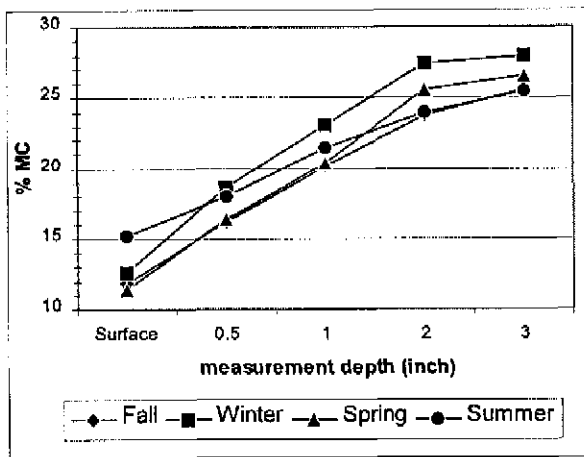
Figure 13 MC of Pier Caps - St. Louis Cty.

The MC profiles for the pier caps in each region are similar to the profiles for the abutment caps. The profiles from St. Louis County are linear up to 2", then level off to ~26% at the 3" depth (Figure 13). Sibley County also has profiles which are roughly linear from 0.5" up to 2" and then level to ~19% at the 3" depth (Figure 14).

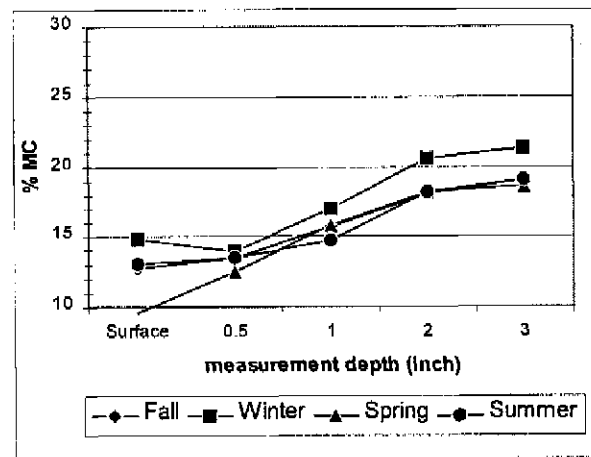
Figure 14 MC of Pier Caps - Sibley Cty.

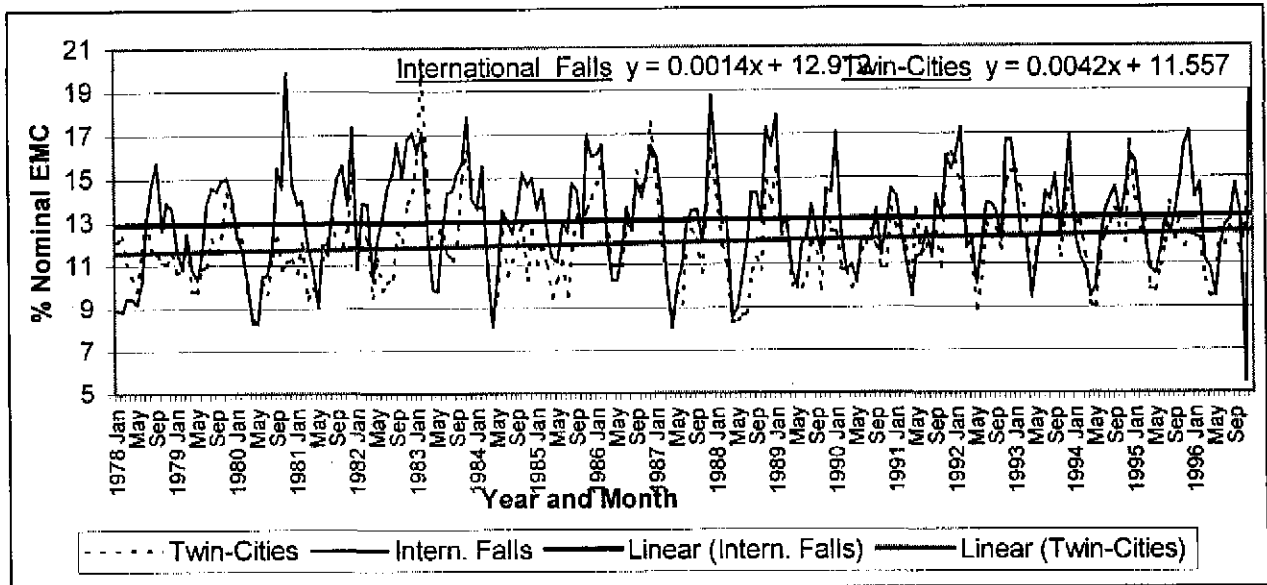
Figure 15 Calculated Nominal EMC for St. Louis and Sibley Counties

It is important to note that calculation of nominal EMC is based on sorption of moisture from the vapor phase and does not consider liquid moisture sorption. The annual nominal EMC for International Falls and Minneapolis respectively was approximately 13% and 11.5 % (Figure 15). The plotted linear regression trend for the 18-years indicates a 2.3% EMC increase for the northern region and a 7.8% increase for the southern region. While the nominal EMC does not directly correlate to the actual bridge EMC, it does support the observed higher EMC in the St. Louis County region.
