QUALITY CONTROL OF GROUTING FOR POST-TENSIONED TENDONS: IN-
LINE DENSITY MEASUREMENTS

A THESIS
SUBMITTED TO THE FACULTY OF
UNIVERSITY OF MINNESOTA
BY

JACOB ALLEN BRAY

MARCH 2019

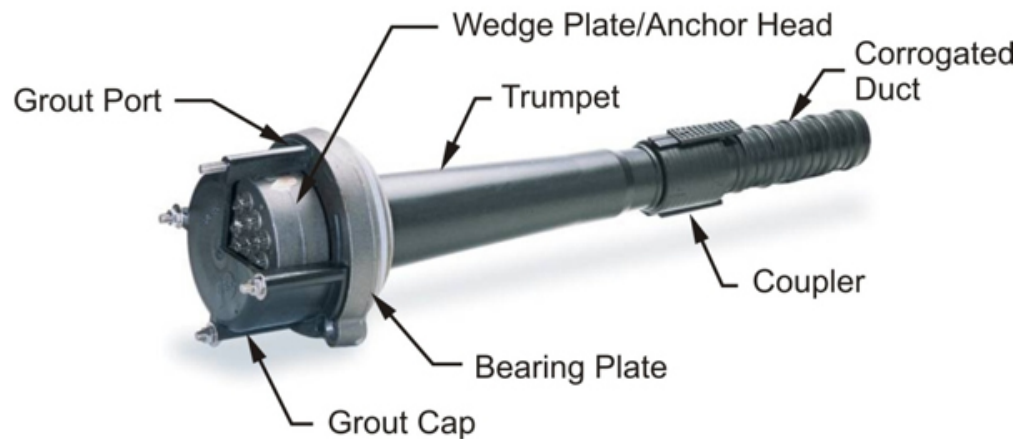
The system consists of concrete, ducts, grout, and high strength steel strand as shown in Figure 1.1. The steel strand is fed through the duct within the concrete member and stressed in the field to induce compression. To mitigate corrosion and provide dependable load carrying capacity, the steel must be protected. This is typically achieved by pumping cementitious grout inside of the duct that can also create a bond to the surrounding concrete structure. Successful PT has two major benefits of corrosion protection over traditional reinforced concrete: minimal cracking (with active forces to close cracks under loading) and multiple levels of corrosion protection.

Figure 1.1 Basic PT anchorage system [2]

The corrosion protection for the system relies on several components including the surrounding concrete, duct, grout, and anchorage protection. Figure 1.1 shows a basic PT anchorage system.

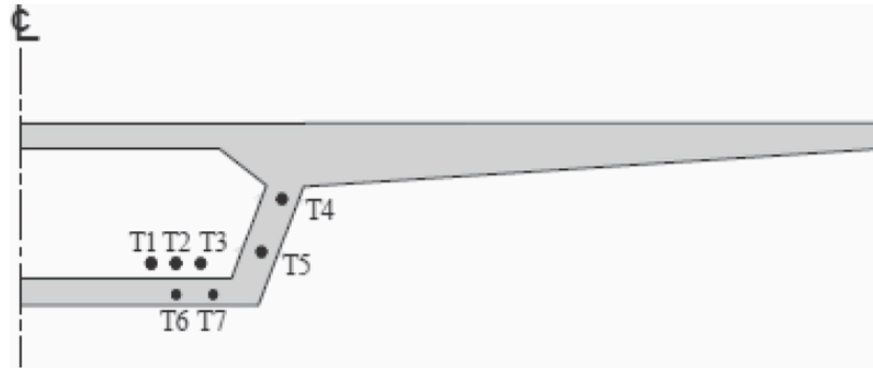
Post-tensioning uses two types of tendons, external and internal. External tendons are located outside the concrete. Examples of external tendons are shown as T1, T2 and T3 in Figure 2.1. The advantages of external tendons are simplified construction and inspection processes due to easier access. However, external tendons are also costlier, can only be used with a few tendon profiles, and the strands are not bonded throughout the structure [16]. Internal tendons (T4, T5, T6, and T7 in Figure 2.1) differ from external tendons by being placed within the concrete member. After grouting, these tendons are

Figure 2.1 Internal and external tendons in segmental bridge section. [17]

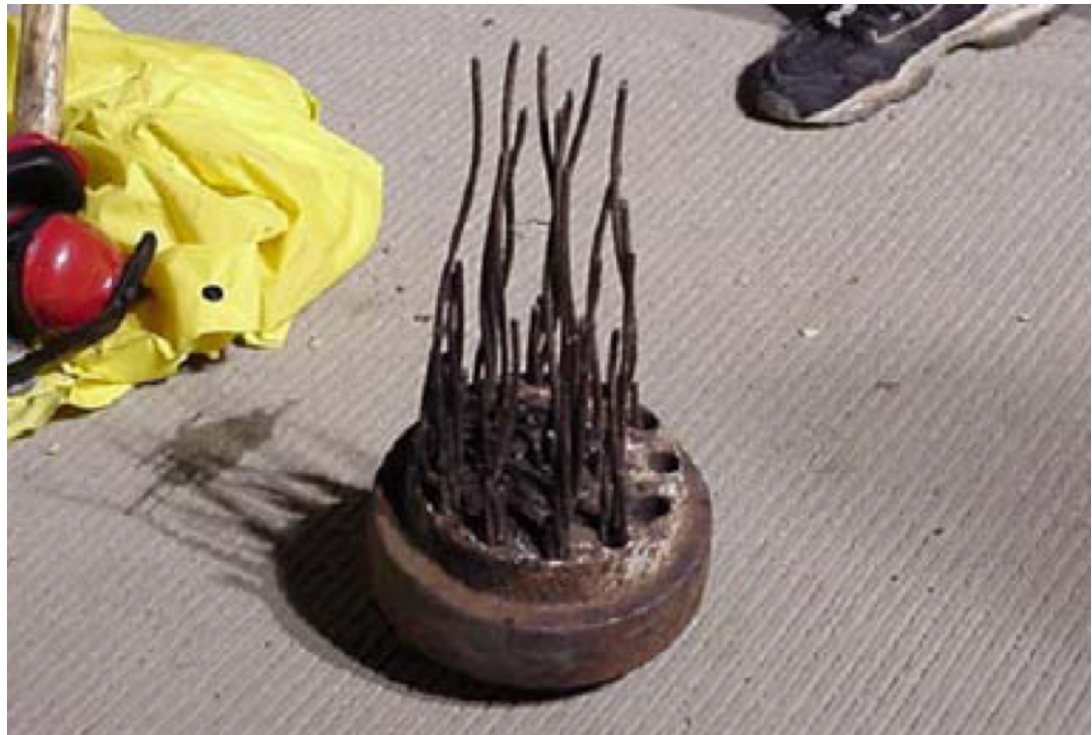
The Niles Channel Bridge is a 4,500 ft bridge made up of segmental precast post-tensioned concrete box beams. The tendons are made up of 19 strands inside a polyethylene duct. During a routine inspection, it was found that spalling concrete had exposed a wedge plate. Further investigation by Powers revealed all 19 strands had separated due to corrosion at that point [5]. The extent of the tendon corrosion is shown in Figure 2.2.

Figure 2.2 Corroded end-cap from a Niles Channel Bridge tendon [29]

The corrosion evaluation determined the upper trumpet (reference Figure 1.1) circumference had not been in contact with grout, merely grout bleed water. Although the failed tendon was demolished prior to the investigation, subsequent random hammer sounding and visual inspection revealed a high incidence of bleed water and voids in the grout.

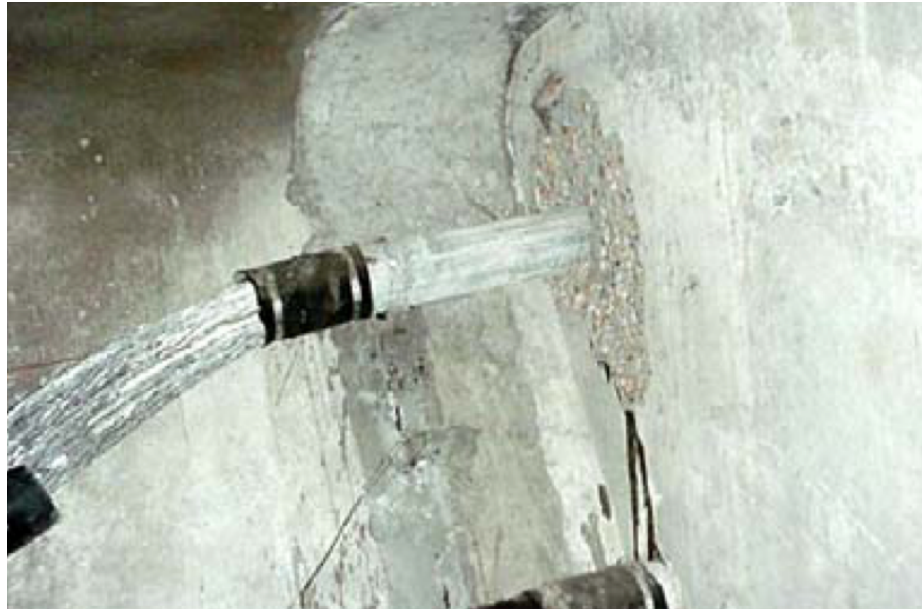
The Midbay Bridge is a concrete segmental box structure with external post-tensioned tendons. The bridge utilized 4-inch diameter polyethylene tendons, one containing 19 0.5-inch diameter strands and the other with 27 0.5-inch strands [6]. During construction, the tendons were stressed, and the ducts filled with a cementitious grout to protect the steel. Nondestructive testing was performed using a method developed by the University of Wisconsin Milwaukee based on magnetic flux leakage. During the testing of the tendons, two tendons were found to have corrosion issues [6]. Figure 2.3 shows the corroded tendon with the deviator pipe blown out after its failure.

Figure 2.3 Midbay Bridge tendon failure [30]

The corrosion of the strands was determined to come from water and oxygen entering the duct through a hole. The reason for the hole was speculative; however, the failure of two systems, both the duct and the grout, led to the corrosion.

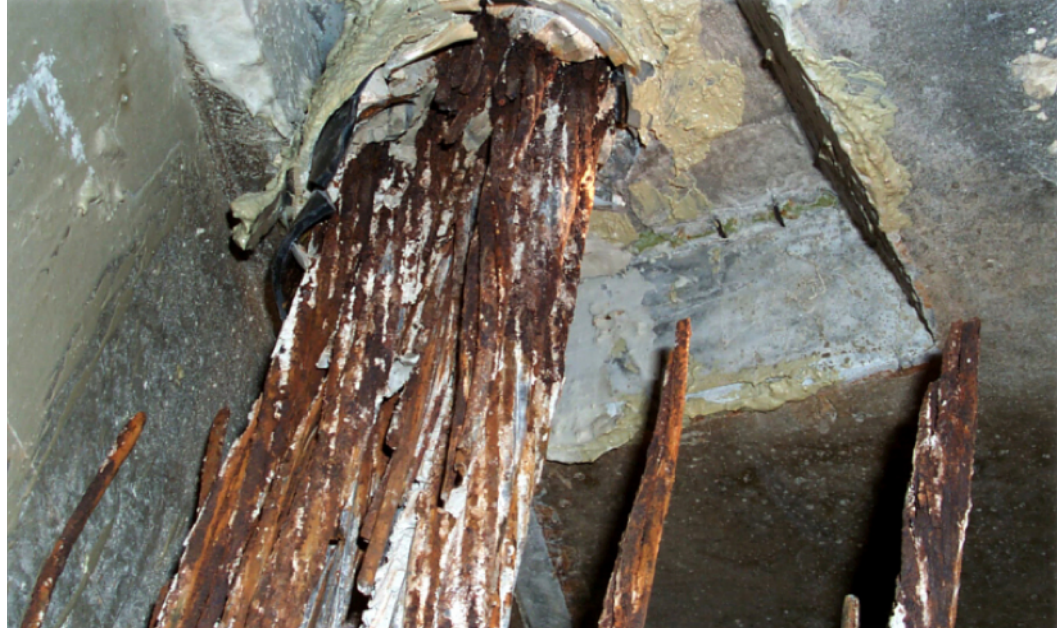
Further investigation found grout containing salt water in 28 of the high-level approach columns [8], [31]. Figure 2.4 shows the severity of the corrosion caused by the chlorides in the mix water.

Figure 2.4 Corroded tendon found in Sunshine Skyway [30]

It was found that grout had been contaminated with chlorides and a significant number of vertical polyethylene ducts had cracks or hollow surrounding areas. Due to the findings of the investigations, the research team recommended a universal repair plan to reach the bridge's original 100-year service life goal.

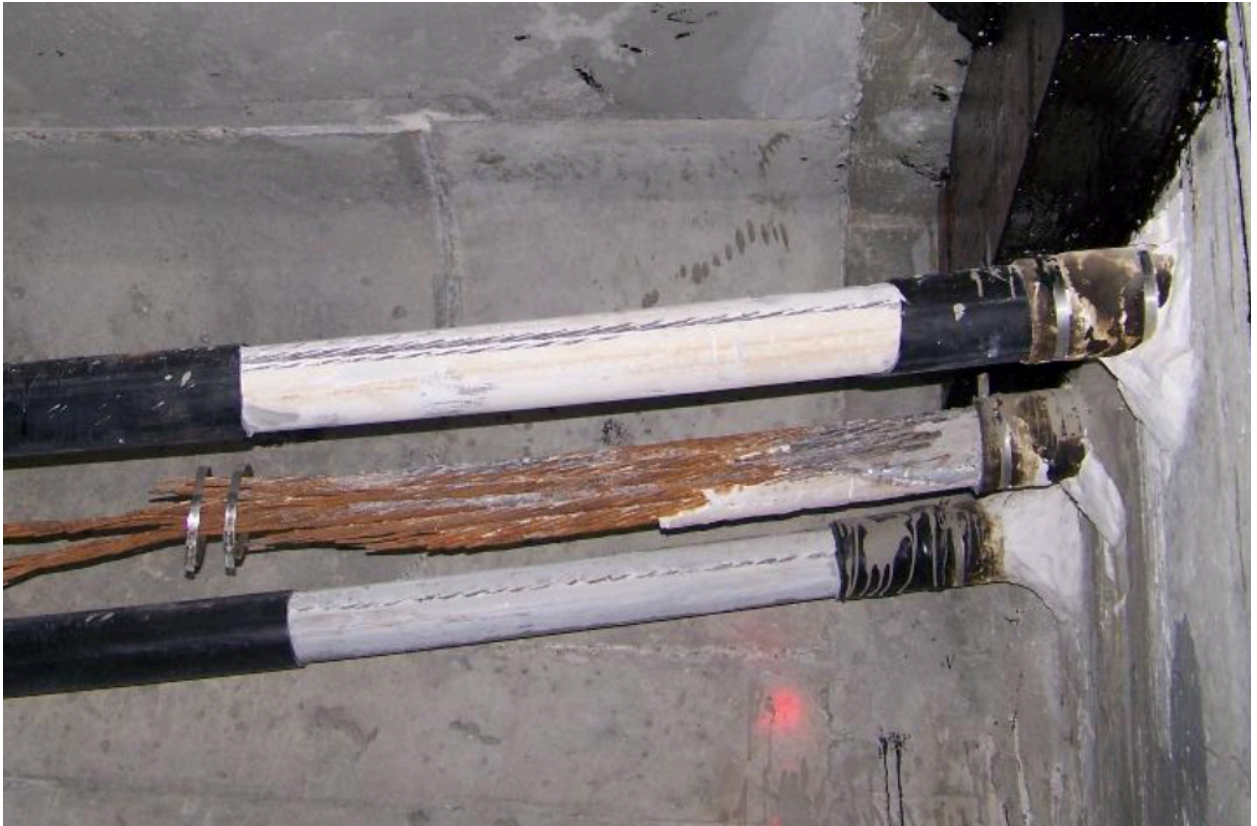
The Varina Enon Bridge was completed in Virginia in 1990. The bridge was approximately 630 ft long with 480 grouted tendons in the superstructure. In 2001, voids were found in many tendons during an inspection of the bridge, leaving the tendons unprotected. Vacuum grouting was used to fill the voids in 2004. Although the strands were not found to be corroded in 2001 and the voids were eventually grouted, a tendon failed in 2007 [7]. Two of the tendons were replaced, including the tendon shown in Figure 2.5, and 20 tendon sites were inspected using destructive measures. Eleven of the twenty sites investigated were found to have various levels of corrosion.

Figure 2.5 Corroded tendon from Verina Enon Bridge [32]

In 2011, it was determined that the grout used in the tendons contained chlorides. Another problem revealed during the investigations was the water-to-cement ratio (w/c) found in the tendons of the bridge exceeded 0.60 [7]. Typically, the recommended water to cement ratio is less than 0.30 meaning that the water content of the grout was more than double than the qualifying mix design. This exemplifies the need to ensure batching and construction practices are performed to the specified level.

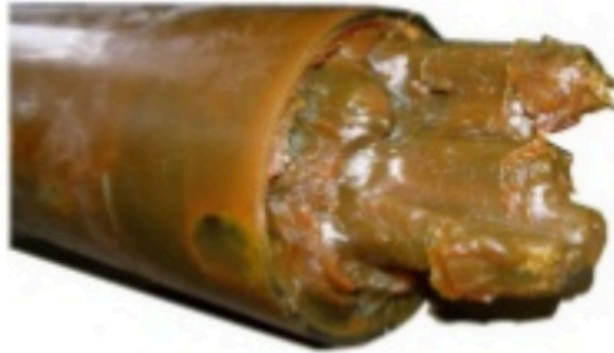
Due to the strand failures in the US and Europe, flexible fillers are gaining traction in the PT bridge industry as an alternative to cementitious grout [3]. Although more common in Europe, flexible fillers such as wax, petroleum gel, and grease were also recently implemented in Florida. These flexible fillers provide corrosion protection without bond to the duct or structure and are thus referred to as unbonded. Flexible fillers are pumped into the tendons at the anchor caps or a pipe saddle, similarly to grouted tendons. As shown in Figure 2.6, the wax filled tendon uses the same concept as grouted tendons. Wax is heated and pumped into the tendons to cover the strands as a physical barrier between potential oxygen, moisture, and chlorides.

Figure 2.6 Tendon injected with wax

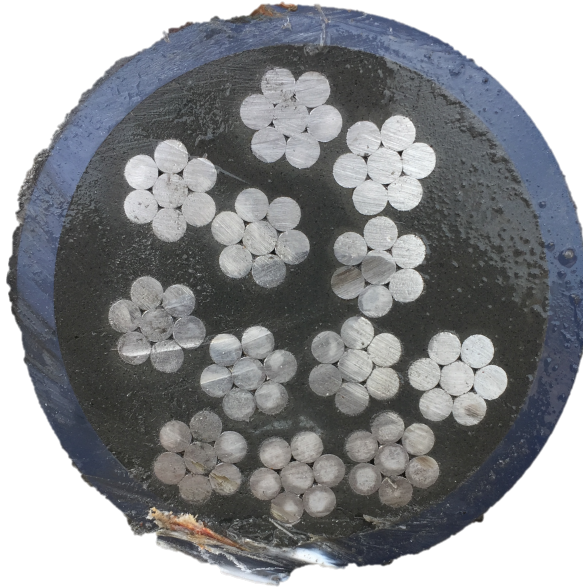
design process. The use of high-performance grouts in conjunction with proper construction practices can lead to well protected tendons such as the tendon shown in Figure 2.7.

Figure 2.7 Tendon adequately full of grout

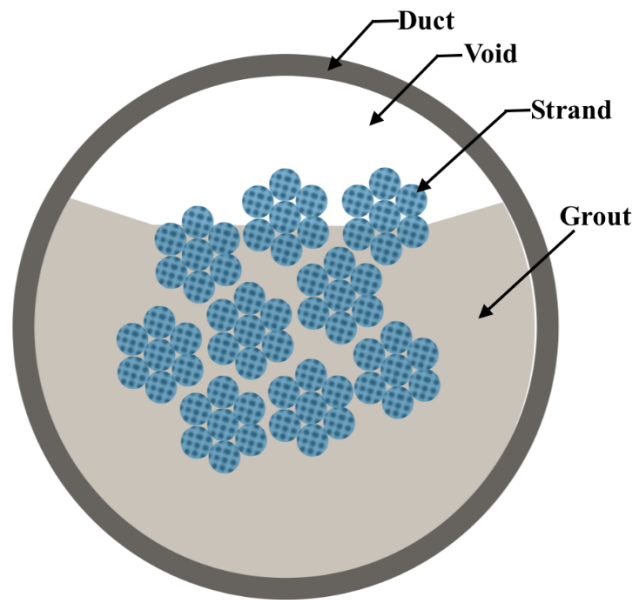
Bleed refers to the process in which individual particles in a fluid suspension of grout settle out of the solution, leaving excess water on the top of the settled solids [50]. Figure 2.8 shows the void left after the bleed water evaporates from the duct. Bleed is the leading cause of grout voids in ducts, increasing the risk of corrosion.

Figure 2.8 Grout Voids in Tendon

Voids in and of themselves do not damage the integrity of the structure, although extensive voids will not bond the strand to the concrete.

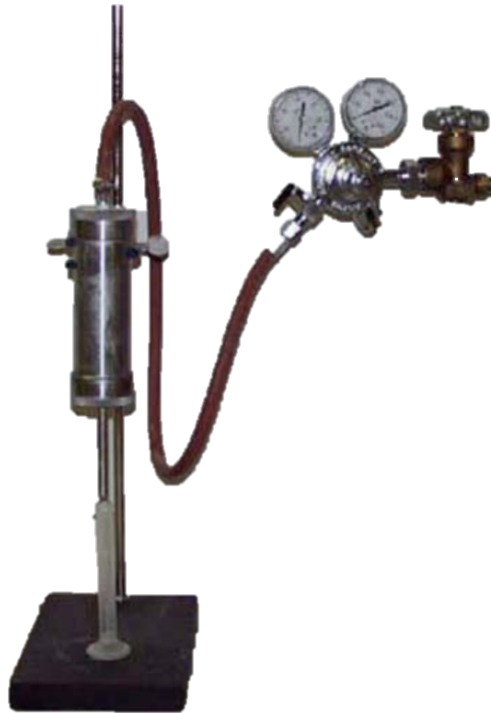
Since high pressure pumping increases the amount of bleed, a pressurized bleed test was developed by Schupack and later modified and developed as a specification by Schokker to simulate conditions where grout ducts experience high pressures (i.e. large changes in elevation) [51]. This test is used in the lab as a qualifying criterion and in the field to assure the proper w/s ratio is used in the ducts. ASTM C1741 Standard Test Method for Bleed Stability of Cementitious Post-Tensioning Tendon Grout is performed to verify the change of bleed at differing w/s ratios. The Schupack pressure bleed test requires the placement of grout in a pressure tube (shown in Figure 2.9) for 10 minutes, then the system is subjected to a specified pressure level within 30 seconds and held for five minutes [53].

Figure 2.9 Schupack Pressure Bleed test apparatus [53]

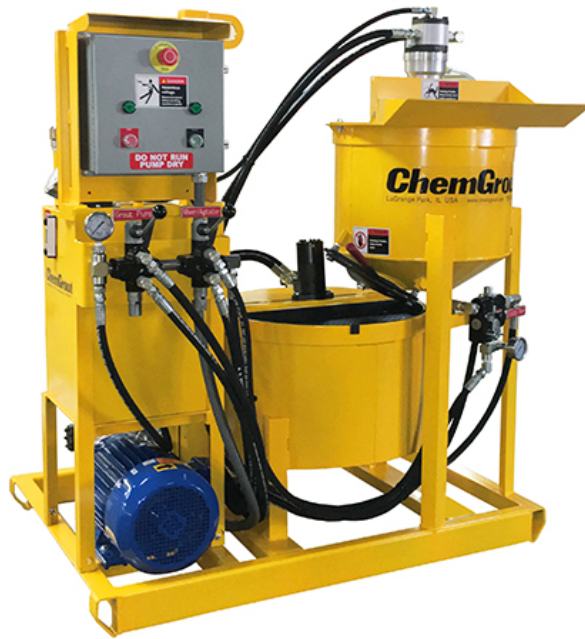
The grout plant used to prepare the mixtures is shown in Figure 3.1. The plant is equipped with a 22-gallon mixer to provide high shear mixing (rotating up to 3000 rpm), allowing complete wetting of the particles and adequate dispersion. The plant is outfitted with a 34-gallon agitator tank with a variable speed paddle mixer to prevent the grout from gelling up after initial high-shear mixing. The grout pump is connected directly to the agitator tank. The grout plant powers the components with electricity and hydraulics.

Figure 3.1 Grout Plant [57]

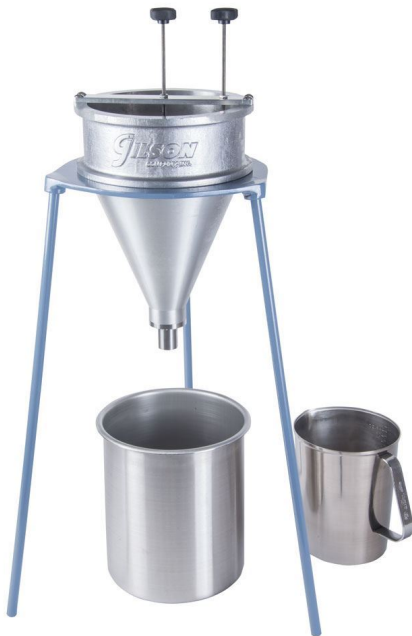
A modified method of ASTM C939 Standard Test Method for Flow of Grout for Preplaced Aggregate Concrete (Flow Cone Method) [48] was performed in accordance with PTI M-55. The test method is used both in the field and in the lab to determine efflux time [1].

Figure 3.2 Flow Cone Apparatus [58]

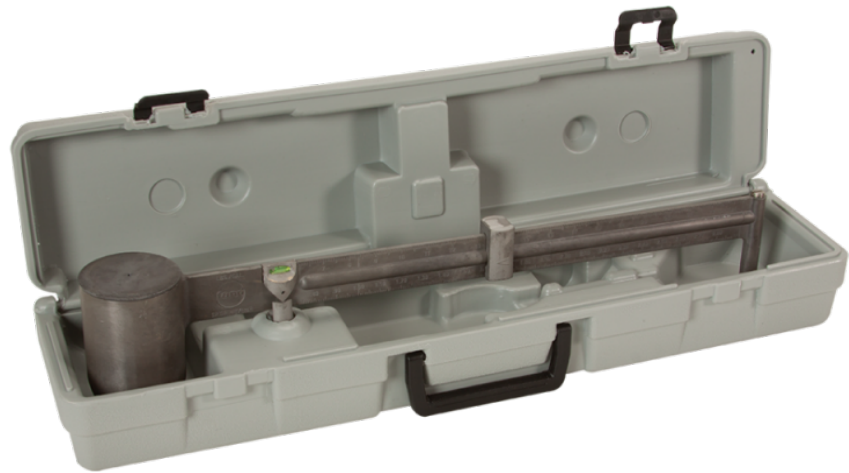
The Mud Balance test was performed according to ANSI/API Mud Balance Test Standards. The grout was tested at the pump outlet four times for each phase at approximately five-minute intervals. A range of wet densities was measured for every phase and repeated for each phase of the test.

Figure 3.3 Mud Balance Apparatus [59]

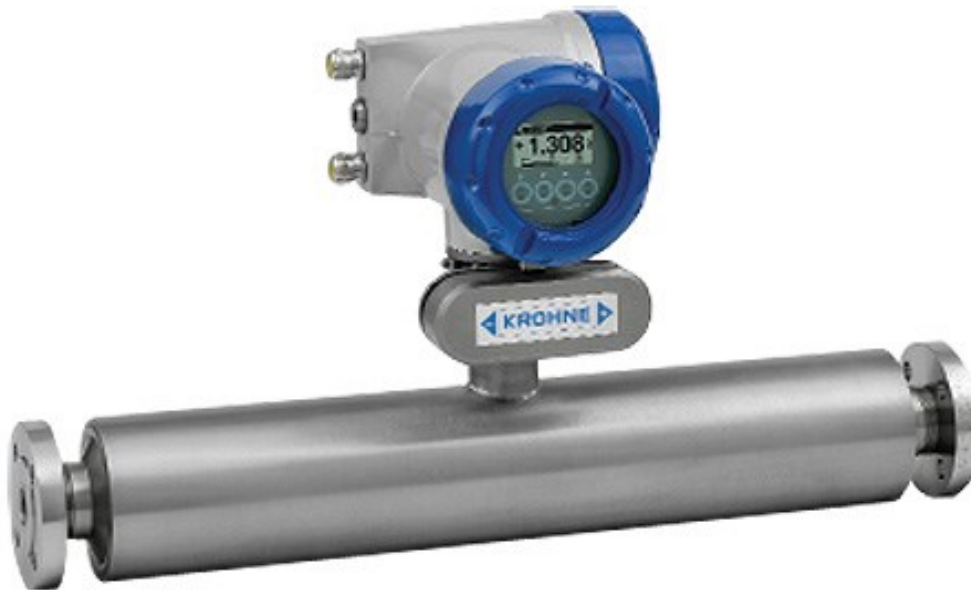
The in-line density meter used throughout testing is shown in Figure 3.4. The meter is placed in-line after the pump. The density, flow, and temperature of the grout was continuously monitored throughout the grouting process.

Figure 3.4 Coriolis mass flow meter [60]

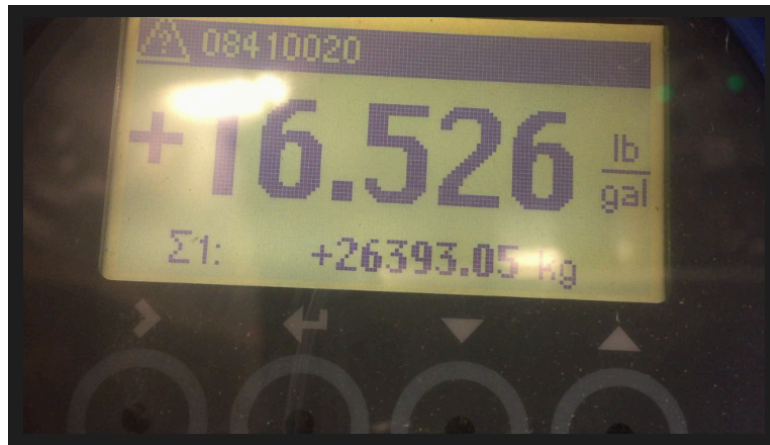
The OPTIMASS flowmeter was set to measure the density of the grout eight times per second. The in-line results show the density of the grout decreases as water dosage increased. The flowmeter had little variability at each water dosage showing the consistency of the meter. A 10% increase in water leads to a decrease of approximately 0.3 lb/gal in density. The mass meter measures the density to the thousandth of a pound per gallon. Given the preciseness of the mass meter some minor volatility was observed. Therefore, the density figures below show wet density averaged over one minute of pumping. The digital reading in Figure 4.1 shows live readings of density. Live readings allow inspectors and pumping crews to know exactly when the grout's density exceeds the manufacturers pre-approved range or when significant density changes occur.

Figure 4.1 Live Density Reading

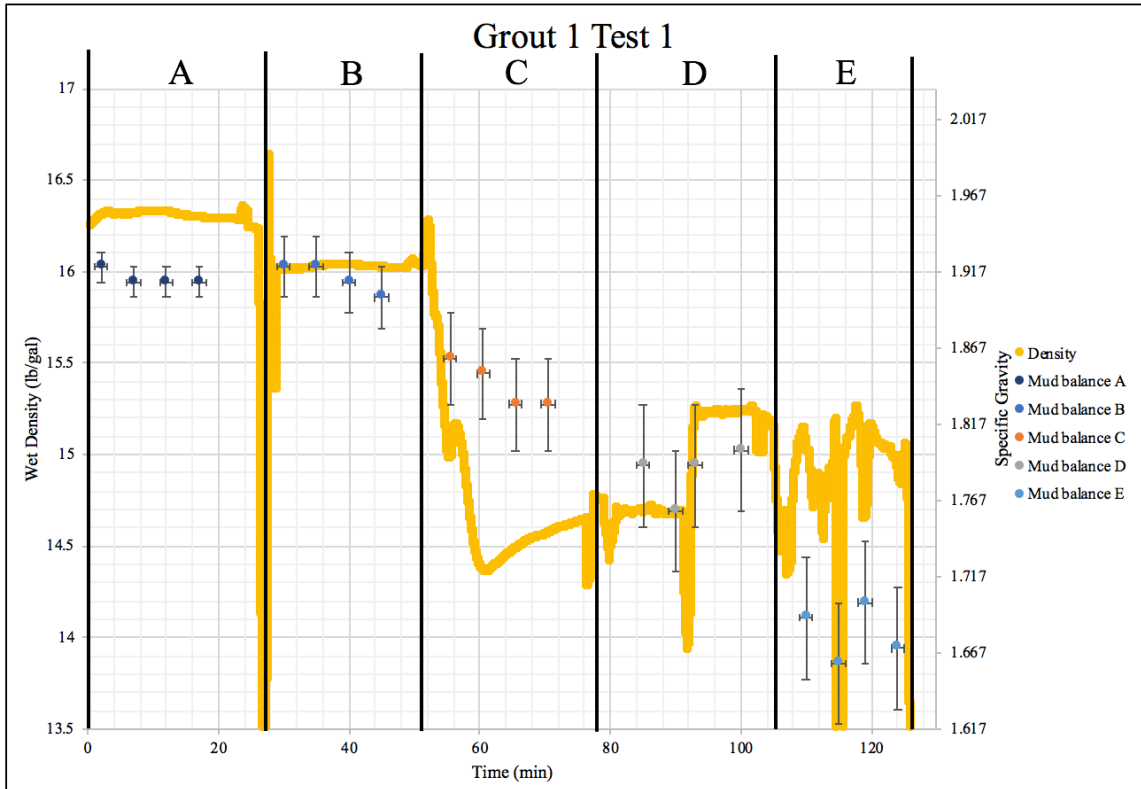
Figure 4.2 Density Results from Test 1 of Grout 1

Figure 4.2 shows the density data for Grout 1, Test 1. Overall, the data followed the same trends between the mud balance and the flow meter. The similar mud balance results between Phase A and B could be due to inadequate mixing. Clumps of unhydrated grout were found on the screen between the mixing tank and agitation tank. The unhydrated grout was then added to the next batch of water. Thus, the water to cement ratio from Phase A to B was similar. PTI M55.1 specifies “If lumps of cement remain on the screen, the mixture is not suitable for grouting.” Therefore, the grout would have been rejected for field use however since the data used in this research is relative, the results are still comparable to each other. During this test, hardened grout chunks were found in the mass meter as discussed previously. It was deduced that the blockage caused the

sudden decrease in measured density as the higher density grout was unable to pass through the blockage. The difference between the mass meter and mud balance during Phase C can be attributed to the blockage decreasing the density of the material allowed to pass through the meter since the mud balance was taken directly from the agitation tank where the density was higher. The pressure increase was noticed at the 110 min mark. At this time researchers fluctuated the pump back and forth between pumping the grout and trying to vacuum grout to release the blockage from in front of the meter. This contributed to the volatility in the graph during Phases D and E. The blockage was unable to dislodge using this method, so the grout was disposed of after Phase E and thoroughly cleaned. It is worth noting that the data recorded and displayed in the graph shows a history of the grouting process. Records like these can be valuable in determining where issues may have occurred and where to look if invasive inspections are needed.

The density graphs in this section show the one-minute average of wet density recorded by the mass flow meter throughout the duration of each test in yellow. The mud balance was measured at multiple intervals throughout each phase and the time of every

sample of grout was recorded. The mud balance results are plotted alongside the flow meter results in blue. The range error bars on the mud balance results show the range of results measured in each phase. The x-axis shows the time in minutes since the beginning of the test and the y-axis show wet density (lb/gal) and specific gravity.

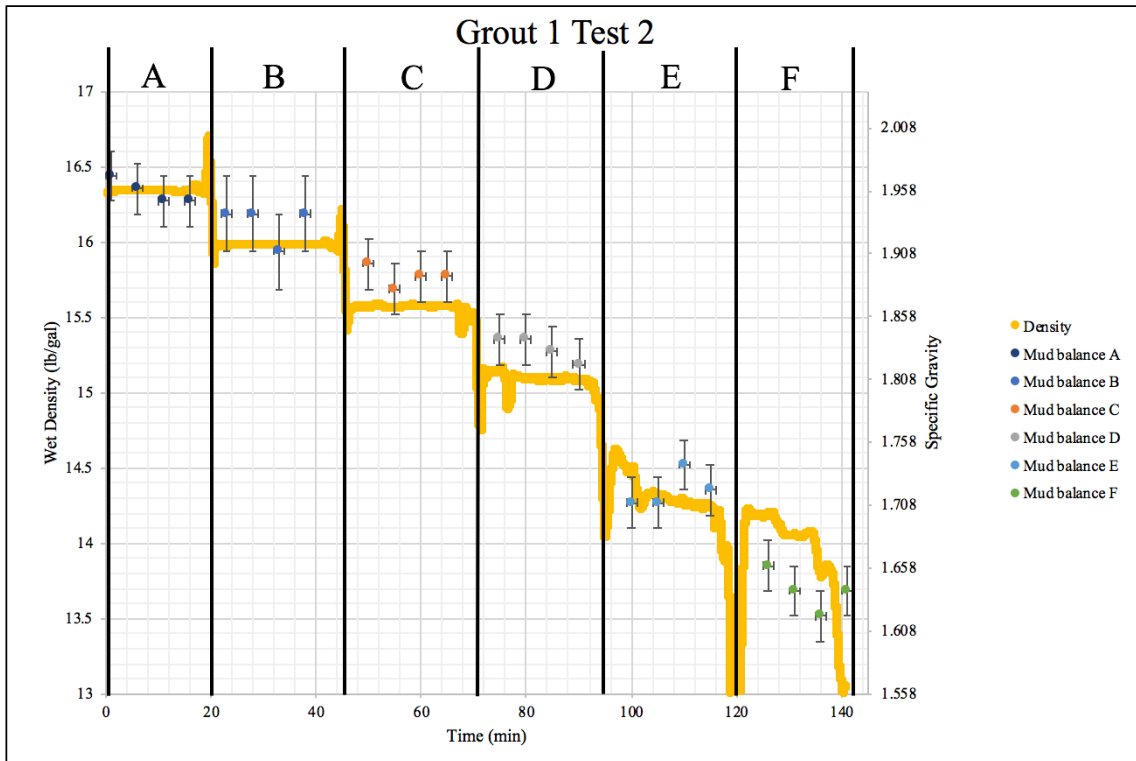
Figure 4.3 Density Results from Test 2 of Grout 1

The graph of Grout 1 Test 2 shows the expected variation of density over time. It can be seen that as water is added in each phase the density decreases. The steps in the density occur when additional water was added to the mixture. The mud balance results follow the trends of data recorded by the density meter giving confidence in the meter results. Additionally, the results are at values expected for this grout at the water ranges used. Note that only Phases A and B represent the allowable water contents for this grout – these show the expected density over 1.9. As water is added, the grout density has a clearly distinguishable drop at each water addition.

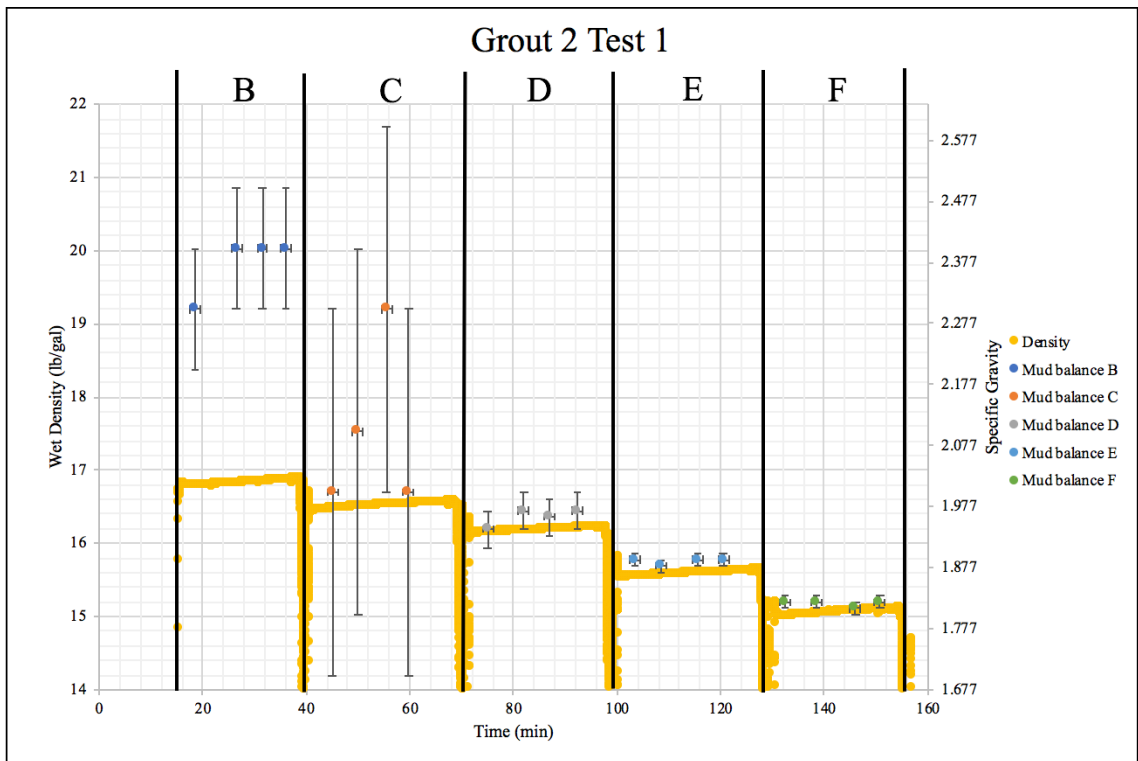
Figure 4.4 Density Results from Test 1 of Grout 2

The data in this figure represents the results of the grout that exhibited flash set behavior. The mud balances in Phases A and B of the tests are further from the graphs than the rest of the water contents. This is likely due to a testing procedure error. As the grout was nearly instantly entering a non-fluid state, the excess grout in the mud balance did not allow grout to flow out through the small vent hole in the cap leading to a higher

volume, higher weight, and thus higher apparent density. Even though the grout was flash setting, the results show the stepping of density described above as long as the grout was able to be pumped. At the end of this test, the mixer seized due to another flash set and could not be water flushed. The mixer had to be disassembled and pumping parts replaced. In the field, any grout exhibiting this behavior should immediately be flushed from the mixer and discarded.

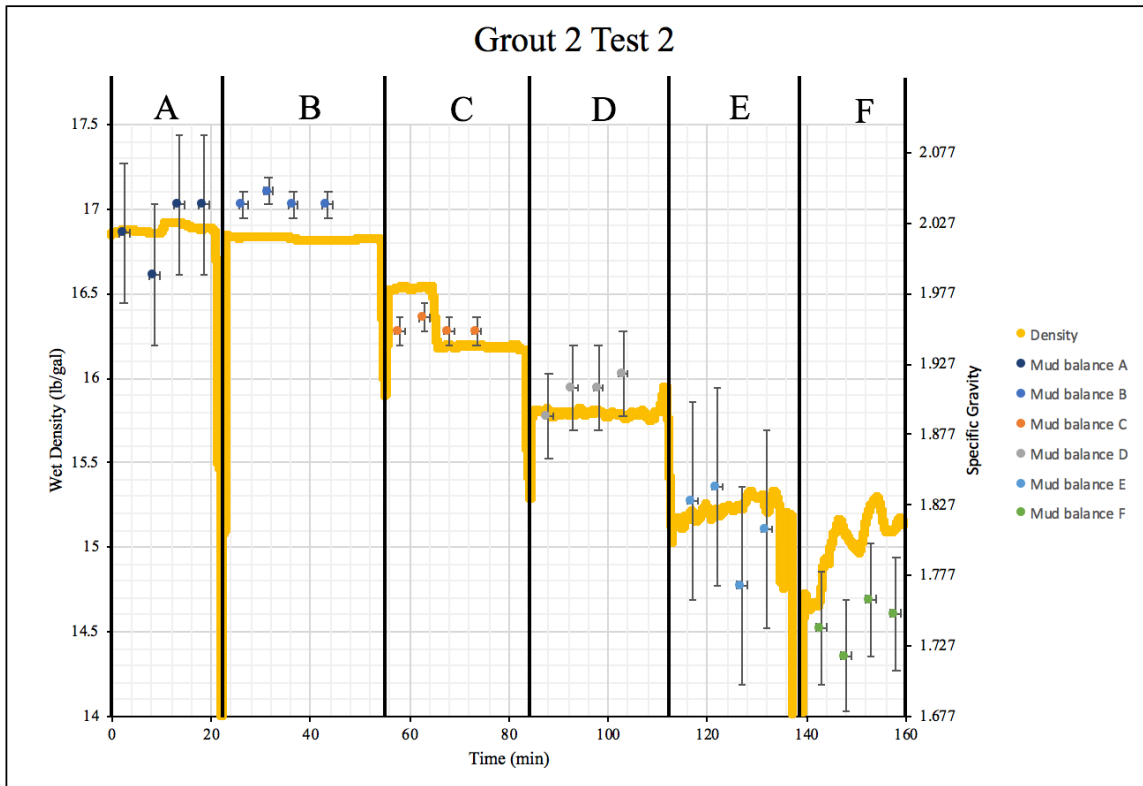
Figure 4.5 Density Results from Test 2 of Grout 2

Grout 2, Test 2 also shows the similar densities in Phases A and B due to clumping of dry grout as described above. The stepping in the density is also seen. The step in Phase C around the 60-minute mark can be attributed to inadequate mixing. Once the grout was fully mixed the density remains constant.

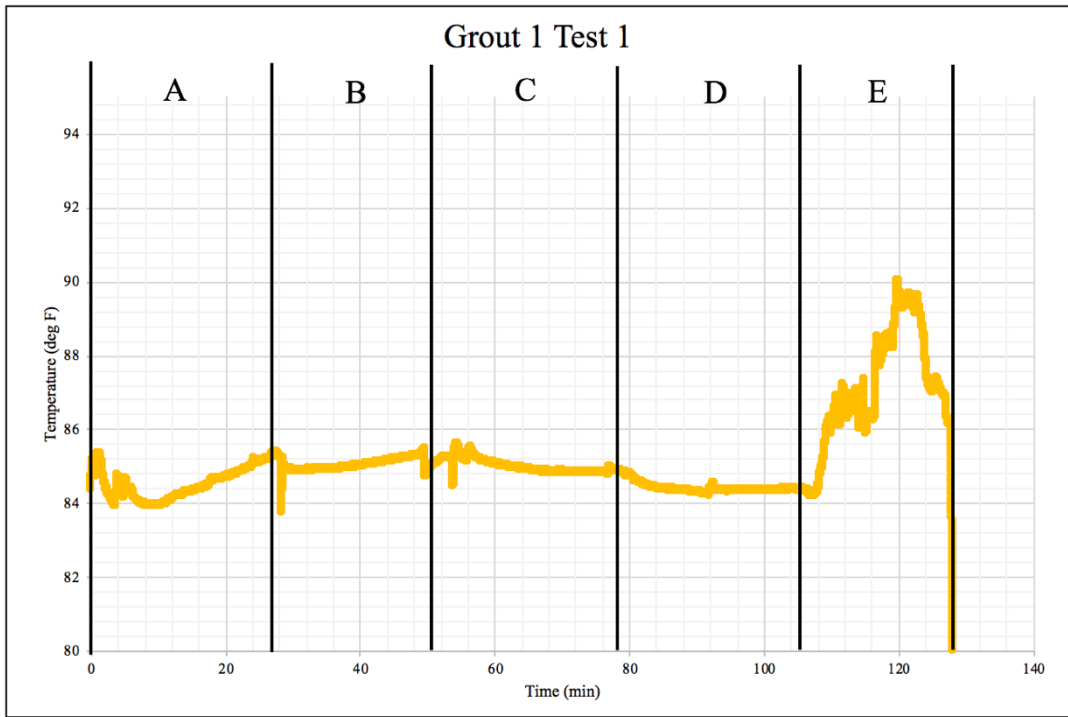
Figure 4.6 Temperature Results from Test 1 of Grout 1

The in-line mass meter measures and records temperature using a Pt500 sensor. The temperature was studied to further detect possible issues during the grouting process. PTI M55.1 specifies special precautions shall be used to ensure the temperature of grout is kept below 90 degrees Fahrenheit. The results show the temperature of the grout rising as the cement begins to hydrate. Grout 1 started around 86 degrees and rose slightly during each phase. At the change of each phase, the temperature drops slightly as cold water is added to the grout. During Test 1 of Grout 1 the temperature is seen to increase dramatically at 110 minutes. This was due to the blockage of the meter described above. Heating of the equipment due to blockages or clumping can also contribute to the heat rise.

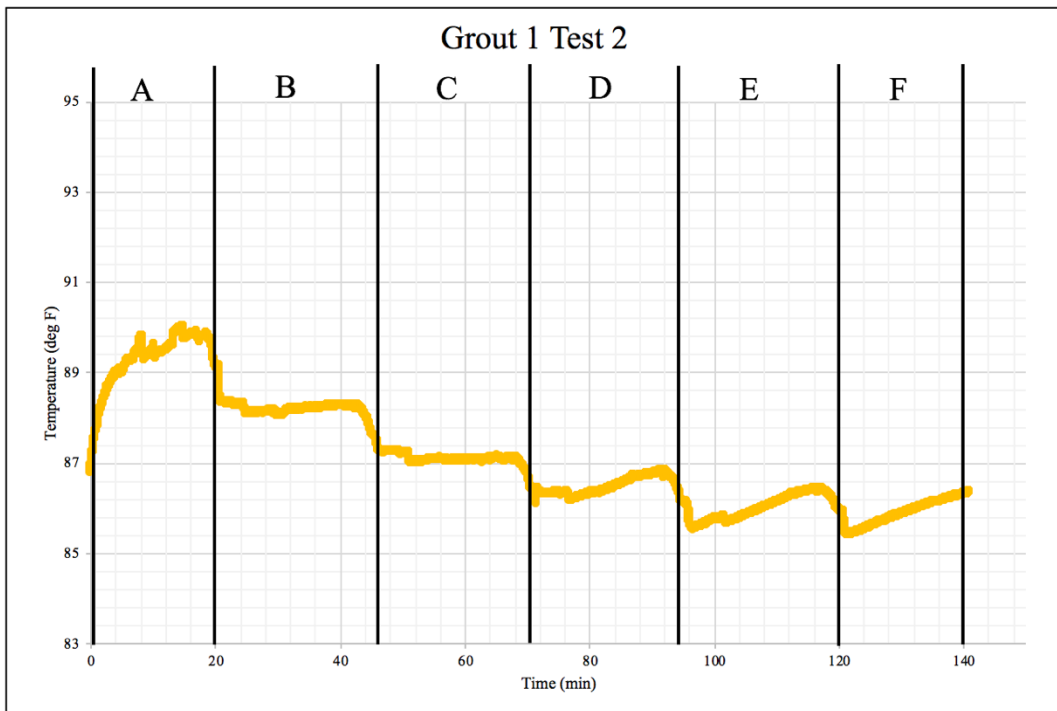
Figure 4.7 Temperature Results from Test 2 of Grout 1

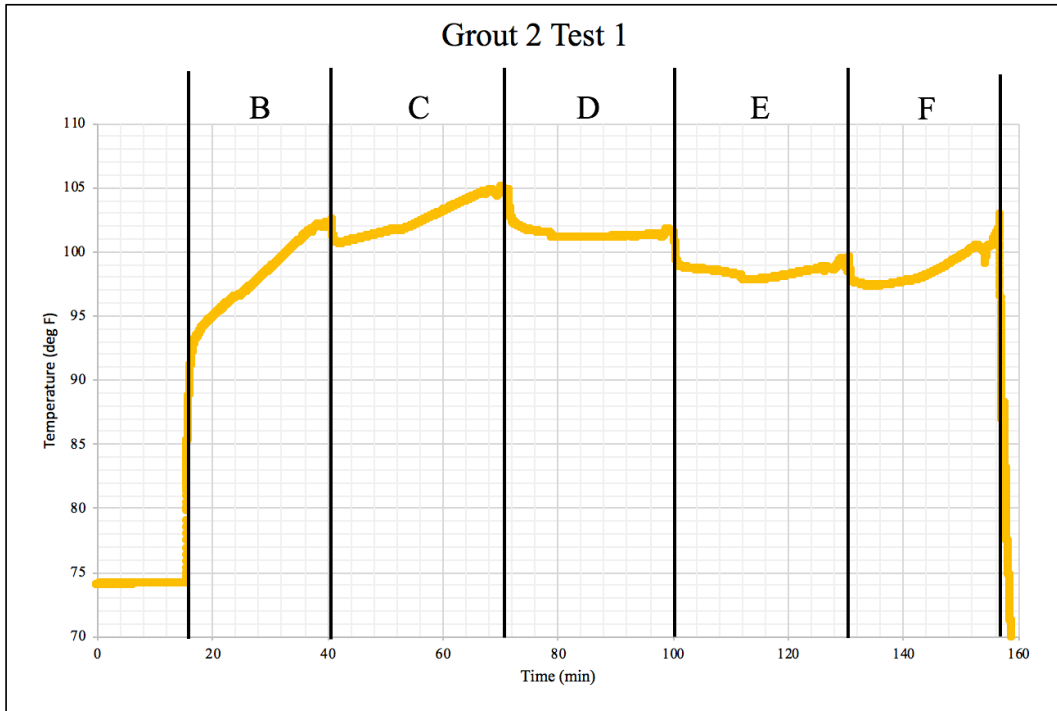
Grout 2 started with an ambient temperature around 74 degrees and rose quickly in both tests. In Test 1 of Grout 2 the temperature immediately increased over the recommended 90 degrees and passed 100 degrees reaching approximately 105 degrees. This temperature rise was a good indicator of the issues to come. Even when cold water was added to the grout the temperature remained above 90 degrees for the entirety of the test showing flash setting behavior described above. During Test 2 of Grout 2 the temperature rose above 90 but as more cold water was added the temperature decreased to an acceptable quantity. The temperature data is shown below.

Figure 4.8 Temperature Results from Test 1 of Grout 2

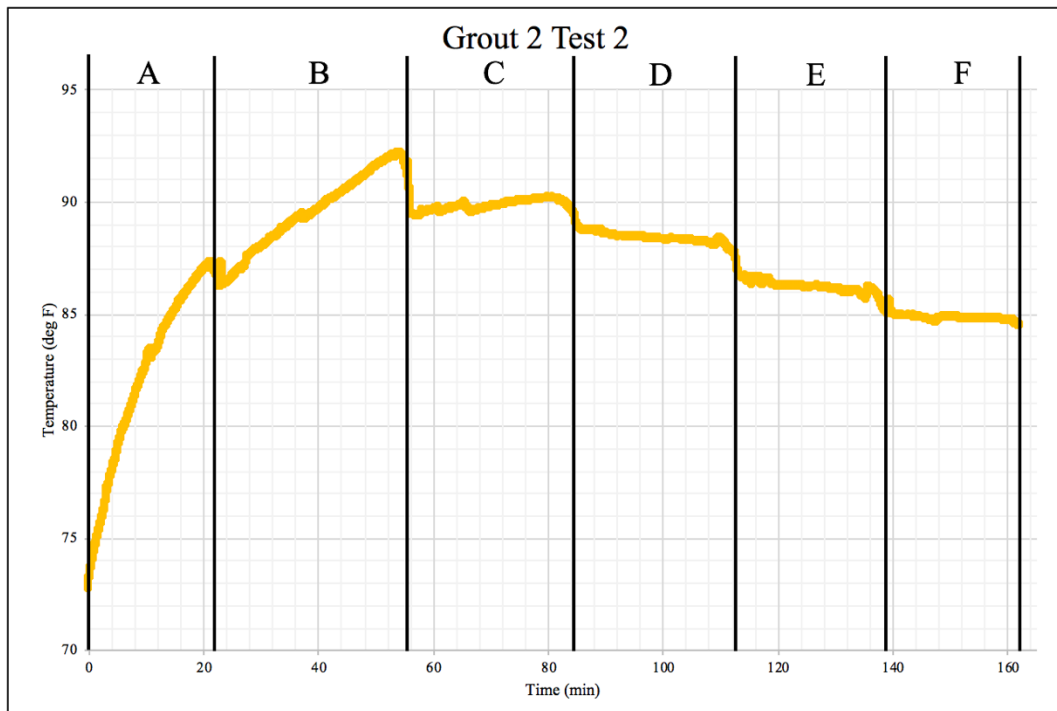
Figure 4.9 Temperature Results from Test 2 of Grout 2
