UNIVERSITY OF MINNESOTA
ST. ANTHONY FALLS LABORATORY
Engineering, Environmental and Geophysical Fluid Dynamics

Project Report 396

**Hydraulic Stability of Channel Lock™
Concrete Block Revetment System
During Overtopping Flow**

EROSION PREVENTION PRODUCTS
Houston, Texas

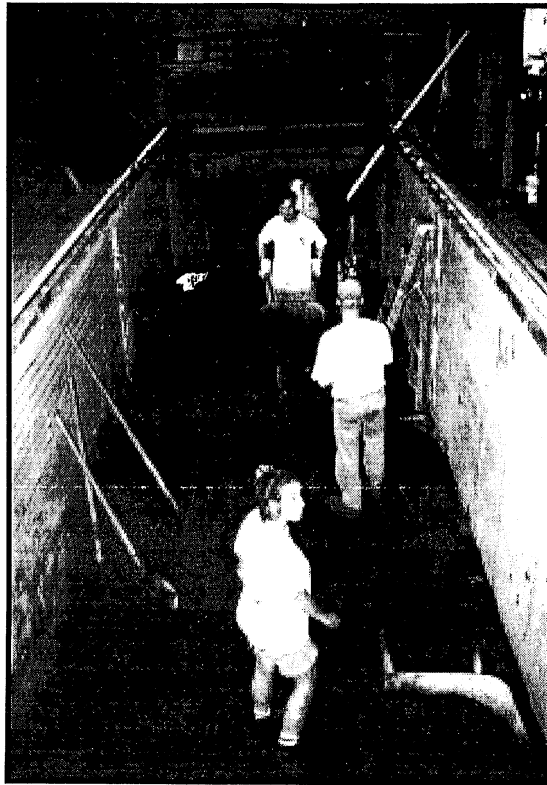
Photo 1. Placing soil in channel.

The soil used to construct the embankment was a silty, clayey sand, designated as SC under the Unified Soil Classification System. This soil was similar to that used in the U.S. Federal Highway Administration's previous tests. The soil was compacted to 90 percent \pm 5 percent of standard Proctor Compaction Density in lifts of approximately 6 to 9 inches. This soil is highly erodible when compacted to less than 95% of standard Proctor density, as it was done for this test. More detailed information about the soil is in Appendix B, page 23. Photo 1, page 6, shows the soil being put into place.

Photos 1, 2, and 3 show the facility prior to testing the Channel Lock™ blocks. Instrumentation included a specially designed point gage to measure both bed surface elevation, water surface elevation, and water depth. A 3-hole pitot cylinder was mounted to the point gage and was orthogonal to the bed surface during all measurements, in both the horizontal and sloped region of the embankment.

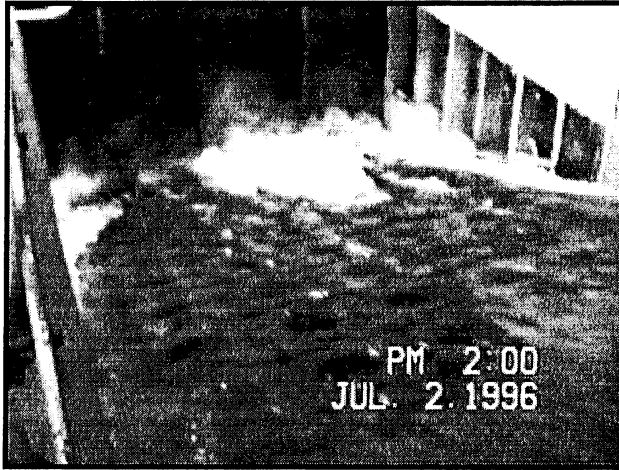
Photo 4. Eighteen inch overtopping flow.

Test Run 1 lasted about 5-1/2 hours due to problems collecting data. Following Run 1, inflow was shut down and an inspection was made of the embankment. The two center blocks at Station number 13 had displaced vertically slightly, approximately 1/2 inch. There was no erosion of soil and none of the other blocks on both the slope and horizontal sections had been displaced.

Station 13 experienced the highest velocity of water, 14.2 feet/sec. The shear stress at this location was 5.1 lbs/ft². This Test Run is shown in Photo 4, page 9.
