SLOPE STABILIZATION FOR LOCAL GOVERNMENT ENGINEERS IN MINNESOTA

A THESIS

UNIVERSITY OF MINNESOTA

May 2017

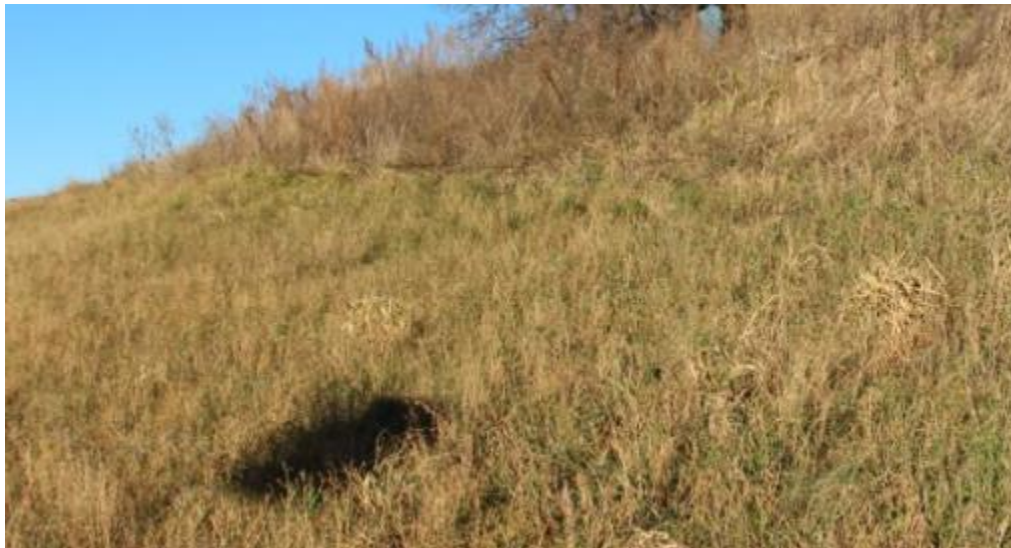
Another advantage of vegetative cover is ease of installation. No specialty equipment is required. Grass seed can be easily placed at low labor cost, and material is readily available. Installing surface vegetation after a slope stabilization project is common practice. Figure 4 shows a site demonstrating steep slopes with vegetative cover.

Figure 4: Naturally vegetated slope in Lac Qui Parle Co., MN

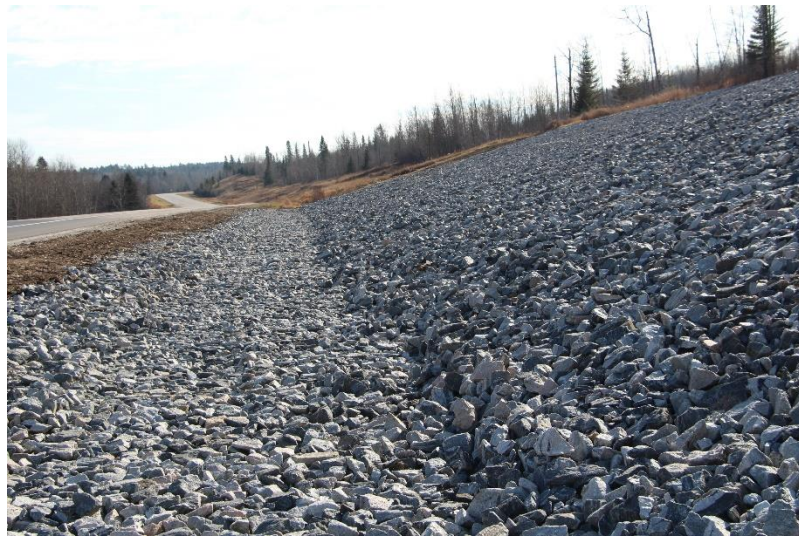
Placing coarse gravel or cobble rip-rap on the slope surface can provide protection from erosion. Figure 6 shows a large slope entirely covered with quarried cobble. Rip-rap placement is labor-intensive and generally has a higher cost than earthwork buttressing, but can provide erosion protection. Using high-flow concrete (shotcrete) is an option with similar cover advantages. Many cover methods are primarily erosion control; adding cover material can increase the weight of a slope and decrease global stability, depending on the material and site geometry.

Figure 6: Slope covered with rip-rap in St. Louis Co., MN

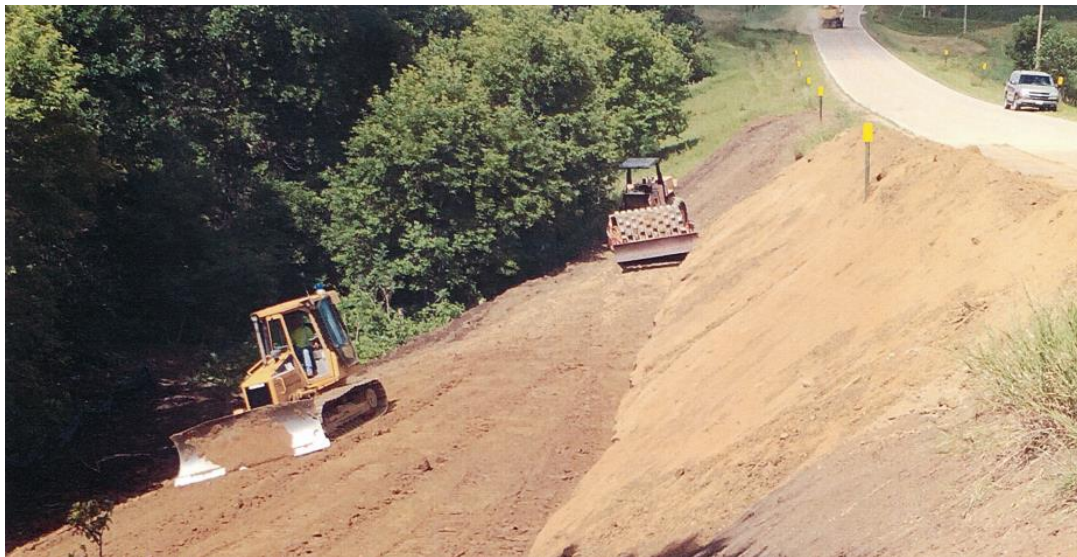
Free draining compacted fill has ideal properties for slope material. Replacing slope soil with engineered fill (i.e. clean sand or tested borrow material) minimizes uncertainty in ground conditions and eliminates factors that lead to slope instability. Removing *in situ* soil and placing fill also allows the design team to control the geometry of the slope. However, space and budget considerations can make this method impractical. In cases where the remove-and-replace option is appropriate, proper fill selection improves *in situ* strength and drainage properties. Figure 7 shows one such case, where a convenient source of fill was located near the site, making the remove-and-replace method feasible.

Figure 7: Slope reconstruction project in Murray Co., MN (From Murray Co. Highway Department)

The Murray County site was located on CSAH 22 near Plum Creek south of Walnut Grove, MN. Evidence of pavement repair identified the site location. The county engineer and maintenance supervisor were present at the site. The slope had been repaired in 2014 using nearby fill, placed and compacted in lifts with geosynthetic reinforcement (shown earlier in Figure 7). Figure 30 shows the reconstructed slope.

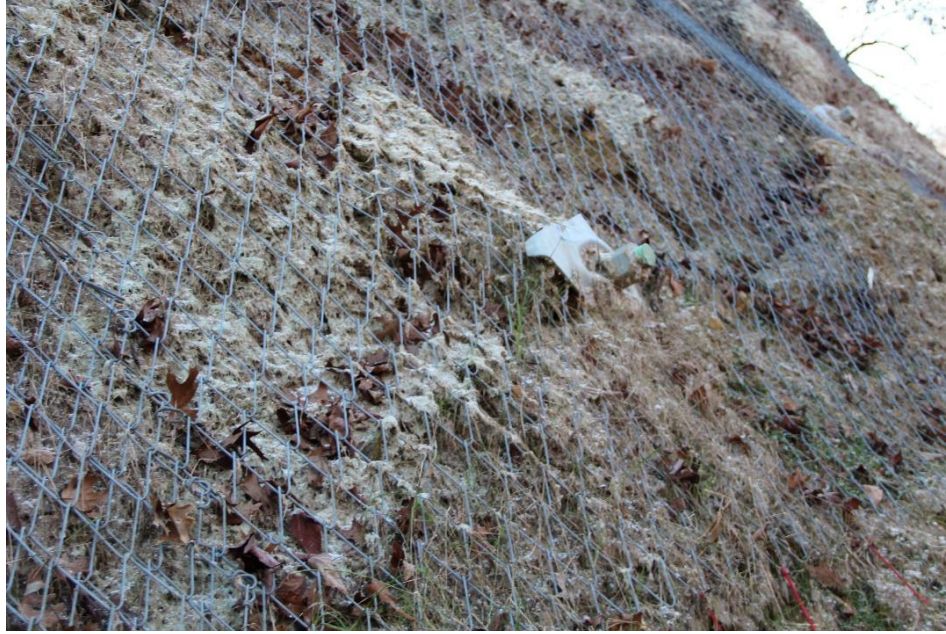
Figure 11: Rock bolts in combination with mesh cover in Washington Co., MN

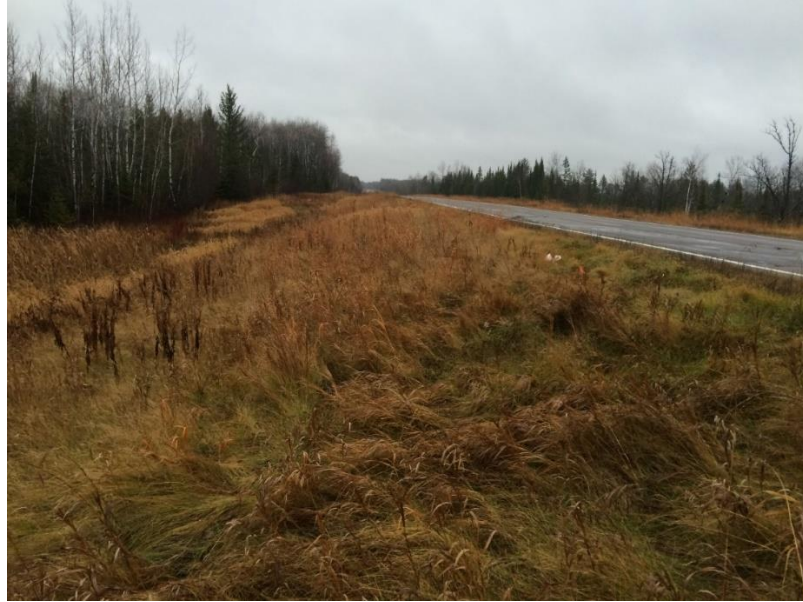
The Carlton County site was located on CSAH 6, approximately 7 miles east of Barnum, MN, near County Road 103. The assistant county engineer described the project history. The failure was identified by pavement distress. The site cover was tall grass, as Figure 19 shows. *In situ* material was red to brown clay with sand seams. The sand was brown to light brown and fine to medium-grained. Field testing indicated an average undrained shear strength (S_u) of 1.25 to 1.5 tsf. DCP testing indicated N_{60} values were approximately 2 blows per foot. There was no observed groundwater during sampling. Ojakangas (2009) identified the site's surficial geology as glacial drift. The observed fine-grained soil is representative of glacial deposits. The geologic identification is consistent with Hobbs & Goebel (1982). There were no observed slope stabilization attempts.

Figure 19: Carlton County site slope

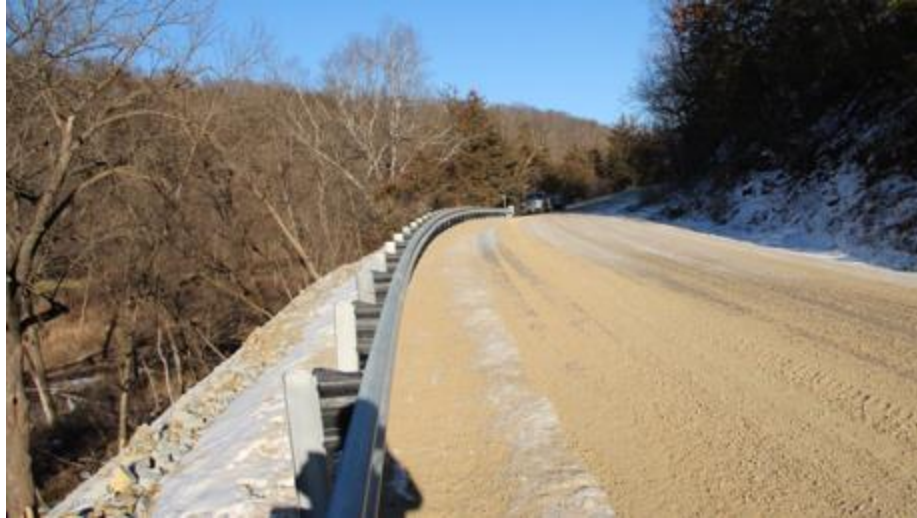
The Houston County site was located on County Road 19, near Riceford Creek, approximately three miles northwest of Spring Grove, MN. The section of roadway was unpaved. A county engineering technician highlighted the project history and details onsite. The technician provided slope geometries from before the failure. The uphill side of the road exhibited no slope failure that affected the roadway. The downhill side of the slope was the subject of the repair and stabilization, shown in Figure 24. The slope's toe immediately bordered the creek. The technician indicated that large flooding events caused most of the county's slope stability problems. The slope failed after flooding in 2013.

Soil samples were collected on the slope above the roadway, shown in Figure 25, which was original slope material. Soil was brown to dark brown silty sand. No DCP testing was conducted at this site. Surficial geology of the region was weathered material on Cambrian-Ordovician bedrock (Ojakangas, 2009; Hobbs & Goebel, 1982). The immediate proximity of the toe of the slope to a stream indicated groundwater concerns.

Figure 25: CSAH 19 (Houston County site) with steep uphill and downhill embankments

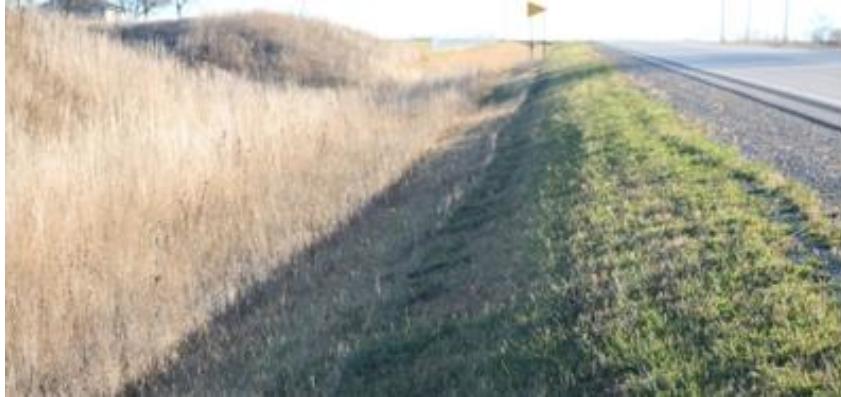
The Lac qui Parle County site was located on CSAH 20 between the Minnesota River and Lac qui Parle Village. The county engineer was onsite to describe erosion issues observed in the area. There was minimal evidence of slope failure affecting the roadway, as Figure 27 shows, but there were some failures at the edge of fields. The main concern was erosion of back slopes between planted fields and the ditch. Several examples of erosion were noted from field runoff causing washout similar to rotational slope failure, as Figure 28 demonstrates.

Figure 27: Steep backslopes at the Lac Qui Parle County site

Soil encountered was brown fine to medium-grained sand with trace gravel. The soil had correlated N_{60} values ranging from 5 to 7 blows per foot. *In situ* testing indicated S_u values of 1.25 to 2 tsf. Ojakangas (2009) and Hobbs & Goebel (1982) identified the geology of the region as sediment from the Minnesota River, consistent with granular soil observed. The county engineer provided project documents from recent roadwork (grading in 2013 and surfacing in 2014). Landowner property boundaries and right-of-way concerns caused geometry limitations next to planted fields. Areas with naturally forested uphill cover did not show evidence of failure. Erosion was the driving force of the failure.

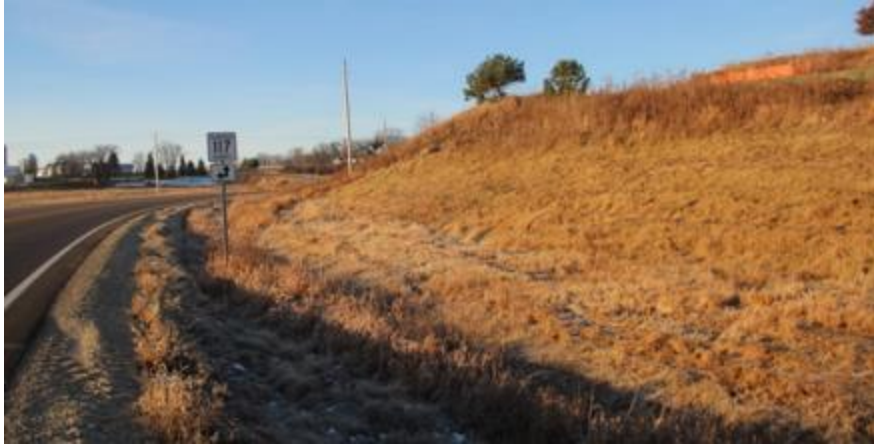
The Olmsted County site (Figure 31) was located on CSAH 15 at County Road 117, west of Rochester, MN. The county engineer identified the location. The site demonstrated steep backslopes. The slope exhibited clear failure marks, shown in Figure 32. The failure in the backslope did not appear to affect the roadway. The site cover was grass and some small trees. Roots were evident in hand sampling, and topsoil extended to a depth of approximately one foot.

Figure 31: Olmsted County site slope

Observed soil was light brown silty sand. Results of DCP testing increasing resistance to penetration with depth. The soil had an average N_{60} value of 2 to 3 blows per foot. Ojakangas (2009) and Hobbs & Goebel (1982) described the geology of the region as glacial drift. No streams or other groundwater indicators were present. There were no stabilization attempts at this site.

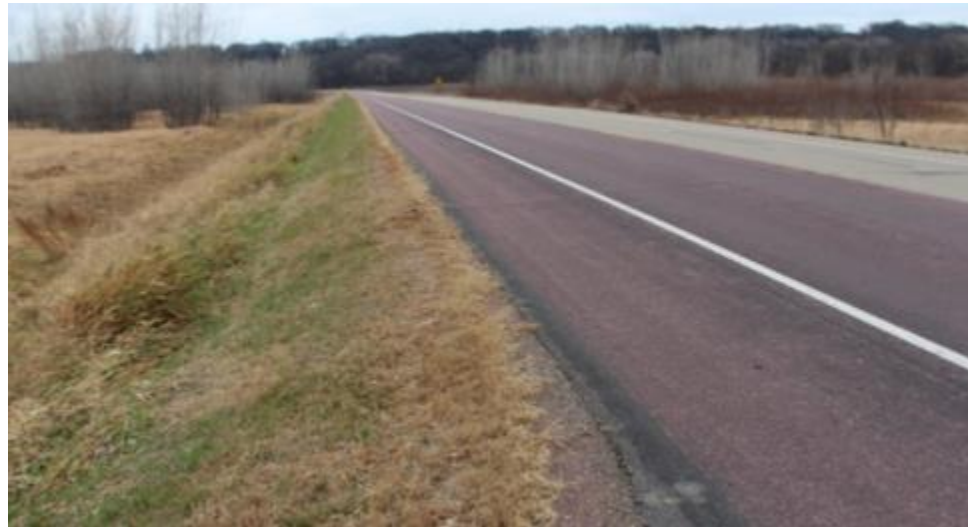
Figure 35: Opposite (west) slope, no observed failure, Redwood Co.

Soil observed was dark brown clay. Average S_u values were approximately 0.5 tsf. DCP testing indicated improving penetration resistance with depth. The average N_{60} values ranged from 4 to 5 blows per foot. Geologically, the site was composed of glacial till (Ojakangas, 2009; Hobbs & Goebel, 1982). A stream was present near the toe of the slope. Rip rap cover was

evidence of slope stabilization attempts. Older rip rap indicated that the site has been previously repaired.

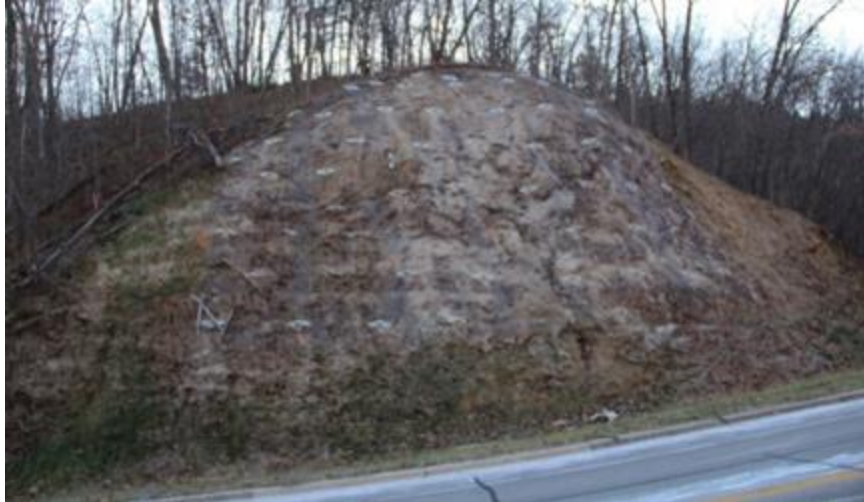
The Washington County site was located on CSAH 21, approximately one mile south of Afton, MN. The assistant county engineer identified the site in the initial survey. While some pavement repair was apparent at the site, the main site identification was wire mesh and rock anchors covering the slope. The slope was steep, and large portions of exposed rock were visible from the road, as shown in Figure 38. The county engineer provided two geotechnical reports from the slope project. The main face of the slope featured wire mesh and rock bolts, as pictured in Figure 39. This site provides examples of using surface cover (i.e. wire mesh) and reinforcing structures (i.e. rock bolts) to stabilize slopes.

Areas on the side and top of the slope were covered with grass and some small trees. DCP testing was not conducted at this site. Soil samples showed brown silty sand at the top and base of the slope. Ojakangas (2009) and Hobbs & Goebel (1982) described the geology of the region as the glacial till. No groundwater was present during sampling.

Figure 38: Washington County site slope

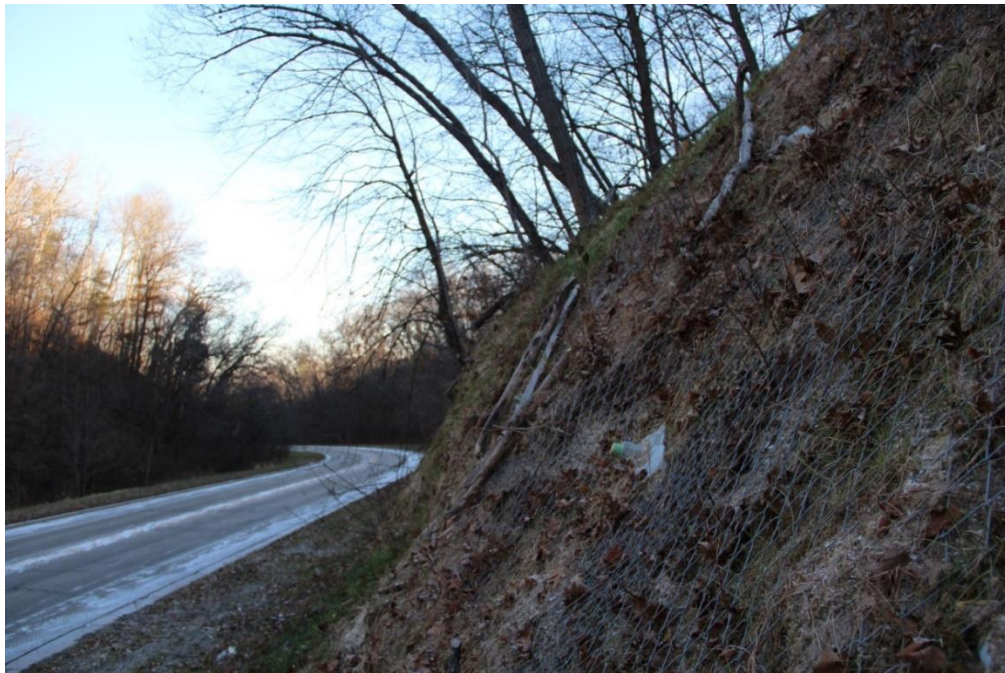
Figure 39: Wire mesh and rock bolt cover at Washington Co. site

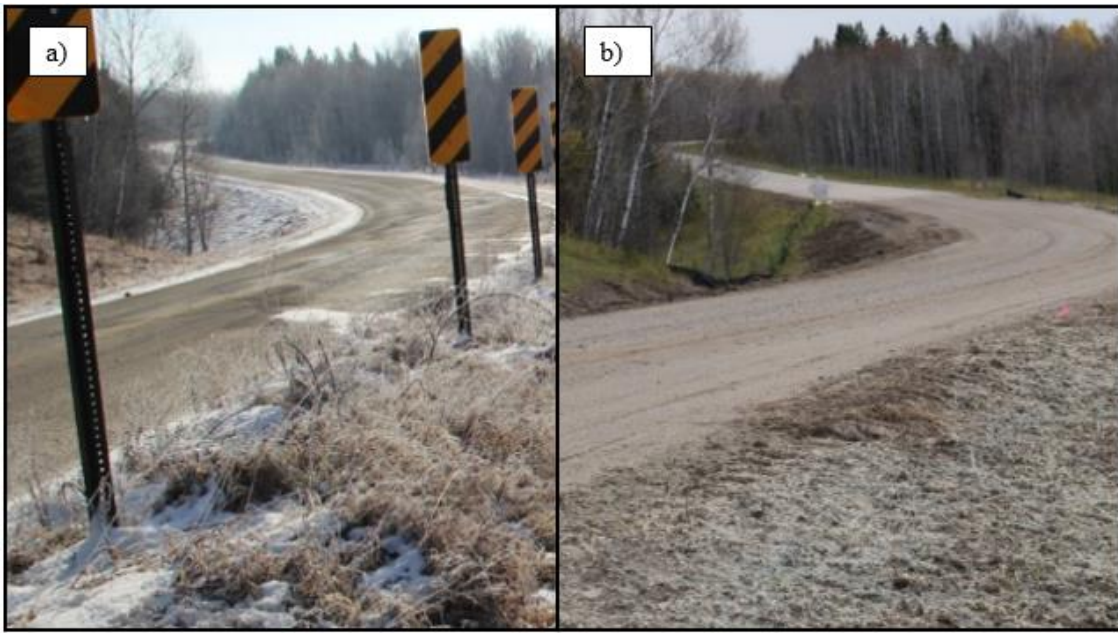
conducting field testing and collecting samples for lab test verification. Testing the same site (Figure 40) provided confidence in the accuracy of results from initial site visits, soil characterization and applicability of sample data to represent a given site.

Figure 40: Koochiching County site a) initial visit Dec. 2015 and b) revisit Oct. 2016

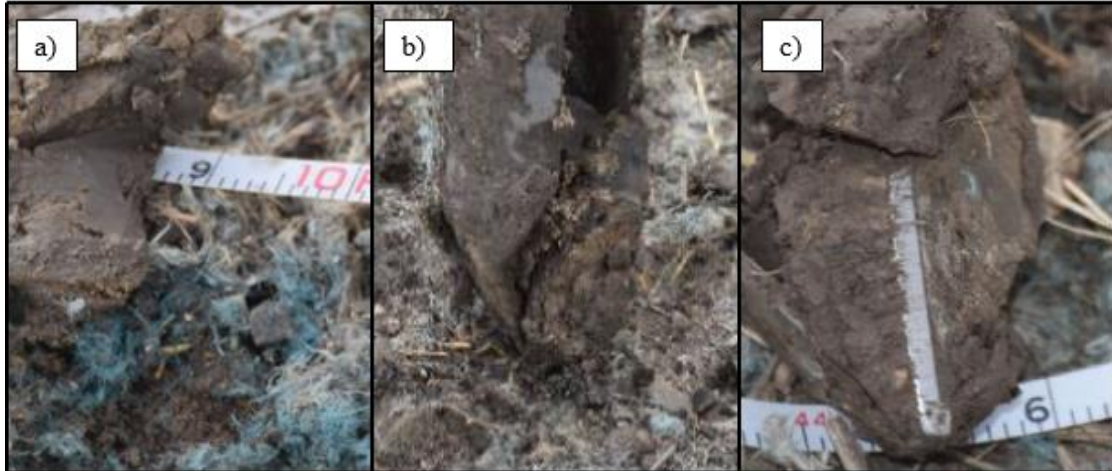
Field testing was conducted at various locations along the cross section of the site, generally corresponding to the top, middle, and toe of the slope. Hand auger samples were collected at a depth of 2.5 to 3 feet at each location. Visual comparison identified samples as the same soil type. This indicated that the same soil layer was present at the top, middle, and bottom of the slope, as illustrated in Figure 41, and that field tests and samples collected from one location on a slope are representative of the given test depth along the slope.

Figure 41: Samples from the a) top, b) middle, and c) toe of the same slope

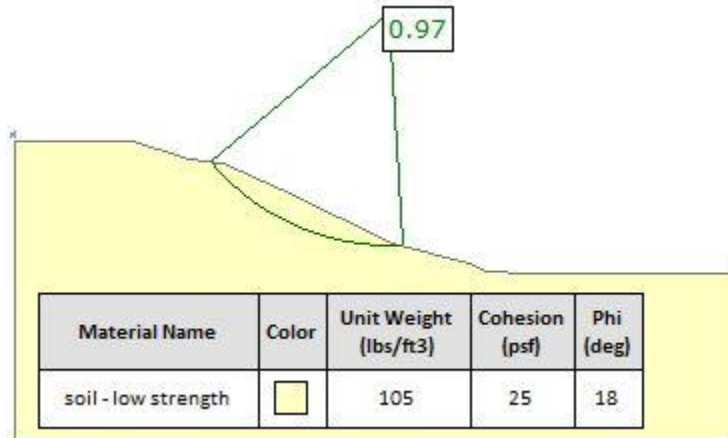
Figure 42: Example failure confirmation, output matches observed slope failure

The example in Figure 42 shows the model of a site where a clear rotational slide was observed, and the model output confirms site observations. The failure is the Olmsted County site (Figure 32). Decreasing ϕ' and c' values caused the software to output a failure corresponding to conditions observed in the field.

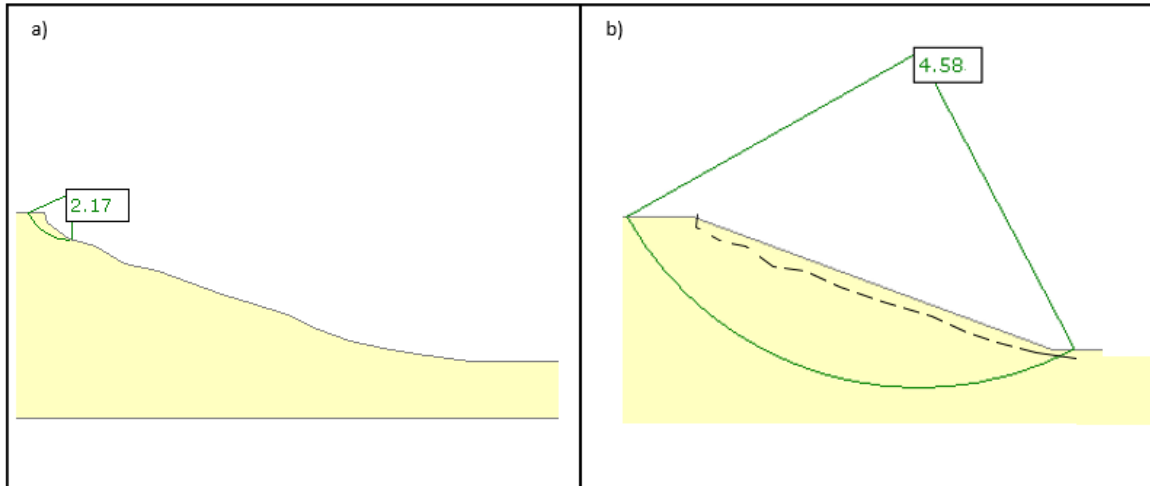
Figure 47: Model of regrading and 'filling in' geometric inconsistencies; a) original and b) regraded

Decreasing slope angles can reduce driving forces. If there is room in the right-of-way, shallow slopes (i.e. lower inclination angle) will be more stable. Regrading, even when not changing the overall slope angle, can increase global FS. The standard practice of re-compacting soil in layers and finishing the slope to a specified grade generally adds stability; fundamentally, soil with higher density will exhibit higher strength values. In some cases, geometric inconsistencies can cause local instability. Regrading is a way of ‘smoothing out’ irregularities. Simply regrading a failed slope to the same overall angle noticeably improved the overall FS at the Olmsted County failure site, as Figure 47 shows.

While the Olmsted County site is an extreme example, regrading typically improves stability. For every method that required excavation, modeling reflected the benefit of regrading, proper construction, and re-compacting. Similar to new construction, for reconstruction and excavation projects, the slope is finished at a specified grade. This ‘straight-line’ slope face avoids geometric inconsistencies encountered *in situ* and exhibits a higher FS, and compacted soil has higher soil strength properties.

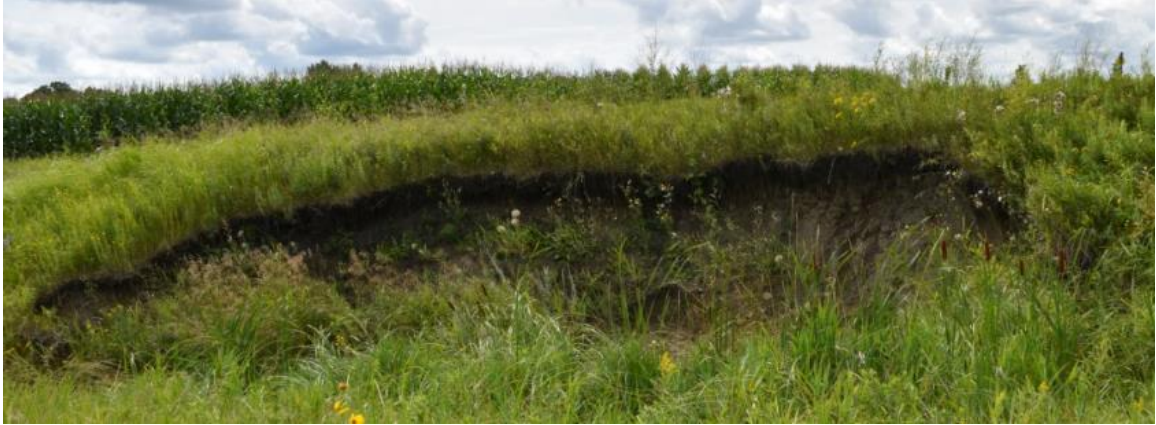
Figure 51: Example of Scenario #1 in Pennington Co., MN

At the Pennington County site, a small stream is located at the toe of the slope and a clear rotational failure is visible. To repair this slope, reconstruction and regrading will be necessary. Maintenance teams should consider either remove-and-replace or regrading with *in situ* soil, adding drainage features, and vegetative cover.

After a rotational failure at least part of the slope will require reconstruction, so excavation is necessary. If strength properties of the *in situ* material are unknown, the author recommends soil testing. If soil has poor strength properties, regrading with engineered sand fill is the best option. After excavation, the new slope surface should have ground cover. When groundwater concerns are present, installing drainage features is recommended. Site investigations included several examples of this combination of site conditions (Figure 51).

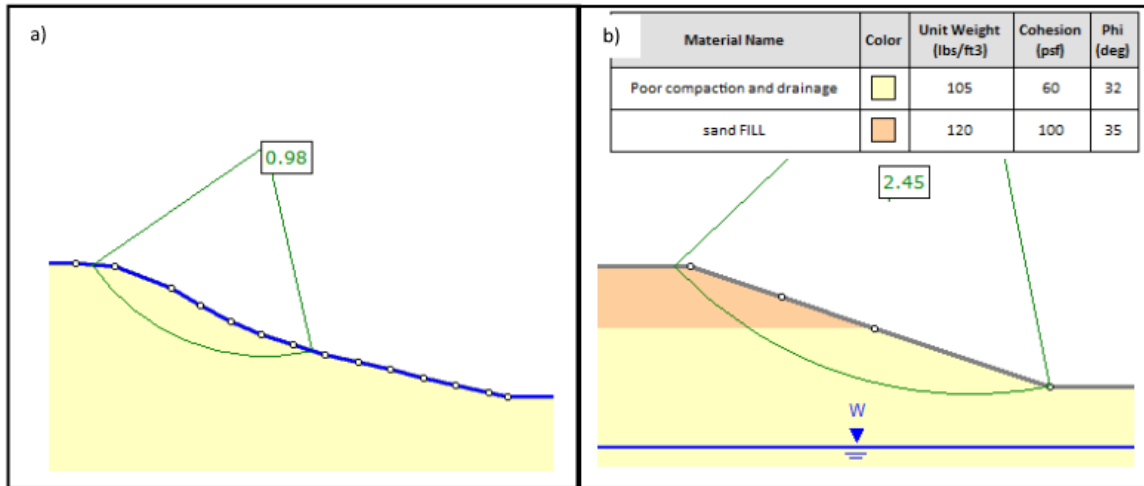
Figure 52: Model representing Scenario #1 a) with observed failure characteristics, and b) after implementing stabilization methods

Figure 52a shows the validated site conditions from the observed failure. The program outputs the observed rotational failure. Drainage features lower the water table; soil replacement and regrading add stability.

Figure 52 shows a modeling example of the recommended stabilization methods. The model represents a rotational failure site with the remove and replace method and additional drainage features.

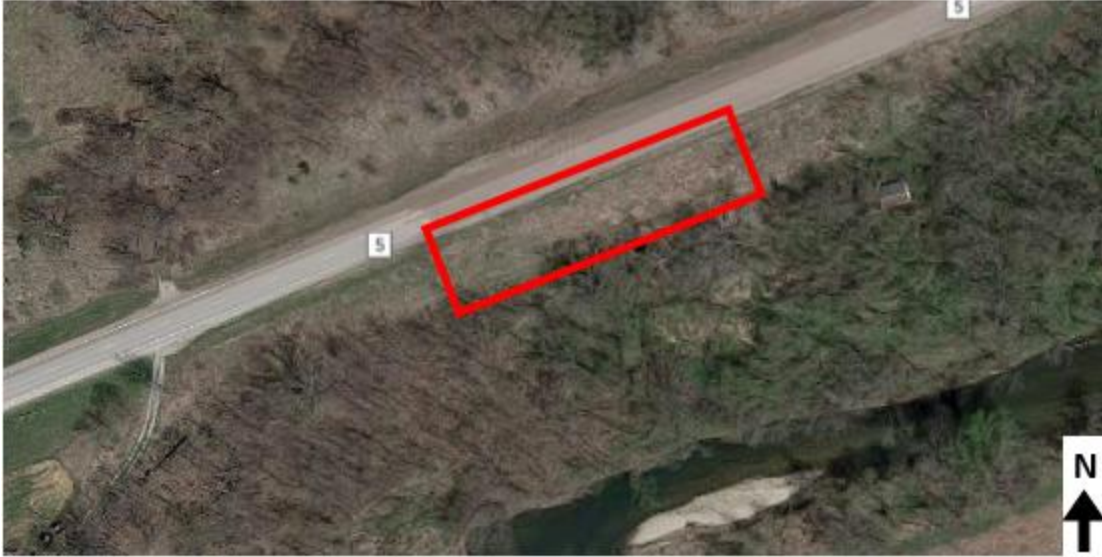
Figure A3.2: Fillmore County site image

Slope failure observed?	Yes
Failure type	Rotational
Evidence / indication of failure	Pavement failure, visible scarp
Water present near toe?	Yes- Middle Branch Root River
Above / below roadway?	Below
Approximate steepness	3.5H : 1V
Observed Stabilization methods	None
Topsoil depth	0.5 ft
Approximate site UTM coordinates	15T N 4849700 E 561700

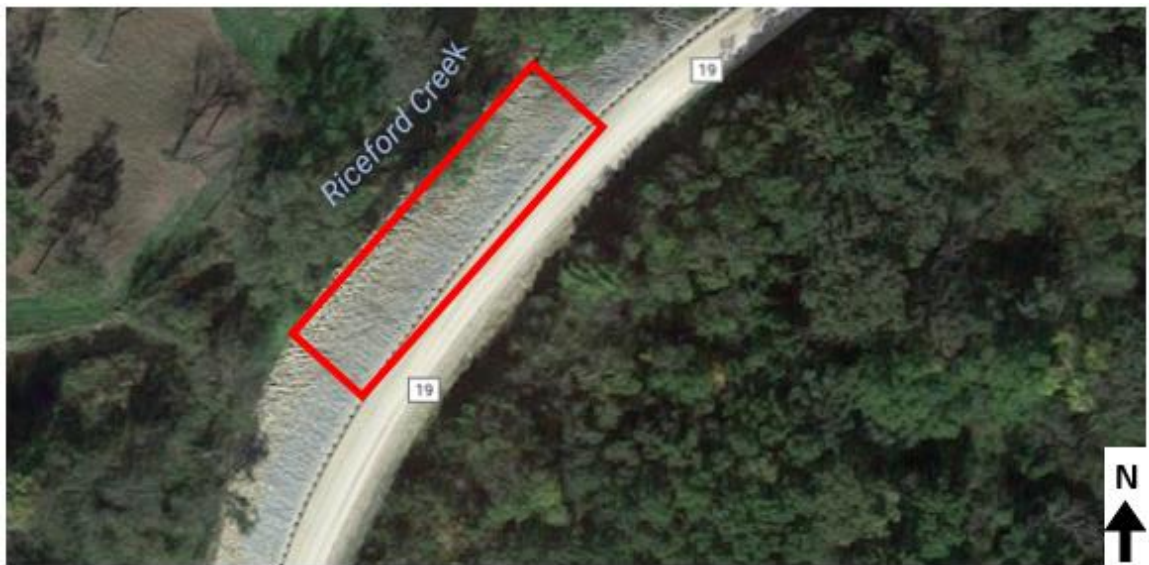
Figure A4.2: Houston County site image

Slope failure observed?	No (repaired)
Failure type	Rotational
Evidence / indication of failure	Failure across road (repaired)
Water present near toe?	Yes - Riceford Creek
Above / below roadway?	Below
Approximate steepness	2H : 1V (repaired)
Observed Stabilization methods	Rip Rap cover
Topsoil depth	not measured
Approximate site UTM coordinates	15T N 4629000 E 604000

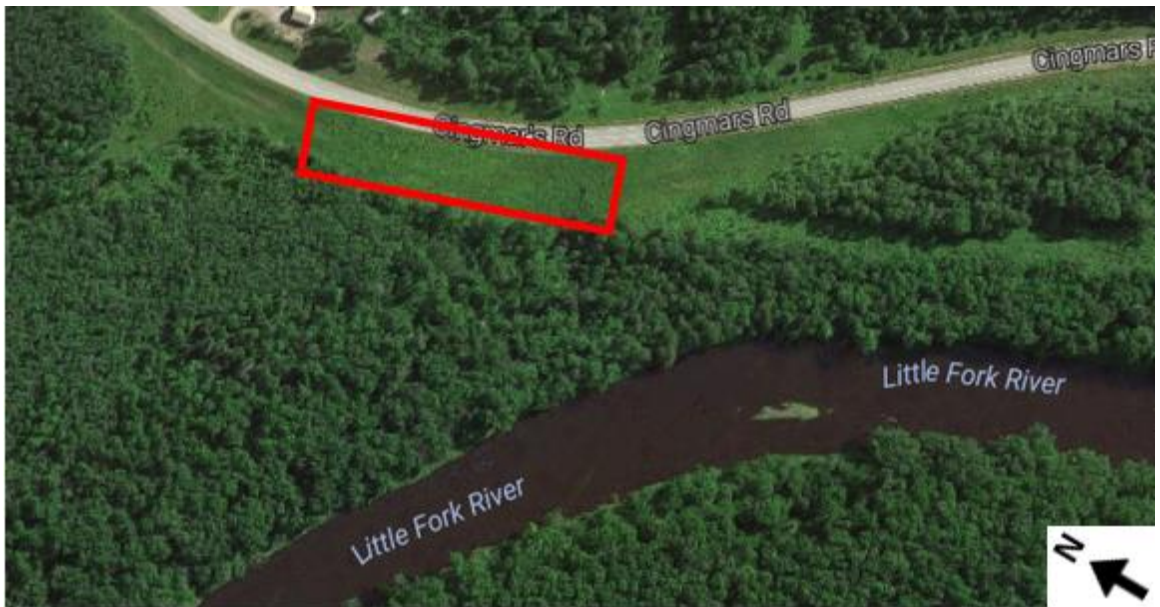
Figure A5.2: Koochiching County site image

Slope failure observed?	Yes
Failure type	Creep
Evidence / indication of failure	Visible Scarp on face
Water present near toe?	Yes - Littlefork River
Above / below roadway?	Below
Approximate steepness	6.5H : 1V
Observed Stabilization methods	None
Topsoil depth	0.5 to 1 ft
Approximate site UTM coordinates	15T N 5349250 E 467400

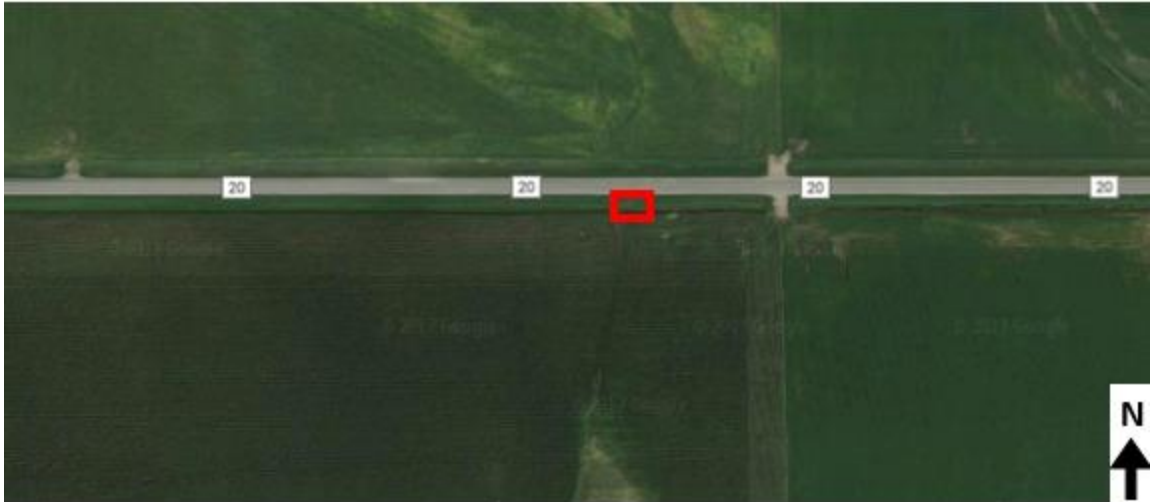
Figure A6.2: Lac Qui Parle County site image

Slope failure observed?	Yes
Failure type	Rotational (erosion)
Evidence / indication of failure	Visible washout failures
Water present near toe?	No
Above / below roadway?	Above
Approximate steepness	1.5H : 1V (backslope)
Observed Stabilization methods	None
Topsoil depth	1 ft
Approximate site UTM coordinates	15T N 4986100 E 274500

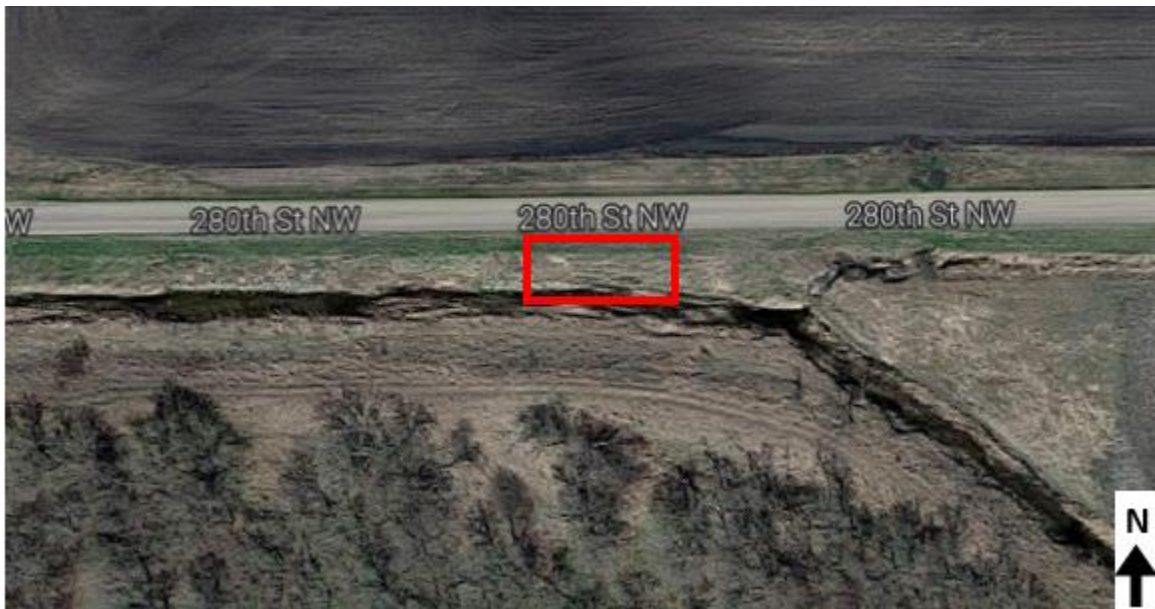
Figure A7.2: Marshall County site image

Slope failure observed?	Yes
Failure type	Creep
Evidence / indication of failure	Visible soil movement
Water present near toe?	yes
Above / below roadway?	below
Approximate steepness	2.5H:1V
Observed Stabilization methods	N/A
Topsoil depth	1 ft
Approximate site UTM coordinates	14U N 5349900 E 660500

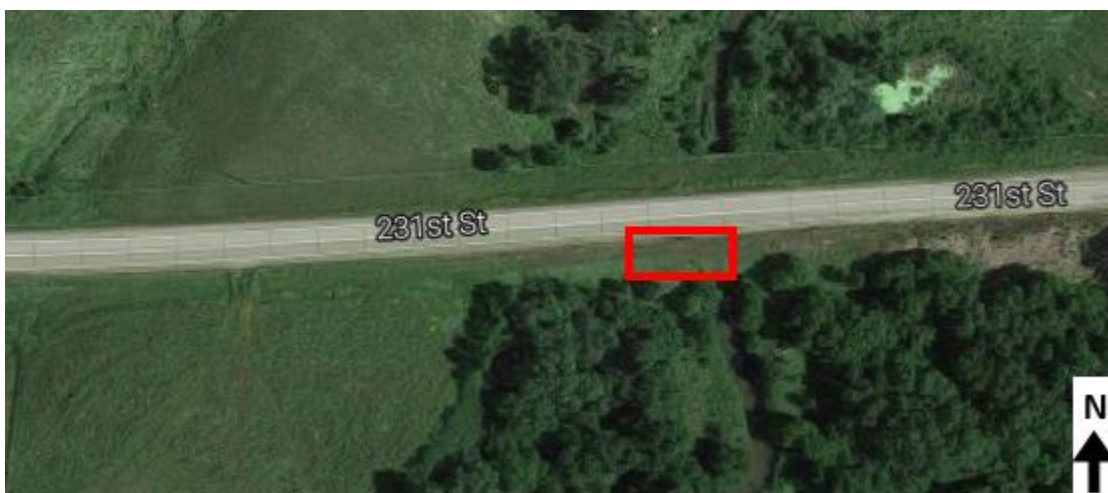
Figure A8.2: Murray County site image

Slope failure observed?	Yes (repaired)
Failure type	Creep at top of slope
Evidence / indication of failure	Pavement distress
Water present near toe?	Yes (Plumb Creek)
Above / below roadway?	Below
Approximate steepness	2H : 1V
Observed Stabilization methods	Remove and Replace
Topsoil depth	0.5 to 1 ft
Approximate site UTM coordinates	15T N 4895100 E 300050

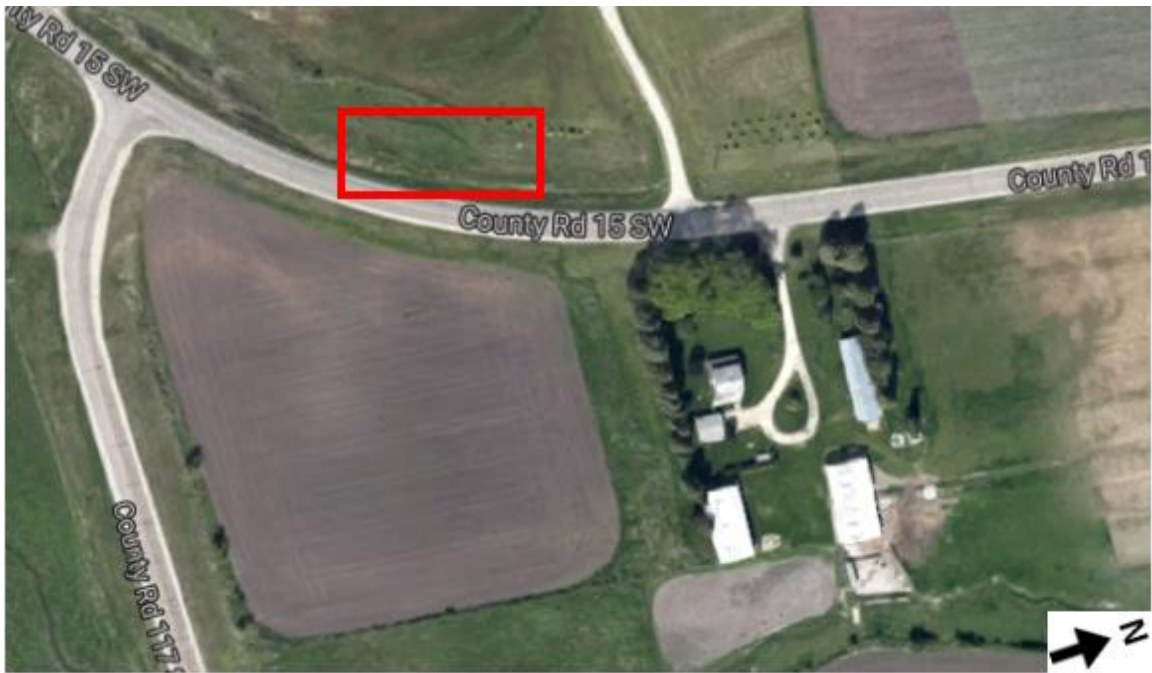
Figure A9.2: Olmsted County site image

Slope failure observed?	Yes
Failure type	Rotational and creep
Evidence / indication of failure	Visible scarp on face
Water present near toe?	No
Above / below roadway?	Above
Approximate steepness	3H : 1V
Observed Stabilization methods	None
Topsoil depth	0.5 to 1 ft
Approximate site UTM coordinates	15T N 4867200 E 533950

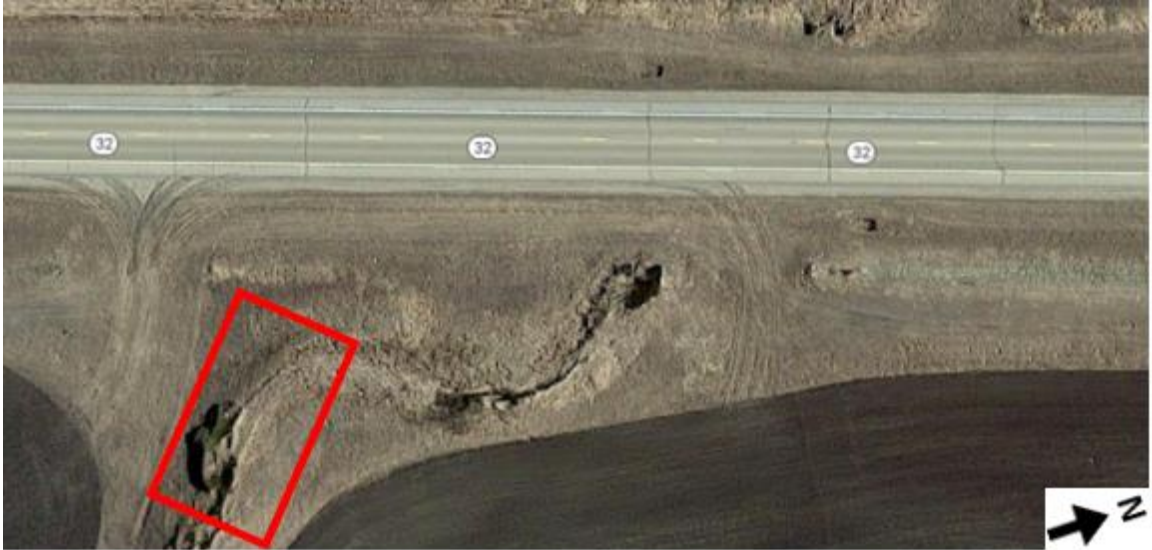
Figure A10.2: Pennington County site image

Slope failure observed?	Yes
Failure type	Rotational
Evidence / indication of failure	Clearly visible failure surface
Water present near toe?	yes
Above / below roadway?	below
Approximate steepness	1.5H:1V
Observed Stabilization methods	N/A
Topsoil depth	1 ft
Approximate site UTM coordinates	14U N 5328200 E 708400

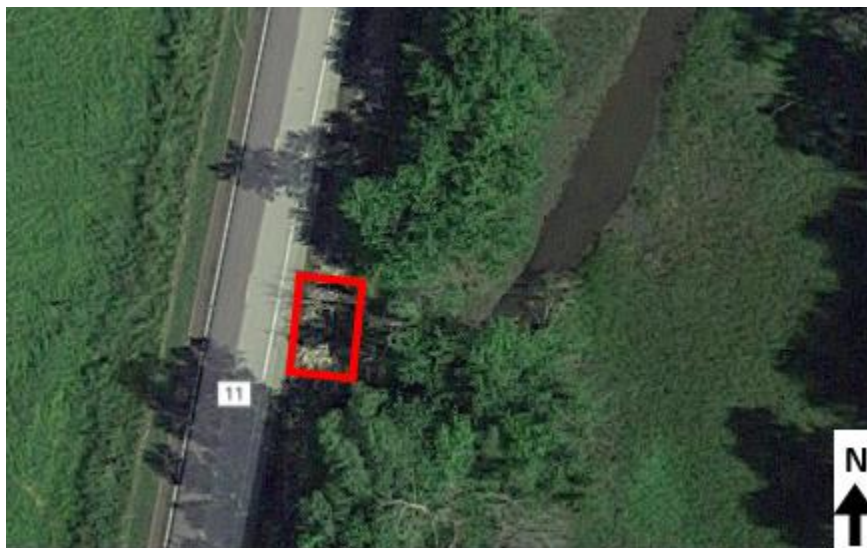
Figure A11.2: Redwood County site image

Slope failure observed?	No (repaired)
Failure type	N/A
Evidence / indication of failure	Pavement distress, Rip Rap cover
Water present near toe?	Yes - Minnesota River
Above / below roadway?	Below
Approximate steepness	3H : 1V
Observed Stabilization methods	Rip Rap cover, geosynthetics
Topsoil depth	0.5 ft
Approximate site UTM coordinates	15T N 4929000 E 350200
