I N V E S T I G A T I O N O F A I R F I E L D D R A I N A G E
A R C T I C A N D S U B A R C T I C R E G I O N S

SUPPLEMENT TO PART I
FIELD RECONNAISSANCE AND ANALYSIS

Project Report No. 18

January, 1950

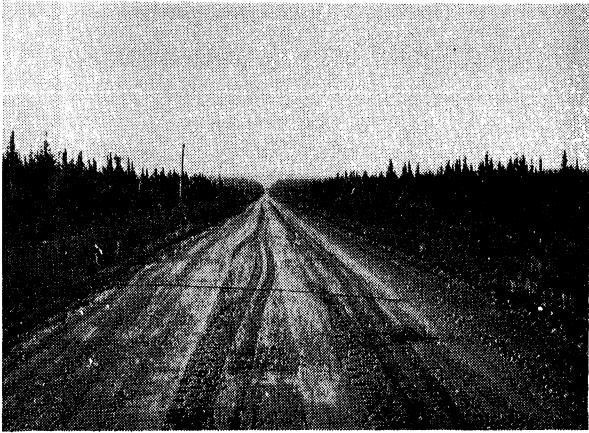
Road conditions are good despite a lack of drainage ditches.

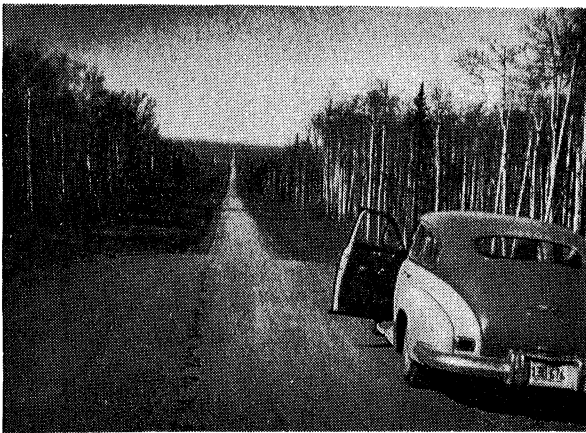
Road side ditches are conspicuously absent along this highway.

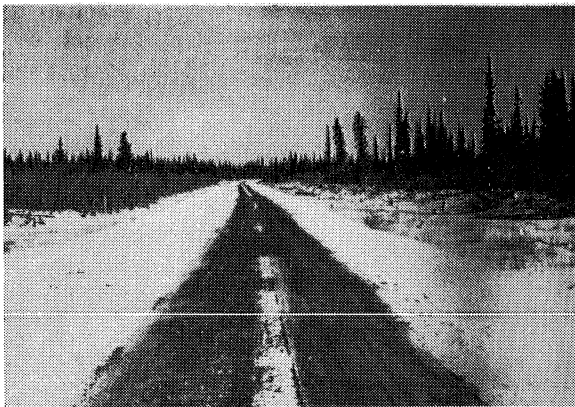
Burwash Creek Road at mile 1104. Many trees are in a tilted position.

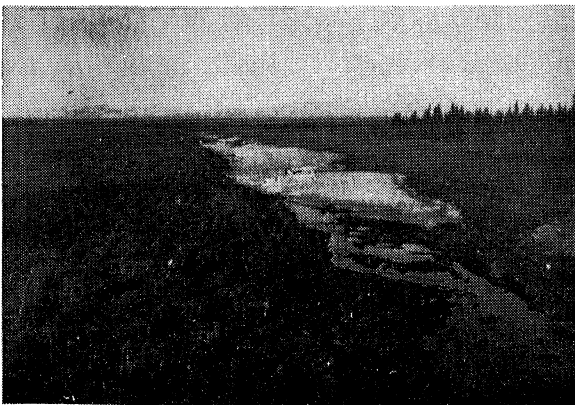
Icing on Chistochina River, Alaska

Water was flowing beneath the icing.
