University of Minnesota
ST. ANTHONY FALLS HYDRAULIC LABORATORY

Project Report No. 132
Hydraulic Model Studies for the
GURI HYDROELECTRIC PROJECT
REPORT ON SPILLWAY CAVITATION DAMAGE

Prepared for
HARZA ENGINEERING COMPANY
and the
CORPORACION VENEZOLANA DE GUAYANA
Republic of Venezuela

A STUDY OF CAVITATION DAMAGE ON THE
DAM SPILLWAY OF THE GURI PROJECT

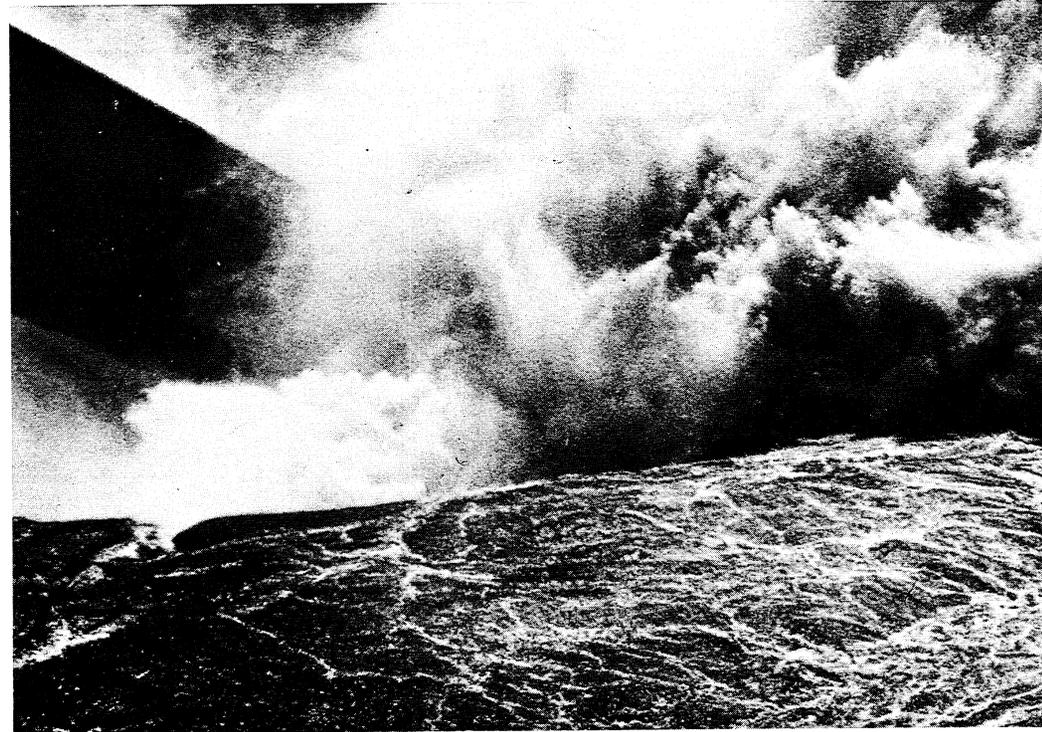
Fig. 7 - Flip Bucket Discharge from the Center Chute with Flow Overtopping the Lower East Training Wall about 3.5 meters (Harza Engineering Co.)

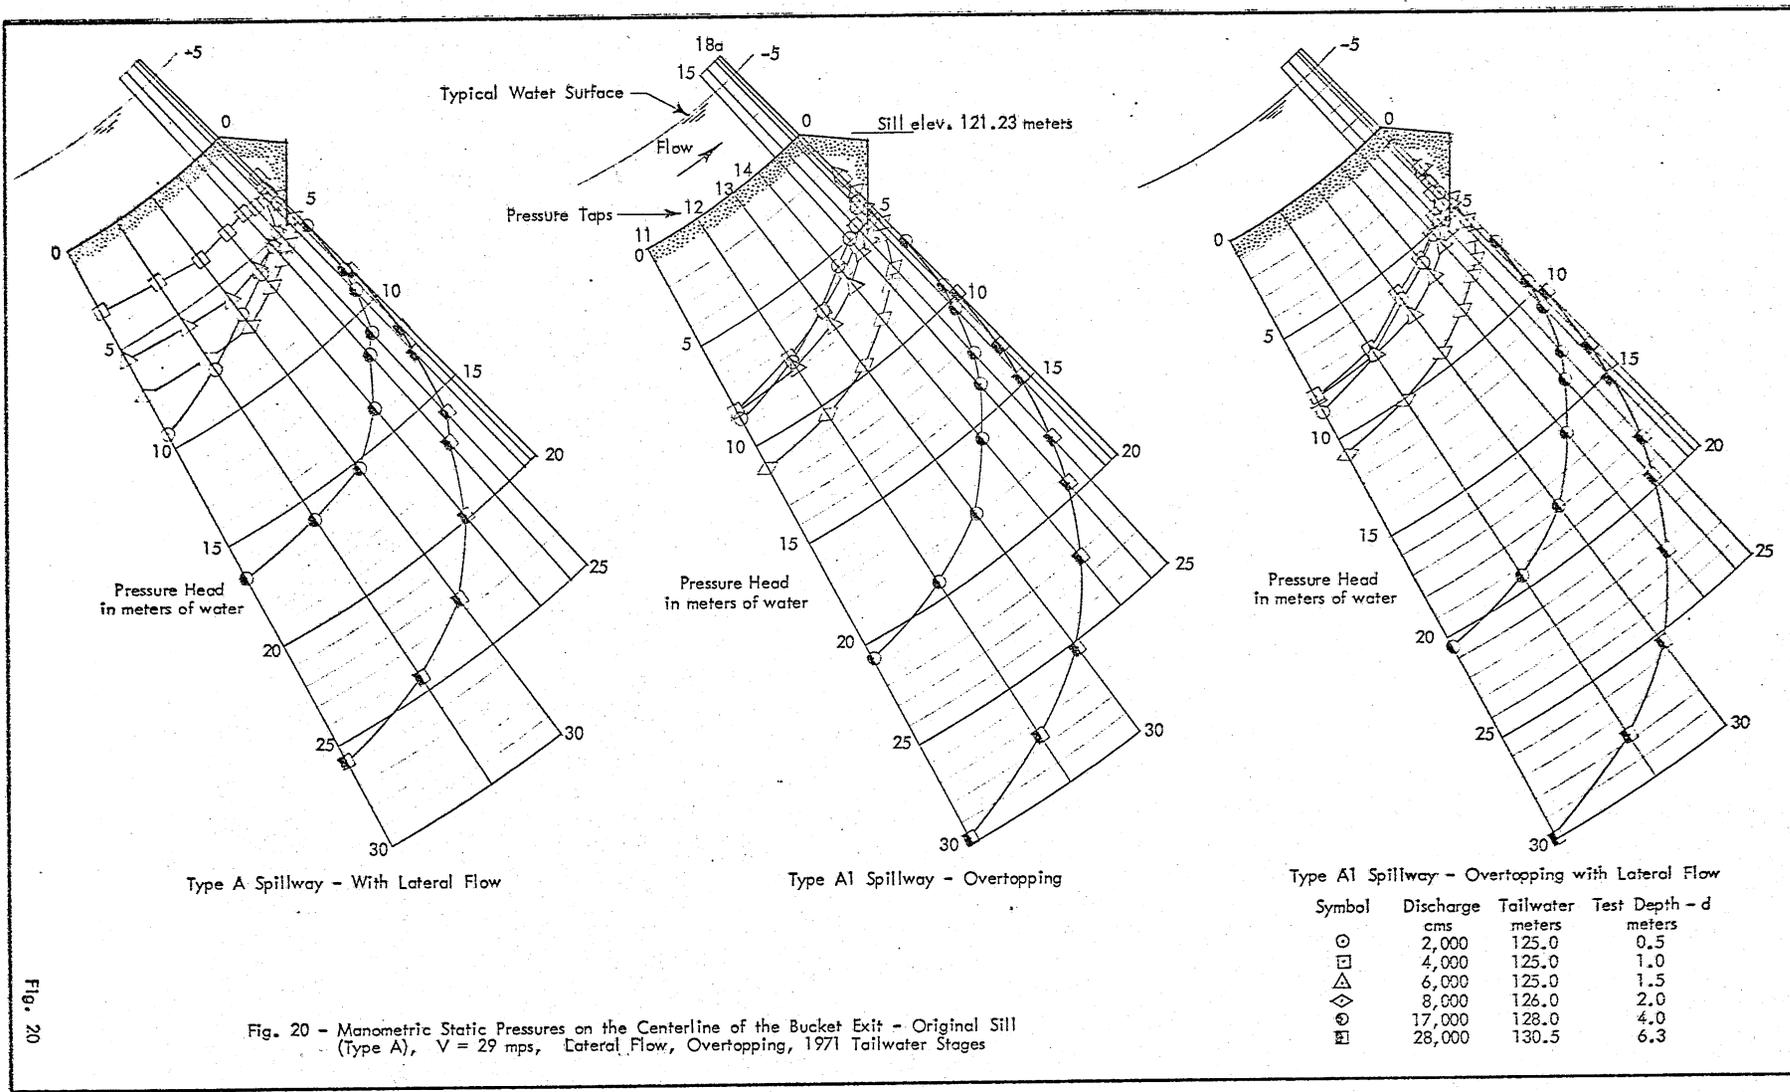
17. An attempt to model the actual formation and collapse of vapor cavities was unsuccessful in these tests. In retrospect, this has been traced to the very small flow length to which the expansion and collapse of the cavities at Guri must be confined. The pressure diagrams (such as Fig. 20) indicate that the physical length of the negative boundary pressure region in the prototype is probably less than $1/10$ m long. At a scale of 78.7, this region is probably less than a few millimeters in the model. Since cavity formation and collapse require a definite time span for the thermodynamics of vaporization and condensation, cavities should not be generated with the conditions prevailing in the small Guri model. Successful modeling of cavitation has been achieved with other, larger models in the

Fig. 20 - Manometric Static Pressures on the Centerline of the Bucket Exit - Original Sill
 (Type A), V = 29 mps, Lateral Flow, Overtopping, 1971 Tailwater Stages

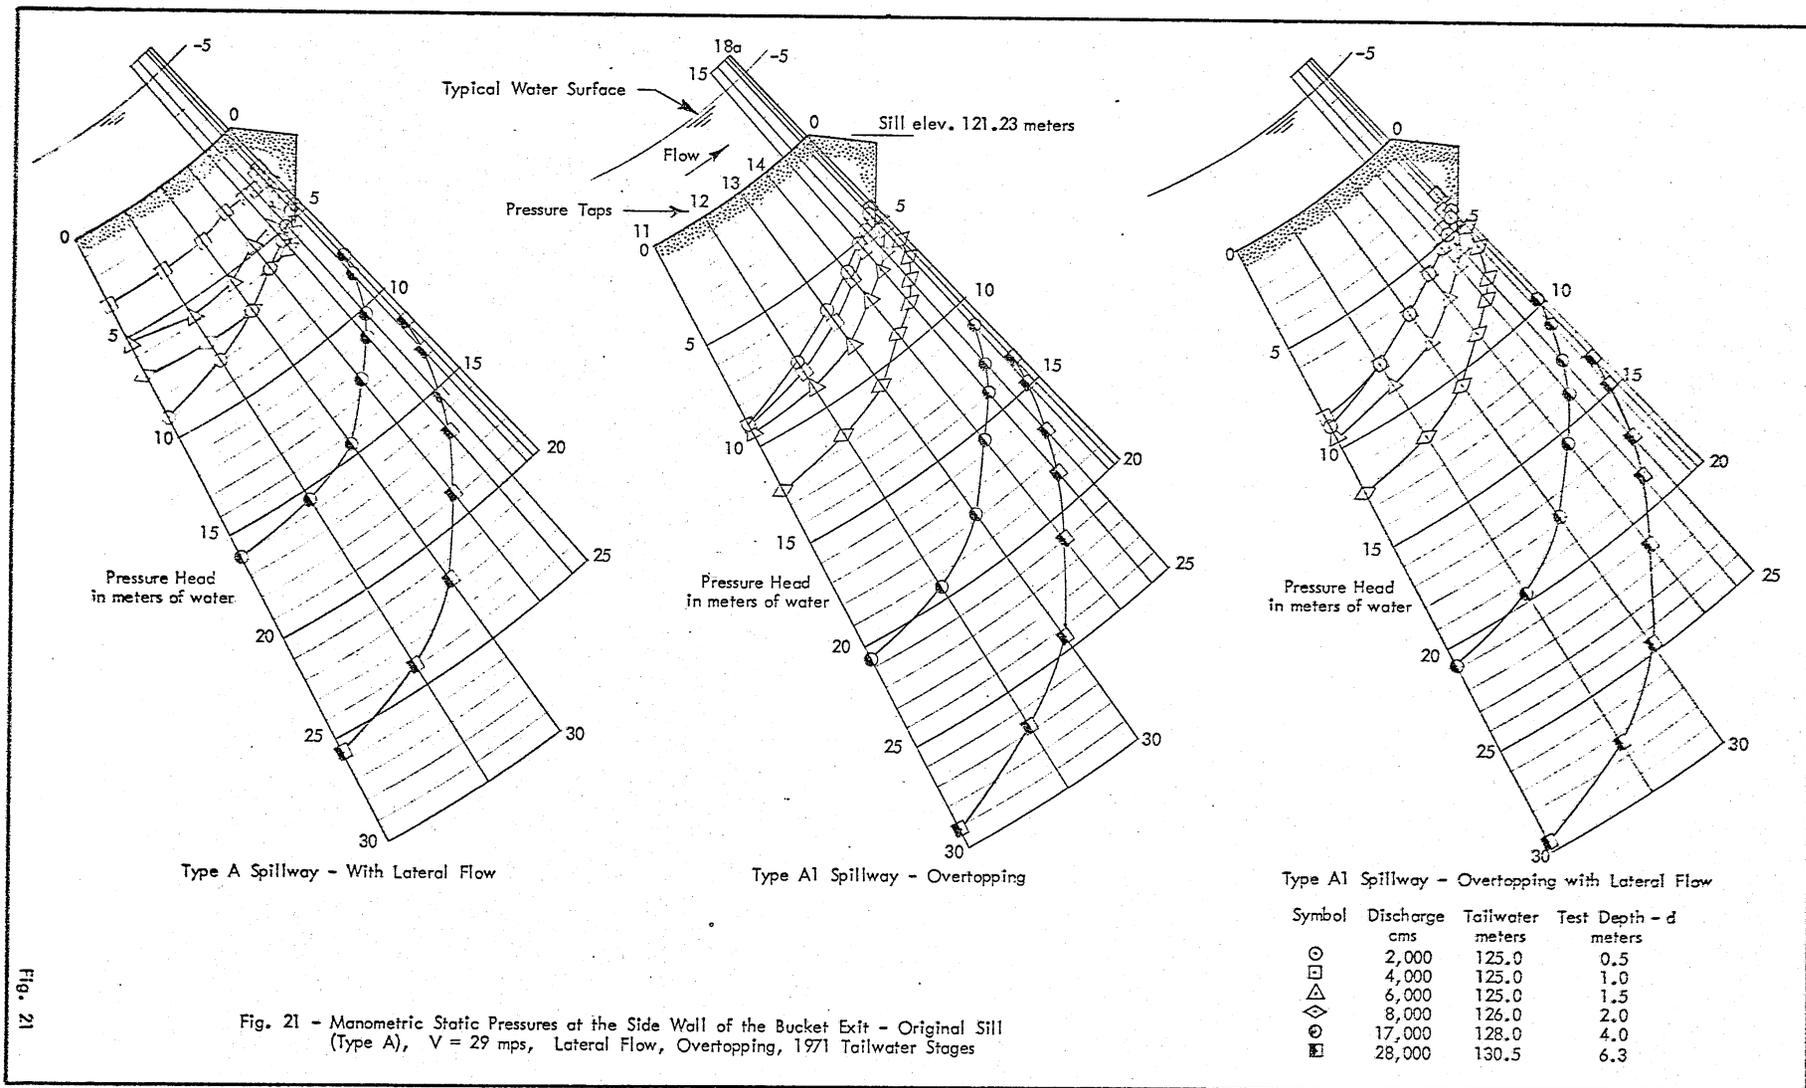
Fig. 21 - Manometric Static Pressures at the Side Wall of the Bucket Exit - Original Sill (Type A), $V = 29$ mps, Lateral Flow, Overtopping, 1971 Tailwater Stages

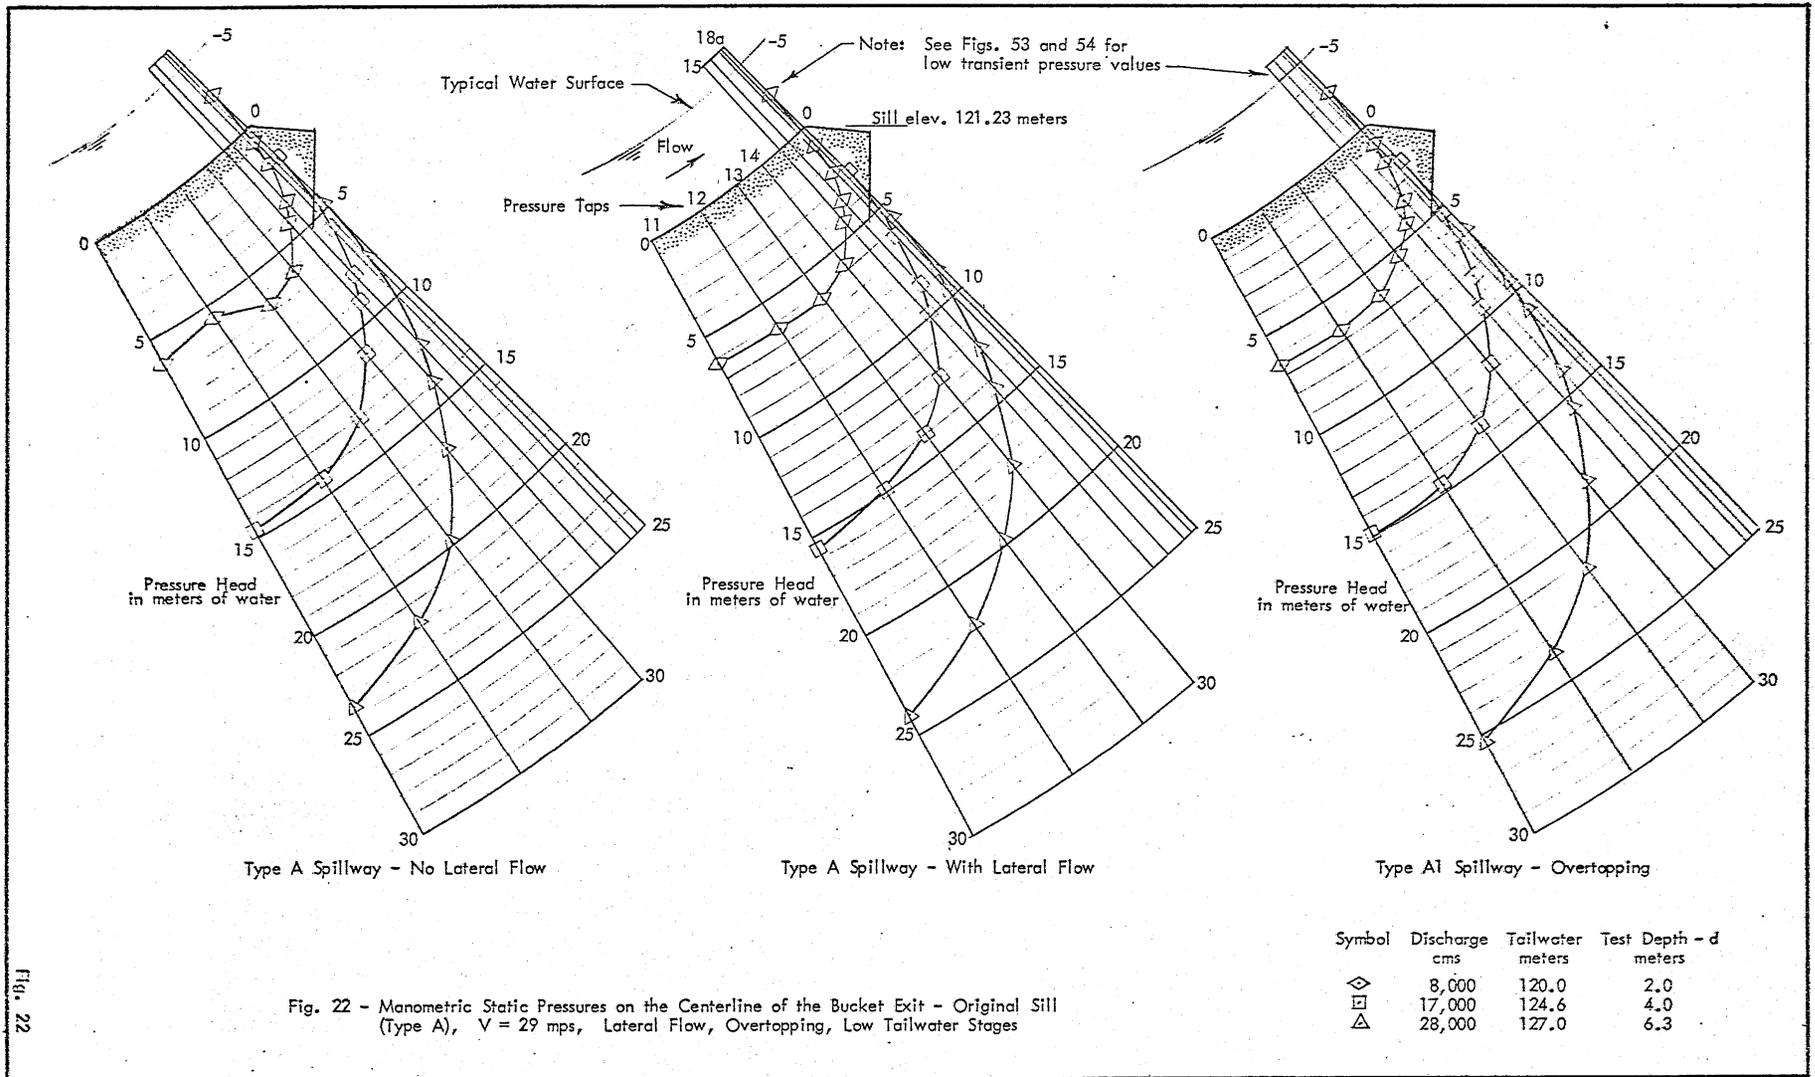
Fig. 22

9. Tailwater back-up effects can also be reduced by rebuilding the bucket to raise the lip above all normal tailwater stages. This is an expensive alternative that should be approached with caution. It should be noted (Fig. 22) that even with the tailwater pool completely removed, a velocity of 29 mps, corresponding to the existing dam head, produced a static lip pressure of -2 m, and a velocity of 37 mps, corresponding to the ultimate dam height, produced -4 m (not shown). Both of these were at a discharge of 8000 cms. If for a corresponding discharge a dynamic negative pressure of -2.0 m is taken from Fig. 52 for $V = 29$ mps and -2.5 m is taken from Fig. 58 for $V = 37$ mps, the total negative values are about -4 m and -6.5 m, respectively. Both of these are potentially damaging pressure values. If discharges less than 8000 cms had been included in the data, it is probable that even lower negative totals would have resulted.

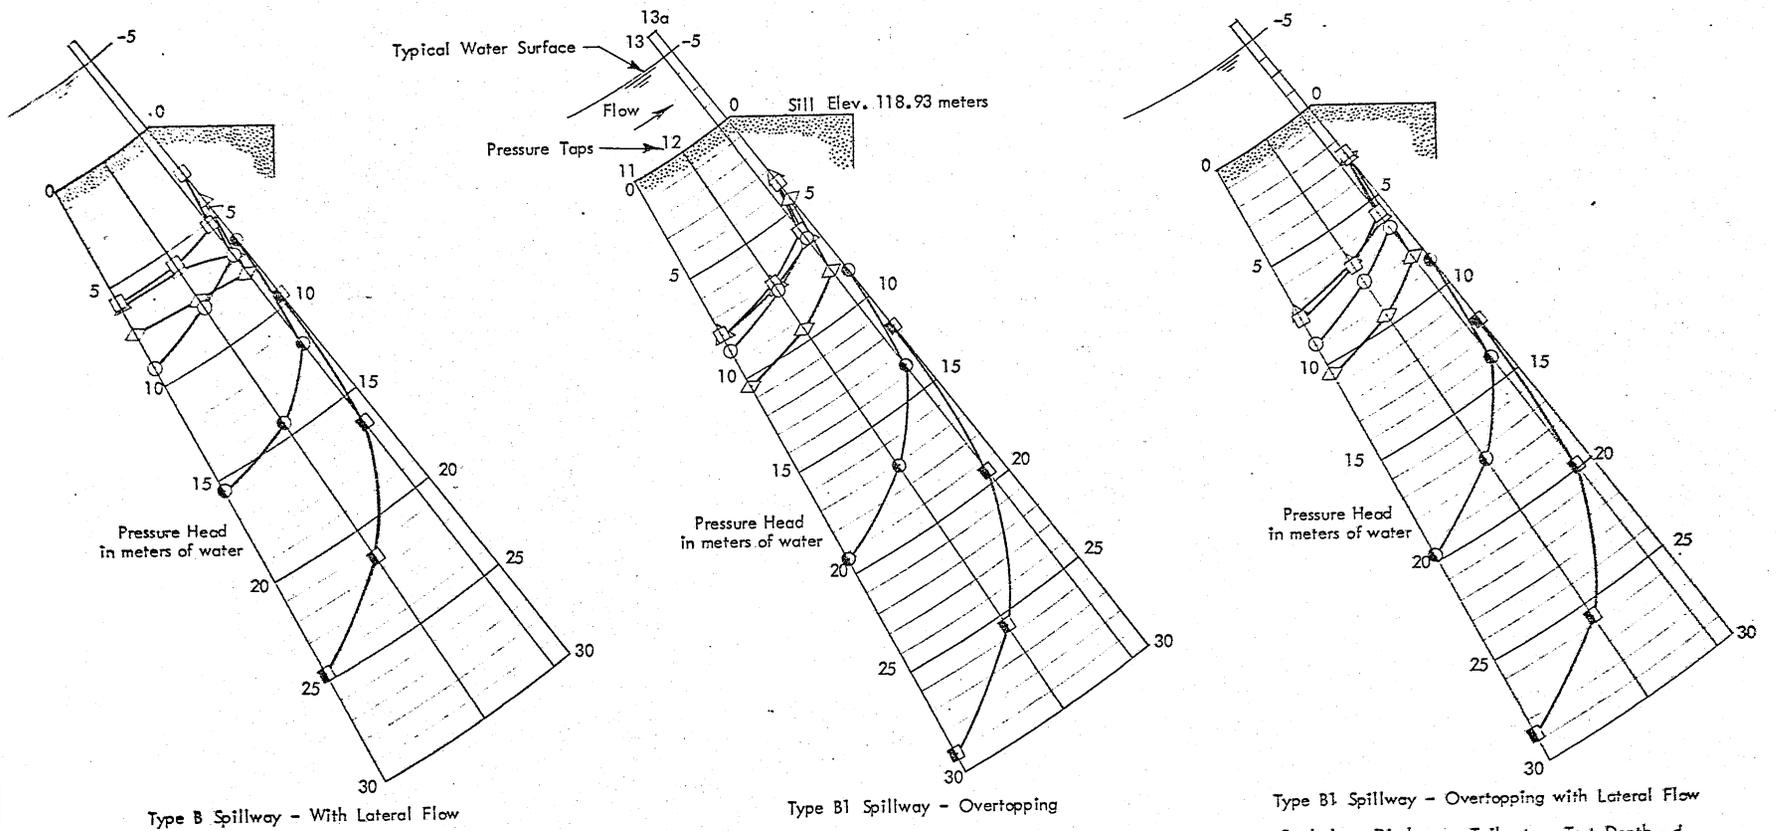
Figures 30 and 31, which extend the data of Figs. 28 and 29 to include the contributions of lateral flow and overtopping, produce much the same kind of additional influences noted for Figs. 20 and 21. These data also suggest that there is no tendency for the cavitation damage to become self-arresting as the erosion proceeds.

Fig. 30 - Manometric Static Pressures on the Centerline of the Bucket Exit - Sill Eroded
 Two Meters (Type B), $V = 29$ mps, Lateral Flow, Overtopping, 1971 Tailwater Stages

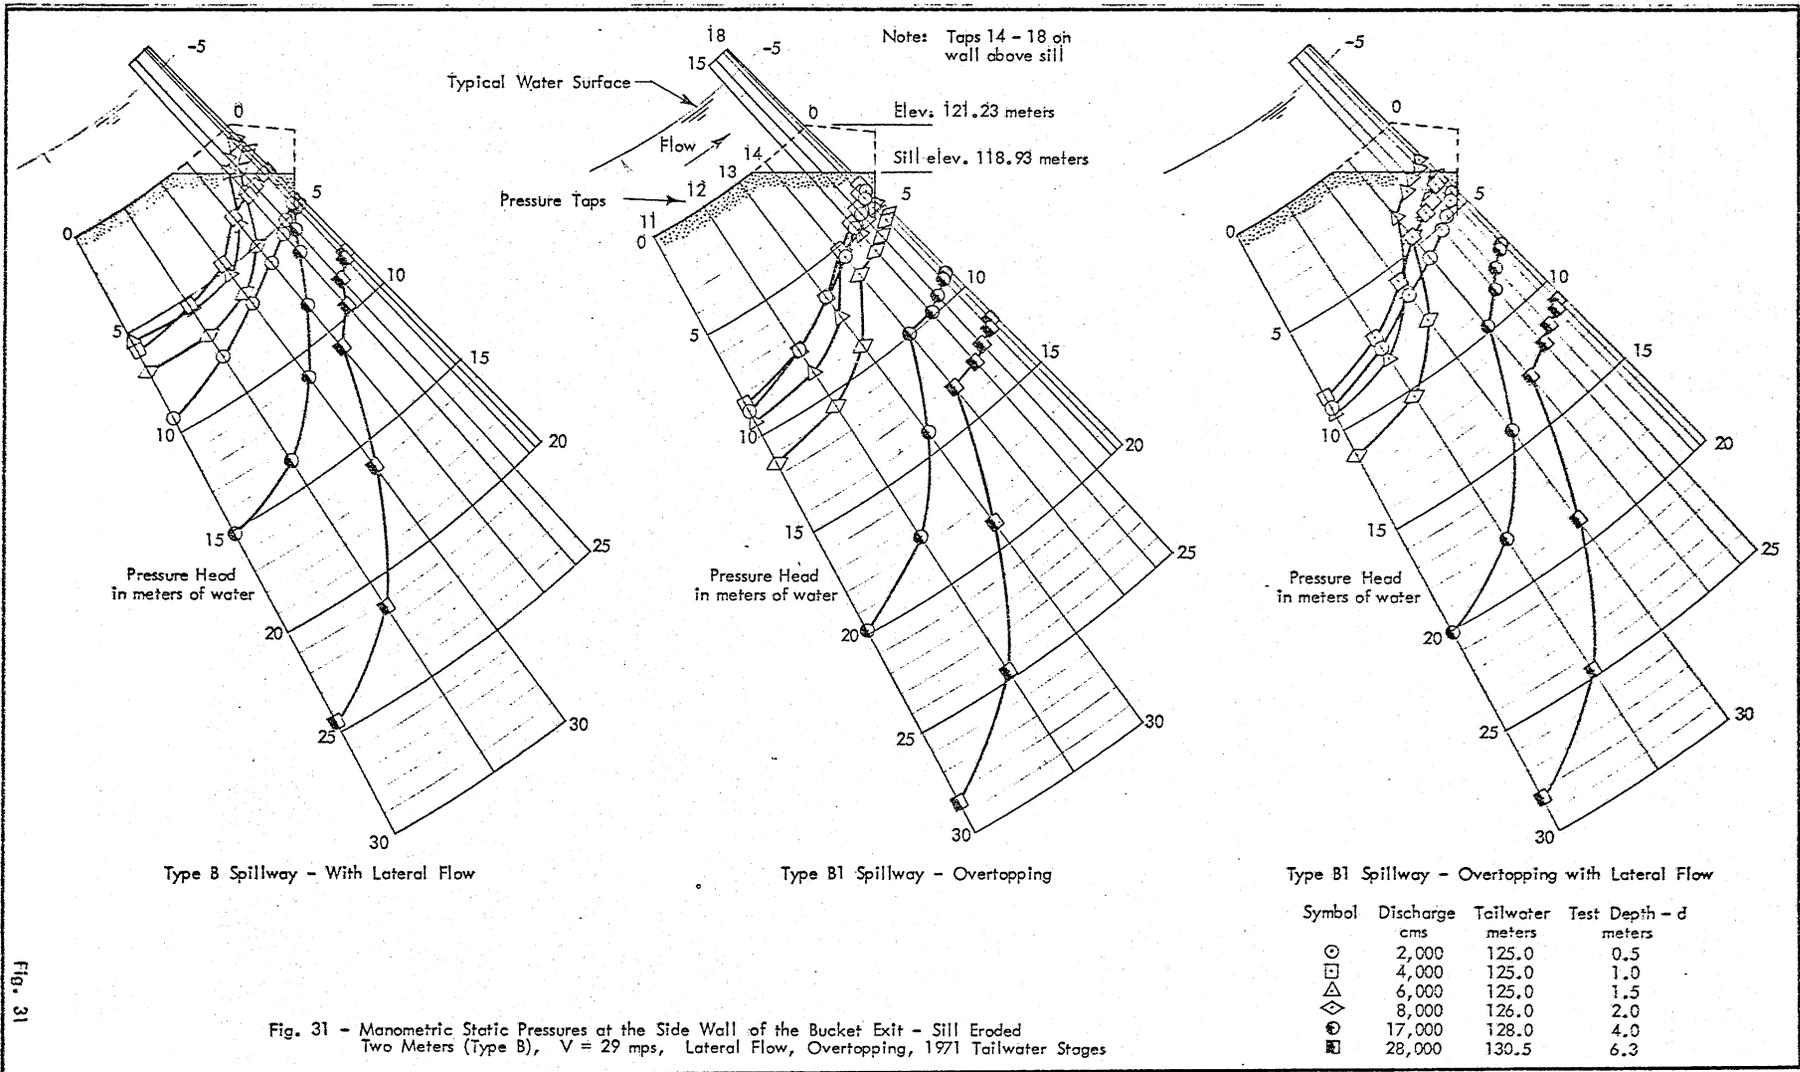
Fig. 31 - Manometric Static Pressures at the Side Wall of the Bucket Exit - Sill Eroded Two Meters (Type B), $V = 29$ mps, Lateral Flow, Overtopping, 1971 Tailwater Stages

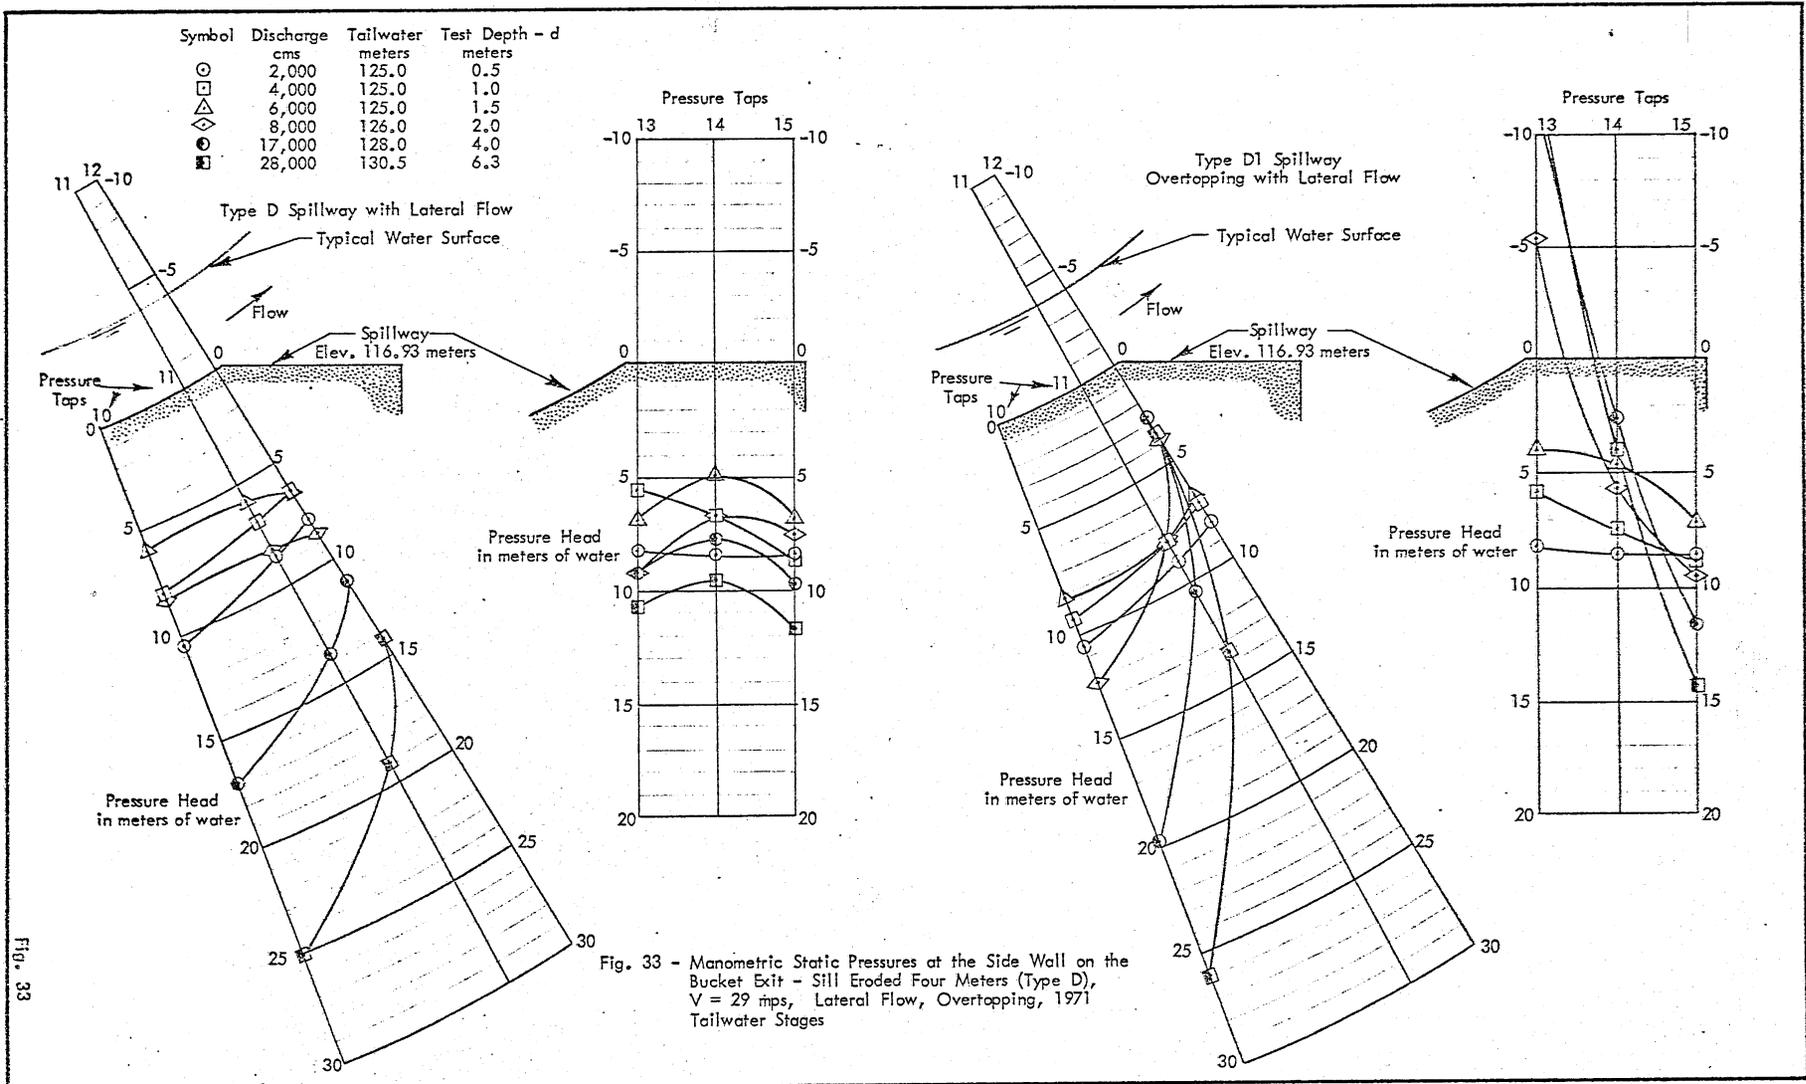
FIG. 33

- d. Near the side wall (see Fig. 33), where the falling overtopping stream does not jet downward as strongly, the aspirated pressures near the lip are not nearly as low as they are farther out from the wall. They are, however, relatively very low and will strongly support cavitation damage. Farther out from the wall beyond the influence of the falling jet the pressures should rise to the higher values of lateral flow alone.

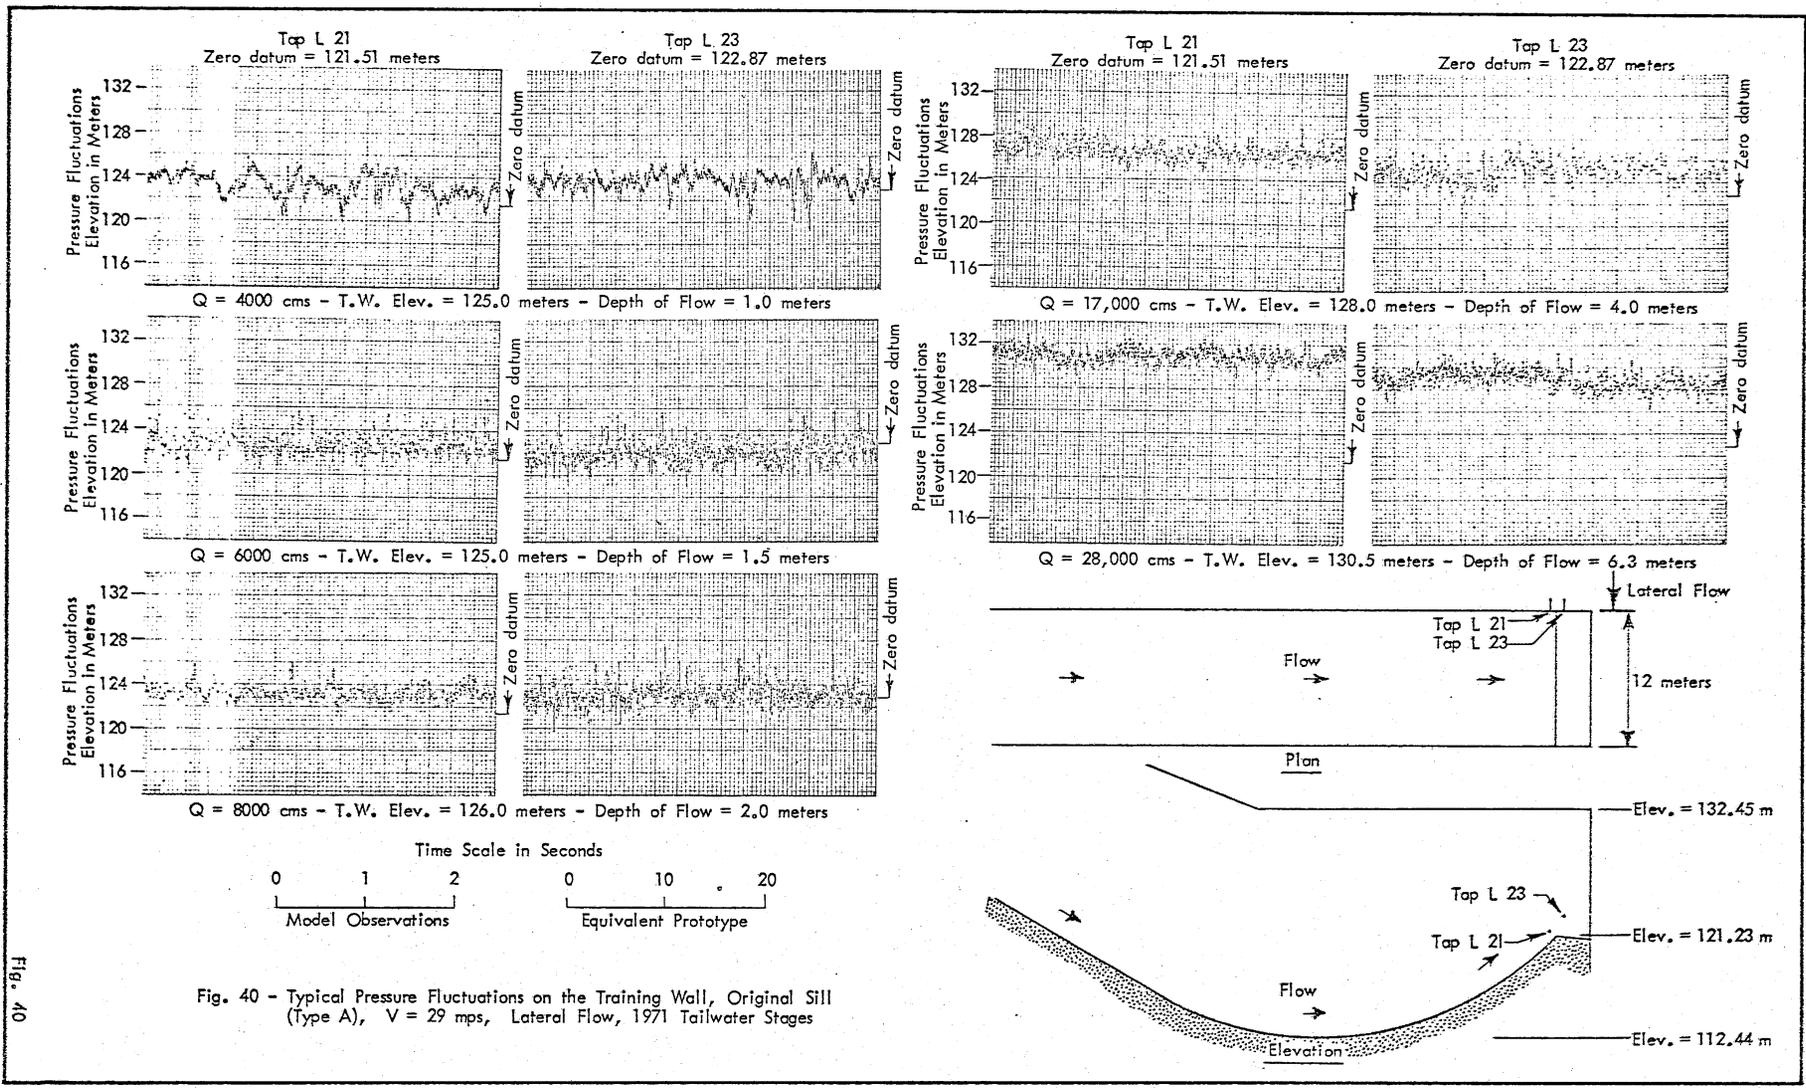
No static measurements were made at these taps, but transient transducer measurements were made under a range of test conditions with results as shown in Figs. 40, 41, and 57. The following points can be gathered from these data:

7. The maximum negative pressures are substantially lower at L 23 than at L 21 and are of a level generally considered to be damaging. This is in essential agreement with the observed damage evidence in Fig. 12.

Fig. 40 - Typical Pressure Fluctuations on the Training Wall, Original Sill (Type A), $V = 29$ mps, Lateral Flow, 1971 Tailwater Stages

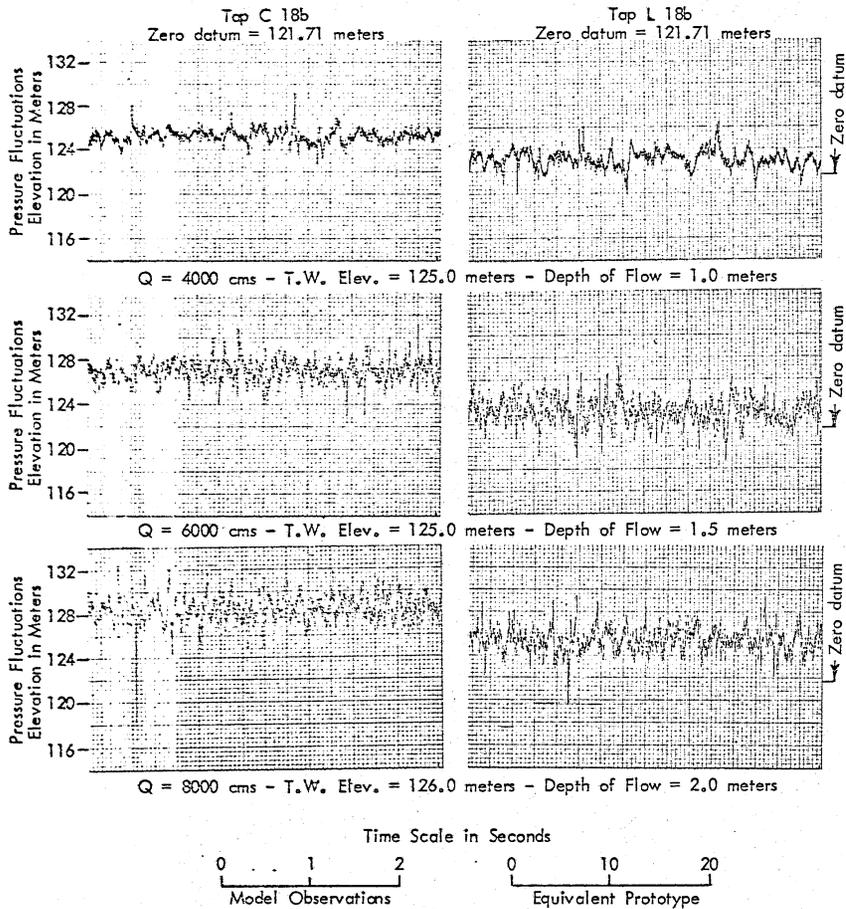
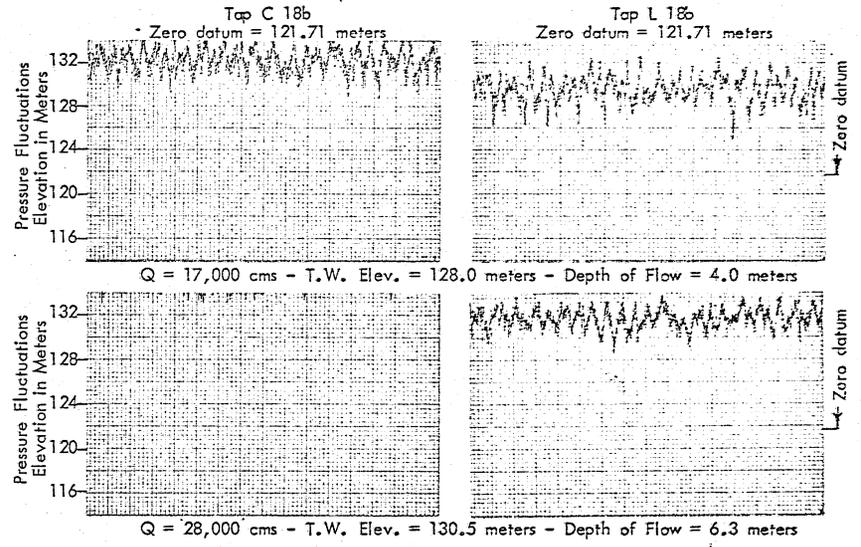
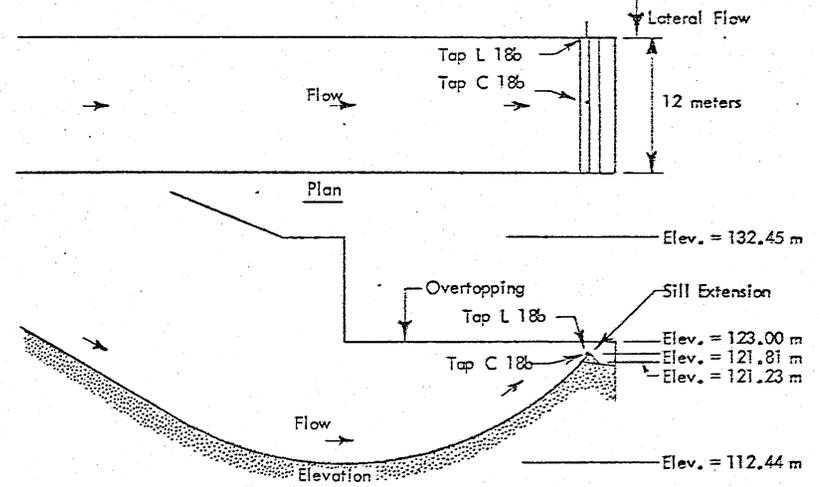
The dimensional changes represented by the added sill and taps are shown in Fig. 17 and the pertinent transient pressure fluctuation data for the velocity of 29 mps prototype in Figs. 44, 46, and 61. The data for the high stage velocity of 37 mps prototype are shown in Figs. 45, 47, and 62. These studies were confined to two pressure taps, C 18b and L 18b. Tap C 18b, which would be 12.5 cm upstream of the extension lip in the prototype, was located at the "centerline." Tap L 18b was similarly positioned, but at the wall. The significant points from the low speed data are discussed below. The high speed data are discussed separately later.

Fig. 44 - Typical Pressure Fluctuations on the Lip of the Sill Extension - Sill Extended (Type C), $V = 29$ mps, Lateral Flow, 1971 Tailwater Stages

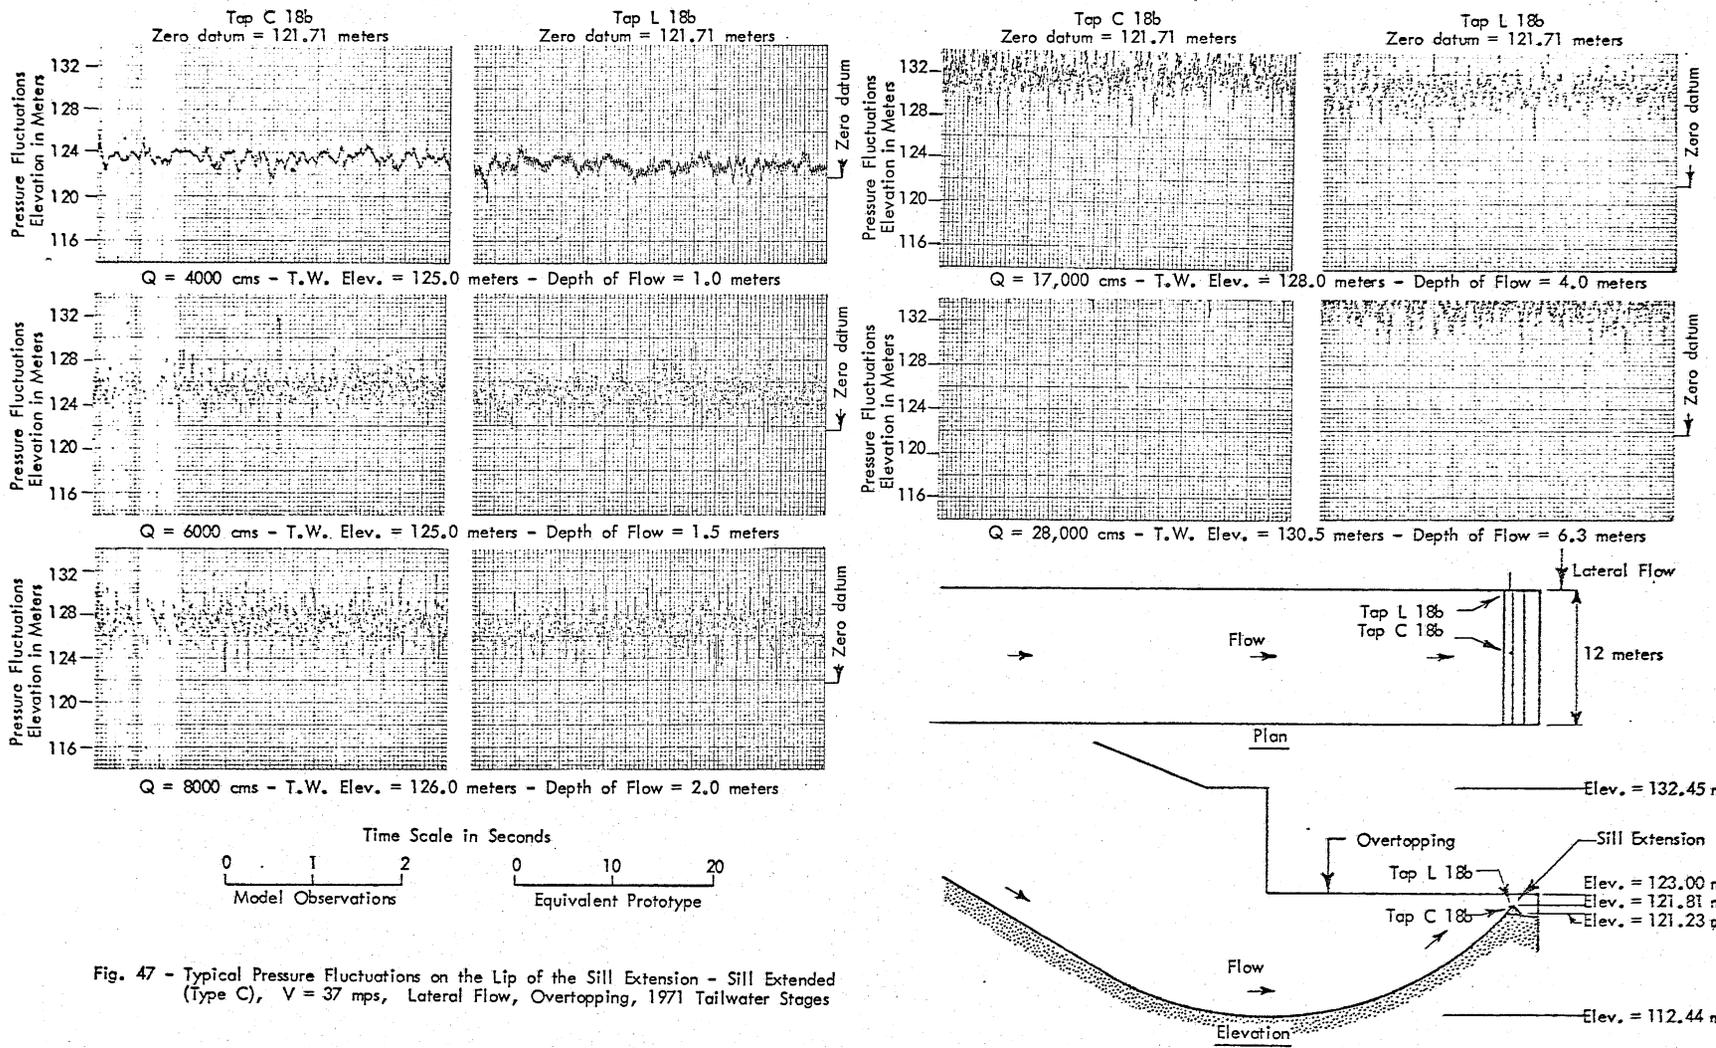
Fig. 46 - Typical Pressure Fluctuations on the Lip of the Sill Extension - Sill Extended (type C), $V = 29$ mps, Lateral Flow, Overtopping, 1971 Tailwater Stages

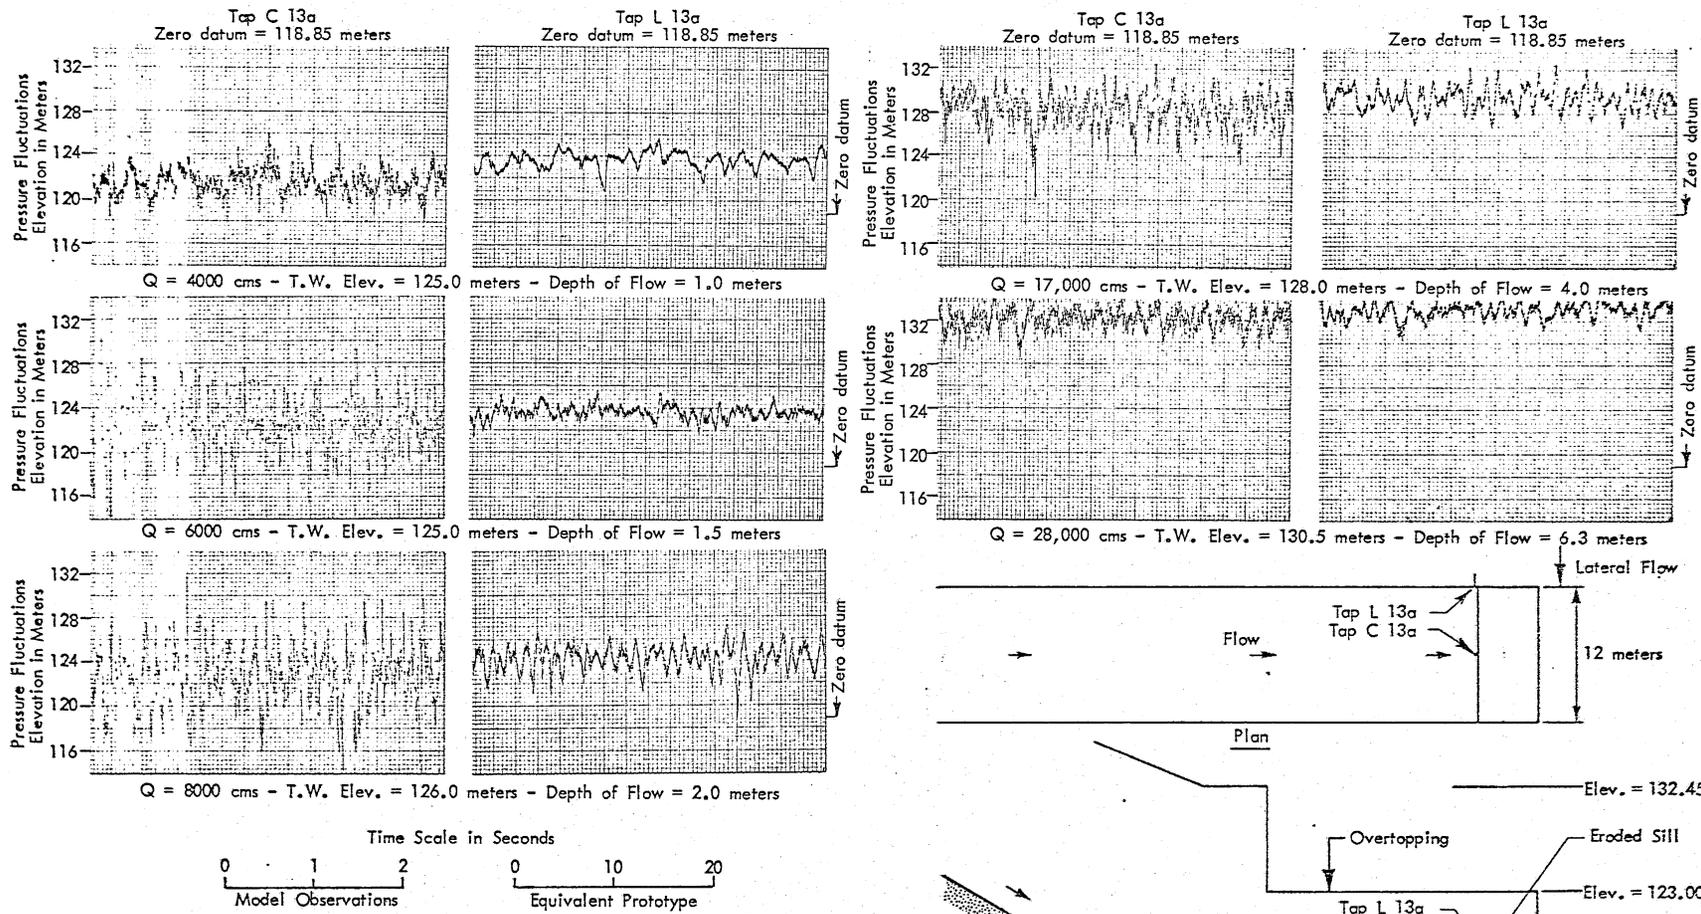
Pressure fluctuation tests were run on the eroded sill to determine whether the potential for cavitation damage was diminishing to the point of becoming self-arresting. Data were taken for a range of discharges and tailwater stages and for lateral flow and overtopping flow. Fluctuation measurements were made at taps C 13a upstream of the lip on the "centerline," L 13a upstream of the lip at the side wall, and C 13b downstream of the lip on the "centerline." All taps are located a distance which would be 12.5 cm from the lip in the prototype. Pressure data for these taps are contained in Figs. 48 through 51 and 63 through 65. The following can be noted from these data:

Fig. 48 - Typical Pressure Fluctuations at the Bucket Lip - Sill Eroded Two Meters (Type B), $V = 29$ mps, Lateral Flow, 1971 Tailwater Stages
