University of Minnesota
ST. ANTHONY FALLS HYDRAULIC LABORATORY

Project Report No. 132
Hydraulic Model Studies for the
GURI HYDROELECTRIC PROJECT
REPORT ON SPILLWAY CAVITATION DAMAGE

Prepared for
HARZA ENGINEERING COMPANY
and the
CORPORACION VENEZOLANA DE GUAYANA
Republic of Venezuela

A STUDY OF CAVITATION DAMAGE ON THE
DAM SPILLWAY OF THE GURI PROJECT

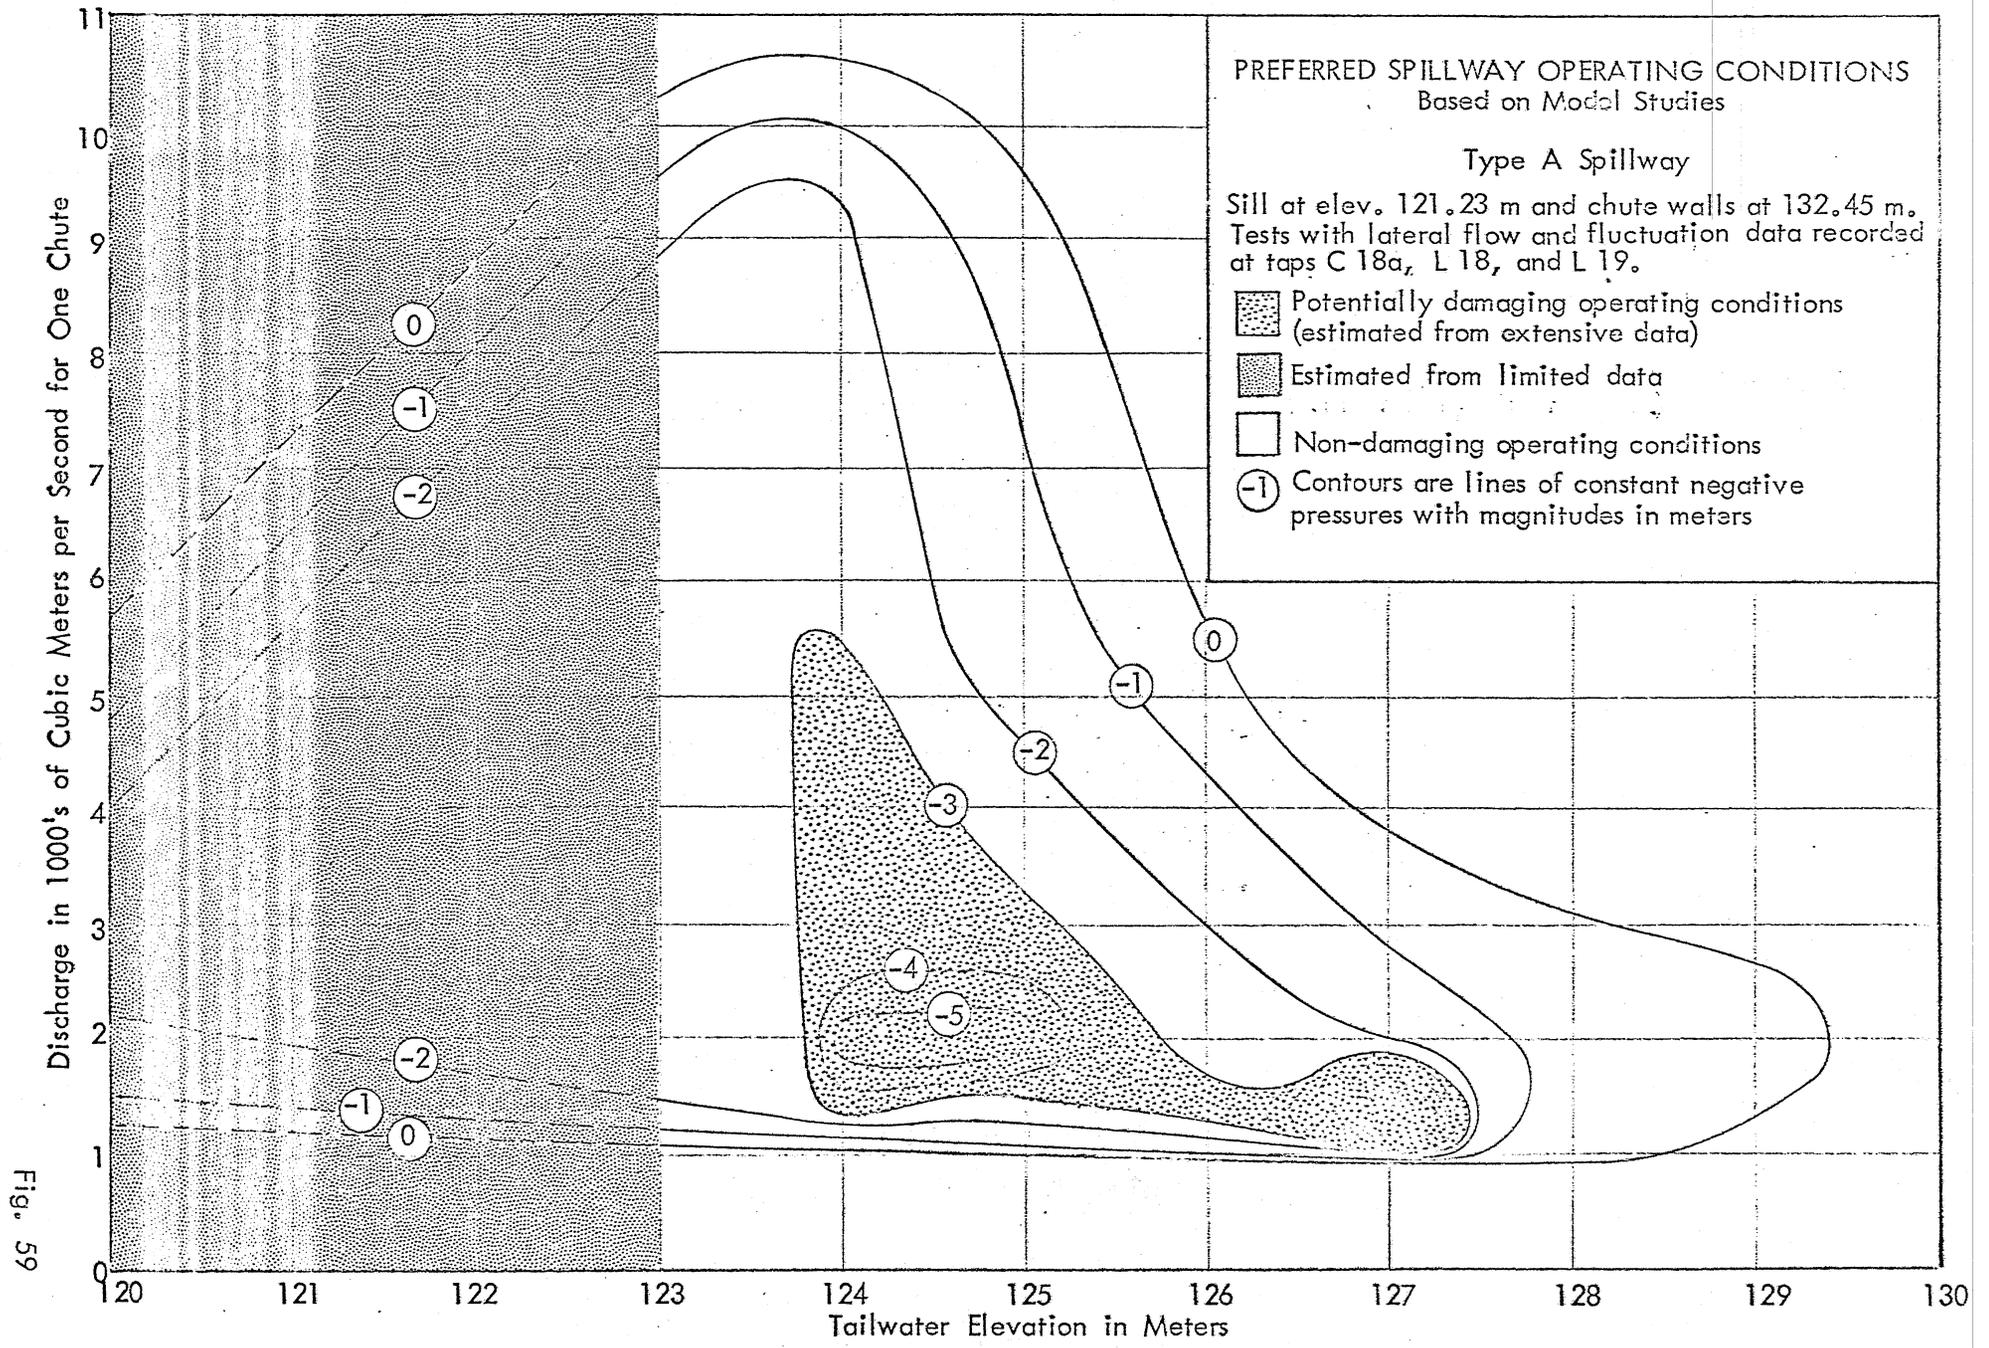
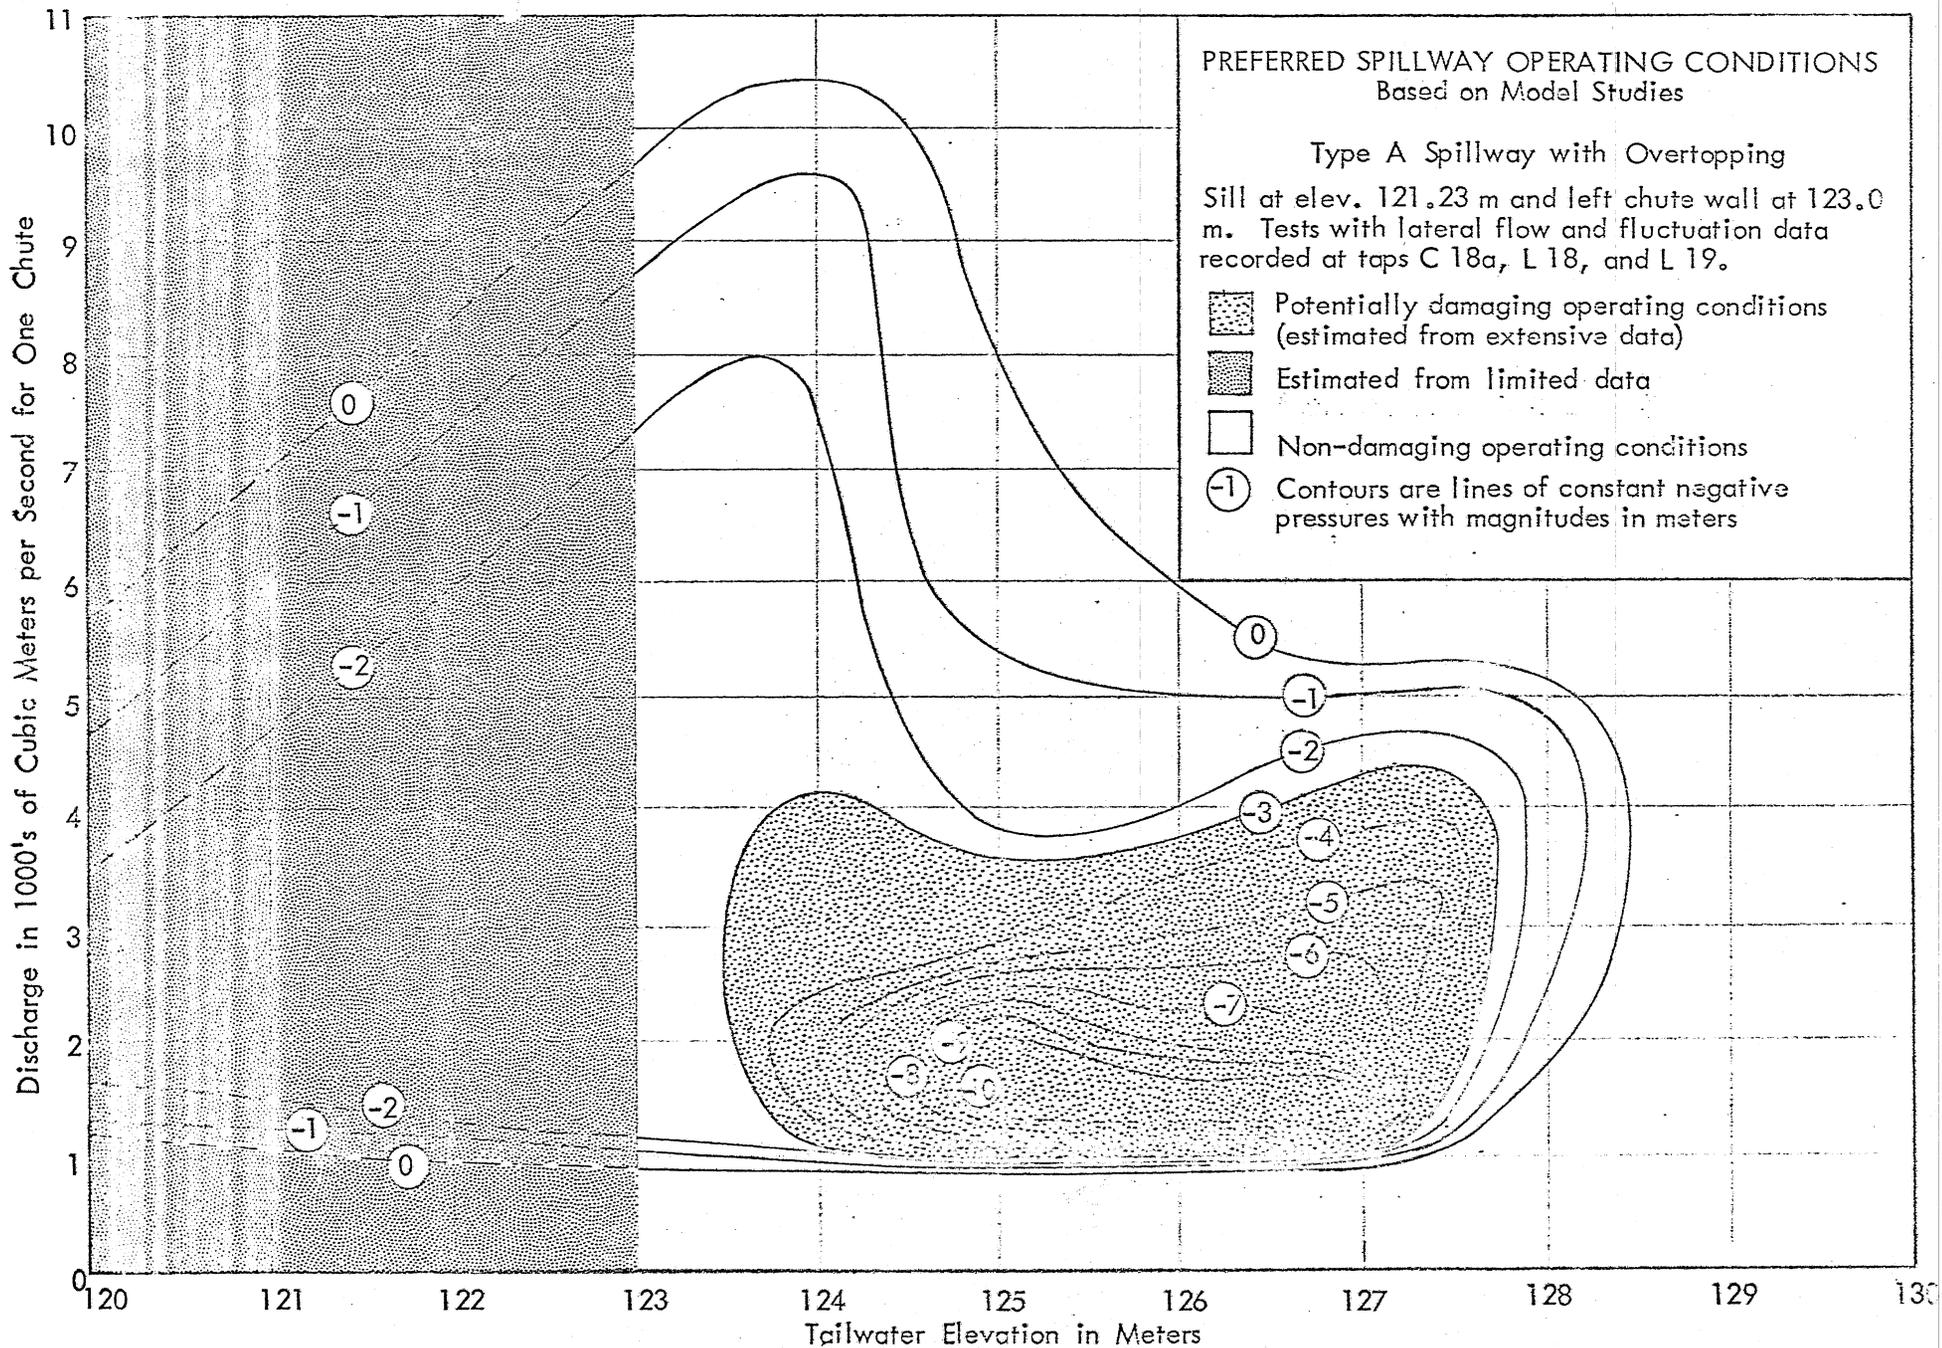
Fig. 59

16. In the model studies of the original sill configuration, damaging low pressures were found on the bucket immediately upstream of the lip. However, the transient pressures on the sill and just a short distance downstream of the lip and near the wall were even lower. The static pressures at sill tap L 19 were positive when only lateral flow existed, but became moderately negative when overtopping flows were added. However, when these same flows were examined for their transient dips, very severe negative pressure values were observed. They constitute the pressures of greatest potential damage for the entire spillway and are the source of the very low pressure dip shown in Figs. 59 and 60.

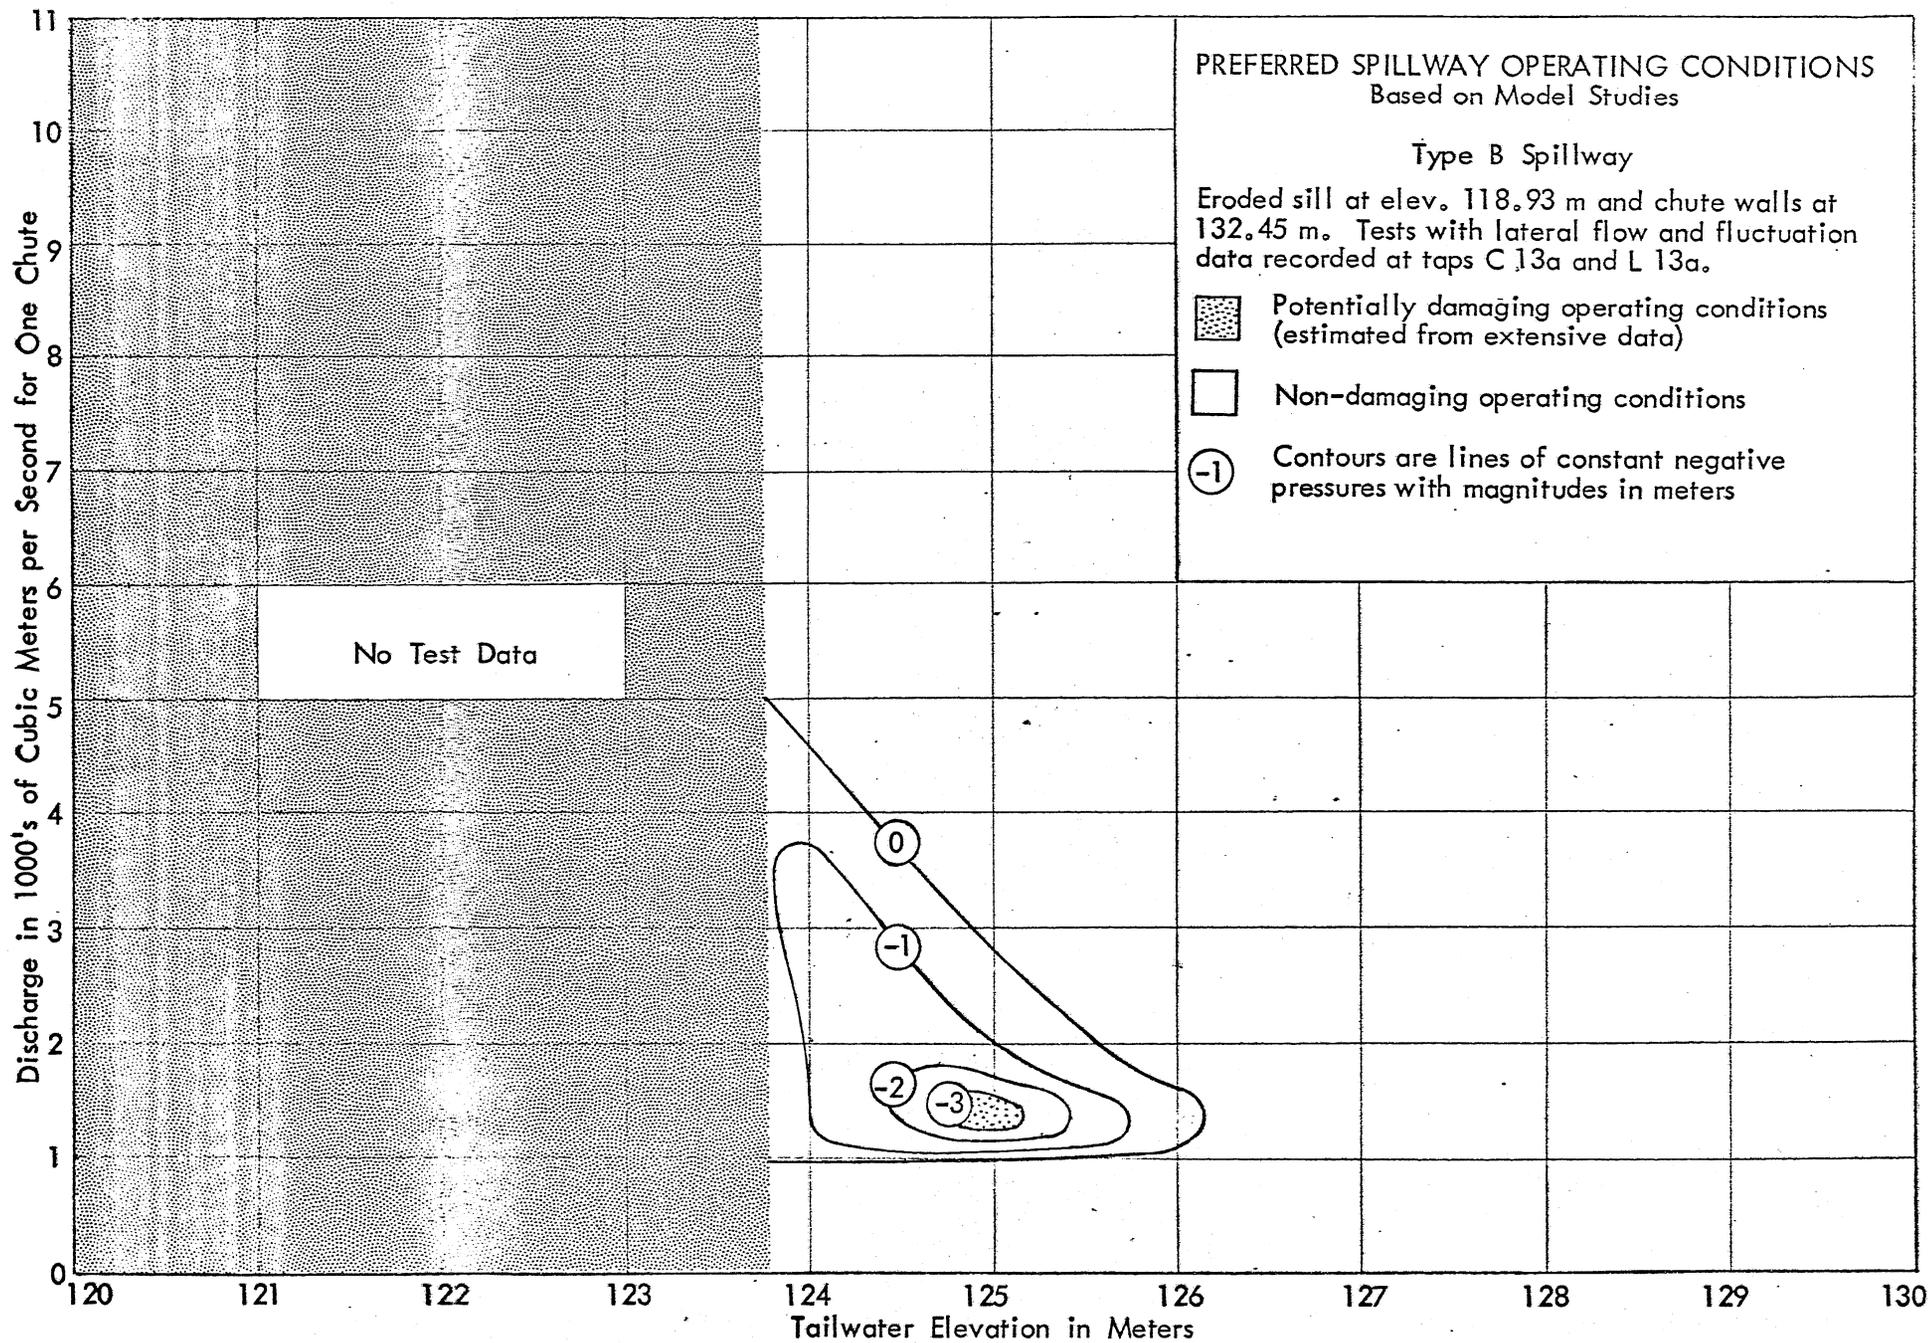
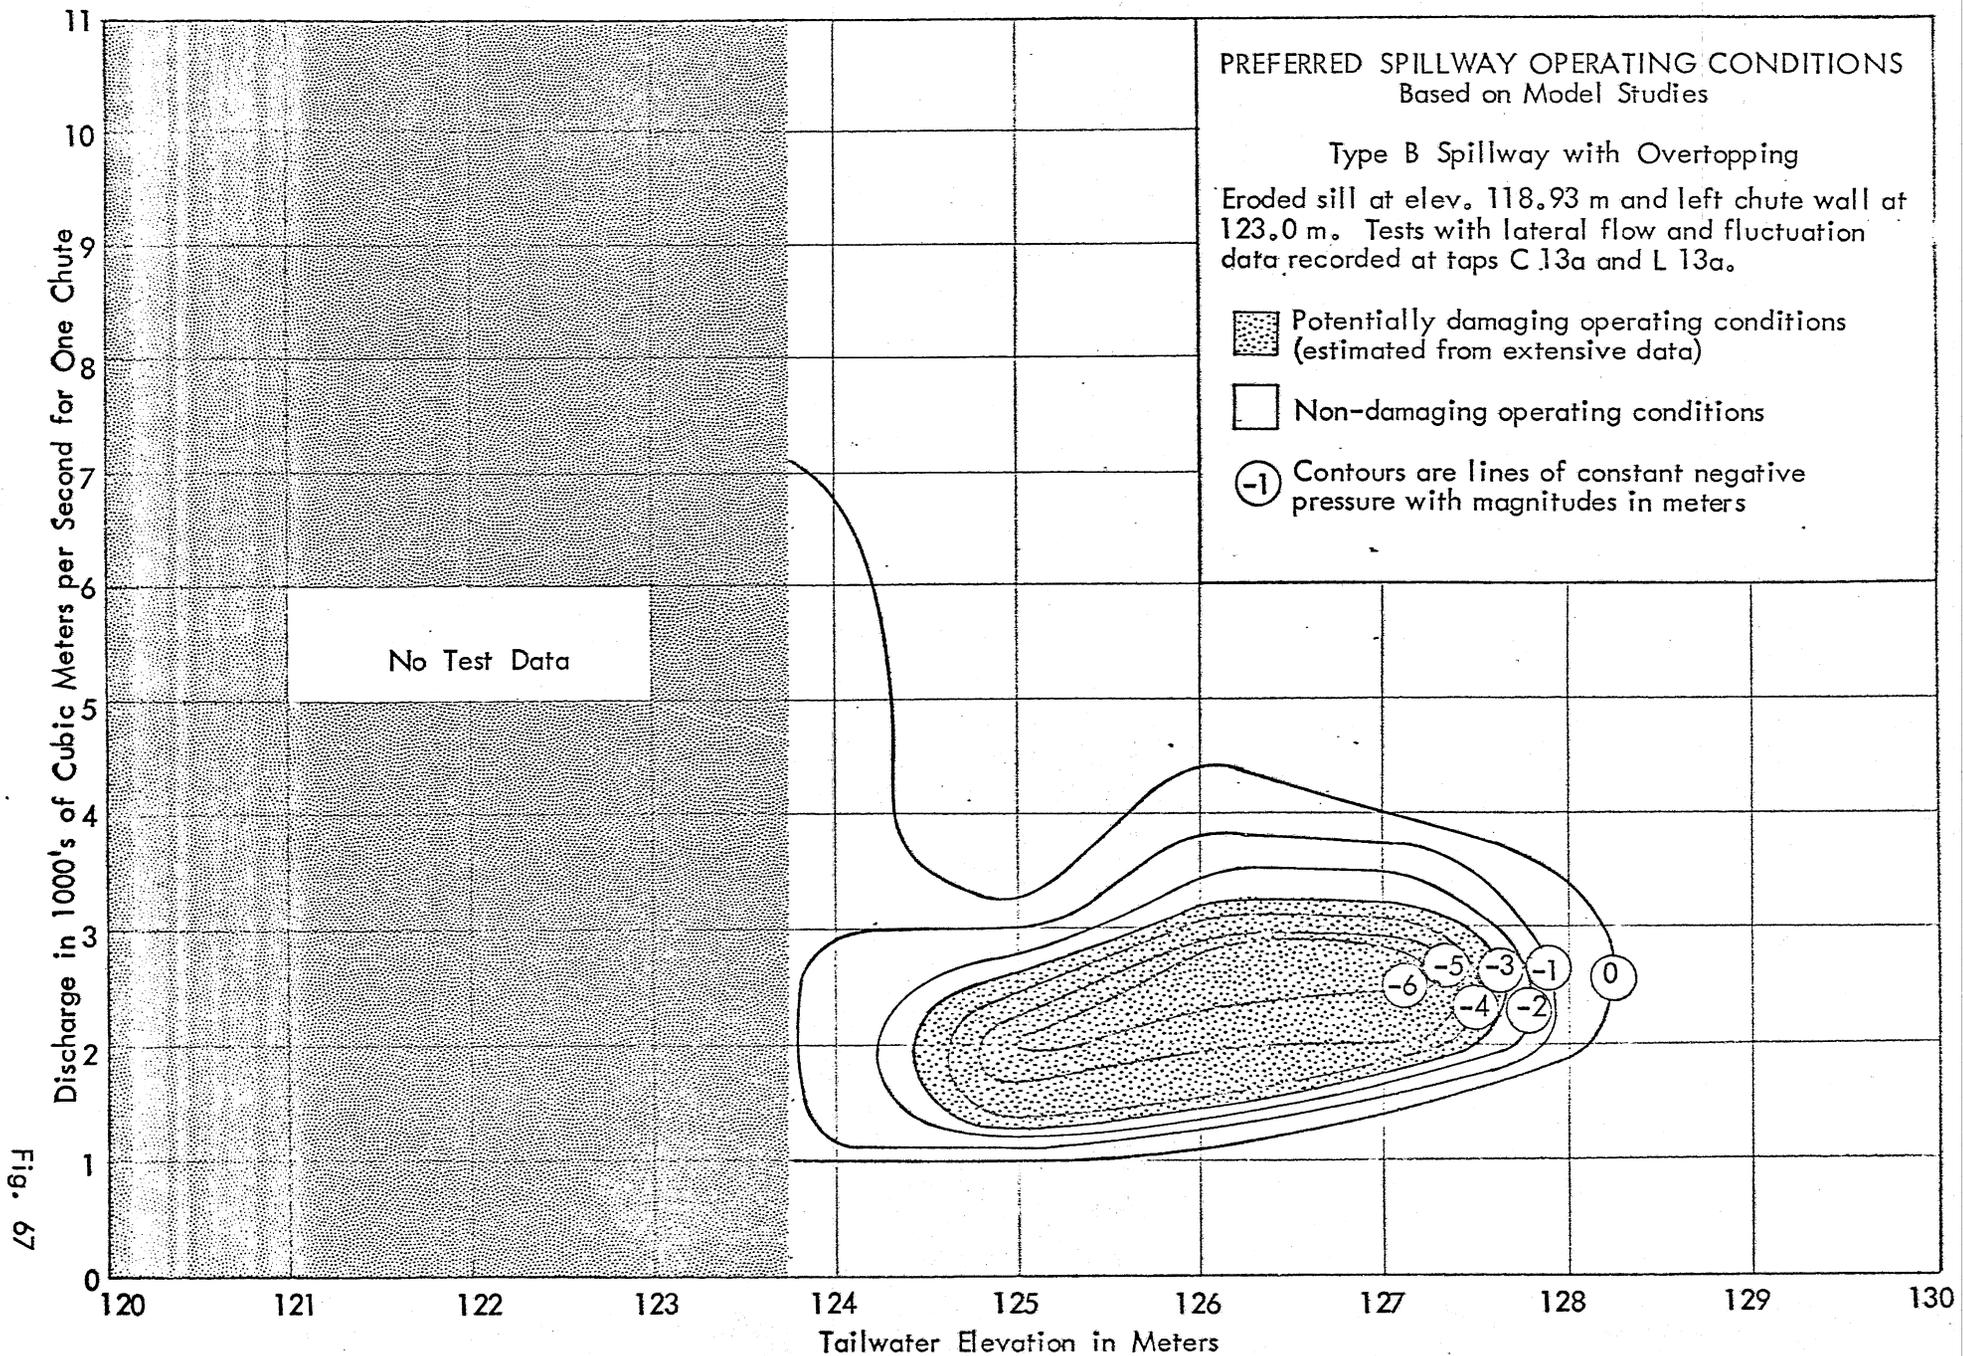
Fig. 66

In order to provide for somewhat easier assimilation of these data, they have been summarized graphically in Figs. 66 and 67. It is quite obvious from these plottings that a considerable potential for cavitation damage continues to exist for the case of overtopping flows and a marginal potential exists with lateral flow without overtopping.

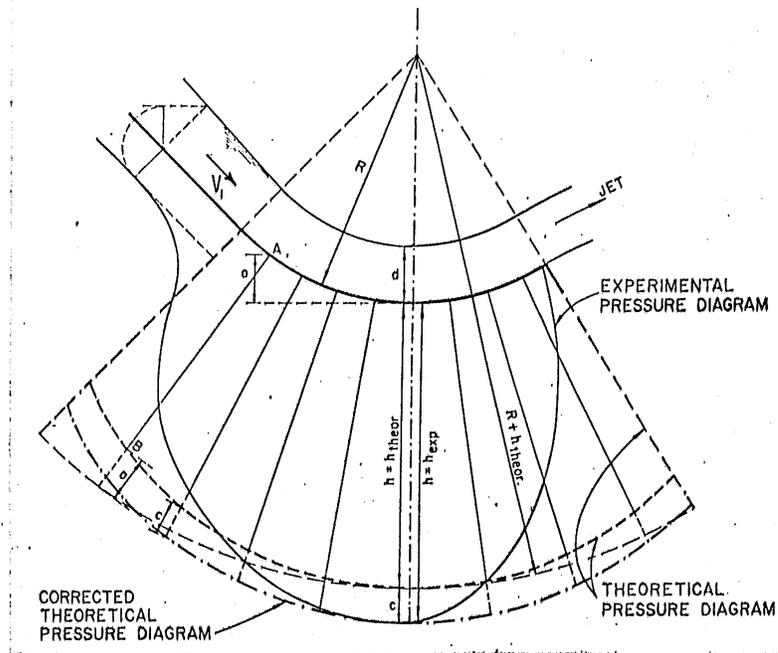
Fig. 68 - Theoretical and Experimental Pressure Diagrams
(from Ref. [2])

As is shown in Fig. 68, the theoretical low chute pressure abruptly jumps to the theoretical high bucket pressure at the upstream tangent point of the bucket curve. The experimental curve shows that the theoretical pressure singularity cannot exist in nature and the real boundary flow lines adjust themselves to a form somewhat different from that of the rigid boundary. This is accomplished physically by a natural separation of the flow from the solid boundary. A similar singularity exists at the lip of the bucket, where the vortex pressure falls abruptly to zero. It is apparent from Fig. 68 that the experimental curve also provides a pressure adjustment in the downstream region. The details of this adjustment in the immediate vicinity of the lip appear to have been ignored both in theory [3] and in the numerous model studies cited in Refs. [2] and [3] in which bucket pressures have been measured. The assumption seems to have been made universally that the pressure falls to zero at the lip. It was, therefore,

rather surprising to find that the free discharge measurements made in the current tests (see Fig. 22) showed definite negative values upstream of the bucket lip. However, contemplation of the possible readjustments of flow lines at the lip suggests that this is simply a response of the freely discharging jet to the influence of the force of gravity. It is not difficult to accept the idea that the streamlines of the water surface must adjust from a-a as shown in Fig. 69 to some form such as b-b. It is conjectured that it is equally reasonable to reject the idea that the bottom streamline must rigorously follow the boundary to the lip, as with c-c, before beginning to curve under the influence of gravity. In light of the previously discussed adjustment that took place at the chute tangent point, it is suggested that flow at the lip does in fact separate upstream of the bucket lip in accord with a streamline of the form d-d. This streamline would require the pressure diagram which is designated as "proposed" in Fig. 69. The proposed diagram is consistent with the limited data obtained at St. Anthony Falls and shown in Fig. 22. The indicated low pressures which were measured as manometric or static values are enhanced negatively when impinging eddies in the flow rebound from the boundary, yielding additive transient negative pulses. The magnitudes of the pressure heads of such added dynamic pulses are given by the ΔP values of Figs. 52 through 58 with their strengths ranging from ≈ 1 to ≈ 10 m, depending on the violence of the impinging eddies. As described in the body of the report, very strong eddies commonly resulted with overtopping flow, but equally strong eddies resulted from certain non-overtopping flows with bucket rollers uniquely positioned above the lip.

It is believed that the combination of a low static pressure and strong eddy pulses caused the cavity-forming negative pressure which resulted in the observed erosion damage at Guri.

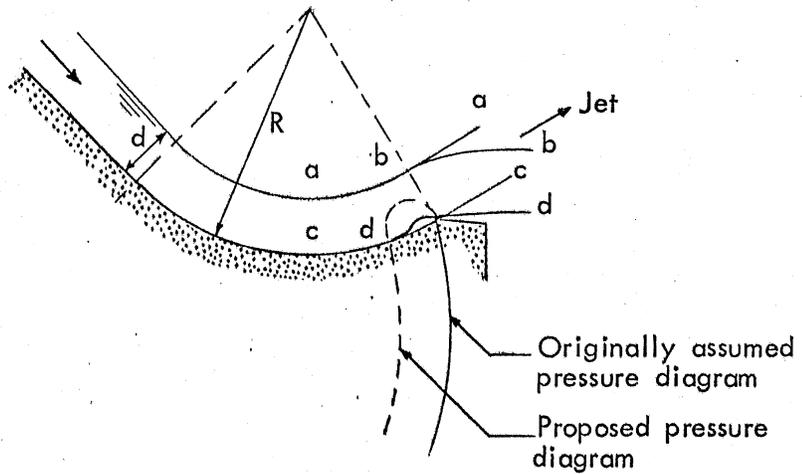
Fig. 69 - Suggested Streamline Adjustments at the Bucket Lip
(Pressure diagram and streamline dd greatly exaggerated)

1. Negative pressure effects can be contributed by the flow passing over a convex portion of the boundary or a convex separation zone that serves as a pseudo-boundary. Appendix A and Fig. 69 describe how gravitational effects on the discharging jet at Guri might cause such a separation zone on the bucket lip. The resulting curved flow generates an essentially static pressure depression on the boundary that depends on the flow velocity, the flow depth, and the radius of curvature. The data of Fig. 22 for a chute velocity of 29 mps demonstrate that manometer measurements of mean pressure on such a boundary may be as low as -2 m even when several meters of water depth exist above the boundary pressure tap. Similar measurements at a chute velocity of 37 mps produced a value as low as -4 m relative to atmospheric.
