Project Report No. 78

Report on
STUDIES OF THE STABILIZATION OF THE BIG SIOUX RIVER
AT THE INTERSTATE 29 BRIDGE CROSSING

by
Alvin G. Anderson

Prepared for
South Dakota Department of Highways
and the
Iowa State Highway Commission

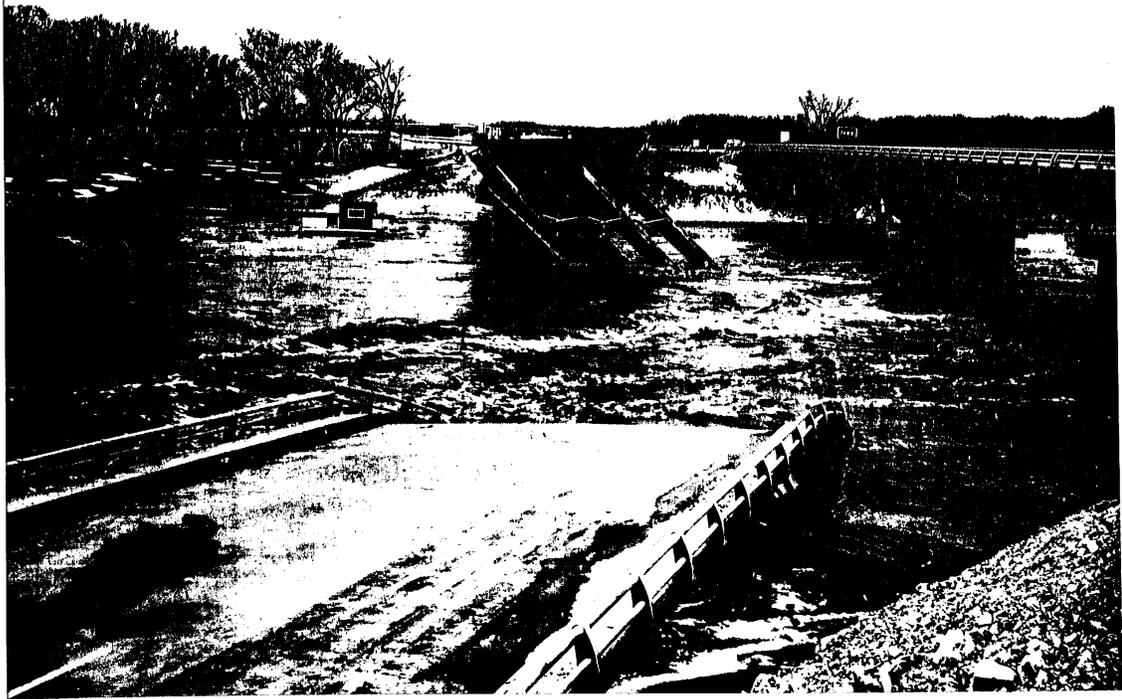
Photo 2

As a consequence of a flood on April 1, 1962, one of the piers of the upstream bridge was undermined by scour and the bridge collapsed. A view of the fallen bridge is shown in Photo 2. Of particular interest, from the hydraulic point of view, was the development of a relatively large scour hole downstream of the two bridges. The precise reason for the occurrence of this scour hole in this area is not clear, although the wake downstream of the piers of the downstream bridge, the higher velocity between the piers of the downstream bridge, and the presence of the collapsed upstream bridge in the channel undoubtedly were factors in causing the excessive scour. Following the flood and during the construction work involved in the replacement of the collapsed bridge and the additional underpinning of the remaining bridge, it was observed that a sizable portion of the left bank downstream of the remaining bridge subsided, as shown in Photo 3. The extent of the subsidence and its approach to the piers of the remaining bridge raised the fear that this pier might be damaged. The model studies were undertaken to investigate and suggest solutions for two conditions: (1) to provide protection for the piers of the reconstructed bridges from damage or undermining in the event of future floods, and (2) to stabilize the banks in order to prevent further subsidence that could endanger the piers.

PHOTO 2 (Serial No. 142-10T) Collapse of the upstream bridge of I-29 crossing of the Big Sioux River. Looking towards Iowa from the abutment of the submerged bridge before the collapse of pier 4. Photo taken by South Dakota Department of Highways.

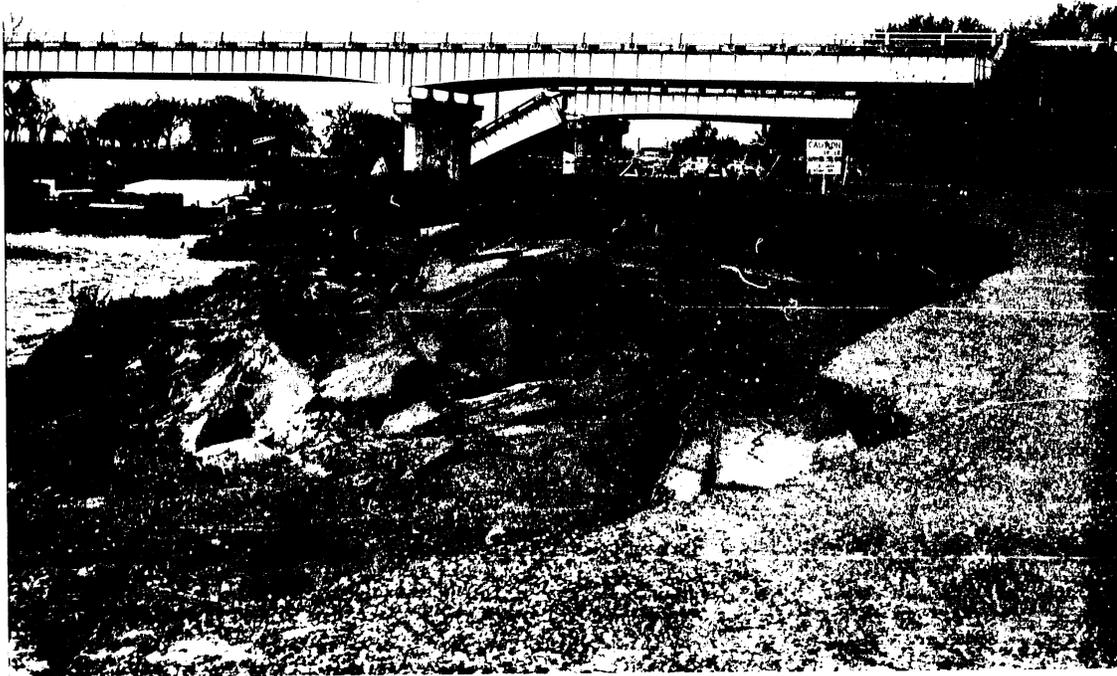
Photo 3

PHOTO 3 Following the collapse of the upstream bridge the left bank downstream of the downstream bridge began to subside and move toward the river.

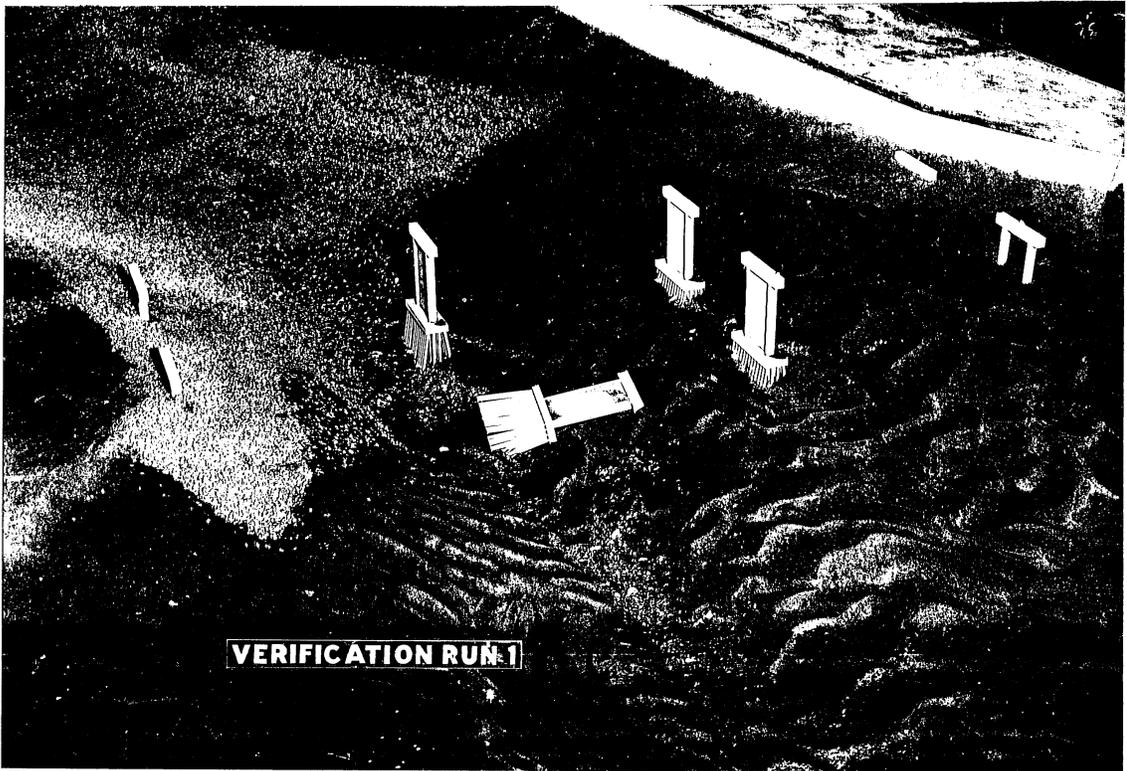
Photo 5

PHOTO 5 (Serial No. 142-60) Erosion pattern following verification test V-1. This view was taken at the end of the experiment after the water had been drained from the model and shows the collapse of the pier 3 of the downstream bridge. It will be noted that pier 3 of the upstream bridge has also been seriously undermined.

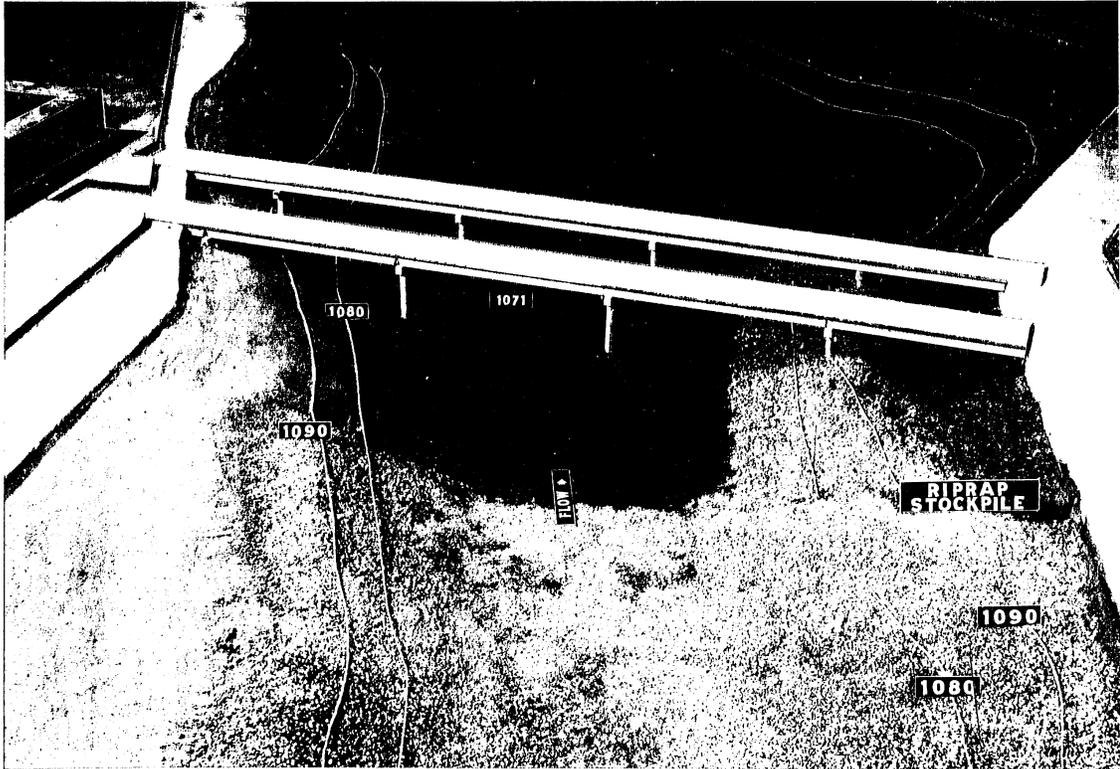
Photo 10

PHOTO 10 (Serial No. 142-70) Big Sioux Verification Test V-4.
A view of the two bridges for the Interstate crossing
in place in the model prior to the actual test.

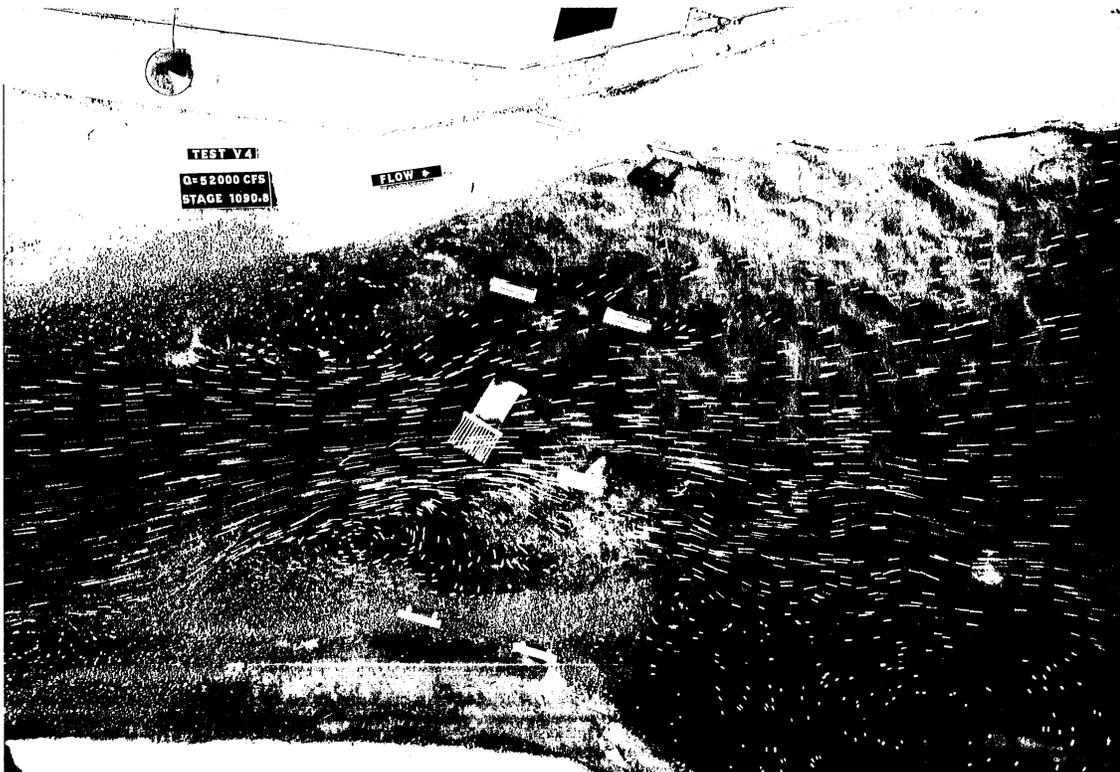
Photo 11

PHOTO 11 (Serial No. 142-72) Big Sioux Verification Test V-4.
A view of the flow pattern after the collapse of pier
3 of the upstream bridge.

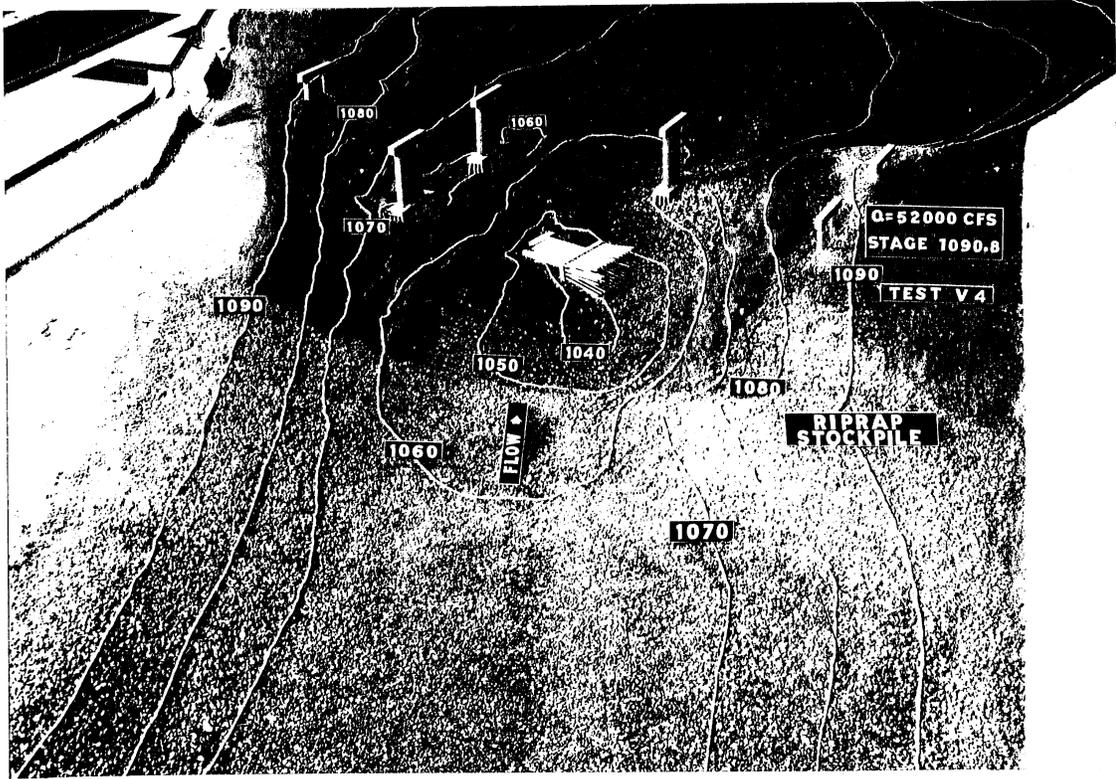
Photo 12

PHOTO 12 (Serial No. 142-73) Big Sioux Verification Test V-4.
The erosion pattern following the collapse of pier 3
of the upstream bridge.

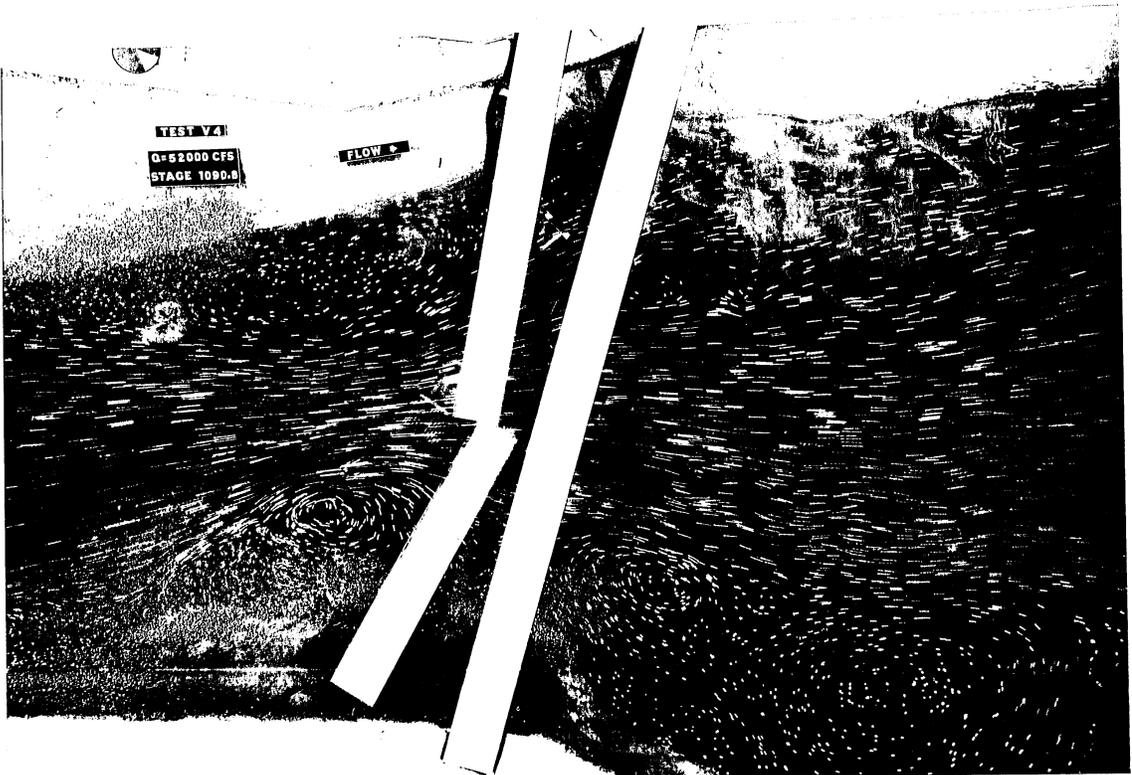
Photo 13

PHOTO 13 (Serial No. 142-75) Big Sioux Verification Test V-4.
This is a view of the flow pattern after the super-
structure had been placed in the flow to simulate
that of the prototype.

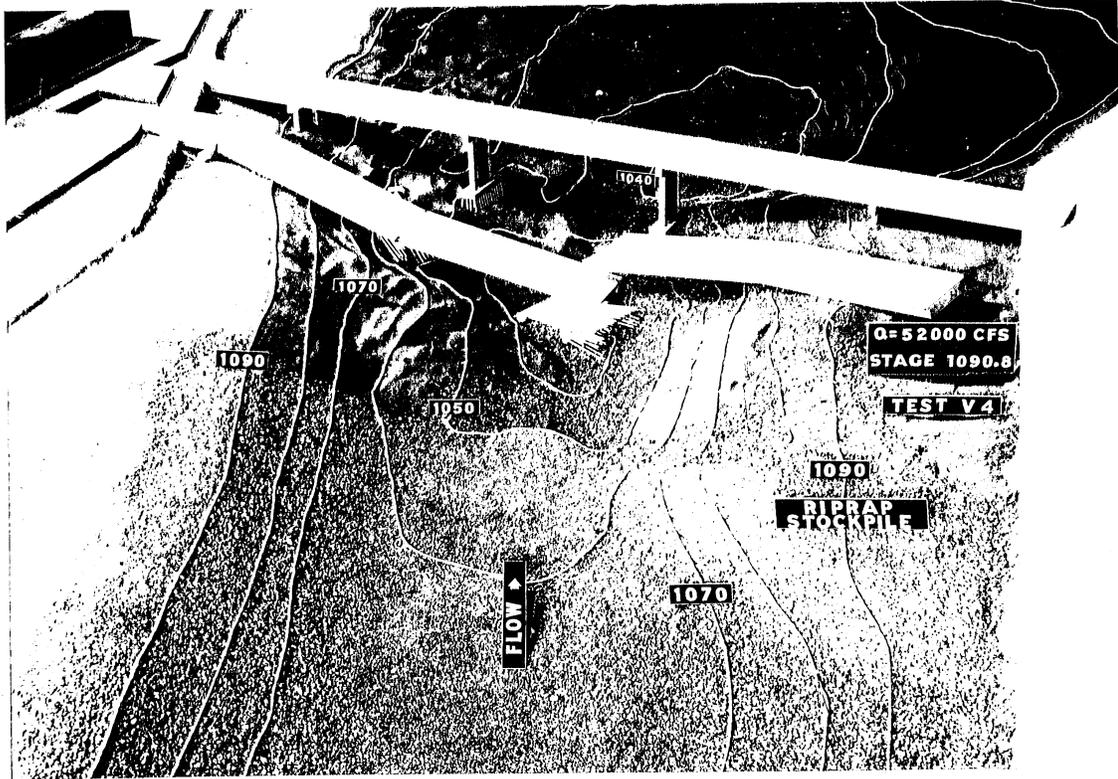
Photo 14

PHOTO 14 (Serial No. 142-76) Big Sioux Verification Test V-4.
A view of the erosion pattern at the end of the test
after the water had been drained from the model to
show the contours and the fallen piers and bridge
spans.

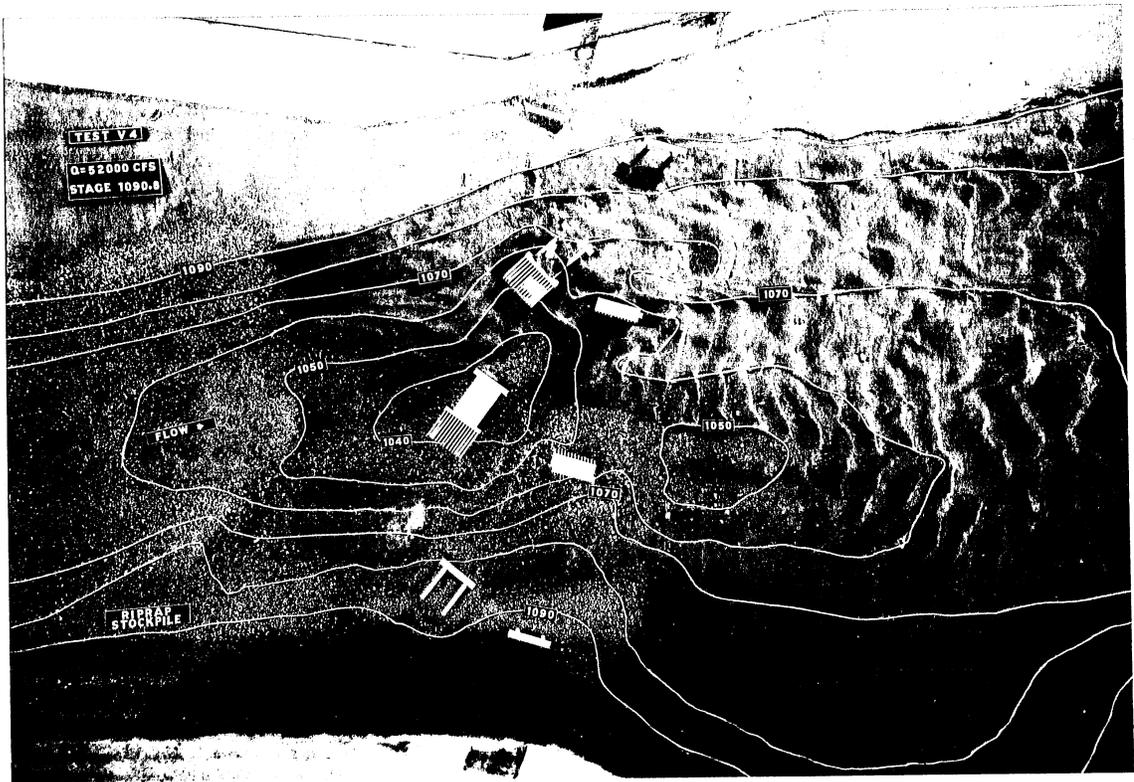
Photo 15

PHOTO 15 (Serial No. 142-77) Big Sioux Verification Test V-4.
A vertical view of the erosion pattern at the completion
of the test with bridge spans removed so that the scour
pattern can be seen.

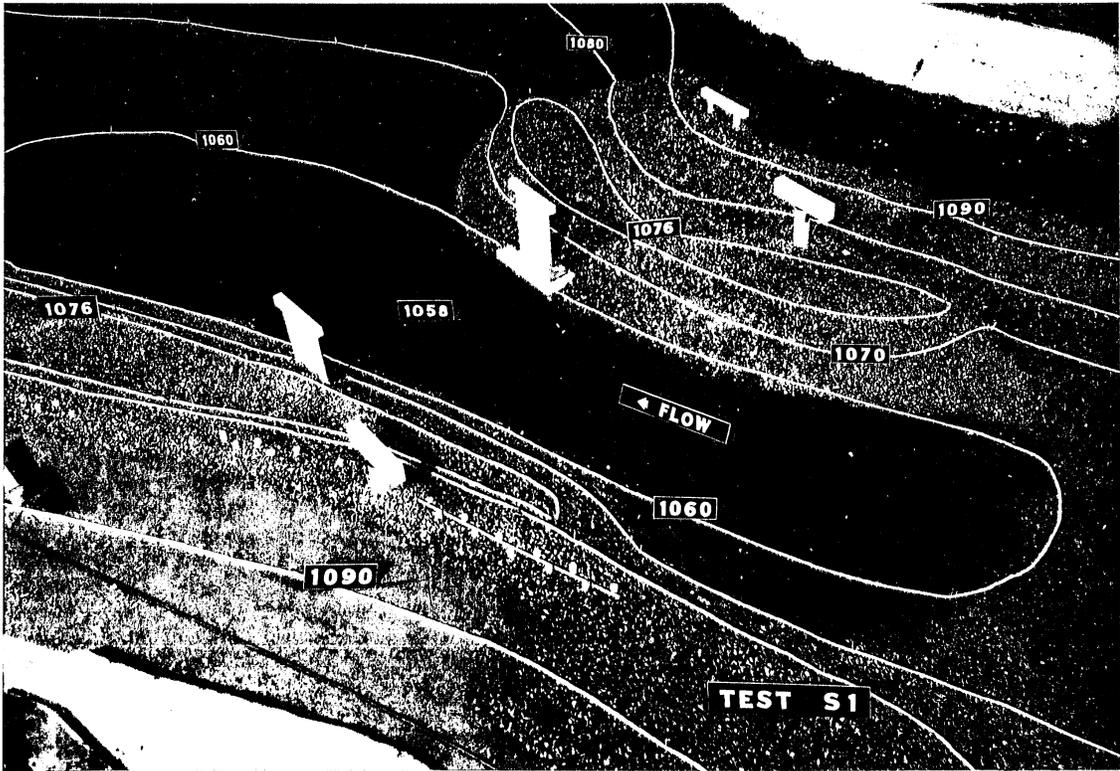
Photo 16

PHOTO 16 (Serial No. 142-80) The bank revetment has been placed in the model in accordance with the proposal. The new piers for the upstream bridge and the pile and rock-filled dike along the left bank have been put in place. Initially, the bed elevation between the revetted banks was molded to Elev. 1060 ft.

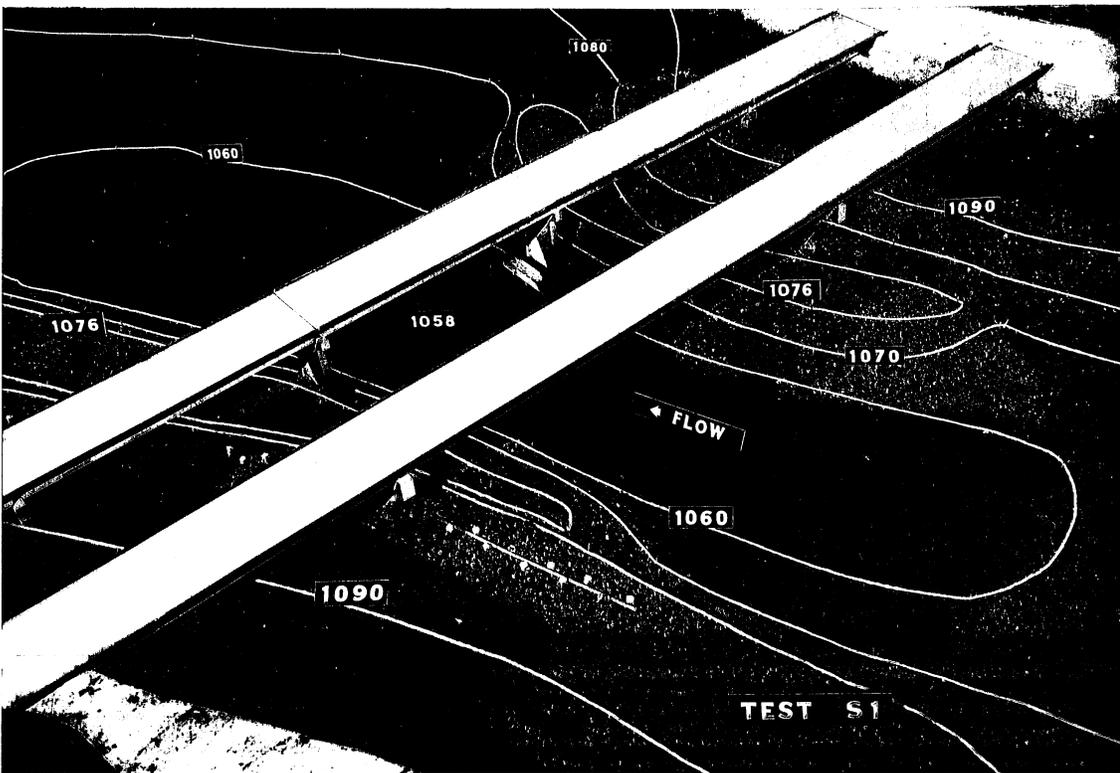
Photo 17

PHOTO 17 (Serial No. 142-81) This photo is similar to Photo 16 except that the bridge decks have been put in place in order to show the relative position of the bank revetment and the river banks under the bridges.

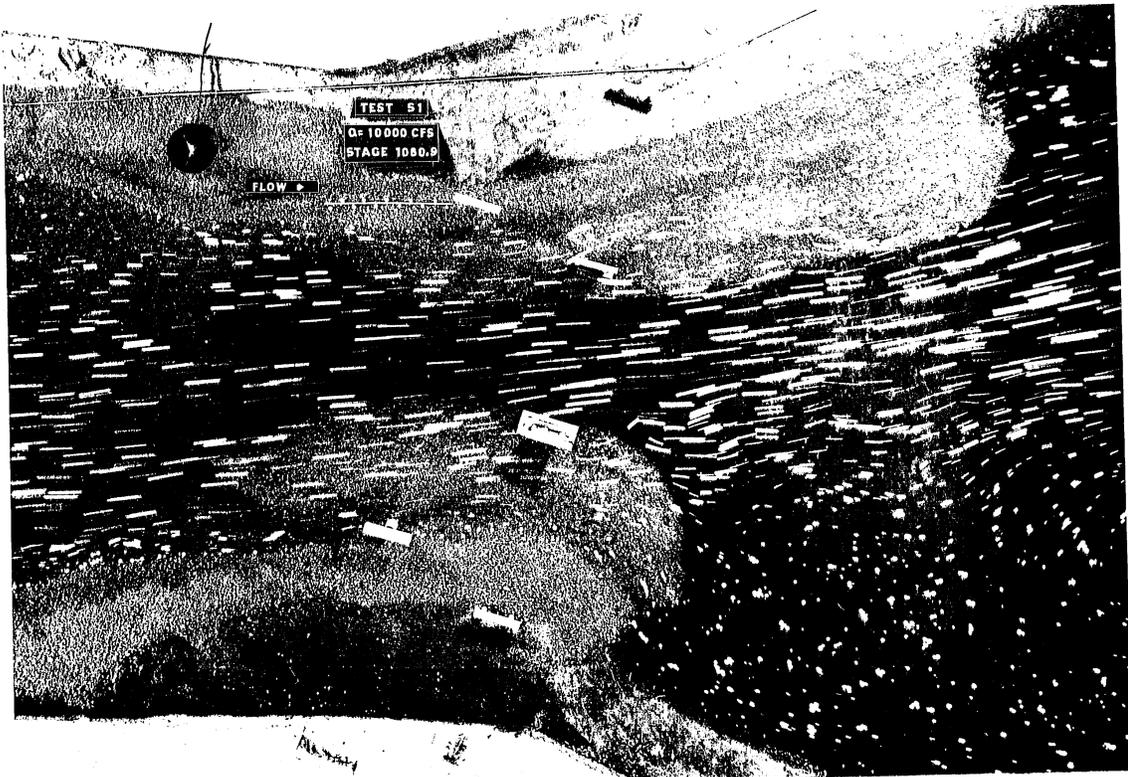
Photo 18

PHOTO 18 (Serial No. 142-82) For a discharge of 10,000 cfs through the constricted bridge section the velocities are relatively low and the flow is relatively smooth. The bank revetment near the bridge piers can be seen through the water.

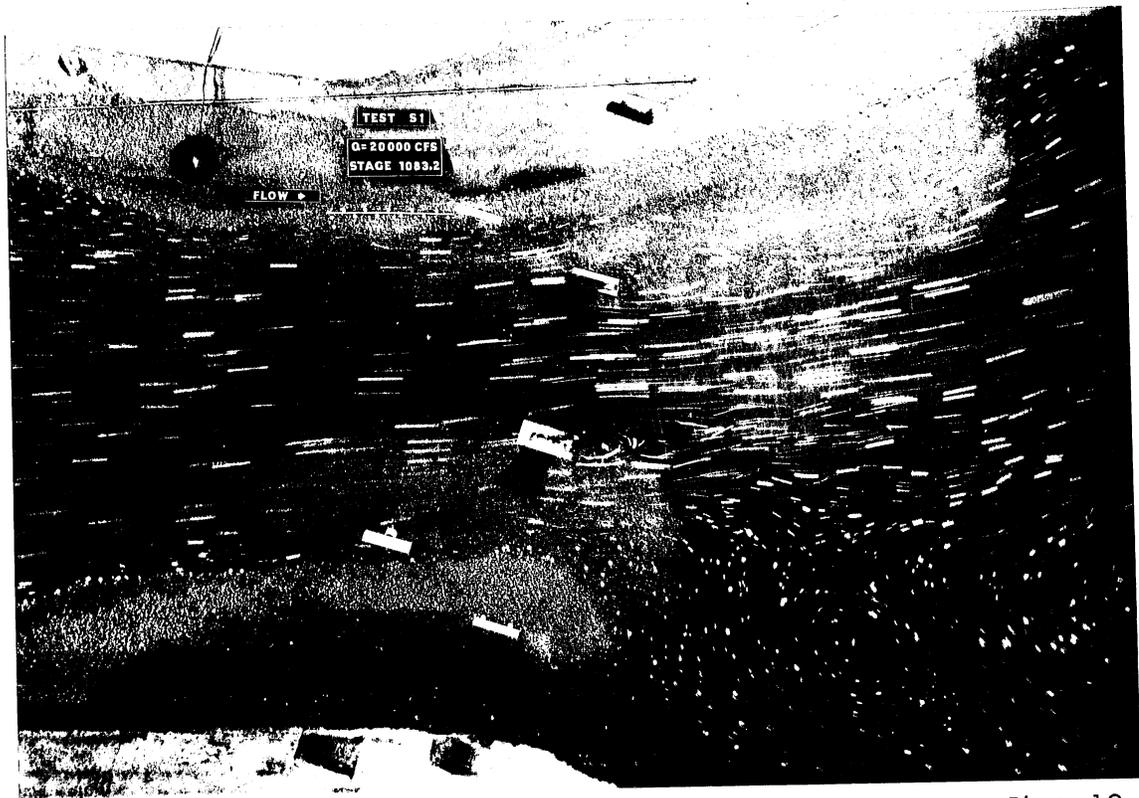
Photo 19

PHOTO 19 (Serial No. 142-83) The discharge shown here is 20,000 cfs and the stage at the bridge section is 1083.2 ft. The velocities through the constriction have increased somewhat and the wakes downstream of the piers of the downstream bridge are becoming more apparent.

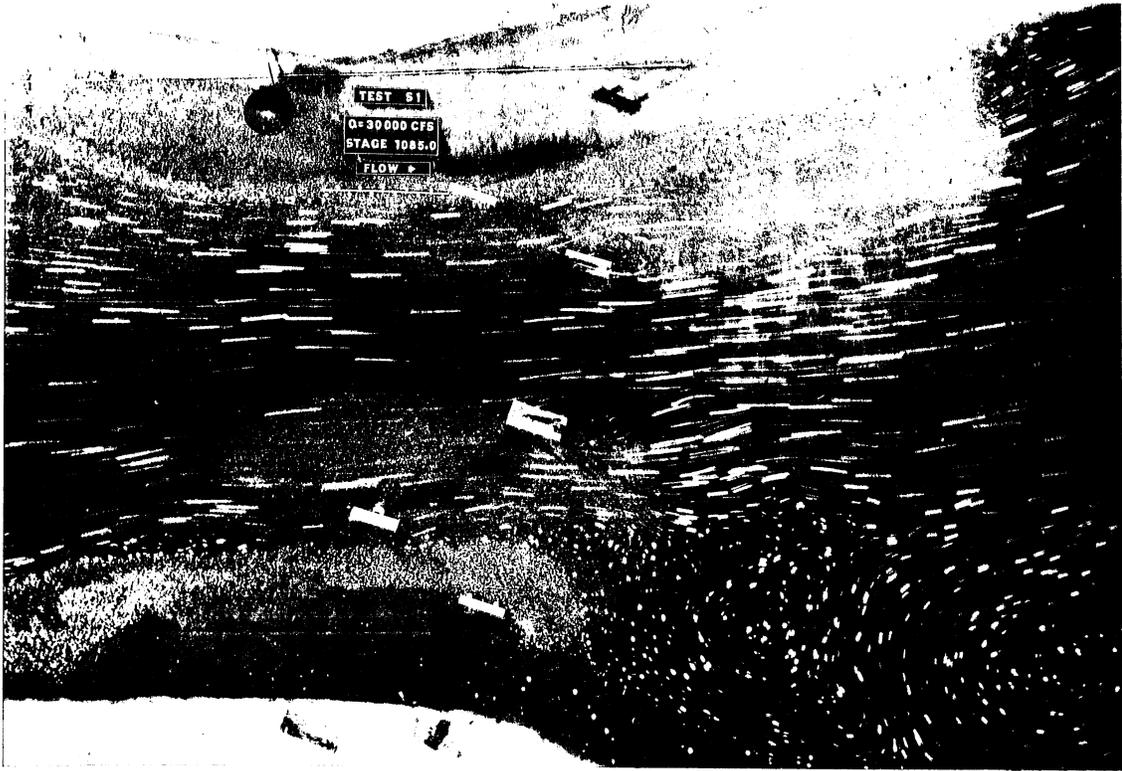
Photo 20

PHOTO 20 (Serial No. 142-84) When the discharge is increased to 30,000 cfs and the stage is increased to 1085 ft, the velocities through the bridge section are correspondingly increased but the flow pattern in general is similar to that observed for the lower discharges.

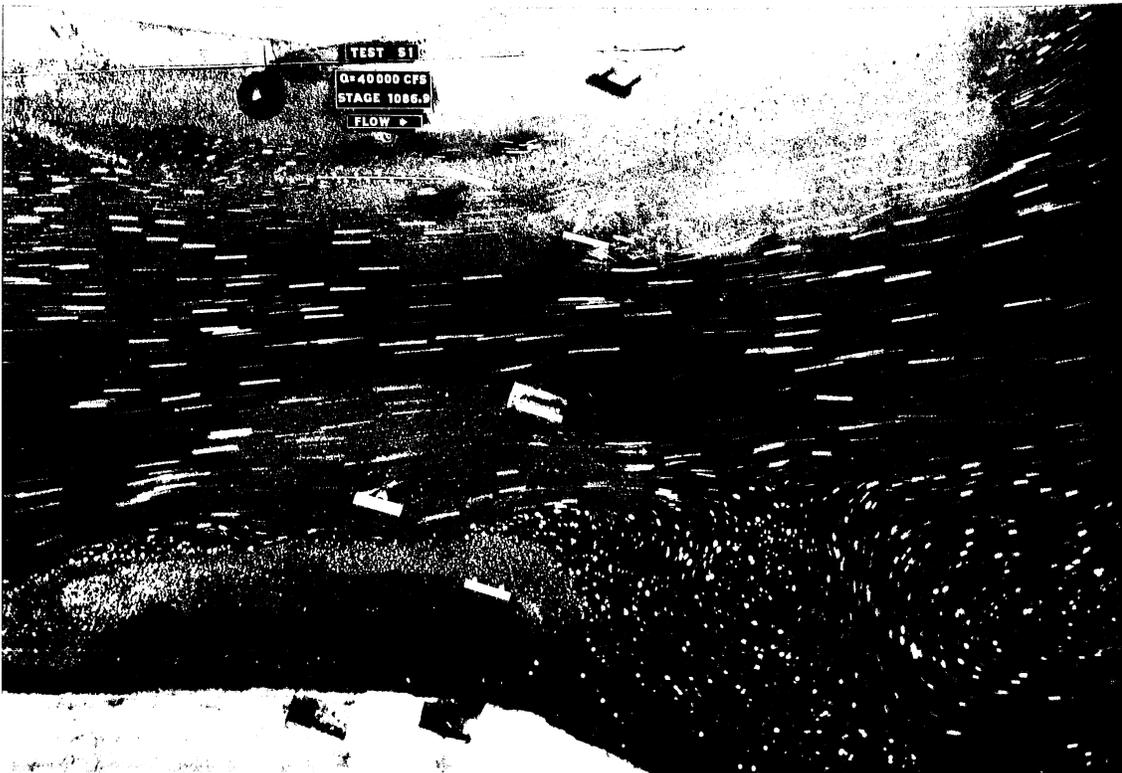
Photo 21

PHOTO 21 (Serial No. 142-85) Here the discharge has been increased to 40,000 cfs and the stage at the bridge section increased to 1086.9 ft. Because of the increased velocity through the constricted section the jet leaving this section extends further downstream before it spreads over the entire channel. Consequently, vortices are formed on both sides of the channel and particularly on the right bank at the outside of the downstream bend.

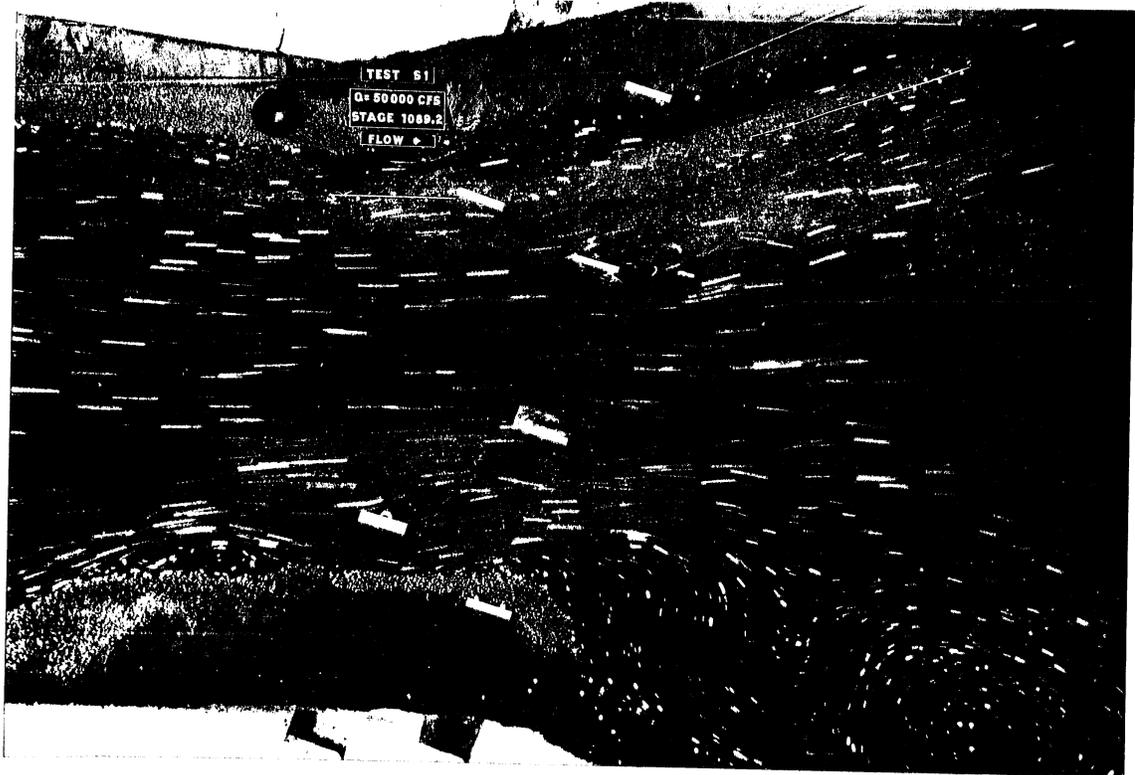
Photo 22

PHOTO 22 (Serial No. 142-86) This photograph shows a still more intensified flow pattern when the discharge is increased to 50,000 cfs and the stage is now at Elev. 1089.2 ft. The vortices are somewhat more pronounced.

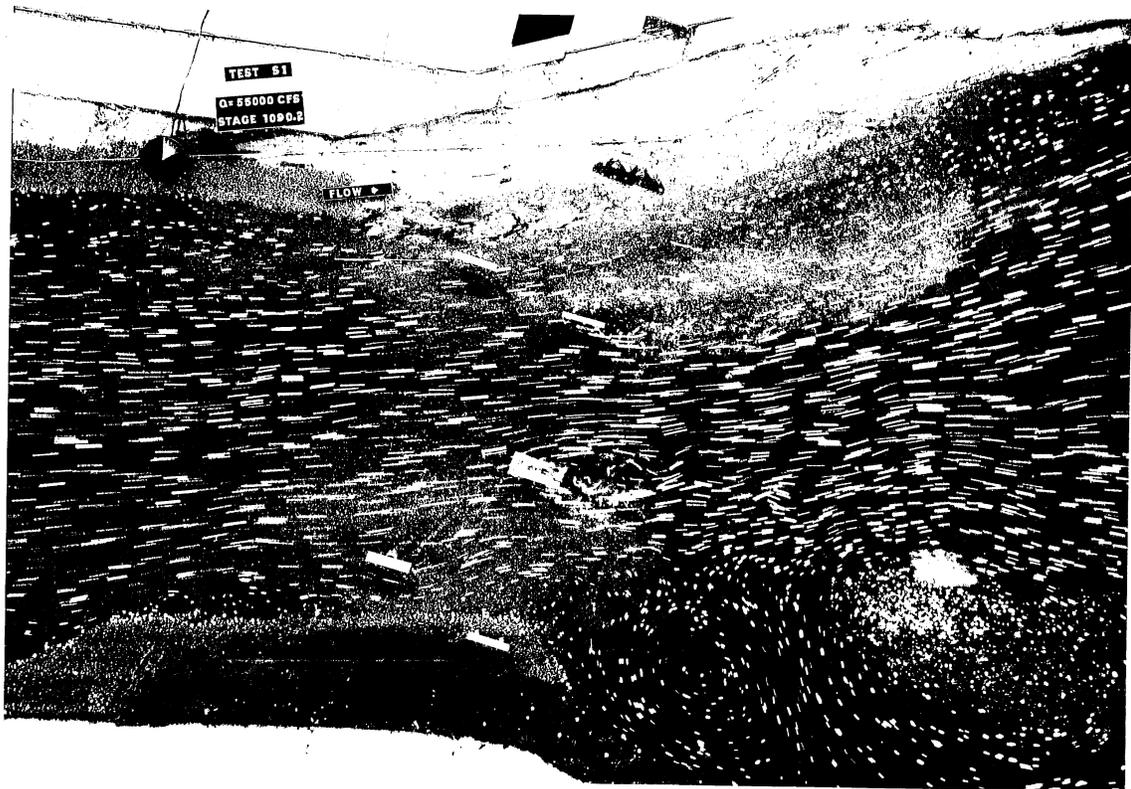
Photo 23

PHOTO 23 (Serial No. 142-87) This photograph shows a discharge of 55,000 cfs through the bridge sections with the stage at Elev. 1090.2 ft. This is just slightly below that which was measured in the prototype. This discharge corresponds approximately to the maximum discharge observed during the flood in the prototype.

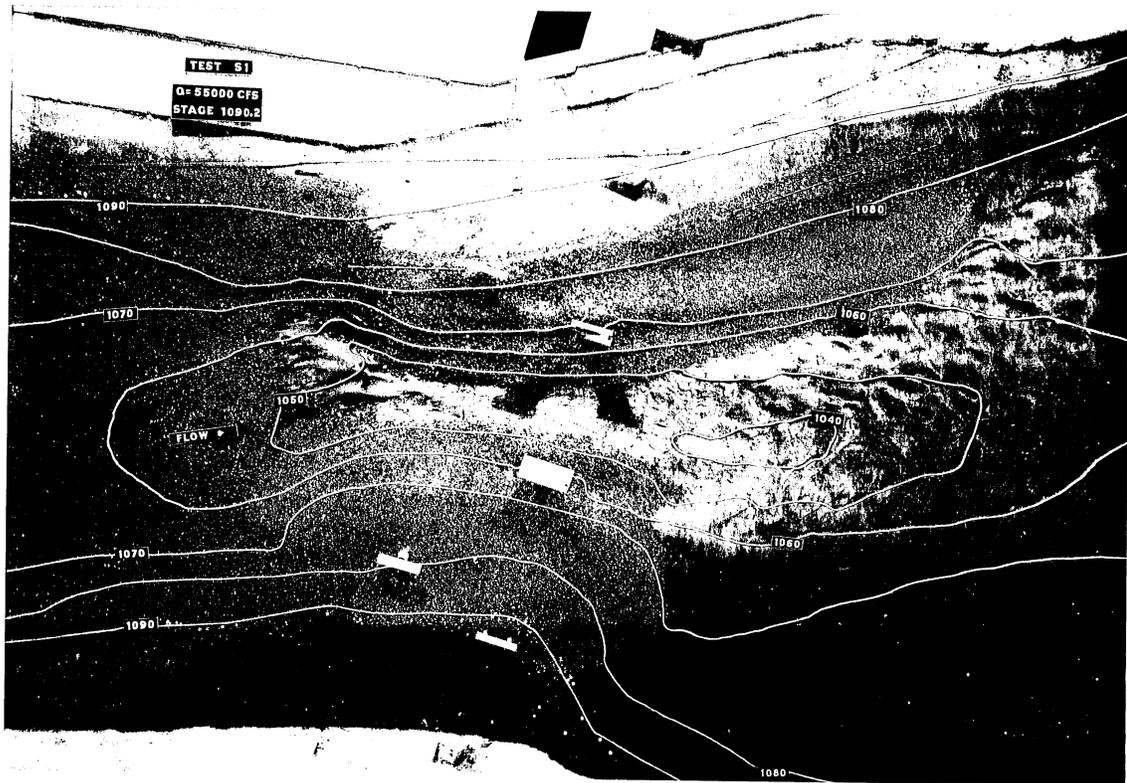
Photo 25

PHOTO 25 (Serial No. 142-90) This photo is a view from above showing the same erosion pattern for the 55,000 cfs discharge. This view shows more clearly the outline of the erosion contours.

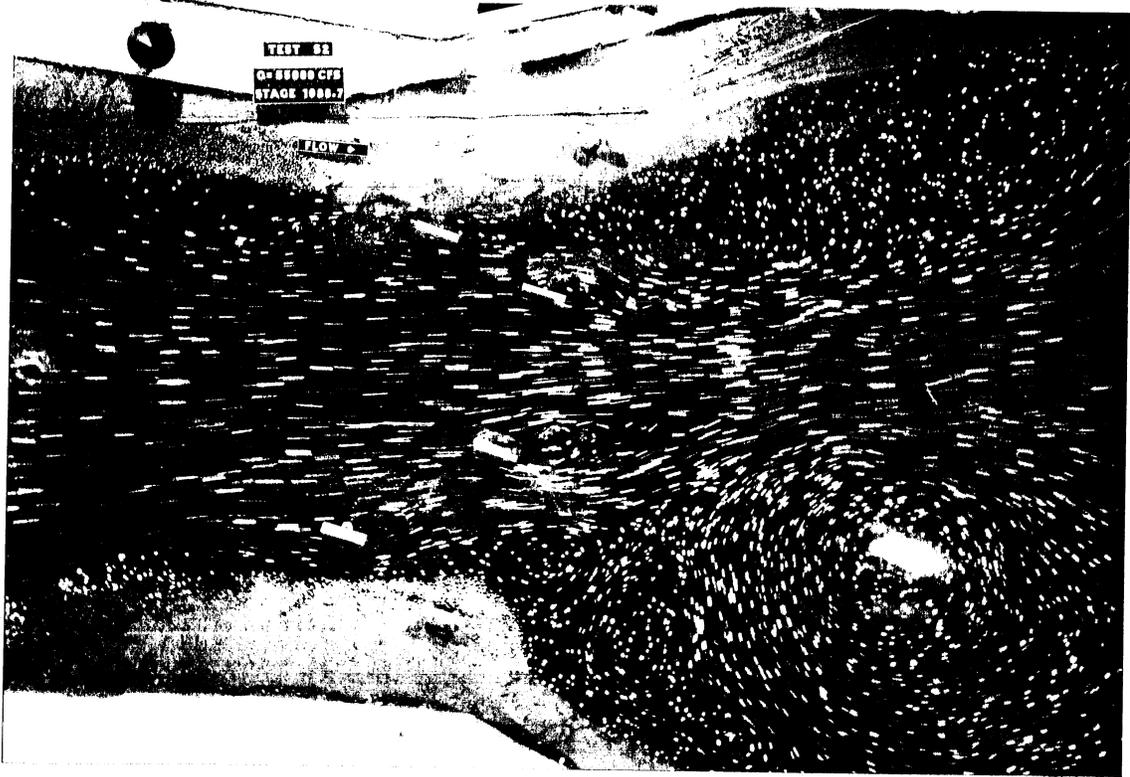
Photo 26

PHOTO 26 (Serial No. 142-91) In this experiment for a discharge of 55,000 cfs the stage was lowered to Elev. 1088.7 ft at the bridges to simulate a low water condition in the Missouri River. The lower water surface elevation results in a higher velocity through the constricted section at the bridge piers and a more pronounced jet into the wider channel downstream of the bridges. The wake downstream of the piers in the flow proper and the vortices generated along either bank are clearly shown.

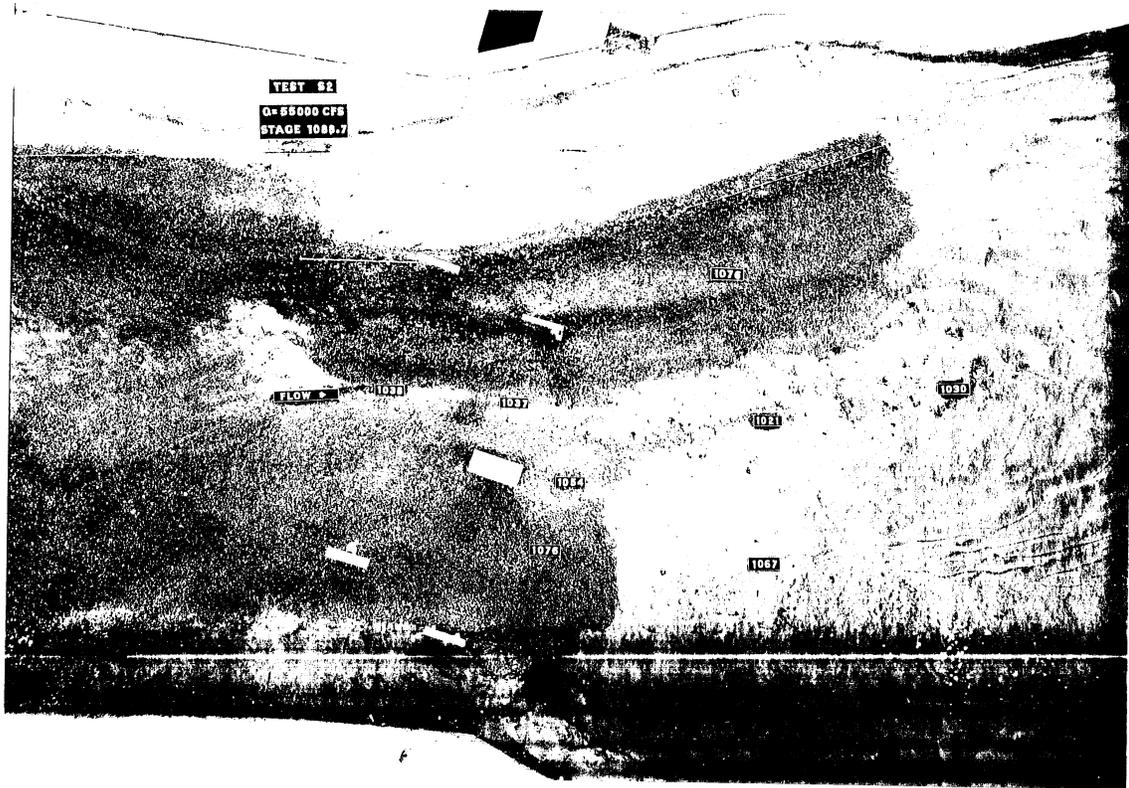
Photo 27

PHOTO 27 (Serial No. 142-92) A vertical view of the erosion pattern developed by the above flow shows that the revetment is just beginning to ravel from the toe of the bank revetment. The increased depth of scour downstream of the bridge section is becoming more apparent.

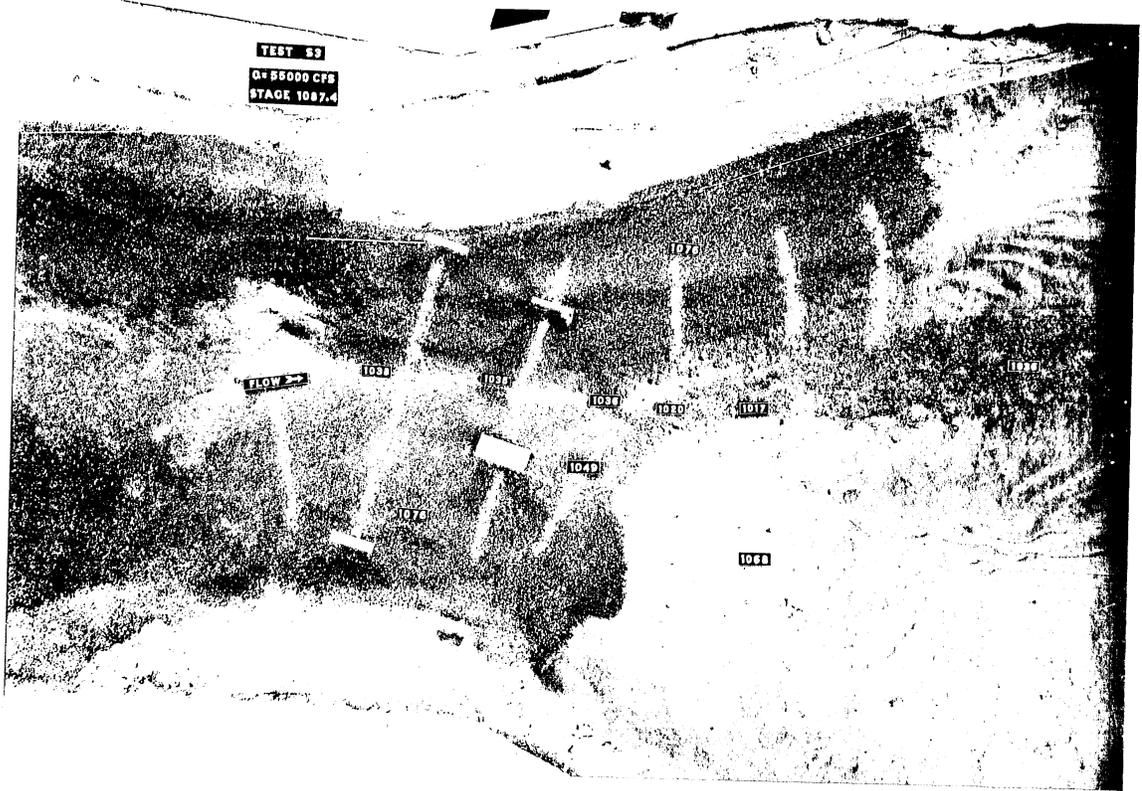
Photo 28

PHOTO 28 (Serial No. 142-93) In order to show more clearly whether the rock revetment is being scoured, strips of colored rock particles have been placed on the bed on the bridge centerline and along the banks. This photo was made before the experiment was performed.

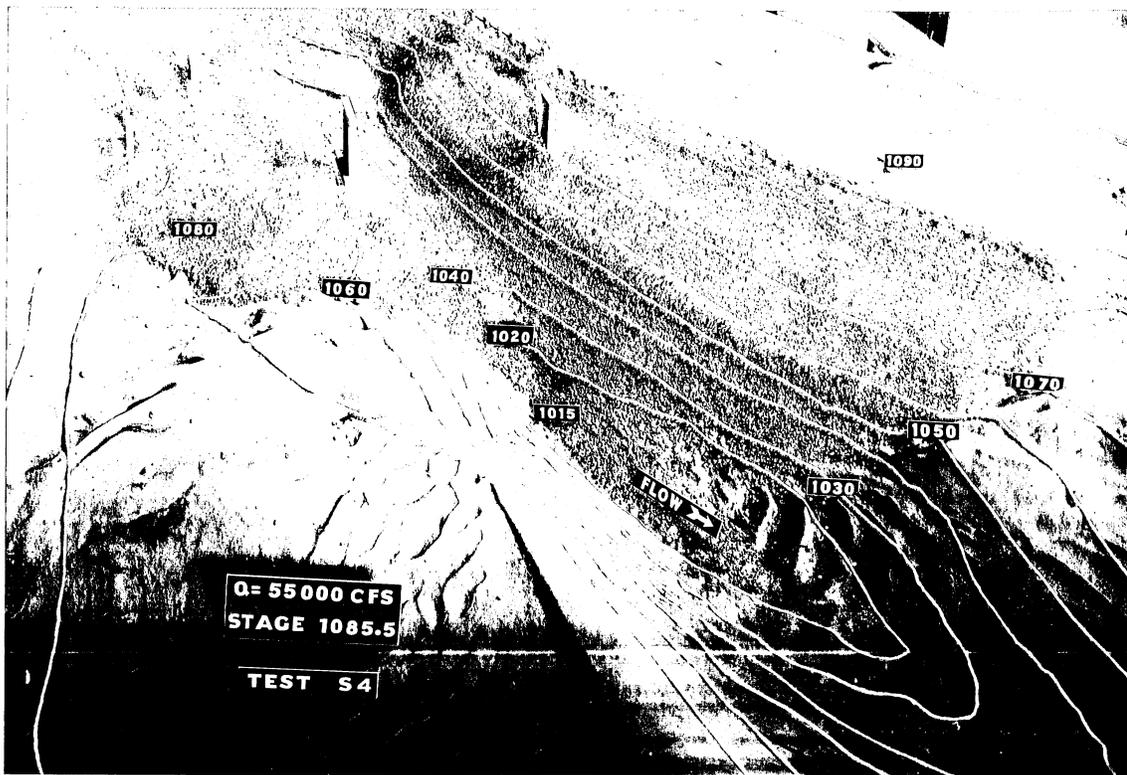
Photo 31

PHOTO 31 (Serial No. 142-98) The extremely high velocities through the constricted section and the jet created thereby which attacks the bed downstream of the bridge have caused very considerable erosion in this region. The photo also shows that the area of the bed between the piers has now been completely covered with rock particles ravelled from the bank revetment on both sides of the channel. Some of the rock has also been carried into the scour hole downstream.

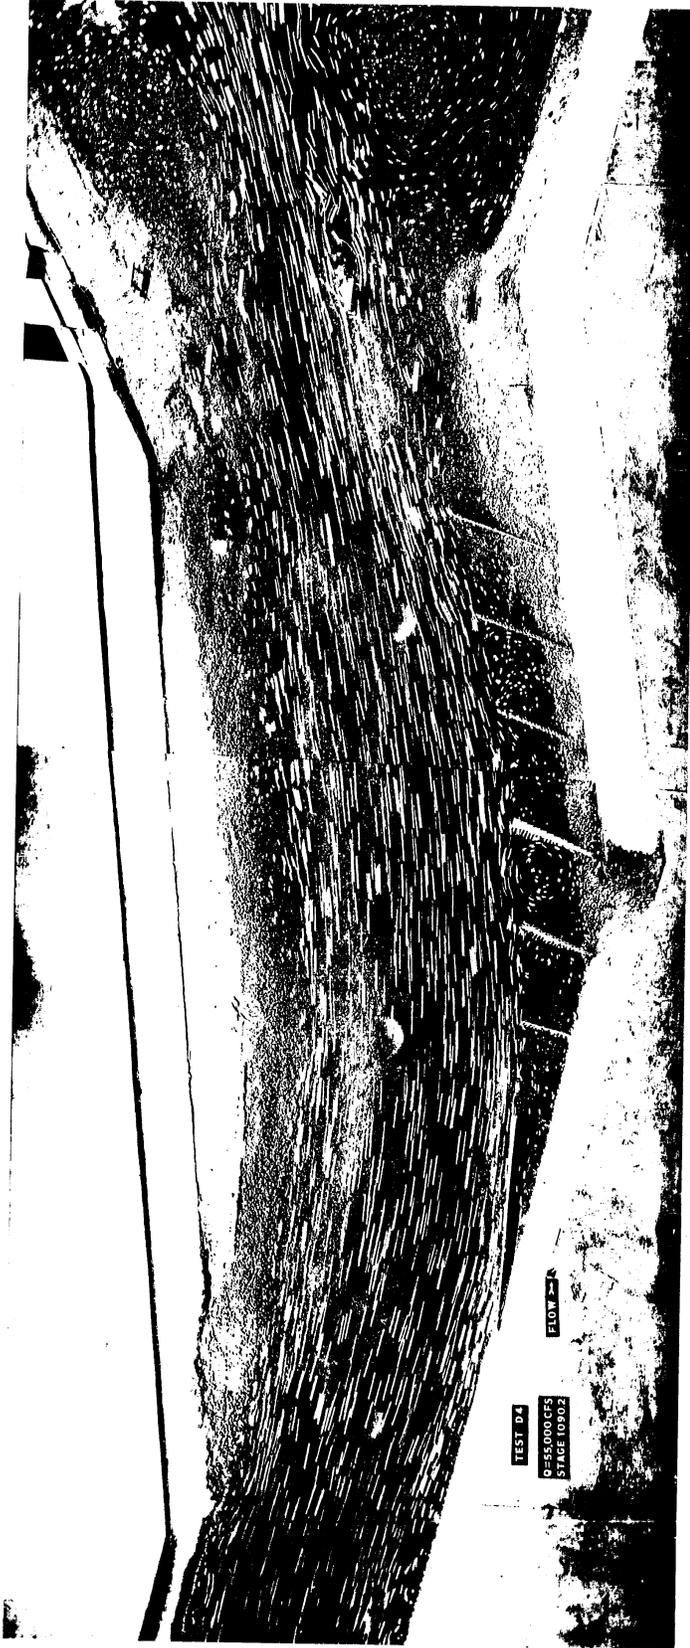
Photo 35

PHOTO 35 (Serial No. 142-121) This test is similar to the previous test except that a training dike has been installed at the upstream end of the dike field in order to provide a better transition from the channel to the first dike. The flow pattern is very similar to that observed in Photo 34.
