Project Report No. 78

Report on
STUDIES OF THE STABILIZATION OF THE BIG SIOUX RIVER
AT THE INTERSTATE 29 BRIDGE CROSSING

by
Alvin G. Anderson

Prepared for
South Dakota Department of Highways
and the
Iowa State Highway Commission

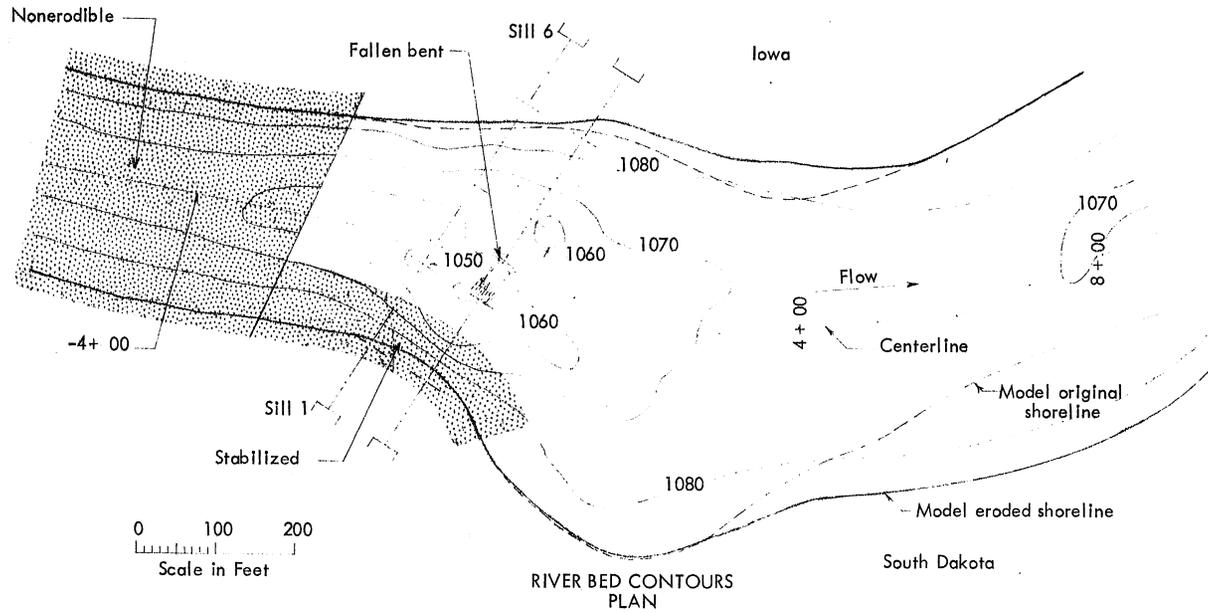
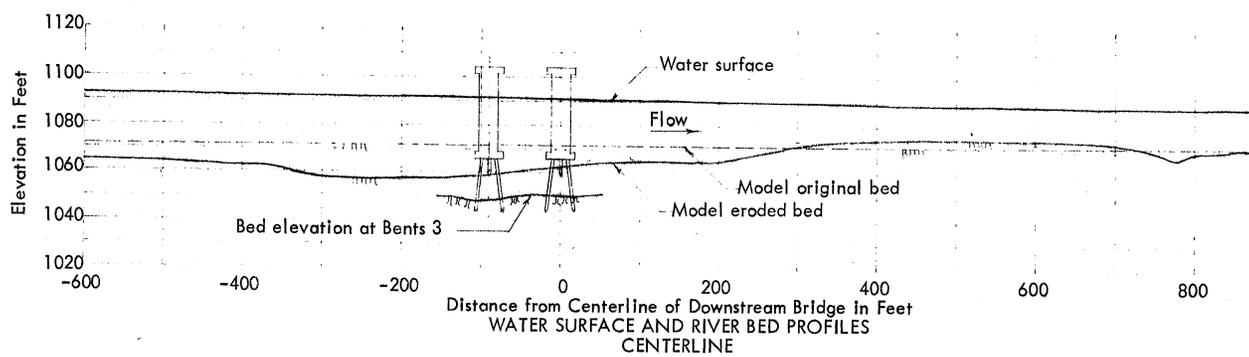
TEST V 1
 River Bed Contours
 Water Surface and River Bed Profiles
 Q = 55,000 cfs
 3.5 Hr. Model Test Run
 Model Scale 1:75

Note: The stage at the bridges was maintained at elevation 1090.8 ft throughout the test.

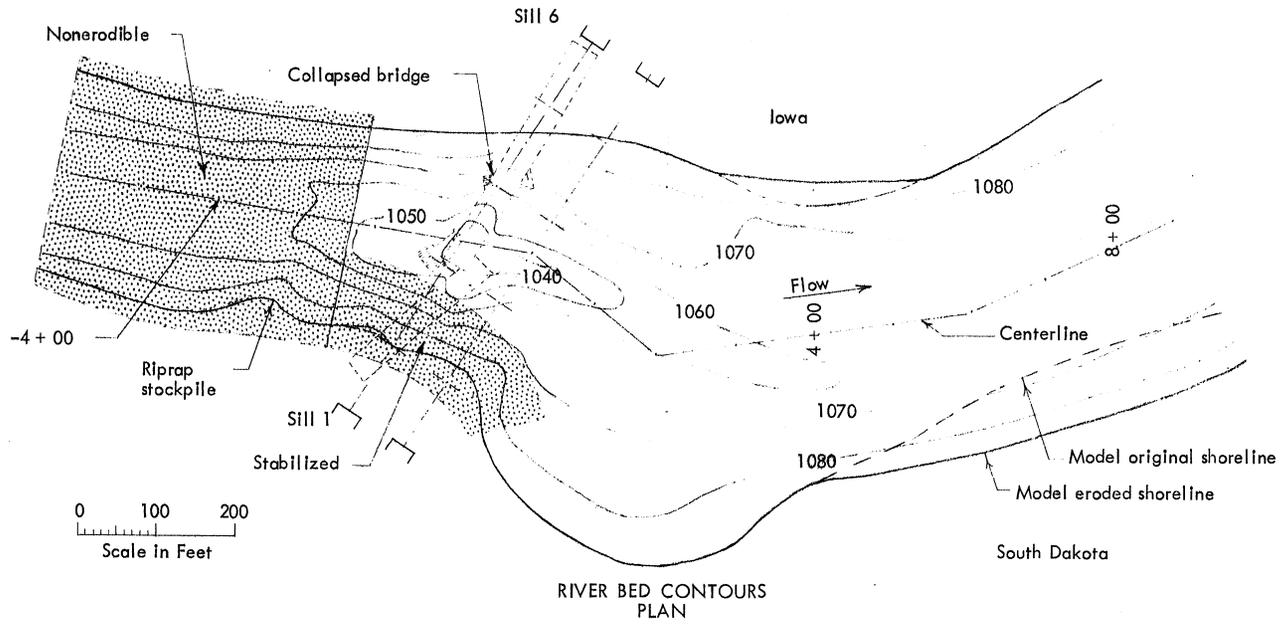
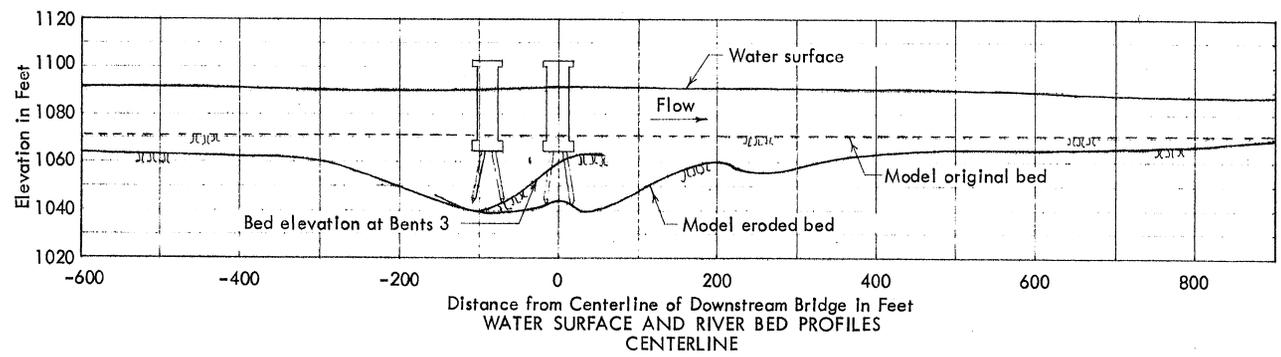
BIG SIOUX PROJECT		
Iowa State Highway Commission South Dakota Department of Highways MODEL VERIFICATION TESTS		
SAINT ANTHONY FALLS HYDRAULIC LABORATORY UNIVERSITY OF MINNESOTA		
DRAWN PJN	CHECKED <i>[Signature]</i>	APPROVED
SCALE	DATE 9-4-64	NO. 142B442-25

TEST V2 - PART 1
 Piers and Collapsed Bridge
 River Bed Contours
 Water Surface and River Bed Profiles
 Q = 55,000 cfs
 10 hr. Model Test Run
 Model Scale 1:75

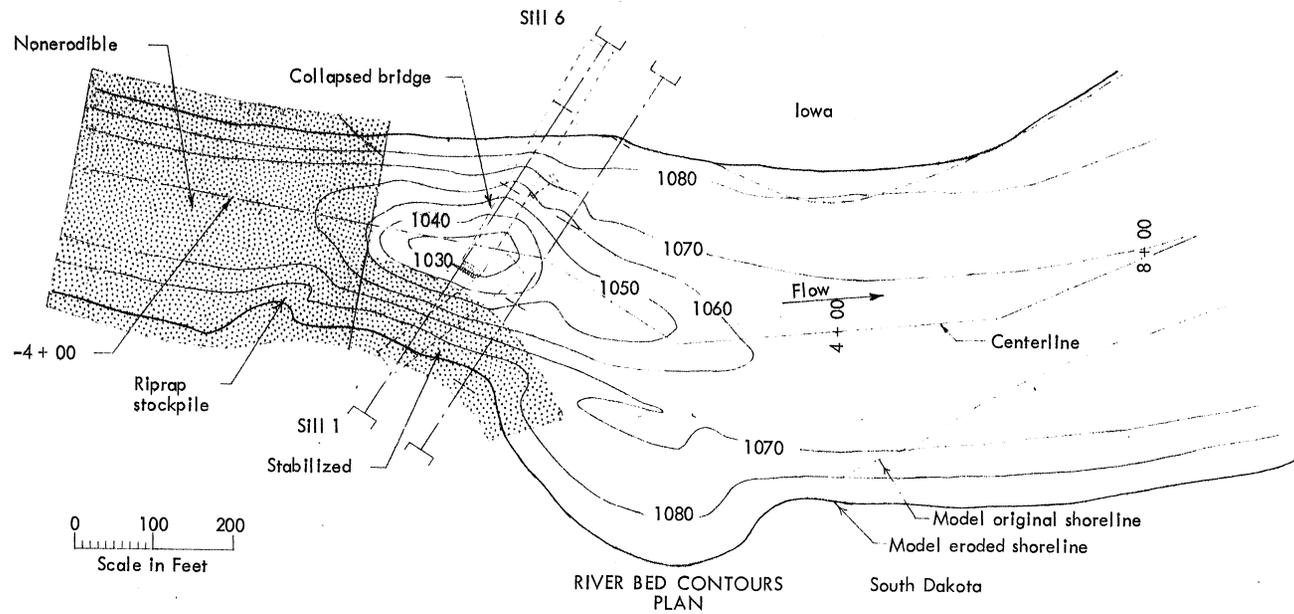
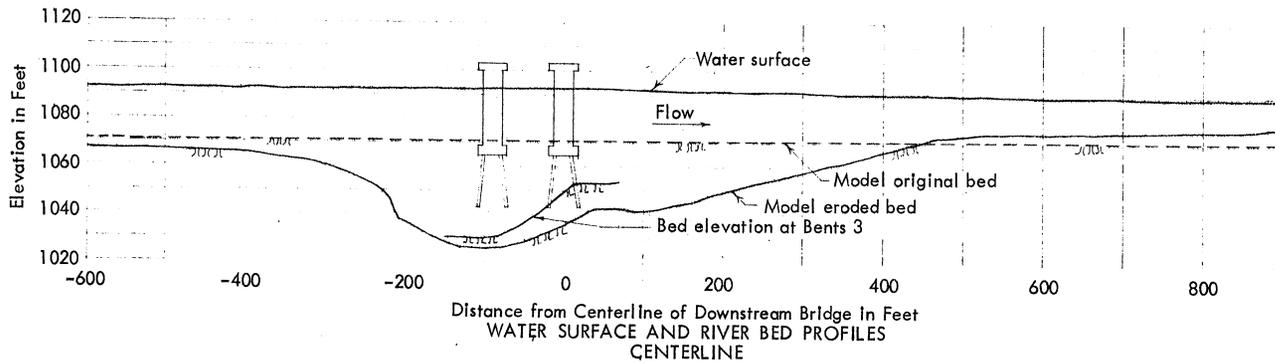
BIG SIOUX PROJECT		
Iowa State Highway Commission South Dakota Department of Highways MODEL VERIFICATION TESTS		
SAINT ANTHONY FALLS HYDRAULIC LABORATORY UNIVERSITY OF MINNESOTA		
DRAWN CLA	CHECKED <i>[Signature]</i>	APPROVED
SCALE	DATE 9-4-64	NO. 142B442-27

TEST V3
 Piers and Collapsed Bridge
 River Bed Contours
 Water Surface and River Bed Profiles
 Q = 65,000 cfs
 Stage = 1092.4 ft
 8.0 hr. Model Test Run
 Model Scale 1:75

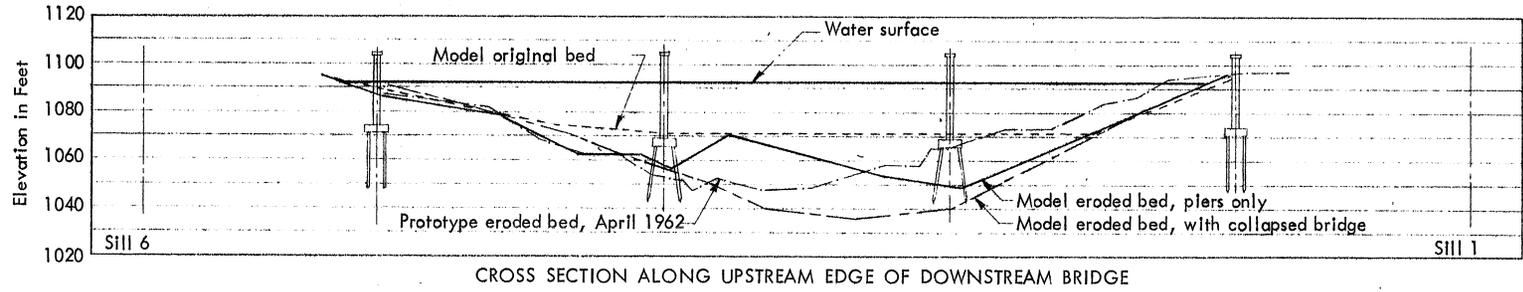
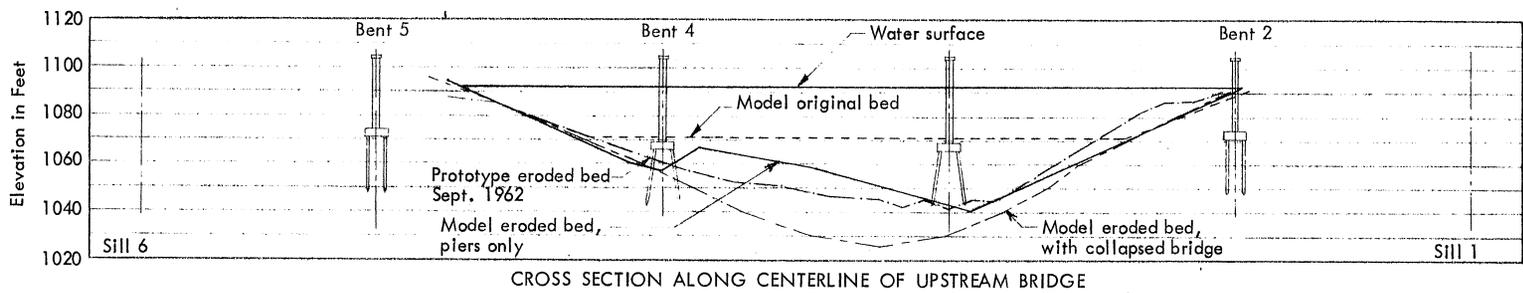
DRAWN	GHC	CHECKED	<i>[Signature]</i>	APPROVED
SCALE		DATE	9-8-64	NO. 142B442-28

TEST V3
 Cross Sections at Bridges
 Q = 65,000 cfs
 Stage = 1092.4 ft
 8.0 hrs. Model Test Run
 Model Scale 1:75

Notes: The model cross sections for piers only were taken at 0.25 hrs., immediately after the failure of Bent 3 of the upstream bridge. Bed erosion had not ceased.

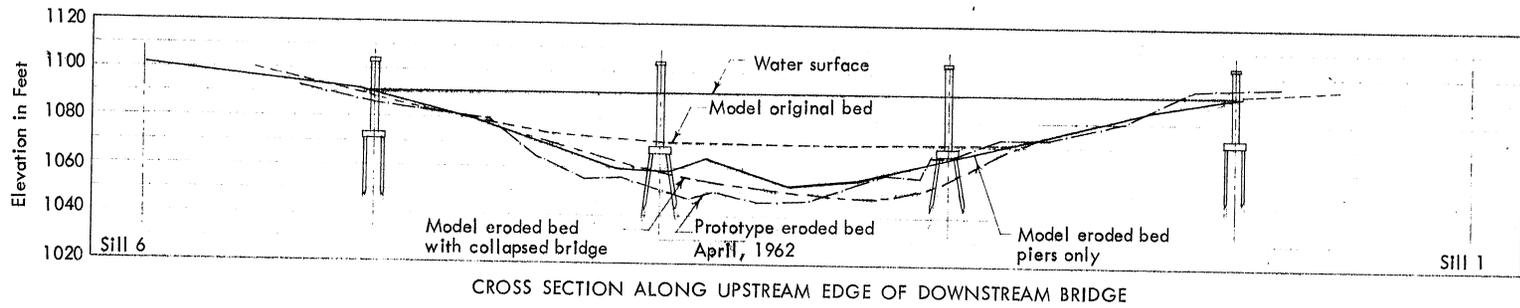
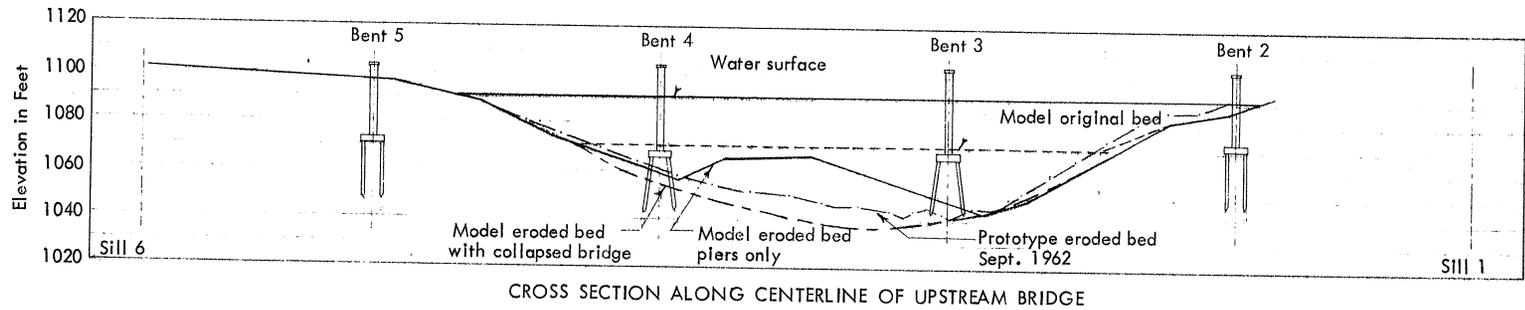
BIG SIOUX PROJECT		
Iowa State Highway Commission South Dakota Department of Highways MODEL VERIFICATION TESTS		
SAINT ANTHONY FALLS HYDRAULIC LABORATORY UNIVERSITY OF MINNESOTA		
DRAWN ACY	CHECKED <i>add</i>	APPROVED
SCALE	DATE 8-18-64	NO. 142B442-31

Note: Test V4:
 Part 1: Piers only; 3.5 hr. model test run
 Part 2: Piers and collapsed bridge;
 6.5 hr. model test run
 Total testing time: 10.0 hrs.

TEST V4
 Cross Sections at Bridge
 Q = 52,000 cfs
 Stage = 1090.8 ft
 Model Scale 1:75

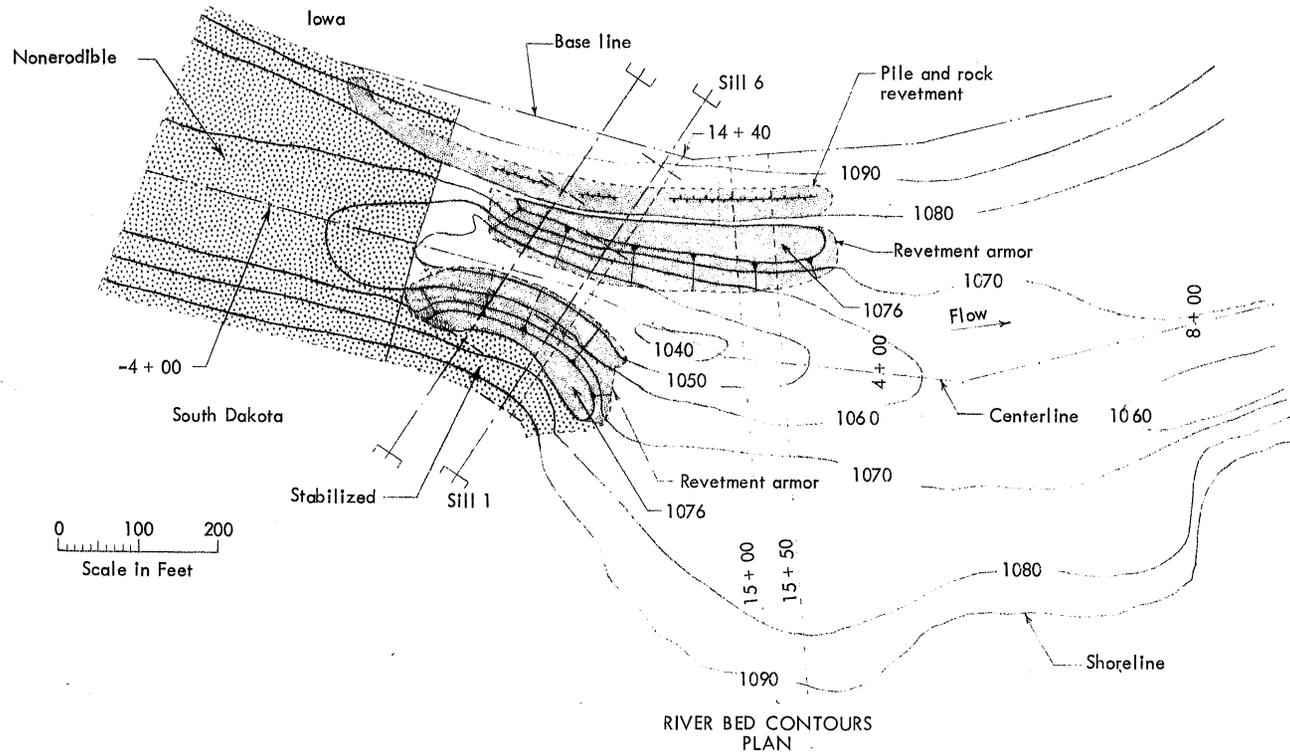
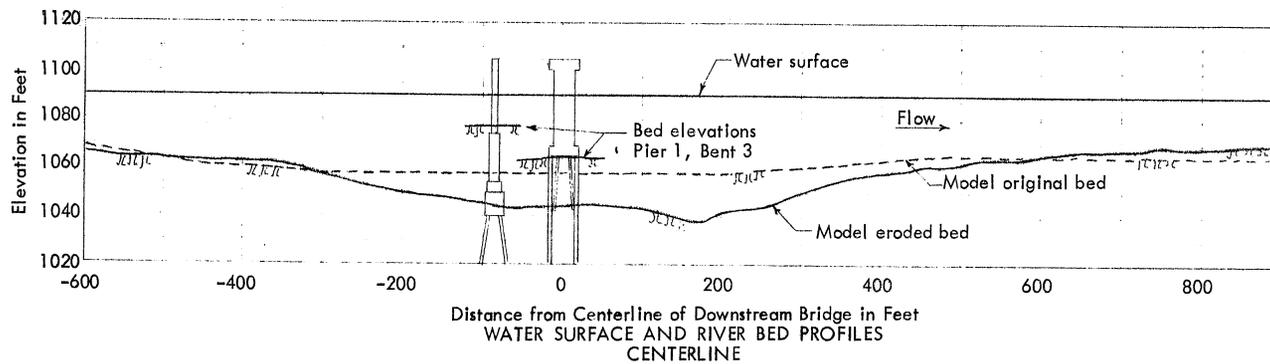
BIG SIOUX PROJECT		
Iowa State Highway Commission South Dakota Department of Highways CHANNEL STABILIZATION TEST		
SAINT ANTHONY FALLS HYDRAULIC LABORATORY UNIVERSITY OF MINNESOTA		
DRAWN	KFW	CHECKED <i>WLD</i>
SCALE	DATE	APPROVED
	9-23-64	NO. 142B442-33

1. Upstream channel straightened by excavation.
2. Bents 3 and 4 of the downstream bridge underpinned.
3. New bridge in place.
4. Pile and rock revetment in place.
5. Stabilization Plan 1 revetment armor.

TEST S1
 Stabilization Plan 1
 River Bed Contours
 Water Surface and River Bed Profiles
 Q = 55,000 cfs
 Stage = 1090.2 ft
 Model Scale 1:75

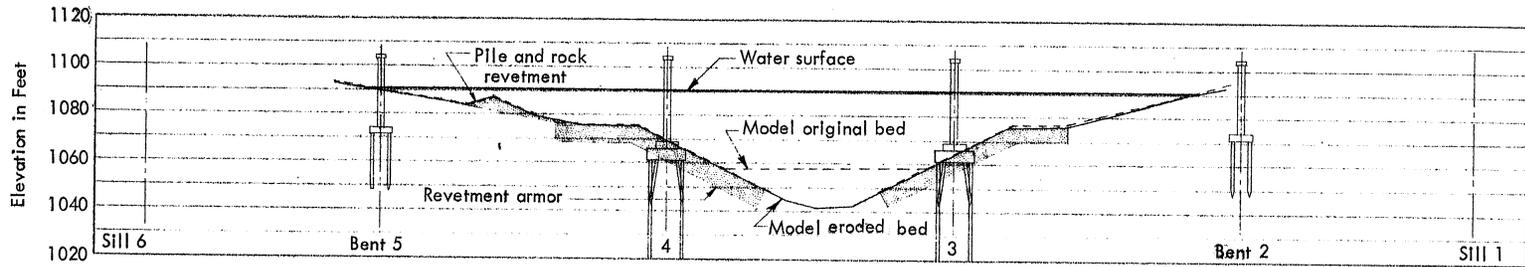
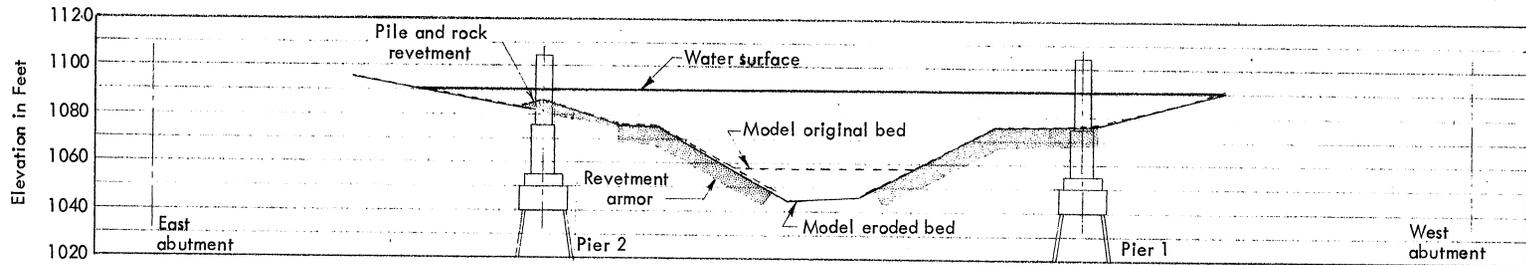
BIG SIOUX PROJECT Iowa State Highway Commission South Dakota Department of Highways CHANNEL STABILIZATION TEST		
SAINT ANTHONY FALLS HYDRAULIC LABORATORY UNIVERSITY OF MINNESOTA		
DRAWN GHC SCALE	CHECKED DATE 9-10-64	APPROVED NO. 142B442-34

Note: During Test S1, flows of 10,000, 20,000, 30,000, 40,000, 50,000 and 55,000 cfs were established (in increasing order of magnitude) and maintained until erosion ceased in the test section.

TEST S1
 STABILIZATION PLAN 1
 Cross Sections at Bridges
 Q = 55,000 cfs
 Stage 1090.2 ft.
 Model Scale 1:75

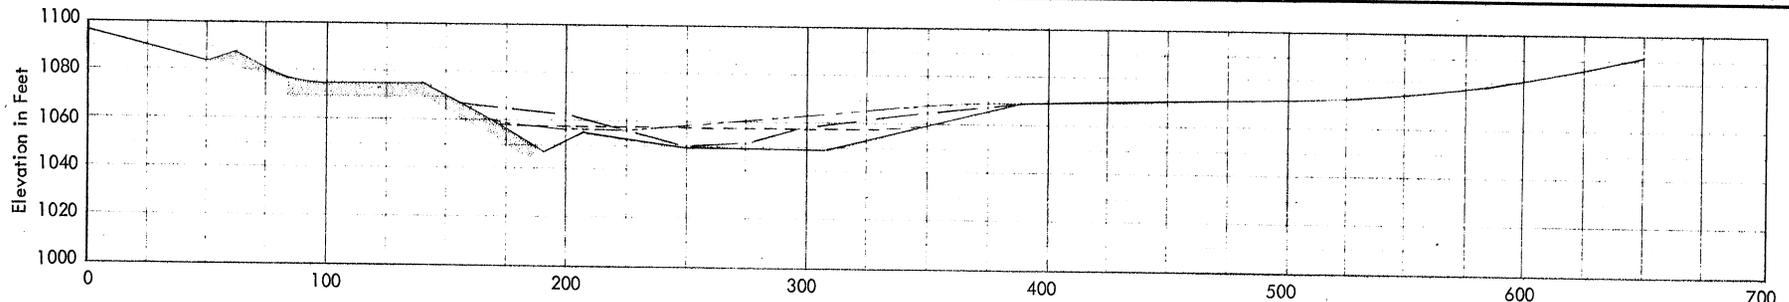
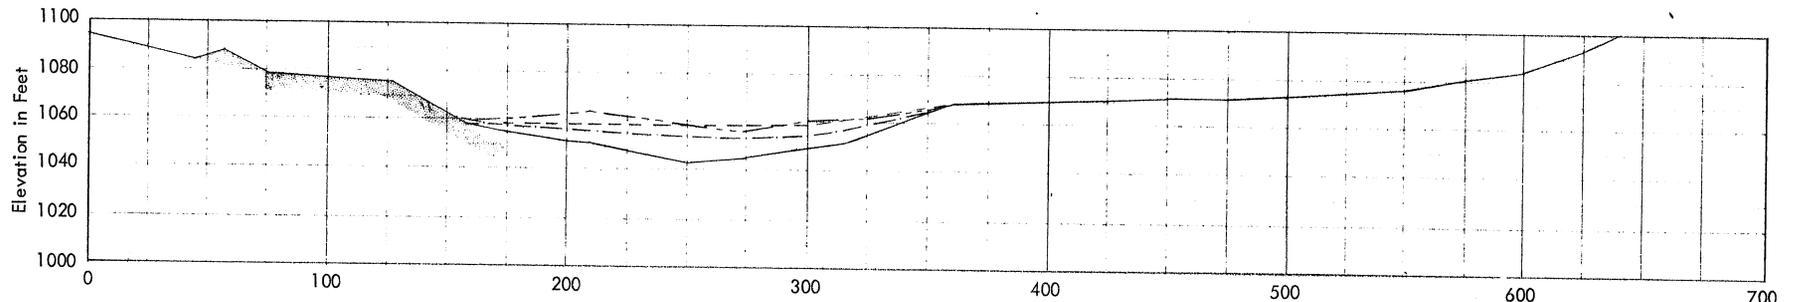
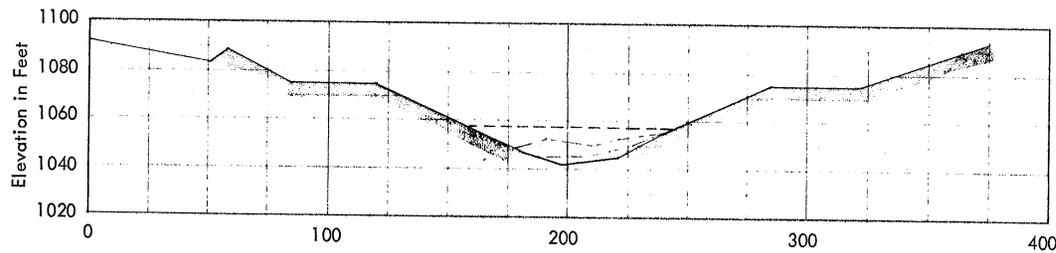
BIG SIOUX PROJECT		
Iowa State Highway Commission South Dakota Department of Highways CHANNEL STABILIZATION TESTS		
SAINT ANTHONY FALLS HYDRAULIC LABORATORY UNIVERSITY OF MINNESOTA		
DRAWN PJN	CHECKED <i>ald</i>	APPROVED
SCALE	DATE 9-23-64	NO. 142B442-38

TEST S1
Stabilization Plan
Eroded River Bed Cross Sections
for Various Discharges
Model Scale 1:75

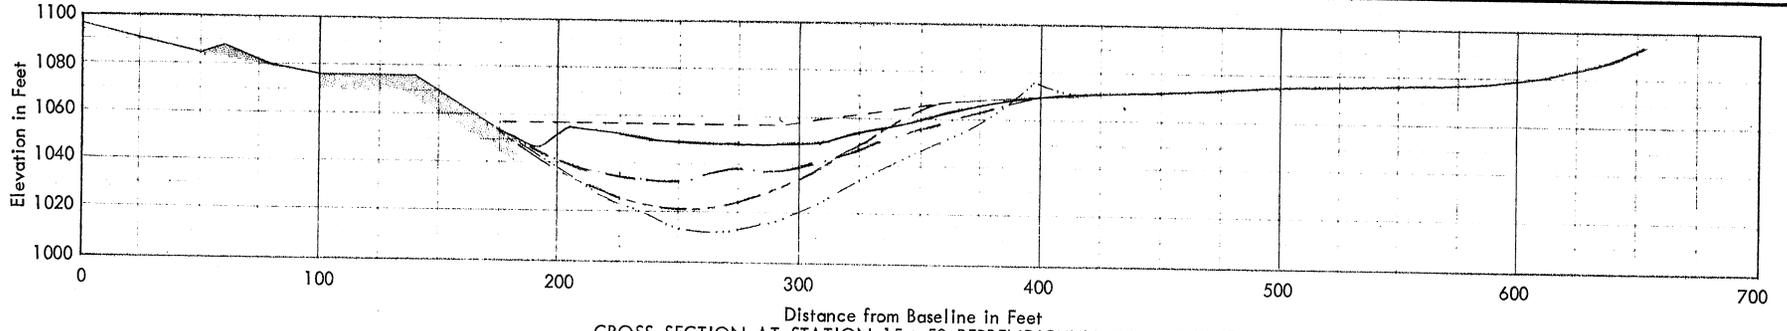
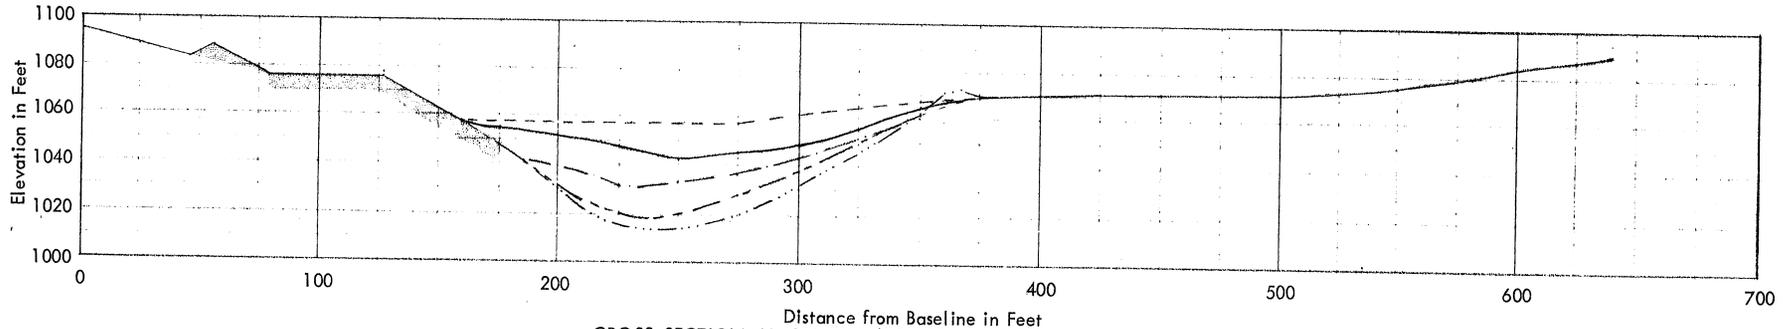
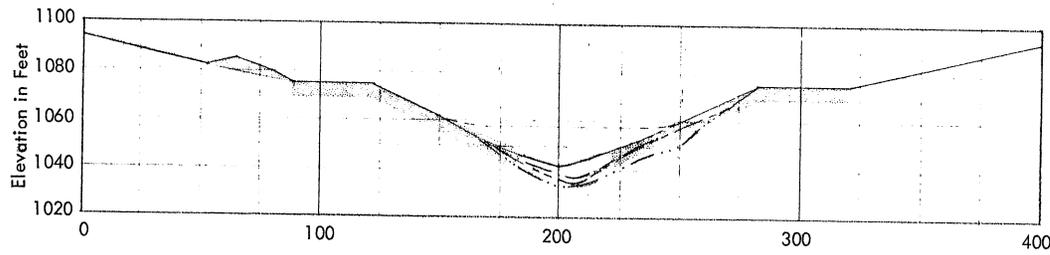
BIG SIOUX PROJECT		
Iowa State Highway Commission South Dakota Department of Highways CHANNEL STABILIZATION TESTS		
SAINT ANTHONY FALLS HYDRAULIC LABORATORY UNIVERSITY OF MINNESOTA		
DRAWN PJN	CHECKED <i>ad</i>	APPROVED
SCALE	DATE 9-23-64	NO. 142B442-39

TESTS S1, S2, S3, and S4
Stabilization Plan 1
Eroded River Bed Cross Sections
Q = 55,000 cfs
Various Stages
Model Scale 1:75
