The Cause and Morphology of Fracture in Acetal Quick Disconnect
Couplings used in a Residential Water Filter Application

A DISSERTATION
SUBMITTED TO THE FACULTY OF THE GRADUATE SCHOOL
OF THE UNIVERSITY OF MINNESOTA
BY

IN PARTIAL FULFILLMENT OF THE REQUIREMENTS
FOR THE DEGREE OF
Master of Materials Science and Engineering

June 2012

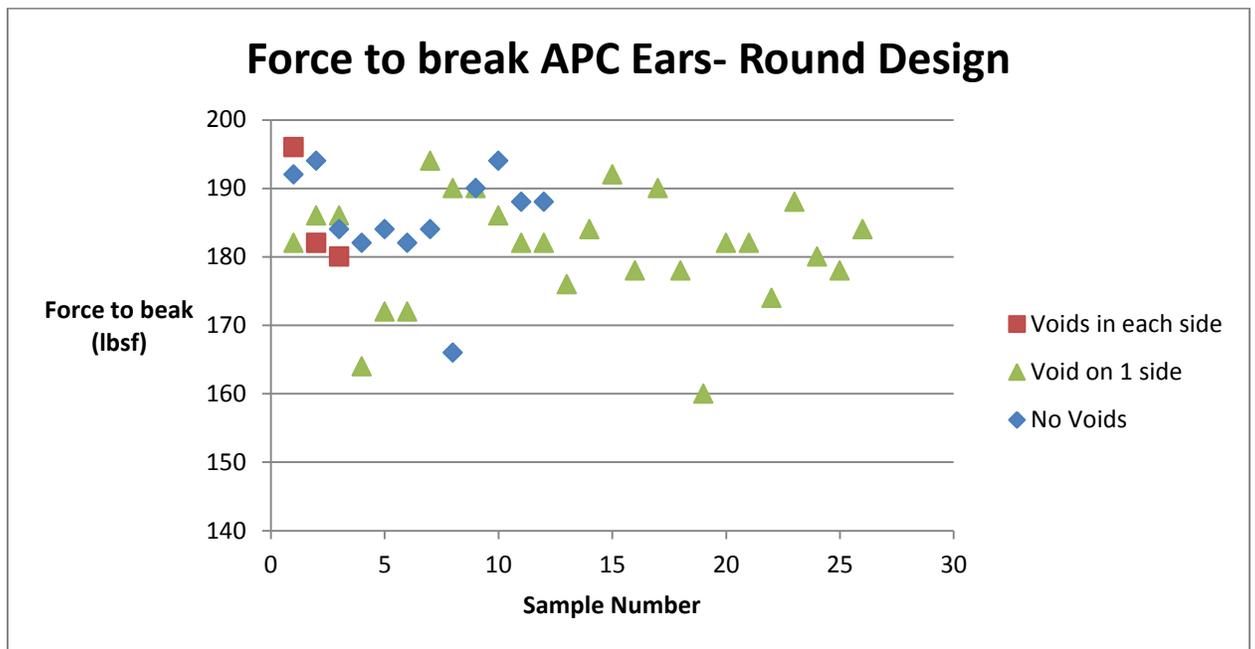
Interestingly, they appear to have little to no effect on the overall strength of the product. Shrinkage voids do not, in themselves, indicate a defective component. Colder's testing and product qualification has demonstrated that a void in this location is common. Further, product validation testing on similar components indicates the

presence or absence of voids in this location does not have a significant effect on part strength, and further, that voids do not predict rupture strength. Test results have indicated no strong relationship between the presence of voids and the force to break parts through the void.

Figure 5: Plot of force to break a part in tensile testing, separated by the presence of voids. Data is shown independently for parts without voids, with voids on the non-gate side, and with voids on both sides of the part.

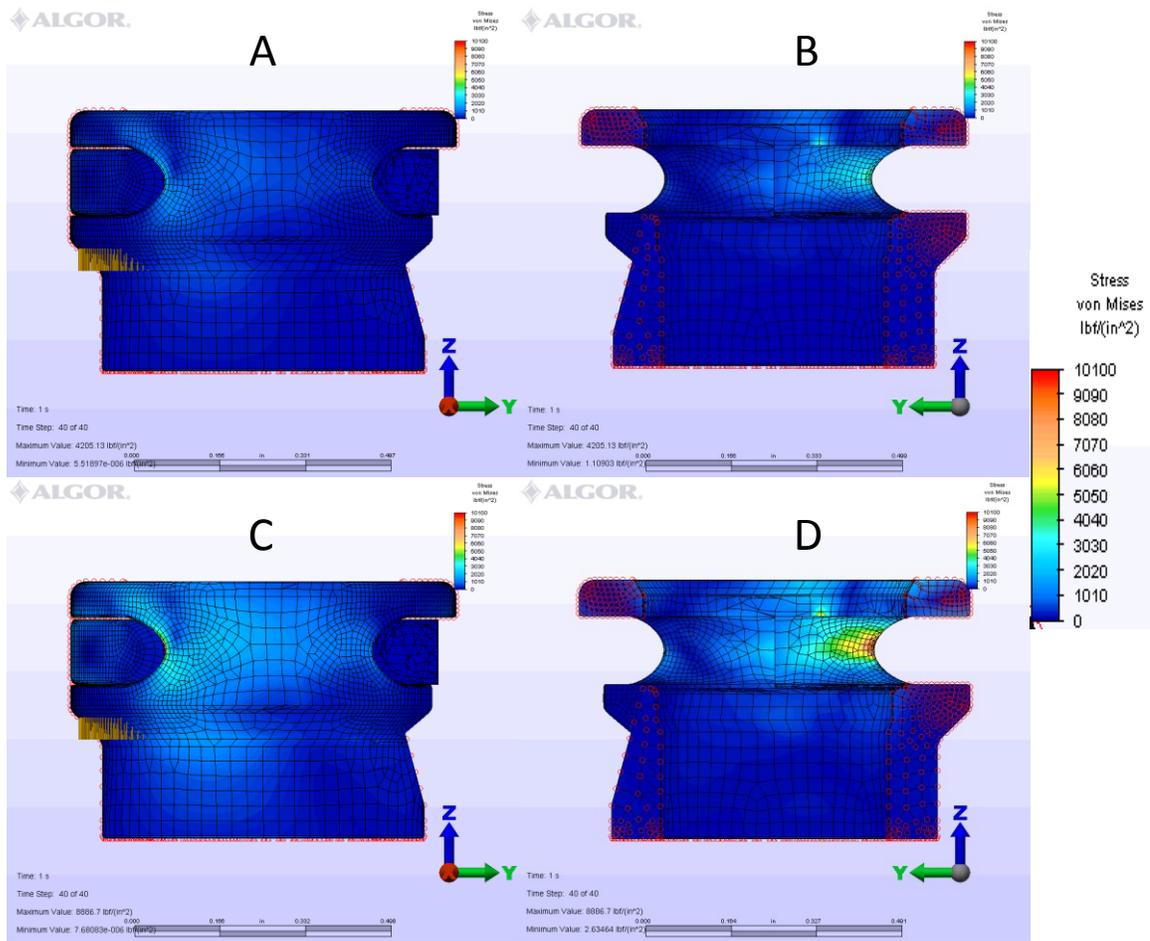
In order to determine the effect of typical pressures on the connector, FEA analysis using the Algor V. 23.1 software was performed. Both 40 PSI and 80 PSI equivalent forces (7.2 and 14.4 lbs) were applied to a simplified APC body component to determine the stress in the clip ears. Output from the analyses is show below. Note that these

analyses were conducted using elastic simulation only, resulting in higher than actual stresses. Note also that all FEA images use the same stress scale, shown in expanded form in Figure 16.

Figure 16: FEA analysis of the connector. Frame A shows a 40 PSI simulation. Frame B shows a 40 PSI simulation from the interior of the clip slot, with the clip suppressed to allow a view of the stressed material. Frame C shows the same part with an 80 PSI simulated pressure. Frame D shows the 80 PSI simulation from the interior of the clip slot, with the clip suppressed to allow a view of the stressed material. All frames use the same color scale for stress, expanded to the right side of the figure.

These FEA analyses must be interpreted in light of experimental data, such as that reviewed in Figure 5, which showed that the parts analyzed can bear a load of ~ 160-195 lbf before failure occurs in a short term test. Long term testing has shown no evidence of cracking despite three months of loading at 60 pounds of force. The 80 PSI simulation shown above was conducted with a load of 14.4 pounds (calculated pressure:force equivalence based on cross sectional area and hydraulic pressure) and shows a stress approaching 7000 PSI at the bottom of the ear, where fracture is expected to begin. This is ~70% of the published yield strength of the Delrin material used to make the part. The water hammer analysis shows considerable portions of the ears at high levels of stress, but experimental results have shown that these parts take 2-4 times the simulated pressure load before failure occurs. Because experimental evidence shows that loads up to ~14x larger than the simulated load are required to break the part, it is clear that the simulation is not closely correlated with reality and are not suitable for a meaningful or accurate engineering analysis of the part design. The departure between the simulation and reality is likely rooted in the elasticity model used in the solver, the complex geometry of the part at the location of maximum stress, inaccuracies in the way the load is transferred by the software from the clip to the ear, and the absence of the insert half of the connection in the model.

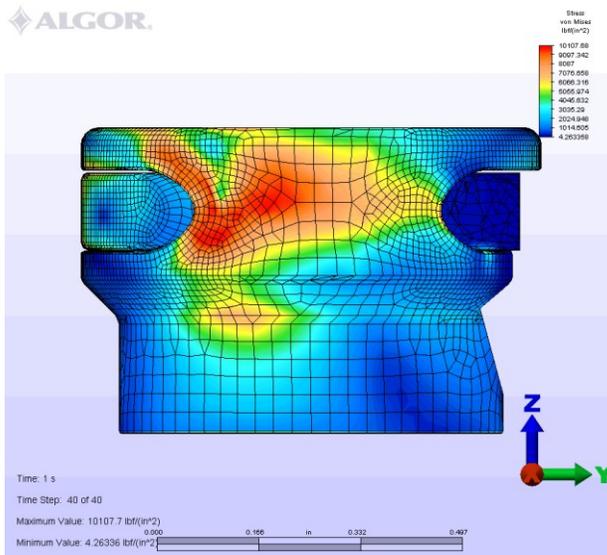
As calculated above, the maximum possible pressure the filter assembly could encounter due to water hammer effects would be 385 PSI. This level of pressure was also simulated using the Algor package. Results are shown below. Note however, that

Figure 17: Simulated effect of water hammer to 385 PSI pressure.

this pressure would be mitigated by the presence of the filter housing and its ability to absorb volumetric fluctuations caused by water hammer. Indeed, in its own testing General Electric, one of the filter manufacturers, performed water hammer testing on samples of these

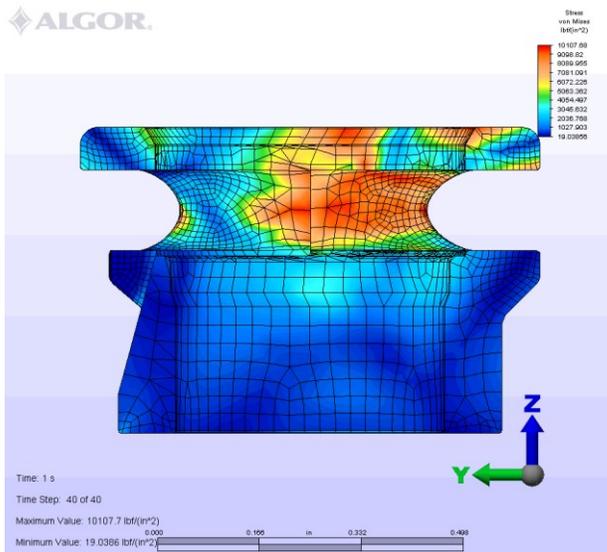
Figure 18: Simulated effect of water pressure to 385 PSI. Clip suppressed to allow view of stress levels at interior surfaces.

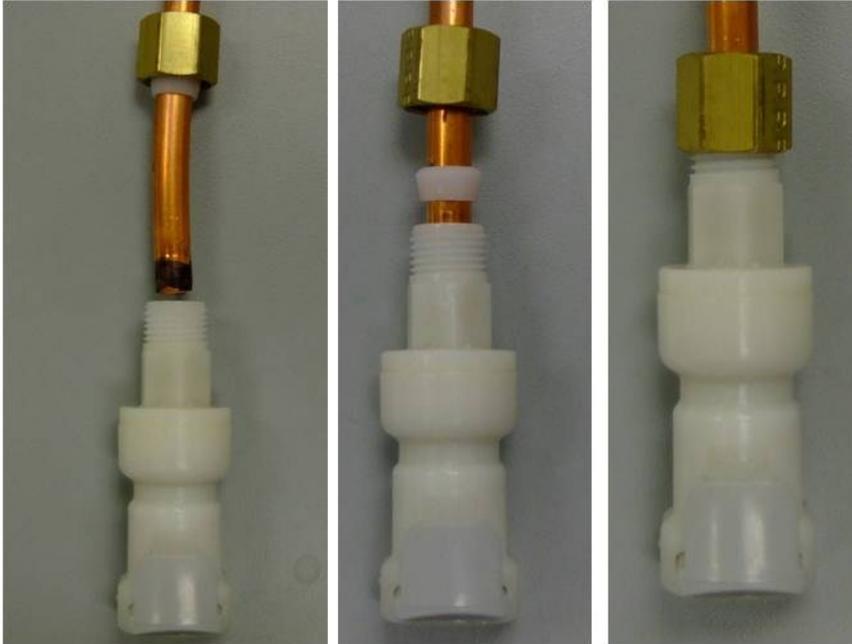
Figure 19: The three stages of tubing installation into a compression termination. The copper tubing is inserted into the termination (note the disappearance of the black region) and a soft plastic ferrule is compressed between the tubing and the inner wall of the termination, forming a seal.

The rigidity of the copper tubing allows the transfer of mechanical loads to the coupling. A large proportion of returned parts show evidence of cracking in the thread region. It is believed that these cracks are caused by bending moments transferred to the plastic by the copper tubing inserted into the ID. A bending moment applied thusly would result in a significant hoop stress at the edge of the plastic thread. Indeed, the cracking observed is confined to one side of the thread in all cases, which appears consistent with such a loading scheme. The only likely alternative explanation for the cracking is general overtightening of the joint, however, were this the cause, the cracking would be expected to occur uniformly around the circumference, and not only along an ~180 degree arc. Figure 20 shows an optical micrograph of the termination cracking phenomenon.

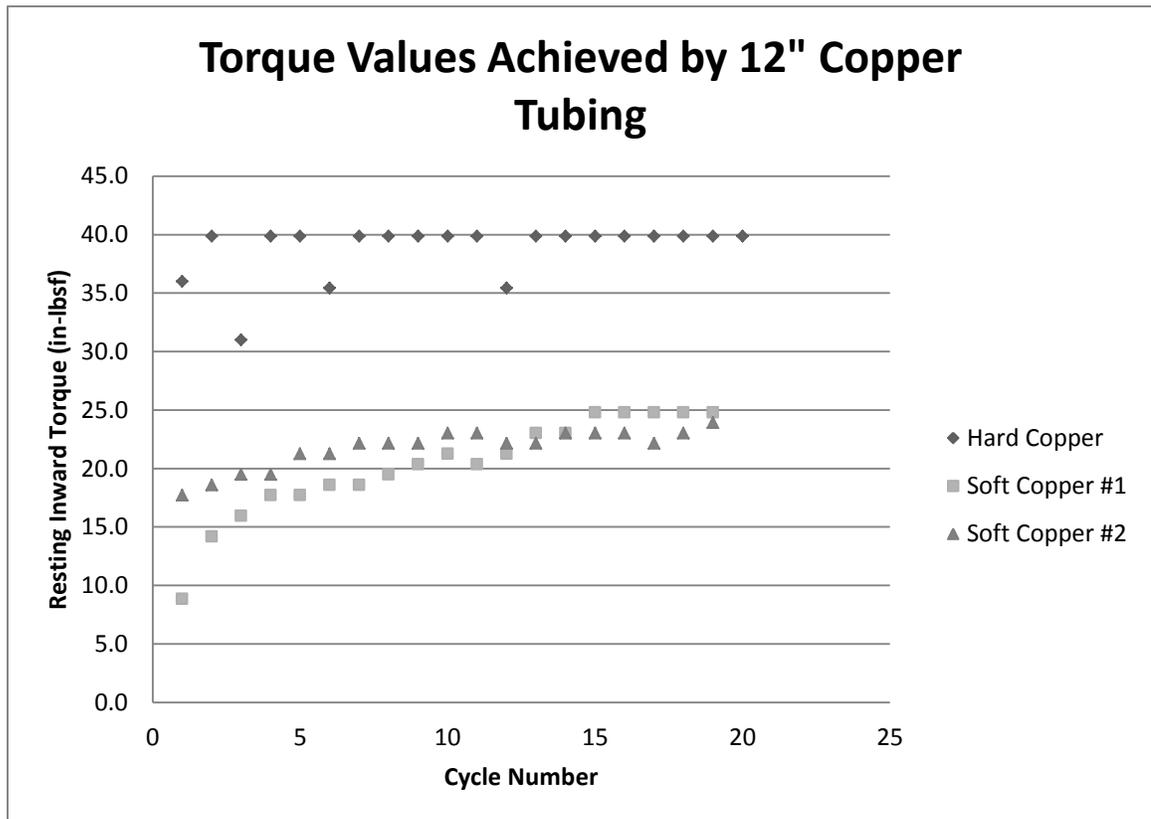
Figure 24: Plot showing torques achieved by bending lengths of copper tubing to approximate effects of filter replacement.

additional force. In this experiment, the maximum achieved level of torque remained 40 in-lbs, indicating that for the harder of the two tubing types available, 40 in-lbs appeared to be the maximum load that a part could be expected to see in service.

Given that bending moment of ~180 in-lbs will break a connector at the threads, 40 in-lbs is not a force to be dismissed, either in terms of a cause of creep loading, or in terms of establishing a baseline level of stress upon which fatigue loads from pressure or other forces would stack.

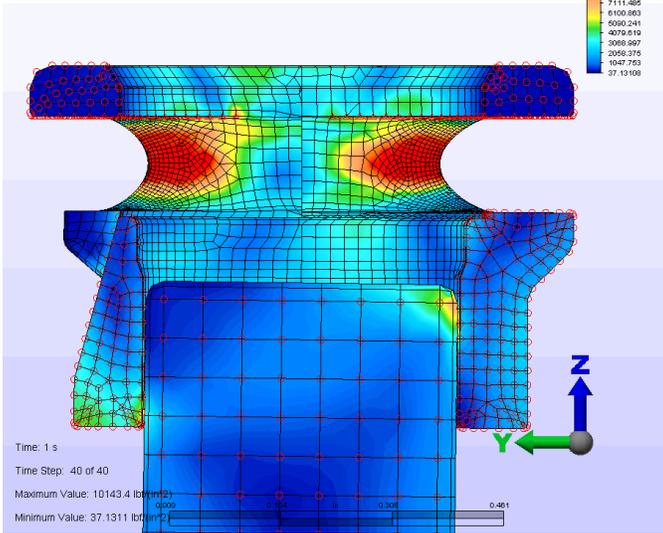
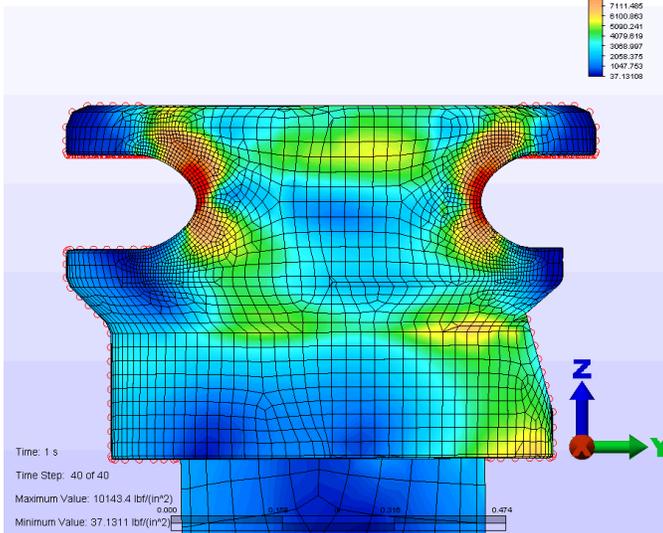
Figure 27: FEA Simulation of effect of interior bending force of 8.5 in-lbs (.95 Nm).

Figure 26: FEA Simulation of effect of interior bending force of 8.5 in-lbs (.95 Nm).

In order to determine the level of stress that such a bending moment may generate in the clip groove region, a Finite Element Analysis (FEA) was conducted using Algor. In this analysis, a rigid beam was modeled inside the inner bore of the part used in the analyses above. This beam was simulated with a force applied to the free end, imparting a bending force on the connector. The surfaces normally in contact with the thumbblatch were considered to be fixed. Two different torques were simulated. Both simulated torques were lower than the measured values.

The results of these simulations indicate an intense stress field arises from relatively small bending moments. Given that both sets of images are from analyses with stresses lower than that which even the softest tubing

measured at the earlier points of its useful life could impart, it is clear that these loads are attainable. The stresses resulting from this loading are subject to the same kind of miscorrelation as was noted in the pressure section above. In order to check the magnitude of the bending stresses calculated by the software to experimental results, an APC body

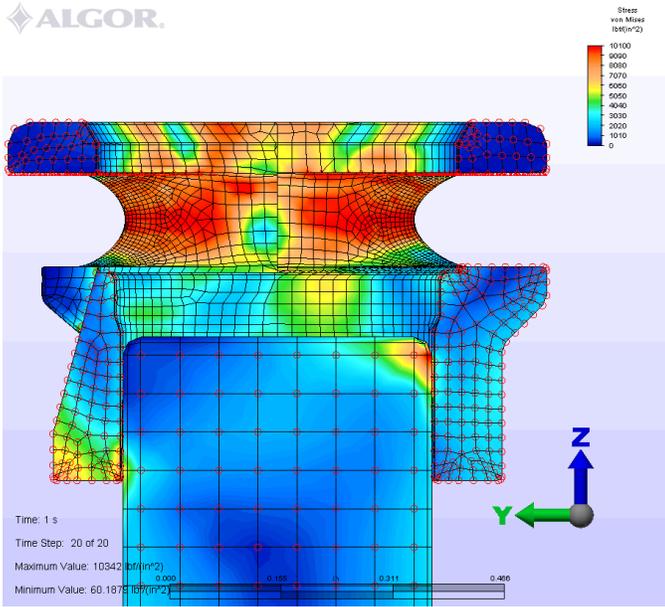
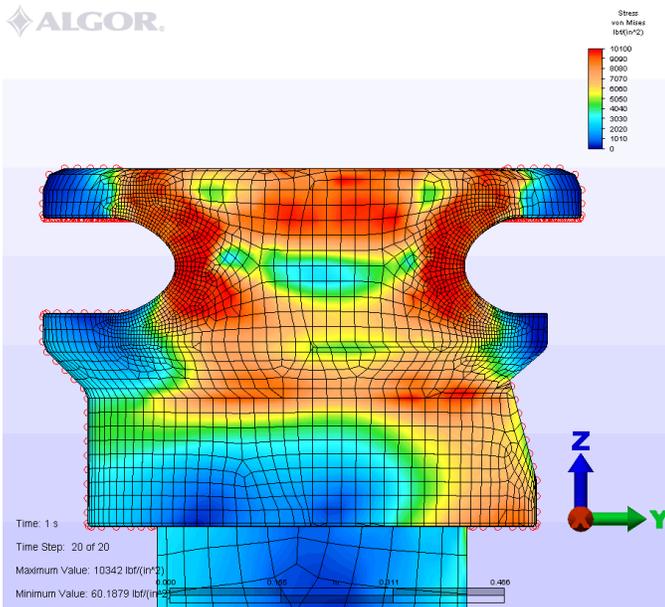
Figure 28: FEA Simulation of effect of interior bending force of 15.5 in-lbs (1.74 Nm).

Figure 29: FEA Simulation of effect of interior bending force of 15.5 in-lbs (1.74 Nm).

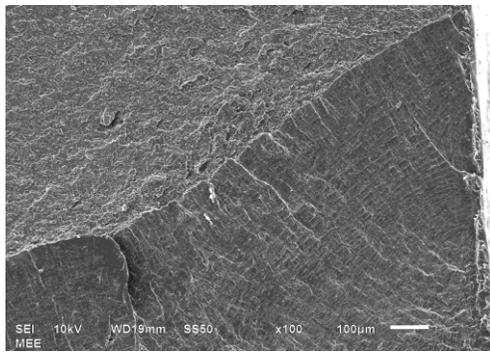
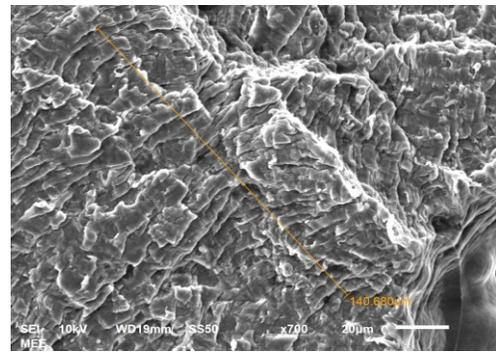
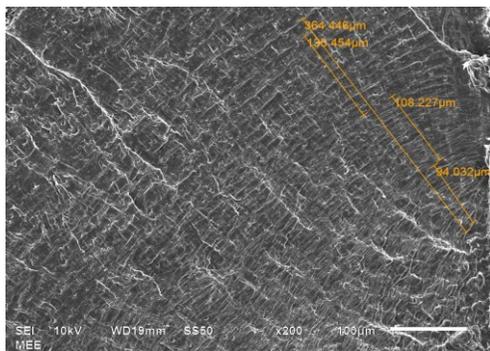
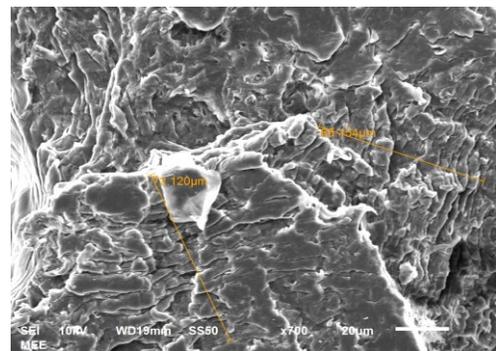
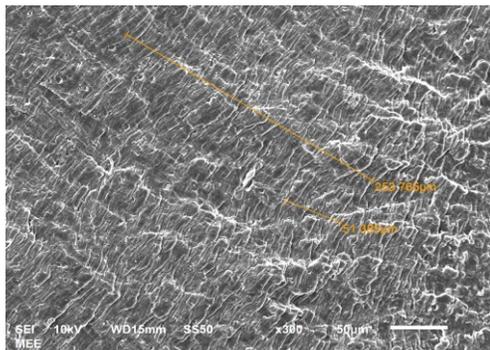
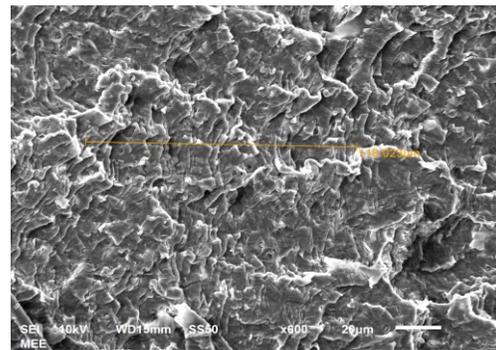
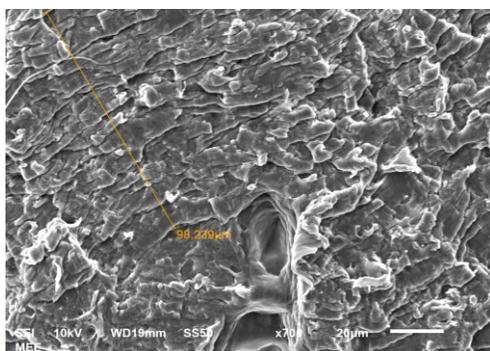
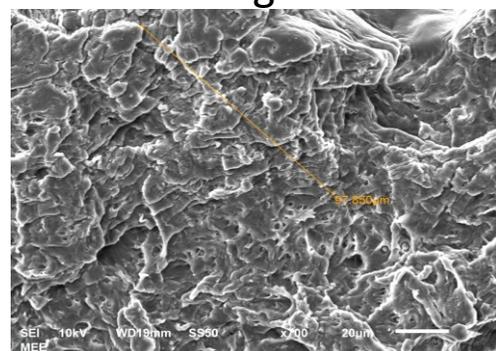
Figure 34: SEM images used for crack progression analysis.

Each of the images shown in Figure 34 provided one or more data points for this analysis. The location of each image on the sample was determined using the coordinates captured in the SEM data files.

Data points from images d, e, f, and h may be impacted by the presence of the void.

The plot shown in Figure 35 is consistent with expectations, showing a long period of relatively constant crack growth across a wide band of ΔK values, followed by a sudden and sharp increase in growth rate. Some irregularity is evident in the points from images a and b immediately preceding final fracture. In part, this is due to the difficulty of establishing an accurate “ a ” length due to the crack progressing at an angle relative to the edges of the cross section and the larger crack length compared to the remaining unfractured length, $W-a$.

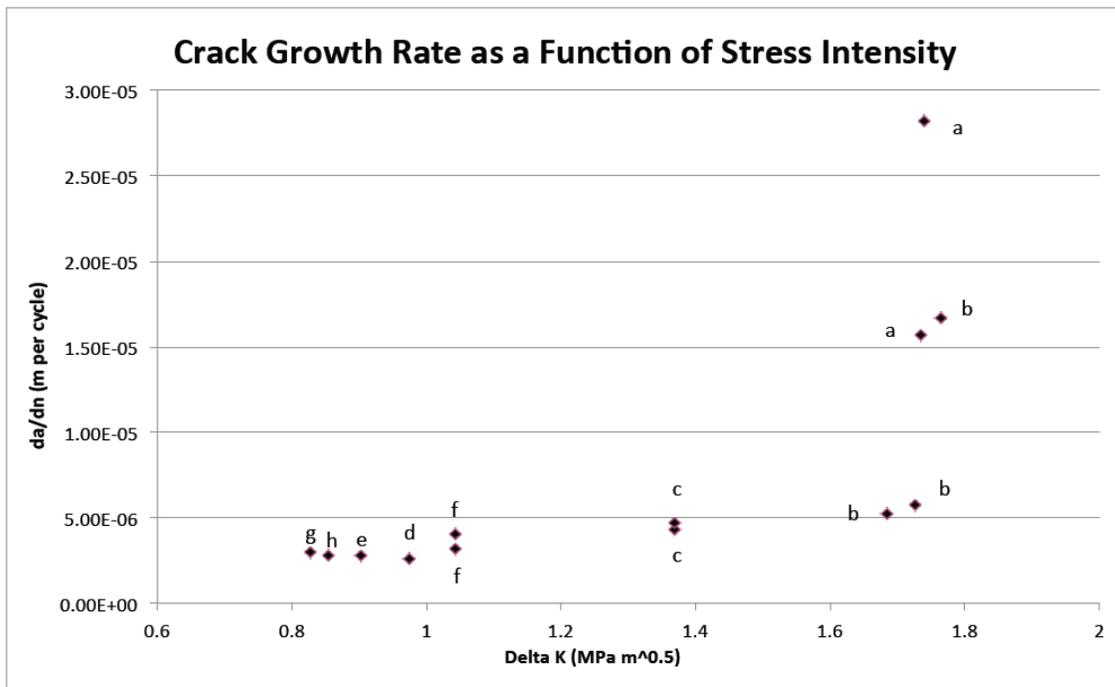
Figure 35: Graph showing experimental crack growth rates versus calculated changes in stress intensity values from high to low loads during the fatigue loading process. Each data point is tagged with the letter corresponding to the image it was derived from.

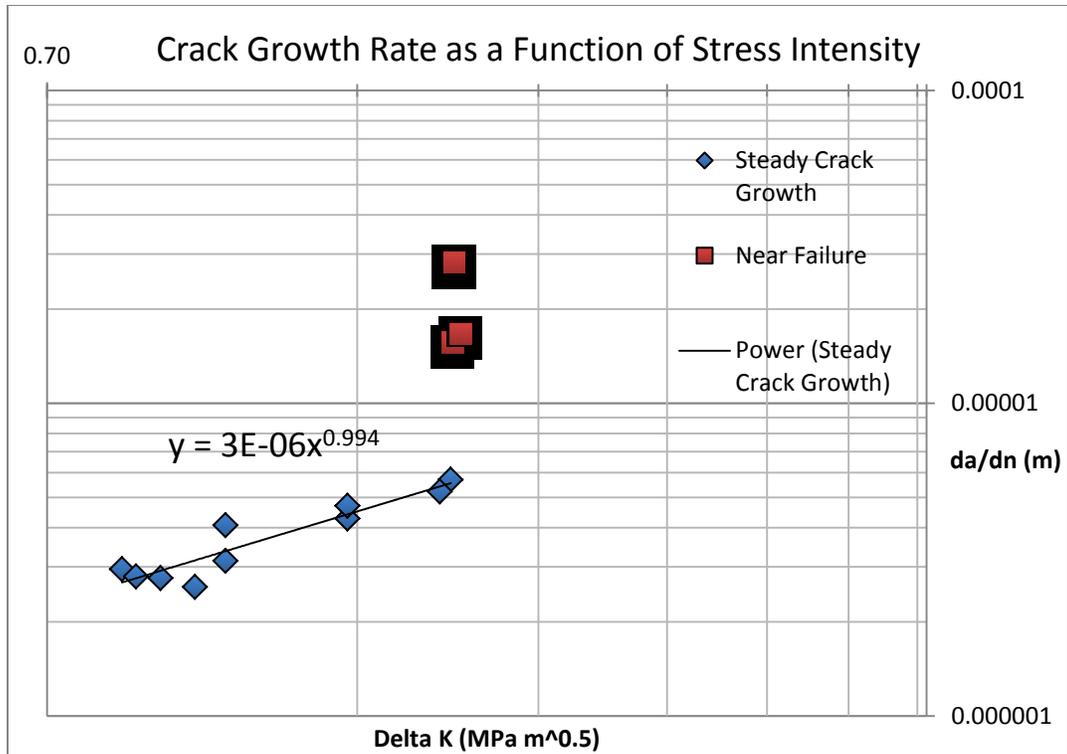
Figure 36: Graph showing the same experimental data shown in Figure 35 but plotted on a log-log scale. A clear shift in propagation behavior is seen between steady growth and propagation to failure.

From Figure 36 it is clear that the Paris law exponent for this system is approximately unity. The results obtained from this fatigued sample are similar to those reported for glass reinforced polypropylene (Alessandro Pegoretti, 1999). In these experiments on polypropylene, also a semi-crystalline polymer, the researchers found a similar Paris law exponent (~1 at low frequencies) and found that the exponent's value did not vary with glass fiber content at a variety of frequencies, including those samples tested at 1 Hz, the load frequency employed here for acetal.

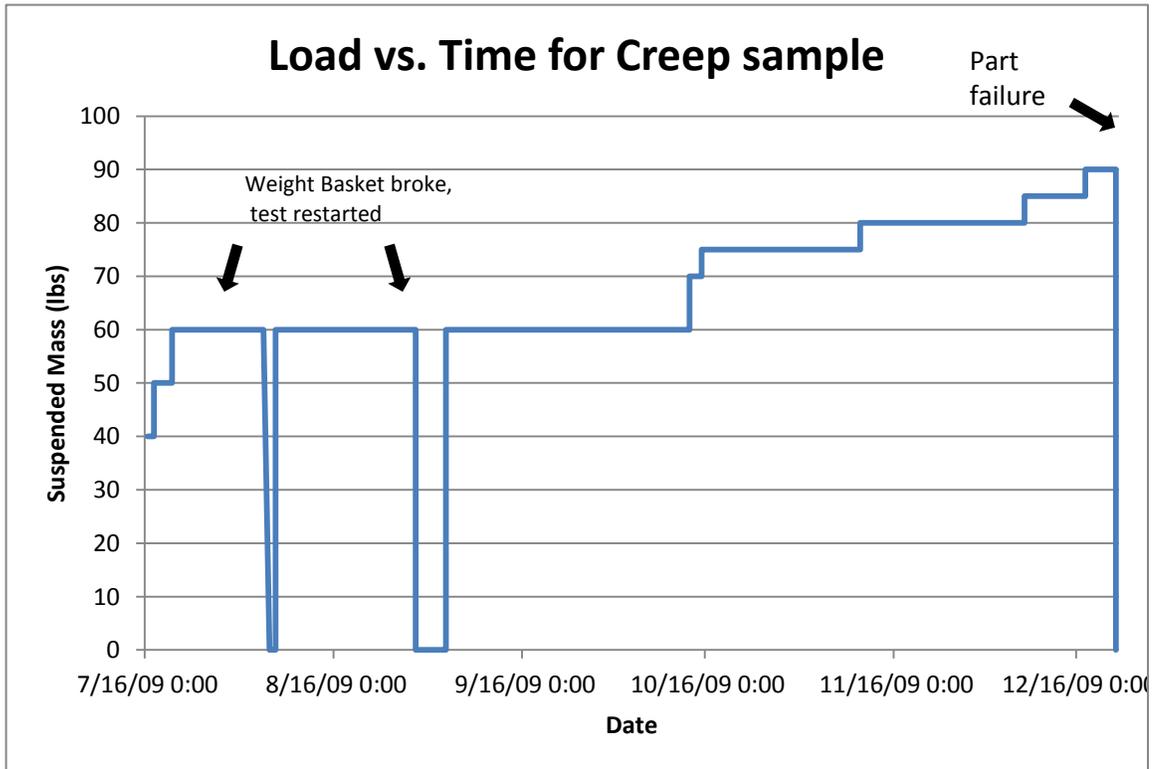
Figure 39: Plot showing the weight suspended from the creep sample in order to generate the failure. Twice the polypropylene basket used to hold the weight failed before the part did. When this occurred, the test was restarted after making repairs and modifications to the suspension system.

To facilitate a comparison of surface morphology between fatigued and creep ruptured samples, a specimen was intentionally exposed to long term, high levels of load. The load was imparted by hanging weights from a coupled APC body/insert set. At several points during the experiment the load was carefully increased in order to generate fracture in an experimentally viable time period.

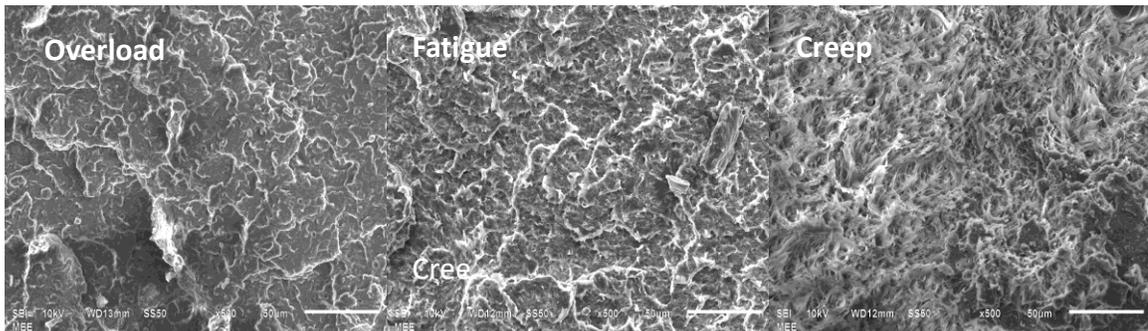
creep samples. Images from this region of each of the three samples are shown in Figure 47. The overload sample has similar surface features compared to the fatigue sample, but the fatigue sample shows more freestanding fibrils of material. The creep sample, similarly, shows even more surface fibrils caused by even more drawdown prior to separation of the fracture surfaces.

Figure 47: Micrographs from the overload, fatigue, and creep samples. All of these images are from the lower quarter of the fracture surface where $.25w > a$.

The presence of a section of the surface with the fibrils shown in Figure 42 and Figure 47 is strong evidence of a creep failure, while the presence of crazes as shown in Figure 41 would provide additional confirmation.

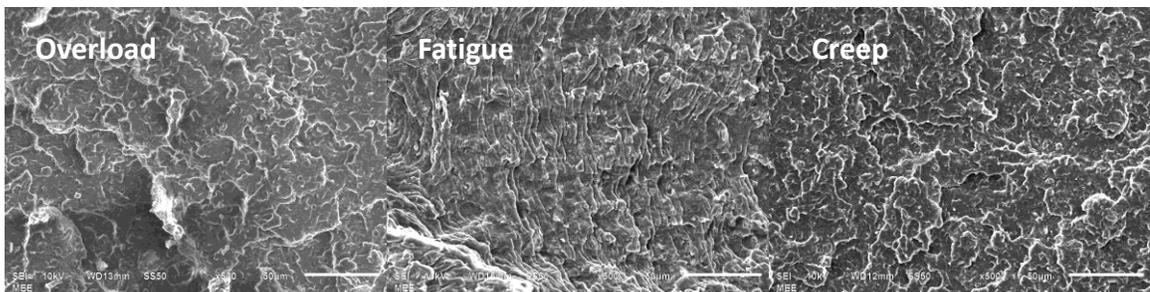
Evaluating the area of the fracture surface near the midpoint shows some changes in the characteristics of the different samples. Images from this region of each of the three samples are shown in Figure 48. At this point in crack advance the overload and fatigue samples diverge in character. The fatigue sample is starting to show alignment of the surface striations as the crack begins to advance from the inner edge of the clip slot rather than the bottom of the sample. Clear orientation is evident at this point in the sample. In contrast, while the overload sample shows definite linear edges, they do not show consistent alignment. The creep sample, in contrast, at this point looks very similar to the overloaded sample at this scale. This is likely due to the fact that at the

load applied to the creep sample, fast fracture initiated as a relatively short crack length and by this point in the sample the creep portion of the failure was already complete. In order to distinguish between the creep and overloading failure modes it would be important to look at the entire fracture surface to note the surface morphology shown in Figure 47 rather than the relatively similar surfaces after the creep phase of crack progression.

Figure 48: Micrographs from the overload, fatigue, and creep samples. All of these images are from the middle of the fracture surface where $.25 w > a > .5 w$

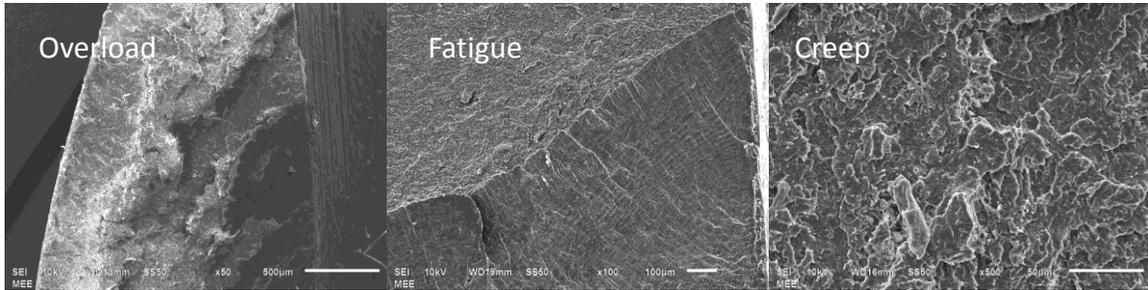
Near the termination point of the crack, again we see a divergence in surface morphology. As the crack length approaches w and the stress intensity rises, the fatigue sample shows a transition in crack progression from fatigue striations to overload failure. The overload sample shows multiple arcs of different z heights radiating from the inner wall of the clip groove, indicating a very dynamic crack growth regime while the creep sample looks relatively the same as it did at smaller a lengths. This indicates that the overloading condition itself (as experienced by all three samples during final crack propagation) can yield different surface morphologies. This may indicate that different mechanisms of local deformation are operating in each case- perhaps

spherulitic fracture in the case of the smoother surfaces and fracture of the amorphous regions surrounding the spherulites in the more rough overload surface. Crack advance around the spherulites may help to explain the greater level of variation in crack surface height in that sample.

Figure 49: Micrographs from the overload, fatigue, and creep samples. All of these images are from the stage of crack growth where $a > .5 w$.
