Scour Monitoring Technology Implementation

Jeff Marr, Principal Investigator
St. Anthony Falls Laboratory
University of Minnesota

September 2014

Research Project
Final Report 2014-37

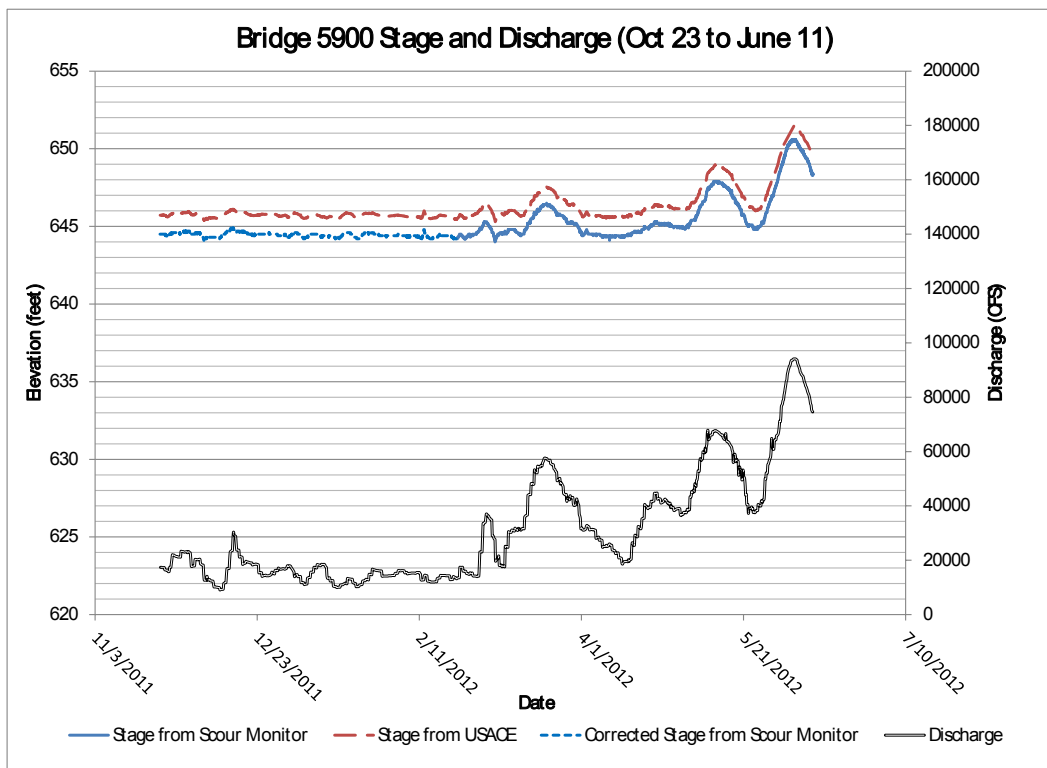
Figure 27: Bridge 5900 Stage and Discharge - Administration 2011-2012

Figure 27, Figure 28, and Figure 29 show the discharge and stage from a local USACE monitoring station and from the scour monitoring equipment. The stage sensor on the Bridge 5900 system is a pressure sensor located a few inches from the front edge of the Pier 19. The USACE gauge is located on the Minnesota side of the river approximately 700 ft downstream of the bridge and uses MSL 1912 as a datum.

- The programmed sensor elevation is 640 and the actual is 640.75 ft based on NGVD 1929.
- Bridge 5900 is likely built with the NGVD 1929 datum and USACE report with the MSL 1912 datum. The 1929 datum is 0.5 ft below the 1912 datum near Winona.

The system was reprogrammed with a stage sensor elevation of 641.25 ft to use the MSL 1912 datum.

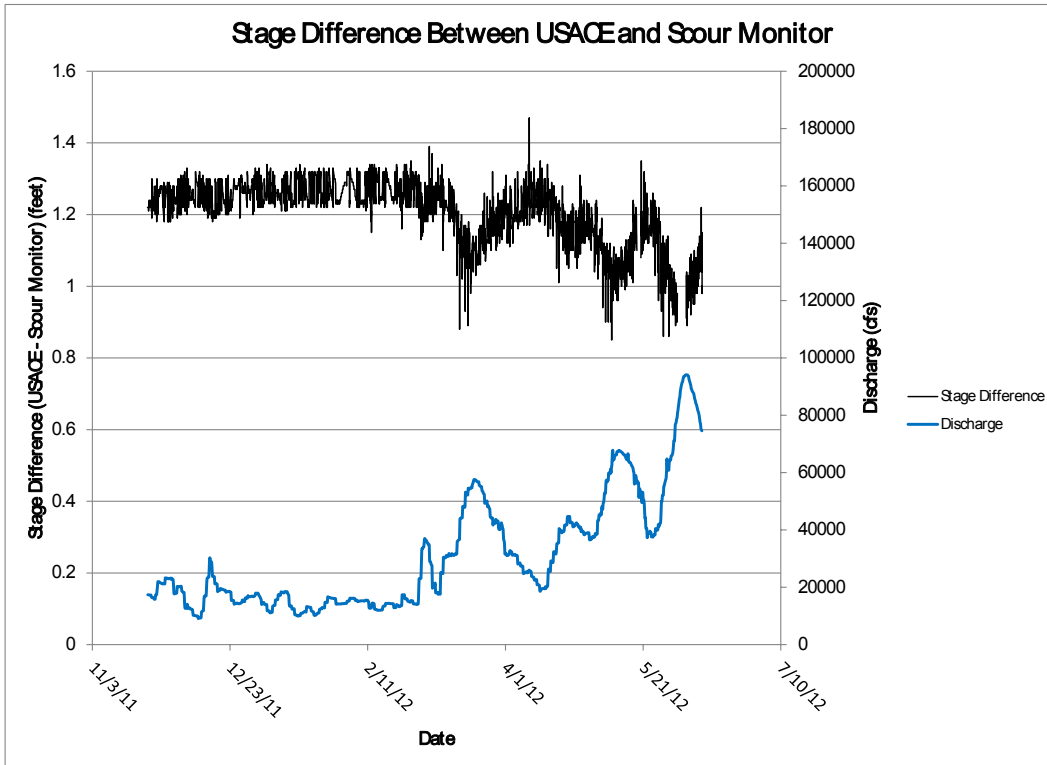
Figure 30: Bridge 5900 Stage Difference between USACE and Scour Monitor - Administration 2011-2012

Figure 30, Figure 31, and Figure 32 show the stage difference between the stages recorded by the scour monitoring equipment and the USACE stage sensor and also shows

the river discharge. At higher discharges, the stage deviates because of slightly higher water surface elevations at the upstream profile of the pier where the stage measurement is taken.

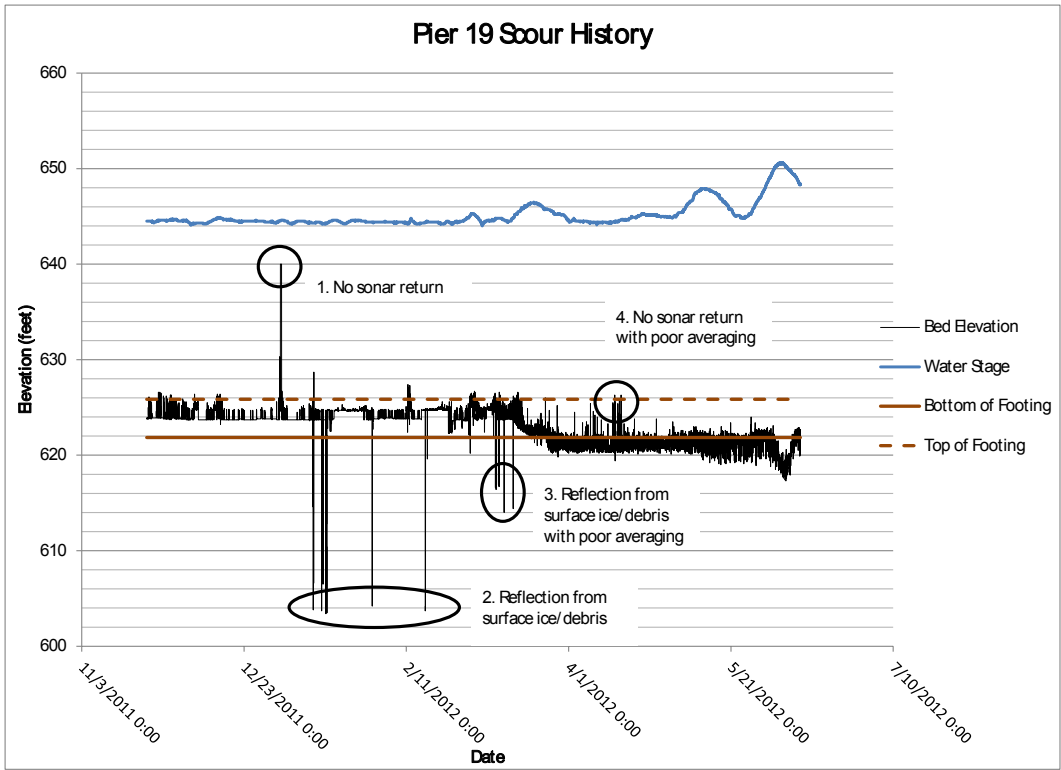
Figure 34: Pier 19 Scour History - Administration 2011-2012

Figure 34 shows the scour around Pier 19 from Oct 23 to June 11. There are a few false spikes in the dataset along with some significant scour events that occurred.

The major false readings during 2011-2012 administration, highlighted as 1 through 4 in Figure 34 are due to one of the following three items.

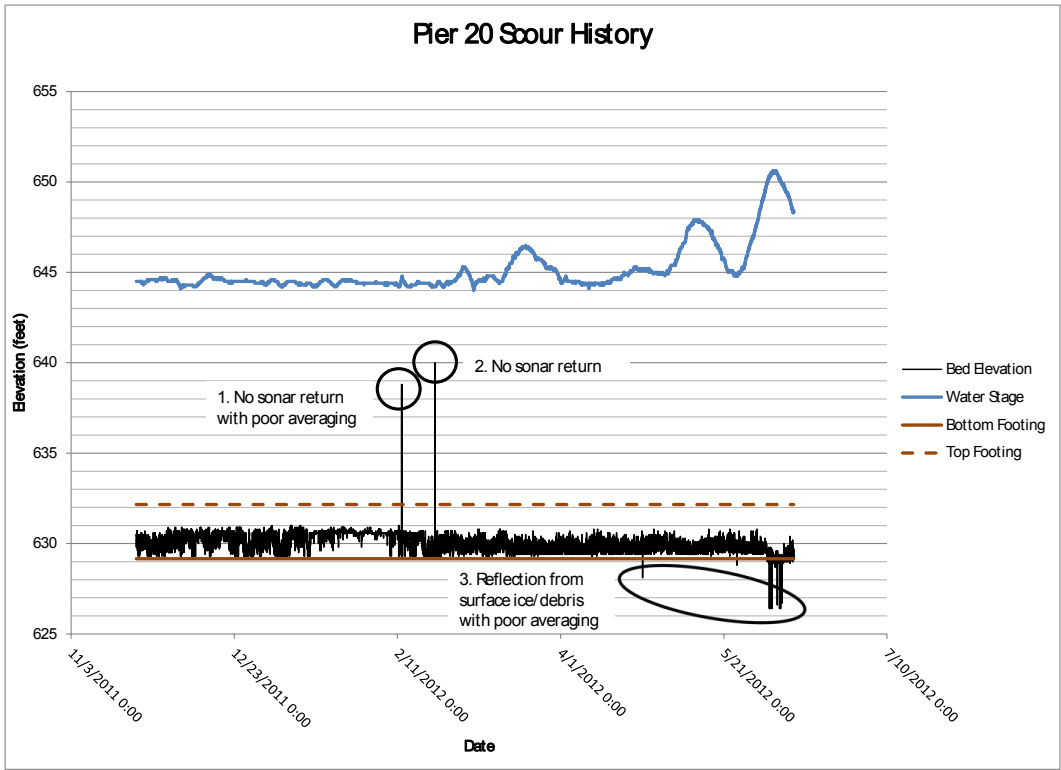
Figure 37: Pier 20 Scour History – Administration 2011-2012

During 2011-2012 administration, the false readings at Pier 20 were likely due to the same causes as with Pier 19. Refer back to Section 6.1.2.1 for a description of these causes.

Overall during 2011-2012 administration, the bed at pier 20 was very constant with few fluctuations during the time frame shown in Figure 37. Over the entire period the bed varied by less than +/- 1 foot. Also, with the exception of the 6/2/2012 event, the data set appears to hit a minimum of 629.6 ft. This is about 0.4 ft above the bottom of the footing and likely has to do with the scour at the front edge of the pier stopping at the bottom of the footing. This same discontinuity in the progression of scour was found at Pier 19. During the 6/2/2012 scour event, the scour did increase until 80,000 cfs. At this point, the scour lowered the bed elevation by about 6 inches, but quickly refilled as the discharge fell back down.

Similar programming modifications as pier 19 are recommended. See Section 6.1.2.3

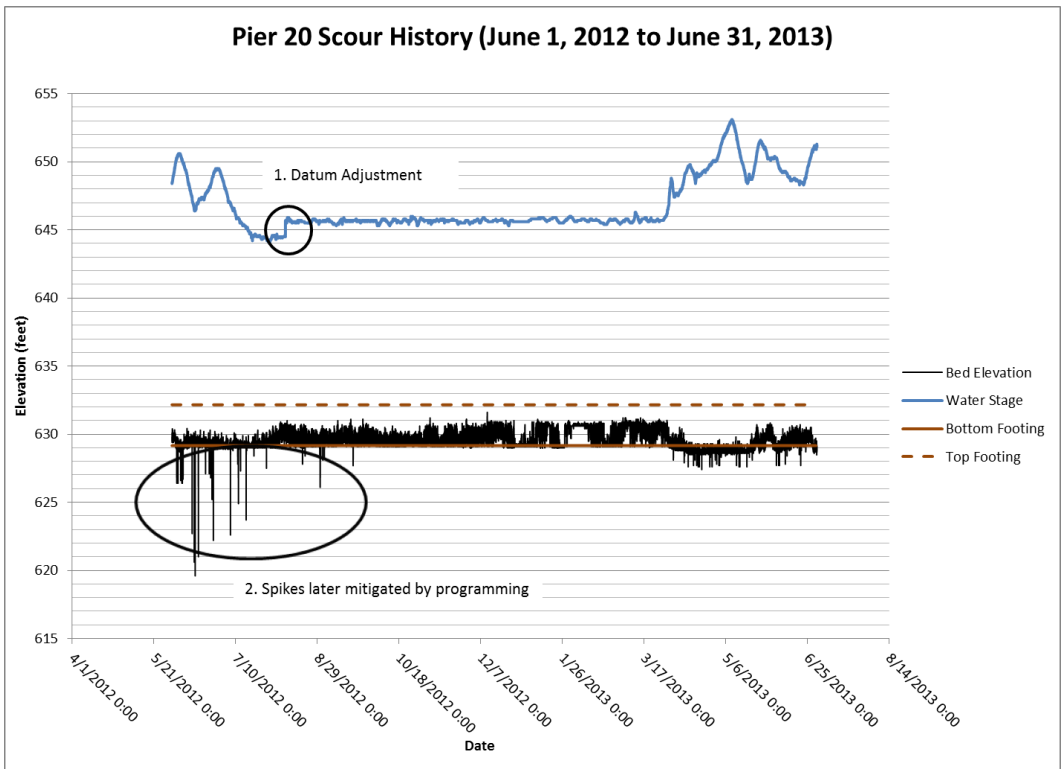
Figure 38: Pier 20 Scour History – Administration 2012-2013

The spike on 2/22/2012, indicated by circle 2 in Figure 38 is likely due to no sonar return affecting all of the 8 readings used to calculate the reported bed elevation.

Overall, the bed was very constant with few fluctuations during the time frame shown in Figure 37. As with the 2011-2012 yearly administration report, the bed during 2012-2013 varied by approximately +/- 1 foot. Over the current year examined, the minimum bed elevation encountered was 628.5 ft. This elevation was maintained for approximately one month during the spring 2013 runoff. The maximum bed elevation was 630.5 ft. This was the same maximum bed elevation from the previous year and likely corresponds to the bed elevation not affected by local scour.

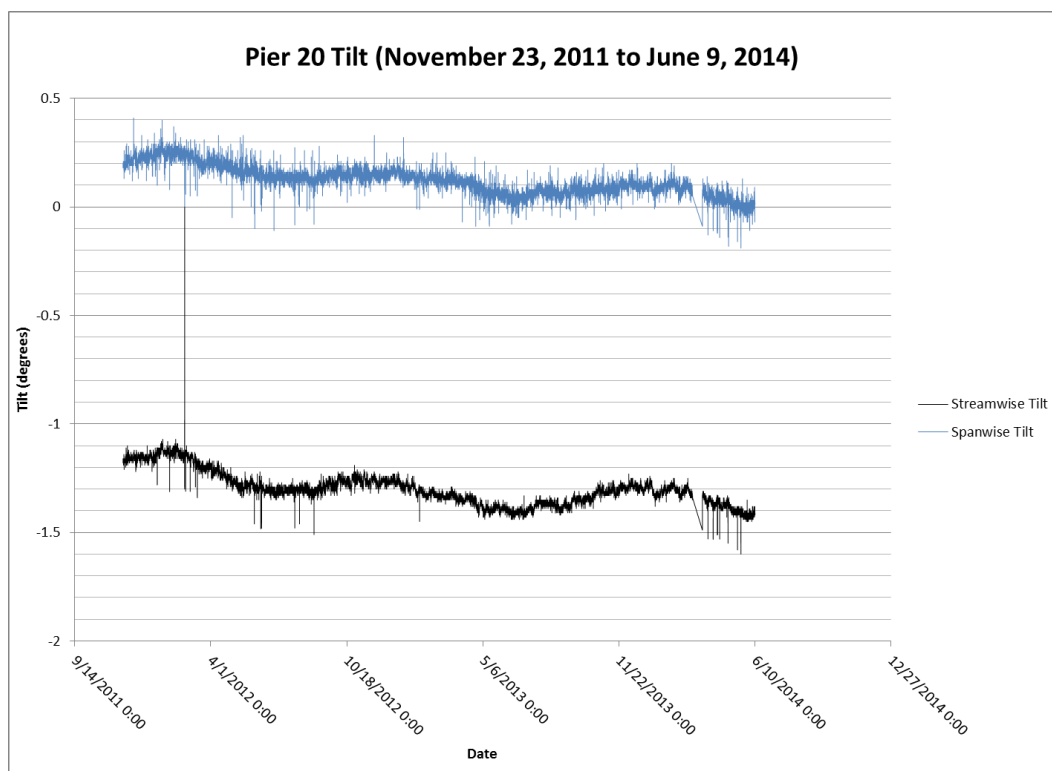
Figure 40: Pier 20 Tilt History for Entire Monitoring Period

Figure 40 shows the tilt history of entire monitored period from 11/23/2011 to 6/9/2014. Frequency analysis shows both signals have dominant frequencies around 24 hours likely correlated to daily heating (day) and cooling (night) of the bridge structure.

- Slightly reduced, but continued sensor drift, about $-0.05^\circ/\text{year}$, for both streamwise and spanwise tilt
- Maximum tilt in winter, minimum tilt in later summer for both stream wise and spanwise tilt.
- Spanwise tilt sensor appears to have more spikes than the stream wise tilt sensor.

There appears to be no significant abrupt changes in tilt. It is not possible to conclude if the tilt reading were related to actual pier movement or sensor drift.

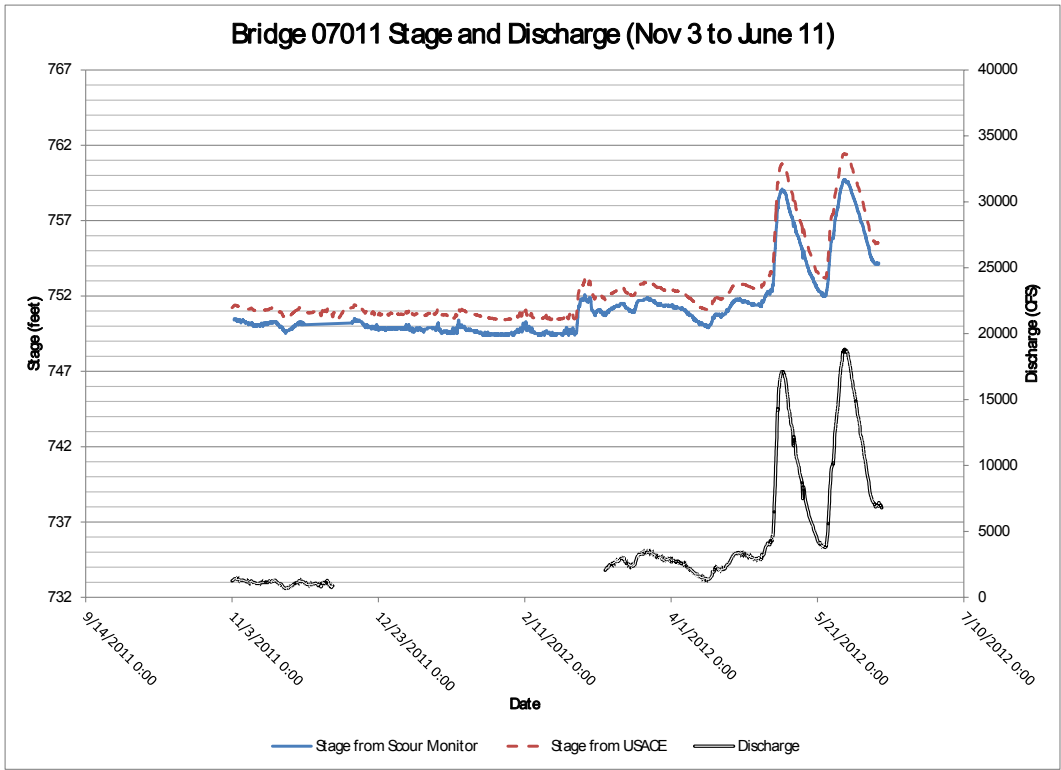
Figure 44: Bridge 07011 Stage and Discharge –Administration 2011-2012

Figure 44, Figure 45, and Figure 46 show the stage and discharge from a local USACE monitoring station and from the scour monitoring equipment for each administration period. The radar stage sensor on the Bridge 07011 system is located on the downstream side of the bridge about 20 ft west of Pier 4. The USACE gauge is located on the east side of the river approximately 1.5 miles upstream of the bridge and uses NGVD 1929 as a datum for elevation. The stage as measured by the scour monitor is consistently 1 ± 0.1 ft below the reported USACE levels when discharges are below 4500 cfs. This agrees well with the reported bed slopes given in flood profiles. Figure 47, Figure 48, and Figure 49 show the difference between local staging station and the stage recorded by the scour monitoring equipment. At larger discharges, the difference increases up to two feet. This is likely due to reduced water surface elevation at the bridge caused by the increase in local velocity head. The time when the scour monitoring station was not operational is shown by the gap in the Figure 44. The USACE stage curve shows that no meaningful data was lost during this time.

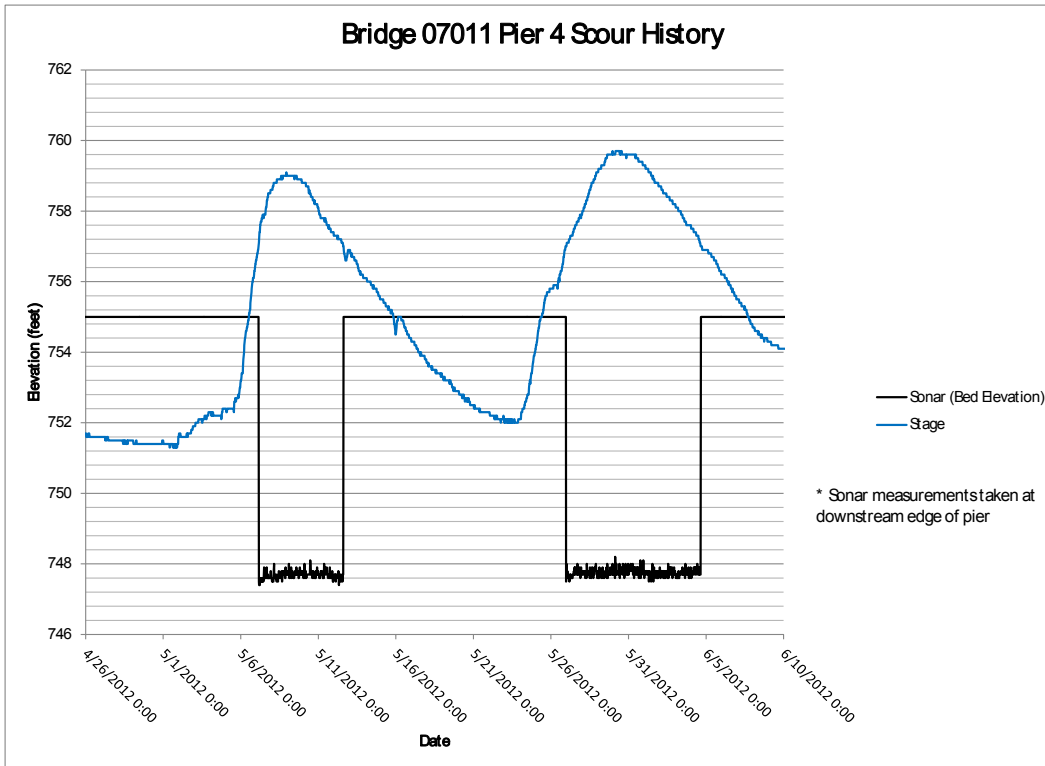
Figure 50: Pier 4 Downstream Bed Elevation – Administration 2011-2012

The sonar is mounted on the downstream side of the bridge at an elevation of 755 ft and the stage needs to reach 757 ft for the sonar to operate. The bed elevation for all events during the monitored period ranged from 747 to 748 ft. This is far above the scour critical elevation of 733 ft.

Figure 50 shows the two events that activated the sonar on Pier 4 during 2011-2012 Administration.

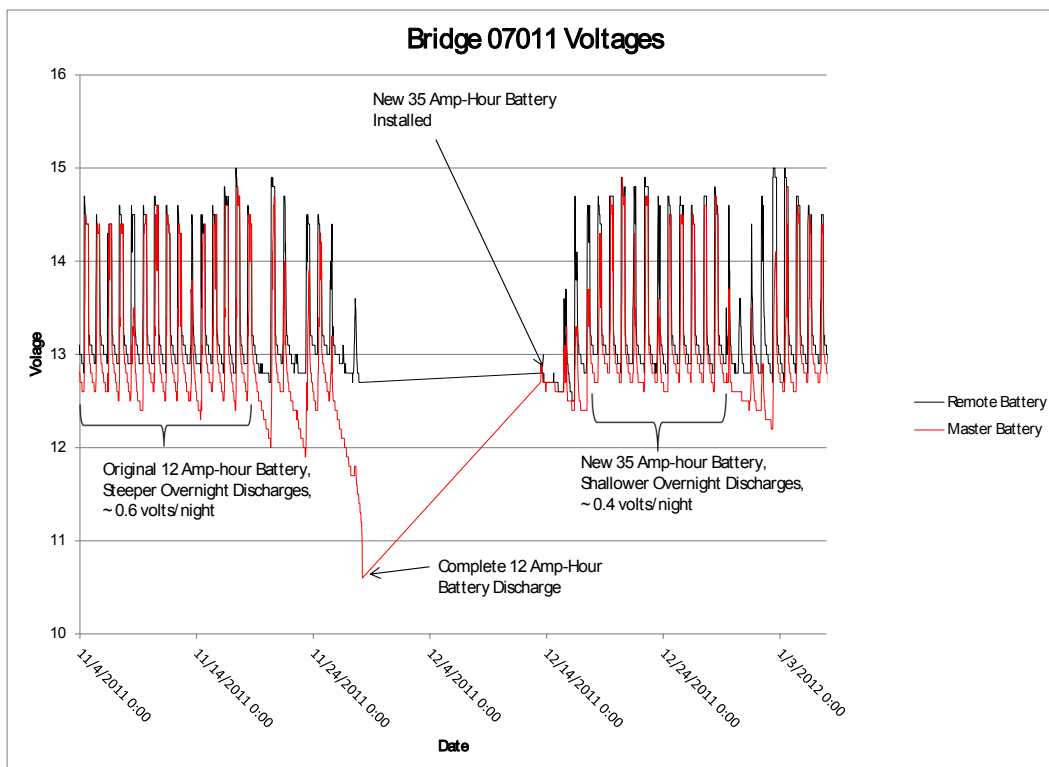
Figure 53: Bridge 07011 Voltages

The initial 12 Amp-hour battery installed on the Master Station of Bridge 07011 was undersized to deal with the continuous operation of the wireless float-out receiver. This receiver needs to operate continuously to ensure the float-out signal is captured before it floats downstream. This issue manifested itself on 11/28/2011 when the master voltage dropped to 10.6 volts and the datalogger quit operating. This occurred after 2.5 days of little solar charging. The 12 Amp-hour battery was replaced with a 35 Amp-hour battery on 12/13/2011 by a District Signal Technician and the system worked well for more than a year. Similar consecutive non-charging days are found in the voltage data and the lowest master battery voltage since the replacement was 12 volts.

Figure 53 shows the comparison of overnight discharge before and after the master battery voltage was replaced. The remote battery voltage is also shown for reference.
