# Development and Integration of Advanced Timber Bridge Inspection Techniques for NBIS

**January 2015**

Research Project  
Final Report 2015-01

**BRIDGE # 69529  
CSAH 52 over DITCH**

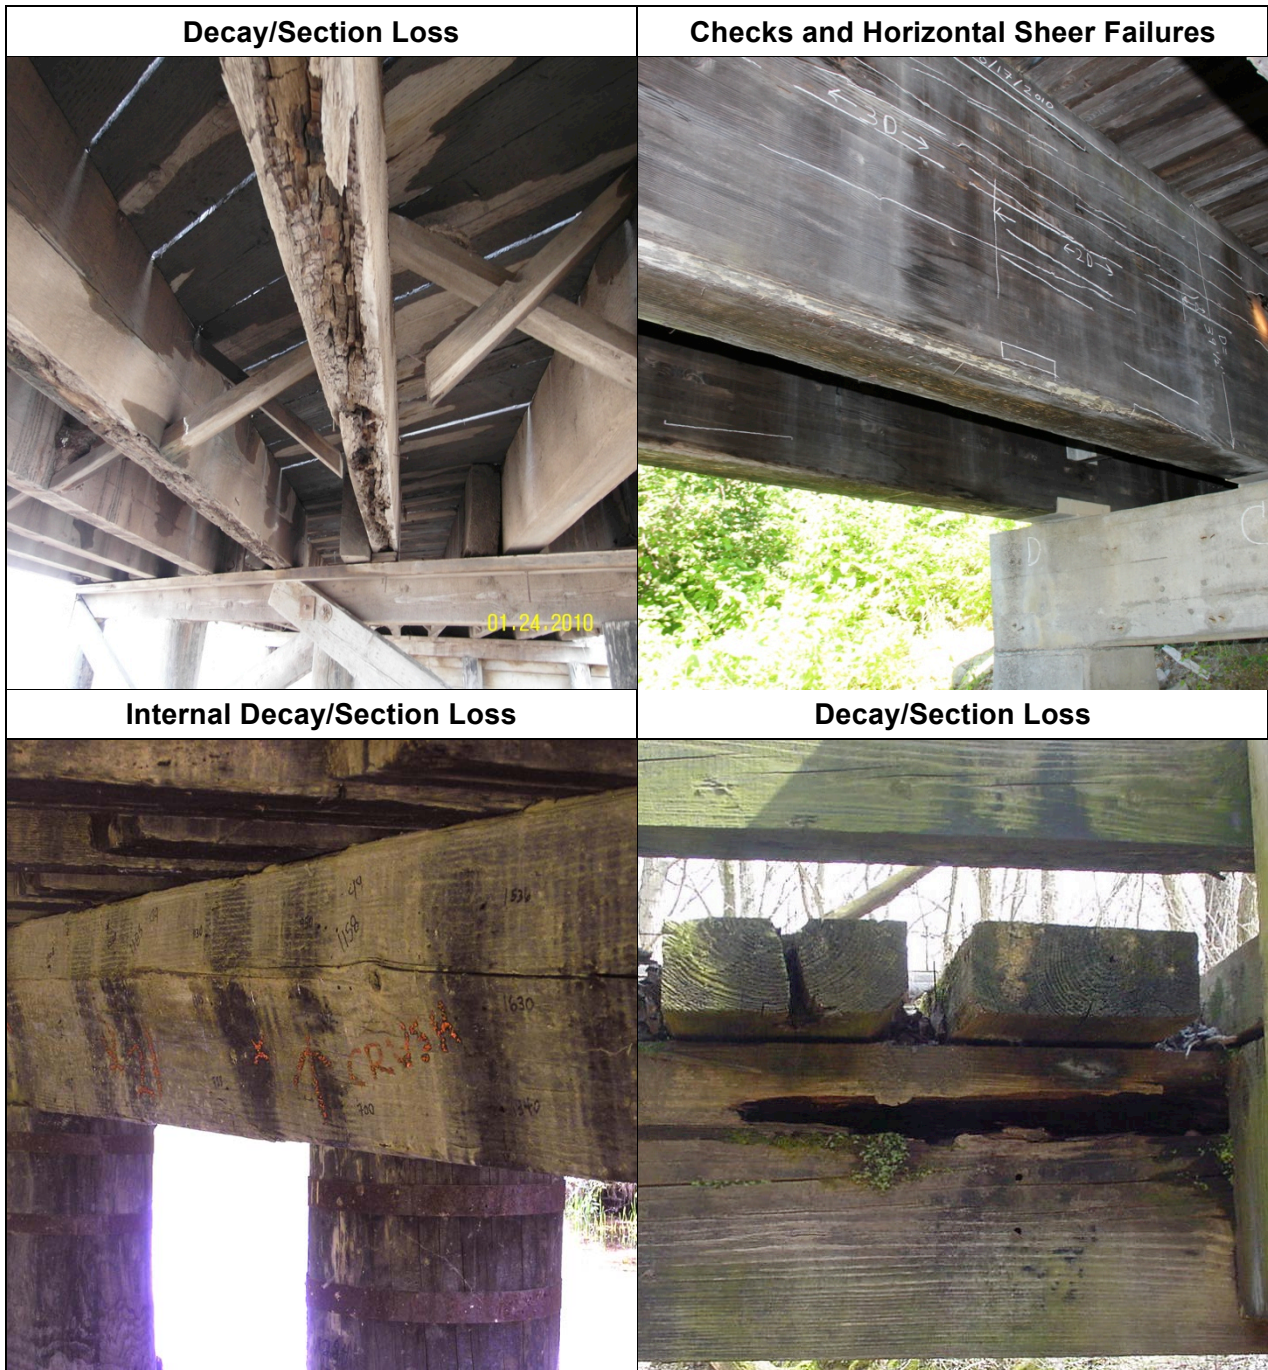
Figure 7.5. Examples of deterioration of timber superstructure elements.

The use of inspection equipment can provide additional information to the definitions provided by AASHTO and MnDOT. Special attention should be focused on the steel connections, and looking for evidence of decay in timber adjacent to the connections. A pick hammer can be used to assess surface quality and possible decay. Feeler gages and awls may be used to assess the extent of cracks, checks, splits and delamination. A moisture meter can establish high levels of moisture. It is important to assess the presence of decay using hammer picks, stress wave timers and resistance microdrills to determine the actual cross-section and location of both sound and deteriorated material. Chapter 5 provided detailed information about the use of stress wave timers for identifying areas of decay. **Table 5.1** should be consulted when assessing the collected data. Chapter 6 provides detailed information about interpreting resistance drill data from a variety of different resistance drill models. **Table 6.1** should be consulted when assessing the collected data. **Figure 7.5** shows examples of damage to timber superstructure elements.

Elements rated CS 3 have the potential to reduce the load rating of the bridge and should be recommended for structural evaluation, particularly if the element is a primary load-carrying member.

Elements rated CS 4 will likely reduce the load capacity or serviceability of the bridge and structural evaluation should be required. Elements that are rated CS 4 and are primary load-carrying members often will lead to a load posting on the bridge unless repaired or replaced.

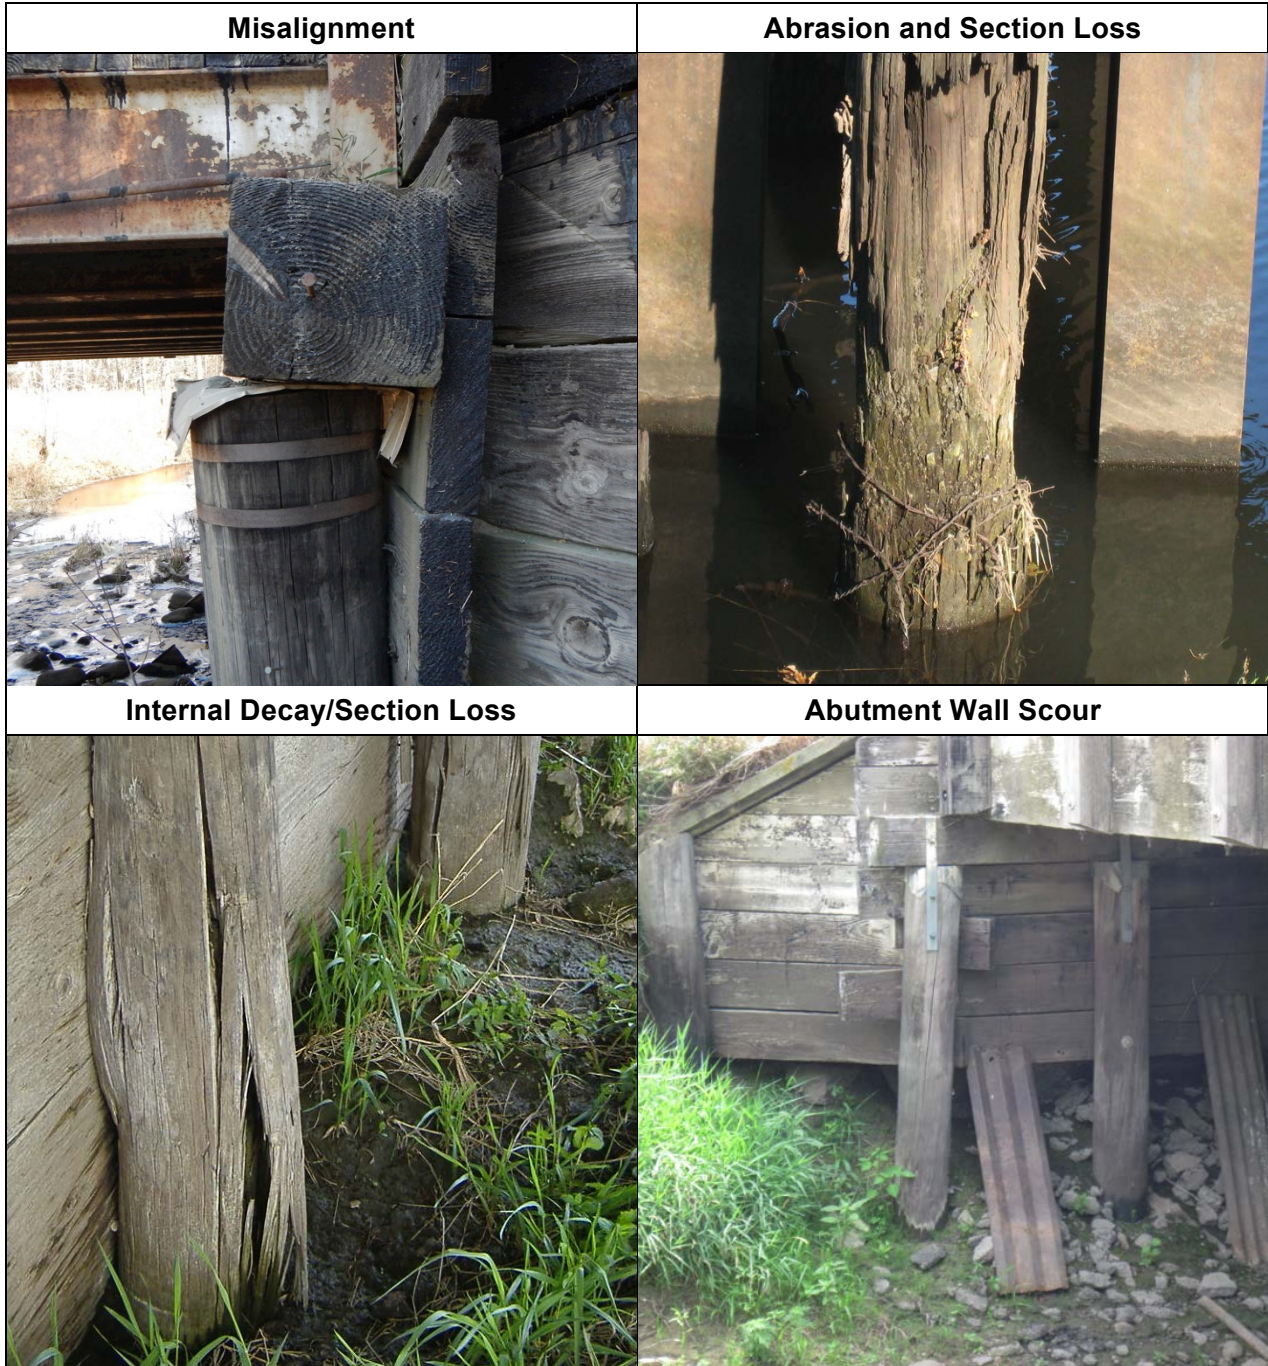
Figure 7.6. Examples of deterioration of timber substructure elements.

The use of inspection equipment can provide additional information to the definitions provided by AASHTO and MnDOT. Special attention should be focused on the steel connections, and looking for evidence of decay in timber adjacent to the connections. A pick hammer can be used to assess surface quality and possible decay. Feeler gages and awls may be used to assess the extent of cracks, checks, splits and delamination. A moisture meter can establish high levels of moisture. It is important to assess the presence of decay using hammer picks, stress wave timers and resistance microdrills to determine the actual cross-section and location of both sound and deteriorated material. Chapter 5 provided detailed information about the use of stress wave timers for identifying areas of decay. **Table 5.1** should be consulted when assessing the collected data. Chapter 6 provides detailed information about interpreting resistance drill data from a variety of different resistance drill models. **Table 6.1** should be consulted when assessing the collected data. **Figure 7.6 and 7.7** shows examples of damage to timber substructure elements.

Decay or deterioration in timber substructures can potentially control the load rating of the bridge, so elements rated CS 3 are strongly recommended for a revised load rating analysis. Because of the variability of timber substructures, such as cap dimensions, pile diameter and pile spacing, decay or deterioration can have a large impact on the capacity of the bridge depending on whether it occurs in an exterior or interior pile, the pile cap, or any combination therein.

Elements rated CS 3 have the potential to reduce the load rating of the bridge and should be recommended for structural evaluation.

Elements rated CS 4 will likely reduce the load capacity or serviceability of the bridge and structural evaluation should be required. Elements that are rated CS 4 and are primary load-carrying members often will lead to a load posting on the bridge unless repaired or replaced.

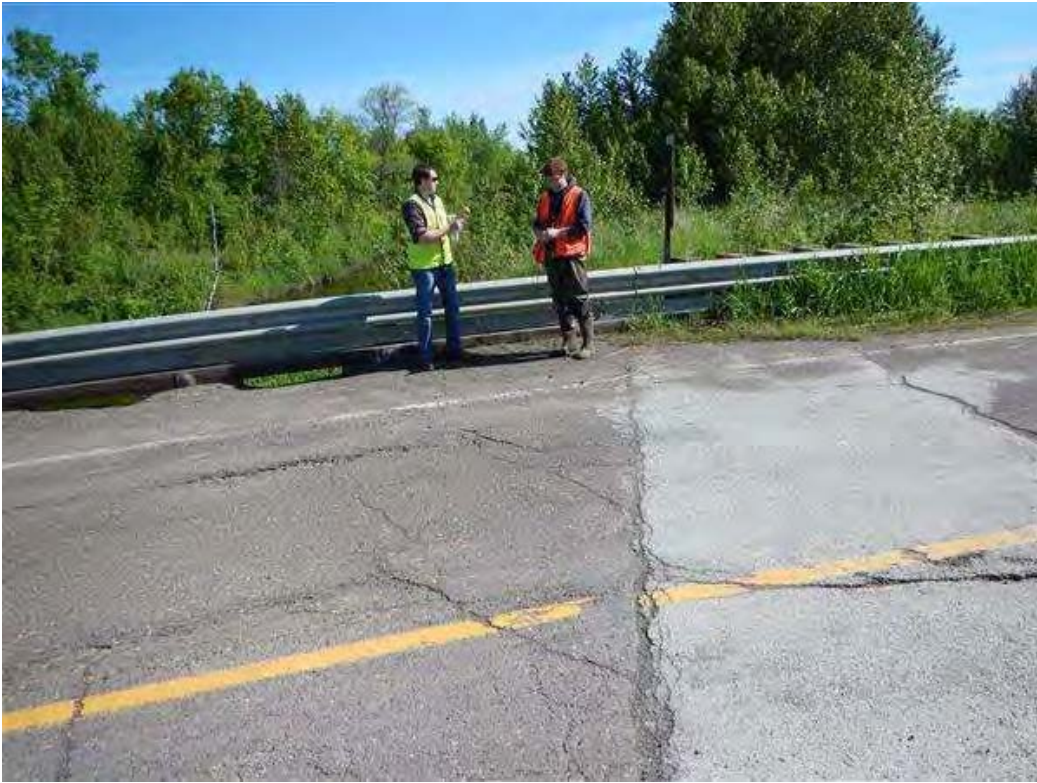
Notes: [2013] Significant deterioration evidenced as cracking and potholing in bituminous wear layer in transverse direction at both bridge abutments and at the piers. There are also longitudinal cracking present, most likely at joints for deck panels. Water infiltration is occurring at these locations, as evidenced by visual staining of the underside and water dripping through the deck. Hammer sounding and pick inspection did not identify any decay present. One area that sounded affected was drilled with Resistance drill. No decay noted using drill in these locations. Water infiltration through deck is also causing high moisture and cracking in pier 1 and pier 2 caps. This moisture is then leading to severe corrosion of CIP plates.

Photo 3 - Bituminous east end before abutment

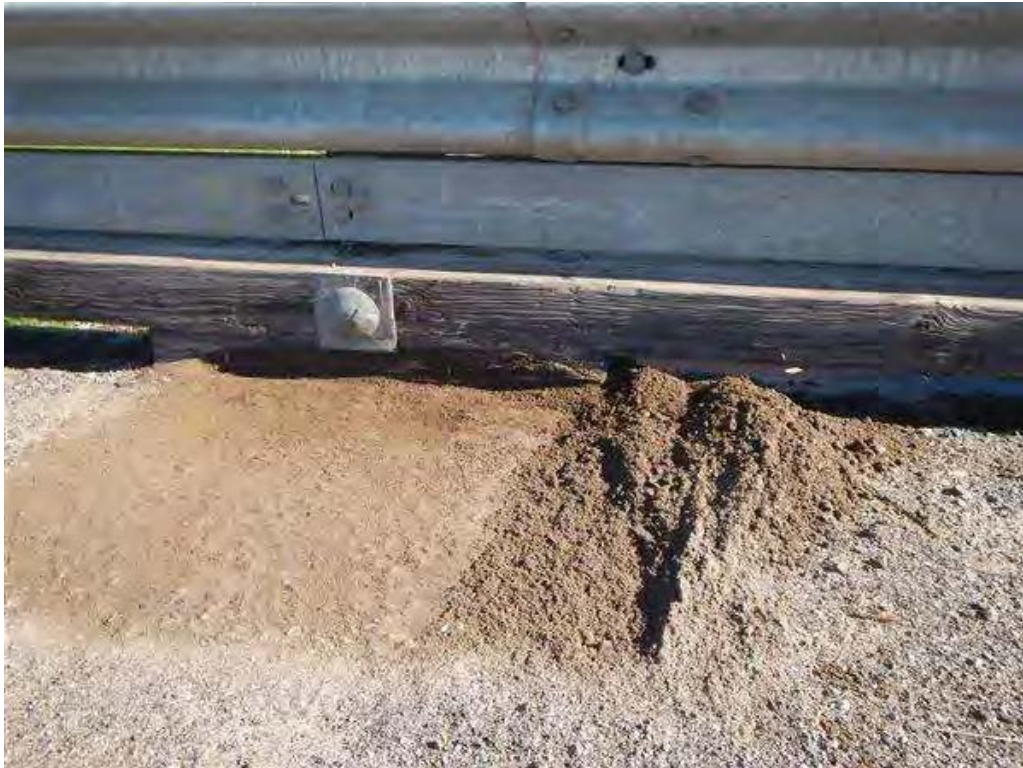
Photo 4 - N. deck-scupper 3" sand on deck

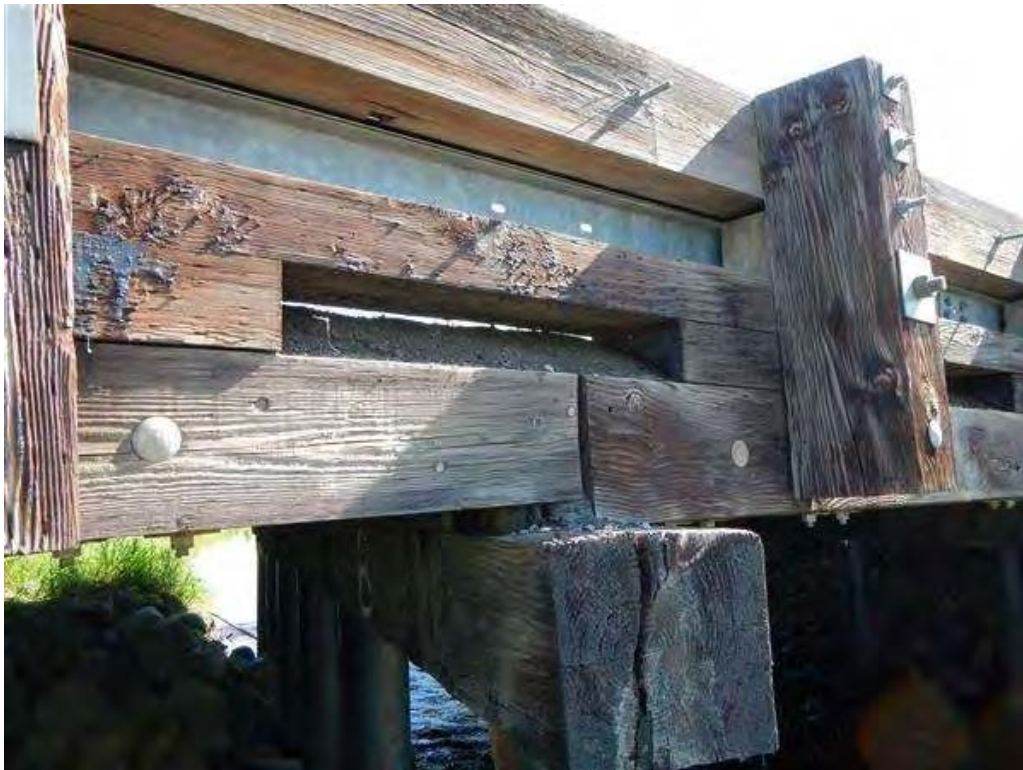
Photo 10 - Pier 2 North end - Through split extending 14" into cap.

Notes: All pilings CIP. Through splits are present on both the upstream and downstream pier cap. Moisture measures are above 25% MC. Moisture is entering splits from ends and through deteriorated bituminous wear layer. Resistance drill data confirms split, but does not indicate decay.

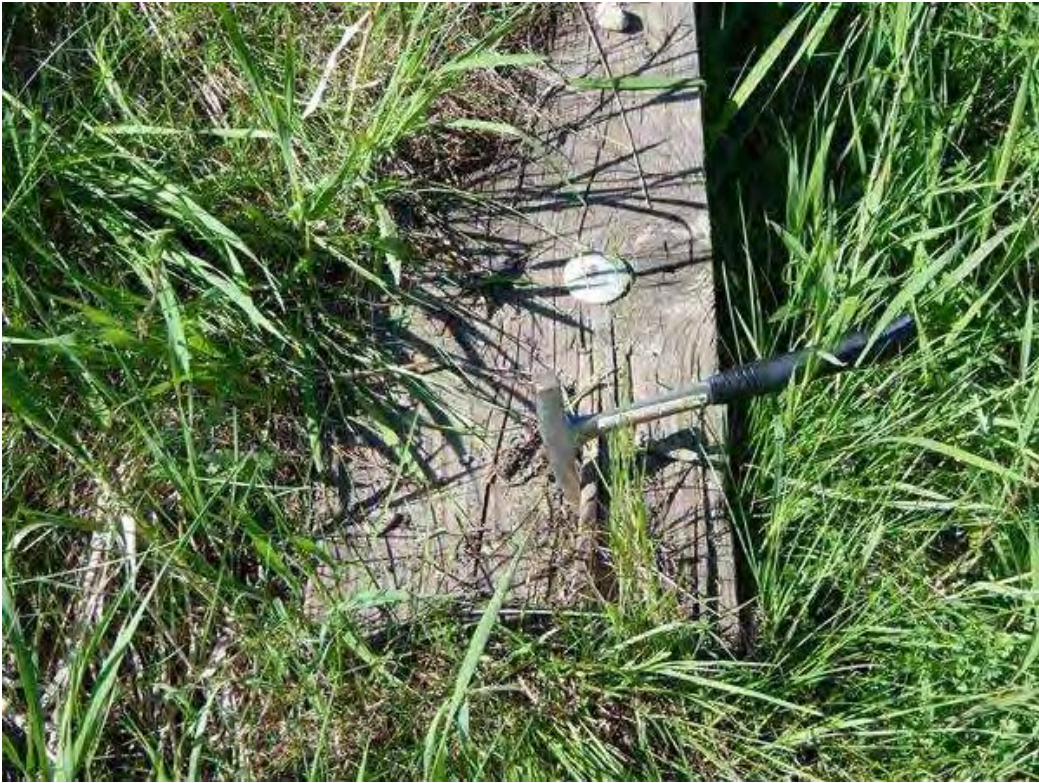
Photo 15 - Wing wall - NE

NE WING CAP DAMAGED.  
SE WING CAP BURIED.  
SW WING PILE ROTTED.  
2012-Covered with brush.

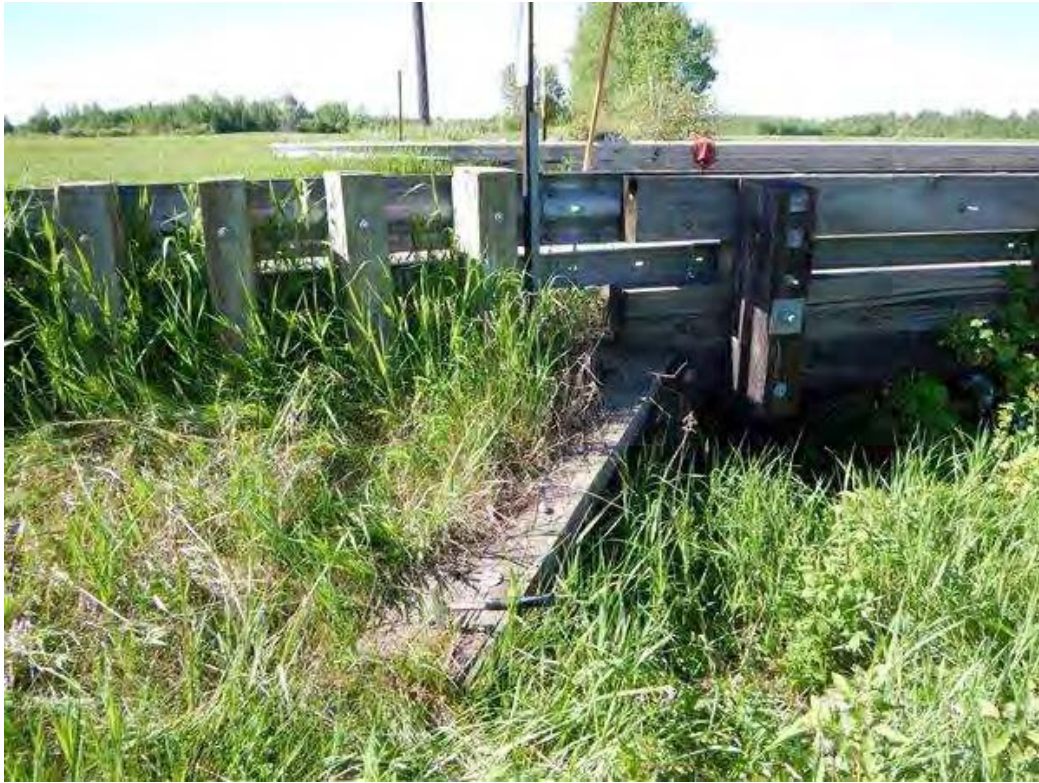
Photo 17 - Wing wall with significant vegetation
