A Comprehensive Evaluation of High Friction Overlay Systems  
on Bridge Decks in Cold Climate Regions

A Thesis

SUBMITTED TO THE FACULTY OF  
UNIVERSITY OF MINNESOTA

Robert D. Kostick

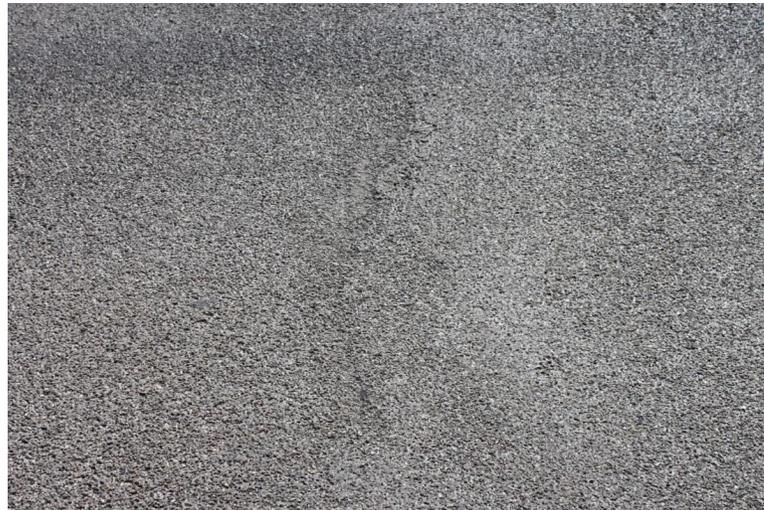
Figure 23: Construction Joint (Bridge 9066)

Uneven distribution of aggregates was apparent in several of the systems visited. This is caused by the manual process of adding aggregate to the epoxy matrix. It is difficult to evenly spread aggregate with shovels. Applying too much aggregate in an area leads to insufficient epoxy coating on the aggregates, and without proper bonding, these aggregates are more prone to popping out of the matrix. An insufficient amount of aggregates in the matrix creates areas prone to polishing. The construction joint in Figure 23 is the line running down the center of the figure that looks similar to a crack. This joint was caused by either a pause in construction or the application of too much aggregate in one spot. Construction joints are mostly a cosmetic distress unless an insufficient amount of aggregates are placed which can affect the skid properties.

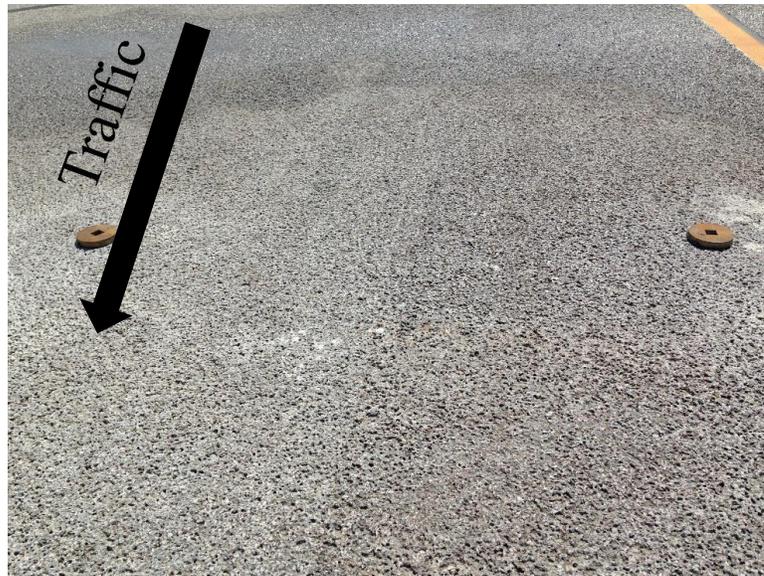
Figure 24: Differences on Both Sides of the Construction Joint (Bridge 14809)

This uneven application can lead to higher amounts of distresses during the life span of an HFO system. Bridge 14809 provided a good example of how the quality of construction during installation can play a role in the performance of epoxy overlay systems. Such a difference is depicted below in Figure 24. The view of the picture is

looking against the direction of traffic. A construction joint exists in the middle of the picture. The system on the left side of the picture is a bit lighter in color. On the right side there appears to be a higher rate of raveling. This is shown best when looking at the bottom right side of the picture.

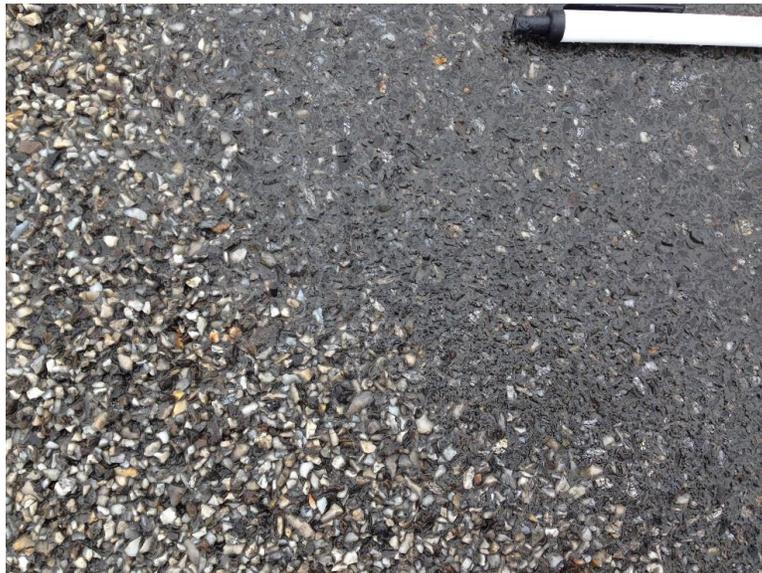
Figure 26: Proper Epoxy Levels (Left Side) Next to Area with Excessive Epoxy (Right Side)

This abrasion along the epoxy plane is exemplified in Figure 26 where the right half of the picture includes an area where the epoxy level is near the top of the aggregate layer. Any aggregate exposed in this heavy epoxy area is now flush with the top of the epoxy due to abrasion.

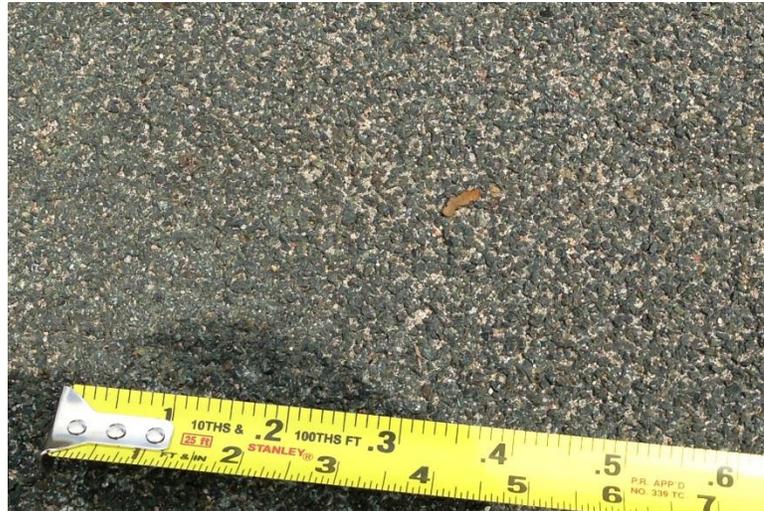
Figure 28: Existing Macrotexture on Bridge 27758

The macrotexture of Bridge 27758 still exists along parts of the bridge, but heavy abrasion has taken its toll on the overlay system. As shown below (Figure 28), areas of the bridge have minimal aggregate pop-out but finer material has been removed between

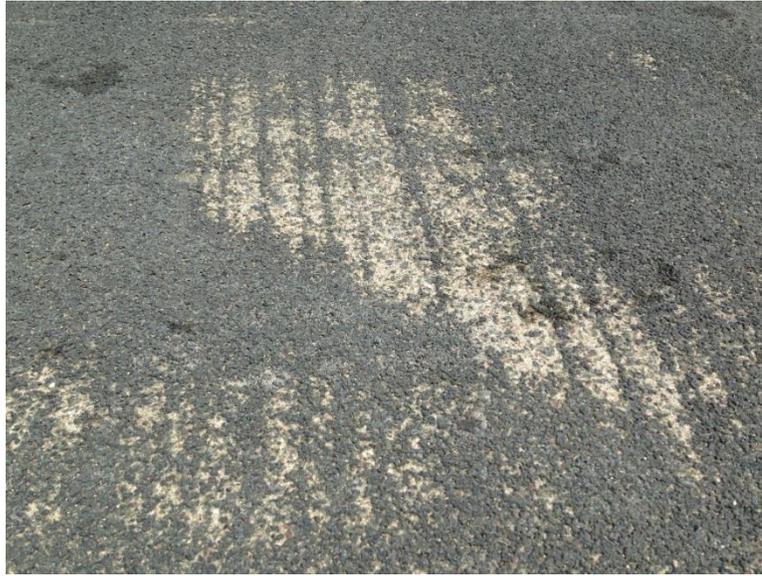
Figure 31: Thin Epoxy System (Br 27758)

The thin cross section of this system is shown in Figure 31. In this picture there is not a distinguishable elevation difference between the bridge deck and the epoxy overlay.

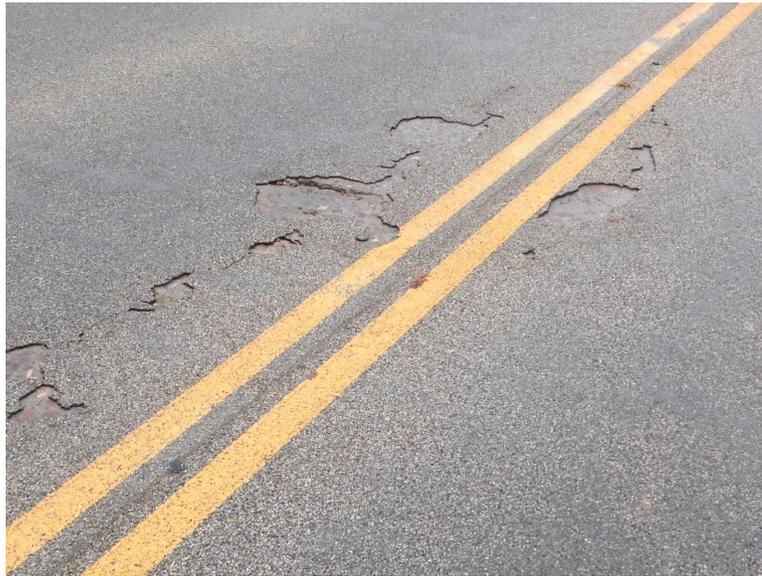
Several bridges in this study have sections where the epoxy overlay has delaminated from the bridge deck. On Bridge 6347 the delamination of the epoxy overlay system has occurred along the centerline of the roadway. The majority of the delamination has occurred along the construction joint which runs down the middle of the bridge. Some of the worst delamination is shown below in Figure 46. The construction joint can be seen in between the no passing lines.

Figure 46: Delamination of Transpo System on Bridge 6347 along Centerline

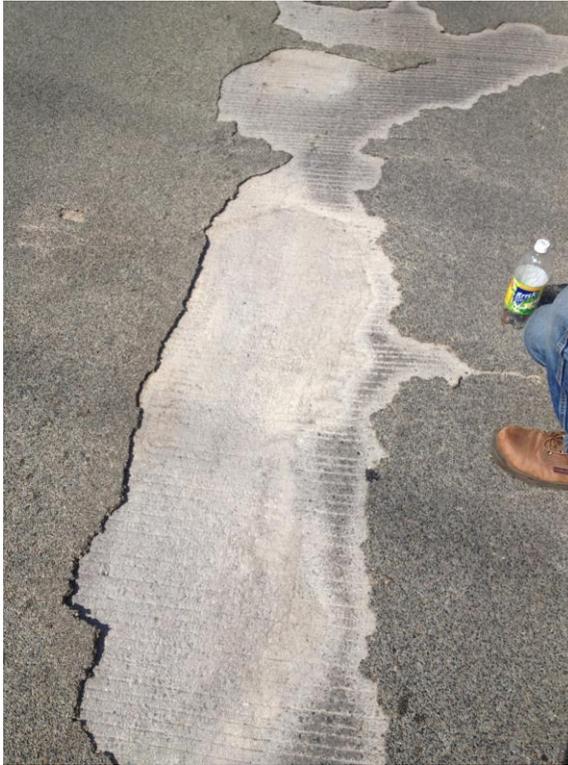
Delamination also occurred in several Poly-Carb systems (Bridge 4190 and 9036). Depictions of such delamination are shown in Figure 47 through Figure 49.

Figure 47: Delamination of HFO on Robert Street Bridge (Br 9036)

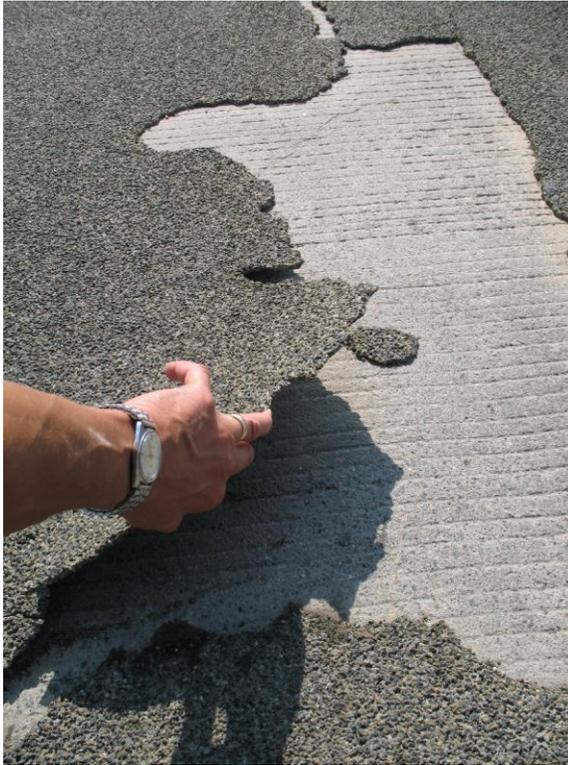
Figure 48: Minimal Bond Strength Existed in the Distressed Areas (Br 9036)

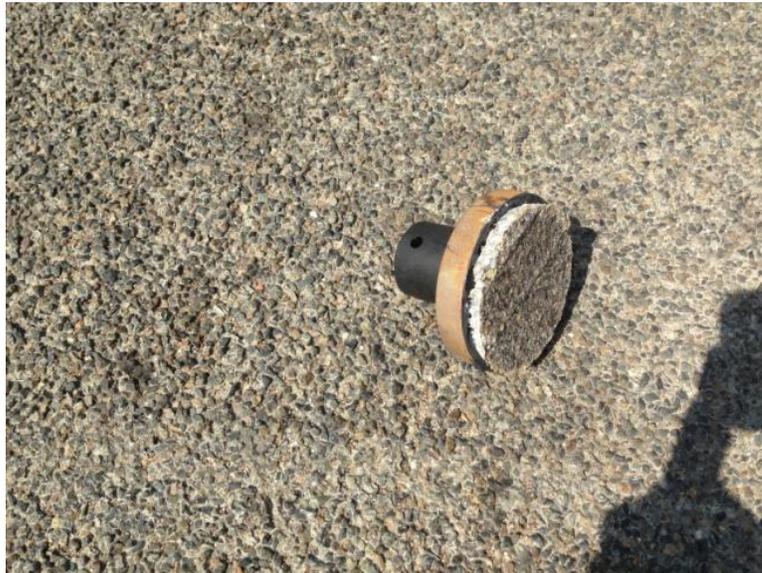
Figure 56: Plate with Debonded Overlay (Br 9036)

In this test a steel plate is bonded to the overlay system using a fast setting epoxy. Once this epoxy is set (approximately two hours) the plate is removed using a torque wrench. This wrench has a readout that provides the torque required to remove the plate. This test measures how well a system is bonding with the concrete bridge deck. Removal of the epoxy system when torque is applied advocates for a poor bond between the system and bridge deck. Figure 55 shows the torque wrench attached to a plate just before testing. Figure 56 and Figure 57 show plates with debonded overlay material at Bridges 9036 and 14810 respectively.

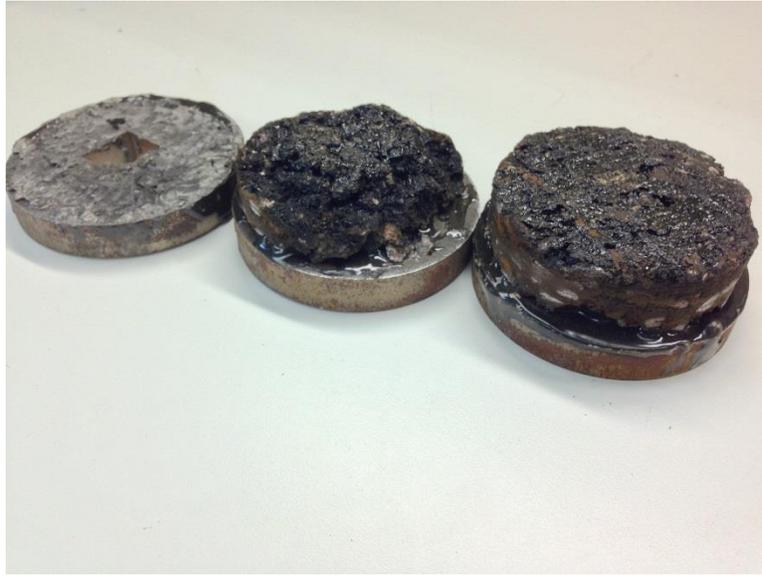
Figure 68: Various Degree of Removal Including "No Removal" (Left), "Partial Removal" (Middle), and "Total Removal" (Right)

A more robust analysis of the bond strength was completed during the second year of the study. The torque bond test was conducted on eight bridges during the year two study. Bond strength results varied greatly compared to results from the first year of study, but the variation is most likely from the small change in the testing procedure. In the second year, the required torque for removal of the steel plates was much lower and the removal of the HFO system was more common. In the first year, excluding Bridge 9036 because it is considered an additional bridge, one of the eighteen tests conducted on three different bridges removed the HFO system from the bridge deck. In Year-2, 30 of the 53 tests conducted on eight bridges removed the HFO system from the bridge deck. A varying degree of removal occurred. This various degree of removal is illustrated below in Figure 68 and is quantified by “no removal” (left), “partial removal” (middle), and “total removal” (right).

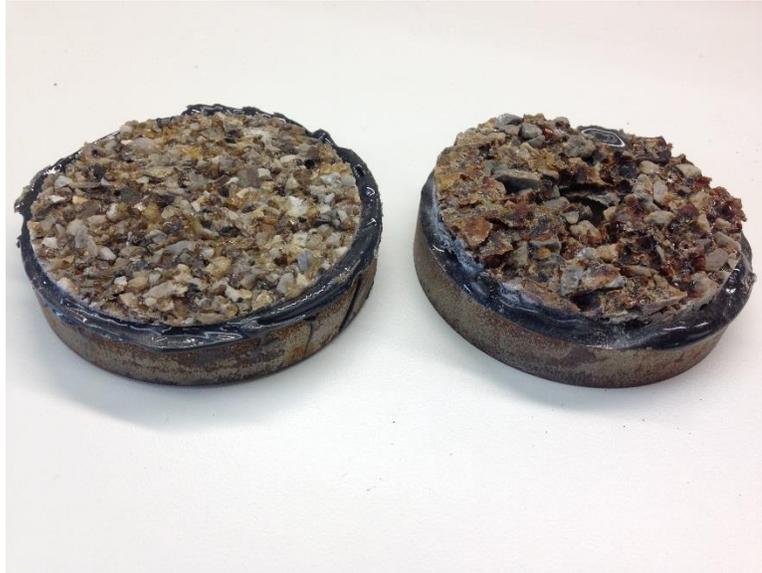
Figure 70: Comparison of Poly-Carb with Flint (Left) and SafeLane Torque Removal Samples

Values from the non-wheel and wheel path are similar for each individual bridge with a variance of 50 N·m [37 ft·lb]. When comparing the difference between passing lane and driving lane values that variance increases to 75 N·m [55 ft·lb]. Bridges 9066 and 9067 (I-94 in Moorhead, Poly-Carb) have a Poly-Carb system with Flint aggregate. These bridges had an average variance of 100 N·m [74 ft·lb] between non-wheel and wheel path. The flint aggregate particles are the smallest used in the HFO systems in this study and tend to be more flat compared to aggregates in other systems. During installation of systems with flint, it is possible to have many of the flat particles placed with similar orientation. This orientation and small particle size reduces the amount of aggregate interlock and can cause a weak plane in the system. This is illustrated below in Figure 70. The figure shows two samples that were removed using the torque bond test. On the left

is the partial removal of a Poly-Carb system with Flint aggregates (Br 9067) while the sample on the right is a partial removal of a SafeLane system (Br 14810). The partial removal of flint happened in a horizontal plane where the SafeLane partial removal depth varies across the sample.

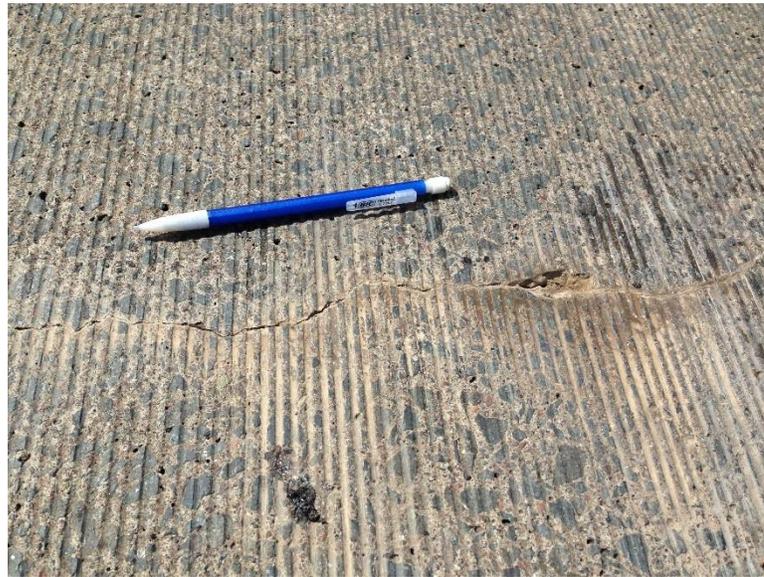
Figure 73: Area of Bridge 9824 Tested for Permeability

crack in the bridge deck (Figure 73) with a resulting K value of  $1.53 \times 10^{-6}$  cm/s. Some Department of Transportation agencies have permeability criteria for asphalt pavements with an acceptable range between 0 and  $125 \times 10^{-5}$  cm/s (Williams, 2009). Table 20 displays the ranges discussed to provide a visual of the differences between the values.
